Curtis Middle School

Town of Sudbury ADA Transition Plan

January 2021

Institute for Human Centered Design

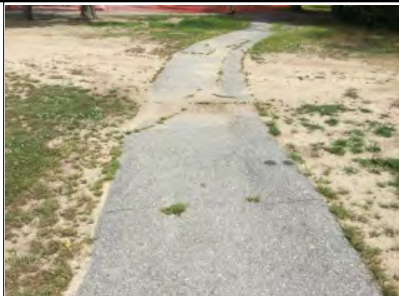
Surface is not stable, firm, and slip-resistant Route not maintained in operable working condition	- -	Repair surface. Ensure the accessible route is maintained in operable working condition. (Cost estimate for 30' long 4' wide of asphalt.)	1	1200	\$1200

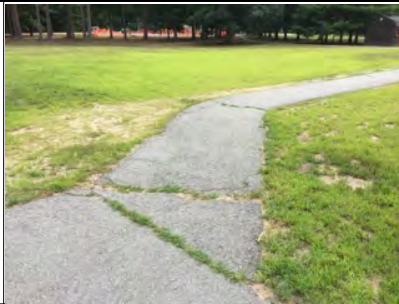
ID	Location	Floor	Room	Element	Type	Photo	Issues	Current Measure	Recommendations	Quantity	Price	Cost Estimation
6	Path to Basketball Court From Back Entrance	Ext.		Exterior Access Route	Walkway

Surface is not stable, firm, and slip-resistant Route not maintained in operable working condition	- -	Repair surface. Ensure the accessible route is maintained in operable working condition. (Cost estimate for 10' long by 4' wide area of asphalt.)	1	400	\$400
7	Path to Basketball Court From Back Entrance	Ext.		Exterior Access Route	Walkway

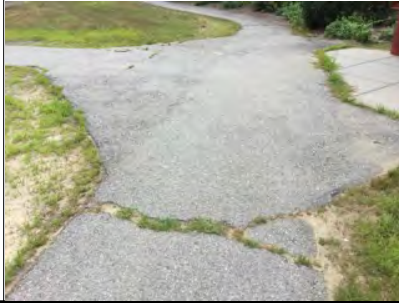
Surface is not stable, firm, and slip-resistant Route not maintained in operable working condition	- -	Repair surface. Ensure the accessible route is maintained in operable working condition. (Cost estimate for 10' long by 4' wide area of asphalt.)	1	400	\$400
8	Corridor Exit 12 by Office 19	1	19	Exterior Access Route	Walkway

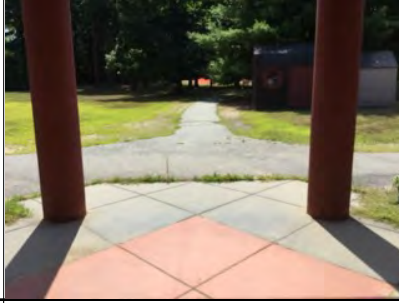
Route not maintained in operable working condition	-	Ensure the accessible route is maintained in operable working condition. (Cost estimate for 4' x 4' asphalt area.)	1	160	\$160

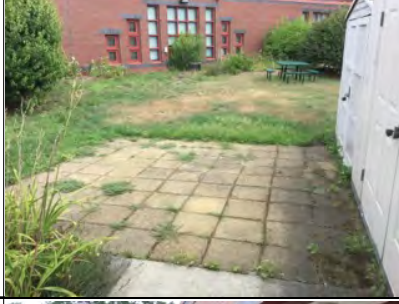
9	Courtyard Patio	Ext.		Exterior Access Route	Exterior

Route not maintained in operable working condition	-	Ensure the accessible route is maintained in operable working condition.	1	Labor	\$0
10	Egress Door 13 Route	Ext.		Exterior Access Route	Exterior

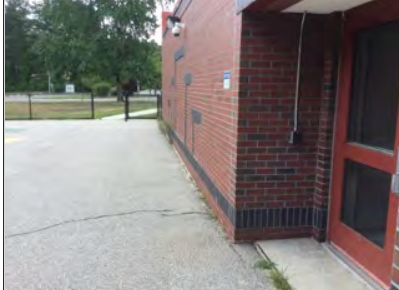
Route not maintained in operable working condition	-	Ensure the accessible route is maintained in operable working condition.	1	160	\$160

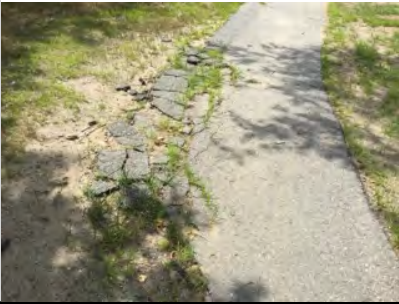
ID	Location	Floor	Room	Element	Type	Photo	Issues	Current Measure	Recommendations	Quantity	Price	Cost Estimation
11	Path to Soccer Field and New Playground	Ext.		Exterior Access Route	Walkway

Route not maintained in operable working condition Surface is not stable, firm, and slip-resistant	- -	Repair surface. Ensure the accessible route is maintained in operable working condition. (Cost estimate for 10' long 4' wide of asphalt.)	1	400	\$400
12	Path to Basketball Court From Back Entrance	Ext.		Exterior Access Route	Walkway

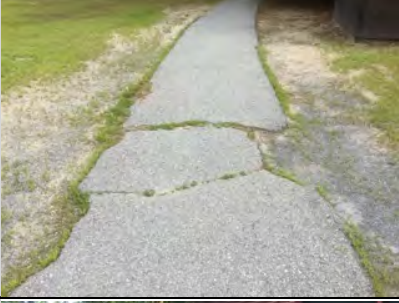
Route not maintained in operable working condition Surface is not stable, firm, and slip-resistant	- -	Repair surface. Ensure the accessible route is maintained in operable working condition. (Cost estimate for 6' long by 4' wide area of asphalt.)	1	240	\$240
13	Courtyard Garden Beds and Bench	Ext.		Exterior Access Route	Exterior

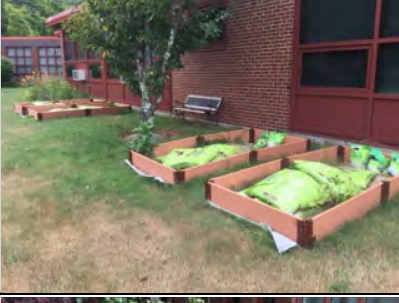
Accessible route not provided	-	Ensure an accessible route is provided to the garden beds and one bench in the courtyard. (Cost estimate for a 83' long by 4' wide stone dust walkway.)	1	2656	\$2656

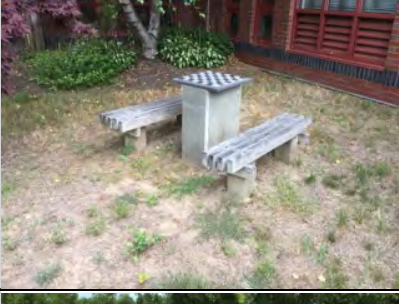
14	Courtyard Chess Table	Ext.		Exterior Access Route	Exterior

Accessible route not provided	-	Provide an accessible route to the chess board. (Cost estimate for a 10' long by 4' wide stone dust walkway.)	1	320	\$320
15	Bike Rack on Left Side of Entrance	Ext.		Exterior Access Route	Walkway

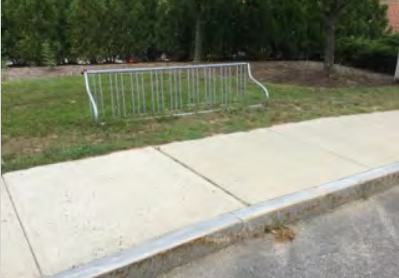
Accessible route not provided	-	Ensure an accessible route is provided. (Cost based on a 6' long by 4' wide stone dust route.)	1	192	\$192

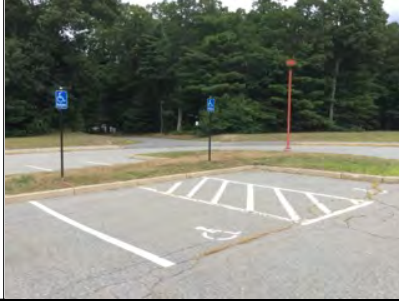
ID	Location	Floor	Room	Element	Type	Photo	Issues	Current Measure	Recommendations	Quantity	Price	Cost Estimation
Off-Street Parking Lot or Garage												
16	Back Parking Lot	Ext.		Off-Street Parking Lot or Garage	Visitor

Total # of parking Total # of designated accessible parking spaces Total # of designated van accessible spaces Sign does not have the designation "Van Accessible"	37 2 0 -	Add the designation "Van Accessible" to one parking space.	1	500	\$500
17	Front Parking Lot	Ext.		Off-Street Parking Lot or Garage	Visitor

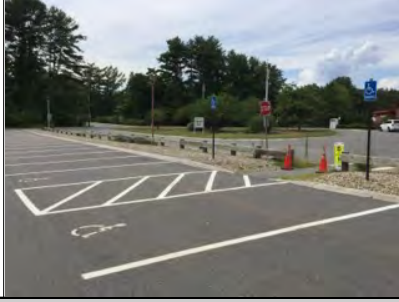
Total # of parking Total # of designated accessible parking spaces Total # of designated van accessible spaces Sign does not have the designation "Van Accessible"	60 3 0 -	Add the designation "Van Accessible" to one of the accessible parking spaces.	1	500	\$500
Emergency Exit												
18	Egress Door 6	1		Emergency Exit	N/A

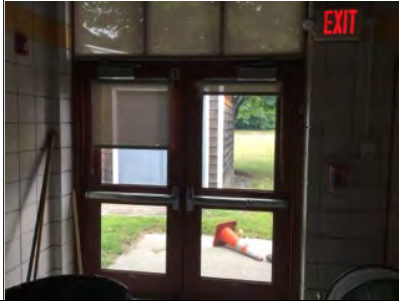
Tactile sign not provided at exit Directional sign to accessible emergency exit not provided	- -	Provide tactile exit signs with raised characters and braille at exit doors. Mount signs between 48"- 60" above the finished floor located on the latch side of the door. Provide a directional sign indicating the location of the nearest accessible emergency exit.	1	464	\$464

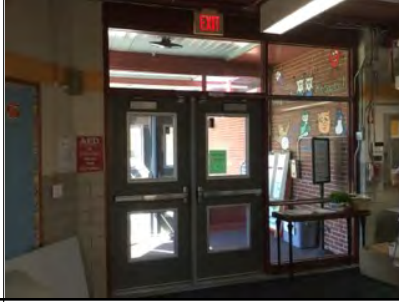
19	Main Entrance Door 1 (Egress)	1		Emergency Exit	N/A

Tactile sign not provided at exit Illuminated Int. Symbol of Acc. not provided (MAAB)	- -	Provide tactile exit signs with raised characters and braille at exit doors. Mount signs between 48"- 60" above the finished floor located on the latch side of the door. Provide an illuminated sign with the International Symbol of Accessibility.	1	432	\$432
20	Egress Door 7	1		Emergency Exit	N/A

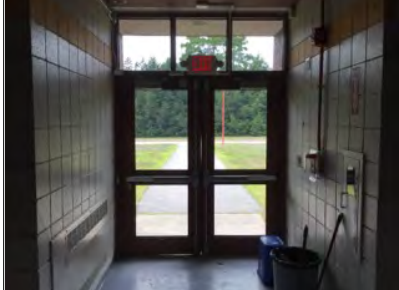
Tactile sign not provided at exit Illuminated Int. Symbol of Acc. not provided (MAAB)	- -	Provide tactile exit signs with raised characters and braille at exit doors. Mount signs between 48"- 60" above the finished floor located on the latch side of the door. Provide an illuminated sign with the International Symbol of Accessibility.	1	432	\$432

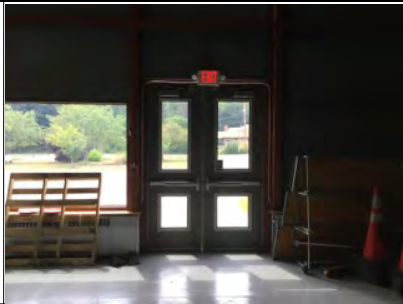
ID	Location	Floor	Room	Element	Type	Photo	Issues	Current Measure	Recommendations	Quantity	Price	Cost Estimation
21	Egress Door 2	1		Emergency Exit	N/A

Tactile sign not provided at exit Illuminated Int. Symbol of Acc. not provided (MAAB)	- -	Provide tactile exit signs with raised characters and braille at exit doors. Mount signs between 48"- 60" above the finished floor located on the latch side of the door. Provide an illuminated sign with the International Symbol of Accessibility.	1	432	\$432
22	Egress Door 13	1		Emergency Exit	N/A

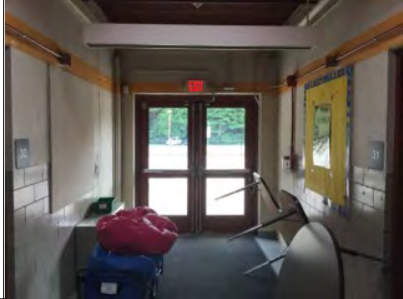
Tactile sign not provided at exit Illuminated Int. Symbol of Acc. not provided (MAAB)	- -	Provide tactile exit signs with raised characters and braille at exit doors. Mount signs between 48"- 60" above the finished floor located on the latch side of the door. Provide an illuminated sign with the International Symbol of Accessibility.	1	432	\$432
23	Egress Door 8	1		Emergency Exit	N/A

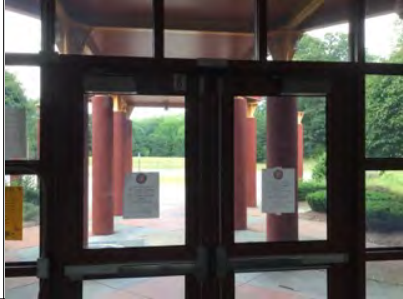
Tactile sign not provided at exit Illuminated Int. Symbol of Acc. not provided (MAAB)	- -	Provide tactile exit signs with raised characters and braille at exit doors. Mount signs between 48"- 60" above the finished floor located on the latch side of the door. Provide an illuminated sign with the International Symbol of Accessibility.	1	432	\$432

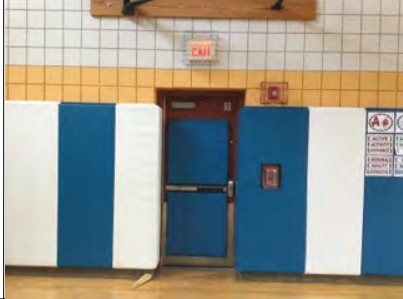
24	Gym Egress Door 9	1	16	Emergency Exit	N/A

Tactile sign not provided at exit Illuminated Int. Symbol of Acc. not provided (MAAB)	- -	Provide tactile exit signs with raised characters and braille at exit doors. Mount signs between 48"- 60" above the finished floor located on the latch side of the door. Provide an illuminated sign with the International Symbol of Accessibility.	1	432	\$432
25	Gym Egress Door 10	1	16	Emergency Exit	N/A

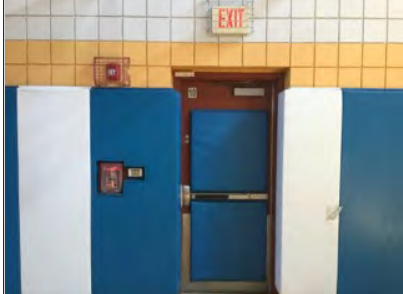
Tactile sign not provided at exit Illuminated Int. Symbol of Acc. not provided (MAAB)	- -	Provide tactile exit signs with raised characters and braille at exit doors. Mount signs between 48"- 60" above the finished floor located on the latch side of the door. Provide an illuminated sign with the International Symbol of Accessibility.	1	432	\$432

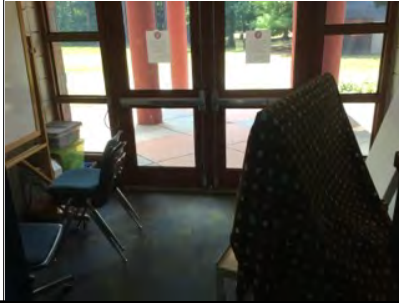
Door requires > 15 lbs. of force to open	20 lbs	Adjust closers of exterior doors so doors do not require more than 15 pounds of force.	1	Labor	\$0
28	Egress Door 8	Ext.		Emergency Exit	N/A

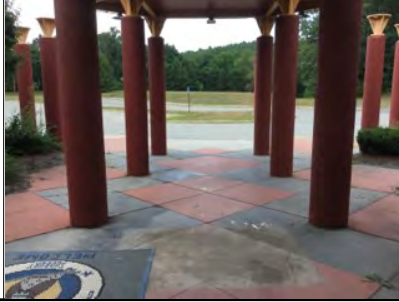
Door requires > 15 lbs. of force to open	18lbs	Adjust closers of exterior doors so doors do not require more than 15 pounds of force.	1	Labor	\$0

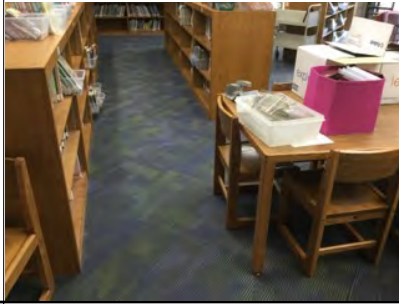
Access to Goods and Services												
Interior Access Route												
29	Library Media Center	1	1	Interior Access Route	N/A

Route < 36" wide	34.5"	Ensure that a clear width of 36" min. is maintained at the accessible route.	1	Labor	\$0
30	Tray Drop by Kitchen Area	1		Interior Access Route	N/A

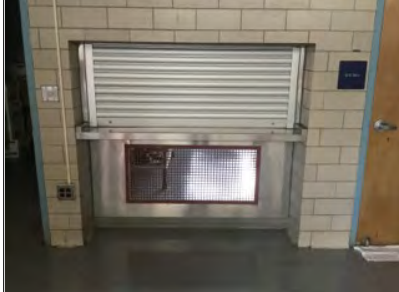
Obstructed by protruding objects	12"	Provide a cane-detectable barrier at each side of the tray drop.	2	306	\$612

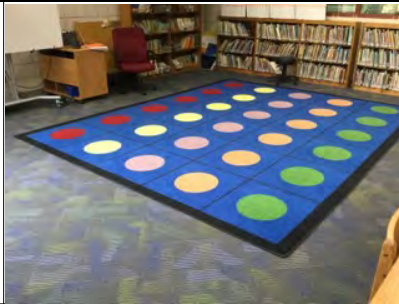
ID	Location	Floor	Room	Element	Type	Photo	Issues	Current Measure	Recommendations	Quantity	Price	Cost Estimation
31	Library Media Center	1	1	Interior Access Route	N/A

Surface not stable, firm, and slip-resistant	-	Secure the mat.	1	Labor	\$0
32	Spanish Class	1	14	Interior Access Route	N/A

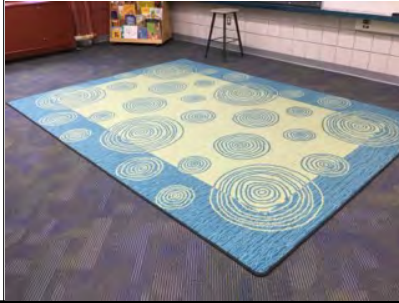
Surface not stable, firm, and slip-resistant	-	Secure the mat.	1	Labor	\$0
Doors, Doorways, & Gates												
33	Office	1	20	Doors, Doorways, & Gates	Office

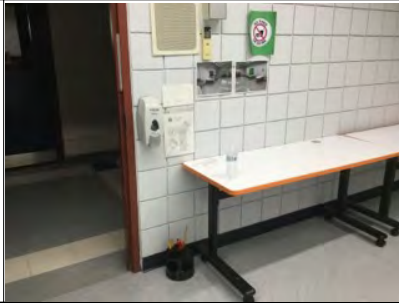
Maneuvering clearance(s) not provided	13"	Relocate the table out of the door maneuvering clearance.	1	Labor	\$0
35	Grade 3 Classroom	1	25	Doors, Doorways, & Gates	Classroom

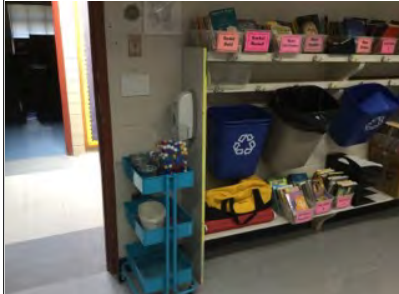
Maneuvering clearance(s) not provided	-	Relocate blue storage cart.	1	Labor	\$0

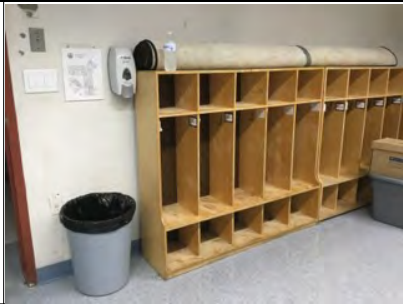
ID	Location	Floor	Room	Element	Type	Photo	Issues	Current Measure	Recommendations	Quantity	Price	Cost Estimation
36	Grade 1 Classroom	1	27	Doors, Doorways, & Gates	Classroom

Maneuvering clearance(s) not provided	-	Relocate trash bin.	1	Labor	\$0
37	Counselor's Office	1	35	Doors, Doorways, & Gates	Office

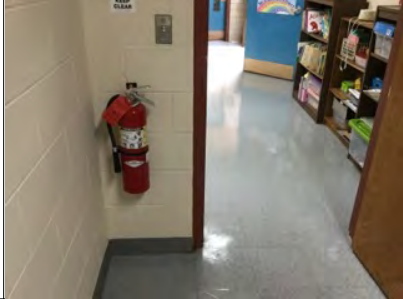
Maneuvering clearance(s) not provided	-	Relocate fire extinguisher out of door maneuvering clearance.	1	Labor	\$0
Ramps												
38	Accessible Stage Access	1		Ramps	Interior

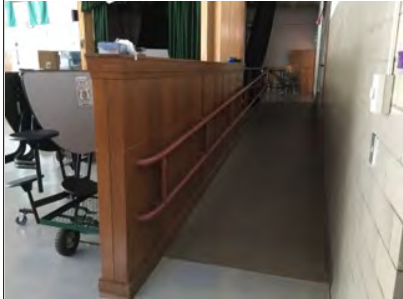
Handrails not provided at both sides if rise is > 6"	-	Provide handrails on both sides.	1	2640	\$2640
Signage												
39	Gym	1	16	Signage	Designation

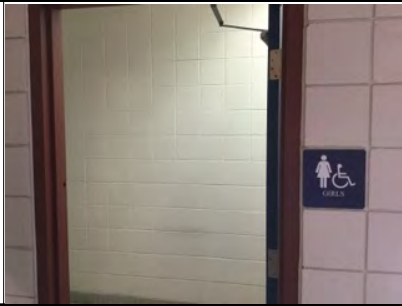
ID	Location	Floor	Room	Element	Type	Photo	Issues	Current Measure	Recommendations	Quantity	Price	Cost Estimation
41	Girls' Toilet Room Near the Gym	1		Signage	Designation

Sign not located on the latch side of the door	-	Locate sign at permanent rooms alongside the door on the latch side.	1	Labor	\$0
Service Counter												
42	Reception	1		Service Counter	N/A

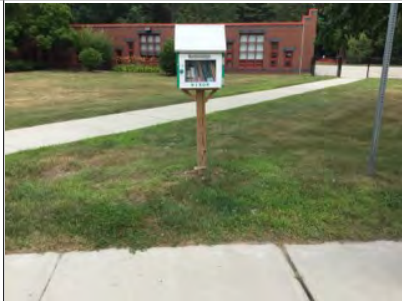
Element not on an accessible route Not operable with a closed fist	- -	Ensure the library box is located on an accessible route. Provide hardware that can be operable with one hand and not require tight grasping, pinching, or twisting of the wrist. (Cost estimate for a 6' long by 4' wide stone dust route.)	1	442	\$442
44	Learning Studio	1	22	Operable Parts	Other

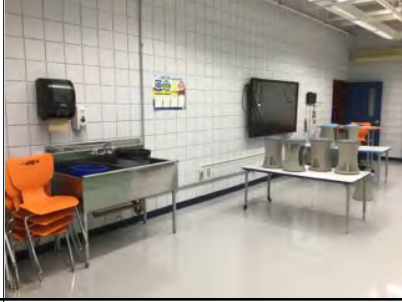
Forward reach if obstruction > 20"- 25" deep is > 44" high	57", 53"	Ensure that the controls for the paper towel dispenser and the soap dispenser are not higher than 44" above the finished floor.	2	256	\$512

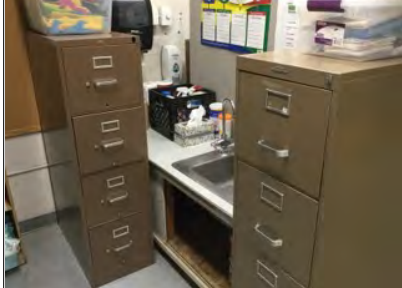
45	Math and Literacy	1	28	Operable Parts	Other

Side reach if obstruction > 24" deep is > 46" high	50" high 32" deep	Ensure that control of the paper towel dispenser is not located any deeper than 24" and any higher than 46" above the finished floor. Relocate file cabinet.	1	Labor 256	\$256

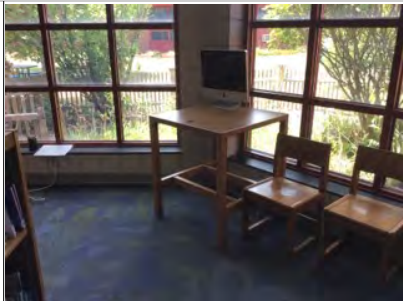
ID	Location	Floor	Room	Element	Type	Photo	Issues	Current Measure	Recommendations	Quantity	Price	Cost Estimation
Dining or Work Surfaces												
46	Library Media Center Computer Terminal	1	1	Dining or Work Surfaces	Work Surface

Knee or toe clearance not provided	8" deep	Provide at least 1 work surface with 24" min. high knee and toe clearance that has 30" min. clear width.	1	200	\$200
47	Grade 4 Classroom	1	12	Dining or Work Surfaces	Work Surface

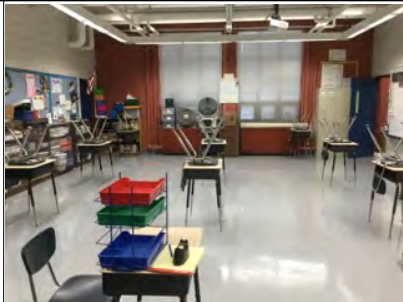
Knee or toe clearance not provided	23.5"	Provide at least 1 work surface with 24" min. high knee and toe clearance that has 30" min. clear width.	1	200	\$200
48	Grade 3 Classroom	1	25	Dining or Work Surfaces	Work Surface

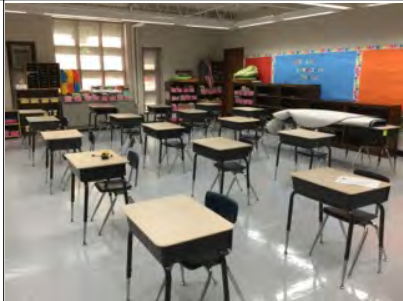
Knee or toe clearance not provided	21" wide	Provide at least 1 work surface with 24" min. high knee and toe clearance that has 30" min. clear width.	1	200	\$200
49	Grade 2 Classroom	1	26	Dining or Work Surfaces	Work Surface

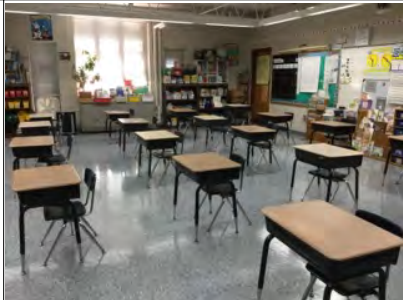
Knee or toe clearance not provided	-	Provide at least 1 work surface with 24" min. high knee and toe clearance that has 30" min. clear width.	1	200	\$200

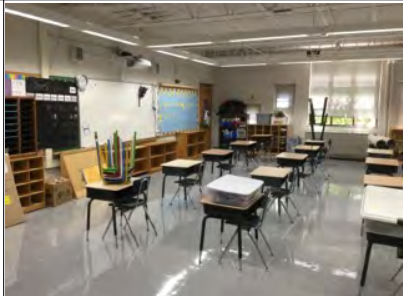
50	Grade 1 Classroom	1	27	Dining or Work Surfaces	Work Surface

Knee or toe clearance not provided	-	Provide at least 1 work surface with 24" min. high knee and toe clearance that has 30" min. clear width.	1	200	\$200

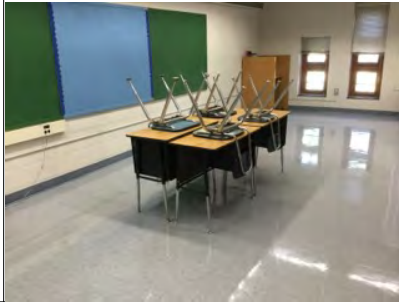
ID	Location	Floor	Room	Element	Type	Photo	Issues	Current Measure	Recommendations	Quantity	Price	Cost Estimation
51	Special Room	1	31	Dining or Work Surfaces	Work Surface

Knee or toe clearance not provided	-	Provide at least 1 work surface with 24" min. high knee and toe clearance that has 30" min. clear width.	1	200	\$200
52	Special Room	1	33	Dining or Work Surfaces	Work Surface

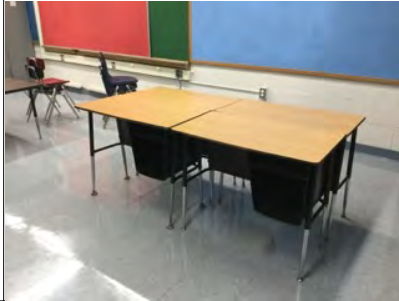
Knee or toe clearance not provided	18" wide	Provide at least 1 work surface with 24" min. high knee and toe clearance that has 30" min. clear width.	1	200	\$200
53	Grade 5 Classroom	1	8	Dining or Work Surfaces	Work Surface

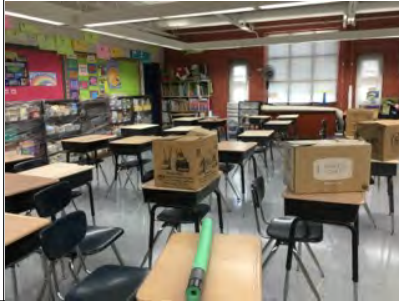
Knee or toe clearance not provided	18.5" wide	Provide at least 1 work surface with 24" min. high knee and toe clearance that has 30" min. clear width.	1	200	\$200
Assembly Area												
54	Music Room	1	18	Assembly Area	N/A

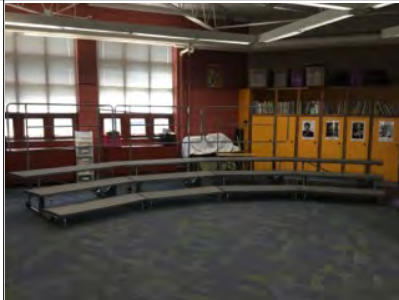
Minimum # wheelchair spaces not provided	-	Provide integrated wheelchair spaces in the bleachers based on ADA 2010 Standards 221.2.1.1.	1	-	\$0

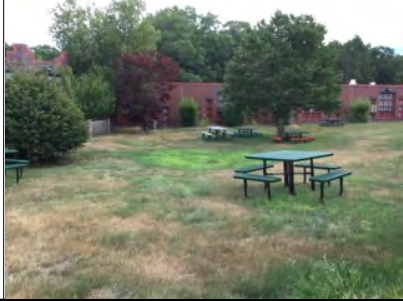
ID	Location	Floor	Room	Element	Type	Photo	Issues	Current Measure	Recommendations	Quantity	Price	Cost Estimation
Picnic Tables												
56	Courtyard Picnic Area	Ext.		Picnic Tables	N/A

Toe or knee clearance at tables not provided Picnic table not on an accessible route	- -	Provide at least one picnic table has toe and knee clearance. Ensure that the picnic table is connected to an accessible route. (Cost estimate for a 50' long by 4' wide stone dust route and an accessible picnic table.)	1	3000	\$3000
57	Picnic Tables by New Playground	Ext.		Picnic Tables	N/A

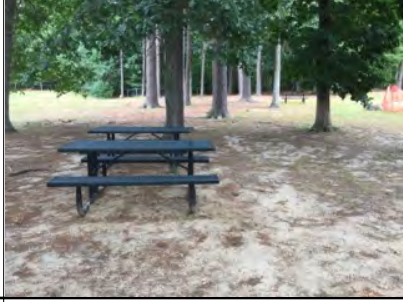
Toe or knee clearance at tables not provided Picnic table not on an accessible route	- -	Provide one accessible picnic table in this area and provide an accessible route to it. (Cost estimate for an accessible picnic table and a 30' long by 4' wide asphalt route to it).	1	2600	\$2600
58	Chess Picnic Table by the New Playground	Ext.		Picnic Tables	N/A

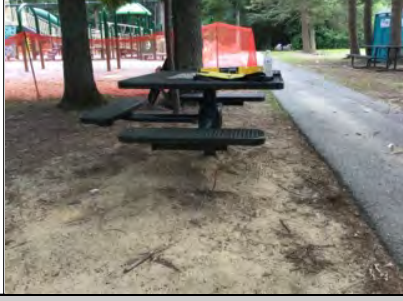
Picnic table not on an accessible route	- -	Provide an accessible route to one picnic table in this area. (Cost estimate for a 6' long by 4' wide asphalt route.)	1	240	\$240

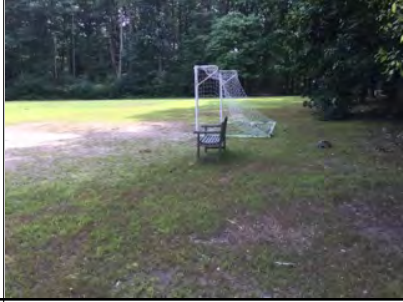
Exterior Benches												
59	Soccer Field Bench	Ext.		Exterior Benches

No accessible route to one bench in area		Locate one bench in this area on an accessible route.	1	Labor	\$0
60	Bench by the New Playground	Ext.		Exterior Benches	N/A

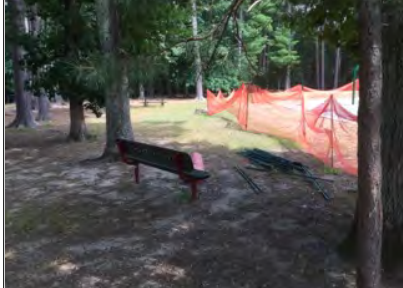
No accessible route to one bench in area		Provide an accessible route to one bench in this area. (Cost estimate for a 30' long, 4' wide asphalt route.)	1	1200	\$1200

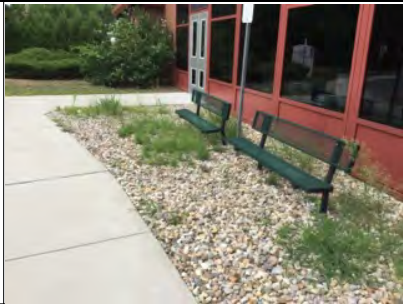
ID	Location	Floor	Room	Element	Type	Photo	Issues	Current Measure	Recommendations	Quantity	Price	Cost Estimation
61	Benches in Front of Cafeteria	Ext.		Exterior Benches	N/A

No accessible route to one bench in area	-	Provide an accessible route to one bench. (Cost estimate for a 6' long 4' wide stone dust walkway.)	1	192	\$192
Toilet & Bathing Rooms												
Overall Access												
62	Girls' Toilet Room by Room 27	1		Overall Access	Toilet Room

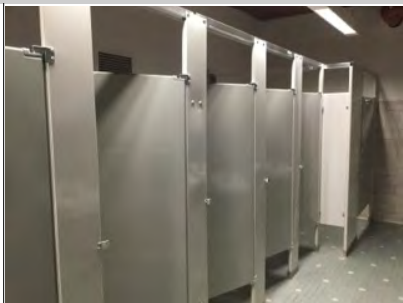
6 fixtures, but no ambulatory compartment provided	-	Provide one ambulatory accessible compartment.	1	3012	\$3012
63	Girls' Toilet Room by the Gym	1		Overall Access	Toilet Room

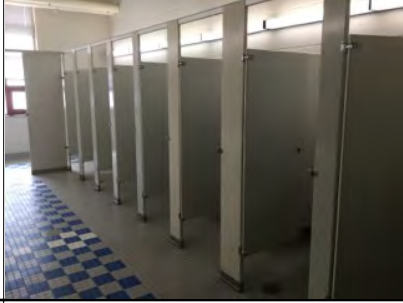
6 fixtures, but no ambulatory compartment provided	-	Provide one ambulatory accessible compartment.	1	3012	\$3012
64	Girls' Toilet Room Near Classroom 8	1		Overall Access	Toilet Room

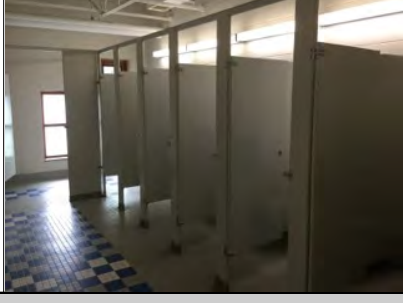
6 fixtures, but no ambulatory compartment provided	-	Provide one ambulatory accessible compartment.	1	3012	\$3012

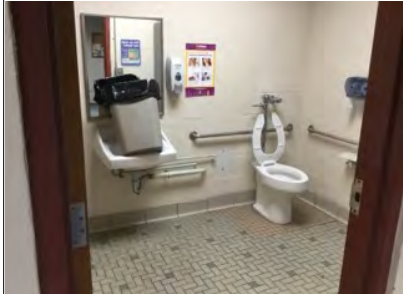
Lavatory												
65	Health Office Toilet Room	1		Lavatory	N/A

Toe or knee clearances not provided Plumbing underneath is exposed	24" -	Provide at least one lavatory with 27" knee and toe clearance positioned for a forward approach. Insulate or otherwise configure pipes to prevent contact at lavatory.	1	1778	\$1778

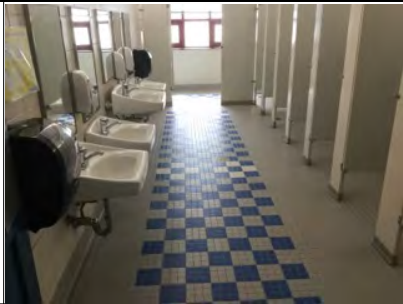
Plumbing underneath is exposed	-	Insulate or otherwise configure pipes to prevent contact for at least one lavatory at the high lavatory.	2	92	\$184
67	Boys' Toilet Room Near Classroom 8	1		Lavatory	N/A

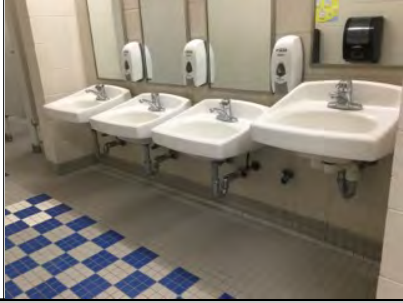
Plumbing underneath is exposed	-	Insulate or otherwise configure pipes to prevent contact for at least one lavatory (the high lavatory).	1	92	\$92
Single-User Toilet												
69	Health Office Toilet Room	1		Single-User Toilet	N/A

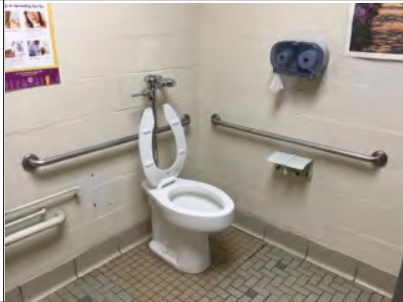
Centerline < or > 18" (MAAB) Side or rear grab bar < 33" or > 36" high Toilet paper dispenser is not compliant	20.5" 30.5" -	Relocate toilet so that the centerline is 18" from the side wall. Mount grab bars 33"- 36" above the floor. Relocate toilet paper so that it is 24" min. high, located under the grab bar, and between 7" and 9" from the front of the toilet. Ensure it is not mounted over the grab bars.	1	3973	\$3973

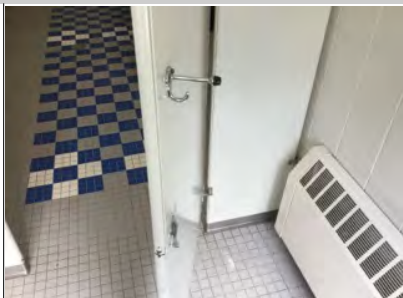
Toilet Compartment												
70	Girls' Toilet Room by the Gym	1		Toilet Compartment	Accessible Compartment

Door has non-compliant hardware Door has malfunctioning self-closing hinge	- -	Provide hardware that can be operable with one hand and not require tight grasping, pinching, or twisting of the wrist. Repair hinge.	1	70 Labor	\$70

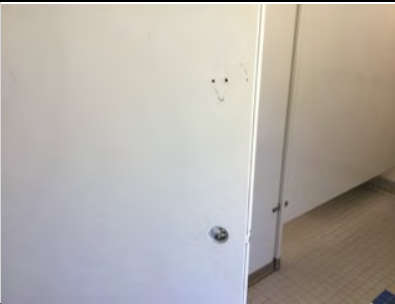
ID	Location	Floor	Room	Element	Type	Photo	Issues	Current Measure	Recommendations	Quantity	Price	Cost Estimation
71	Boys' Toilet Room by the Gym	1		Toilet Compartment	Accessible Compartment

Door has malfunctioning self-closing hinge		Repair hinge.	1	Labor	\$0
72	Girls' Toilet Room Near Classroom 8	1		Toilet Compartment	Accessible Compartment

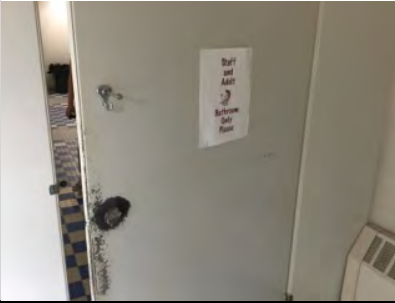
Door has malfunctioning self-closing hinge	-	Repair hinge.	1	Labor	\$0
73	Boys' Toilet Room Near Classroom 8	1		Toilet Compartment	Accessible Compartment

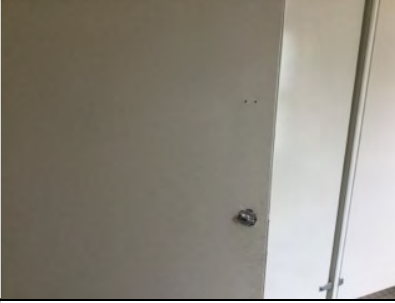
Door has malfunctioning self-closing hinge	-	Repair hinge.	1	Labor	\$0
74	Girls' Toilet Room Near Classroom 8	1		Toilet Compartment	Accessible Compartment

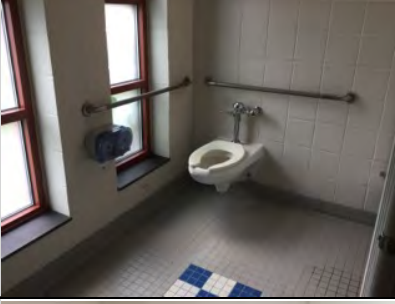
Flush control not on open side	-	Provide the flush control on the open side of the toilet (transfer side).	1	374	\$374
75	Girls' Toilet Room by the Gym	1		Toilet Compartment	Accessible Compartment

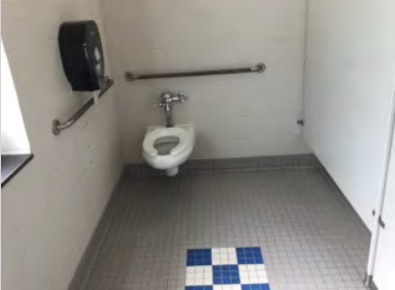
Flush control not on open side Non-compliant toilet paper dispenser	- -	Provide the flush control on the open side of the toilet (transfer side). Relocate toilet paper so that it is 24" min. high, located under the grab bar, and between 7" and 9" from the front of the toilet.	1	630	\$630

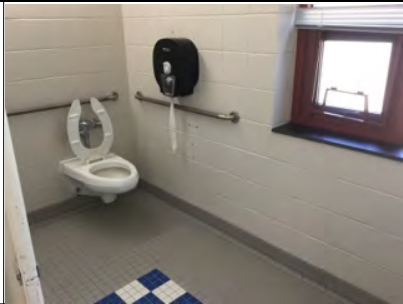
ID	Location	Floor	Room	Element	Type	Photo	Issues	Current Measure	Recommendations	Quantity	Price	Cost Estimation
76	Boys' Toilet Room by the Gym	1		Toilet Compartment	Accessible Compartment

Non-compliant toilet paper dispenser		Relocate toilet paper so that it is 24" min. high, located under the grab bar, and between 7" and 9" from the front of the toilet.	1	256	\$256
Dispensers												
77	Health Office	1		Dispensers	Paper Towel Dispenser

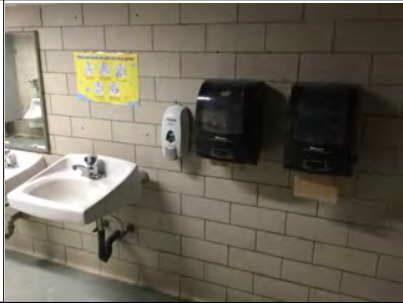
Dispenser acts as a protruding object	-	Relocate paper towel dispensers out of the circulation path.	4	353	\$1412
79	Girls' Toilet Room Near Classroom 8	1		Dispensers	Paper Towel Dispenser

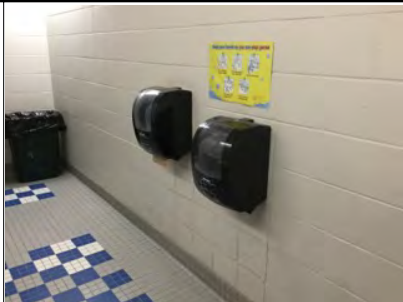
Dispenser acts as a protruding object	10"	Relocate higher paper towel dispenser out of the circulation path. Alternatively, lower it so that the bottom edge is at 27" max.	1	256	\$256

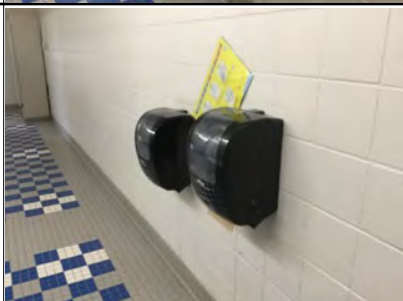
80	Boys' Toilet Room Near Classroom 8	1		Dispensers	Paper Towel Dispenser

Dispenser acts as a protruding object	-	Relocate dispensers out of the circulation path. Alternatively, lower them so that the bottom edge is at 27" max.	2	256	\$512

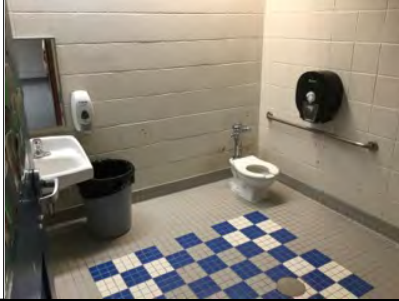
ID	Location	Floor	Room	Element	Type	Photo	Issues	Current Measure	Recommendations	Quantity	Price	Cost Estimation
Single-User Toilet (Children)												
81	Kindergarten Toilet Room	1		Single-User Toilet (Children)	N/A

Toilet seat < 12" or > 15" high (K - 3) Side or rear grab bar < 42" long Non-compliant toilet paper dispenser	10.5" 0 -	Install a toilet with a seat between 12"- 15" high above the finished floor. Provide a rear wall grab bar that is 42" long located 6" max. from the interior corner. Relocate toilet paper dispenser so that it is between 14"- 19" above the floor and between 7"- 9" in front of the toilet. Ensure dispensers and other devices are not mounted above grab bars.	1	3417	\$3417
Toilet Compartment (Children)												
82	Boys' Toilet Room by Room 27	1		Toilet Compartment (Children)	Accessible Compartment

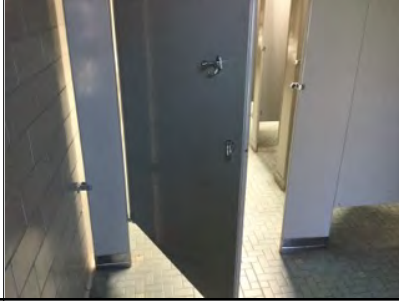
Door with non-compliant hardware Coat hook not within reach range	- 51"	Provide hardware that can be operable with one hand and not require tight grasping, pinching, or twisting of the wrist. Lower hook so that it is no higher than 44" for children ages 9-12.	1	220	\$220

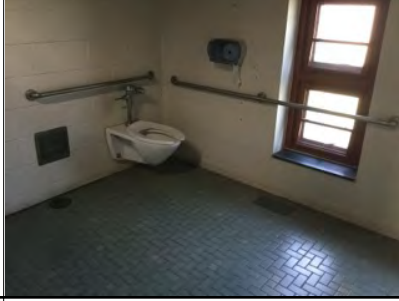
83	Boys' Toilet Room by Room 27	1		Toilet Compartment (Children)	Accessible Compartment

Side or rear grab bar < 25" or > 27" high (Ages 9 - 12) Non-compliant toilet paper dispenser	32.5" 30" -	Relocate both grab bars to 25"- 27" above the floor. Relocate toilet paper dispenser so that it is between 14"- 19" above the floor and between 7"- 9" in front of the toilet. Ensure dispensers and other devices are not mounted above grab bars.	1	768	\$768
84	Girls' Toilet Room by Room 27	1		Toilet Compartment (Children)	Accessible Compartment

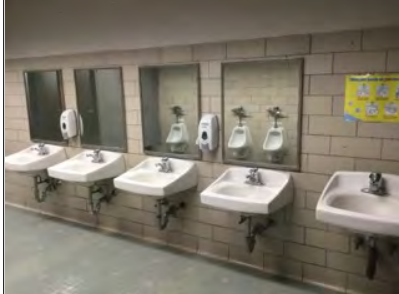
Toe or knee clearances not provided Exposed plumbing underneath Mirror above lavatory w/reflective surface > 31"	23" - 35"	Provide at least one lavatory with 25" min. knee clearance positioned for a forward approach. Ensure toe clearance is also provided. Insulate or otherwise configure pipes to prevent contact, for at least one lavatory. Lower mirror so that the bottom surface is at 31" above finished floor.	1	2034	\$2034

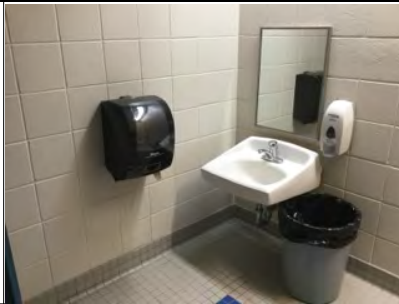
ID	Location	Floor	Room	Element	Type	Photo	Issues	Current Measure	Recommendations	Quantity	Price	Cost Estimation
86	Kindergarten Toilet Room	1		Lavatory (Children)	N/A

Exposed plumbing underneath		Insulate or otherwise configure pipes to prevent contact at lavatory.	1	92	\$92
87	Girls' Toilet Room by Room 27	1		Lavatory (Children)	N/A

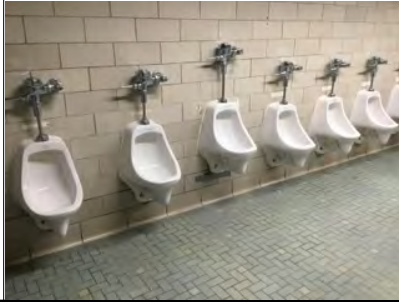
Rim > 15" high (MAAB)	18"	Provide at least one urinal with the rim no higher than 15" above the finished floor.	1	3248	\$3248
Additional Access												
Drinking Fountains												
89	Drinking Fountain Next to Boys' Toilet Room by Room 27	1		Drinking Fountains	Low

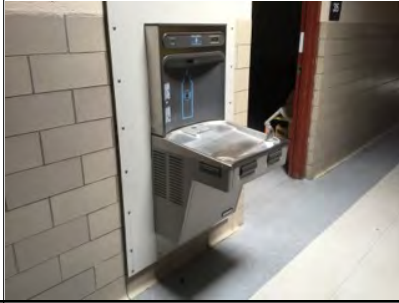
No drinking fountain provided for standing users		Provide an additional drinking fountain for standing users.	1	4028	\$4028

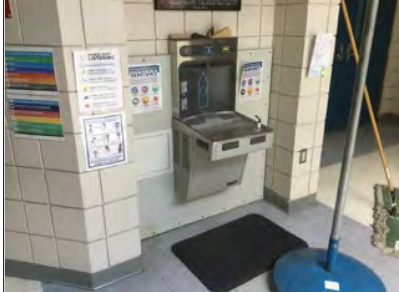
90	Fountain Next to Gym	1		Drinking Fountains	Low

No drinking fountain provided for standing users	-	Provide an additional drinking fountain for standing users.	1	4028	\$4028

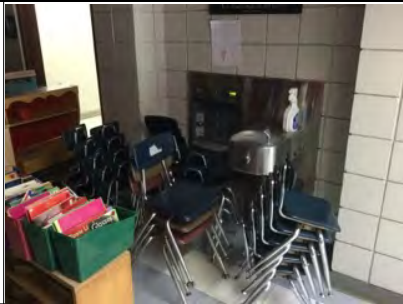
No drinking fountain provided for standing users		Provide an additional drinking fountain for standing users.	1	4028	\$4028
92	Fountain Next to Cafeteria	1		Drinking Fountains	Low

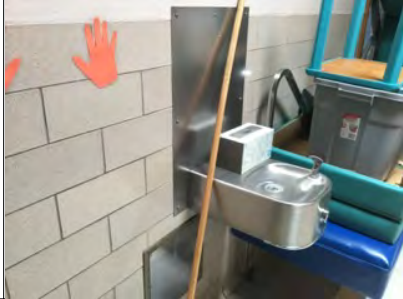
No drinking fountain provided for standing users	-	Provide an additional drinking fountain for standing users.	1	4028	\$4028
93	Drinking Fountain by Kitchen Area	1		Drinking Fountains	Low

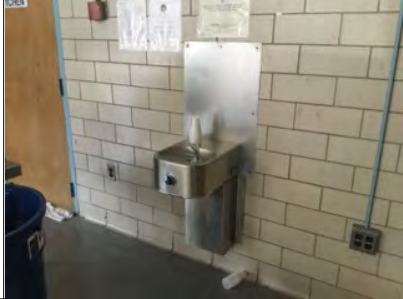
No drinking fountain provided for standing users	-	Install a Hi-Lo drinking fountain.	1	4216	\$4216
94	Drinking Fountain at Playground	Ext.		Drinking Fountains	Low

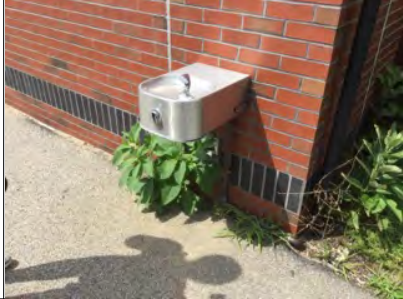
No drinking fountain provided for standing users	-	Provide an additional drinking fountain for standing users.	1	4028	\$4028
Sink												
95	Health Office	1		Sink	Other

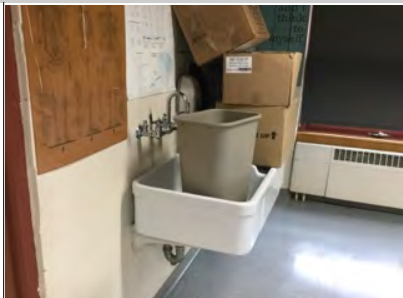
Exposed plumbing underneath sink	-	Insulate or otherwise configure pipes at sink.	1	92	\$92

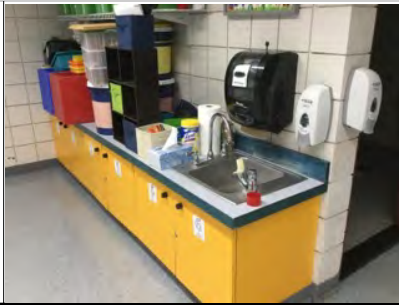
ID	Location	Floor	Room	Element	Type	Photo	Issues	Current Measure	Recommendations	Quantity	Price	Cost Estimation
Sinks for Children's Use												
96	Kindergarten Classroom	1		Sinks for Children's Use	Classroom

Non-compliant or malfunctioning faucet Exposed plumbing underneath Knee or toe clearance not provided	- - -	Provide a faucet that can be operable with one hand and not require tight grasping, pinching or twisting of the wrist for at least one sink. Insulate or otherwise configure pipes to prevent contact at the sink. Provide at least one sink with 24" high knee and toe clearance positioned for a forward approach.	1	2764	\$2764
97	Grade 4 Classroom	1	12	Sinks for Children's Use	Classroom

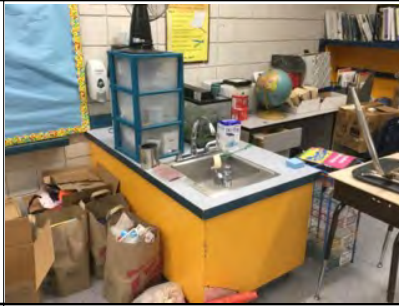
Non-compliant or malfunctioning faucet Exposed plumbing underneath Knee or toe clearance not provided	- - -	Provide a faucet that can be operable with one hand and not require tight grasping, pinching or twisting of the wrist for at least one sink. Insulate or otherwise configure pipes to prevent contact at the sink. Provide at least one sink with 24" high knee and toe clearance positioned for a forward approach.	1	2764	\$2764

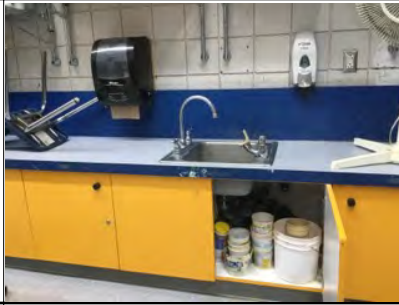
98	Art Room	1	13	Sinks for Children's Use	Classroom

Non-compliant or malfunctioning faucet Exposed plumbing underneath Knee or toe clearance not provided	- - -	Provide a faucet that can be operable with one hand and not require tight grasping, pinching or twisting of the wrist for at least one sink. Insulate or otherwise configure pipes to prevent contact at the sink. Provide at least one sink with 24" high knee and toe clearance positioned for a forward approach.	1	2764	\$2764
99	Learning Center	1	21	Sinks for Children's Use	Classroom

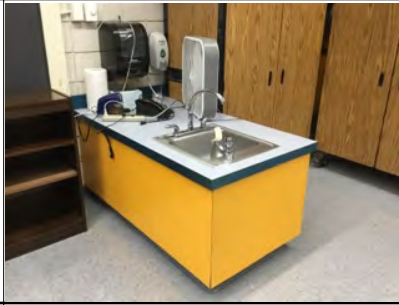
Non-compliant or malfunctioning faucet Exposed plumbing underneath Knee or toe clearance not provided	- - -	Provide a faucet that can be operable with one hand and not require tight grasping, pinching or twisting of the wrist for at least one sink. Insulate or otherwise configure pipes to prevent contact at the sink. Provide at least one sink with 24" high knee and toe clearance positioned for a forward approach.	1	2764	\$2764

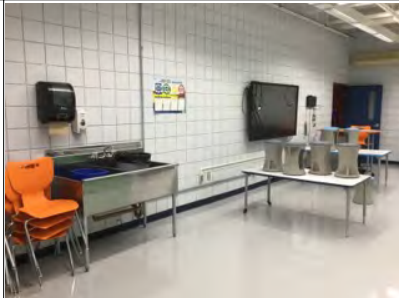
100	Learning Studio	1	22	Sinks for Children's Use	Classroom

Non-compliant or malfunctioning faucet Exposed plumbing underneath Knee or toe clearance not provided	- - -	Provide a faucet that can be operable with one hand and not require tight grasping, pinching or twisting of the wrist for at least one sink. Insulate or otherwise configure pipes to prevent contact at the sink. Provide at least one sink with 24" high knee and toe clearance positioned for a forward approach.	1	2764	\$2764

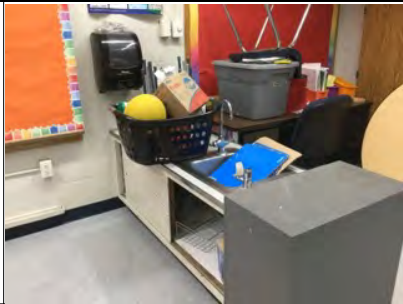
ID	Location	Floor	Room	Element	Type	Photo	Issues	Current Measure	Recommendations	Quantity	Price	Cost Estimation
101	Grade 3 Classroom	1	25	Sinks for Children's Use	Classroom

Non-compliant or malfunctioning faucet Exposed plumbing underneath Knee or toe clearance not provided	- - -	Provide a faucet that can be operable with one hand and not require tight grasping, pinching or twisting of the wrist for at least one sink. Insulate or otherwise configure pipes to prevent contact at the sink. Provide at least one sink with 24" high knee and toe clearance positioned for a forward approach.	1	2764	\$2764
102	Grade 2 Classroom	1	26	Sinks for Children's Use	Classroom

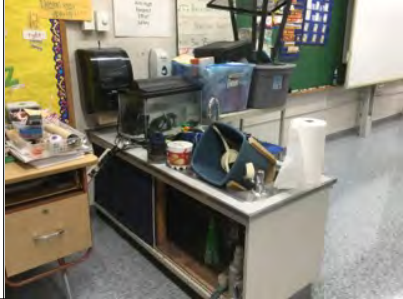
Non-compliant or malfunctioning faucet Exposed plumbing underneath Knee or toe clearance not provided	- - -	Provide a faucet that can be operable with one hand and not require tight grasping, pinching or twisting of the wrist for at least one sink. Insulate or otherwise configure pipes to prevent contact, for at least one sink. Provide at least one sink with 24" high knee and toe clearance positioned for a forward approach.	1	2764	\$2764

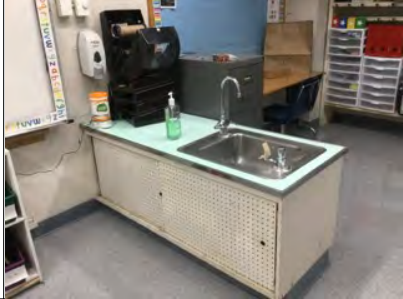
103	Grade 1 Classroom	1	27	Sinks for Children's Use	Classroom

Non-compliant or malfunctioning faucet Exposed plumbing underneath Knee or toe clearance not provided	- - -	Provide a faucet that can be operable with one hand and not require tight grasping, pinching or twisting of the wrist for at least one sink. Insulate or otherwise configure pipes to prevent contact at the sink. Provide at least one sink with 24" high knee and toe clearance positioned for a forward approach.	1	2764	\$2764
104	Math and Literacy	1	28	Sinks for Children's Use	Other

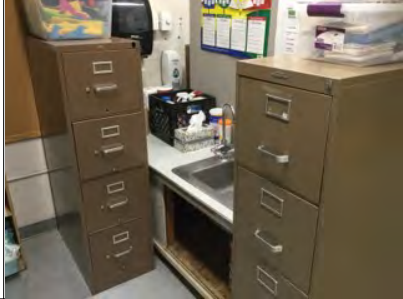
Non-compliant or malfunctioning faucet Exposed plumbing underneath Knee or toe clearance not provided	- - -	Provide a faucet that can be operable with one hand and not require tight grasping, pinching or twisting of the wrist for at least one sink. Insulate or otherwise configure pipes to prevent contact, for at least one sink. Provide at least one sink with 24" high knee and toe clearance positioned for a forward approach.	1	2764	\$2764

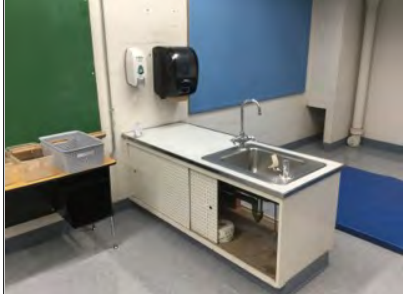
105	Special Room	1	31	Sinks for Children's Use	Classroom

Non-compliant or malfunctioning faucet Exposed plumbing underneath Knee or toe clearance not provided	- - -	Provide a faucet that can be operable with one hand and not require tight grasping, pinching or twisting of the wrist for at least one sink. Insulate or otherwise configure pipes to prevent contact at the sink. . Provide at least one sink with 24" high knee and toe clearance positioned for a forward approach.	1	2764	\$2764

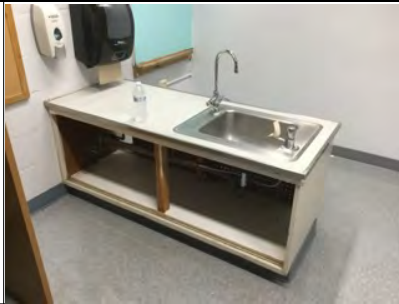
ID	Location	Floor	Room	Element	Type	Photo	Issues	Current Measure	Recommendations	Quantity	Price	Cost Estimation
106	Classroom	1	32	Sinks for Children's Use	Classroom

Non-compliant or malfunctioning faucet Exposed plumbing underneath Knee or toe clearance not provided	- - -	Provide a faucet that can be operable with one hand and not require tight grasping, pinching or twisting of the wrist for at least one sink. Insulate or otherwise configure pipes to prevent contact, for at least one sink. Provide at least one sink with 24" high knee and toe clearance positioned for a forward approach.	1	2764	\$2764
107	Special Room	1	33	Sinks for Children's Use	Other

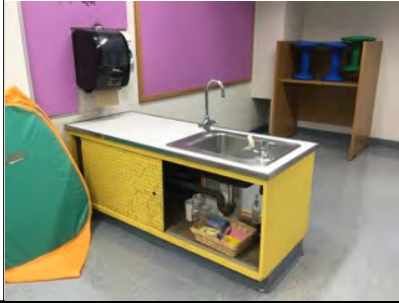
Non-compliant or malfunctioning faucet Exposed plumbing underneath Knee or toe clearance not provided	- - -	Provide a faucet that can be operable with one hand and not require tight grasping, pinching or twisting of the wrist for at least one sink. Insulate or otherwise configure pipes to prevent contact at the sink. Provide at least one sink with 24" high knee and toe clearance positioned for a forward approach.	1	2764	\$2764

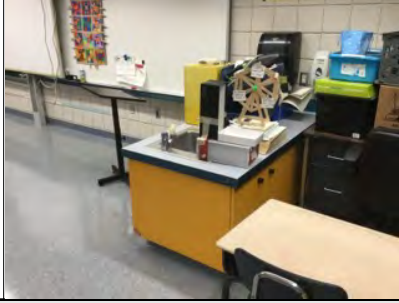
108	Grade 5 Classroom	1	8	Sinks for Children's Use	Classroom

Non-compliant or malfunctioning faucet Exposed plumbing underneath Knee or toe clearance not provided	- - -	Provide a faucet that can be operable with one hand and not require tight grasping, pinching or twisting of the wrist for at least one sink. Insulate or otherwise configure pipes to prevent contact, for at least one sink. Provide at least one sink with 24" high knee and toe clearance positioned for a forward approach.	1	2764	\$2764
Play and Sport Areas												
Field												
109	Soccer Field	Ext.		Field	Soccer

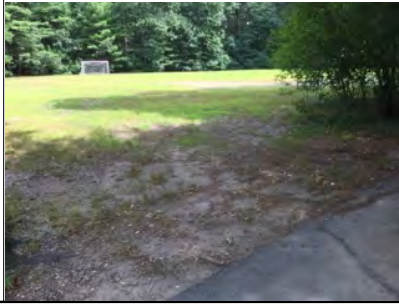
Field not connected to an accessible route	-	Provide an accessible route to the field. (Cost estimate for 30' long by 4' wide stone dust walkway.)	1	960	\$960
Overall Review												
110	New Playground	Ext.

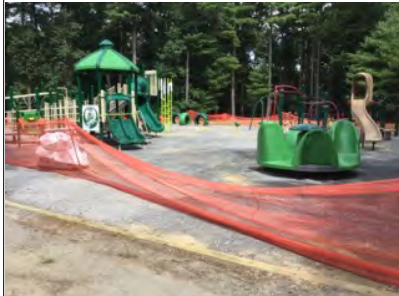
Note: Playground was under construction and could not be surveyed.	1	-	\$0

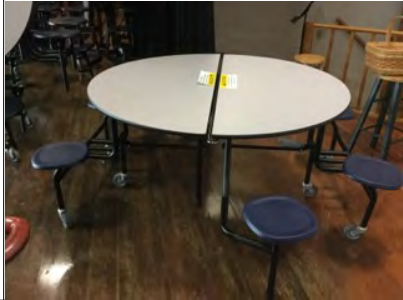
ID	Location	Floor	Room	Element	Type	Photo	Issues	Current Measure	Recommendations	Quantity	Price	Cost Estimation
Best Practice												
111	Cafeteria, Accessible Table	1

This is a good example of a table with knee and toe clearance.	1	-	\$0
112	Stage Steps	1

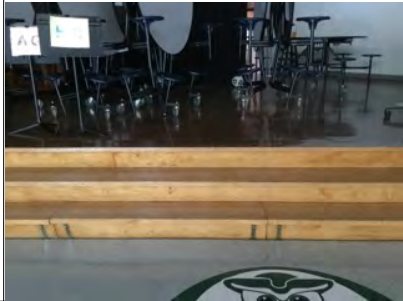
-	Recommend providing handrails on each side.	1	-	\$0
113	Principal's Office	1

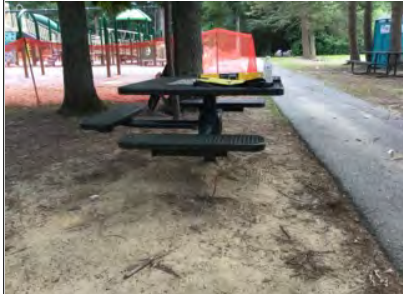
-	Recommend providing a 48" wide accessible route around the accessible picnic table.	1	-	\$0

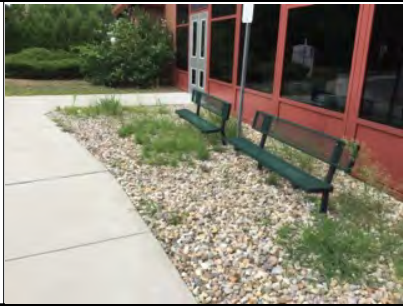
ID	Location	Floor	Room	Element	Type	Photo	Issues	Current Measure	Recommendations	Quantity	Price	Cost Estimation
116	Benches in Front of Cafeteria	Ext.

-	Recommend providing a 36" x 48" space alongside one bench positioned so that a person using a wheelchair can sit shoulder to shoulder with someone seated on the bench. Recommend providing a variety of benches, including benches with backs and armrests.	1	-	\$0

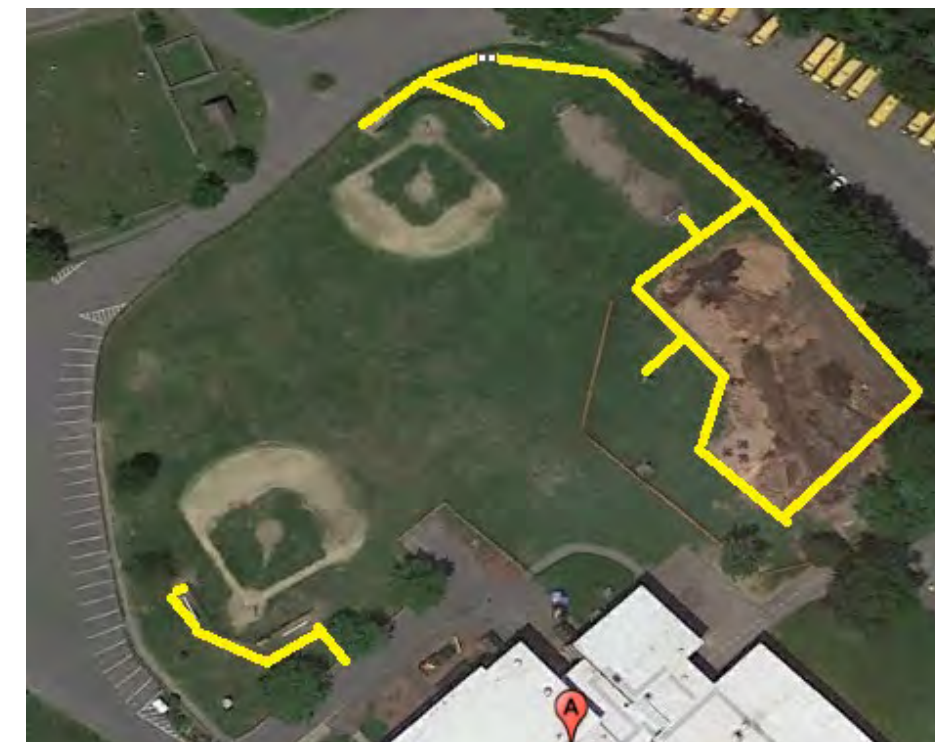
Figure 1: Yellow lines indicate the approximate location of a suggested accessible route around the exterior of the playground and connecting amenities such as the boundaries of sport activity at the soccer field, the two baseball fields and player and fan seating.

Accessible route not provided around playground	-	Provide an accessible route around the perimeter of the play area. (Cost estimate for 4' wide min. x 420' long stone dust path around the perimeter of the playground. See Figure 1 in the report narrative.)	1	13440	\$13440

Accessible route not provided to play components	- -	Provide an accessible route to the play element. (Cost for a 4' wide min. x 12' long stone dust path from playground to play element. See Figure 1 in the report narrative.)	1	384	\$384

Accessible spaces not provided at team seating Accessible spaces not provided at sidelines seating Field not connected to an accessible route	- - -	Provide an accessible route to the boundary of sport activity at both baseball fields and to player and fan seating at both fields. See Figure 1 in the report narrative.) (Cost based on 420' X' of 4' wide min. of stone dust path connecting elements.)	1	13440	\$13440
101	Soccer Field - Northwest of Playground	Ext.		Field	Soccer

Field not connected to an accessible route	- -	Provide an accessible route to the boundary of sport activity at the soccer field. (Cost for a 4' wide min. x 30' long stone dust path from playground to play element. Actual cost dependent on where soccer nets are positioned in the field. See Figure 1 in the report narrative.)	1	480	\$480

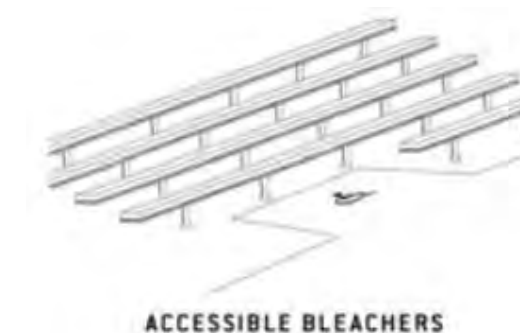
Note: The following graphics illustrate placement of accessible spaces alongside bleachers. Space for wheelchair users should be positioned so that a wheelchair user sits shoulder to shoulder next to a person seated in the bleachers.

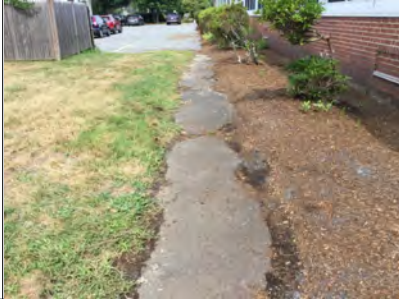
ID	Location	Floor	Room	Element	Type	Photo	Issues	Current Measure	Recommendations	Quantity	Price	Cost Estimation
Approach and Entrance												
Exterior Access Route												
1	Route From Doors 9, 10, and 11 to East Side of Building	Ext.		Exterior Access Route	Walkway

Exterior route < 36" wide	30"	Ensure that a clear width of 36" min. is maintained at the accessible route. (Cost based on 3'x20' of asphalt to correct slope.)	1	600	\$600
2	Main Entrance	Ext.		Exterior Access Route	Exterior
