Curtis Middle School

Town of Sudbury ADA Transition Plan

January 2021

Institute for Human Centered Design

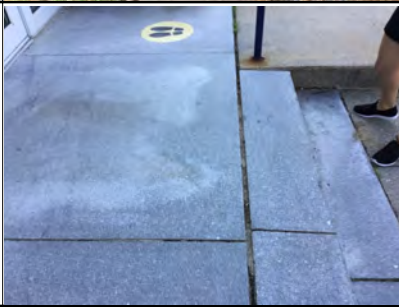
Surface openings > 1/2"	1"	Fill or seal gap at top of stairs.	1	Labor	\$0
3	Path at Doors 10 and 11	Ext.		Exterior Access Route	Walkway

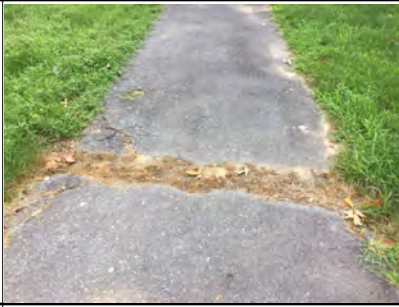
Surface openings > 1/2"	11"	Repair asphalt. (Cost for a 4'x4' asphalt patch.)	1	160	\$160
4	West Walkway to Playground	Ext.		Exterior Access Route	Walkway

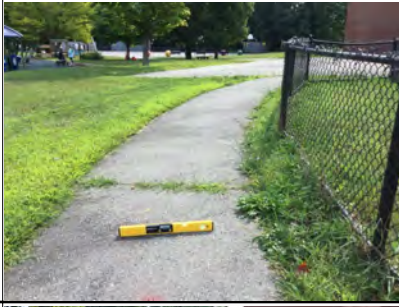
Cross slope > 1:50 (2.00%)	3.3%	Reduce cross slope to be no steeper than 1:50 (2.00%). (Cost based on 3'x4' of asphalt to correct slope.)	1	120	\$120

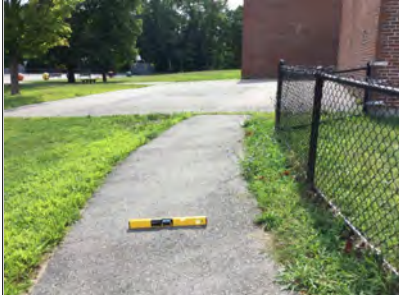
5	West Walkway to Playground	Ext.		Exterior Access Route	Walkway

Cross slope > 1:50 (2.00%)	5.6%	Reduce cross slope to be no steeper than 1:50 (2.00%). (Cost based on 3'x4' of asphalt to correct slope.)	1	120	\$120

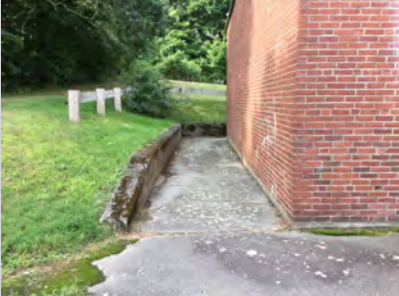
ID	Location	Floor	Room	Element	Type	Photo	Issues	Current Measure	Recommendations	Quantity	Price	Cost Estimation
6	Route From Doors 9, 10, and 11 to East Side of Building	Ext.		Exterior Access Route	Walkway

Cross slope > 1:50 (2.00%)	9.7%	Reduce cross slope to be no steeper than 1:50 (2.00%). (Cost based on 3'x20' of asphalt to correct slope.)	1	600	\$600
7	Route From Doors 9, 10, and 11 to East Side of Building	Ext.		Exterior Access Route	Walkway

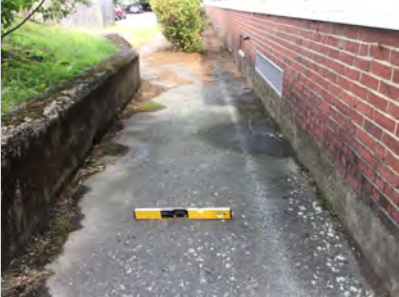
Cross slope > 1:50 (2.00%)	6.1%	Reduce cross slope to be no steeper than 1:50 (2.00%). (Cost based on 3'x40' of asphalt to correct slope.)	1	1200	\$1200
8	West Side of School - Curb Ramp Leads to Playground	Ext.		Exterior Access Route	Walkway

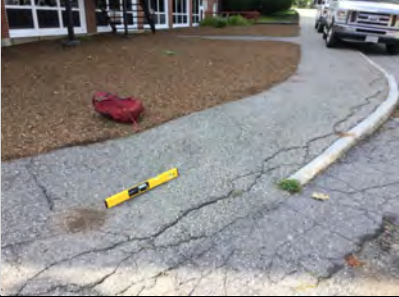
Cross slope > 1:50 (2.00%) Running slope > 1:20 (5%)	20" 15%	Reduce cross slope to be no steeper than 1:50 (2.00%). Reduce running slope to be no steeper than 1:20 (5%). (Cost base on 3'x15' of asphalt to correct slope.)	1	450	\$450

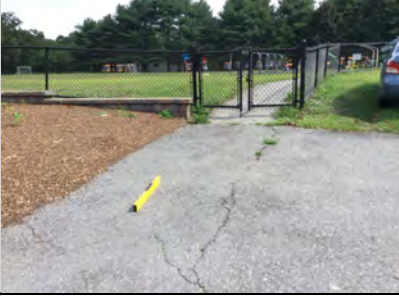
9	West Side of School - Leads to Playground	Ext.		Exterior Access Route	Exterior

Running slope > 1:20 (5%)	9.9%	Reduce running slope to be no steeper than 1:20 (5%). (Cost base on 3'x15' of asphalt to correct slope.)	1	450	\$450
10	Door 10	Ext.		Exterior Access Route	Exterior

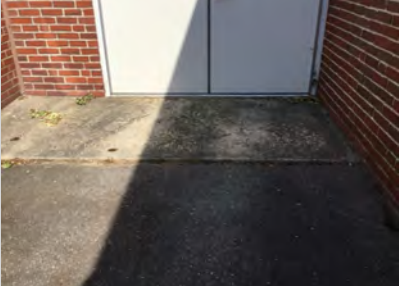
Level changes > 1/4"	.75"	Alter change in level to be 1/4" high max. where door landing meets asphalt walkway. (Cost for a 4'x4' asphalt patch.)	1	160	\$160

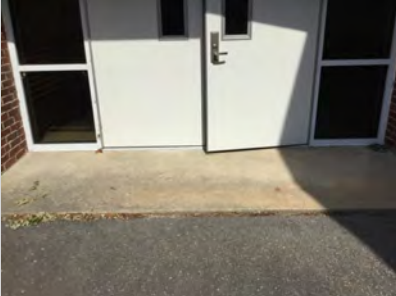
ID	Location	Floor	Room	Element	Type	Photo	Issues	Current Measure	Recommendations	Quantity	Price	Cost Estimation
11	Door 9	Ext.		Exterior Access Route	Exterior

Level changes > 1/4"	2"	Alter change in level to be 1/4" high max. where door landing meets asphalt walkway. (Cost for a 4'x4' asphalt patch.)	1	160	\$160
12	Walkway to Playground From Door 7	Ext.		Exterior Access Route	Walkway

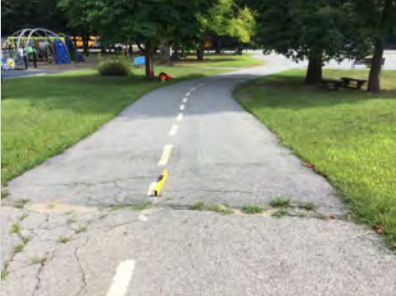
Level changes > 1/4"	2"	Alter change in level to be 1/4" high max., repair asphalt. (Cost based on a 4'x4' asphalt patch.)	1	160	\$160
13	Route From Doors 9, 10, and 11 to East Side of Building	Ext.		Exterior Access Route	Walkway

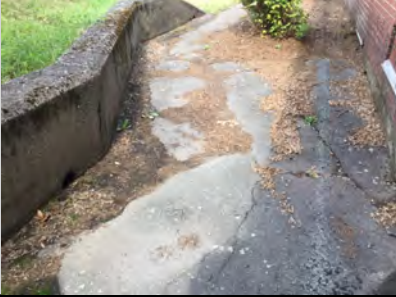
Accessible route not provided	-	Ensure an accessible route is provided. Repair walkway. (Cost based on 3'x20' of asphalt to correct walkway.)	1	600	\$600
14	Southeast Side of Building	Ext.		Exterior Access Route	Walkway

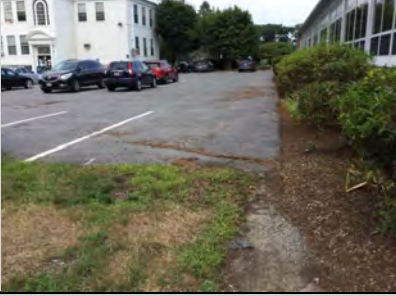
Accessible route not provided	-	Ensure an accessible route is provided. (Cost based on new 4' wide min. x 15' long asphalt walkway.)	1	600	\$600

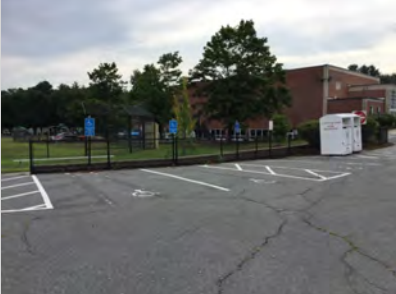
Off-Street Parking Lot or Garage												
15	West Parking Lot	Ext.		Off-Street Parking Lot or Garage	N/A

Total # of parking Total # of designated accessible parking spaces Total # of designated van accessible spaces Sign bottom < 60" above finished grade	75 2 1 50"	Locate sign with the bottom of the sign 60" above the ground.	3	Labor	\$0

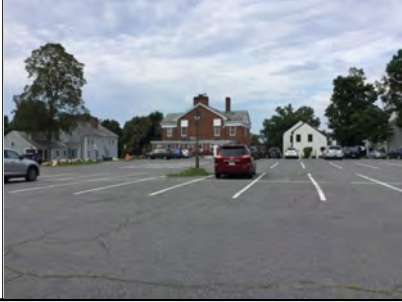
ID	Location	Floor	Room	Element	Type	Photo	Issues	Current Measure	Recommendations	Quantity	Price	Cost Estimation
16	West Parking Lot	Ext.		Off-Street Parking Lot or Garage	N/A

Total # of designated accessible parking spaces Total # of designated van accessible spaces	- -	Provide one van accessible space 11' wide min. with a marked access aisle 5' wide min. Include a sign with the International Symbol of Accessibility (ISA) and a sign with the word "Van Accessible" at the van accessible space. Provide a car accessible parking space 8' wide min. with a marked access aisle 5' wide min. and a sign with the International Symbol of Accessibility (ISA).	2	1850	\$3700
Access to Goods and Services												
Means of Egress												
17	Door 11	3		Means of Egress	N/A

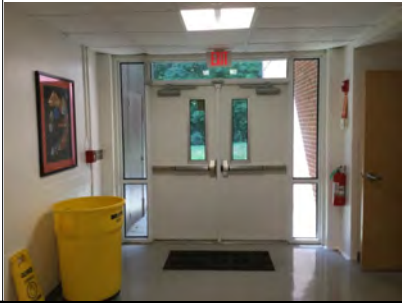
Tactile exit sign not provided	-	Ensure tactile exit signs with raised characters and braille are provided at exit doors. Mount signs between 48"- 60" above the finished floor located on the latch side of the door.	1	232	\$232

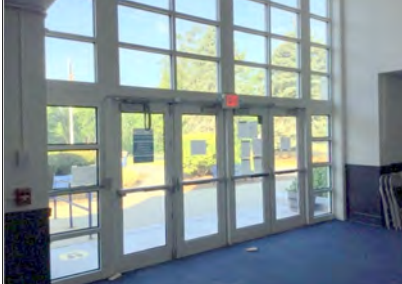
Tactile exit sign not provided Illuminated ISA symbol not provided (MAAB)	- -	Ensure tactile exit signs with raised characters and braille are provided at exit doors. Mount signs between 48"- 60" above the finished floor located on the latch side of the door. Provide an illuminated sign with the International Symbol of Accessibility.	1	432	\$432

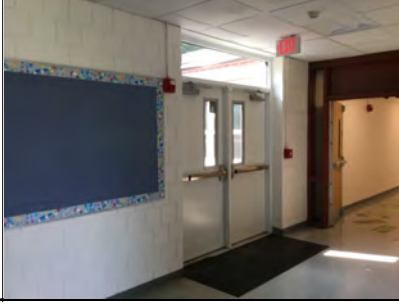
ID	Location	Floor	Room	Element	Type	Photo	Issues	Current Measure	Recommendations	Quantity	Price	Cost Estimation
21	Door 10	3		Means of Egress	N/A

Tactile exit sign not provided Illuminated ISA symbol not provided (MAAB)	- -	Ensure tactile exit signs with raised characters and braille are provided at exit doors. Mount signs between 48" - 60" above the finished floor located on the latch side of the door. Provide an illuminated sign with the International Symbol of Accessibility. (Exterior landing is just .75" high and can be patched to make accessible.)	1	432	\$432
22	Door 7	2		Means of Egress	N/A

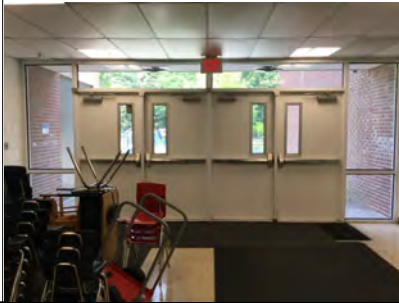
Tactile exit sign not provided Illuminated ISA symbol not provided (MAAB)	- -	Ensure tactile exit signs with raised characters and braille are provided at exit doors. Mount signs between 48" - 60" above the finished floor located on the latch side of the door. Provide an illuminated sign with the International Symbol of Accessibility.	1	432	\$432

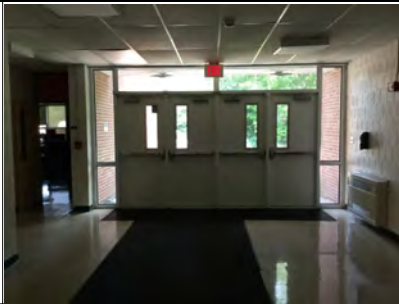
23	Door 8	2		Means of Egress	N/A

Tactile exit sign not provided Illuminated ISA symbol not provided (MAAB)	- -	Ensure tactile exit signs with raised characters and braille are provided at exit doors. Mount signs between 48" - 60" above the finished floor located on the latch side of the door. Provide an illuminated sign with the International Symbol of Accessibility.	1	432	\$432
24	Door 9	Ext.		Means of Egress	N/A

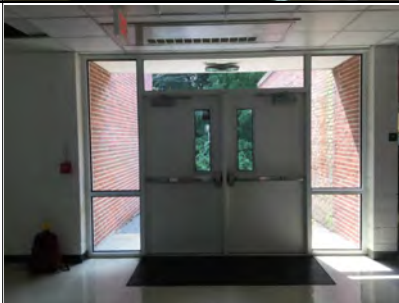
Tactile exit sign not provided Illuminated ISA symbol not provided (MAAB)	- -	Ensure tactile exit signs with raised characters and braille are provided at exit doors. Mount signs between 48" - 60" above the finished floor located on the latch side of the door. Provide an illuminated sign with the International Symbol of Accessibility. (Exterior landing is just .2" high and can be patched to make accessible.)	1	432	\$432
Interior Access Route												
25	Cafeteria	1		Interior Access Route	N/A

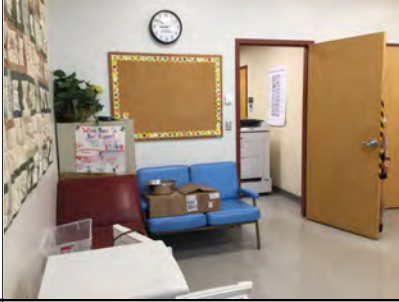
ID	Location	Floor	Room	Element	Type	Photo	Issues	Current Measure	Recommendations	Quantity	Price	Cost Estimation
Doors, Doorways, & Gates												
26	Office - Nurse's Room	3		Doors, Doorways, & Gates	Office

Maneuvering clearance(s) not provided	-	Remove furniture to provide 18" min. pull-side maneuvering clearance at door.	1	Labor	\$0
27	School Psychologist	3		Doors, Doorways, & Gates	Other

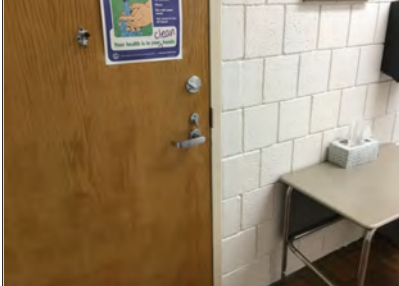
30	Gender Neutral Toilet Room	2		Doors, Doorways, & Gates	Toilet Room

Maneuvering clearance(s) not provided	14"	Remove desk to provide 18" min. pull side maneuvering clearance at the door.	1	Labor	\$0

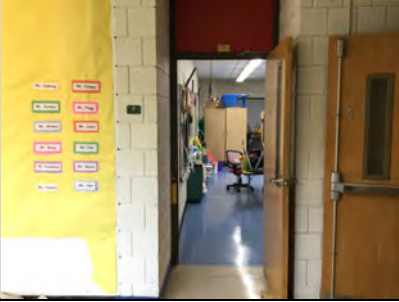
ID	Location	Floor	Room	Element	Type	Photo	Issues	Current Measure	Recommendations	Quantity	Price	Cost Estimation
31	Special Education Room	4	7	Doors, Doorways, & Gates	Classroom

Maneuvering clearance not provided at recess > 6"	32"	Install an automatic door opener.	1	3060	\$3060
32	Learning Center - Grades 3-5	4	1	Doors, Doorways, & Gates	Classroom

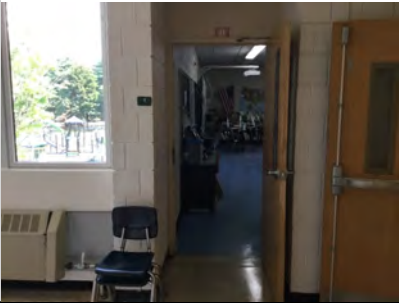
Maneuvering clearance not provided at recess > 6"	-	Install an automatic door opener.	1	3060	\$3060
33	Girls' Toilet Room	1		Doors, Doorways, & Gates	Toilet Room

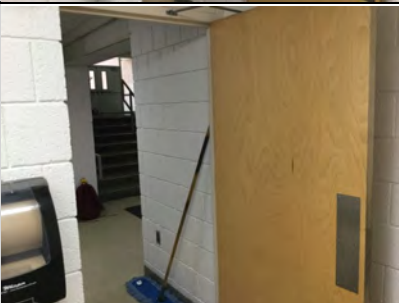
Maneuvering clearance not provided at recess > 6"	14.75"	Install an automatic door opener.	1	3060	\$3060
35	Learning Center - Grades K-2	4	1	Doors, Doorways, & Gates	Classroom

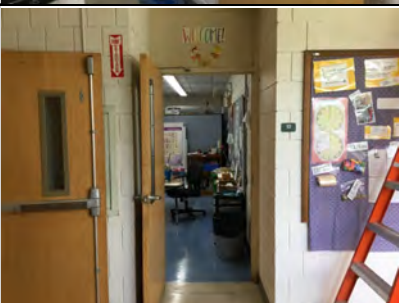
Maneuvering clearance not provided at recess > 6"	-	Install an automatic door opener./Reverse the swing of the door to provide maneuvering clearance.	1	3060	\$3060

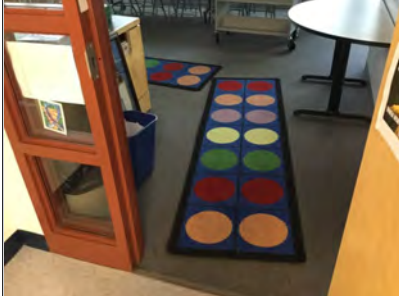
ID	Location	Floor	Room	Element	Type	Photo	Issues	Current Measure	Recommendations	Quantity	Price	Cost Estimation
36	Library	3		Doors, Doorways, & Gates	Other

Mat not securely attached	-	Secure the mat.	1	Labor	\$0
37	Door 7	2		Doors, Doorways, & Gates	Other

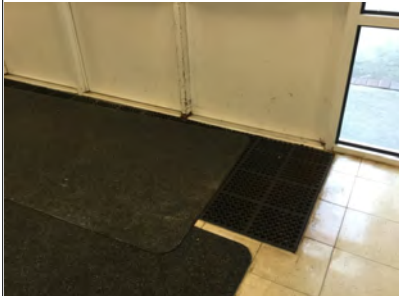
Mat not securely attached	-	Secure the mat.	1	Labor	\$0
38	Occupational Therapy Office	4		Doors, Doorways, & Gates	Other

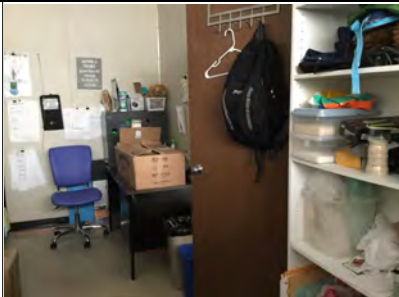
Hardware not operable with a closed fist	-	Provide hardware that can be operable with one hand and not require tight grasping, pinching, or twisting of the wrist.	1	484	\$484
39	Learning Center	4	43	Doors, Doorways, & Gates	Other

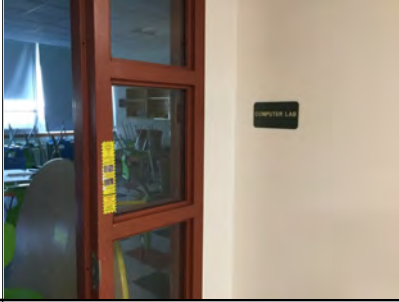
ID	Location	Floor	Room	Element	Type	Photo	Issues	Current Measure	Recommendations	Quantity	Price	Cost Estimation
Signage												
41	Learning Studio	3	39	Signage	Designation

Signage is not provided	-	Provide designation signage with the words, "Learning Studio" Current sign says, "Computer Lab" Locate compliant signage alongside the door on the latch side.	1	232	\$232
42	Occupational Therapy Office	4		Signage	Designation

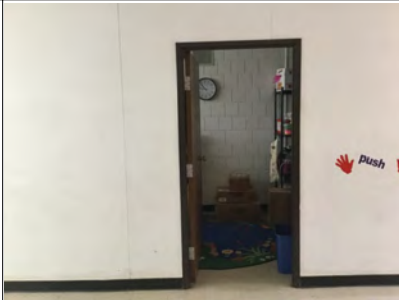
Signage is not provided	-	Locate compliant signage with raised characters and braille alongside the door on the latch side.	1	232	\$232
43	School Psychologist	3		Signage	Designation

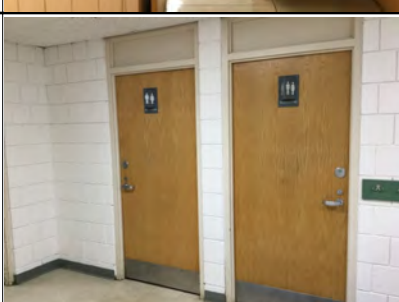
45	Inaccessible Toilet Rooms	1		Signage	Designation

Raised characters < 48" or > 60" above ground	66.5"	Mount signs so that the baseline of the lowest tactile character is 48" min. above finished floor and the baseline of the highest tactile character is 60" max. above the finished floor.	2	Labor	\$0

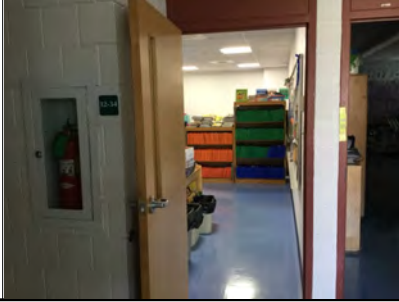
ID	Location	Floor	Room	Element	Type	Photo	Issues	Current Measure	Recommendations	Quantity	Price	Cost Estimation
46	Literacy Center	3	34	Signage	Designation

Sign not located on the latch side of the door	-	Locate sign at permanent rooms alongside the door on the latch side.	1	Labor	\$0
Children's Reach Ranges												
47	Learning Studio	3	39	Children's Reach Ranges	N/A

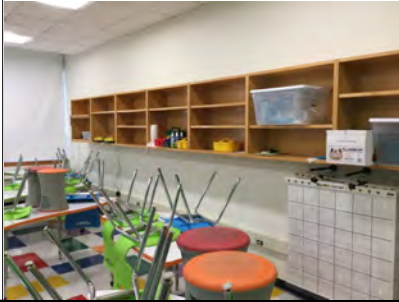
Reach < 18" or > 40" (Ages 5 - 8)	-	Provide at least one storage bin located between 18" and 40" above the finished floor.	1	256	\$256
48	Hallway - Kindergarten Wing	3		Children's Reach Ranges	N/A

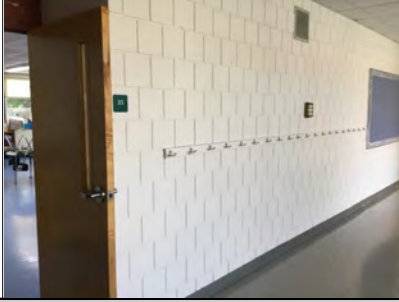
Reach < 18" or > 40" (Ages 5 - 8)	46.75"	Provide at least one coat hook for children no higher that 40" above the finished floor.	1	256	\$256
Dining or Work Surfaces												
49	Cafeteria	1		Dining or Work Surfaces	Dining Surface

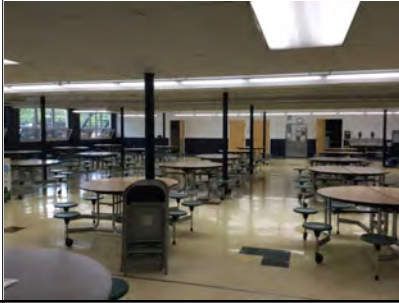
At least one or 5% accessible tables not provided	-	Ensure that 5% min. of the 21 dining surfaces in the cafeteria are accessible (have knee and toe clearance).	3	1100	\$3300

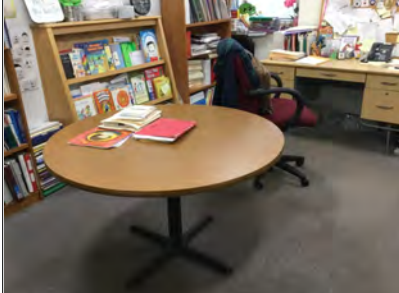
50	Guidance Counselor	3		Dining or Work Surfaces	Work Surface

Knee or toe clearance not provided	-	Provide at least 1 dining or work surface with 27" min. knee and toe clearance. (Table feet block toe clearance.)	1	700	\$700

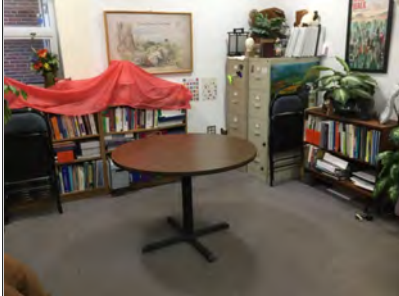
ID	Location	Floor	Room	Element	Type	Photo	Issues	Current Measure	Recommendations	Quantity	Price	Cost Estimation
51	School Psychologist	3		Dining or Work Surfaces	Work Surface

Knee or toe clearance not provided	-	Provide at least 1 work surface with 27" min. knee and toe clearance. (Table feet block toe clearance.)	1	700	\$700
52	Library	3		Dining or Work Surfaces	Work Surface

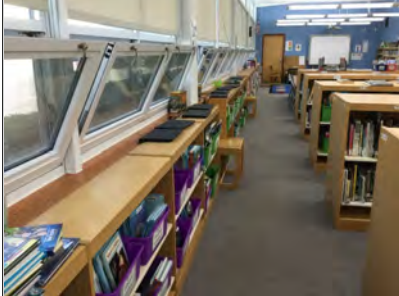
Top of dining/work surface < 28" or > 34"	-	Provide at least one computer station work surface with tops between 28"- 34" above the floor and 27" clear height underneath. Relocate one computer.	1	Labor	\$0
Sign												
53	Office - Future Nurse's Office	3		Sign	N/A

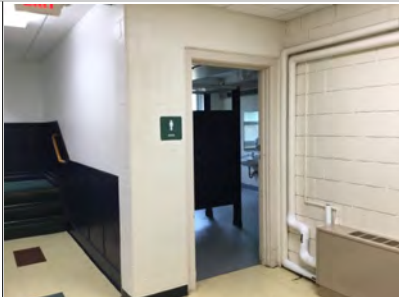
54	Boys' Toilet Room by Cafeteria	1		Overall Access	Toilet Room

Sign to accessible toilet not provided	-	Provide a directional sign indicating the location of the nearest accessible toilet or bathing room.	1	232	\$232
55	Girls' Toilet Room by Cafeteria	1		Overall Access	Toilet Room

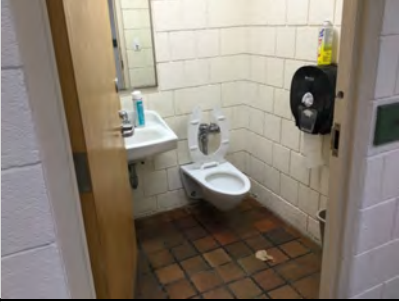
ID	Location	Floor	Room	Element	Type	Photo	Issues	Current Measure	Recommendations	Quantity	Price	Cost Estimation
56	Inaccessible Toilet Rooms	1		Overall Access	Toilet Room

Sign to accessible toilet not provided	-	Provide a directional sign indicating the location of the nearest accessible toilet or bathing room.	2	232	\$464
57	Inaccessible Toilet Rooms	1		Overall Access	Toilet Room

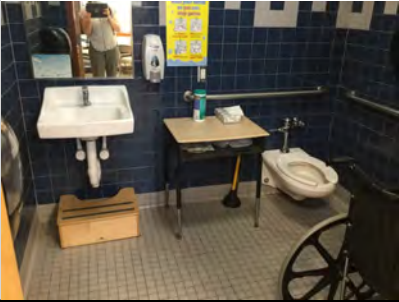
59	Office - Nurse's Room	3		Single-User Toilet (Children)	N/A

Clearance at toilet < 60" clear wide	-	Remove desk from transfer clear floor space at toilet.	1	Labor	\$0
60	Girls' Toilet Room	3		Single-User Toilet (Children)	N/A

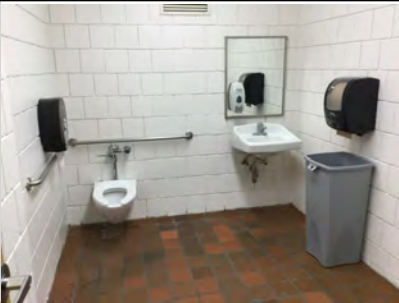
Flush control not on open side Non-compliant toilet paper dispenser	- -	Move the flush control to the open side. Mount flush control between 20" - 30" above the floor. Relocate toilet paper dispenser so that it is between 14"- 19" above the floor and between 7"- 9" in front of the toilet. Ensure dispensers and other devices are not mounted above grab bars./Replace dispenser as it does not allow continuous paper flow.	1	727	\$727

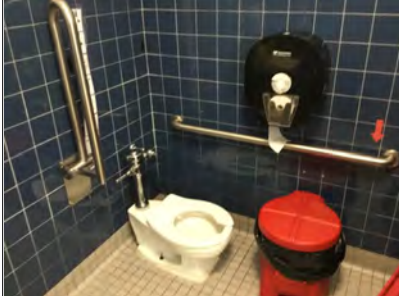
ID	Location	Floor	Room	Element	Type	Photo	Issues	Current Measure	Recommendations	Quantity	Price	Cost Estimation
61	Pre-K Classroom	3	25	Single-User Toilet (Children)	N/A

Side or rear grab bar not provided Non-compliant toilet paper dispenser	- -	Provide one grab bar on the rear wall. Relocate toilet paper dispenser so that it is between 14"- 19" above the floor and between 7"- 9" in front of the toilet. Ensure dispensers and other devices are not mounted above grab bars./Replace dispenser as it does not allow continuous paper flow.	1	802	\$802
62	Office - Nurse's Room	3		Single-User Toilet (Children)	N/A

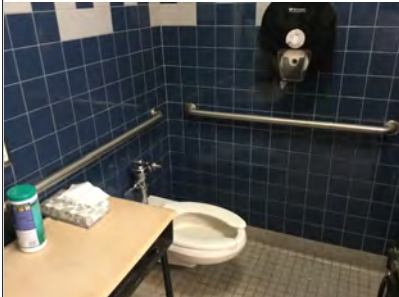
Non-compliant toilet paper dispenser	-	Relocate toilet paper dispenser so that it is between 14"- 19" above the floor and between 7"- 9" in front of the toilet. Ensure dispensers and other devices are not mounted above grab bars./Replace dispenser as it does not allow continuous paper flow.	1	353	\$353

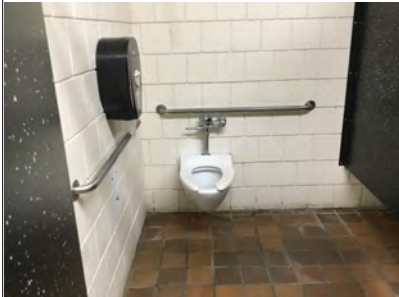
Toilet Compartment (Children)												
63	Boys' Toilet Room	4		Toilet Compartment (Children)	Accessible Compartment

Toilet seat < 12" or > 15" high (Ages 5 - 8) Flush control not on open side Centerline < 12" or > 15" (Ages 5 - 8) Non-compliant toilet paper dispenser	18.75" - 19.25" -	Install a toilet with a seat between 12"- 15" high above the finished floor. Provide the flush control on the open side of the toilet (transfer side), no higher than 44". Relocate toilet so that the centerline is between 12" and 15" from the side wall. Relocate toilet paper dispenser so that it is between 14"- 19" above the floor and between 7"- 9" in front of the toilet below grab bar.	1	3555	\$3555
64	Girls' Toilet Room	1		Toilet Compartment (Children)	Accessible Compartment

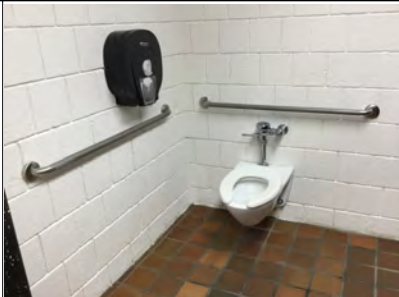
Flush control not on open side Centerline < 12" or > 15" (Ages 5 - 8) Non-compliant toilet paper dispenser	- 24.25" -	Provide the flush control on the open side of the toilet (transfer side), no higher than 44". Relocate toilet so that the centerline is between 12" and 15" from the side wall. Relocate toilet paper dispenser so that it is between 14"- 19" above the floor and between 7"- 9" in front of the toilet. Ensure dispensers and other devices are not mounted above grab bars.	1	3555	\$3555

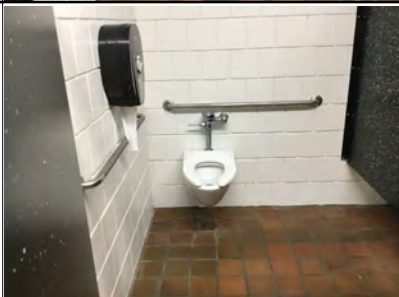
65	Boys' Toilet Room	2		Toilet Compartment (Children)	Accessible Compartment

Flush control not on open side Non-compliant toilet paper dispenser	- -	Provide the flush control on the open side of the toilet (transfer side), no higher than 44". Relocate toilet paper dispenser so that it is between 14"- 19" above the floor and between 7"- 9" in front of the toilet. Ensure dispensers and other devices are not mounted above grab bars. / Replace dispenser as it does not allow continuous paper flow.	1	727	\$727

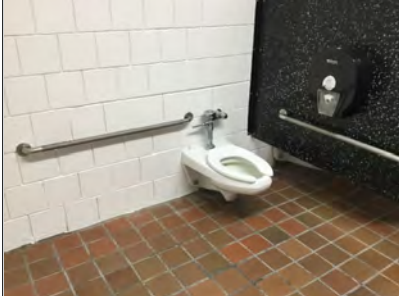
ID	Location	Floor	Room	Element	Type	Photo	Issues	Current Measure	Recommendations	Quantity	Price	Cost Estimation
66	Girls' Toilet Room	2		Toilet Compartment (Children)	Accessible Compartment

Centerline < 12" or > 15" (Ages 5 - 8) Non-compliant toilet paper dispenser	18" -	Relocate toilet so that the centerline is between 12" and 15" from the side wall. Relocate toilet paper dispenser so that it is between 14"- 19" above the floor and between 7"- 9" in front of the toilet. Ensure dispensers and other devices are not mounted above grab bars.	1	3181	\$3181
67	Girls' Toilet Room	4		Toilet Compartment (Children)	Accessible Compartment

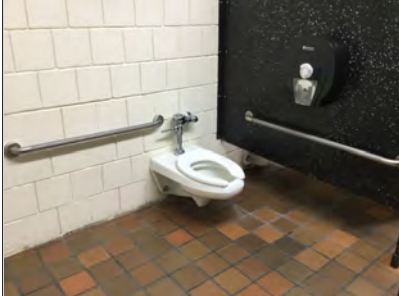
Non-compliant toilet paper dispenser	-	Relocate toilet paper dispenser so that it is between 14"- 19" above the floor and between 7"- 9" in front of the toilet. Ensure dispensers and other devices are not mounted above grab bars./Replace dispenser as it does not allow continuous paper flow.	1	353	\$353

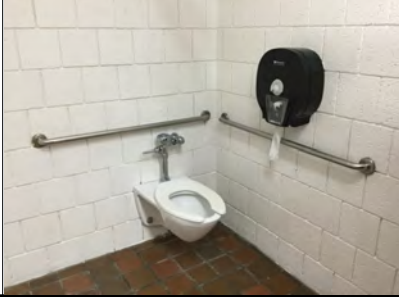
68	Boys' Toilet Room	3		Toilet Compartment (Children)	Accessible Compartment

Non-compliant toilet paper dispenser	-	Relocate toilet paper dispenser so that it is between 14"- 19" above the floor and between 7"- 9" in front of the toilet. Ensure dispensers and other devices are not mounted above grab bars./Replace dispenser as it does not allow continuous paper flow.	1	353	\$353
69	Boys' Toilet Room	1		Toilet Compartment (Children)	Accessible Compartment

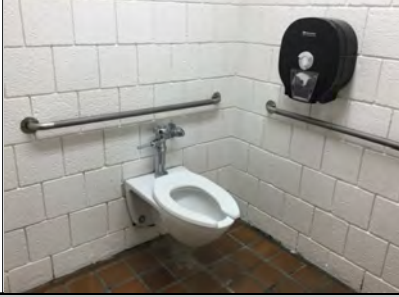
Non-compliant toilet paper dispenser	-	Relocate toilet paper dispenser so that it is between 14"- 19" above the floor and between 7"- 9" in front of the toilet. Ensure dispensers and other devices are not mounted above grab bars./Replace dispenser as it does not allow continuous paper flow.	1	353	\$353
Lavatory (Children)												
70	Boys' Toilet Room	3		Lavatory (Children)	N/A

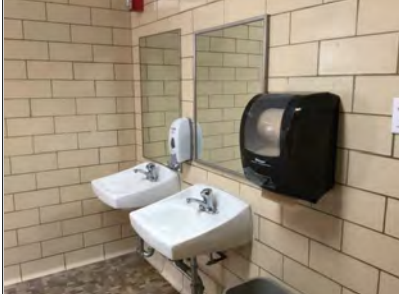
Toe or knee clearances not provided Exposed plumbing underneath Mirror above lavatory w/reflective surface > 31"	23.25" - 39"	Provide at least one lavatory with 25" min. knee clearance positioned for a forward approach. Ensure toe clearance is also provided. Insulate or otherwise configure pipes to prevent contact, for at least one lavatory. Lower mirror so that the bottom surface is at 31" above finished floor.	1	2034	\$2034

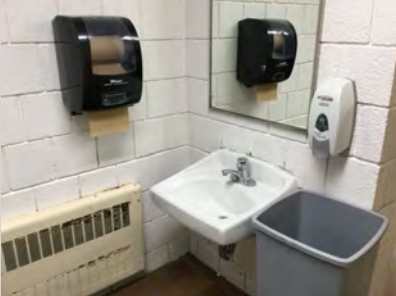
ID	Location	Floor	Room	Element	Type	Photo	Issues	Current Measure	Recommendations	Quantity	Price	Cost Estimation
71	Girls' Toilet Room	1		Lavatory (Children)	N/A

Toe or knee clearances not provided Exposed plumbing underneath Mirror above lavatory w/reflective surface > 31"	23" - 41"	Provide at least one lavatory with 25" min. knee clearance positioned for a forward approach. Ensure toe clearance is also provided. Insulate or otherwise configure pipes to prevent contact, for at least one lavatory. Lower mirror so that the bottom surface is at 31" above finished floor.	1	2034	\$2034
72	Pre-K Classroom	3	25	Lavatory (Children)	N/A

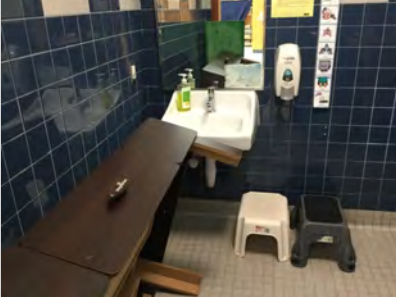
Toe or knee clearances not provided Mirror above lavatory w/reflective surface > 31"	23.75" 35.25"	Provide at least one lavatory with 25" min. knee clearance positioned for a forward approach. Ensure toe clearance is also provided. Lower mirror so that the bottom surface is at 31" above finished floor.	1	1942	\$1942

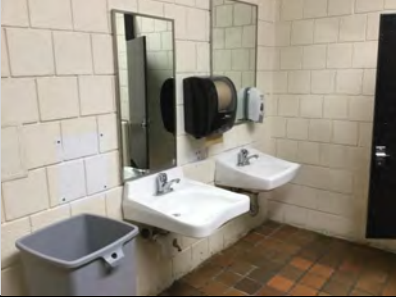
73	Girls' Toilet Room	4		Lavatory (Children)	N/A

Toe or knee clearances not provided Mirror above lavatory w/reflective surface > 31"	23.25" 33.25"	Provide at least one lavatory with 25" min. knee clearance positioned for a forward approach. Ensure toe clearance is also provided. Lower mirror so that the bottom surface is at 31" above finished floor.	1	1942	\$1942
74	Boys' Toilet Room	4		Lavatory (Children)	N/A

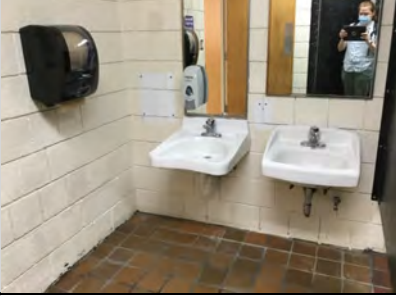
Toe or knee clearances not provided Mirror above lavatory w/reflective surface > 31"	23.5" 34.5"	Provide at least one lavatory with 25" min. knee clearance positioned for a forward approach. Ensure toe clearance is also provided. Lower mirror so that the bottom surface is at 31" above finished floor.	1	1942	\$1942
75	Girls' Toilet Room	3		Lavatory (Children)	N/A

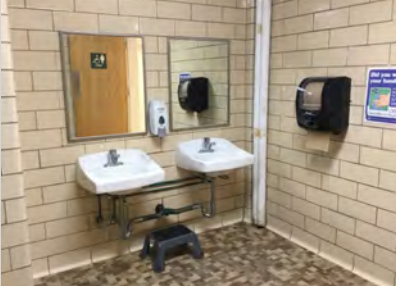
Exposed plumbing underneath Mirror above lavatory w/reflective surface > 31"	- -	Insulate or otherwise configure pipes to prevent contact, for at least one lavatory. Lower mirror so that the bottom surface is at 31" above finished floor.	1	348	\$348

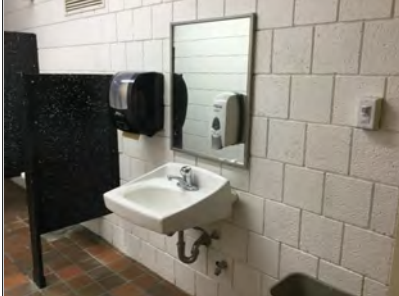
ID	Location	Floor	Room	Element	Type	Photo	Issues	Current Measure	Recommendations	Quantity	Price	Cost Estimation
76	Boys' Toilet Room	3		Lavatory (Children)	N/A

Exposed plumbing underneath Mirror above lavatory w/reflective surface > 31"	- 38.5"	Insulate or otherwise configure pipes to prevent contact, for at least one lavatory. Lower mirror so that the bottom surface is at 31" above finished floor.	1	348	\$348
77	Boys' Toilet Room	1		Lavatory (Children)	N/A

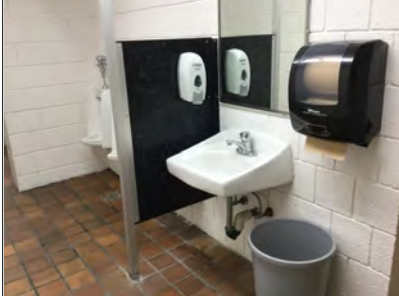
Exposed plumbing underneath Mirror above lavatory w/reflective surface > 31"	- 40"	Insulate or otherwise configure pipes to prevent contact, for at least one lavatory. Lower mirror so that the bottom surface is at 31" above finished floor.	1	348	\$348
78	Girls' Toilet Room	3		Lavatory (Children)	N/A

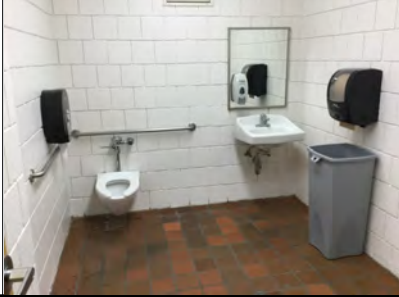
Exposed plumbing underneath Mirror above lavatory w/reflective surface > 31"	- 39" -	Insulate or otherwise configure pipes to prevent contact, for at least one lavatory. Lower mirror so that the bottom surface is at 31" above finished floor.	1	348	\$348

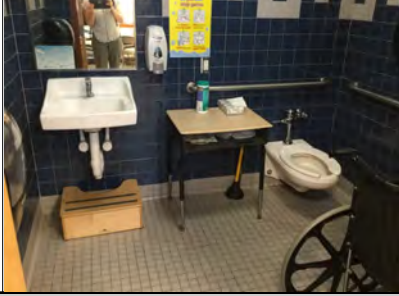
79	Office - Nurse's Room	3		Lavatory (Children)	N/A

Mirror above lavatory w/reflective surface > 31"	-	Lower mirror so that the bottom surface is at 31" above finished floor.	1	256	\$256
Dispensers (Children)												
80	Girls' Toilet Room	2		Dispensers (Children)	Paper Towel Dispenser

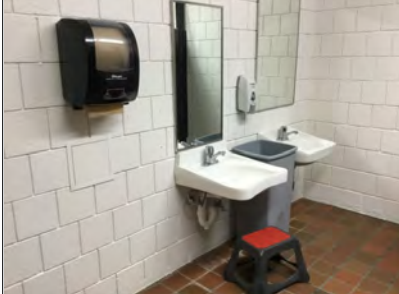
Dispenser controls > 42" high Dispenser is a protruding object	47.75" -	Relocate so the operable part of the paper towel dispenser is 42" max. above the finished floor. Relocate dispenser out of the circulation path or provide a cane-detectible-barrier.	1	353	\$353

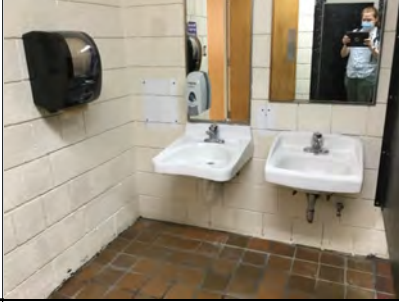
ID	Location	Floor	Room	Element	Type	Photo	Issues	Current Measure	Recommendations	Quantity	Price	Cost Estimation
81	Boys' Toilet Room	4		Dispensers (Children)	Paper Towel Dispenser

Dispenser is a protruding object	-	Relocate dispenser out of the circulation path or provide a cane-detectible barrier.	1	353	\$353
82	Girls' Toilet Room	3		Dispensers (Children)	Paper Towel Dispenser

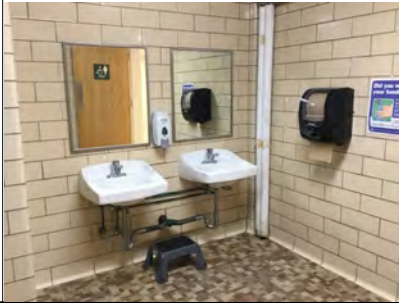
Dispenser is a protruding object	-	Relocate dispenser out of the circulation path or provide a cane-detectible barrier.	1	353	\$353
Additional Access												
Drinking Fountains												
83	Near Toilet Rooms	3		Drinking Fountains	Low

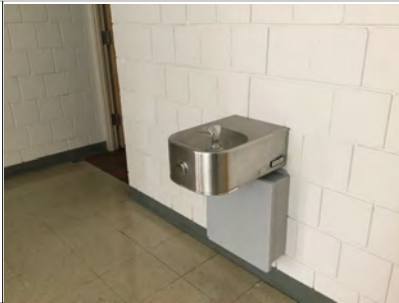
No drinking fountain provided for standing users	-	Provide an additional drinking fountain for standing users or install a Hi-Lo drinking fountain.	1	4216	\$4216
84	Cafeteria	1		Drinking Fountains	Low

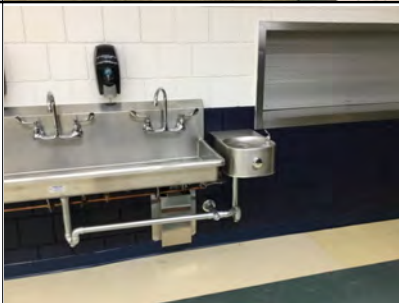
No drinking fountain provided for standing users	-	Provide an additional drinking fountain for standing users or install a Hi-Lo drinking fountain.	1	4216	\$4216

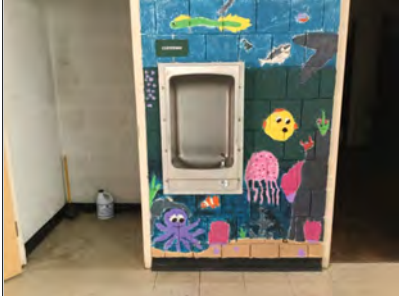
ID	Location	Floor	Room	Element	Type	Photo	Issues	Current Measure	Recommendations	Quantity	Price	Cost Estimation
86	Near Toilet Rooms	4		Drinking Fountains	Low

No drinking fountain provided for standing users Knee or toe clearance not provided	- -	Provide an additional drinking fountain for standing users or install a Hi-Lo drinking fountain. Provide knee and toe clearance, 27" min. high at drinking fountain for seated users. (Cost based on a new Hi-Lo drinking fountain.)	1	4216	\$4216
87	Near Toilet Rooms	2		Drinking Fountains	Low

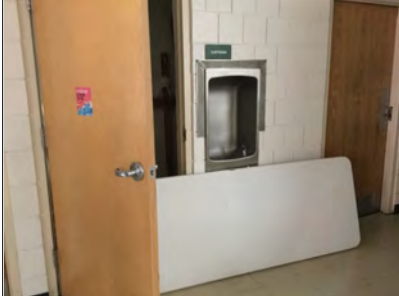
No drinking fountain provided for standing users Knee or toe clearance not provided	- -	Provide an additional drinking fountain for standing users or install a Hi-Lo drinking fountain. Provide knee and toe clearance, 27" min. high at drinking fountain for seated users. (Cost based on a new Hi-Lo drinking fountain.)	1	4216	\$4216
88	Hallway to Pre-K Classrooms	3		Drinking Fountains	Low

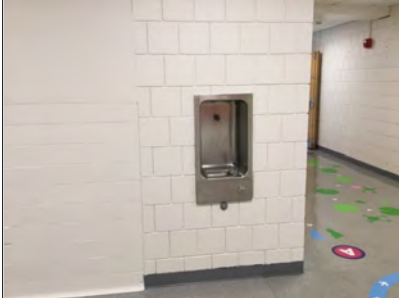
Knee or toe clearance not provided No drinking fountain provided for standing users	- -	Provide an additional drinking fountain for standing users or install a Hi-Lo drinking fountain. Provide knee and toe clearance, 27" min. high at drinking fountain for seated users. (Cost based on a new Hi-Lo drinking fountain.)	1	4216	\$4216

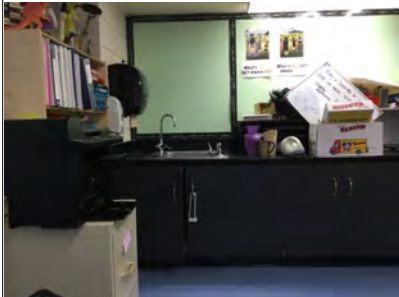
Sink												
89	Special Education Room	4	7	Sink	Classroom

Clear floor space not provided at sink Toe and knee clearances not provided	- -	Provide a 30" by 48" clear floor space positioned for a forward approach. Ensure there is a 27" knee clearance positioned for a forward approach.	1	1686	\$1686
90	Learning Studio	3	39	Sink	Classroom

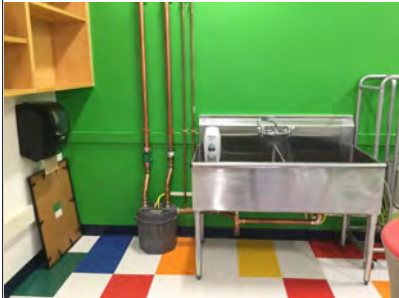
Toe and knee clearances not provided	-	Ensure there is a 27" knee clearance positioned for a forward approach.	1	1686	\$1686

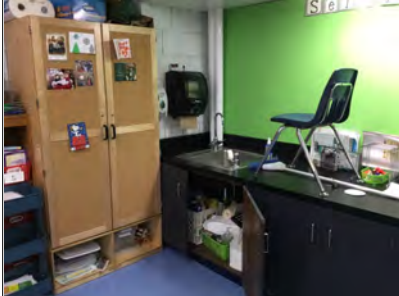
ID	Location	Floor	Room	Element	Type	Photo	Issues	Current Measure	Recommendations	Quantity	Price	Cost Estimation
91	Kindergarten	3	35	Sink	Classroom

Toe and knee clearances not provided	-	Ensure there is a 27" knee clearance positioned for a forward approach.	1	1686	\$1686
92	Grade 4	4	8	Sink	Classroom

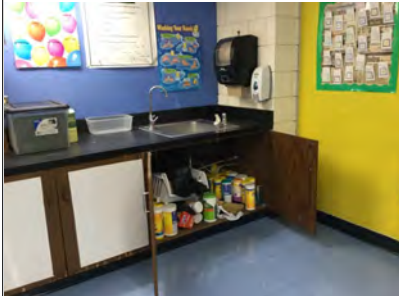
Toe and knee clearances not provided	-	Ensure there is a 27" knee clearance positioned for a forward approach.	1	1686	\$1686
93	Learning Center - Grades 3-5	4	1	Sink	Classroom

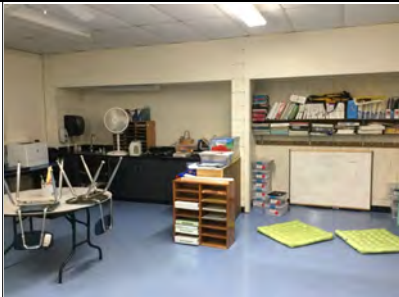
Toe and knee clearances not provided	-	Ensure there is a 27" knee clearance positioned for a forward approach.	1	1686	\$1686
94	Learning Center - Grades K-2	4	12	Sink	Classroom

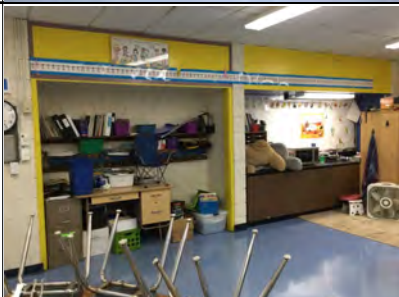
Toe and knee clearances not provided	-	Ensure there is a 27" knee clearance positioned for a forward approach.	1	1686	\$1686
95	Grade 2	2	22	Sink	Classroom

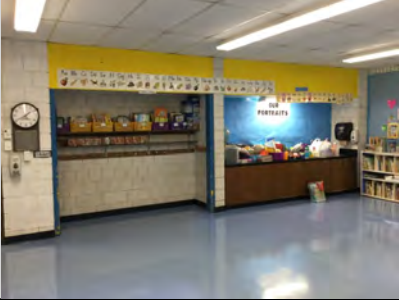
ID	Location	Floor	Room	Element	Type	Photo	Issues	Current Measure	Recommendations	Quantity	Price	Cost Estimation
96	Grade 1	2	20	Sink	Classroom

Toe and knee clearances not provided	-	Ensure there is a 27" knee clearance positioned for a forward approach.	1	1686	\$1686
Sinks for Children's Use												
97	Pre-K Classroom	3	25	Sinks for Children's Use	Classroom

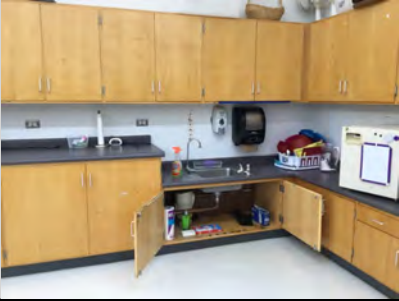
Exposed plumbing underneath Knee or toe clearance not provided	- -	Insulate or otherwise configure pipes to prevent contact, for at least one sink. Provide at least one sink with 25" high knee and toe clearance positioned for a forward approach.	1	1778	\$1778
Play and Sport Areas												
Play Areas												
98	Playground	Ext.		Play Areas	N/A

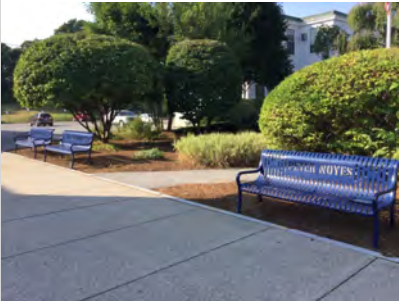
Accessible spaces are not provided at sidelines seating	-	When bleachers are replaced, purchase bleachers with integrated accessible seating.	1	-	\$0
Best Practice												
Bench												
103	Main Entrance	Ext.		Bench	N/A

Recommend a 36"x48" stable, firm and slip resistant space at the end of at least one bench in each area so a companion in a wheeled mobility device can sit alongside someone on the bench.	1	-	\$0

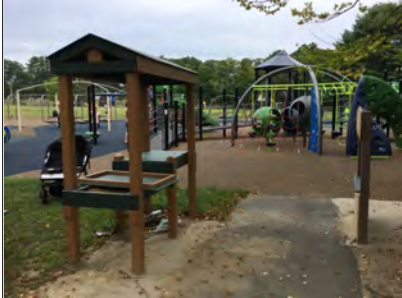
ID	Location	Floor	Room	Element	Type	Photo	Issues	Current Measure	Recommendations	Quantity	Price	Cost Estimation
Sandbox Play Area												
104	Entrance to Playground	Ext.		Sandbox Play Area	N/A

Recommend repositioning sandbox at playground entrance away from accessible route to playground so children playing with the sandbox don't obstruct the accessible route to the playground.	1	-	\$0
