Re: Mold Air Sampling, Hosmer House – 299 Old Sudbury Road, Sudbury, MA

Photo Log (9-17-24)

Hosmer House
299 Old Sudbury Road, Sudbury, Massachusetts

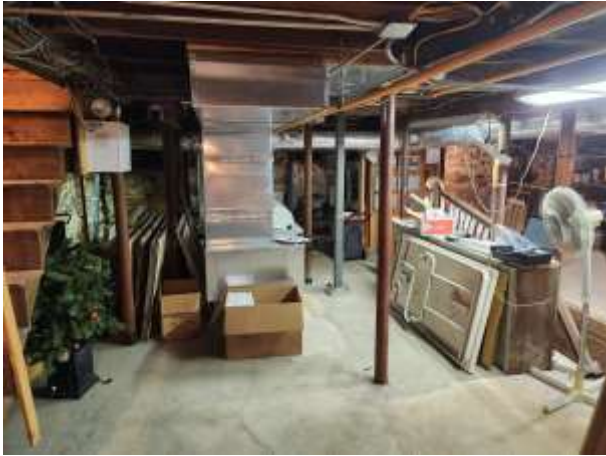
Moisture Findings – SWA tested representative finishes throughout the impact areas and the majority of all finishes were determined to be within the air-dry 0-18% range. The basement appeared to be dry this visit and was somewhat dank during our August evaluation.

Basement Area, dry conditions

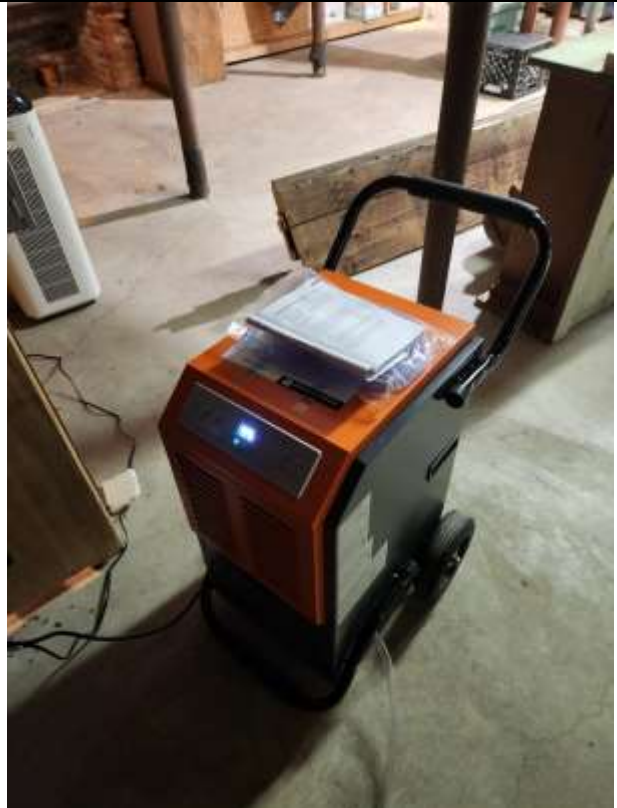
During the September 17, 2024 assessment, SWA noted that two dehumidifiers and a HEPA air filtration unit operating in the basement. HEPA air filtration units were also operating in the stairwell areas on the main floors. No moisture was detected in any of the finishes and no visible mold growth or water staining was evident. The relative humidity (RH) was in the 40% range within the recommended comfort level of 30% to 60%.

Unit operating in basement

- Based on the diminished number of airborne spores noted in the basement, it appears that the installation of the dehumidifiers and HEPA air filtration unit has successfully mitigated the airborne mold issue in that space. The 2nd floor Art Storage room and adjacent spaces appear to be maintaining expected levels of airborne mold spores and types. No further concerns were noted in those spaces. However, it would be prudent to conduct periodic testing to be certain conditions remain stable.

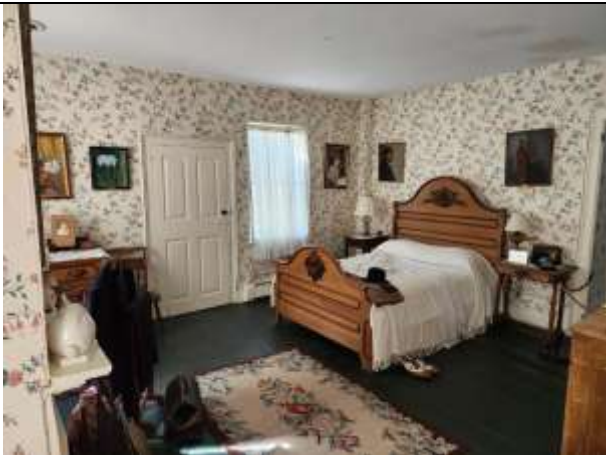
2nd Floor, bedroom, no issues

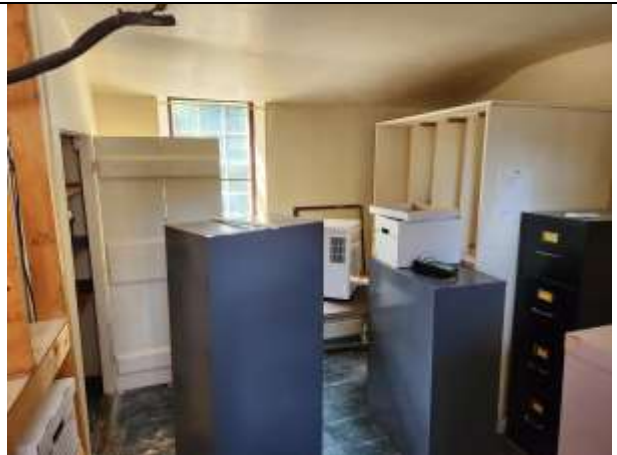
2nd Floor, Art Storage Room, no issue
