## Weekly Environmental Compliance Summary

**Sudbury to Hudson Transmission Reliability Project (USEPA Tracking # MAR1003UW)**

Week of: November 7 to November 11, 2022 (no work on Nov. 11 – Veterans Day)

# CONSTRUCTION MONITORING REPORT

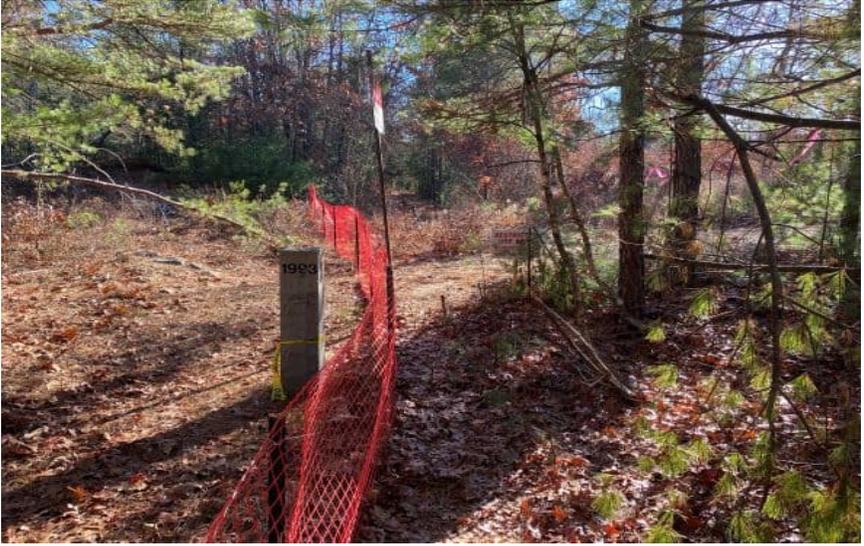
<b>PHOTOGRAPHIC LOG</b>	
Client Name: Eversource		Site Location: Sudbury to Hudson Transmission Reliability Project	Town: Hudson/Sudbury
Photo No.: 5	Date: 11-10-22

Description:  Town bound at Hudson, Sudbury & Marlboro lines, looking eastward.
