**Weekly Environmental Compliance Summary**

**Sudbury to Hudson Transmission Reliability Project (USEPA Tracking # MAR1003UW)**

Sudbury, Hudson, and Stow, MA

Week of: February 13 to February 17, 2023

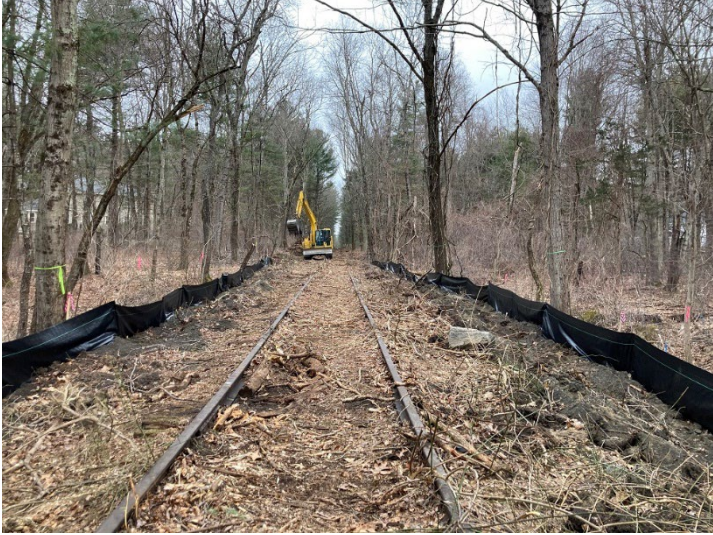
<p align="right"><b>PHOTOGRAPHIC LOG</b></p>	
<p><b>Client Name:</b> Eversource</p>		<p><b>Site Location:</b> Sudbury to Hudson Transmission Reliability Project</p>	<p><b>Town:</b> Sudbury</p>
<p><b>Photo No.:</b> 3</p>	<p><b>Date:</b> 2/13/2023</p>

<p><b>Description:</b> View of Moosehead conducting stump/rail/tie removal in segment 9. Facing west.</p>

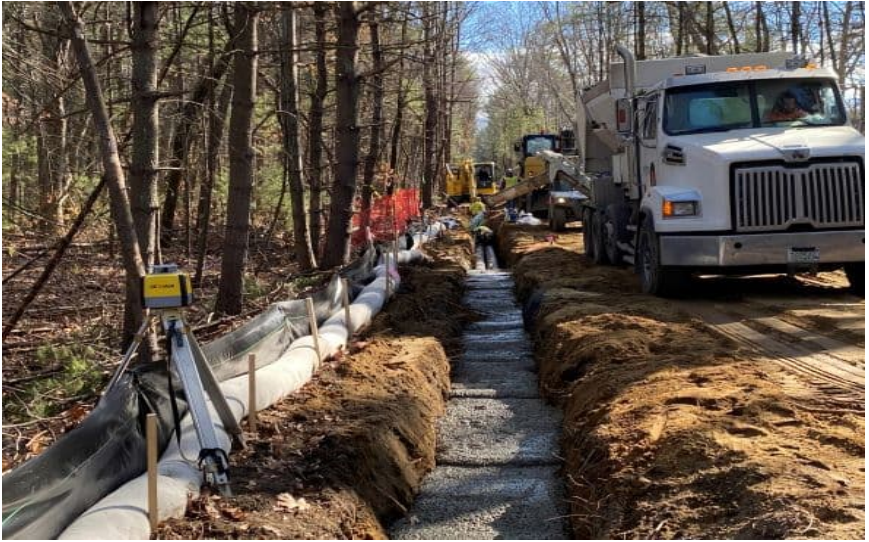
<p>PHOTOGRAPHIC LOG</p>	
<p>Client Name: Eversource</p>		<p>Site Location: Sudbury to Hudson Transmission Reliability Project</p>	<p>Town: Hudson</p>
<p>Photo No.: 1</p>	<p>Date: 2-14-23</p>

<p>Description:</p> <p>Backfilling of ROW from MH#10 (following conduit installation) within Segment 4 at approximate Sta#204+00, looking eastward.</p>

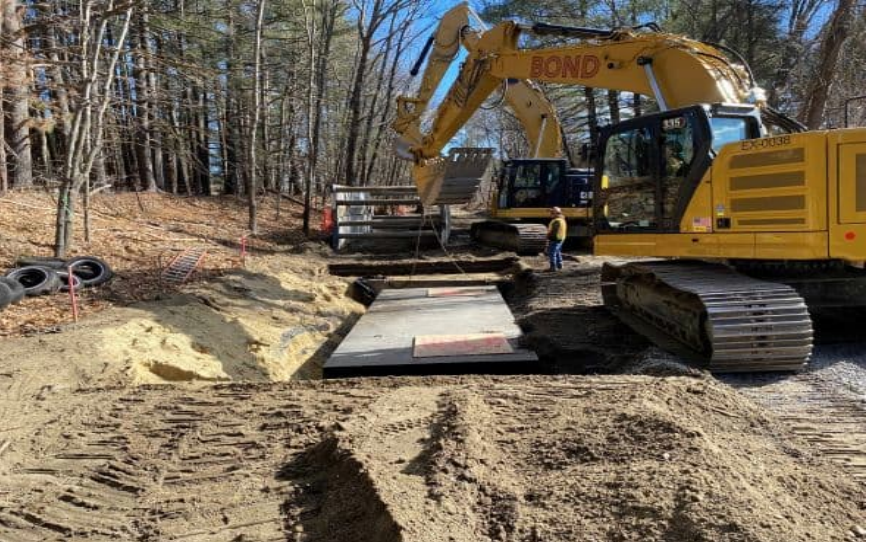
<p>PHOTOGRAPHIC LOG</p>	
<p>Client Name: Eversource</p>		<p>Site Location: Sudbury to Hudson Transmission Reliability Project</p>	<p>Town: Hudson</p>
<p>Photo No.: 2</p>	<p>Date: 2-14-23</p>

<p>Description:</p> <p>Bond conducting site work at MH#9 within Segment 3 at approximate Sta#177+00, looking eastward.</p>

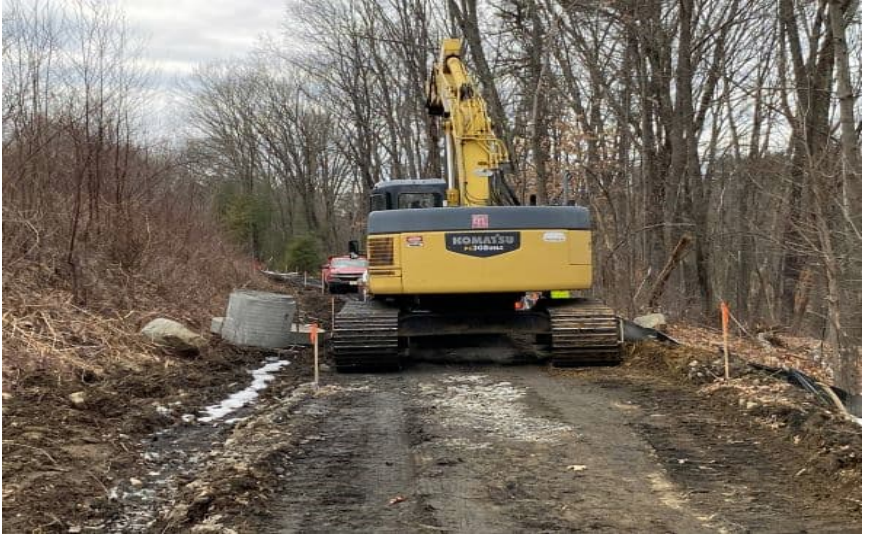
<p>PHOTOGRAPHIC LOG</p>	
<p>Client Name: Eversource</p>		<p>Site Location: Sudbury to Hudson Transmission Reliability Project</p>	<p>Town: Hudson</p>
<p>Photo No.: 4</p>	<p>Date: 2-14-23</p>

<p>Description:</p> <p>ET&amp;L installing leaching structure within Segment 1 at approximately Sta#119+00, looking westward.</p>

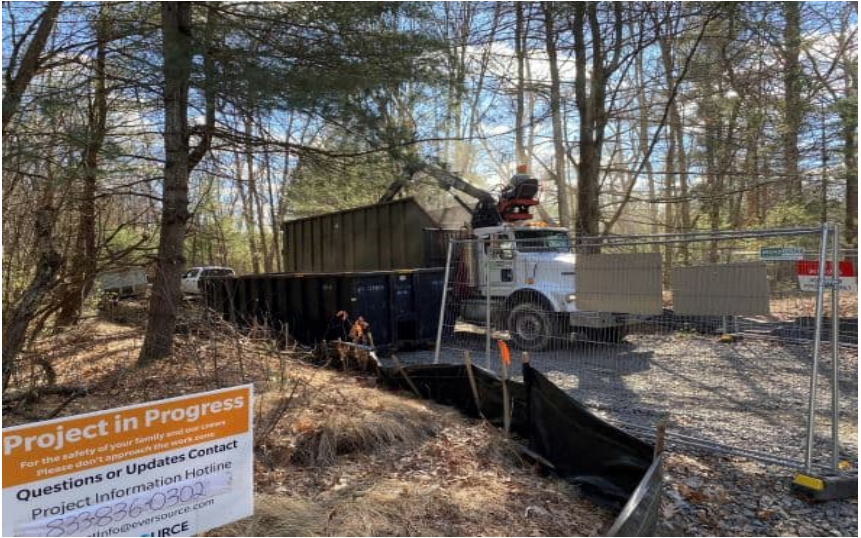
<p>PHOTOGRAPHIC LOG</p>	
<p>Client Name: Eversource</p>		<p>Site Location: Sudbury to Hudson Transmission Reliability Project</p>	<p>Town: Hudson</p>
<p>Photo No.: 7</p>	<p>Date: 2-14-23</p>

<p>Description:</p> <p>Moosehead removing debris from Segment 7 and placing cut rail within dumpsters off White Pond Road, looking eastward.</p>

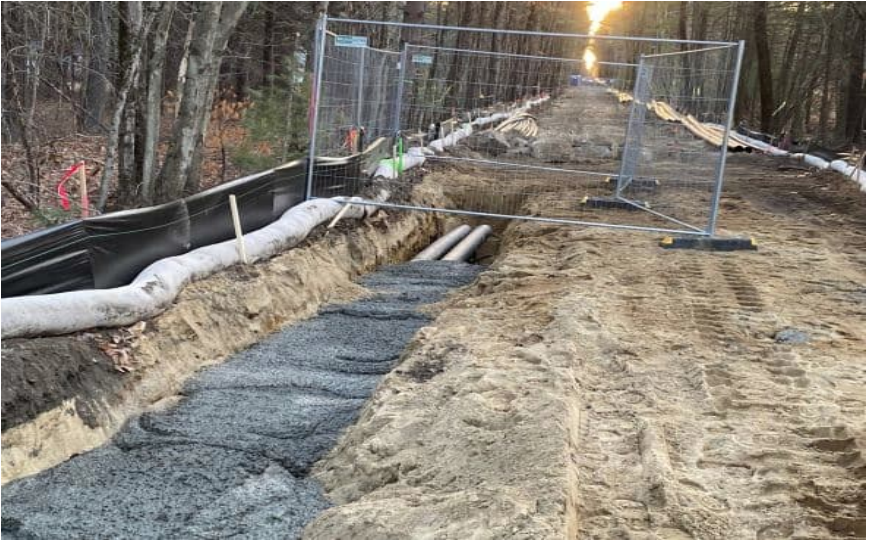
<p>PHOTOGRAPHIC LOG</p>	
<p>Client Name: Eversource</p>		<p>Site Location: Sudbury to Hudson Transmission Reliability Project</p>	<p>Town: Hudson</p>
<p>Photo No.: 1</p>	<p>Date: 2-16-23</p>

<p>Description:</p> <p>Backfilling of ROW from MH#10 (following conduit installation) within Segment 4 at approximate Sta#206+50, looking eastward.</p>

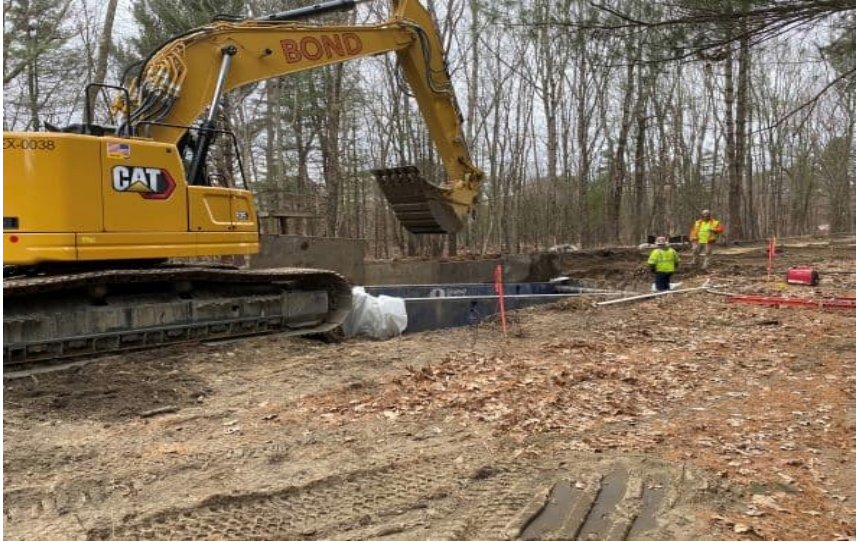
<p>PHOTOGRAPHIC LOG</p>	
<p>Client Name: Eversource</p>		<p>Site Location: Sudbury to Hudson Transmission Reliability Project</p>	<p>Town: Hudson</p>
<p>Photo No.: 2</p>	<p>Date: 2-16-23</p>

<p>Description:</p> <p>Bond conducting site work at MH#7 within Segment 2 at approximate Sta#139+00, looking westward.</p>

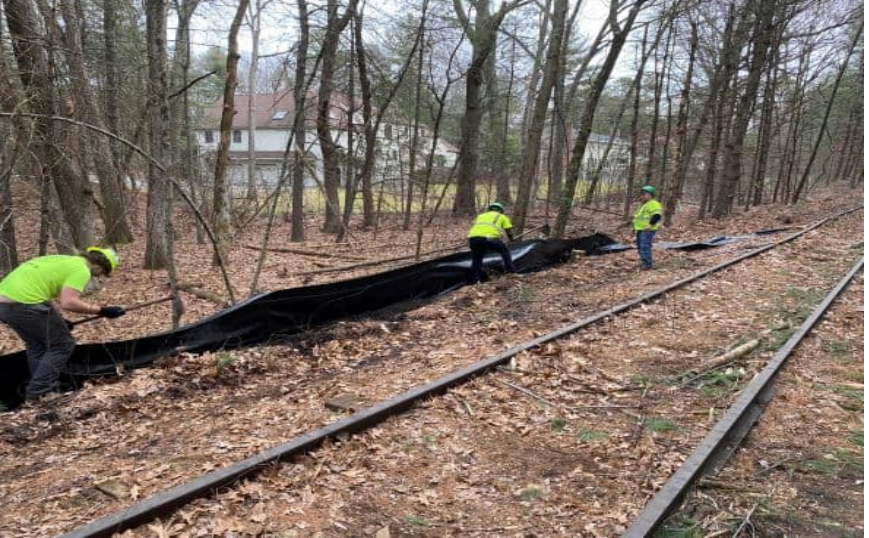
<p>PHOTOGRAPHIC LOG</p>	
<p>Client Name: Eversource</p>		<p>Site Location: Sudbury to Hudson Transmission Reliability Project</p>	<p>Town: Sudbury</p>
<p>Photo No.: 4</p>	<p>Date: 2-16-23</p>

<p>Description:</p> <p>MON installing silt fencing within Segment 11 at approximate Sta# 545+00, looking eastward.</p>

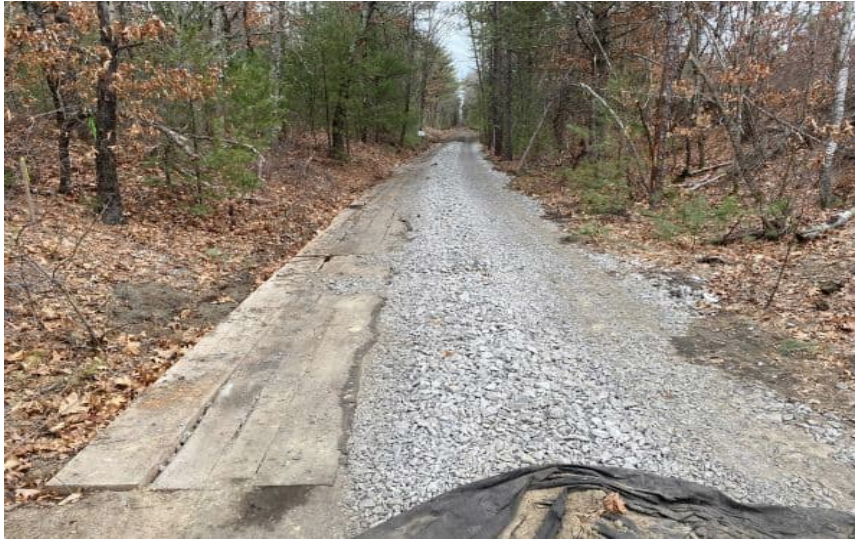
<p>PHOTOGRAPHIC LOG</p>	
<p>Client Name: Eversource</p>		<p>Site Location: Sudbury to Hudson Transmission Reliability Project</p>	<p>Town: Sudbury</p>
<p>Photo No.: 5</p>	<p>Date: 2-16-23</p>

<p>Description:</p> <p>Black Racer restrictive area (current condition), looking eastward.</p>

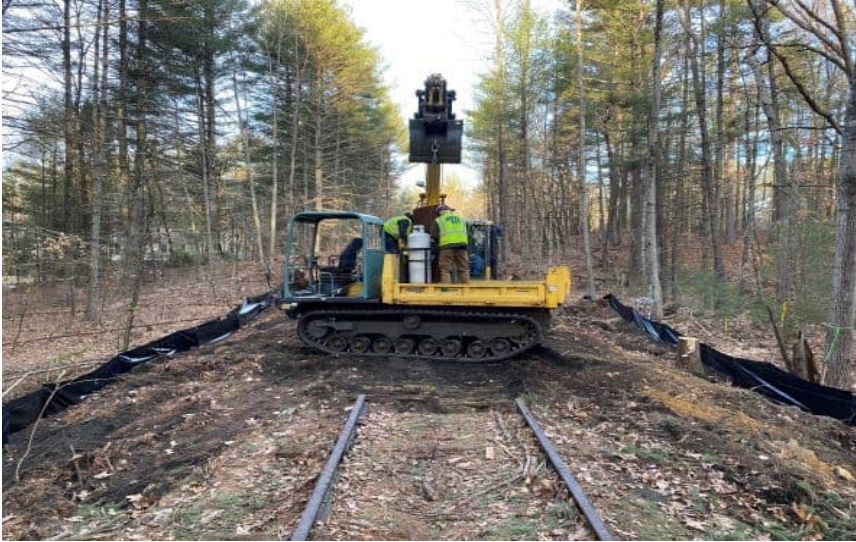
<p>PHOTOGRAPHIC LOG</p>	
<p>Client Name: Eversource</p>		<p>Site Location: Sudbury to Hudson Transmission Reliability Project</p>	<p>Town: Sudbury</p>
<p>Photo No.: 6</p>	<p>Date: 2-16-23</p>

<p>Description:</p> <p>Moosehead preparing for rail cutting within Segment 10 at approximate Sta# 534+50, looking eastward.</p>

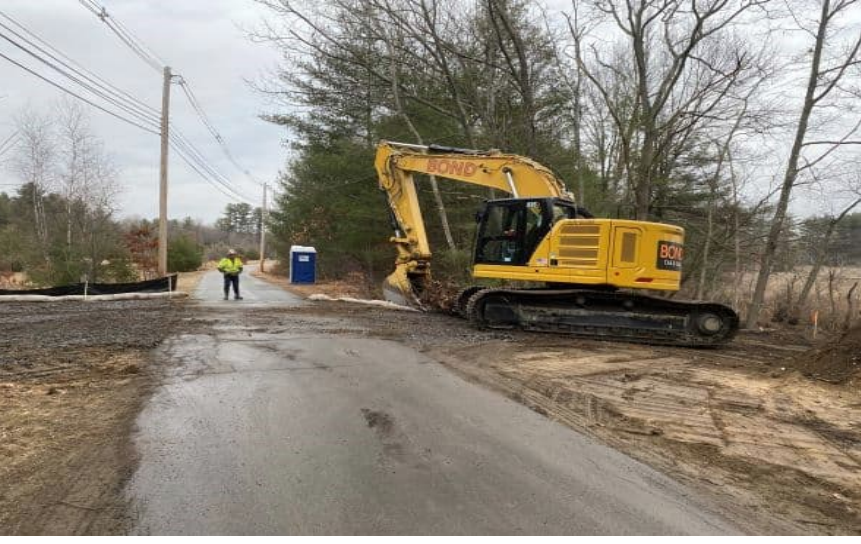
<p>PHOTOGRAPHIC LOG</p>	
<p>Client Name: Eversource</p>		<p>Site Location: Sudbury to Hudson Transmission Reliability Project</p>	<p>Town: Hudson</p>
<p>Photo No.: 2</p>	<p>Date: 2-17-23</p>

<p>Description:</p> <p>Bond conducting site work at water supply road within Segment 2 at approximate Sta#142+00, looking eastward.</p>

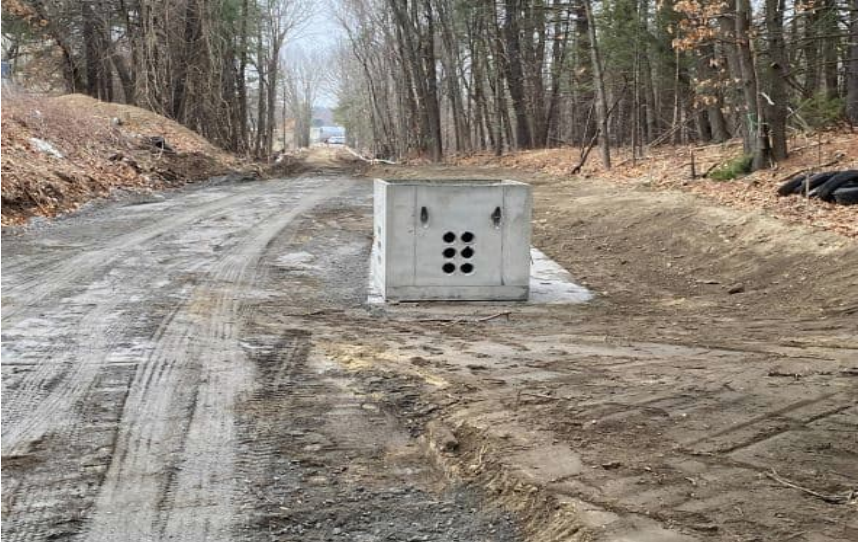
<p>PHOTOGRAPHIC LOG</p>	
<p>Client Name: Eversource</p>		<p>Site Location: Sudbury to Hudson Transmission Reliability Project</p>	<p>Town: Hudson</p>
<p>Photo No.: 4</p>	<p>Date: 2-17-23</p>

<p>Description:</p> <p>Previously installed MH#9 within segment 3 off Main Street, looking westward.</p>

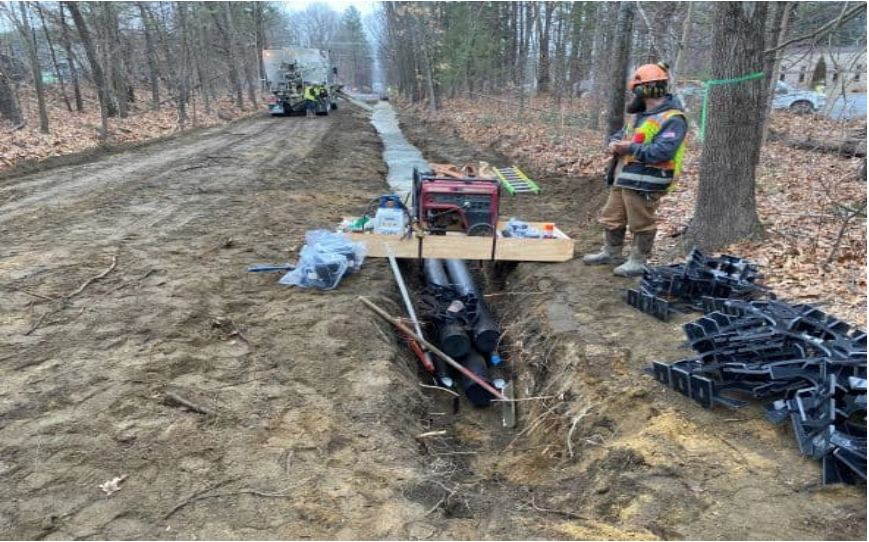
<p align="center">PHOTOGRAPHIC LOG</p>	
<p>Client Name: Eversource</p>		<p>Site Location: Sudbury to Hudson Transmission Reliability Project</p>	<p>Town: Hudson</p>
<p>Photo No.: 5</p>	<p>Date: 2-17-23</p>

<p>Description:</p> <p>Backfilling of ROW (following conduit installation) within Segment 4 at approximate Sta#185+00, looking westward.</p>

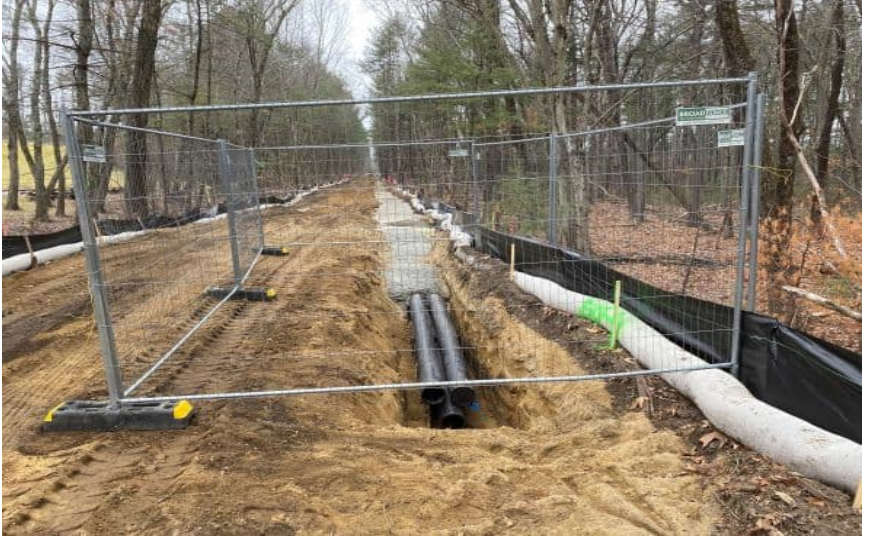
<p align="center">PHOTOGRAPHIC LOG</p>	
<p>Client Name: Eversource</p>		<p>Site Location: Sudbury to Hudson Transmission Reliability Project</p>	<p>Town: Hudson</p>
<p>Photo No.: 6</p>	<p>Date: 2-17-23</p>

<p>Description:</p> <p>Previous backfilling of ROW (following conduit installation) within Segment 4 at approximate Sta#206+50, looking westward.</p>

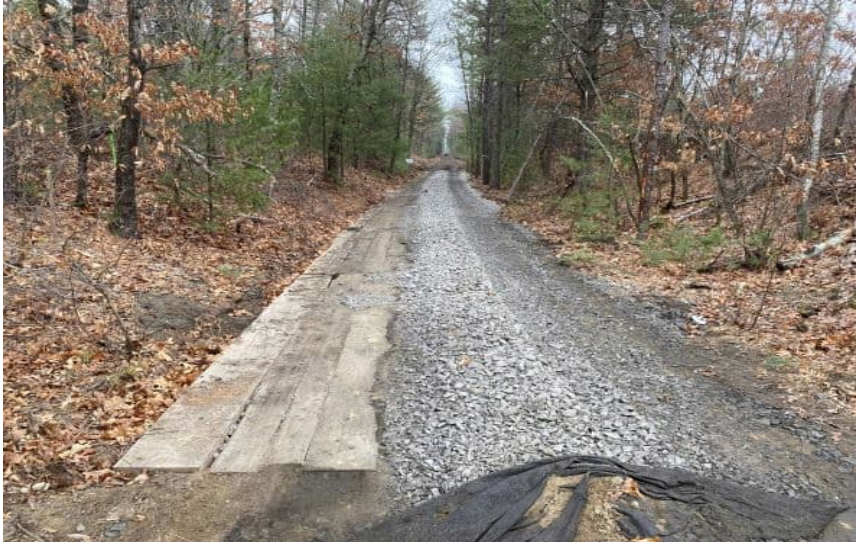
<p>PHOTOGRAPHIC LOG</p>	
<p>Client Name: Eversource</p>		<p>Site Location: Sudbury to Hudson Transmission Reliability Project</p>	<p>Town: Sudbury</p>
<p>Photo No.: 8</p>	<p>Date: 2-17-23</p>

<p>Description:</p> <p>Black Racer restrictive area (current condition), looking eastward.</p>

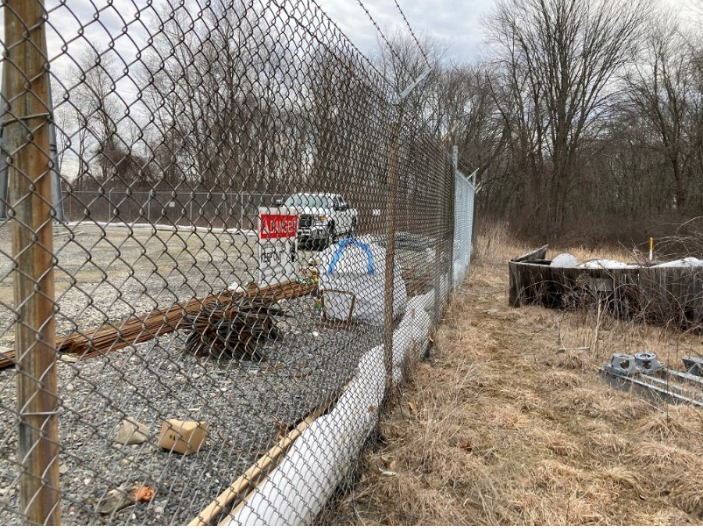
<b>PHOTOGRAPHIC LOG</b>	
<b>Client Name:</b> Eversource		<b>Site Location:</b> Sudbury to Hudson Transmission Reliability Project	
<b>Photo No.:</b> 2 <b>Date:</b> 2-15-2023		<b>Town:</b> Sudbury	
<b>Description:</b> View of filter tubes at Sudbury Substation. Filter tubes are in good condition and operating properly. Facing east.

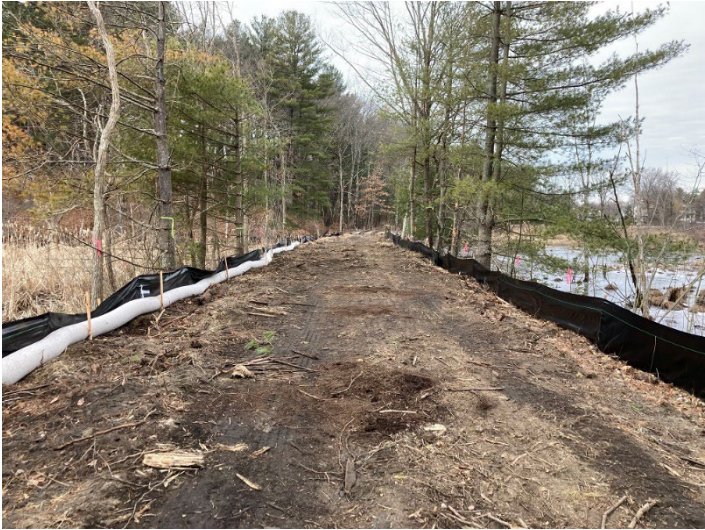
<b>PHOTOGRAPHIC LOG</b>	
<b>Client Name:</b> Eversource		<b>Site Location:</b> Sudbury to Hudson Transmission Reliability Project	<b>Town:</b> Sudbury
<b>Photo No.:</b> 3	<b>Date:</b> 2-15-2023

<b>Description:</b> Filter tube installation in progress in segment 14. Facing west.

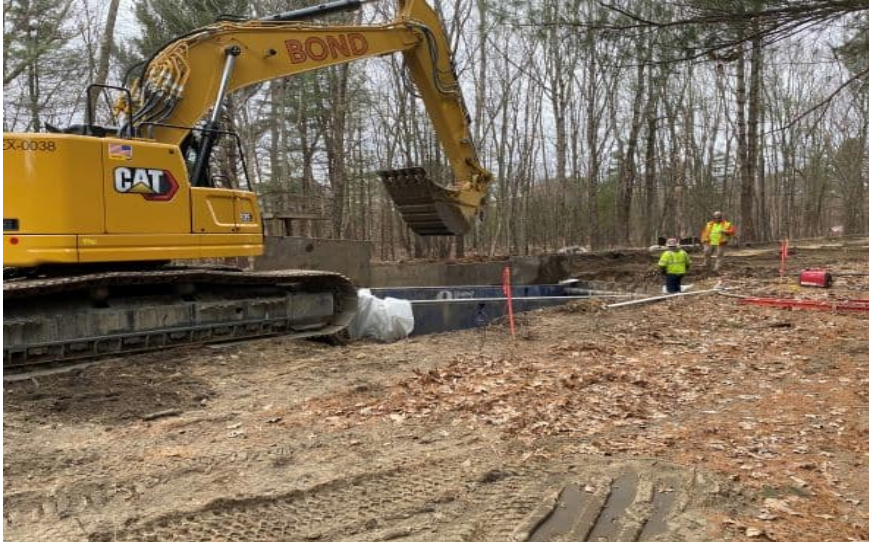
<b>PHOTOGRAPHIC LOG</b>	
Client Name: Eversource		Site Location: Sudbury to Hudson Transmission Reliability Project	Town: Hudson
Photo No.: 1	Date: 2/16/2023

Description: View of area being pumped at work operation at MH#7, at approximate Sta.# 139+00 in Segment 2, looking westward.

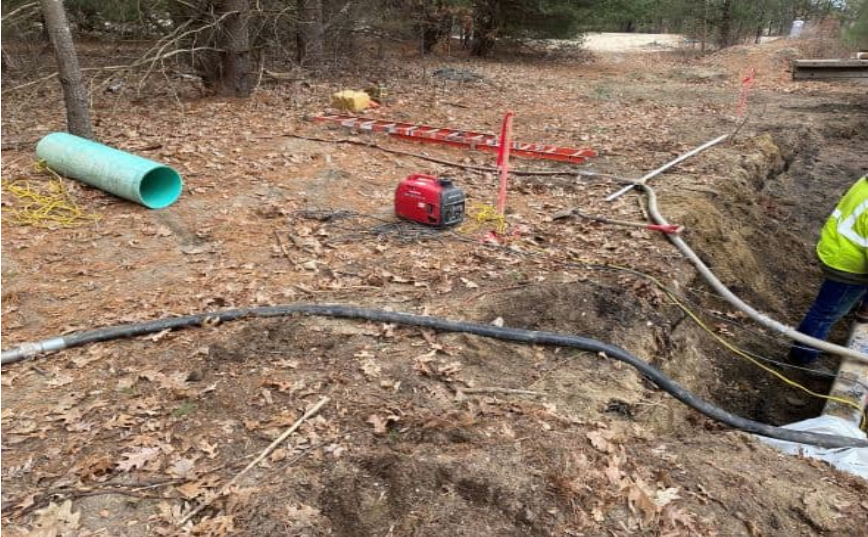
PHOTOGRAPHIC LOG	
Client Name: Eversource		Site Location: Sudbury to Hudson Transmission Reliability Project	Town: Hudson
Photo No.: 3	Date: 2/16/2023

Description: MH#7. View of dewatering operation, looking eastward.

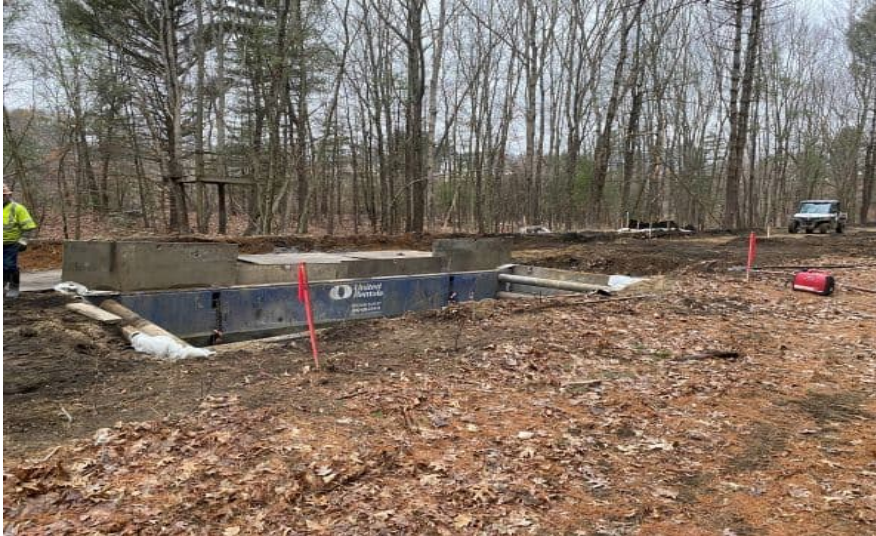
<b>PHOTOGRAPHIC LOG</b>	
Client Name: Eversource		Site Location: Sudbury to Hudson Transmission Reliability Project	Town: Hudson
Photo No.: 1	Date: 2/17/2023

Description: View of area being pumped at work operation at MH#7, at approximate Sta.# 139+00 in Segment 2, looking westward.

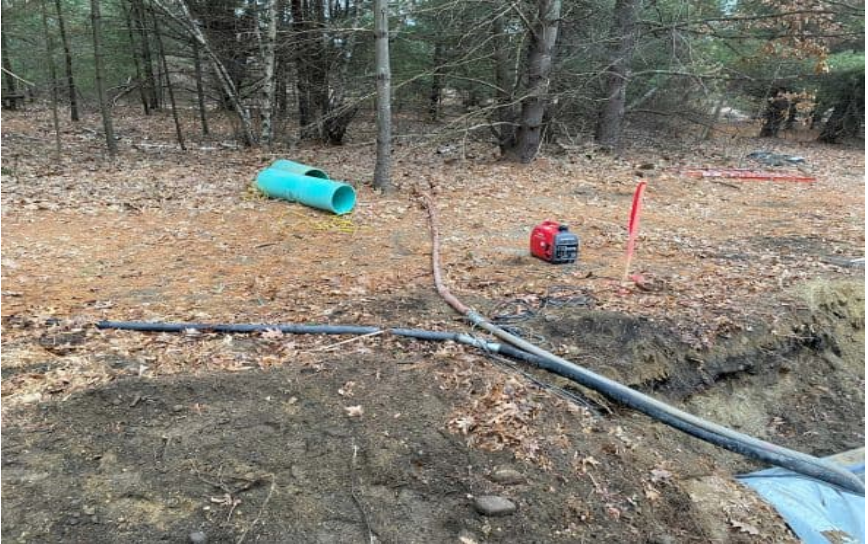
PHOTOGRAPHIC LOG	
Client Name: Eversource		Site Location: Sudbury to Hudson Transmission Reliability Project	Town: Hudson
Photo No.: 3	Date: 2/17/2023

Description: MH#7. View of dewatering operation, looking eastward.
