**Weekly Environmental Compliance Summary**

**Sudbury to Hudson Transmission Reliability Project (USEPA Tracking # MAR1003UW)**

Week of: March 13 to March 17, 2023

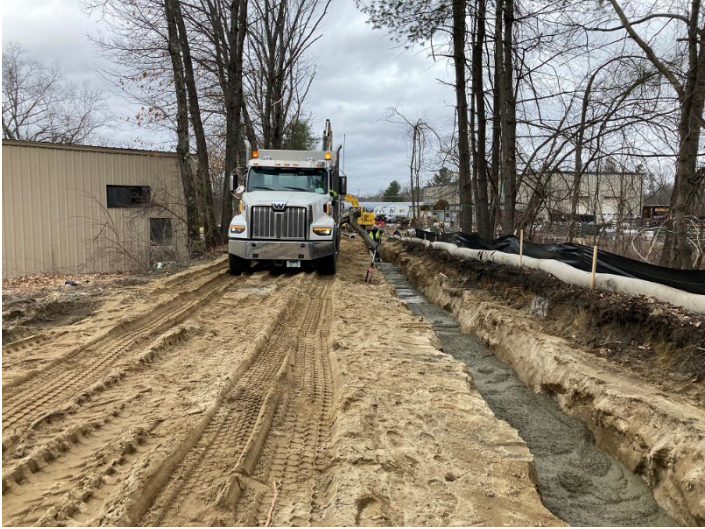
<p><b>PHOTOGRAPHIC LOG</b></p>	
<p><b>Client Name:</b> Eversource</p>		<p><b>Site Location:</b> Sudbury to Hudson Transmission Reliability Project</p>	<p><b>Town:</b> Hudson</p>
<p><b>Photo No.:</b> 1</p>	<p><b>Date:</b> 3/13/2023</p>

<p><b>Description:</b> View of Bond performing conduit installation in segment 3. Facing west.</p>

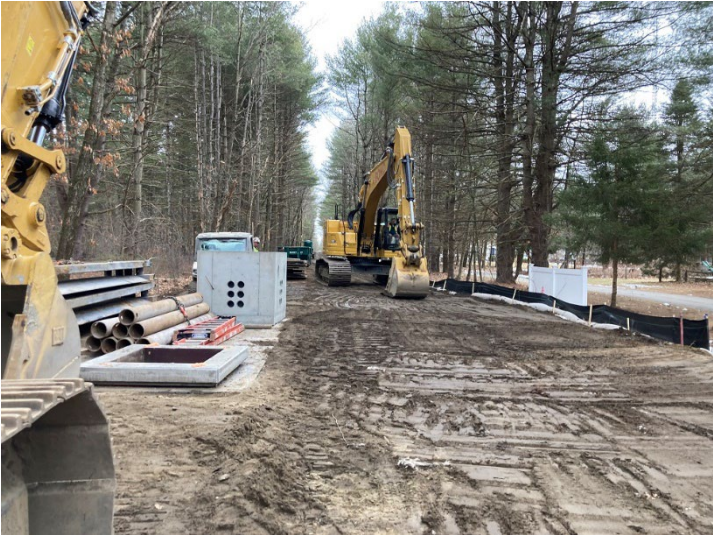
<p><b>PHOTOGRAPHIC LOG</b></p>	
<p><b>Client Name:</b> Eversource</p>		<p><b>Site Location:</b> Sudbury to Hudson Transmission Reliability Project</p>	<p><b>Town:</b> Hudson</p>
<p><b>Photo No.:</b> 2</p>	<p><b>Date:</b> 3/13/2023</p>

<p><b>Description:</b> View of Bond working at MH #11 in segment 5 off Parmenter Rd. Facing east.</p>

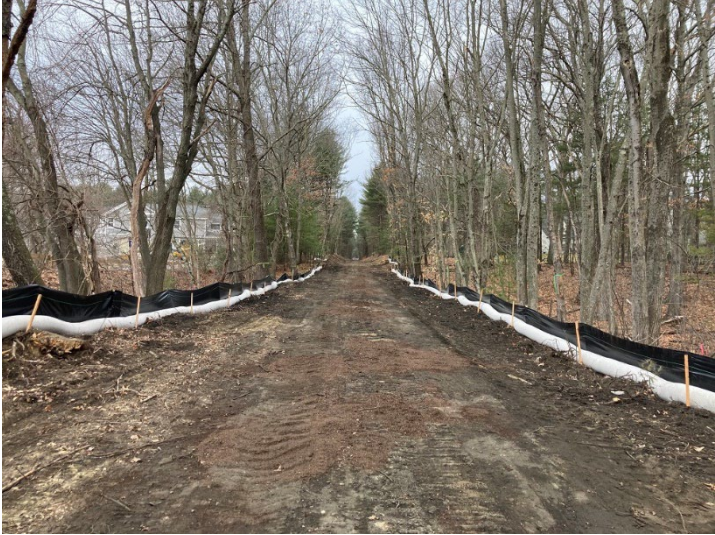
<b>PHOTOGRAPHIC LOG</b>	
<b>Client Name:</b> Eversource		<b>Site Location:</b> Sudbury to Hudson Transmission Reliability Project	<b>Town:</b> Sudbury
<b>Photo No.:</b> 3	<b>Date:</b> 3/13/2023

<b>Description:</b> View of recently installed filter tubes in segment 11. Facing west.

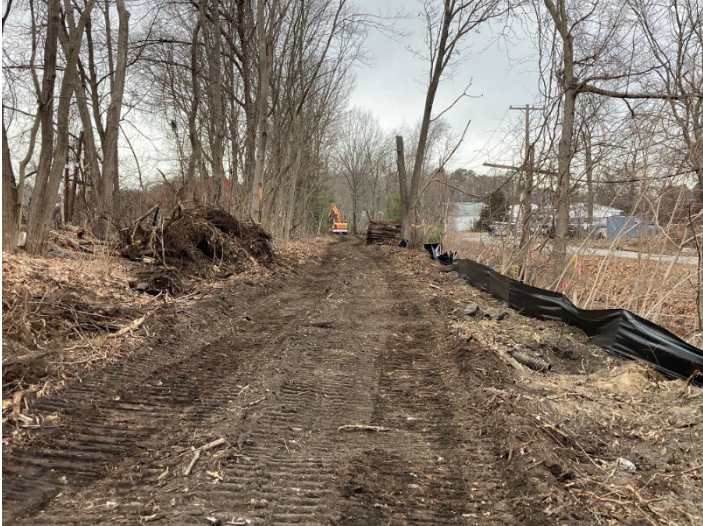
<b>PHOTOGRAPHIC LOG</b>	
<b>Client Name:</b> Eversource		<b>Site Location:</b> Sudbury to Hudson Transmission Reliability Project	<b>Town:</b> Sudbury
<b>Photo No.:</b> 4	<b>Date:</b> 3/13/2023

<b>Description:</b> View of Moosehead performing rail, tie, and stump removal in segment 12. Facing west.

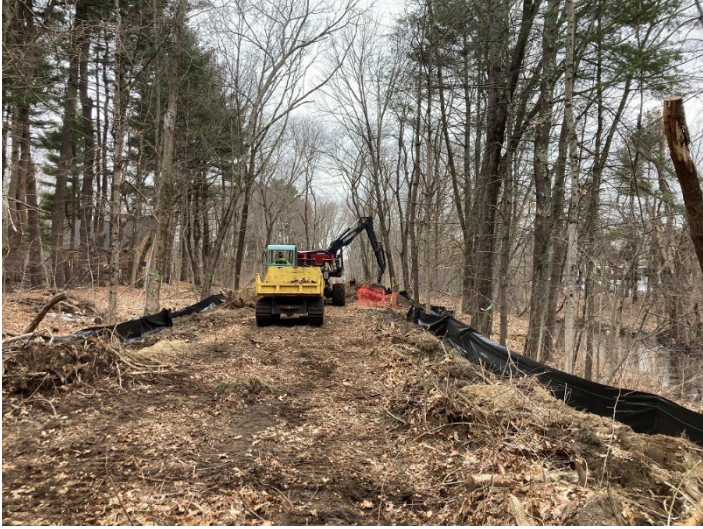
<p><b>PHOTOGRAPHIC LOG</b></p>	
<p><b>Client Name:</b> Eversource</p>		<p><b>Site Location:</b> Sudbury to Hudson Transmission Reliability Project</p>	<p><b>Town:</b> Sudbury</p>
<p><b>Photo No.:</b> 5</p>	<p><b>Date:</b> 3/13/2023</p>

<p><b>Description:</b> View of Moosehead performing rail, tie, and stump removal in segment 13. Facing west.</p>

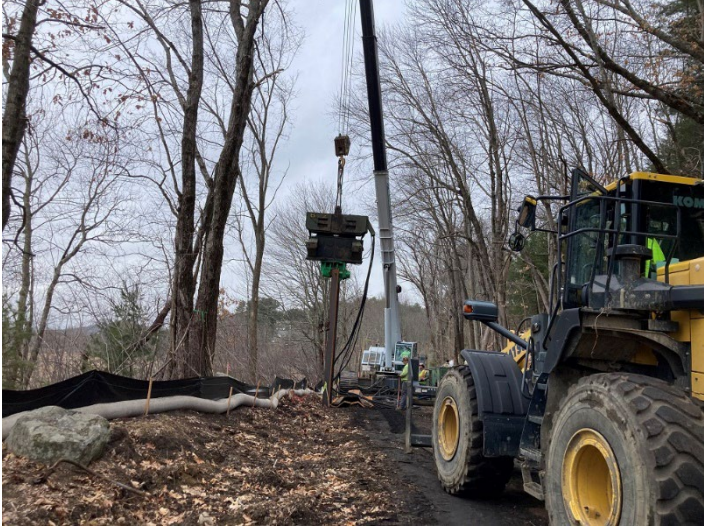
<p><b>PHOTOGRAPHIC LOG</b></p>	
<p><b>Client Name:</b> Eversource</p>		<p><b>Site Location:</b> Sudbury to Hudson Transmission Reliability Project</p>	<p><b>Town:</b> Sudbury</p>
<p><b>Photo No.:</b> 6</p>	<p><b>Date:</b> 3/13/2023</p>

<p><b>Description:</b> View of ET&amp;L performing sheet installation at wall #13 in segment 14. Facing west.</p>

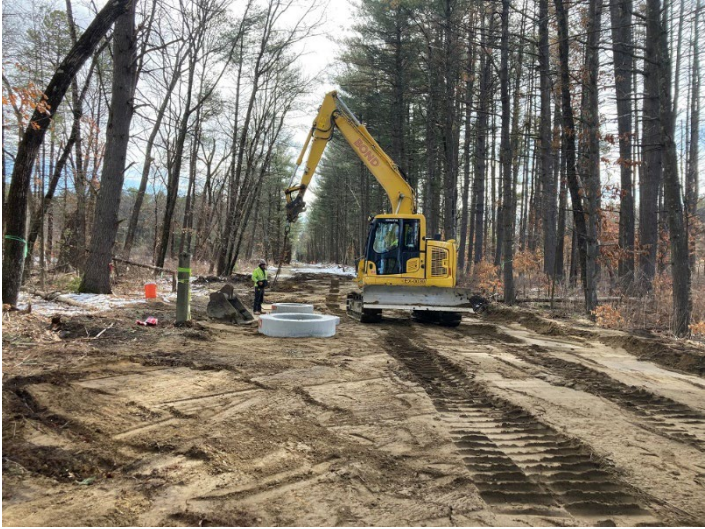
<p align="right"><b>PHOTOGRAPHIC LOG</b></p>	
<p><b>Client Name:</b> Eversource</p>		<p><b>Site Location:</b> Sudbury to Hudson Transmission Reliability Project</p>	<p><b>Town:</b> Hudson</p>
<p><b>Photo No.:</b> 1</p>	<p><b>Date:</b> 3/16/2023</p>

<p><b>Description:</b> View of Bond working at HH#10 in segment 4. Facing east.</p>

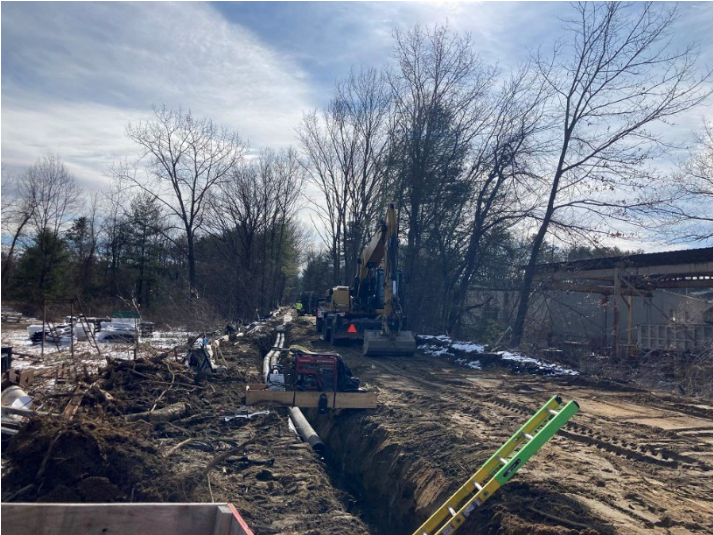
<p align="right"><b>PHOTOGRAPHIC LOG</b></p>	
<p><b>Client Name:</b> Eversource</p>		<p><b>Site Location:</b> Sudbury to Hudson Transmission Reliability Project</p>	<p><b>Town:</b> Hudson</p>
<p><b>Photo No.:</b> 2</p>	<p><b>Date:</b> 3/16/2023</p>

<p><b>Description:</b> View of Bond performing conduit installation in segment 3. Facing east.</p>

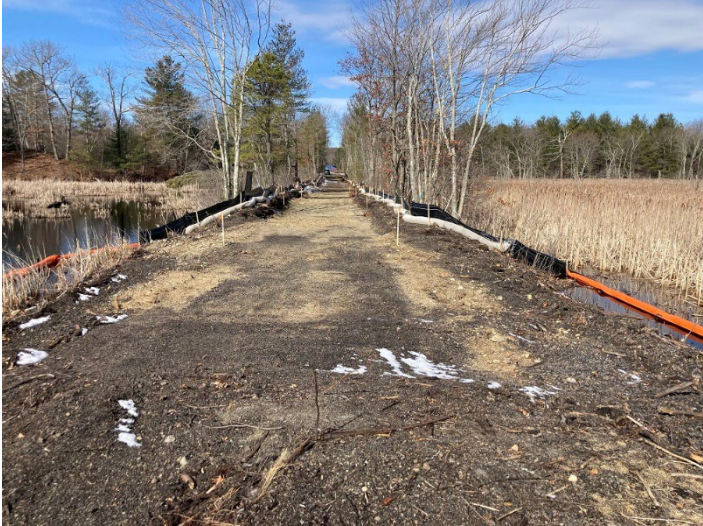
<p align="center"><b>PHOTOGRAPHIC LOG</b></p>	
<p><b>Client Name:</b> Eversource</p>		<p><b>Site Location:</b> Sudbury to Hudson Transmission Reliability Project</p>	
<p><b>Town:</b> Hudson</p>			
<p><b>Photo No.:</b> 4</p>	<p><b>Date:</b> 3/16/2023</p>

<p><b>Description:</b> View of E&amp;S controls in segment 2 from bridge 130. Facing west.</p>

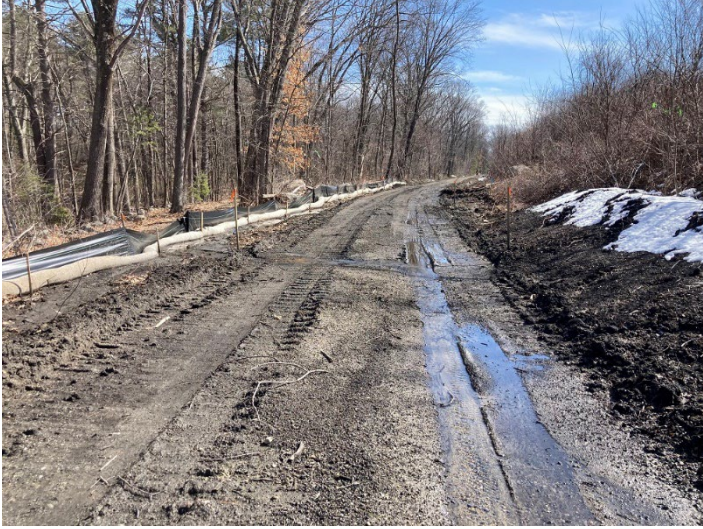
<b>PHOTOGRAPHIC LOG</b>	
<b>Client Name:</b> Eversource		<b>Site Location:</b> Sudbury to Hudson Transmission Reliability Project	
<b>Town:</b> Hudson			
<b>Photo No.:</b> 5	<b>Date:</b> 3/16/2023

<b>Description:</b> View of segment 1 near Sta.# 117/ Sta. #90+75. Facing east.

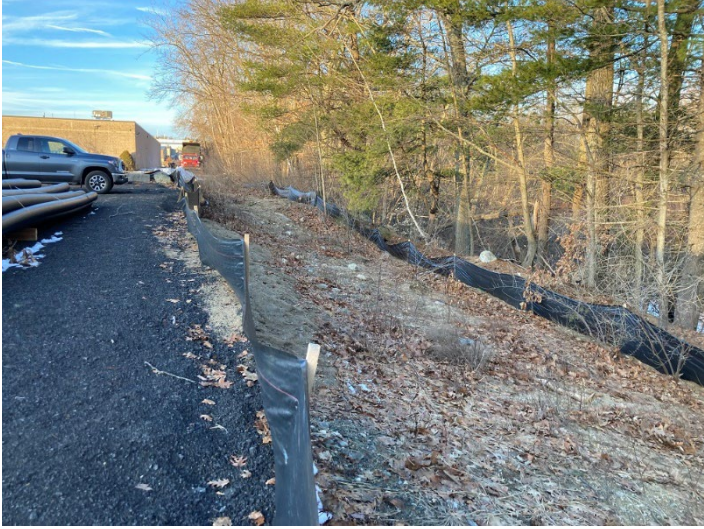
<b>PHOTOGRAPHIC LOG</b>	
<b>Client Name:</b> Eversource		<b>Site Location:</b> Sudbury to Hudson Transmission Reliability Project	
<b>Town:</b> Hudson			
<b>Photo No.:</b> 6	<b>Date:</b> 3/16/2023

<b>Description:</b> View of silt fence at laydown yard at Robert Bonazzoli Ave. Facing southwest.

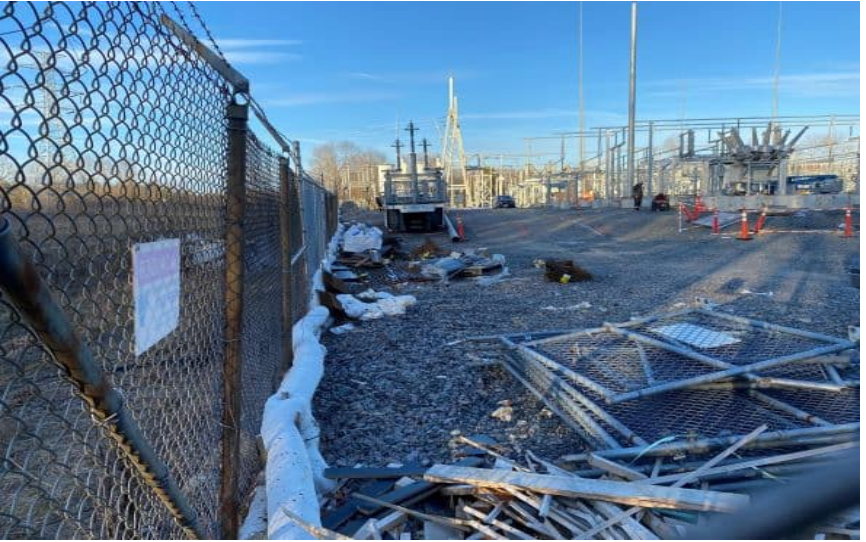
<p>PHOTOGRAPHIC LOG</p>	
<p>Client Name: Eversource</p>		<p>Site Location: Sudbury to Hudson Transmission Reliability Project</p>	<p>Town: Sudbury</p>
<p>Photo No.: 1</p>	<p>Date: 3-16-23</p>

<p>Description: Compost filter tubing at Sudbury Substation, looking westward.</p>

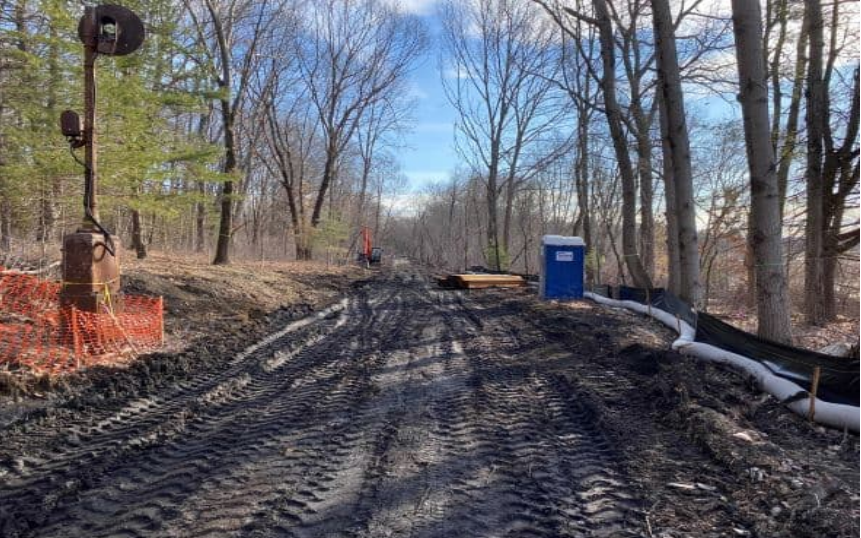
<p>PHOTOGRAPHIC LOG</p>	
<p>Client Name: Eversource</p>		<p>Site Location: Sudbury to Hudson Transmission Reliability Project</p>	<p>Town: Sudbury</p>
<p>Photo No.: 4</p>	<p>Date: 3-16-23</p>

<p>Description:</p> <p>ROW within Segment 14, looking eastward.</p>

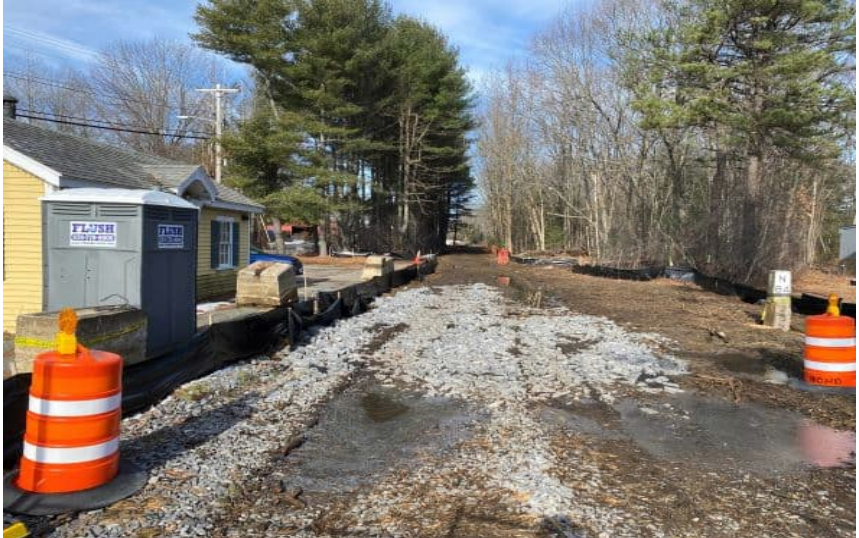
<p>PHOTOGRAPHIC LOG</p>	
<p>Client Name: Eversource</p>		<p>Site Location: Sudbury to Hudson Transmission Reliability Project</p>	<p>Town: Sudbury</p>
<p>Photo No.: 6</p>	<p>Date: 3-16-23</p>

<p>Description:</p> <p>ROW within Segment 11 at Union Street, looking westward.</p>

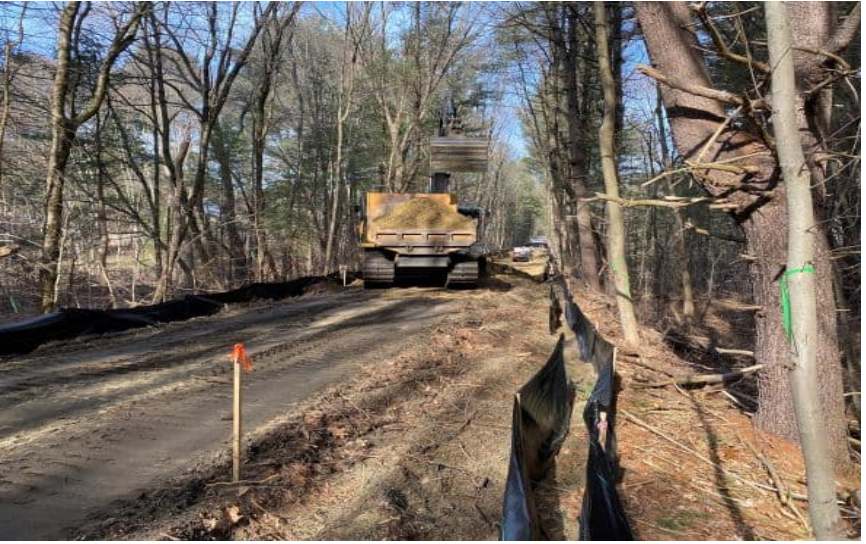
<p>PHOTOGRAPHIC LOG</p>	
<p>Client Name: Eversource</p>		<p>Site Location: Sudbury to Hudson Transmission Reliability Project</p>	<p>Town: Sudbury</p>
<p>Photo No.: 7</p>	<p>Date: 3-16-23</p>

<p>Description:</p> <p>ET&amp;L conducting grading within Segment 10 between Sta#'s 542+00 to 549+00, looking westward.</p>

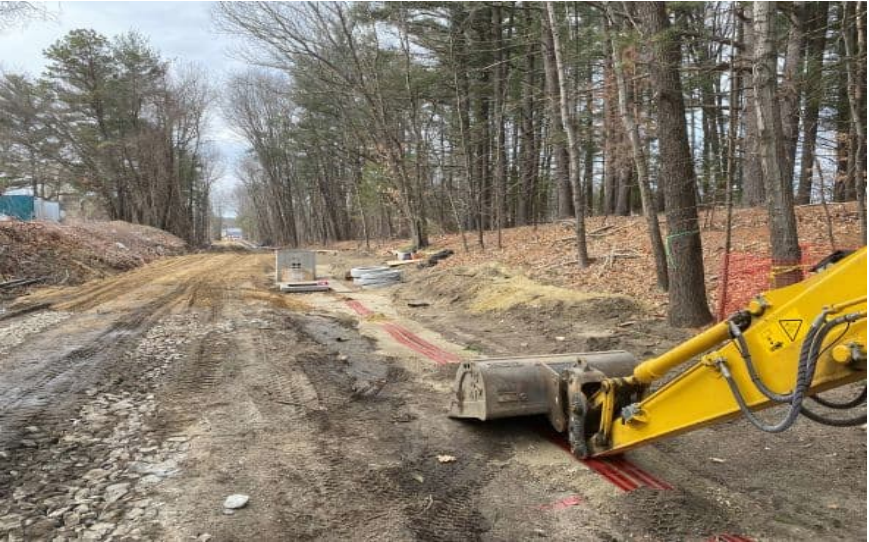
<p>PHOTOGRAPHIC LOG</p>	
<p>Client Name: Eversource</p>		<p>Site Location: Sudbury to Hudson Transmission Reliability Project</p>	<p>Town: Hudson</p>
<p>Photo No.: 1</p>	<p>Date: 3-17-23</p>

<p>Description:</p> <p>MH#9 within Segment 3 at approximate Sta# 177+00 showing recently installed caution tape, looking westward.</p>

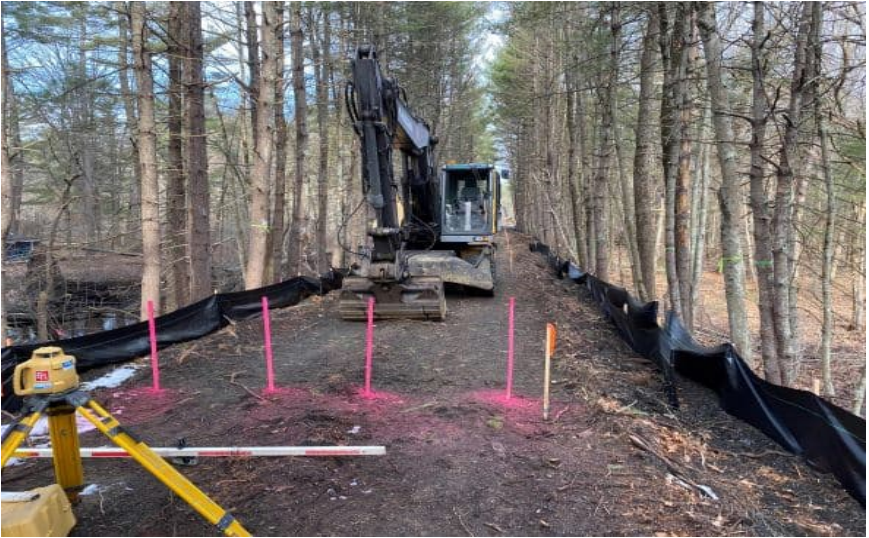
<p>PHOTOGRAPHIC LOG</p>	
<p>Client Name: Eversource</p>		<p>Site Location: Sudbury to Hudson Transmission Reliability Project</p>	<p>Town: Sudbury</p>
<p>Photo No.: 3</p>	<p>Date: 3-17-23</p>

<p>Description:</p> <p>ET&amp;L conducting grading within Segment 10 at approximate Sta# 539+00, looking westward.</p>

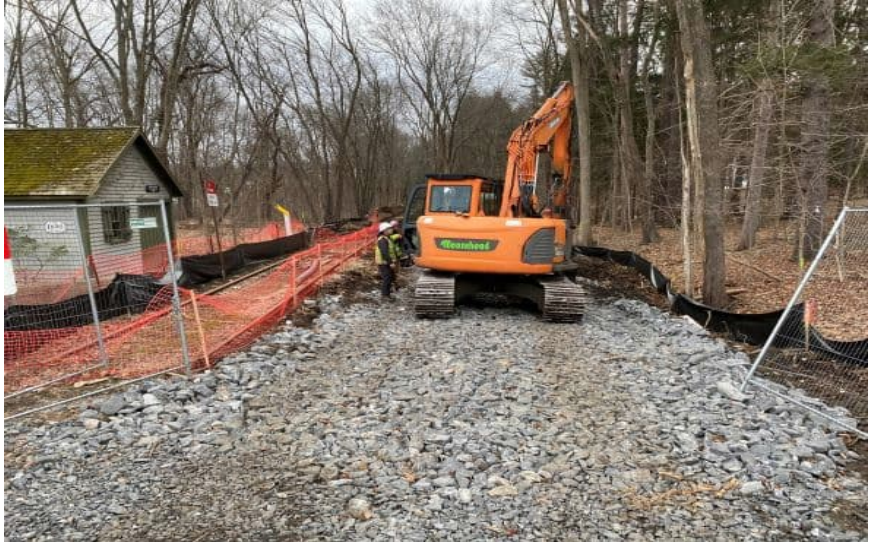
<p>PHOTOGRAPHIC LOG</p>	
<p>Client Name: Eversource</p>		<p>Site Location: Sudbury to Hudson Transmission Reliability Project</p>	<p>Town: Sudbury</p>
<p>Photo No.: 6</p>	<p>Date: 3-17-23</p>

<p>Description:                  Moosehead conducting site work within Segment 13, looking eastward.</p>

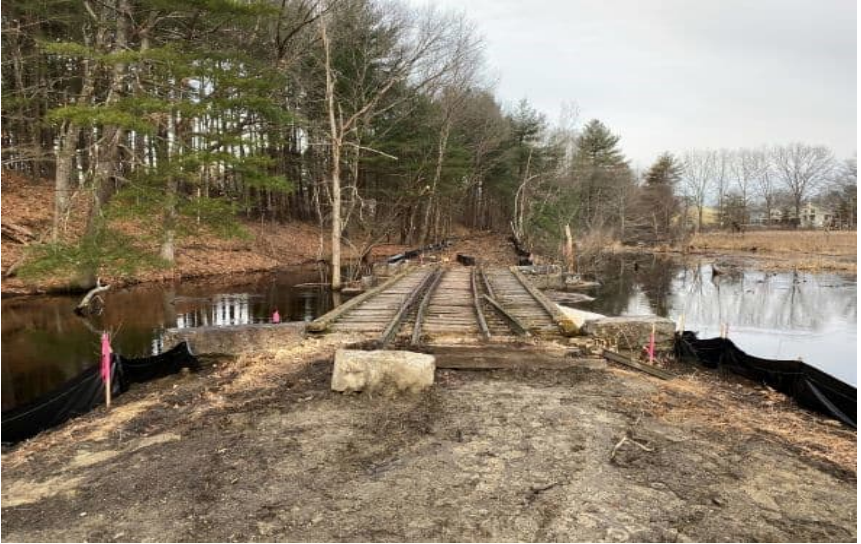
<p>PHOTOGRAPHIC LOG</p>	
<p>Client Name: Eversource</p>		<p>Site Location: Sudbury to Hudson Transmission Reliability Project</p>	<p>Town: Sudbury</p>
<p>Photo No.: 8</p>	<p>Date: 3-17-23</p>

<p>Description:                  Bridge 127 (Segments 14/13), looking westward.</p>

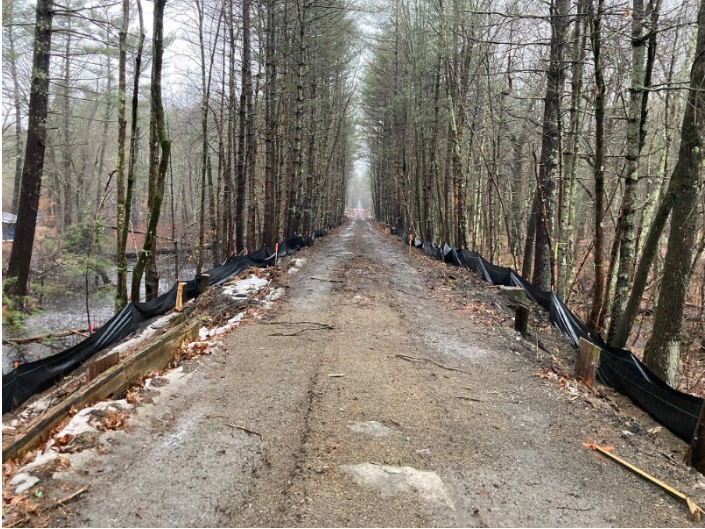
<b>PHOTOGRAPHIC LOG</b>	
<b>Client Name:</b> Eversource		<b>Site Location:</b> Sudbury to Hudson Transmission Reliability Project	<b>Town:</b> Sudbury
<b>Photo No.:</b> 2	<b>Date:</b> 3-14-2023

<b>Description:</b> View of syncopated silt fence in segment 10. Facing west.

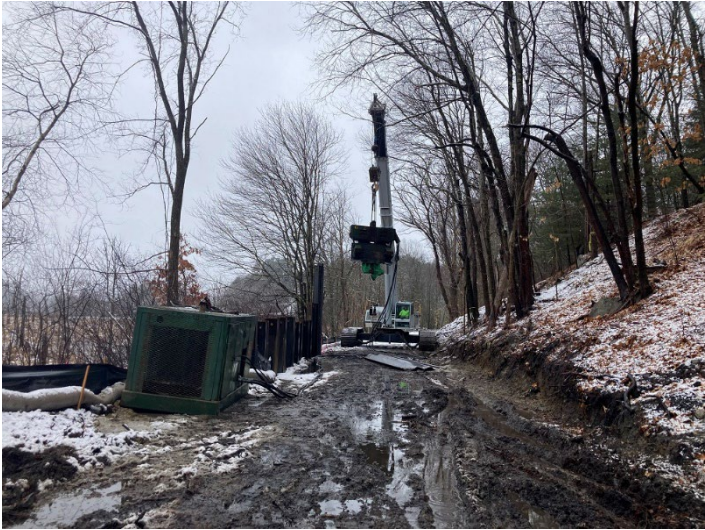
<b>PHOTOGRAPHIC LOG</b>	
<b>Client Name:</b> Eversource		<b>Site Location:</b> Sudbury to Hudson Transmission Reliability Project	<b>Town:</b> Sudbury
<b>Photo No.:</b> 3	<b>Date:</b> 3-14-2023

<b>Description:</b> View of ET&L performing sheet installation at sheetwall #13 in segment 14. Facing west

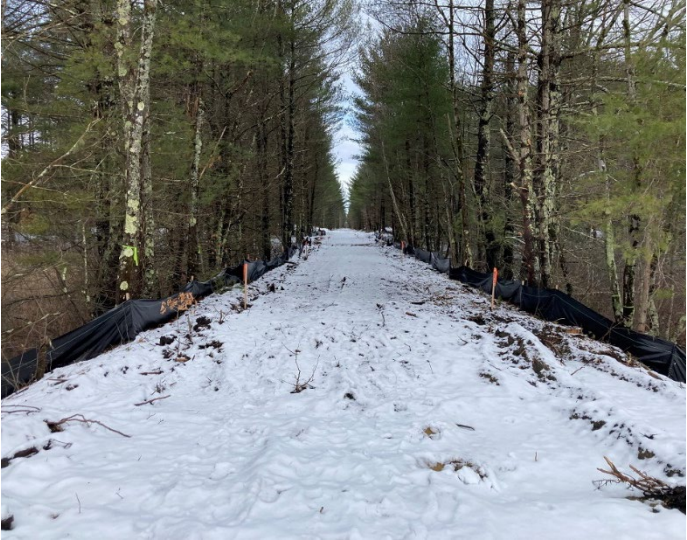
<b>PHOTOGRAPHIC LOG</b>	
<b>Client Name:</b> Eversource		<b>Site Location:</b> Sudbury to Hudson Transmission Reliability Project	<b>Town:</b> Sudbury
<b>Photo No.:</b> 1	<b>Date:</b> 3-15-2023

<b>Description:</b> View of E&S controls in segment 7. Facing west.

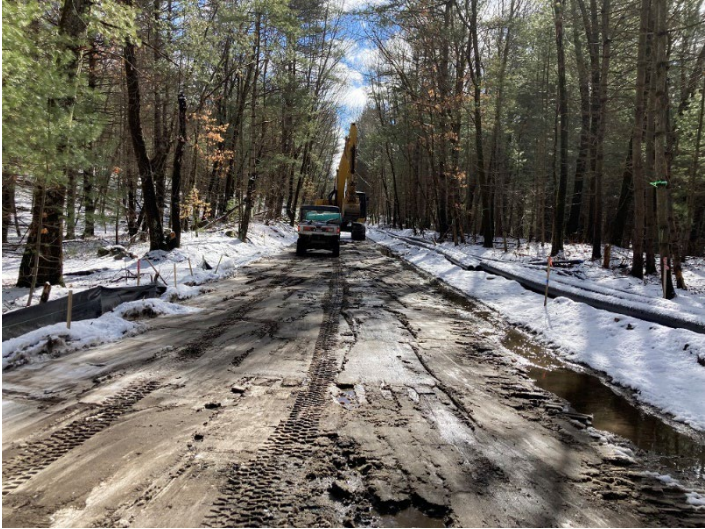
<b>PHOTOGRAPHIC LOG</b>	
<b>Client Name:</b> Eversource		<b>Site Location:</b> Sudbury to Hudson Transmission Reliability Project	<b>Town:</b> Hudson
<b>Photo No.:</b> 2	<b>Date:</b> 3-15-2023

<b>Description:</b> View of Bond performing snow removal near MH #11 in segment 5. Facing east.

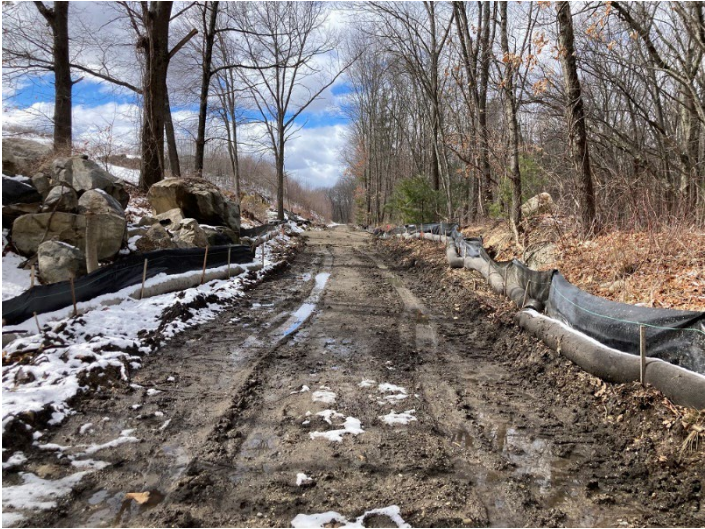
<b>Epsilon</b> ASSOCIATES INC.		<b>PHOTOGRAPHIC LOG</b>	
<b>Client Name:</b> Eversource		<b>Site Location:</b> Sudbury to Hudson Transmission Reliability Project	<b>Town:</b> Stow
<b>Photo No.:</b> 6	<b>Date:</b> 3-15-2023

<b>Description:</b> View of Stow portion of project in segment 1. Facing west.

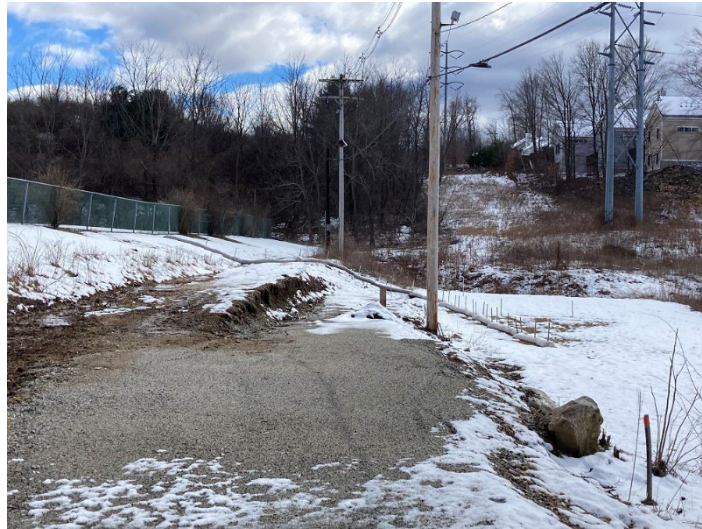
View of filter tubes at MH#1 area. Facing south.

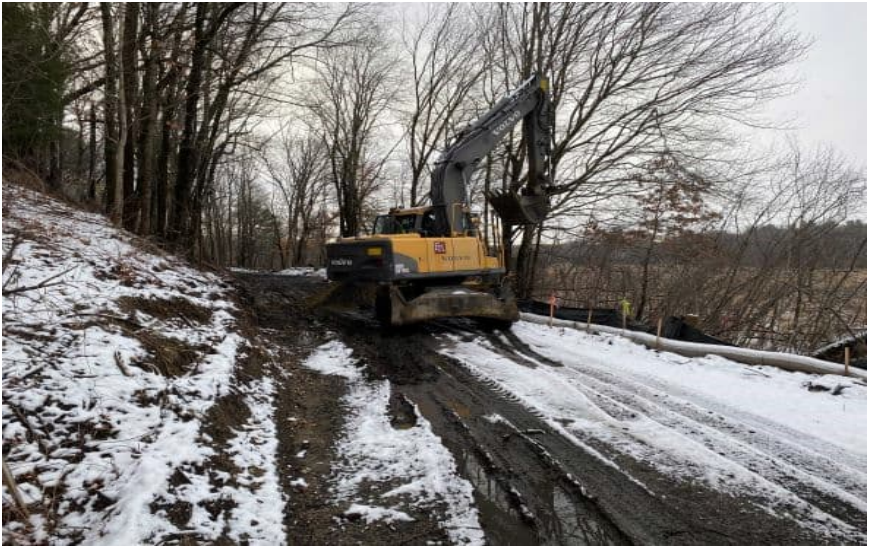
<b>PHOTOGRAPHIC LOG</b>	
Client Name: Eversource		Site Location: Sudbury to Hudson Transmission Reliability Project	Town: Sudbury
Photo No.: 3	Date: 3-15-23

Description:  ET&L within Segment 14 at approximate Sta# 733+50 conducting sheeting installation, looking eastward.

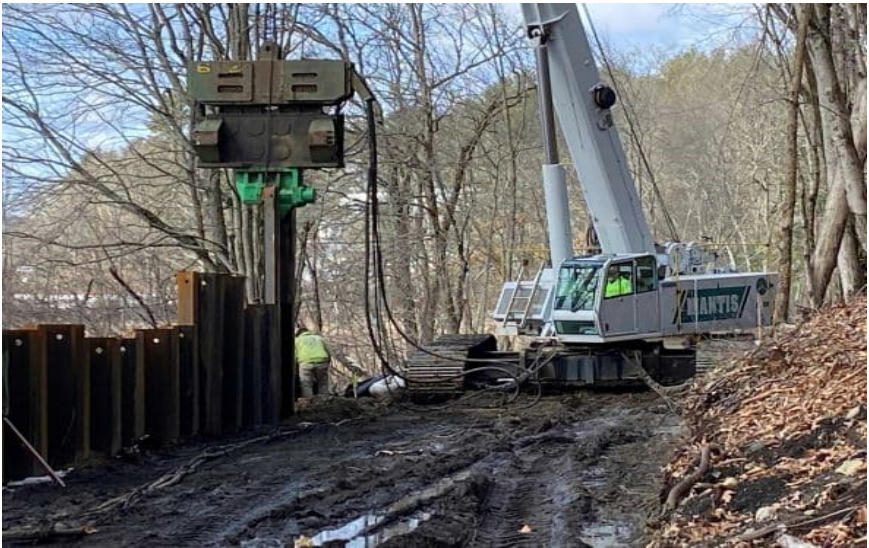
<b>PHOTOGRAPHIC LOG</b>	
Client Name: Eversource		Site Location: Sudbury to Hudson Transmission Reliability Project	Town: Sudbury
Photo No.: 4	Date: 3-15-23

Description:  ET&L within Segment 14 at approximate Sta# 733+50 conducting sheeting installation, looking westward.

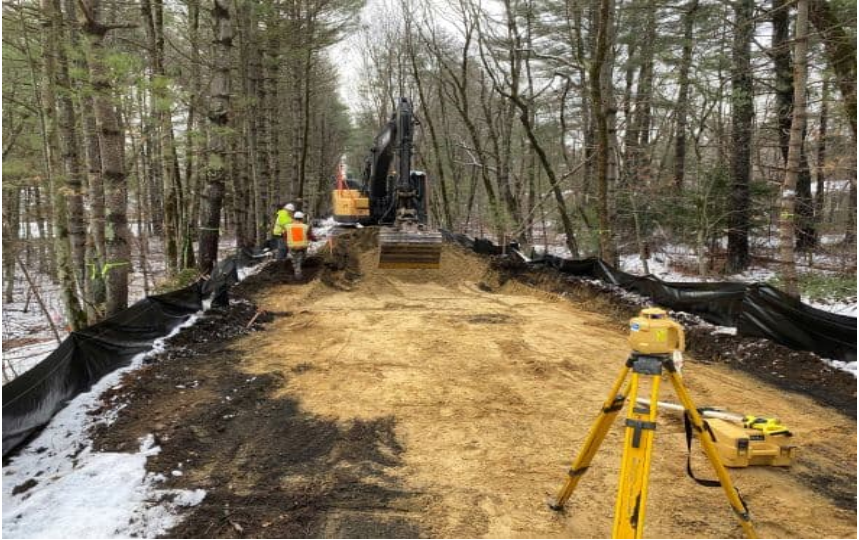
PHOTOGRAPHIC LOG	
Client Name: Eversource		Site Location: Sudbury to Hudson Transmission Reliability Project	Town: Sudbury
Photo No.: 5	Date: 3-15-23

Description:  ET&L conducting grading within Segment 10 at approximate Sta# 539+00, looking westward.

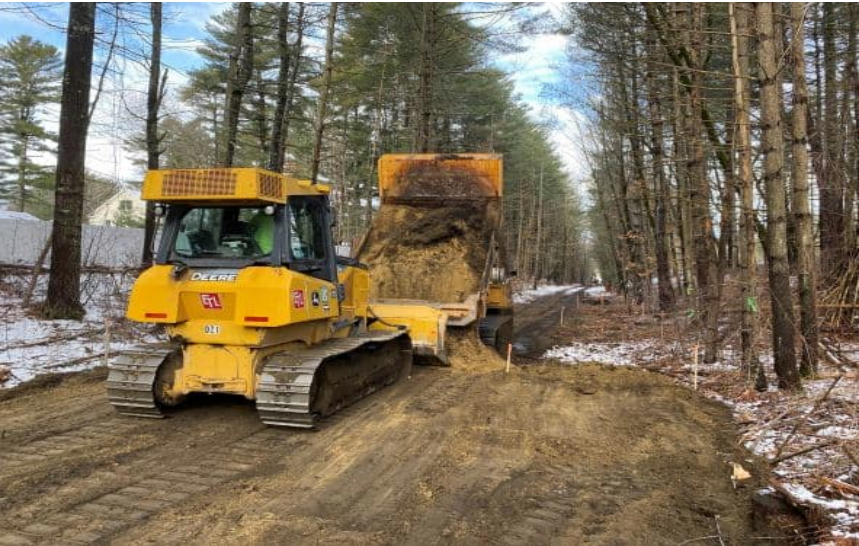
PHOTOGRAPHIC LOG	
Client Name: Eversource		Site Location: Sudbury to Hudson Transmission Reliability Project	Town: Sudbury
Photo No.: 6	Date: 3-15-23

Description:  ET&L conducting grading within Segment 10 approximately 300' west of Horsepond Road, looking westward.

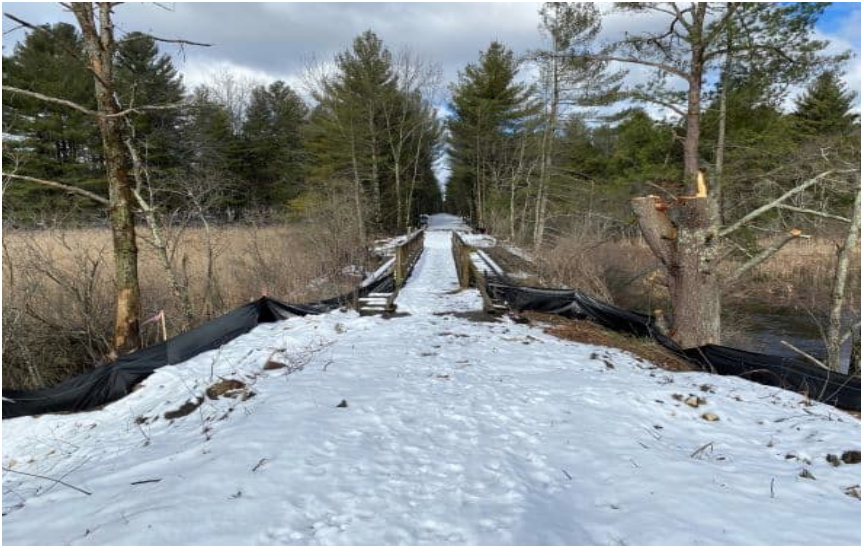
<b>PHOTOGRAPHIC LOG</b>	
Client Name: Eversource		Site Location: Sudbury to Hudson Transmission Reliability Project	Town: Sudbury
Photo No.: 7	Date: 3-15-23

Description:  Bridge 128 within Segment 8, looking westward.

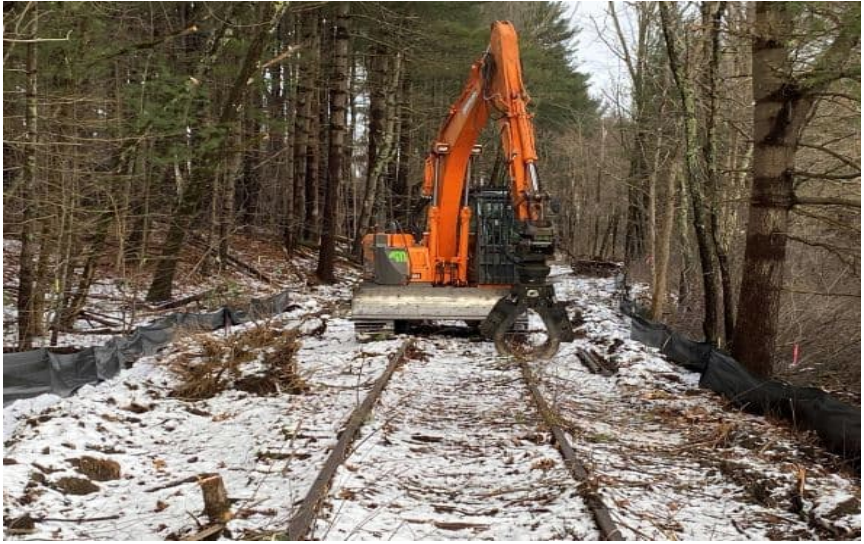
<b>PHOTOGRAPHIC LOG</b>	
Client Name: Eversource		Site Location: Sudbury to Hudson Transmission Reliability Project	Town: Sudbury
Photo No.: 8	Date: 3-15-23

Description:  Moosehead removing rail/ties within Segment 13 at approximate Sta# 723+00, looking westward.
