**Weekly Environmental Compliance Summary**

**Sudbury to Hudson Transmission Reliability Project (USEPA Tracking # MAR1003UW)**

Sudbury, Hudson, and Stow, MA

Week of: March 20 to March 24, 2023

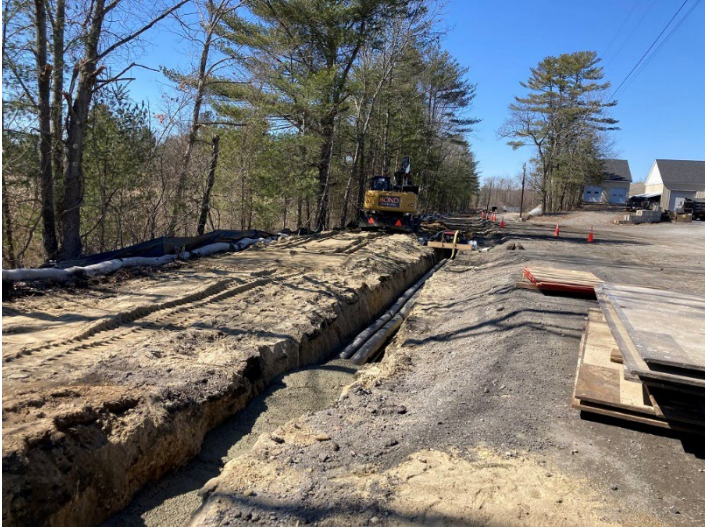
<b>PHOTOGRAPHIC LOG</b>	
<b>Client Name:</b> Eversource		<b>Site Location:</b> Sudbury to Hudson Transmission Reliability Project	<b>Town:</b> Hudson
<b>Photo No.:</b> 1	<b>Date:</b> 3/20/2023

<b>Description:</b> View of Bond performing conduit installation in segment 3. Facing west.

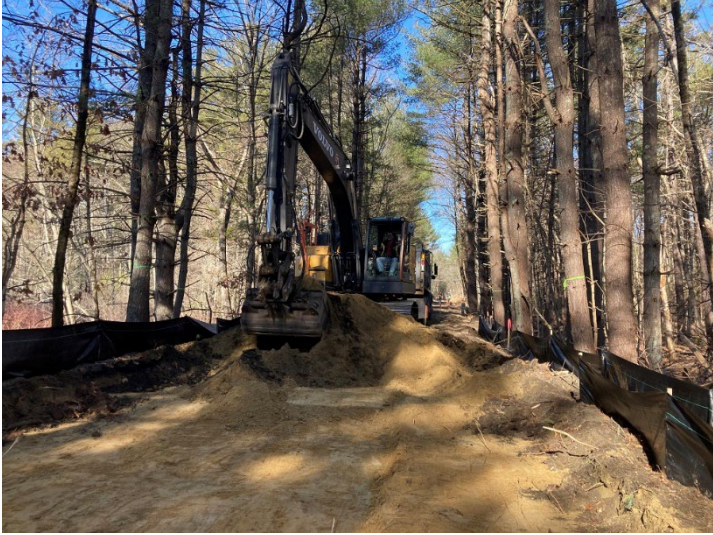
<b>PHOTOGRAPHIC LOG</b>	
<b>Client Name:</b> Eversource		<b>Site Location:</b> Sudbury to Hudson Transmission Reliability Project	<b>Town:</b> Sudbury
<b>Photo No.:</b> 3	<b>Date:</b> 3/20/2023

<b>Description:</b> View of ET&L performing cut & fill activities in segment 10. Facing west.

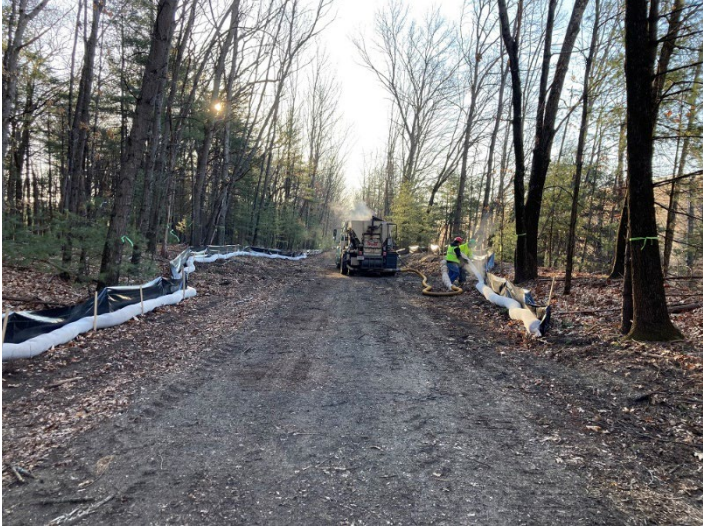
<b>PHOTOGRAPHIC LOG</b>	
<b>Client Name:</b> Eversource		<b>Site Location:</b> Sudbury to Hudson Transmission Reliability Project	<b>Town:</b> Sudbury
<b>Photo No.:</b> 4	<b>Date:</b> 3/20/2023

<b>Description:</b> View of MON installing filter tubes in segment 11. Facing west.

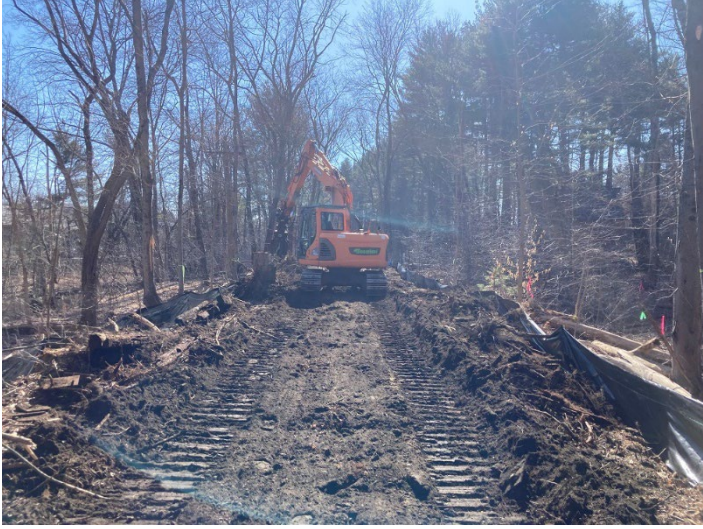
<b>PHOTOGRAPHIC LOG</b>	
<b>Client Name:</b> Eversource		<b>Site Location:</b> Sudbury to Hudson Transmission Reliability Project	
<b>Town:</b> Sudbury			
<b>Photo No.:</b> 5	<b>Date:</b> 3/20/2023

<b>Description:</b> View of Moosehead performing rail, tie, & stump removal in segment 13. Facing east.

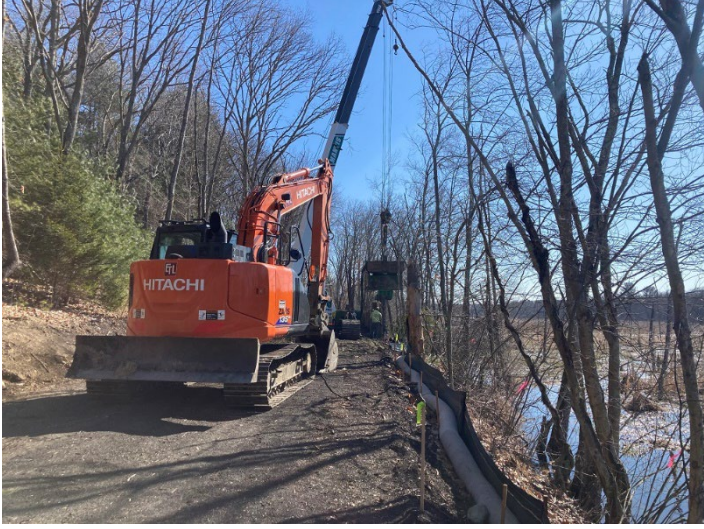
<b>PHOTOGRAPHIC LOG</b>	
<b>Client Name:</b> Eversource		<b>Site Location:</b> Sudbury to Hudson Transmission Reliability Project	
<b>Town:</b> Sudbury			
<b>Photo No.:</b> 6	<b>Date:</b> 3/20/2023

<b>Description:</b> View of ET&L driving sheets for wall #13 in segment 14. Facing east.

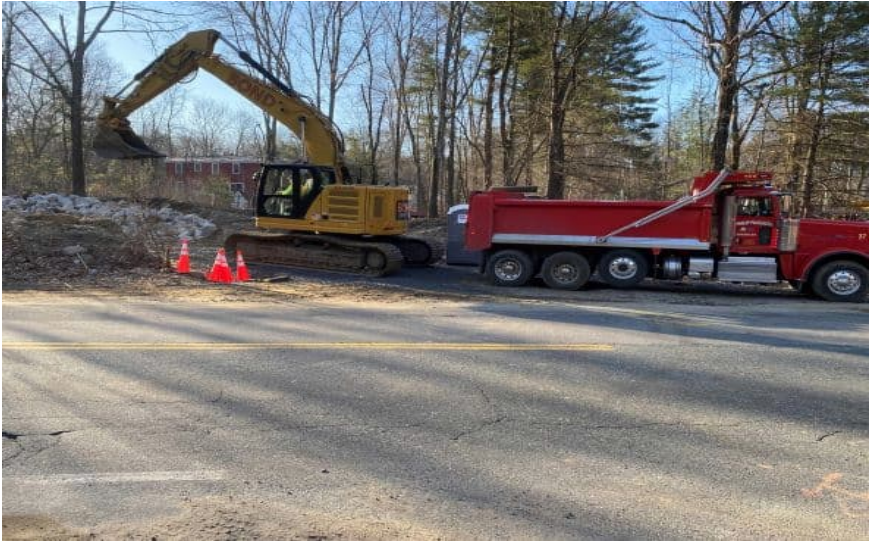
<p>PHOTOGRAPHIC LOG</p>	
<p>Client Name: Eversource</p>		<p>Site Location: Sudbury to Hudson Transmission Reliability Project</p>	<p>Town: Hudson</p>
<p>Photo No.: 1</p>	<p>Date: 3-21-23</p>

<p>Description:</p> <p>Bond conducting site work within Segment 1, looking eastward.</p>

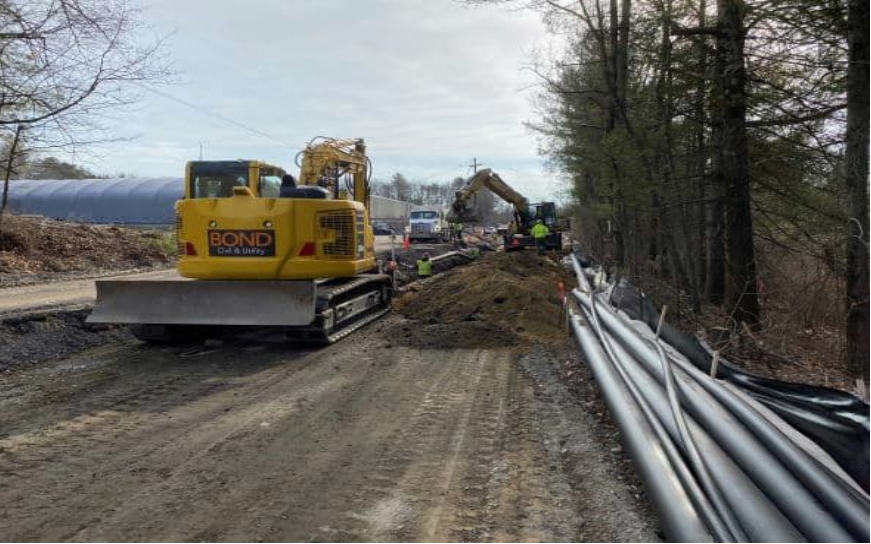
<p>PHOTOGRAPHIC LOG</p>	
<p>Client Name: Eversource</p>		<p>Site Location: Sudbury to Hudson Transmission Reliability Project</p>	<p>Town: Hudson</p>
<p>Photo No.: 2</p>	<p>Date: 3-21-23</p>

<p>Description:</p> <p>Bond conducting conduit work within Segment 3 at approximate Sta# 163+00, looking eastward.</p>

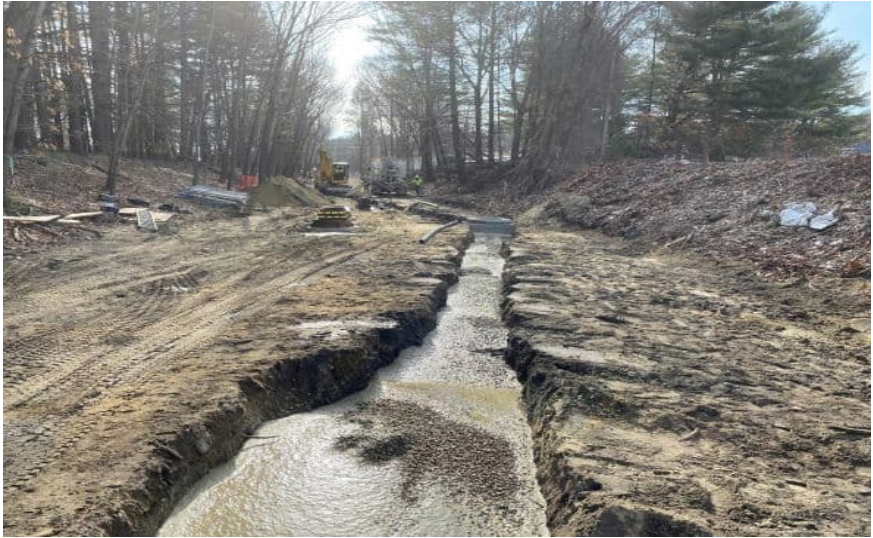
<p>PHOTOGRAPHIC LOG</p>	
<p>Client Name: Eversource</p>		<p>Site Location: Sudbury to Hudson Transmission Reliability Project</p>	<p>Town: Hudson</p>
<p>Photo No.: 3</p>	<p>Date: 3-21-23</p>

<p>Description:                  Bond conducting conduit work within Segment 3 at approximate Sta# 175+00, looking eastward.</p>

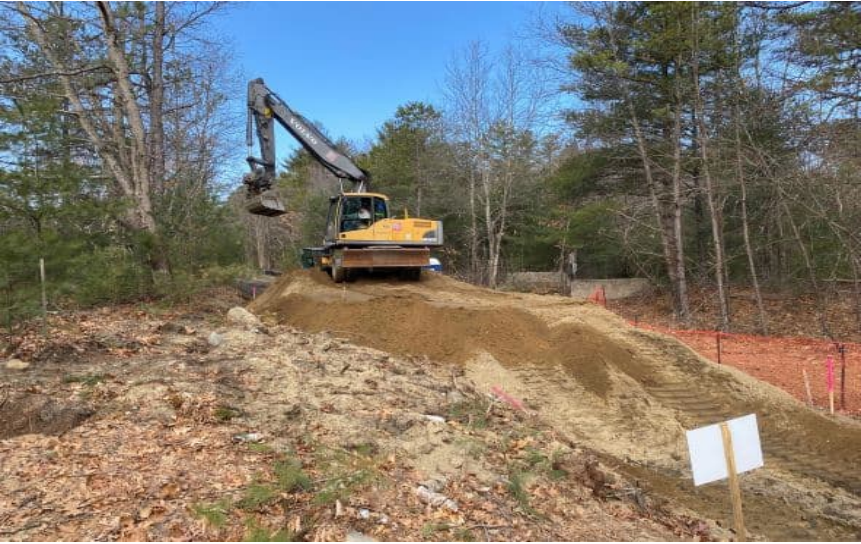
<p>PHOTOGRAPHIC LOG</p>	
<p>Client Name: Eversource</p>		<p>Site Location: Sudbury to Hudson Transmission Reliability Project</p>	<p>Town: Hudson</p>
<p>Photo No.: 5</p>	<p>Date: 3-21-23</p>

<p>Description:                  ET&amp;L conducting grading within Segment 6 at town line, looking eastward.</p>

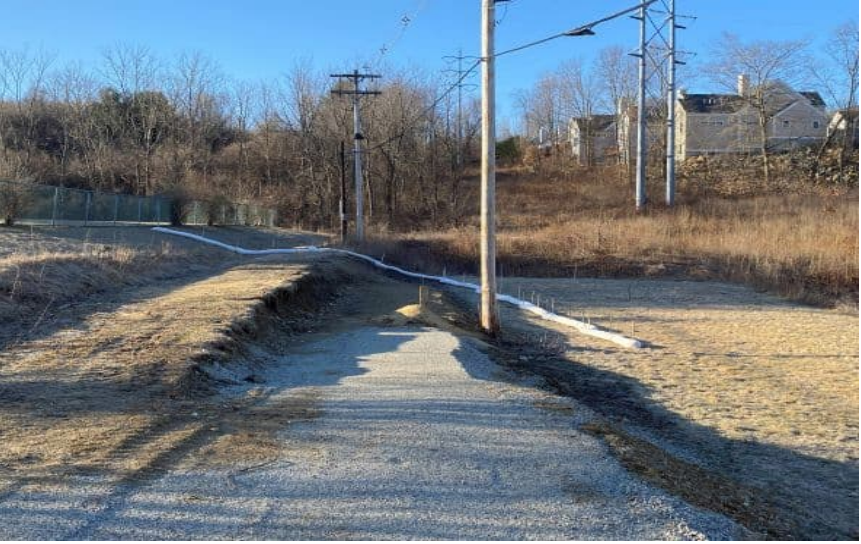
<p>PHOTOGRAPHIC LOG</p>	
<p>Client Name: Eversource</p>		<p>Site Location: Sudbury to Hudson Transmission Reliability Project</p>	<p>Town: Hudson</p>
<p>Photo No.: 6</p>	<p>Date: 3-21-23</p>

<p>Description:                  Compost filter tubes at MH#1 area, looking eastward.</p>

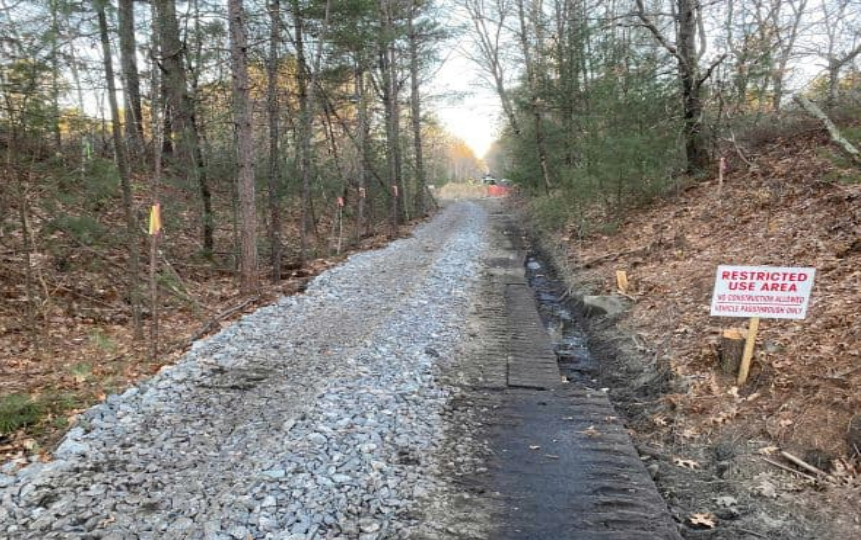
<p>PHOTOGRAPHIC LOG</p>	
<p>Client Name: Eversource</p>		<p>Site Location: Sudbury to Hudson Transmission Reliability Project</p>	<p>Town: Sudbury</p>
<p>Photo No.: 8</p>	<p>Date: 3-21-23</p>

<p>Description:                  Black Racer restrictive area, current condition, looking westward.</p>

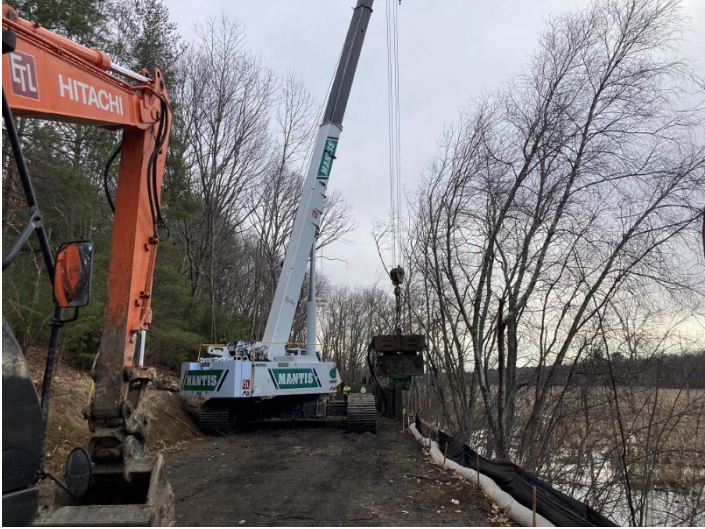
<b>PHOTOGRAPHIC LOG</b>	
<b>Client Name: Eversource</b>		<b>Site Location: Sudbury to Hudson Transmission Reliability Project</b>	<b>Town: Sudbury</b>
<b>Photo No.: 1</b>	<b>Date:</b> 3/21/2023

<b>Description:</b> View of ET&L driving sheets for wall #13 in segment 14. Facing east.

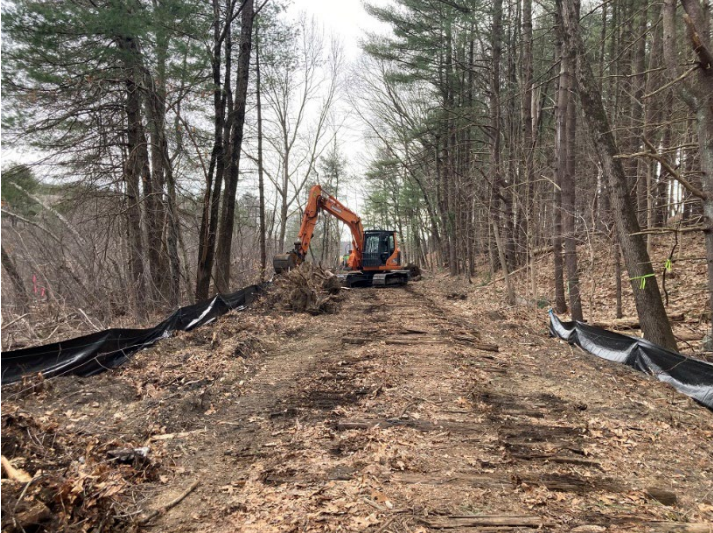
<b>PHOTOGRAPHIC LOG</b>	
<b>Client Name: Eversource</b>		<b>Site Location: Sudbury to Hudson Transmission Reliability Project</b>	<b>Town: Sudbury</b>
<b>Photo No.: 2</b>	<b>Date:</b> 3/21/2023

<b>Description:</b> View of Moosehead performing rail, tie, & stump removal in segment 13. Facing east.

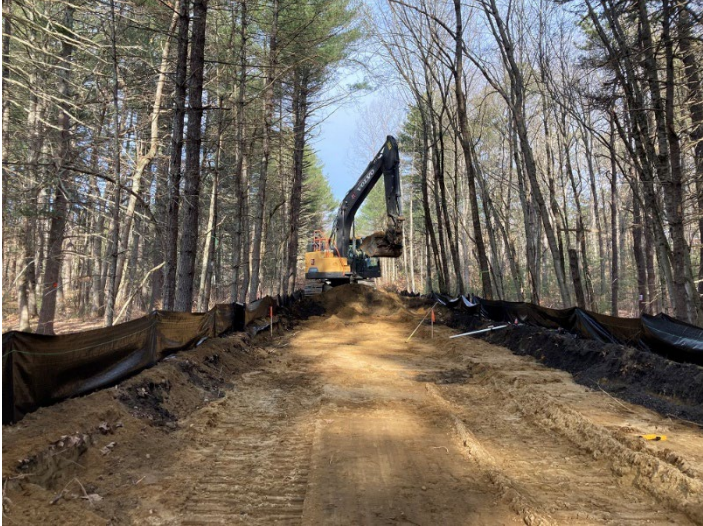
<b>PHOTOGRAPHIC LOG</b>	
<b>Client Name:</b> Eversource		<b>Site Location:</b> Sudbury to Hudson Transmission Reliability Project	<b>Town:</b> Sudbury
<b>Photo No.:</b> 4	<b>Date:</b> 3/21/2023

<b>Description:</b> View of ET&L performing cut & fill activities in segment 10. Facing west.

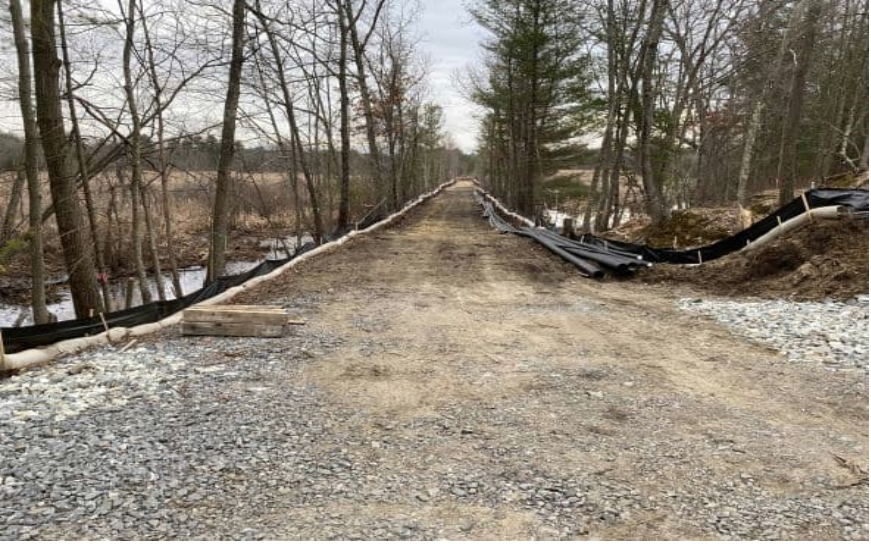
<p>PHOTOGRAPHIC LOG</p>	
<p>Client Name: Eversource</p>		<p>Site Location: Sudbury to Hudson Transmission Reliability Project</p>	<p>Town: Hudson</p>
<p>Photo No.: 2</p>	<p>Date: 3-23-23</p>

<p>Description:</p> <p>Right-of-way (ROW) within Segment 2 at approximate Sta# 142+00, looking eastward.</p>

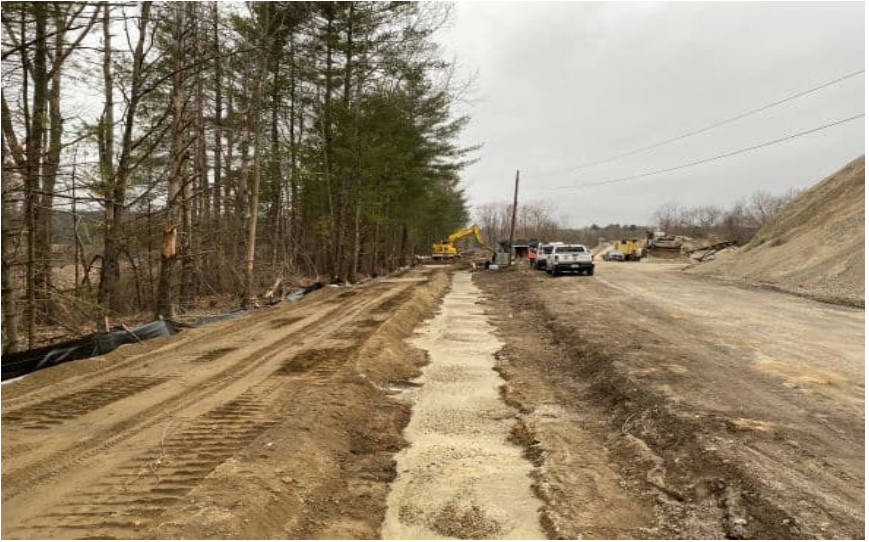
<p>PHOTOGRAPHIC LOG</p>	
<p>Client Name: Eversource</p>		<p>Site Location: Sudbury to Hudson Transmission Reliability Project</p>	<p>Town: Hudson</p>
<p>Photo No.: 3</p>	<p>Date: 3-23-23</p>

<p>Description:</p> <p>Bond conducting conduit work within Segment 3 (backfilled with flowable fill) at approximate Sta# 166+00, looking westward.</p>

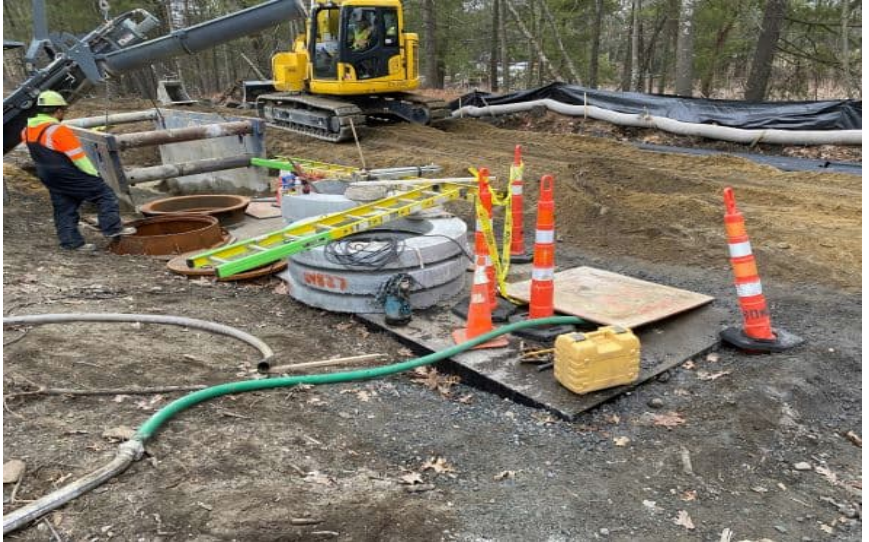
<p>PHOTOGRAPHIC LOG</p>	
<p>Client Name: Eversource</p>		<p>Site Location: Sudbury to Hudson Transmission Reliability Project</p>	<p>Town: Hudson</p>
<p>Photo No.: 4</p>	<p>Date: 3-23-23</p>

<p>Description:</p> <p>Bond conducting conduit work within Segment 3 at MH#8, looking westward.</p>

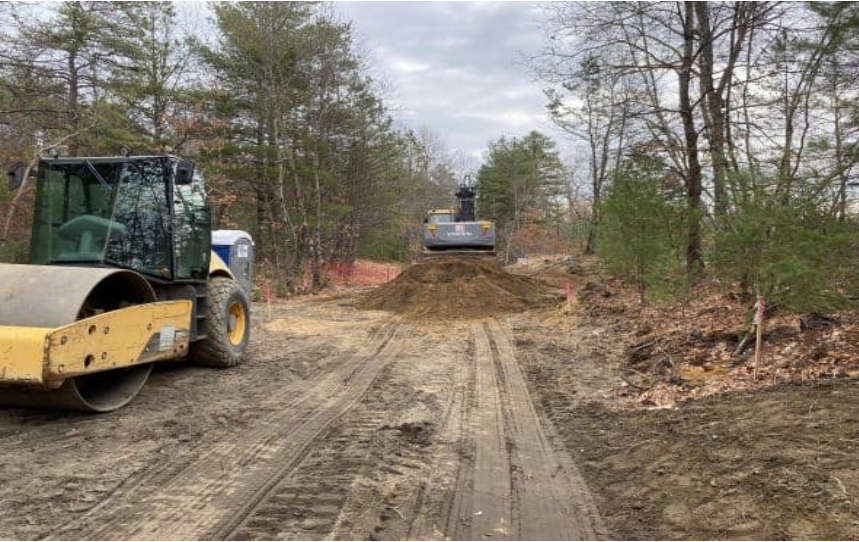
<p>PHOTOGRAPHIC LOG</p>	
<p>Client Name: Eversource</p>		<p>Site Location: Sudbury to Hudson Transmission Reliability Project</p>	<p>Town: Hudson</p>
<p>Photo No.: 5</p>	<p>Date: 3-23-23</p>

<p>Description:</p> <p>ET&amp;L conducting grading within Segment 6 at town line, looking eastward.</p>

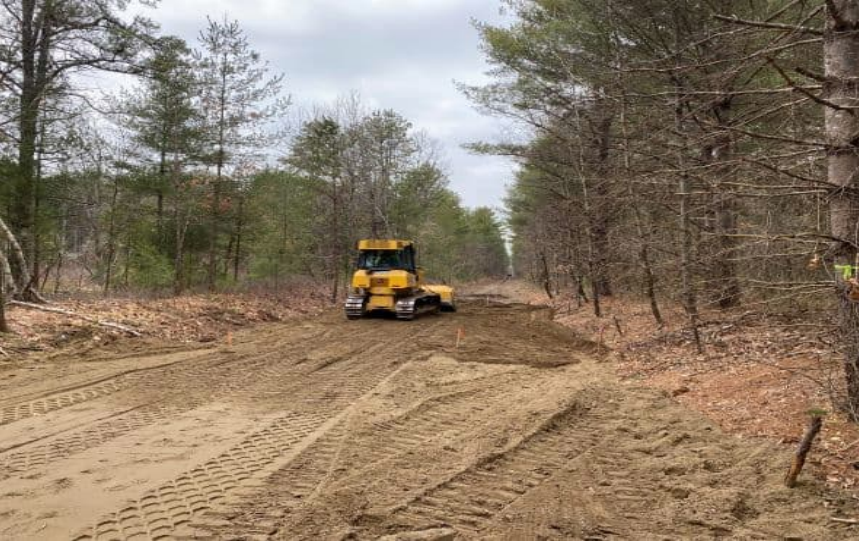
<p>PHOTOGRAPHIC LOG</p>	
<p>Client Name: Eversource</p>		<p>Site Location: Sudbury to Hudson Transmission Reliability Project</p>	<p>Town: Sudbury</p>
<p>Photo No.: 6</p>	<p>Date: 3-23-23</p>

<p>Description:</p> <p>ET&amp;L conducting grading within Segment 7 at approximate Sta#389+00, looking westward.</p>

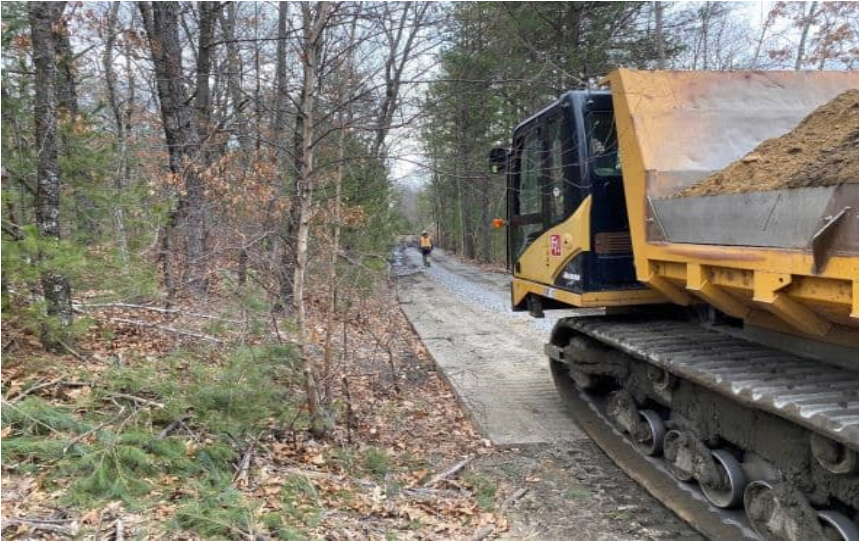
<p>PHOTOGRAPHIC LOG</p>	
<p>Client Name: Eversource</p>		<p>Site Location: Sudbury to Hudson Transmission Reliability Project</p>	<p>Town: Sudbury</p>
<p>Photo No.: 7</p>	<p>Date: 3-23-23</p>

<p>Description:</p> <p>Grading activity within Segment 7 with vernal pool monitor preceding Morooka crawler movement, looking eastward.</p>

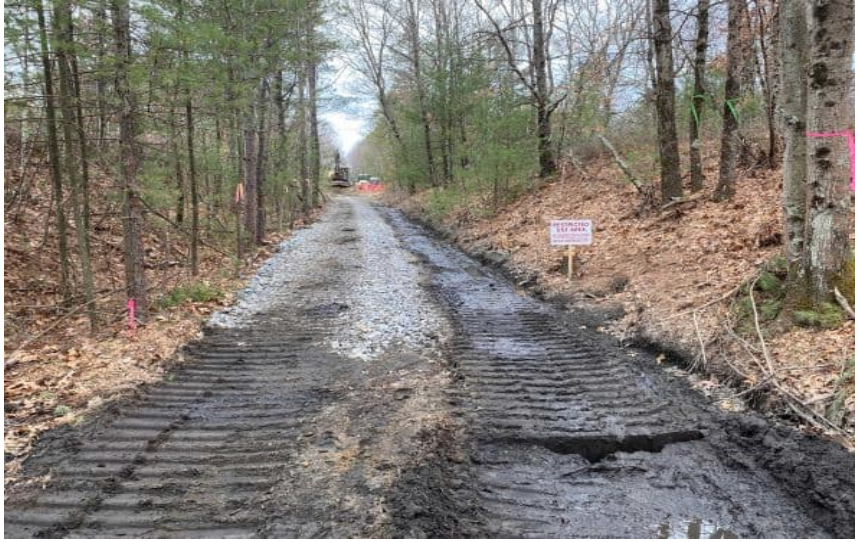
<p>PHOTOGRAPHIC LOG</p>	
<p>Client Name: Eversource</p>		<p>Site Location: Sudbury to Hudson Transmission Reliability Project</p>	<p>Town: Sudbury</p>
<p>Photo No.: 8</p>	<p>Date: 3-23-23</p>

<p>Description:</p> <p>Black Racer restrictive area, current condition, looking westward.</p>

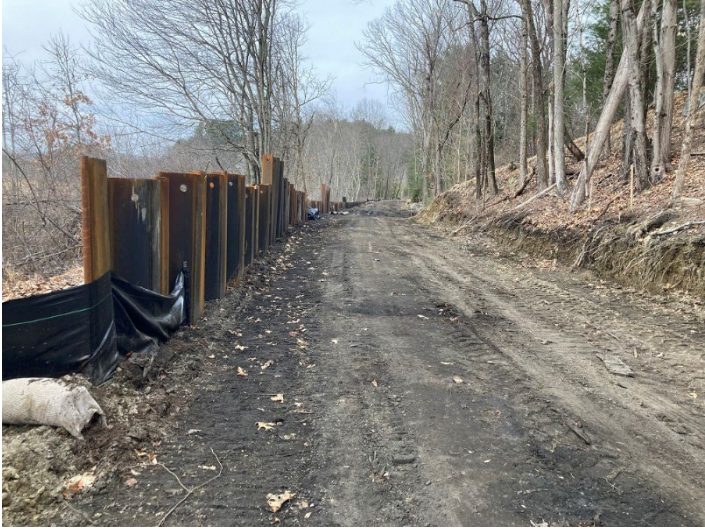
<p align="center"><b>PHOTOGRAPHIC LOG</b></p>	
<b>Client Name: Eversource</b>		<b>Site Location: Sudbury to Hudson Transmission Reliability Project</b>	<b>Town: Sudbury</b>
<b>Photo No.: 1</b>	<b>Date:</b> 3/23/2023

<b>Description:</b> View of sheetwall #13 in segment 14. Facing west.

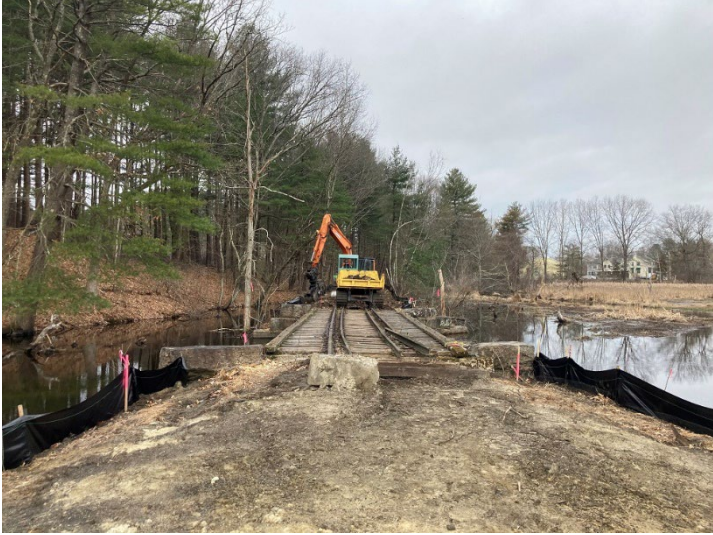
<b>PHOTOGRAPHIC LOG</b>	
<b>Client Name:</b> Eversource		<b>Site Location:</b> Sudbury to Hudson Transmission Reliability Project	
<b>Town:</b> Sudbury			
<b>Photo No.:</b> 3	<b>Date:</b> 3/23/2023

<b>Description:</b> View of Moosehead performing rail, tie, & stump removal in segment 13 near bridge 127. Facing west.

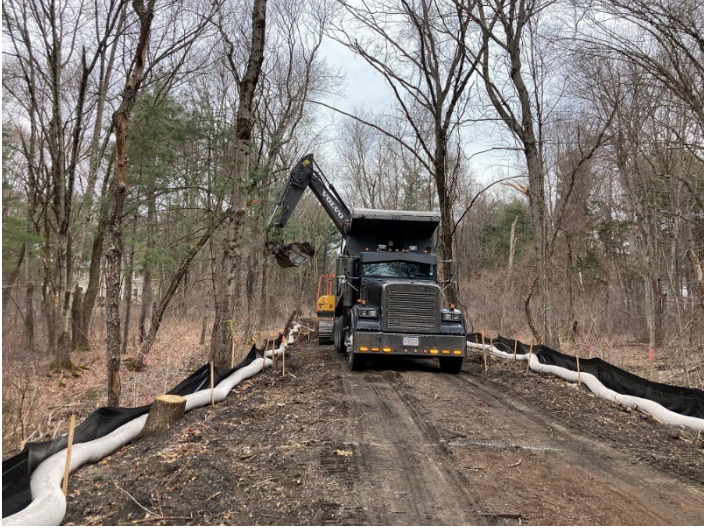
<b>PHOTOGRAPHIC LOG</b>	
<b>Client Name:</b> Eversource		<b>Site Location:</b> Sudbury to Hudson Transmission Reliability Project	
<b>Town:</b> Sudbury			
<b>Photo No.:</b> 6	<b>Date:</b> 3/23/2023

<b>Description:</b> View of ET&L performing cut & fill activities in segment 9. Facing west.

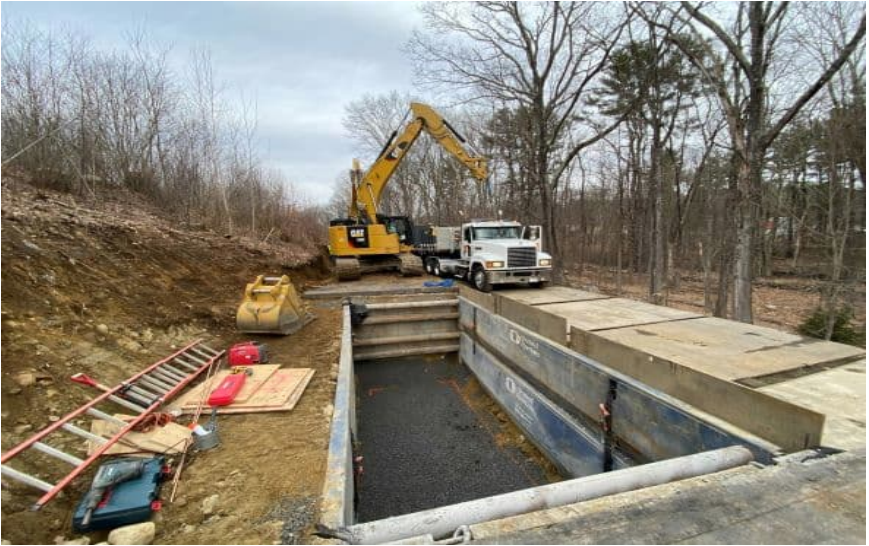
<p>PHOTOGRAPHIC LOG</p>	
<p>Client Name: Eversource</p>		<p>Site Location: Sudbury to Hudson Transmission Reliability Project</p>	<p>Town: Hudson</p>
<p>Photo No.: 1</p>	<p>Date: 3-24-23</p>

<p>Description:</p> <p>MH#6 within Segment 1 at approximate Sta# 121+00, looking westward.</p>

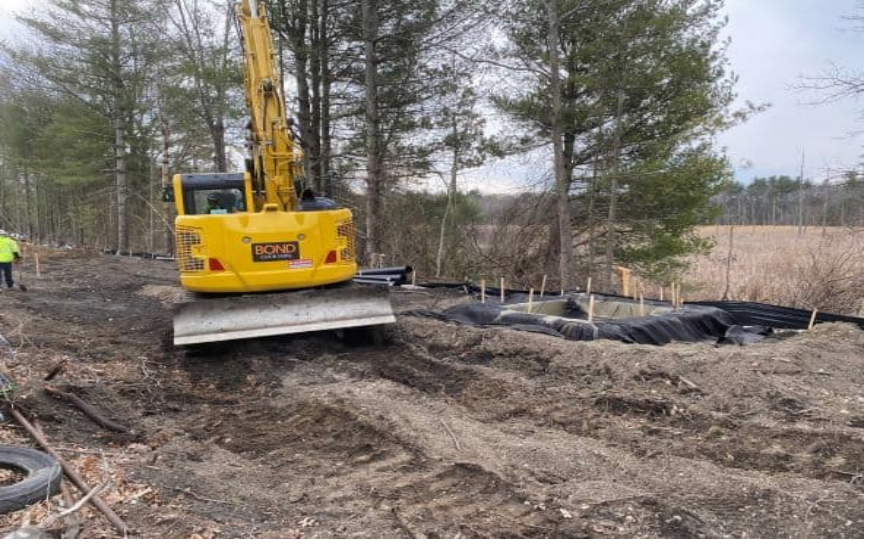
<p>PHOTOGRAPHIC LOG</p>	
<p>Client Name: Eversource</p>		<p>Site Location: Sudbury to Hudson Transmission Reliability Project</p>	<p>Town: Hudson</p>
<p>Photo No.: 2</p>	<p>Date: 3-24-23</p>

<p>Description:</p> <p>Bond conducting site work within Segment 3, at approximate Sta# 155+75, looking eastward.</p>

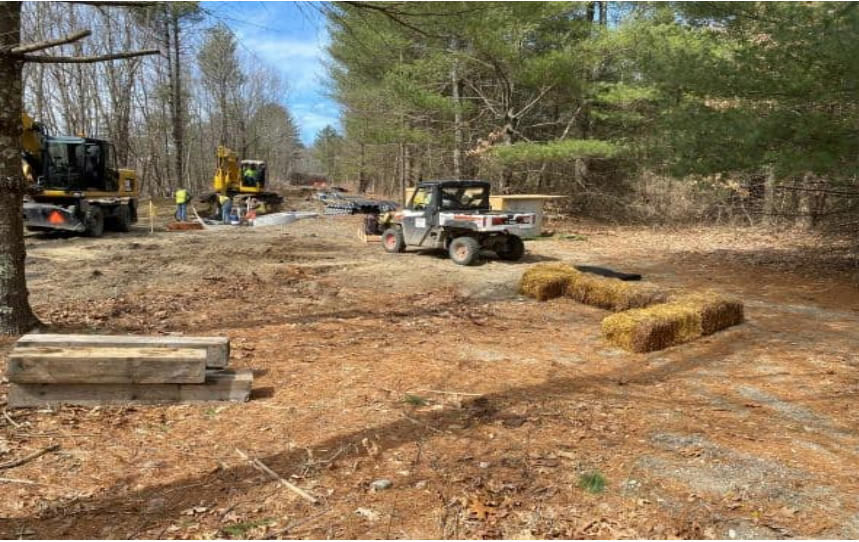
<p>PHOTOGRAPHIC LOG</p>	
<p>Client Name: Eversource</p>		<p>Site Location: Sudbury to Hudson Transmission Reliability Project</p>	<p>Town: Hudson</p>
<p>Photo No.: 3</p>	<p>Date: 3-24-23</p>

<p>Description:</p> <p>Bond conducting conduit work within Segment 3 (MH#7) at approximate Sta# 139+00, looking westward.</p>

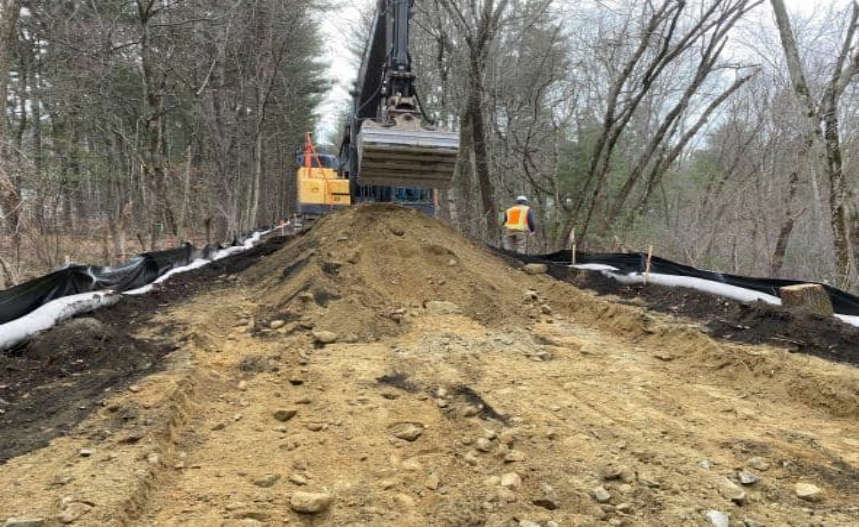
<p>PHOTOGRAPHIC LOG</p>	
<p>Client Name: Eversource</p>		<p>Site Location: Sudbury to Hudson Transmission Reliability Project</p>	<p>Town: Sudbury</p>
<p>Photo No.: 4</p>	<p>Date: 3-24-23</p>

<p>Description:</p> <p>ET&amp;L conducting grading within Segment 9 over culvert at approximate Sta# 518+00, looking eastward.</p>

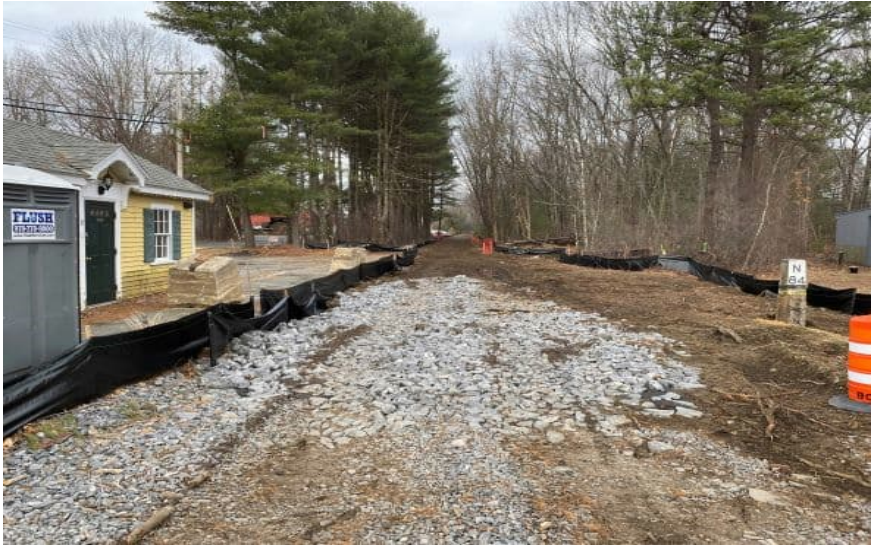
<p>PHOTOGRAPHIC LOG</p>	
<p>Client Name: Eversource</p>		<p>Site Location: Sudbury to Hudson Transmission Reliability Project</p>	<p>Town: Sudbury</p>
<p>Photo No.: 5</p>	<p>Date: 3-24-23</p>

<p>Description:</p> <p>Right-of-way within Segment 11, just off Union Avenue, looking westward.</p>

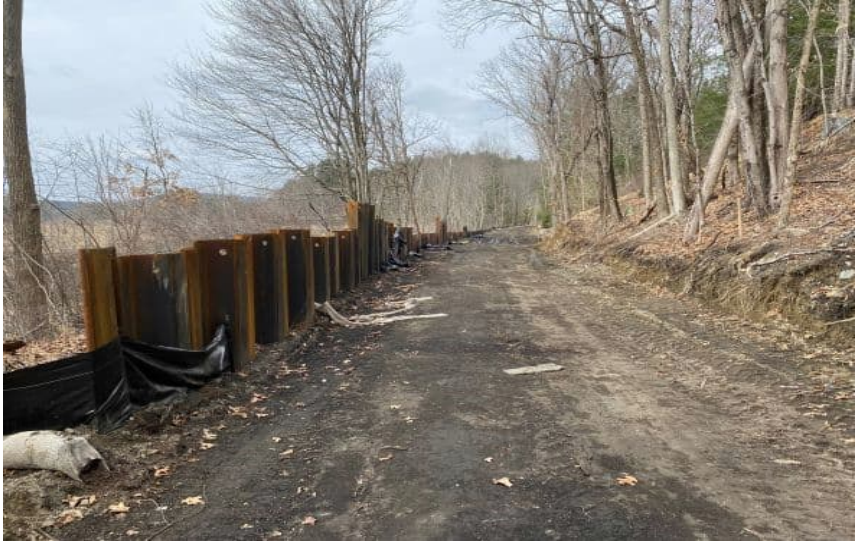
<p>PHOTOGRAPHIC LOG</p>	
<p>Client Name: Eversource</p>		<p>Site Location: Sudbury to Hudson Transmission Reliability Project</p>	<p>Town: Sudbury</p>
<p>Photo No.: 8</p>	<p>Date: 3-24-23</p>

<p>Description:</p> <p>Recently installed sheeting within Segment 14, looking westward.</p>

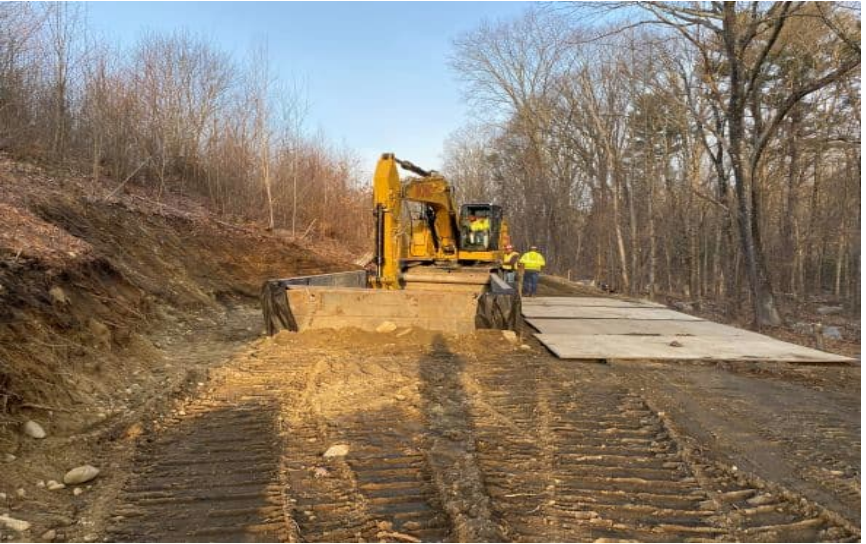
<b>PHOTOGRAPHIC LOG</b>	
Client Name: Eversource		Site Location: Sudbury to Hudson Transmission Reliability Project	Town: Hudson
Photo No.: 1	Date: 3-22-23

Description:  Bond conducting MH#6 work within Segment 1, at approximate Sta# 121+00, looking westward.

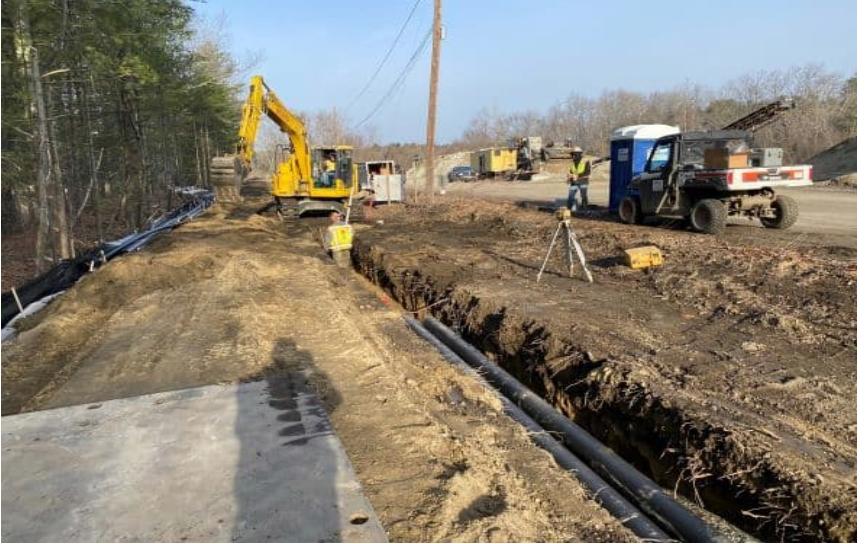
<b>PHOTOGRAPHIC LOG</b>	
Client Name: Eversource		Site Location: Sudbury to Hudson Transmission Reliability Project	Town: Hudson
Photo No.: 2	Date: 3-22-23

Description:  Bond conducting conduit work within Segment 3, at approximate Sta# 162+50, looking westward.

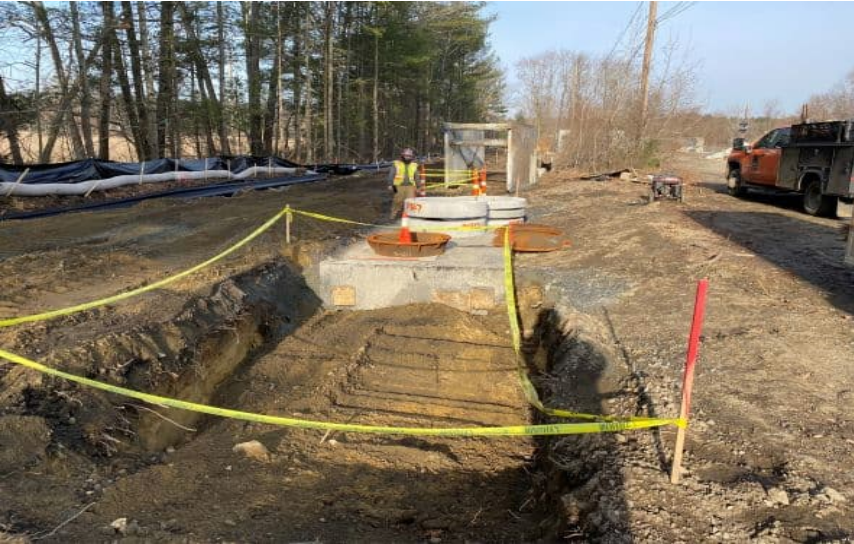
<b>PHOTOGRAPHIC LOG</b>	
Client Name: Eversource		Site Location: Sudbury to Hudson Transmission Reliability Project	Town: Hudson
Photo No.: 3	Date: 3-22-23

Description:  Bond conducting conduit work at MH#8, within Segment 3, looking westward.

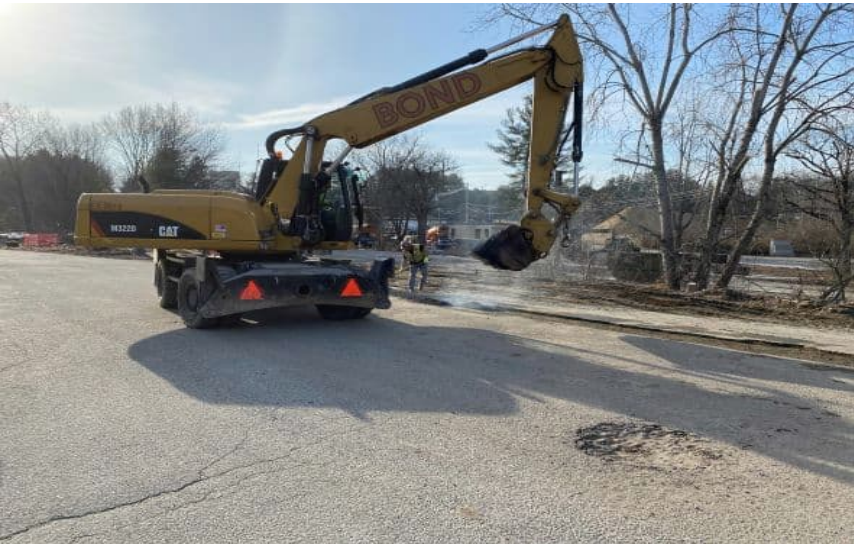
<b>PHOTOGRAPHIC LOG</b>	
Client Name: Eversource		Site Location: Sudbury to Hudson Transmission Reliability Project	Town: Hudson
Photo No.: 4	Date: 3-22-23

Description:  Bond conducting asphalt work, within Segment 3, looking westward.

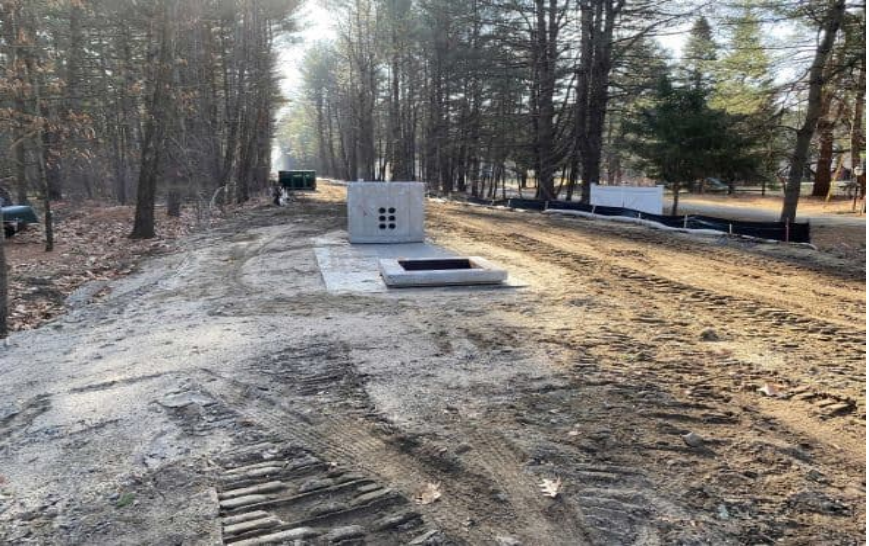
<b>PHOTOGRAPHIC LOG</b>	
Client Name: Eversource		Site Location: Sudbury to Hudson Transmission Reliability Project	Town: Hudson
Photo No.: 6	Date: 3-22-23

Description:  MH#11 area, within Segment 5, looking eastward.

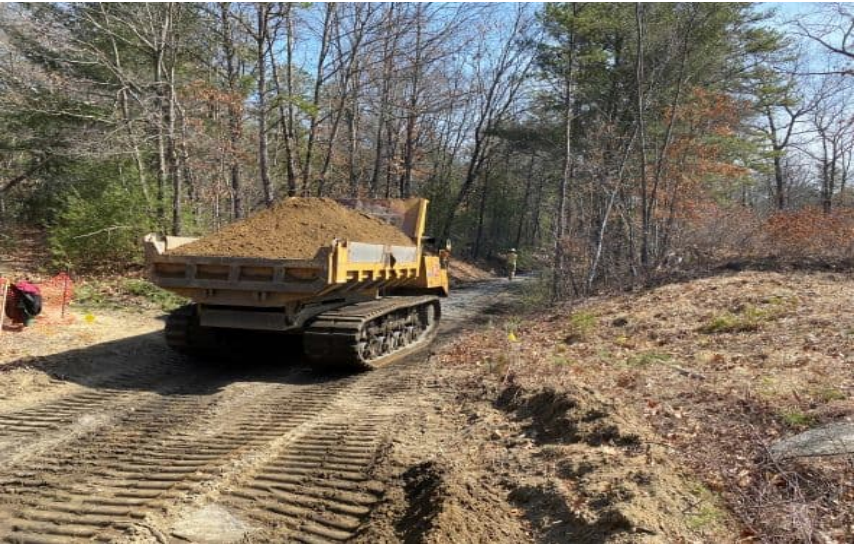
<b>PHOTOGRAPHIC LOG</b>	
Client Name: Eversource		Site Location: Sudbury to Hudson Transmission Reliability Project	Town: Sudbury
Photo No.: 7	Date: 3-22-23

Description:  ET&L conducting grading activities, within Segment 7, with vernal pool monitor preceding Morooka carrier, looking eastward

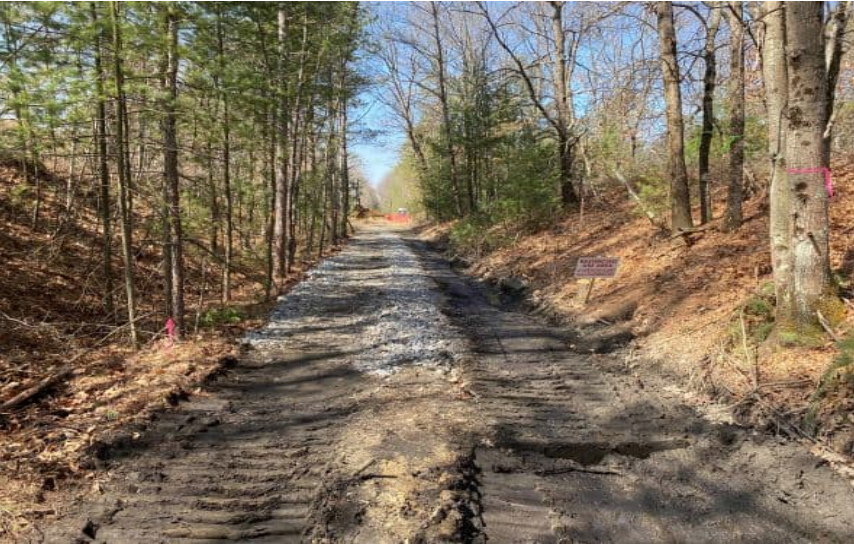
<b>PHOTOGRAPHIC LOG</b>	
Client Name: Eversource		Site Location: Sudbury to Hudson Transmission Reliability Project	Town: Sudbury
Photo No.: 8	Date: 3-22-23

Description:  Current state of 200' Black Racer time of year restrictive area with new stone access, looking westward.

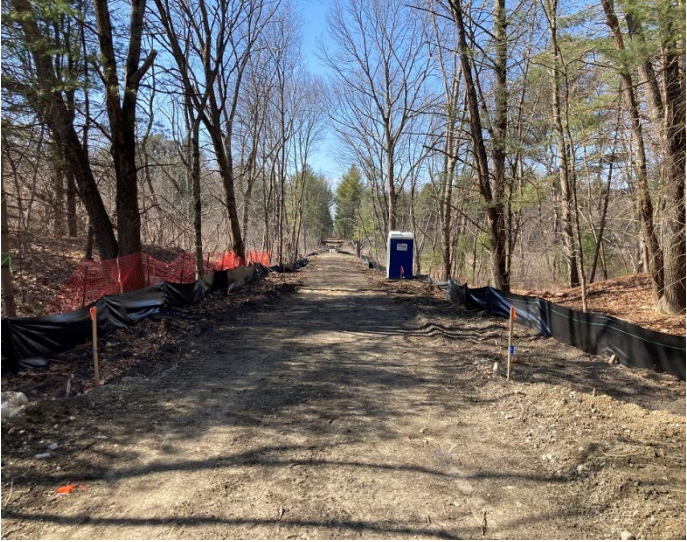
<b>PHOTOGRAPHIC LOG</b>	
<b>Client Name:</b> Eversource		<b>Site Location:</b> Sudbury to Hudson Transmission Reliability Project	<b>Town:</b> Sudbury
<b>Photo No.:</b> 1	<b>Date:</b> 3-22-2023

<b>Description:</b> View of segment 8. Facing west.

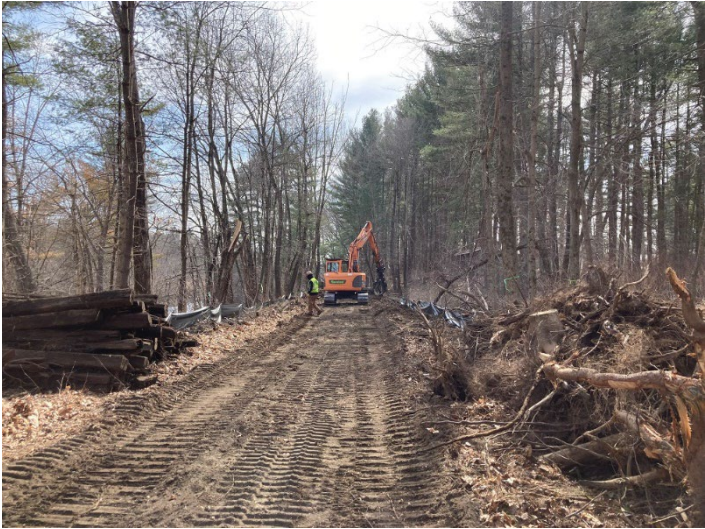
<b>Epsilon</b> ASSOCIATES INC.		<b>PHOTOGRAPHIC LOG</b>	
<b>Client Name:</b> Eversource		<b>Site Location:</b> Sudbury to Hudson Transmission Reliability Project	<b>Town:</b> Sudbury
<b>Photo No.:</b> 6	<b>Date:</b> 3-22-2023

<b>Description:</b> View of Moosehead performing rail, ties, & stump removal in segment 13. Facing east.

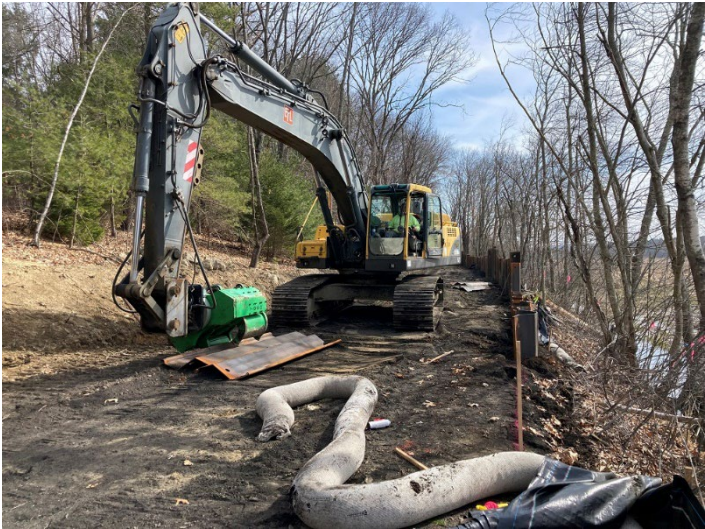
<b>Epsilon</b> ASSOCIATES INC.		<b>PHOTOGRAPHIC LOG</b>	
Client Name: Eversource		Site Location: Sudbury to Hudson Transmission Reliability Project	Town: Sudbury
Photo No.: 7	Date: 3-22-2023

<b>Description:</b> View of ET&L installing sheets for wall #13 in segment 14. Facing northeast.

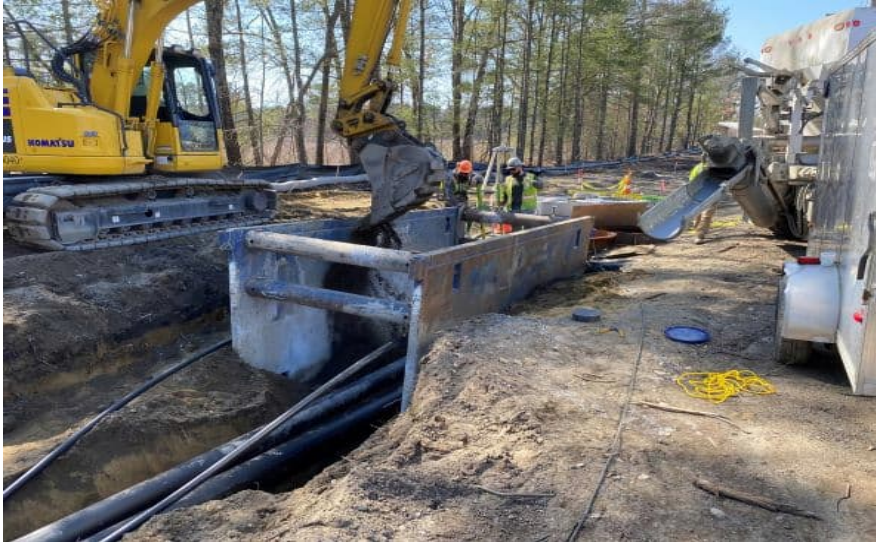
<b>PHOTOGRAPHIC LOG</b>	
Client Name: Eversource		Site Location: Sudbury to Hudson Transmission Reliability Project	Town: Hudson
Photo No.: 1	Date: 3/22/2023

Description: View of area being pumped at work operation at MH#8, at approximate Sta.# 157+50 within Segment 3, looking westward.

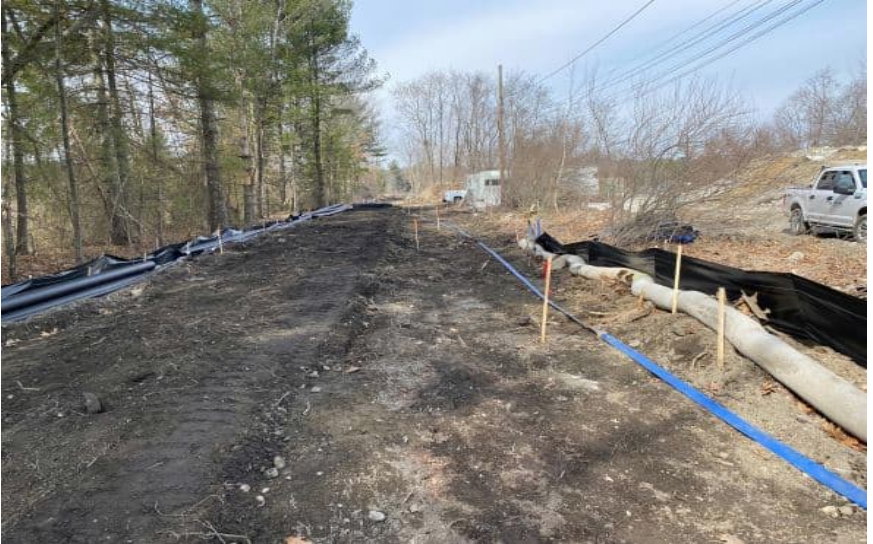
<b>PHOTOGRAPHIC LOG</b>	
Client Name: Eversource		Site Location: Sudbury to Hudson Transmission Reliability Project	Town: Hudson
Photo No.: 3	Date: 3/22/2023

Description: MH#8. View of dewatering operation, looking westward.

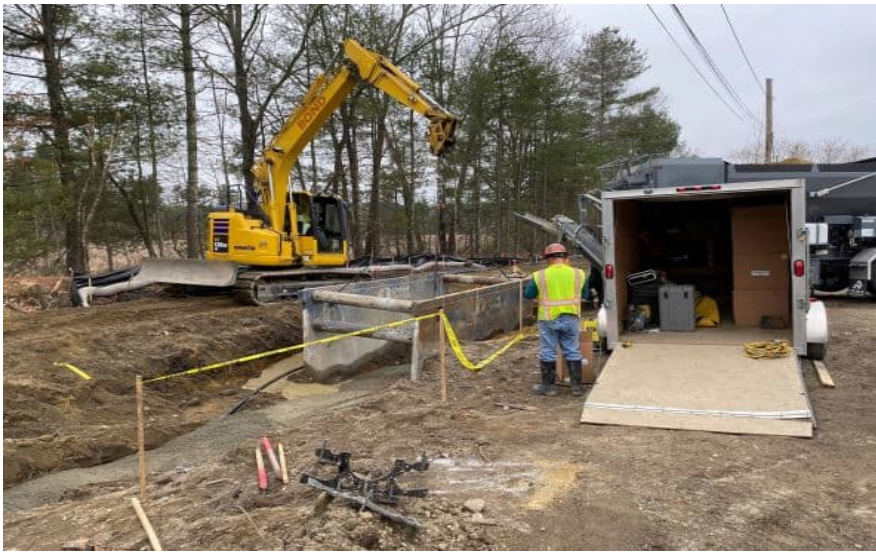
<b>PHOTOGRAPHIC LOG</b>	
Client Name: Eversource		Site Location: Sudbury to Hudson Transmission Reliability Project	Town: Hudson
Photo No.: 1	Date: 3/23/2023

Description: View of area being pumped at work operation at MH#8, at approximate Sta.# 157+50 within Segment 3, looking westward.

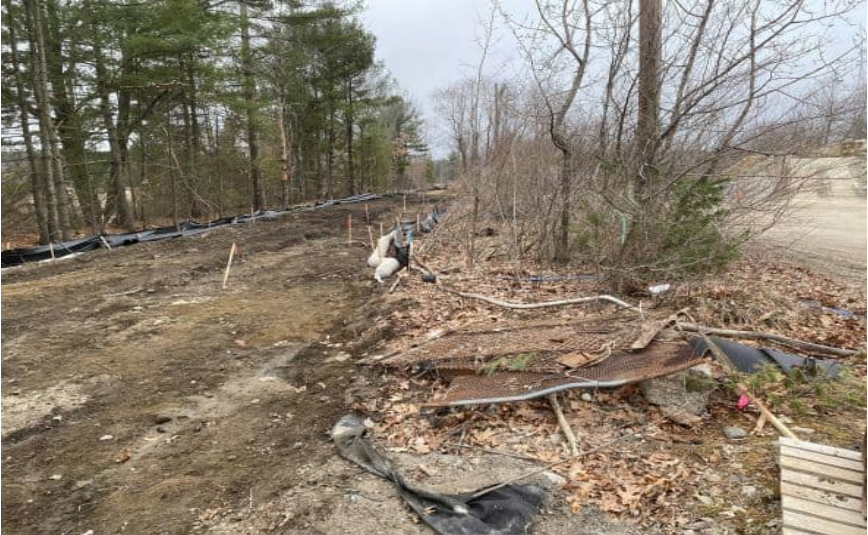
<b>PHOTOGRAPHIC LOG</b>	
Client Name: Eversource		Site Location: Sudbury to Hudson Transmission Reliability Project	Town: Hudson
Photo No.: 3	Date: 3/23/2023

Description: MH#8. View of dewatering operation, looking westward.
