**Weekly Environmental Compliance Summary**

**Sudbury to Hudson Transmission Reliability Project (USEPA Tracking # MAR1003UW)**

Sudbury, Hudson, and Stow, MA

Week of: March 20 to March 24, 2023

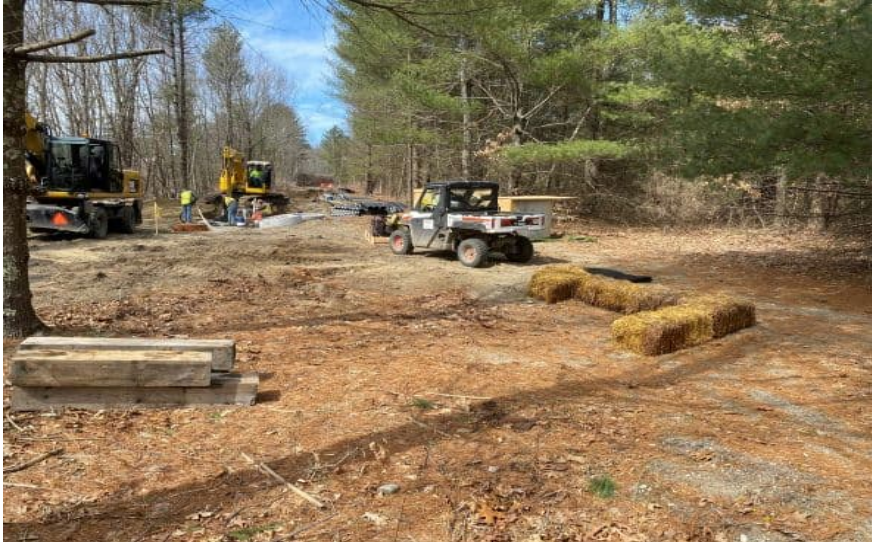
<b>PHOTOGRAPHIC LOG</b>	
Client Name: Eversource		Site Location: Sudbury to Hudson Transmission Reliability Project	Town: Hudson
Photo No.: 1	Date: 3/24/2023

Description: View of area being pumped at work operation at MH#7, at approximate Sta.# 139+00 in Segment 2, looking westward.

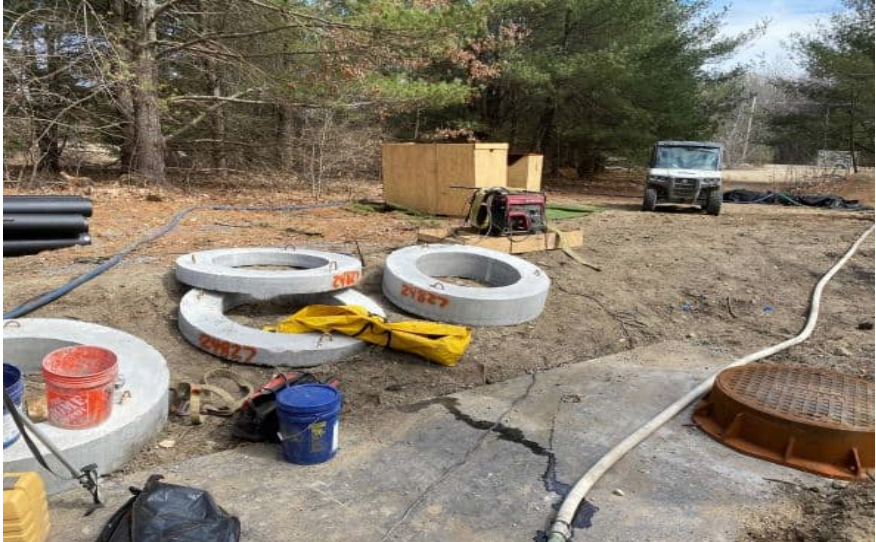
<b>PHOTOGRAPHIC LOG</b>	
Client Name: Eversource		Site Location: Sudbury to Hudson Transmission Reliability Project	Town: Hudson
Photo No.: 3	Date: 3/24/2023

Description: MH#7. View of dewatering operation, looking eastward.
