Weekly Environmental Compliance Summary

Sudbury to Hudson Transmission Reliability Project (USEPA Tracking # MAR1003UW)

Week of: March 27 to March 31, 2023

CONSTRUCTION MONITORING REPORT
Sudbury to Hudson Transmission Project

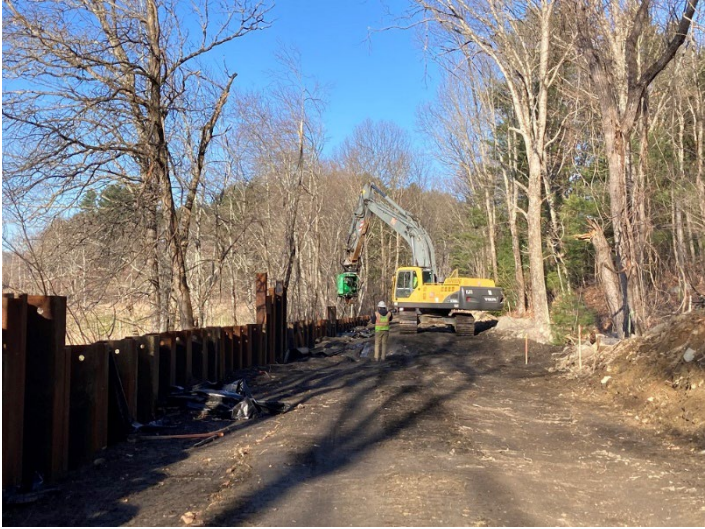
<p align="right">PHOTOGRAPHIC LOG</p>	
Client Name: Eversource		Site Location: Sudbury to Hudson Transmission Reliability Project	Town: Sudbury
Photo No.: 1	Date: 3/27/2023

Description: View of ET&L performing work at sheetwall #13 in segment 14. Facing west.

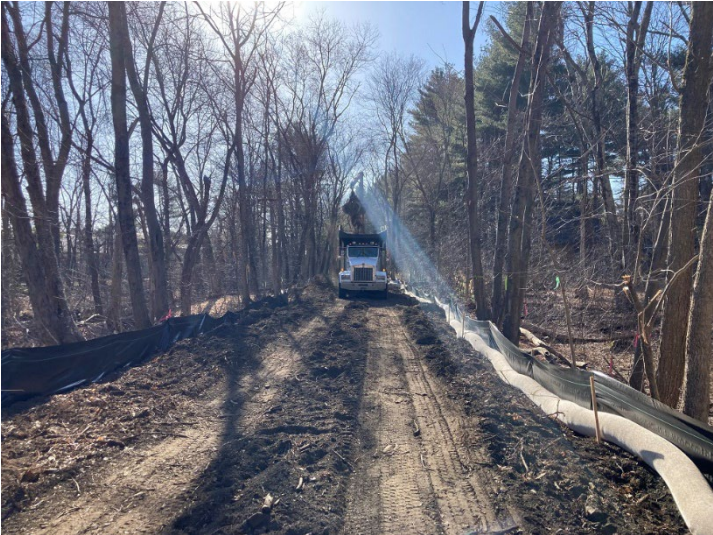
<p align="right">PHOTOGRAPHIC LOG</p>	
Client Name: Eversource		Site Location: Sudbury to Hudson Transmission Reliability Project	Town: Sudbury
Photo No.: 2	Date: 3/27/2023

Description: View of Moosehead performing rail, tie, and stump removal activities in segment 13. Facing east.

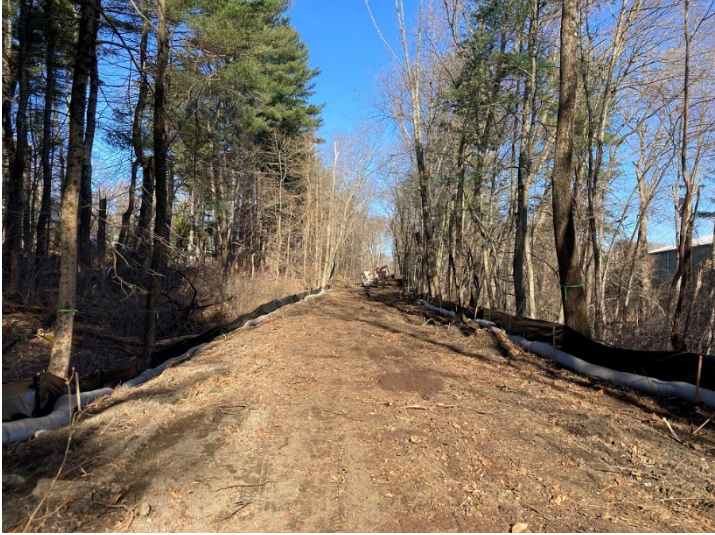
PHOTOGRAPHIC LOG	
Client Name: Eversource		Site Location: Sudbury to Hudson Transmission Reliability Project	Town: Sudbury
Photo No.: 3	Date: 3/27/2023

Description: View of newly installed filter tubes in segment 13. Facing west.

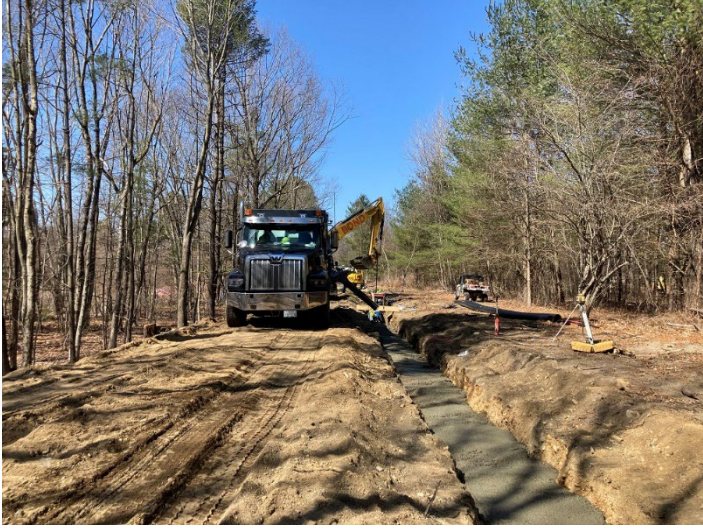
PHOTOGRAPHIC LOG	
Client Name: Eversource		Site Location: Sudbury to Hudson Transmission Reliability Project	
Town: Hudson			
Photo No.: 5	Date: 3/27/2023

Description: View of Bond performing duct bank work in segment 2. Facing west.

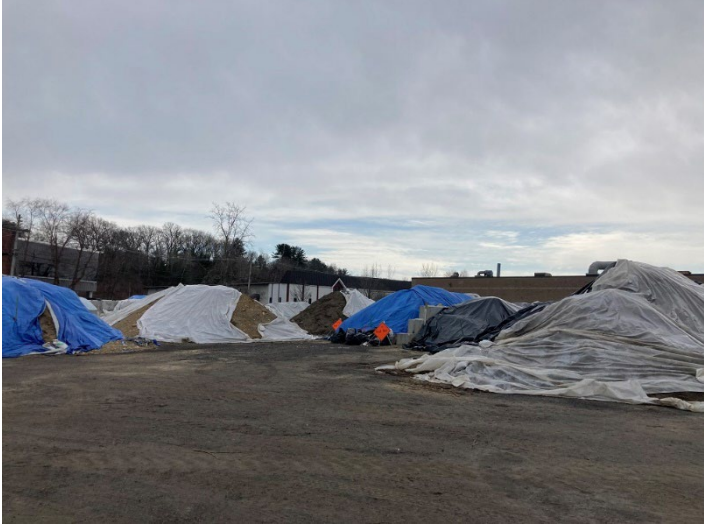
PHOTOGRAPHIC LOG	
Client Name: Eversource		Site Location: Sudbury to Hudson Transmission Reliability Project	
Town: Hudson			
Photo No.: 6	Date: 3/27/2023

Description: View of laydown yard at Robert Bonazzoli Drive. Facing southwest.

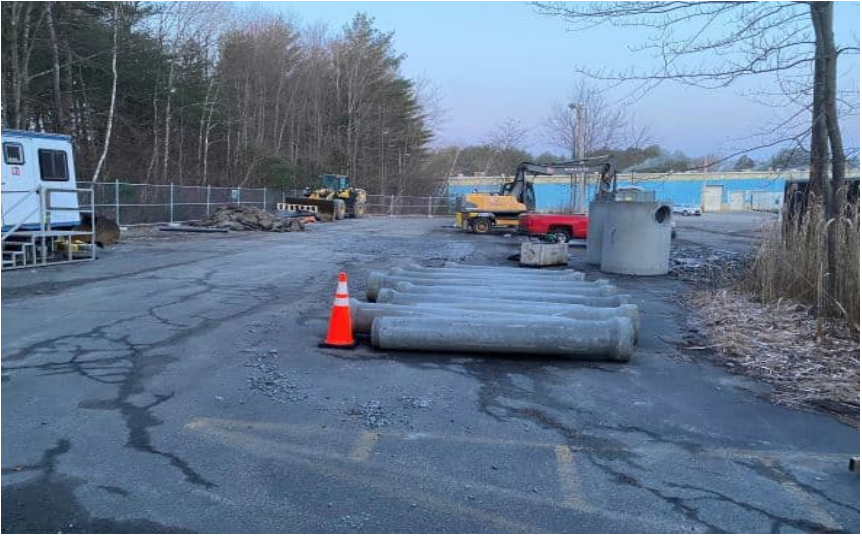
<p>PHOTOGRAPHIC LOG</p>	
<p>Client Name: Eversource</p>		<p>Site Location: Sudbury to Hudson Transmission Reliability Project</p>	<p>Town: Hudson</p>
<p>Photo No.: 1</p>	<p>Date: 3-29-23</p>

<p>Description:</p> <p>Laydown yard at 555 Main Street, looking westward.</p>

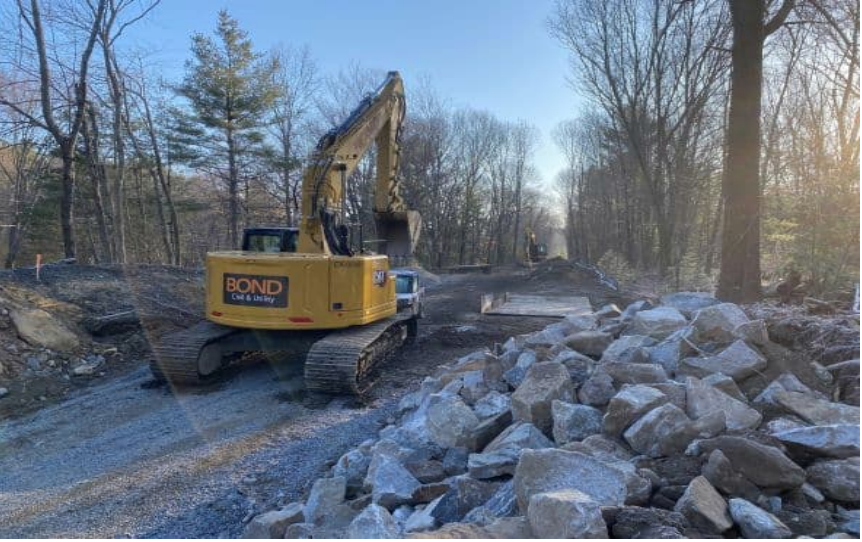
<p>PHOTOGRAPHIC LOG</p>	
<p>Client Name: Eversource</p>		<p>Site Location: Sudbury to Hudson Transmission Reliability Project</p>	<p>Town: Hudson</p>
<p>Photo No.: 2</p>	<p>Date: 3-29-23</p>

<p>Description:</p> <p>Bond conducting work within Segment 1 at MH#5 at approximate Sta# 102+00, looking eastward.</p>

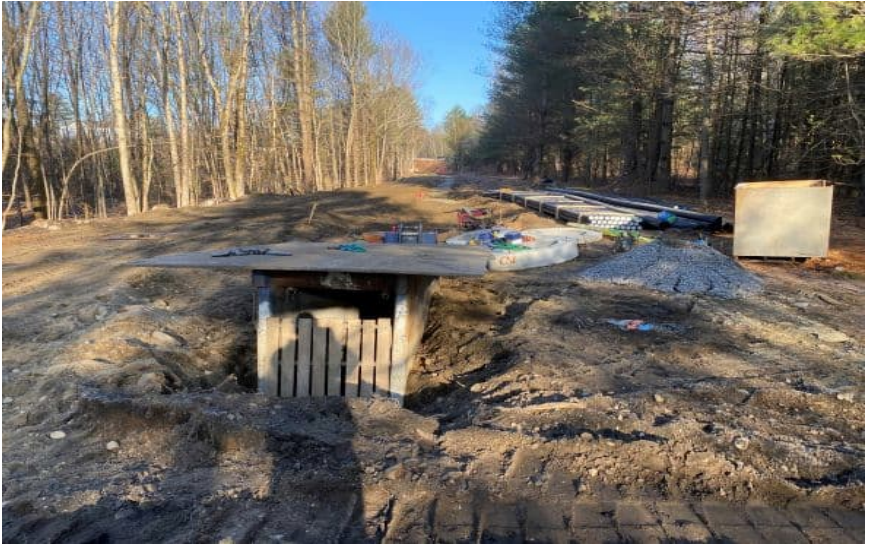
<p>PHOTOGRAPHIC LOG</p>	
<p>Client Name: Eversource</p>		<p>Site Location: Sudbury to Hudson Transmission Reliability Project</p>	<p>Town: Hudson</p>
<p>Photo No.: 3</p>	<p>Date: 3-29-23</p>

<p>Description: MH#7, within Segment 2, looking westward.</p>

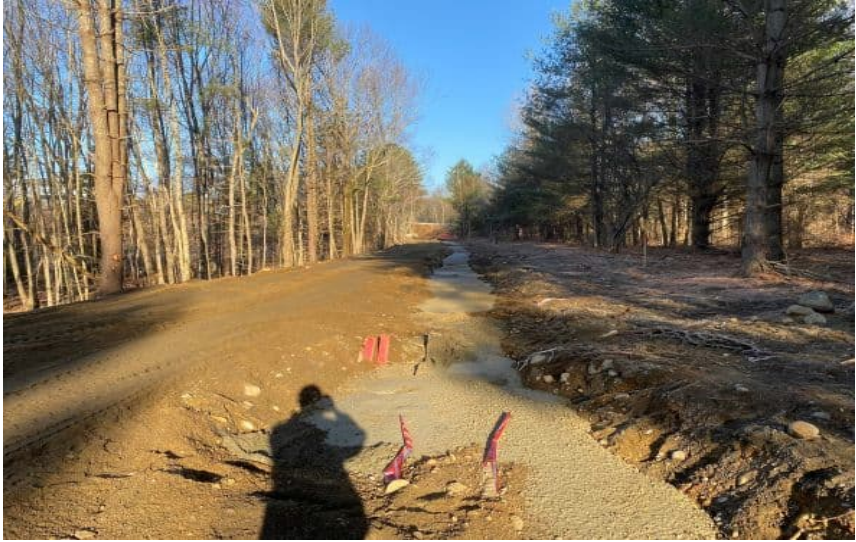
<p>PHOTOGRAPHIC LOG</p>	
<p>Client Name: Eversource</p>		<p>Site Location: Sudbury to Hudson Transmission Reliability Project</p>	<p>Town: Hudson</p>
<p>Photo No.: 4</p>	<p>Date: 3-29-23</p>

<p>Description: Previously backfilled conduit from MH#7 toward Chestnut Street, within Segment 2, looking eastward.</p>

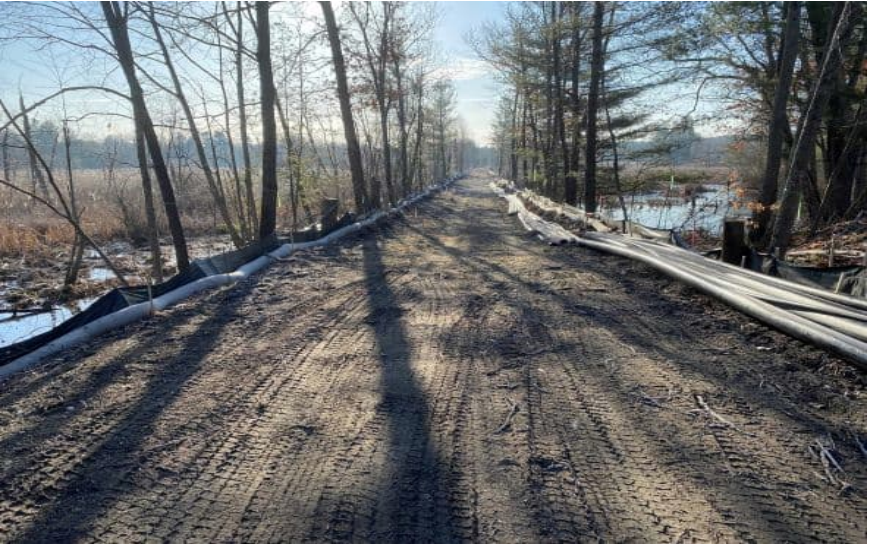
<p>PHOTOGRAPHIC LOG</p>	
<p>Client Name: Eversource</p>		<p>Site Location: Sudbury to Hudson Transmission Reliability Project</p>	<p>Town: Hudson</p>
<p>Photo No.: 5</p>	<p>Date: 3-29-23</p>

<p>Description:</p> <p>Right-of-way (ROW) within Segment 2 at approximate Sta# 142+00, looking eastward.</p>

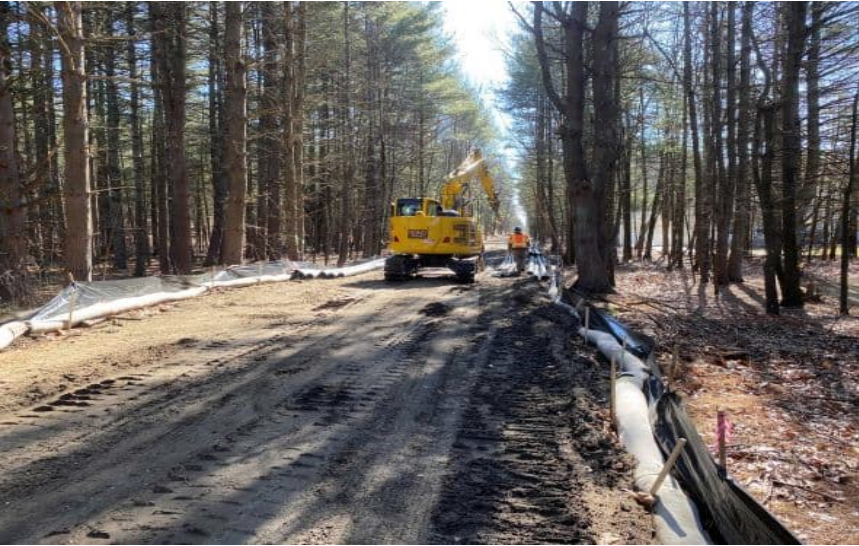
<p>PHOTOGRAPHIC LOG</p>	
<p>Client Name: Eversource</p>		<p>Site Location: Sudbury to Hudson Transmission Reliability Project</p>	<p>Town: Hudson</p>
<p>Photo No.: 7</p>	<p>Date: 3-29-23</p>

<p>Description:</p> <p>Bond conducting conduit staging near MH#11, Segment 5, looking eastward.</p>

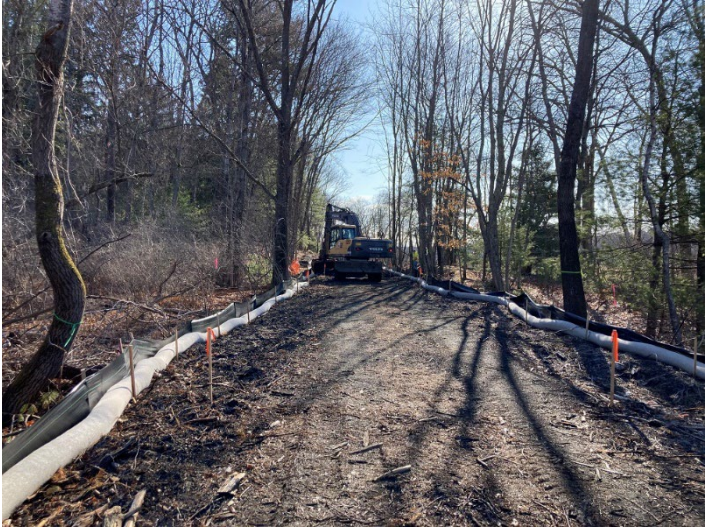
PHOTOGRAPHIC LOG	
Client Name: Eversource		Site Location: Sudbury to Hudson Transmission Reliability Project	Town: Sudbury
Photo No.: 1	Date: 3/29/2023

Description: View of ET&L performing cut & fill in segment 14 near historic area. David Gutbrod (Commonwealth Heritage) oversaw work at this location. Facing east.

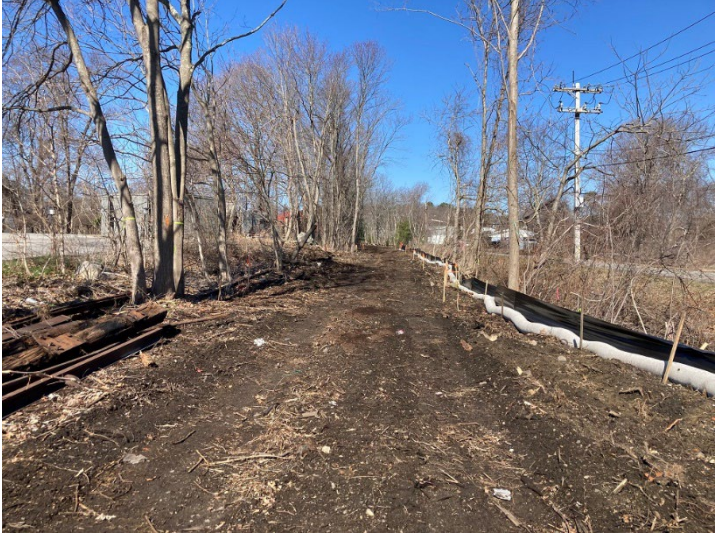
PHOTOGRAPHIC LOG	
Client Name: Eversource		Site Location: Sudbury to Hudson Transmission Reliability Project	Town: Sudbury
Photo No.: 3	Date: 3/29/2023

Description: View of E&S controls in segment 12. Facing west.

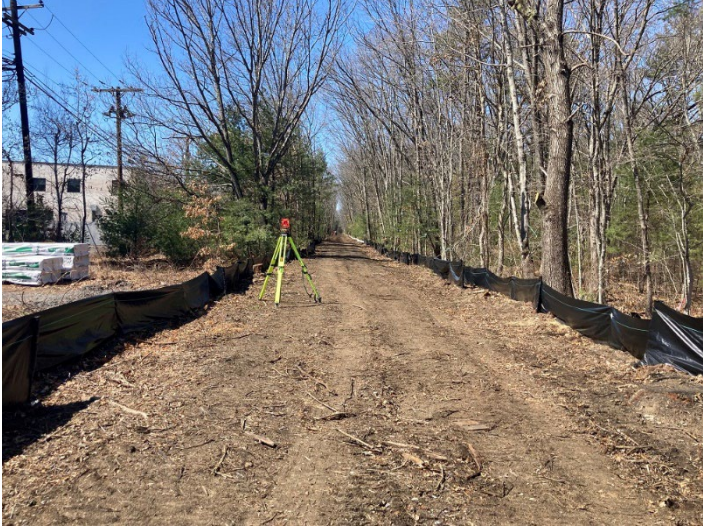
PHOTOGRAPHIC LOG	
Client Name: Eversource		Site Location: Sudbury to Hudson Transmission Reliability Project	Town: Sudbury
Photo No.: 4	Date: 3/29/2023

Description: View of ET&L performing layout work in segment 11. Facing west.

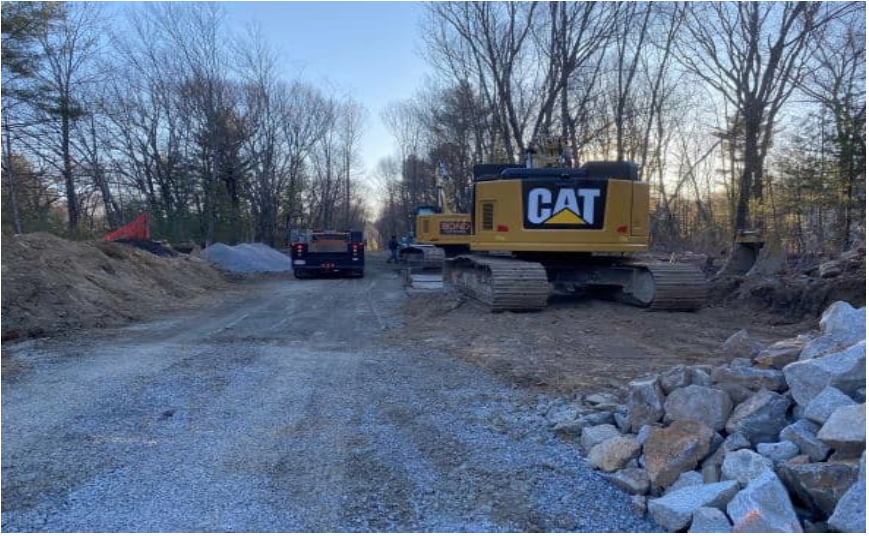
<p>PHOTOGRAPHIC LOG</p>	
<p>Client Name: Eversource</p>		<p>Site Location: Sudbury to Hudson Transmission Reliability Project</p>	<p>Town: Hudson</p>
<p>Photo No.: 3</p>	<p>Date: 3-30-23</p>

<p>Description: Bond conducting work within Segment 1 at MH#5 at approximate Sta# 102+00, looking eastward.</p>

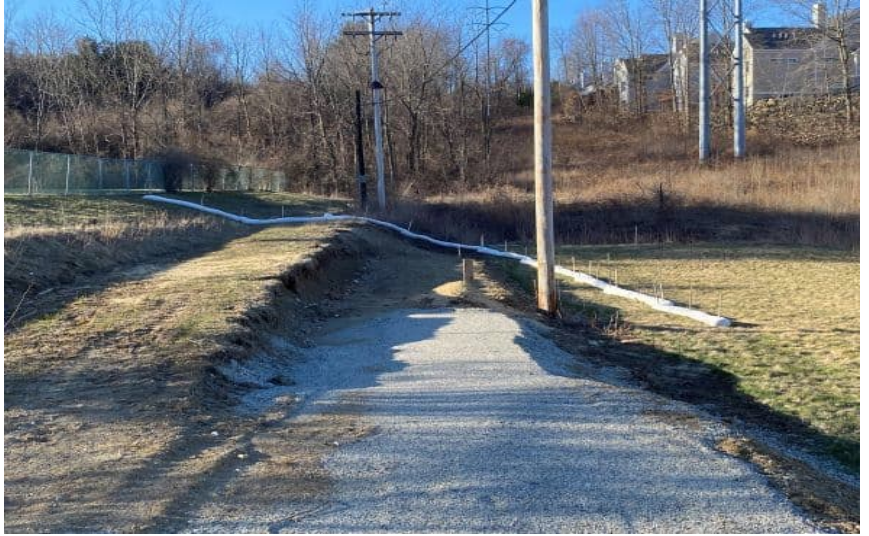
<p>PHOTOGRAPHIC LOG</p>	
<p>Client Name: Eversource</p>		<p>Site Location: Sudbury to Hudson Transmission Reliability Project</p>	<p>Town: Hudson</p>
<p>Photo No.: 4</p>	<p>Date: 3-30-23</p>

<p>Description: MH#1 area, Hudson Light & Power facility at 49 Forest Avenue, compost filter tubes, looking eastward.</p>

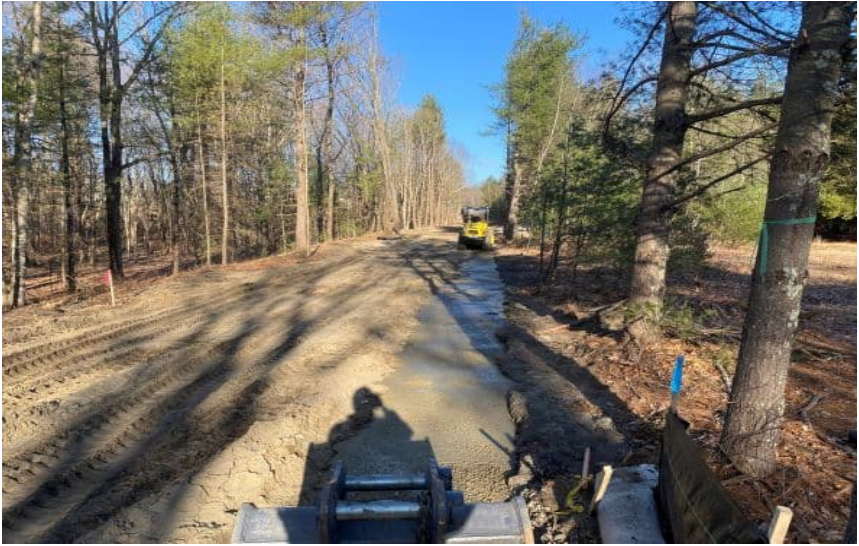
<p>PHOTOGRAPHIC LOG</p>	
<p>Client Name: Eversource</p>		<p>Site Location: Sudbury to Hudson Transmission Reliability Project</p>	<p>Town: Hudson</p>
<p>Photo No.: 5</p>	<p>Date: 3-30-23</p>

<p>Description:</p> <p>Right-of-way (ROW) within Segment 2 at approximate Sta# 141+00, previously backfilled, looking westward.</p>

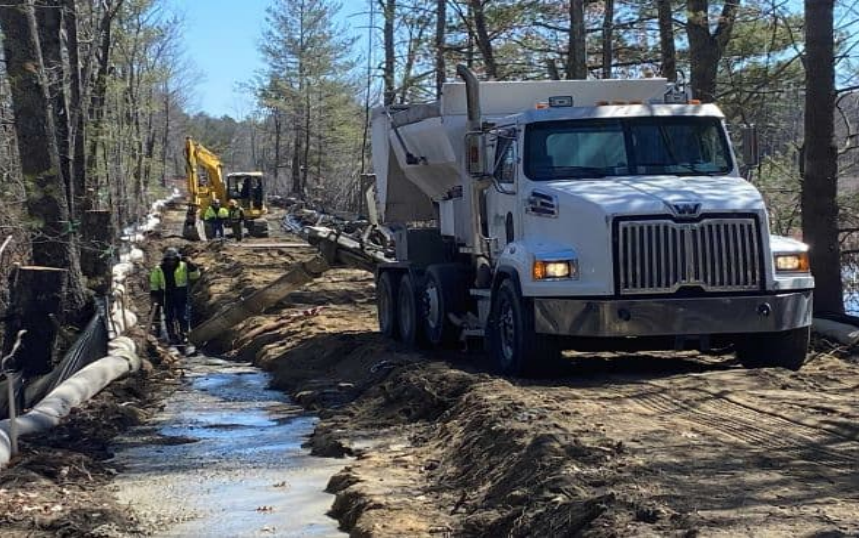
<p>PHOTOGRAPHIC LOG</p>	
<p>Client Name: Eversource</p>		<p>Site Location: Sudbury to Hudson Transmission Reliability Project</p>	<p>Town: Hudson</p>
<p>Photo No.: 6</p>	<p>Date: 3-30-23</p>

<p>Description:</p> <p>Bond conducting conduit work within Segment 3 at approximate Sta# 143+00, looking eastward</p>

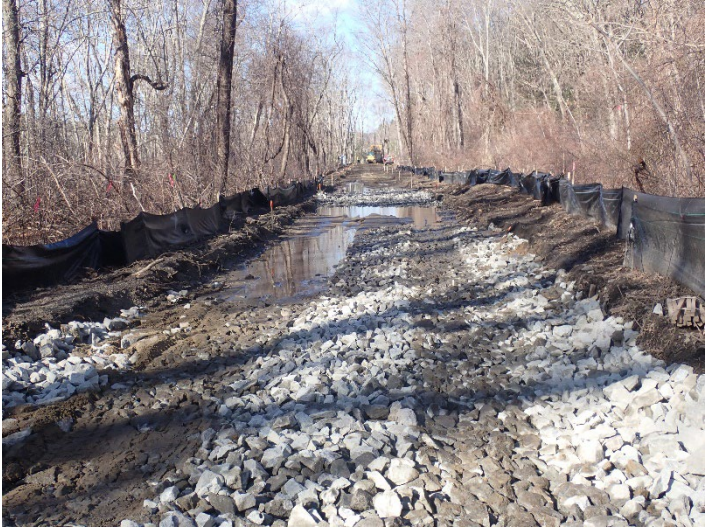
<p align="right">PHOTOGRAPHIC LOG</p>	
Client Name: Eversource		Site Location: Sudbury to Hudson Transmission Reliability Project	Town: Sudbury
Photo No.: 1	Date: 3/30/2023

Description: View of ET&L performing cut & fill in segment 14 near historic area. David Gutbrod (Commonwealth Heritage) oversaw work at this location. Facing east.

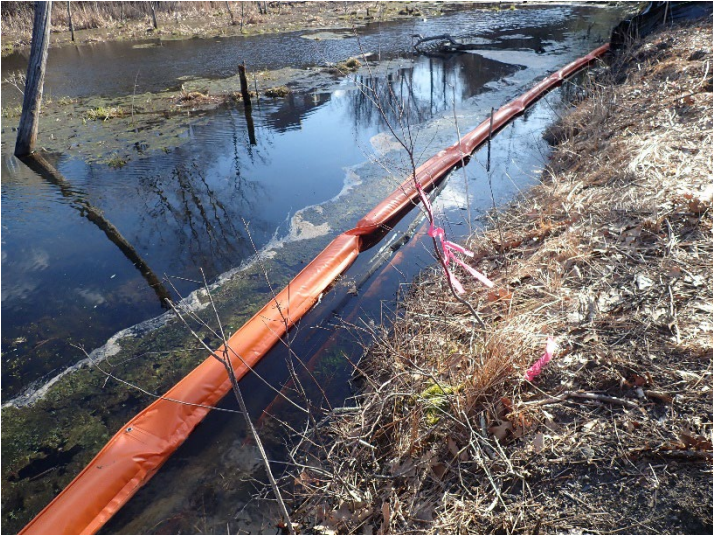
<p align="right">PHOTOGRAPHIC LOG</p>	
Client Name: Eversource		Site Location: Sudbury to Hudson Transmission Reliability Project	Town: Sudbury
Photo No.: 2	Date: 3/30/2023

Description: View of turbidity curtain on northern side in segment 14. Facing northeast.

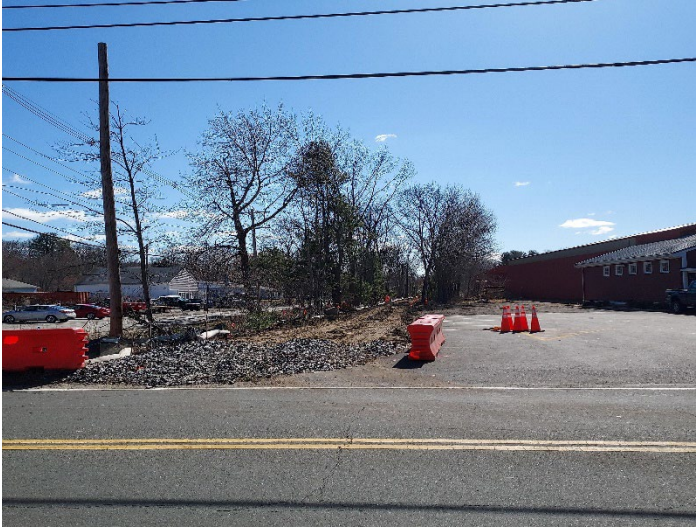
PHOTOGRAPHIC LOG	
Client Name: Eversource		Site Location: Sudbury to Hudson Transmission Reliability Project	Town: Sudbury
Photo No.: 5	Date: 3/30/2023

Description: View of construction entrance at the western end of segment 12. ET&L performing layout work in this segment. Facing east.

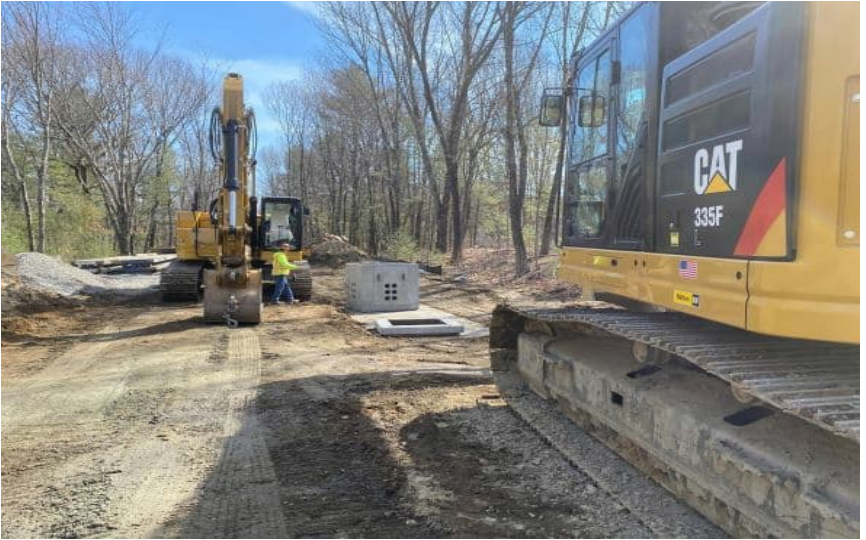
<p>PHOTOGRAPHIC LOG</p>	
<p>Client Name: Eversource</p>		<p>Site Location: Sudbury to Hudson Transmission Reliability Project</p>	<p>Town: Hudson</p>
<p>Photo No.: 1</p>	<p>Date: 3-31-23</p>

<p>Description:</p> <p>MH#5 within Segment 1 at approximate Sta# 102+00, looking eastward.</p>

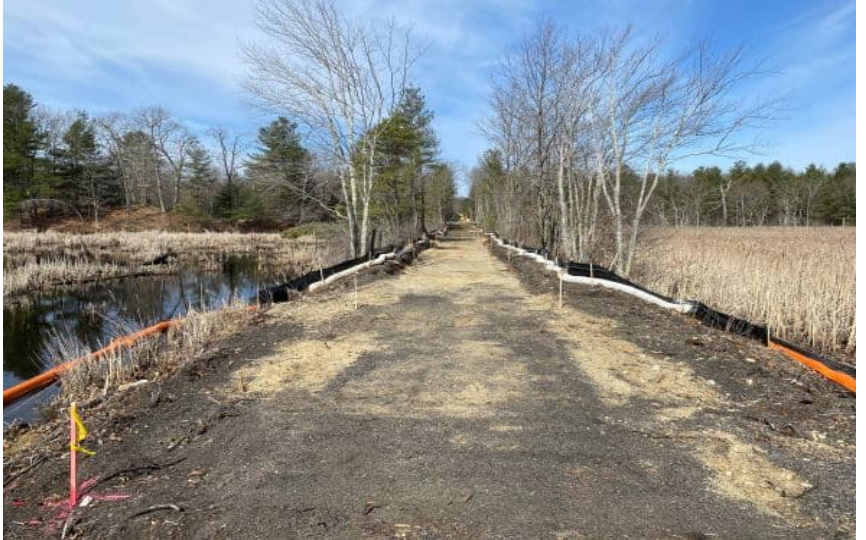
<p>PHOTOGRAPHIC LOG</p>	
<p>Client Name: Eversource</p>		<p>Site Location: Sudbury to Hudson Transmission Reliability Project</p>	<p>Town: Hudson</p>
<p>Photo No.: 2</p>	<p>Date: 3-31-23</p>

<p>Description:</p> <p>Right-of-way within Segment 2 from Bridge 130, looking westward.</p>

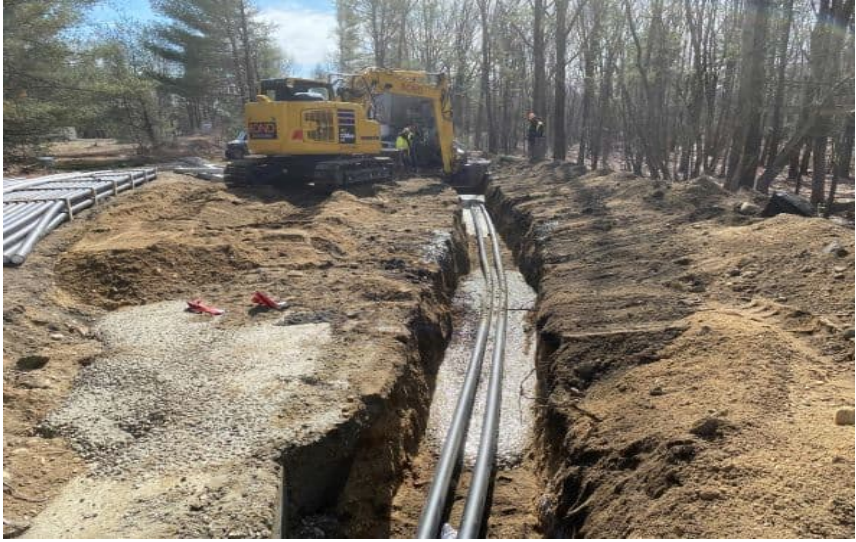
<p>PHOTOGRAPHIC LOG</p>	
<p>Client Name: Eversource</p>		<p>Site Location: Sudbury to Hudson Transmission Reliability Project</p>	<p>Town: Hudson</p>
<p>Photo No.: 4</p>	<p>Date: 3-31-23</p>

<p>Description:</p> <p>Conduit work (active backfilling) within Segment 2 at approximate Sta# 139+00, looking eastward.</p>

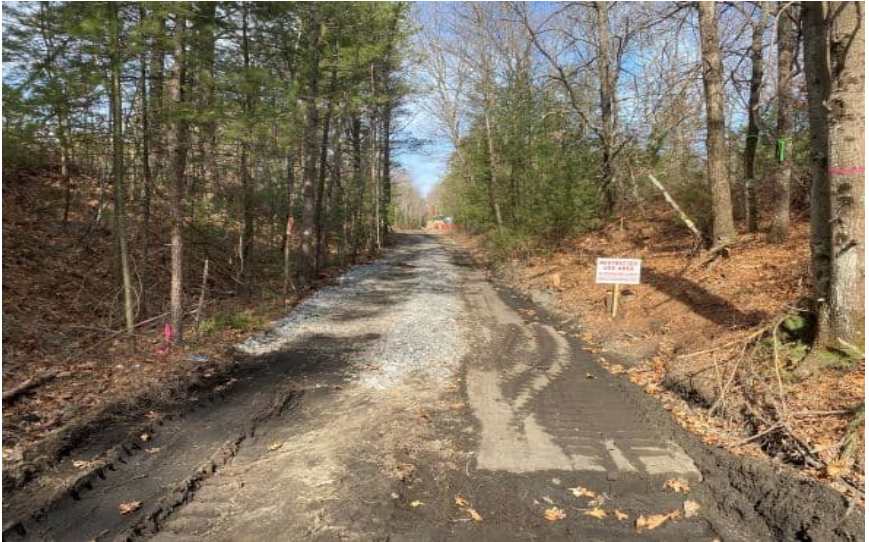
<p>PHOTOGRAPHIC LOG</p>	
<p>Client Name: Eversource</p>		<p>Site Location: Sudbury to Hudson Transmission Reliability Project</p>	<p>Town: Sudbury</p>
<p>Photo No.: 5</p>	<p>Date: 3-31-23</p>

<p>Description:</p> <p>Right-of-way within Black Racer restriction area within Segment 7, looking westward.</p>

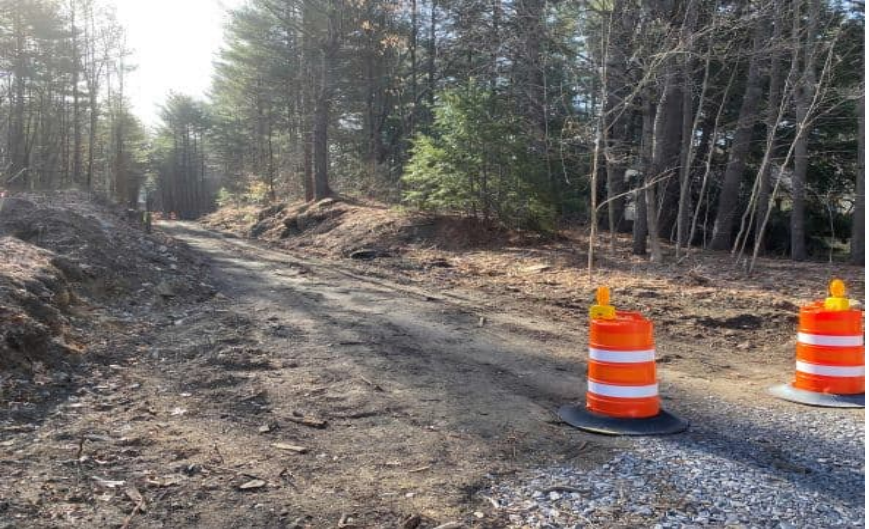
<p>PHOTOGRAPHIC LOG</p>	
<p>Client Name: Eversource</p>		<p>Site Location: Sudbury to Hudson Transmission Reliability Project</p>	<p>Town: Sudbury</p>
<p>Photo No.: 6</p>	<p>Date: 3-31-23</p>

<p>Description:</p> <p>Right-of-way within Segment 10, just off Peakham Road, looking eastward.</p>

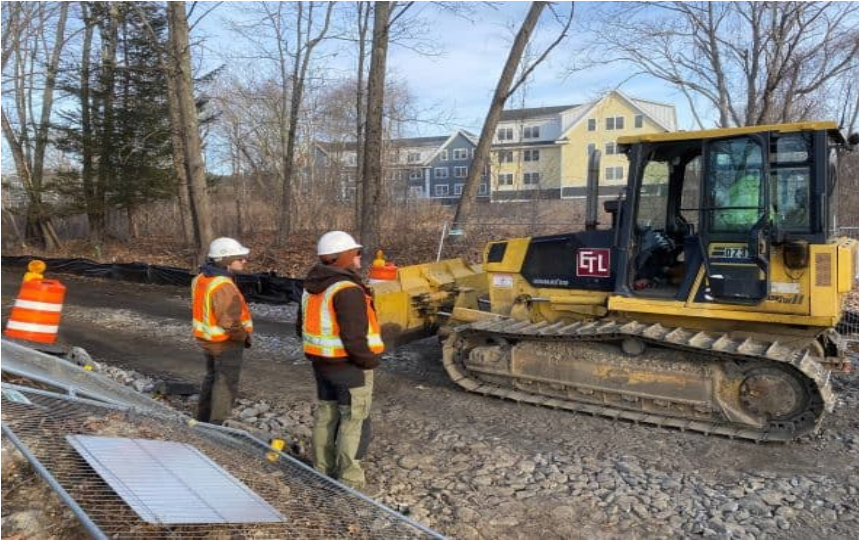
<p>PHOTOGRAPHIC LOG</p>	
<p>Client Name: Eversource</p>		<p>Site Location: Sudbury to Hudson Transmission Reliability Project</p>	<p>Town: Sudbury</p>
<p>Photo No.: 7</p>	<p>Date: 3-31-23</p>

<p>Description:</p> <p>ET&L moving into Segment 14 to conduct cut-fill work, with vernal pool monitors, just off Sudbury Substation Road, looking westward.</p>

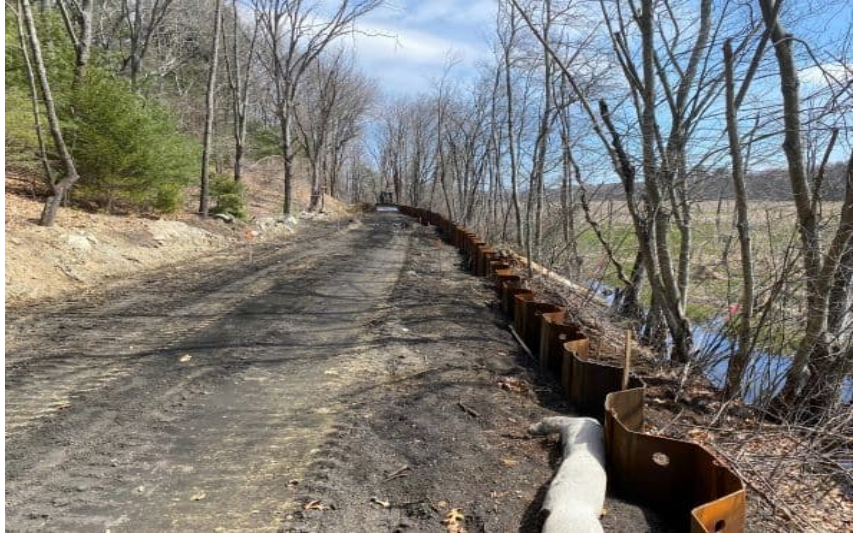
<p>PHOTOGRAPHIC LOG</p>	
<p>Client Name: Eversource</p>		<p>Site Location: Sudbury to Hudson Transmission Reliability Project</p>	<p>Town: Sudbury</p>
<p>Photo No.: 8</p>	<p>Date: 3-31-23</p>

<p>Description:</p> <p>Recently installed sheeting within Segment 14, looking eastward.</p>

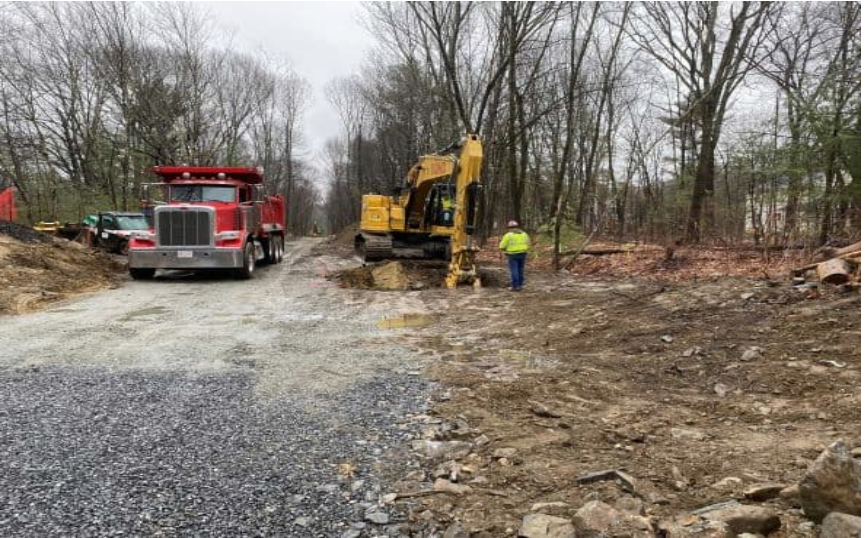
PHOTOGRAPHIC LOG	
Client Name: Eversource		Site Location: Sudbury to Hudson Transmission Reliability Project	Town: Hudson
Photo No.: 1	Date: 3-28-23

Description: Bond conducting MH#5 work within Segment 1, just off Wilkins Avenue, looking eastward.

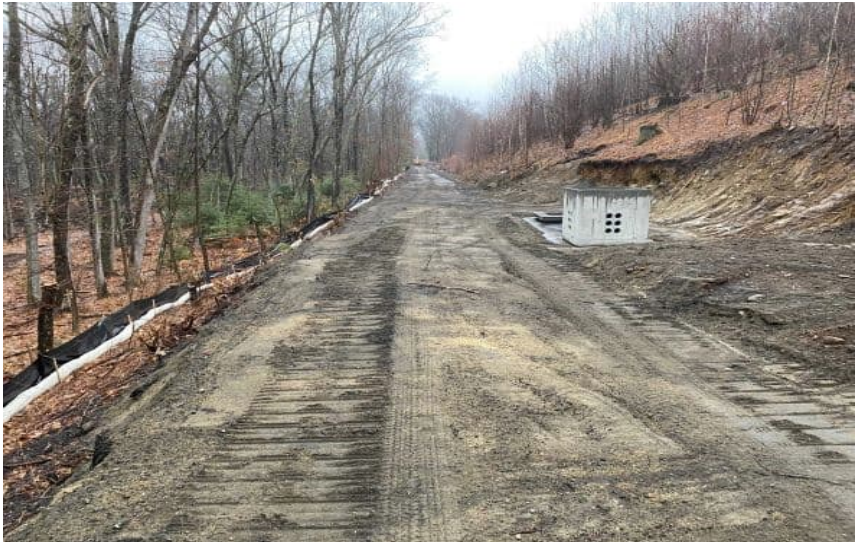
PHOTOGRAPHIC LOG	
Client Name: Eversource		Site Location: Sudbury to Hudson Transmission Reliability Project	Town: Hudson
Photo No.: 2	Date: 3-28-23

Description: MH#6 within Segment 1, at approximate Sta# 121+00, looking eastward.

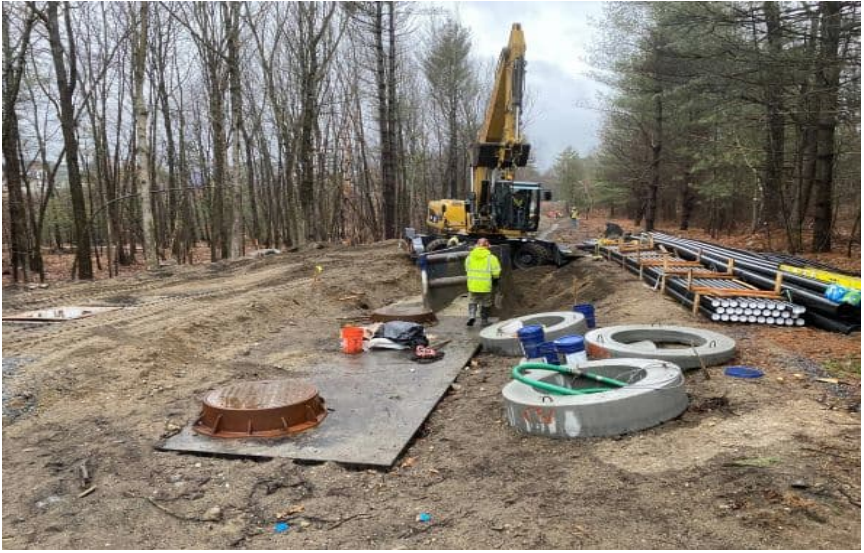
PHOTOGRAPHIC LOG	
Client Name: Eversource		Site Location: Sudbury to Hudson Transmission Reliability Project	Town: Hudson
Photo No.: 3	Date: 3-28-23

Description: Bond conducting conduit work at MH#7, within Segment 2, looking westward.

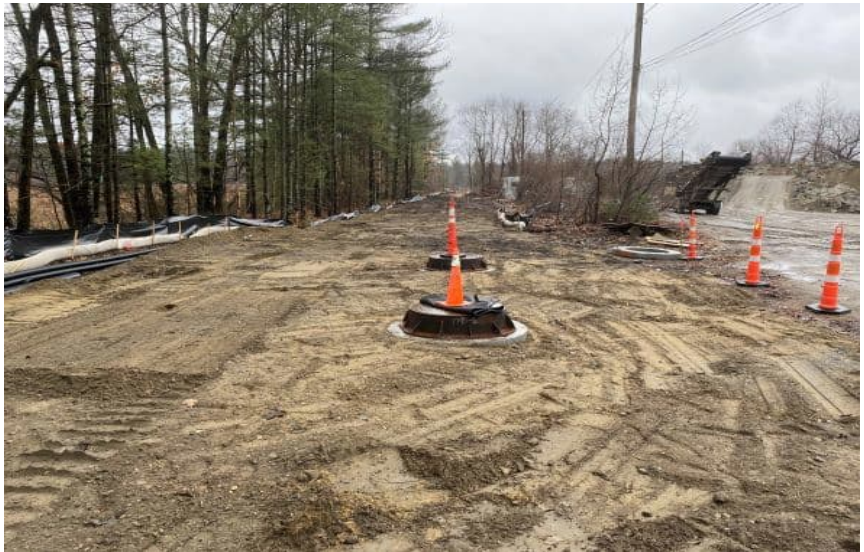
PHOTOGRAPHIC LOG	
Client Name: Eversource		Site Location: Sudbury to Hudson Transmission Reliability Project	Town: Hudson
Photo No.: 4	Date: 3-28-23

Description: MH#8, within Segment 3, looking westward.

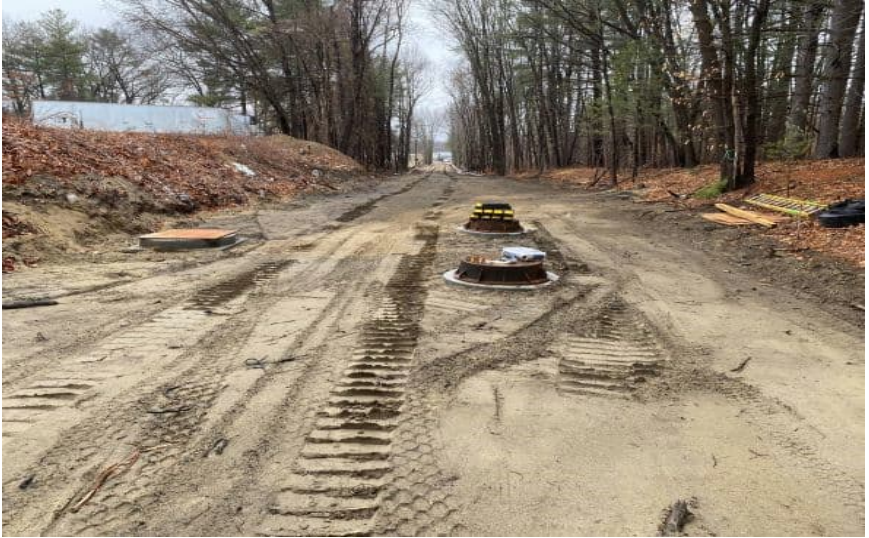
PHOTOGRAPHIC LOG	
Client Name: Eversource		Site Location: Sudbury to Hudson Transmission Reliability Project	Town: Hudson
Photo No.: 5	Date: 3-28-23

Description: MH#9 area, within Segment 3, looking westward.

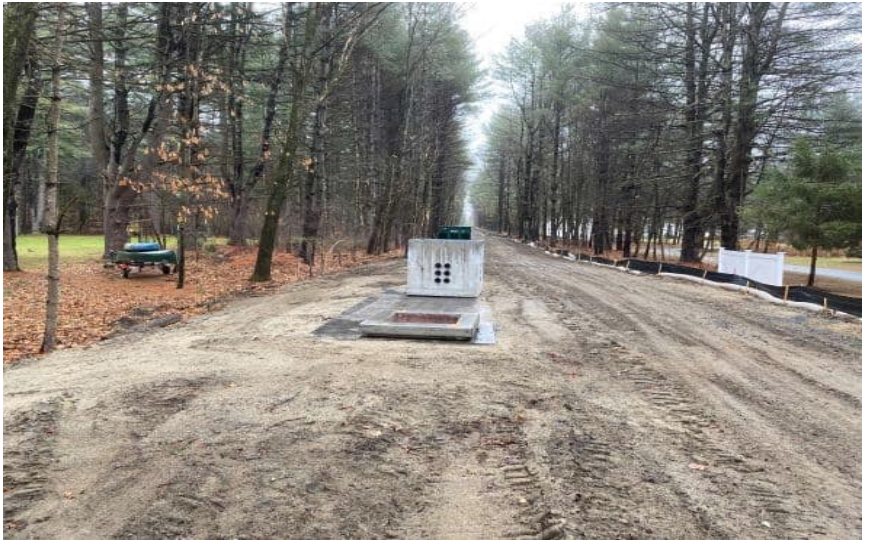
PHOTOGRAPHIC LOG	
Client Name: Eversource		Site Location: Sudbury to Hudson Transmission Reliability Project	Town: Hudson
Photo No.: 6	Date: 3-28-23

Description: MH#11 area, within Segment 5, looking eastward.

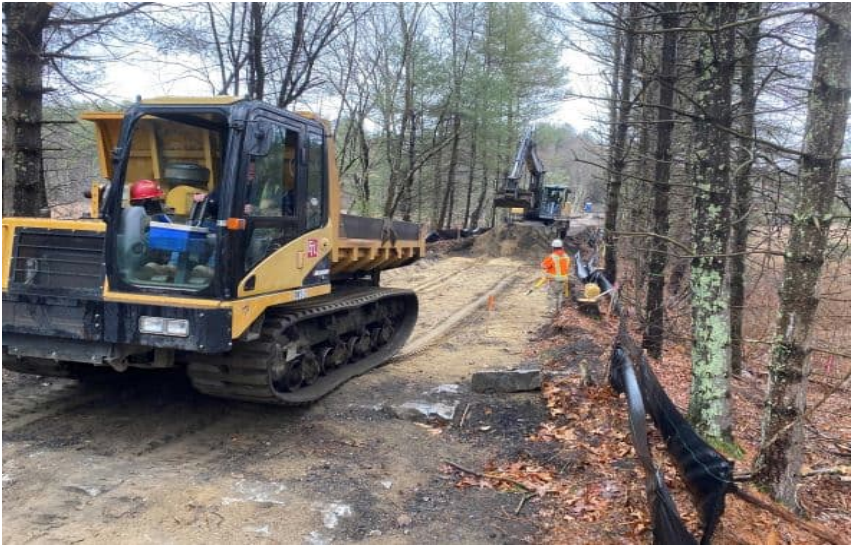
PHOTOGRAPHIC LOG	
Client Name: Eversource		Site Location: Sudbury to Hudson Transmission Reliability Project	Town: Sudbury
Photo No.: 7	Date: 3-28-23

Description: ET&L conducting grading activities, within Segment 7, looking westward

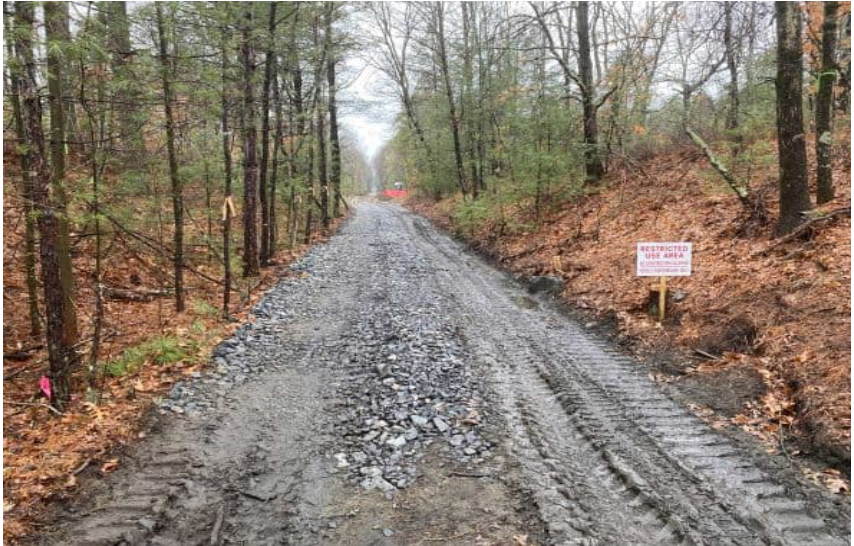
PHOTOGRAPHIC LOG	
Client Name: Eversource		Site Location: Sudbury to Hudson Transmission Reliability Project	Town: Sudbury
Photo No.: 8	Date: 3-28-23

Description: Current state of 200' Black Racer time of year restrictive area with new stone access, looking westward.

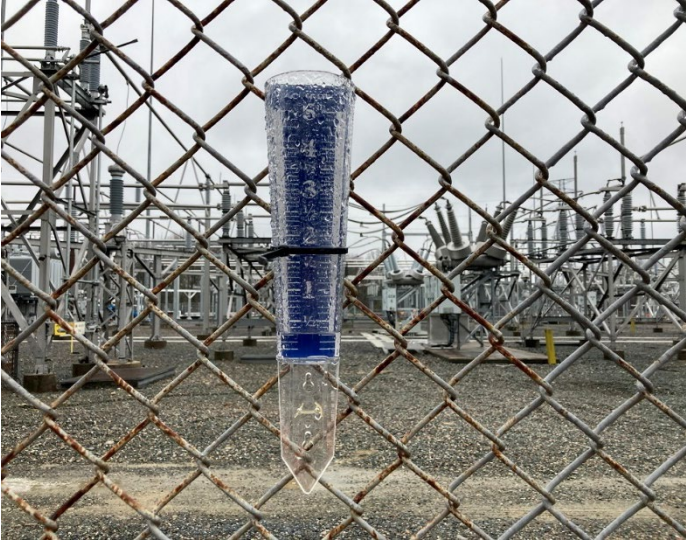
PHOTOGRAPHIC LOG	
Client Name: Eversource		Site Location: Sudbury to Hudson Transmission Reliability Project	Town: Sudbury
Photo No.: 1	Date: 3-28-2023

Description: View of rain gauge. 0.35" recorded in gauge at 9am. Facing south.

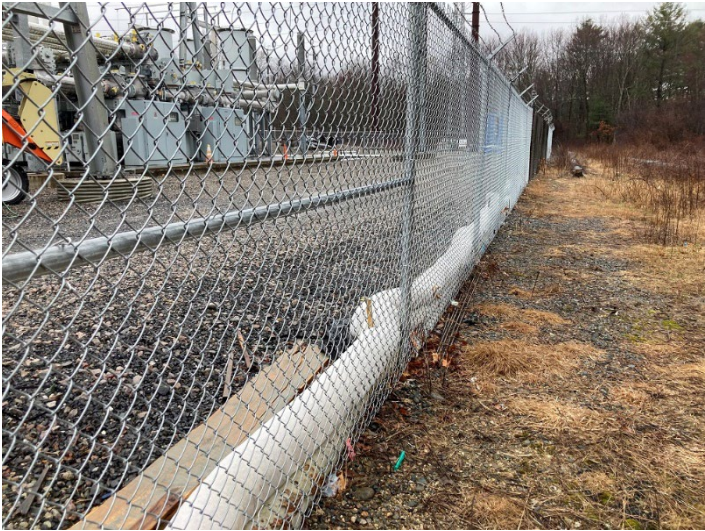
PHOTOGRAPHIC LOG	
Client Name: Eversource		Site Location: Sudbury to Hudson Transmission Reliability Project	Town: Sudbury
Photo No.: 2	Date: 3-28-2023

Description: View of filter tubes at Sudbury substation. Facing north.

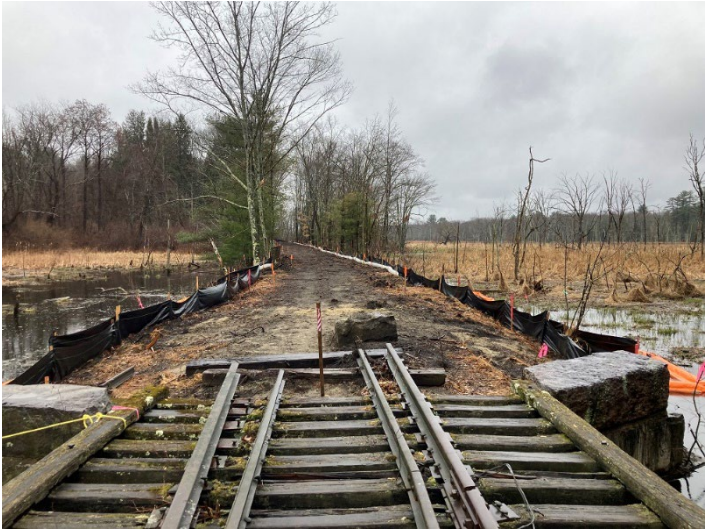
PHOTOGRAPHIC LOG	
Client Name: Eversource		Site Location: Sudbury to Hudson Transmission Reliability Project	Town: Sudbury
Photo No.: 3	Date: 3-28-2023

Description: View of E&S controls at west end of segment 14 from bridge 127. Facing east.

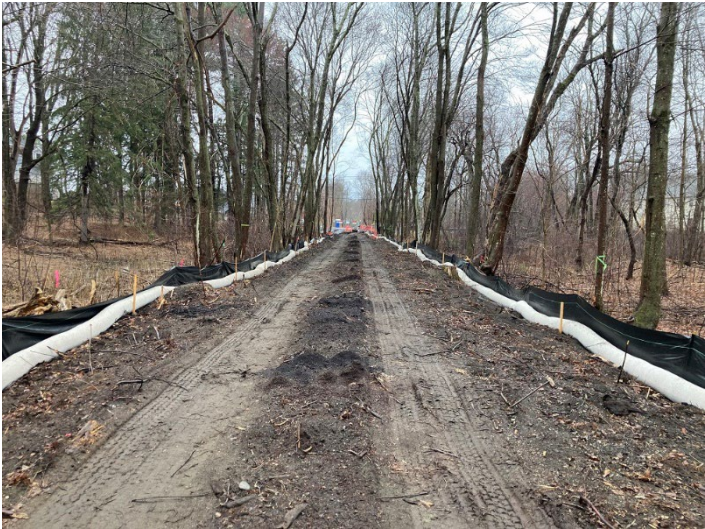
PHOTOGRAPHIC LOG	
Client Name: Eversource		Site Location: Sudbury to Hudson Transmission Reliability Project	Town: Sudbury
Photo No.: 4	Date: 3-28-2023

Description: View of E&S controls in segment 13. Facing west.

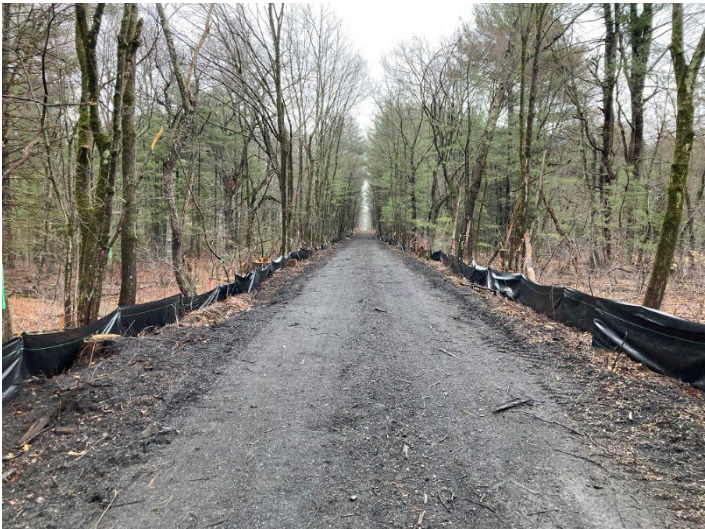
Epsilon ASSOCIATES INC.		PHOTOGRAPHIC LOG	
Client Name: Eversource		Site Location: Sudbury to Hudson Transmission Reliability Project	Town: Sudbury
Photo No.: 5	Date: 3-28-2023

Description: View of E&S controls in segment 11. Facing east.

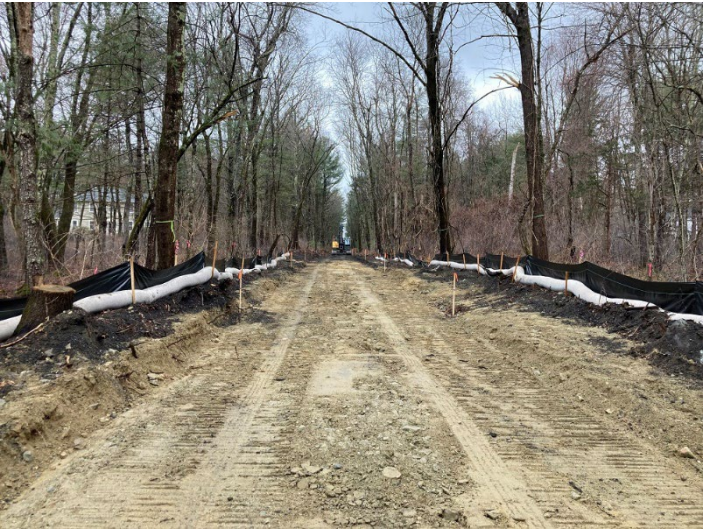
Epsilon ASSOCIATES INC.		PHOTOGRAPHIC LOG	
Client Name: Eversource		Site Location: Sudbury to Hudson Transmission Reliability Project	Town: Sudbury
Photo No.: 7	Date: 3-28-2023

Description: View of E&S controls in segment 9. Facing west.

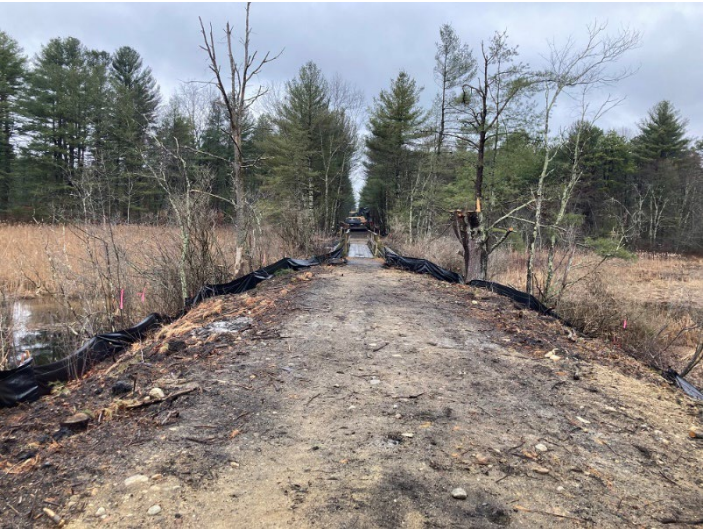
Epsilon ASSOCIATES INC.		PHOTOGRAPHIC LOG	
Client Name: Eversource		Site Location: Sudbury to Hudson Transmission Reliability Project	Town: Sudbury
Photo No.: 8	Date: 3-28-2023

Description: View of bridge 128 in segment 8. Facing west.

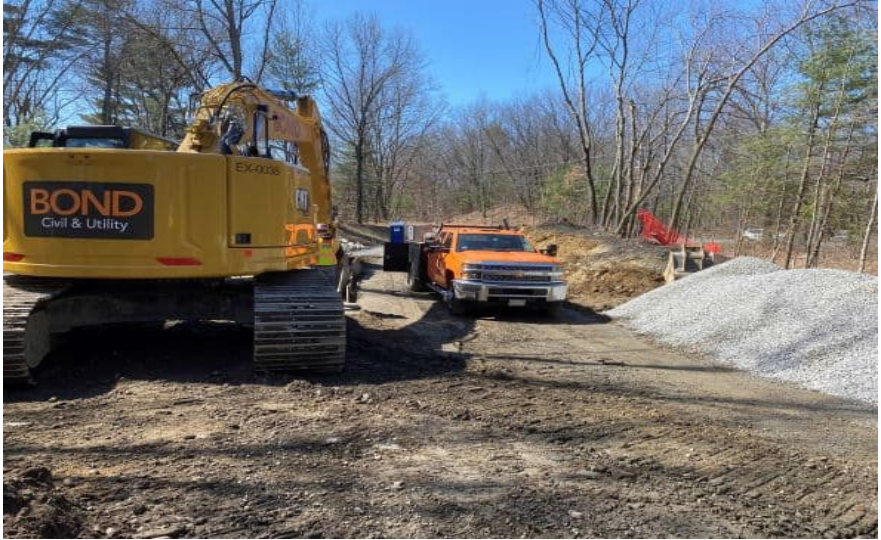
PHOTOGRAPHIC LOG	
Client Name: Eversource		Site Location: Sudbury to Hudson Transmission Reliability Project	Town: Hudson
Photo No.: 1	Date: 3/29/2023

Description: View of area being pumped at work operation at MH#5, at approximate Sta.# 102+00 in Segment 1, looking westward.

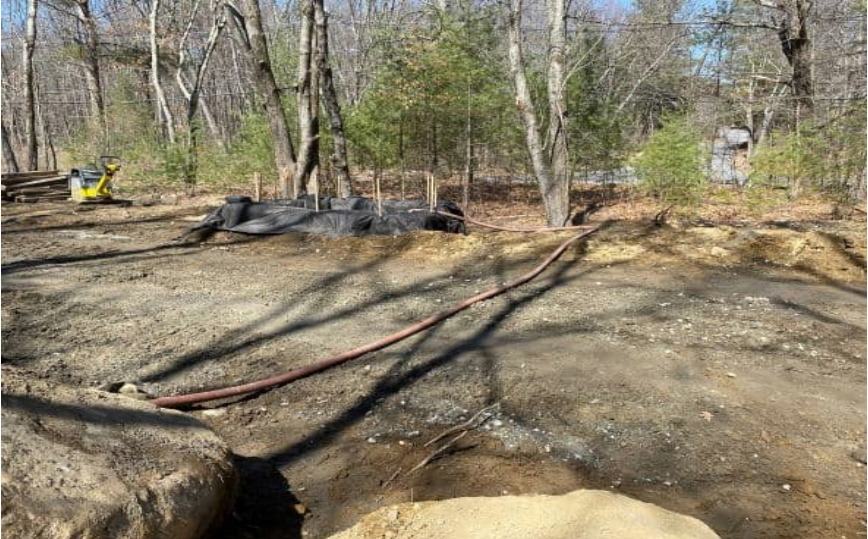
PHOTOGRAPHIC LOG	
Client Name: Eversource		Site Location: Sudbury to Hudson Transmission Reliability Project	Town: Hudson
Photo No.: 3	Date: 3/29/2023

Description: MH#5. View of dewatering operation, looking northward.
