Weekly Environmental Compliance Summary

Sudbury to Hudson Transmission Reliability Project (USEPA Tracking # MAR1003UW)

Week of: March 27 to March 31, 2023

CONSTRUCTION MONITORING REPORT
Sudbury to Hudson Transmission Project

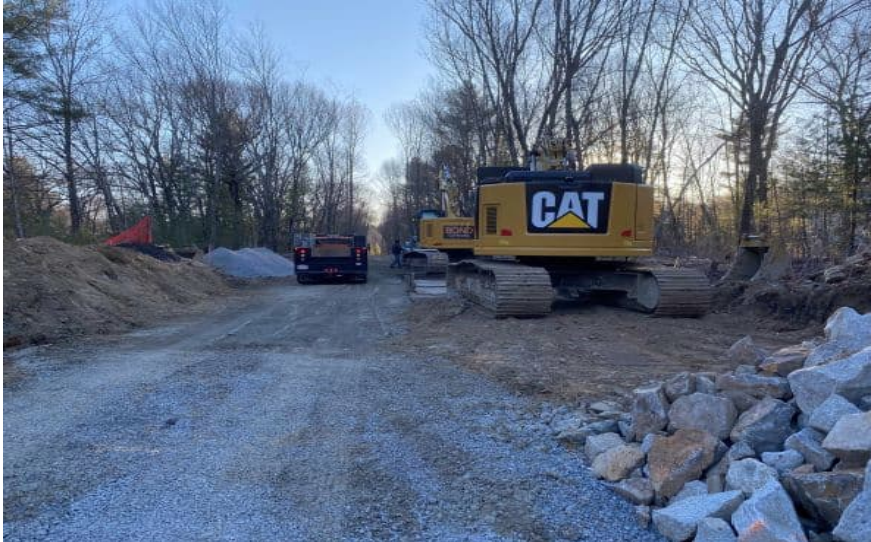
PHOTOGRAPHIC LOG	
Client Name: Eversource		Site Location: Sudbury to Hudson Transmission Reliability Project	Town: Hudson
Photo No.: 1	Date: 3/30/2023

Description: View of area being pumped at work operation at MH#5, at approximate Sta.# 102+00 in Segment 1, looking westward.

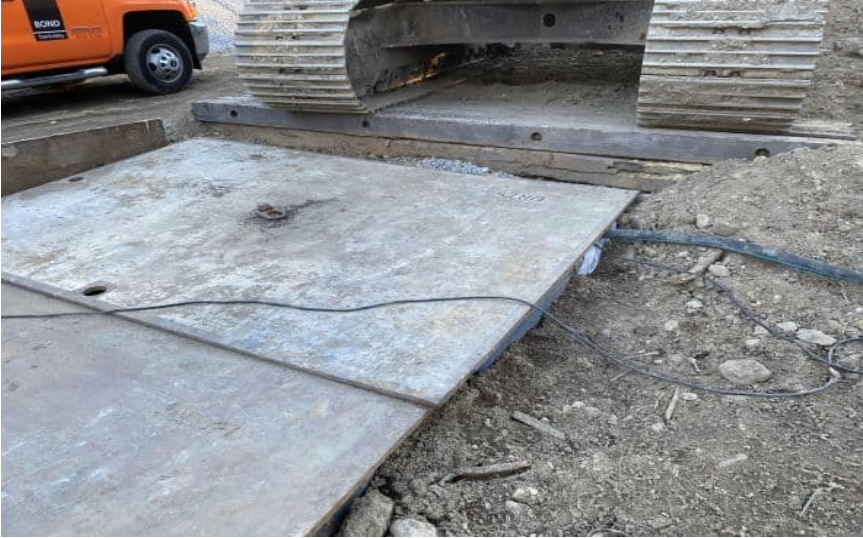
PHOTOGRAPHIC LOG	
Client Name: Eversource		Site Location: Sudbury to Hudson Transmission Reliability Project	Town: Hudson
Photo No.: 3	Date: 3/30/2023

Description: MH#5. View of dewatering operation, looking westward.
