Weekly Environmental Compliance Summary

Sudbury to Hudson Transmission Reliability Project (USEPA Tracking # MAR1003UW)

Week of: April 3 to April 7, 2023

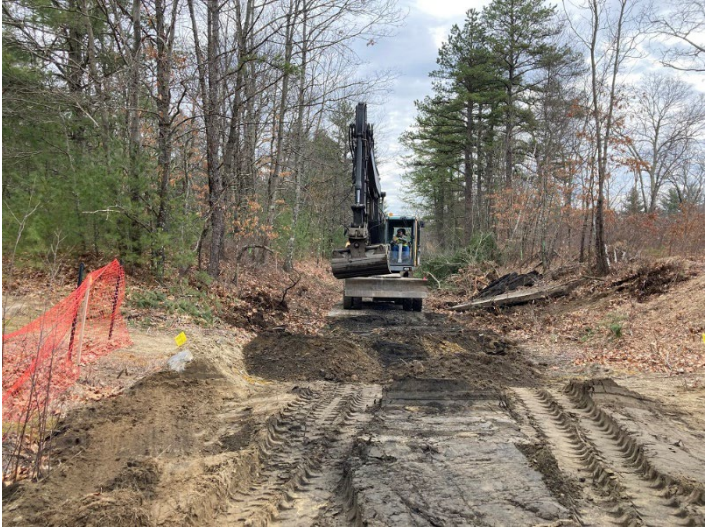
PHOTOGRAPHIC LOG	
Client Name: Eversource		Site Location: Sudbury to Hudson Transmission Reliability Project	Town: Sudbury
Photo No.: 1	Date: 4/04/2023

Description: View of tie and stump removal in Black Racer Snake TOY restriction area in segment 7. TOY restriction ended/work permitted in this area as of 4/01/2023. Facing east.

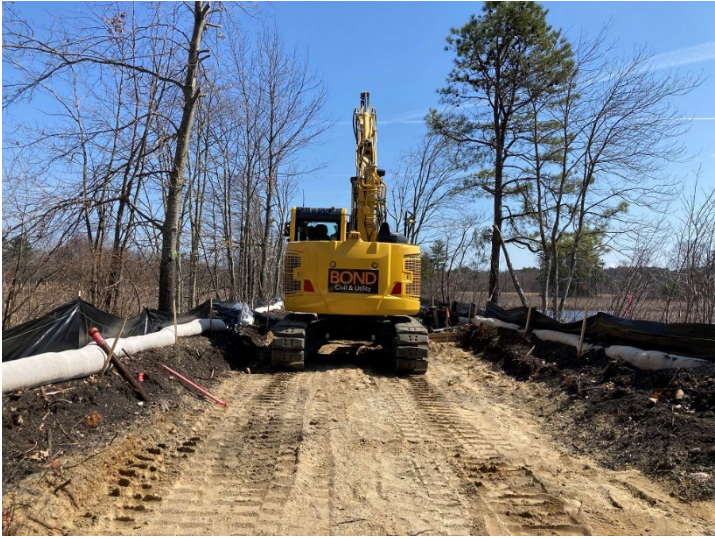
PHOTOGRAPHIC LOG	
Client Name: Eversource		Site Location: Sudbury to Hudson Transmission Reliability Project	Town: Hudson
Photo No.: 3	Date: 4/04/2023

Description: View of Bond performing conduit installation in segment 2. Facing east.

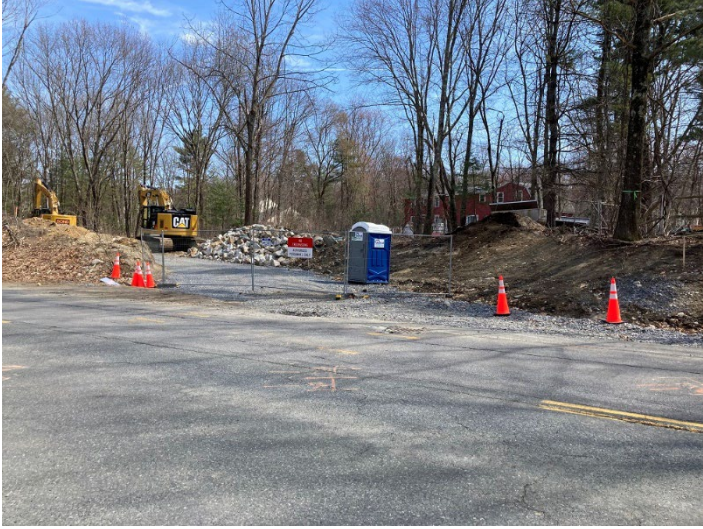
PHOTOGRAPHIC LOG	
Client Name: Eversource		Site Location: Sudbury to Hudson Transmission Reliability Project	Town: Hudson
Photo No.: 4	Date: 4/04/2023

Description: View of construction entrance to segment 1 off Wilkins St. Facing east.

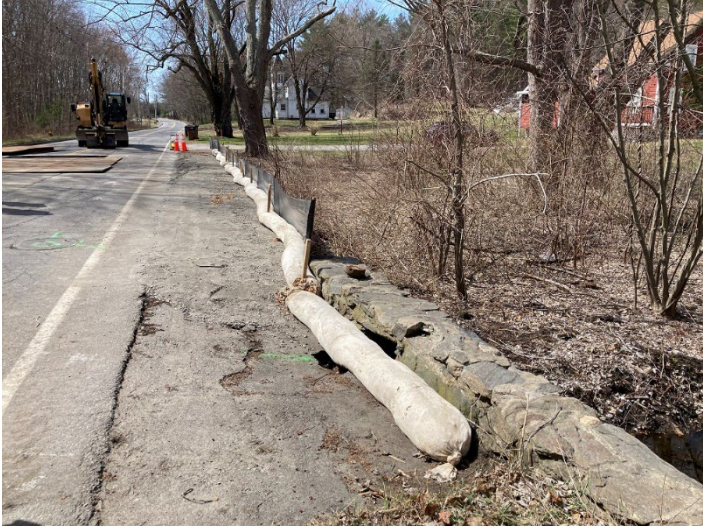
PHOTOGRAPHIC LOG	
Client Name: Eversource		Site Location: Sudbury to Hudson Transmission Reliability Project	Town: Hudson
Photo No.: 5	Date: 4/04/2023

Description: View of Bond performing work at MH #4 on Forest Ave. E&S controls have been installed along work area. Controls along west side of road pictured here. Facing south.

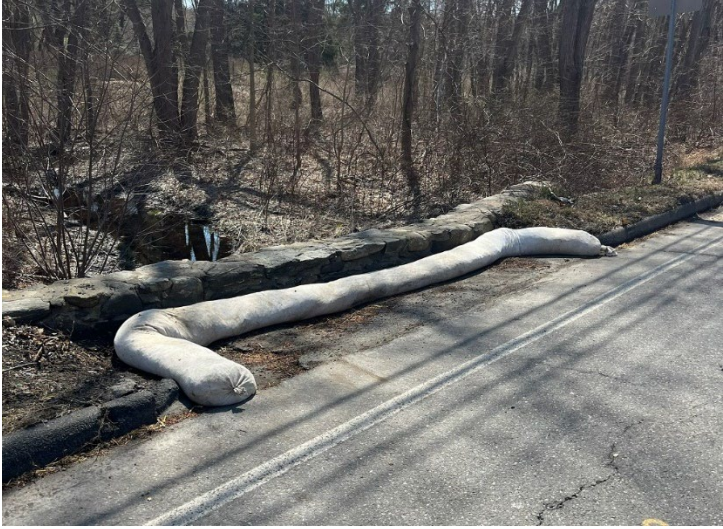
PHOTOGRAPHIC LOG	
Client Name: Eversource		Site Location: Sudbury to Hudson Transmission Reliability Project	Town: Hudson
Photo No.: 6	Date: 4/04/2023

Description: View of compost filter tube installed at storm outlet on east side of work area on Forest Ave. Facing southeast.

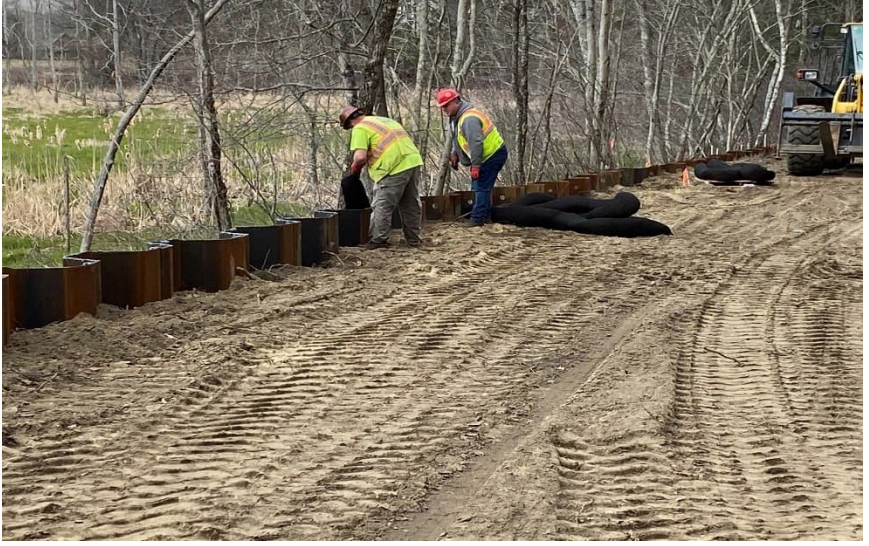
<p>PHOTOGRAPHIC LOG</p>	
<p>Client Name: Eversource</p>		<p>Site Location: Sudbury to Hudson Transmission Reliability Project</p>	<p>Town: Sudbury</p>
<p>Photo No.: 8</p>	<p>Date: 4-4-23</p>

<p>Description:</p> <p>ET&L placing compost filter tubes on the "wetland" side of the sheeting within Segment 14, looking westward.</p>

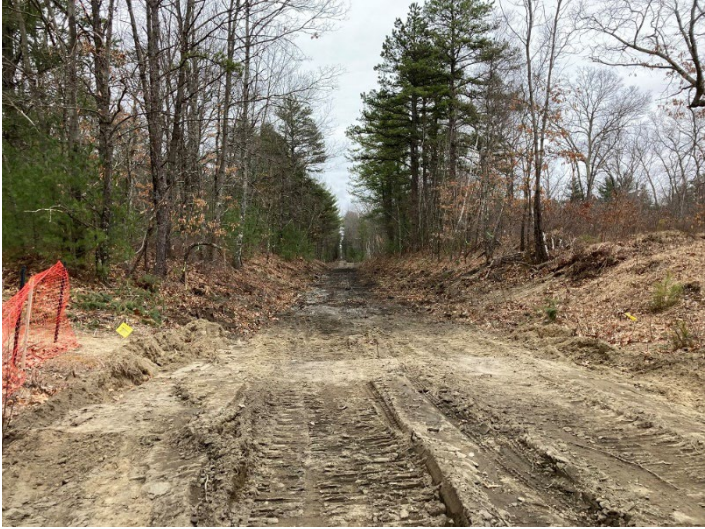
PHOTOGRAPHIC LOG	
Client Name: Eversource		Site Location: Sudbury to Hudson Transmission Reliability Project	Town: Sudbury
Photo No.: 1	Date: 4/05/2023

Description: View of Black Racer Snake TOY restriction area in segment 7. Vegetation removal and rail/tie/stump removal is complete. Facing east.

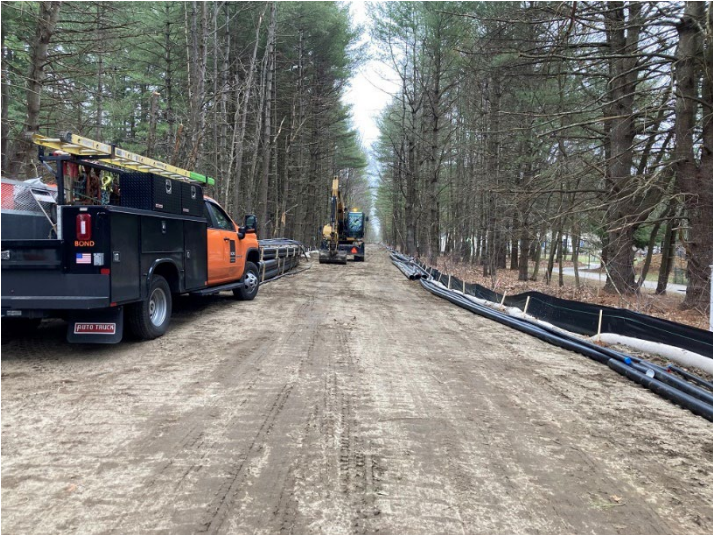
PHOTOGRAPHIC LOG	
Client Name: Eversource		Site Location: Sudbury to Hudson Transmission Reliability Project	Town: Hudson
Photo No.: 2	Date: 4/05/2023

Description: View of Bond conducting E&S repairs and various other activities in segment 5. Facing east.

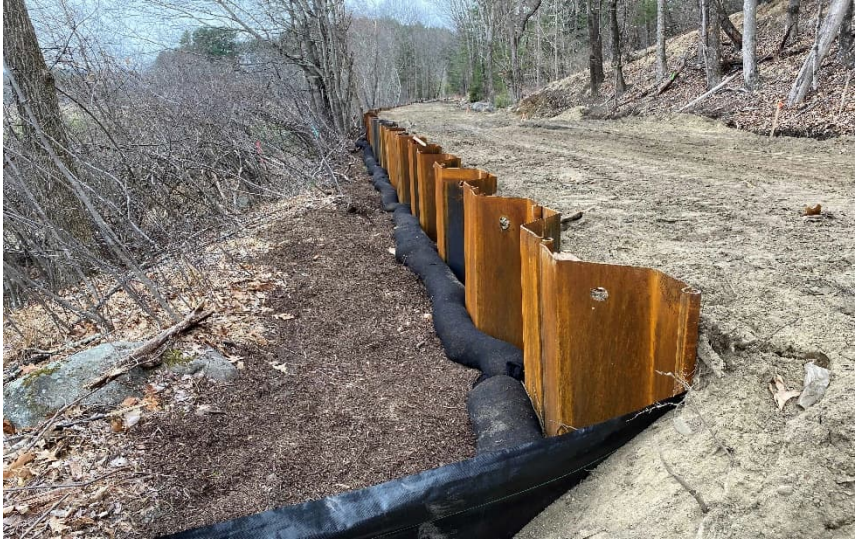
<p>PHOTOGRAPHIC LOG</p>	
<p>Client Name: Eversource</p>		<p>Site Location: Sudbury to Hudson Transmission Reliability Project</p>	<p>Town: Sudbury</p>
<p>Photo No.: 6</p>	<p>Date: 4-5-23</p>

<p>Description:</p> <p>New compost filter tubes on the "wetland" side of the sheeting within Segment 14, looking westward.</p>

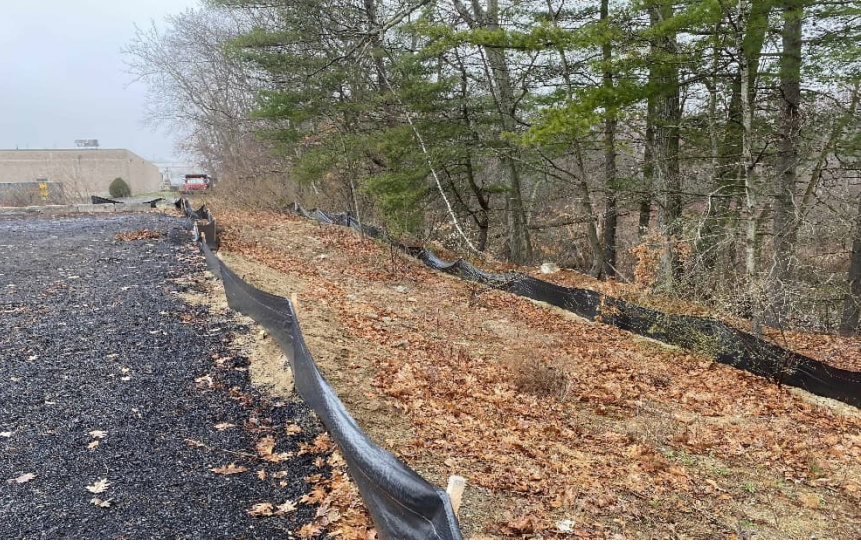
<p>PHOTOGRAPHIC LOG</p>	
<p>Client Name: Eversource</p>		<p>Site Location: Sudbury to Hudson Transmission Reliability Project</p>	<p>Town: Hudson</p>
<p>Photo No.: 2</p>	<p>Date: 4-6-23</p>

<p>Description:</p> <p>Laydown yard at Bonazzoli Avenue, silt fencing north of site, looking westward.</p>

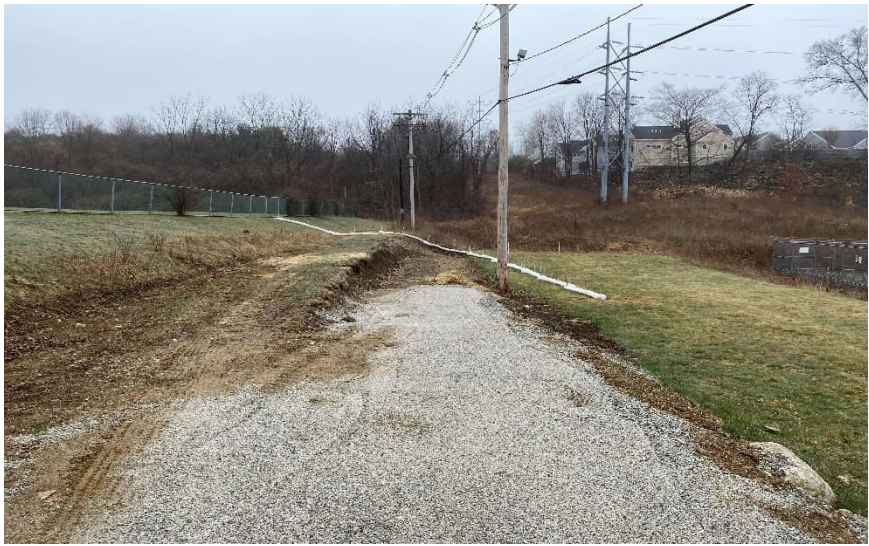
<p>PHOTOGRAPHIC LOG</p>	
<p>Client Name: Eversource</p>		<p>Site Location: Sudbury to Hudson Transmission Reliability Project</p>	<p>Town: Hudson</p>
<p>Photo No.: 4</p>	<p>Date: 4-6-23</p>

<p>Description:</p> <p>MH#1 area, Hudson Light & Power facility at 49 Forest Avenue, compost filter tubes, looking eastward.</p>

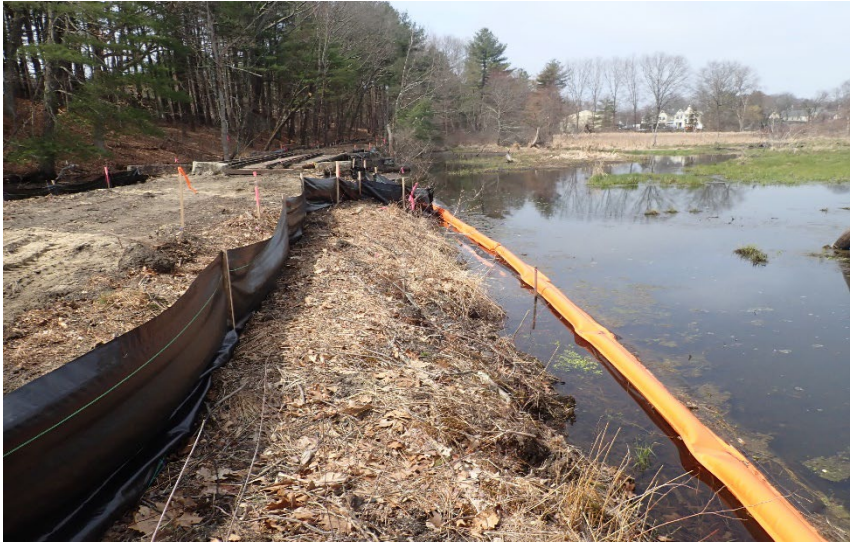
<p align="center">PHOTOGRAPHIC LOG</p>	
<p>Client Name: Eversource</p>		<p>Site Location: Sudbury to Hudson Transmission Reliability Project</p>	<p>Town: Sudbury</p>
<p>Photo No.: 3</p>	<p>Date: 4-6-23</p>

<p>Description:</p> <p>View of Bridge 127 and turbidity curtains, within segment 14. Facing west.</p>

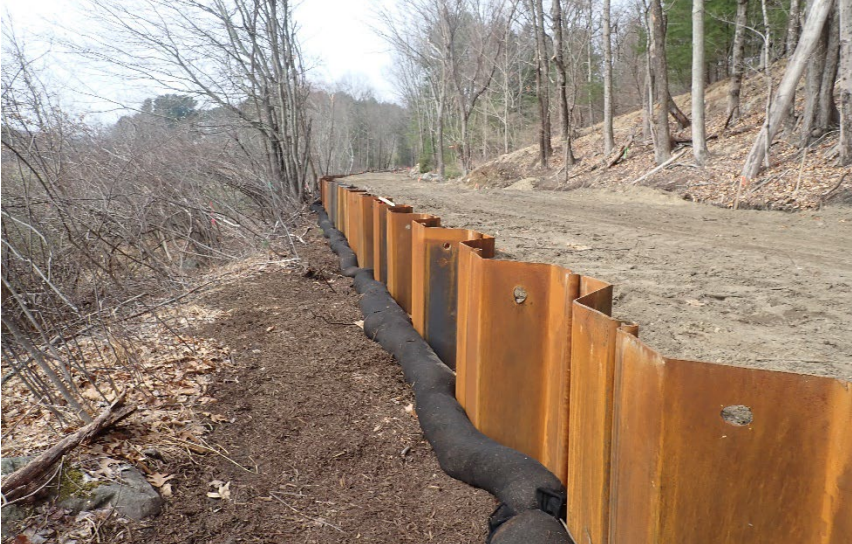
<p align="center">PHOTOGRAPHIC LOG</p>	
<p>Client Name: Eversource</p>		<p>Site Location: Sudbury to Hudson Transmission Reliability Project</p>	<p>Town: Sudbury</p>
<p>Photo No.: 4</p>	<p>Date: 4-6-23</p>

<p>Description:</p> <p>View of compost tube along the installed sheetwall within Segment 14. Facing west.</p>

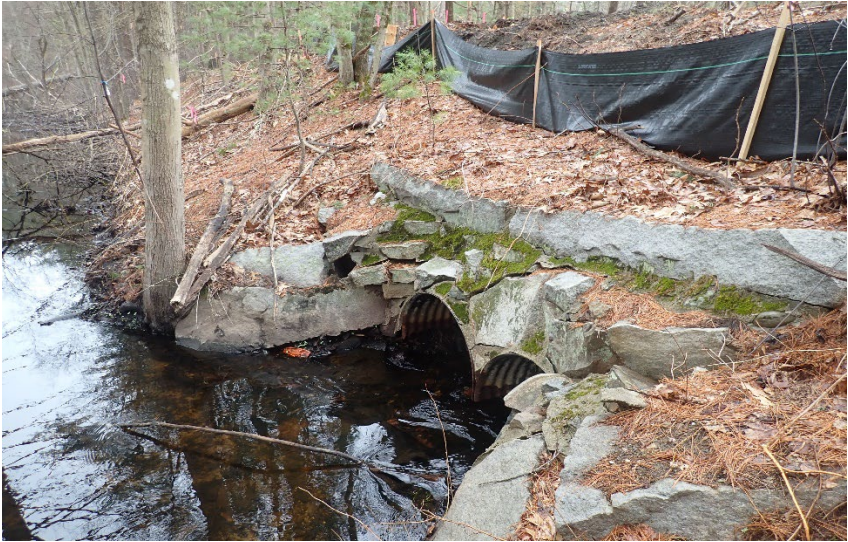
PHOTOGRAPHIC LOG	
Client Name: Eversource		Site Location: Sudbury to Hudson Transmission Reliability Project	Town: Sudbury
Photo No.: 7	Date: 4-6-23

Description: View of culvert within Segment 10. No work occurring over the existing culvert. Facing northwest.

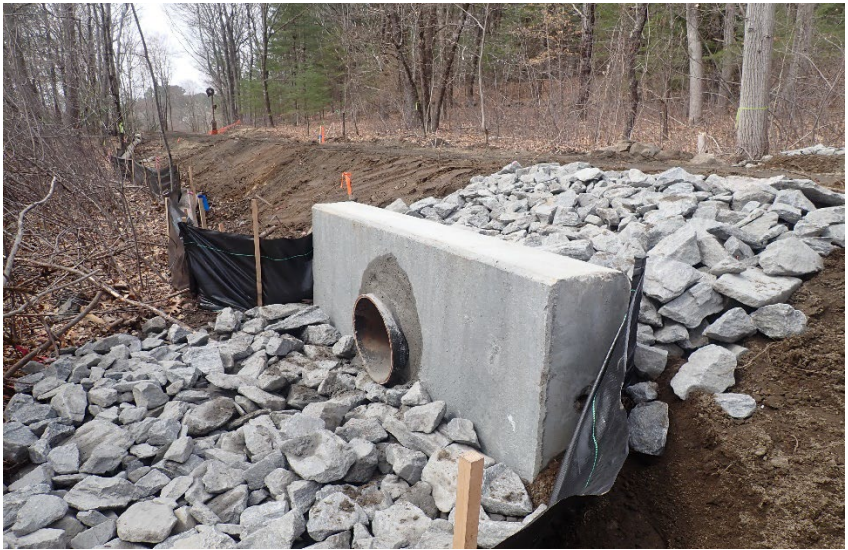
PHOTOGRAPHIC LOG	
Client Name: Eversource		Site Location: Sudbury to Hudson Transmission Reliability Project	Town: Sudbury
Photo No.: 8	Date: 4-6-23

Description: ET&L installed headwall within Segment 14. Facing west.

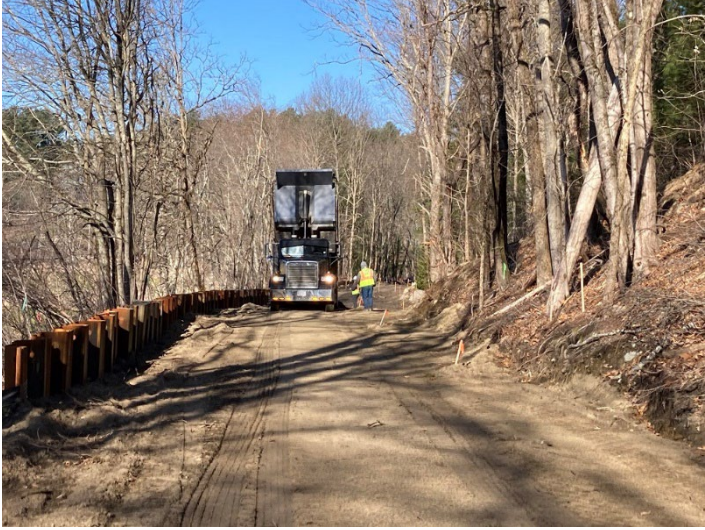
PHOTOGRAPHIC LOG	
Client Name: Eversource		Site Location: Sudbury to Hudson Transmission Reliability Project	Town: Sudbury
Photo No.: 3	Date: 4-03-2023

Description: View of ET&L performing cut and fill activities in segment 14. Facing west.

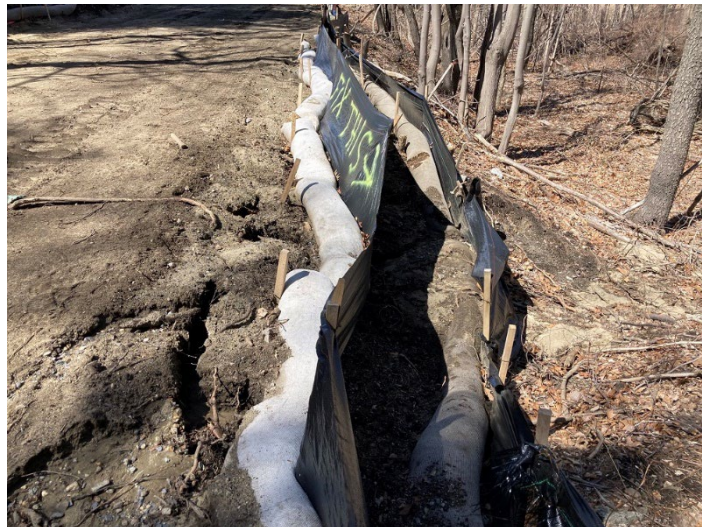
View of E&S controls at Sta. #174/ Sta. #147+75. Repair silt fence and filter tubes where damaged in multiple places in segment 3. Remove sediment that has deposited beyond controls at location pictured (corrective action). Facing west.

Provide a description of the specific condition that triggered the need for corrective action and the cause (if identifiable):	
Silt fence and filter tubes were damaged in multiple places in segment 3 due to site work and stormwater flow from adjacent property. Small amount of sediment appears to have deposited just beyond controls at approximately Sta. #174/Sta. #147+75.	
Section C – Corrective Action Completion (CGP Part 5.4.1.b)	
Complete this section <u>within 24 hours</u> after completing the corrective action.	
For site condition # 1, 2, 3, 4, or 6 (those not related to a dewatering discharge) confirm that you met the following deadlines (CGP Part 5.2.1):	
<input type="checkbox"/> Immediately took all reasonable steps to address the condition, including cleaning up any contaminated surfaces so the material will not discharge in subsequent storm events. AND	
<input type="checkbox"/> Completed corrective action by the close of the next business day, unless a new or replacement control, or significant repair, was required. OR

Describe any modification(s) made as part of corrective action: (Insert additional rows below if applicable)	Date of completion:	SWPPP update necessary?	If yes, date SWPPP was updated:
1. No modifications made- erosion controls were replaced where needed.	4/05/2023	<input type="checkbox"/> Yes <input checked="" type="checkbox"/> No	N/A
2.		<input type="checkbox"/> Yes <input type="checkbox"/> No

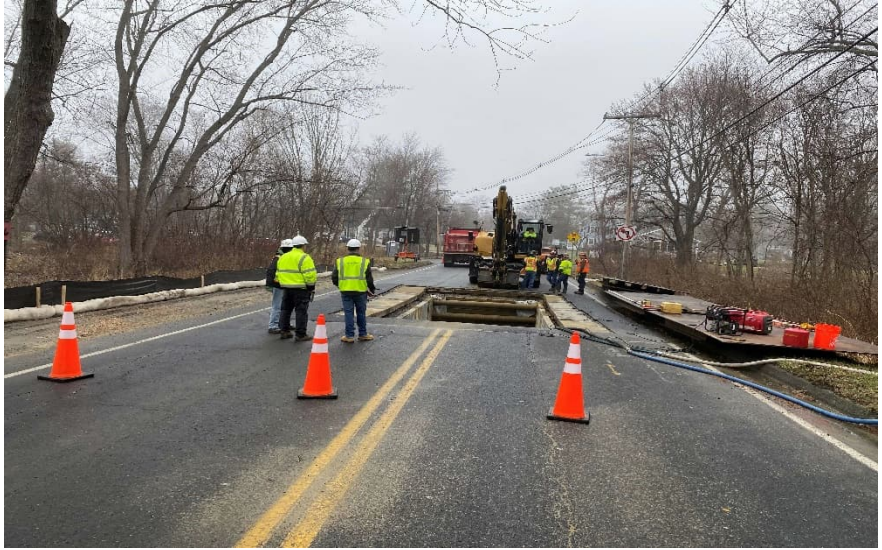
PHOTOGRAPHIC LOG	
Client Name: Eversource		Site Location: Sudbury to Hudson Transmission Reliability Project	Town: Hudson
Photo No.: 1	Date: 4/6/2023

Description: View of area being pumped at work operation at MH#4, in Forest Avenue, looking northward.

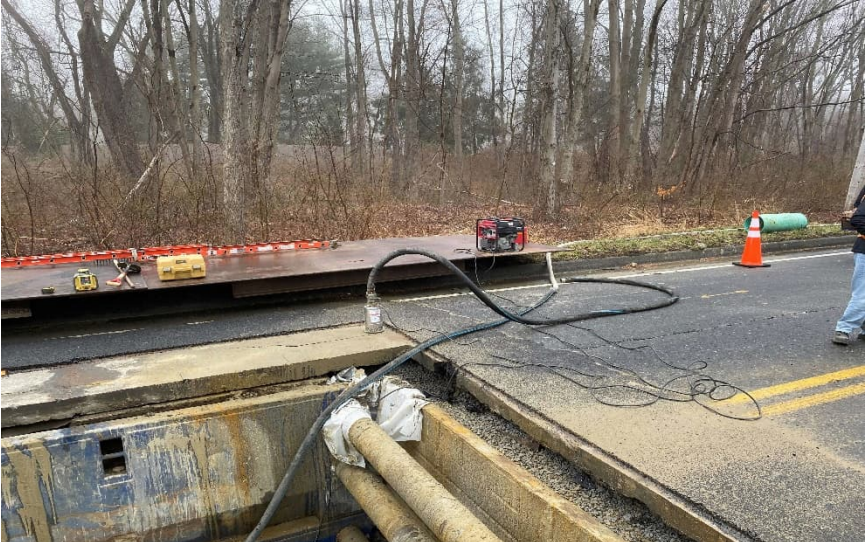
PHOTOGRAPHIC LOG	
Client Name: Eversource		Site Location: Sudbury to Hudson Transmission Reliability Project	Town: Hudson
Photo No.: 3	Date: 4/6/2023

Description: MH#4. View of dewatering operation, looking westward.

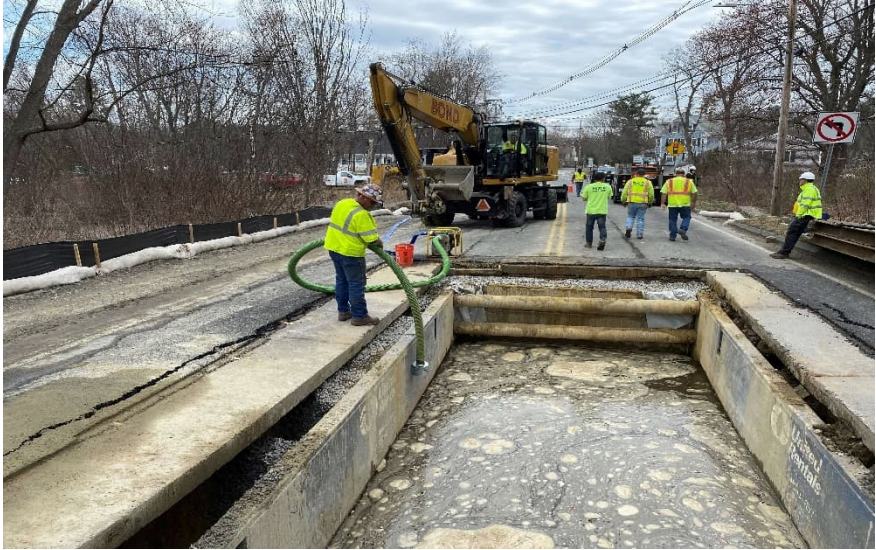
PHOTOGRAPHIC LOG	
Client Name: Eversource		Site Location: Sudbury to Hudson Transmission Reliability Project	Town: Hudson
Photo No.: 1	Date: 4/6/2023

Description: View of area being pumped at work operation at MH#4, in Forest Avenue, looking northward.

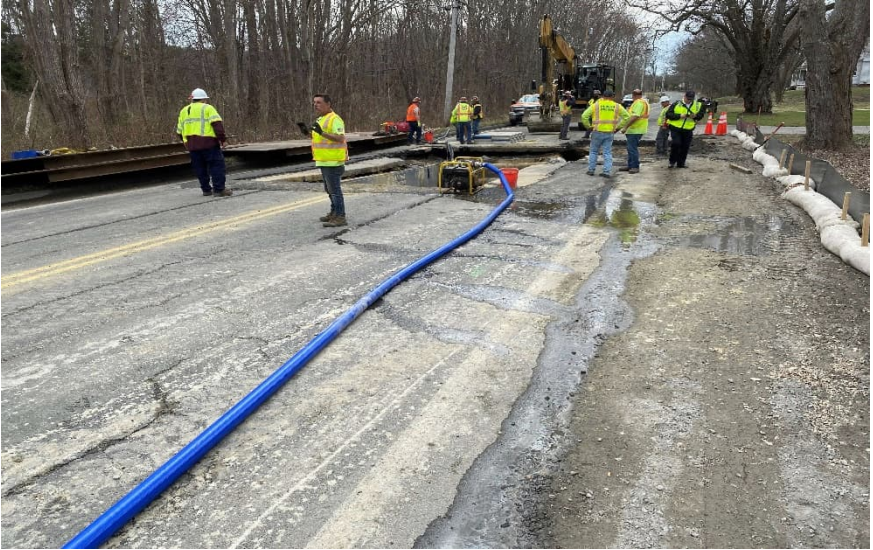
PHOTOGRAPHIC LOG	
Client Name: Eversource		Site Location: Sudbury to Hudson Transmission Reliability Project	
Town: Hudson			
Photo No.: 3	Date: 4/6/2023

Description: MH#4. View of dewatering operation, looking northward.

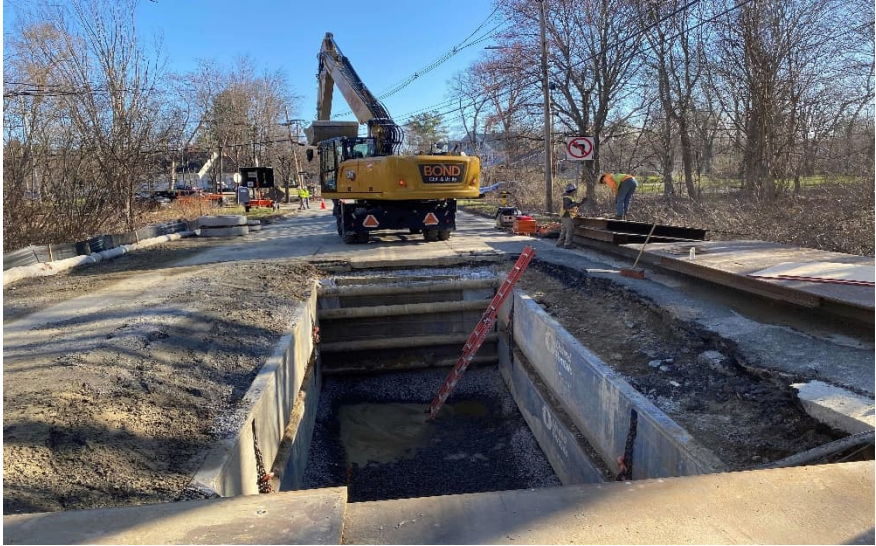
PHOTOGRAPHIC LOG	
Client Name: Eversource		Site Location: Sudbury to Hudson Transmission Reliability Project	Town: Hudson
Photo No.: 1	Date: 4/7/2023

Description: View of area being pumped at work operation at MH#4, in Forest Avenue, looking northward.

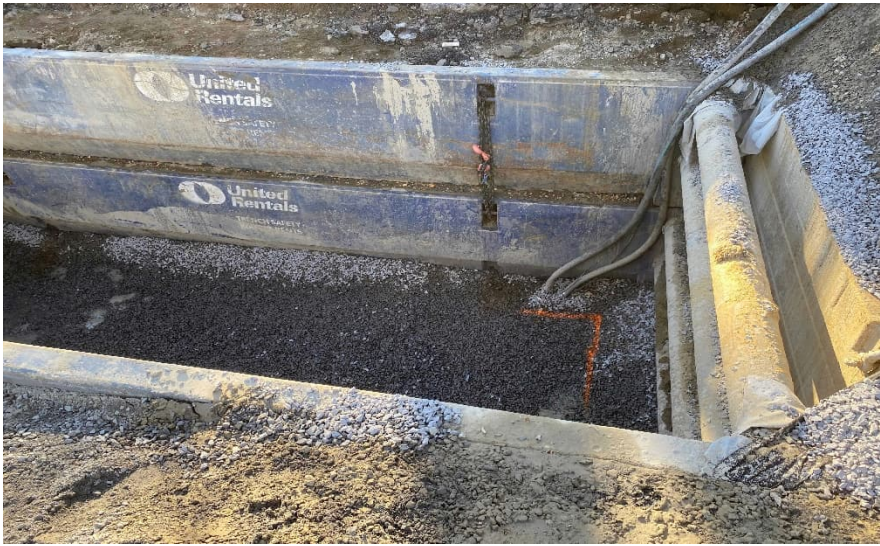
PHOTOGRAPHIC LOG	
Client Name: Eversource		Site Location: Sudbury to Hudson Transmission Reliability Project	Town: Hudson
Photo No.: 2	Date: 4/7/2023

Description: View of pumping operation at MH#4. This is the location of dewatering water prior to treatment. Water appeared to be clear.

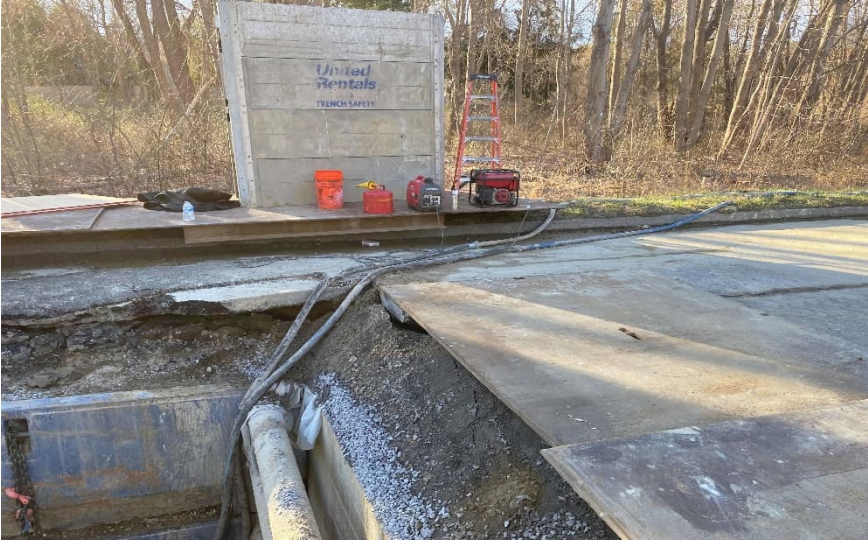
PHOTOGRAPHIC LOG	
Client Name: Eversource		Site Location: Sudbury to Hudson Transmission Reliability Project	Town: Hudson
Photo No.: 3	Date: 4/7/2023

Description: MH#4. View of dewatering operation, looking eastward.

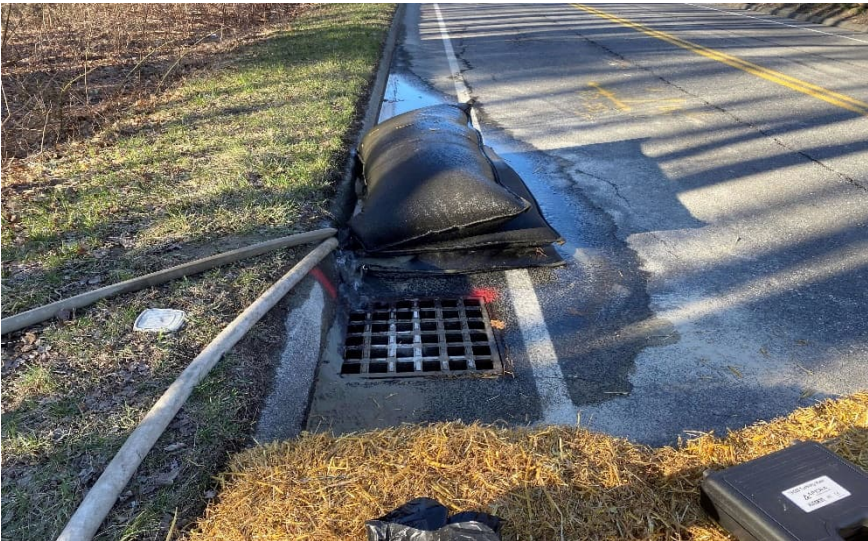
PHOTOGRAPHIC LOG	
Client Name: Eversource		Site Location: Sudbury to Hudson Transmission Reliability Project	Town: Hudson
Photo No.: 4	Date: 4/7/2023

Description: MH#4. View of discharge bag/bales, looking southward. Water appeared to be clear.

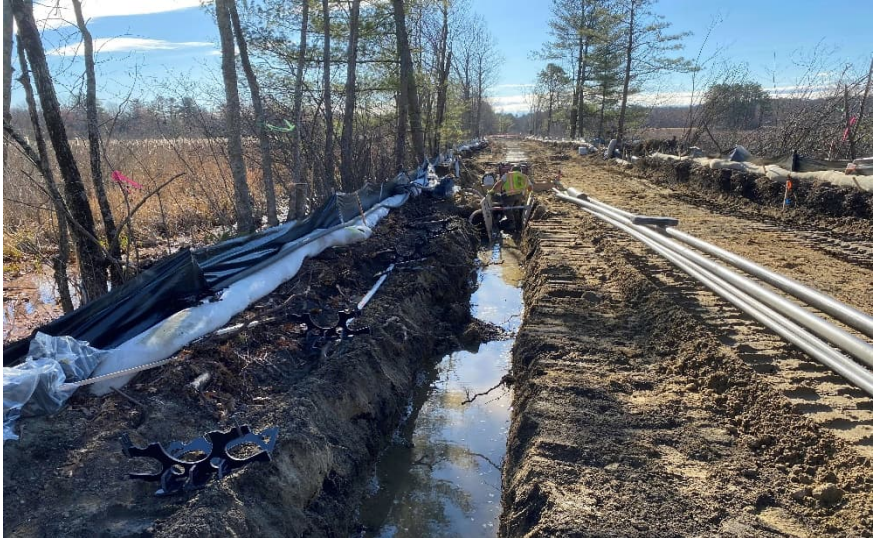
PHOTOGRAPHIC LOG	
Client Name: Eversource		Site Location: Sudbury to Hudson Transmission Reliability Project	Town: Hudson
Photo No.: 1	Date: 4/7/2023

Description: View of area being pumped at work operation within Segment 2 at approximate Sta# 144+50, looking eastward.

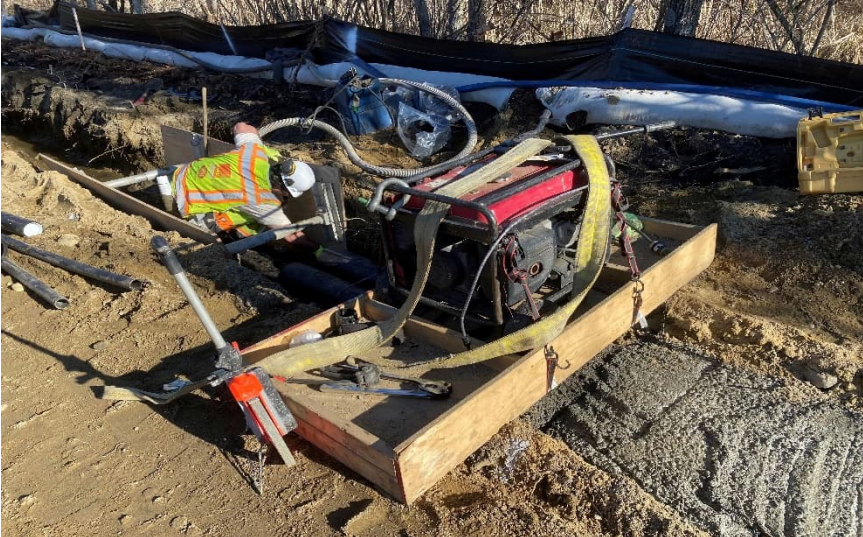
PHOTOGRAPHIC LOG	
Client Name: Eversource		Site Location: Sudbury to Hudson Transmission Reliability Project	Town: Hudson
Photo No.: 3	Date: 4/7/2023

Description: Segment 2. View of dewatering operation, looking eastward.

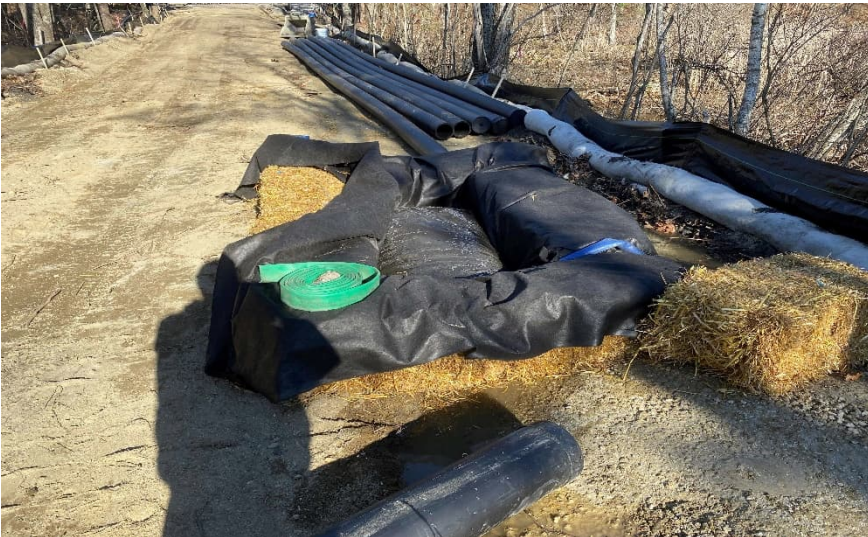
PHOTOGRAPHIC LOG	
Client Name: Eversource		Site Location: Sudbury to Hudson Transmission Reliability Project	Town: Hudson
Photo No.: 4	Date: 4/7/2023

Description: Segment 2. View of discharge bag/bales, looking westward. Water appeared to be clear.
