Weekly Environmental Compliance Summary

Sudbury to Hudson Transmission Reliability Project (USEPA Tracking # MAR1003UW)

Week of: April 17 to April 21, 2023

CONSTRUCTION MONITORING REPORT

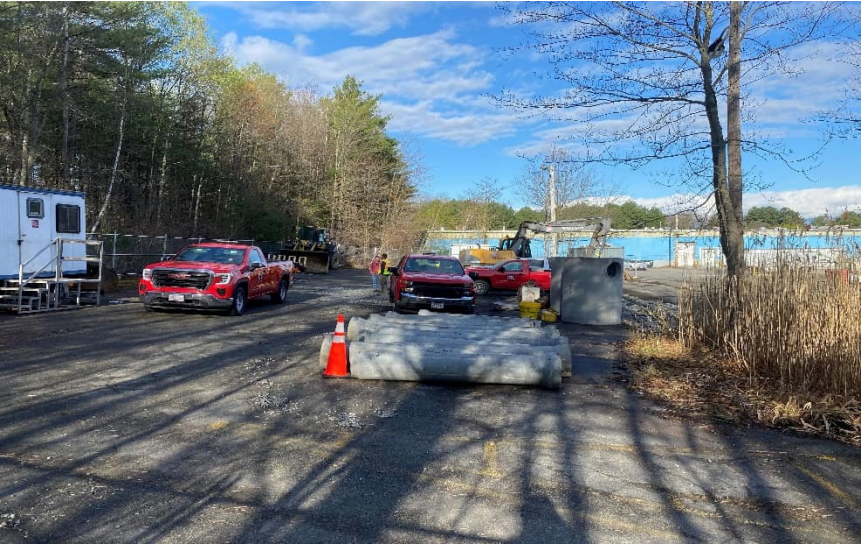
<p>PHOTOGRAPHIC LOG</p>	
<p>Client Name: Eversource</p>		<p>Site Location: Sudbury to Hudson Transmission Reliability Project</p>	<p>Town: Hudson</p>
<p>Photo No.: 3</p>	<p>Date: 4-18-23</p>

<p>Description: Laydown yard at 555 Main Street, looking northward.</p>

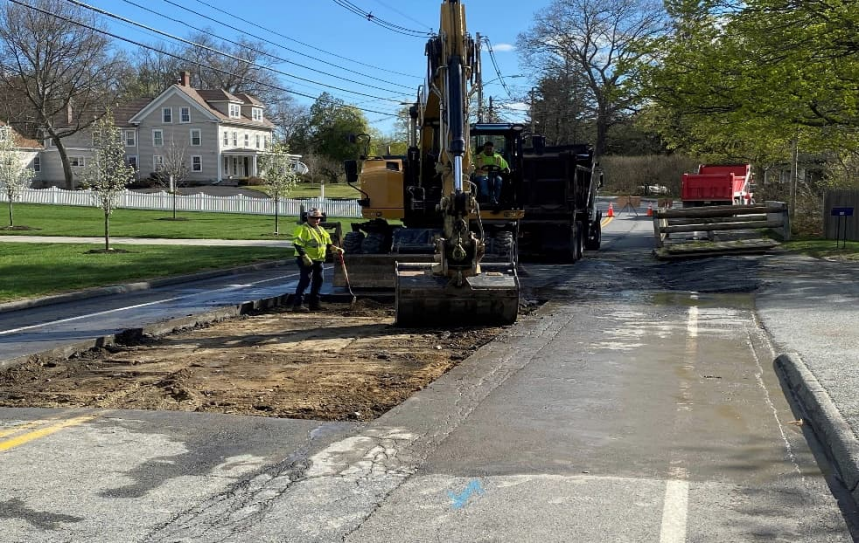
<p>PHOTOGRAPHIC LOG</p>	
<p>Client Name: Eversource</p>		<p>Site Location: Sudbury to Hudson Transmission Reliability Project</p>	<p>Town: Hudson</p>
<p>Photo No.: 4</p>	<p>Date: 4-18-23</p>

<p>Description: MH#3 area, along Forest Avenue, looking northward.</p>

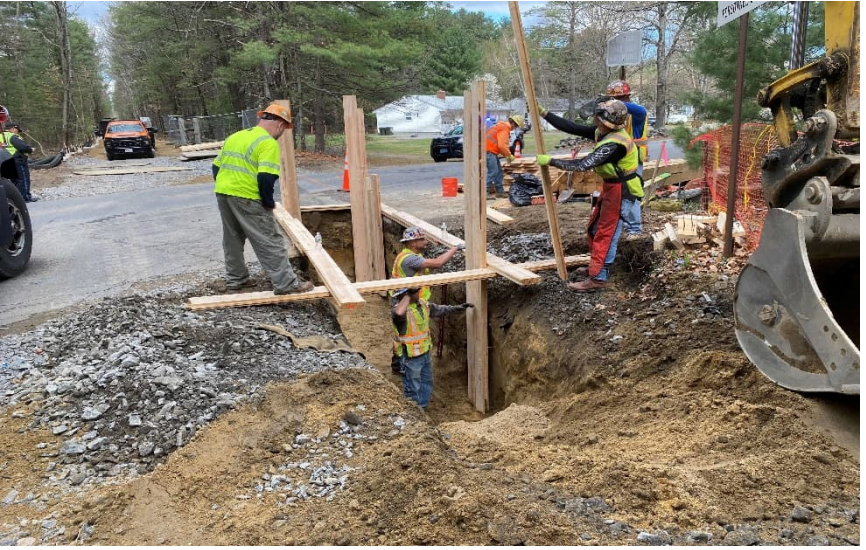
<p>PHOTOGRAPHIC LOG</p>	
<p>Client Name: Eversource</p>		<p>Site Location: Sudbury to Hudson Transmission Reliability Project</p>	<p>Town: Hudson</p>
<p>Photo No.: 7</p>	<p>Date: 4-18-23</p>

<p>Description:</p> <p>Bond conducting conduit work within Segment 5 (installation of shoring) at Parmenter Road, looking westward.</p>

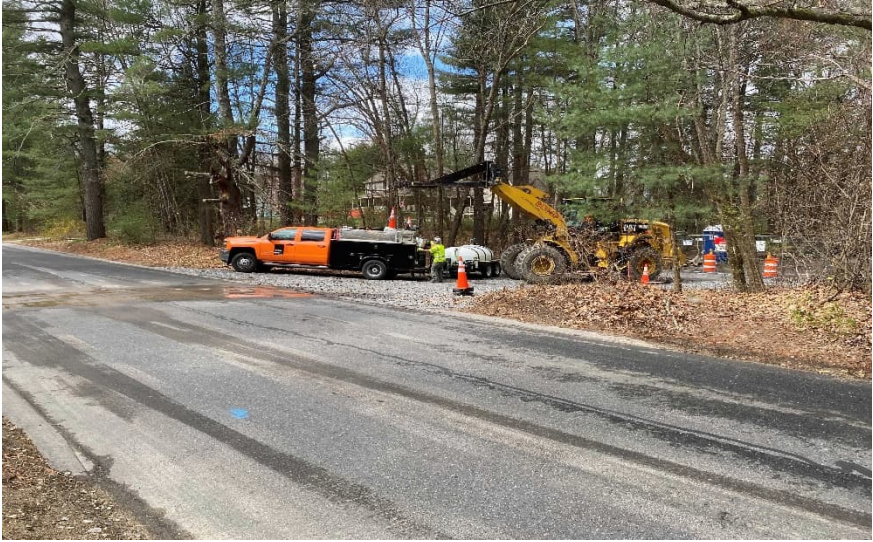
<p>PHOTOGRAPHIC LOG</p>	
<p>Client Name: Eversource</p>		<p>Site Location: Sudbury to Hudson Transmission Reliability Project</p>	<p>Town: Hudson</p>
<p>Photo No.: 8</p>	<p>Date: 4-18-23</p>

<p>Description:</p> <p>Bond conducting road cutting across White Pond Road, looking southward.</p>

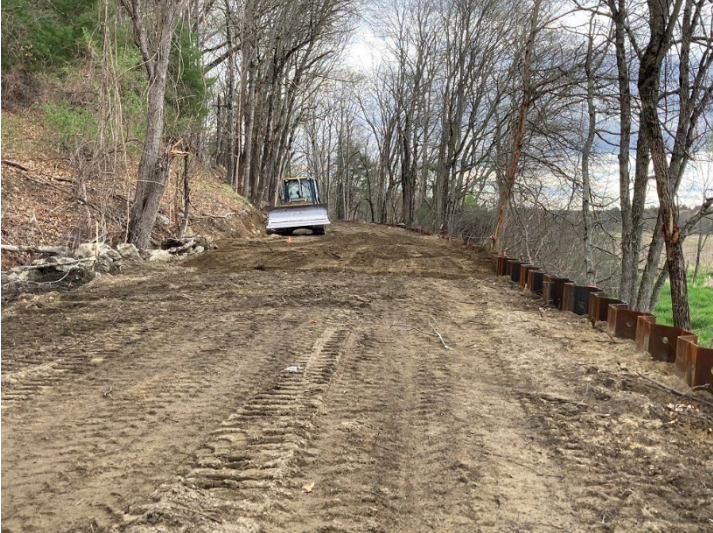
<p align="center">PHOTOGRAPHIC LOG</p>	
Client Name: Eversource		Site Location: Sudbury to Hudson Transmission Reliability Project	Town: Sudbury
Photo No.: 2	Date: 4/18/2023

Description: View of ET&L performing cut & fill activities in segment 14. Facing east.

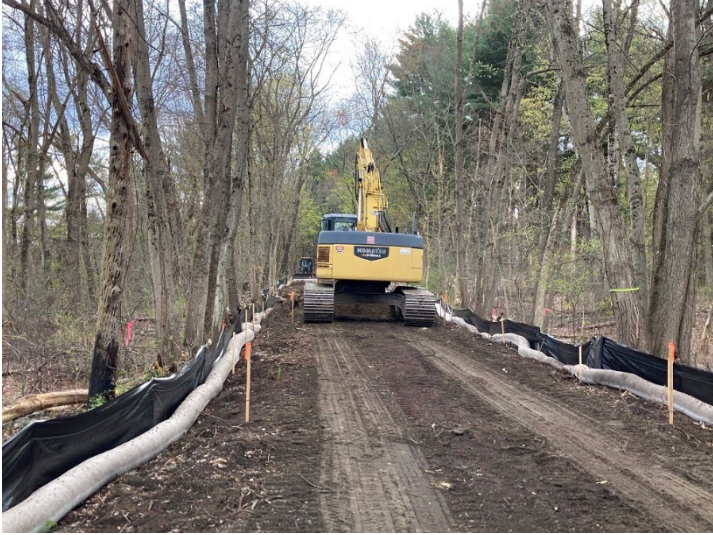
<p align="right">PHOTOGRAPHIC LOG</p>	
Client Name: Eversource		Site Location: Sudbury to Hudson Transmission Reliability Project	Town: Sudbury
Photo No.: 3	Date: 4/18/2023

Description: View of ET&L performing cut & fill activities in segment 13. Facing east.

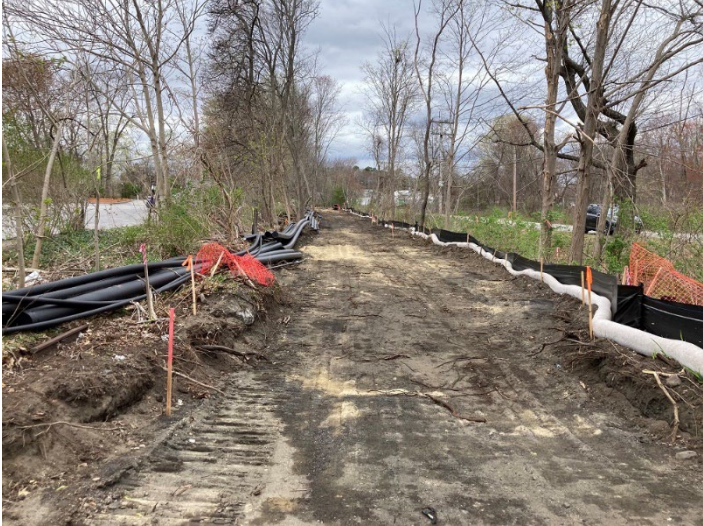
<p align="right">PHOTOGRAPHIC LOG</p>	
Client Name: Eversource		Site Location: Sudbury to Hudson Transmission Reliability Project	Town: Sudbury
Photo No.: 4	Date: 4/18/2023

Description: View of eastern end of segment 12. Facing west.

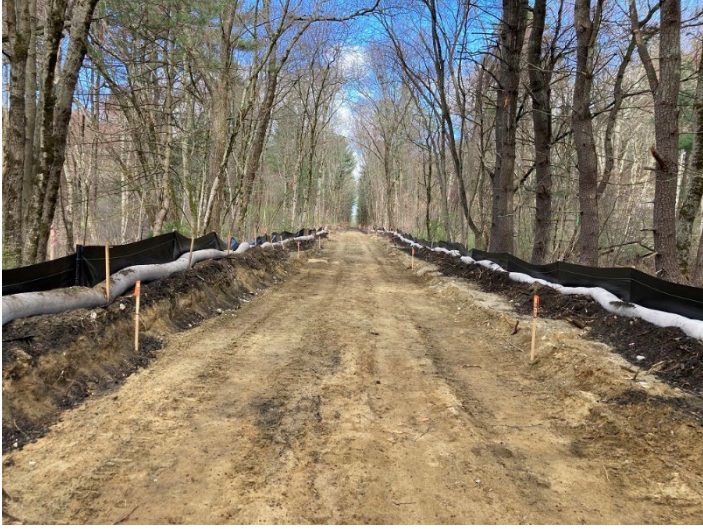
<p>PHOTOGRAPHIC LOG</p>	
<p>Client Name: Eversource</p>		<p>Site Location: Sudbury to Hudson Transmission Reliability Project</p>	<p>Town: Sudbury</p>
<p>Photo No.: 5</p>	<p>Date: 4/18/2023</p>

<p>Description: View of Type A E&S controls in segment 9. Facing west.</p>

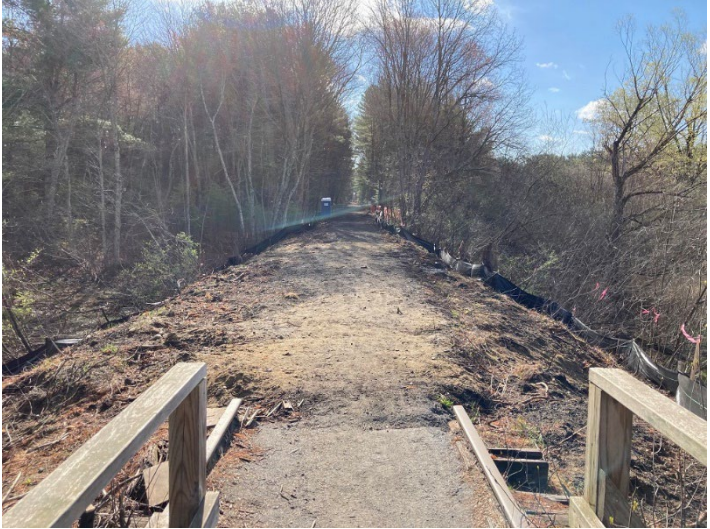
<p>PHOTOGRAPHIC LOG</p>	
<p>Client Name: Eversource</p>		<p>Site Location: Sudbury to Hudson Transmission Reliability Project</p>	<p>Town: Sudbury</p>
<p>Photo No.: 6</p>	<p>Date: 4/18/2023</p>

<p>Description: View of segment 8 from bridge 128. Facing east.</p>

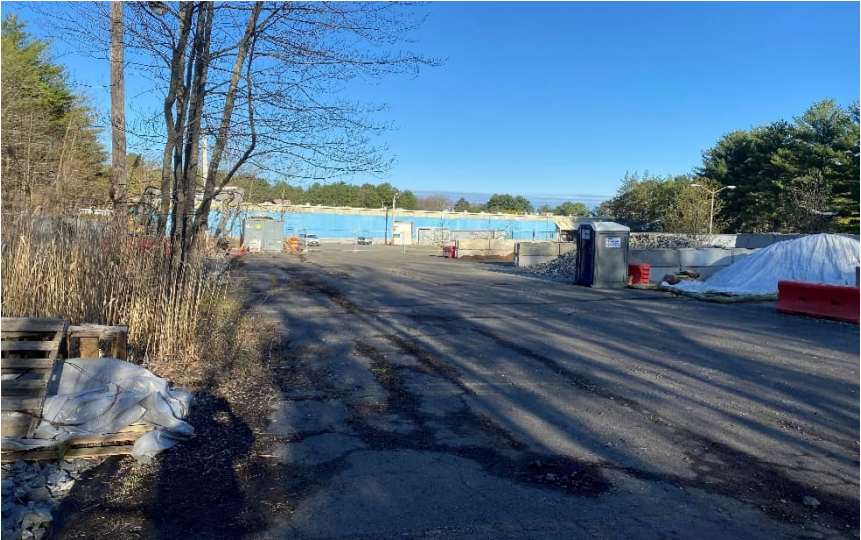
<p>PHOTOGRAPHIC LOG</p>	
<p>Client Name: Eversource</p>		<p>Site Location: Sudbury to Hudson Transmission Reliability Project</p>	<p>Town: Hudson</p>
<p>Photo No.: 1</p>	<p>Date: 4-19-23</p>

<p>Description:</p> <p>Laydown yard at 555 Main Street, looking northward.</p>

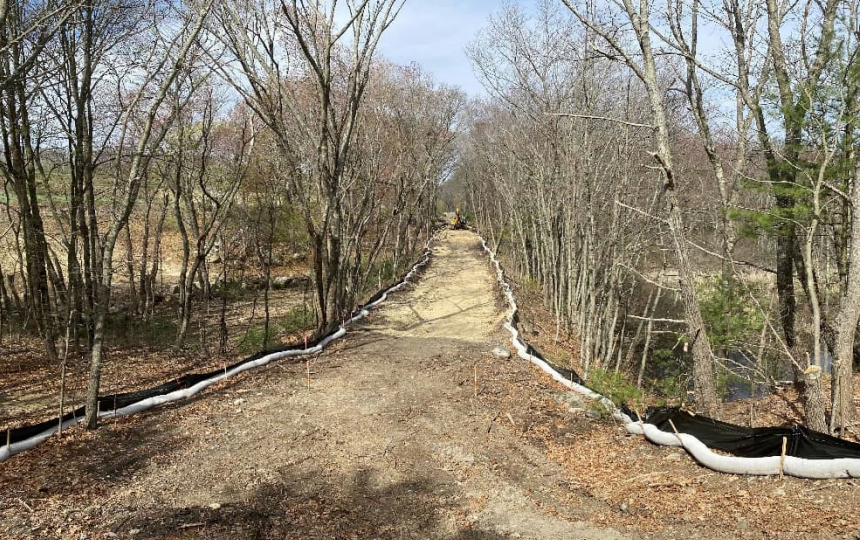
<p>PHOTOGRAPHIC LOG</p>	
<p>Client Name: Eversource</p>		<p>Site Location: Sudbury to Hudson Transmission Reliability Project</p>	<p>Town: Hudson</p>
<p>Photo No.: 2</p>	<p>Date: 4-19-23</p>

<p>Description:</p> <p>Right-of-way within segment 1 from Chestnut Street, looking westward.</p>

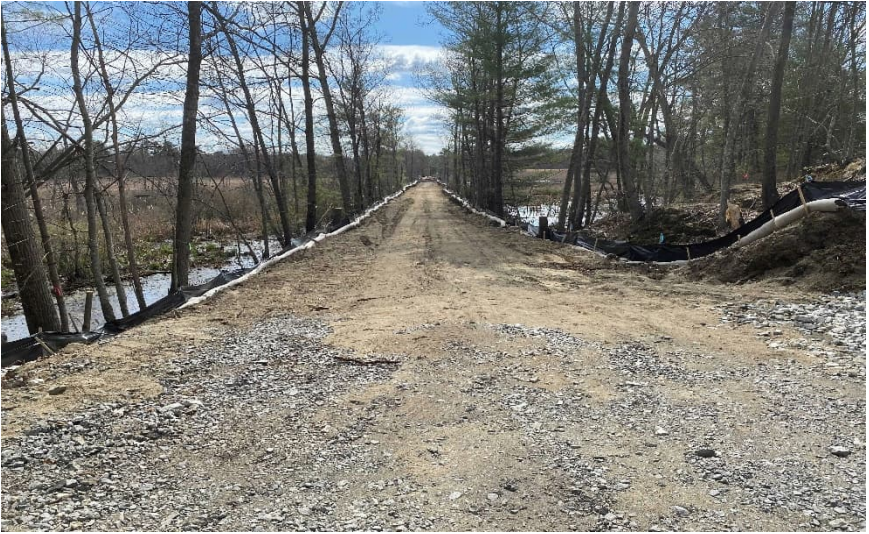
<p>PHOTOGRAPHIC LOG</p>	
<p>Client Name: Eversource</p>		<p>Site Location: Sudbury to Hudson Transmission Reliability Project</p>	<p>Town: Hudson</p>
<p>Photo No.: 3</p>	<p>Date: 4-19-23</p>

<p>Description: Right-of-way within segment 2 from water supply road, looking eastward.</p>

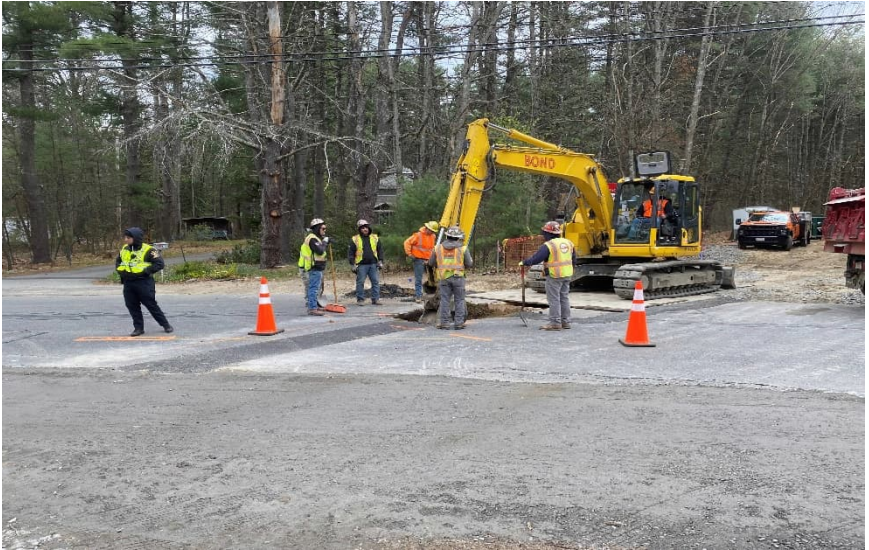
<p>PHOTOGRAPHIC LOG</p>	
<p>Client Name: Eversource</p>		<p>Site Location: Sudbury to Hudson Transmission Reliability Project</p>	<p>Town: Hudson</p>
<p>Photo No.: 7</p>	<p>Date: 4-19-23</p>

<p>Description: Bond conducting conduit work within Segment 5 at Parmenter Road, looking westward.</p>

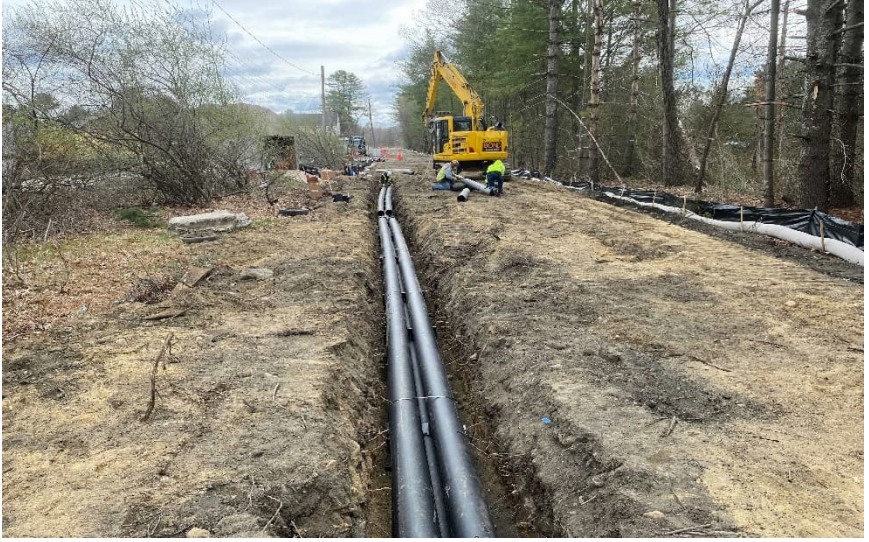
<p>PHOTOGRAPHIC LOG</p>	
<p>Client Name: Eversource</p>		<p>Site Location: Sudbury to Hudson Transmission Reliability Project</p>	<p>Town: Hudson</p>
<p>Photo No.: 8</p>	<p>Date: 4-19-23</p>

<p>Description: Bond conducting conduit work within Segment 3, looking eastward.</p>

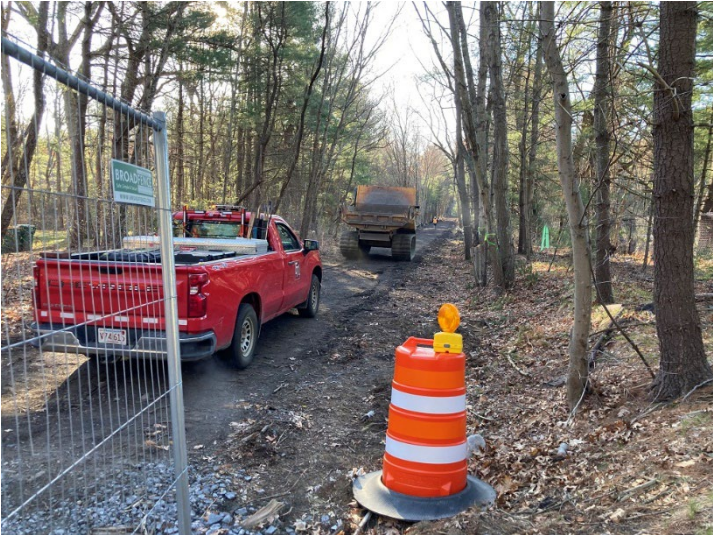
<p align="right">PHOTOGRAPHIC LOG</p>	
<p>Client Name: Eversource</p>		<p>Site Location: Sudbury to Hudson Transmission Reliability Project</p>	<p>Town: Sudbury</p>
<p>Photo No.: 2</p>	<p>Date: 4/19/2023</p>

<p>Description: View of ET&L transporting equipment through segment 11, escorted by biological monitor. Facing east.</p>

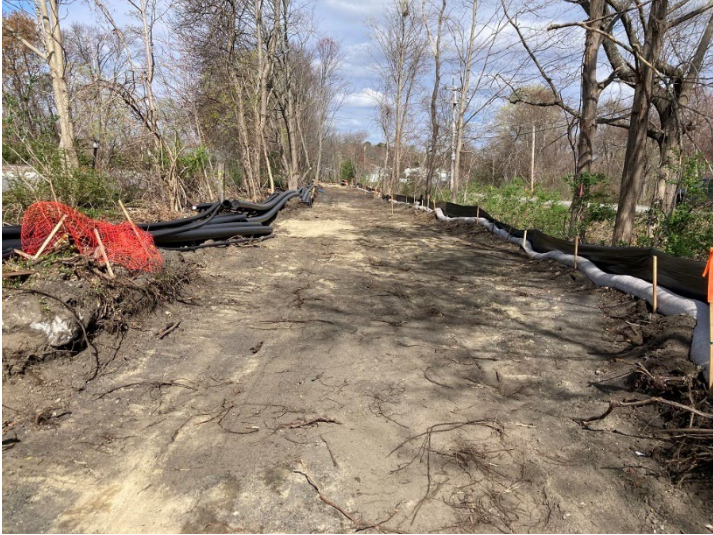
PHOTOGRAPHIC LOG	
Client Name: Eversource		Site Location: Sudbury to Hudson Transmission Reliability Project	Town: Sudbury
Photo No.: 3	Date: 4/19/2023

Description: View of segment 12. Facing west.

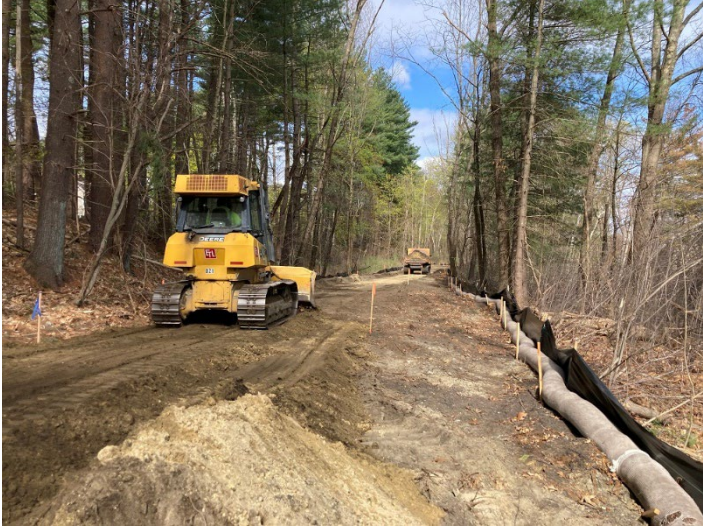
PHOTOGRAPHIC LOG	
Client Name: Eversource		Site Location: Sudbury to Hudson Transmission Reliability Project	Town: Sudbury
Photo No.: 4	Date: 4/19/2023

Description: View of ET&L performing cut & fill activities in segment 13. Facing west.

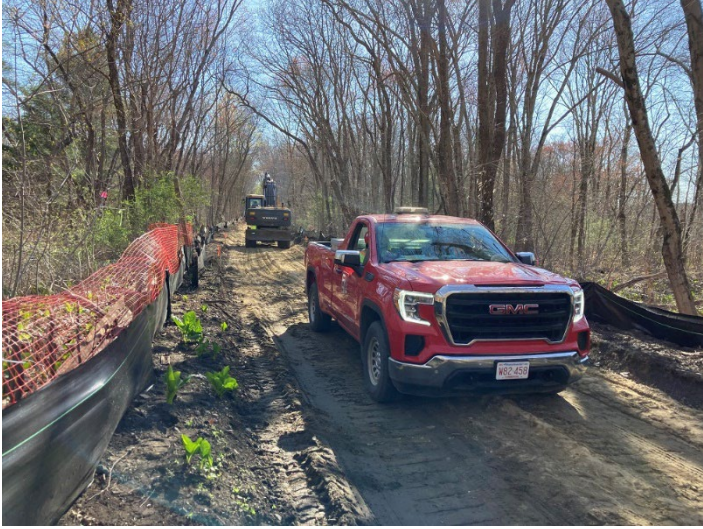
PHOTOGRAPHIC LOG	
Client Name: Eversource		Site Location: Sudbury to Hudson Transmission Reliability Project	Town: Sudbury
Photo No.: 5	Date: 4/19/2023

Description: View of ET&L leaving segment 14, escorted by biological monitor. Facing east.

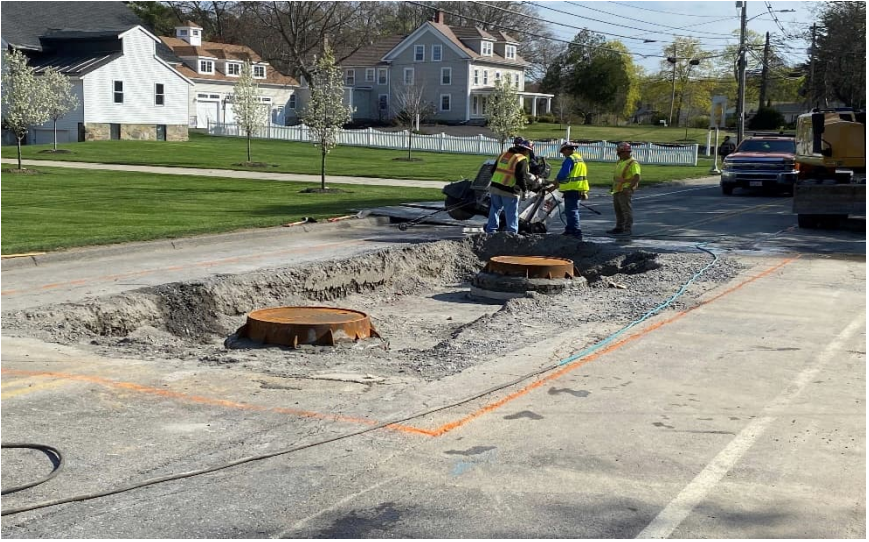
<p>PHOTOGRAPHIC LOG</p>	
<p>Client Name: Eversource</p>		<p>Site Location: Sudbury to Hudson Transmission Reliability Project</p>	<p>Town: Hudson</p>
<p>Photo No.: 1</p>	<p>Date: 4-21-23</p>

<p>Description:</p> <p>MH#3 within Forest Avenue, placing access points, looking northward.</p>

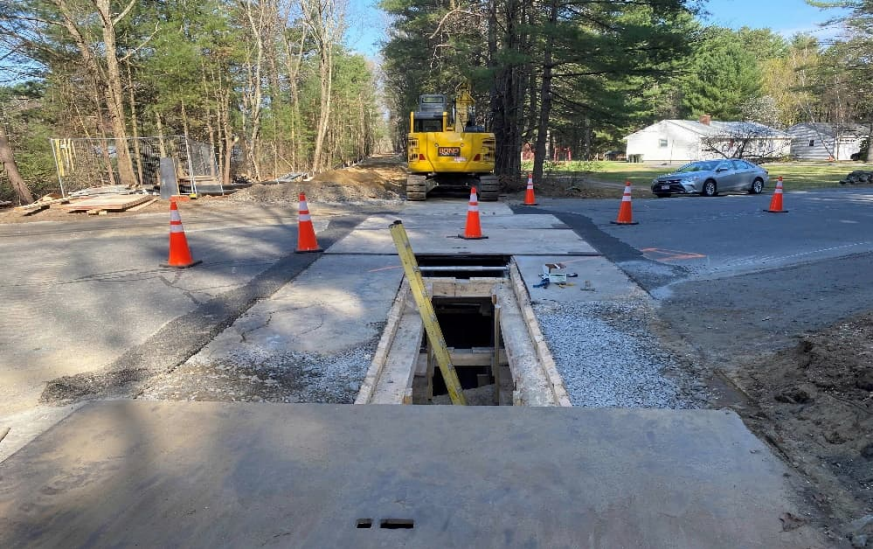
<p>PHOTOGRAPHIC LOG</p>	
<p>Client Name: Eversource</p>		<p>Site Location: Sudbury to Hudson Transmission Reliability Project</p>	<p>Town: Hudson</p>
<p>Photo No.: 2</p>	<p>Date: 4-21-23</p>

<p>Description:</p> <p>Conduit work within Parmenter Road segments 4/5, looking westward.</p>

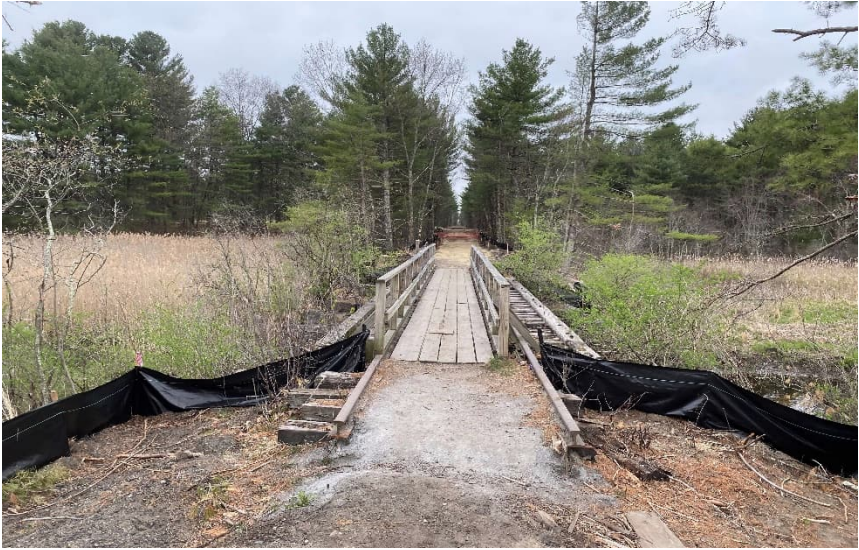
<p>PHOTOGRAPHIC LOG</p>	
<p>Client Name: Eversource</p>		<p>Site Location: Sudbury to Hudson Transmission Reliability Project</p>	<p>Town: Sudbury</p>
<p>Photo No.: 5</p>	<p>Date: 4-21-23</p>

<p>Description:</p> <p>Bridge 128 at segments 7/8, looking westward.</p>

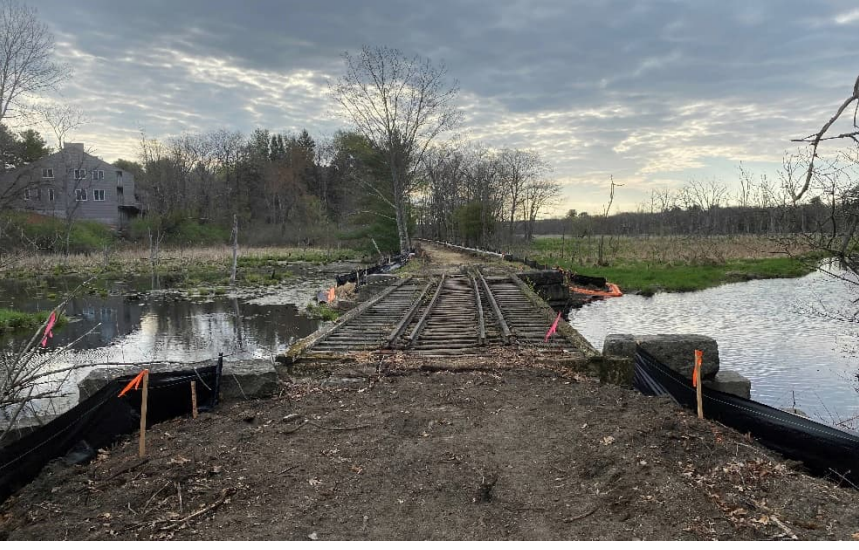
<p>PHOTOGRAPHIC LOG</p>	
<p>Client Name: Eversource</p>		<p>Site Location: Sudbury to Hudson Transmission Reliability Project</p>	<p>Town: Sudbury</p>
<p>Photo No.: 6</p>	<p>Date: 4-21-23</p>

<p>Description:</p> <p>Bridge 127 at segments 13/14, looking eastward.</p>

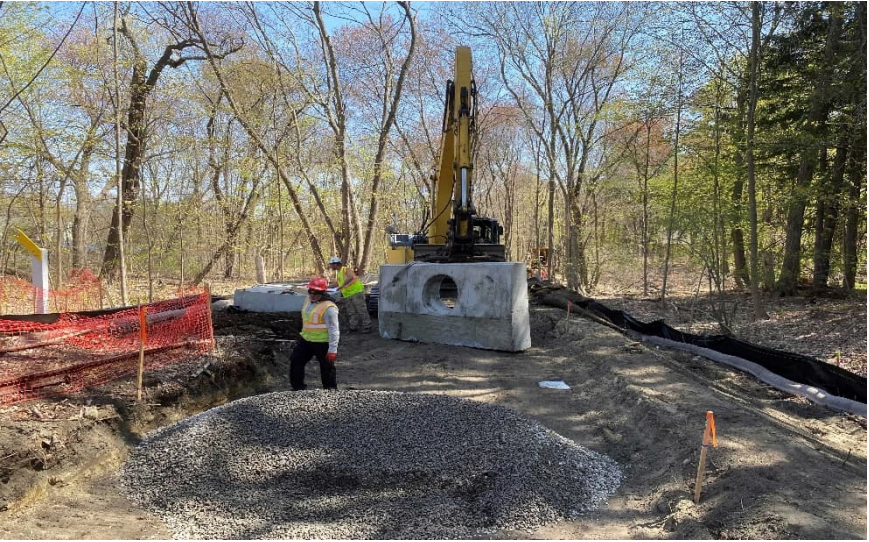
<p>PHOTOGRAPHIC LOG</p>	
<p>Client Name: Eversource</p>		<p>Site Location: Sudbury to Hudson Transmission Reliability Project</p>	<p>Town: Sudbury</p>
<p>Photo No.: 7</p>	<p>Date: 4-21-23</p>

<p>Description:</p> <p>ET&L installing headwall within Segment 13, looking eastward.</p>

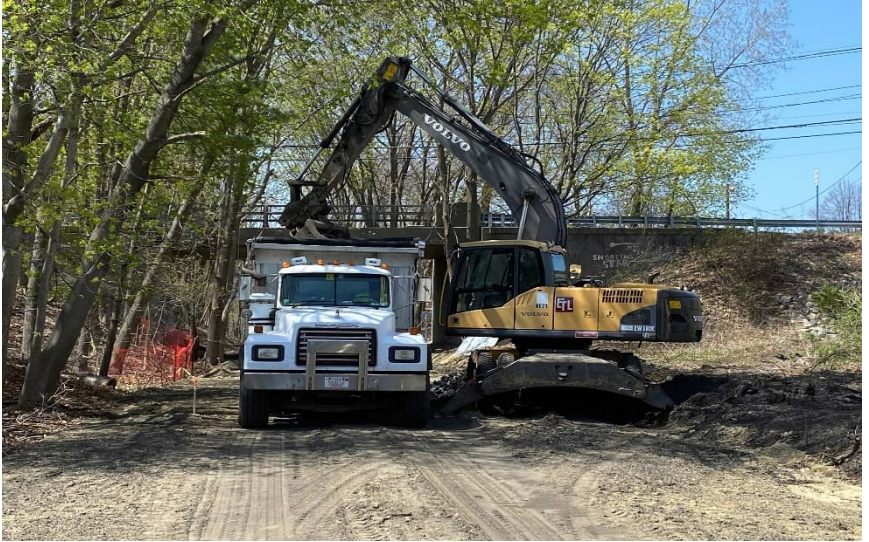
<p>PHOTOGRAPHIC LOG</p>	
<p>Client Name: Eversource</p>		<p>Site Location: Sudbury to Hudson Transmission Reliability Project</p>	<p>Town: Sudbury</p>
<p>Photo No.: 8</p>	<p>Date: 4-21-23</p>

<p>Description:</p> <p>ET&L removing stone within Segment 14, looking westward.</p>

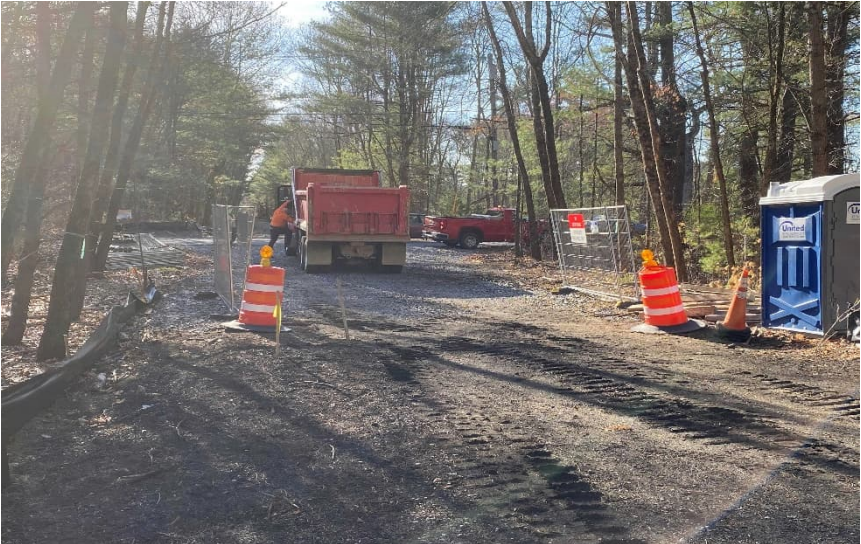
PHOTOGRAPHIC LOG	
Client Name: Eversource		Site Location: Sudbury to Hudson Transmission Reliability Project	Town: Hudson
Photo No.: 1	Date: 4-20-23

Description: Spoil repurposing within Segment 5, just off White Pond Road, looking eastward.

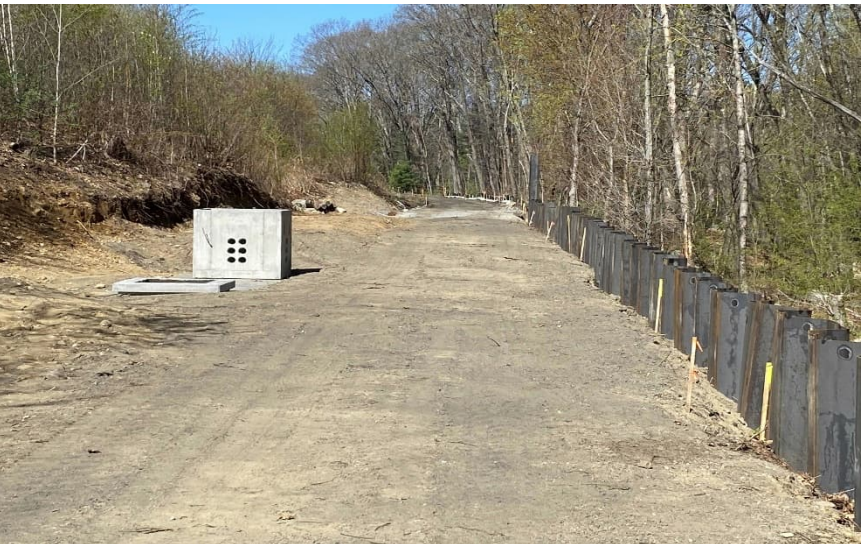
PHOTOGRAPHIC LOG	
Client Name: Eversource		Site Location: Sudbury to Hudson Transmission Reliability Project	Town: Hudson
Photo No.: 2	Date: 4-20-23

Description: MH#6 area/newly installed sheeting within Segment 1, at approximate Sta# 121+00, looking westward.

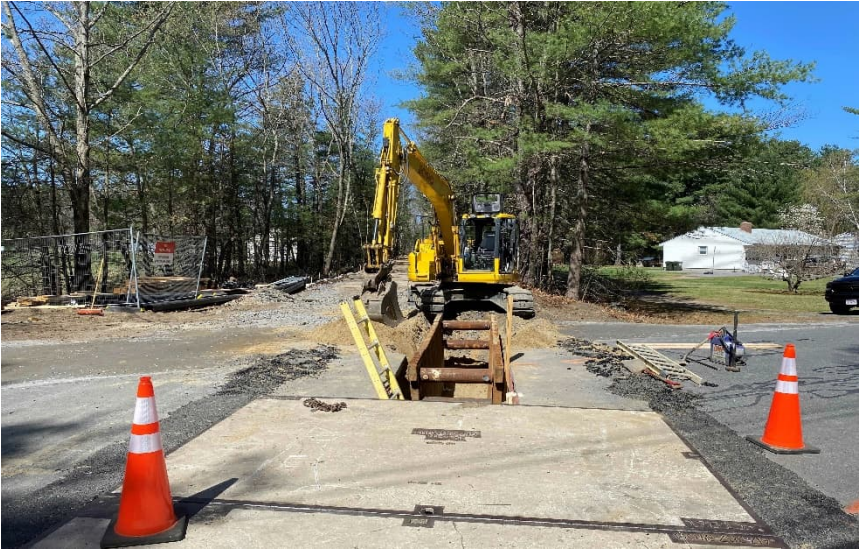
PHOTOGRAPHIC LOG	
Client Name: Eversource		Site Location: Sudbury to Hudson Transmission Reliability Project	Town: Hudson
Photo No.: 3	Date: 4-20-23

Description: Bond conducting conduit work within Parmenter Road, within Segments 4/5, looking westward.

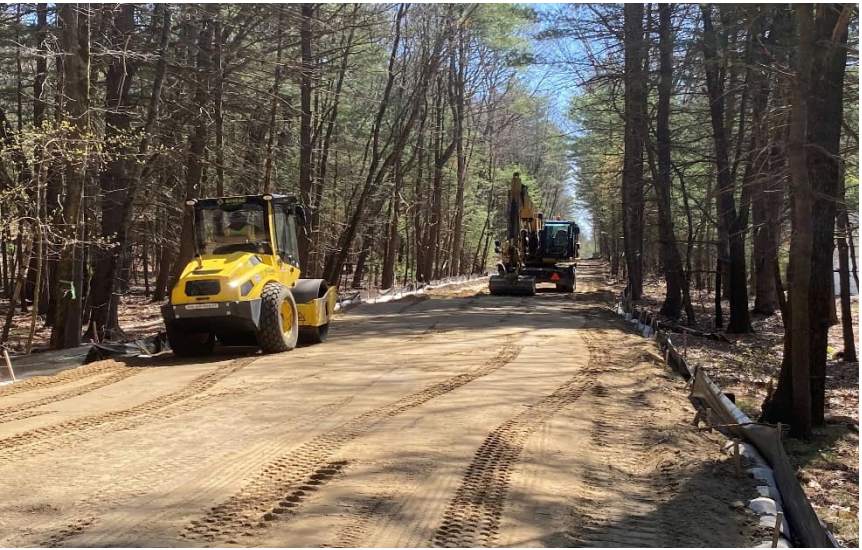
PHOTOGRAPHIC LOG	
Client Name: Eversource		Site Location: Sudbury to Hudson Transmission Reliability Project	Town: Hudson
Photo No.: 4	Date: 4-20-23

Description: Bond conducting site work, within Segment 5, off Parmenter Road, looking eastward.

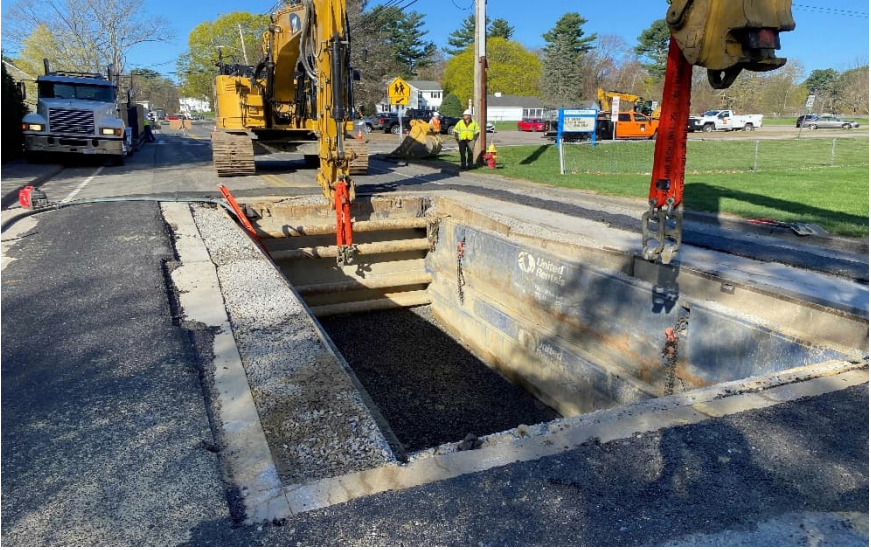
PHOTOGRAPHIC LOG	
Client Name: Eversource		Site Location: Sudbury to Hudson Transmission Reliability Project	
Town: Hudson			
Photo No.: 5	Date: 4-20-23

Description: MH#3 area, within Forest Avenue, looking northward.

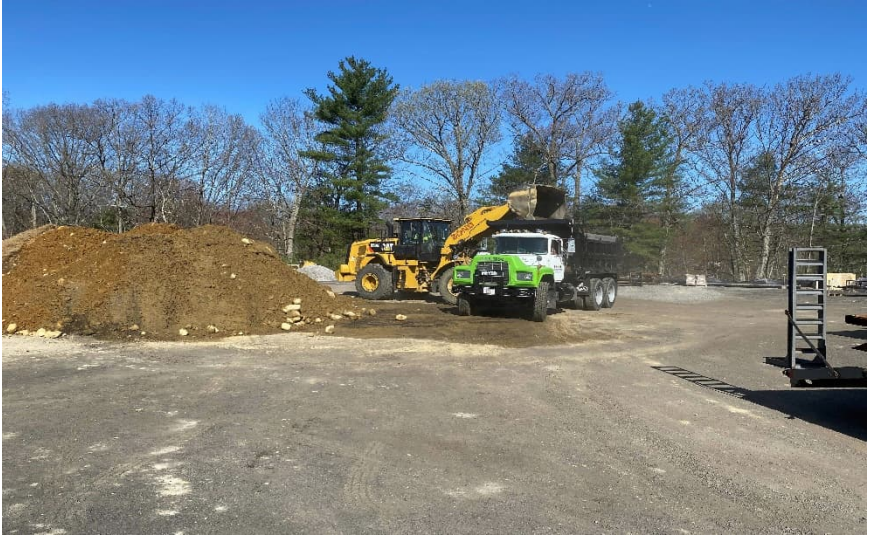
PHOTOGRAPHIC LOG	
Client Name: Eversource		Site Location: Sudbury to Hudson Transmission Reliability Project	
Town: Hudson			
Photo No.: 6	Date: 4-20-23

Description: Spoil removal at Bonazzoli laydown yard for repurposing into Segment 5, looking northward.

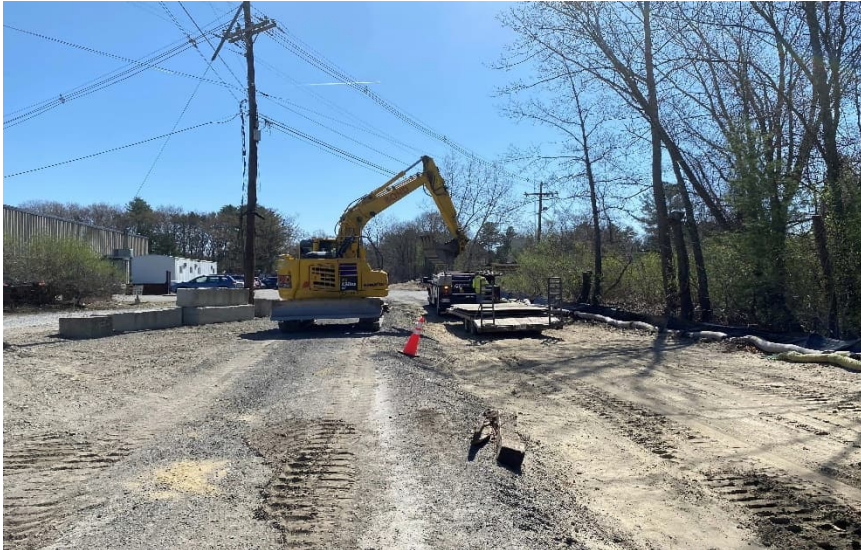
PHOTOGRAPHIC LOG	
Client Name: Eversource		Site Location: Sudbury to Hudson Transmission Reliability Project	Town: Hudson
Photo No.: 8	Date: 4-20-23

Description: Bond conducting cleanup within Segment 3 following conduit work, looking eastward.

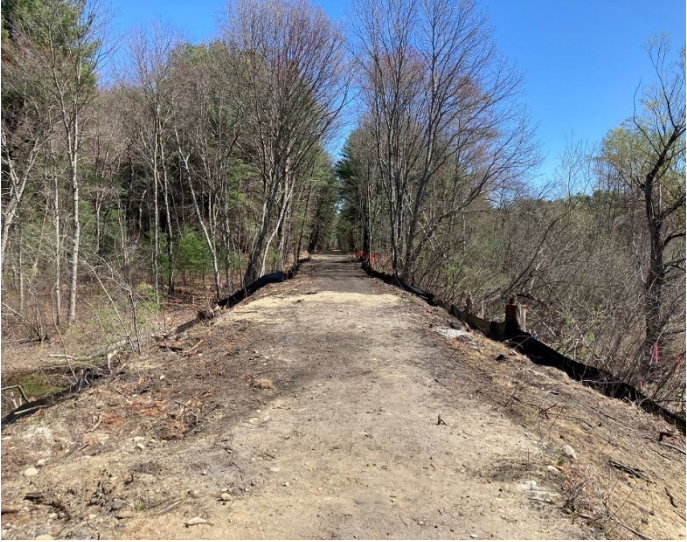
PHOTOGRAPHIC LOG	
Client Name: Eversource		Site Location: Sudbury to Hudson Transmission Reliability Project	Town: Sudbury
Photo No.: 1	Date: 4-20-2023

Description: View of segment 8 from bridge 128. Facing west.

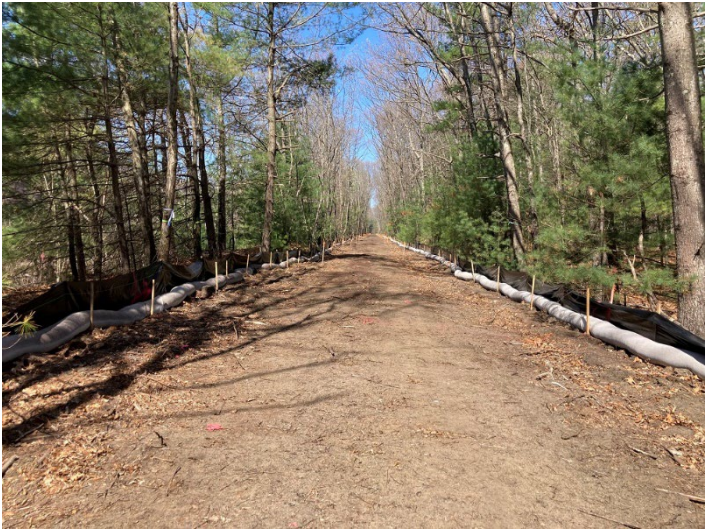
PHOTOGRAPHIC LOG	
Client Name: Eversource		Site Location: Sudbury to Hudson Transmission Reliability Project	Town: Sudbury
Photo No.: 4	Date: 4-20-2023

Description: View of Type A E&S controls in segment 11. Facing west.

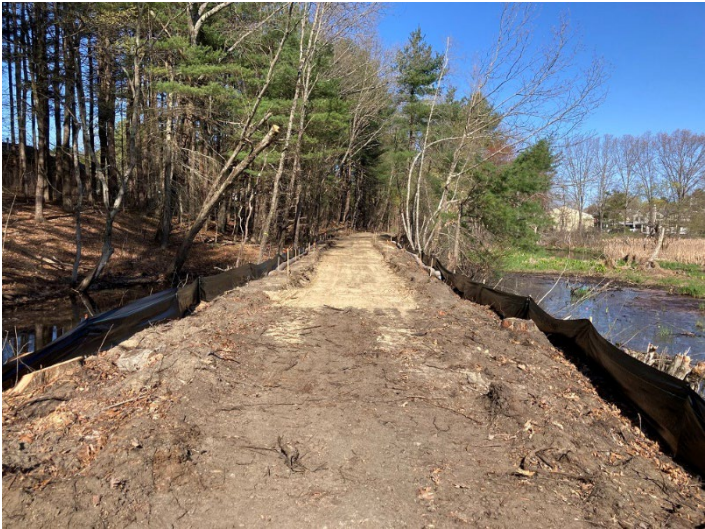
Client Name: Eversource		Site Location: Sudbury to Hudson Transmission Reliability Project	Town: Sudbury
Photo No.: 5	Date: 4-20-2023

Description: View of segment 13 from bridge 127. Facing west.

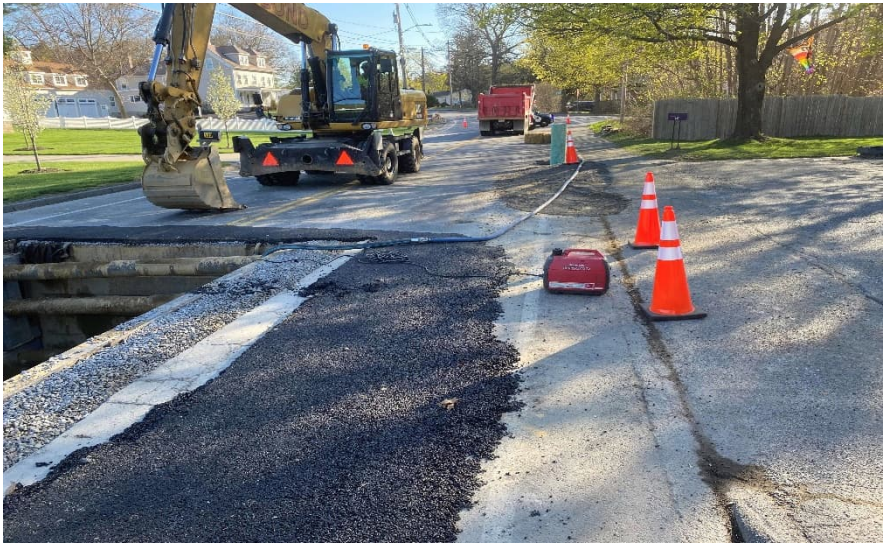
PHOTOGRAPHIC LOG	
Client Name: Eversource		Site Location: Sudbury to Hudson Transmission Reliability Project	Town: Hudson
Photo No.: 2	Date: 4/19/2023

Description: View of pumping operation at MH#3. This is the location of dewatering water prior to treatment.

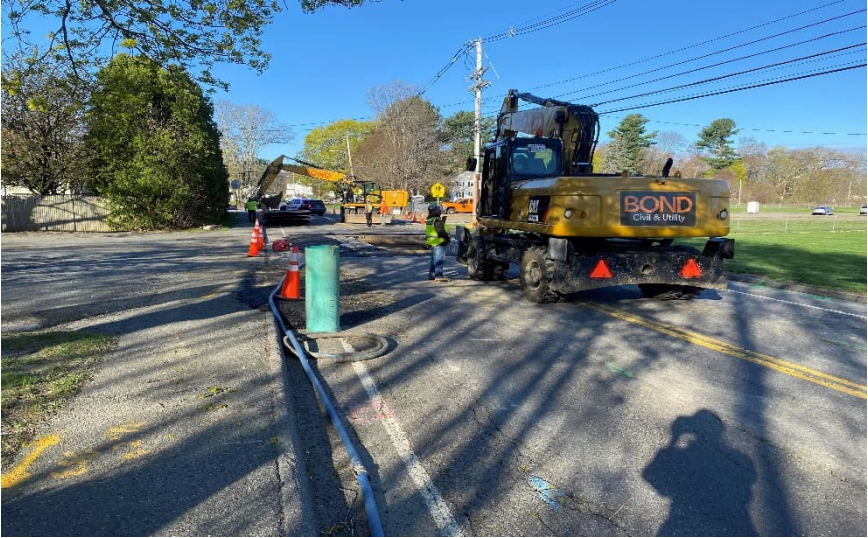
PHOTOGRAPHIC LOG		
Client Name: Eversource		Site Location: Sudbury to Hudson Transmission Reliability Project		Town: Hudson
Photo No.: 3	Date: 4/19/2023

Description: MH#3. View of dewatering operation, looking northward.

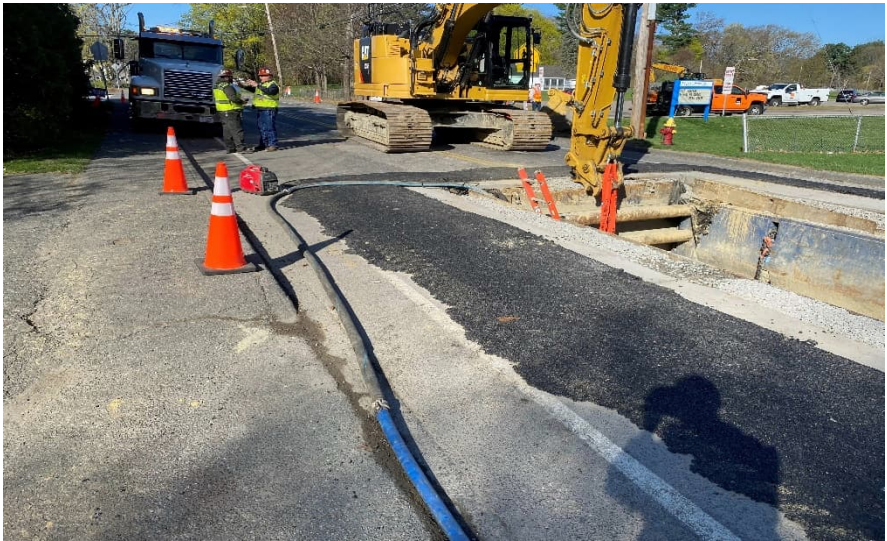
PHOTOGRAPHIC LOG	
Client Name: Eversource		Site Location: Sudbury to Hudson Transmission Reliability Project	Town: Hudson
Photo No.: 2	Date: 4/20/2023

Description: View of pumping operation at MH#3. This is the location of dewatering water prior to treatment.

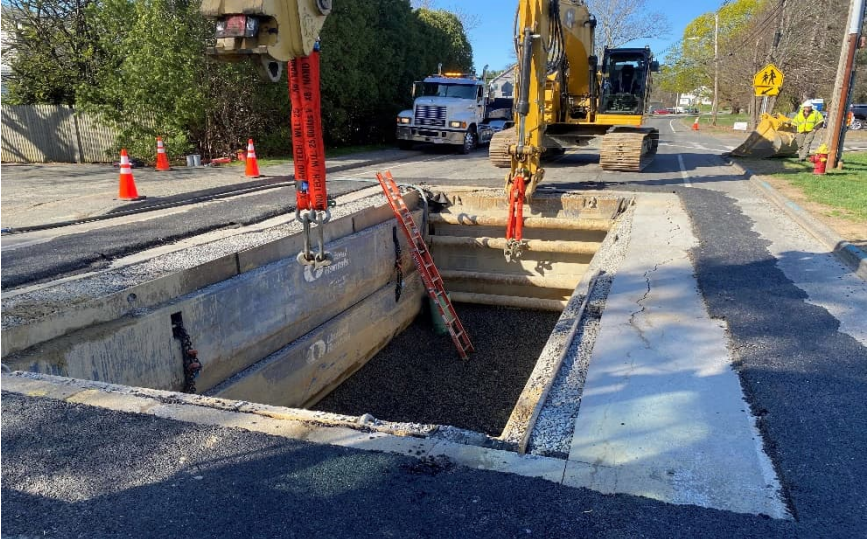
PHOTOGRAPHIC LOG	
Client Name: Eversource		Site Location: Sudbury to Hudson Transmission Reliability Project	Town: Hudson
Photo No.: 3	Date: 4/20/2023

Description: MH#3. View of dewatering operation, looking northward.
