Weekly Environmental Compliance Summary

Sudbury to Hudson Transmission Reliability Project (USEPA Tracking # MAR1003UW)

Week of: April 24 to April 28, 2023

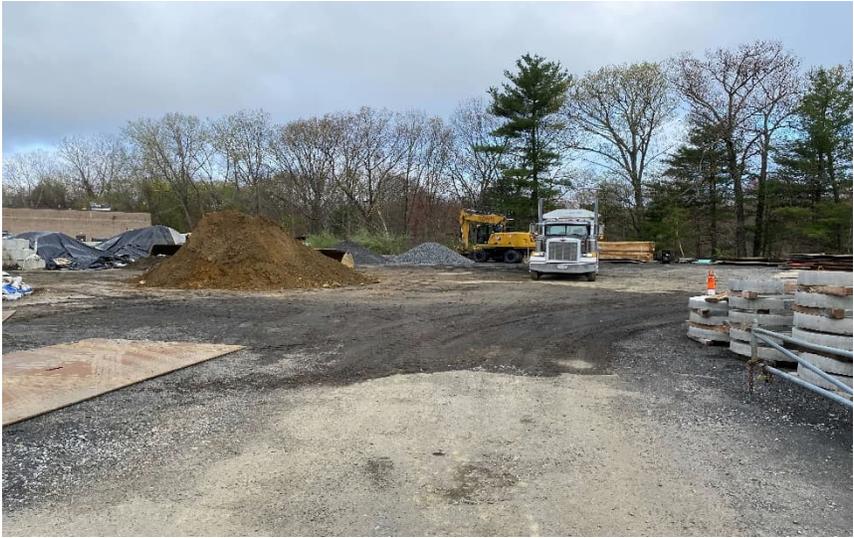
<p>PHOTOGRAPHIC LOG</p>	
<p>Client Name: Eversource</p>		<p>Site Location: Sudbury to Hudson Transmission Reliability Project</p>	<p>Town: Hudson</p>
<p>Photo No.: 1</p>	<p>Date: 4-25-23</p>

<p>Description: Laydown yard at Bonazzoli Avenue, looking westward.</p>

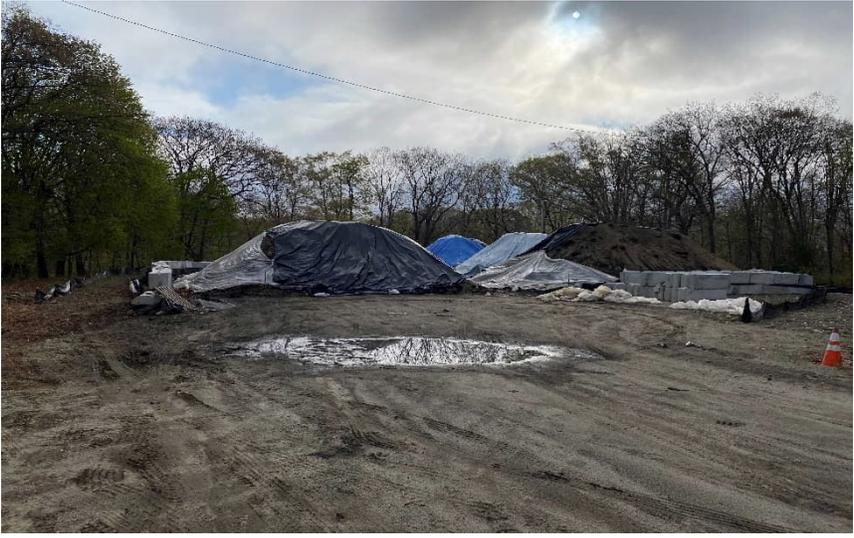
<p>PHOTOGRAPHIC LOG</p>	
<p>Client Name: Eversource</p>		<p>Site Location: Sudbury to Hudson Transmission Reliability Project</p>	<p>Town: Hudson</p>
<p>Photo No.: 2</p>	<p>Date: 4-25-23</p>

<p>Description: Laydown yard at Stowe Court, looking southward</p>

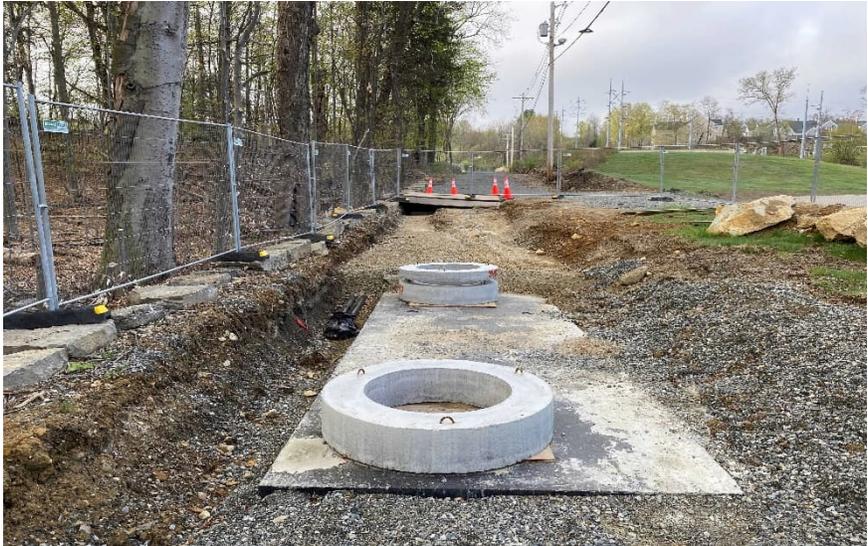
<p>PHOTOGRAPHIC LOG</p>	
<p>Client Name: Eversource</p>		<p>Site Location: Sudbury to Hudson Transmission Reliability Project</p>	<p>Town: Hudson</p>
<p>Photo No.: 3</p>	<p>Date: 4-25-23</p>

<p>Description: MH#1 area, off Forest Avenue, looking eastward.</p>

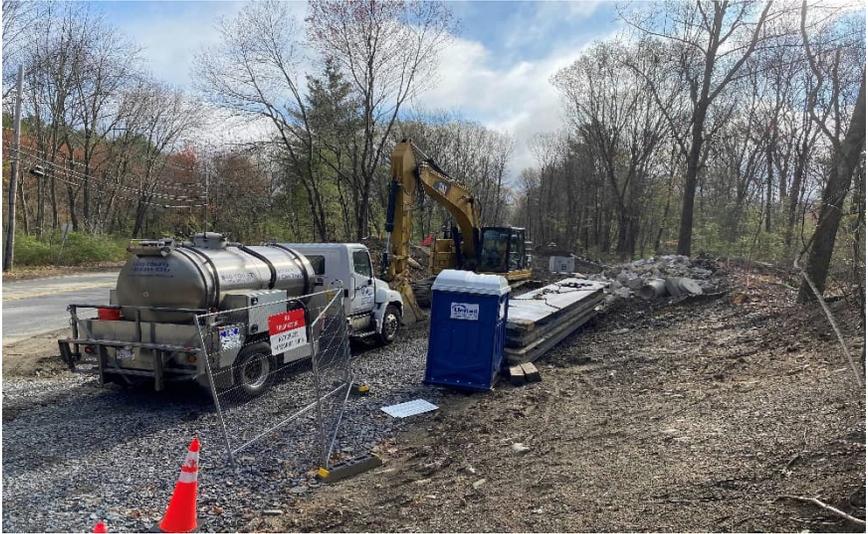
<p>PHOTOGRAPHIC LOG</p>	
<p>Client Name: Eversource</p>		<p>Site Location: Sudbury to Hudson Transmission Reliability Project</p>	<p>Town: Hudson</p>
<p>Photo No.: 4</p>	<p>Date: 4-25-23</p>

<p>Description: Bond working, off Wilkins, within segment 1, looking eastward.</p>

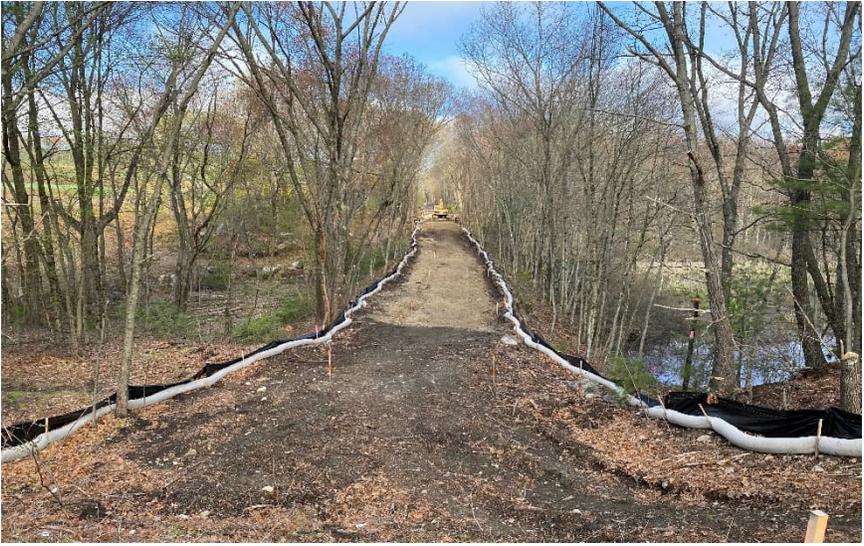
<p>PHOTOGRAPHIC LOG</p>	
<p>Client Name: Eversource</p>		<p>Site Location: Sudbury to Hudson Transmission Reliability Project</p>	<p>Town: Hudson</p>
<p>Photo No.: 5</p>	<p>Date: 4-25-23</p>

<p>Description: Right-of-way within segment 1, from Chestnut Street, looking westward.</p>

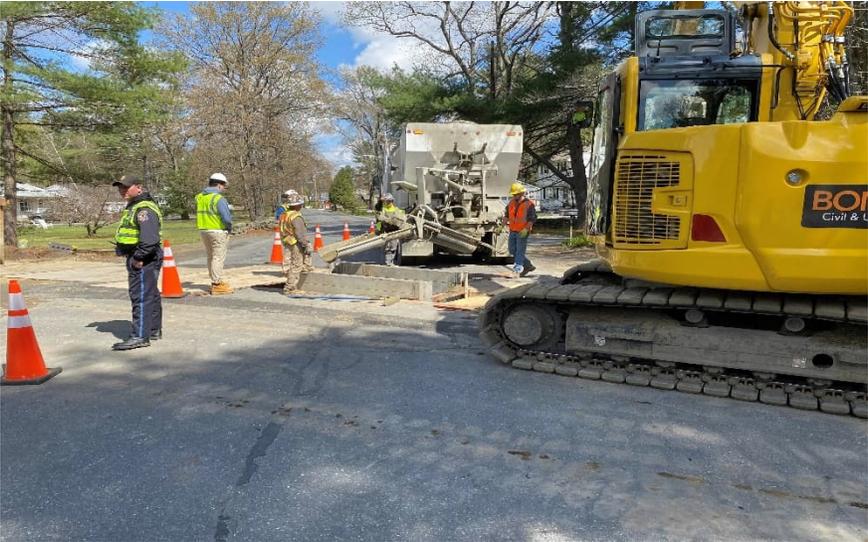
<p>PHOTOGRAPHIC LOG</p>	
<p>Client Name: Eversource</p>		<p>Site Location: Sudbury to Hudson Transmission Reliability Project</p>	<p>Town: Hudson</p>
<p>Photo No.: 7</p>	<p>Date: 4-25-23</p>

<p>Description:</p> <p>Bond conducting conduit work within Segment 5, at Parmenter Road, looking eastward.</p>

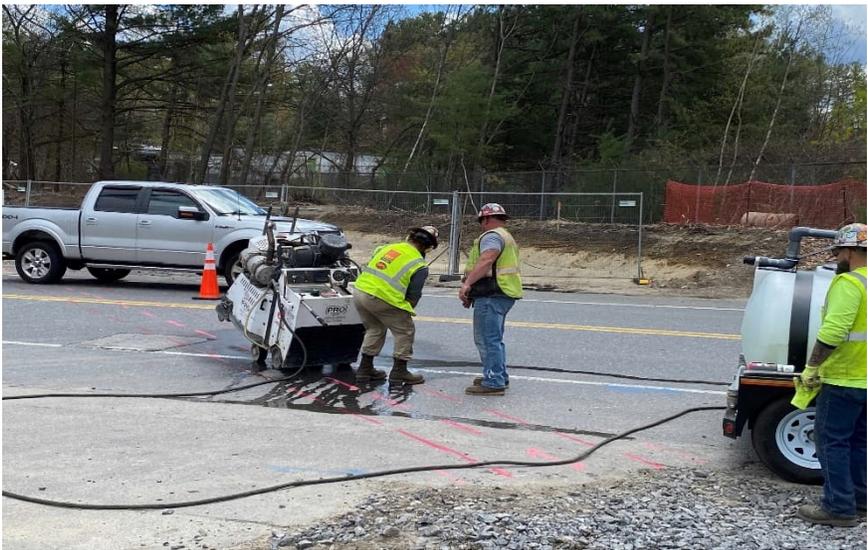
<p>PHOTOGRAPHIC LOG</p>	
<p>Client Name: Eversource</p>		<p>Site Location: Sudbury to Hudson Transmission Reliability Project</p>	<p>Town: Hudson</p>
<p>Photo No.: 8</p>	<p>Date: 4-25-23</p>

<p>Description:</p> <p>Bond conducting concrete cutting, within Main Street, looking eastward.</p>

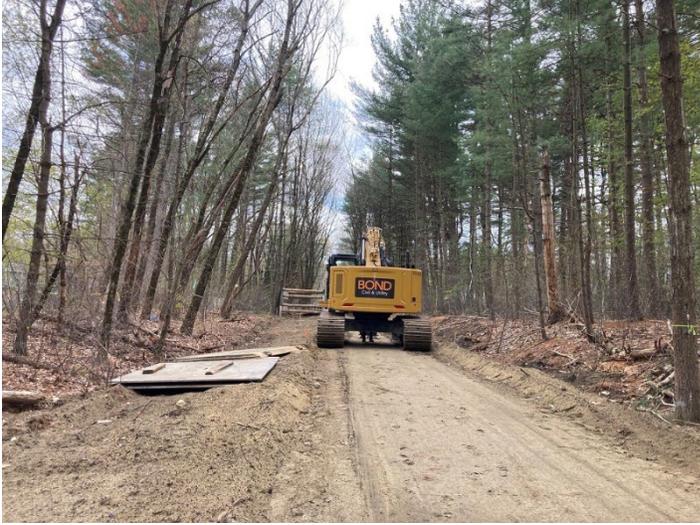
PHOTOGRAPHIC LOG	
Client Name: Eversource		Site Location: Sudbury to Hudson Transmission Reliability Project	Town: Sudbury
Photo No.: 1	Date: 4/25/2023

Description: View of Bond preparing for installation of MH #21 in segment 10. Facing east.

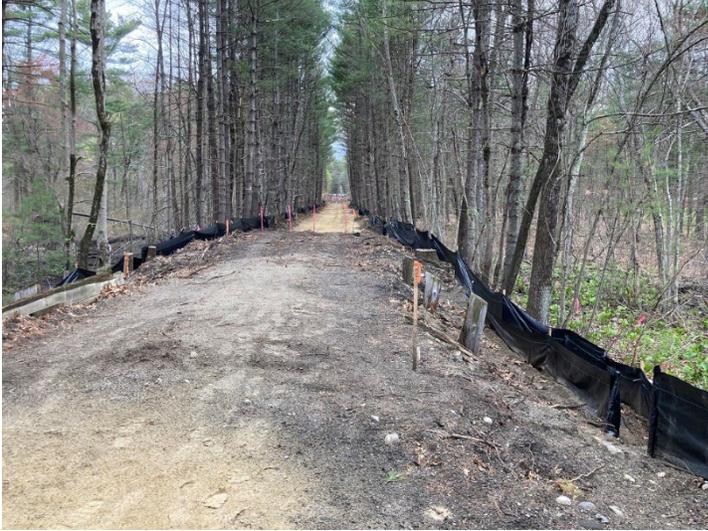
PHOTOGRAPHIC LOG	
Client Name: Eversource		Site Location: Sudbury to Hudson Transmission Reliability Project	Town: Sudbury
Photo No.: 3	Date: 4/25/2023

Description: View of Dudley Brook culvert area in segment 10. Facing west.

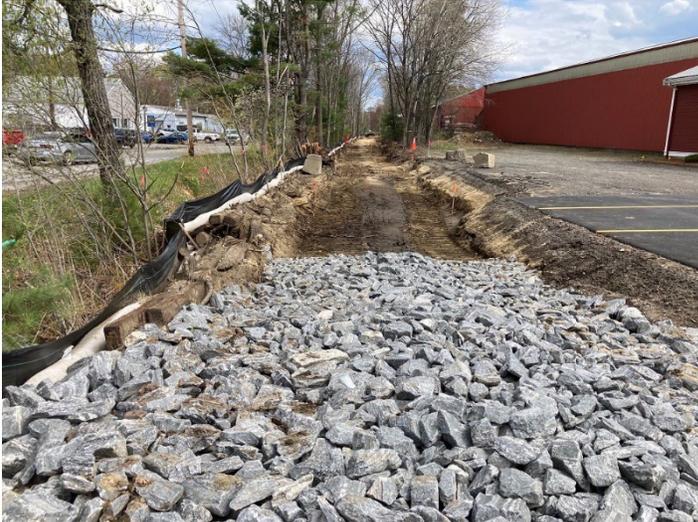
PHOTOGRAPHIC LOG	
Client Name: Eversource		Site Location: Sudbury to Hudson Transmission Reliability Project	Town: Sudbury
Photo No.: 4	Date: 4/25/2023

Description: View of segment 12 from construction entrance pad off Union Ave. Facing east.

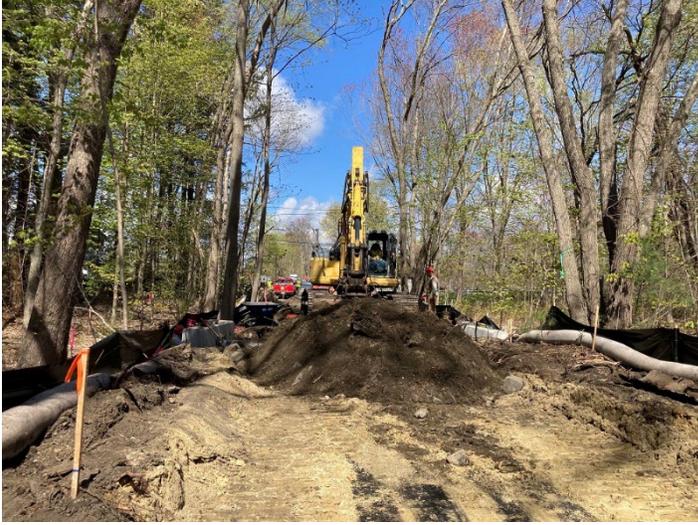
PHOTOGRAPHIC LOG	
Client Name: Eversource		Site Location: Sudbury to Hudson Transmission Reliability Project	Town: Sudbury
Photo No.: 5	Date: 4/25/2023

Description: View of ET&L installing ductile pipe drain in segment 13. Facing west.

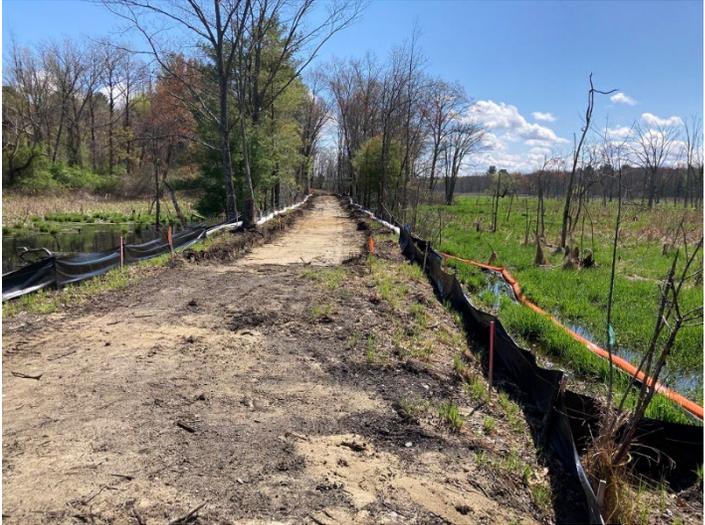
PHOTOGRAPHIC LOG	
Client Name: Eversource		Site Location: Sudbury to Hudson Transmission Reliability Project	Town: Sudbury
Photo No.: 6	Date: 4/25/2023

Description: View of segment 14 from bridge 127. Facing east.

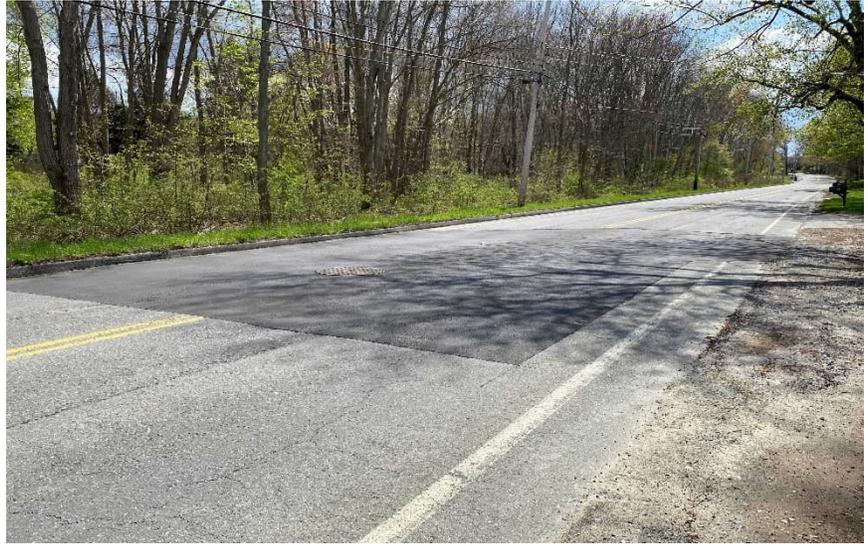
<p>PHOTOGRAPHIC LOG</p>	
<p>Client Name: Eversource</p>		<p>Site Location: Sudbury to Hudson Transmission Reliability Project</p>	<p>Town: Hudson</p>
<p>Photo No.: 2</p>	<p>Date: 4-26-23</p>

<p>Description:</p> <p>MH #4 within Forest Avenue, looking southward.</p>

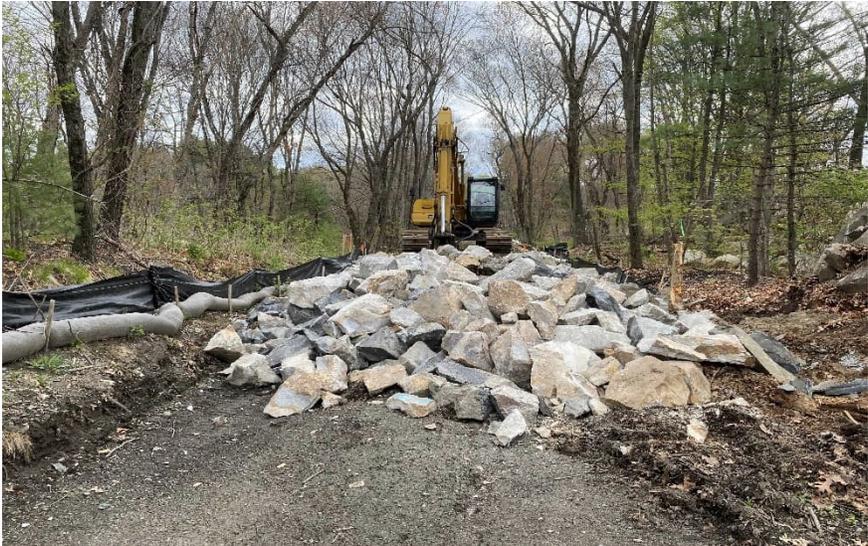
<p>PHOTOGRAPHIC LOG</p>	
<p>Client Name: Eversource</p>		<p>Site Location: Sudbury to Hudson Transmission Reliability Project</p>	<p>Town: Hudson</p>
<p>Photo No.: 3</p>	<p>Date: 4-26-23</p>

<p>Description:</p> <p>Site work (rock removal) within Segment 1, looking westward.</p>

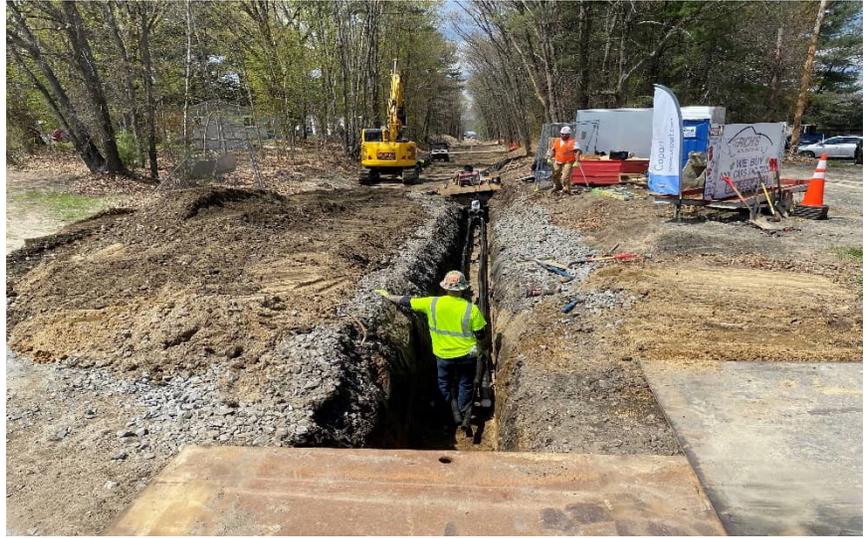
<p>PHOTOGRAPHIC LOG</p>	
<p>Client Name: Eversource</p>		<p>Site Location: Sudbury to Hudson Transmission Reliability Project</p>	<p>Town: Hudson</p>
<p>Photo No.: 4</p>	<p>Date: 4-26-23</p>

<p>Description:</p> <p>Bond conducting conduit work within Segment 4 at Main Street, looking westward.</p>

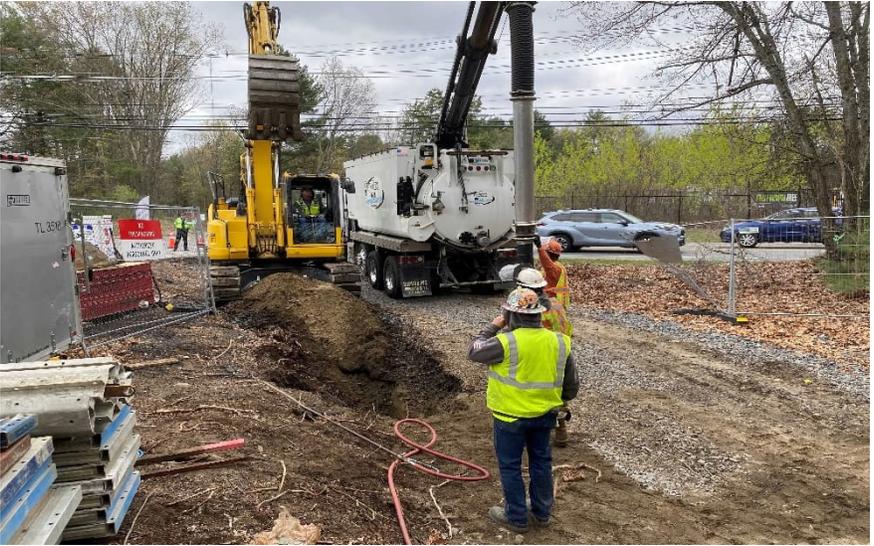
<p>PHOTOGRAPHIC LOG</p>	
<p>Client Name: Eversource</p>		<p>Site Location: Sudbury to Hudson Transmission Reliability Project</p>	<p>Town: Hudson</p>
<p>Photo No.: 5</p>	<p>Date: 4-26-23</p>

<p>Description:</p> <p>Bond conducting conduit work within Segment 3 at Main Street, looking eastward.</p>

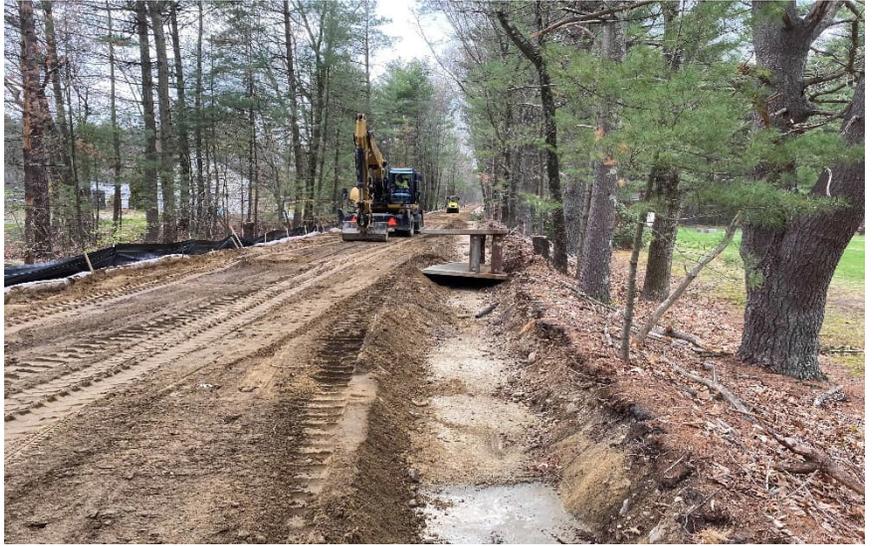
<p>PHOTOGRAPHIC LOG</p>	
<p>Client Name: Eversource</p>		<p>Site Location: Sudbury to Hudson Transmission Reliability Project</p>	<p>Town: Hudson</p>
<p>Photo No.: 6</p>	<p>Date: 4-26-23</p>

<p>Description:</p> <p>Site work (conduit work & spoil placement) within Segment 4, looking westward.</p>

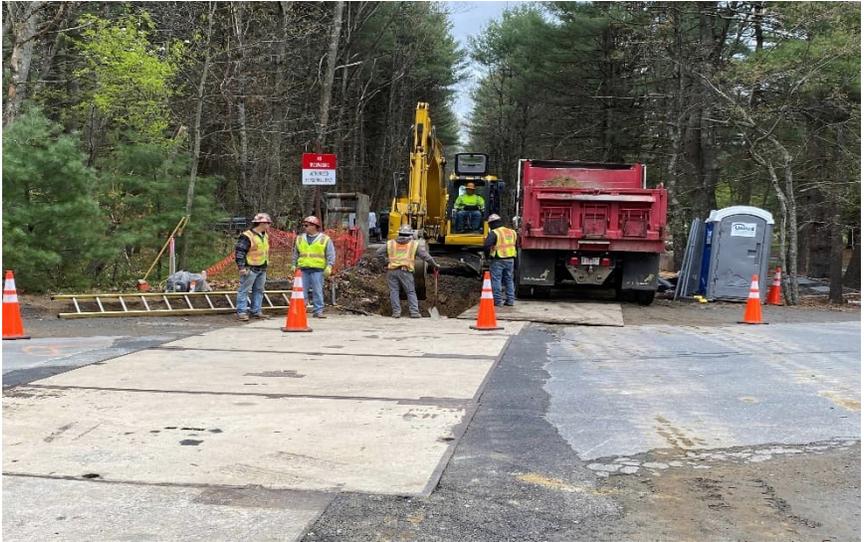
<p>PHOTOGRAPHIC LOG</p>	
<p>Client Name: Eversource</p>		<p>Site Location: Sudbury to Hudson Transmission Reliability Project</p>	<p>Town: Hudson</p>
<p>Photo No.: 7</p>	<p>Date: 4-26-23</p>

<p>Description:</p> <p>Bond conducting conduit work within Segment 5 at Parmenter Road, looking eastward.</p>

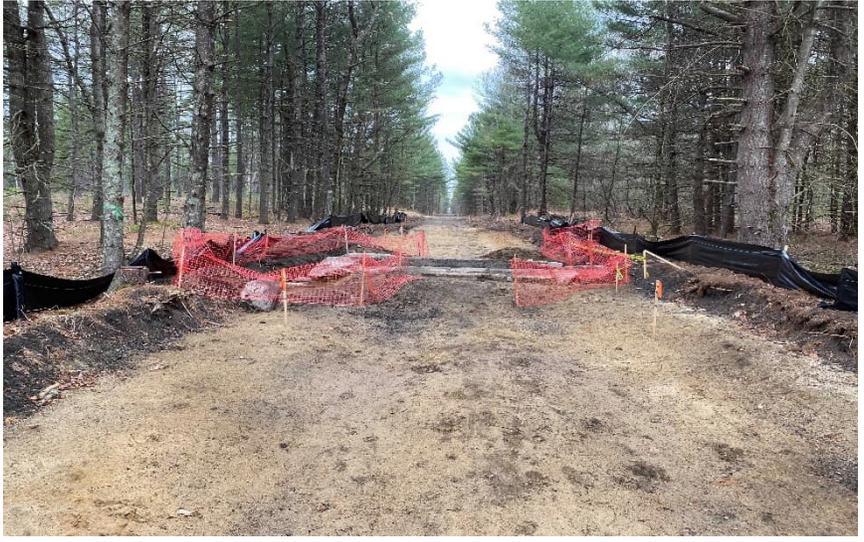
<p>PHOTOGRAPHIC LOG</p>	
<p>Client Name: Eversource</p>		<p>Site Location: Sudbury to Hudson Transmission Reliability Project</p>	<p>Town: Sudbury</p>
<p>Photo No.: 8</p>	<p>Date: 4-26-23</p>

<p>Description:</p> <p>Historic feature (cattle crossing) within Segment 7 near bridge 128, looking westward.</p>

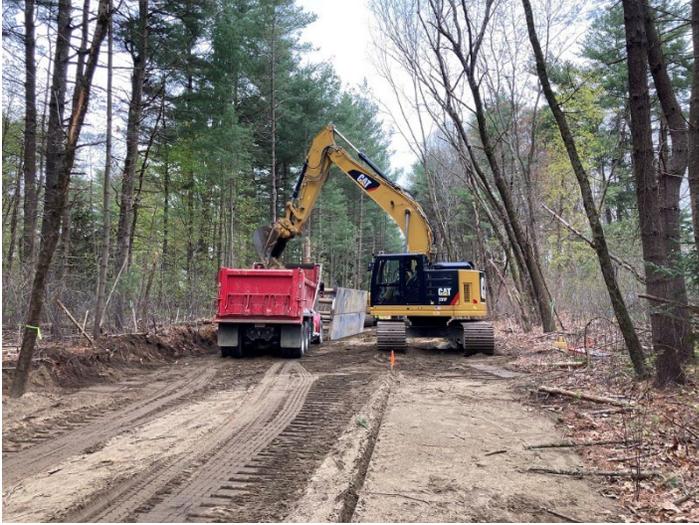
<p align="right">PHOTOGRAPHIC LOG</p>	
Client Name: Eversource		Site Location: Sudbury to Hudson Transmission Reliability Project	Town: Sudbury
Photo No.: 1	Date: 4/26/2023

Description: View of Bond excavating for installation of MH #21 in segment 10. Facing west.

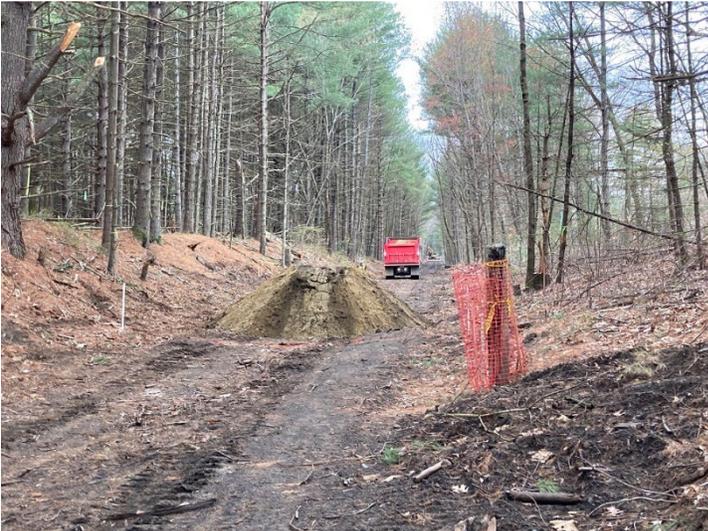
<p align="right">PHOTOGRAPHIC LOG</p>	
Client Name: Eversource		Site Location: Sudbury to Hudson Transmission Reliability Project	Town: Sudbury
Photo No.: 2	Date: 4/26/2023

Description: View of dump truck traveling in segment 11, escorted by biological monitor. Facing west.

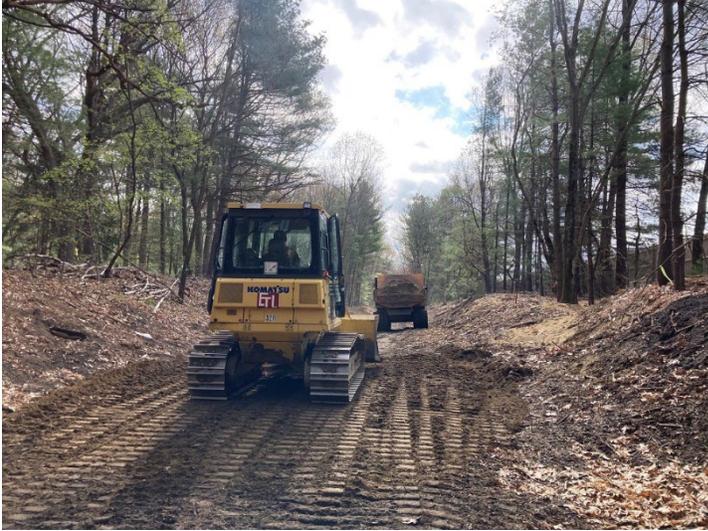
PHOTOGRAPHIC LOG	
Client Name: Eversource		Site Location: Sudbury to Hudson Transmission Reliability Project	Town: Sudbury
Photo No.: 3	Date: 4/26/2023

Description: View of ET&L performing cut & fill activities in segment 11. Facing west.

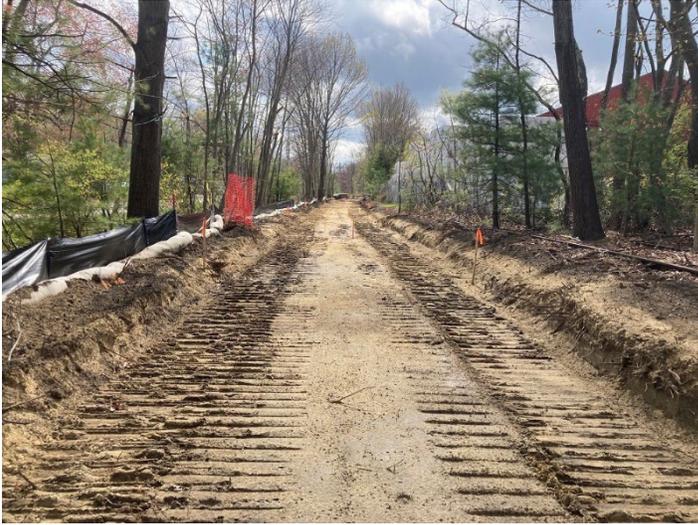
PHOTOGRAPHIC LOG	
Client Name: Eversource		Site Location: Sudbury to Hudson Transmission Reliability Project	Town: Sudbury
Photo No.: 4	Date: 4/26/2023

Description: View of segment 12. Facing east.

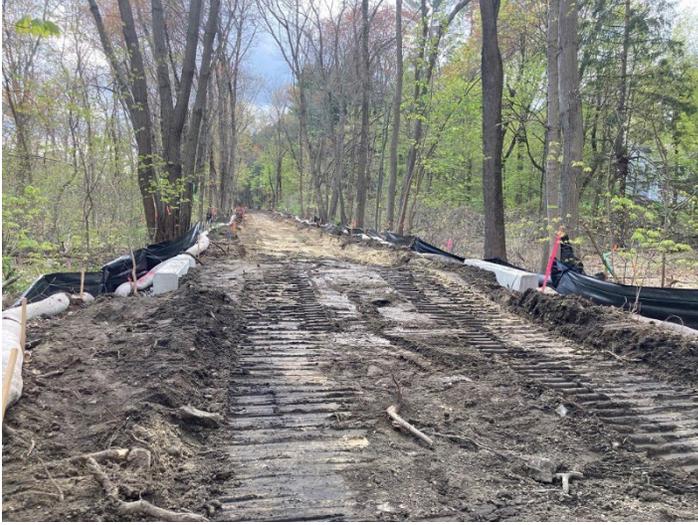
<p>PHOTOGRAPHIC LOG</p>	
<p>Client Name: Eversource</p>		<p>Site Location: Sudbury to Hudson Transmission Reliability Project</p>	<p>Town: Sudbury</p>
<p>Photo No.: 5</p>	<p>Date: 4/26/2023</p>

<p>Description: View of ductile pipe drain installed in segment 13. Facing east.</p>

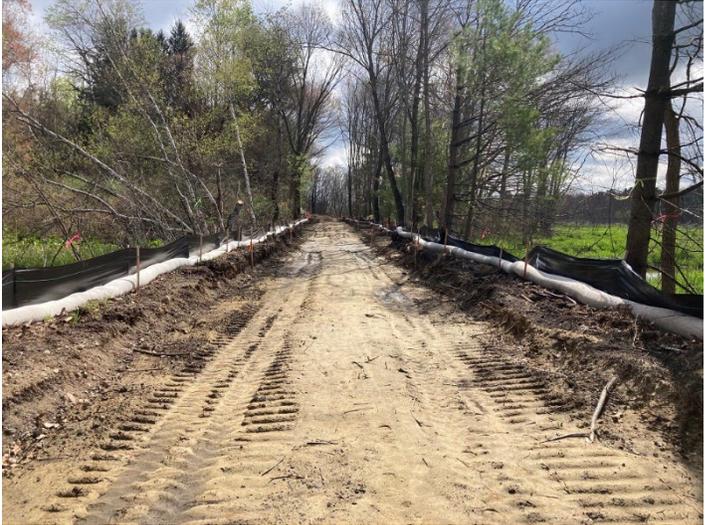
<p>PHOTOGRAPHIC LOG</p>	
<p>Client Name: Eversource</p>		<p>Site Location: Sudbury to Hudson Transmission Reliability Project</p>	<p>Town: Sudbury</p>
<p>Photo No.: 6</p>	<p>Date: 4/26/2023</p>

<p>Description: View of west end of segment 14. Facing east.</p>

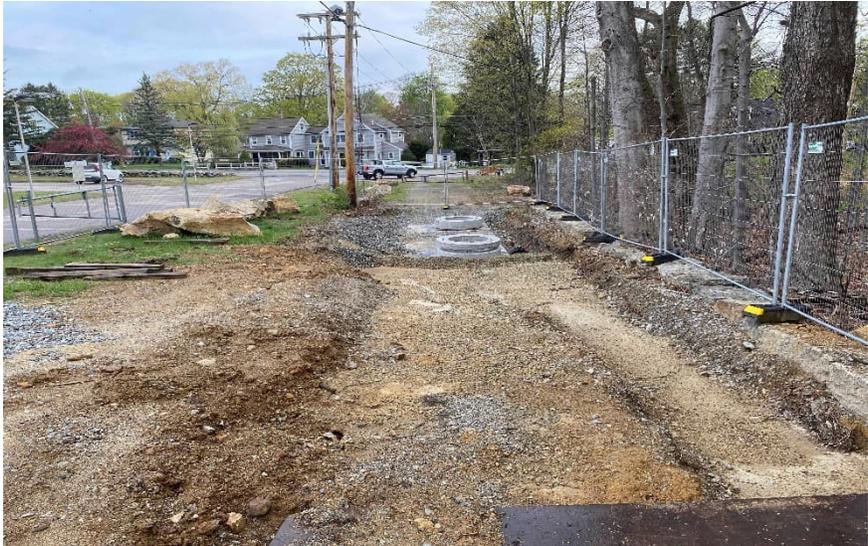
<p>PHOTOGRAPHIC LOG</p>	
<p>Client Name: Eversource</p>		<p>Site Location: Sudbury to Hudson Transmission Reliability Project</p>	<p>Town: Hudson</p>
<p>Photo No.: 1</p>	<p>Date: 4-27-23</p>

<p>Description:</p> <p>MH#1 area, off Forest Avenue, looking westward.</p>

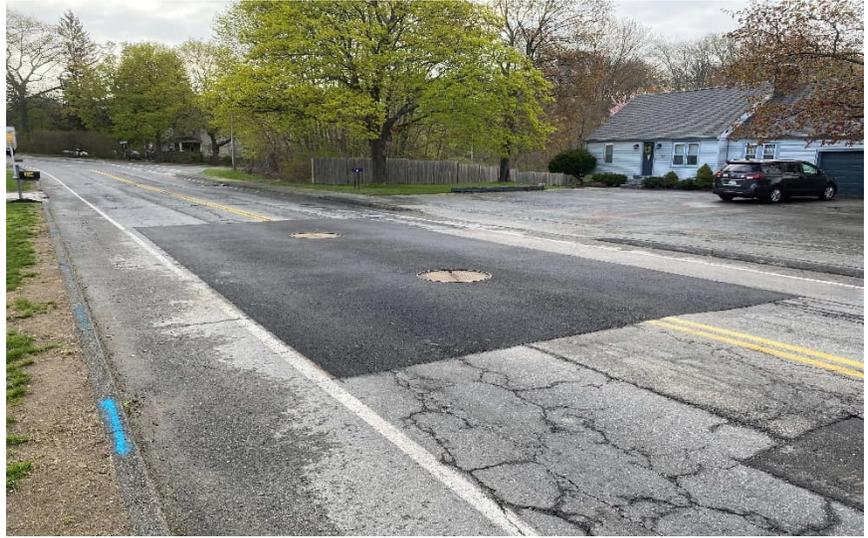
<p>PHOTOGRAPHIC LOG</p>	
<p>Client Name: Eversource</p>		<p>Site Location: Sudbury to Hudson Transmission Reliability Project</p>	<p>Town: Hudson</p>
<p>Photo No.: 2</p>	<p>Date: 4-27-23</p>

<p>Description:</p> <p>MH #3 within Forest Avenue, looking northward</p>

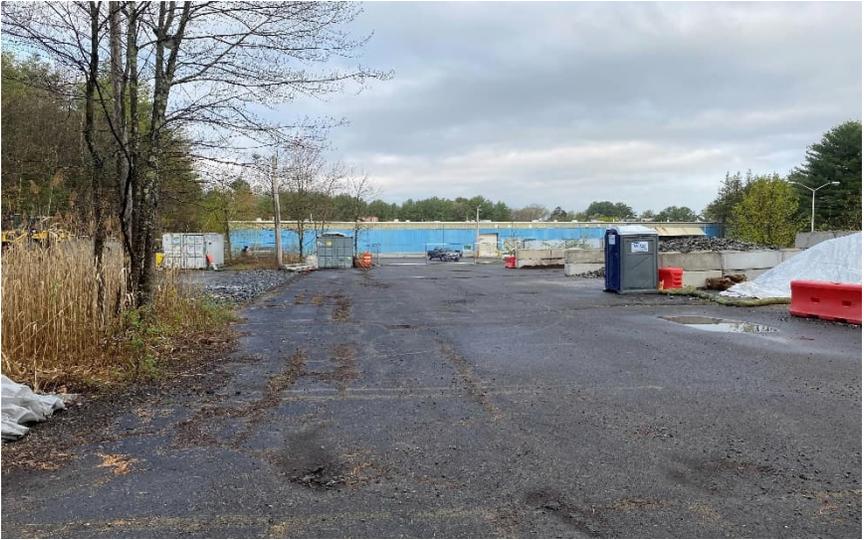
<p>PHOTOGRAPHIC LOG</p>	
<p>Client Name: Eversource</p>		<p>Site Location: Sudbury to Hudson Transmission Reliability Project</p>	<p>Town: Hudson</p>
<p>Photo No.: 3</p>	<p>Date: 4-27-23</p>

<p>Description: Laydown yard at 555 Main Street, looking northward.</p>

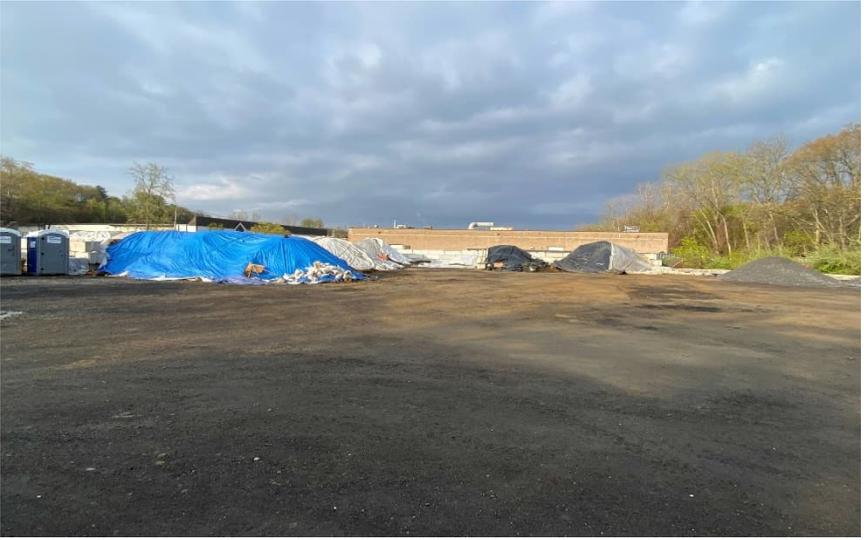
<p>PHOTOGRAPHIC LOG</p>	
<p>Client Name: Eversource</p>		<p>Site Location: Sudbury to Hudson Transmission Reliability Project</p>	<p>Town: Hudson</p>
<p>Photo No.: 4</p>	<p>Date: 4-27-23</p>

<p>Description: Laydown yard at 17 Bonazzoli Avenue, looking northward.</p>

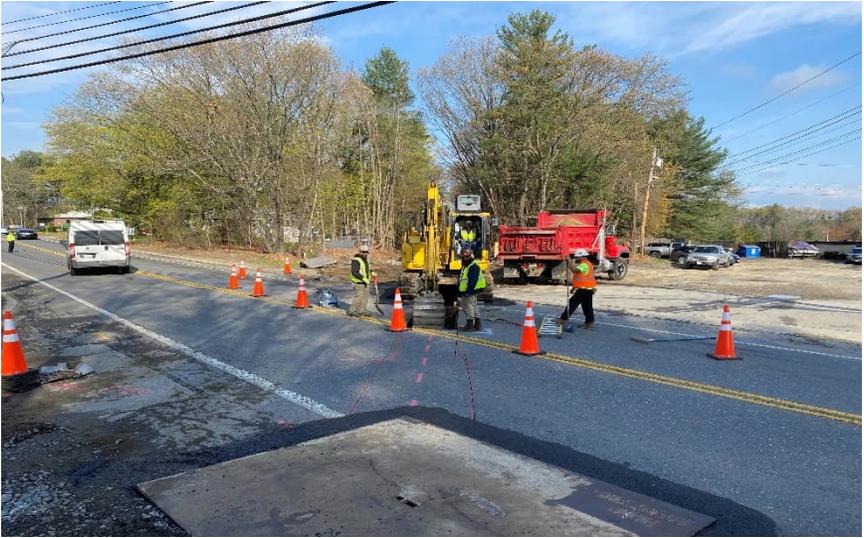
<p>PHOTOGRAPHIC LOG</p>	
<p>Client Name: Eversource</p>		<p>Site Location: Sudbury to Hudson Transmission Reliability Project</p>	<p>Town: Hudson</p>
<p>Photo No.: 5</p>	<p>Date: 4-27-23</p>

<p>Description:</p> <p>Bond conducting conduit work within Segment 3, at Main Street, looking westward.</p>

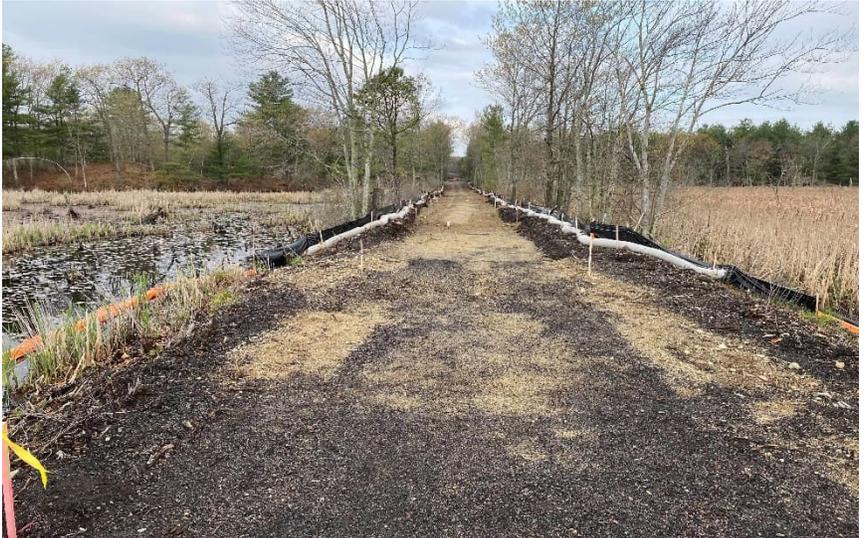
<p>PHOTOGRAPHIC LOG</p>	
<p>Client Name: Eversource</p>		<p>Site Location: Sudbury to Hudson Transmission Reliability Project</p>	<p>Town: Hudson</p>
<p>Photo No.: 6</p>	<p>Date: 4-27-23</p>

<p>Description:</p> <p>Right-of-way (existing erosion control) from Bridge 130 (segment 2), looking westward.</p>

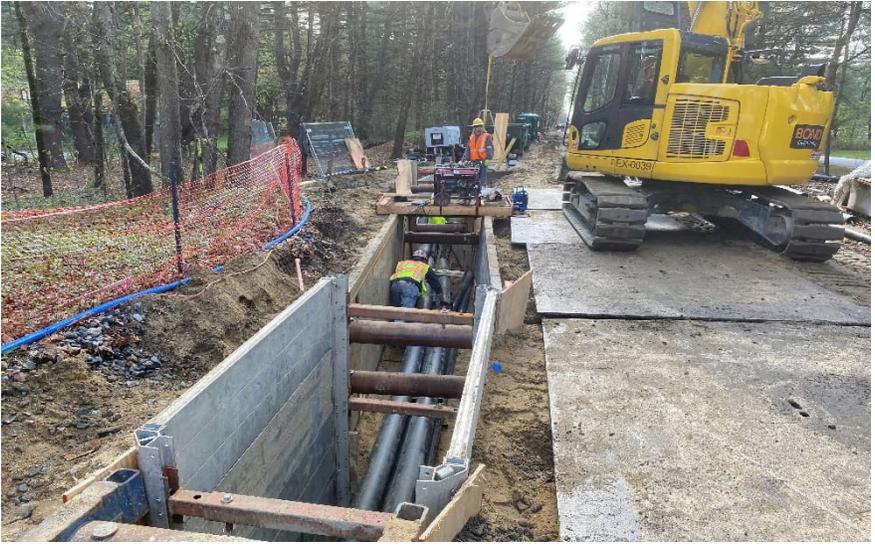
<p>PHOTOGRAPHIC LOG</p>	
<p>Client Name: Eversource</p>		<p>Site Location: Sudbury to Hudson Transmission Reliability Project</p>	<p>Town: Hudson</p>
<p>Photo No.: 7</p>	<p>Date: 4-27-23</p>

<p>Description: Bond conducting conduit work within Segment 5, at Parmenter Road, looking eastward.</p>

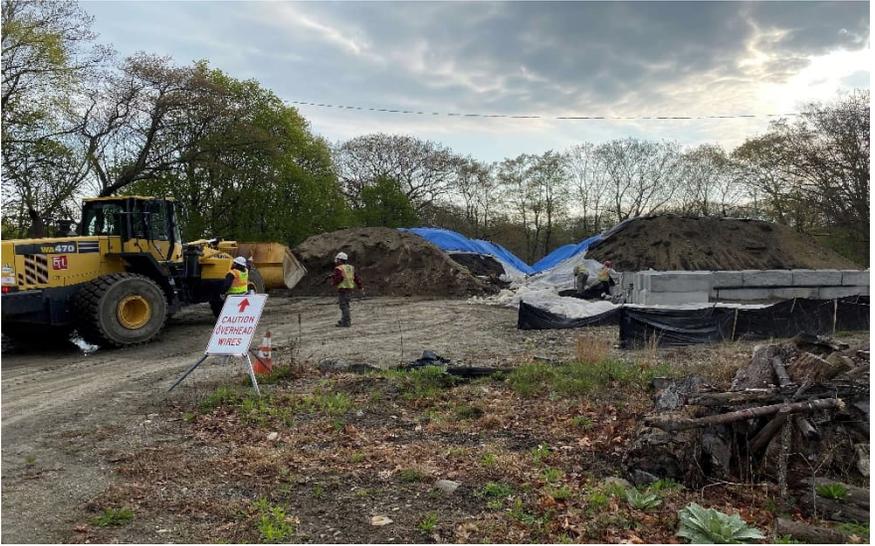
<p>PHOTOGRAPHIC LOG</p>	
<p>Client Name: Eversource</p>		<p>Site Location: Sudbury to Hudson Transmission Reliability Project</p>	<p>Town: Hudson</p>
<p>Photo No.: 8</p>	<p>Date: 4-27-23</p>

<p>Description: Laydown yard at 25 Stowe Court, out loading of stockpiled spoils, looking northward.</p>

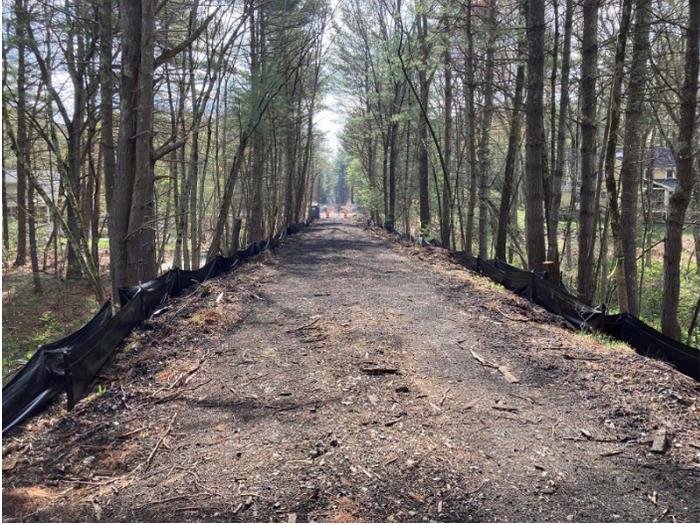
PHOTOGRAPHIC LOG	
Client Name: Eversource		Site Location: Sudbury to Hudson Transmission Reliability Project	Town: Sudbury
Photo No.: 1	Date: 4/27/2023

Description: View of east end of segment 9. Facing east.

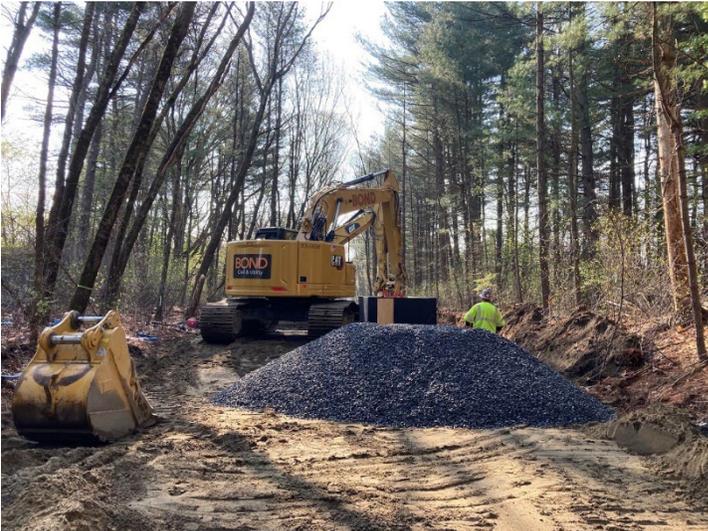
PHOTOGRAPHIC LOG	
Client Name: Eversource		Site Location: Sudbury to Hudson Transmission Reliability Project	Town: Sudbury
Photo No.: 2	Date: 4/27/2023

Description: View of Bond installing MH #21 in segment 10. Facing east.

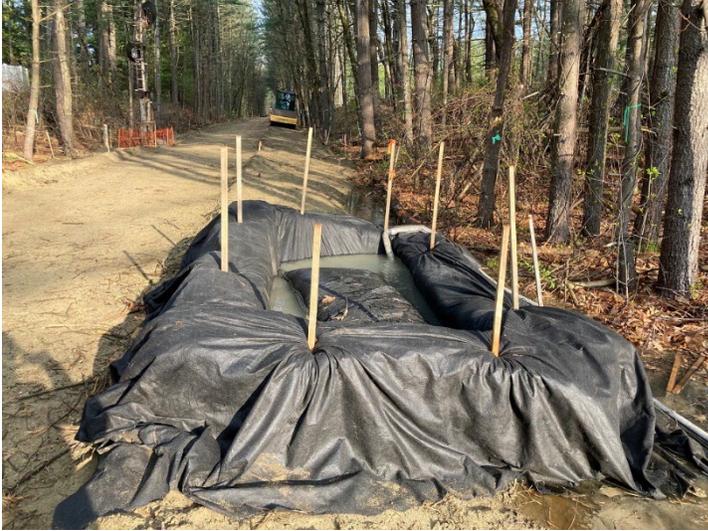
PHOTOGRAPHIC LOG	
Client Name: Eversource		Site Location: Sudbury to Hudson Transmission Reliability Project	Town: Sudbury
Photo No.: 3	Date: 4/27/2023

Description: View of dewatering operation at MH #21 in segment 10. See additional dewatering inspection report. Facing west.

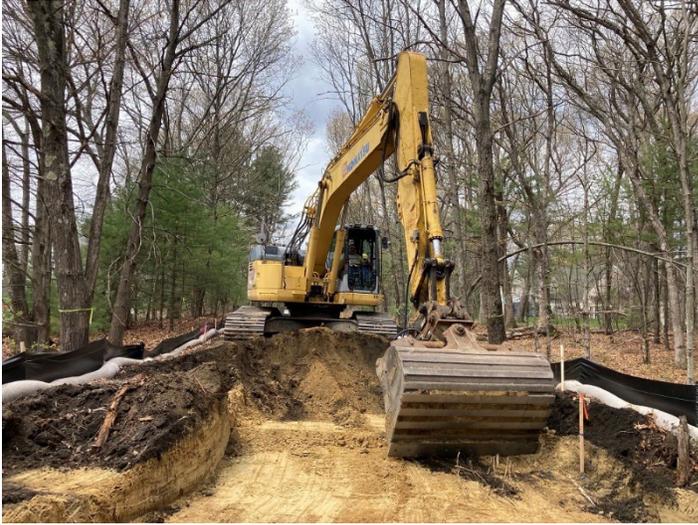
PHOTOGRAPHIC LOG	
Client Name: Eversource		Site Location: Sudbury to Hudson Transmission Reliability Project	Town: Sudbury
Photo No.: 4	Date: 4/27/2023

Description: View of ET&L performing cut & fill activities in segment 11. Facing west.

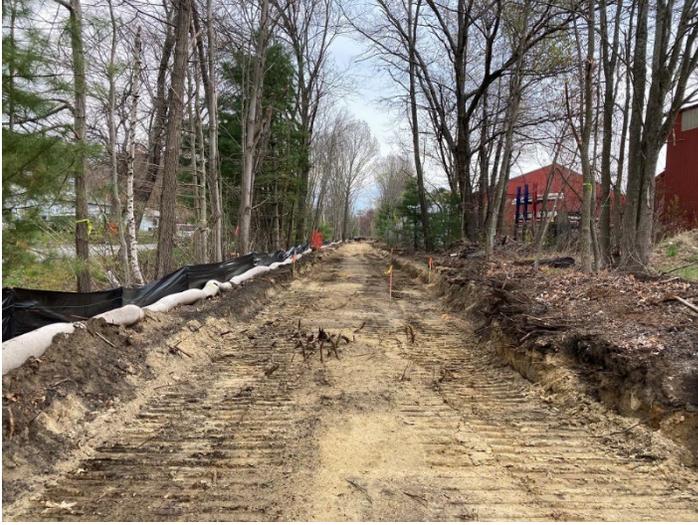
PHOTOGRAPHIC LOG	
Client Name: Eversource		Site Location: Sudbury to Hudson Transmission Reliability Project	
Town: Sudbury			
Photo No.: 5	Date: 4/27/2023

Description: View of segment 12. Facing east.

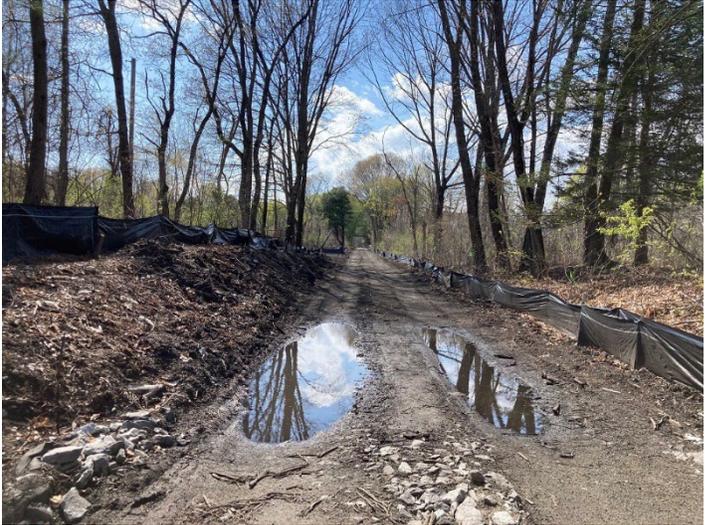
PHOTOGRAPHIC LOG	
Client Name: Eversource		Site Location: Sudbury to Hudson Transmission Reliability Project	
Town: Sudbury			
Photo No.: 6	Date: 4/27/2023

Description: View of east end of segment 14. Facing west.

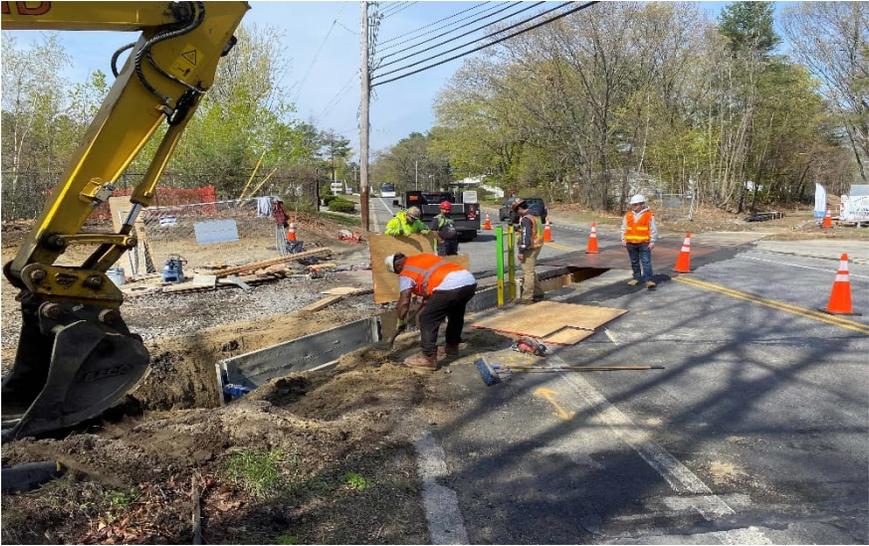
<p>PHOTOGRAPHIC LOG</p>	
<p>Client Name: Eversource</p>		<p>Site Location: Sudbury to Hudson Transmission Reliability Project</p>	<p>Town: Hudson</p>
<p>Photo No.: 1</p>	<p>Date: 4-28-23</p>

<p>Description:</p> <p>Conduit work, across Main Street, looking westward.</p>

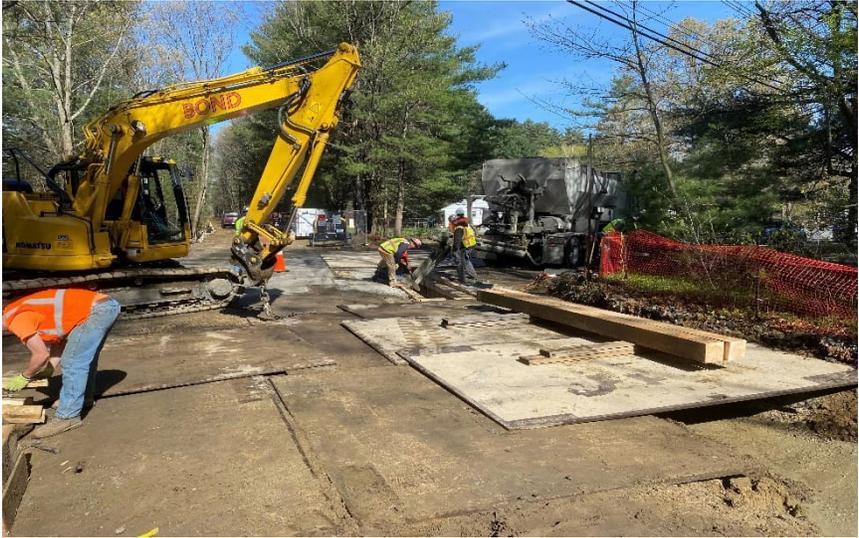
<p>PHOTOGRAPHIC LOG</p>	
<p>Client Name: Eversource</p>		<p>Site Location: Sudbury to Hudson Transmission Reliability Project</p>	<p>Town: Hudson</p>
<p>Photo No.: 2</p>	<p>Date: 4-28-23</p>

<p>Description:</p> <p>Conduit work, within segment 5, looking westward.</p>

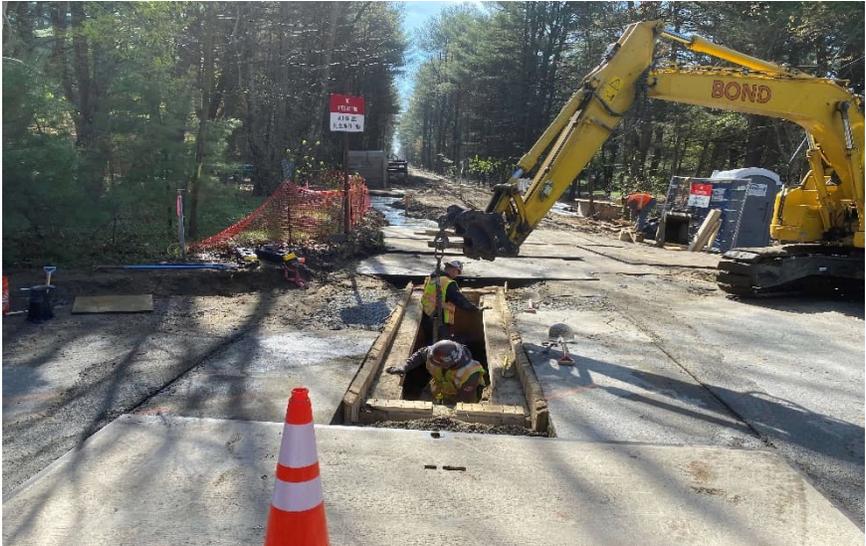
<p>PHOTOGRAPHIC LOG</p>	
<p>Client Name: Eversource</p>		<p>Site Location: Sudbury to Hudson Transmission Reliability Project</p>	<p>Town: Hudson</p>
<p>Photo No.: 3</p>	<p>Date: 4-28-23</p>

<p>Description:</p> <p>Conduit work, within Parmenter Road, looking eastward.</p>

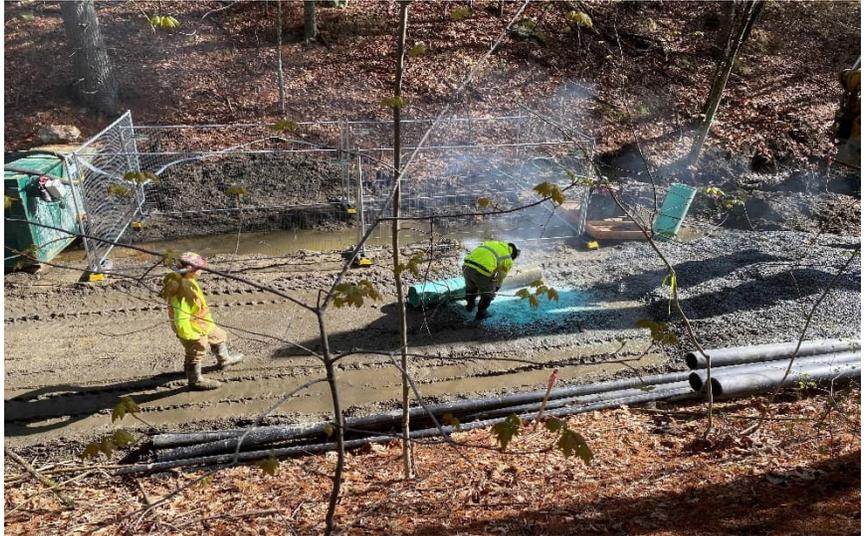
<p>PHOTOGRAPHIC LOG</p>	
<p>Client Name: Eversource</p>		<p>Site Location: Sudbury to Hudson Transmission Reliability Project</p>	<p>Town: Hudson</p>
<p>Photo No.: 4</p>	<p>Date: 4-28-23</p>

<p>Description:</p> <p>Bond setting sumps to help dewater segment 5, looking eastward.</p>

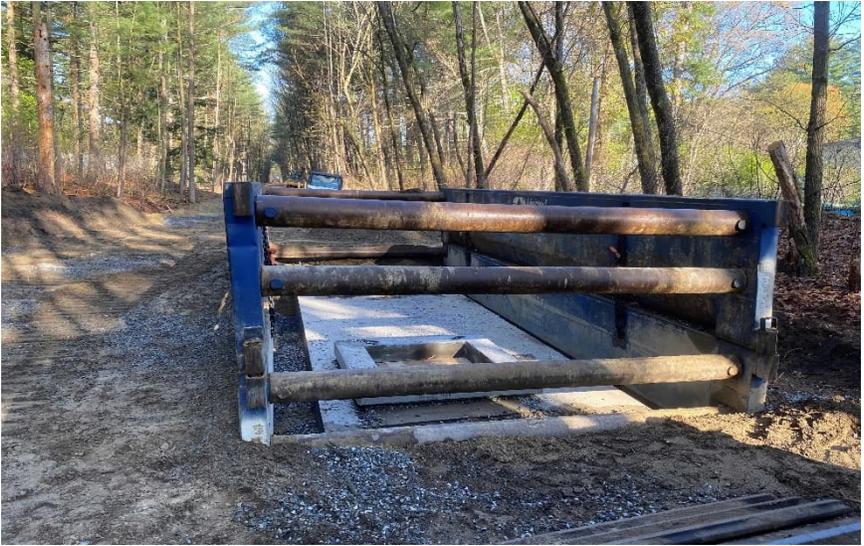
<p>PHOTOGRAPHIC LOG</p>	
<p>Client Name: Eversource</p>		<p>Site Location: Sudbury to Hudson Transmission Reliability Project</p>	<p>Town: Sudbury</p>
<p>Photo No.: 5</p>	<p>Date: 4-28-23</p>

<p>Description:</p> <p>Manhole #21, within segment 10, looking westward.</p>

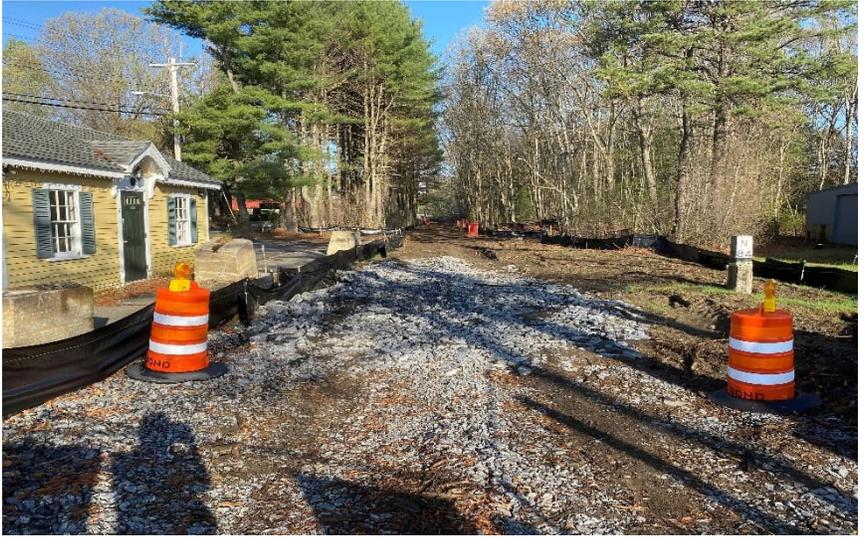
<p>PHOTOGRAPHIC LOG</p>	
<p>Client Name: Eversource</p>		<p>Site Location: Sudbury to Hudson Transmission Reliability Project</p>	<p>Town: Sudbury</p>
<p>Photo No.: 6</p>	<p>Date: 4-28-23</p>

<p>Description:</p> <p>Right-of-way within segment 11, existing erosion control, looking westward.</p>
