Weekly Environmental Compliance Summary

Sudbury to Hudson Transmission Reliability Project (USEPA Tracking # MAR1003UW)

Week of: April 24 to April 28, 2023

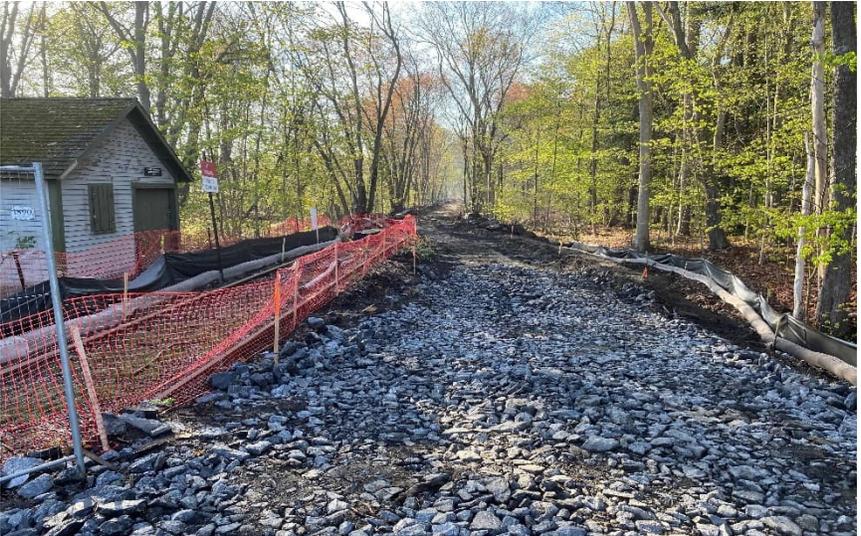
<p>PHOTOGRAPHIC LOG</p>	
<p>Client Name: Eversource</p>		<p>Site Location: Sudbury to Hudson Transmission Reliability Project</p>	<p>Town: Sudbury</p>
<p>Photo No.: 7</p>	<p>Date: 4-28-23</p>

<p>Description:</p> <p>Right-of-way within segment 13, existing erosion control, looking eastward.</p>

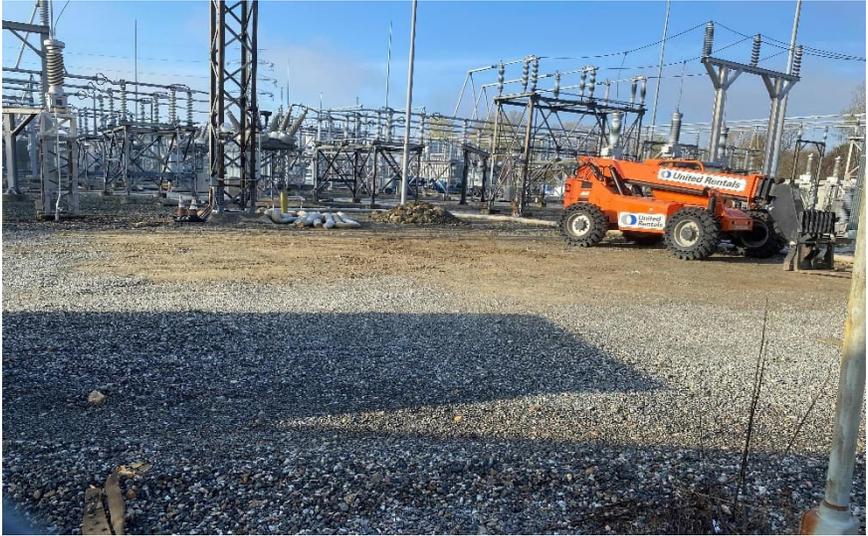
<p>PHOTOGRAPHIC LOG</p>	
<p>Client Name: Eversource</p>		<p>Site Location: Sudbury to Hudson Transmission Reliability Project</p>	<p>Town: Sudbury</p>
<p>Photo No.: 8</p>	<p>Date: 4-28-23</p>

<p>Description:</p> <p>Sudbury substation, looking westward.</p>

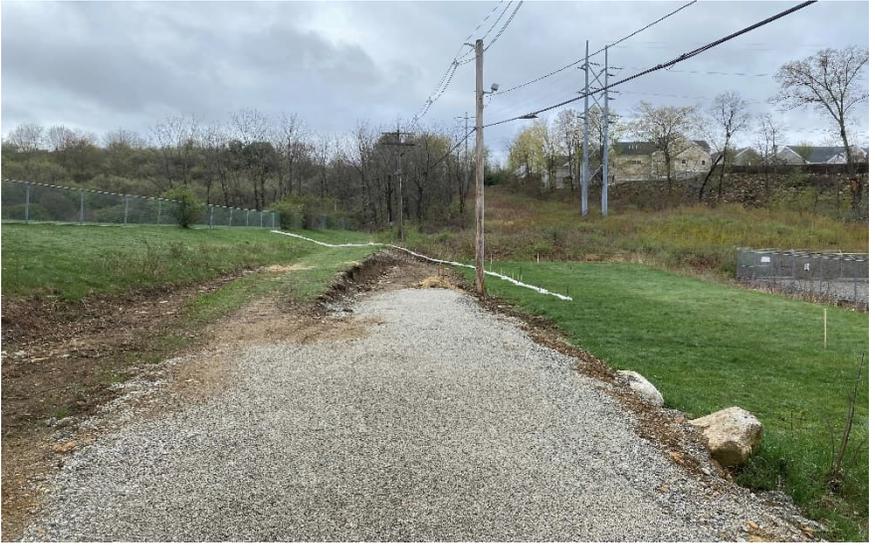
PHOTOGRAPHIC LOG	
Client Name: Eversource		Site Location: Sudbury to Hudson Transmission Reliability Project	Town: Hudson
Photo No.: 1	Date: 4-24-23

Description: Compost filter tubes at MH#1 area at Hudson Power & Light facility off Forest Avenue, looking eastward.

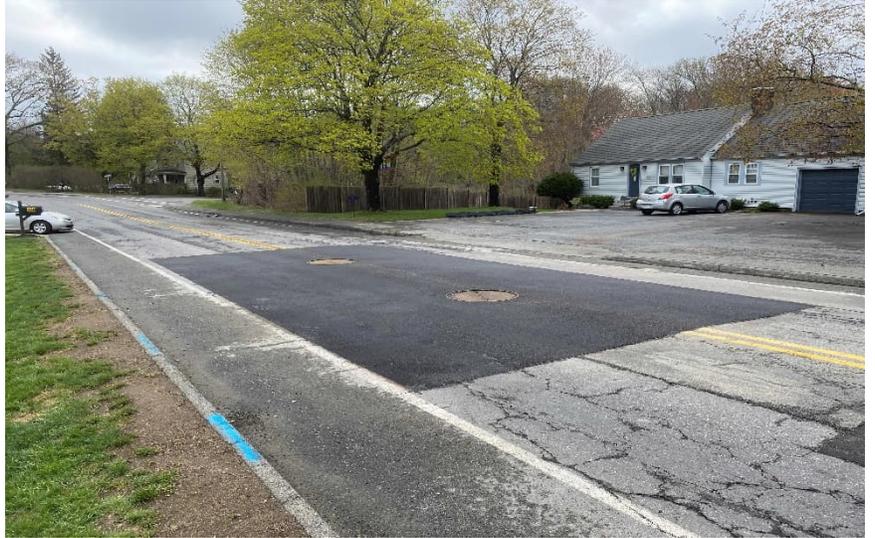
PHOTOGRAPHIC LOG	
Client Name: Eversource		Site Location: Sudbury to Hudson Transmission Reliability Project	Town: Hudson
Photo No.: 2	Date: 4-24-23

Description: MH#3 area/newly installed within Forest Avenue, looking northward.

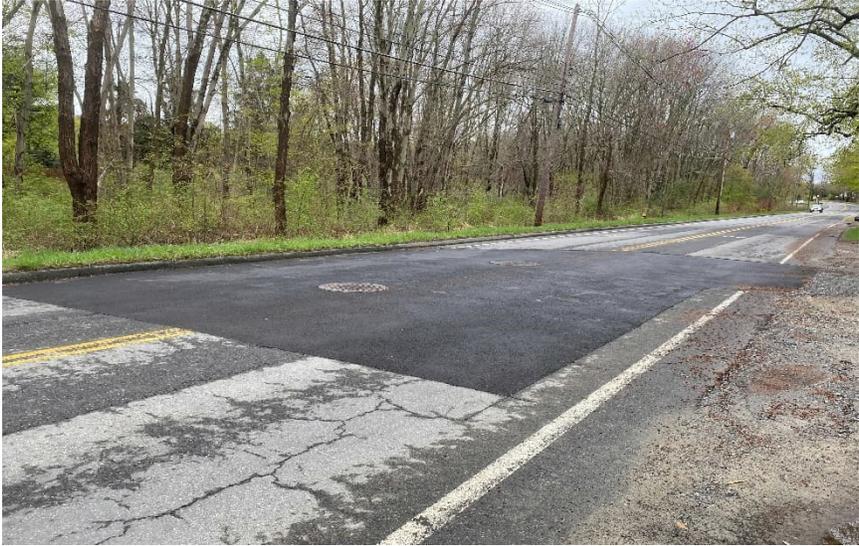
PHOTOGRAPHIC LOG	
Client Name: Eversource		Site Location: Sudbury to Hudson Transmission Reliability Project	Town: Hudson
Photo No.: 3	Date: 4-24-23

Description: MH#4 area/newly installed within Forest Avenue, looking southward.

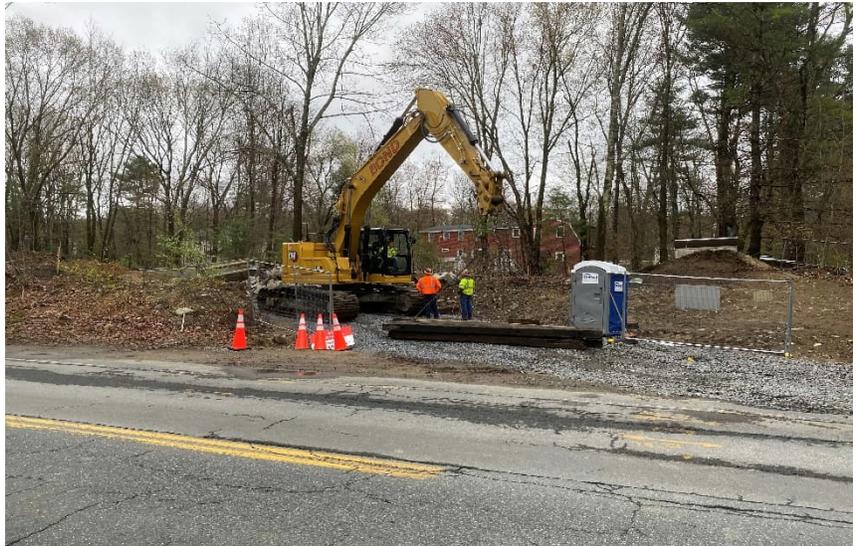
PHOTOGRAPHIC LOG	
Client Name: Eversource		Site Location: Sudbury to Hudson Transmission Reliability Project	Town: Hudson
Photo No.: 4	Date: 4-24-23

Description: Bond conducting site work, within Segment 1, off Wilkins Avenue, looking southward.

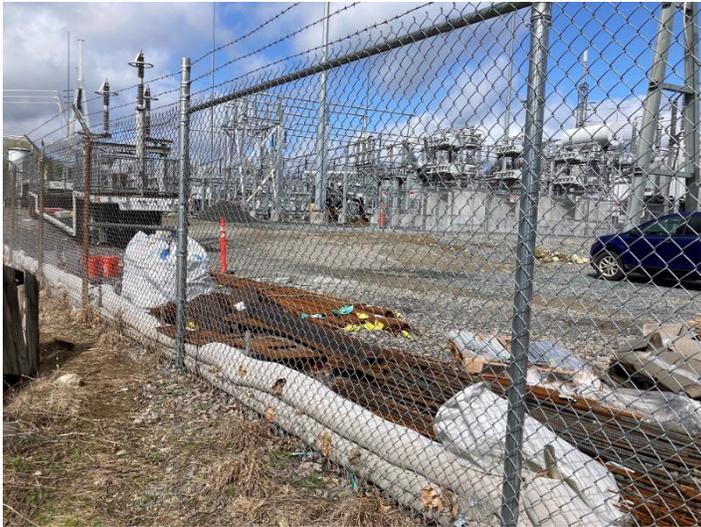
PHOTOGRAPHIC LOG	
Client Name: Eversource		Site Location: Sudbury to Hudson Transmission Reliability Project	Town: Sudbury
Photo No.: 2	Date: 4-24-2023

Description: View of active work at Sudbury Substation. Facing northwest.

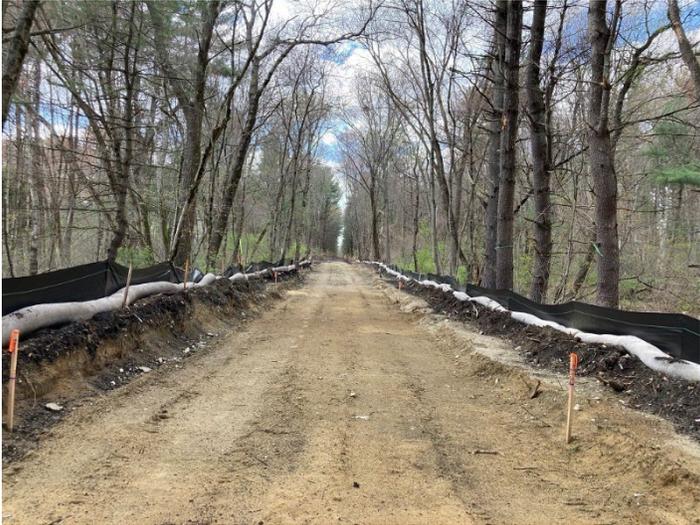
PHOTOGRAPHIC LOG	
Client Name: Eversource		Site Location: Sudbury to Hudson Transmission Reliability Project	Town: Sudbury
Photo No.: 3	Date: 4-24-2023

Description: View of Type A E&S controls in segment 9. Facing west.

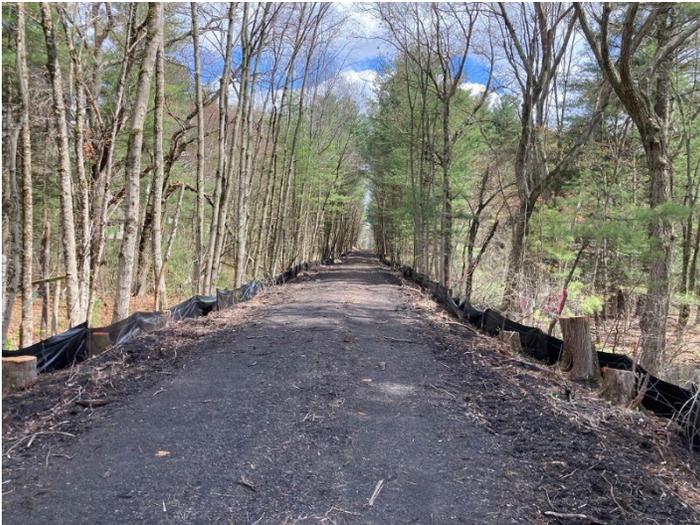
Epsilon ASSOCIATES INC.		PHOTOGRAPHIC LOG	
Client Name: Eversource		Site Location: Sudbury to Hudson Transmission Reliability Project	Town: Sudbury
Photo No.: 5	Date: 4-24-2023

Description: View of syncopated silt fence in segment 11. Facing east.

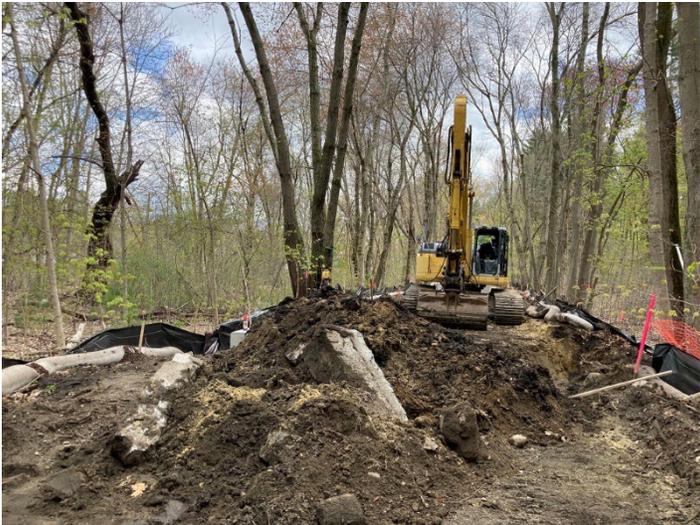
Epsilon ASSOCIATES INC.		PHOTOGRAPHIC LOG	
Client Name: Eversource		Site Location: Sudbury to Hudson Transmission Reliability Project	Town: Sudbury
Photo No.: 7	Date: 4-24-2023

Description: View of ET&L installing headwall #12 in segment 13. Facing east.

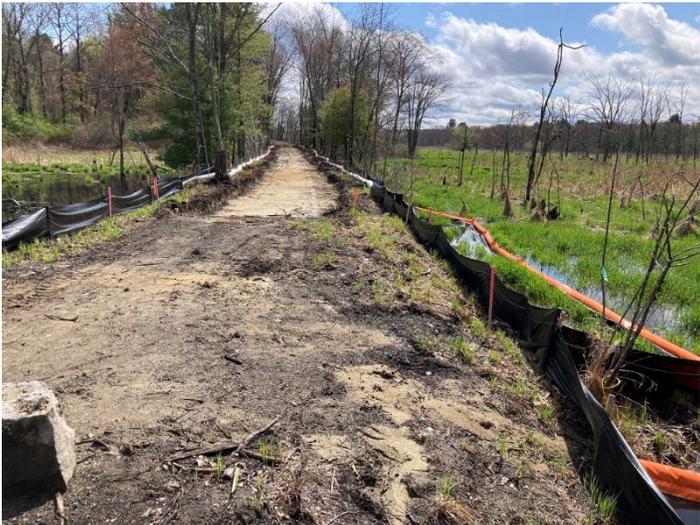
Epsilon ASSOCIATES INC.		PHOTOGRAPHIC LOG	
Client Name: Eversource		Site Location: Sudbury to Hudson Transmission Reliability Project	Town: Sudbury
Photo No.: 8	Date: 4-24-2023

Description: View of segment 14 from bridge 127. Facing east.

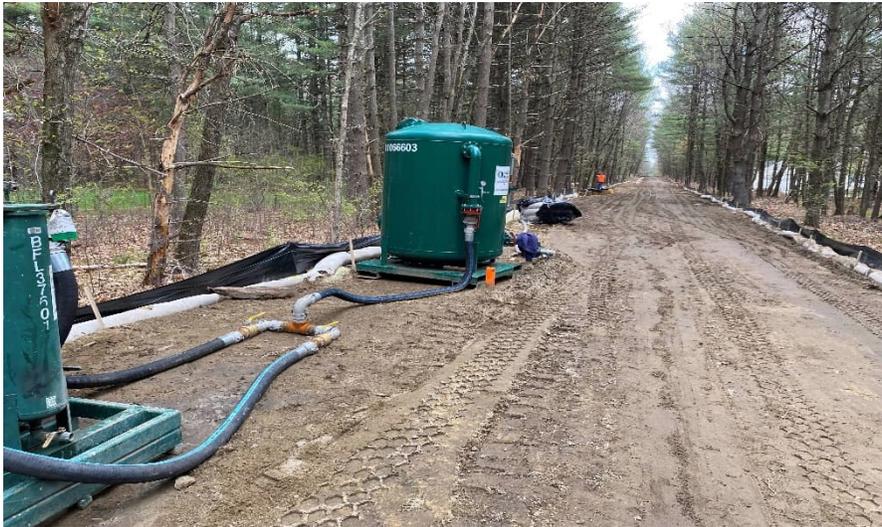
PHOTOGRAPHIC LOG	
Client Name: Eversource		Site Location: Sudbury to Hudson Transmission Reliability Project	Town: Hudson
Photo No.: 2	Date: 4/25/2023

Description: View of pumping operation at Segment 5 at approximate Sta# 300+50 (frac tank to filtration system to dewatering bag within bale corral), looking eastward.

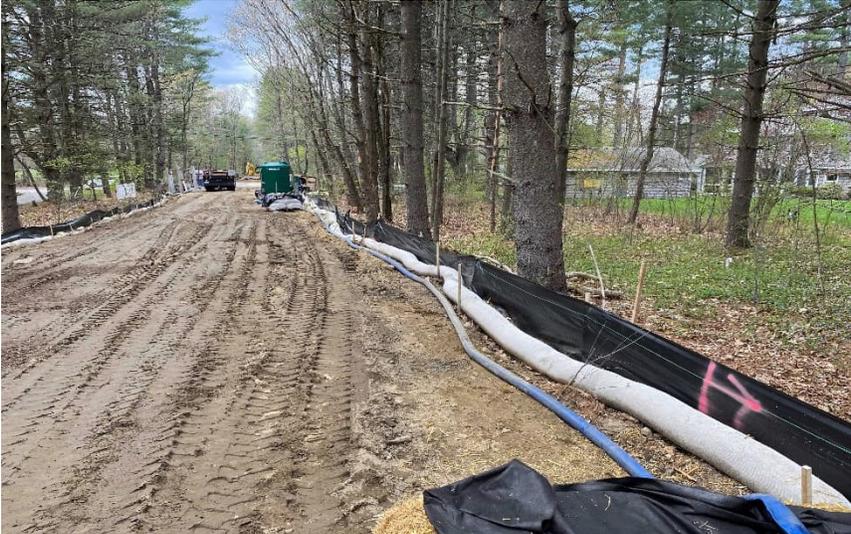
PHOTOGRAPHIC LOG	
Client Name: Eversource		Site Location: Sudbury to Hudson Transmission Reliability Project	Town: Hudson
Photo No.: 3	Date: 4/25/2023

Description: Segment 5 at approximate Sta# 300+50. View of dewatering operation, looking westward.

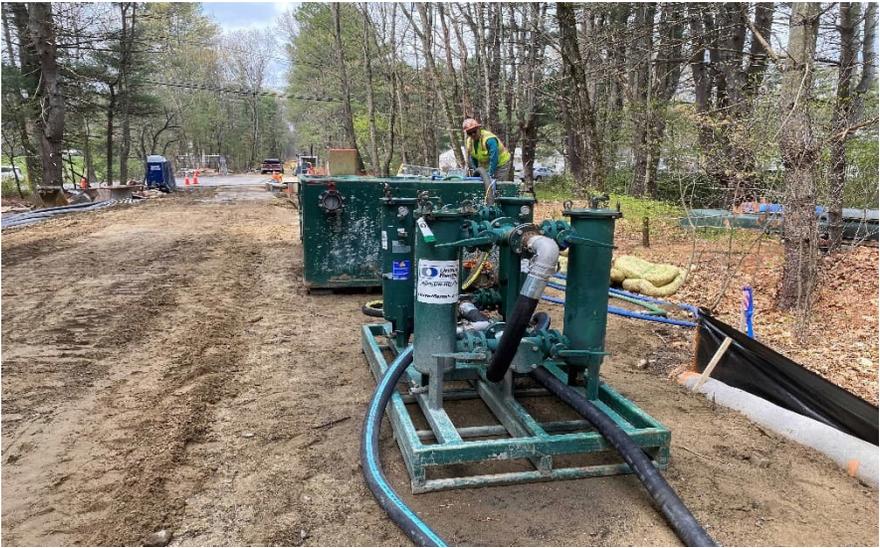
PHOTOGRAPHIC LOG	
Client Name: Eversource		Site Location: Sudbury to Hudson Transmission Reliability Project	Town: Hudson
Photo No.: 2	Date: 4/27/2023

Description: View of pumping operation at Segment 5 at approximate Sta# 300+50 (frac tank to filtration system to dewatering bag within bale corral), looking westward.

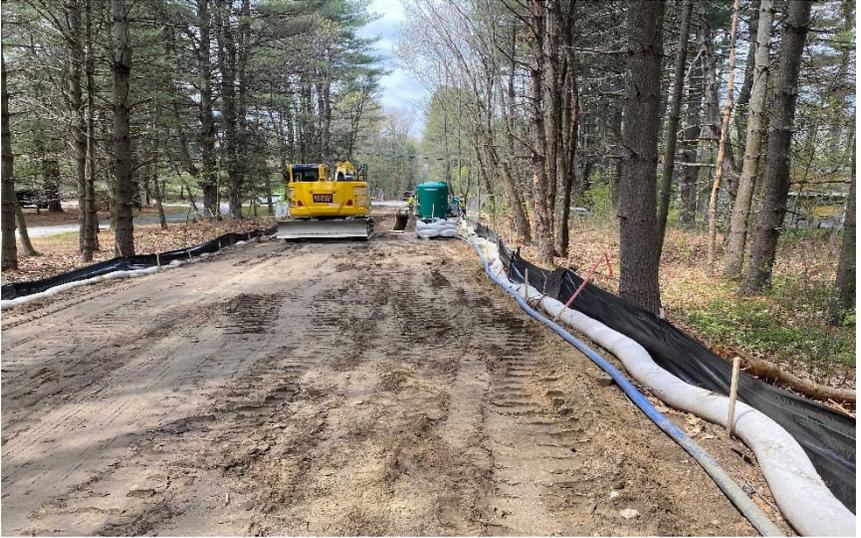
PHOTOGRAPHIC LOG	
Client Name: Eversource		Site Location: Sudbury to Hudson Transmission Reliability Project	Town: Hudson
Photo No.: 3	Date: 4/27/2023

Description: Segment 5 at approximate Sta# 300+50. View of dewatering operation, looking westward.

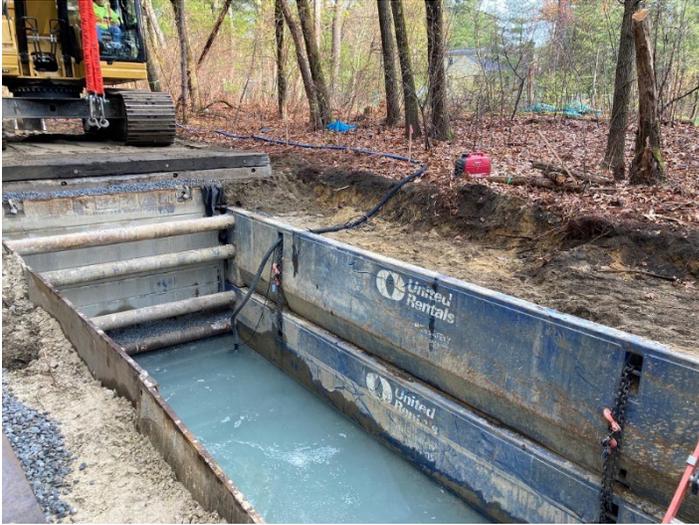
PHOTOGRAPHIC LOG		
Client Name: Eversource		Site Location: Sudbury to Hudson Transmission Reliability Project		Town: Sudbury
Photo No.: 1	Date: 4/27/2023

Description: View of pumping/dewatering operation at MH#21 in segment 10. Facing northwest.

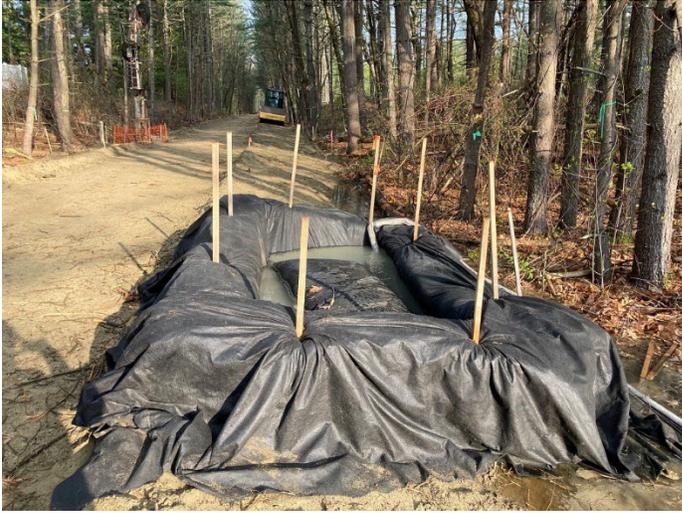
PHOTOGRAPHIC LOG		
Client Name: Eversource		Site Location: Sudbury to Hudson Transmission Reliability Project		Town: Sudbury
Photo No.: 3	Date: 4/27/2023

Description: Additional view of dewatering controls. Facing west.

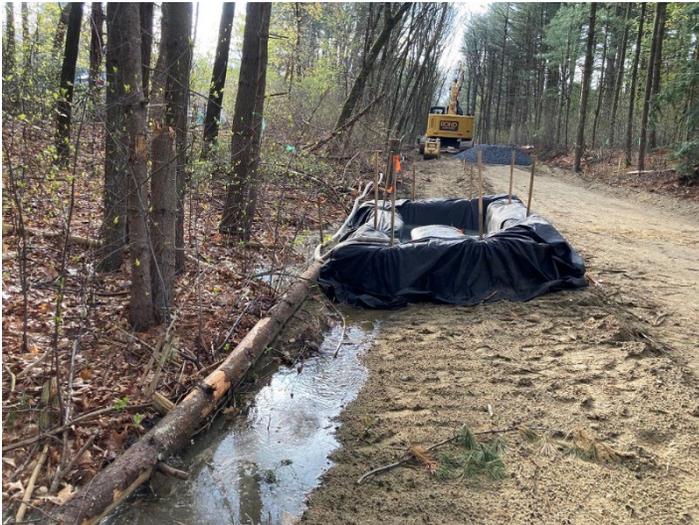
PHOTOGRAPHIC LOG		
Client Name: Eversource		Site Location: Sudbury to Hudson Transmission Reliability Project		Town: Sudbury
Photo No.: 4	Date: 4/27/2023

Description: View of discharge in natural drainage swale. Facing east.
