## Weekly Environmental Compliance Summary

**Sudbury to Hudson Transmission Reliability Project (USEPA Tracking # MAR1003UW)**

Week of: May 15 to May 19, 2023

# CONSTRUCTION MONITORING REPORT

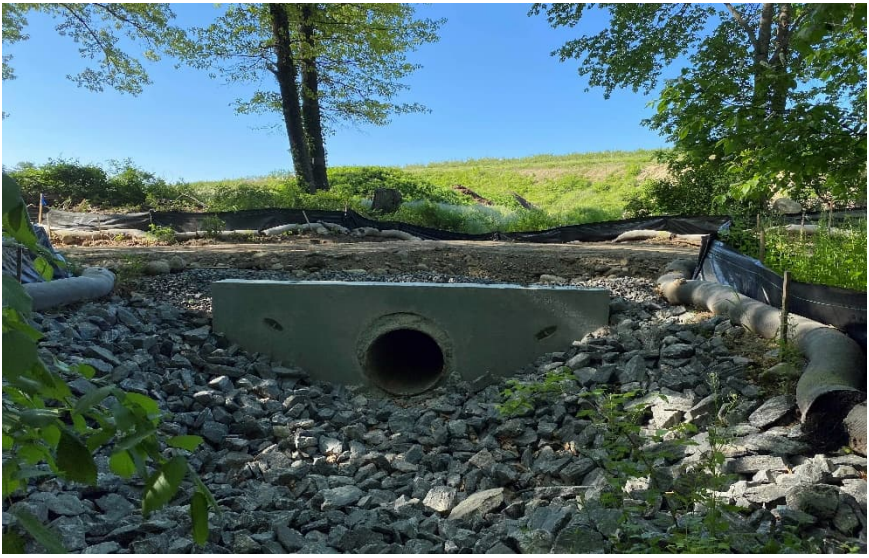
<b>PHOTOGRAPHIC LOG</b>	
Client Name: Eversource		Site Location: Sudbury to Hudson Transmission Reliability Project	Town: Stow
Photo No.: 4	Date: 5-18-23

Description:  Headwall & culvert, within segment 1, looking westward.

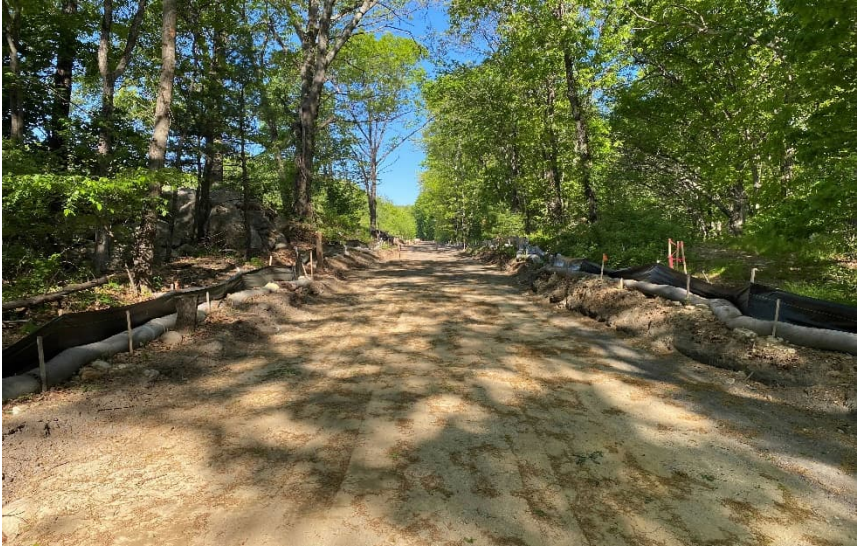
<b>PHOTOGRAPHIC LOG</b>	
Client Name: Eversource		Site Location: Sudbury to Hudson Transmission Reliability Project	Town: Stow
Photo No.: 5	Date: 5-18-23

Description:  Right-of-way, within Segment 1, existing erosion control, looking westward

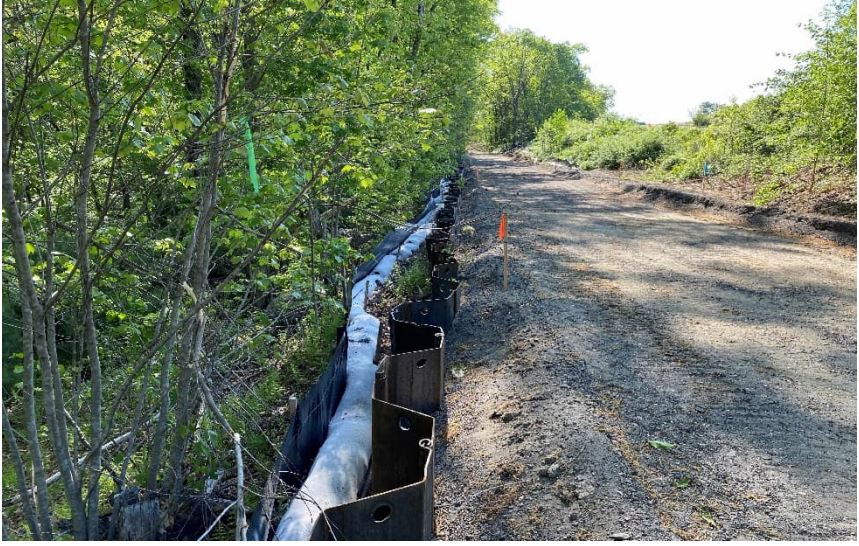
<b>PHOTOGRAPHIC LOG</b>	
Client Name: Eversource		Site Location: Sudbury to Hudson Transmission Reliability Project	Town: Hudson
Photo No.: 6	Date: 5-18-23

Description:  Right-of-way, within segment 1, existing erosion control & new sheeting, looking eastward.

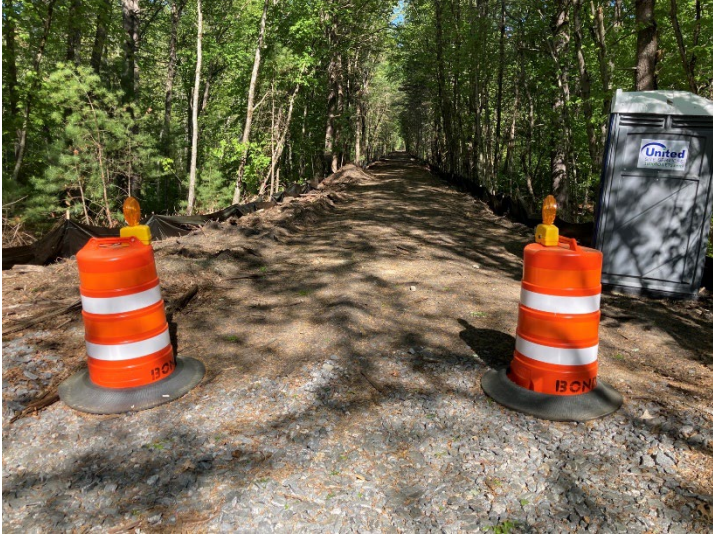
<b>PHOTOGRAPHIC LOG</b>	
<b>Client Name:</b> Eversource		<b>Site Location:</b> Sudbury to Hudson Transmission Reliability Project	<b>Town:</b> Sudbury
<b>Photo No.:</b> 3	<b>Date:</b> 5/18/2023

<b>Description:</b> View of segment 9 from construction entrance at Peakham Rd. Barrels in place to demarcate vernal pool TOY restricted area. Facing west.

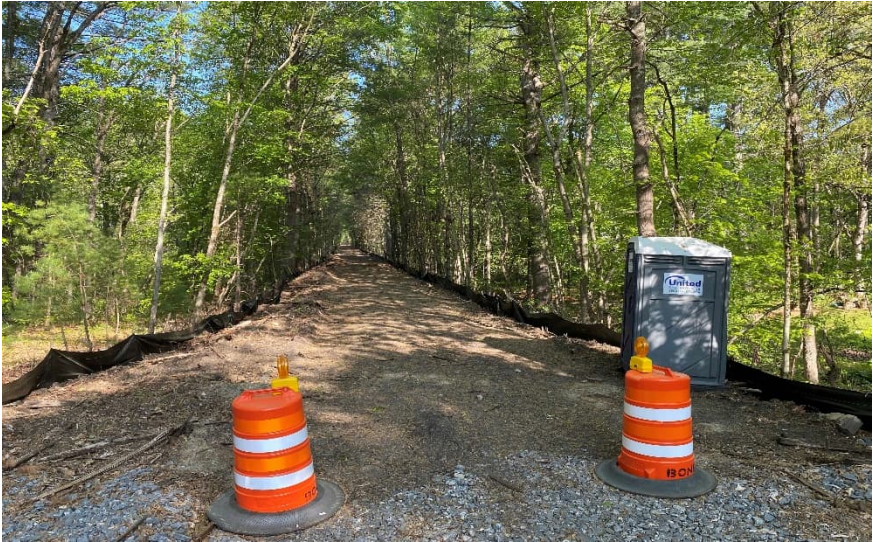
<p>PHOTOGRAPHIC LOG</p>	
<p>Client Name: Eversource</p>		<p>Site Location: Sudbury to Hudson Transmission Reliability Project</p>	<p>Town: Sudbury</p>
<p>Photo No.: 1</p>	<p>Date: 5-19-23</p>

<p>Description:</p> <p>Right-of-way within segment 9, existing erosion control, looking westward.</p>

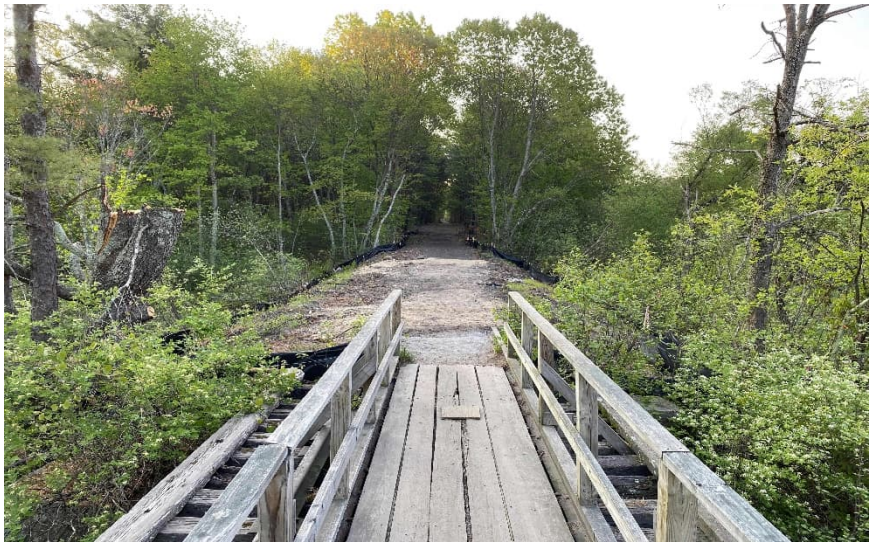
<p>PHOTOGRAPHIC LOG</p>	
<p>Client Name: Eversource</p>		<p>Site Location: Sudbury to Hudson Transmission Reliability Project</p>	<p>Town: Sudbury</p>
<p>Photo No.: 2</p>	<p>Date: 5-19-23</p>

<p>Description:</p> <p>Bridge 128 looking into segment 8, existing erosion control, looking eastward.</p>

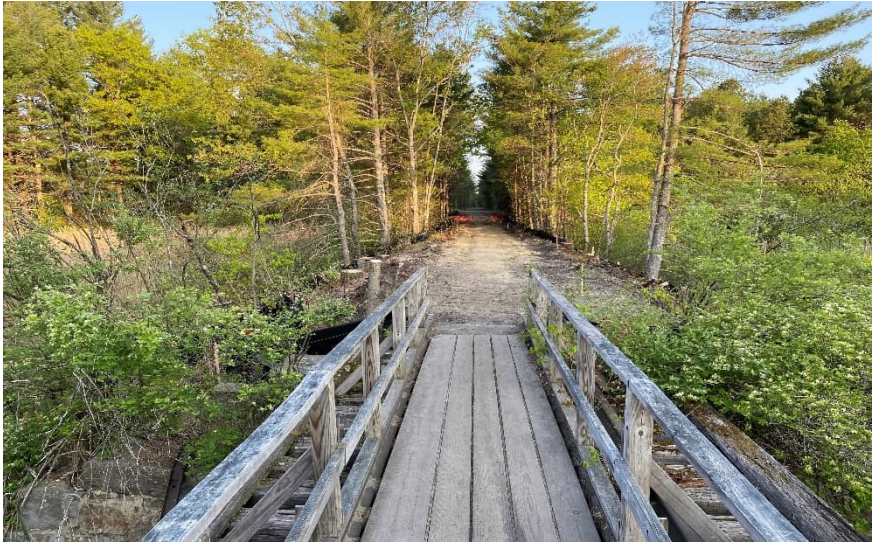
<p>PHOTOGRAPHIC LOG</p>	
<p>Client Name: Eversource</p>		<p>Site Location: Sudbury to Hudson Transmission Reliability Project</p>	<p>Town: Sudbury</p>
<p>Photo No.: 3</p>	<p>Date: 5-19-23</p>

<p>Description:</p> <p>Bridge 128 looking into segment 7, existing erosion control, looking westward.</p>

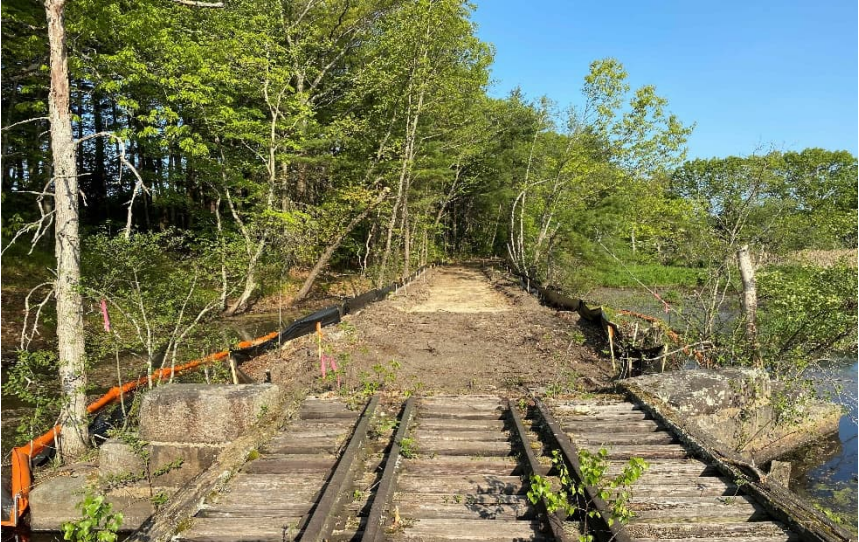
<p>PHOTOGRAPHIC LOG</p>	
<p>Client Name: Eversource</p>		<p>Site Location: Sudbury to Hudson Transmission Reliability Project</p>	<p>Town: Sudbury</p>
<p>Photo No.: 4</p>	<p>Date: 5-19-23</p>

<p>Description:</p> <p>Bridge 127 at segment 13/14 boundary looking into segment 13, existing erosion control, looking westward.</p>

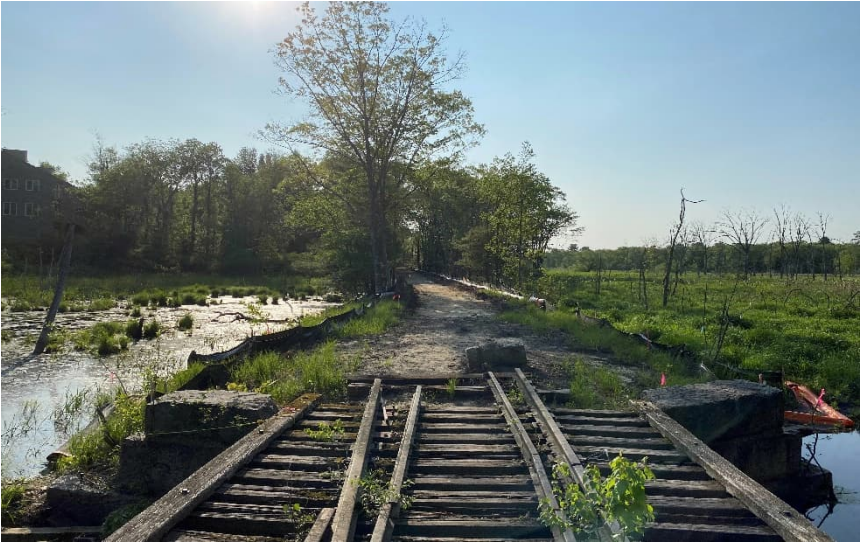
<p>PHOTOGRAPHIC LOG</p>	
<p>Client Name: Eversource</p>		<p>Site Location: Sudbury to Hudson Transmission Reliability Project</p>	<p>Town: Sudbury</p>
<p>Photo No.: 5</p>	<p>Date: 5-19-23</p>

<p>Description:</p> <p>Bridge 127 at segment 13/14 boundary looking into segment 14, existing erosion control, looking eastward.</p>

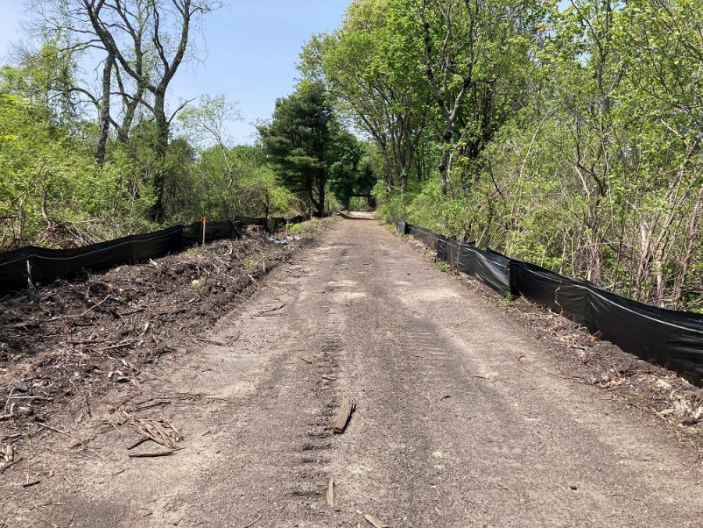
<b>PHOTOGRAPHIC LOG</b>	
Client Name: Eversource		Site Location: Sudbury to Hudson Transmission Reliability Project	Town: Sudbury
Photo No.: 2	Date: 5-15-2023

<b>Description:</b> View of syncopated silt fence at east end of segment 14. Facing west.

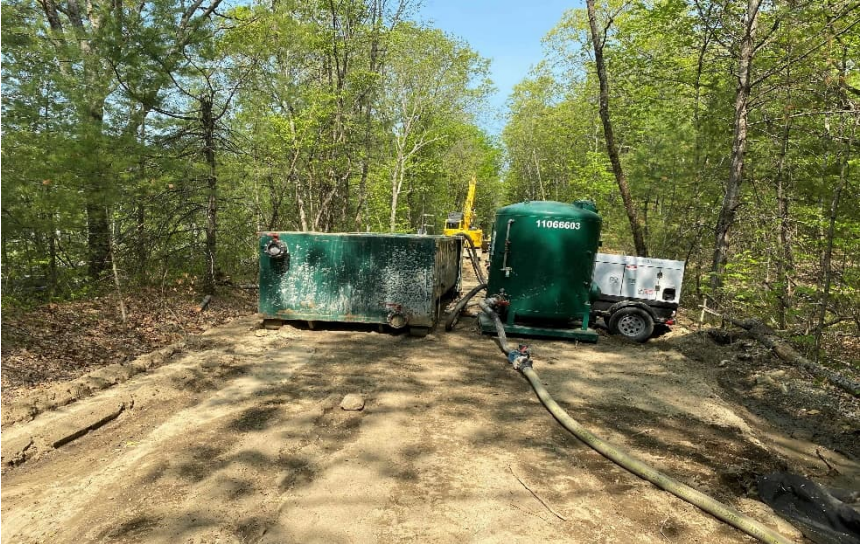
<b>PHOTOGRAPHIC LOG</b>	
Client Name: Eversource		Site Location: Sudbury to Hudson Transmission Reliability Project	Town: Hudson
Photo No.: 3	Date: 5/15/2023

Description: Segment 5 at manhole #12. View of dewatering operation, looking eastward.

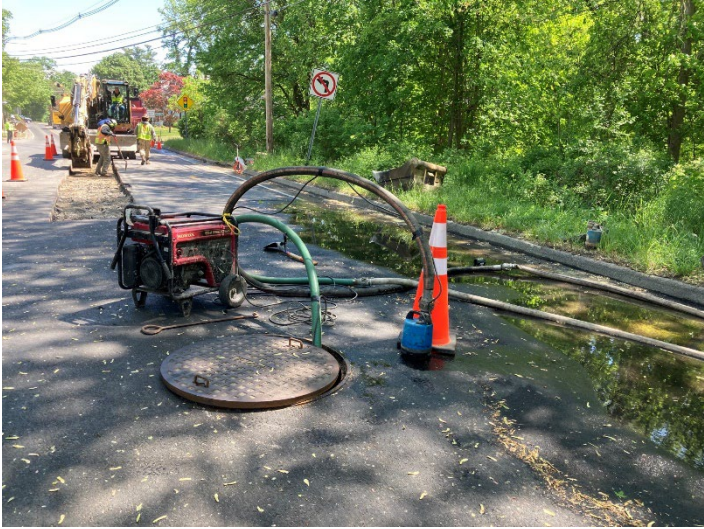
<b>PHOTOGRAPHIC LOG</b>		
<b>Client Name:</b> Eversource		<b>Site Location:</b> Sudbury to Hudson Transmission Reliability Project		<b>Town:</b> Hudson
<b>Photo No.:</b> 1	<b>Date:</b> 5/17/2023

<b>Description:</b> View of dewatering operation at MH #4 on Forest Ave in Hudson. Facing northeast.

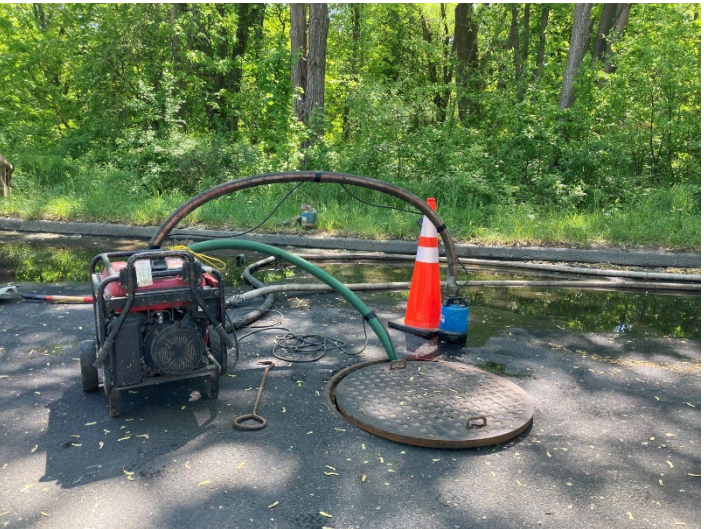
<b>PHOTOGRAPHIC LOG</b>		
<b>Client Name:</b> Eversource		<b>Site Location:</b> Sudbury to Hudson Transmission Reliability Project		<b>Town:</b> Hudson
<b>Photo No.:</b> 2	<b>Date:</b> 5/17/2023

<b>Description:</b> Additional view of dewatering operation. Facing southeast.

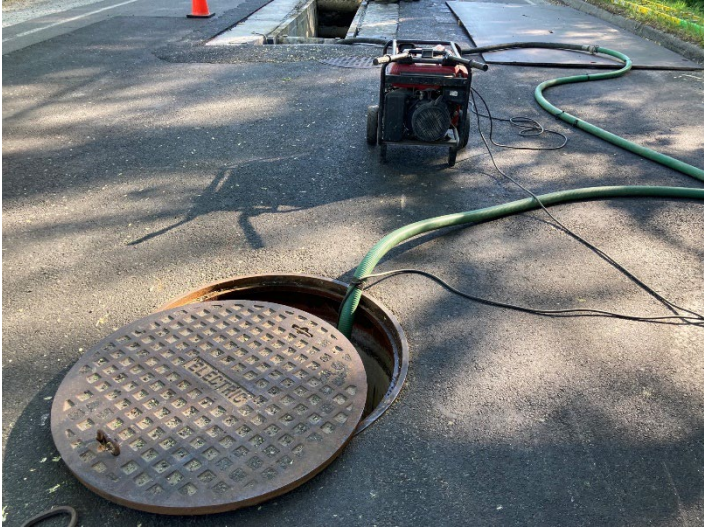
<b>PHOTOGRAPHIC LOG</b>		
<b>Client Name:</b> Eversource		<b>Site Location:</b> Sudbury to Hudson Transmission Reliability Project		<b>Town:</b> Hudson
<b>Photo No.:</b> 1	<b>Date:</b> 5/18/2023

<b>Description:</b> View of dewatering operation at MH #4 on Forest Ave in Hudson. Facing northeast.

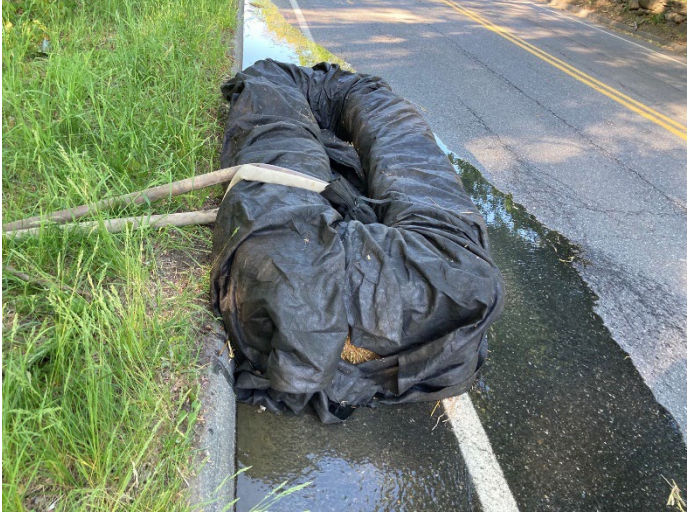
<b>PHOTOGRAPHIC LOG</b>		
<b>Client Name:</b> Eversource		<b>Site Location:</b> Sudbury to Hudson Transmission Reliability Project		<b>Town:</b> Hudson
<b>Photo No.:</b> 3	<b>Date:</b> 5/18/2023

<b>Description:</b> View of dewatering controls (straw bale corral with filter fabric and silt bag). Facing southwest.

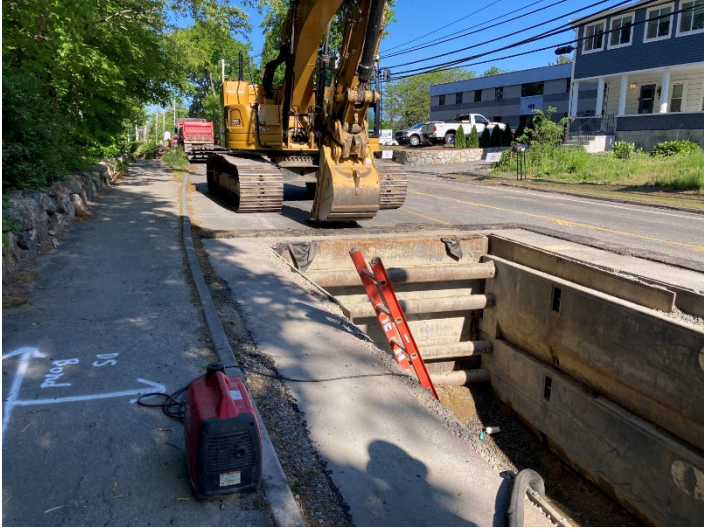
<b>PHOTOGRAPHIC LOG</b>		
<b>Client Name:</b> Eversource		<b>Site Location:</b> Sudbury to Hudson Transmission Reliability Project		<b>Town:</b> Hudson
<b>Photo No.:</b> 1	<b>Date:</b> 5/18/2023

<b>Description:</b> View of dewatering operation at MH #2 on Forest Ave in Hudson. Facing west.

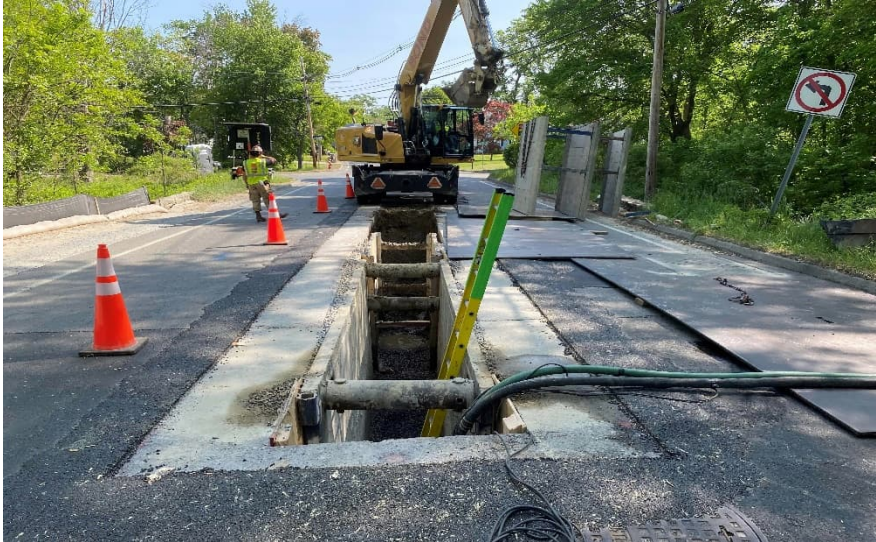
<b>PHOTOGRAPHIC LOG</b>	
Client Name: Eversource		Site Location: Sudbury to Hudson Transmission Reliability Project	Town: Hudson
Photo No.: 1	Date: 5/19/2023

Description: View of area being pumped at work operation at MH#4, in Forest Avenue, looking northward.

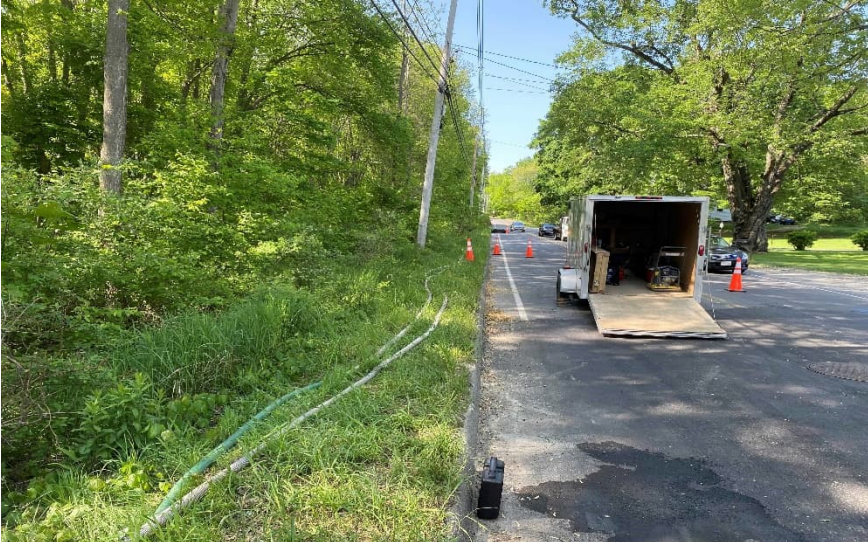
<b>PHOTOGRAPHIC LOG</b>	
Client Name: Eversource		Site Location: Sudbury to Hudson Transmission Reliability Project	Town: Hudson
Photo No.: 3	Date: 5/19/2023

Description: MH#4. View of dewatering operation, looking southward.
