**Weekly Environmental Compliance Summary**

**Sudbury to Hudson Transmission Reliability Project (USEPA Tracking # MAR1003UW)**

Week of: May 22 to May 26, 2023

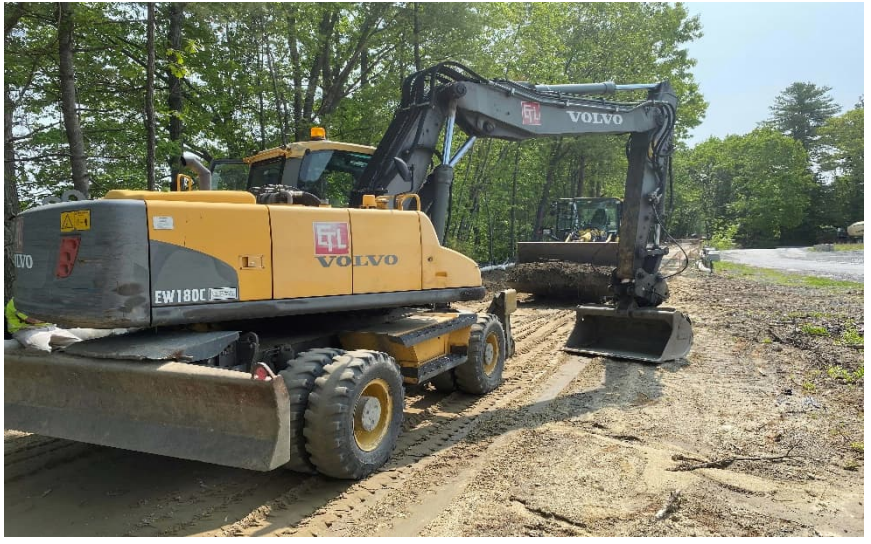
<b>PHOTOGRAPHIC LOG</b>	
Client Name: Eversource		Site Location: Sudbury to Hudson Transmission Reliability Project	Town: Hudson
Photo No.: 6	Date: 5-23-23

Description:  ET&L conducting site work within segment 3, looking eastward.

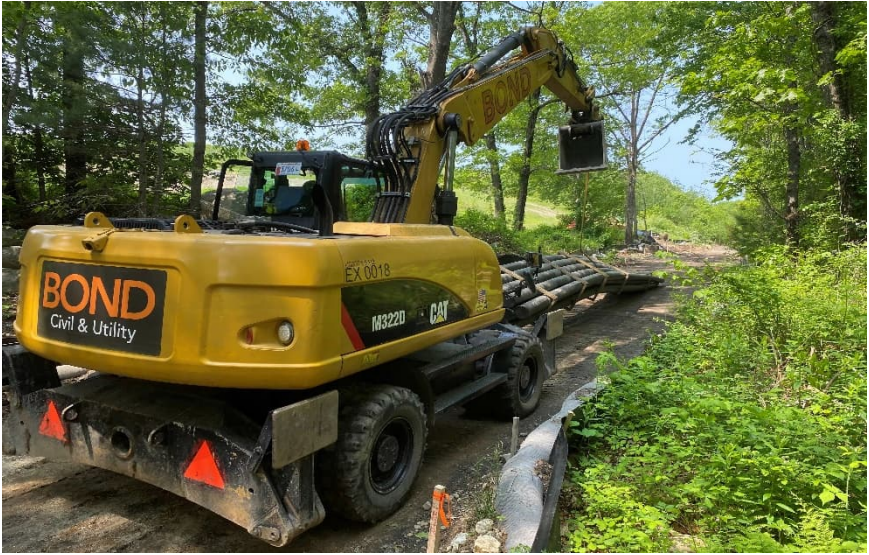
<b>PHOTOGRAPHIC LOG</b>	
Client Name: Eversource		Site Location: Sudbury to Hudson Transmission Reliability Project	Town: Hudson
Photo No.: 7	Date: 5-23-23

Description:  Bond staging conduit within segment 1, off Chestnut Street, looking westward.

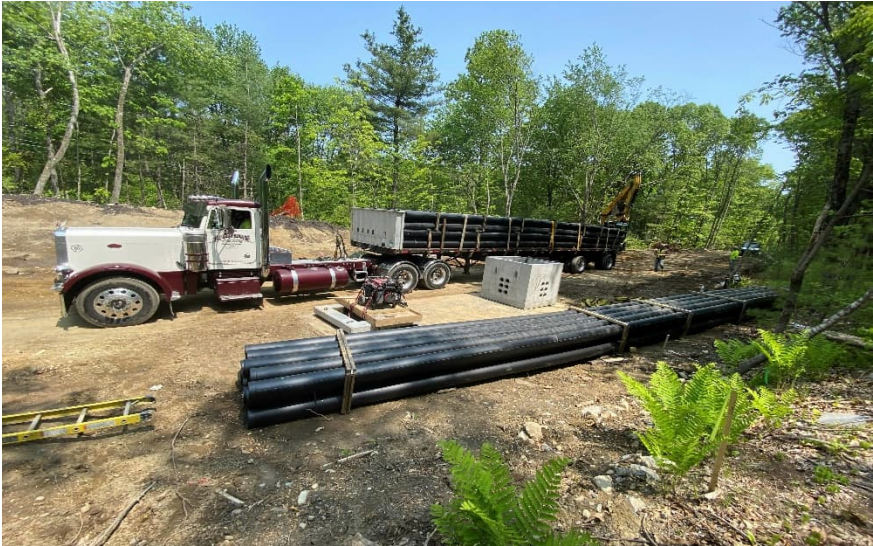
<b>PHOTOGRAPHIC LOG</b>	
Client Name: Eversource		Site Location: Sudbury to Hudson Transmission Reliability Project	Town: Hudson
Photo No.: 8	Date: 5-23-23

Description:  Bond delivering conduit within segment 1, off Wilkins Avenue, looking eastward.

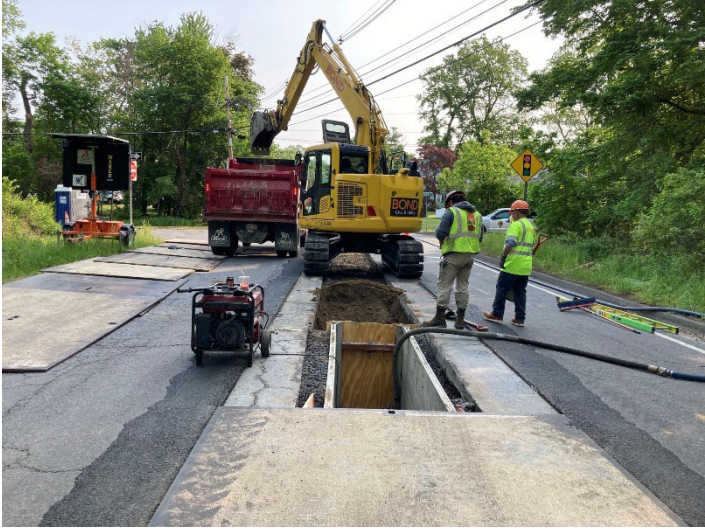
<p align="right"><b>PHOTOGRAPHIC LOG</b></p>	
<p><b>Client Name:</b> Eversource</p>		<p><b>Site Location:</b> Sudbury to Hudson Transmission Reliability Project</p>	<p><b>Town:</b> Hudson</p>
<p><b>Photo No.:</b> 1</p>	<p><b>Date:</b> 5/23/2023</p>

<p><b>Description:</b> View of Bond working near MH #4 on Forest Ave. See additional dewatering inspection reports. Facing north.</p>

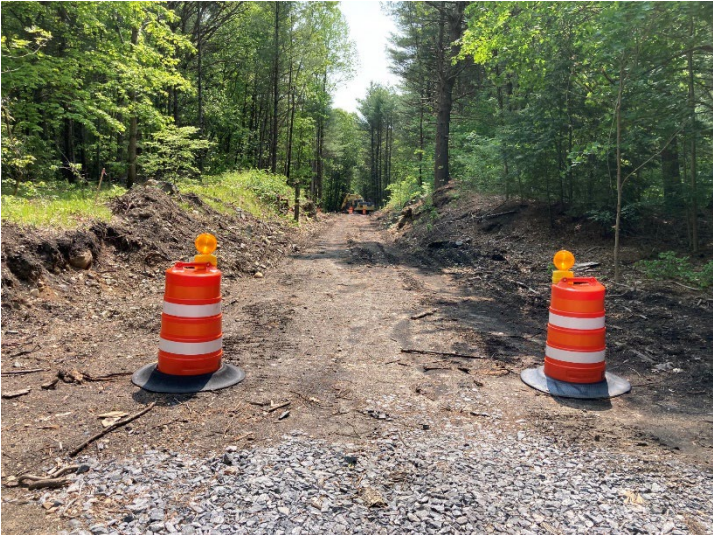
<p align="right"><b>PHOTOGRAPHIC LOG</b></p>	
<p><b>Client Name:</b> Eversource</p>		<p><b>Site Location:</b> Sudbury to Hudson Transmission Reliability Project</p>	<p><b>Town:</b> Sudbury</p>
<p><b>Photo No.:</b> 2</p>	<p><b>Date:</b> 5/23/2023</p>

<p><b>Description:</b> View of segment 10 from construction entrance at Peakham Rd. ET&amp;L has staged equipment in this segment for future work. Facing east.</p>

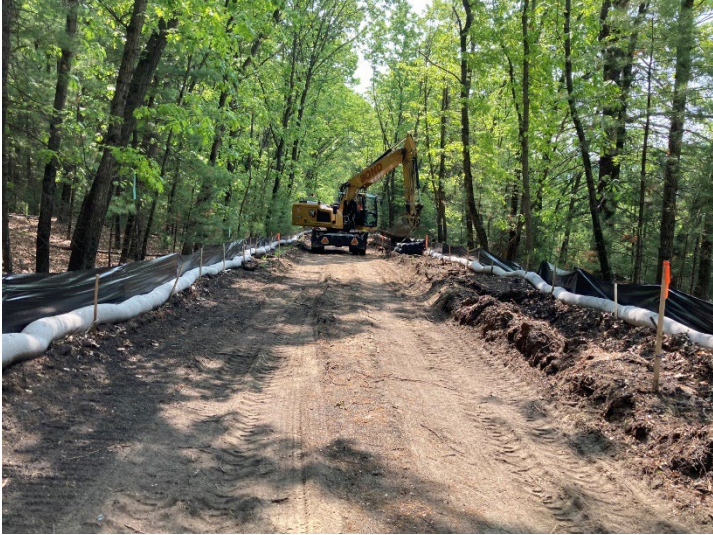
<b>PHOTOGRAPHIC LOG</b>	
<b>Client Name:</b> Eversource		<b>Site Location:</b> Sudbury to Hudson Transmission Reliability Project	<b>Town:</b> Sudbury
<b>Photo No.:</b> 3	<b>Date:</b> 5/23/2023

<b>Description:</b> View of Bond stringing conduit in segment 11. Facing west.

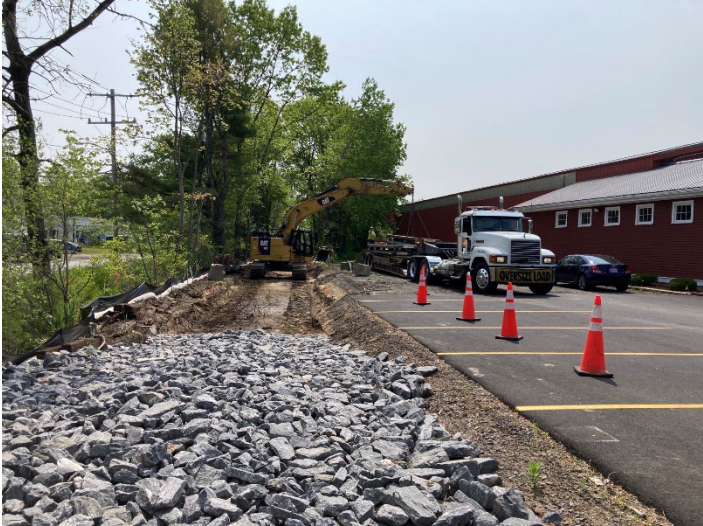
<b>PHOTOGRAPHIC LOG</b>	
<b>Client Name:</b> Eversource		<b>Site Location:</b> Sudbury to Hudson Transmission Reliability Project	<b>Town:</b> Sudbury
<b>Photo No.:</b> 4	<b>Date:</b> 5/23/2023

<b>Description:</b> View of segment 12 from construction entrance at Union Ave. Bond unloaded manhole boxes here for MH #25 in segment 13. Facing east.

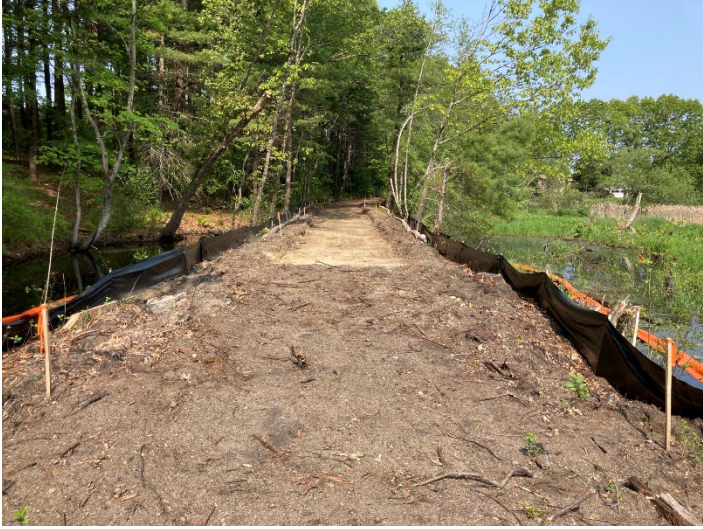
<b>PHOTOGRAPHIC LOG</b>	
<b>Client Name:</b> Eversource		<b>Site Location:</b> Sudbury to Hudson Transmission Reliability Project	<b>Town:</b> Sudbury
<b>Photo No.:</b> 5	<b>Date:</b> 5/23/2023

<b>Description:</b> View of segment 13 from bridge 127. Facing west.

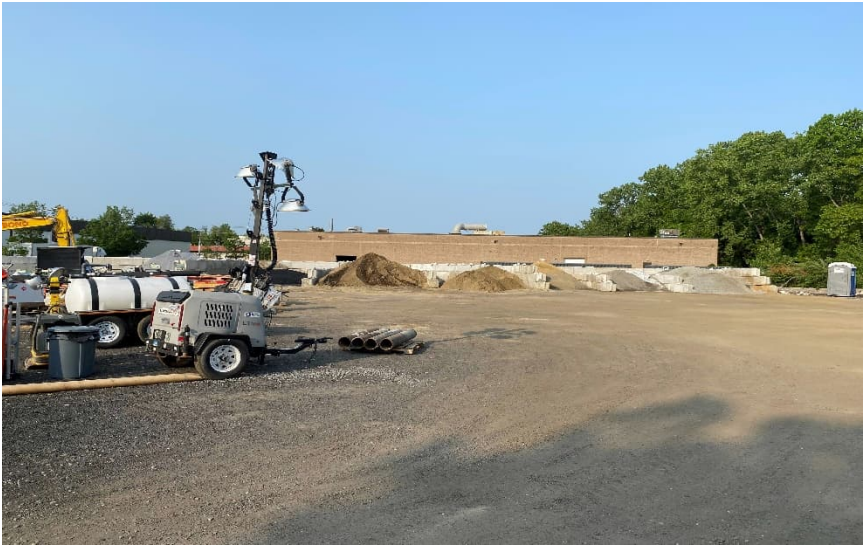
<b>PHOTOGRAPHIC LOG</b>	
Client Name: Eversource		Site Location: Sudbury to Hudson Transmission Reliability Project	Town: Hudson
Photo No.: 3	Date: 5-24-23

Description:  Laydown yard on Bonazzoli Avenue, looking westward.

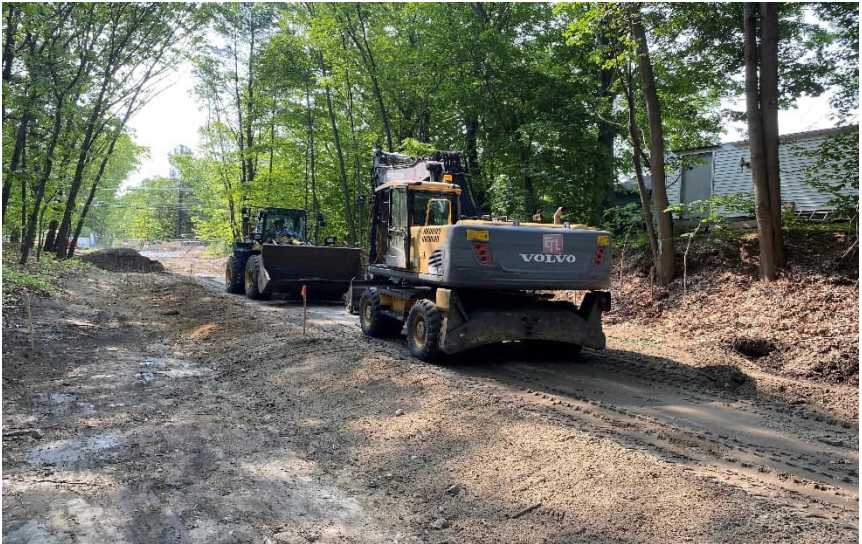
<b>PHOTOGRAPHIC LOG</b>	
Client Name: Eversource		Site Location: Sudbury to Hudson Transmission Reliability Project	Town: Hudson
Photo No.: 7	Date: 5-24-23

Description:  ET&L conducting site work within segment 3, looking eastward.

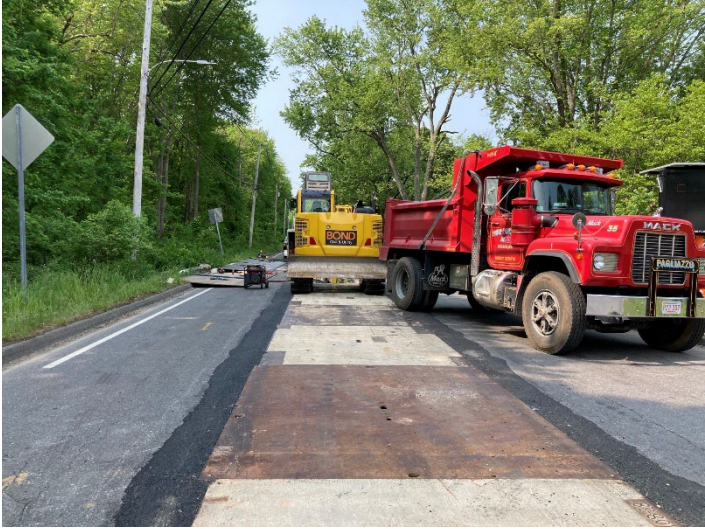
<p align="right"><b>PHOTOGRAPHIC LOG</b></p>	
<p><b>Client Name:</b> Eversource</p>		<p><b>Site Location:</b> Sudbury to Hudson Transmission Reliability Project</p>	<p><b>Town:</b> Hudson</p>
<p><b>Photo No.:</b> 1</p>	<p><b>Date:</b> 5/24/2023</p>

<p><b>Description:</b> View of Bond working near MH #4 on Forest Ave. See additional dewatering inspection reports. Facing south.</p>

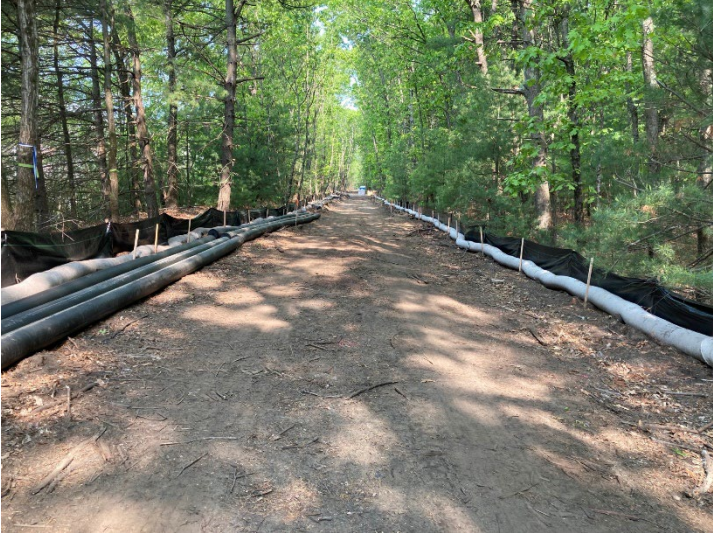
<p align="right"><b>PHOTOGRAPHIC LOG</b></p>	
<p><b>Client Name:</b> Eversource</p>		<p><b>Site Location:</b> Sudbury to Hudson Transmission Reliability Project</p>	<p><b>Town:</b> Sudbury</p>
<p><b>Photo No.:</b> 2</p>	<p><b>Date:</b> 5/24/2023</p>

<p><b>Description:</b> View of segment 11. Facing west.</p>

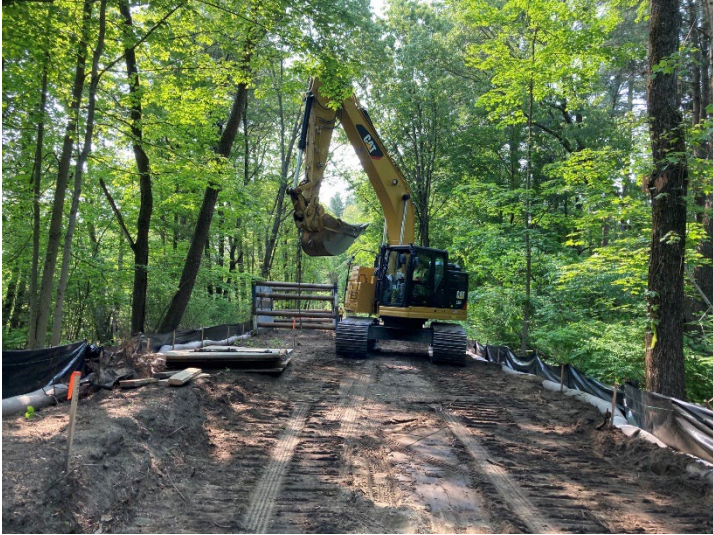
<b>PHOTOGRAPHIC LOG</b>	
<b>Client Name:</b> Eversource		<b>Site Location:</b> Sudbury to Hudson Transmission Reliability Project	<b>Town:</b> Sudbury
<b>Photo No.:</b> 3	<b>Date:</b> 5/24/2023

<b>Description:</b> View of Bond preparing to install MH #25 in segment 13. Facing east.

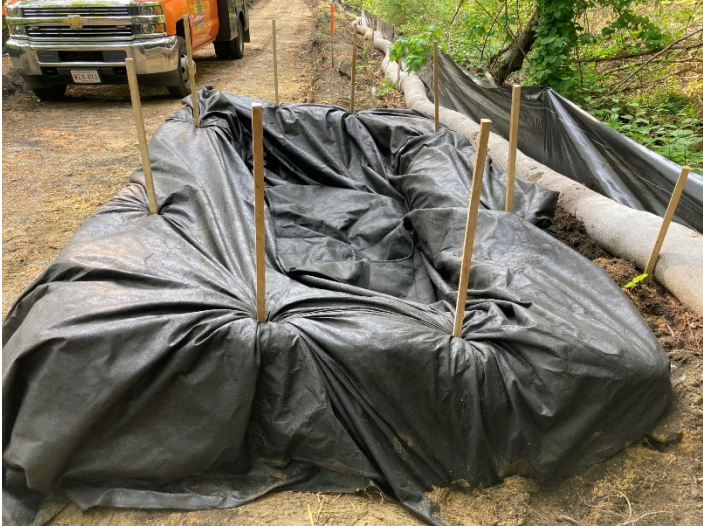
<b>PHOTOGRAPHIC LOG</b>	
<b>Client Name:</b> Eversource		<b>Site Location:</b> Sudbury to Hudson Transmission Reliability Project	<b>Town:</b> Sudbury
<b>Photo No.:</b> 4	<b>Date:</b> 5/24/2023

<b>Description:</b> View of dewatering control (straw bale corral) that has been installed in segment 13 in anticipation of dewatering activities during installation of MH #25. Facing east.

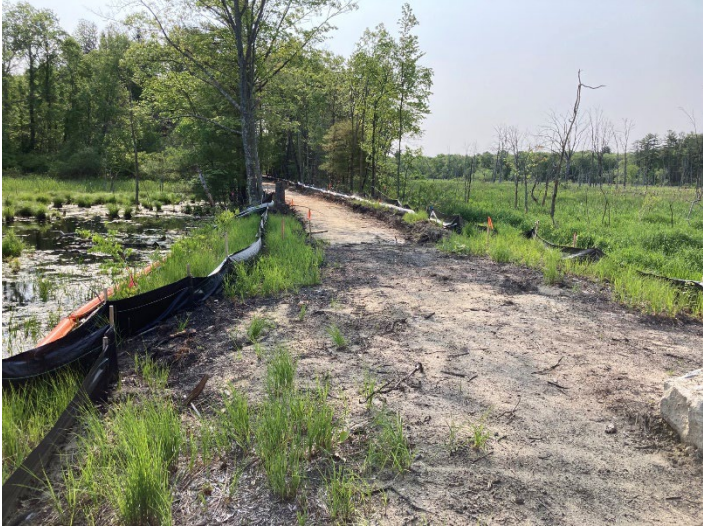
<b>PHOTOGRAPHIC LOG</b>	
<b>Client Name:</b> Eversource		<b>Site Location:</b> Sudbury to Hudson Transmission Reliability Project	<b>Town:</b> Sudbury
<b>Photo No.:</b> 5	<b>Date:</b> 5/24/2023

<b>Description:</b> View of segment 14 from bridge 127. Facing east.

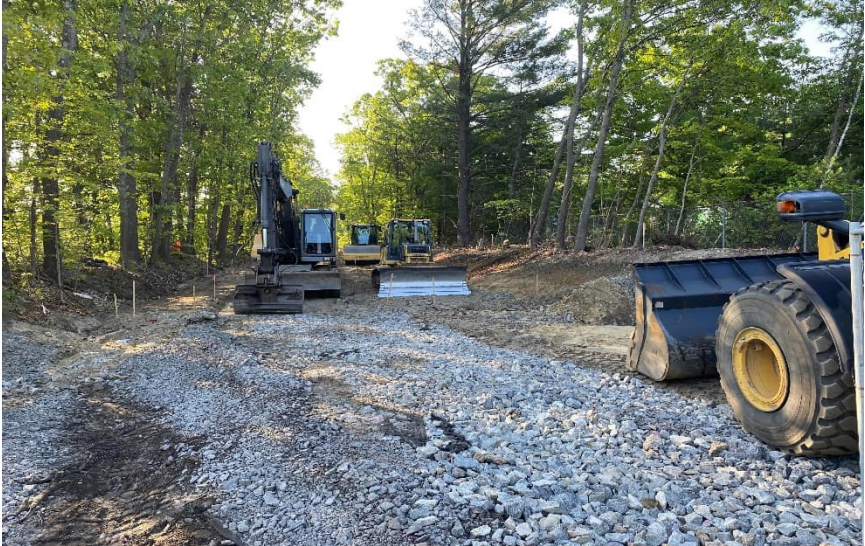
<p>PHOTOGRAPHIC LOG</p>	
<p>Client Name: Eversource</p>		<p>Site Location: Sudbury to Hudson Transmission Reliability Project</p>	<p>Town: Hudson</p>
<p>Photo No.: 6</p>	<p>Date: 5-26-23</p>

<p>Description:</p> <p>Staged equipment, within segment 4 off Main Street, looking eastward.</p>

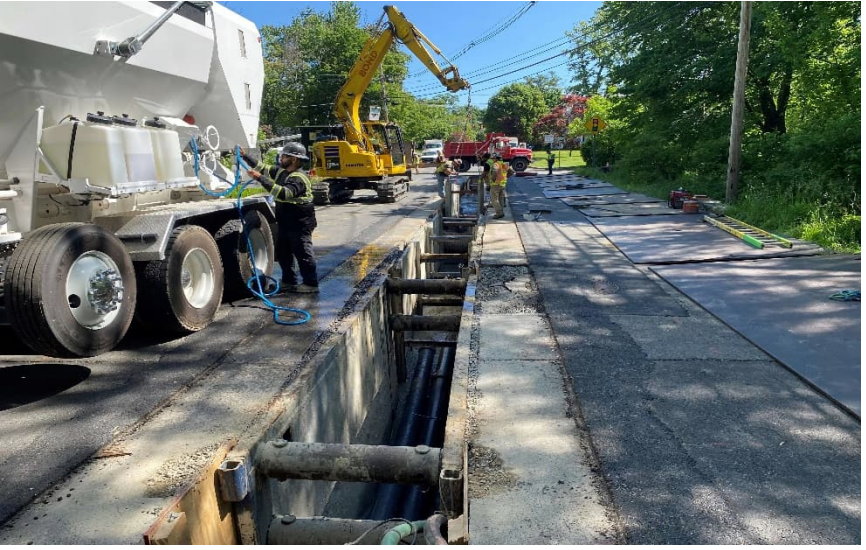
<p>PHOTOGRAPHIC LOG</p>	
<p>Client Name: Eversource</p>		<p>Site Location: Sudbury to Hudson Transmission Reliability Project</p>	<p>Town: Hudson</p>
<p>Photo No.: 7</p>	<p>Date: 5-26-23</p>

<p>Description:</p> <p>Bond conducting conduit work near Manhole #4, within Forest Avenue, looking northward.</p>

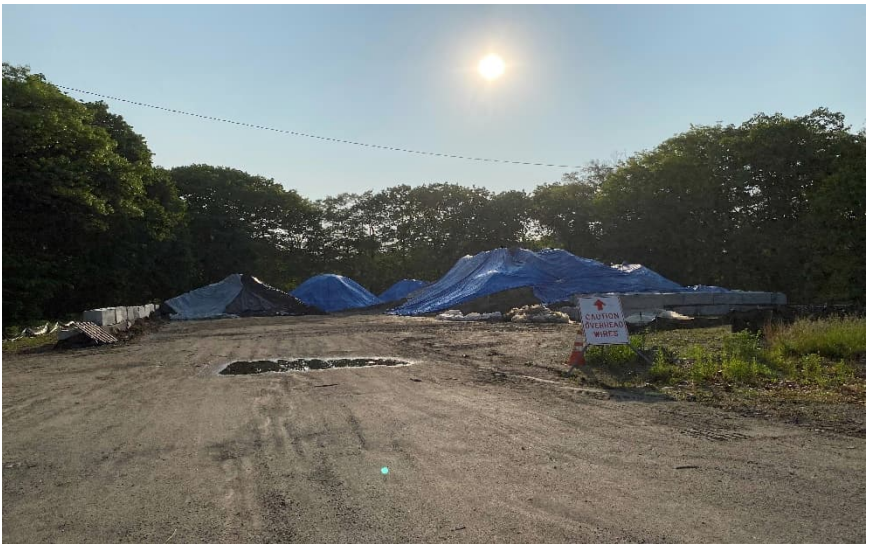
<b>PHOTOGRAPHIC LOG</b>	
Client Name: Eversource		Site Location: Sudbury to Hudson Transmission Reliability Project	Town: Hudson
Photo No.: 2	Date: 5-22-23

Description:  Laydown yard at Stowe Court, looking westward.

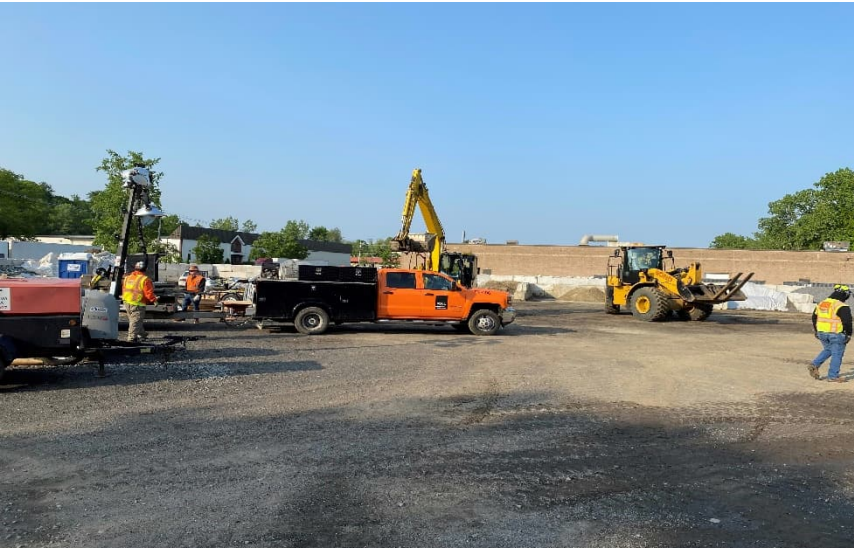
<b>PHOTOGRAPHIC LOG</b>	
Client Name: Eversource		Site Location: Sudbury to Hudson Transmission Reliability Project	Town: Hudson
Photo No.: 3	Date: 5-22-23

Description:  Laydown yard at Bonazzoli Avenue, Bond preparing for conduit work within Forest Avenue, looking southward.

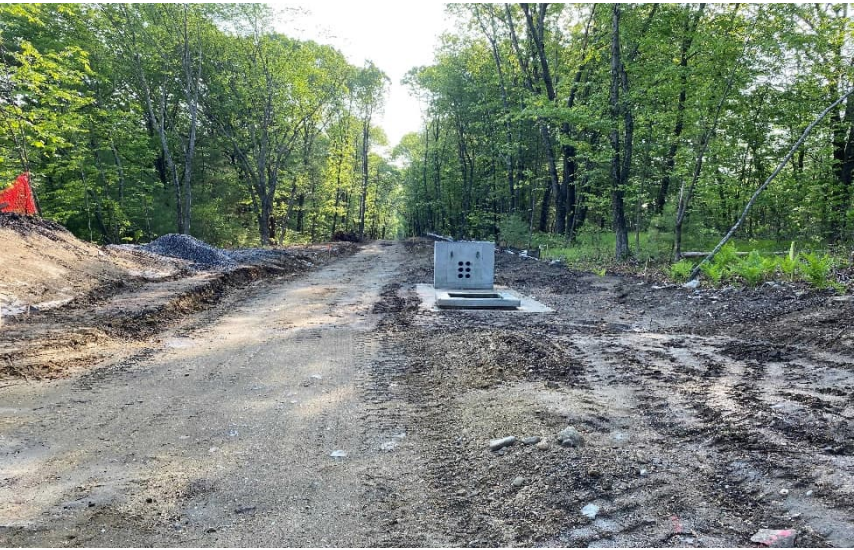
<b>PHOTOGRAPHIC LOG</b>	
Client Name: Eversource		Site Location: Sudbury to Hudson Transmission Reliability Project	Town: Hudson
Photo No.: 4	Date: 5-22-23

Description:  Manhole #5, within Segment 1, looking eastward.

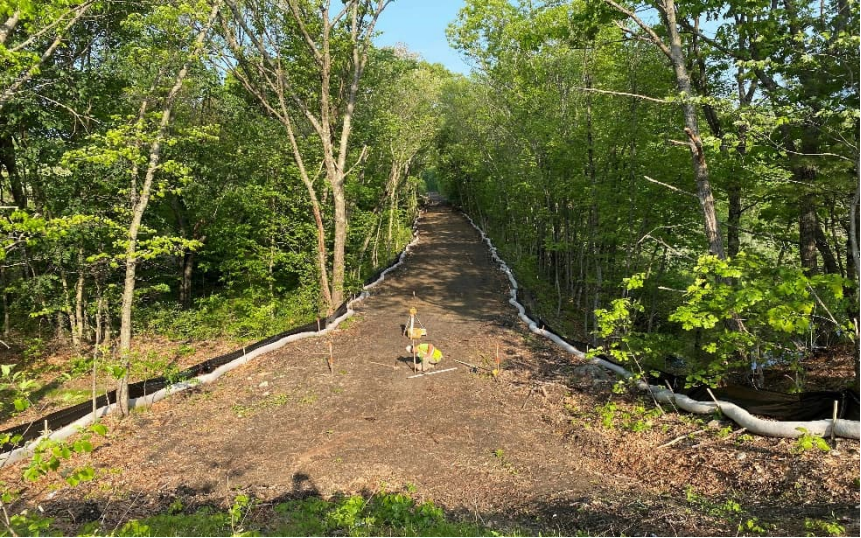
<b>PHOTOGRAPHIC LOG</b>	
Client Name: Eversource		Site Location: Sudbury to Hudson Transmission Reliability Project	Town: Hudson
Photo No.: 5	Date: 5-22-23

Description:  ET&L conducting survey work within Segment 1, looking westward.

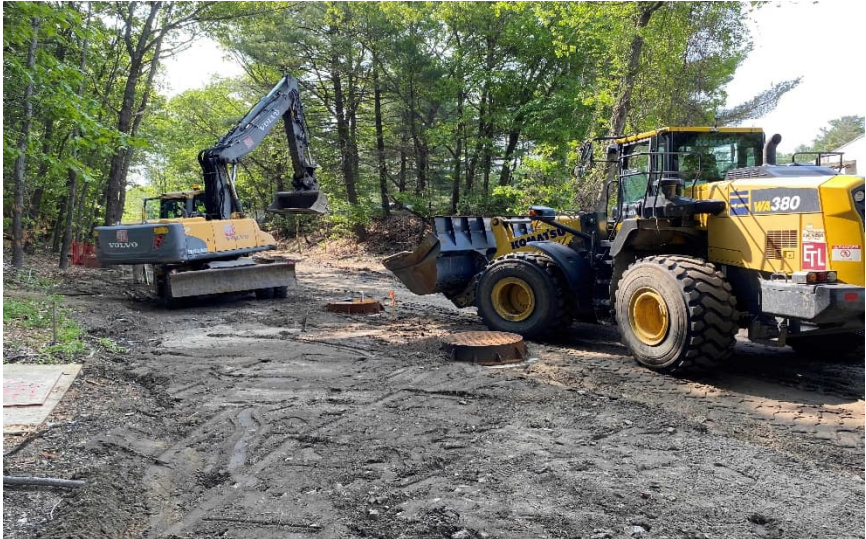
<b>PHOTOGRAPHIC LOG</b>	
Client Name: Eversource		Site Location: Sudbury to Hudson Transmission Reliability Project	Town: Hudson
Photo No.: 8	Date: 5-22-23

Description:  ET&L conducting site work within segment 3 at manhole #9, looking westward.

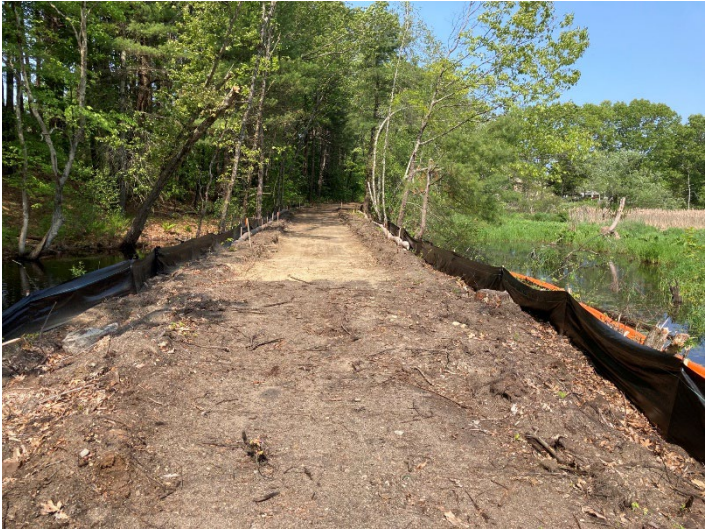
<b>PHOTOGRAPHIC LOG</b>	
<b>Client Name:</b> Eversource		<b>Site Location:</b> Sudbury to Hudson Transmission Reliability Project	<b>Town:</b> Sudbury
<b>Photo No.:</b> 3	<b>Date:</b> 5-22-2023

<b>Description:</b> View of segment 13 from Bridge 127. Facing west.

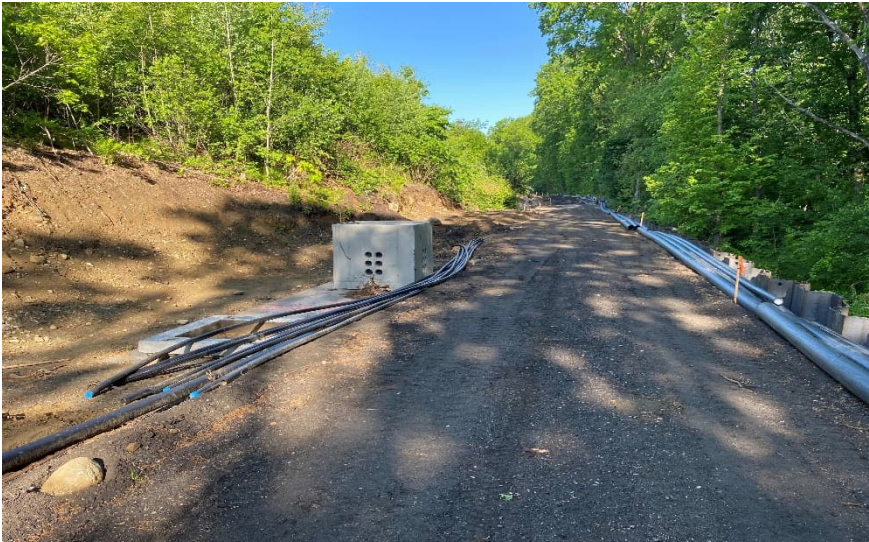
<b>PHOTOGRAPHIC LOG</b>	
Client Name: Eversource		Site Location: Sudbury to Hudson Transmission Reliability Project	Town: Hudson
Photo No.: 2	Date: 5-25-23

Description:  Manhole #6, within segment 1, looking westward.

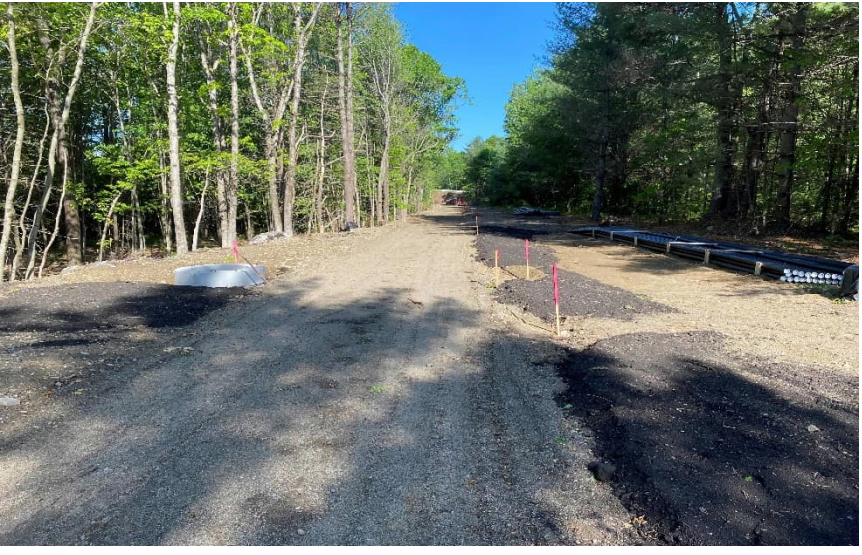
<b>PHOTOGRAPHIC LOG</b>	
Client Name: Eversource		Site Location: Sudbury to Hudson Transmission Reliability Project	Town: Hudson
Photo No.: 3	Date: 5-25-23

Description:  Manhole #7, within segment 2, looking westward.

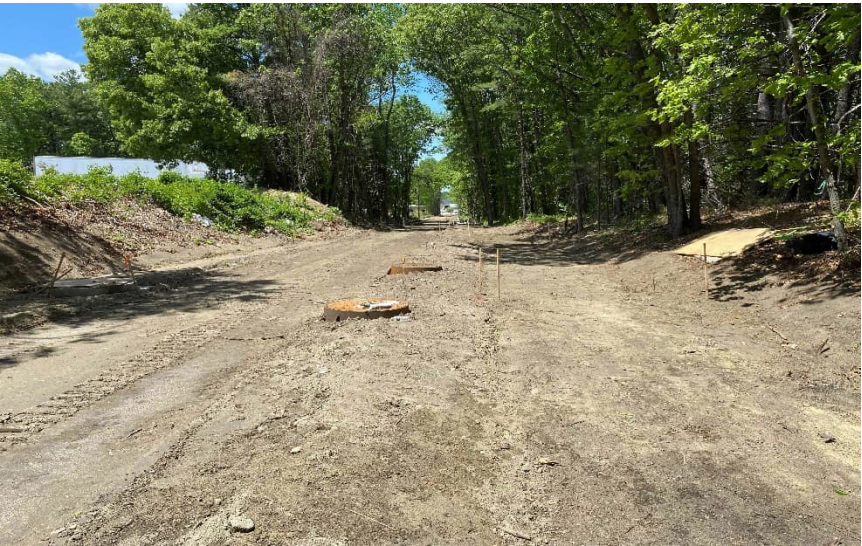
<b>PHOTOGRAPHIC LOG</b>	
Client Name: Eversource		Site Location: Sudbury to Hudson Transmission Reliability Project	Town: Hudson
Photo No.: 4	Date: 5-25-23

Description:  Manhole #9, within Segment 3, looking westward.

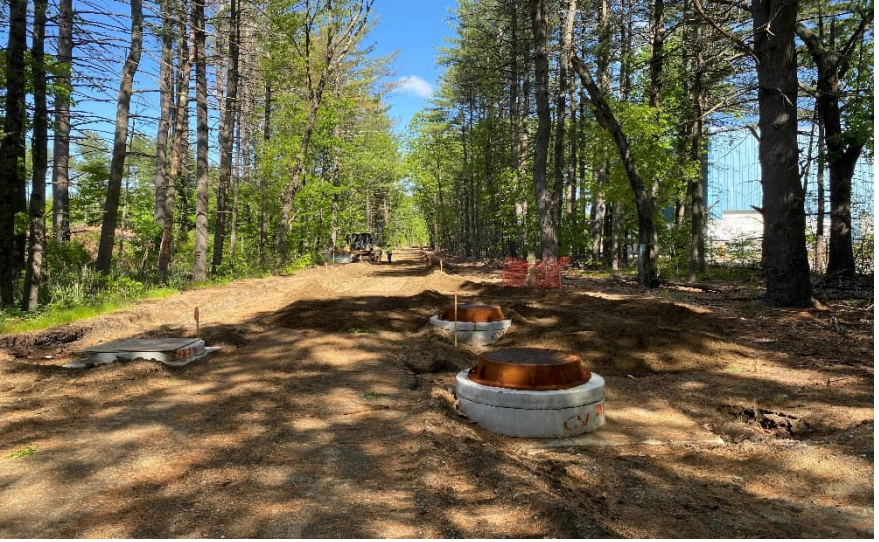
<b>PHOTOGRAPHIC LOG</b>	
Client Name: Eversource		Site Location: Sudbury to Hudson Transmission Reliability Project	Town: Hudson
Photo No.: 5	Date: 5-25-23

Description:  Manhole #10, within segment 4, looking westward.

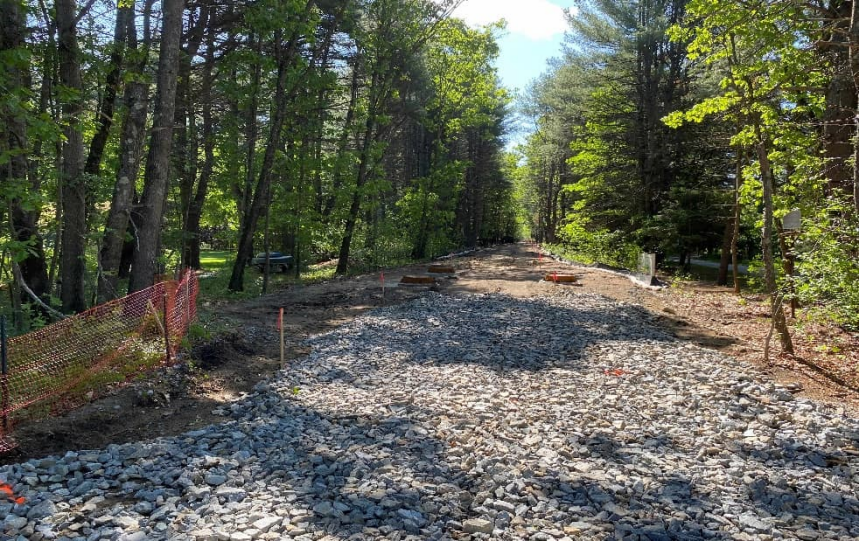
<b>PHOTOGRAPHIC LOG</b>	
Client Name: Eversource		Site Location: Sudbury to Hudson Transmission Reliability Project	Town: Hudson
Photo No.: 6	Date: 5-25-23

Description:  Manhole 11, within segment 5, looking eastward.

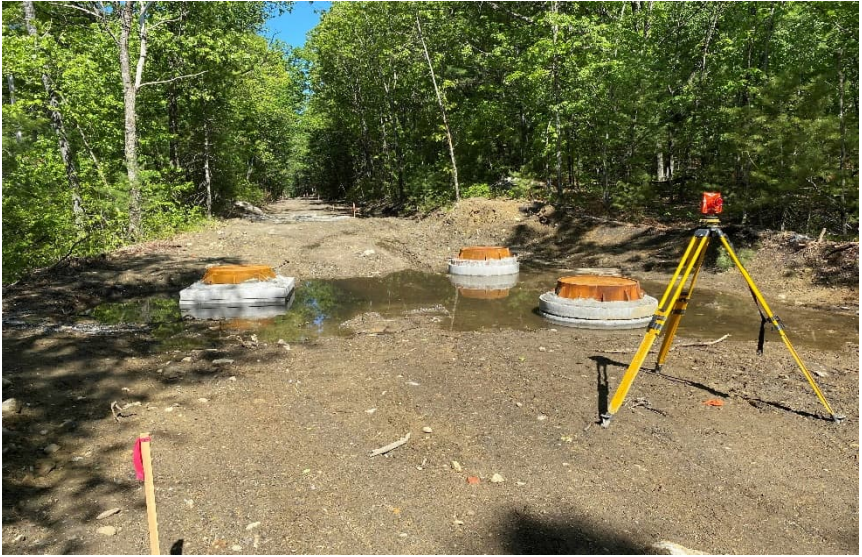
<b>PHOTOGRAPHIC LOG</b>	
Client Name: Eversource		Site Location: Sudbury to Hudson Transmission Reliability Project	Town: Hudson
Photo No.: 7	Date: 5-25-23

Description:  Manhole 12, within segment 5, looking westward.

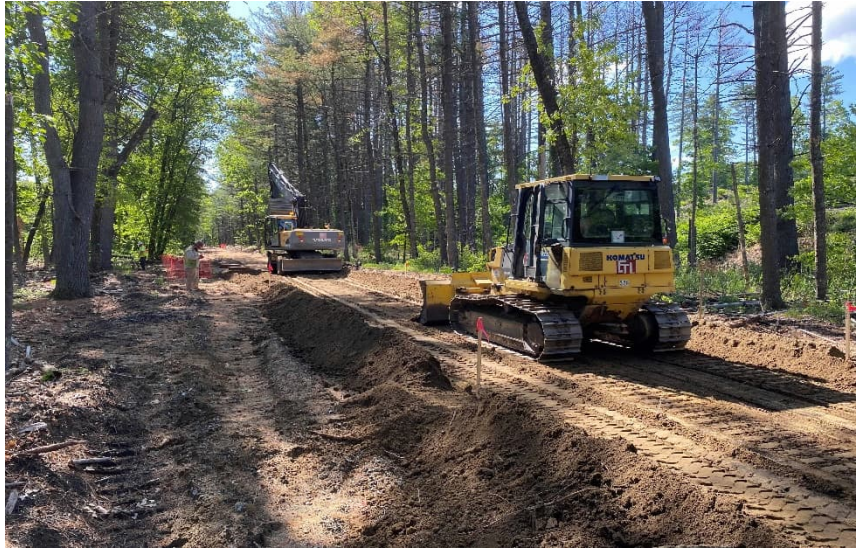
<b>PHOTOGRAPHIC LOG</b>	
Client Name: Eversource		Site Location: Sudbury to Hudson Transmission Reliability Project	Town: Hudson
Photo No.: 8	Date: 5-25-23

Description:  ET&L conducting site work within segment 4 at manhole #10, looking westward.

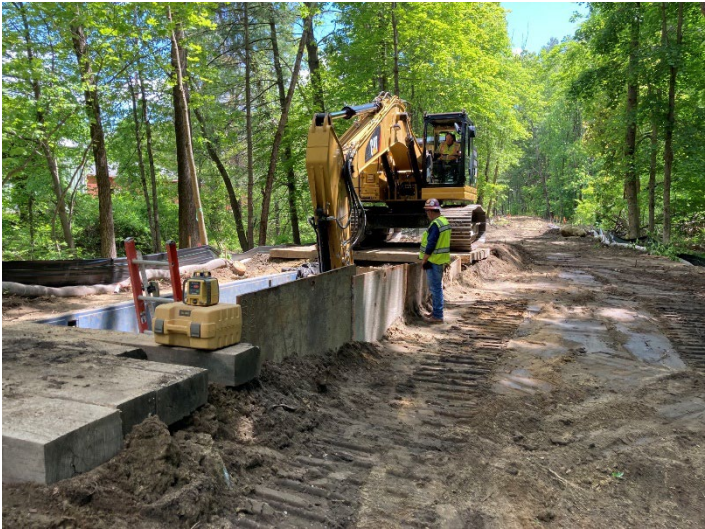
<b>PHOTOGRAPHIC LOG</b>	
<b>Client Name:</b> Eversource		<b>Site Location:</b> Sudbury to Hudson Transmission Reliability Project	<b>Town:</b> Sudbury
<b>Photo No.:</b> 4	<b>Date:</b> 5-25-2023

<b>Description:</b> View of Bond excavating for MH #25 installation in segment 13. Facing east.

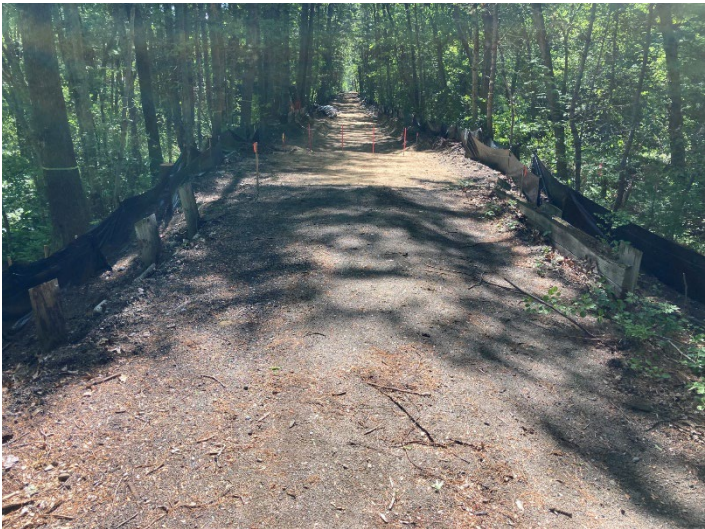
<b>Client Name: Eversource</b>		<b>Site Location: Sudbury to Hudson Transmission Reliability Project</b>	<b>Town: Sudbury</b>
<b>Photo No.: 6</b>	<b>Date: 5-25-2023</b>

<b>Description:</b> View of Dudley Brook culvert area in segment 10. Facing east.

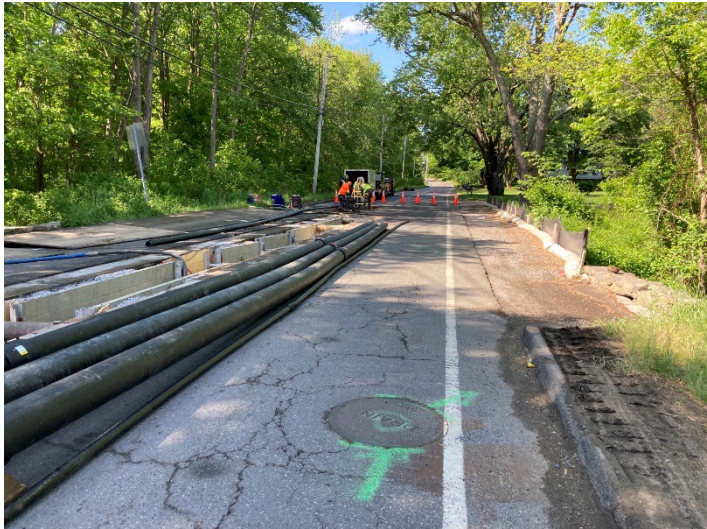
<b>Client Name: Eversource</b>		<b>Site Location: Sudbury to Hudson Transmission Reliability Project</b>	<b>Town: Hudson</b>
<b>Photo No.: 8</b>	<b>Date: 5-25-2023</b>

<b>Description:</b> View of Bond working near MH #4 on Forest Ave. See additional dewatering inspection reports. Facing south.

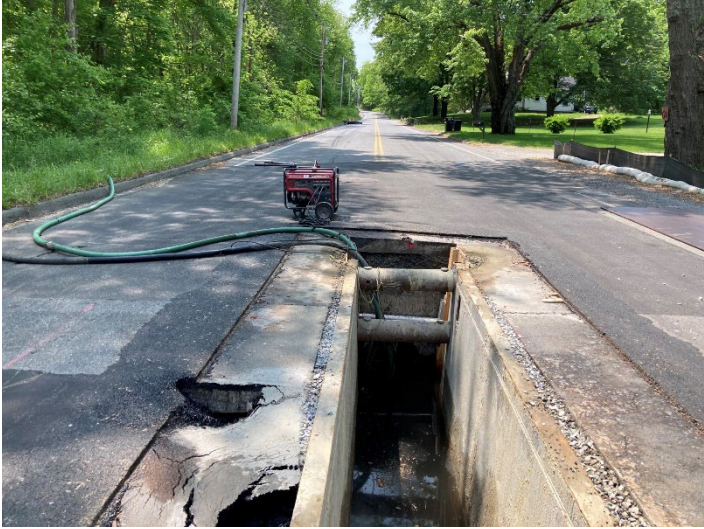
<b>PHOTOGRAPHIC LOG</b>		
<b>Client Name:</b> Eversource		<b>Site Location:</b> Sudbury to Hudson Transmission Reliability Project		<b>Town:</b> Hudson
<b>Photo No.:</b> 1	<b>Date:</b> 5/23/2023

<b>Description:</b> View of dewatering operation to catch basin south of MH #4 on Forest Ave in Hudson. Facing south.

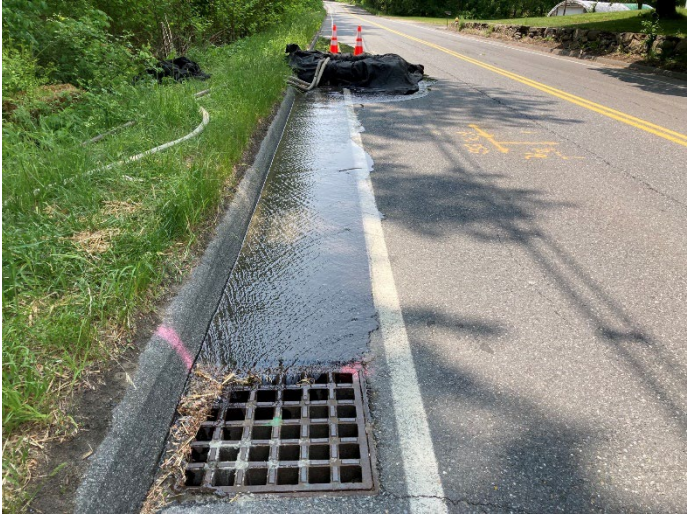
<b>PHOTOGRAPHIC LOG</b>		
<b>Client Name:</b> Eversource		<b>Site Location:</b> Sudbury to Hudson Transmission Reliability Project		<b>Town:</b> Hudson
<b>Photo No.:</b> 3	<b>Date:</b> 5/23/2023

<b>Description:</b> View of water flowing from dewatering controls into catch basin. Facing south.

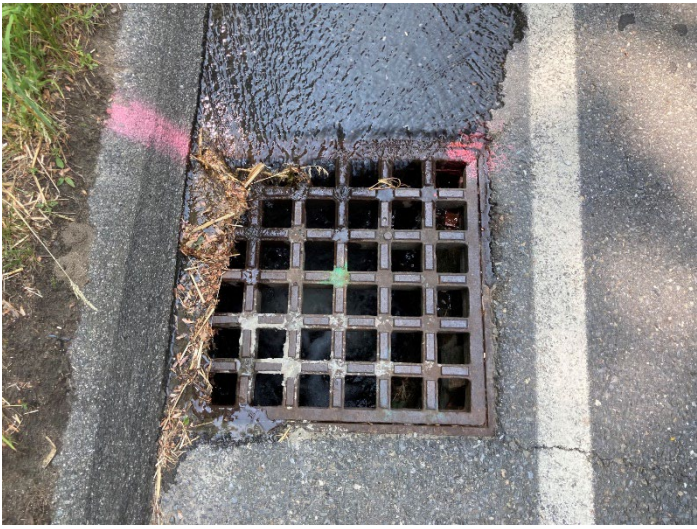
<b>PHOTOGRAPHIC LOG</b>		
<b>Client Name:</b> Eversource		<b>Site Location:</b> Sudbury to Hudson Transmission Reliability Project		<b>Town:</b> Hudson
<b>Photo No.:</b> 4	<b>Date:</b> 5/23/2023

<b>Section A – Dewatering Discharges (CGP Part 4.6.3)</b> Complete this section <u>within 24 hours</u> of completing the inspection. (If necessary, complete additional inspection reports for each separate inspection location.)	
Inspector Information	
Inspector Name: Ariel Leclerc	Title: Compliance Monitor, CESSWI, QCIS, QPSWPPP
Company Name: SWCA Environmental Consultants	Email: ariel.leclerc@swca.com
Address: 153 Cordaville Road, Suite 130, Southborough, MA 01772	Phone Number: 401-496-8471
Inspection Details	
Inspection Date: 5/23/2023	Inspection Location: MH #4 on Forest Ave- discharge point south of MH #4
Discharge Start Time: 7:55am	Discharge End Time: 2:30pm
Rate of Discharge (gallons per day): 50,400 (35 gallons per minute)	Corrective Action Required? <sup>1</sup> <input type="checkbox"/> Yes <input checked="" type="checkbox"/> No
<b>Describe Indicators of Pollutant Discharge at Point of Dewatering Discharge:<sup>1</sup></b> Turbidity sampling conducted. Dewatering set up to discharge to a Town of Hudson catch basin along Forest Avenue approximately 200' south of the area dewatered. Catch basin appears to discharge into stream below culvert at Forest Ave/Glendale Rd. Turbidity sampling > 50 NTUs.

<b>Description:</b> View of discharge point from project (catch basin below hay bale corral on Forest Ave). Discharge appeared clear. Turbidity reading was slightly above 50 NTUs.

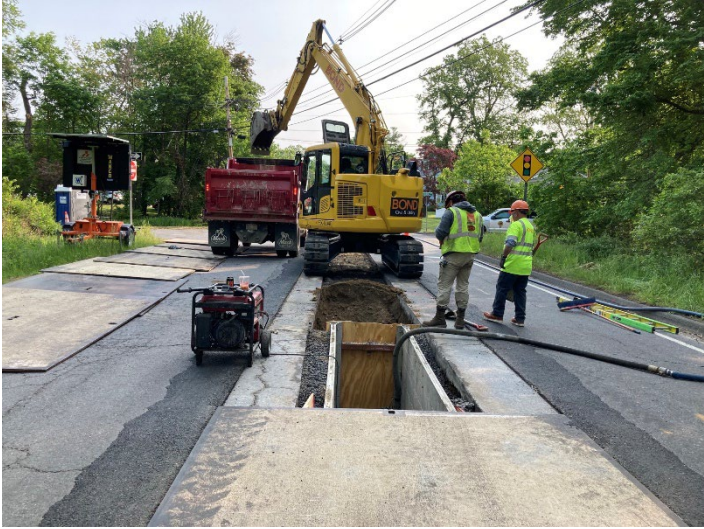
<b>PHOTOGRAPHIC LOG</b>		
<b>Client Name:</b> Eversource		<b>Site Location:</b> Sudbury to Hudson Transmission Reliability Project		<b>Town:</b> Hudson
<b>Photo No.:</b> 1	<b>Date:</b> 5/23/2023

<b>Description:</b> View of dewatering operation to catch basins north of MH #4 on Forest Ave in Hudson. Facing north.

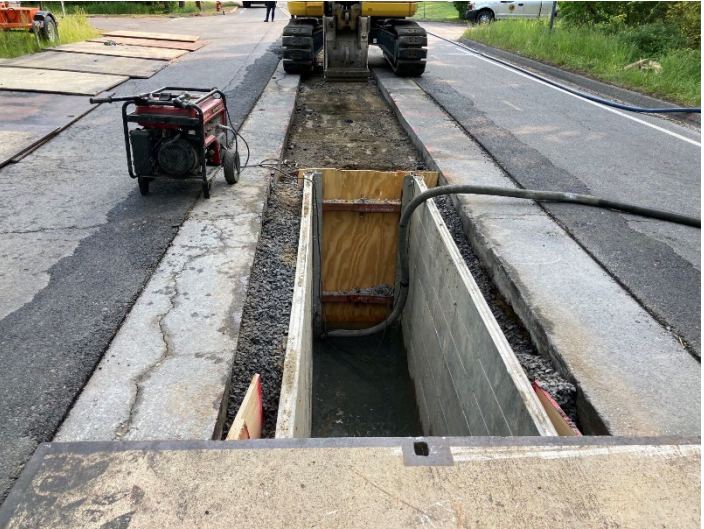
<b>PHOTOGRAPHIC LOG</b>		
<b>Client Name:</b> Eversource		<b>Site Location:</b> Sudbury to Hudson Transmission Reliability Project		<b>Town:</b> Hudson
<b>Photo No.:</b> 2	<b>Date:</b> 5/23/2023

<b>Description:</b> View of dewatering water in trench prior to treatment. Facing north.

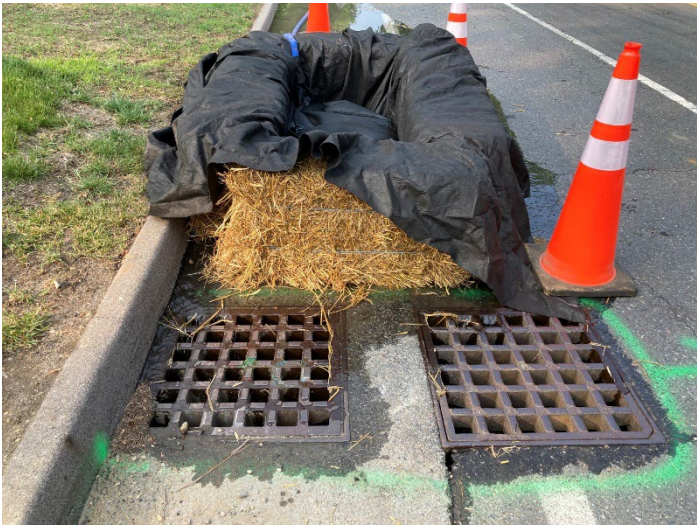
<b>PHOTOGRAPHIC LOG</b>		
<b>Client Name:</b> Eversource		<b>Site Location:</b> Sudbury to Hudson Transmission Reliability Project		<b>Town:</b> Hudson
<b>Photo No.:</b> 4	<b>Date:</b> 5/23/2023

<b>Description:</b> View of discharge point from project (catch basins below hay bale corral on Forest Ave). Discharge appeared clear. Turbidity reading was less than 50 NTUs. Facing south.

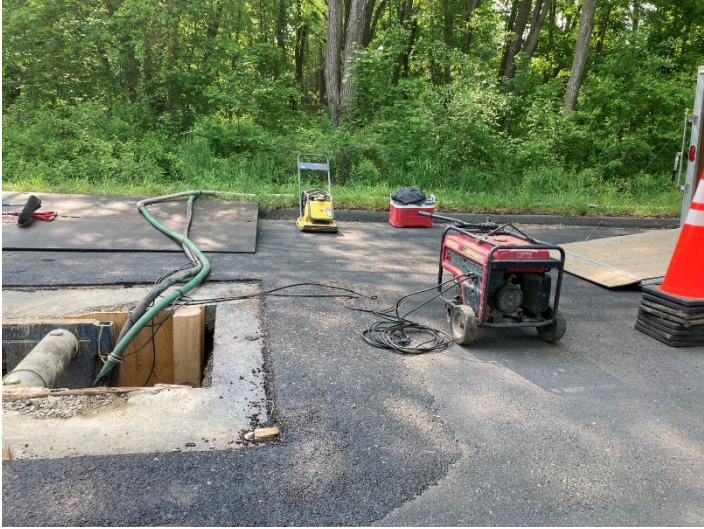
<b>PHOTOGRAPHIC LOG</b>	
<b>Client Name:</b> Eversource		<b>Site Location:</b> Sudbury to Hudson Transmission Reliability Project	<b>Town:</b> Hudson
<b>Photo No.:</b> 1	<b>Date:</b> 5/24/2023

<b>Description:</b> View of dewatering operation to catch basin south of MH #4 on Forest Ave in Hudson. Facing east.

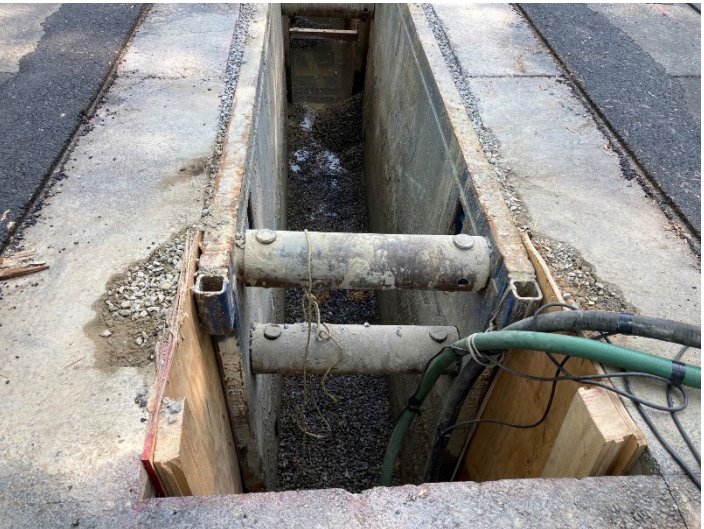
<b>PHOTOGRAPHIC LOG</b>	
<b>Client Name:</b> Eversource		<b>Site Location:</b> Sudbury to Hudson Transmission Reliability Project	<b>Town:</b> Hudson
<b>Photo No.:</b> 2	<b>Date:</b> 5/24/2023

<b>Description:</b> View of dewatering water in trench prior to treatment.

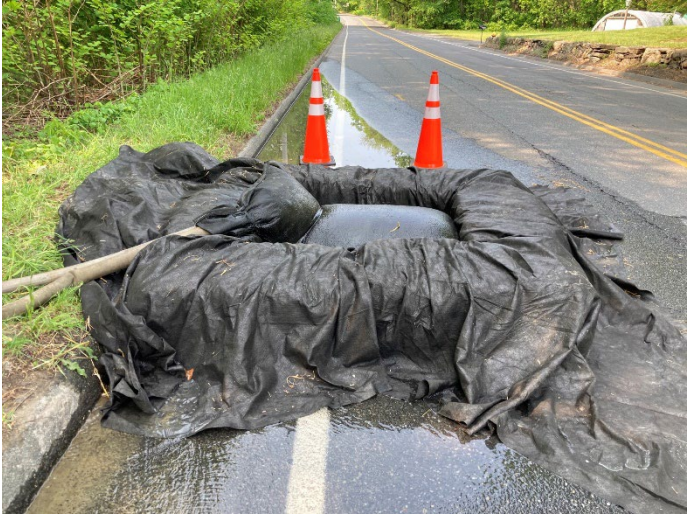
<b>PHOTOGRAPHIC LOG</b>		
<b>Client Name:</b> Eversource		<b>Site Location:</b> Sudbury to Hudson Transmission Reliability Project		<b>Town:</b> Hudson
<b>Photo No.:</b> 3	<b>Date:</b> 5/24/2023

<b>Description:</b> View of dewatering controls (straw bale corral with filter fabric and silt bag). Facing south.

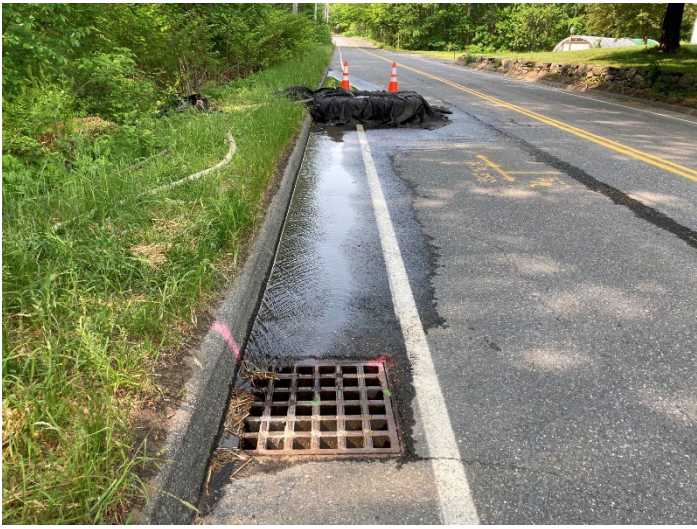
<b>PHOTOGRAPHIC LOG</b>		
<b>Client Name:</b> Eversource		<b>Site Location:</b> Sudbury to Hudson Transmission Reliability Project		<b>Town:</b> Hudson
<b>Photo No.:</b> 4	<b>Date:</b> 5/24/2023

<b>Description:</b> View of water flowing from dewatering controls into discharge point from project (catch basin below hay bale corral on Forest Ave). Discharge appeared clear. Turbidity reading was less than 50 NTUs. Facing south.

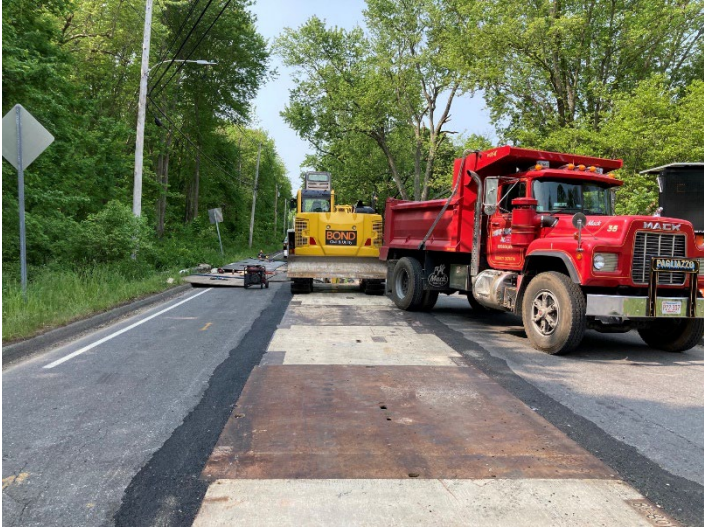
<b>PHOTOGRAPHIC LOG</b>		
<b>Client Name:</b> Eversource		<b>Site Location:</b> Sudbury to Hudson Transmission Reliability Project		<b>Town:</b> Hudson
<b>Photo No.:</b> 1	<b>Date:</b> 5/24/2023

<b>Description:</b> View of dewatering operation to catch basins north of MH #4 on Forest Ave in Hudson. Facing south.

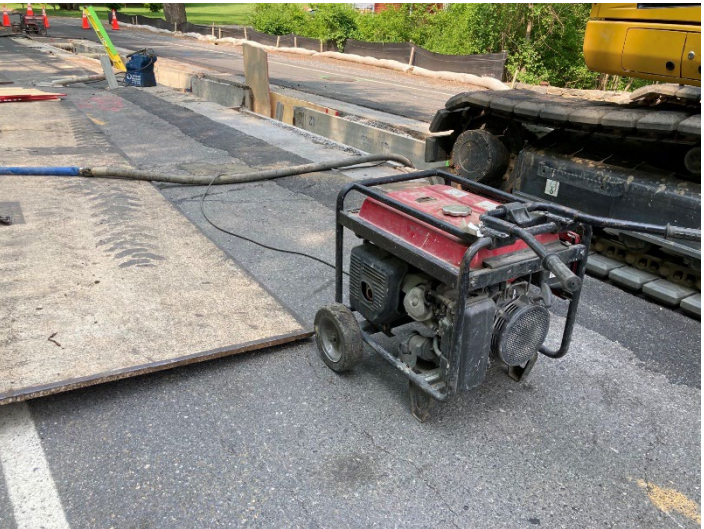
<b>PHOTOGRAPHIC LOG</b>		
<b>Client Name:</b> Eversource		<b>Site Location:</b> Sudbury to Hudson Transmission Reliability Project		<b>Town:</b> Hudson
<b>Photo No.:</b> 2	<b>Date:</b> 5/24/2023

<b>Description:</b> Additional view of dewatering operation to catch basins north of MH #4 on Forest Ave in Hudson. Facing southwest.
