**Weekly Environmental Compliance Summary**

**Sudbury to Hudson Transmission Reliability Project (USEPA Tracking # MAR1003UW)**

Week of: May 22 to May 26, 2023

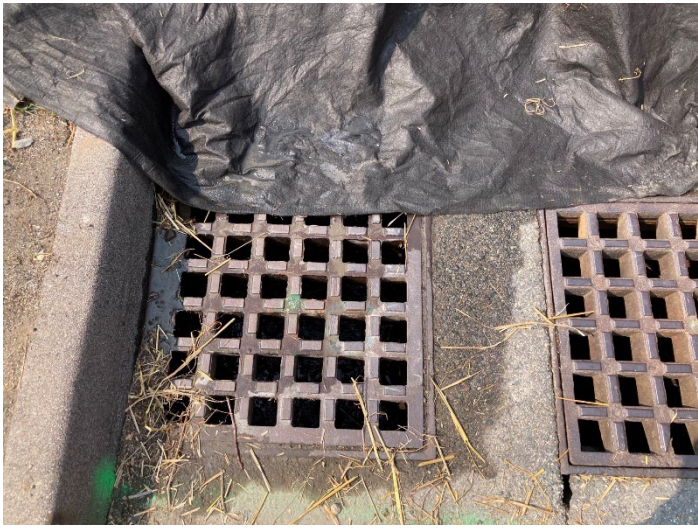
<b>PHOTOGRAPHIC LOG</b>		
<b>Client Name:</b> Eversource		<b>Site Location:</b> Sudbury to Hudson Transmission Reliability Project		<b>Town:</b> Hudson
<b>Photo No.:</b> 4	<b>Date:</b> 5/24/2023

<b>Description:</b> View of discharge point from project (catch basins below hay bale corral on Forest Ave). Discharge appeared slightly turbid. Turbidity reading was higher than 50 NTUs.

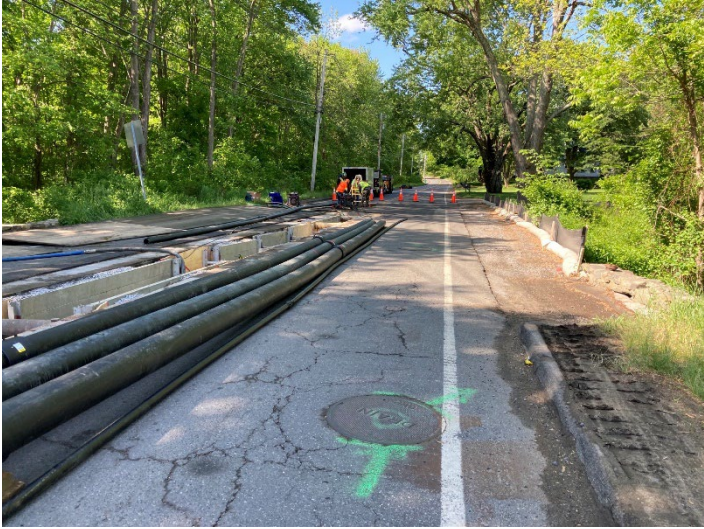
<b>PHOTOGRAPHIC LOG</b>	
<b>Client Name:</b> Eversource		<b>Site Location:</b> Sudbury to Hudson Transmission Reliability Project	<b>Town:</b> Hudson
<b>Photo No.:</b> 1	<b>Date:</b> 5/25/2023

<b>Description:</b> View of work area and dewatering operations at MH #4 on Forest Ave in Hudson. Facing south.

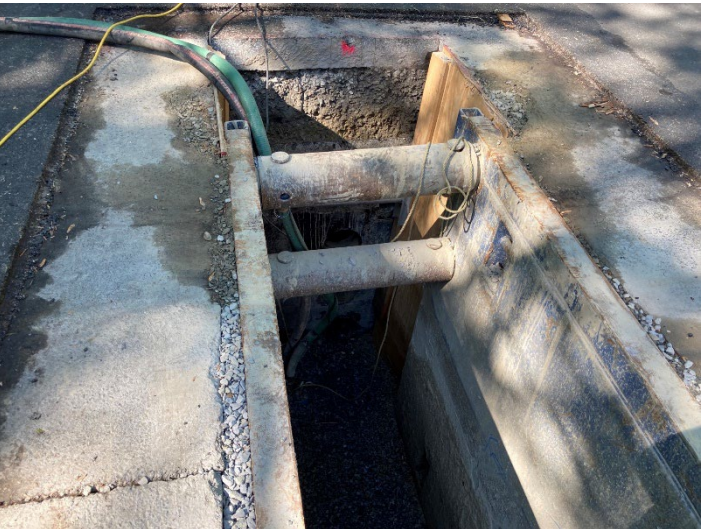
<b>PHOTOGRAPHIC LOG</b>	
<b>Client Name:</b> Eversource		<b>Site Location:</b> Sudbury to Hudson Transmission Reliability Project	<b>Town:</b> Hudson
<b>Photo No.:</b> 2	<b>Date:</b> 5/25/2023

<b>Description:</b> View of dewatering water in trench prior to treatment.

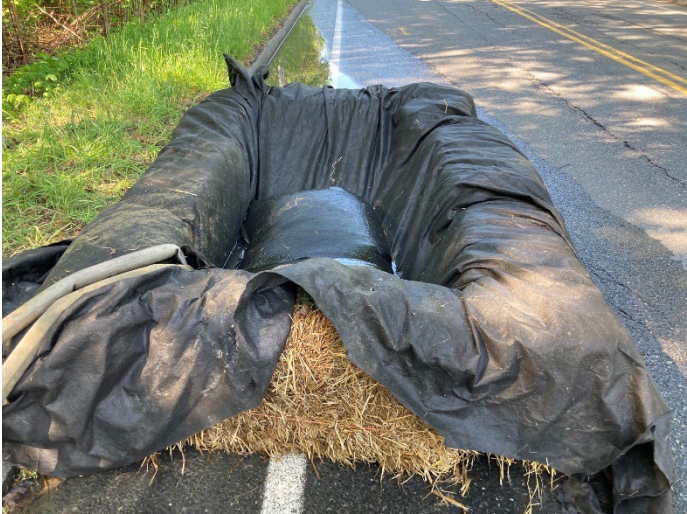
<b>PHOTOGRAPHIC LOG</b>		
<b>Client Name:</b> Eversource		<b>Site Location:</b> Sudbury to Hudson Transmission Reliability Project		<b>Town:</b> Hudson
<b>Photo No.:</b> 3	<b>Date:</b> 5/25/2023

<b>Description:</b> View of dewatering controls (straw bale corral with filter fabric and silt bag). Facing south.

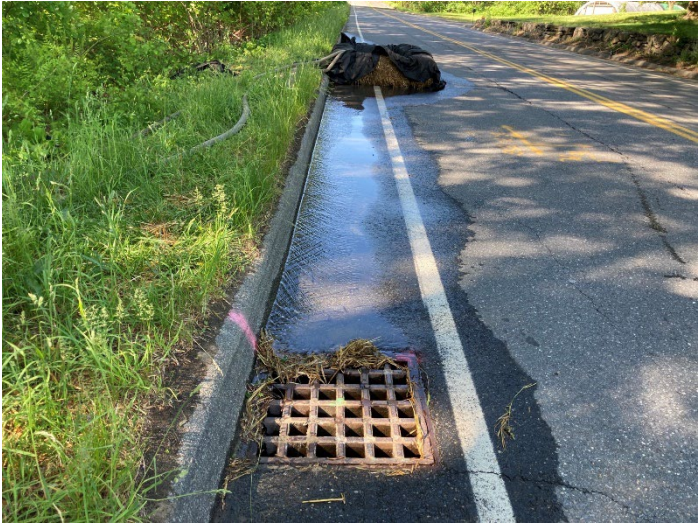
<b>PHOTOGRAPHIC LOG</b>		
<b>Client Name:</b> Eversource		<b>Site Location:</b> Sudbury to Hudson Transmission Reliability Project		<b>Town:</b> Hudson
<b>Photo No.:</b> 4	<b>Date:</b> 5/25/2023

<b>Description:</b> View of water flowing from dewatering controls into discharge point from project (catch basin below hay bale corral on Forest Ave). Discharge appeared clear. Turbidity reading was less than 50 NTUs. Facing south.

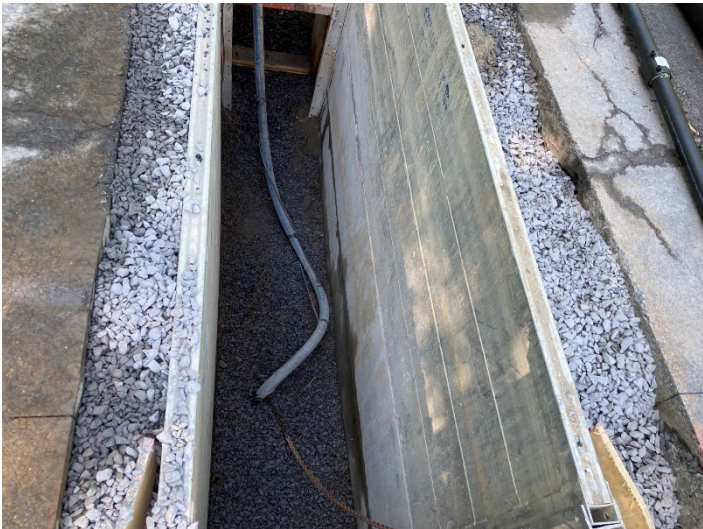
<b>PHOTOGRAPHIC LOG</b>		
<b>Client Name:</b> Eversource		<b>Site Location:</b> Sudbury to Hudson Transmission Reliability Project		<b>Town:</b> Hudson
<b>Photo No.:</b> 2	<b>Date:</b> 5/25/2023

<b>Description:</b> Additional view of dewatering operation to catch basins north of MH #4 on Forest Ave in Hudson.

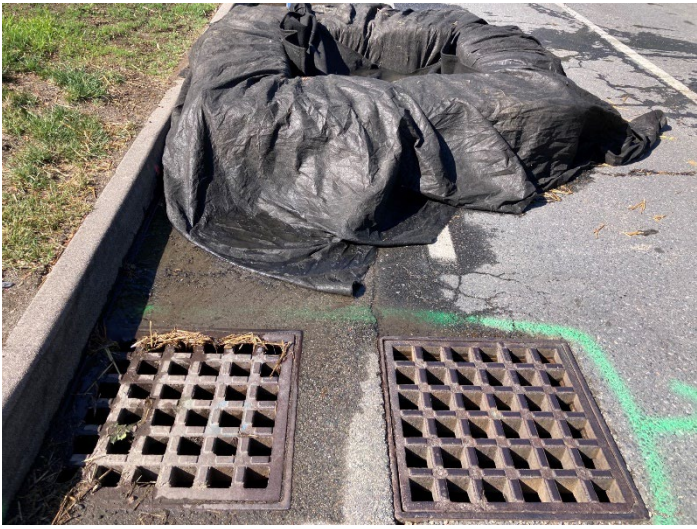
<b>PHOTOGRAPHIC LOG</b>		
<b>Client Name:</b> Eversource		<b>Site Location:</b> Sudbury to Hudson Transmission Reliability Project		<b>Town:</b> Hudson
<b>Photo No.:</b> 4	<b>Date:</b> 5/25/2023

<b>Description:</b> View of discharge point from project (catch basins below hay bale corral on Forest Ave). Discharge appeared slightly turbid. Turbidity reading was slightly higher than 50 NTUs. Facing south.

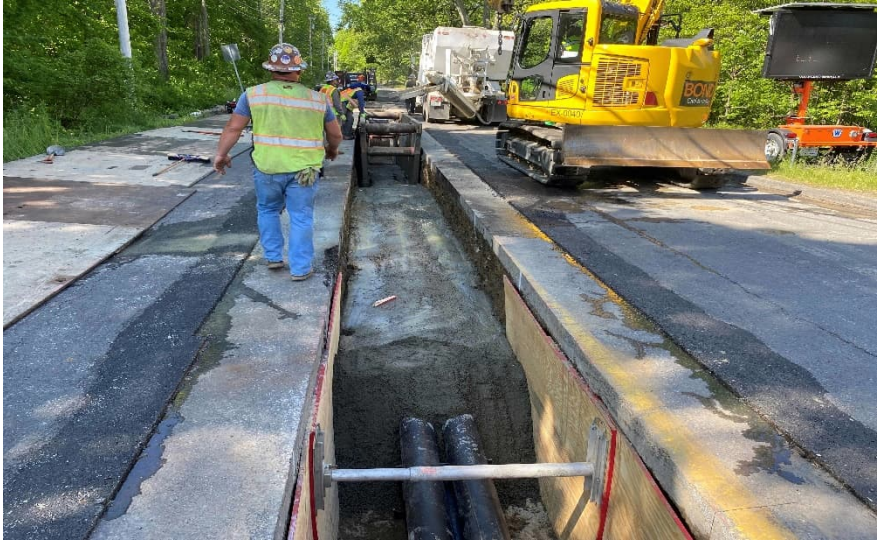
<b>PHOTOGRAPHIC LOG</b>	
Client Name: Eversource		Site Location: Sudbury to Hudson Transmission Reliability Project	Town: Hudson
Photo No.: 1	Date: 5/26/2023

Description: View of area being pumped at work operation at MH#4, in Forest Avenue, looking southward.

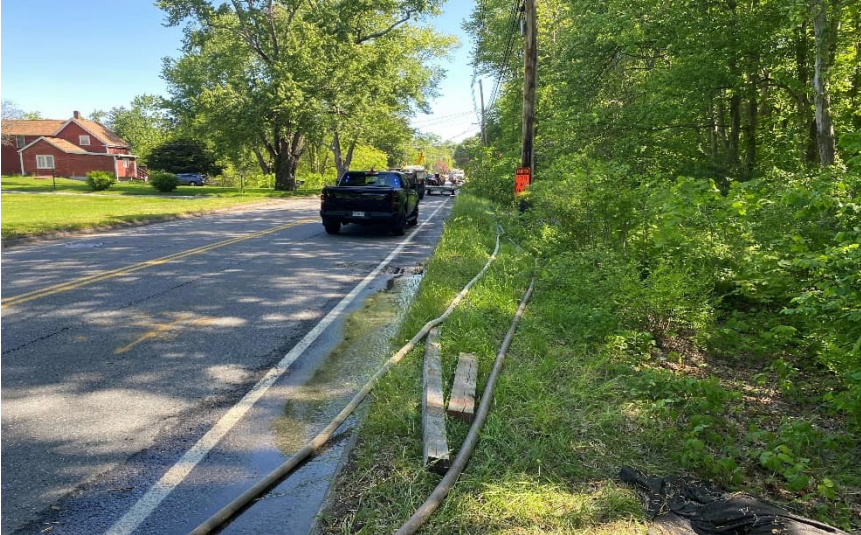
<b>PHOTOGRAPHIC LOG</b>	
Client Name: Eversource		Site Location: Sudbury to Hudson Transmission Reliability Project	Town: Hudson
Photo No.: 3	Date: 5/26/2023

Description: MH#4. View of dewatering operation, looking northward.
