Weekly Environmental Compliance Summary

Sudbury to Hudson Transmission Reliability Project (USEPA Tracking # MAR1003UW)

Week of: June 5 to June 9, 2023

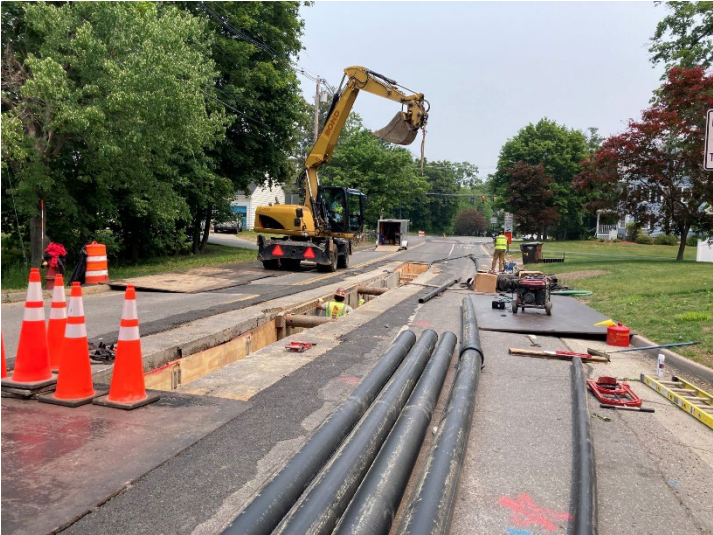
Description: View of Bond working near MH #4 on Forest Ave. See additional dewatering inspection report. Facing north.

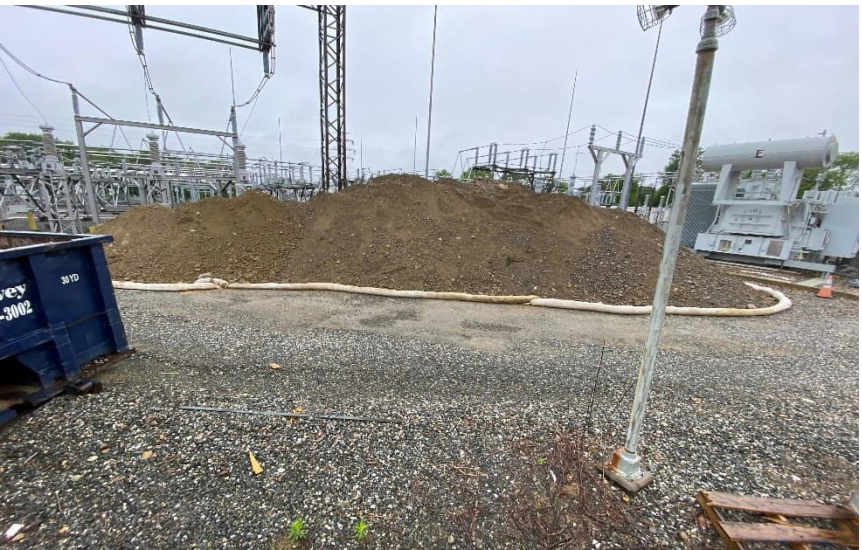
Description: Spoil pile within substation, erosion control (compost filter tube) installed correctly & functioning properly, looking southward.

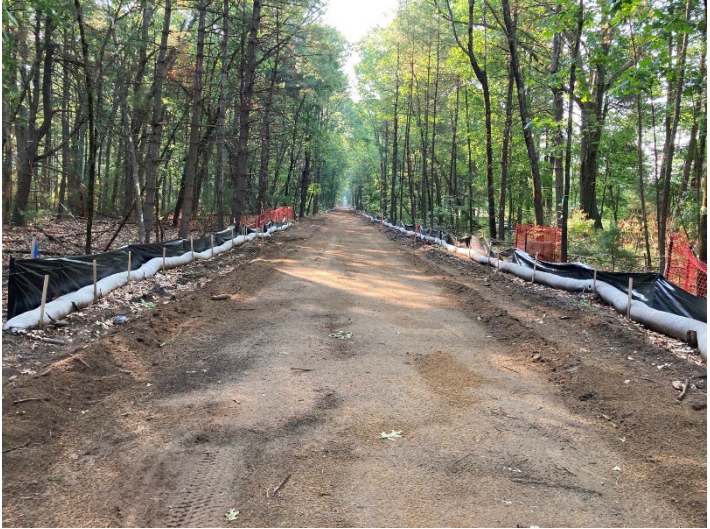
Description: View of Type A E&S controls in segment 4. Facing east.

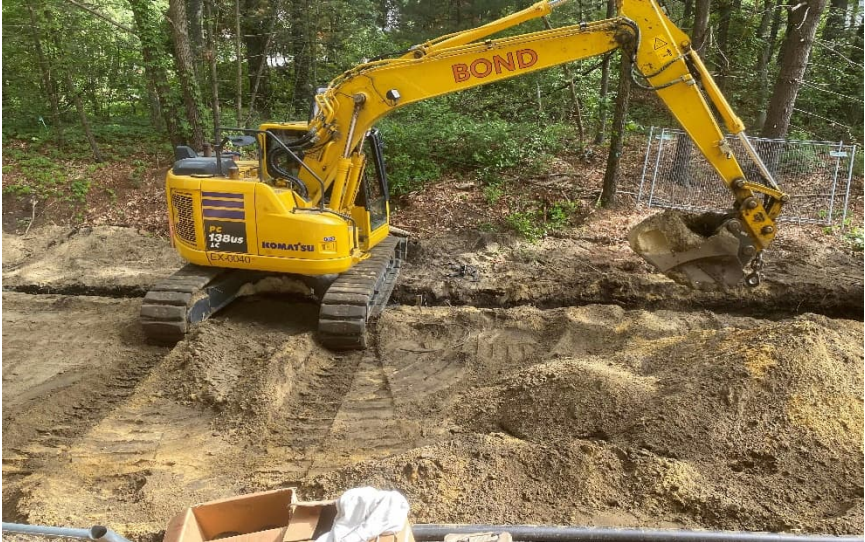
<p>PHOTOGRAPHIC LOG</p>	
<p>Client Name: Eversource</p>		<p>Site Location: Sudbury to Hudson Transmission Reliability Project</p>	<p>Town: Sudbury</p>
<p>Photo No.: 6</p>	<p>Date: 6-9-23</p>

<p>Description:</p> <p>Bond conducting conduit work within Segment 11, looking northward.</p>

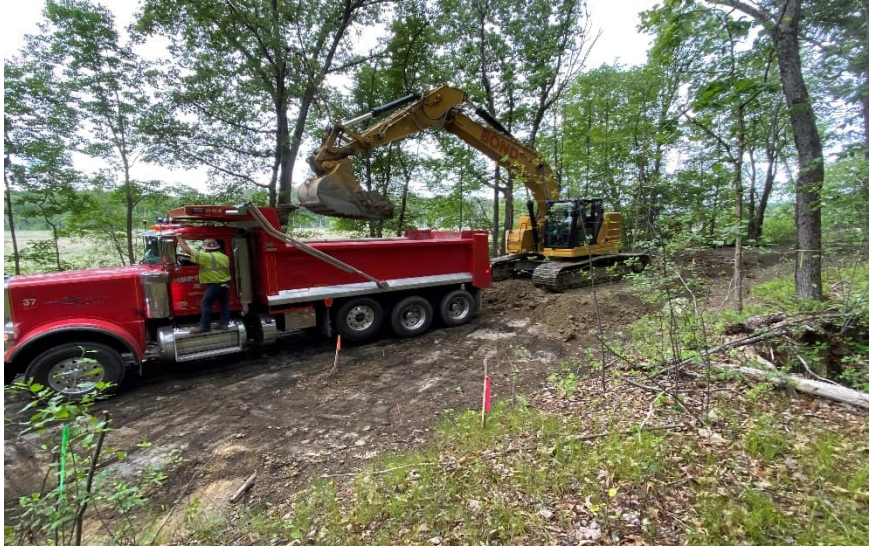
<p>PHOTOGRAPHIC LOG</p>	
<p>Client Name: Eversource</p>		<p>Site Location: Sudbury to Hudson Transmission Reliability Project</p>	<p>Town: Sudbury</p>
<p>Photo No.: 8</p>	<p>Date: 6-9-23</p>

<p>Description: Right-of-way within segment 14, spoil removal from manhole #26 area, existing erosion control, looking westward.</p>

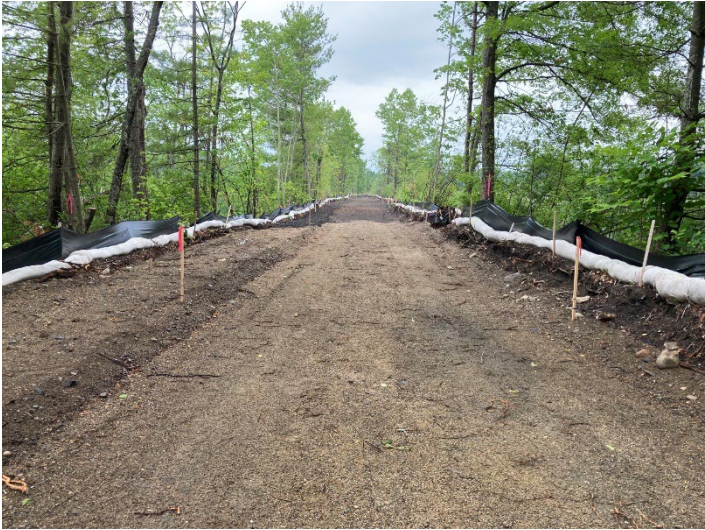
PHOTOGRAPHIC LOG	
Client Name: Eversource		Site Location: Sudbury to Hudson Transmission Reliability Project	Town: Hudson
Photo No.: 3	Date: 6-08-2023

Description: View of Type A E&S controls in segment 2. Facing east.

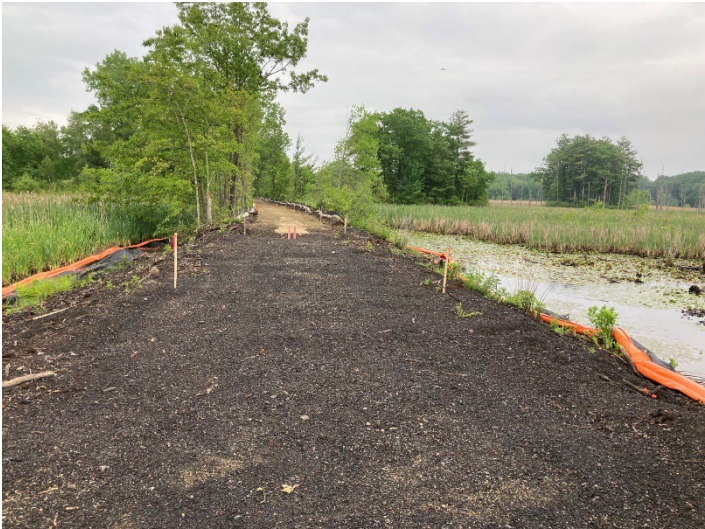
PHOTOGRAPHIC LOG	
Client Name: Eversource		Site Location: Sudbury to Hudson Transmission Reliability Project	Town: Hudson
Photo No.: 4	Date: 6-08-2023

Description: View of segment 3 from bridge 130. Facing east.

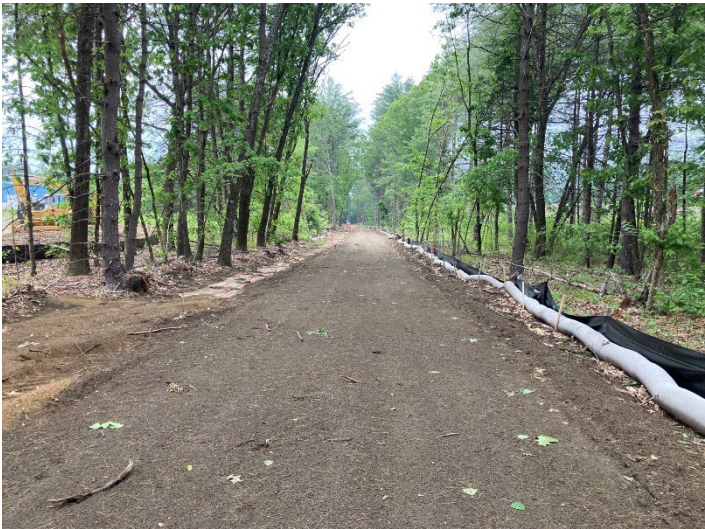
Epsilon ASSOCIATES INC.		PHOTOGRAPHIC LOG	
Client Name: Eversource		Site Location: Sudbury to Hudson Transmission Reliability Project	Town: Hudson
Photo No.: 5	Date: 6-08-2023

Description: View of Type A E&S controls in segment 4. Facing east.

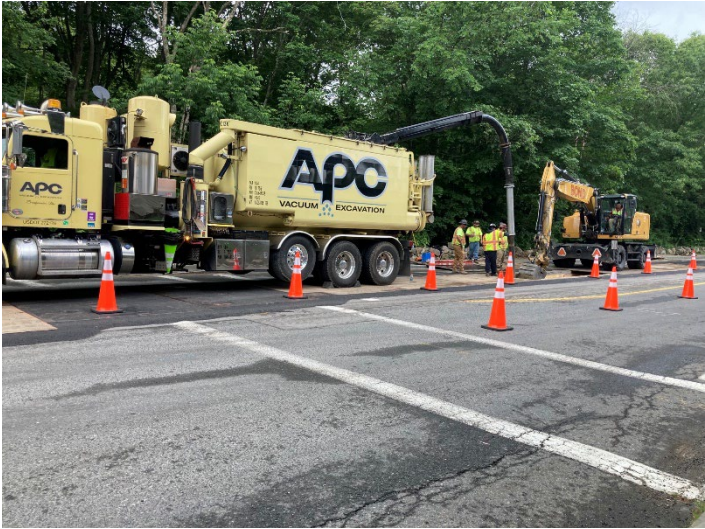
Epsilon ASSOCIATES INC.		PHOTOGRAPHIC LOG	
Client Name: Eversource		Site Location: Sudbury to Hudson Transmission Reliability Project	Town: Hudson
Photo No.: 6	Date: 6-08-2023

Description: View of Bond working near MH #2 on Forest Ave. Facing southwest.

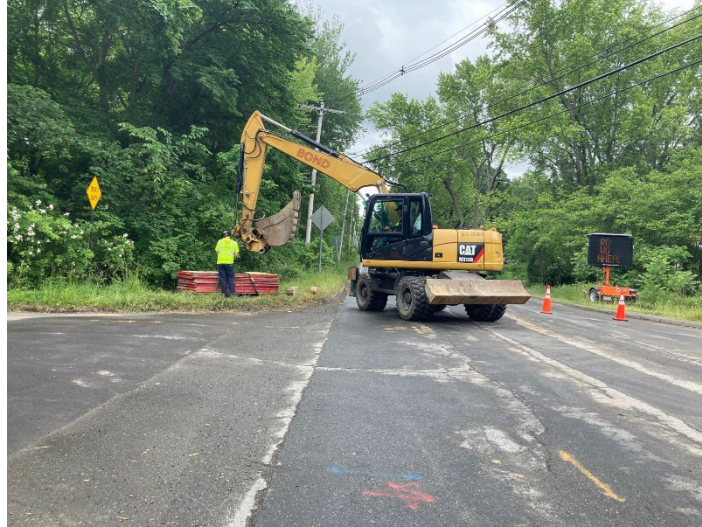
Description:
View of Bond working near MH #4 on Forest Ave. Facing south.

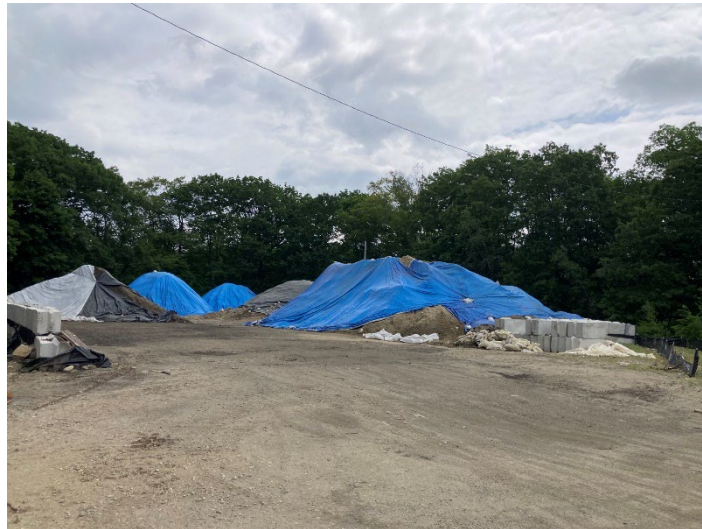
Description:
View of laydown yard at Stowe Ct. Facing northeast.

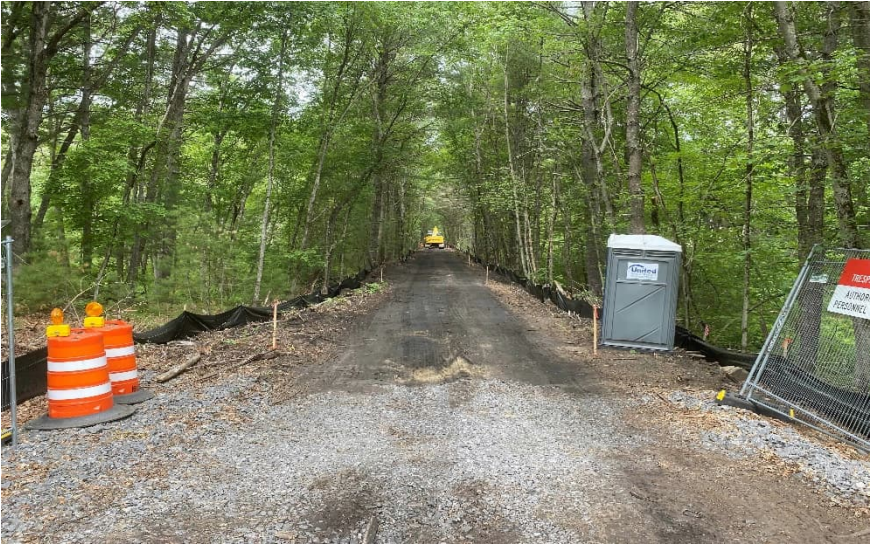
PHOTOGRAPHIC LOG	
Client Name: Eversource		Site Location: Sudbury to Hudson Transmission Reliability Project	Town: Sudbury
Photo No.: 1	Date: 6-8-23

Description: Right-of-way within segment 9, existing erosion control, looking westward.

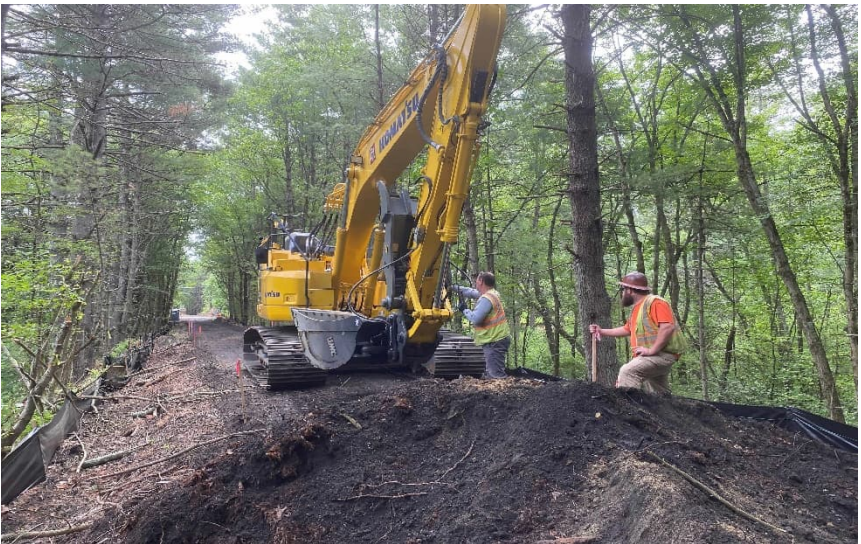
PHOTOGRAPHIC LOG	
Client Name: Eversource		Site Location: Sudbury to Hudson Transmission Reliability Project	Town: Sudbury
Photo No.: 2	Date: 6-8-23

Description: ET&L conducting grading within segment 9, existing erosion control, looking eastward.

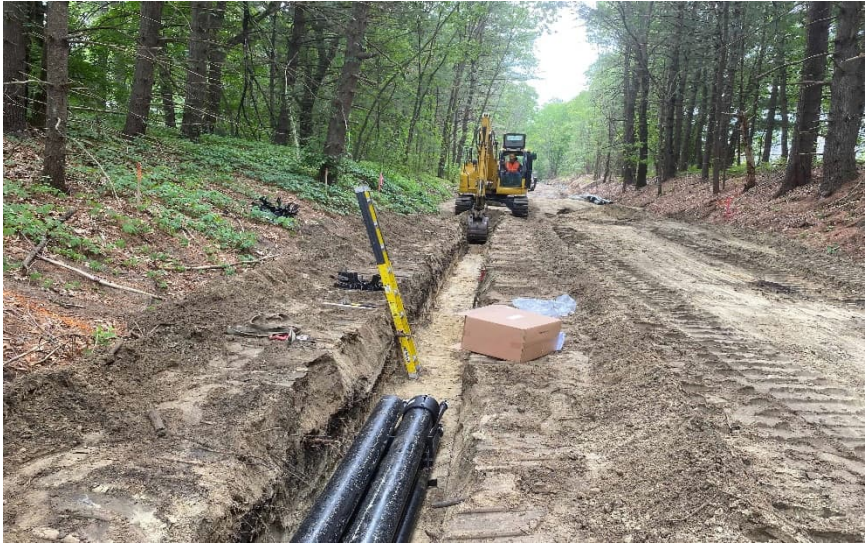
PHOTOGRAPHIC LOG	
Client Name: Eversource		Site Location: Sudbury to Hudson Transmission Reliability Project	Town: Sudbury
Photo No.: 3	Date: 6-8-23

Description: Bond conducting conduit work within segment 11, existing erosion control, looking eastward.

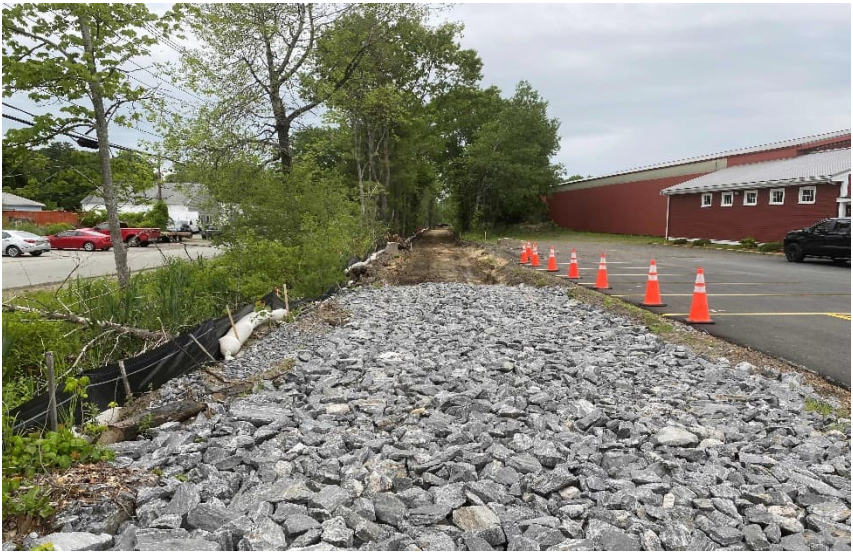
PHOTOGRAPHIC LOG	
Client Name: Eversource		Site Location: Sudbury to Hudson Transmission Reliability Project	Town: Sudbury
Photo No.: 4	Date: 6-8-23

Description: Right-of-way within segment 12, existing erosion control, looking eastward.

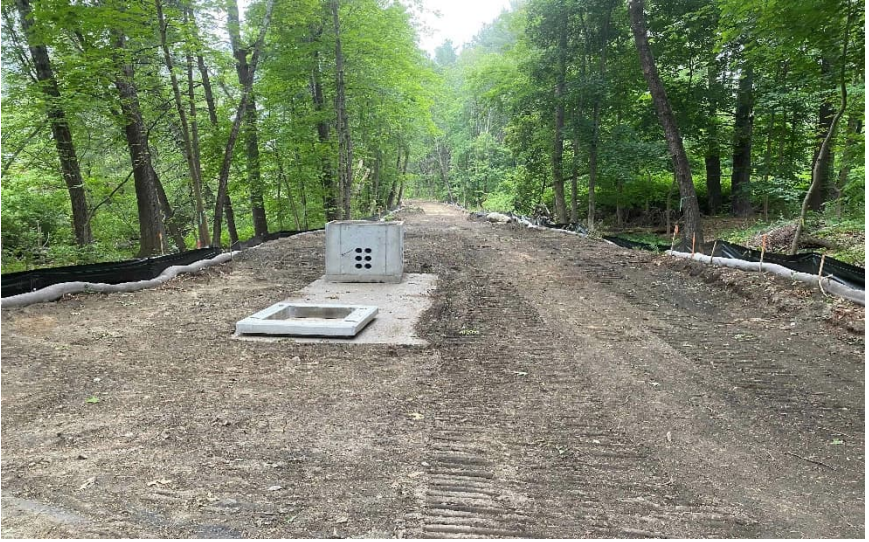
PHOTOGRAPHIC LOG	
Client Name: Eversource		Site Location: Sudbury to Hudson Transmission Reliability Project	Town: Sudbury
Photo No.: 5	Date: 6-8-23

Description: Right-of-way within segment 13, manhole #25, existing erosion control, looking eastward.

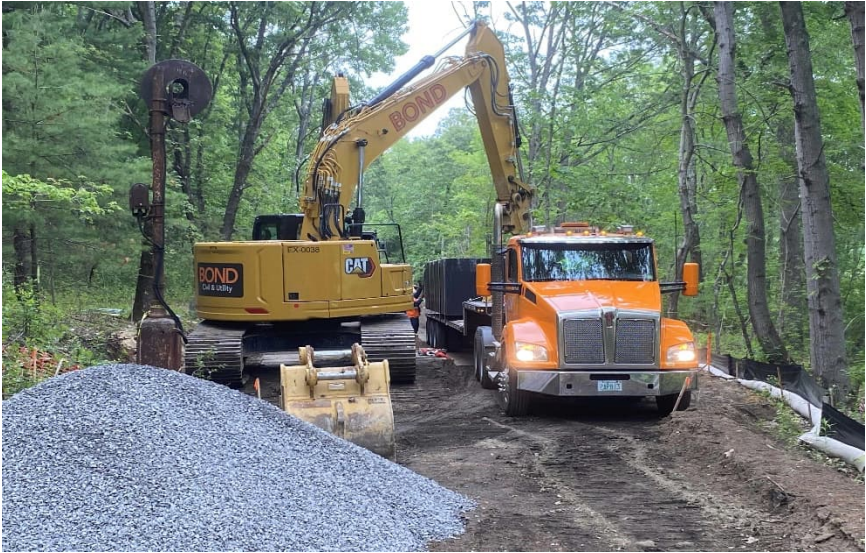
PHOTOGRAPHIC LOG	
Client Name: Eversource		Site Location: Sudbury to Hudson Transmission Reliability Project	Town: Sudbury
Photo No.: 7	Date: 6-8-23

Description: Right-of-way within Segment 14, installation of manhole #26, existing erosion control, looking eastward.

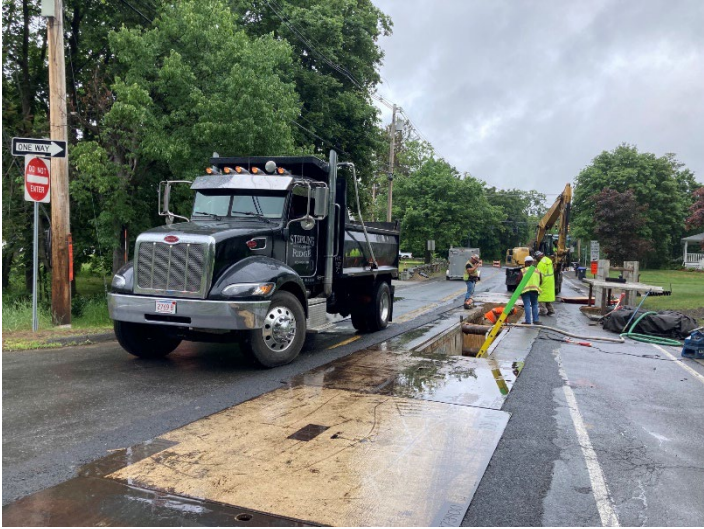
PHOTOGRAPHIC LOG	
Client Name: Eversource		Site Location: Sudbury to Hudson Transmission Reliability Project	Town: Hudson
Photo No.: 1	Date: 6/05/2023

Description: View of work area and dewatering operation at MH #4 on Forest Ave in Hudson. Facing north.

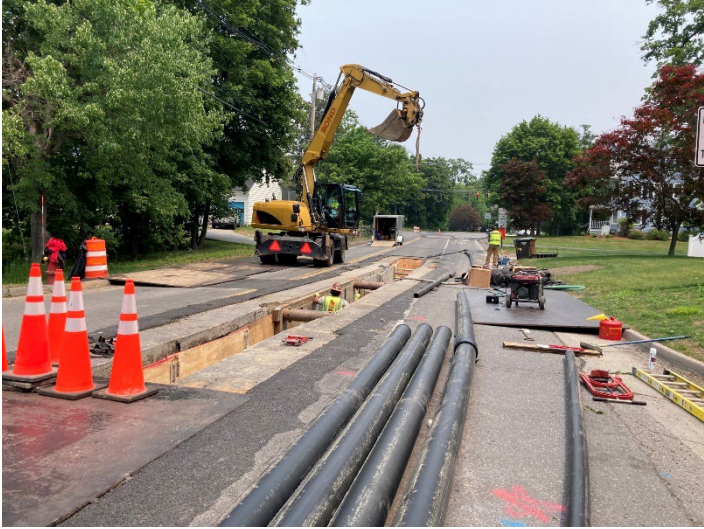
PHOTOGRAPHIC LOG		
Client Name: Eversource		Site Location: Sudbury to Hudson Transmission Reliability Project		Town: Hudson
Photo No.: 1	Date: 6/06/2023

Description: View of work area and dewatering operation at MH #4 on Forest Ave in Hudson. Facing north.

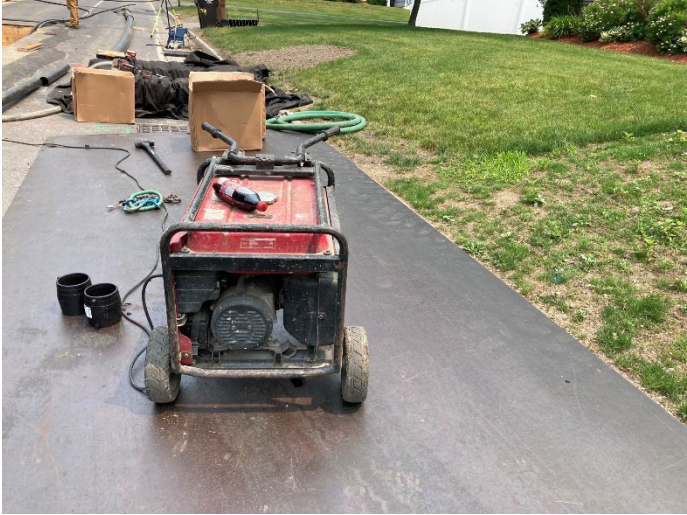
PHOTOGRAPHIC LOG	
Client Name: Eversource		Site Location: Sudbury to Hudson Transmission Reliability Project	
Town: Hudson		Photo No.: 3	
Date: 6/06/2023		Description: View of pumping/dewatering operation. Facing north.

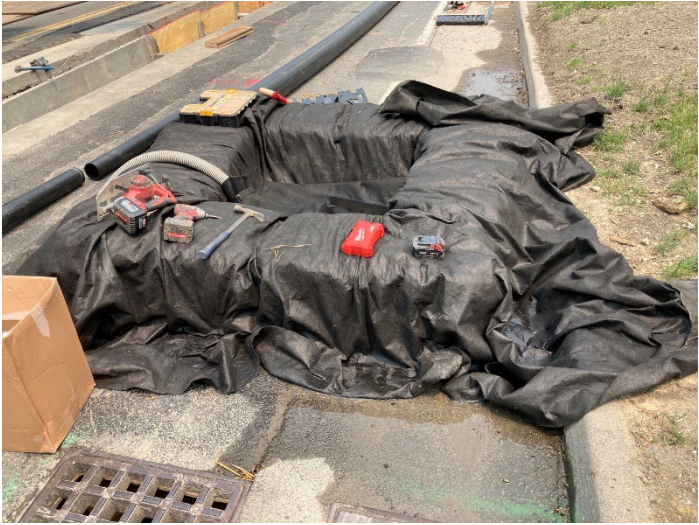
PHOTOGRAPHIC LOG	
Client Name: Eversource		Site Location: Sudbury to Hudson Transmission Reliability Project	
Town: Hudson		Photo No.: 4	
Date: 6/06/2023		Description: View dewatering controls (straw bale corral with filter fabric and silt bag) and discharge point from project (catch basins below hay bale corral on Forest Ave). Discharge appeared slightly turbid. Turbidity reading was slightly higher than 50 NTUs. Facing north.
