Weekly Environmental Compliance Summary

Sudbury to Hudson Transmission Reliability Project (USEPA Tracking # MAR1003UW)

Week of: June 12 to June 16, 2023

CONSTRUCTION MONITORING REPORT

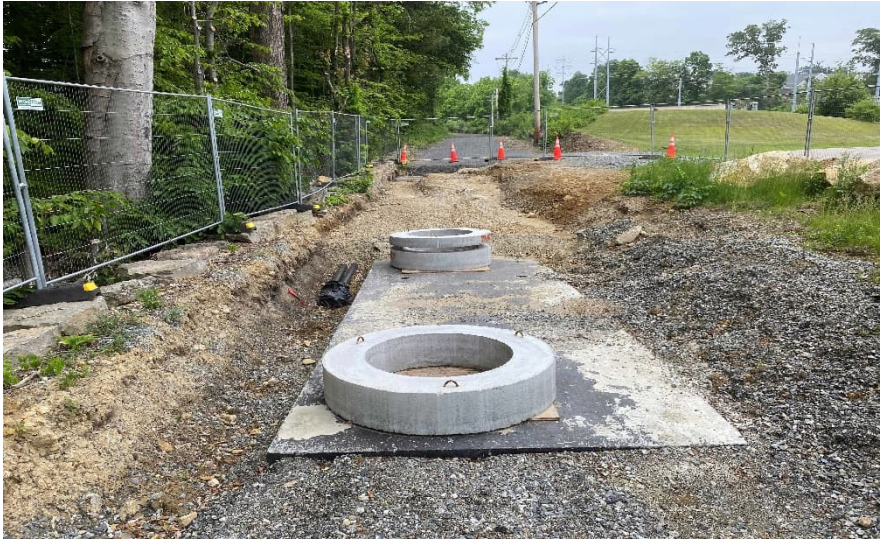
PHOTOGRAPHIC LOG	
Client Name: Eversource		Site Location: Sudbury to Hudson Transmission Reliability Project	Town: Hudson
Photo No.: 1	Date: 6-12-23

Description: Manhole #1, looking eastward.

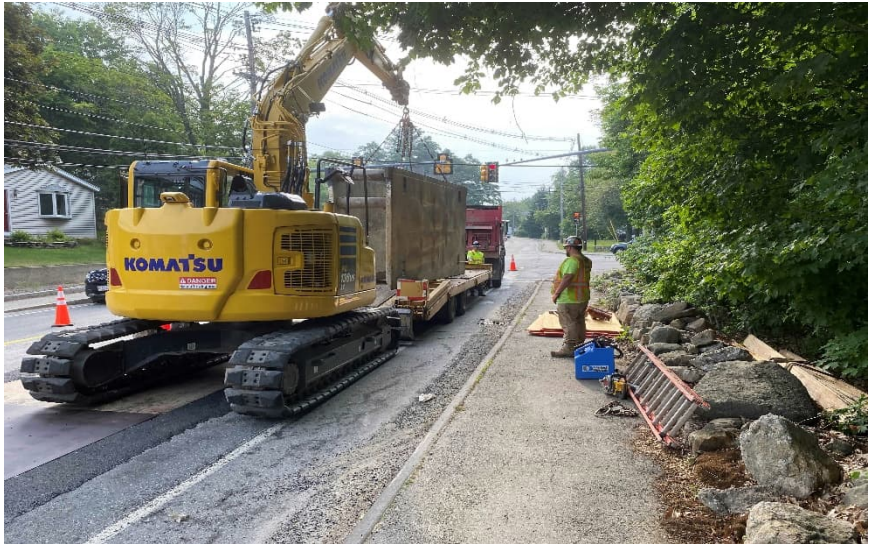
PHOTOGRAPHIC LOG	
Client Name: Eversource		Site Location: Sudbury to Hudson Transmission Reliability Project	Town: Hudson
Photo No.: 2	Date: 6-12-23

Description: Bond conducting conduit work, within Forest Avenue near manhole #2, looking northward.

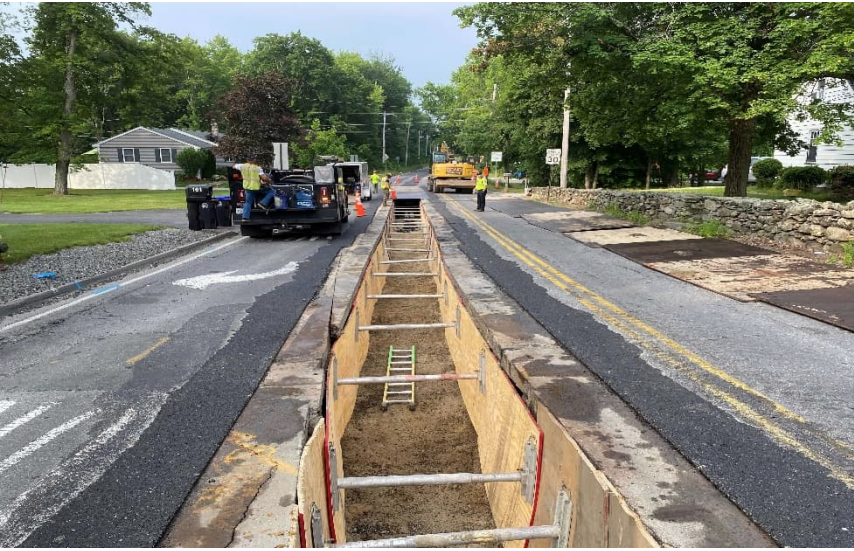
PHOTOGRAPHIC LOG	
Client Name: Eversource		Site Location: Sudbury to Hudson Transmission Reliability Project	Town: Hudson
Photo No.: 3	Date: 6-12-23

Description: Bond conducting conduit work, within Forest Avenue near manhole #4, looking southward.

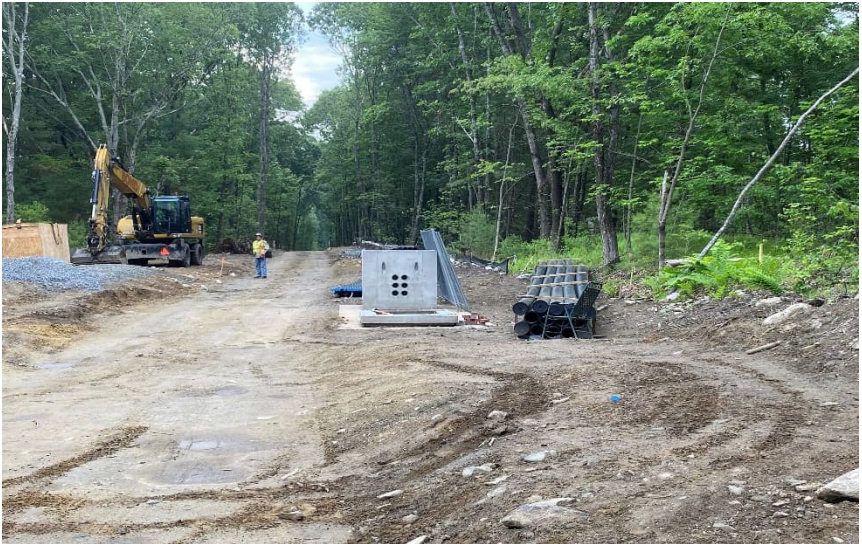
PHOTOGRAPHIC LOG	
Client Name: Eversource		Site Location: Sudbury to Hudson Transmission Reliability Project	Town: Hudson
Photo No.: 7	Date: 6-12-23

Description: Manhole #5 within segment 1, existing erosion control, looking eastward.

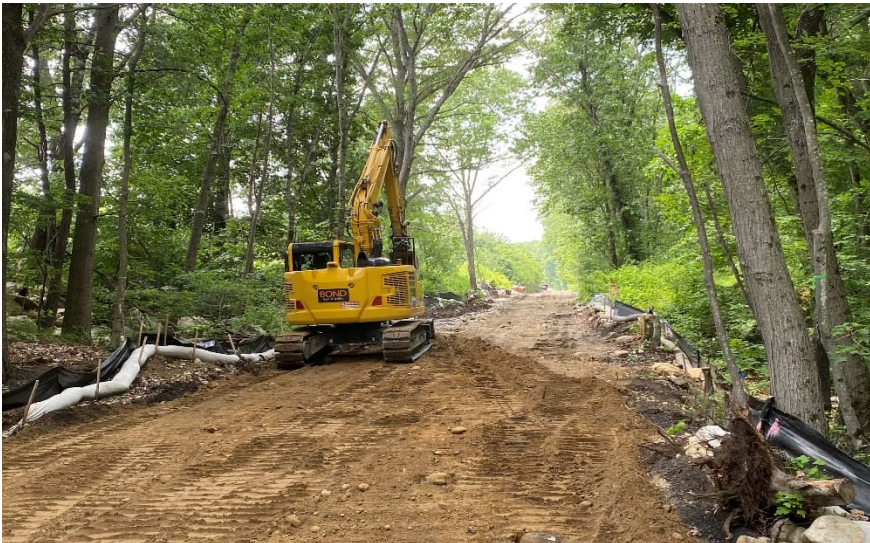
PHOTOGRAPHIC LOG	
Client Name: Eversource		Site Location: Sudbury to Hudson Transmission Reliability Project	Town: Hudson
Photo No.: 8	Date: 6-12-23

Description: Right-of-way, within Segment 1, Bond conducting conduit work, existing erosion control, looking westward.

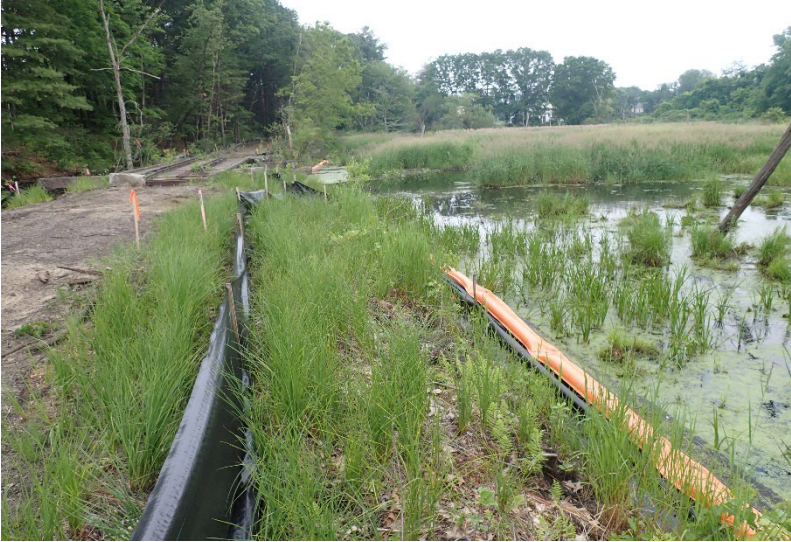
PHOTOGRAPHIC LOG	
Client Name: Eversource		Site Location: Sudbury to Hudson Transmission Reliability Project	Town: Sudbury
Photo No.: 1	Date: 6-12-23

Description: View of turbidity curtain and silt fence installed near the bridge within Segment 14. Facing westward.

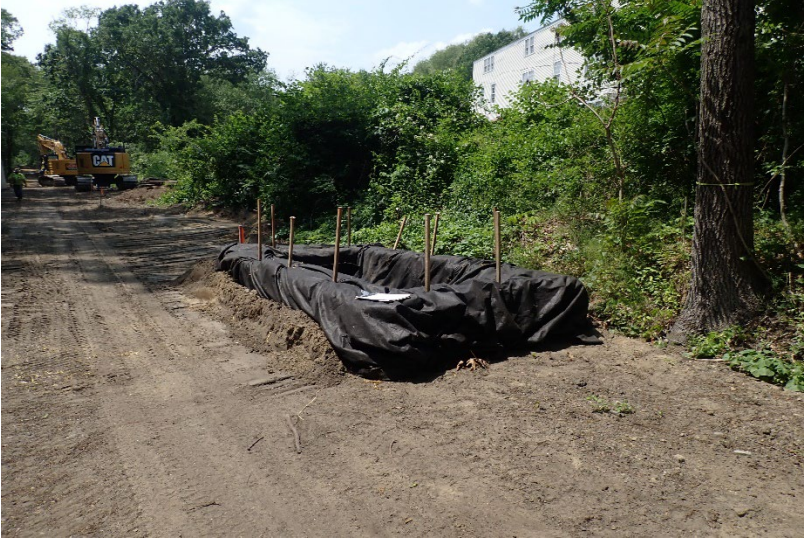
PHOTOGRAPHIC LOG	
Client Name: Eversource		Site Location: Sudbury to Hudson Transmission Reliability Project	Town: Sudbury
Photo No.: 2	Date: 6-12-23

Description: View of installed dewatering basin for work on manhole #27 within segment 14. Facing westward.

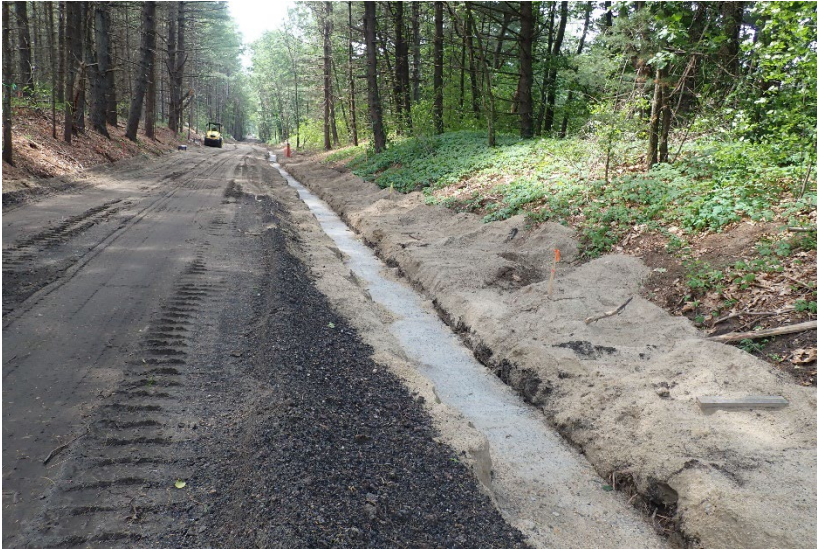
PHOTOGRAPHIC LOG	
Client Name: Eversource		Site Location: Sudbury to Hudson Transmission Reliability Project	Town: Sudbury
Photo No.: 3	Date: 6-12-23

Description: View of Bond conducting conduit work within right-of-way within segment 11. Facing westward.

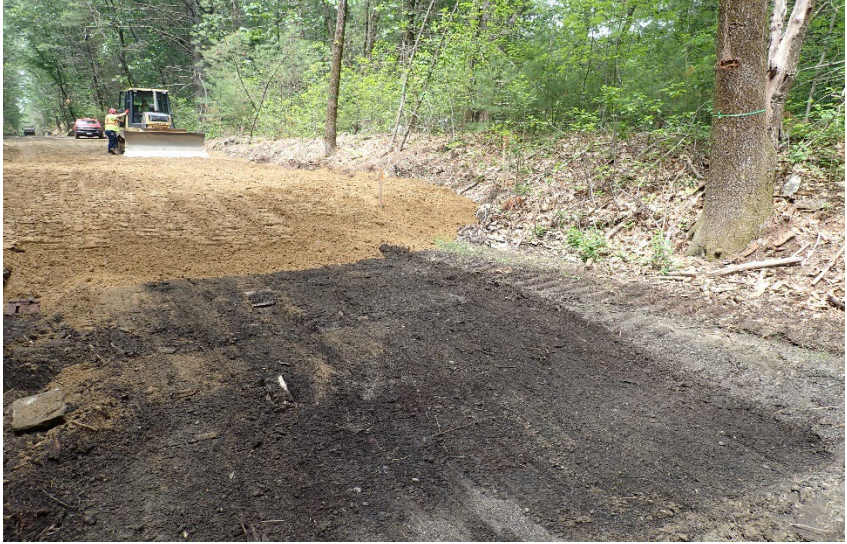
PHOTOGRAPHIC LOG	
Client Name: Eversource		Site Location: Sudbury to Hudson Transmission Reliability Project	Town: Sudbury
Photo No.: 5	Date: 6-12-23

Description: View of ET&L conducting grading work within segment 9. Facing westward.

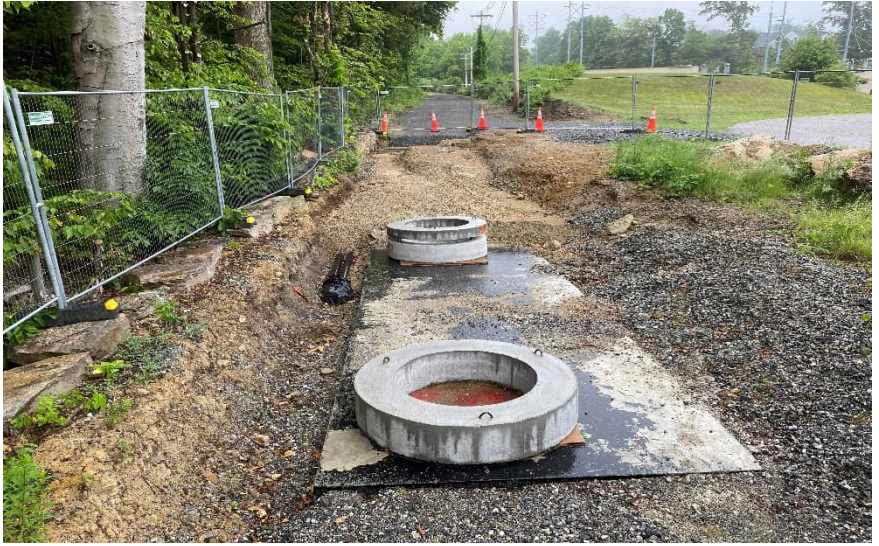
PHOTOGRAPHIC LOG	
Client Name: Eversource		Site Location: Sudbury to Hudson Transmission Reliability Project	Town: Hudson
Photo No.: 1	Date: 6-13-23

Description: Manhole #1, looking eastward.

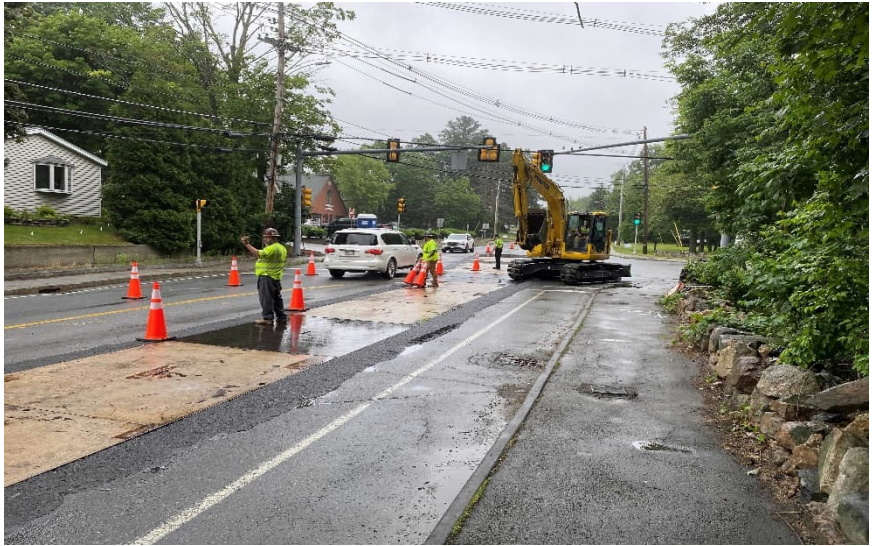
PHOTOGRAPHIC LOG	
Client Name: Eversource		Site Location: Sudbury to Hudson Transmission Reliability Project	Town: Hudson
Photo No.: 2	Date: 6-13-23

Description: Bond conducting conduit work, within Forest Avenue near manhole #2, looking northward.

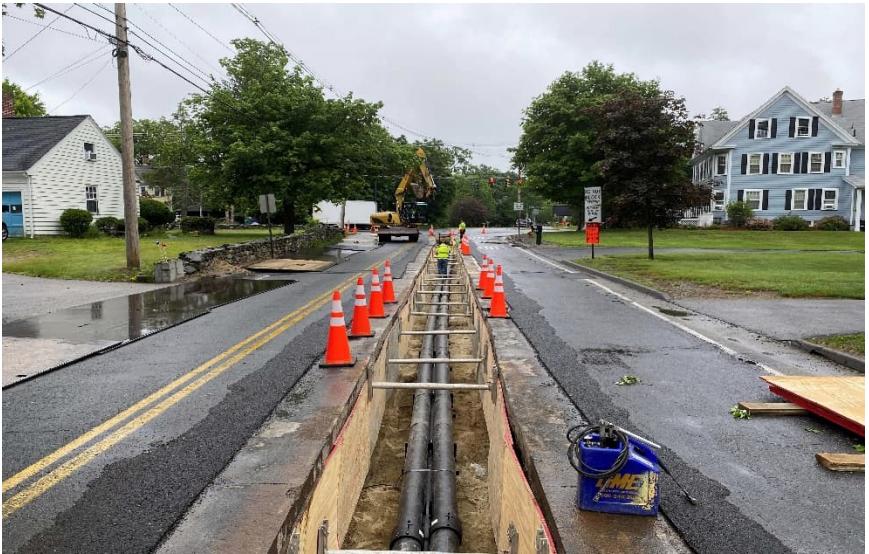
PHOTOGRAPHIC LOG	
Client Name: Eversource		Site Location: Sudbury to Hudson Transmission Reliability Project	Town: Hudson
Photo No.: 4	Date: 6-13-23

Description: Bond conducting conduit work, within Forest Avenue near manhole #4, looking northward.

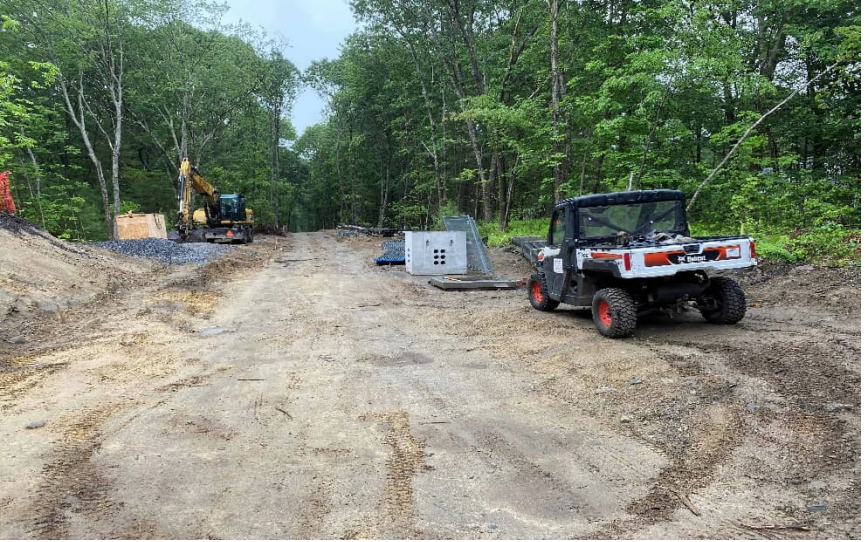
PHOTOGRAPHIC LOG	
Client Name: Eversource		Site Location: Sudbury to Hudson Transmission Reliability Project	Town: Hudson
Photo No.: 5	Date: 6-13-23

Description: Right-of-way within segment 1, manhole #5, looking eastward.

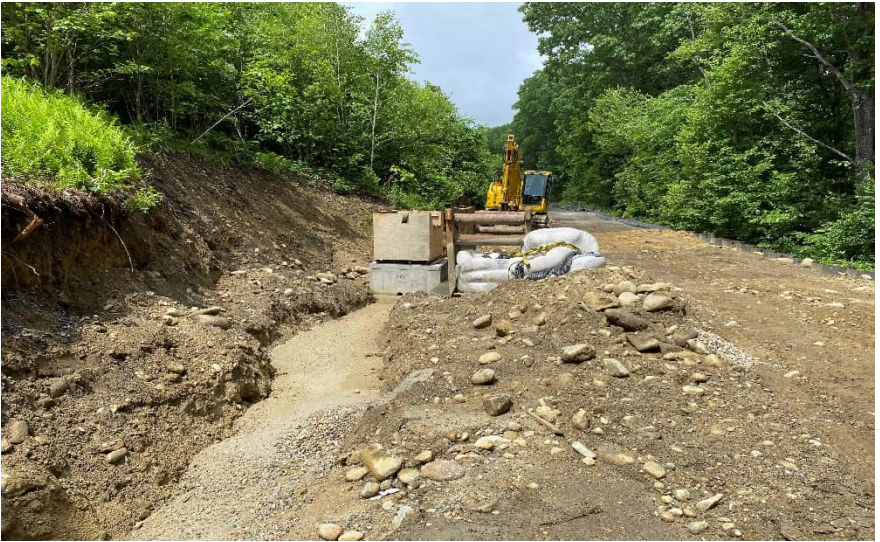
PHOTOGRAPHIC LOG	
Client Name: Eversource		Site Location: Sudbury to Hudson Transmission Reliability Project	Town: Hudson
Photo No.: 6	Date: 6-13-23

Description: Right-of-way within segment 1, manhole #6, looking westward.

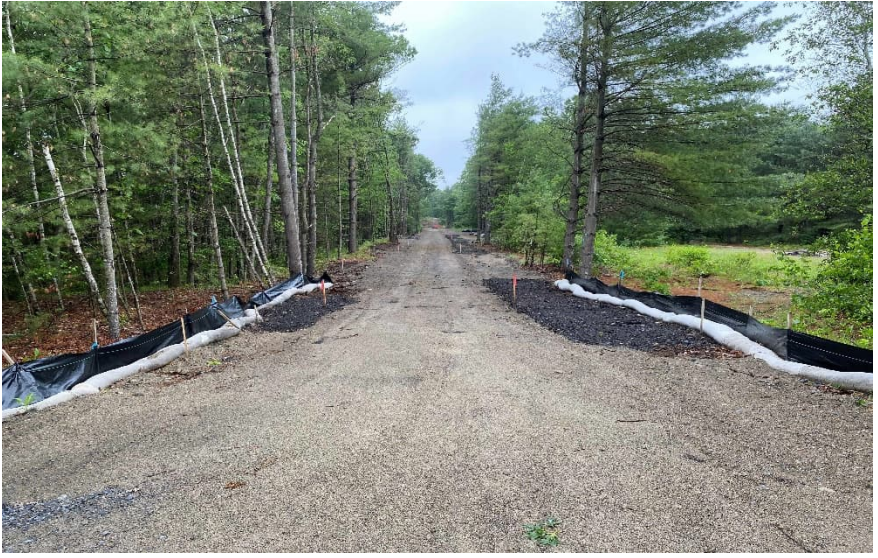
PHOTOGRAPHIC LOG	
Client Name: Eversource		Site Location: Sudbury to Hudson Transmission Reliability Project	Town: Hudson
Photo No.: 7	Date: 6-13-23

Description: Manhole #7, segment 2, existing erosion control, looking westward.

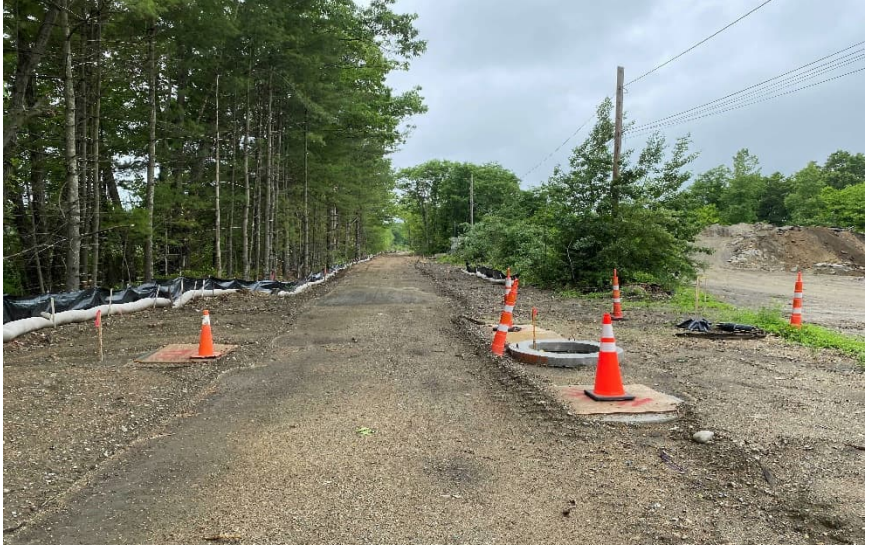
PHOTOGRAPHIC LOG	
Client Name: Eversource		Site Location: Sudbury to Hudson Transmission Reliability Project	Town: Hudson
Photo No.: 8	Date: 6-13-23

Description: Manhole #8 within segment 3, existing erosion control, looking westward.

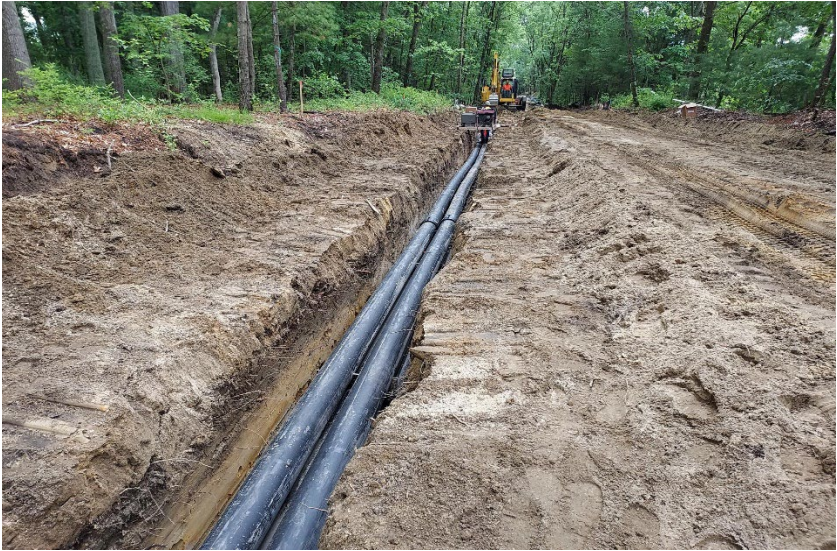
PHOTOGRAPHIC LOG	
Client Name: Eversource		Site Location: Sudbury to Hudson Transmission Reliability Project	Town: Sudbury
Photo No.: 3	Date: 6-13-23

Description: View of Bond conducting conduit work within right-of-way within segment 11. Facing eastward.

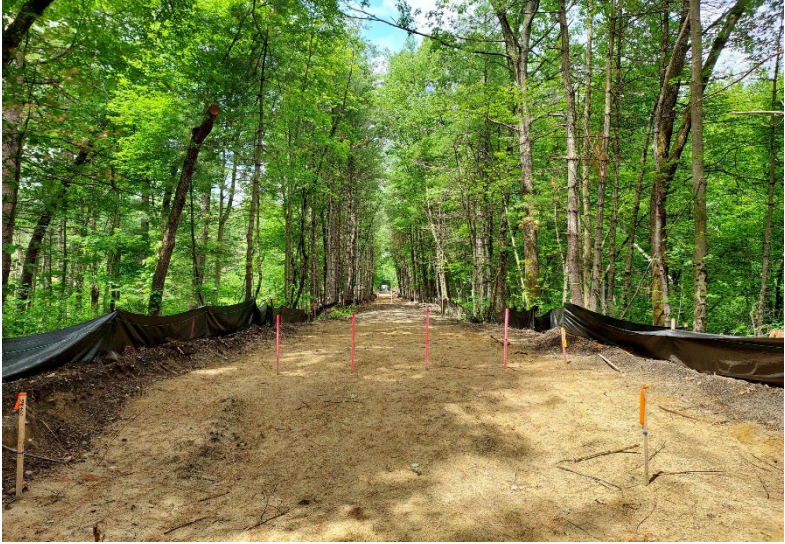
PHOTOGRAPHIC LOG	
Client Name: Eversource		Site Location: Sudbury to Hudson Transmission Reliability Project	Town: Sudbury
Photo No.: 5	Date: 6-13-23

Description: View of culvert crossing within segment 10. Work is anticipated to begin within the right-of-way over the culvert on Wednesday (6/14). Facing westward.

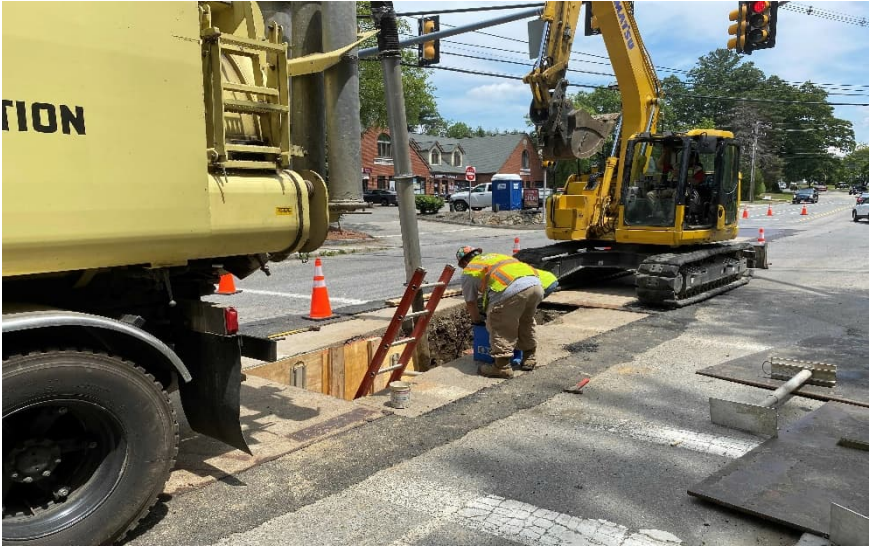
<p align="center">PHOTOGRAPHIC LOG</p>	
<p>Client Name: Eversource</p>		<p>Site Location: Sudbury to Hudson Transmission Reliability Project</p>	<p>Town: Hudson</p>
<p>Photo No.: 1</p>	<p>Date: 6-14-23</p>

<p>Description:</p> <p>Conduit work within Forest Avenue, north of manhole #2, looking northward.</p>

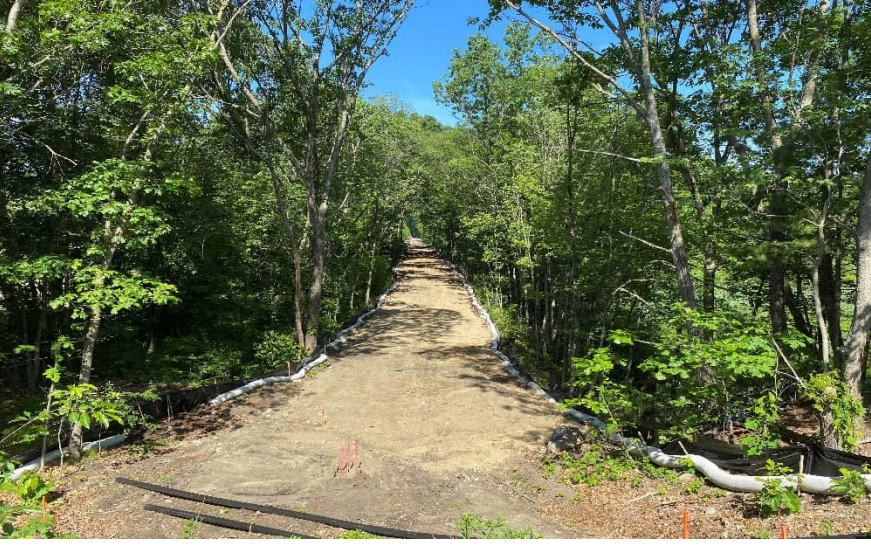
<p align="center">PHOTOGRAPHIC LOG</p>	
<p>Client Name: Eversource</p>		<p>Site Location: Sudbury to Hudson Transmission Reliability Project</p>	<p>Town: Hudson</p>
<p>Photo No.: 2</p>	<p>Date: 6-14-23</p>

<p>Description:</p> <p>Right-of-way within Segment 1, existing erosion control, looking westward.</p>

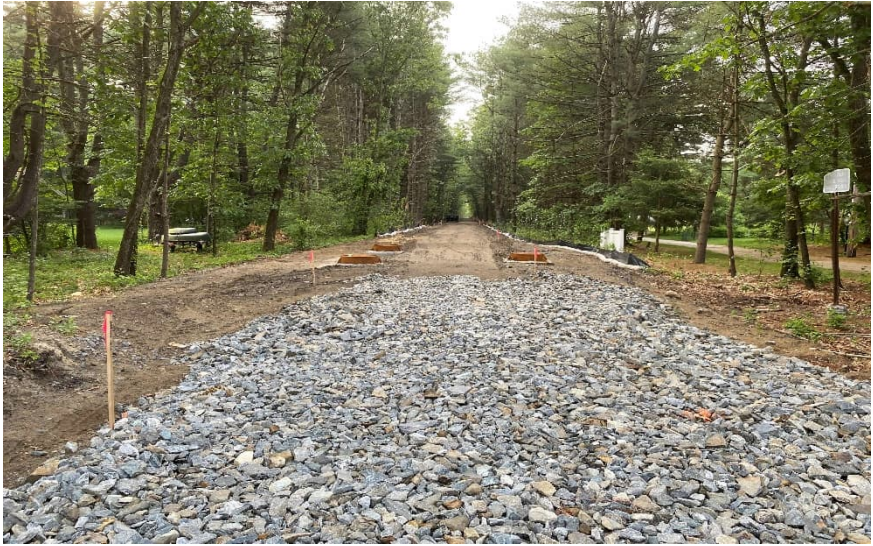
<p>PHOTOGRAPHIC LOG</p>	
<p>Client Name: Eversource</p>		<p>Site Location: Sudbury to Hudson Transmission Reliability Project</p>	<p>Town: Hudson</p>
<p>Photo No.: 3</p>	<p>Date: 6-14-23</p>

<p>Description:</p> <p>Right-of-way within segment 5, near manhole #11, existing erosion control, looking eastward.</p>

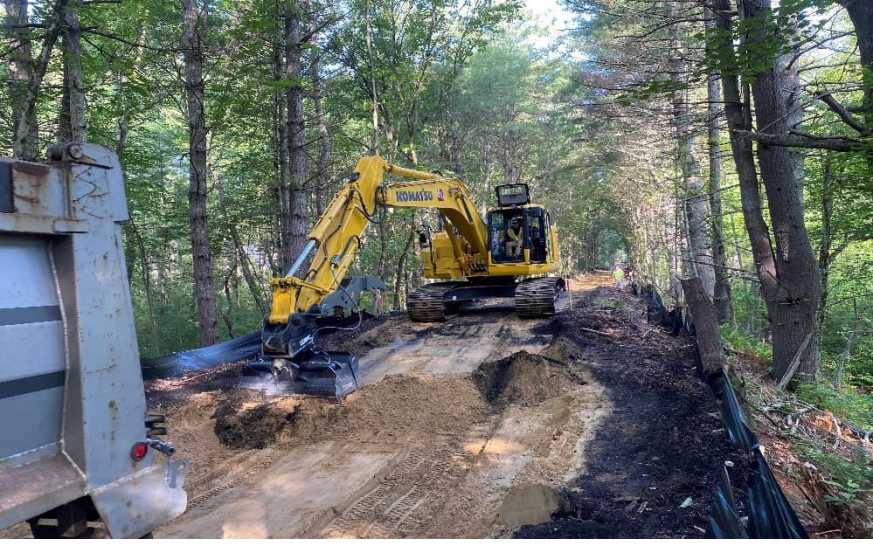
<p>PHOTOGRAPHIC LOG</p>	
<p>Client Name: Eversource</p>		<p>Site Location: Sudbury to Hudson Transmission Reliability Project</p>	<p>Town: Sudbury</p>
<p>Photo No.: 4</p>	<p>Date: 6-14-23</p>

<p>Description:</p> <p>Right-of-way within segment 9, work over existing culvert, existing erosion control, looking westward.</p>

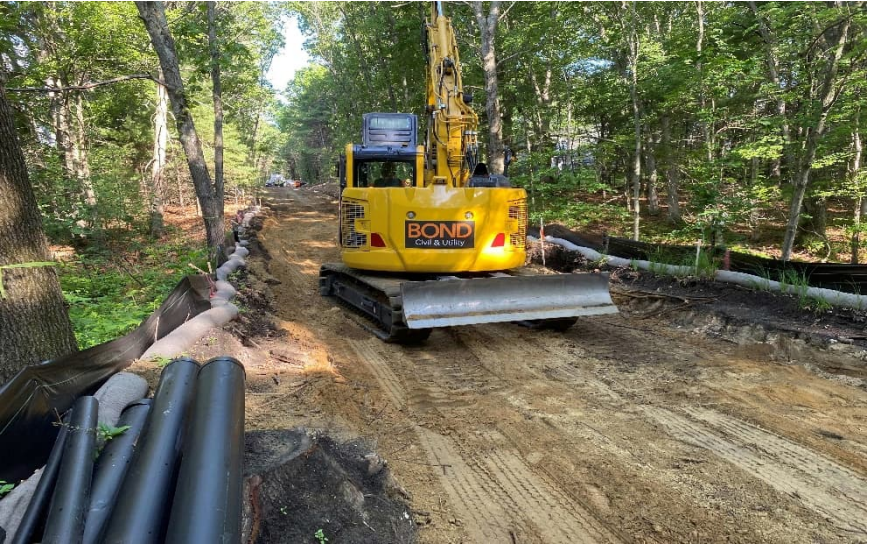
<p>PHOTOGRAPHIC LOG</p>	
<p>Client Name: Eversource</p>		<p>Site Location: Sudbury to Hudson Transmission Reliability Project</p>	<p>Town: Sudbury</p>
<p>Photo No.: 5</p>	<p>Date: 6-14-23</p>

<p>Description:</p> <p>Right-of-way within segment 11, conduit work over existing culvert, existing erosion control, looking westward.</p>

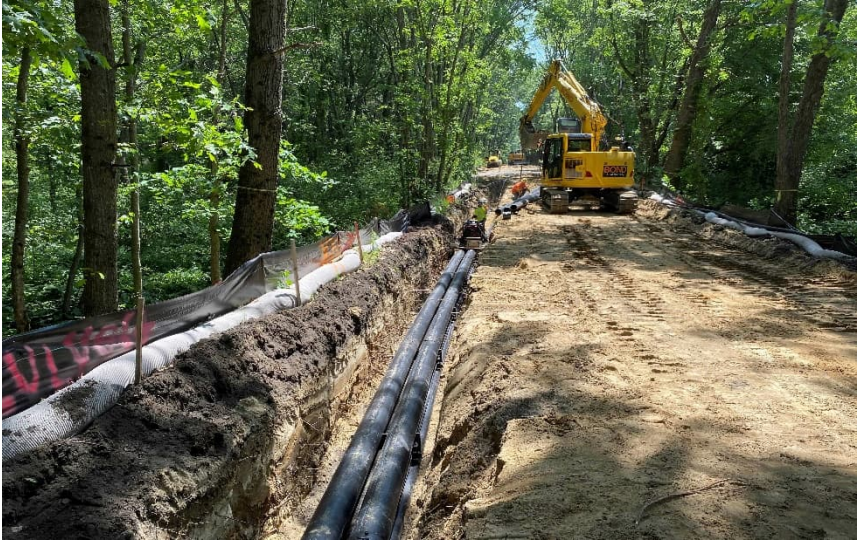
<p>PHOTOGRAPHIC LOG</p>	
<p>Client Name: Eversource</p>		<p>Site Location: Sudbury to Hudson Transmission Reliability Project</p>	<p>Town: Sudbury</p>
<p>Photo No.: 6</p>	<p>Date: 6-14-23</p>

<p>Description:</p> <p>Bond conducting conduit work within Segment 11, existing erosion control, looking eastward.</p>

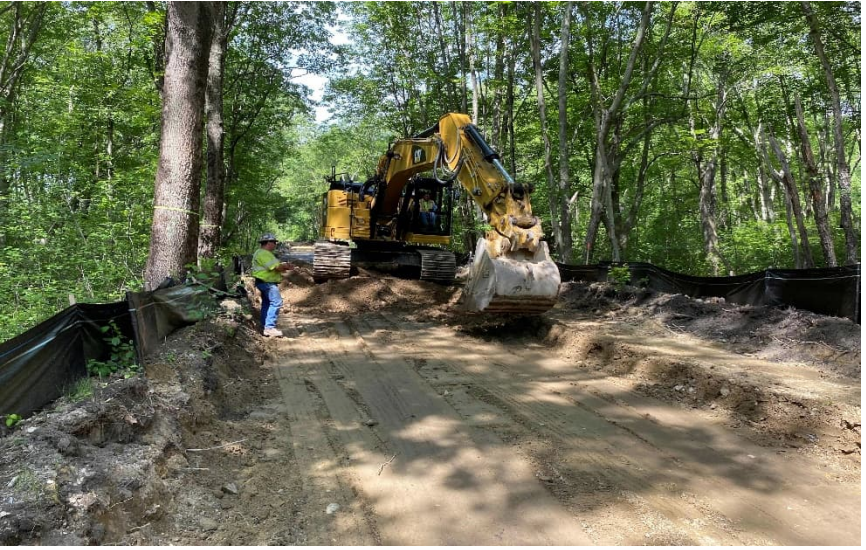
<p>PHOTOGRAPHIC LOG</p>	
<p>Client Name: Eversource</p>		<p>Site Location: Sudbury to Hudson Transmission Reliability Project</p>	<p>Town: Sudbury</p>
<p>Photo No.: 7</p>	<p>Date: 6-14-23</p>

<p>Description:</p> <p>Bond conducting site work within Segment 14, existing erosion control, looking westward.</p>

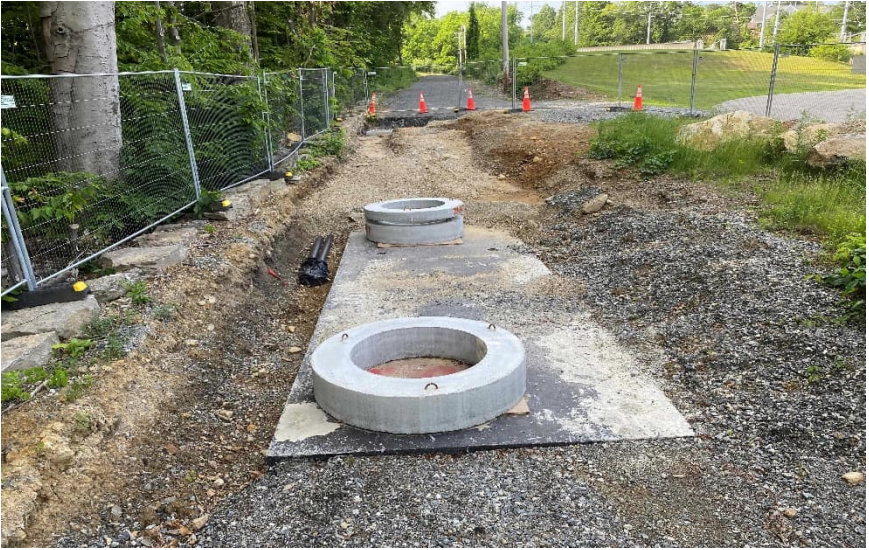
PHOTOGRAPHIC LOG	
Client Name: Eversource		Site Location: Sudbury to Hudson Transmission Reliability Project	Town: Hudson
Photo No.: 1	Date: 6-16-23

Description: Manhole #1, looking eastward.

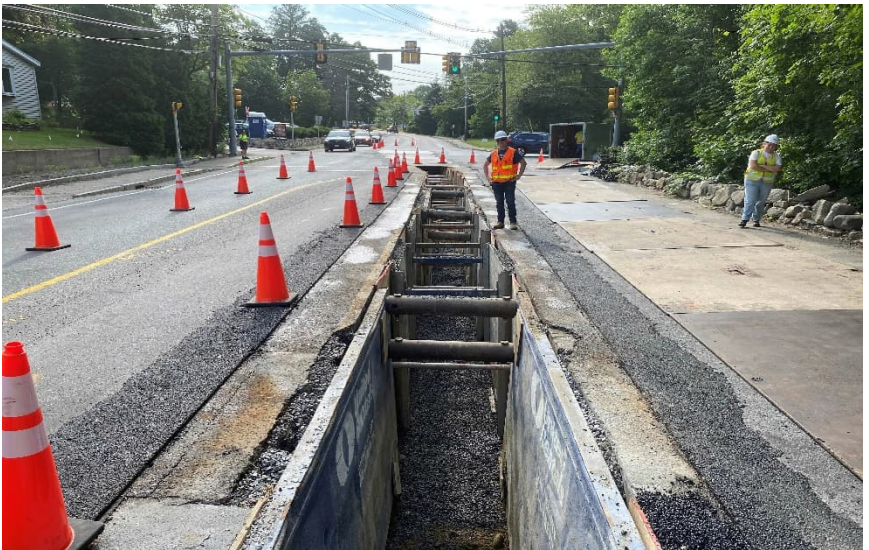
PHOTOGRAPHIC LOG	
Client Name: Eversource		Site Location: Sudbury to Hudson Transmission Reliability Project	Town: Hudson
Photo No.: 2	Date: 6-16-23

Description: Conduit work, within Forest Avenue near manhole #2, looking northward.

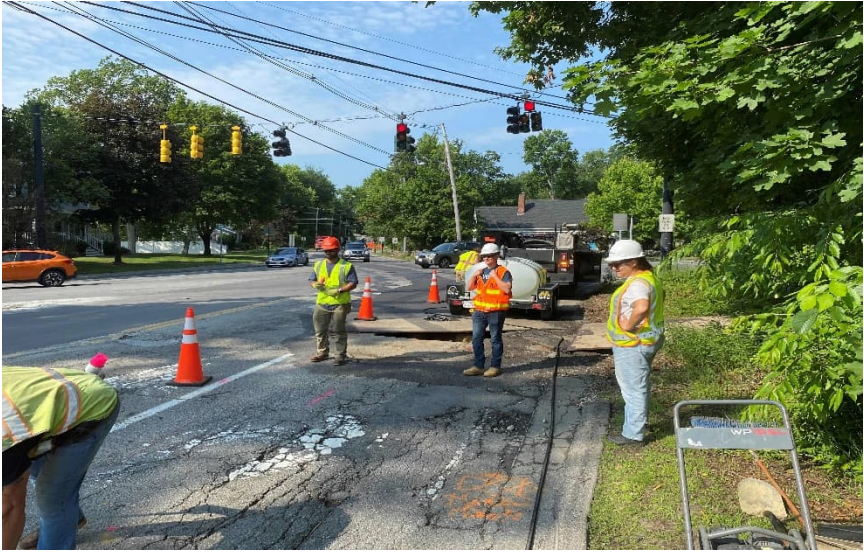
PHOTOGRAPHIC LOG	
Client Name: Eversource		Site Location: Sudbury to Hudson Transmission Reliability Project	Town: Hudson
Photo No.: 3	Date: 6-16-23

Description: Bond conducting conduit work, within Wilkins at intersection with Forest Avenue/Main Street, looking westward.

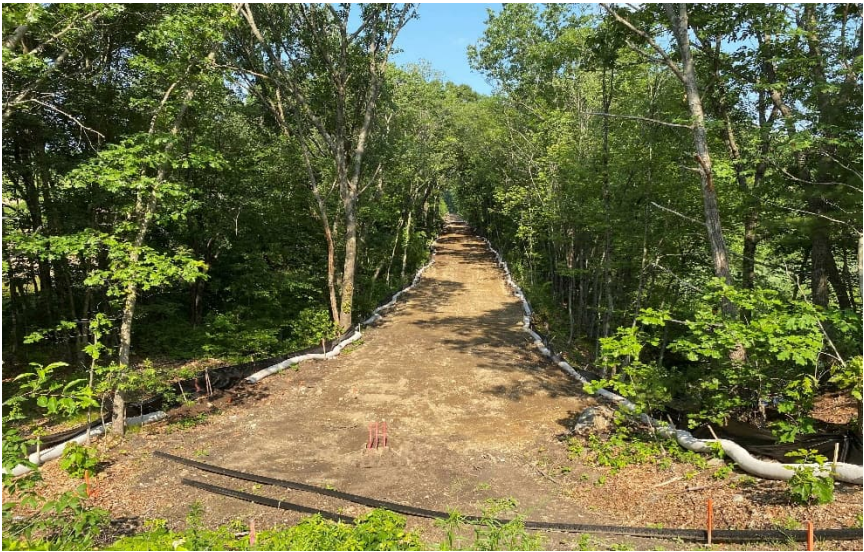
PHOTOGRAPHIC LOG	
Client Name: Eversource		Site Location: Sudbury to Hudson Transmission Reliability Project	Town: Hudson
Photo No.: 4	Date: 6-16-23

Description: Right-of-way within segment 1, off Chestnut Street, existing erosion control, looking westward.

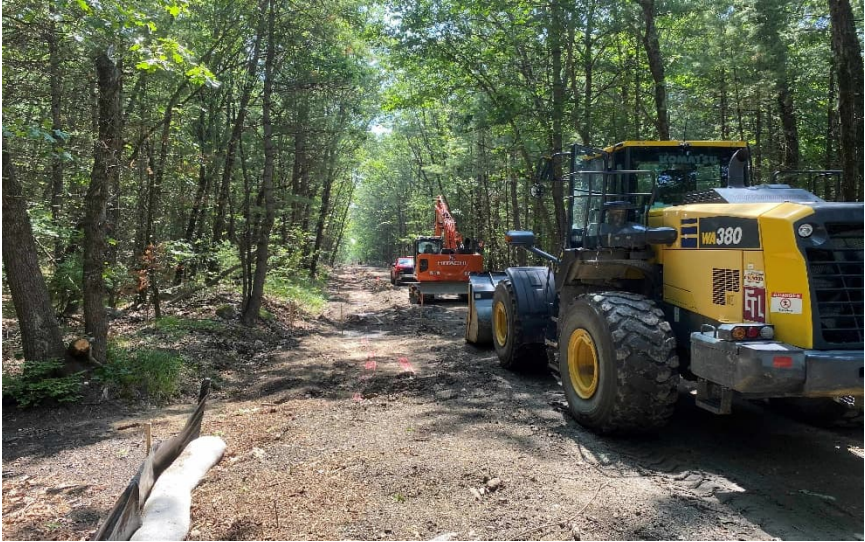
PHOTOGRAPHIC LOG	
Client Name: Eversource		Site Location: Sudbury to Hudson Transmission Reliability Project	Town: Hudson
Photo No.: 6	Date: 6-16-23

Description: ET&L conducting grading within segment 5, existing erosion control, looking eastward.

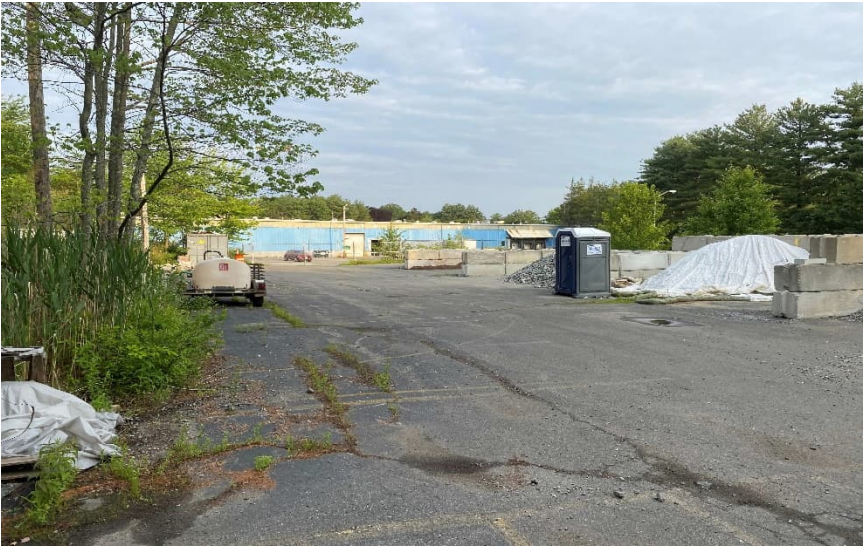
PHOTOGRAPHIC LOG	
Client Name: Eversource		Site Location: Sudbury to Hudson Transmission Reliability Project	Town: Hudson
Photo No.: 7	Date: 6-16-23

Description: Laydown yard at 555 Main, looking westward.

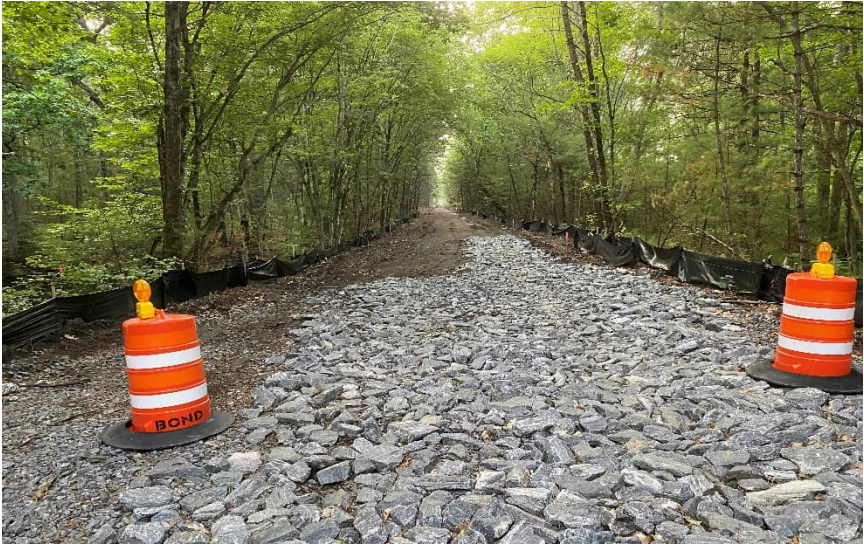
PHOTOGRAPHIC LOG	
Client Name: Eversource		Site Location: Sudbury to Hudson Transmission Reliability Project	Town: Hudson
Photo No.: 8	Date: 6-16-23

Description: Right-of-way within segment 6, existing erosion control, looking eastward.

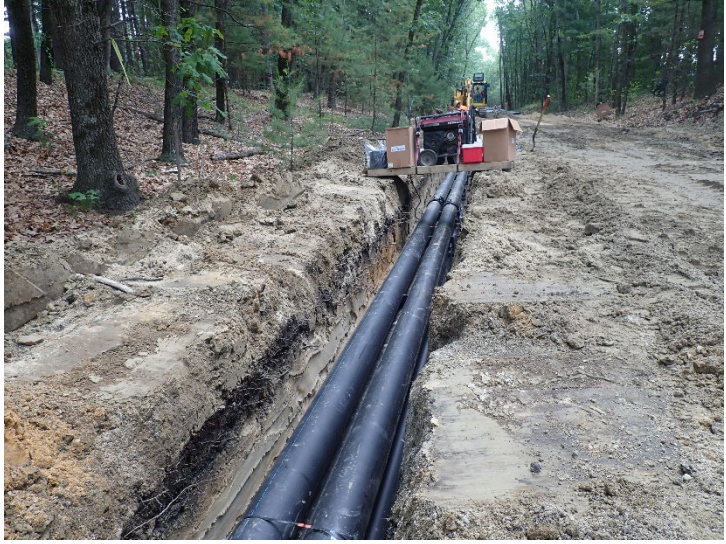
PHOTOGRAPHIC LOG	
Client Name: Eversource		Site Location: Sudbury to Hudson Transmission Reliability Project	Town: Sudbury
Photo No.: 2	Date: 6-16-23

Description: View of Bond conducting conduit work within right-of-way within segment 11. Facing eastward.

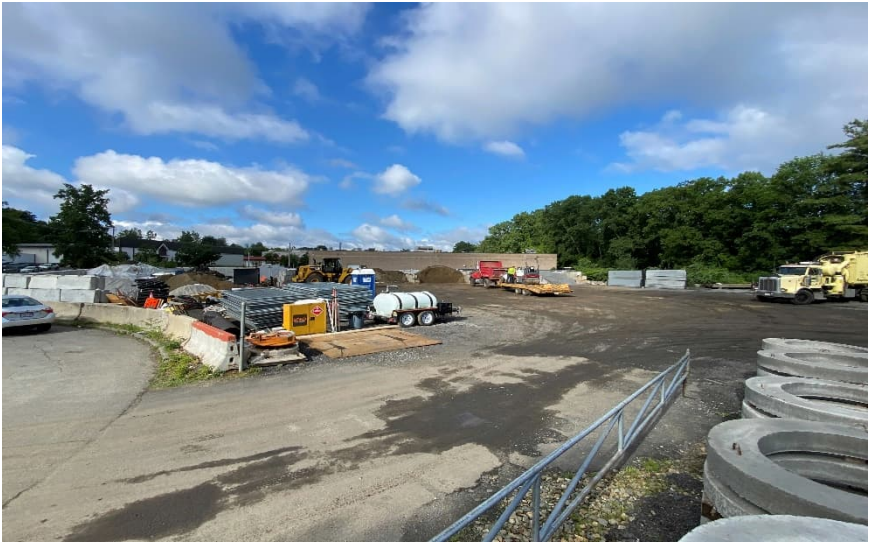
PHOTOGRAPHIC LOG	
Client Name: Eversource		Site Location: Sudbury to Hudson Transmission Reliability Project	Town: Hudson
Photo No.: 2	Date: 6-15-23

Description: Activities (spoil stock piling) within Bonazzoli laydown yard, looking westward.

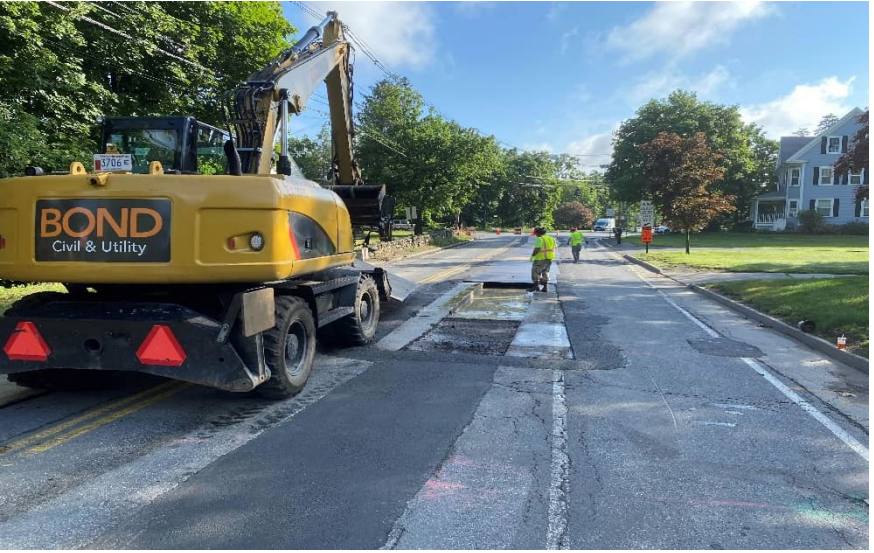
PHOTOGRAPHIC LOG	
Client Name: Eversource		Site Location: Sudbury to Hudson Transmission Reliability Project	Town: Hudson
Photo No.: 3	Date: 6-15-23

Description: Manhole #4 area within Forest Avenue, looking northward.

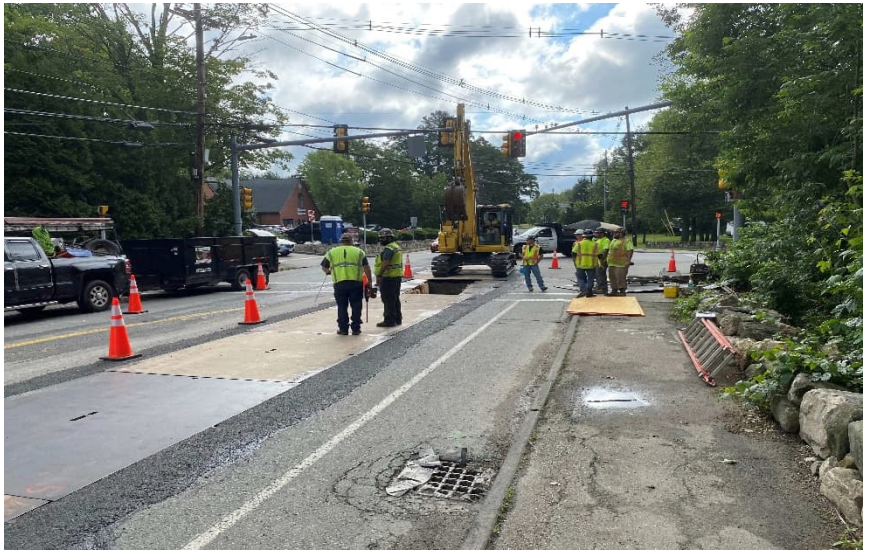
PHOTOGRAPHIC LOG	
Client Name: Eversource		Site Location: Sudbury to Hudson Transmission Reliability Project	Town: Hudson
Photo No.: 4	Date: 6-15-23

Description: Manhole #2 area within Forest Avenue, looking northward.

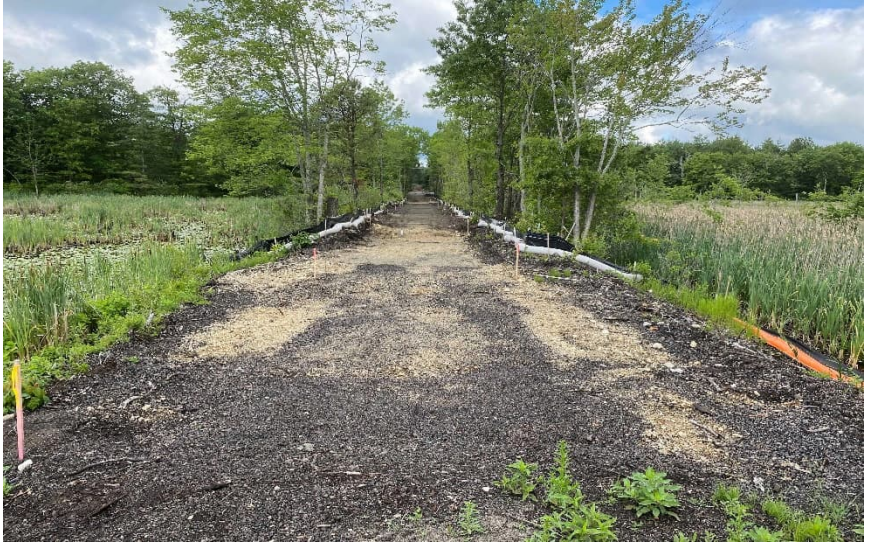
PHOTOGRAPHIC LOG	
Client Name: Eversource		Site Location: Sudbury to Hudson Transmission Reliability Project	Town: Hudson
Photo No.: 5	Date: 6-15-23

Description: Right-of-way within segment 2, existing erosion control, looking westward.

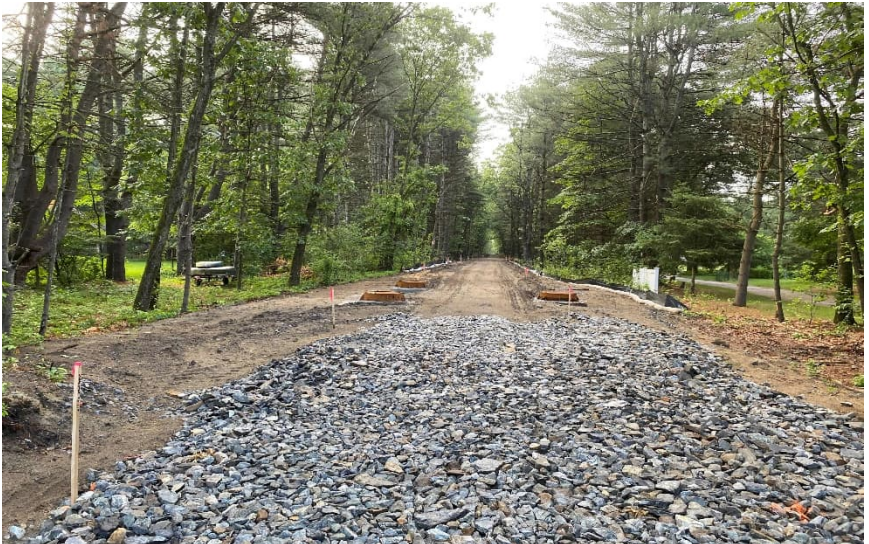
PHOTOGRAPHIC LOG	
Client Name: Eversource		Site Location: Sudbury to Hudson Transmission Reliability Project	Town: Hudson
Photo No.: 6	Date: 6-15-23

Description: Manhole 11, within segment 5, existing erosion control, looking eastward.

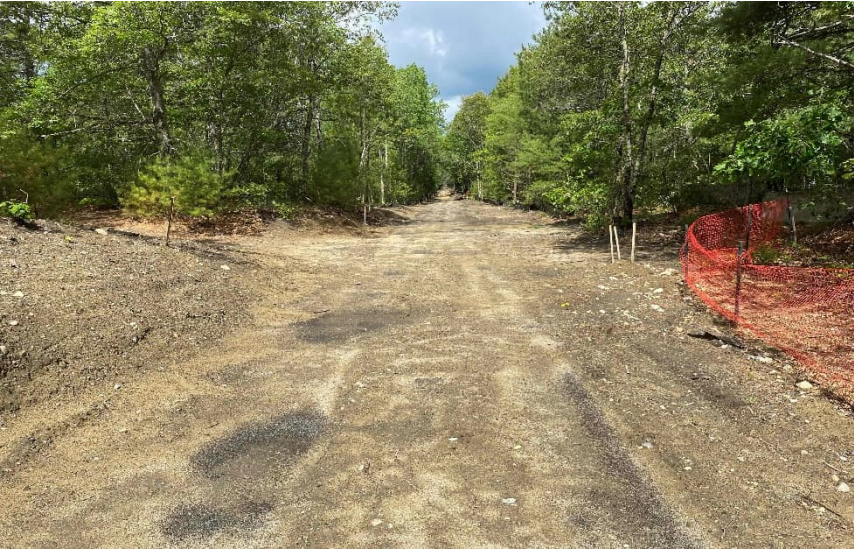
PHOTOGRAPHIC LOG	
Client Name: Eversource		Site Location: Sudbury to Hudson Transmission Reliability Project	Town: Hudson
Photo No.: 7	Date: 6-15-23

Description: Right-of-way within segment 6, looking westward.

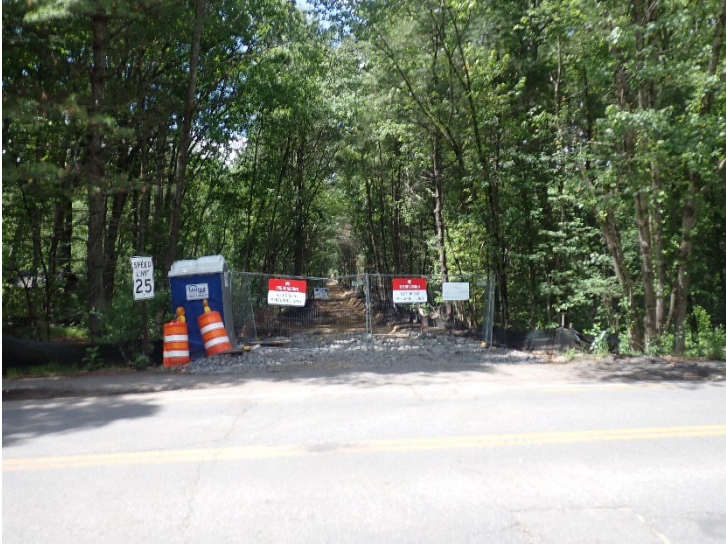
PHOTOGRAPHIC LOG	
Client Name: Eversource		Site Location: Sudbury to Hudson Transmission Reliability Project	Town: Sudbury
Photo No.: 1	Date: 6-15-23

Description: View of construction entrance to segment 9 off Peakham Road. Facing westward.

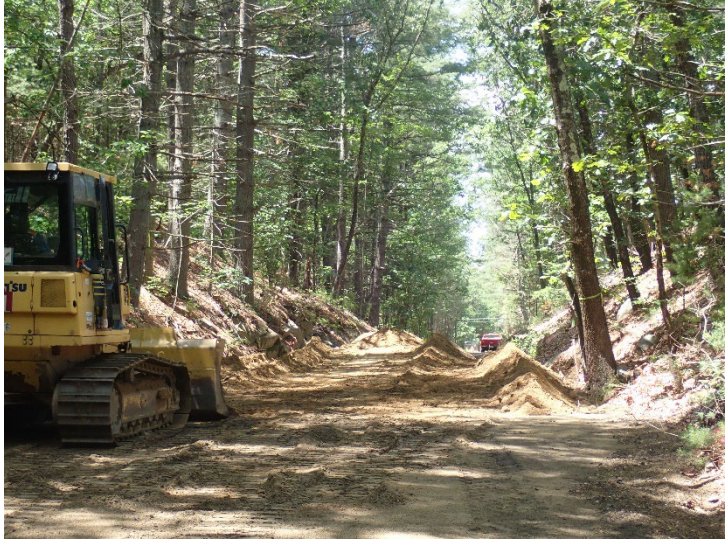
PHOTOGRAPHIC LOG	
Client Name: Eversource		Site Location: Sudbury to Hudson Transmission Reliability Project	Town: Sudbury
Photo No.: 2	Date: 6-15-23

Description: View of ET&L conducting grading within segment 9. Facing westward.

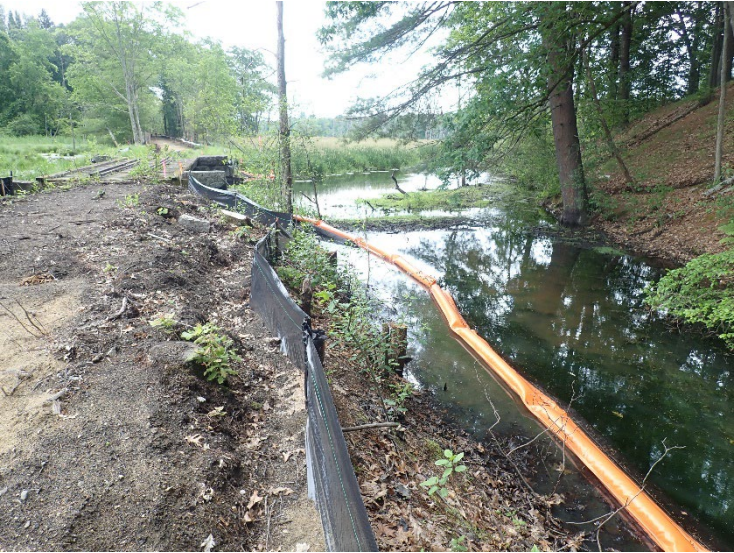
Epsilon ASSOCIATES INC.		PHOTOGRAPHIC LOG	
Client Name: Eversource		Site Location: Sudbury to Hudson Transmission Reliability Project	Town: Sudbury
Photo No.: 7	Date: 6-15-23

Description: View of turbidity curtain in segment 13 along with silt fencing, near Bridge 127. Facing eastward.

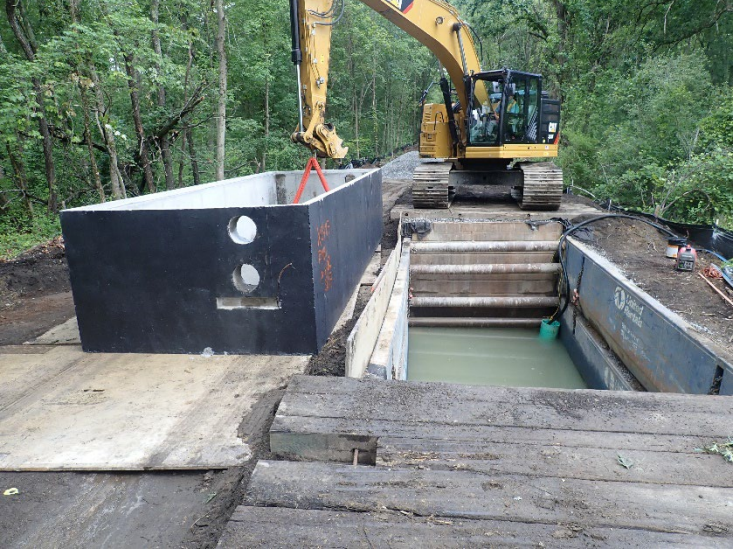
PHOTOGRAPHIC LOG	
Client Name: Eversource		Site Location: Sudbury to Hudson Transmission Reliability Project	Town: Sudbury
Photo No.: 9	Date: 6-15-23

Description: View of work on manhole #27 in segment 14. Facing westward.
