Weekly Environmental Compliance Summary

Sudbury to Hudson Transmission Reliability Project (USEPA Tracking # MAR1003UW)

Week of: June 12 to June 16, 2023

CONSTRUCTION MONITORING REPORT

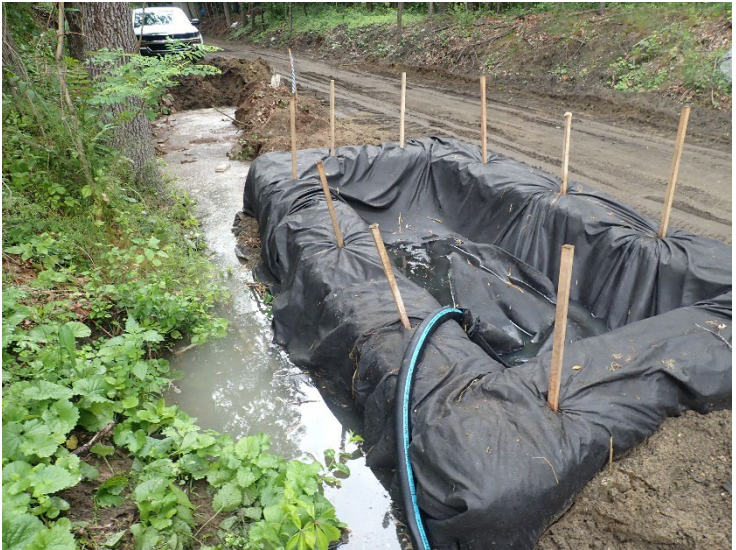
PHOTOGRAPHIC LOG	
Client Name: Eversource		Site Location: Sudbury to Hudson Transmission Reliability Project	Town: Sudbury
Photo No.: 10	Date: 6-15-23

Description: View of active dewatering, associated with work at manhole #27, in segment 14. See additional dewatering inspection report. Facing eastward.

Section A – Dewatering Discharges (CGP Part 4.6.3) Complete this section <u>within 24 hours</u> of completing the inspection. (If necessary, complete additional inspection reports for each separate inspection location.)	
Inspector Information	
Inspector Name: Polina Safran (SWCA), EPA (CGP) Site Inspector	Title: Environmental Scientist
Company Name: SWCA	Email: polina.safran@swca.com
Address: 153 Cordaville Road, Suite 130, Southborough, MA 01772	Phone Number: 781-801-4973
Inspection Details	
Inspection Date: 6/15/23	Inspection Location: MH#27 (Off Boston Post Road, segment 14)
Discharge Start Time: 7:15 AM	Discharge End Time: 10:30 AM
Rate of Discharge (gallons per day): 50,400 (35 gallons per minute)	Corrective Action Required? ¹ <input type="checkbox"/> Yes <input checked="" type="checkbox"/> No
Describe Indicators of Pollutant Discharge at Point of Dewatering Discharge:¹ Turbidity sampling conducted, however dewatering setup or discharge not within 100 feet of or discharge to either impaired or sensitive waters associated with this project. Dewatering setup to discharge to right-of-way west of the manhole #27. Turbidity sampling > 50 NTUs.

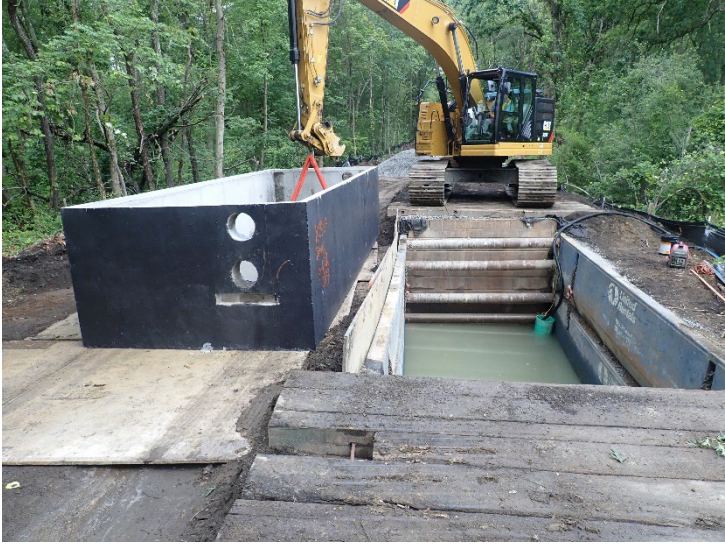
PHOTOGRAPHIC LOG		
Client Name: Eversource		Site Location: Sudbury to Hudson Transmission Reliability Project		Town: Sudbury
Photo No.: 2	Date: 6/15/2023

Description: View of pumping operation at MH#27. Facing westward.
