Weekly Environmental Compliance Summary

Sudbury to Hudson Transmission Reliability Project (USEPA Tracking # MAR1003UW)

Sudbury, Hudson, and Stow, MA

Week of: June 19 to June 23, 2023

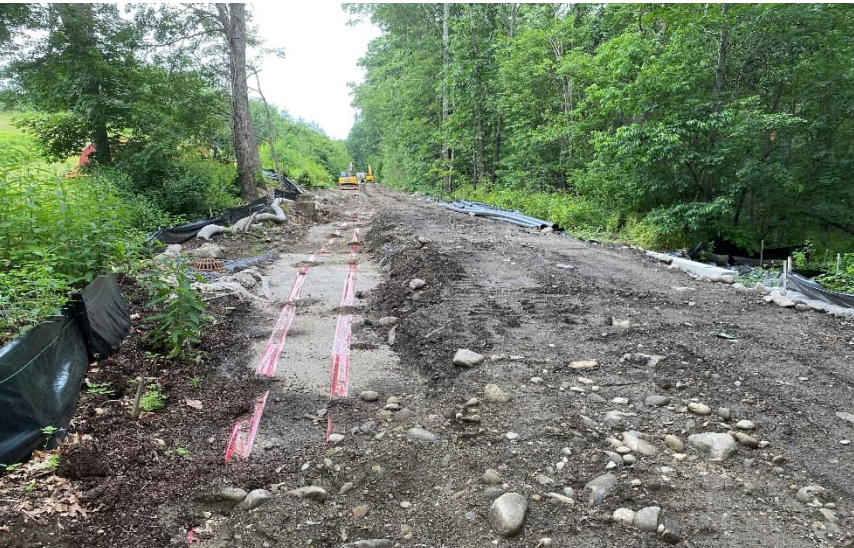
PHOTOGRAPHIC LOG	
Client Name: Eversource		Site Location: Sudbury to Hudson Transmission Reliability Project	Town: Stow
Photo No.: 4	Date: 6-20-23

Description: Right-of-way within segment 1, within Stow, off Chestnut Street, existing erosion control, recent conduit placement, looking westward.

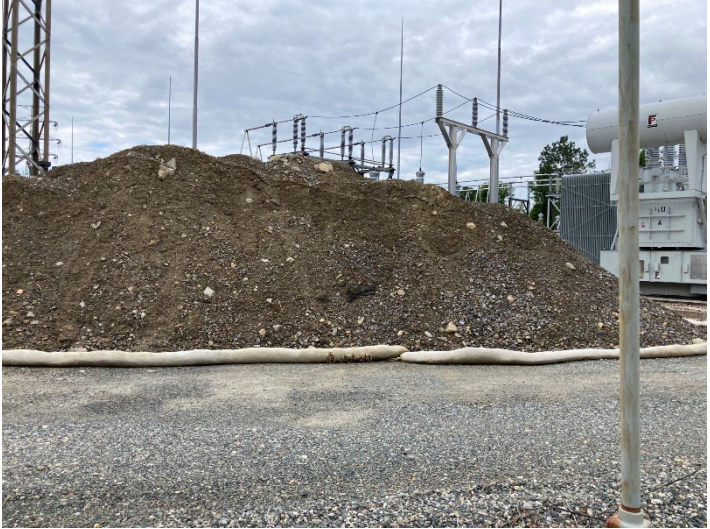
PHOTOGRAPHIC LOG	
Client Name: Eversource		Site Location: Sudbury to Hudson Transmission Reliability Project	Town: Sudbury
Photo No.: 6	Date: 6/20/2023

Description: View of soil stockpile at Sudbury Substation. Filter tubes are installed along pile. Facing south.

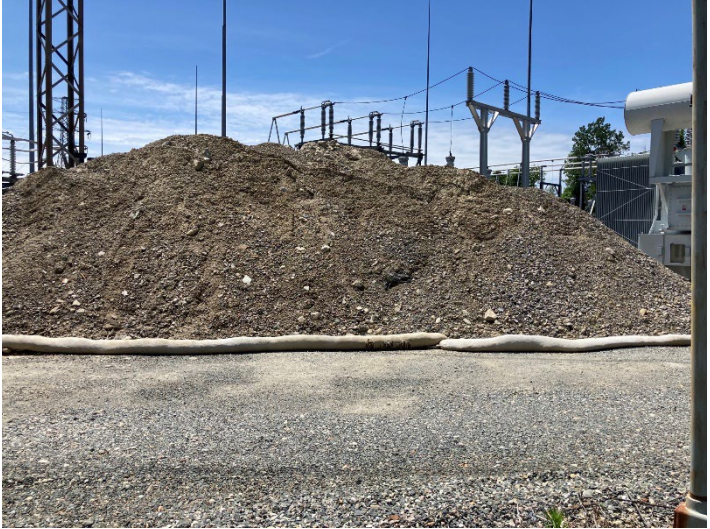
<p>PHOTOGRAPHIC LOG</p>	
<p>Client Name: Eversource</p>		<p>Site Location: Sudbury to Hudson Transmission Reliability Project</p>	<p>Town: Sudbury</p>
<p>Photo No.: 6</p>	<p>Date: 6/22/2023</p>

<p>Description: View of soil stockpile at Sudbury Substation. Facing south.</p>

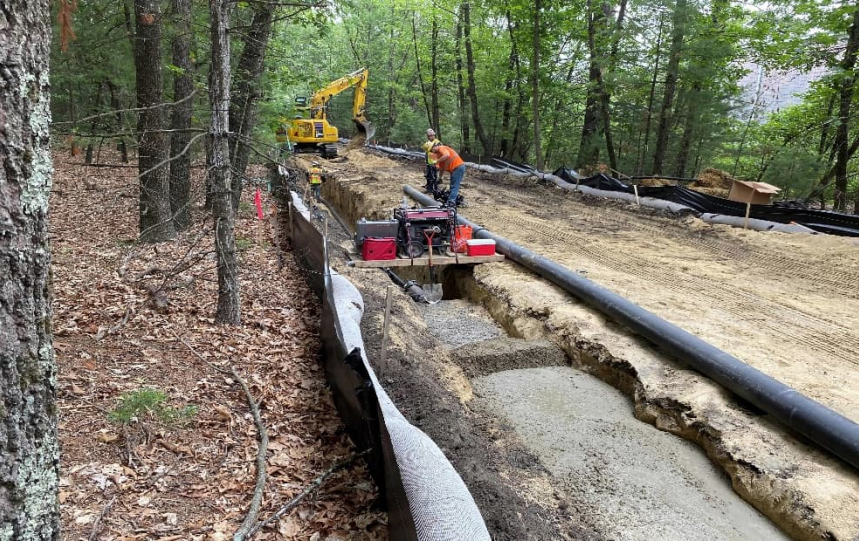
<p>PHOTOGRAPHIC LOG</p>	
<p>Client Name: Eversource</p>		<p>Site Location: Sudbury to Hudson Transmission Reliability Project</p>	<p>Town: Sudbury</p>
<p>Photo No.: 6</p>	<p>Date: 6-23-23</p>

<p>Description:</p> <p>Bond conducting conduit work within Segment 11, existing erosion control, looking eastward.</p>

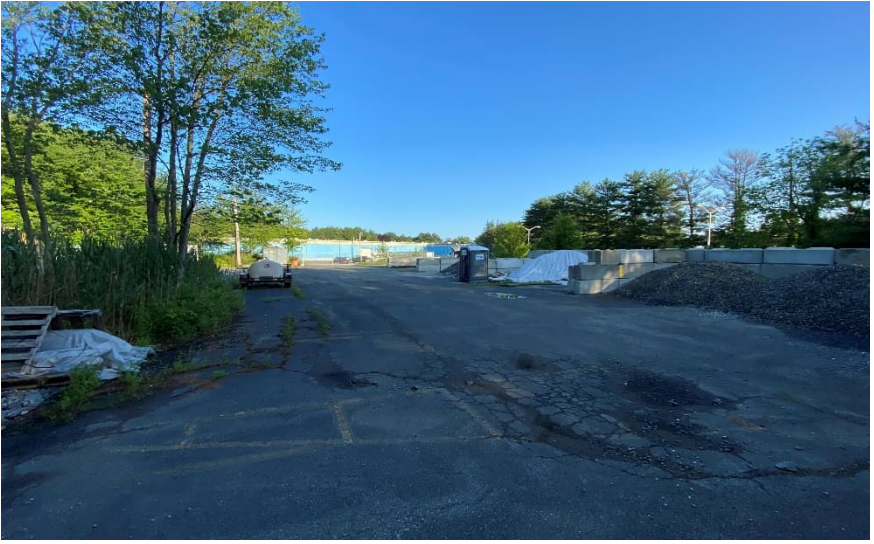
PHOTOGRAPHIC LOG	
Client Name: Eversource		Site Location: Sudbury to Hudson Transmission Reliability Project	Town: Hudson
Photo No.: 1	Date: 6-19-23

Description: Main Street laydown yard, looking northward.

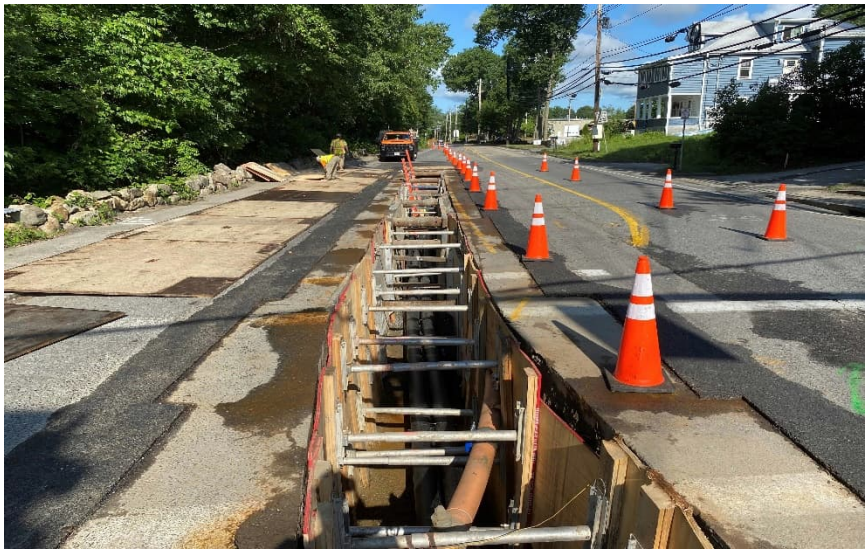
PHOTOGRAPHIC LOG	
Client Name: Eversource		Site Location: Sudbury to Hudson Transmission Reliability Project	Town: Hudson
Photo No.: 2	Date: 6-19-23

Description: Manhole #2 area within Forest Avenue, looking southward.

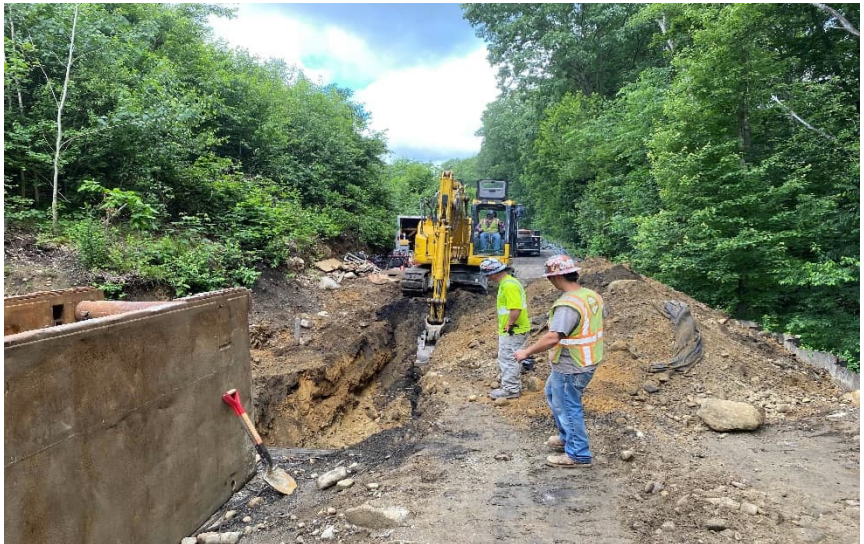
PHOTOGRAPHIC LOG	
Client Name: Eversource		Site Location: Sudbury to Hudson Transmission Reliability Project	Town: Hudson
Photo No.: 4	Date: 6-19-23

Description: Conduit work within segment 1 near manhole #6, looking westward.

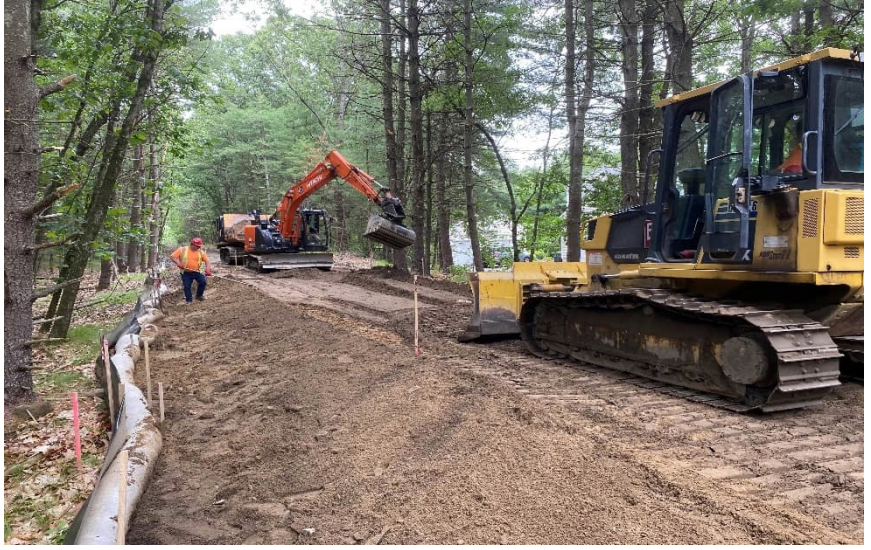
PHOTOGRAPHIC LOG	
Client Name: Eversource		Site Location: Sudbury to Hudson Transmission Reliability Project	Town: Hudson
Photo No.: 6	Date: 6-19-23

Description: Grading by ET&L, within segment 5, existing erosion control, looking eastward.

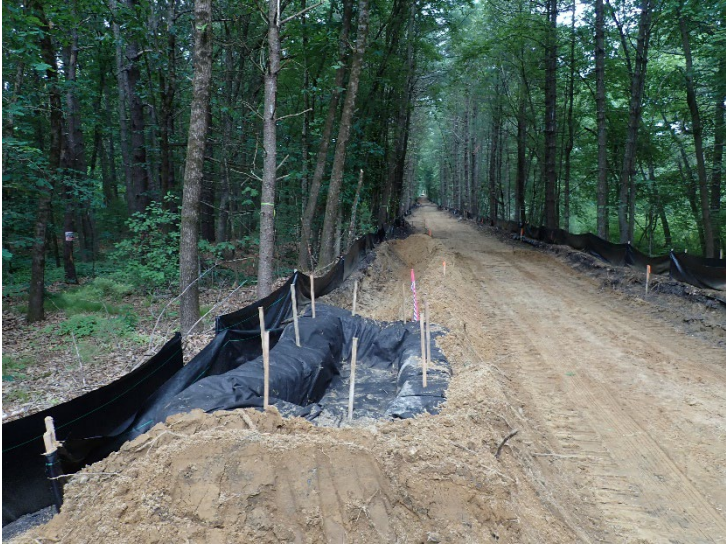
PHOTOGRAPHIC LOG	
Client Name: Eversource		Site Location: Sudbury to Hudson Transmission Reliability Project	Town: Sudbury
Photo No.: 1	Date: 6-19-23

Description: View of dewatering basin set up in segment 10, in preparation for work on manhole #20. Facing eastward.

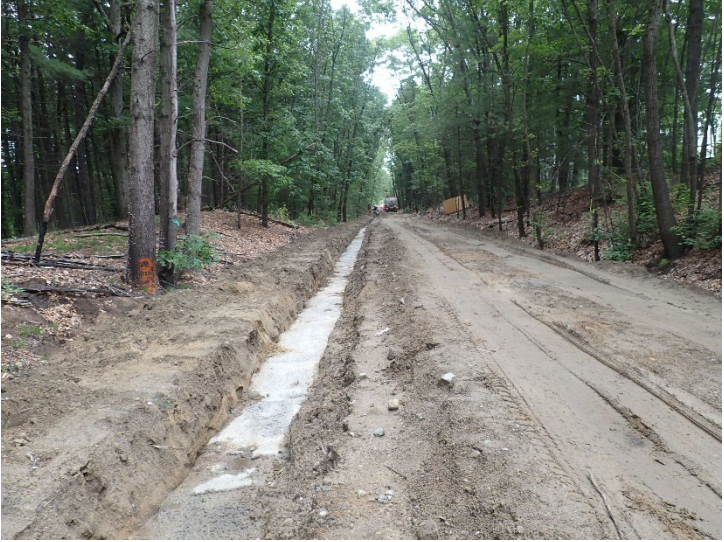
PHOTOGRAPHIC LOG	
Client Name: Eversource		Site Location: Sudbury to Hudson Transmission Reliability Project	Town: Sudbury
Photo No.: 3	Date: 6-19-23

Description: View of Bond conducting conduit work within segment 11. Facing eastward.

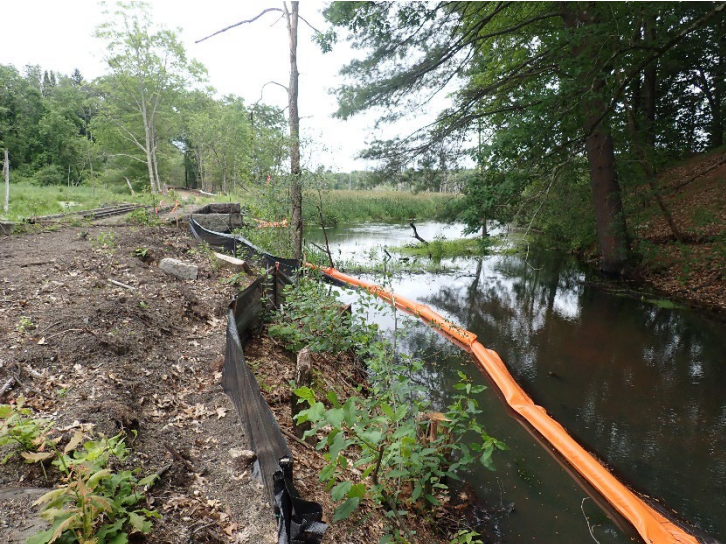
PHOTOGRAPHIC LOG	
Client Name: Eversource		Site Location: Sudbury to Hudson Transmission Reliability Project	Town: Sudbury
Photo No.: 6	Date: 6-19-23

Description: View of turbidity curtain in segment 13 along with silt fencing, near Bridge 127. Facing eastward.
