Weekly Environmental Compliance Summary

Sudbury to Hudson Transmission Reliability Project (USEPA Tracking # MAR1003UW)

Week of: June 26 to June 30, 2023

CONSTRUCTION MONITORING REPORT

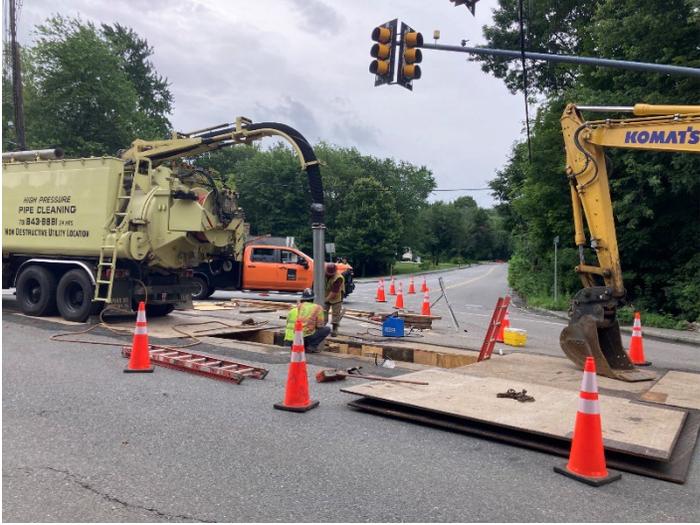
PHOTOGRAPHIC LOG	
Client Name: Eversource		Site Location: Sudbury to Hudson Transmission Reliability Project	Town: Hudson
Photo No.: 1	Date: 6/27/2023

Description: View of Bond working near MH #2 on Forest Ave. Facing southeast.

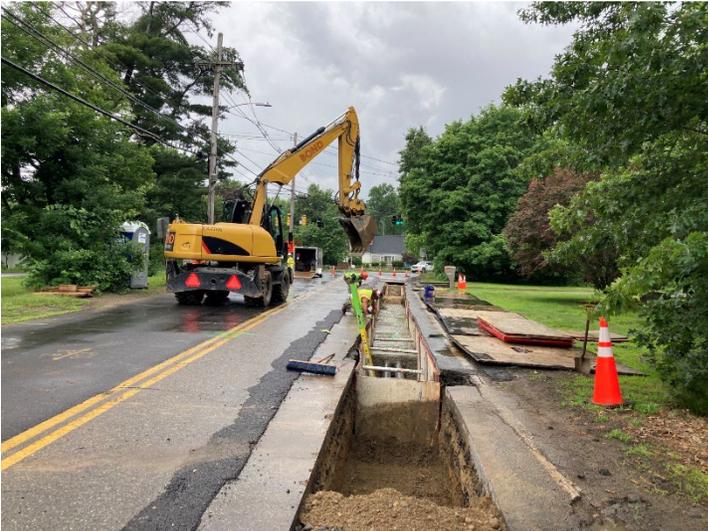
PHOTOGRAPHIC LOG	
Client Name: Eversource		Site Location: Sudbury to Hudson Transmission Reliability Project	Town: Hudson
Photo No.: 2	Date: 6/27/2023

Description: View of Bond working on Wilkins St. Facing southwest.

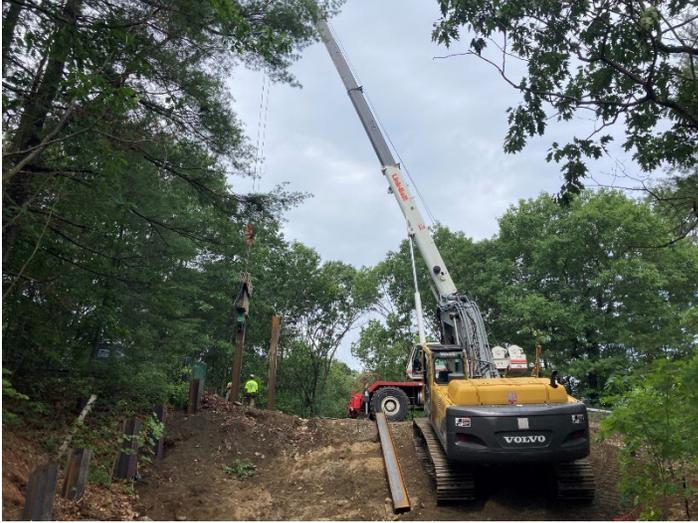
PHOTOGRAPHIC LOG	
Client Name: Eversource		Site Location: Sudbury to Hudson Transmission Reliability Project	Town: Hudson
Photo No.: 4	Date: 6/27/2023

Description: View of ET&L working at Chestnut St. Facing west.

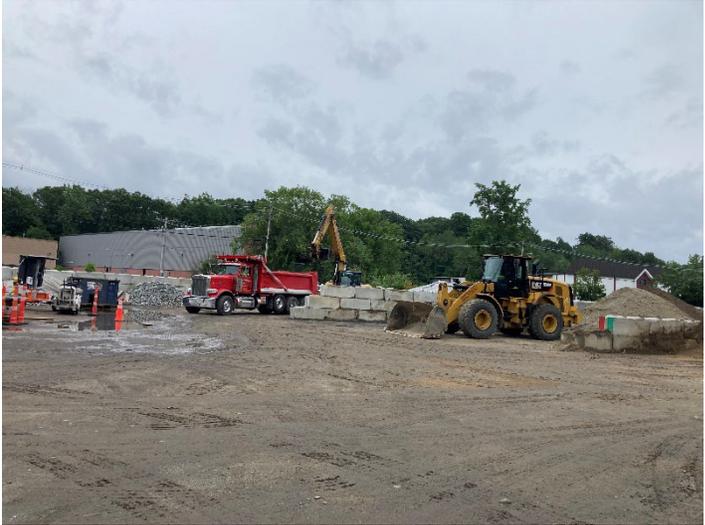
PHOTOGRAPHIC LOG	
Client Name: Eversource		Site Location: Sudbury to Hudson Transmission Reliability Project	Town: Hudson
Photo No.: 6	Date: 6/27/2023

Description: View of activities at laydown yard on Robert Bonazzoli Ave. Facing southwest.

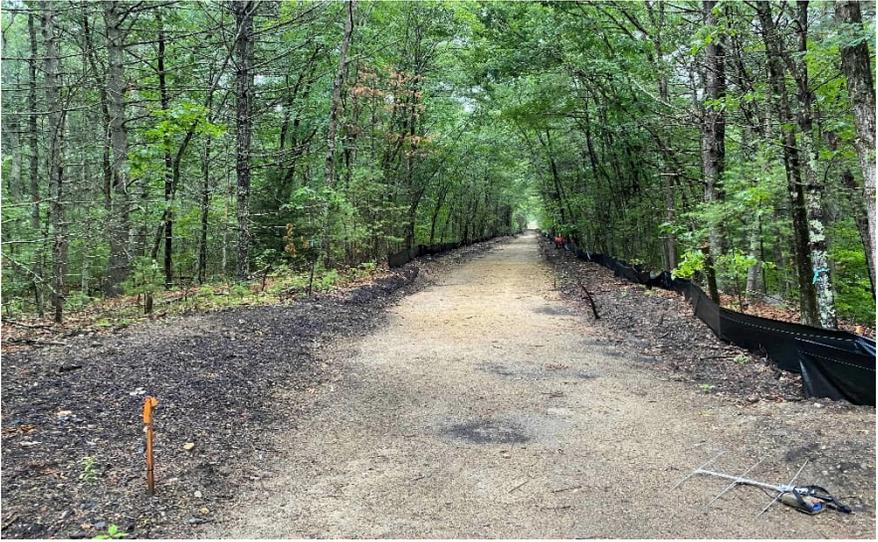
PHOTOGRAPHIC LOG	
Client Name: Eversource		Site Location: Sudbury to Hudson Transmission Reliability Project	Town: Sudbury
Photo No.: 1	Date: 6-27-23

Description: Work area within Segment 8, existing erosion control, looking westward.

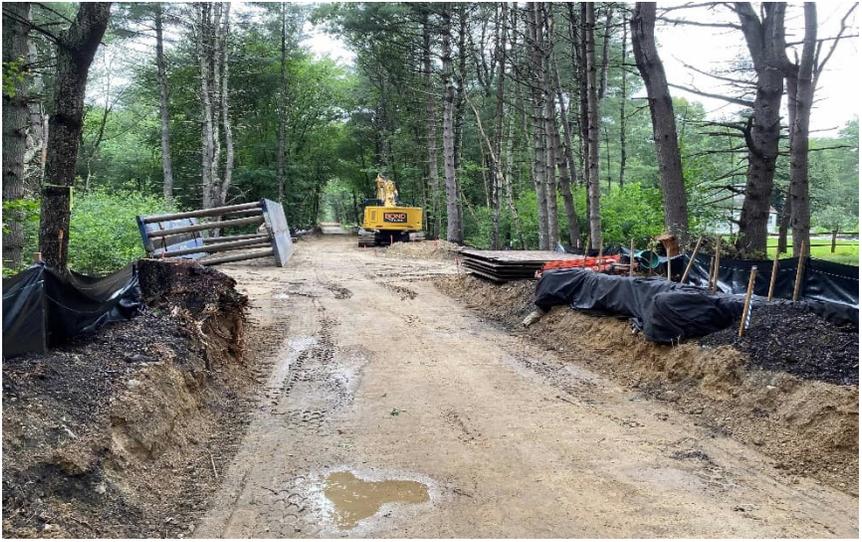
PHOTOGRAPHIC LOG	
Client Name: Eversource		Site Location: Sudbury to Hudson Transmission Reliability Project	Town: Sudbury
Photo No.: 2	Date: 6-27-23

Description: Work area within segment 9, manhole 19 area, existing erosion control, looking westward.

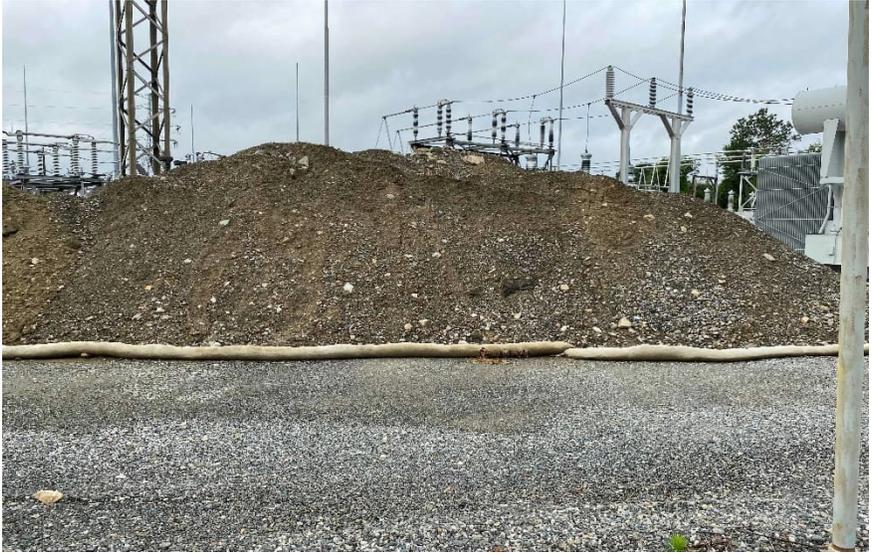
PHOTOGRAPHIC LOG	
Client Name: Eversource		Site Location: Sudbury to Hudson Transmission Reliability Project	Town: Sudbury
Photo No.: 3	Date: 6-27-23

Description: Spoil pile within substation, existing erosion control (compost filter tubes), looking westward.

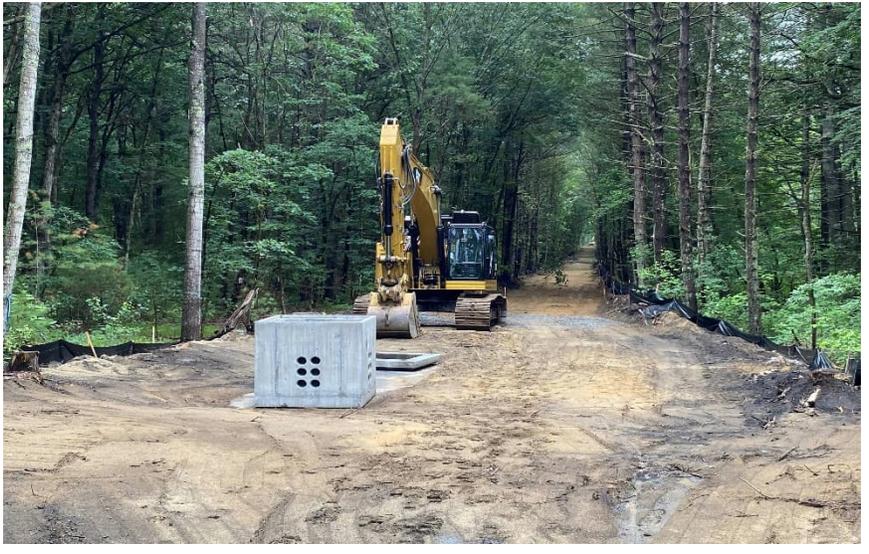
PHOTOGRAPHIC LOG	
Client Name: Eversource		Site Location: Sudbury to Hudson Transmission Reliability Project	Town: Sudbury
Photo No.: 4	Date: 6-27-23

Description: Work area within segment 10, manhole #20, existing erosion control, looking eastward.

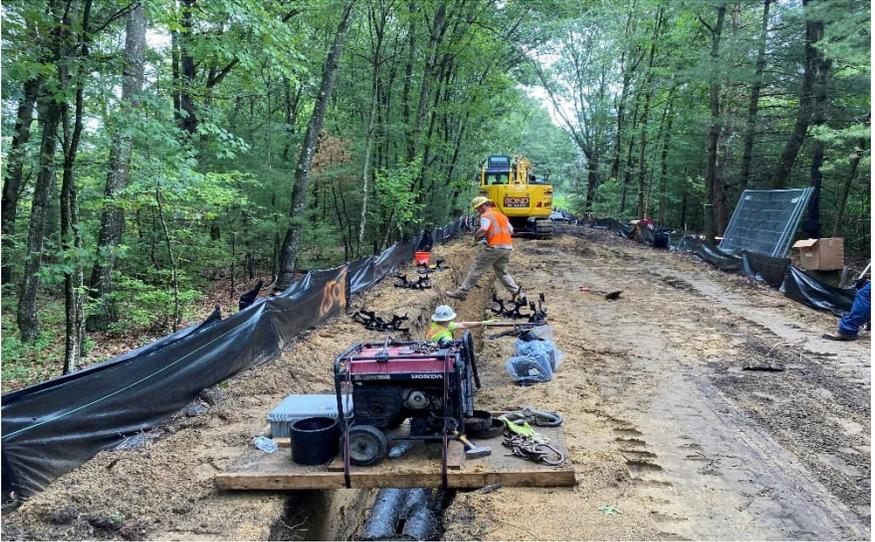
PHOTOGRAPHIC LOG	
Client Name: Eversource		Site Location: Sudbury to Hudson Transmission Reliability Project	Town: Sudbury
Photo No.: 5	Date: 6-27-23

Description: Work area within segment 11, conduit work, existing erosion control, looking eastward.

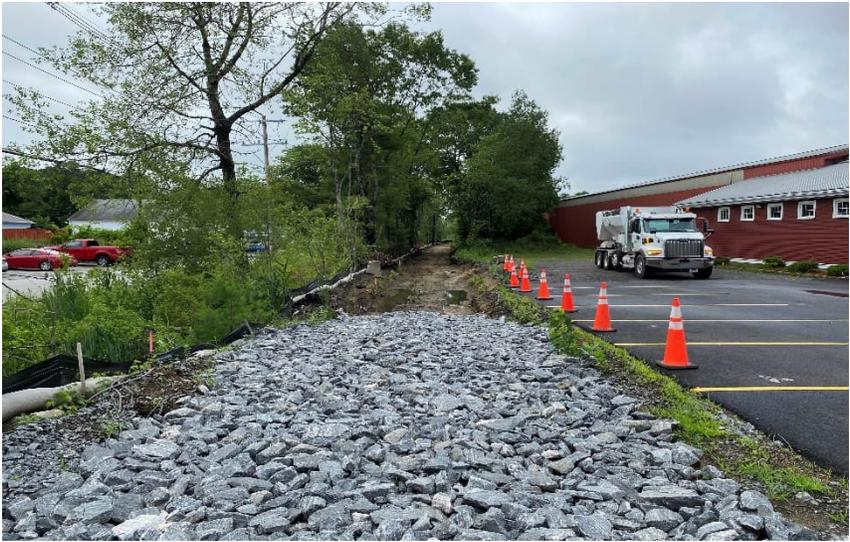
PHOTOGRAPHIC LOG	
Client Name: Eversource		Site Location: Sudbury to Hudson Transmission Reliability Project	Town: Sudbury
Photo No.: 6	Date: 6-27-23

Description: Work area within segment 12, existing erosion control, looking eastward.

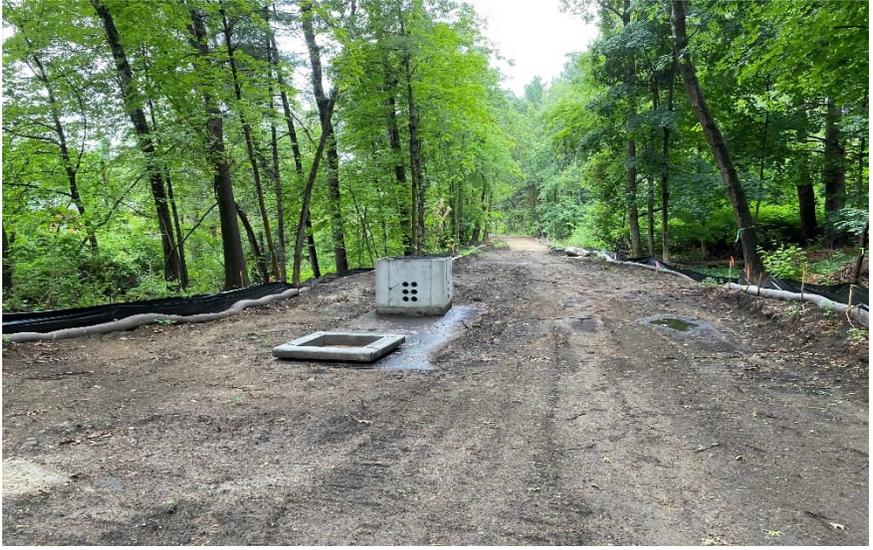
PHOTOGRAPHIC LOG	
Client Name: Eversource		Site Location: Sudbury to Hudson Transmission Reliability Project	Town: Sudbury
Photo No.: 7	Date: 6-27-23

Description: Work area within Segment 13, manhole #25, existing erosion control, looking eastward.

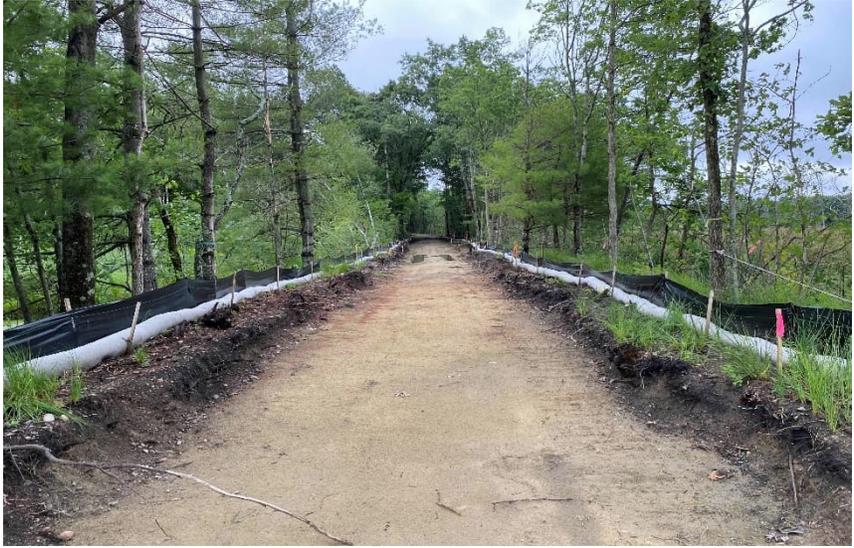
PHOTOGRAPHIC LOG	
Client Name: Eversource		Site Location: Sudbury to Hudson Transmission Reliability Project	Town: Sudbury
Photo No.: 8	Date: 6-27-23

Description: Work area within Segment 14, existing erosion control, looking eastward.

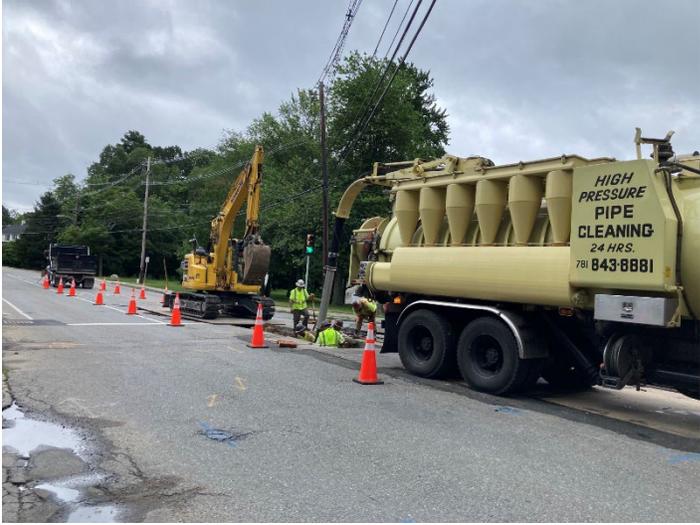
<p align="center">PHOTOGRAPHIC LOG</p>	
<p>Client Name: Eversource</p>		<p>Site Location: Sudbury to Hudson Transmission Reliability Project</p>	<p>Town: Hudson</p>
<p>Photo No.: 1</p>	<p>Date: 6/28/2023</p>

<p>Description: View of Bond working near MH #2 on Forest Ave. Facing southeast.</p>

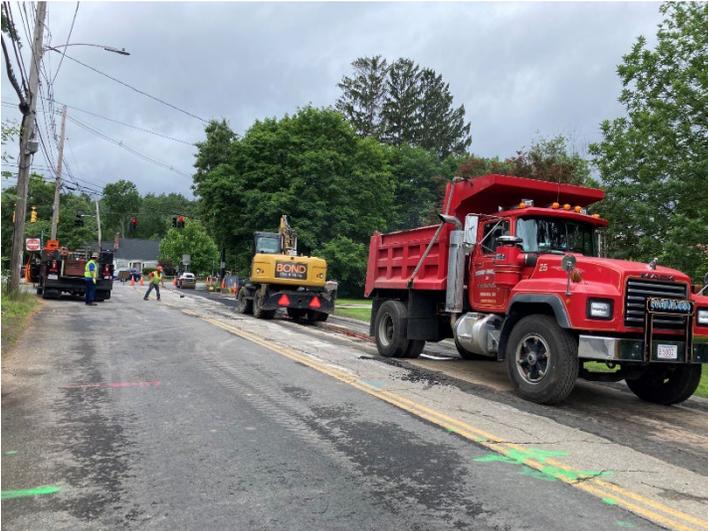
<p align="center">PHOTOGRAPHIC LOG</p>	
<p>Client Name: Eversource</p>		<p>Site Location: Sudbury to Hudson Transmission Reliability Project</p>	<p>Town: Hudson</p>
<p>Photo No.: 2</p>	<p>Date: 6/28/2023</p>

<p>Description: View of Bond working on Wilkins St. Facing southwest.</p>

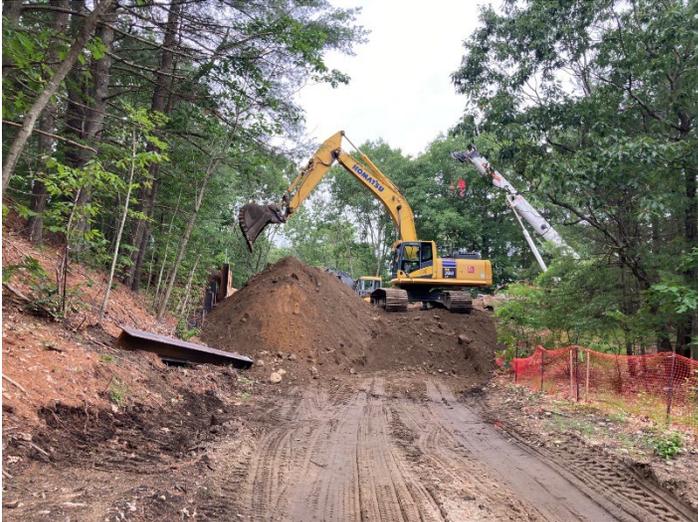
PHOTOGRAPHIC LOG	
Client Name: Eversource		Site Location: Sudbury to Hudson Transmission Reliability Project	Town: Hudson
Photo No.: 4	Date: 6/28/2023

Description: View of ET&L working at Chestnut St. Facing west.

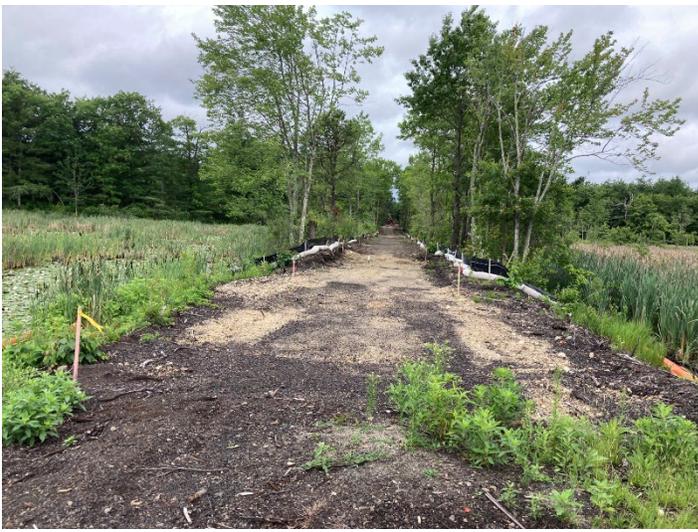
PHOTOGRAPHIC LOG	
Client Name: Eversource		Site Location: Sudbury to Hudson Transmission Reliability Project	Town: Hudson
Photo No.: 5	Date: 6/28/2023

Description: View of segment 2 from Bridge 130. Facing west.

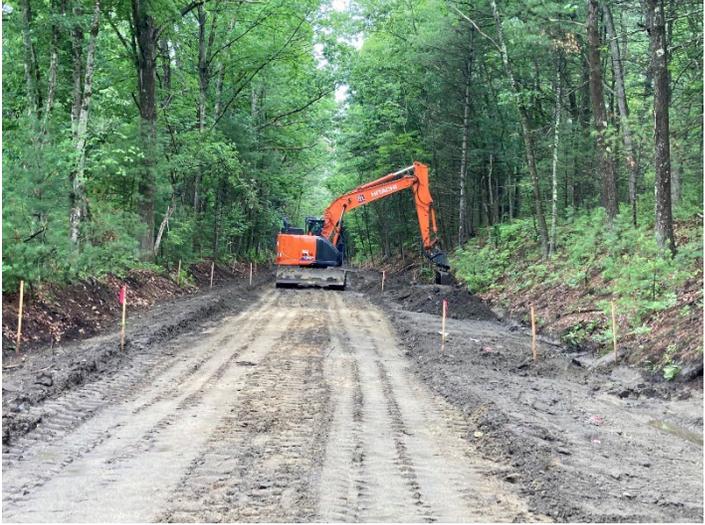
PHOTOGRAPHIC LOG	
Client Name: Eversource		Site Location: Sudbury to Hudson Transmission Reliability Project	Town: Hudson
Photo No.: 6	Date: 6/28/2023

Description: View of ET&L grading in segment 5. Facing west.

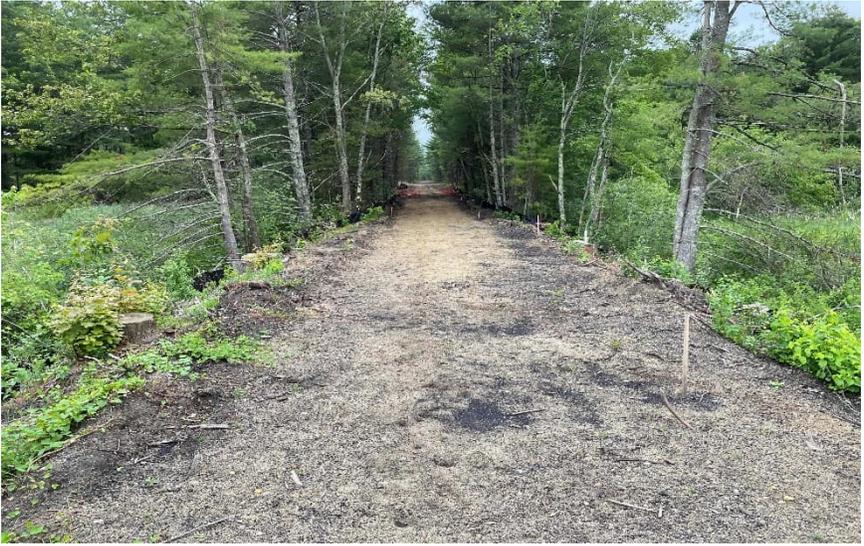
PHOTOGRAPHIC LOG	
Client Name: Eversource		Site Location: Sudbury to Hudson Transmission Reliability Project	Town: Sudbury
Photo No.: 1	Date: 6-28-23

Description: Work area within Segment 7, existing erosion control, looking westward.

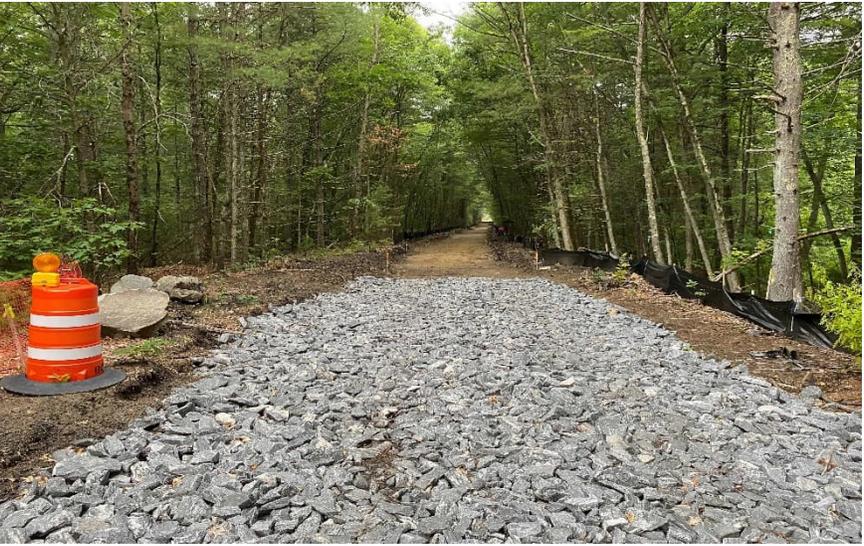
PHOTOGRAPHIC LOG	
Client Name: Eversource		Site Location: Sudbury to Hudson Transmission Reliability Project	Town: Sudbury
Photo No.: 2	Date: 6-28-23

Description: Work area within segment 8, existing erosion control, looking westward.

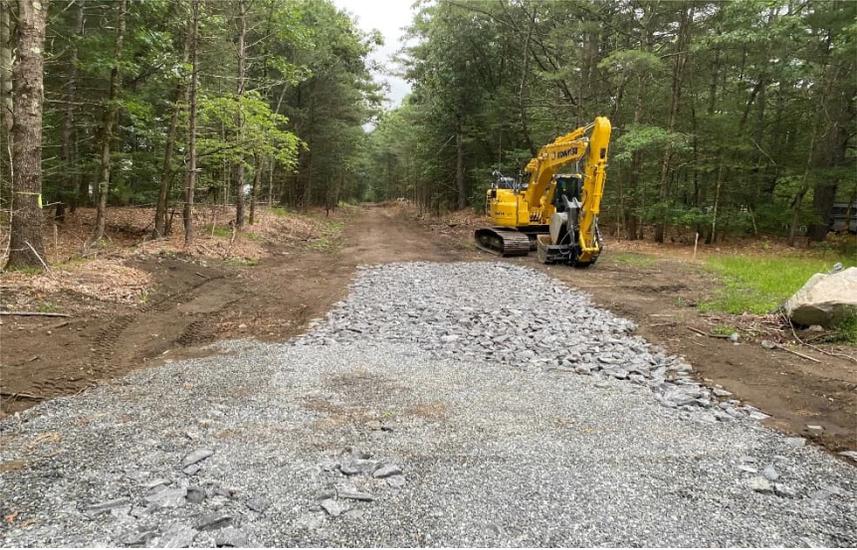
PHOTOGRAPHIC LOG	
Client Name: Eversource		Site Location: Sudbury to Hudson Transmission Reliability Project	Town: Sudbury
Photo No.: 3	Date: 6-28-23

Description: Work area within segment 9, existing erosion control, looking eastward.

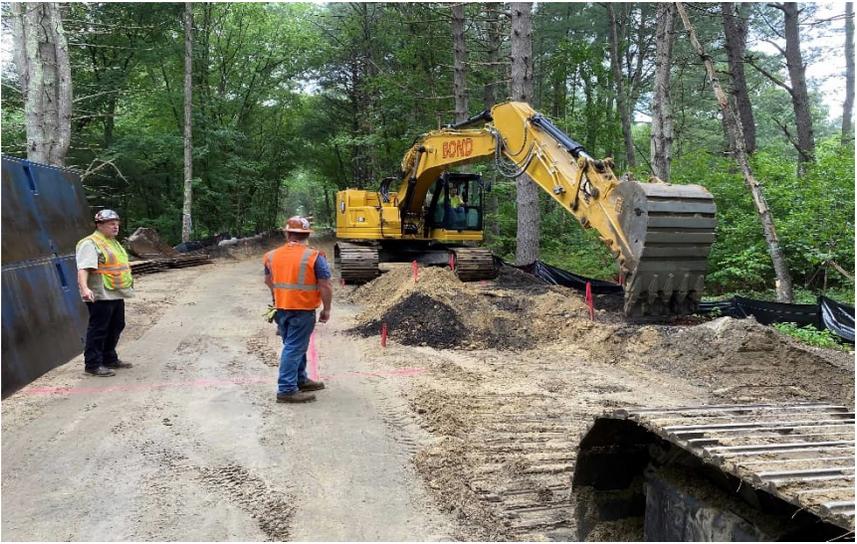
PHOTOGRAPHIC LOG	
Client Name: Eversource		Site Location: Sudbury to Hudson Transmission Reliability Project	Town: Sudbury
Photo No.: 4	Date: 6-28-23

Description: Work area within segment 9, manhole #19, existing erosion control, looking westward.

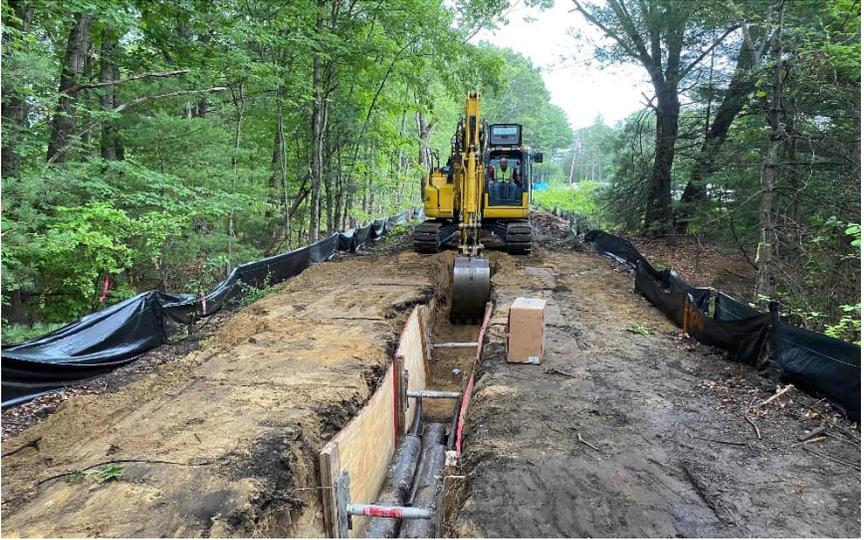
PHOTOGRAPHIC LOG	
Client Name: Eversource		Site Location: Sudbury to Hudson Transmission Reliability Project	Town: Sudbury
Photo No.: 5	Date: 6-28-23

Description: Work area within segment 11, conduit work, existing erosion control, looking eastward.

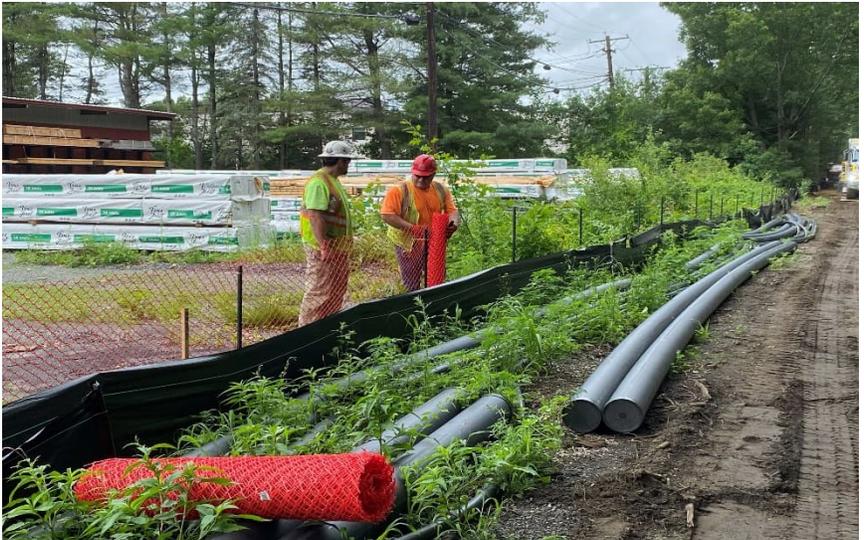
PHOTOGRAPHIC LOG	
Client Name: Eversource		Site Location: Sudbury to Hudson Transmission Reliability Project	Town: Sudbury
Photo No.: 6	Date: 6-28-23

Description: Work area within segment 11, ET&L installing orange fencing, existing erosion control, looking westward.

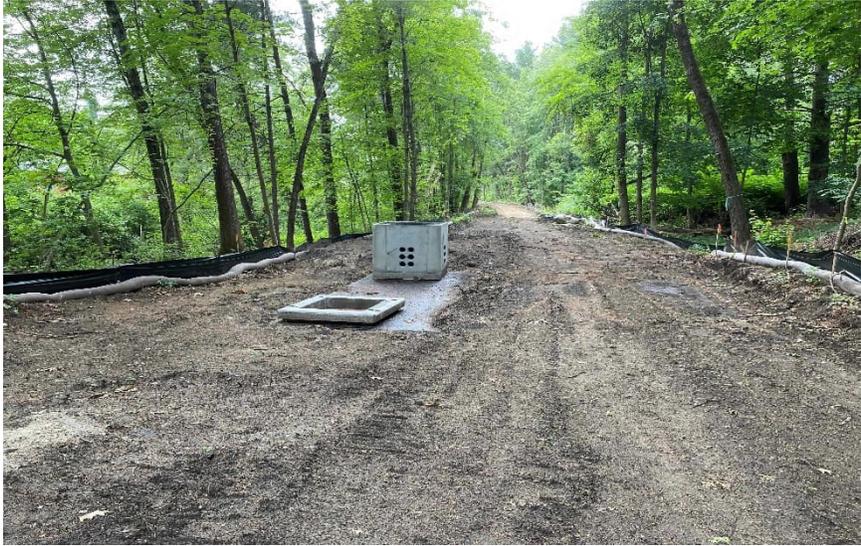
PHOTOGRAPHIC LOG	
Client Name: Eversource		Site Location: Sudbury to Hudson Transmission Reliability Project	Town: Sudbury
Photo No.: 7	Date: 6-28-23

Description: Work area within Segment 13, manhole #25, existing erosion control, looking eastward.

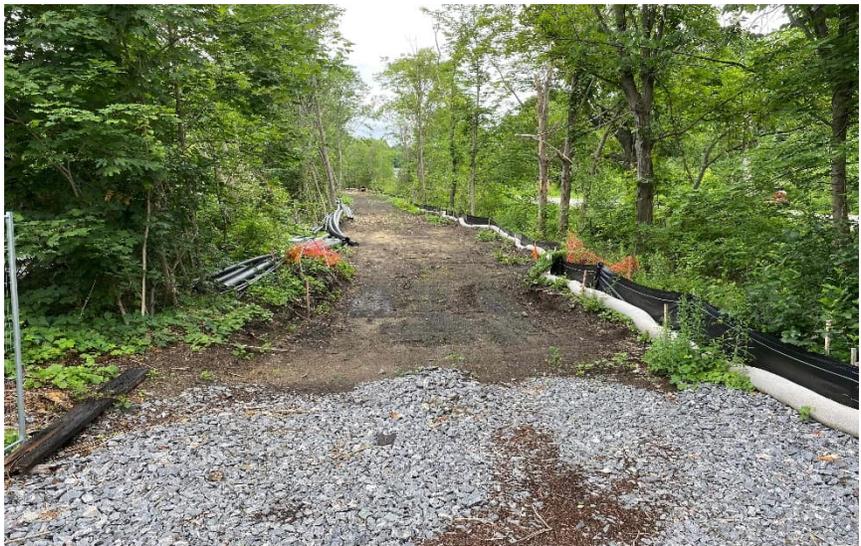
PHOTOGRAPHIC LOG	
Client Name: Eversource		Site Location: Sudbury to Hudson Transmission Reliability Project	Town: Sudbury
Photo No.: 8	Date: 6-28-23

Description: Work area within Segment 12, existing erosion control, looking westward.

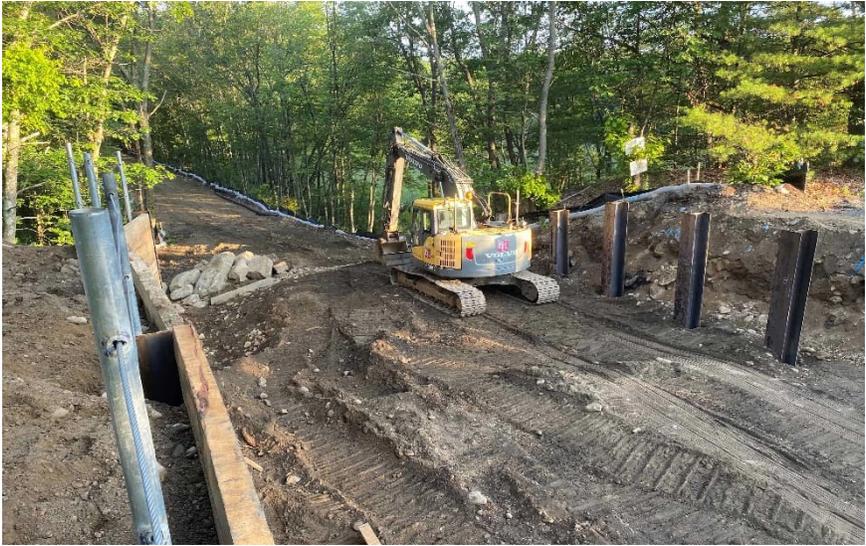
<p>PHOTOGRAPHIC LOG</p>	
<p>Client Name: Eversource</p>		<p>Site Location: Sudbury to Hudson Transmission Reliability Project</p>	<p>Town: Hudson</p>
<p>Photo No.: 1</p>	<p>Date: 6-30-23</p>

<p>Description:</p> <p>Chestnut Street crossing, toward segment 1, looking westward.</p>

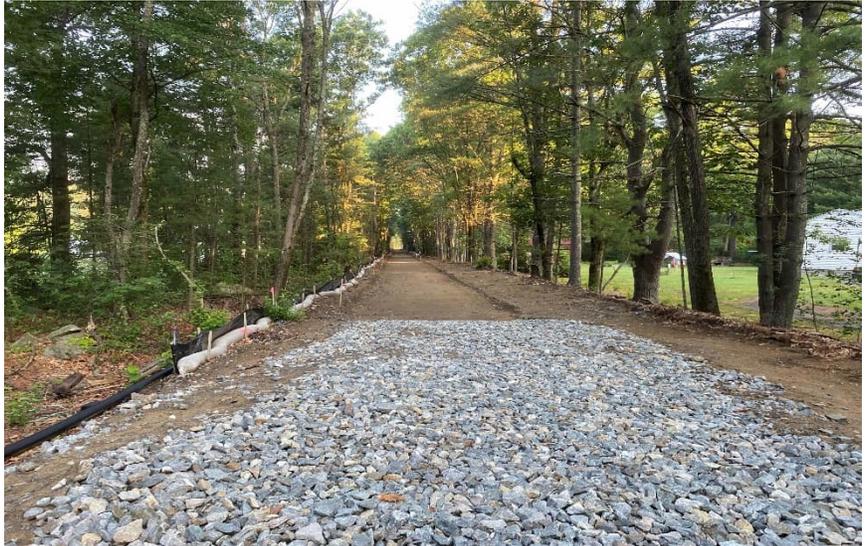
<p>PHOTOGRAPHIC LOG</p>	
<p>Client Name: Eversource</p>		<p>Site Location: Sudbury to Hudson Transmission Reliability Project</p>	<p>Town: Hudson</p>
<p>Photo No.: 2</p>	<p>Date: 6-30-23</p>

<p>Description:</p> <p>Work area within segment 4, existing erosion control, looking westward.</p>

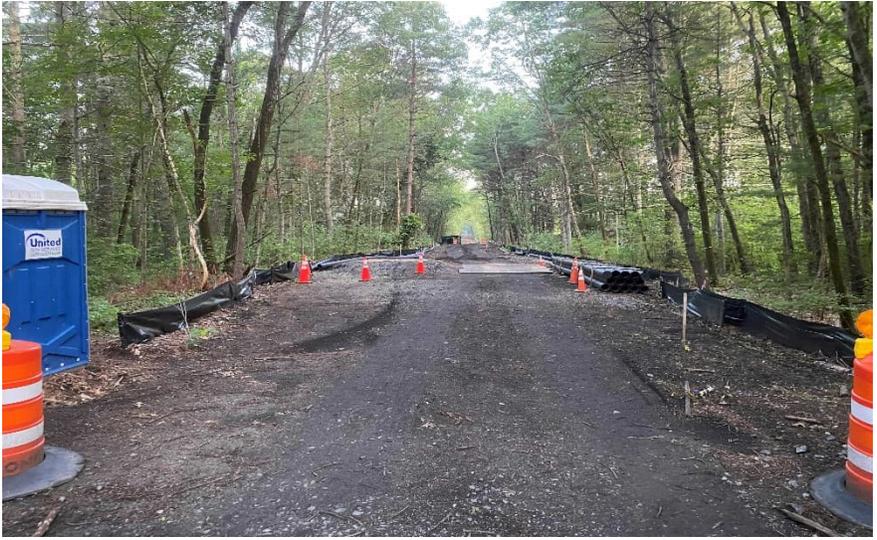
<p>PHOTOGRAPHIC LOG</p>	
<p>Client Name: Eversource</p>		<p>Site Location: Sudbury to Hudson Transmission Reliability Project</p>	<p>Town: Hudson</p>
<p>Photo No.: 3</p>	<p>Date: 6-30-23</p>

<p>Description:</p> <p>Work area within segment 5, existing erosion control, looking westward.</p>

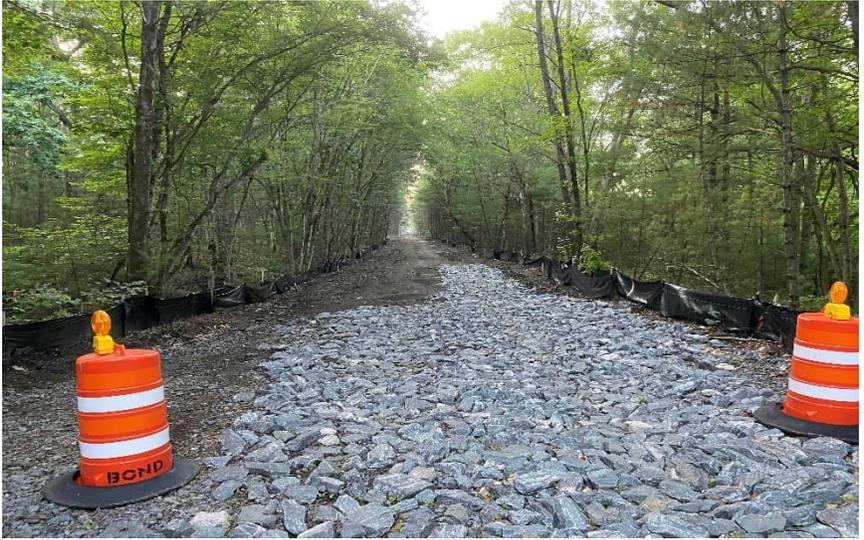
<p>PHOTOGRAPHIC LOG</p>	
<p>Client Name: Eversource</p>		<p>Site Location: Sudbury to Hudson Transmission Reliability Project</p>	<p>Town: Hudson</p>
<p>Photo No.: 4</p>	<p>Date: 6-30-23</p>

<p>Description:</p> <p>Work area within segment 6, existing erosion control, looking eastward.</p>

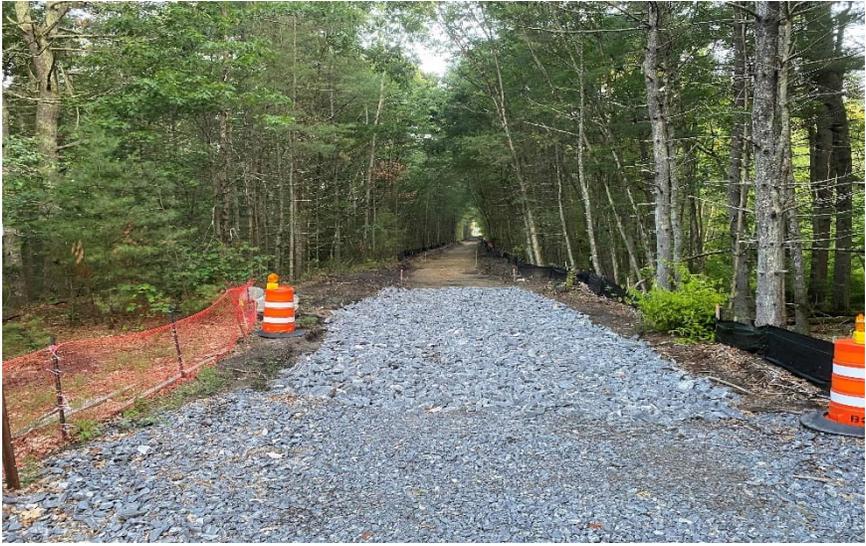
<p align="center">PHOTOGRAPHIC LOG</p>	
<p>Client Name: Eversource</p>		<p>Site Location: Sudbury to Hudson Transmission Reliability Project</p>	<p>Town: Sudbury</p>
<p>Photo No.: 5</p>	<p>Date: 6-30-23</p>

<p>Description:</p> <p>Work area within segment 8, existing erosion control, looking westward.</p>

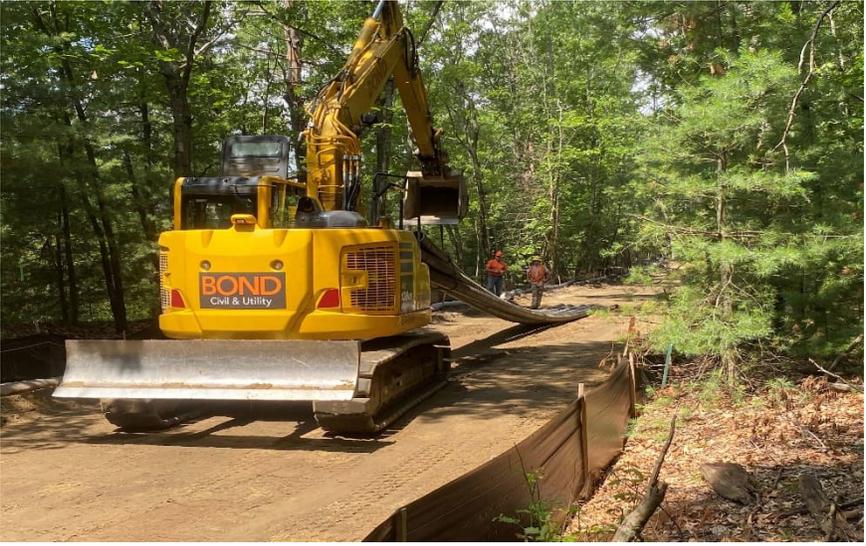
<p align="center">PHOTOGRAPHIC LOG</p>	
<p>Client Name: Eversource</p>		<p>Site Location: Sudbury to Hudson Transmission Reliability Project</p>	<p>Town: Sudbury</p>
<p>Photo No.: 6</p>	<p>Date: 6-30-23</p>

<p>Description:</p> <p>Bond conducting conduit work within Segment 11, existing erosion control, looking westward.</p>

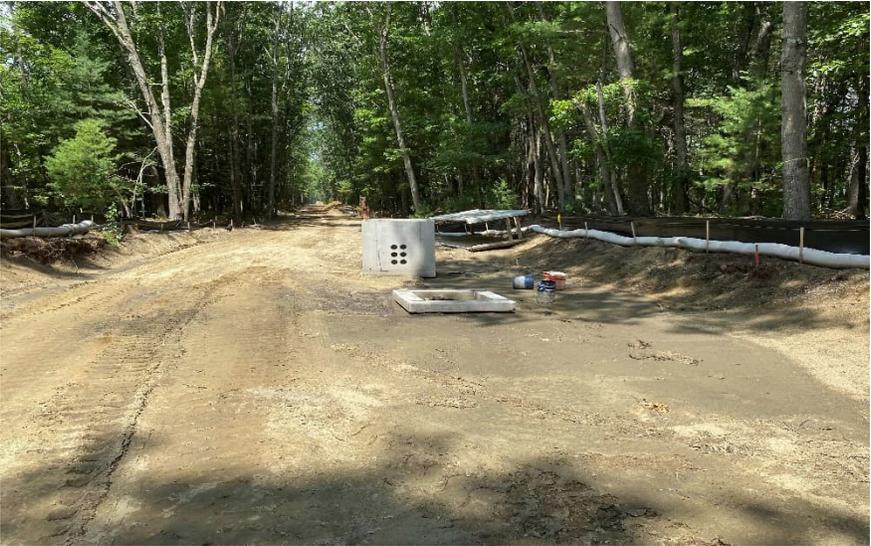
<p>PHOTOGRAPHIC LOG</p>	
<p>Client Name: Eversource</p>		<p>Site Location: Sudbury to Hudson Transmission Reliability Project</p>	<p>Town: Sudbury</p>
<p>Photo No.: 7</p>	<p>Date: 6-30-23</p>

<p>Description:</p> <p>Segment 11 manhole #23, existing erosion control, looking westward.</p>

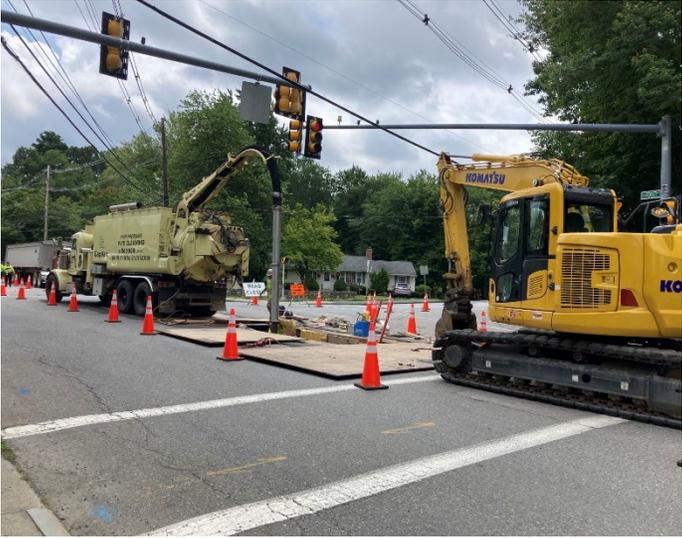
PHOTOGRAPHIC LOG	
Client Name: Eversource		Site Location: Sudbury to Hudson Transmission Reliability Project	Town: Hudson
Photo No.: 1	Date: 6-26-2023

Description: View of Bond working near MH #2 on Forest Ave. Facing southeast.

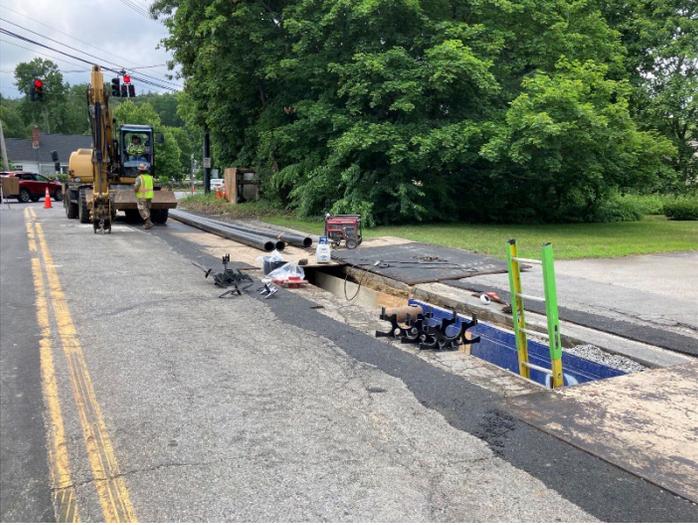
PHOTOGRAPHIC LOG	
Client Name: Eversource		Site Location: Sudbury to Hudson Transmission Reliability Project	Town: Hudson
Photo No.: 2	Date: 6-26-2023

Description: View of Bond working on Wilkins St. Facing southwest.

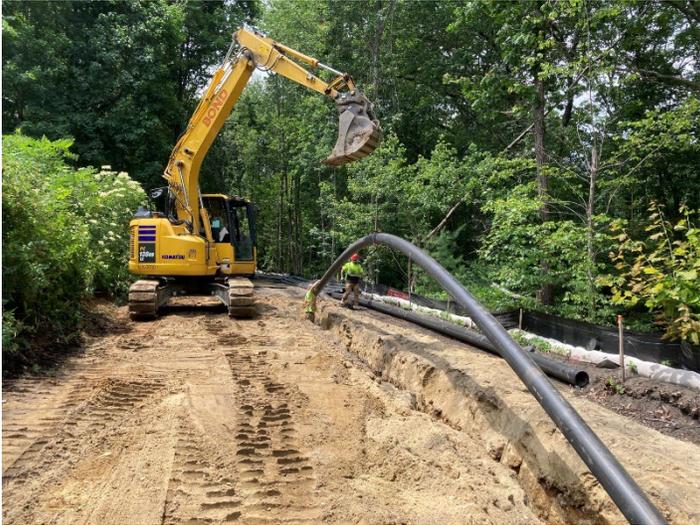
PHOTOGRAPHIC LOG	
Client Name: Eversource		Site Location: Sudbury to Hudson Transmission Reliability Project	Town: Hudson
Photo No.: 3	Date: 6-26-2023

Description: View of Bond installing conduit in segment 1. Facing west.

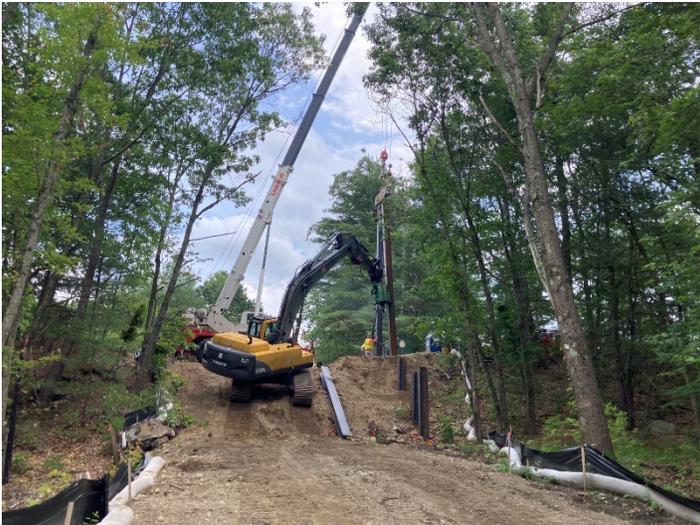
Client Name: Eversource		Site Location: Sudbury to Hudson Transmission Reliability Project	Town: Hudson
Photo No.: 5	Date: 6-26-2023

Description: View of ET&L working at Chestnut St. Facing east.

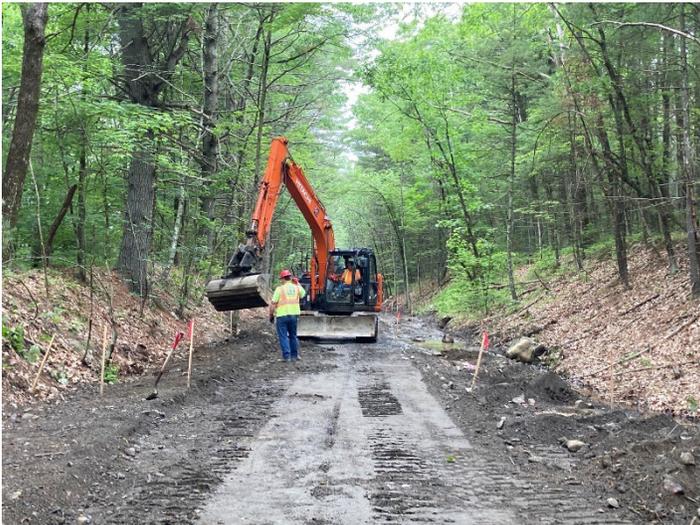
Epsilon ASSOCIATES INC.		PHOTOGRAPHIC LOG	
Client Name: Eversource		Site Location: Sudbury to Hudson Transmission Reliability Project	Town: Hudson
Photo No.: 8	Date: 6-26-2023

Description: View of ET&L performing grading activities in segment 5. Facing west.

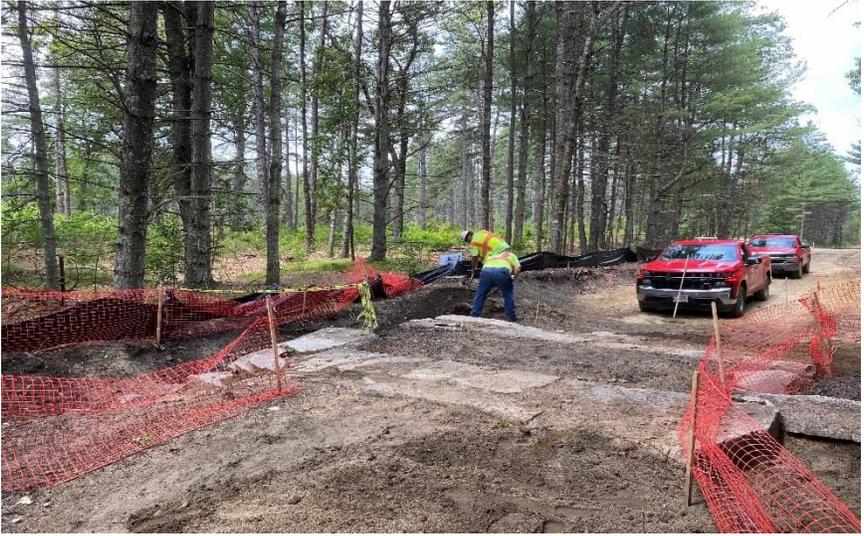
PHOTOGRAPHIC LOG	
Client Name: Eversource		Site Location: Sudbury to Hudson Transmission Reliability Project	Town: Sudbury
Photo No.: 1	Date: 6-26-23

Description: Work area within Segment 7, backfilling of historic cattle guard by hand, existing erosion control, looking westward.

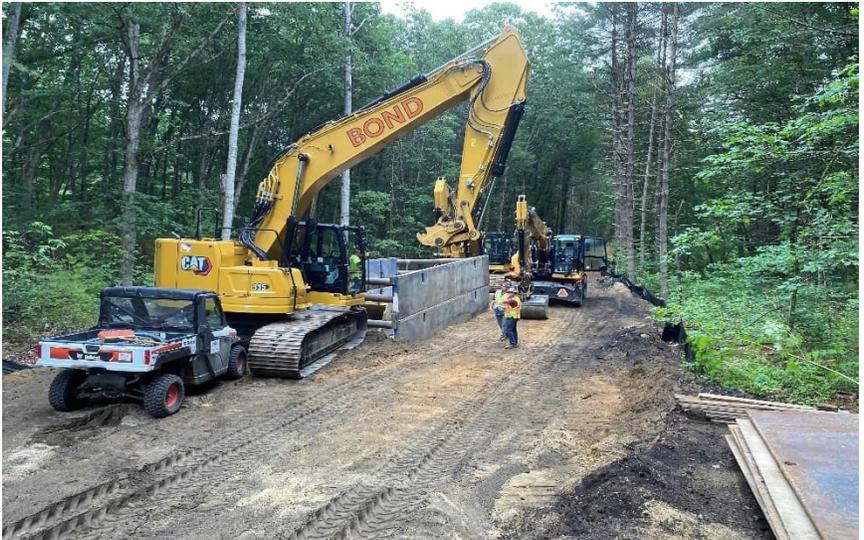
PHOTOGRAPHIC LOG	
Client Name: Eversource		Site Location: Sudbury to Hudson Transmission Reliability Project	Town: Sudbury
Photo No.: 2	Date: 6-26-23

Description: Work area within Segment 10, Bond removing equipment to move to segment 9, existing erosion control, looking eastward.

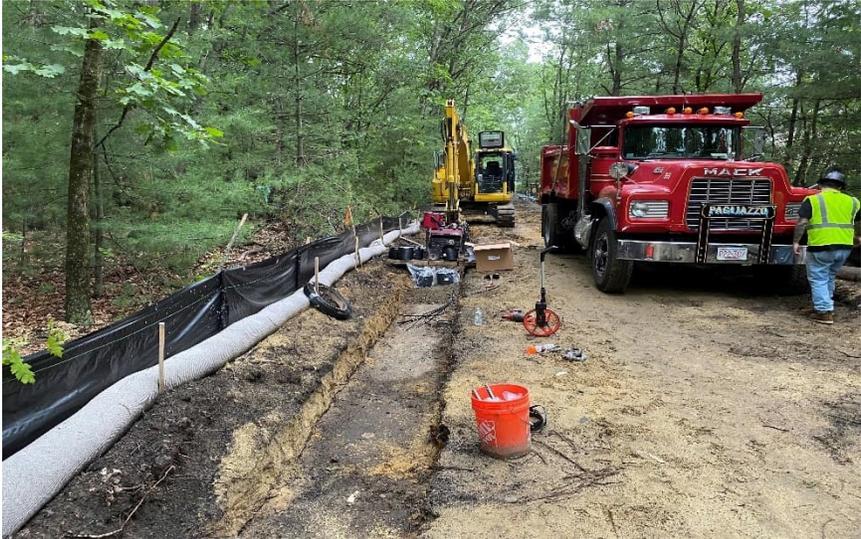
PHOTOGRAPHIC LOG	
Client Name: Eversource		Site Location: Sudbury to Hudson Transmission Reliability Project	Town: Sudbury
Photo No.: 3	Date: 6-26-23

Description: Bond conducting conduit work within segment 11, existing erosion control, looking eastward.

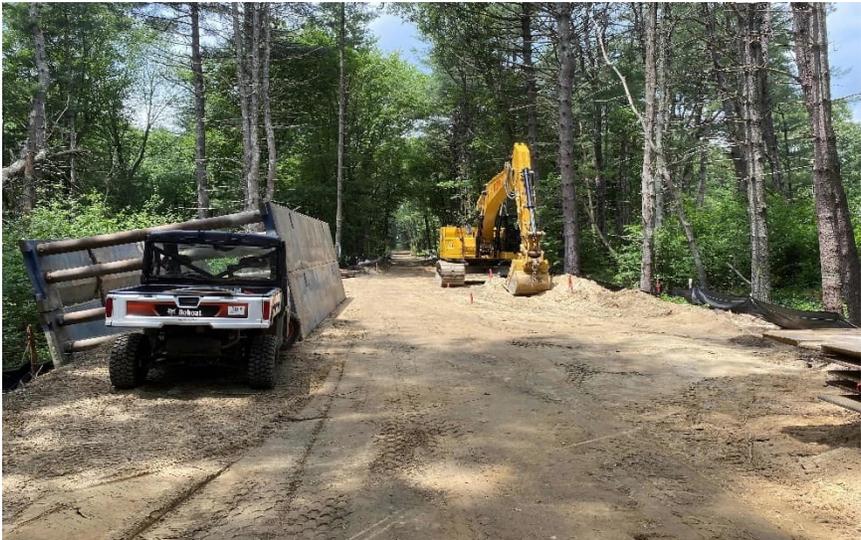
PHOTOGRAPHIC LOG	
Client Name: Eversource		Site Location: Sudbury to Hudson Transmission Reliability Project	Town: Sudbury
Photo No.: 4	Date: 6-26-23

Description: Work area within segment 9, manhole 19 area, existing erosion control, looking westward.

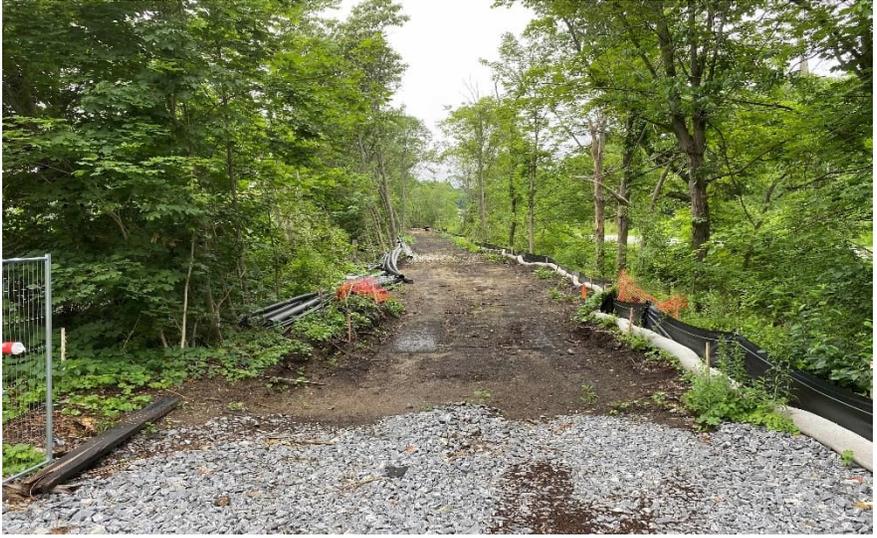
PHOTOGRAPHIC LOG	
Client Name: Eversource		Site Location: Sudbury to Hudson Transmission Reliability Project	Town: Sudbury
Photo No.: 5	Date: 6-26-23

Description: Work area within segment 12, existing erosion control, looking westward.

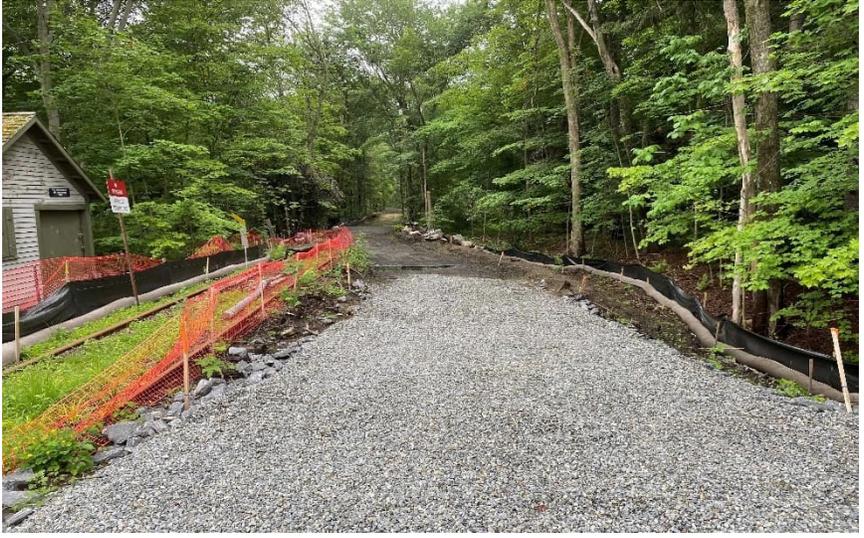
PHOTOGRAPHIC LOG	
Client Name: Eversource		Site Location: Sudbury to Hudson Transmission Reliability Project	Town: Sudbury
Photo No.: 6	Date: 6-26-23

Description: Work area within segment 13, existing erosion control, looking eastward.

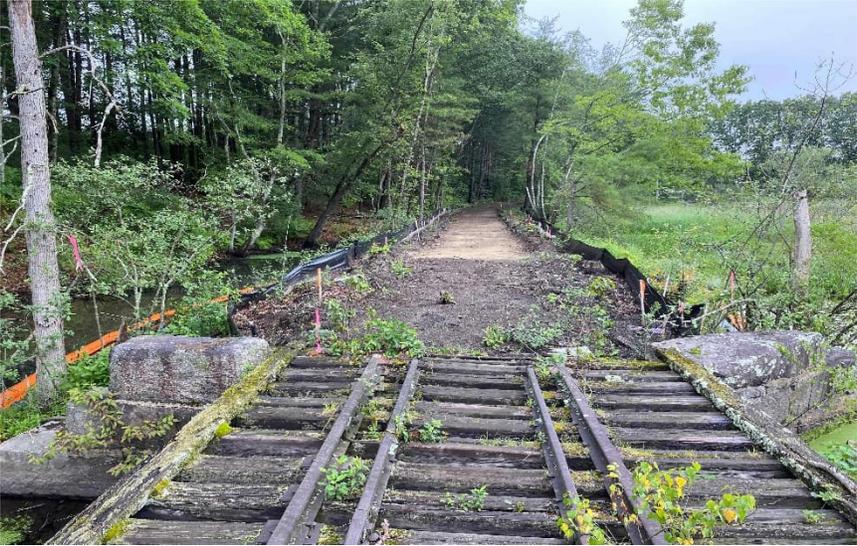
PHOTOGRAPHIC LOG	
Client Name: Eversource		Site Location: Sudbury to Hudson Transmission Reliability Project	Town: Sudbury
Photo No.: 7	Date: 6-26-23

Description: Bridge 127 looking into segment 13, existing erosion control, looking westward.

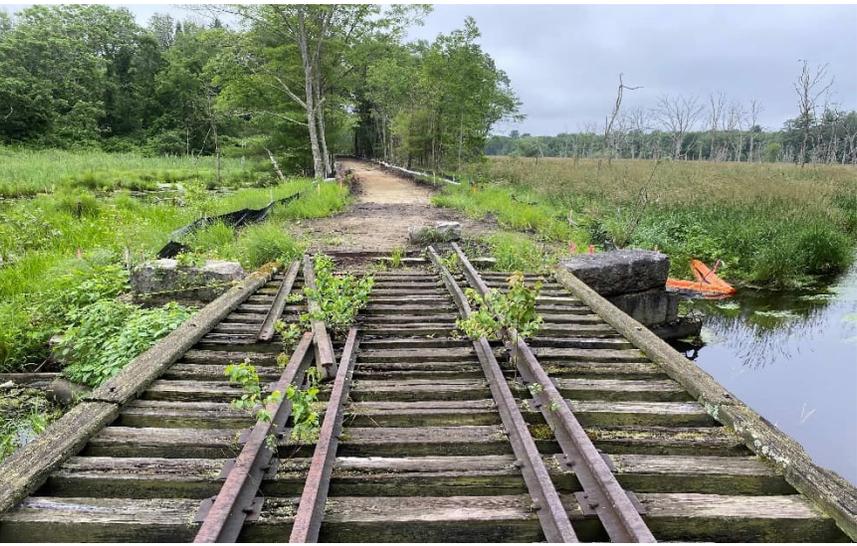
PHOTOGRAPHIC LOG	
Client Name: Eversource		Site Location: Sudbury to Hudson Transmission Reliability Project	Town: Sudbury
Photo No.: 8	Date: 6-26-23

Description: Bridge 127 looking into segment 14, existing erosion control, looking eastward.
