Weekly Environmental Compliance Summary

Sudbury to Hudson Transmission Reliability Project (USEPA Tracking # MAR1003UW)

Week of: June 26 to June 30, 2023

CONSTRUCTION MONITORING REPORT

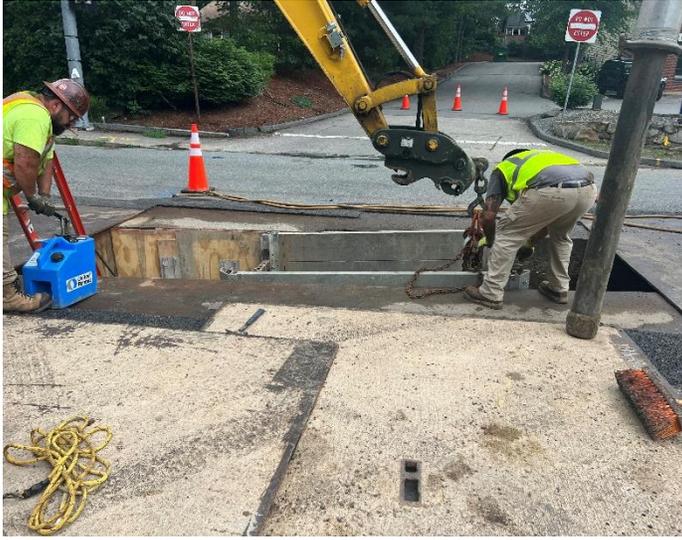
PHOTOGRAPHIC LOG	
Client Name: Eversource		Site Location: Sudbury to Hudson Transmission Reliability Project	Town: Hudson
Photo No.: 1	Date: 6-29-2023

Description: View of Bond working near MH #2 on Forest Ave. Facing north.

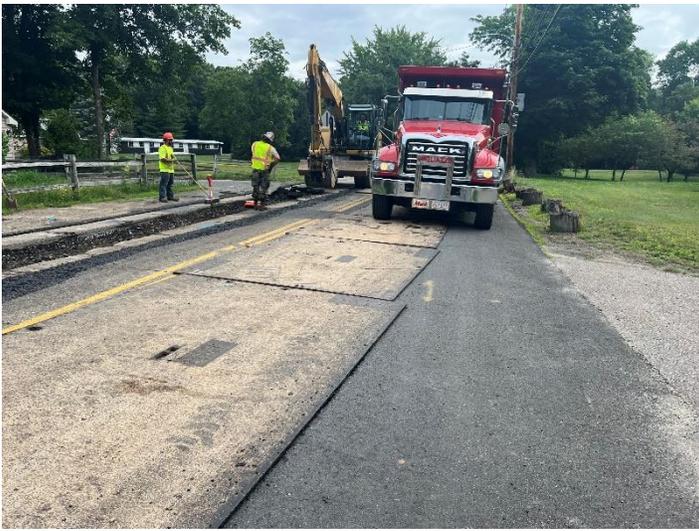
PHOTOGRAPHIC LOG	
Client Name: Eversource		Site Location: Sudbury to Hudson Transmission Reliability Project	Town: Hudson
Photo No.: 2	Date: 6-29-2023

Description: View of Bond working on Wilkins St. Facing northeast.

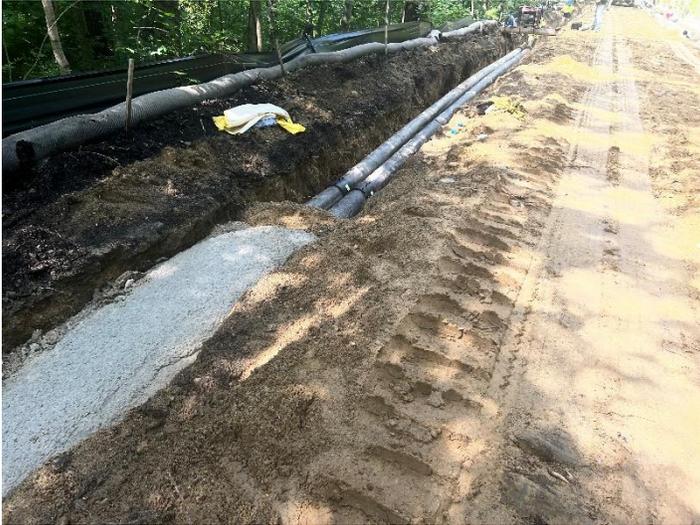
PHOTOGRAPHIC LOG	
Client Name: Eversource		Site Location: Sudbury to Hudson Transmission Reliability Project	Town: Hudson
Photo No.: 3	Date: 6-29-2023

Description: View of Bond installing conduit in segment 1. Facing east.

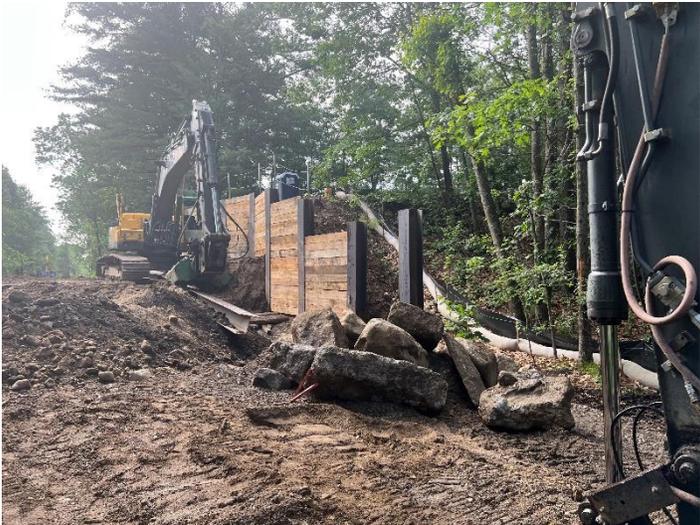
PHOTOGRAPHIC LOG	
Client Name: Eversource		Site Location: Sudbury to Hudson Transmission Reliability Project	Town: Hudson
Photo No.: 5	Date: 6-29-2023

Description: View of ET&L installing H-piles at Chestnut St. Facing east.

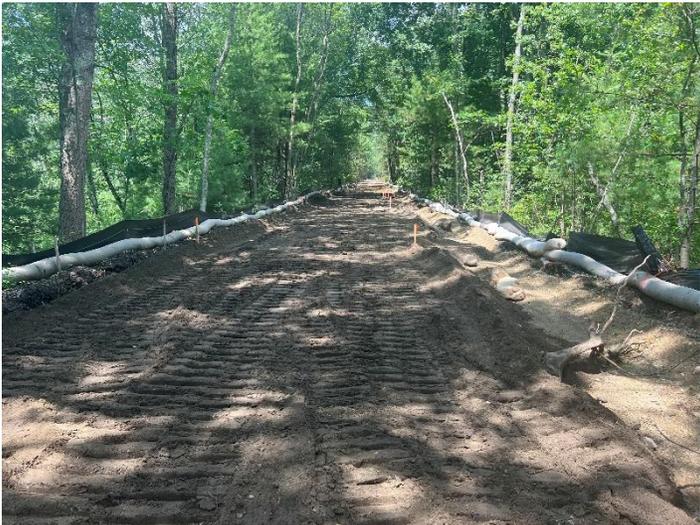
Epsilon ASSOCIATES INC.		PHOTOGRAPHIC LOG	
Client Name: Eversource		Site Location: Sudbury to Hudson Transmission Reliability Project	Town: Hudson
Photo No.: 8	Date: 6-29-2023

Description: View of the area where ET&L is performing grading activities in segment 5. Facing west.

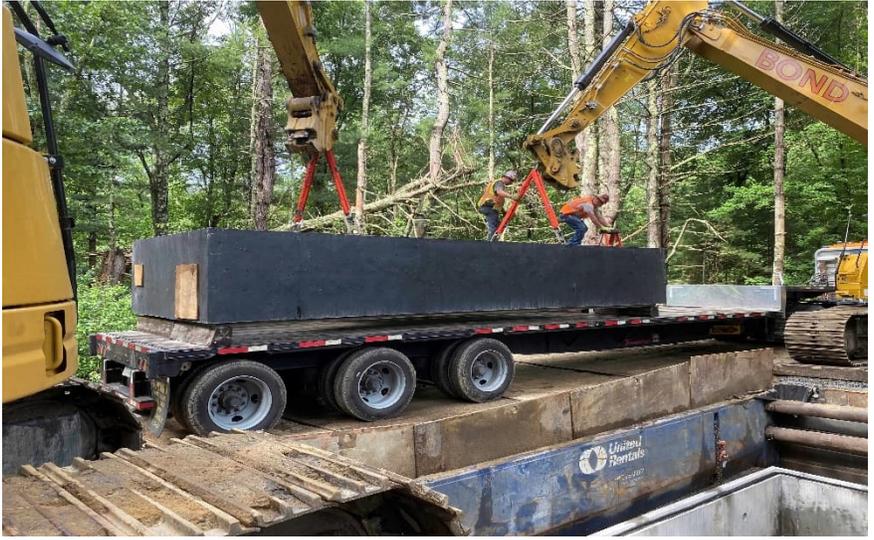
PHOTOGRAPHIC LOG	
Client Name: Eversource		Site Location: Sudbury to Hudson Transmission Reliability Project	Town: Sudbury
Photo No.: 1	Date: 6-29-23

Description: Work area within Segment 9, installing manhole 19, lower half in trench & upper half to be installed, looking westward.

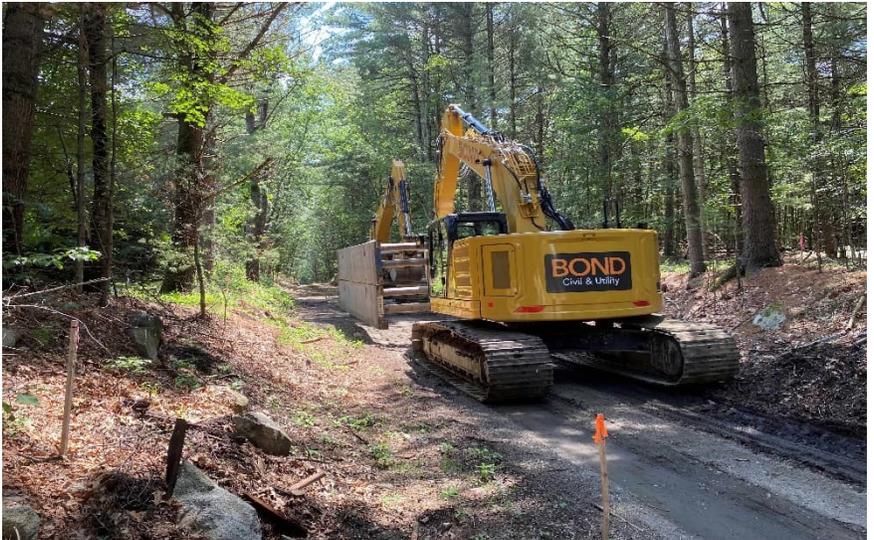
PHOTOGRAPHIC LOG	
Client Name: Eversource		Site Location: Sudbury to Hudson Transmission Reliability Project	Town: Sudbury
Photo No.: 2	Date: 6-29-23

Description: Segment 9, Bond moving equipment (trench box) to manhole 18 area within segment 9, looking westward.

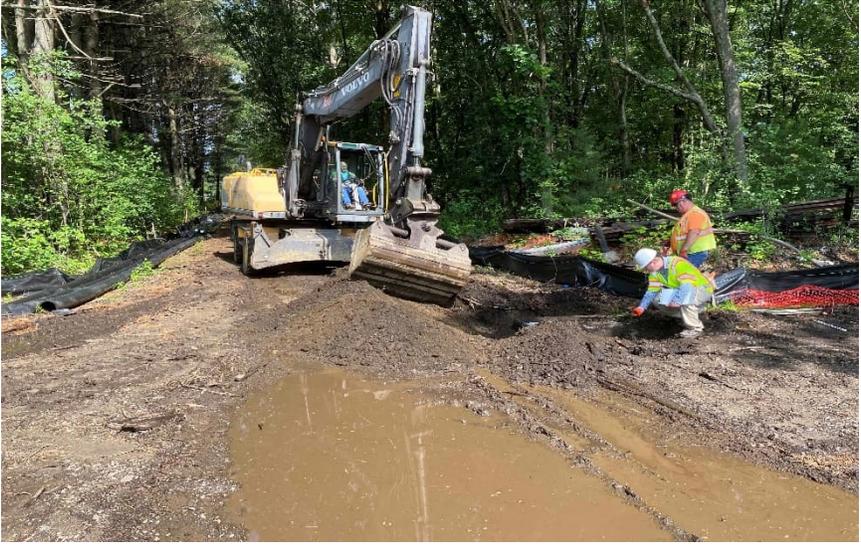
PHOTOGRAPHIC LOG	
Client Name: Eversource		Site Location: Sudbury to Hudson Transmission Reliability Project	Town: Sudbury
Photo No.: 3	Date: 6-29-23

Description: ET&L assisting Commonwealth Heritage in exposing cultural resources (railroad features) within segment 11, existing erosion control, looking westward.
