Weekly Environmental Compliance Summary

Sudbury to Hudson Transmission Reliability Project (USEPA Tracking # MAR1003UW)

Week of: July 3 to July 7, 2023

CONSTRUCTION MONITORING REPORT

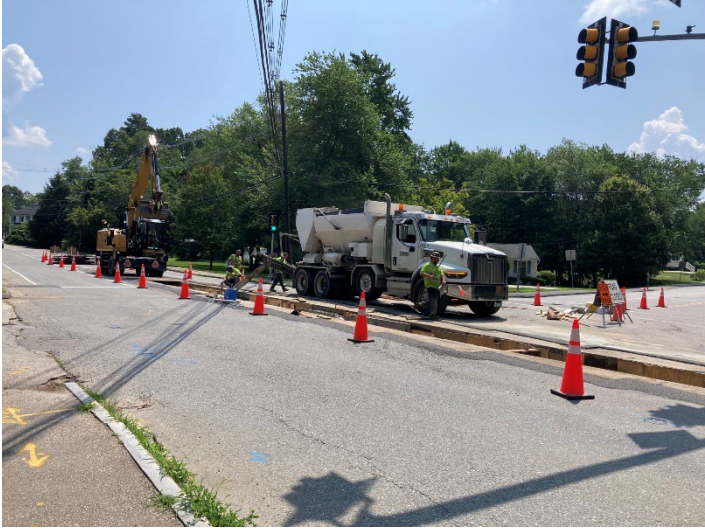
<p align="center">PHOTOGRAPHIC LOG</p>	
<p>Client Name: Eversource</p>		<p>Site Location: Sudbury to Hudson Transmission Reliability Project</p>	<p>Town: Hudson</p>
<p>Photo No.: 1</p>	<p>Date: 7/06/2023</p>

<p>Description: View of Bond working near MH #2 on Forest Ave. Facing southeast.</p>

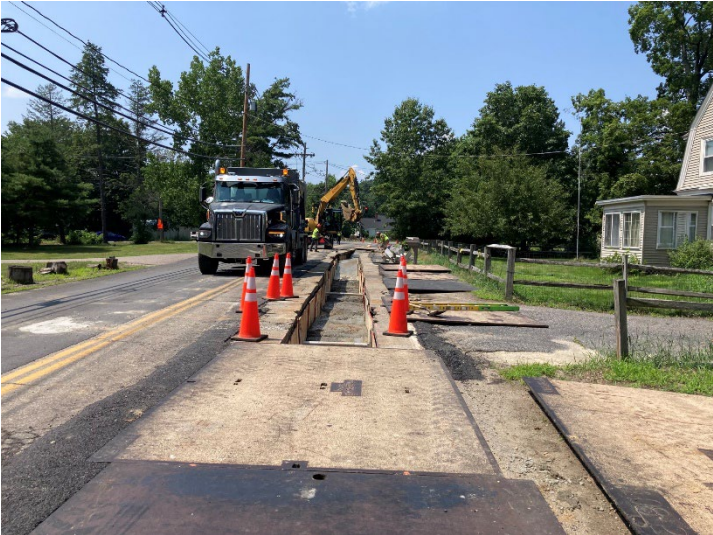
<p align="center">PHOTOGRAPHIC LOG</p>	
<p>Client Name: Eversource</p>		<p>Site Location: Sudbury to Hudson Transmission Reliability Project</p>	<p>Town: Hudson</p>
<p>Photo No.: 2</p>	<p>Date: 7/06/2023</p>

<p>Description: View of Bond working on Wilkins St. Facing southwest.</p>

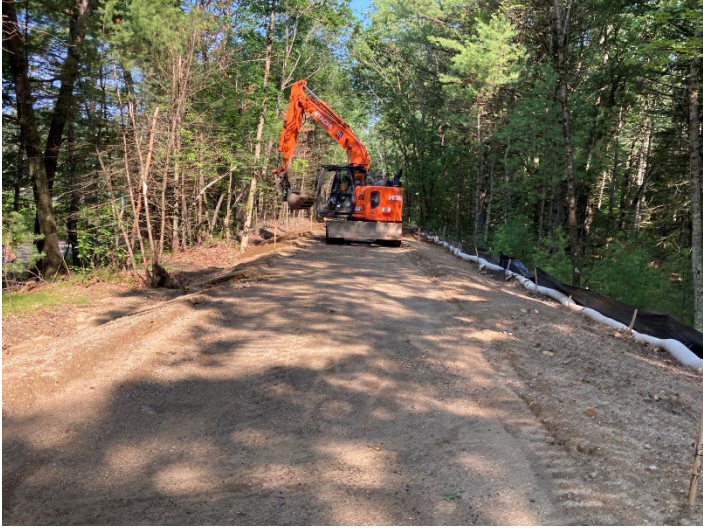
PHOTOGRAPHIC LOG	
Client Name: Eversource		Site Location: Sudbury to Hudson Transmission Reliability Project	
Town: Hudson			
Photo No.: 5	Date: 7/06/2023

Description: View of ET&L working in segment 5. Facing west.

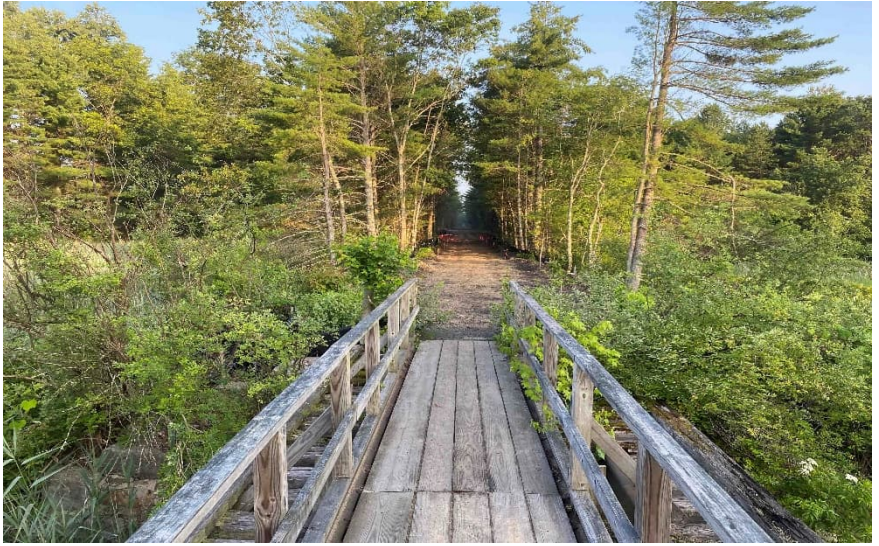
PHOTOGRAPHIC LOG	
Client Name: Eversource		Site Location: Sudbury to Hudson Transmission Reliability Project	Town: Sudbury
Photo No.: 1	Date: 7-6-23

Description: Bridge 128 at segment 7/8 boundary. Work area within Segment 7, existing erosion control, looking westward.

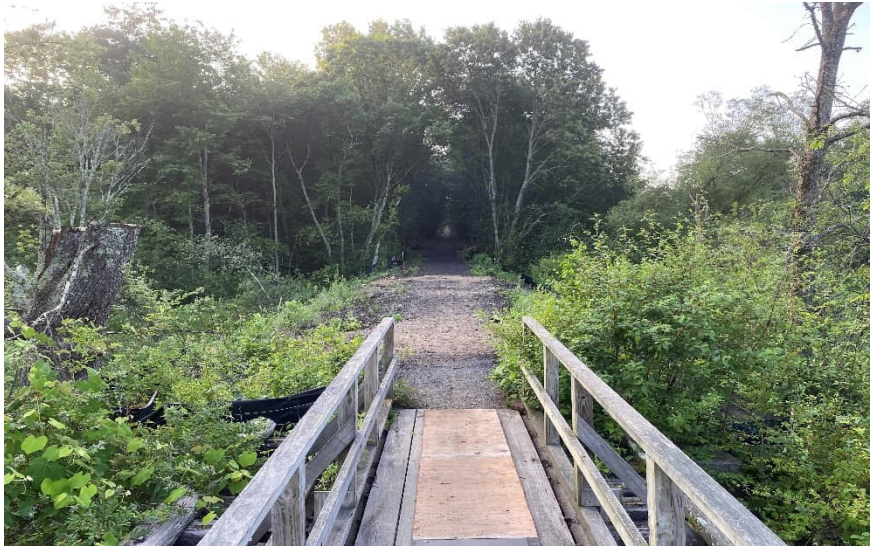
PHOTOGRAPHIC LOG	
Client Name: Eversource		Site Location: Sudbury to Hudson Transmission Reliability Project	Town: Sudbury
Photo No.: 2	Date: 7-6-23

Description: Bridge 128 at segment 7/8 boundary. Work area within Segment 8, existing erosion control, looking eastward.

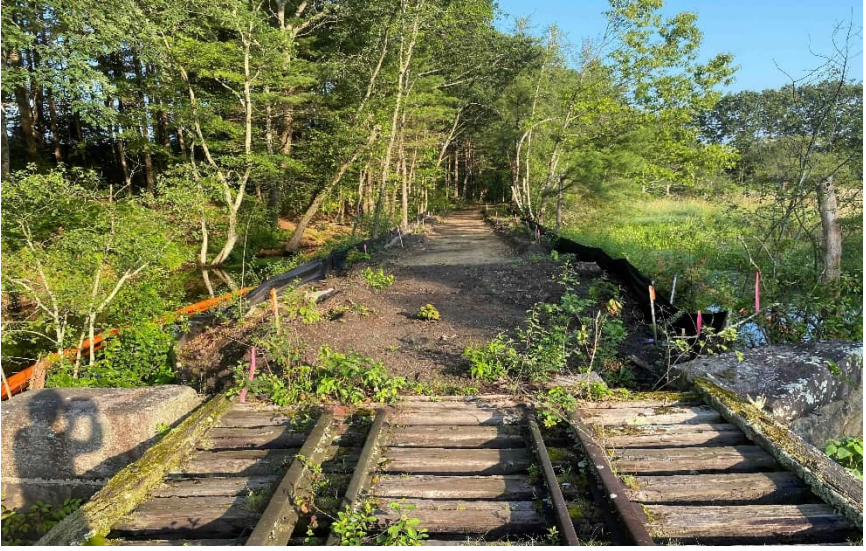
PHOTOGRAPHIC LOG	
Client Name: Eversource		Site Location: Sudbury to Hudson Transmission Reliability Project	Town: Sudbury
Photo No.: 3	Date: 7-6-23

Description: Bridge 127 at segment 13/14 boundary. Work area within Segment 13, existing erosion control, looking westward.

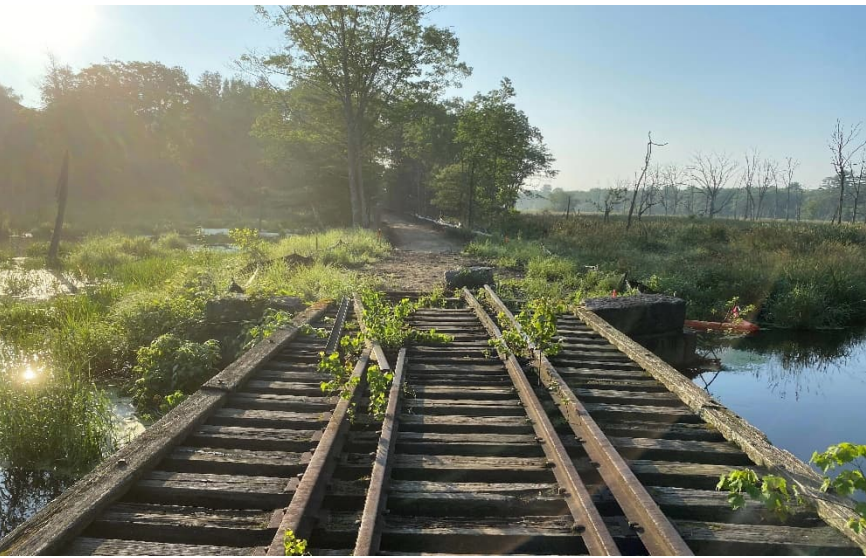
PHOTOGRAPHIC LOG	
Client Name: Eversource		Site Location: Sudbury to Hudson Transmission Reliability Project	Town: Sudbury
Photo No.: 4	Date: 7-6-23

Description: Bridge 127 at segment 13/14 boundary. Work area within Segment 14, existing erosion control, looking eastward.

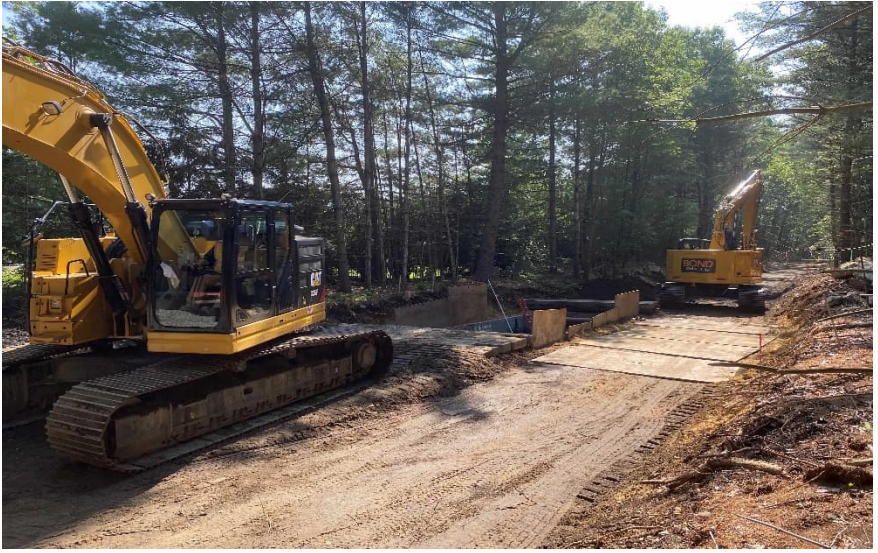
PHOTOGRAPHIC LOG	
Client Name: Eversource		Site Location: Sudbury to Hudson Transmission Reliability Project	Town: Sudbury
Photo No.: 7	Date: 7-6-23

Description: Work area within Segment 9, manhole #18, existing erosion control, looking eastward.

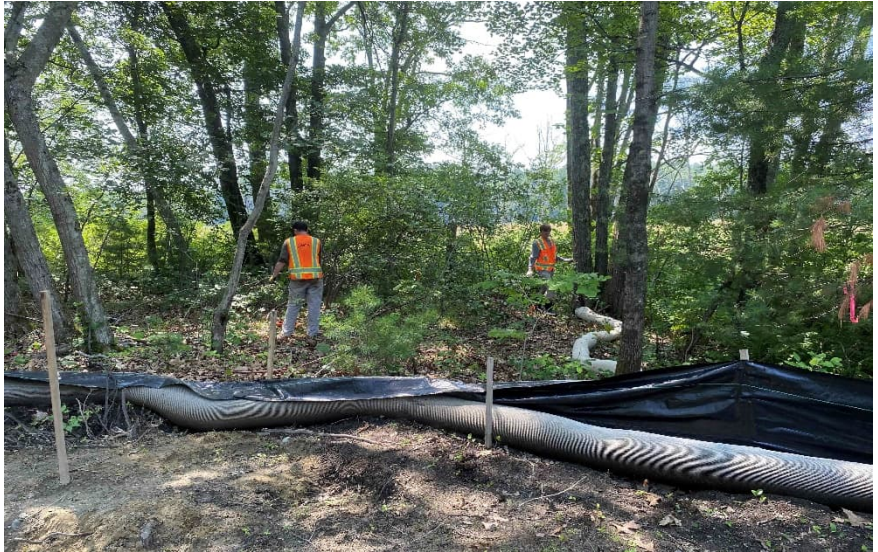
PHOTOGRAPHIC LOG	
Client Name: Eversource		Site Location: Sudbury to Hudson Transmission Reliability Project	Town: Sudbury
Photo No.: 8	Date: 7-6-23

Description: Removal of invasive species (buckthorn) within Segment 14 area, looking westward.

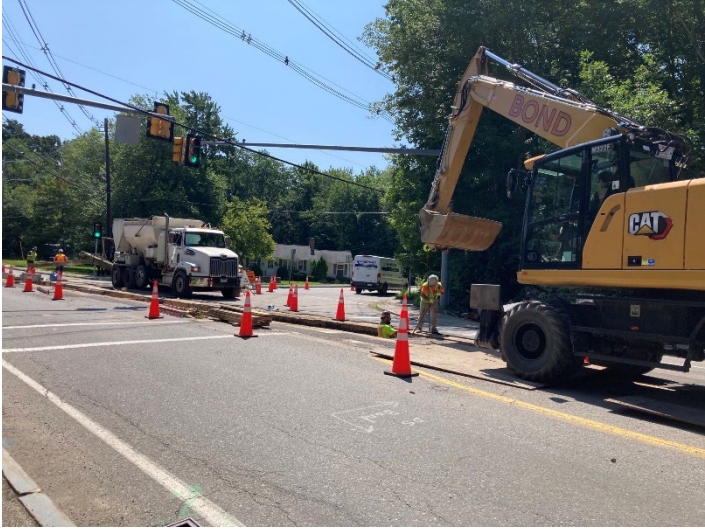
PHOTOGRAPHIC LOG	
Client Name: Eversource		Site Location: Sudbury to Hudson Transmission Reliability Project	Town: Hudson
Photo No.: 1	Date: 7/07/2023

Description: View of Bond working near MH #2 on Forest Ave. Facing southeast.

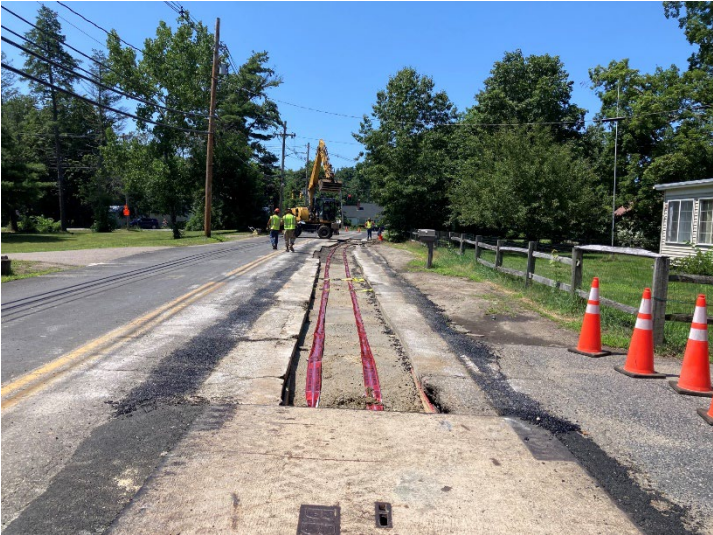
PHOTOGRAPHIC LOG	
Client Name: Eversource		Site Location: Sudbury to Hudson Transmission Reliability Project	Town: Hudson
Photo No.: 2	Date: 7/07/2023

Description: View of Bond working on Wilkins St. Facing southwest.

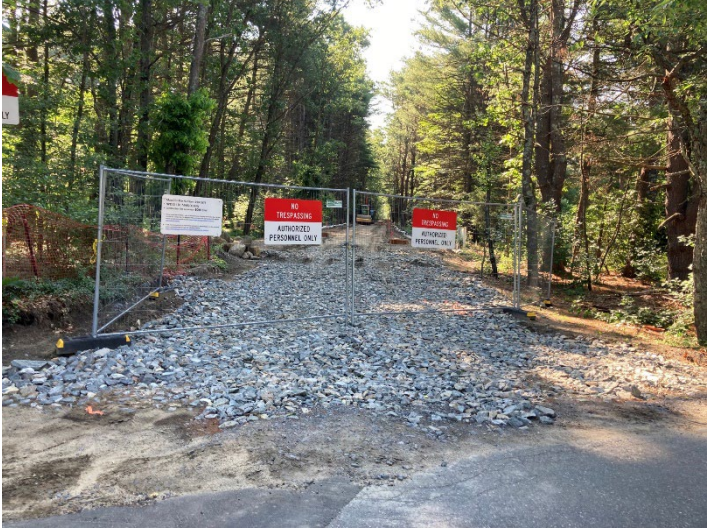
PHOTOGRAPHIC LOG	
Client Name: Eversource		Site Location: Sudbury to Hudson Transmission Reliability Project	
Photo No.: 6		Town: Hudson	
Date: 7/07/2023

Description: View of construction entrance to segment 5 at Parmenter Road. Facing east.

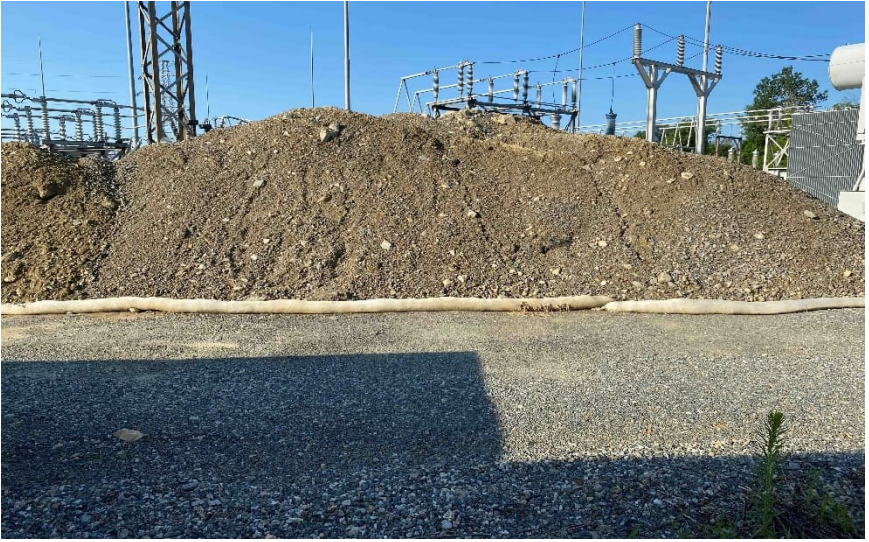
PHOTOGRAPHIC LOG	
Client Name: Eversource		Site Location: Sudbury to Hudson Transmission Reliability Project	Town: Sudbury
Photo No.: 1	Date: 7-7-23

Description: Sudbury substation, spoil pile with compost filter tubes surrounding pile, looking westward.

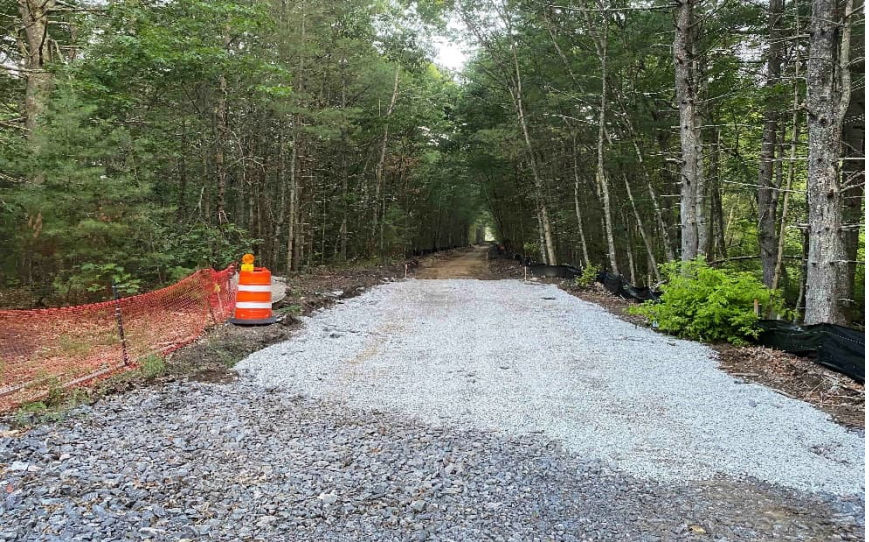
PHOTOGRAPHIC LOG	
Client Name: Eversource		Site Location: Sudbury to Hudson Transmission Reliability Project	Town: Sudbury
Photo No.: 2	Date: 7-7-23

Description: Work area within segment 8, existing erosion control, looking westward.

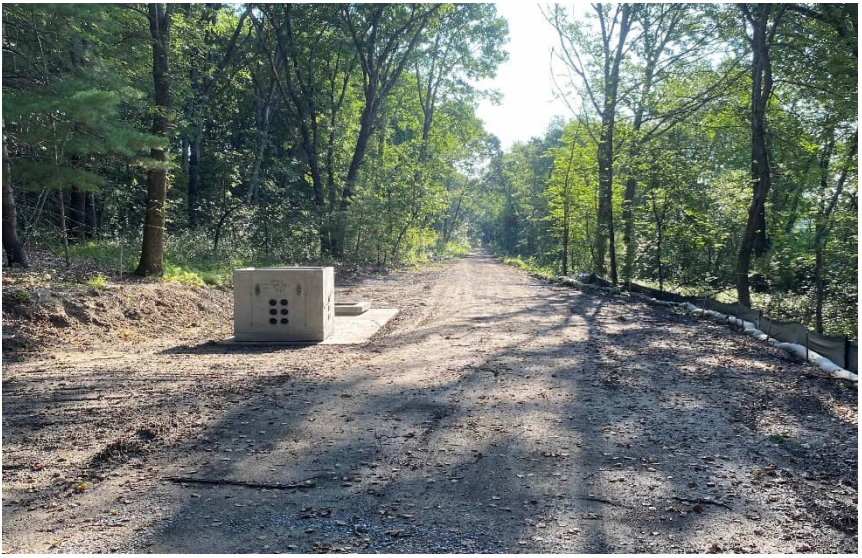
PHOTOGRAPHIC LOG	
Client Name: Eversource		Site Location: Sudbury to Hudson Transmission Reliability Project	Town: Sudbury
Photo No.: 4	Date: 7-7-23

Description: Work area within segment 14, manhole #26, existing erosion control, looking eastward.

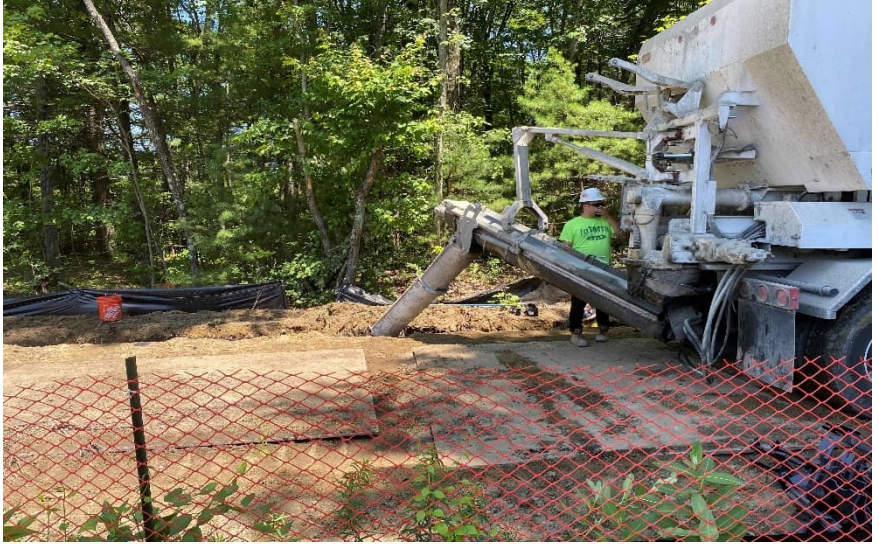
PHOTOGRAPHIC LOG	
Client Name: Eversource		Site Location: Sudbury to Hudson Transmission Reliability Project	Town: Sudbury
Photo No.: 5	Date: 7-7-23

Description: Work area within segment 11, conduit work (flowable fill placement), existing erosion control, looking eastward.

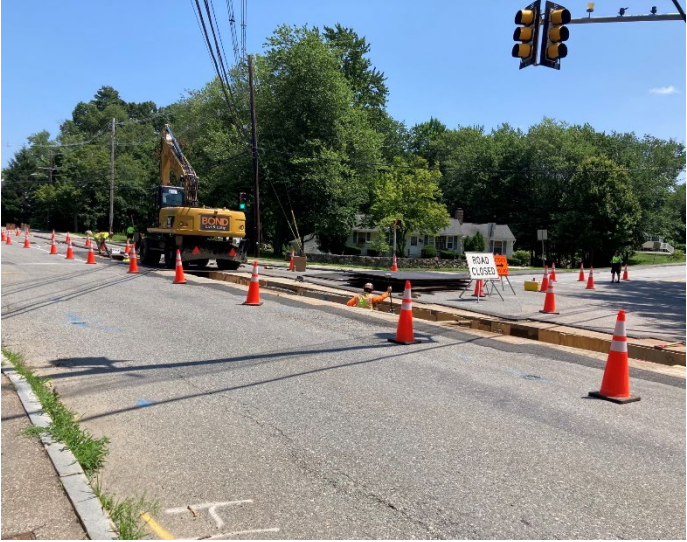
PHOTOGRAPHIC LOG	
Client Name: Eversource		Site Location: Sudbury to Hudson Transmission Reliability Project	Town: Hudson
Photo No.: 1	Date: 7-05-2023

Description: View of Bond working near MH #2 on Forest Ave. Facing southeast.

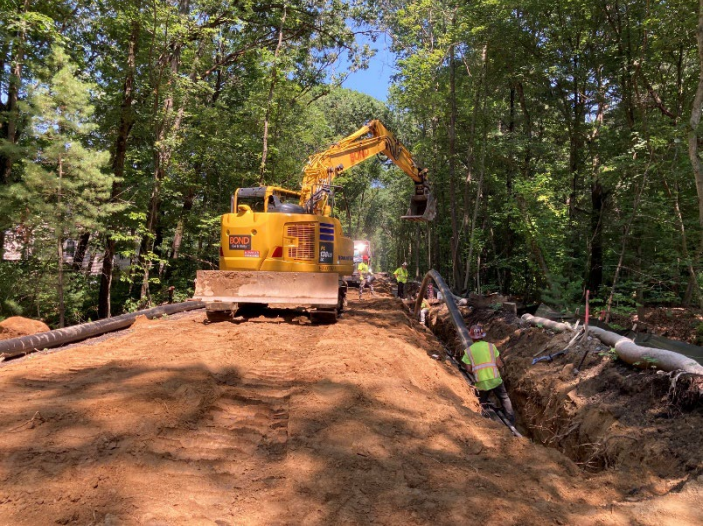
PHOTOGRAPHIC LOG	
Client Name: Eversource		Site Location: Sudbury to Hudson Transmission Reliability Project	Town: Hudson
Photo No.: 2	Date: 7-05-2023

Description: View of Bond installing conduit in segment 1. Facing east.

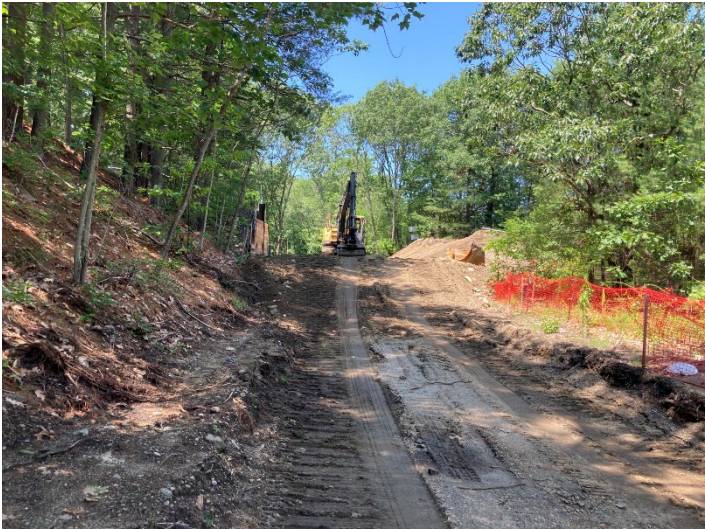
PHOTOGRAPHIC LOG	
Client Name: Eversource		Site Location: Sudbury to Hudson Transmission Reliability Project	Town: Hudson
Photo No.: 4	Date: 7-05-2023

Description: View of ET&L working at Chestnut St. Facing west from segment 2.

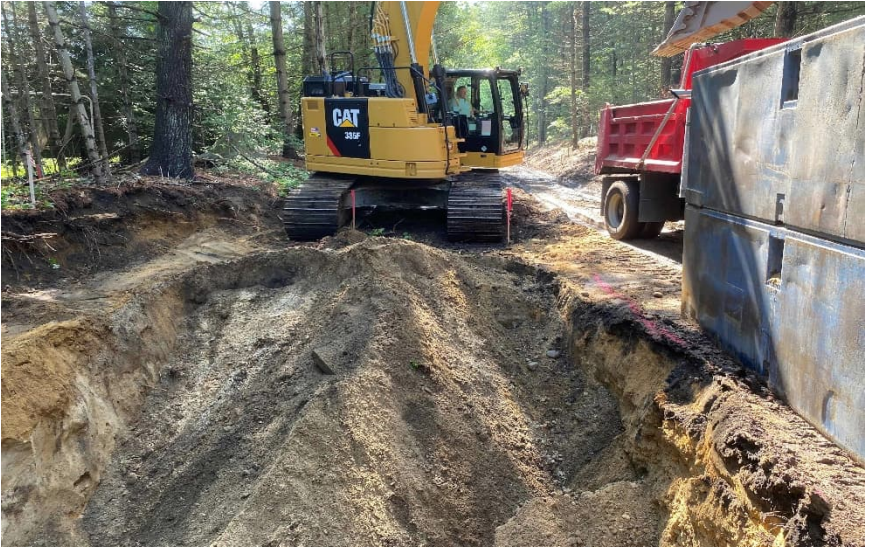
PHOTOGRAPHIC LOG	
Client Name: Eversource		Site Location: Sudbury to Hudson Transmission Reliability Project	Town: Sudbury
Photo No.: 1	Date: 7-5-23

Description: Work area within Segment 9, Bond conducting manhole #18 work, looking eastward.

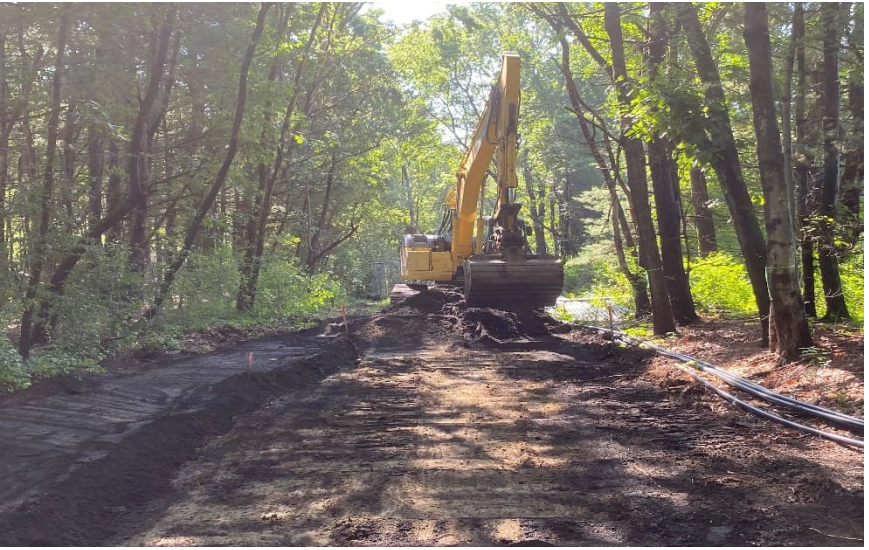
PHOTOGRAPHIC LOG	
Client Name: Eversource		Site Location: Sudbury to Hudson Transmission Reliability Project	Town: Sudbury
Photo No.: 2	Date: 7-5-23

Description: Work area within Segment 11, ET&L cut-fill work, looking westward.

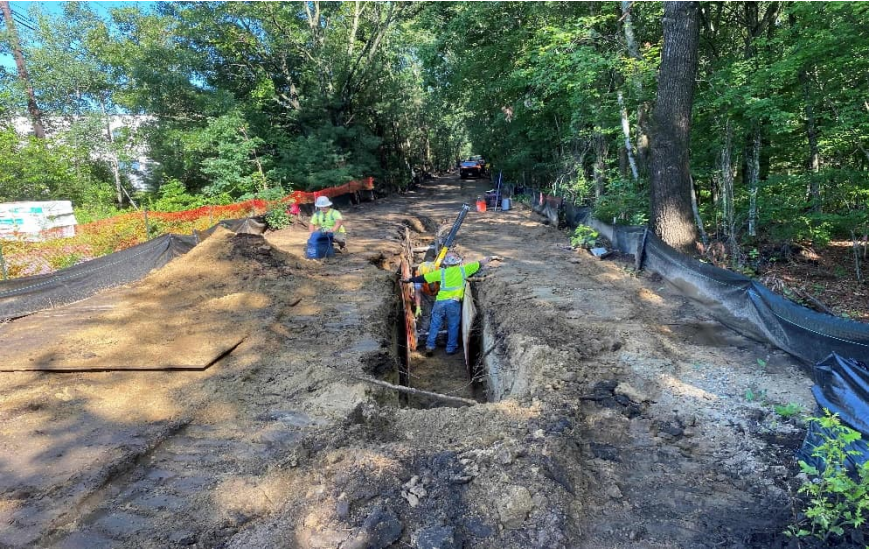
PHOTOGRAPHIC LOG	
Client Name: Eversource		Site Location: Sudbury to Hudson Transmission Reliability Project	Town: Sudbury
Photo No.: 3	Date: 7-5-23

Description: Bond conducting conduit work within segment 11, existing erosion control, looking westward.

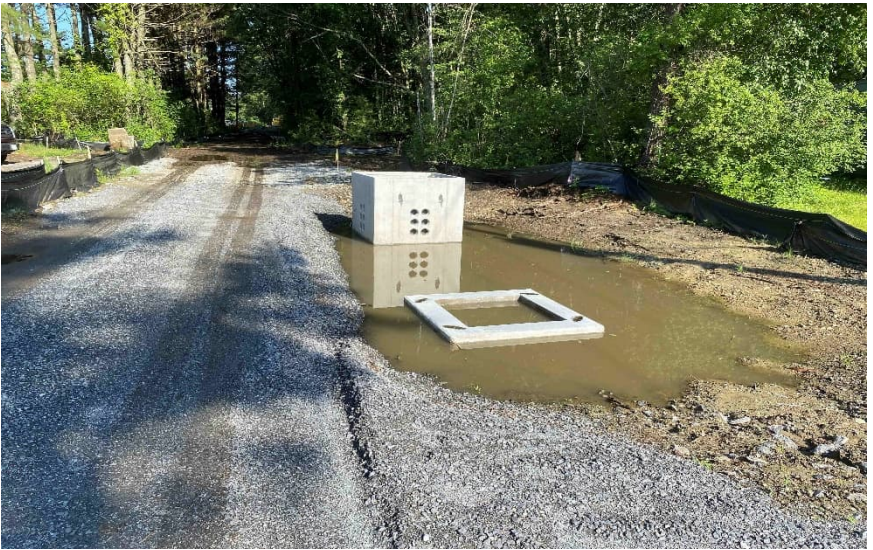
PHOTOGRAPHIC LOG	
Client Name: Eversource		Site Location: Sudbury to Hudson Transmission Reliability Project	Town: Sudbury
Photo No.: 4	Date: 7-5-23

Description: Work area within segment 11, manhole 24 area, existing erosion control, looking westward.

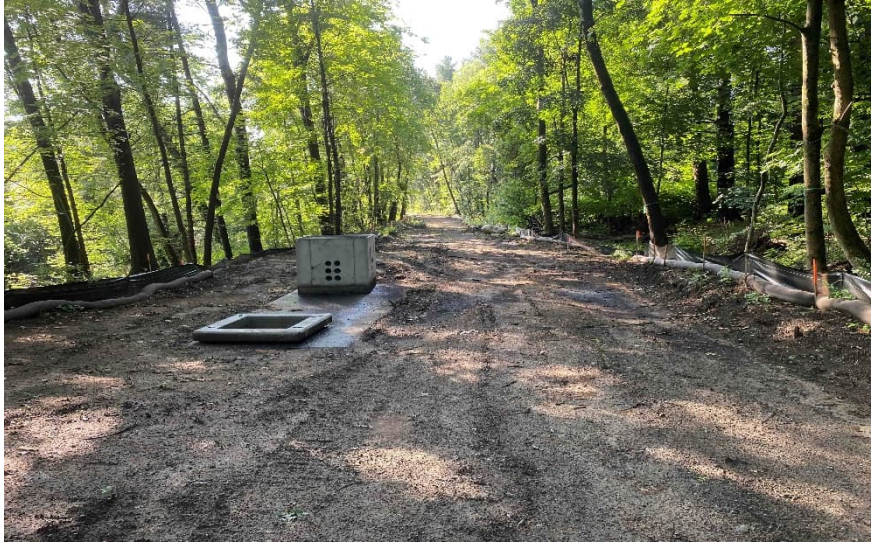
PHOTOGRAPHIC LOG	
Client Name: Eversource		Site Location: Sudbury to Hudson Transmission Reliability Project	Town: Sudbury
Photo No.: 5	Date: 7-5-23

Description: Work area within segment 13, manhole 25 area, existing erosion control, looking eastward.

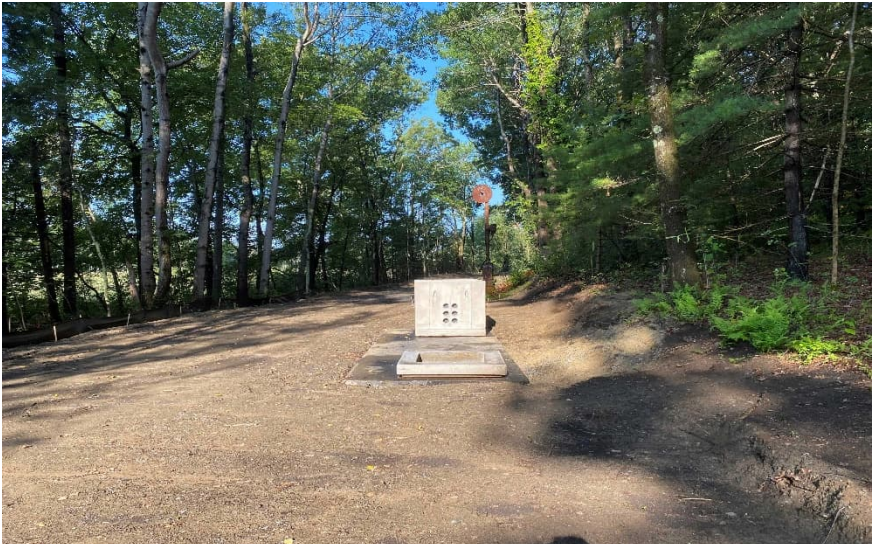
PHOTOGRAPHIC LOG	
Client Name: Eversource		Site Location: Sudbury to Hudson Transmission Reliability Project	Town: Sudbury
Photo No.: 6	Date: 7-5-23

Description: Work area within segment 14, manhole 26 area, existing erosion control, looking westward.

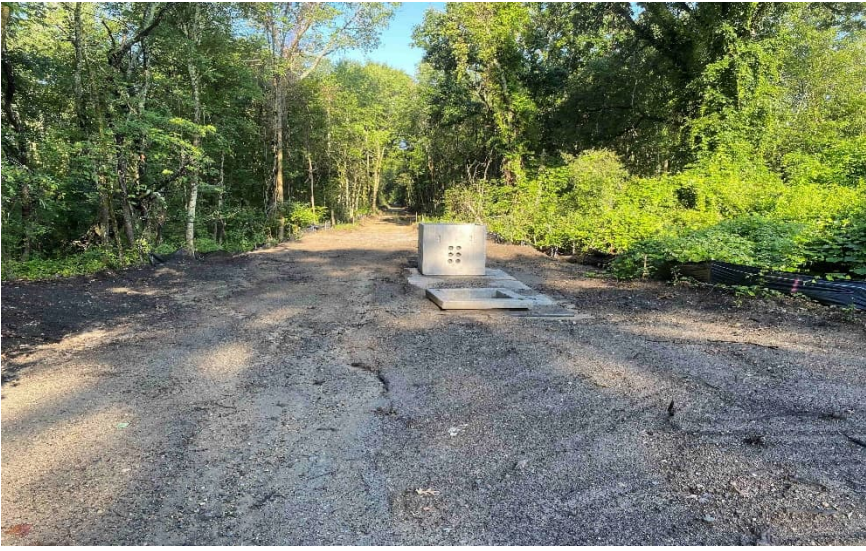
PHOTOGRAPHIC LOG	
Client Name: Eversource		Site Location: Sudbury to Hudson Transmission Reliability Project	Town: Sudbury
Photo No.: 7	Date: 7-5-23

Description: Work area within segment 14, manhole 27 area, existing erosion control, looking westward.

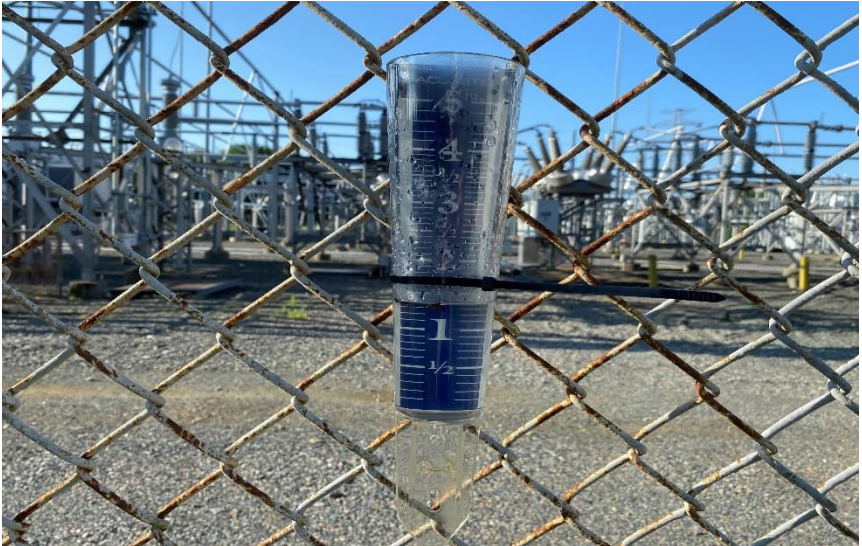
PHOTOGRAPHIC LOG	
Client Name: Eversource		Site Location: Sudbury to Hudson Transmission Reliability Project	Town: Sudbury
Photo No.: 8	Date: 7-5-23

Description: Rain gauge at Sudbury Substation showing 1.4" of rainfall, looking southward.

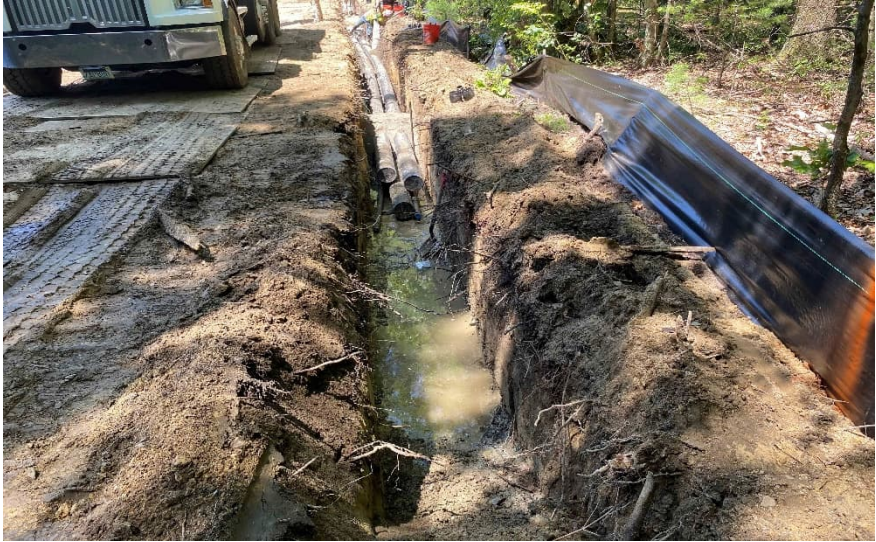
PHOTOGRAPHIC LOG	
Client Name: Eversource		Site Location: Sudbury to Hudson Transmission Reliability Project	Town: Sudbury
Photo No.: 1	Date: 7/7/2023

Description: View of area being pumped at work operation at Segment 11, off Union Avenue, looking westward.
