**Weekly Environmental Compliance Summary**

**Sudbury to Hudson Transmission Reliability Project (USEPA Tracking # MAR1003UW)**

Sudbury, Hudson, and Stow, MA

Week of: July 17 to July 21, 2023

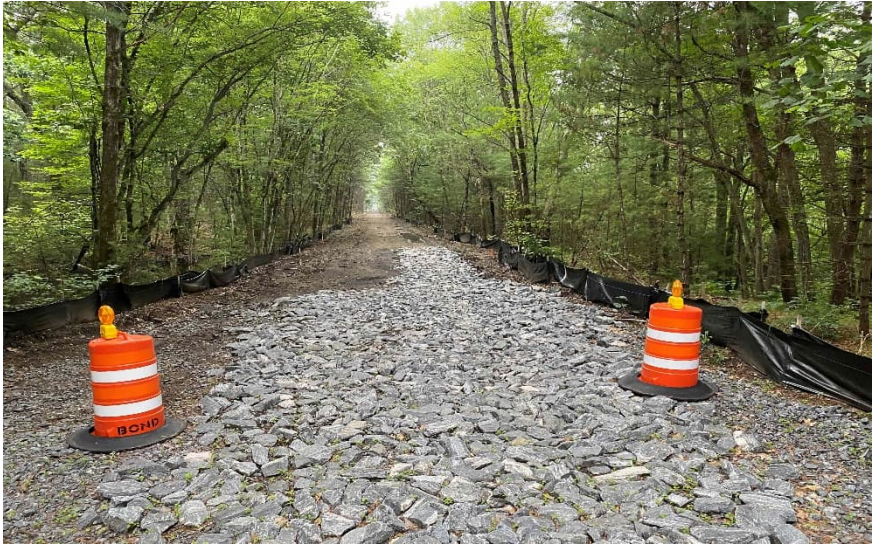
| Photo No.: 1 | Date: 7-18-23 | | |

| Description:<br><br>Work area within segment 6, existing erosion control, looking eastward. | | | |

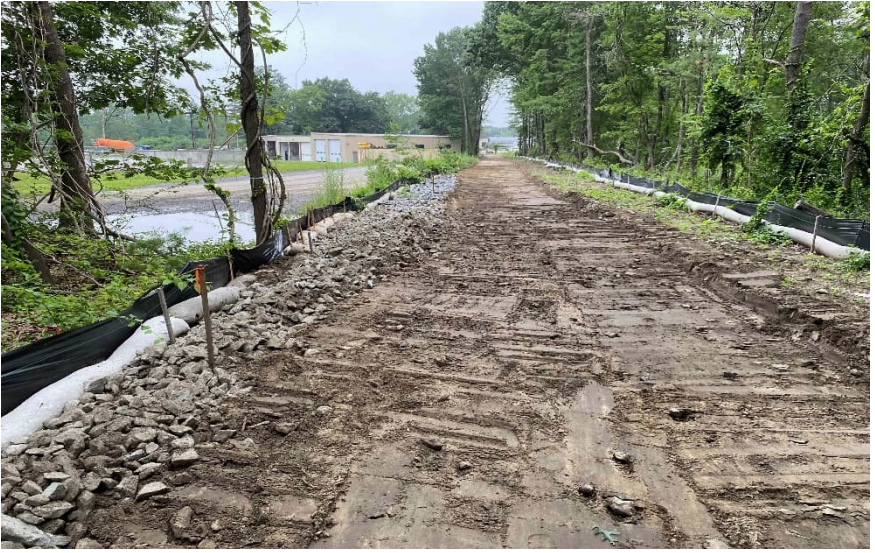
| Photo No.: 3 | Date: 7-18-23 | | |

| Description:<br><br>Work area within segment 3, recent erosion controls repairs, existing erosion control, looking westward. | | | |

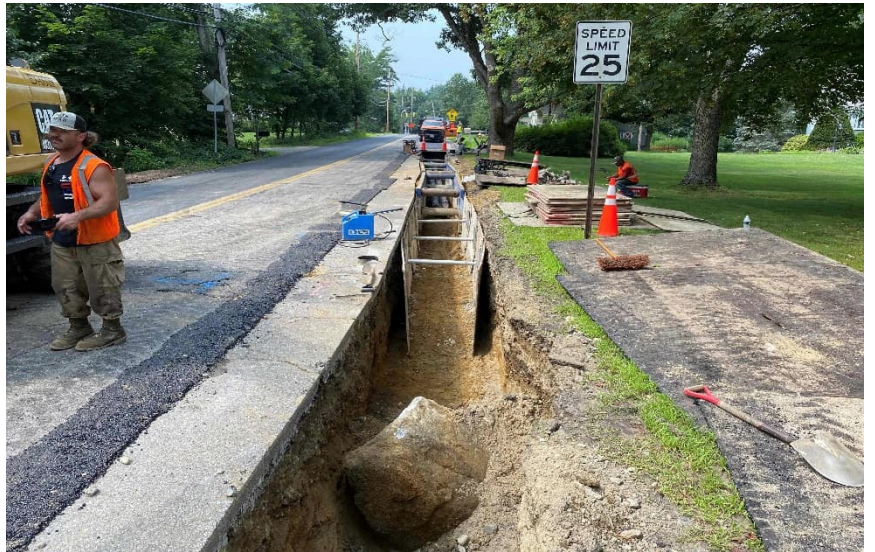
| Photo No.: 4 | Date: 7-18-23 | | |

| Description:<br><br>Conduit work within Wilkins Avenue, within Hudson, looking westward. | | | |

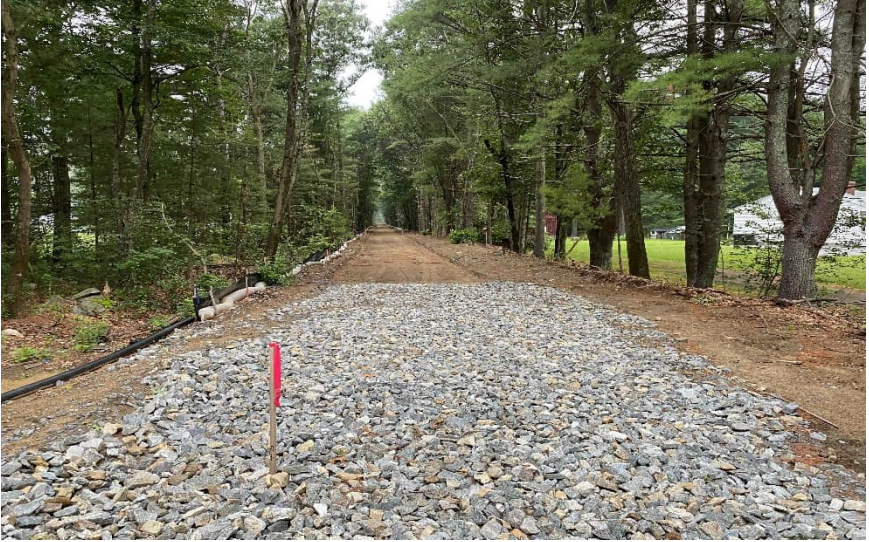
| Photo No.: 5 | Date: 7-18-23 | | |

| Description:<br><br>Work area within segment 4, existing erosion control, looking westward. | | | |

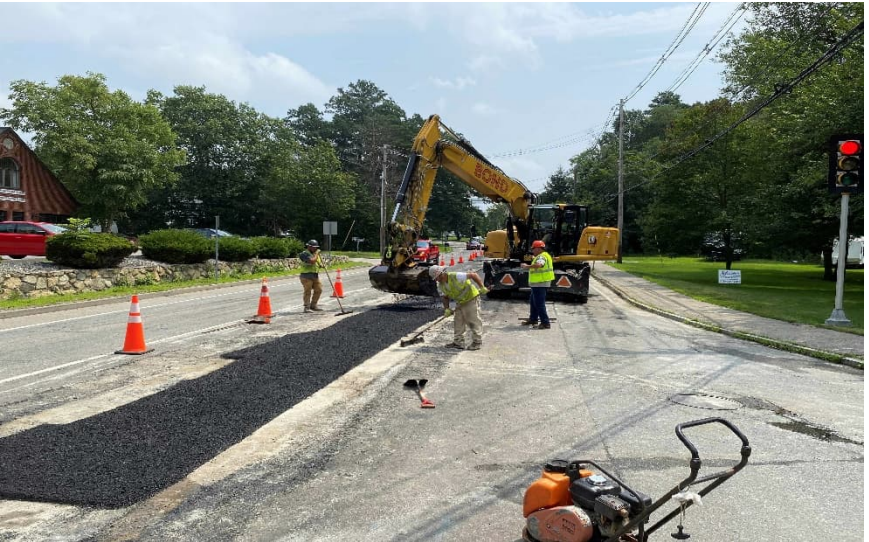
| Photo No.: 6 | Date: 7-18-23 | | |

| Description:<br><br>Conduit work within Forest Avenue, within Hudson, looking westward. | | | |

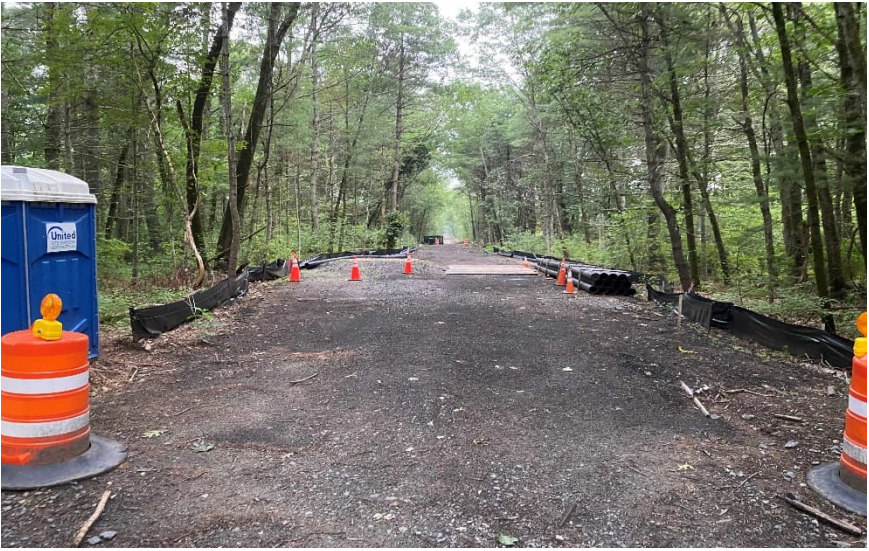
| Photo No.: 7 | Date: 7-18-23 | | |

| Description:<br><br>Work area within segment 5, existing erosion control, looking westward. | | | |

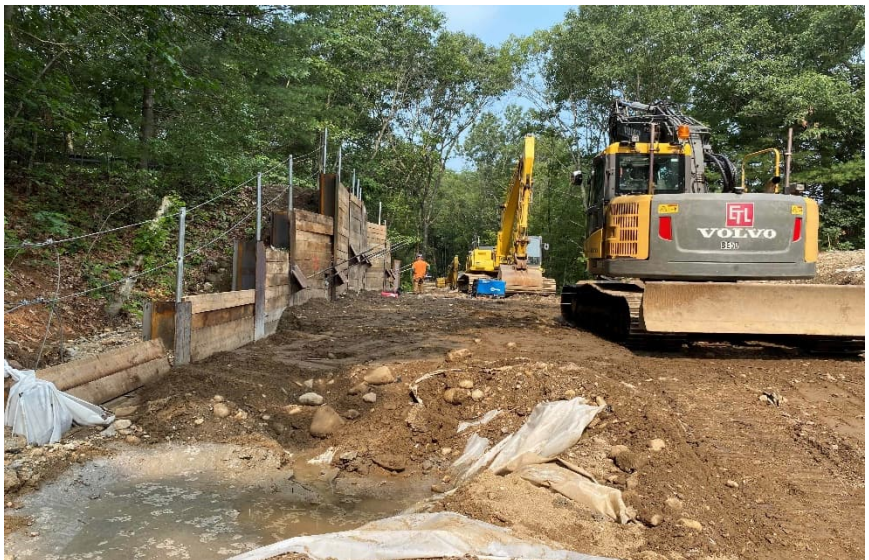
| Photo No.: 8 | Date: 7-18-23 | | |

| Description:<br><br>Chestnut Street closure work, looking westward. | | | |

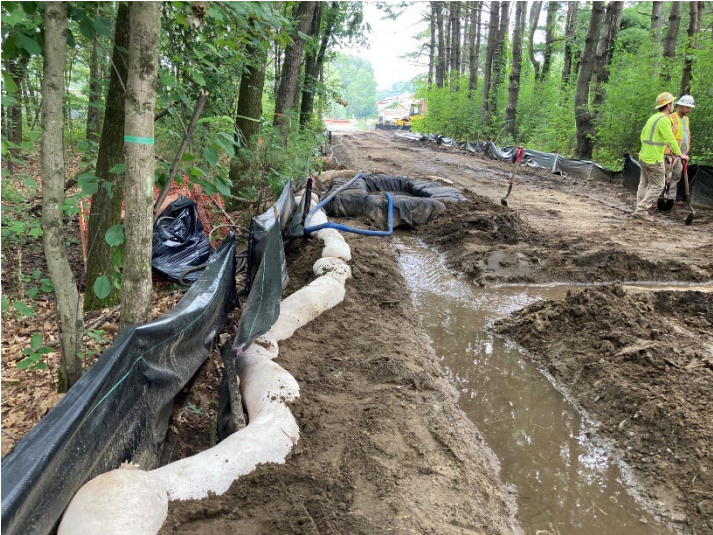
| <b>Photo No.:</b> 2 | <b>Date:</b><br>7/18/2023 | | |

| <b>Description:</b><br>View of dewatering operation in segment 11. See additional dewatering inspection report. Facing east. | | | |

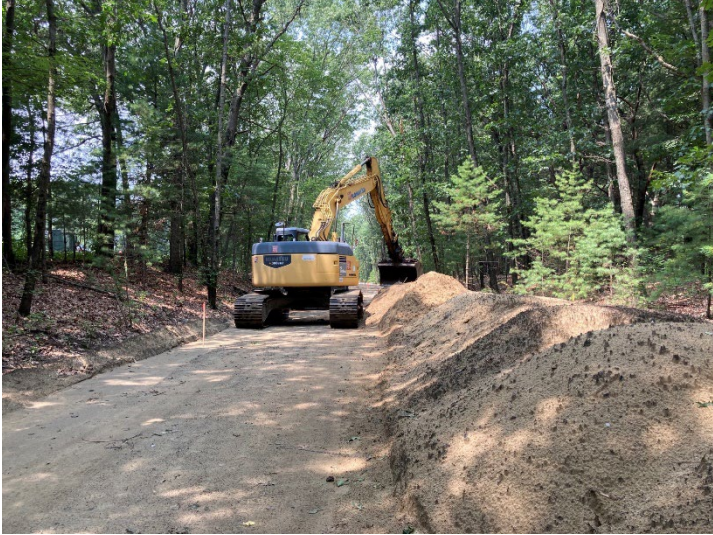
| <b>Photo No.:</b> 3 | <b>Date:</b> 7/18/2023 | | |

| <b>Description:</b><br>View of ET&L working in segment 11. Facing west. | | | |

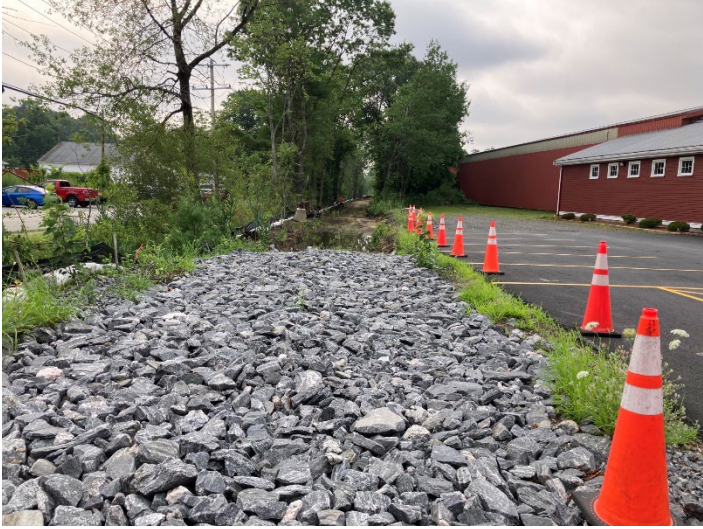
| <b>Photo No.:</b> 4 | <b>Date:</b> 7/18/2023 | | |

| <b>Description:</b><br>View of construction entrance to segment 12 off Union Ave. Facing east. | | | |

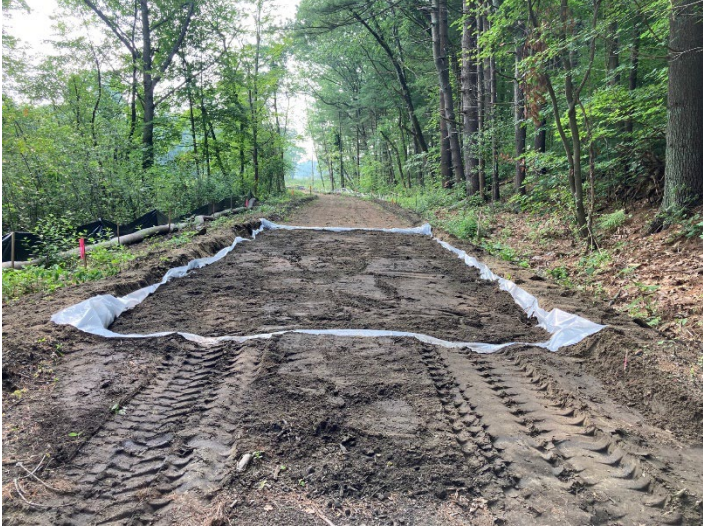
| <b>Photo No.:</b> 5 | <b>Date:</b><br>7/18/2023 | | |

| <b>Description:</b><br>View of containment pit that has been installed in segment 13 for equipment storage. Facing east. | | | |

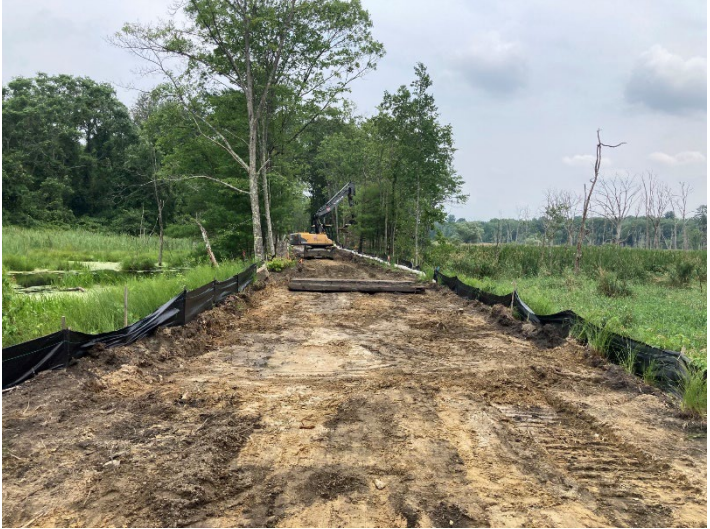
| <b>Photo No.:</b> 6 | <b>Date:</b><br>7/18/2023 | | |

| <b>Description:</b><br>View of ET&L installing timber mats for crane at bridge 127 in segment 14. Facing east. | | | |

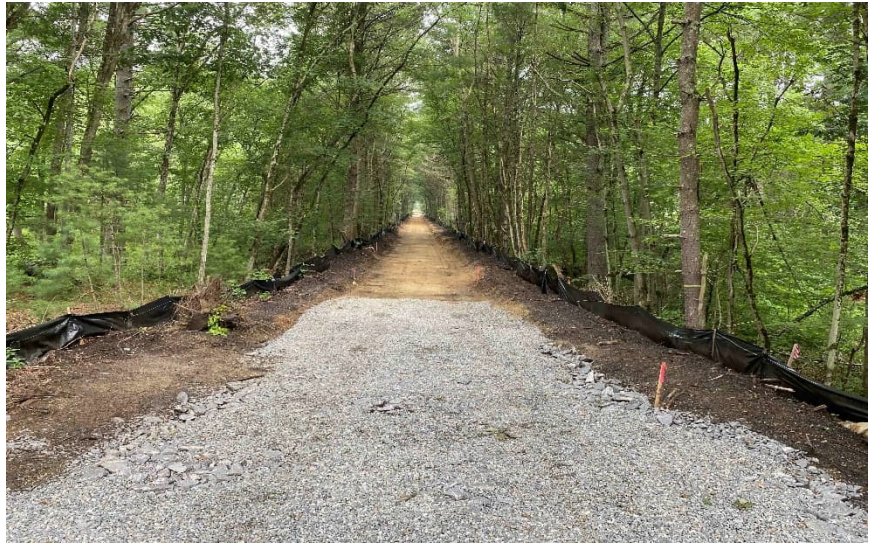
| Photo No.: 2 | Date: 7-19-23 | | |

| Description:<br><br>Work area within segment 9, existing erosion control, looking westward. | | | |

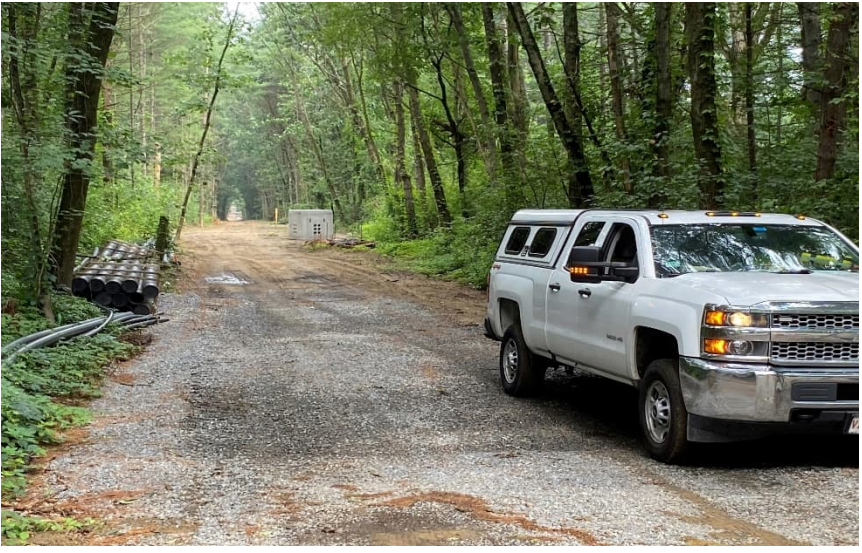
| Photo No.: 3 | Date: 7-19-23 | | |

| Description:<br><br>Work area within segment 10, existing erosion control, looking westward. | | | |

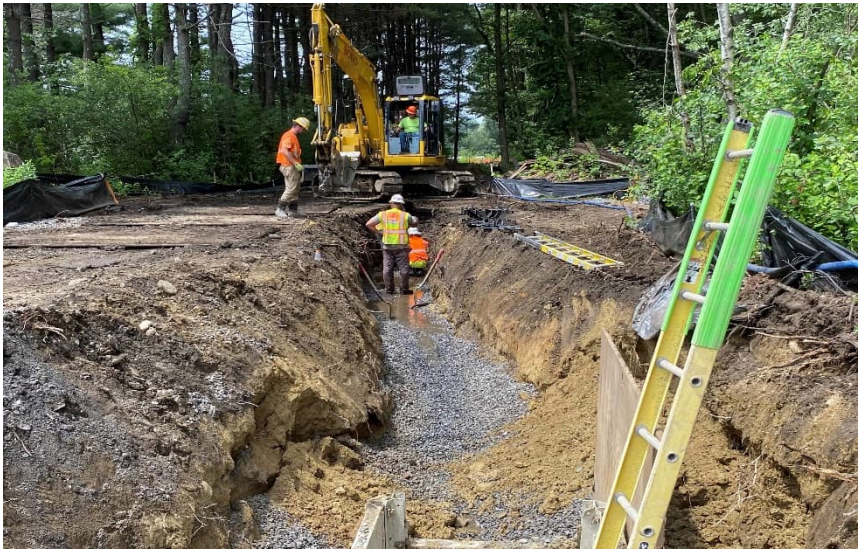
| Photo No.: 4 | Date: 7-19-23 | | |

| Description:<br><br>Work area within segment 11, conduit work, existing erosion control, looking westward. | | | |

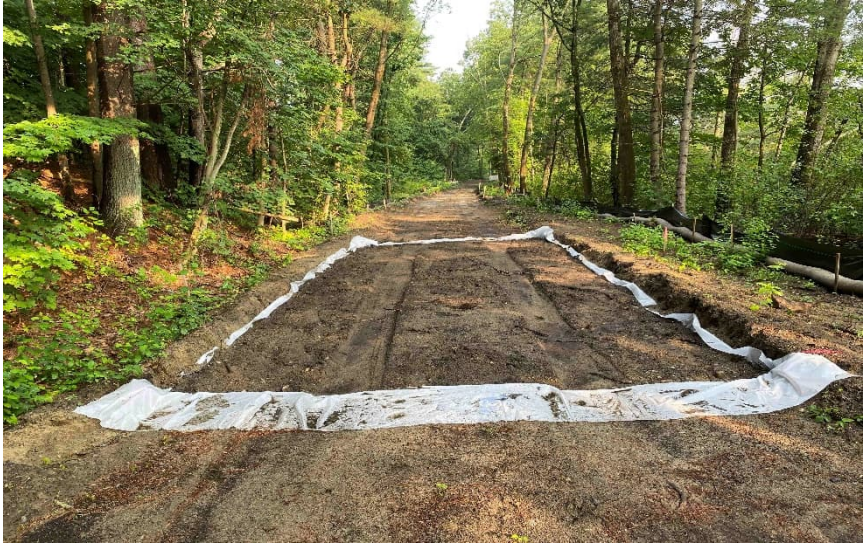
| Photo No.: 5 | Date: 7-19-23 | | |

| Description:<br><br>Work area within segment 13, existing erosion control, staging containment area, looking westward. | | | |

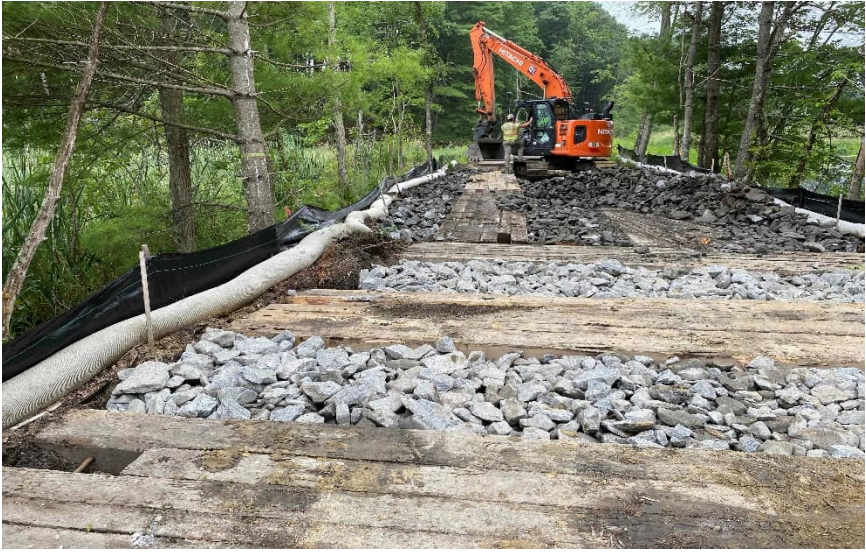
| Photo No.: 7 | Date: 7-19-23 | | |

| Description:<br><br>Work area within segment 14, existing erosion control, ET&L building crane pad for bridge work, looking westward. | | | |

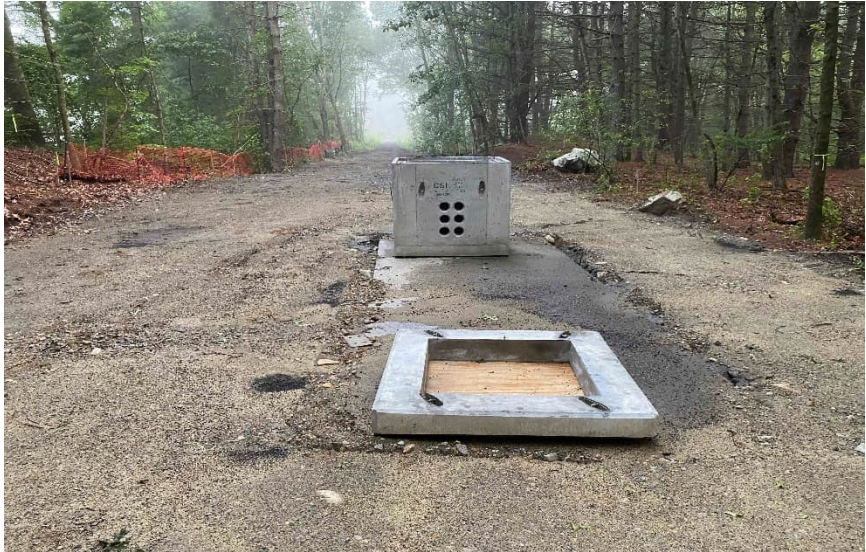
| Photo No.: 8 | Date: 7-19-23 | | |

| Description:<br><br>Work area within segment 8, manhole #17, looking westward. | | | |

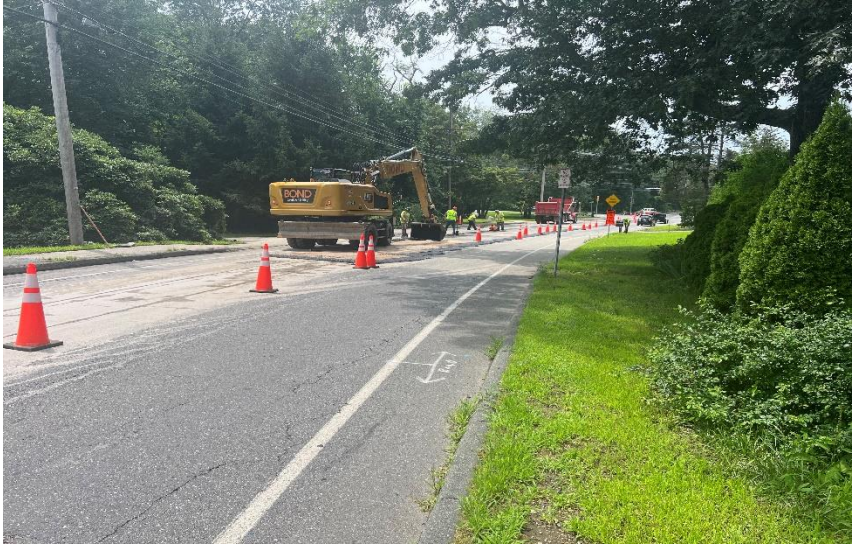
| Photo No.: 1 | Date: 7-19-23 | | |

| Description:<br><br>Conduit installation along Forest Avenue. Facing West. | | | |

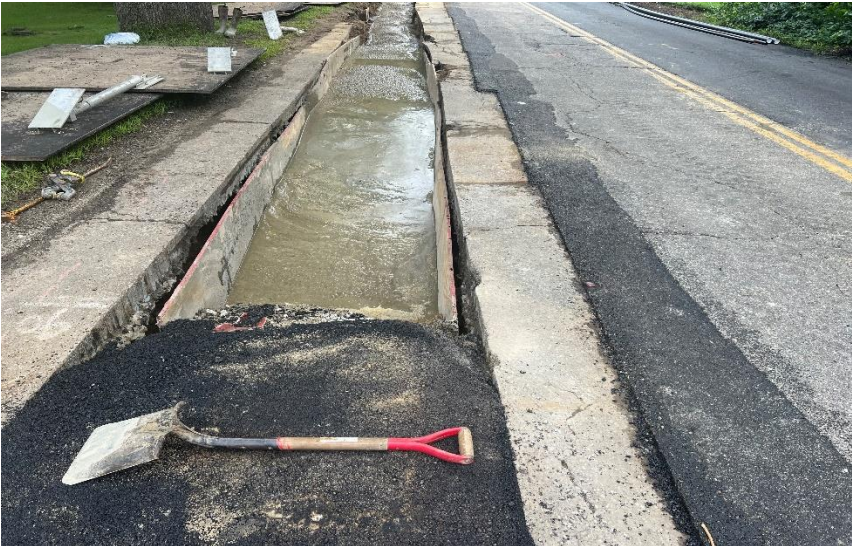
| Photo No.: 2 | Date: 7-19-23 | | |

| Description:<br><br>Concrete being poured for the conduit installation along Wilkins Street. Facing North. | | | |

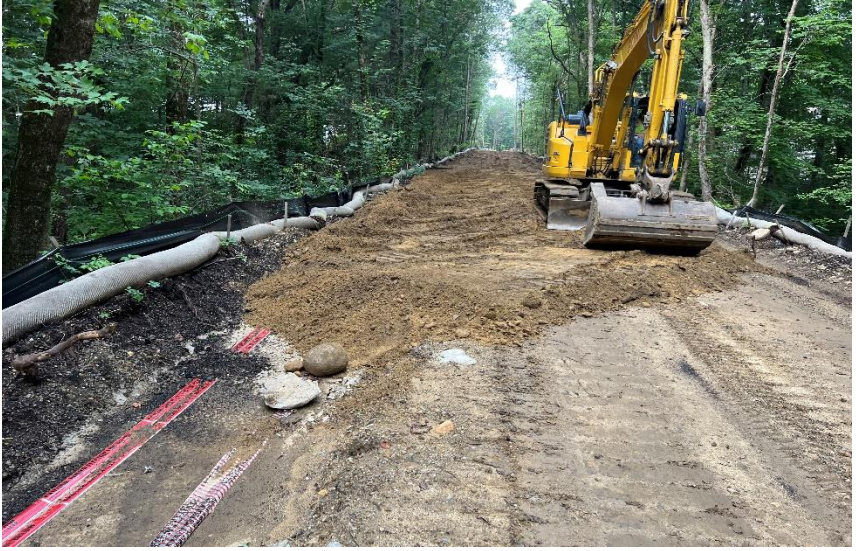
| <b>Photo No.:</b> 3 | <b>Date:</b> 7-19-23 | | |

| <b>Description:</b><br><br>Backfilling the installed conduit within segment 1. <i>Facing West.</i> | | | |

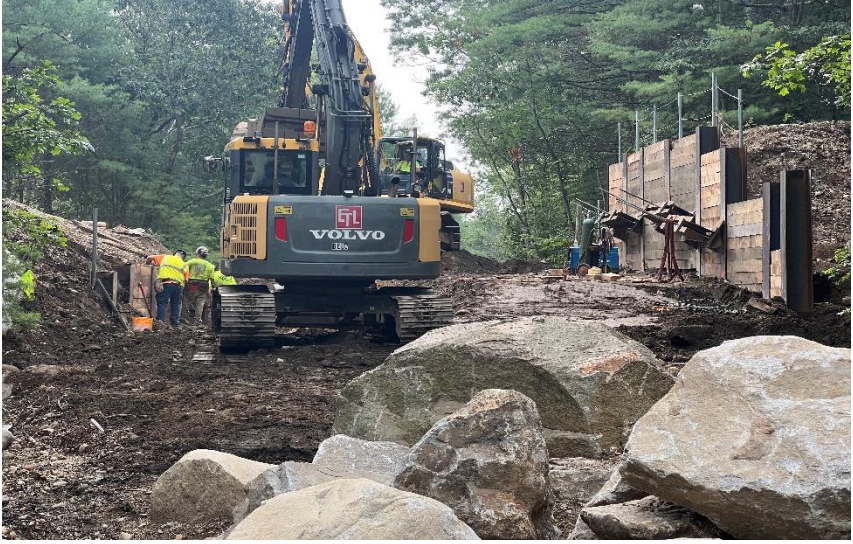
| <b>Photo No.:</b> 5 | <b>Date:</b> 7-19-23 | | |

| <b>Description:</b><br><br>Chestnut Street closure work. Facing east. | | | |

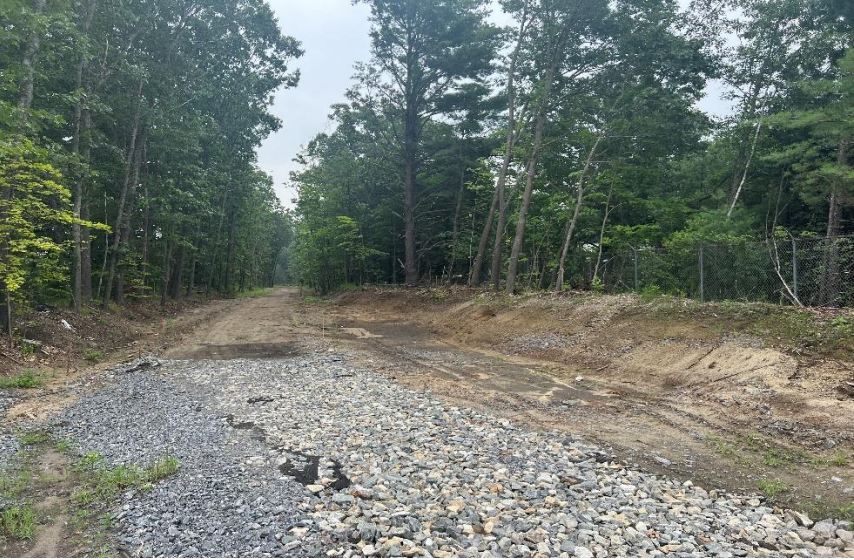
| <b>Photo No.:</b> 8 | <b>Date:</b> 7-19-23 | | |

| <b>Description:</b><br><br>Work area within segment 4, existing erosion controls are in proper working condition. <i>Facing East.</i> | | | |

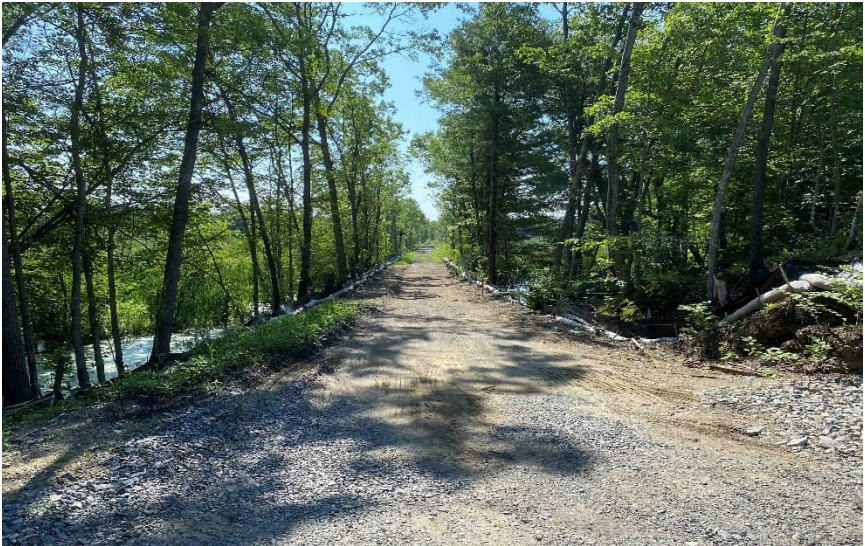
| Photo No.: 2 | Date: 7-20-23 | | |

| Description:<br><br>Work area within segment 2, existing erosion control, looking eastward. | | | |

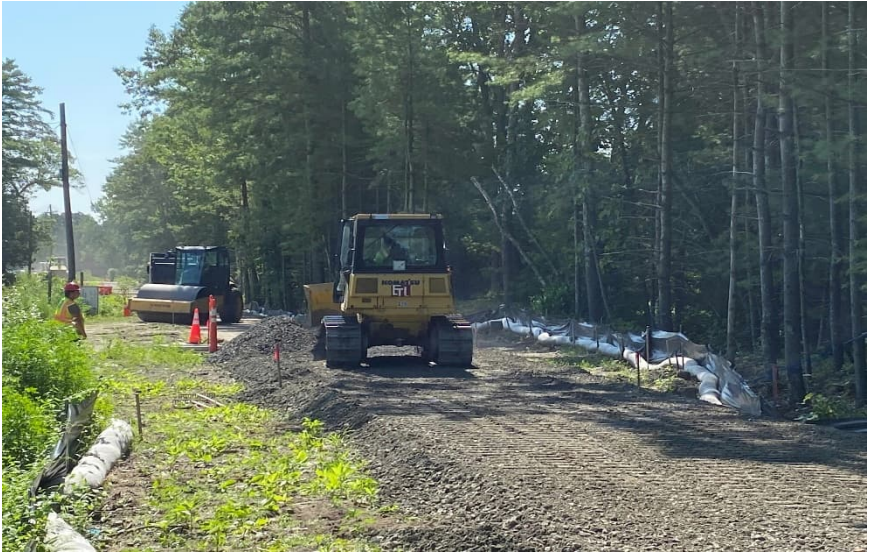
| Photo No.: 3 | Date: 7-20-23 | | |

| Description:<br><br>Work area within segment 3, grading, existing erosion control, looking eastward. | | | |

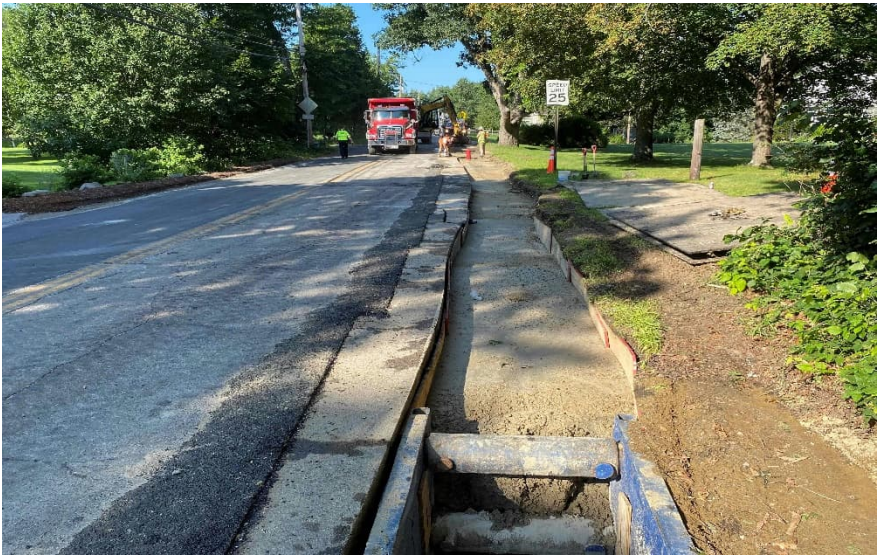
| Photo No.: 4 | Date: 7-20-23 | | |

| Description:<br><br>Conduit work within Wilkins Avenue, within Hudson, looking westward. | | | |

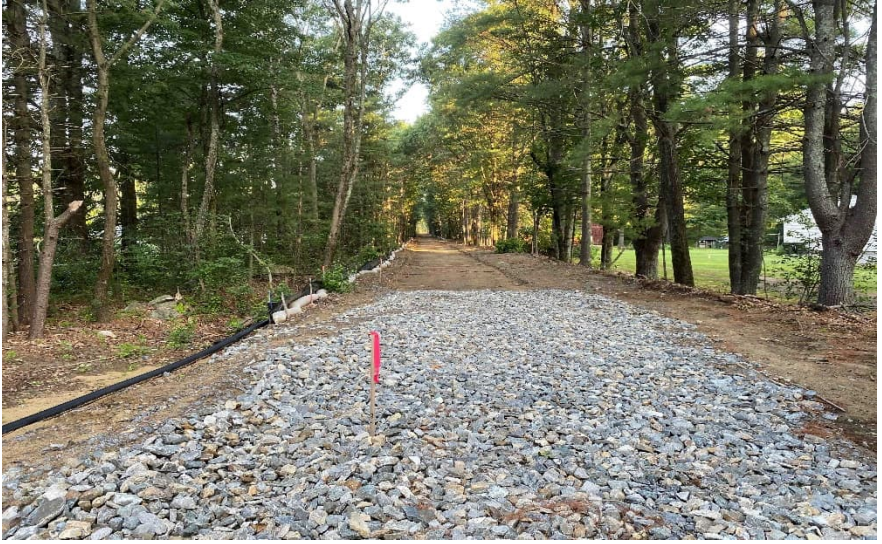
| Photo No.: 5 | Date: 7-20-23 | | |

| Description:<br><br>Work area within segment 4, existing erosion control, looking westward. | | | |

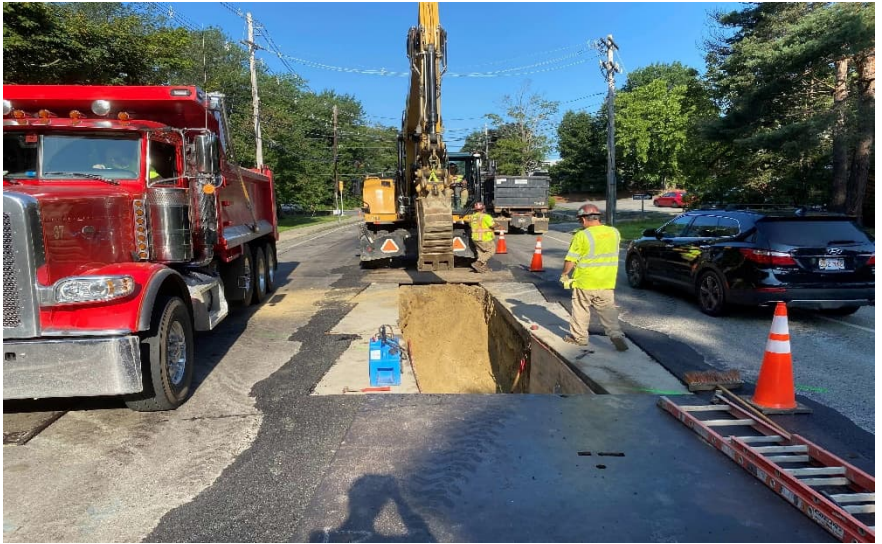
| Photo No.: 6 | Date: 7-20-23 | | |

| Description:<br><br>Conduit work within Forest Avenue, within Hudson, looking westward. | | | |

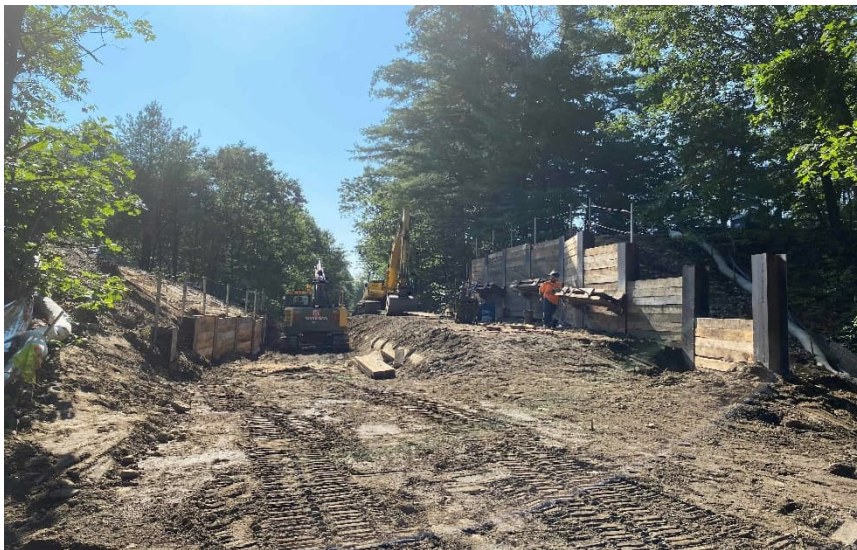
| Photo No.: 8 | Date: 7-20-23 | | |

| Description:<br><br>Chestnut Street closure work, looking westward. | | | |

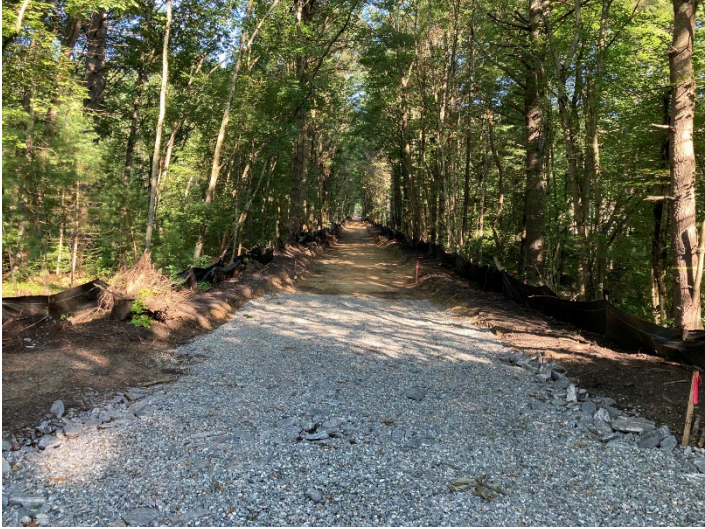
| <b>Photo No.:</b> 1 | <b>Date:</b><br>7/20/2023 | | |

| <b>Description:</b><br>View of segment 9 from construction entrance at Peakham Rd. Facing west. | | | |

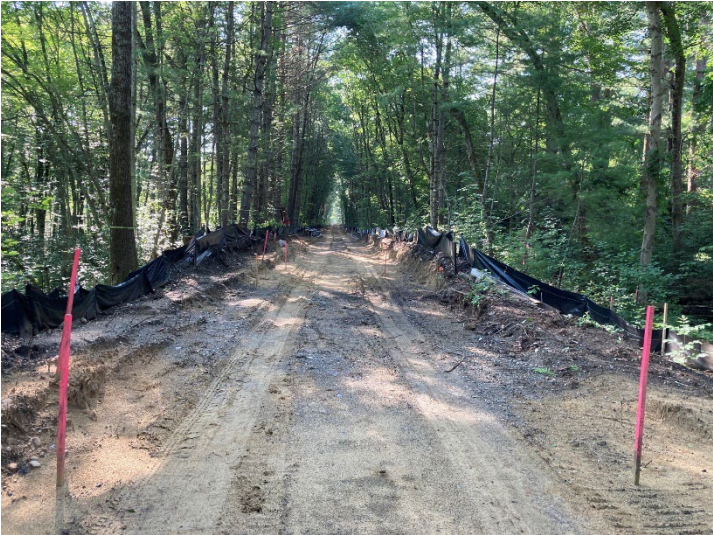
| <b>Photo No.:</b> 2 | <b>Date:</b><br>7/20/2023 | | |

| <b>Description:</b><br>View of Dudley Brook culvert area in segment 10. Facing west. | | | |

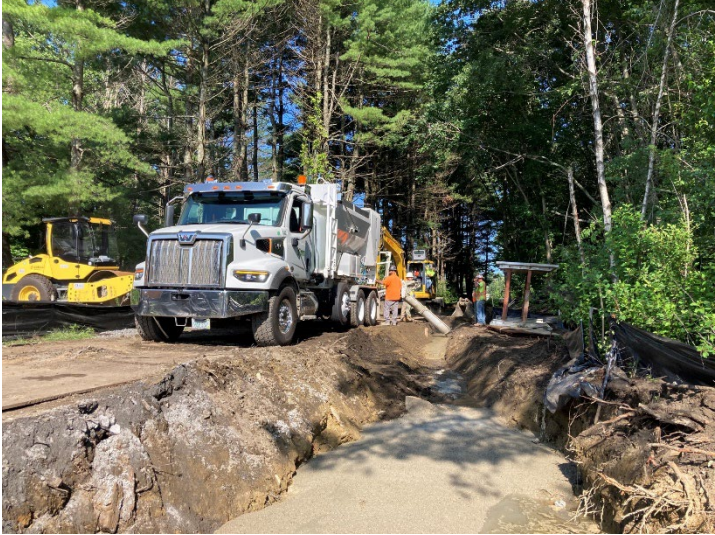
| <p><b>Photo No.:</b> 3</p> | <p><b>Date:</b><br/>7/20/2023</p> | | |

| <p><b>Description:</b><br/>View of Bond installing ductbank in segment 11. Facing west.</p> | | | |

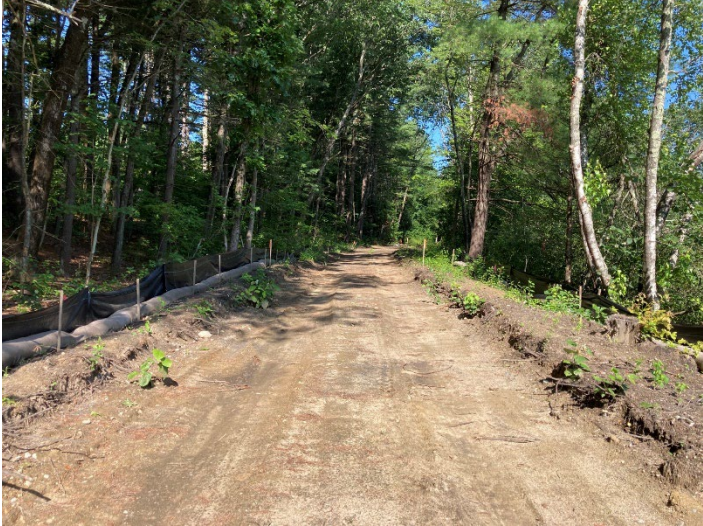
| <p><b>Photo No.:</b> 4</p> | <p><b>Date:</b><br/>7/20/2023</p> | | |

| <p><b>Description:</b><br/>View of east end of segment 13. Facing west.</p> | | | |

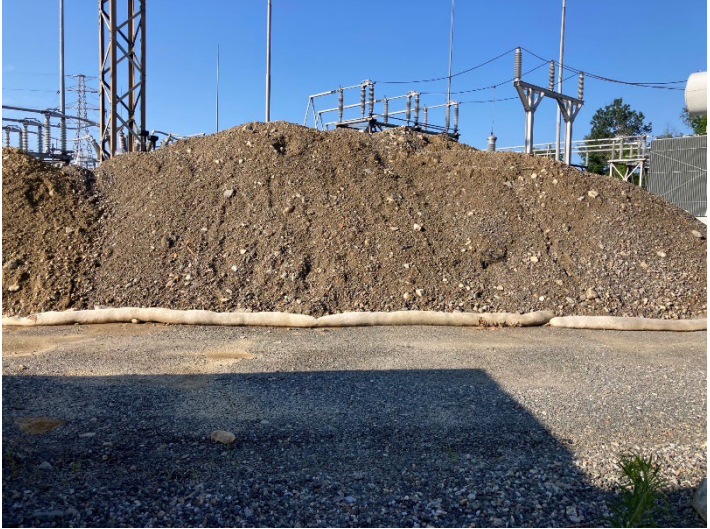
| <p><b>Photo No.:</b> 6</p> | <p><b>Date:</b><br/>7/20/2023</p> | | |

| <p><b>Description:</b><br/>View of stockpile at Sudbury Substation. Facing south.</p> | | | |

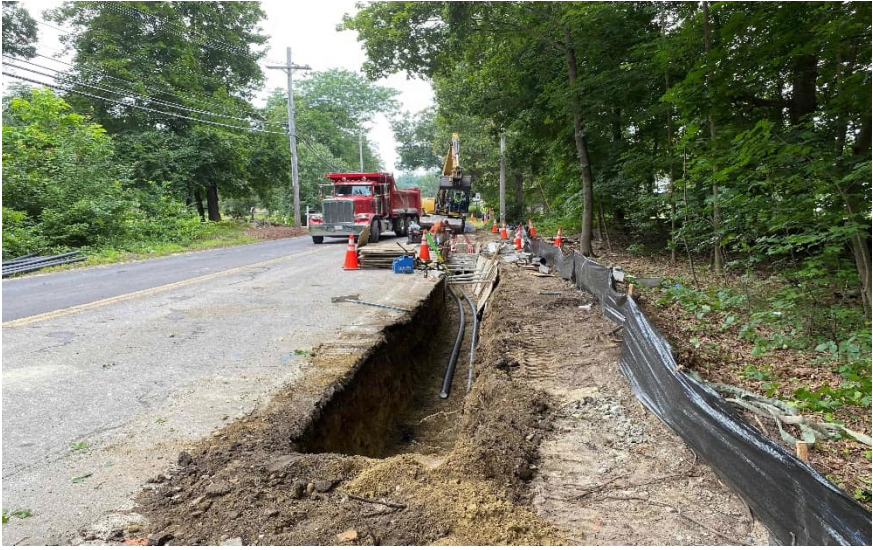
| <p>Photo No.: 1</p> | <p>Date: 7-21-23</p> | | |

| <p>Description:</p> <p>Work area within Wilkins Street, conduit work, looking westward.</p> | | | |

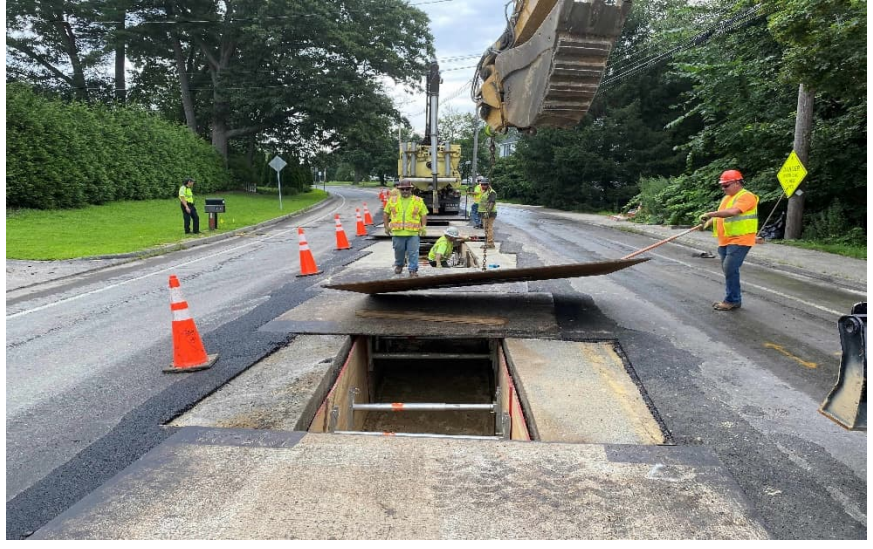
| <p>Photo No.: 2</p> | <p>Date: 7-21-23</p> | | |

| <p>Description:</p> <p>Work area within Forest Avenue, conduit work, looking northward.</p> | | | |

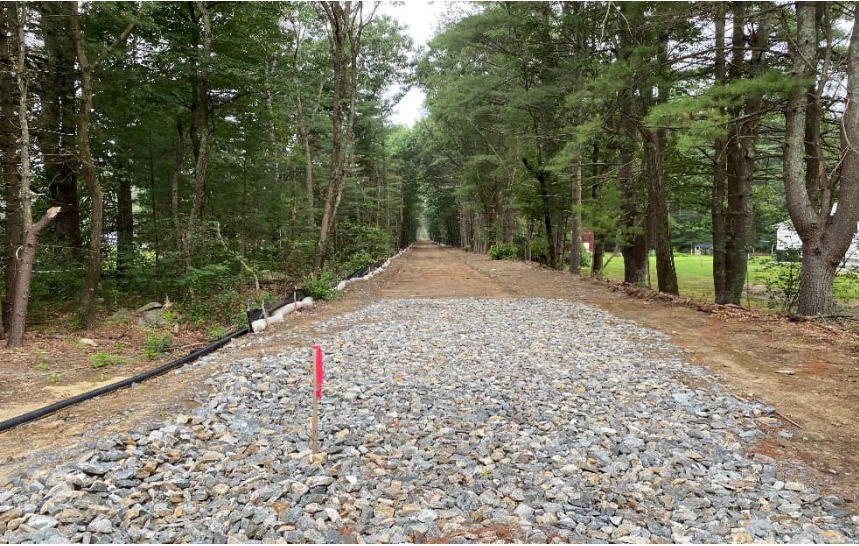
| <p>Photo No.: 3</p> | <p>Date: 7-21-23</p> | | |

| <p>Description:</p> <p>Work area within segment 4, existing erosion control, looking westward.</p> | | | |

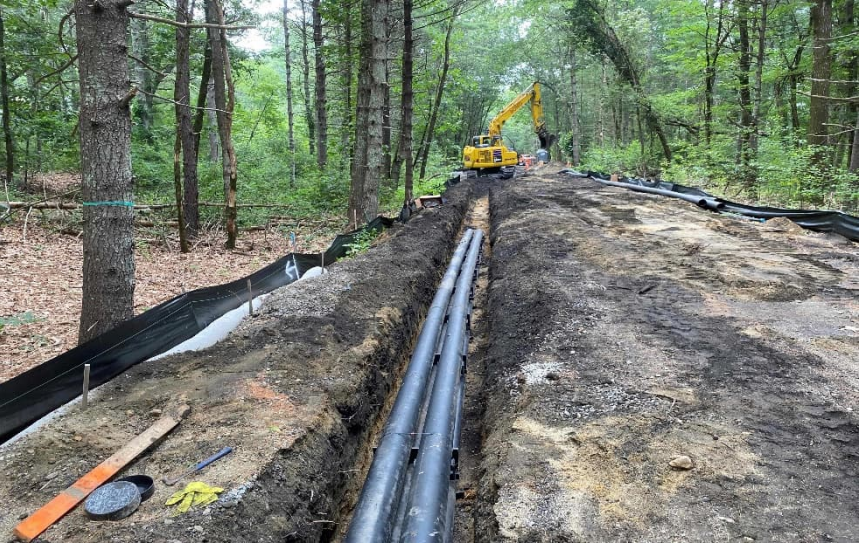
| <p>Photo No.: 4</p> | <p>Date: 7-21-23</p> | | |

| <p>Description:</p> <p>Work area within segment 5, conduit work, existing erosion control, looking eastward.</p> | | | |

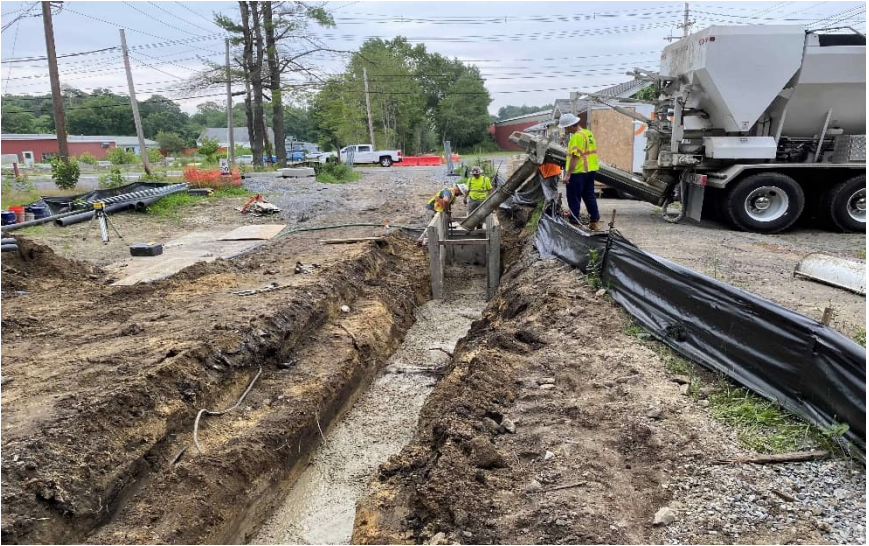
| <p>Photo No.: 5</p> | <p>Date: 7-21-23</p> | | |

| <p>Description:<br/> Work area within segment 11, conduit work, looking eastward.</p> | | | |

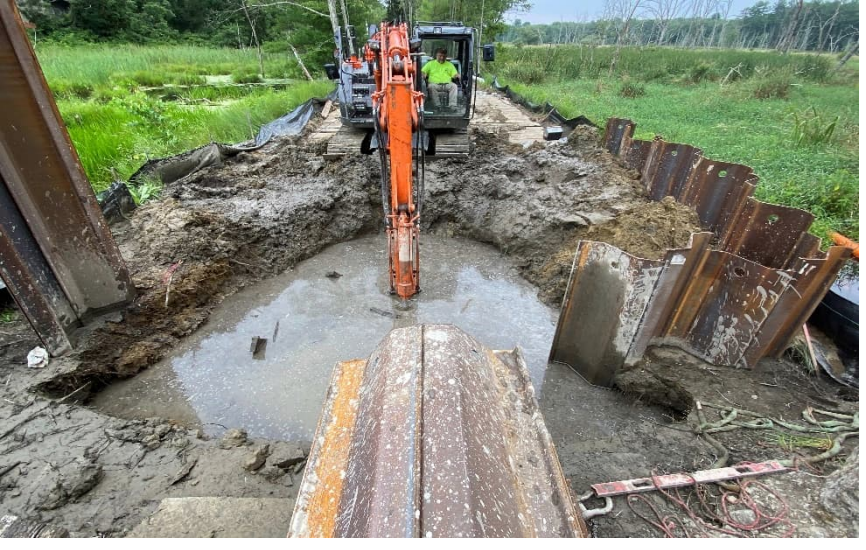
| <p>Photo No.: 8</p> | <p>Date: 7-21-23</p> | | |

| <p>Description:</p> <p>Work area within segment 14, work for bridge 127 update, looking eastward.</p> | | | |

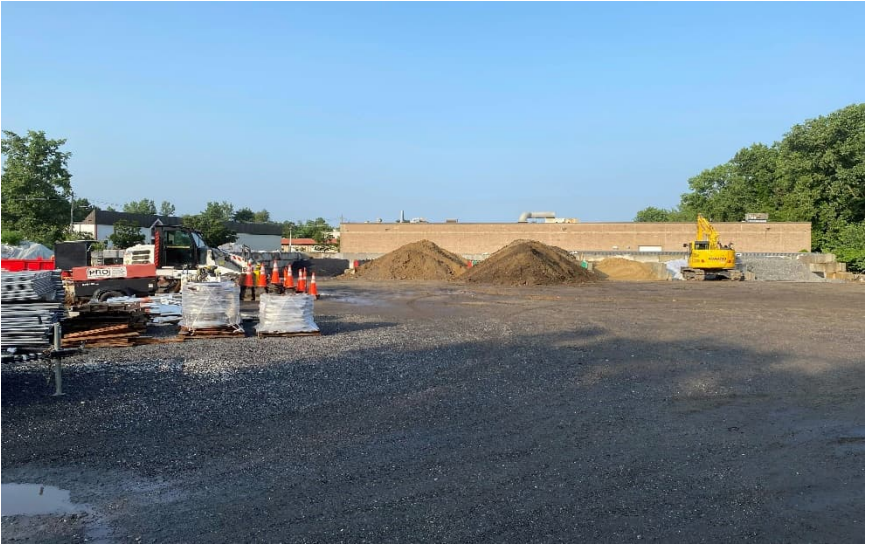
| Photo No.: 1 | Date: 7-17-23 | | |

| Description:<br><br>Bonazzoli Avenue laydown yard, looking westward. | | | |

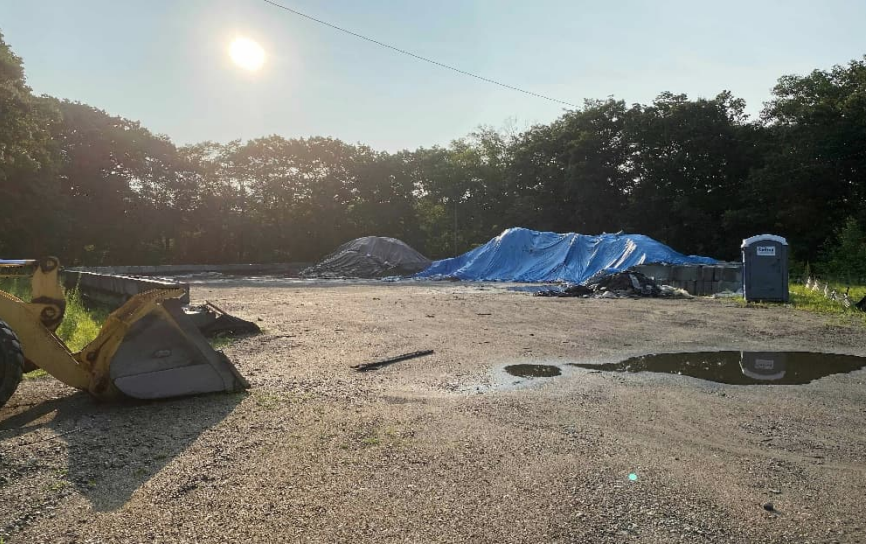
| Photo No.: 2 | Date: 7-17-23 | | |

| Description:<br><br>Stowe Court laydown yard, looking southward. | | | |

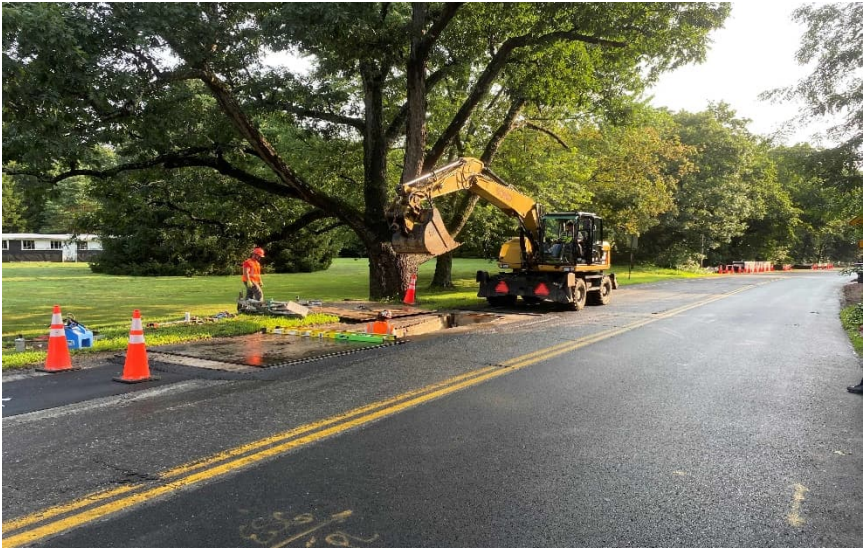
| Photo No.: 3 | Date: 7-17-23 | | |

| Description:<br><br>Conduit work within Wilkins Avenue near Main Street intersection, looking eastward. | | | |

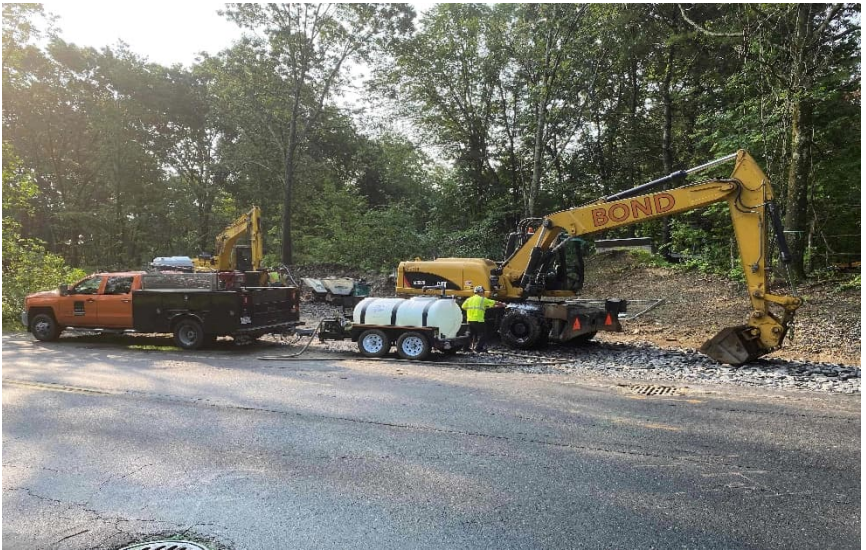
| Photo No.: 4 | Date: 7-17-23 | | |

| Description:<br><br>Cleaning work within segment 1 near manhole #5, looking eastward. | | | |

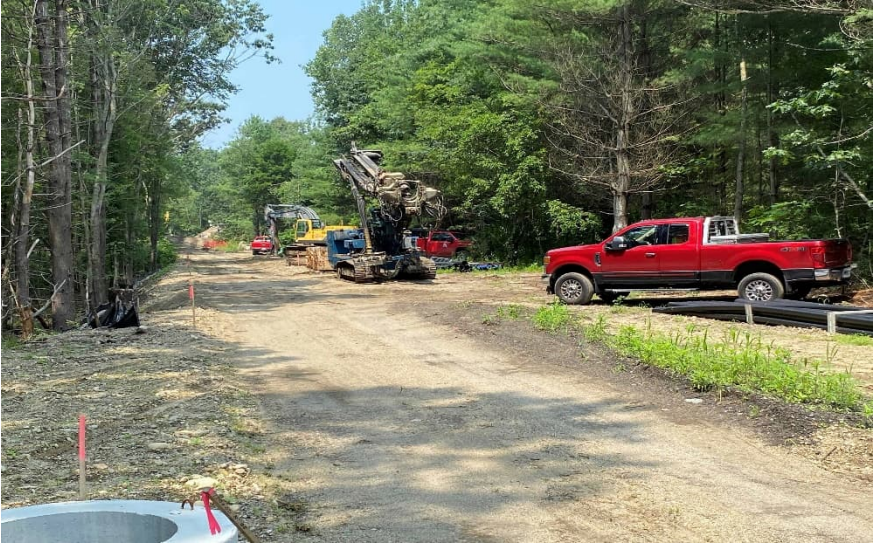
| Photo No.: 5 | Date: 7-17-23 | | |

| Description:<br><br>Work by ET&L, within Chestnut Street crossing (segment 2), looking westward. | | | |

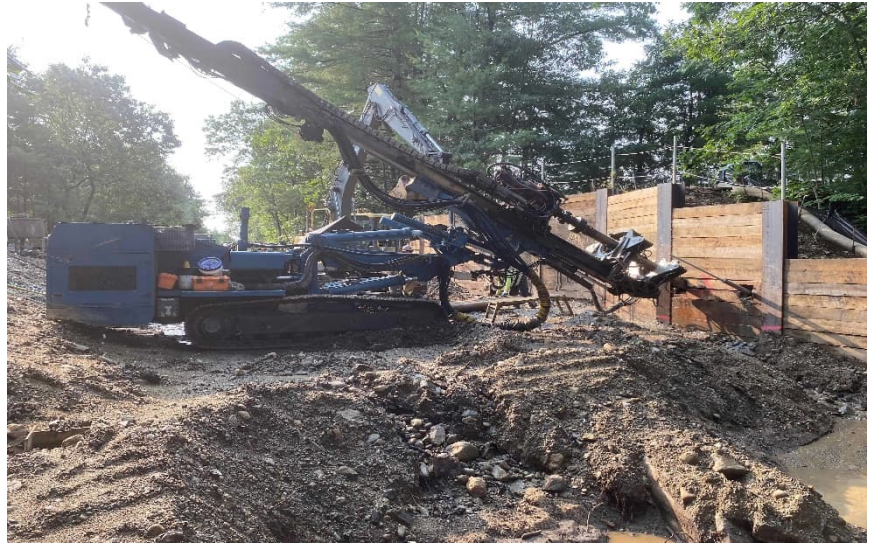
| Photo No.: 6 | Date: 7-17-23 | | |

| Description:<br><br>Work by ET&L, within Chestnut Street crossing (segment 1), looking eastward. | | | |
