**Weekly Environmental Compliance Summary**

**Sudbury to Hudson Transmission Reliability Project (USEPA Tracking # MAR1003UW)**

Sudbury, Hudson, and Stow, MA

Week of: July 17 to July 21, 2023

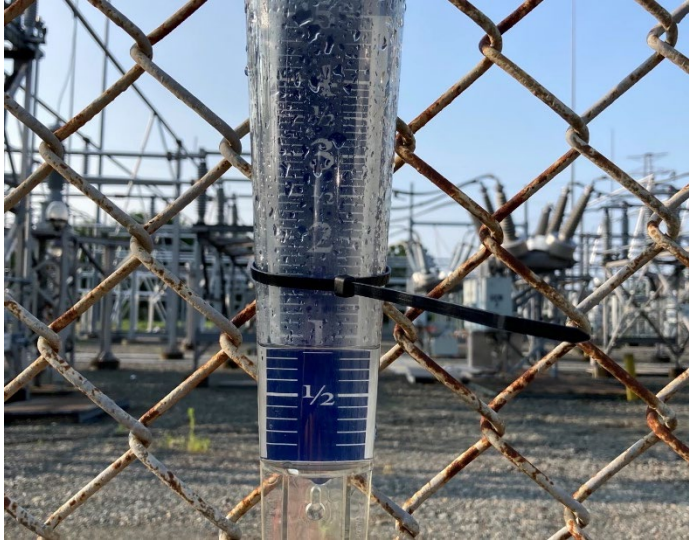
| Photo No.: 1 | Date: 7-17-2023 | | |

| <p><b>Description:</b><br/>View of rain gauge at Sudbury Substation. 0.90" observed in gauge at 7:30am. Facing south.</p> | | | |

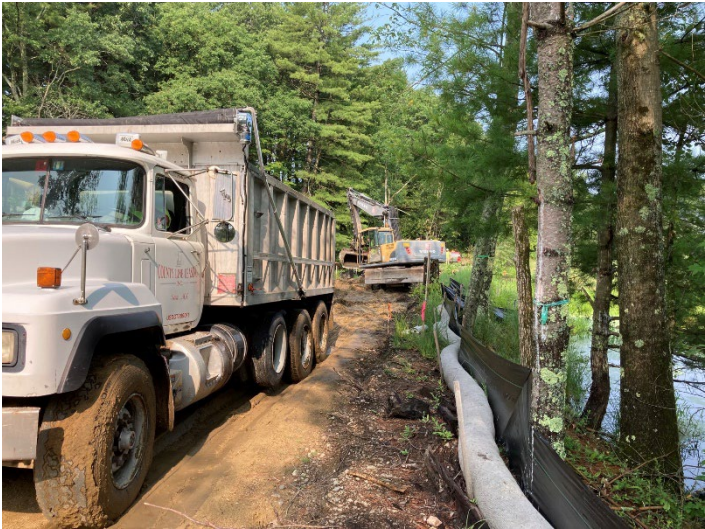
| <b>Photo No.:</b> 4 | <b>Date:</b> 7-17-2023 | | |

| <b>Description:</b><br>View of ET&L creating crane pad in segment 14 for work at bridge 127. Facing west. | | | |

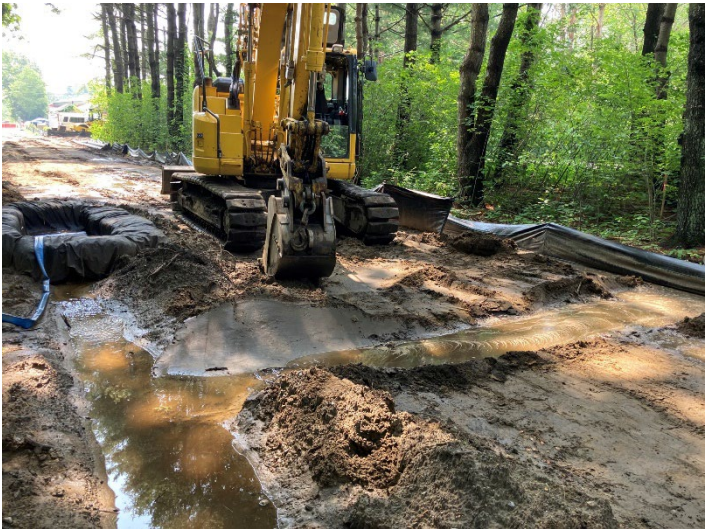
| <b>Photo No.:</b> 5 | <b>Date:</b> 7-17-2023 | | |

| <b>Description:</b><br>View of Bond conducting dewatering operations in segment 11. See additional dewatering inspection report. Facing west. | | | |

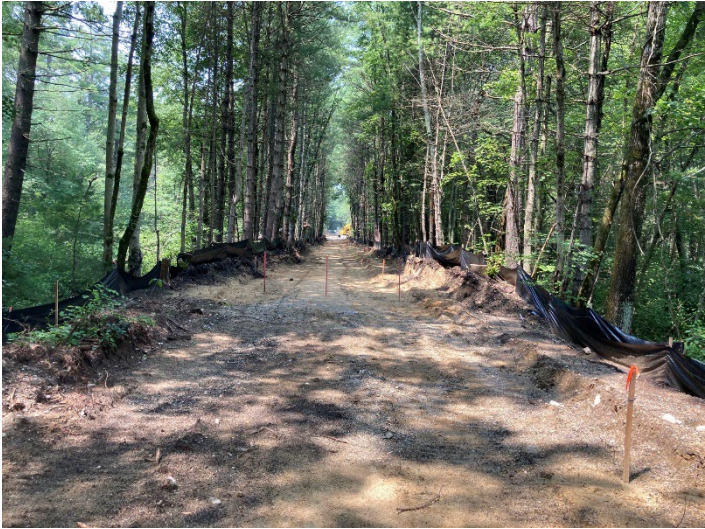
| <b>Photo No.:</b> 6 | <b>Date:</b> 7-17-2023 | | |

| <b>Description:</b><br>View of Dudley Brook culvert area in segment 10. Facing west. | | | |

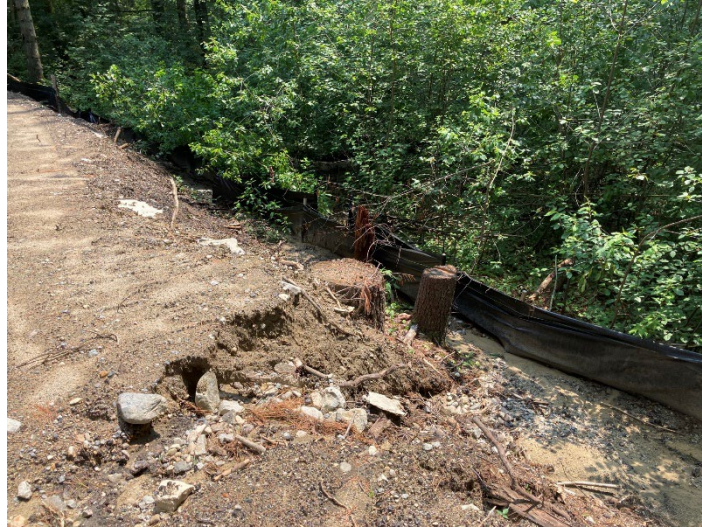
-During heavy rains, erosion occurred on slope at approximately Sta. 520 rt in segment 9. Sediment escaped through gap in syncopated silt fence below eroded slope. Sediment deposited beyond limit of work, but did not reach any jurisdictional areas. Site personnel and Lori Capone (Sudbury CC agent) were notified immediately upon discovery. Repairs are scheduled.

View of erosion at approximately Sta. 520 rt in segment 9. Sediment escaped through gap in syncopated silt fence below. See photo 8. Facing southeast.

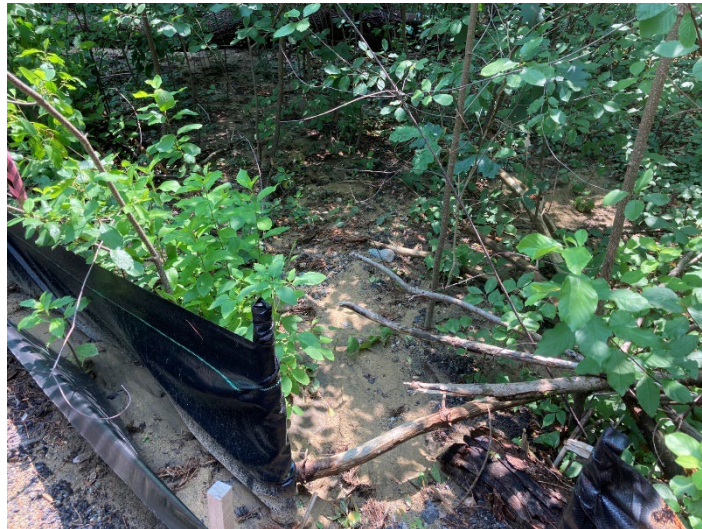
View of sediment that escaped through gap in syncopated silt fence at approximately Sta. 520 rt in segment 9. Sediment deposited beyond limit of work, but did not reach any jurisdictional areas. Facing southeast.

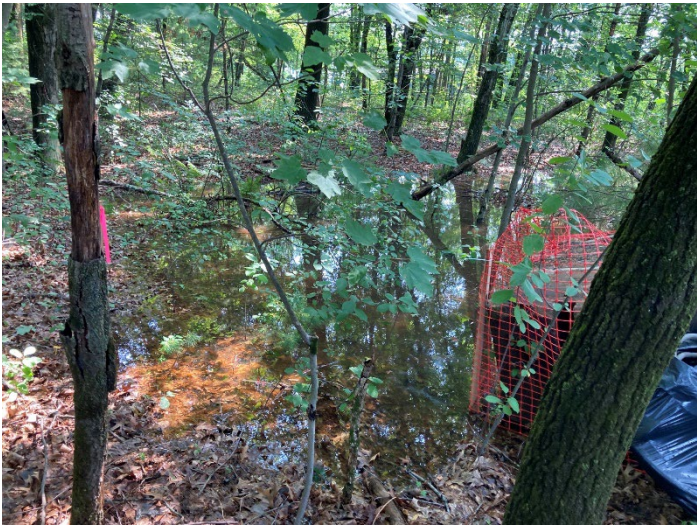
| <b>Photo No.:</b> 4 | <b>Date:</b><br>7/17/2023 | | |

| <b>Description:</b><br>Dewatering water was eventually discharged beyond perimeter controls above wetland 24A/vernal pool 5 but did not reach the wetland. Discharge appeared slightly turbid. Turbidity reading was higher than 50 NTUs. Dewatering operation was cut short to ensure water did not reach the wetland. Facing northeast. | | | |

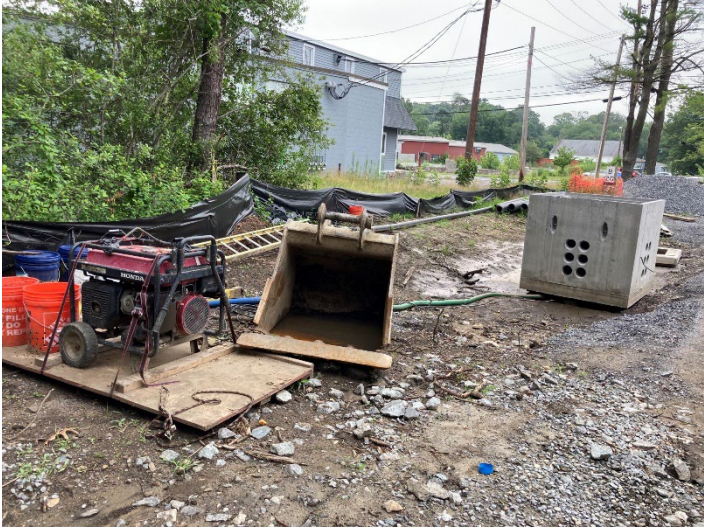
| <b>Photo No.:</b> 1 | <b>Date:</b><br>7/18/2023 | | | |

| <b>Description:</b><br>View of pumping/dewatering operation at MH #24 in segment 11. Facing east. | | | | |

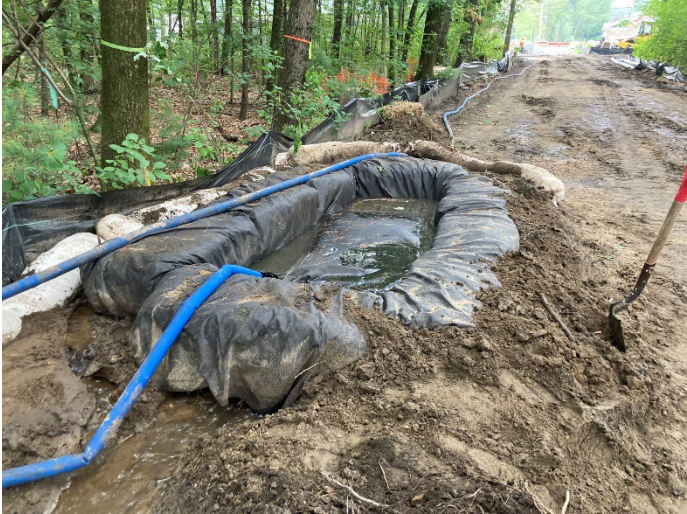
| <b>Photo No.:</b> 3 | <b>Date:</b><br>7/18/2023 | | |

| <b>Description:</b><br>View of dewatering controls (straw bale corral with filter fabric and silt bag). Facing east. | | | |

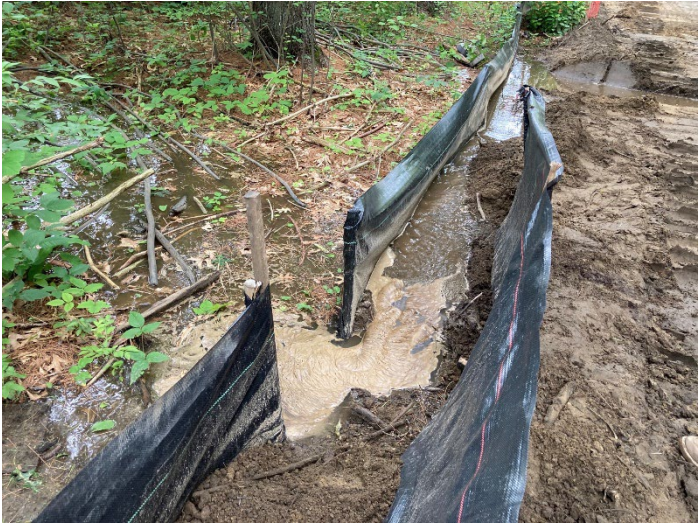
| <b>Photo No.:</b> 4 | <b>Date:</b><br>7/18/2023 | | |

| <b>Description:</b><br>Early in the day, dewatering water was discharged beyond perimeter controls on right side of ROW (opposite side from wetland 24A/vernal pool 5). Water did not reach any jurisdictional areas. Discharge appeared slightly turbid. Turbidity reading was higher than 50 NTUs. Facing west. | | | |

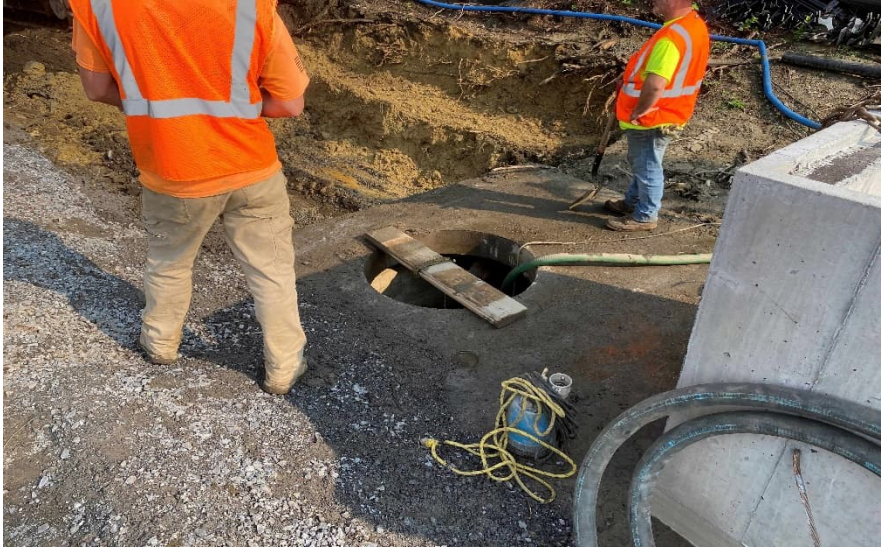
| Photo No.: 1 | Date:<br>7/19/2023 | | |

| Description:<br>View of area being pumped at Segment 11, Manhole #24, off Union Avenue, looking eastward. | | | |

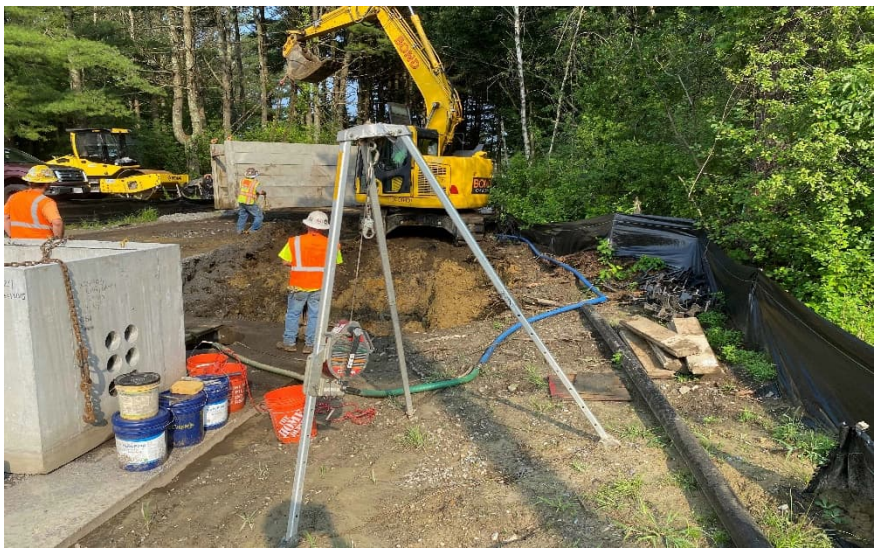
| Photo No.: 2 | Date:<br>7/19/2023 | | |

| Description:<br>Segment 11. View of dewatering operation, looking westward. | | | |

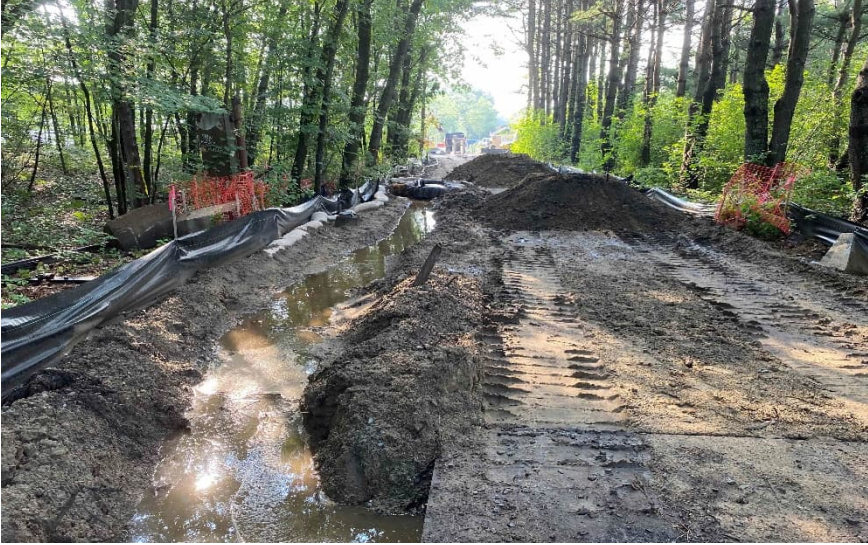
| Photo No.: 3 | Date:<br>7/19/2023 | | |

| Description:<br>Segment 11. View of dewatering operation, looking eastward. | | | |

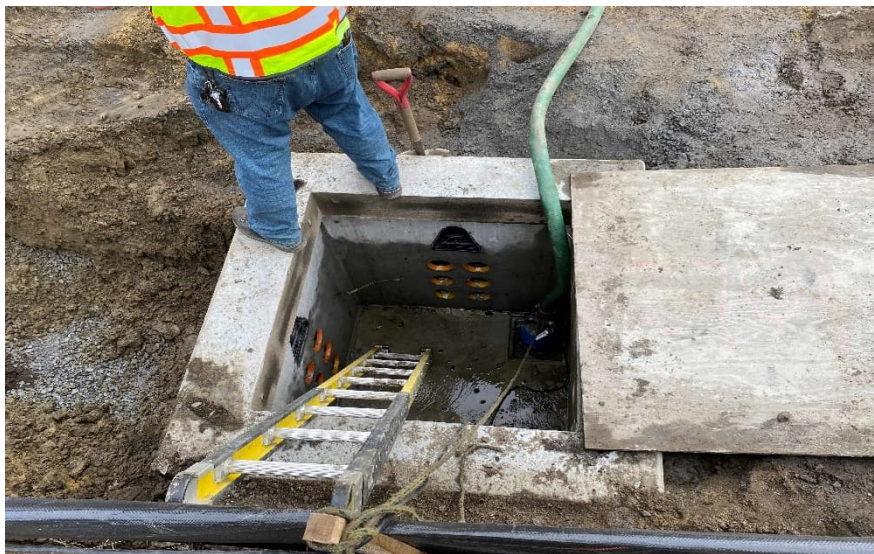
Photo No.: 1      Date: 7/21/2023

Description:  
View of area being pumped at Segment 11, Manhole #24, off Union Avenue, looking eastward.

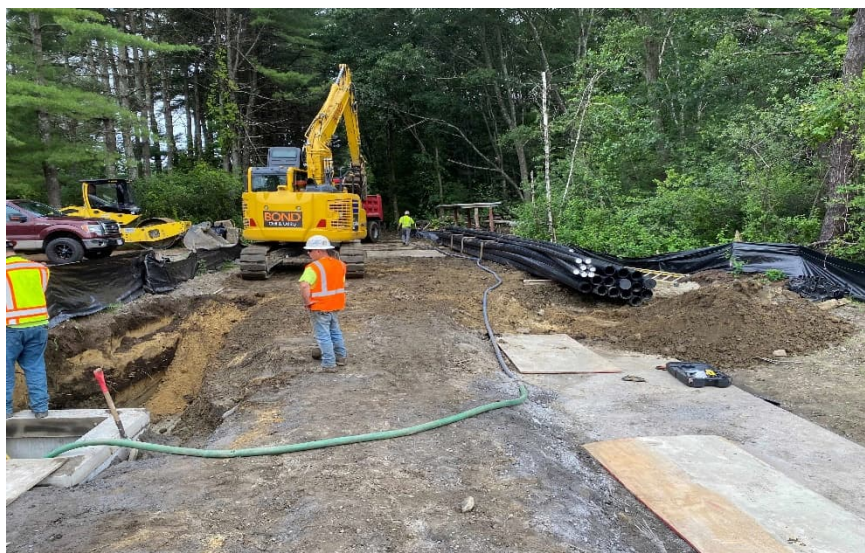
Photo No.: 2      Date: 7/21/2023

Description:  
Segment 11. View of dewatering operation, looking westward.

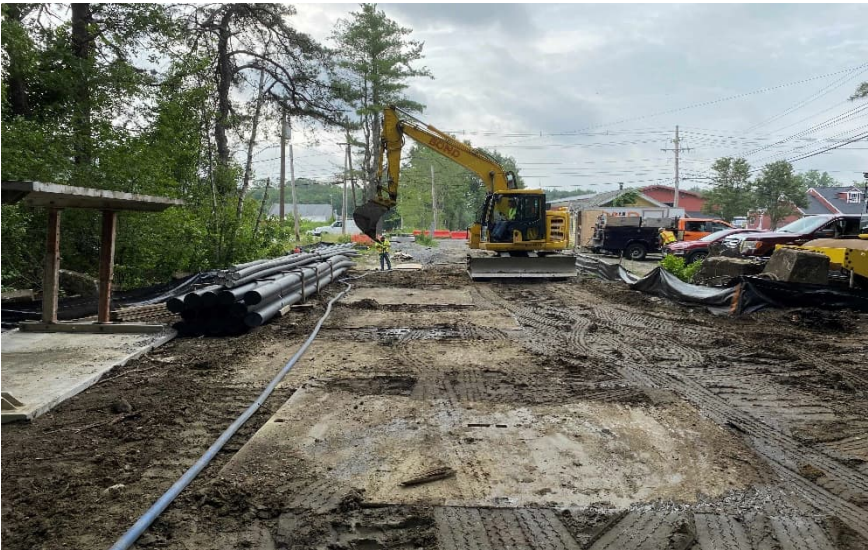
| Photo No.: 3 | Date:<br>7/21/2023 | | |

| Description:<br>Segment 11. View of dewatering operation, looking eastward. | | | |
