Weekly Environmental Compliance Summary

Sudbury to Hudson Transmission Reliability Project (USEPA Tracking # MAR1003UW)

Week of: July 31 to August 4, 2023

CONSTRUCTION MONITORING REPORT
Sudbury to Hudson Transmission Project

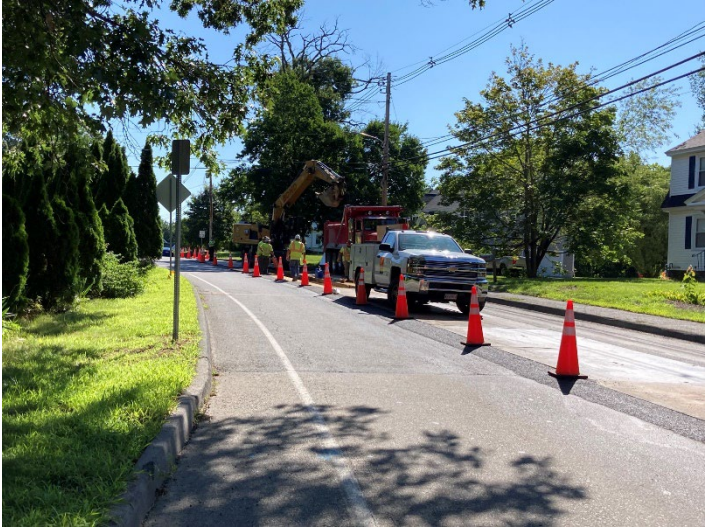
PHOTOGRAPHIC LOG	
Client Name: Eversource		Site Location: Sudbury to Hudson Transmission Reliability Project	Town: Hudson
Photo No.: 1	Date: 8/01/2023

Description: View of Bond working near MH #2 on Forest Ave. Facing north.

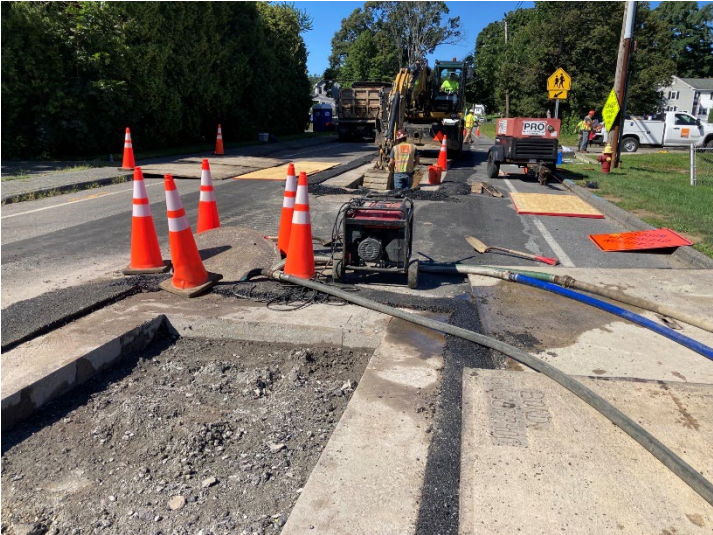
PHOTOGRAPHIC LOG	
Client Name: Eversource		Site Location: Sudbury to Hudson Transmission Reliability Project	Town: Hudson
Photo No.: 2	Date: 8/01/2023

Description: View of Bond installing conduit and dewatering near MH #3 on Forest Ave. See additional dewatering inspection report. Facing north.

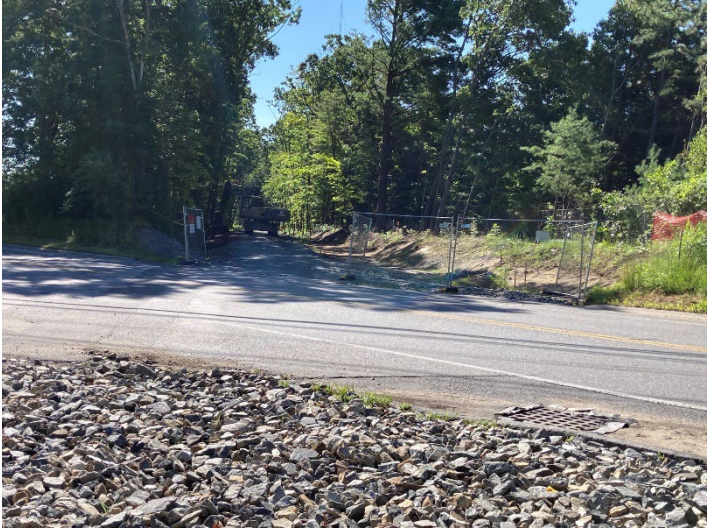
PHOTOGRAPHIC LOG	
Client Name: Eversource		Site Location: Sudbury to Hudson Transmission Reliability Project	Town: Hudson
Photo No.: 6	Date: 8/01/2023

Description: View of construction entrance to segment 4 at Main St. ET&L is working in this segment. Facing east.

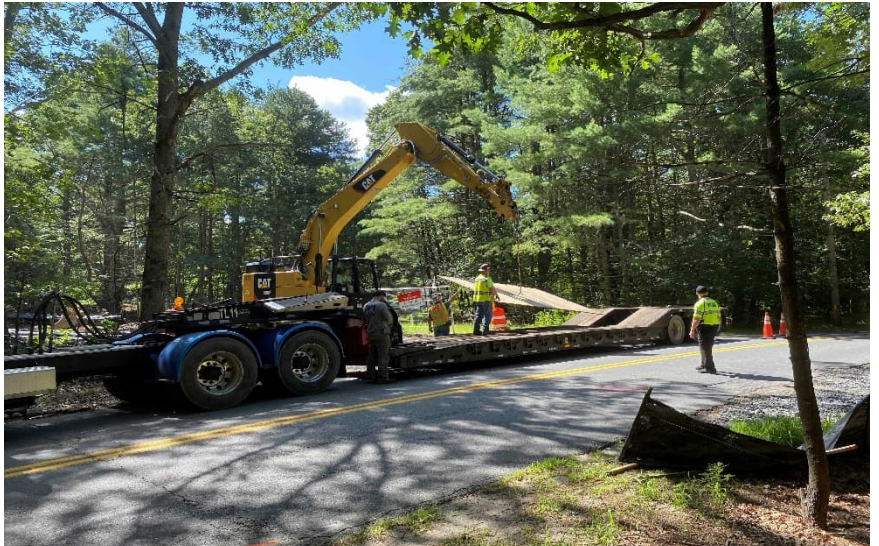
PHOTOGRAPHIC LOG	
Client Name: Eversource		Site Location: Sudbury to Hudson Transmission Reliability Project	Town: Sudbury
Photo No.: 2	Date: 8-1-23

Description: Work area within segment 9, removing equipment, looking eastward.

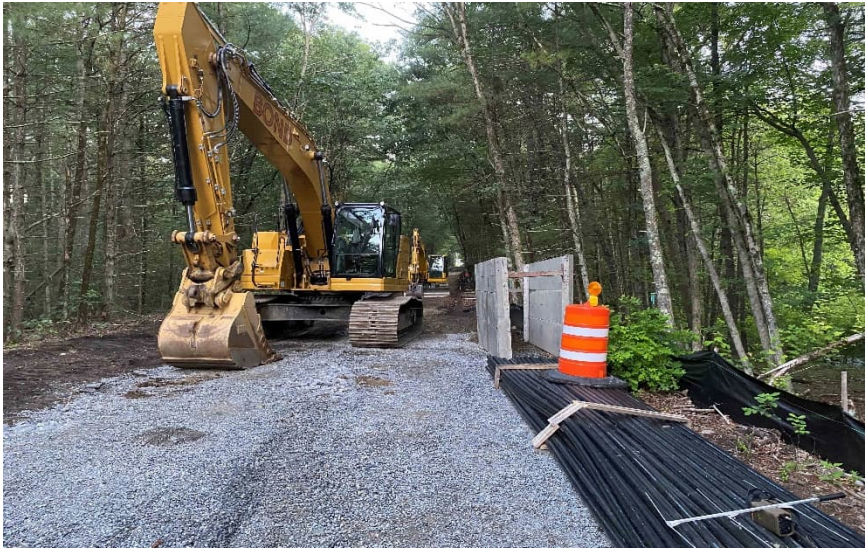
PHOTOGRAPHIC LOG	
Client Name: Eversource		Site Location: Sudbury to Hudson Transmission Reliability Project	Town: Sudbury
Photo No.: 3	Date: 8-1-23

Description: Work area within segment 8, existing erosion control, looking westward.

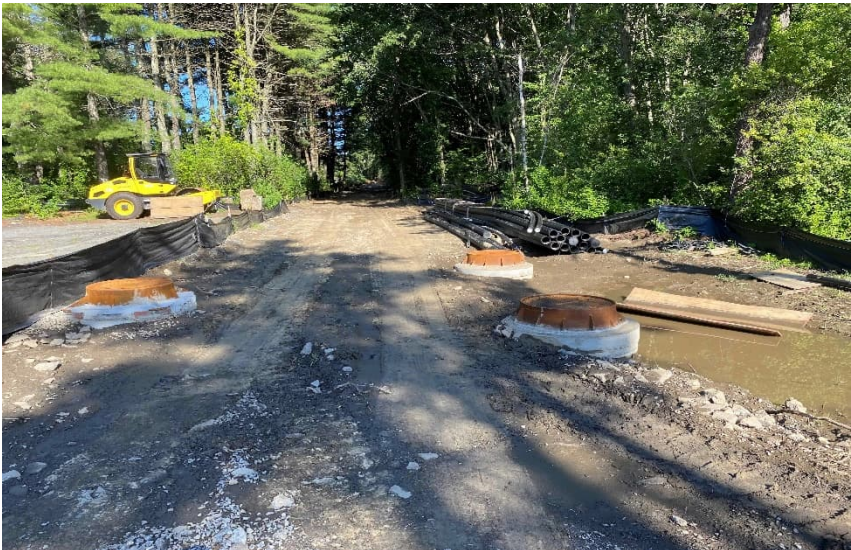
PHOTOGRAPHIC LOG	
Client Name: Eversource		Site Location: Sudbury to Hudson Transmission Reliability Project	Town: Sudbury
Photo No.: 4	Date: 8-1-23

Description: Work area within segment 11, manhole #24, existing erosion control, looking westward.

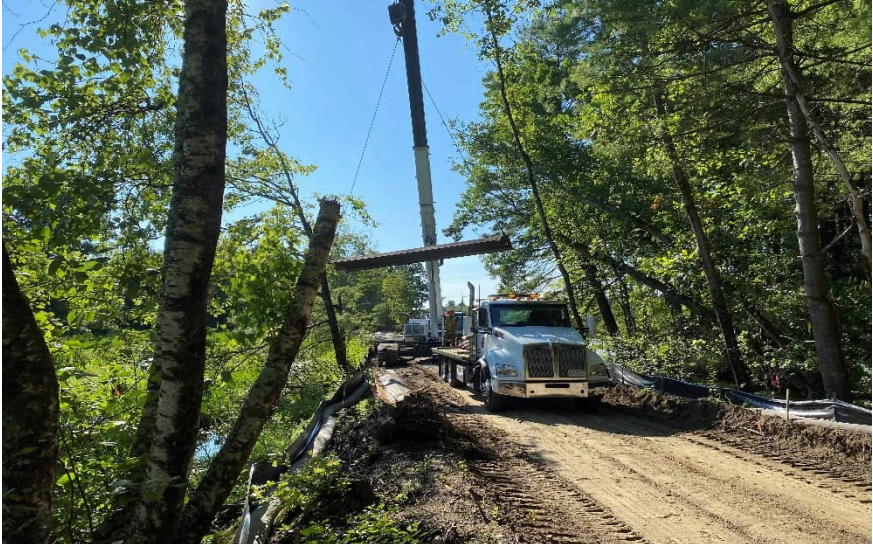
PHOTOGRAPHIC LOG	
Client Name: Eversource		Site Location: Sudbury to Hudson Transmission Reliability Project	Town: Sudbury
Photo No.: 5	Date: 8-1-23

Description: Work area within segment 13, bridge 127 work, existing erosion control, looking eastward.

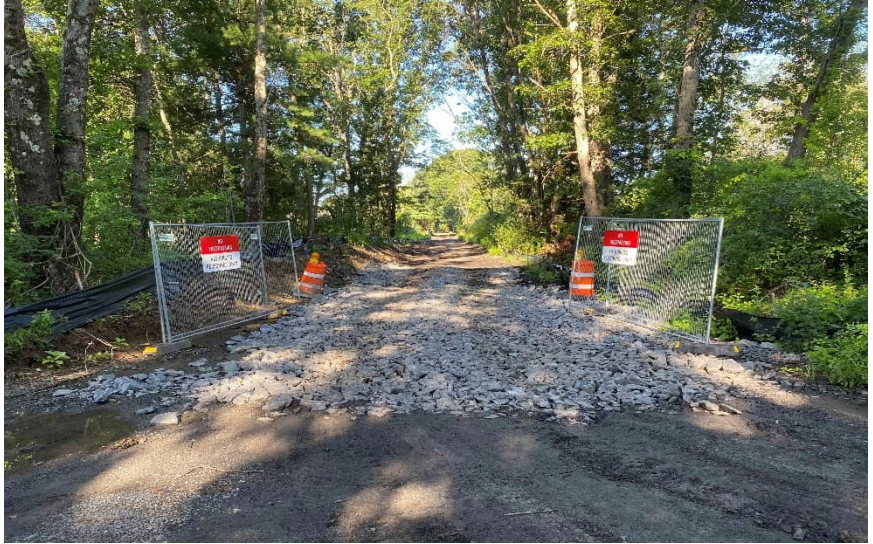
PHOTOGRAPHIC LOG	
Client Name: Eversource		Site Location: Sudbury to Hudson Transmission Reliability Project	Town: Sudbury
Photo No.: 6	Date: 8-1-23

Description: Segment 14, existing erosion control, looking westward.

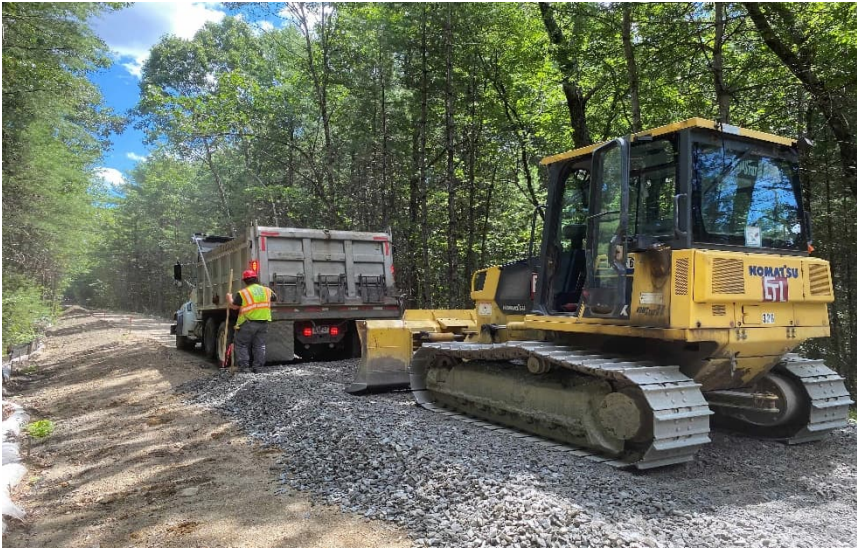
PHOTOGRAPHIC LOG	
Client Name: Eversource		Site Location: Sudbury to Hudson Transmission Reliability Project	Town: Hudson
Photo No.: 7	Date: 8-1-23

Description: ET&L grading within segment 5, existing erosion control, looking eastward.

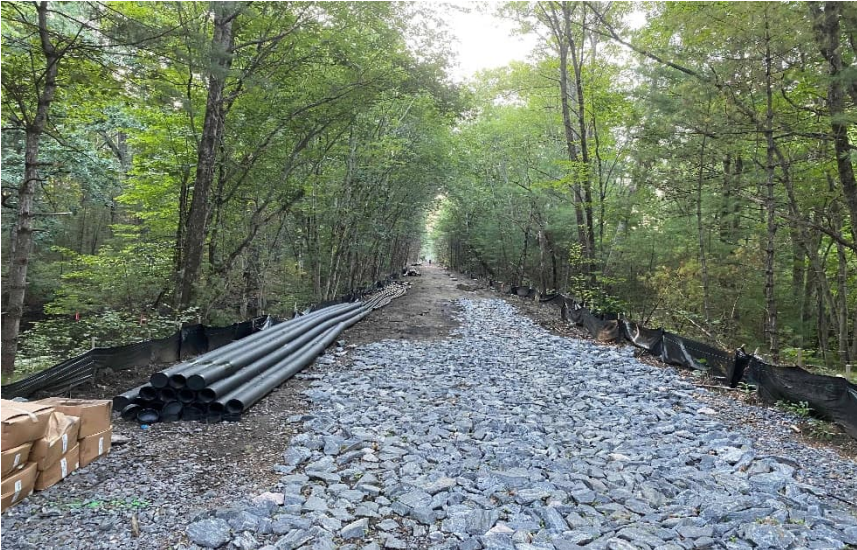
PHOTOGRAPHIC LOG	
Client Name: Eversource		Site Location: Sudbury to Hudson Transmission Reliability Project	Town: Hudson
Photo No.: 8	Date: 8-1-23

Description: Work area within segment 6, existing erosion control, looking eastward.

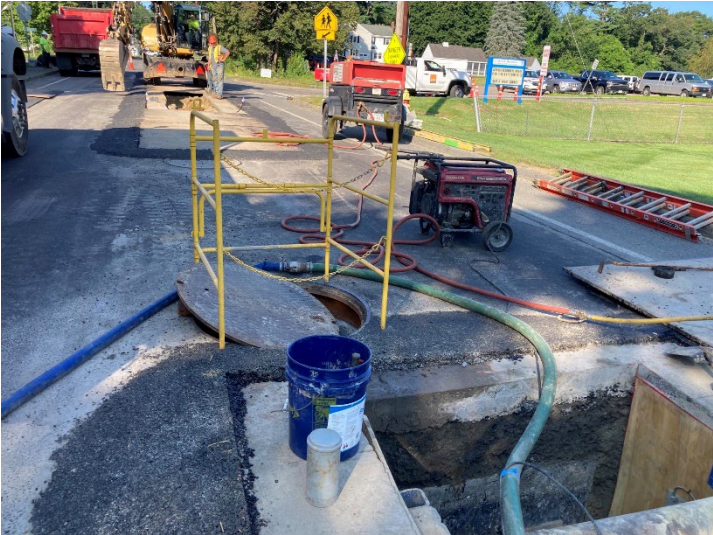
PHOTOGRAPHIC LOG	
Client Name: Eversource		Site Location: Sudbury to Hudson Transmission Reliability Project	Town: Hudson
Photo No.: 2	Date: 8/02/2023

Description: View of Bond installing conduit and dewatering near MH #3 on Forest Ave. See additional dewatering inspection report. Facing south.

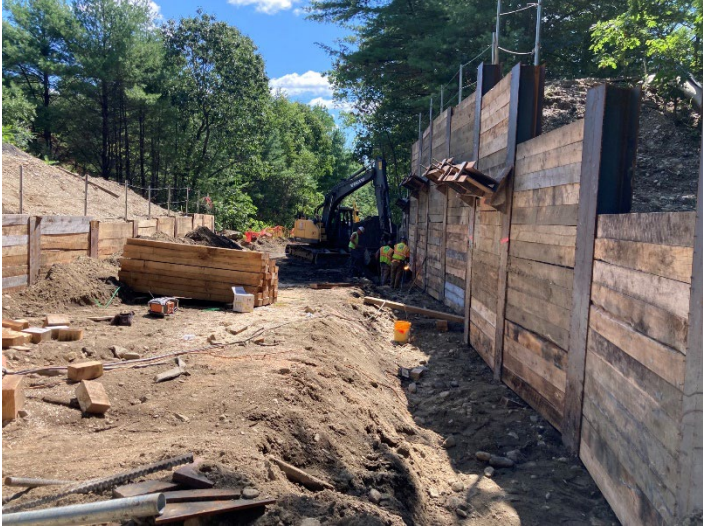
PHOTOGRAPHIC LOG	
Client Name: Eversource		Site Location: Sudbury to Hudson Transmission Reliability Project	Town: Hudson
Photo No.: 4	Date: 8/02/2023

Description: View of ET&L working at Chestnut St. Facing west.

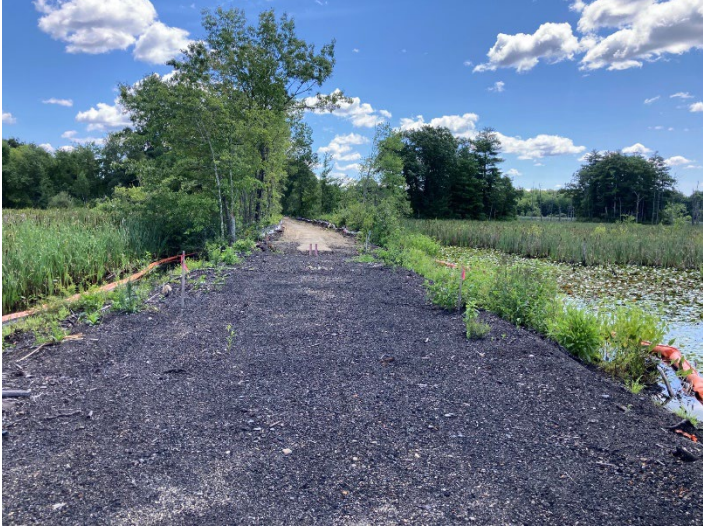
PHOTOGRAPHIC LOG	
Client Name: Eversource		Site Location: Sudbury to Hudson Transmission Reliability Project	
Town: Hudson			
Photo No.: 5	Date: 8/02/2023

Description: View of segment 3 from Bridge 130. Facing east.

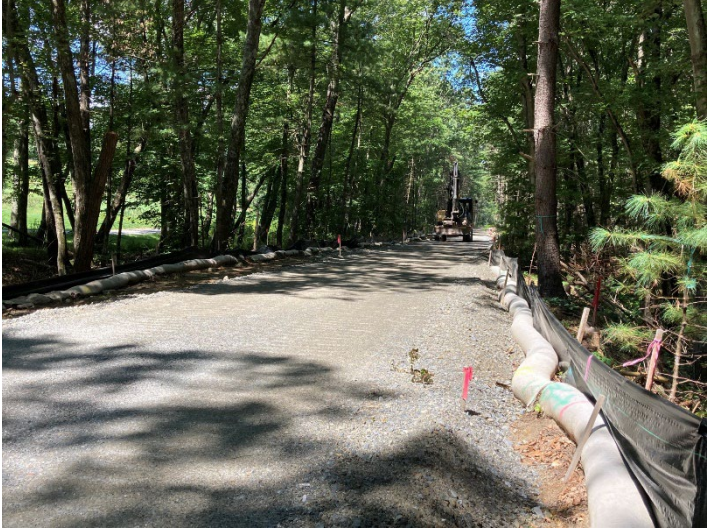
PHOTOGRAPHIC LOG	
Client Name: Eversource		Site Location: Sudbury to Hudson Transmission Reliability Project	
Town: Hudson			
Photo No.: 6	Date: 8/02/2023

Description: View of east end of segment 4. ET&L is working in this segment. Facing west.

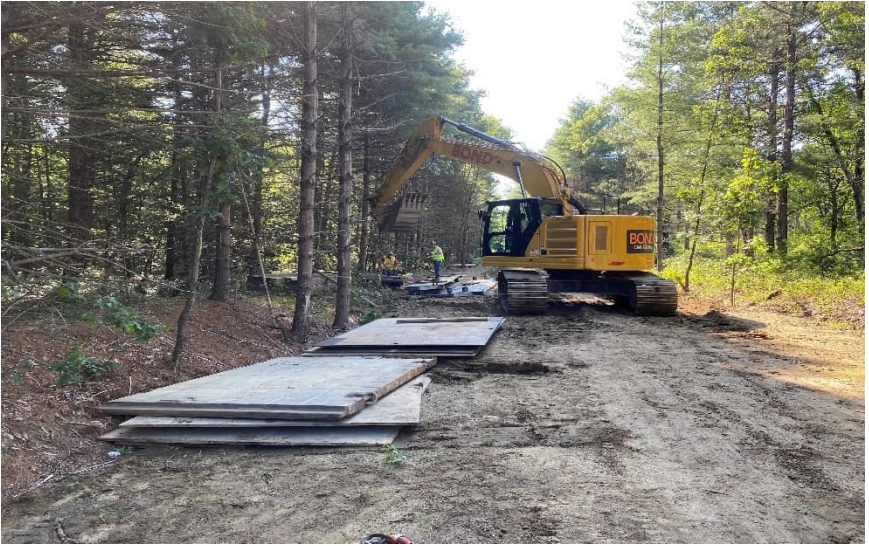
PHOTOGRAPHIC LOG	
Client Name: Eversource		Site Location: Sudbury to Hudson Transmission Reliability Project	Town: Sudbury
Photo No.: 1	Date: 8-2-23

Description: Work area within segment 7, prep work for manhole #16, existing erosion control, looking eastward.

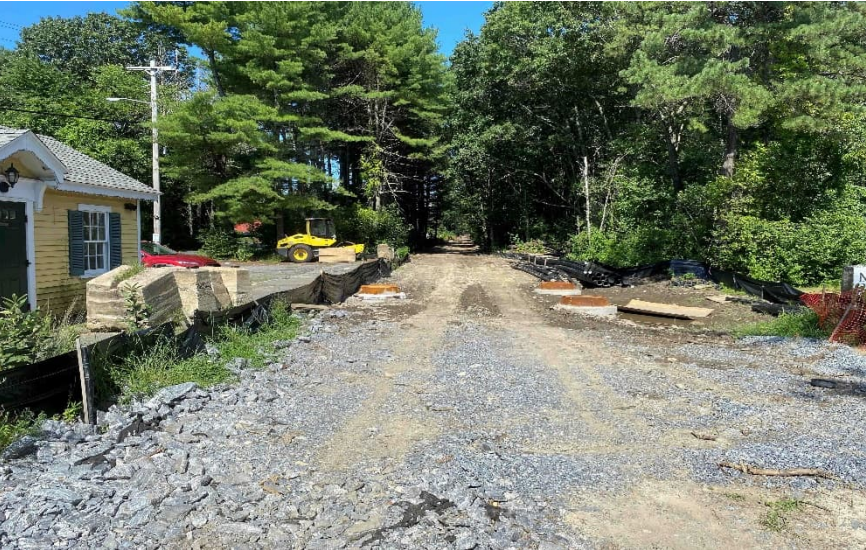
PHOTOGRAPHIC LOG	
Client Name: Eversource		Site Location: Sudbury to Hudson Transmission Reliability Project	Town: Sudbury
Photo No.: 4	Date: 8-2-23

Description: Work area within segment 11, manhole #24, existing erosion control, looking westward.

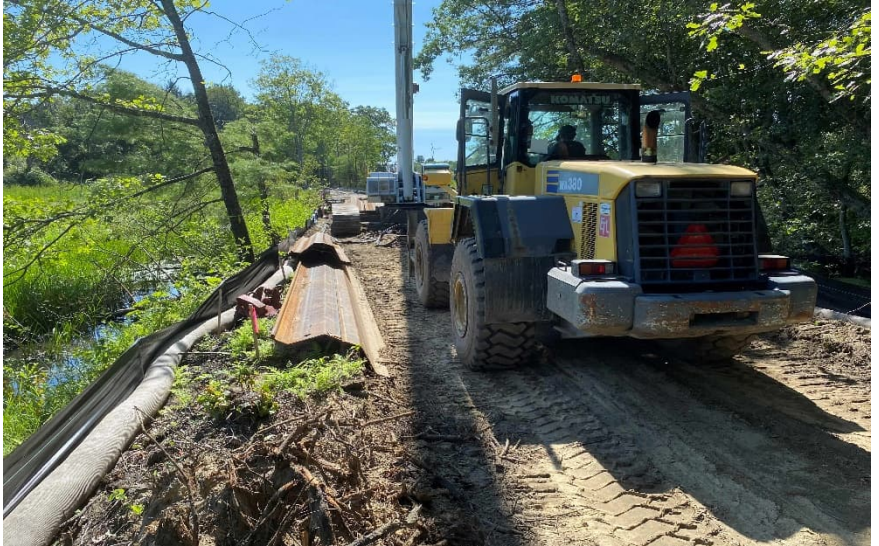
PHOTOGRAPHIC LOG	
Client Name: Eversource		Site Location: Sudbury to Hudson Transmission Reliability Project	Town: Sudbury
Photo No.: 5	Date: 8-2-23

Description: Work area within segment 13, bridge 127 work, existing erosion control, looking eastward.

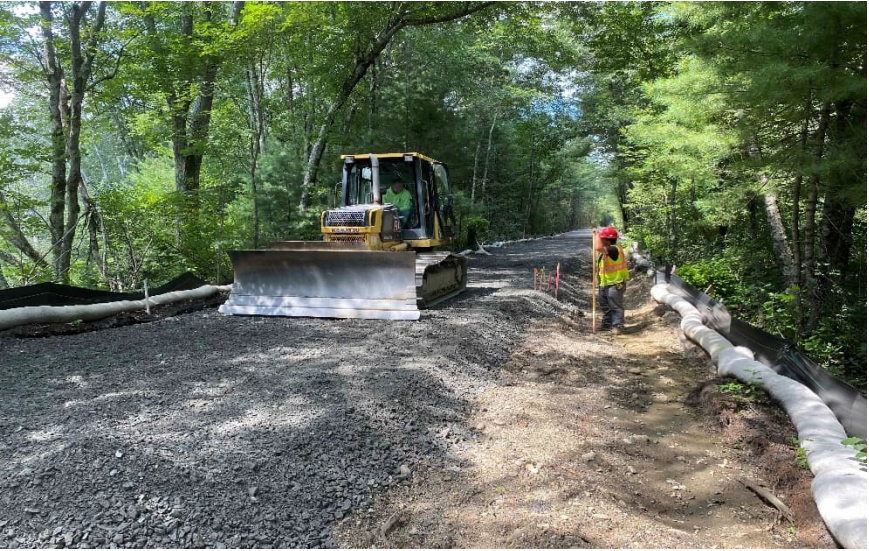
PHOTOGRAPHIC LOG	
Client Name: Eversource		Site Location: Sudbury to Hudson Transmission Reliability Project	Town: Hudson
Photo No.: 7	Date: 8-2-23

Description: ET&L grading within segment 5, existing erosion control, looking westward.

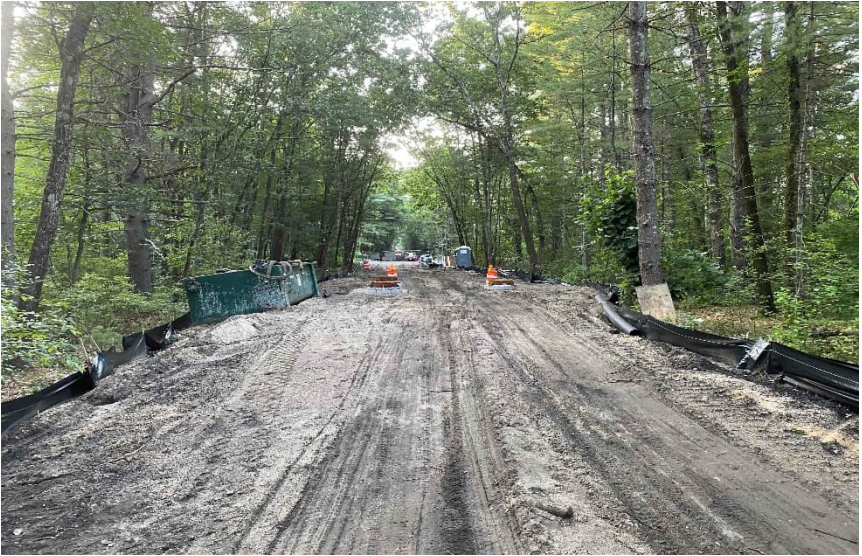
PHOTOGRAPHIC LOG	
Client Name: Eversource		Site Location: Sudbury to Hudson Transmission Reliability Project	Town: Hudson
Photo No.: 8	Date: 8-2-23

Description: Work area within segment 5, existing erosion control, looking eastward.

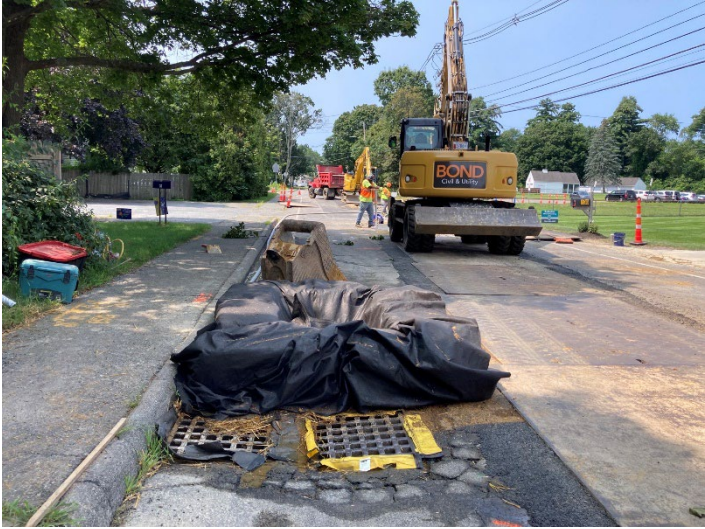
<p align="center">PHOTOGRAPHIC LOG</p>	
<p>Client Name: Eversource</p>		<p>Site Location: Sudbury to Hudson Transmission Reliability Project</p>	<p>Town: Hudson</p>
<p>Photo No.: 1</p>	<p>Date: 8/03/2023</p>

<p>Description: View of Bond installing conduit and dewatering near MH #3 on Forest Ave. See additional dewatering inspection report. Facing south.</p>

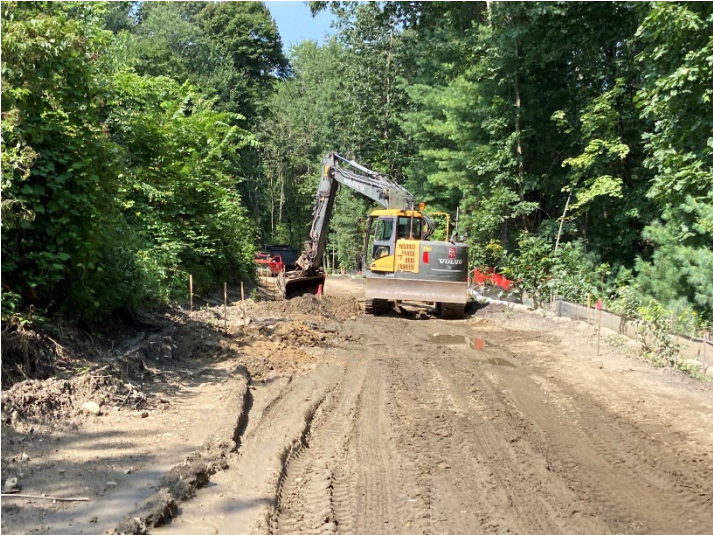
<p align="center">PHOTOGRAPHIC LOG</p>	
<p>Client Name: Eversource</p>		<p>Site Location: Sudbury to Hudson Transmission Reliability Project</p>	<p>Town: Hudson</p>
<p>Photo No.: 2</p>	<p>Date: 8/03/2023</p>

<p>Description: View of ET&L grading in segment 1. Facing west.</p>

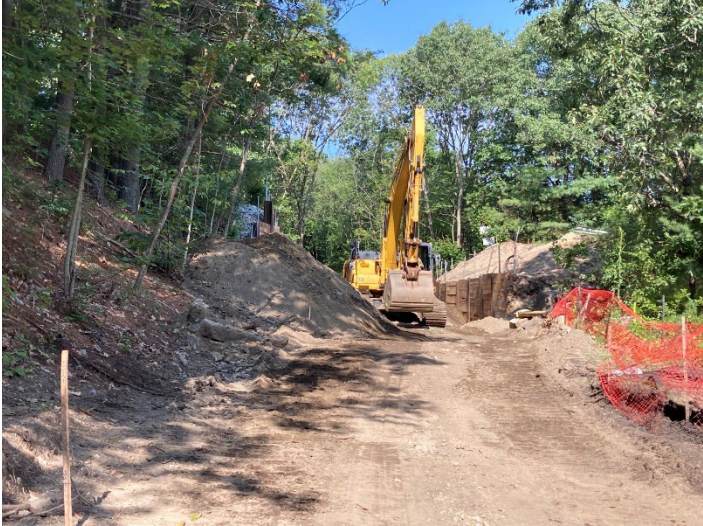
<p align="right">PHOTOGRAPHIC LOG</p>	
<p>Client Name: Eversource</p>		<p>Site Location: Sudbury to Hudson Transmission Reliability Project</p>	<p>Town: Hudson</p>
<p>Photo No.: 4</p>	<p>Date: 8/03/2023</p>

<p>Description: View of ET&L working at Chestnut St. Facing west.</p>

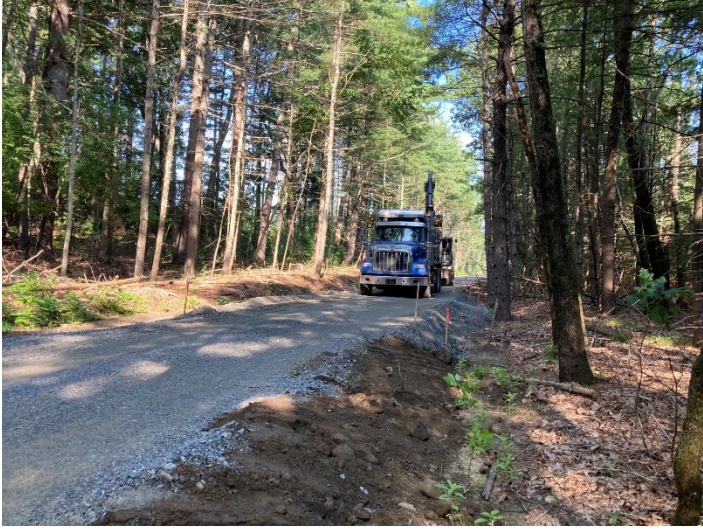
PHOTOGRAPHIC LOG	
Client Name: Eversource		Site Location: Sudbury to Hudson Transmission Reliability Project	Town: Hudson
Photo No.: 5	Date: 8/03/2023

Description: View of east end of segment 4. ET&L is working in this segment. Facing west.

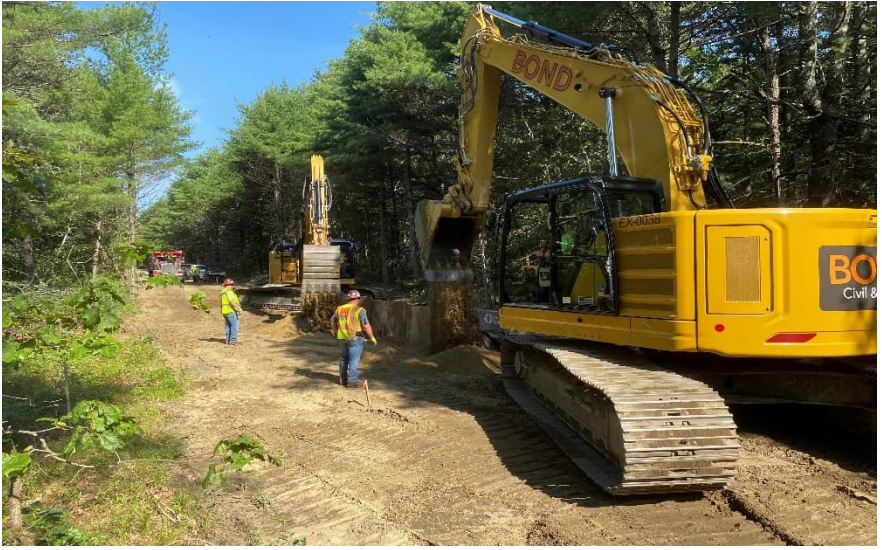
PHOTOGRAPHIC LOG	
Client Name: Eversource		Site Location: Sudbury to Hudson Transmission Reliability Project	Town: Sudbury
Photo No.: 1	Date: 8-3-23

Description: Work area within segment 7, manhole #16, existing erosion control, looking westward.

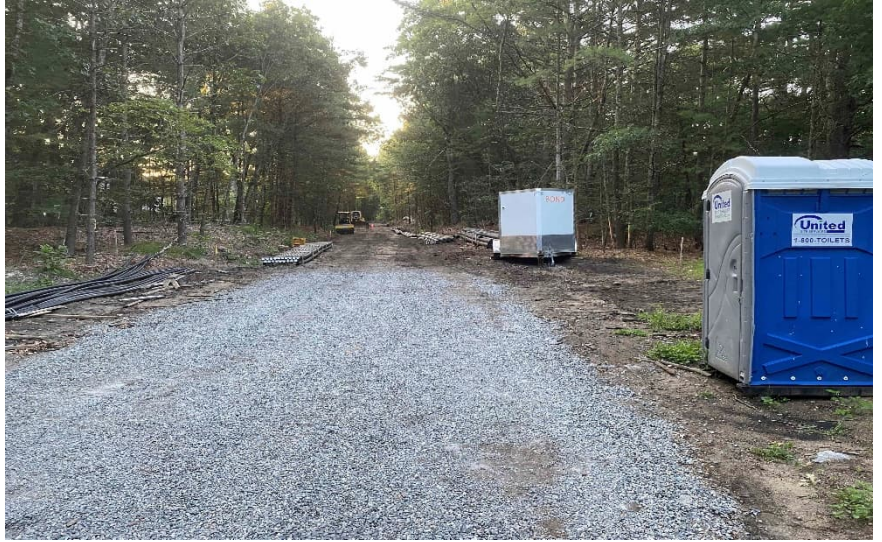
PHOTOGRAPHIC LOG	
Client Name: Eversource		Site Location: Sudbury to Hudson Transmission Reliability Project	Town: Sudbury
Photo No.: 2	Date: 8-3-23

Description: Work area within segment 9, looking eastward.

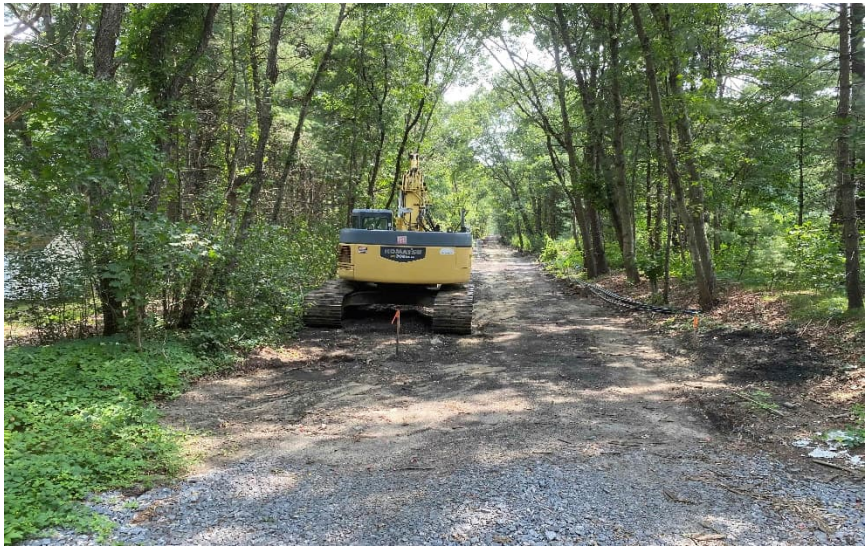
PHOTOGRAPHIC LOG	
Client Name: Eversource		Site Location: Sudbury to Hudson Transmission Reliability Project	Town: Sudbury
Photo No.: 4	Date: 8-3-23

Description: Work area within segment 11, existing erosion control, looking eastward.

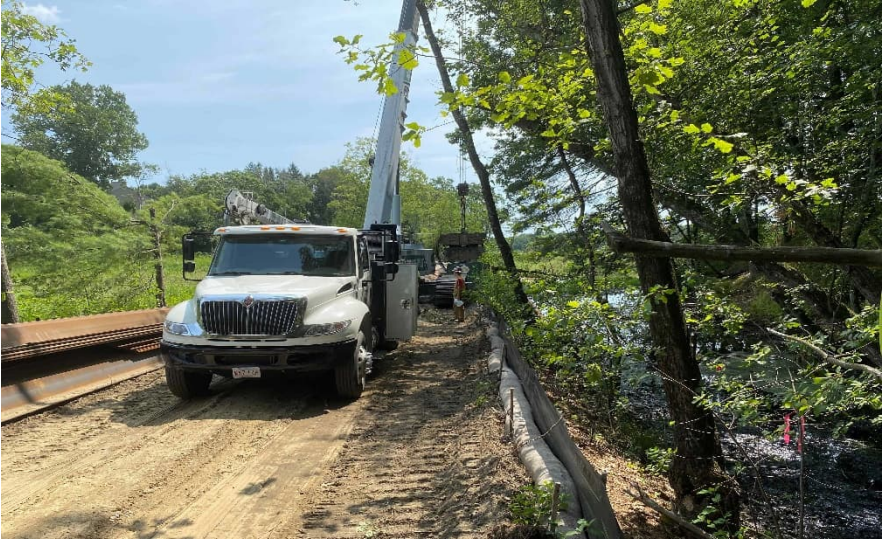
PHOTOGRAPHIC LOG	
Client Name: Eversource		Site Location: Sudbury to Hudson Transmission Reliability Project	Town: Sudbury
Photo No.: 5	Date: 8-3-23

Description: Work area within segment 13, bridge 127 work, existing erosion control, looking eastward.

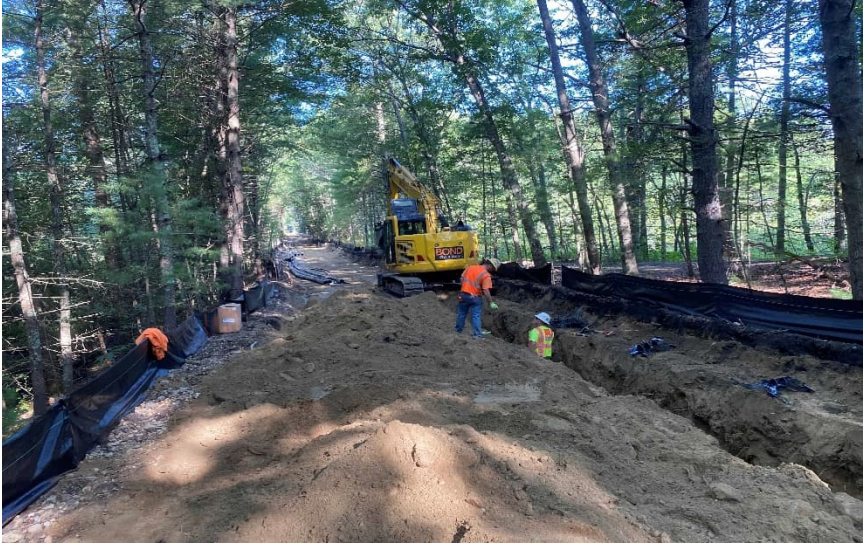
PHOTOGRAPHIC LOG	
Client Name: Eversource		Site Location: Sudbury to Hudson Transmission Reliability Project	Town: Sudbury
Photo No.: 6	Date: 8-3-23

Description: Segment 8, conduit work, existing erosion control, looking westward.

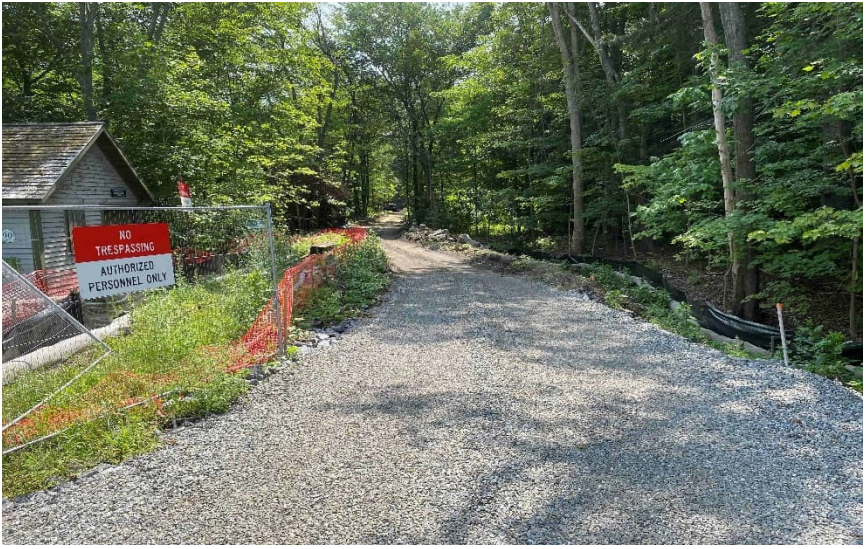
PHOTOGRAPHIC LOG	
Client Name: Eversource		Site Location: Sudbury to Hudson Transmission Reliability Project	Town: Sudbury
Photo No.: 7	Date: 8-3-23

Description: Work area within segment 13, existing erosion control, looking eastward.

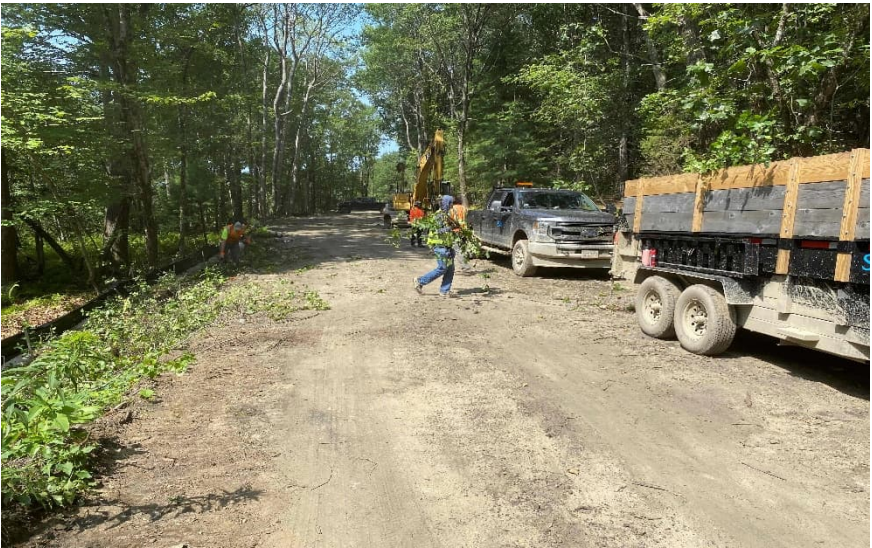
PHOTOGRAPHIC LOG	
Client Name: Eversource		Site Location: Sudbury to Hudson Transmission Reliability Project	Town: Sudbury
Photo No.: 8	Date: 8-3-23

Description: Work area within segment 14, invasive species removal, existing erosion control, looking westward.

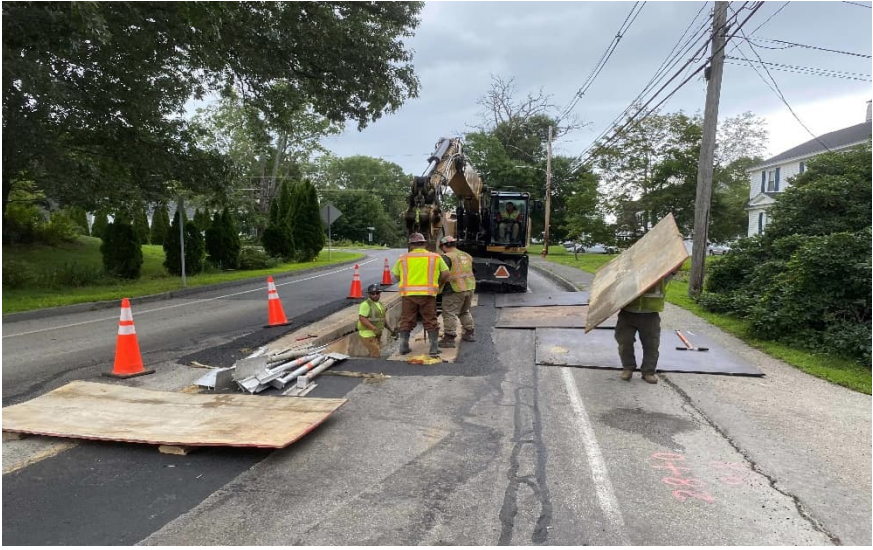
<p>PHOTOGRAPHIC LOG</p>	
<p>Client Name: Eversource</p>		<p>Site Location: Sudbury to Hudson Transmission Reliability Project</p>	<p>Town: Hudson</p>
<p>Photo No.: 1</p>	<p>Date: 8-4-23</p>

<p>Description:</p> <p>Work area within Forest Avenue, conduit work near manhole #2, looking northward.</p>

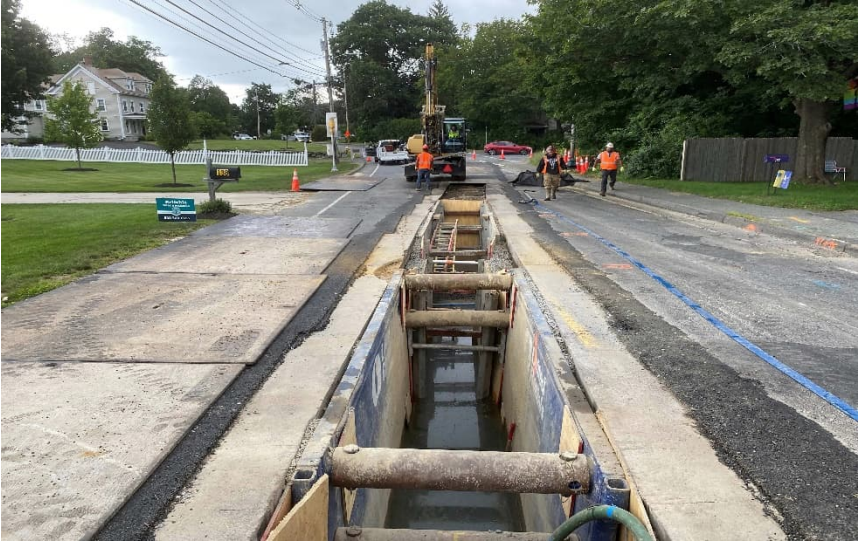
<p>PHOTOGRAPHIC LOG</p>	
<p>Client Name: Eversource</p>		<p>Site Location: Sudbury to Hudson Transmission Reliability Project</p>	<p>Town: Hudson</p>
<p>Photo No.: 2</p>	<p>Date: 8-4-23</p>

<p>Description:</p> <p>Work area within Forest Avenue, conduit work near manhole #3, looking northward.</p>

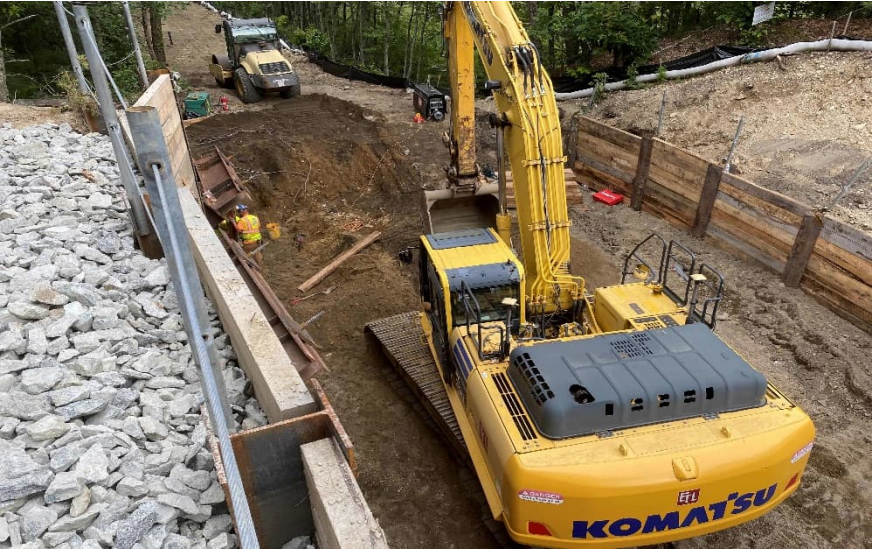
<p>PHOTOGRAPHIC LOG</p>	
<p>Client Name: Eversource</p>		<p>Site Location: Sudbury to Hudson Transmission Reliability Project</p>	<p>Town: Hudson</p>
<p>Photo No.: 3</p>	<p>Date: 8-4-23</p>

<p>Description:</p> <p>Work area within segment 1, Chestnut Street crossing, existing erosion control, looking westward.</p>

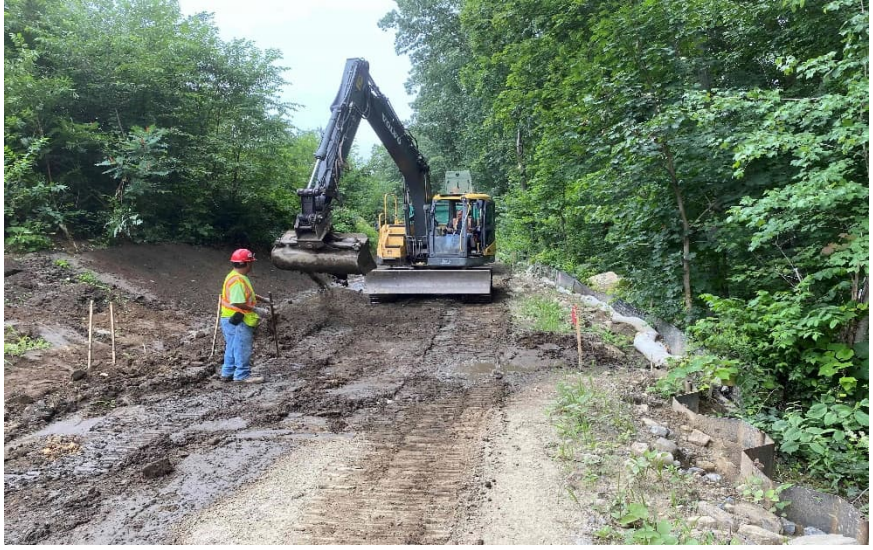
<p>PHOTOGRAPHIC LOG</p>	
<p>Client Name: Eversource</p>		<p>Site Location: Sudbury to Hudson Transmission Reliability Project</p>	<p>Town: Hudson</p>
<p>Photo No.: 4</p>	<p>Date: 8-4-23</p>

<p>Description:</p> <p>Work area within segment 1, grading & shaping by ET&L, looking westward.</p>

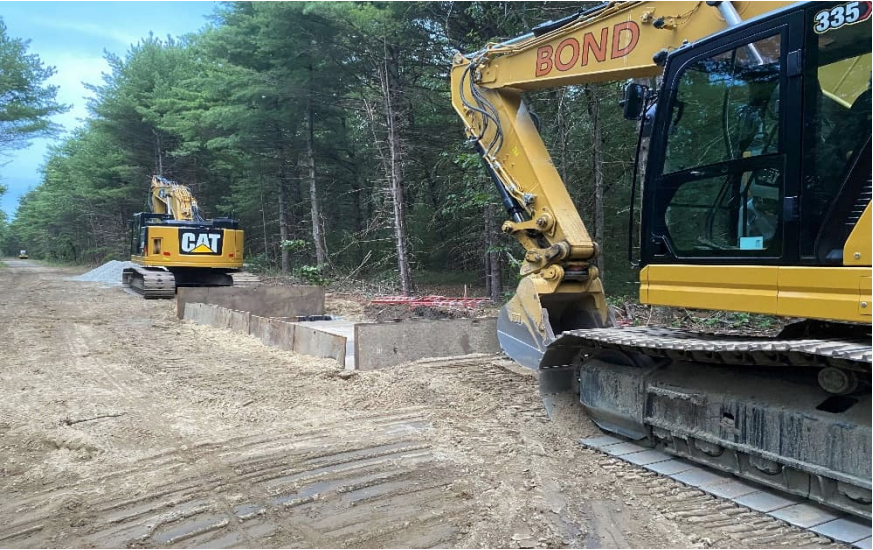
<p>PHOTOGRAPHIC LOG</p>	
<p>Client Name: Eversource</p>		<p>Site Location: Sudbury to Hudson Transmission Reliability Project</p>	<p>Town: Sudbury</p>
<p>Photo No.: 5</p>	<p>Date: 8-4-23</p>

<p>Description: Work area within segment 7, manhole 16, looking westward.</p>

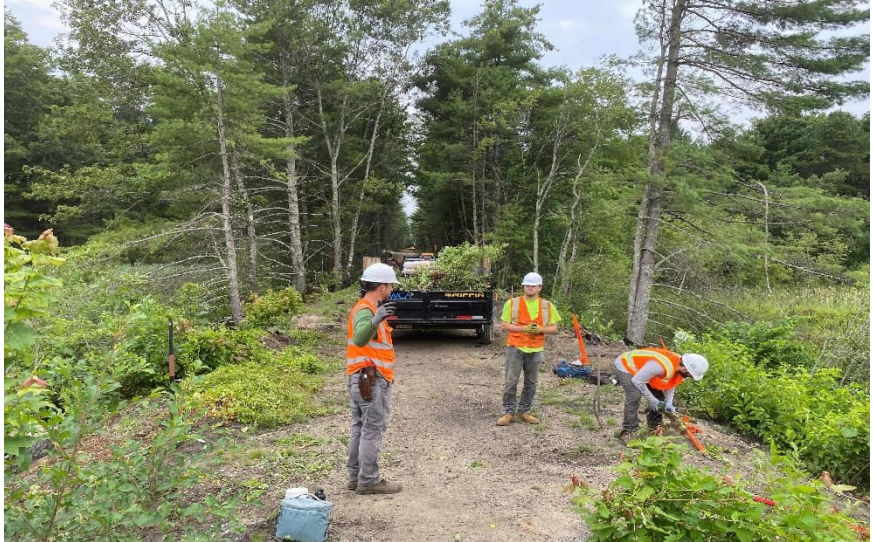
<p>PHOTOGRAPHIC LOG</p>	
<p>Client Name: Eversource</p>		<p>Site Location: Sudbury to Hudson Transmission Reliability Project</p>	<p>Town: Sudbury</p>
<p>Photo No.: 6</p>	<p>Date: 8-4-23</p>

<p>Description: Work area within segment 7, invasive species removal, looking westward.</p>

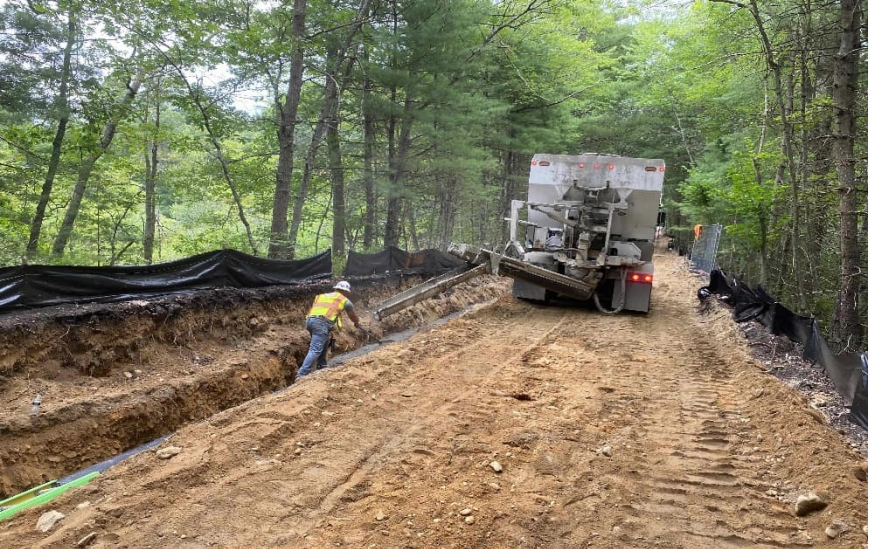
<p>PHOTOGRAPHIC LOG</p>	
<p>Client Name: Eversource</p>		<p>Site Location: Sudbury to Hudson Transmission Reliability Project</p>	<p>Town: Sudbury</p>
<p>Photo No.: 8</p>	<p>Date: 8-4-23</p>		
<p>Description:</p> <p>Work area within segment 8, conduit work, looking eastward.</p>

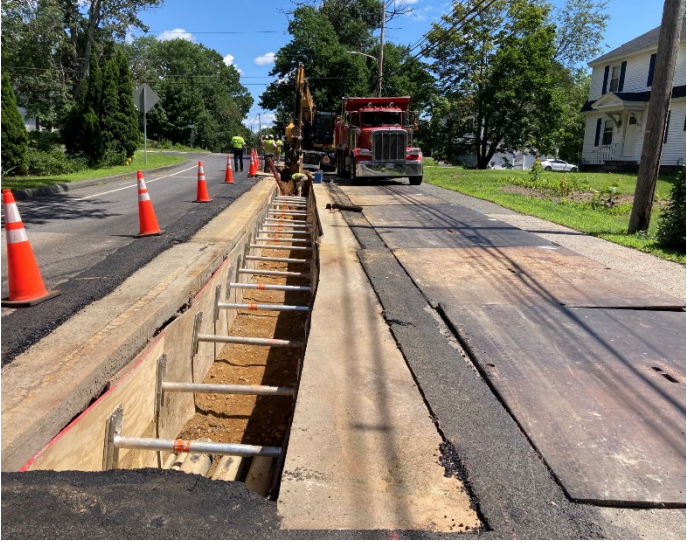
PHOTOGRAPHIC LOG	
Client Name: Eversource		Site Location: Sudbury to Hudson Transmission Reliability Project	Town: Hudson
Photo No.: 1	Date: 7-31-2023

Description: View of Bond working near MH #2 on Forest Ave. Facing north.

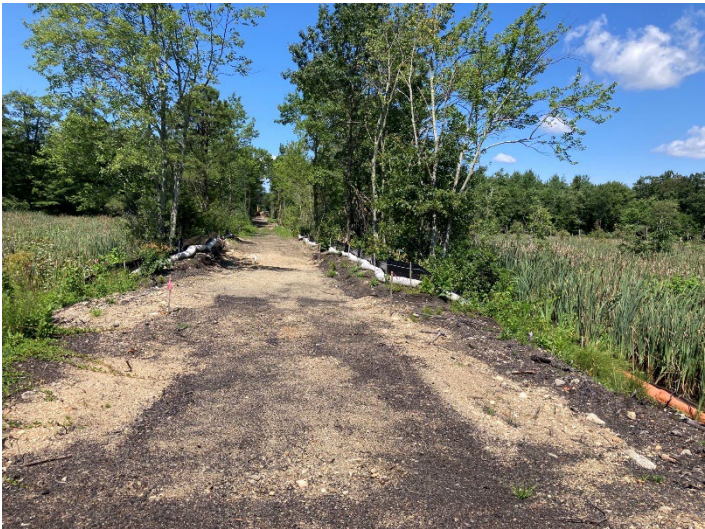
Epsilon ASSOCIATES INC.		PHOTOGRAPHIC LOG	
Client Name: Eversource		Site Location: Sudbury to Hudson Transmission Reliability Project	Town: Hudson
Photo No.: 5	Date: 7-31-2023

Description: View of segment 2 from Bridge 130. Facing west.

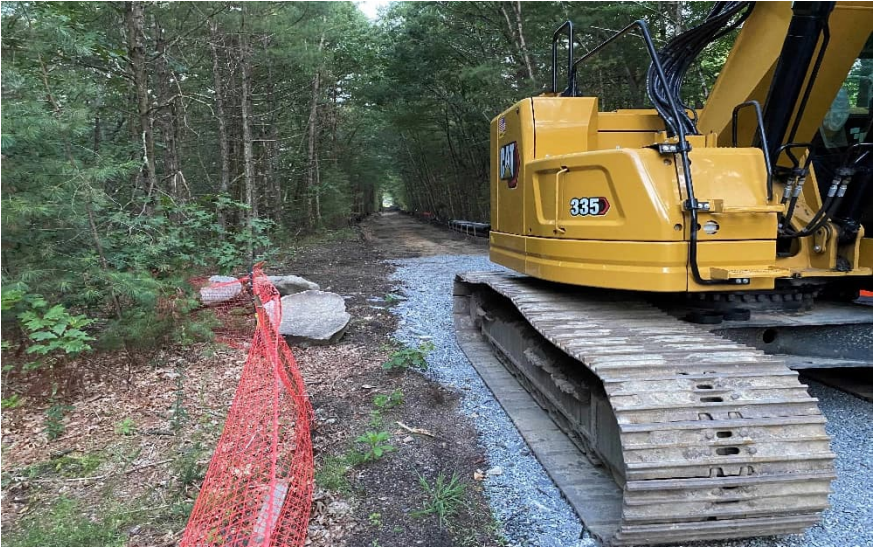
PHOTOGRAPHIC LOG	
Client Name: Eversource		Site Location: Sudbury to Hudson Transmission Reliability Project	Town: Sudbury
Photo No.: 1	Date: 7-31-23

Description: Work area within Segment 8, existing erosion control, looking westward.

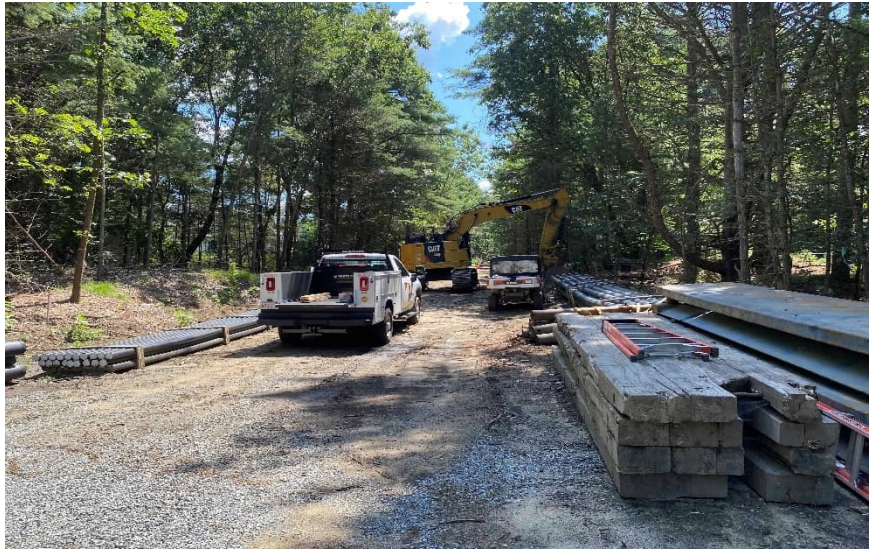
PHOTOGRAPHIC LOG	
Client Name: Eversource		Site Location: Sudbury to Hudson Transmission Reliability Project	Town: Sudbury
Photo No.: 2	Date: 7-31-23

Description: Work area within Segment 9, cleanup, looking eastward.

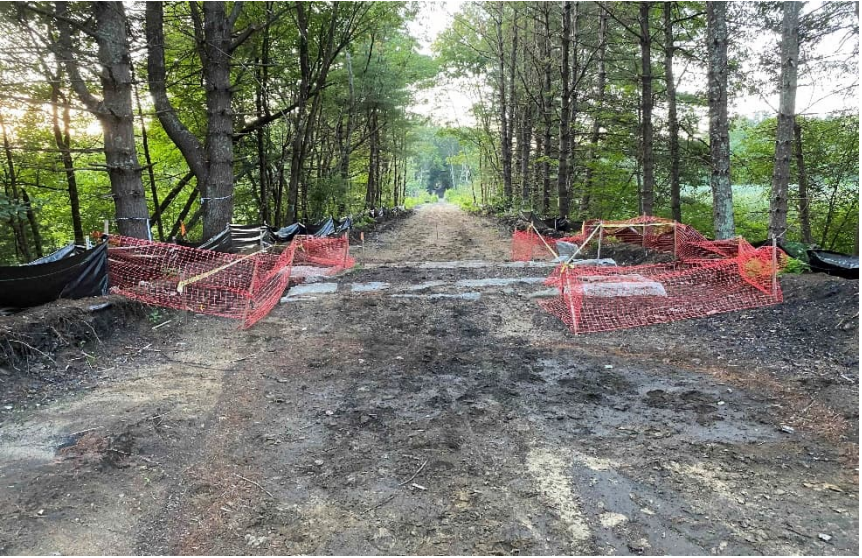
PHOTOGRAPHIC LOG	
Client Name: Eversource		Site Location: Sudbury to Hudson Transmission Reliability Project	Town: Sudbury
Photo No.: 3	Date: 7-31-23

Description: Work area within segment 7, historical cattle guard, looking westward.

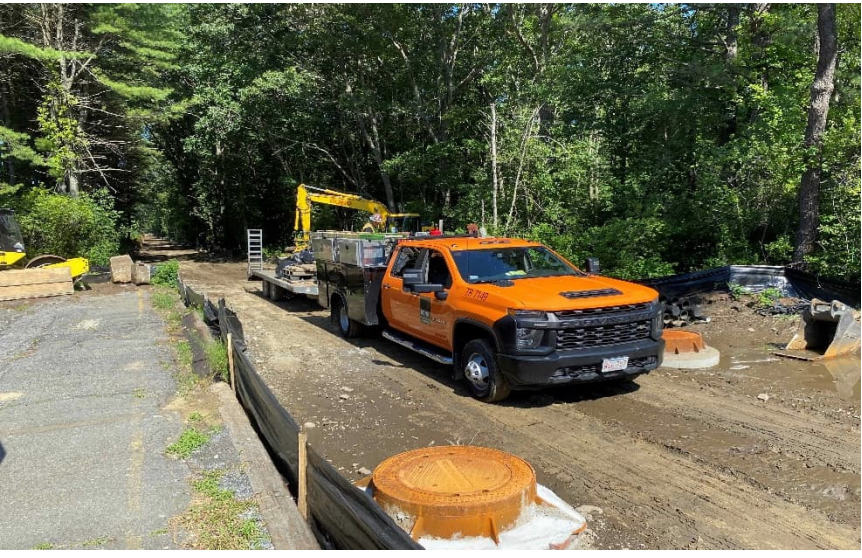
PHOTOGRAPHIC LOG	
Client Name: Eversource		Site Location: Sudbury to Hudson Transmission Reliability Project	Town: Sudbury
Photo No.: 4	Date: 7-31-23

Description: Work area within segment 11, cleanup work, existing erosion control, looking westward.

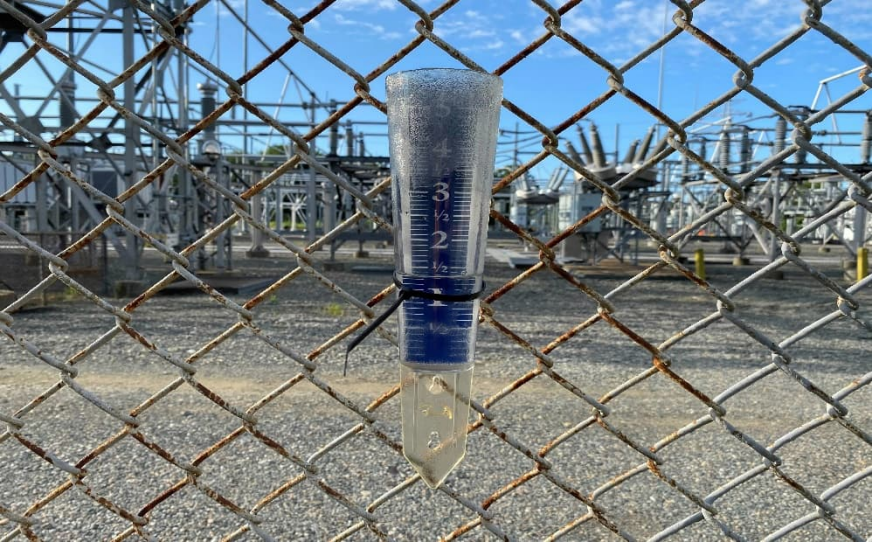
PHOTOGRAPHIC LOG	
Client Name: Eversource		Site Location: Sudbury to Hudson Transmission Reliability Project	Town: Sudbury
Photo No.: 6	Date: 7-31-23

Description: Rain gauge at Sudbury substation showing 1.4" of rainfall, looking southward.
