Weekly Environmental Compliance Summary

Sudbury to Hudson Transmission Reliability Project (USEPA Tracking # MAR1003UW)

Week of: July 31 to August 4, 2023

CONSTRUCTION MONITORING REPORT
Sudbury to Hudson Transmission Project

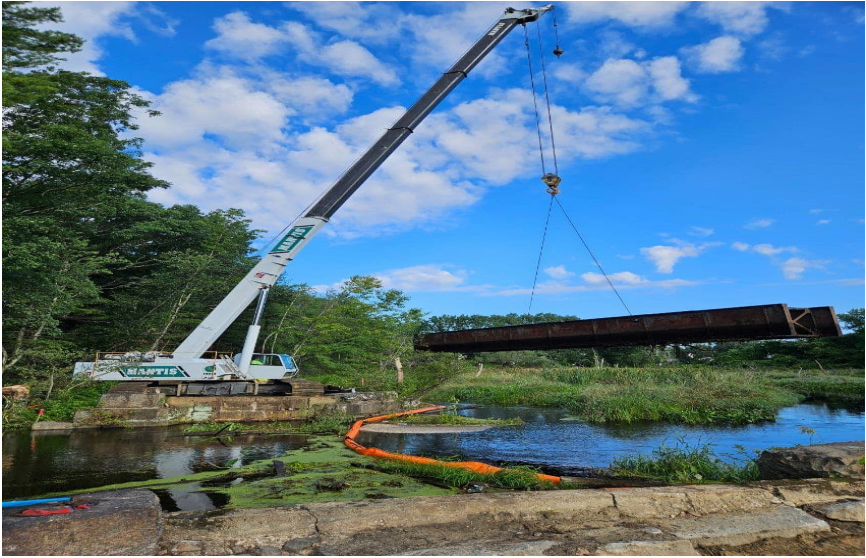
PHOTOGRAPHIC LOG	
Client Name: Eversource		Site Location: Sudbury to Hudson Transmission Reliability Project	Town: Sudbury
Photo No.: 7	Date: 7-31-23

Description: Bridge 127 removal at segment 13/14 boundary, looking eastward.

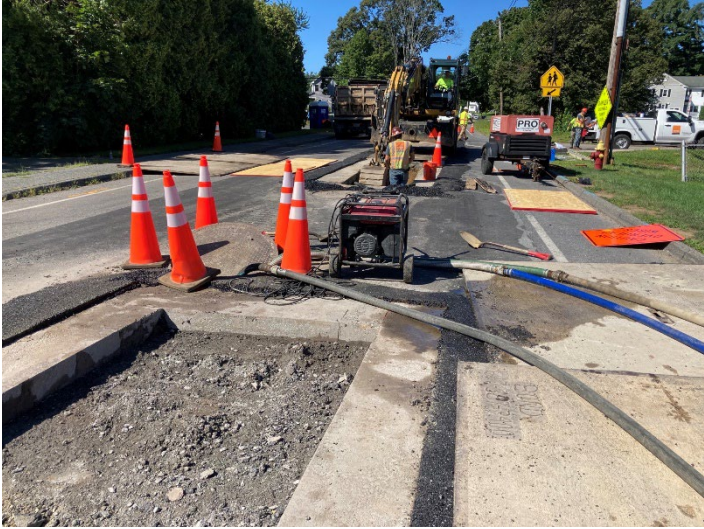
PHOTOGRAPHIC LOG		
Client Name: Eversource		Site Location: Sudbury to Hudson Transmission Reliability Project		Town: Hudson
Photo No.: 1	Date: 8/01/2023

Description: View of work area and dewatering operation at MH #3 on Forest Ave in Hudson. Facing south.

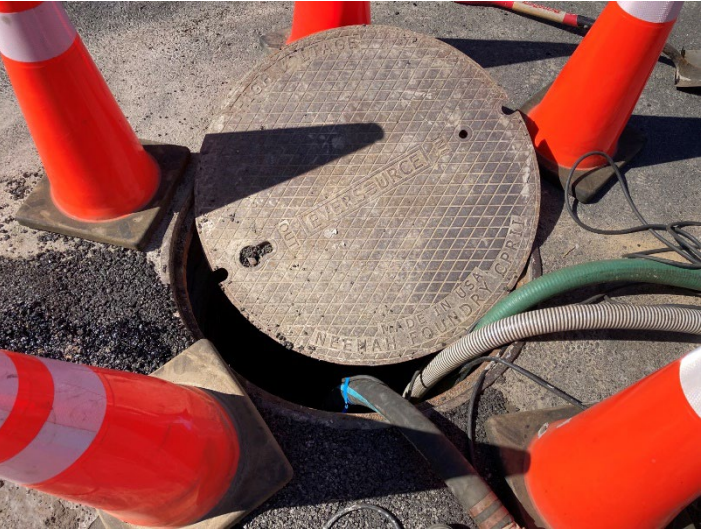
PHOTOGRAPHIC LOG		
Client Name: Eversource		Site Location: Sudbury to Hudson Transmission Reliability Project		Town: Hudson
Photo No.: 2	Date: 8/01/2023

Description: View of manhole. Unable to visualize water prior to treatment.

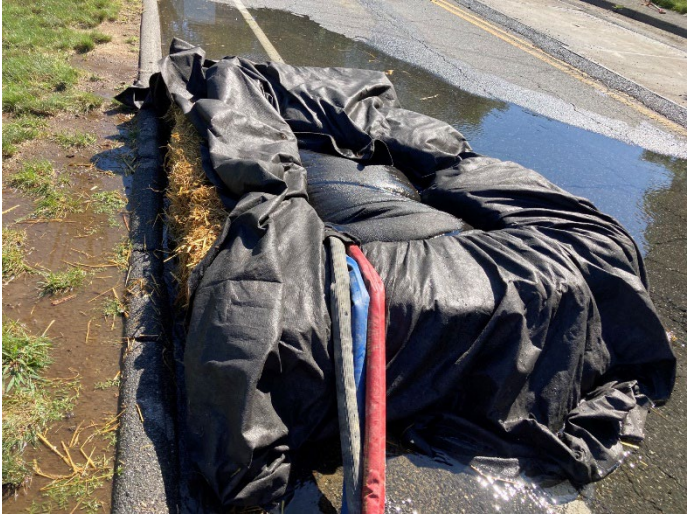
PHOTOGRAPHIC LOG	
Client Name: Eversource		Site Location: Sudbury to Hudson Transmission Reliability Project	Town: Hudson
Photo No.: 3	Date: 8/01/2023

Description: View of dewatering controls (straw bale corral with filter fabric and silt bag). Facing north.

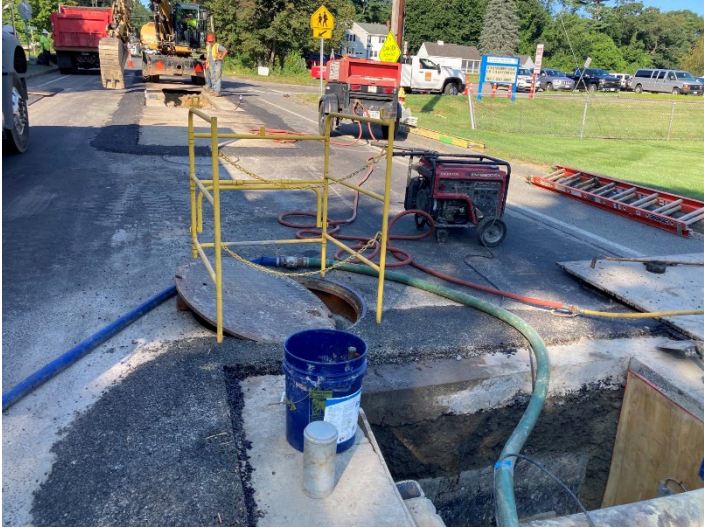
PHOTOGRAPHIC LOG		
Client Name: Eversource		Site Location: Sudbury to Hudson Transmission Reliability Project		Town: Hudson
Photo No.: 1	Date: 8/02/2023

Description: View of work area and dewatering operation at MH #3 on Forest Ave in Hudson. Facing south.

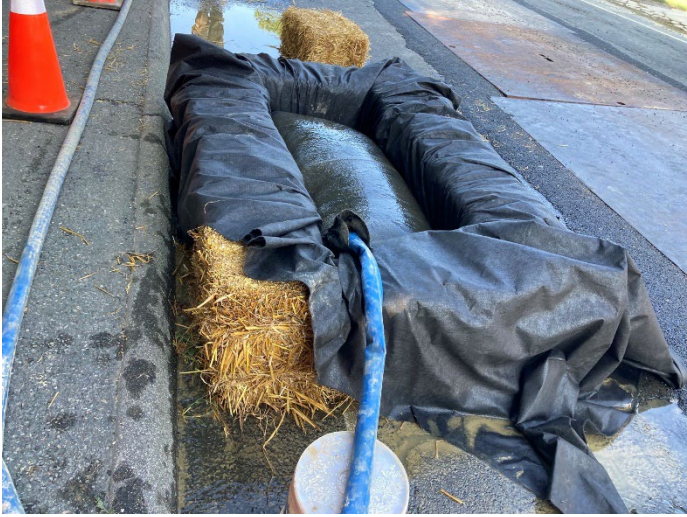
PHOTOGRAPHIC LOG		
Client Name: Eversource		Site Location: Sudbury to Hudson Transmission Reliability Project		Town: Hudson
Photo No.: 3	Date: 8/02/2023

Description: View of dewatering controls (straw bale corral with filter fabric and silt bag). Facing south.

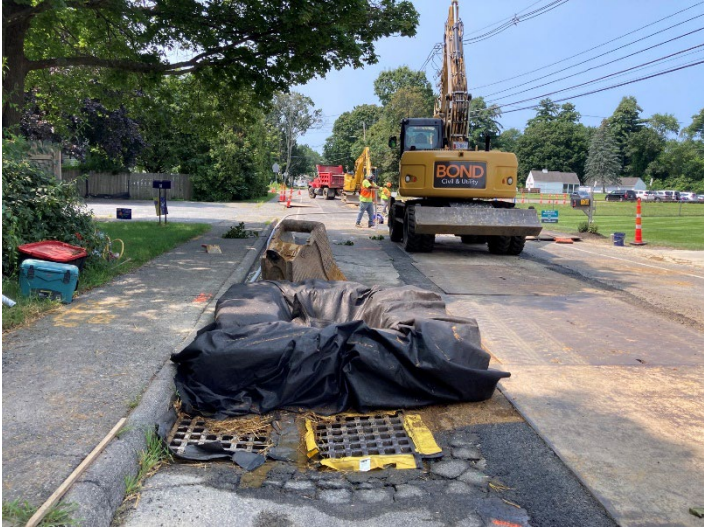
PHOTOGRAPHIC LOG		
Client Name: Eversource		Site Location: Sudbury to Hudson Transmission Reliability Project		Town: Hudson
Photo No.: 1	Date: 8/03/2023

Description: View of work area and dewatering operation at MH #3 on Forest Ave in Hudson. Facing south.

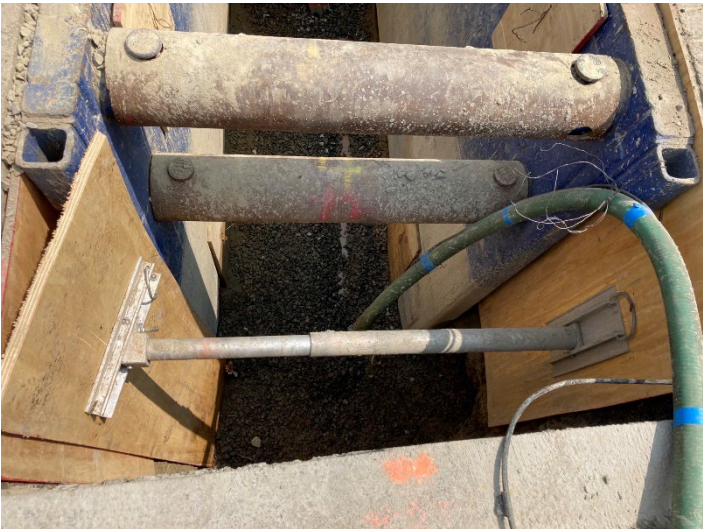
PHOTOGRAPHIC LOG		
Client Name: Eversource		Site Location: Sudbury to Hudson Transmission Reliability Project		Town: Hudson
Photo No.: 2	Date: 8/03/2023

Description: View of trench. Unable to visualize water prior to treatment.

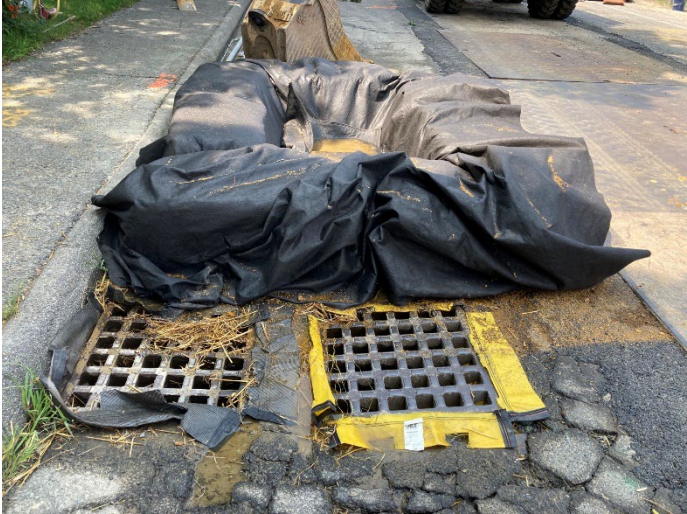
PHOTOGRAPHIC LOG	
Client Name: Eversource		Site Location: Sudbury to Hudson Transmission Reliability Project	Town: Hudson
Photo No.: 3	Date: 8/03/2023

Description: View of dewatering controls (straw bale corral with filter fabric and silt bag) and discharge point from project (catch basins below hay bale corral on Forest Ave). Facing south.

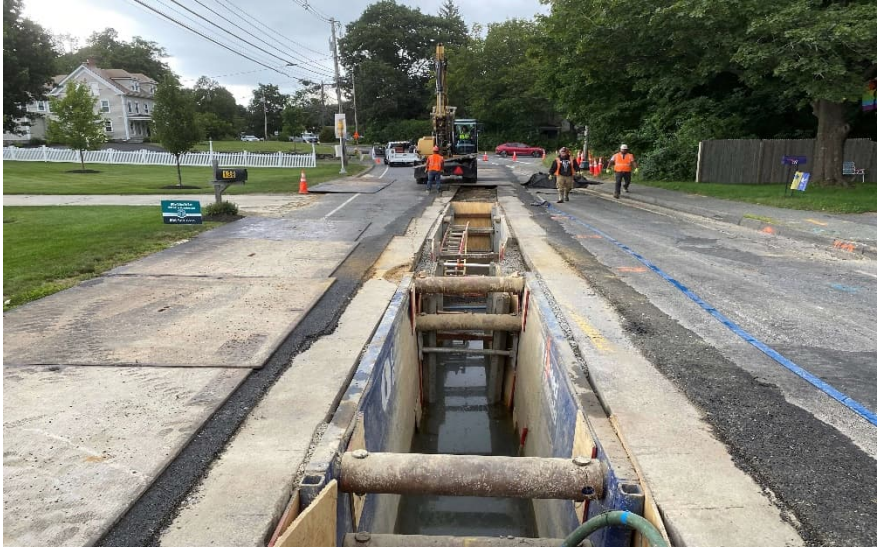
<h2 style="margin: 0;">PHOTOGRAPHIC LOG</h2>	
Client Name: Eversource		Site Location: Sudbury to Hudson Transmission Reliability Project	Town: Hudson
Photo No.: 1	Date: 8/4/2023

Description: View of area being pumped at Forest Avenue (water in trench), bale/corral in background (upper right), looking northward.

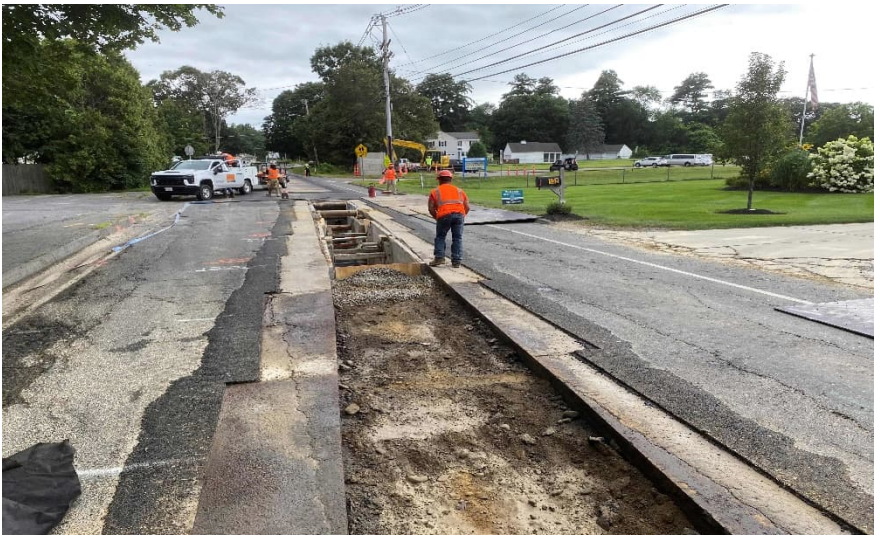
<h2 style="margin: 0;">PHOTOGRAPHIC LOG</h2>	
Client Name: Eversource		Site Location: Sudbury to Hudson Transmission Reliability Project	Town: Hudson
Photo No.: 2	Date: 8/4/2023

Description: Forest Avenue. View of dewatering operation (pumping at far end of trench), looking southward.
