Weekly Environmental Compliance Summary

Sudbury to Hudson Transmission Reliability Project (USEPA Tracking # MAR1003UW)

Week of: August 7 to August 11, 2023

CONSTRUCTION MONITORING REPORT

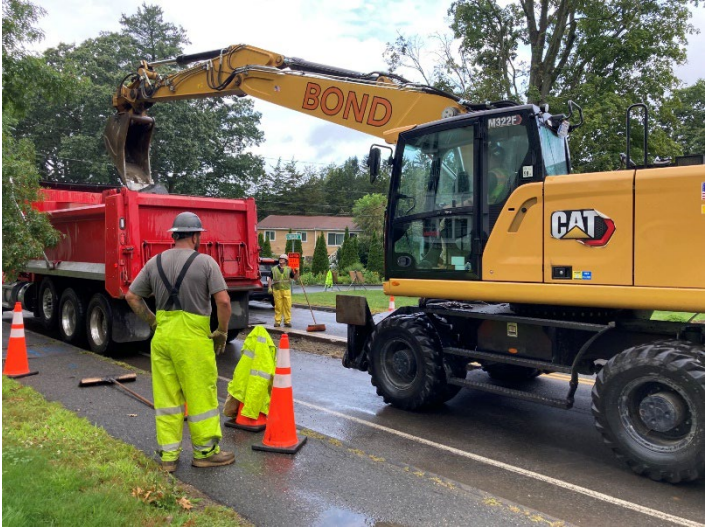
PHOTOGRAPHIC LOG	
Client Name: Eversource		Site Location: Sudbury to Hudson Transmission Reliability Project	Town: Hudson
Photo No.: 1	Date: 8/08/2023

Description: View of Bond working east of MH #2 on Forest Ave. Facing west.

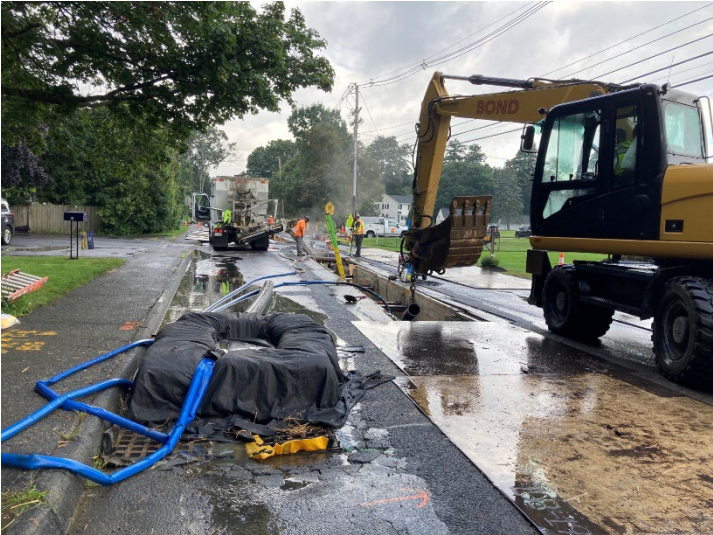
PHOTOGRAPHIC LOG	
Client Name: Eversource		Site Location: Sudbury to Hudson Transmission Reliability Project	Town: Hudson
Photo No.: 2	Date: 8/08/2023

Description: View of Bond crew #2 installing ductbank between MH#3 and MH#4 on Forest Ave. See additional dewatering inspection report. Facing south.

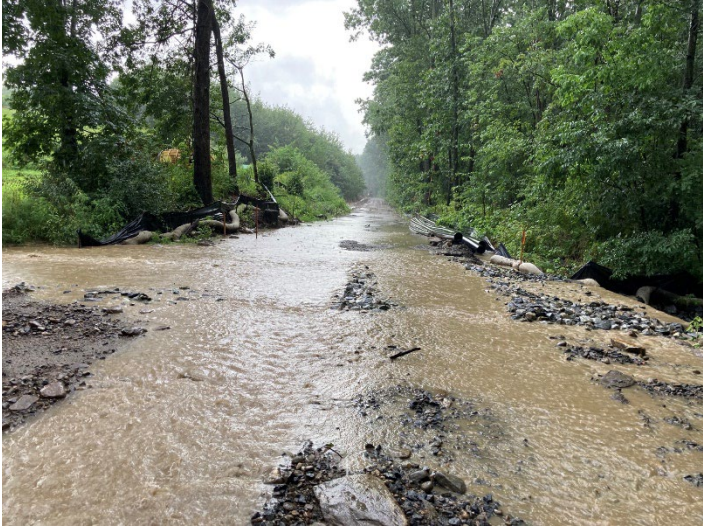
PHOTOGRAPHIC LOG	
Client Name: Eversource		Site Location: Sudbury to Hudson Transmission Reliability Project	Town: Stow
Photo No.: 4	Date: 8/08/2023

Description: View of stormwater flow at drainage structures #5-6 in segment 1. Facing west.

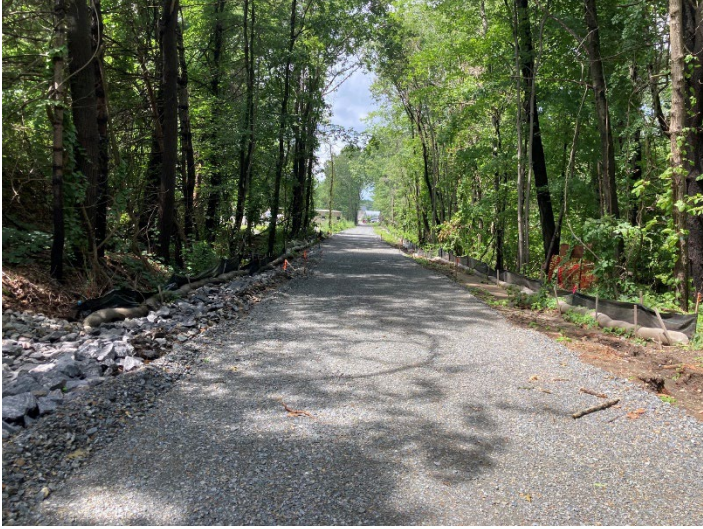
PHOTOGRAPHIC LOG	
Client Name: Eversource		Site Location: Sudbury to Hudson Transmission Reliability Project	Town: Hudson
Photo No.: 5	Date: 8/08/2023

Description: View of east end of segment 3. Facing west.

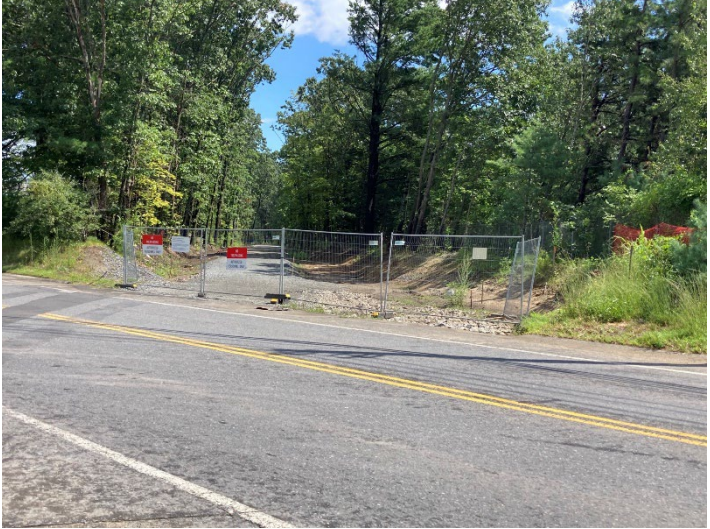
PHOTOGRAPHIC LOG	
Client Name: Eversource		Site Location: Sudbury to Hudson Transmission Reliability Project	Town: Hudson
Photo No.: 6	Date: 8/08/2023

Description: View of construction entrance to segment 4 at Main St. Facing east.

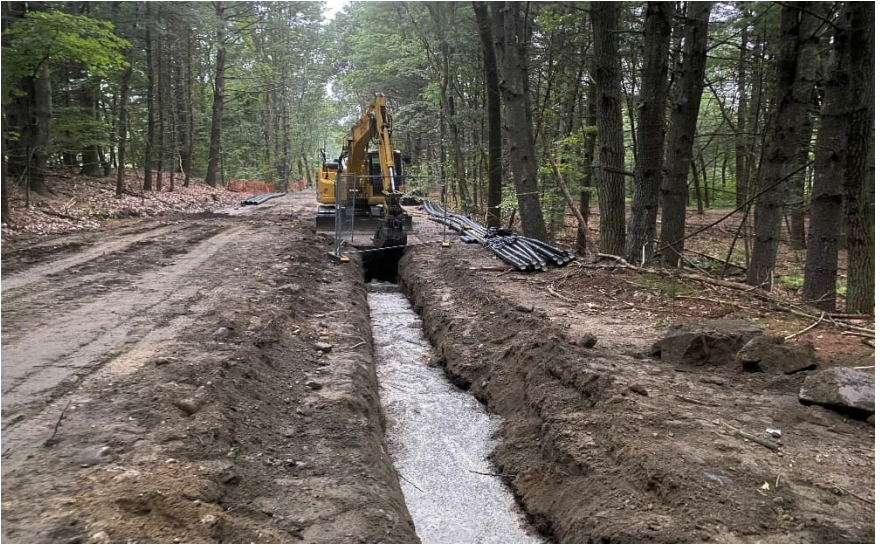
PHOTOGRAPHIC LOG	
Client Name: Eversource		Site Location: Sudbury to Hudson Transmission Reliability Project	Town: Sudbury
Photo No.: 1	Date: 8-8-23

Description: Work area within segment 8, conduit work, looking westward.

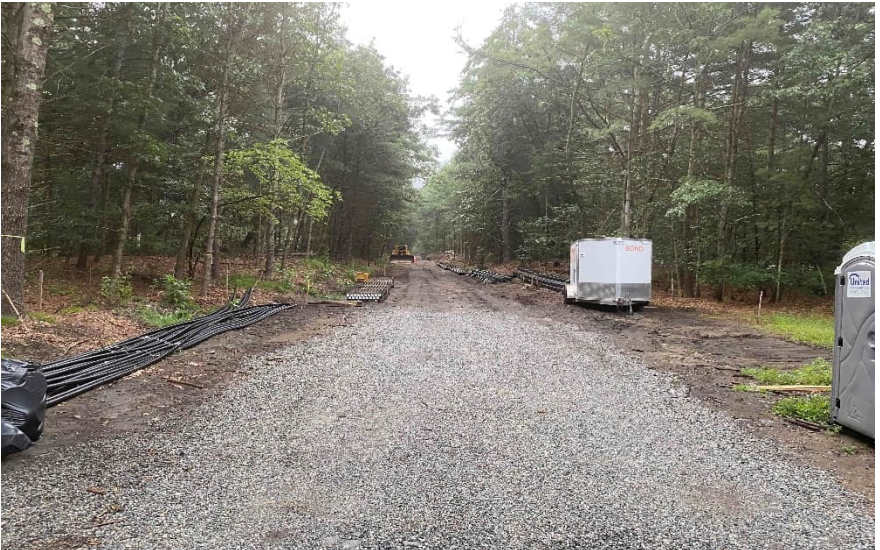
PHOTOGRAPHIC LOG	
Client Name: Eversource		Site Location: Sudbury to Hudson Transmission Reliability Project	Town: Sudbury
Photo No.: 2	Date: 8-8-23

Description: Work area within segment 9, looking eastward.

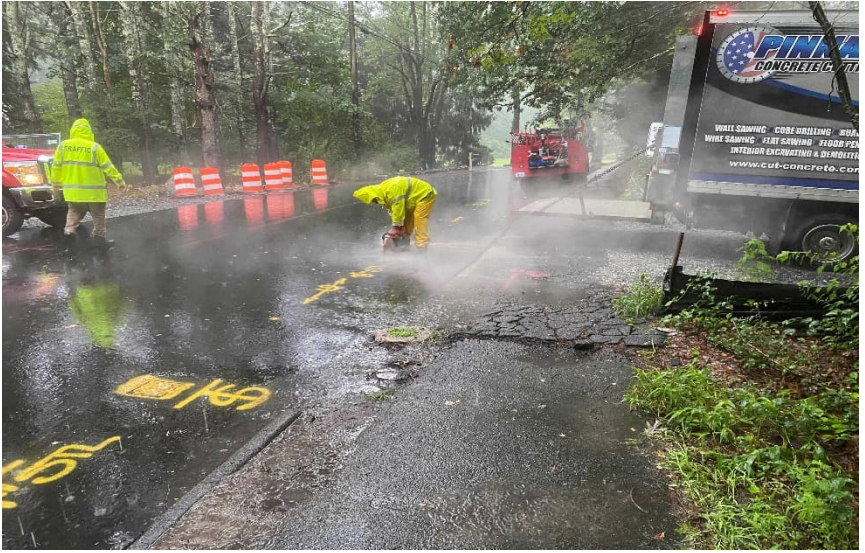
PHOTOGRAPHIC LOG	
Client Name: Eversource		Site Location: Sudbury to Hudson Transmission Reliability Project	Town: Sudbury
Photo No.: 3	Date: 8-8-23

Description: Work area within Peakham Road, test pitting for water line (thought to be on west side of road), looking southward.

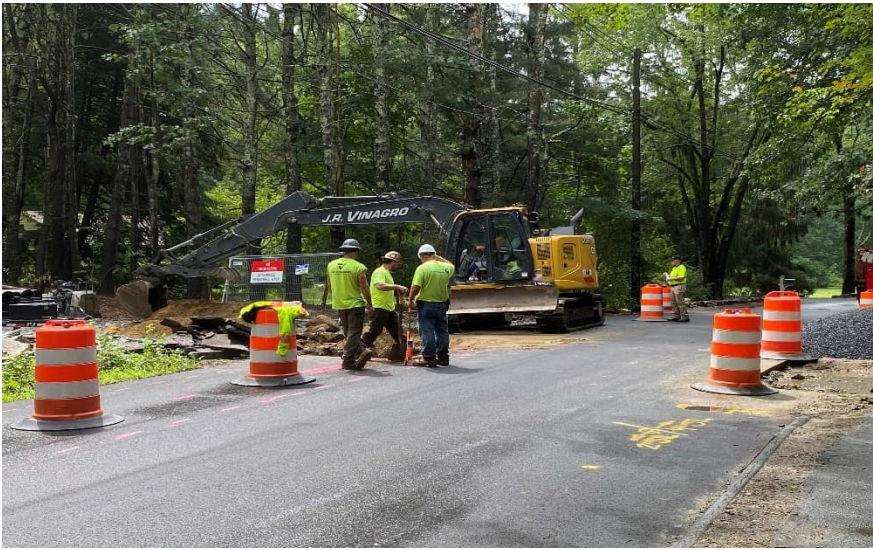
PHOTOGRAPHIC LOG	
Client Name: Eversource		Site Location: Sudbury to Hudson Transmission Reliability Project	Town: Sudbury
Photo No.: 4	Date: 8-8-23

Description: Work area within Peakham Road, backfilling of exposed water line (east side of road), looking southward.

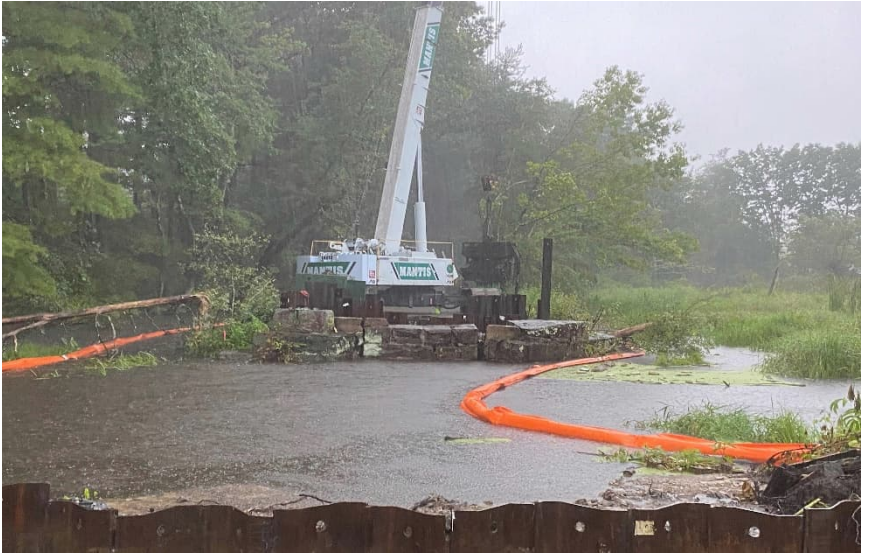
PHOTOGRAPHIC LOG	
Client Name: Eversource		Site Location: Sudbury to Hudson Transmission Reliability Project	Town: Sudbury
Photo No.: 7	Date: 8-8-23

Description: Work area within segment 13, bridge 127 work, existing erosion control, looking westward.

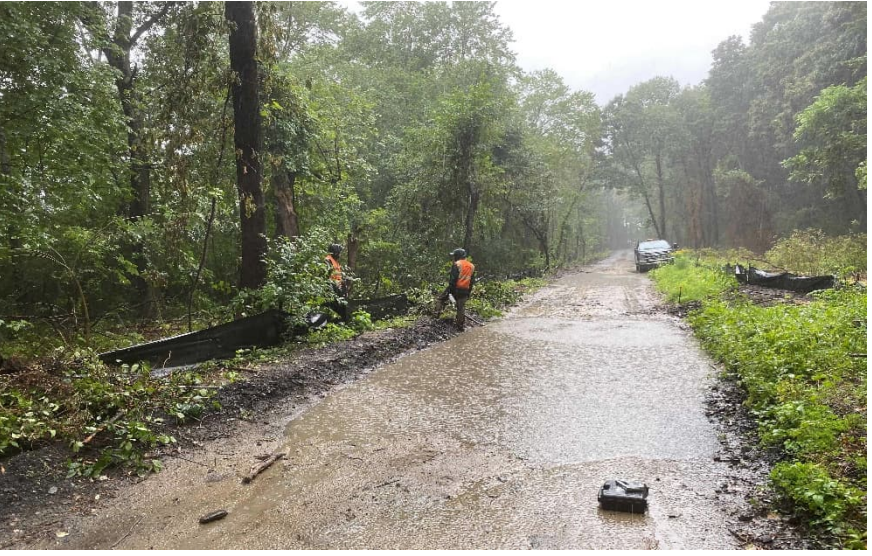
PHOTOGRAPHIC LOG	
Client Name: Eversource		Site Location: Sudbury to Hudson Transmission Reliability Project	Town: Sudbury
Photo No.: 8	Date: 8-8-23

Description: Work area within segment 14, invasive species removal, existing erosion control, looking westward.

Erosion control (silt fencing) within segment 14 previously disturbed as a result of heavy rain event repaired today.

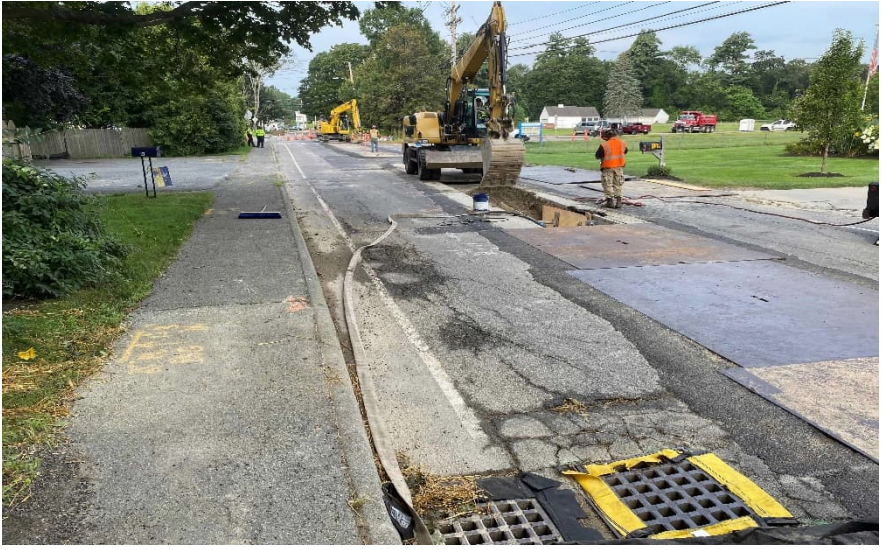
<p>PHOTOGRAPHIC LOG</p>	
<p>Client Name: Eversource</p>		<p>Site Location: Sudbury to Hudson Transmission Reliability Project</p>	<p>Town: Hudson</p>
<p>Photo No.: 1</p>	<p>Date: 8-10-23</p>

<p>Description:</p> <p>Work area within Forest Avenue, conduit work near manhole #3, looking northward.</p>

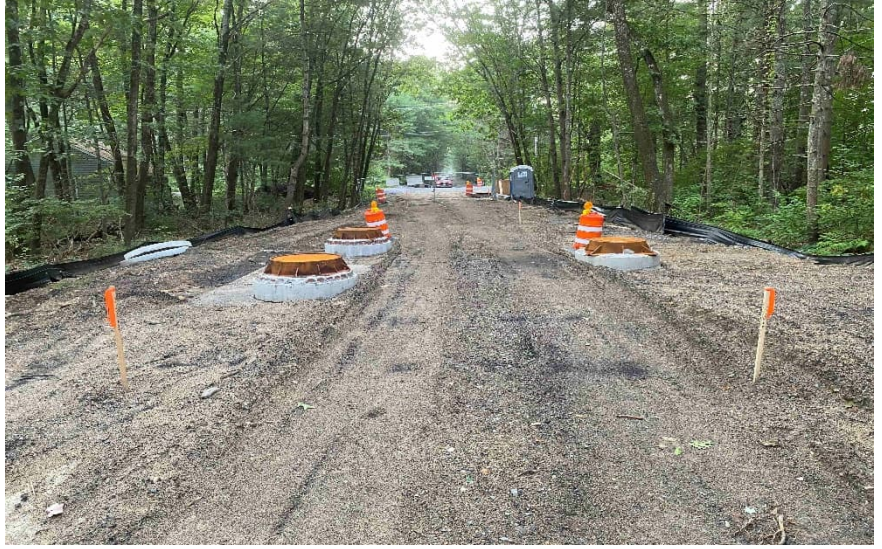
<p>PHOTOGRAPHIC LOG</p>	
<p>Client Name: Eversource</p>		<p>Site Location: Sudbury to Hudson Transmission Reliability Project</p>	<p>Town: Hudson</p>
<p>Photo No.: 2</p>	<p>Date: 8-10-23</p>

<p>Description:</p> <p>Work area within Segment 5 near manhole #11, looking westward.</p>

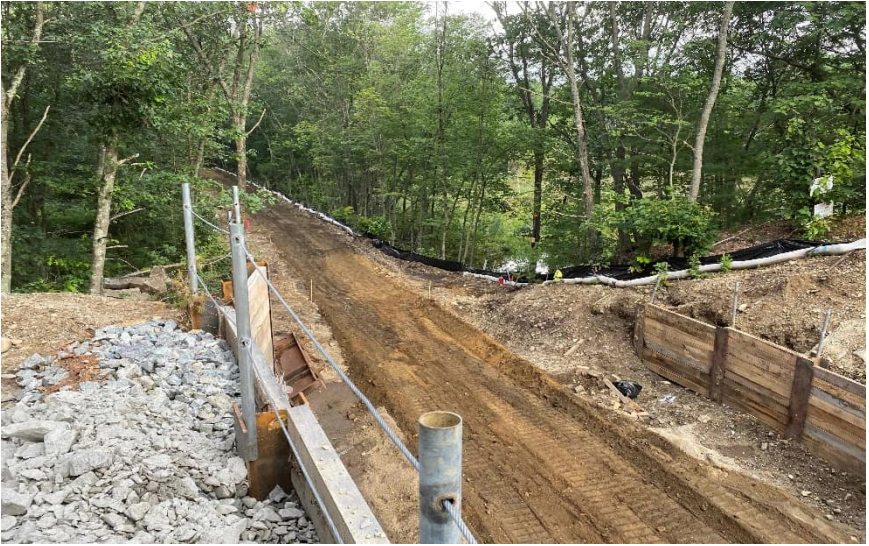
<p>PHOTOGRAPHIC LOG</p>	
<p>Client Name: Eversource</p>		<p>Site Location: Sudbury to Hudson Transmission Reliability Project</p>	<p>Town: Hudson</p>
<p>Photo No.: 3</p>	<p>Date: 8-10-23</p>

<p>Description:</p> <p>Work area within segment 1, Chestnut Street crossing, existing erosion control, looking westward.</p>

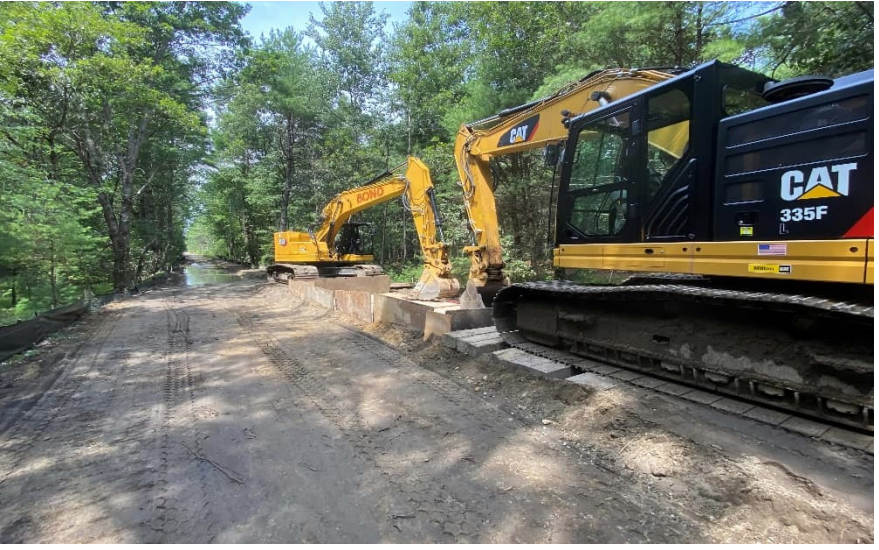
<p>PHOTOGRAPHIC LOG</p>	
<p>Client Name: Eversource</p>		<p>Site Location: Sudbury to Hudson Transmission Reliability Project</p>	<p>Town: Sudbury</p>
<p>Photo No.: 5</p>	<p>Date: 8-10-23</p>

<p>Description:</p> <p>Work area within segment 7, manhole 15, looking westward.</p>

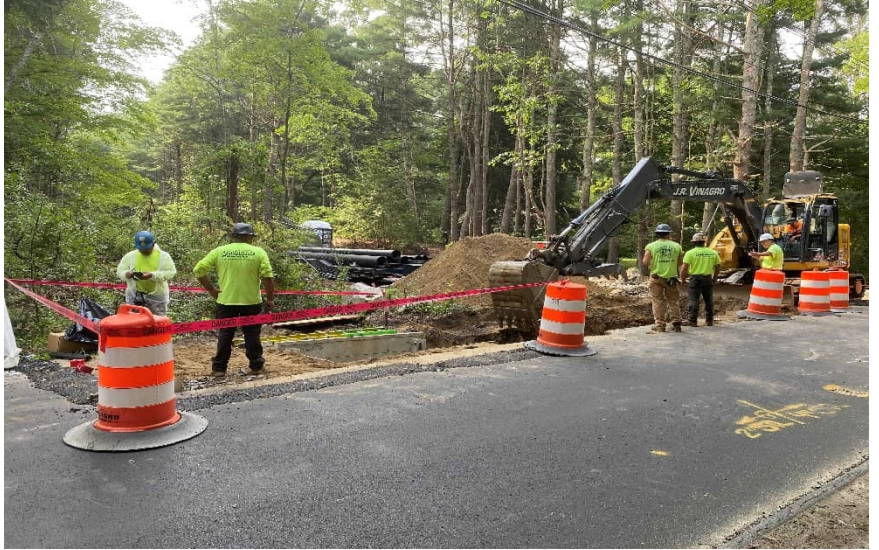
<p>PHOTOGRAPHIC LOG</p>	
<p>Client Name: Eversource</p>		<p>Site Location: Sudbury to Hudson Transmission Reliability Project</p>	<p>Town: Sudbury</p>
<p>Photo No.: 6</p>	<p>Date: 8-10-23</p>

<p>Description:</p> <p>Water line replacement within Peakham Road, looking eastward.</p>

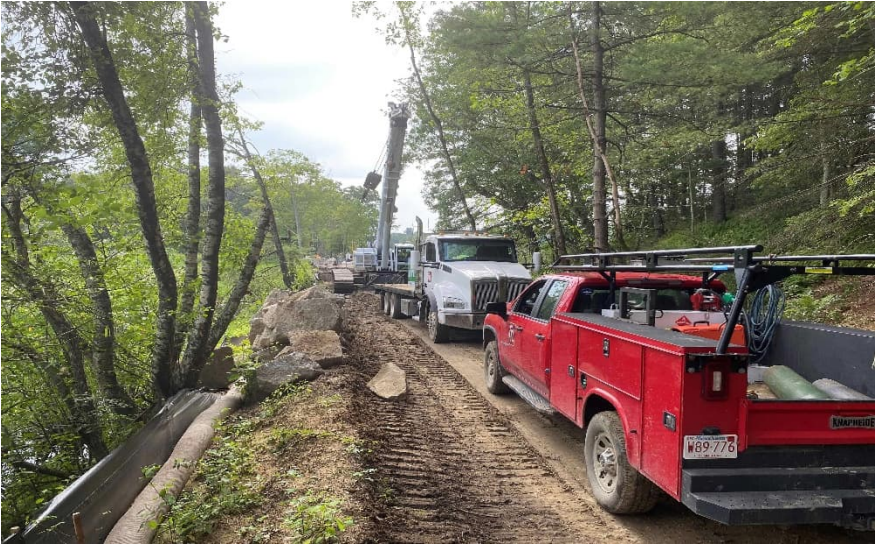
<p>PHOTOGRAPHIC LOG</p>	
<p>Client Name: Eversource</p>		<p>Site Location: Sudbury to Hudson Transmission Reliability Project</p>	<p>Town: Sudbury</p>
<p>Photo No.: 7</p>	<p>Date: 8-10-23</p>

<p>Description:</p> <p>Work area within Segment 13, near Bridge 127, looking eastward.</p>

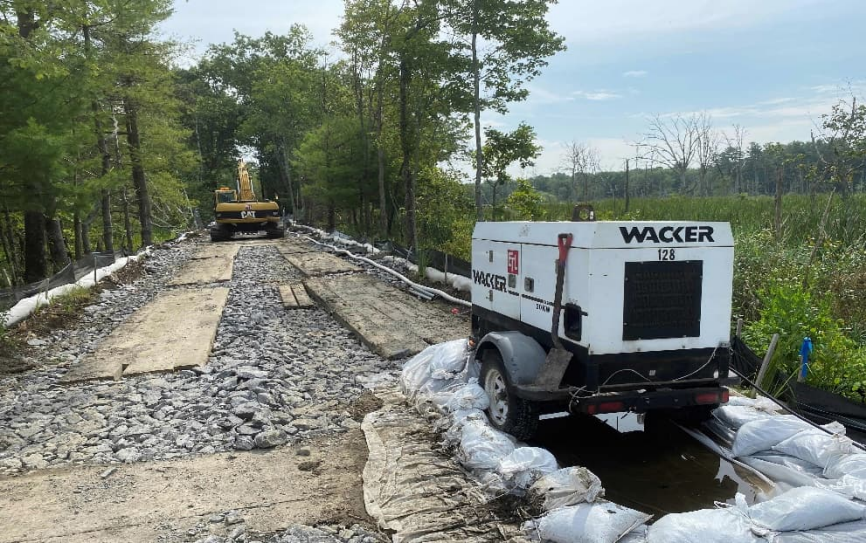
<p>PHOTOGRAPHIC LOG</p>	
<p>Client Name: Eversource</p>		<p>Site Location: Sudbury to Hudson Transmission Reliability Project</p>	<p>Town: Sudbury</p>
<p>Photo No.: 8</p>	<p>Date: 8-10-23</p>

<p>Description:</p> <p>Work area within segment 14, dewatering work near bridge 127, looking eastward.</p>

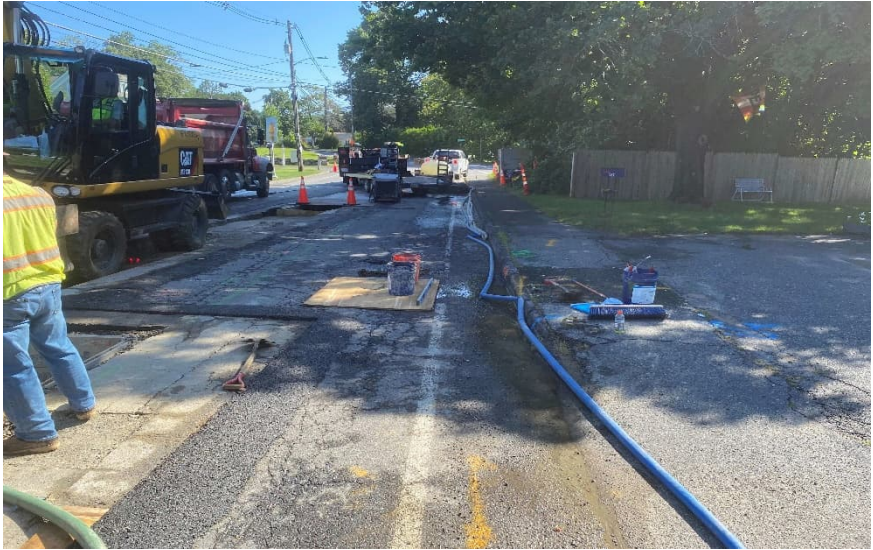
<p>PHOTOGRAPHIC LOG</p>	
<p>Client Name: Eversource</p>		<p>Site Location: Sudbury to Hudson Transmission Reliability Project</p>	<p>Town: Hudson</p>
<p>Photo No.: 1</p>	<p>Date: 8-11-23</p>

<p>Description:</p> <p>Work area within Forest Avenue, conduit work north of manhole #3, looking northward.</p>

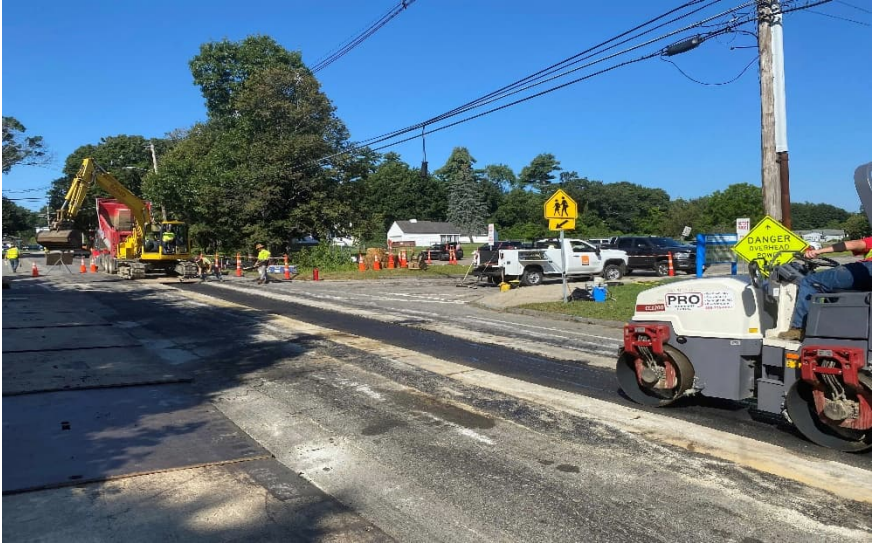
<p>PHOTOGRAPHIC LOG</p>	
<p>Client Name: Eversource</p>		<p>Site Location: Sudbury to Hudson Transmission Reliability Project</p>	<p>Town: Hudson</p>
<p>Photo No.: 2</p>	<p>Date: 8-11-23</p>

<p>Description:</p> <p>Work area within Forest Avenue, conduit work south of manhole #3, looking southward.</p>

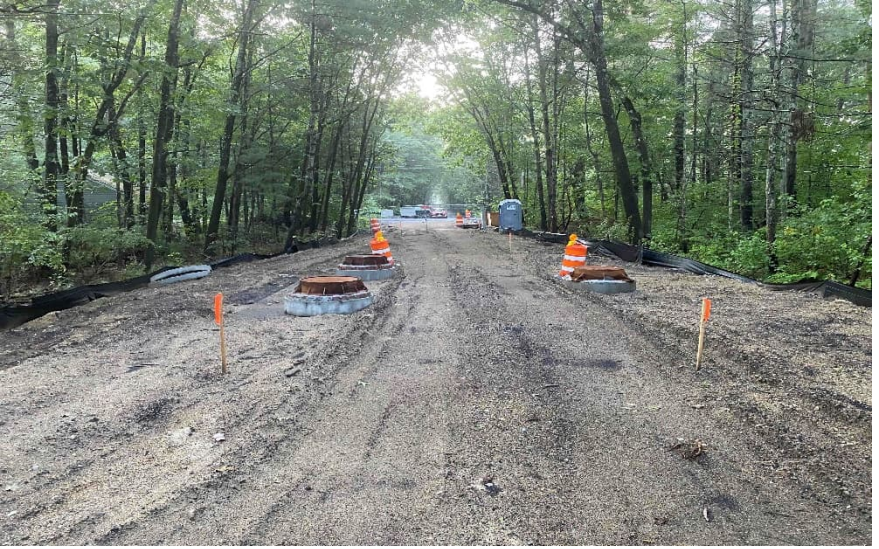
<p>PHOTOGRAPHIC LOG</p>	
<p>Client Name: Eversource</p>		<p>Site Location: Sudbury to Hudson Transmission Reliability Project</p>	<p>Town: Hudson</p>
<p>Photo No.: 4</p>	<p>Date: 8-11-23</p>

<p>Description:</p> <p>Work area within segment 5, manhole #11, existing erosion control, looking eastward.</p>

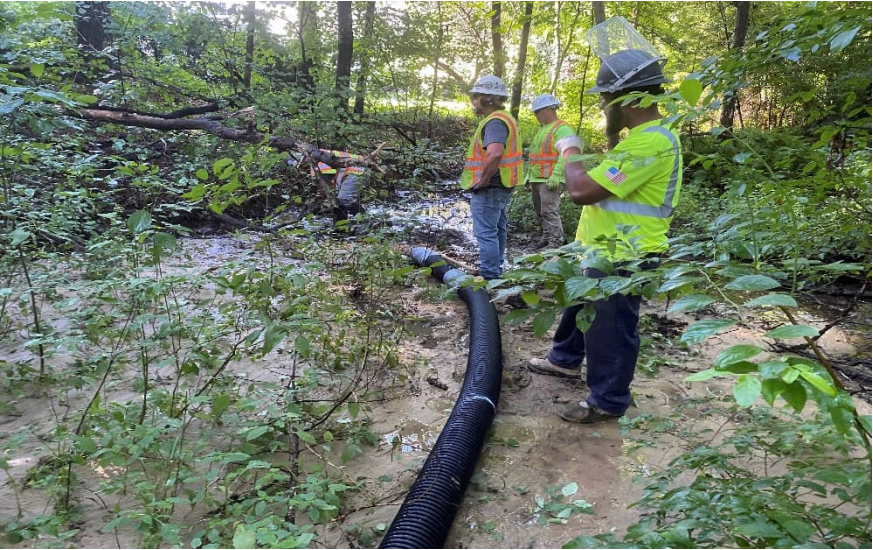
<p align="center">PHOTOGRAPHIC LOG</p>	
<p>Client Name: Eversource</p>		<p>Site Location: Sudbury to Hudson Transmission Reliability Project</p>	<p>Town: Sudbury</p>
<p>Photo No.: 5</p>	<p>Date: 8-11-23</p>

<p>Description: Wetland off segment 9, cleanup work by Bond, looking southward.</p>

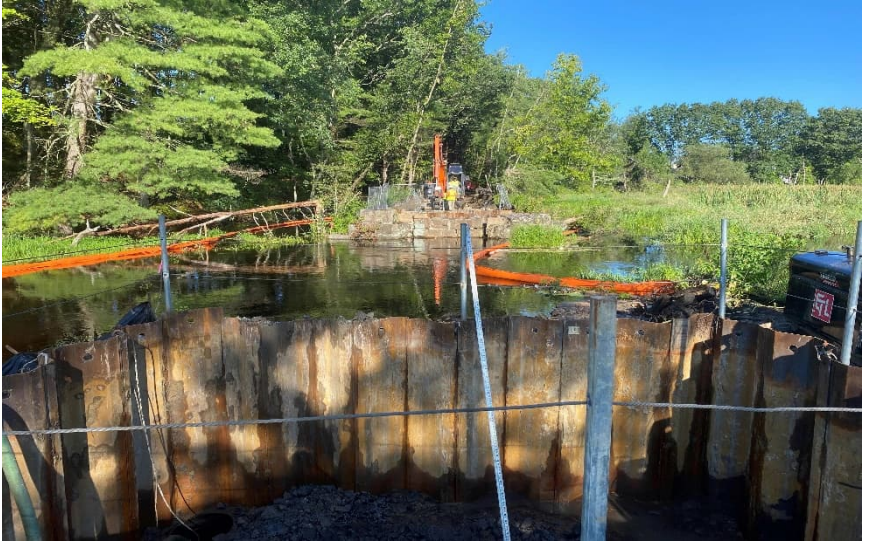
<p>PHOTOGRAPHIC LOG</p>	
<p>Client Name: Eversource</p>		<p>Site Location: Sudbury to Hudson Transmission Reliability Project</p>	<p>Town: Sudbury</p>
<p>Photo No.: 8</p>	<p>Date: 8-11-23</p>

<p>Description: Work area within segment 14, work near bridge 127, looking westward.</p>

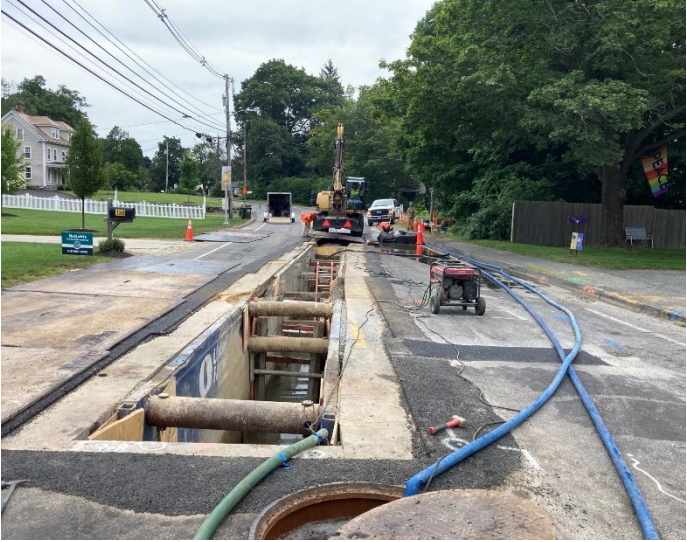
PHOTOGRAPHIC LOG	
Client Name: Eversource		Site Location: Sudbury to Hudson Transmission Reliability Project	Town: Hudson
Photo No.: 1	Date: 8-07-2023

Description: View of Bond crew #2 installing ductbank between MH#3 and MH#4 on Forest Ave. See additional dewatering inspection report. Facing north.

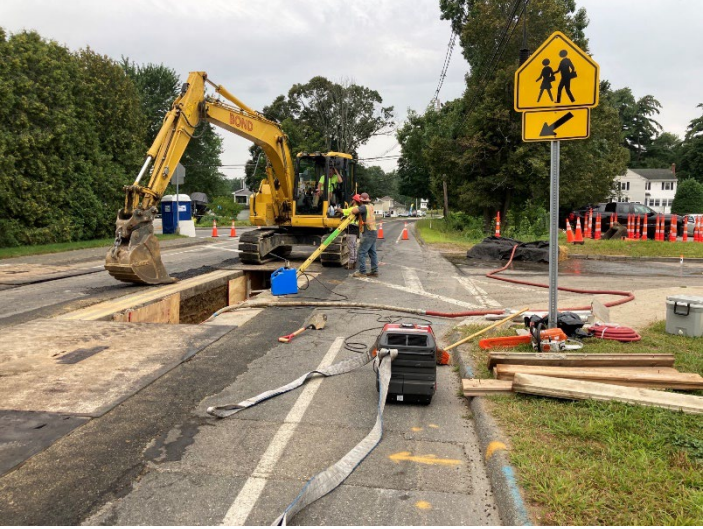
PHOTOGRAPHIC LOG	
Client Name: Eversource		Site Location: Sudbury to Hudson Transmission Reliability Project	Town: Hudson
Photo No.: 2	Date: 8-07-2023

Description: View of Bond crew #6 installing ductbank between MH#2 and MH#3 on Forest Ave. See additional dewatering inspection report. Facing south.

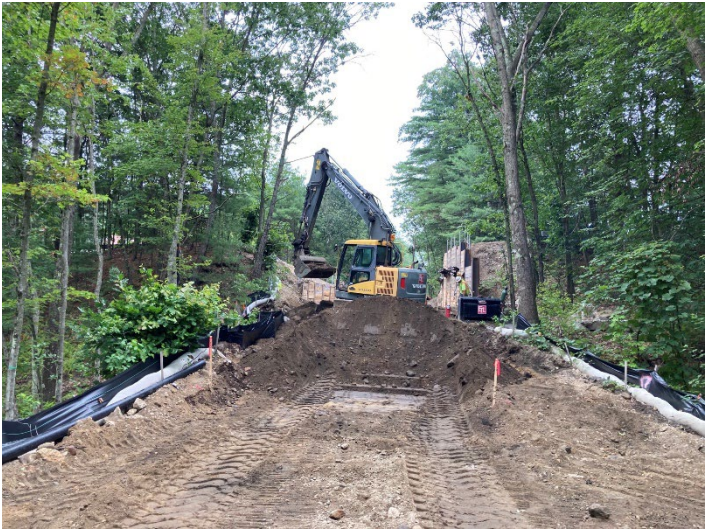
Epsilon ASSOCIATES INC.		PHOTOGRAPHIC LOG	
Client Name: Eversource		Site Location: Sudbury to Hudson Transmission Reliability Project	Town: Hudson
Photo No.: 4	Date: 8-07-2023

Description: View of ET&L grading in segment 1 near Chestnut St. Facing east.

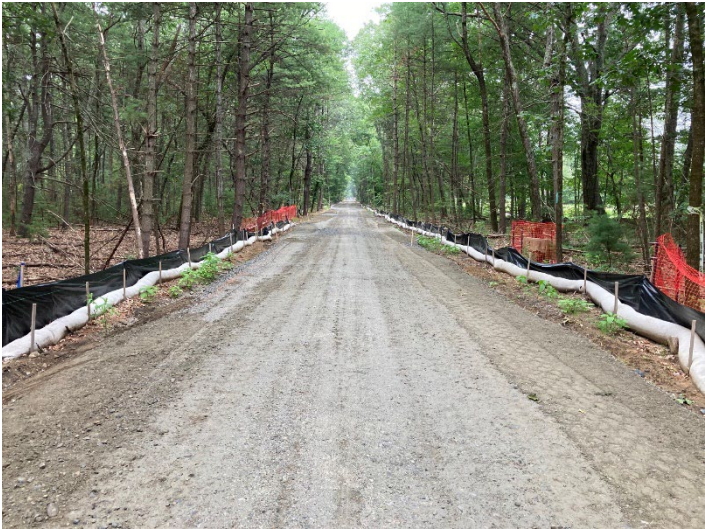
Epsilon ASSOCIATES INC.		PHOTOGRAPHIC LOG	
Client Name: Eversource		Site Location: Sudbury to Hudson Transmission Reliability Project	Town: Hudson
Photo No.: 7	Date: 8-07-2023

Description: View of Type A E&S controls in segment 4. Controls are operating properly. Facing west.

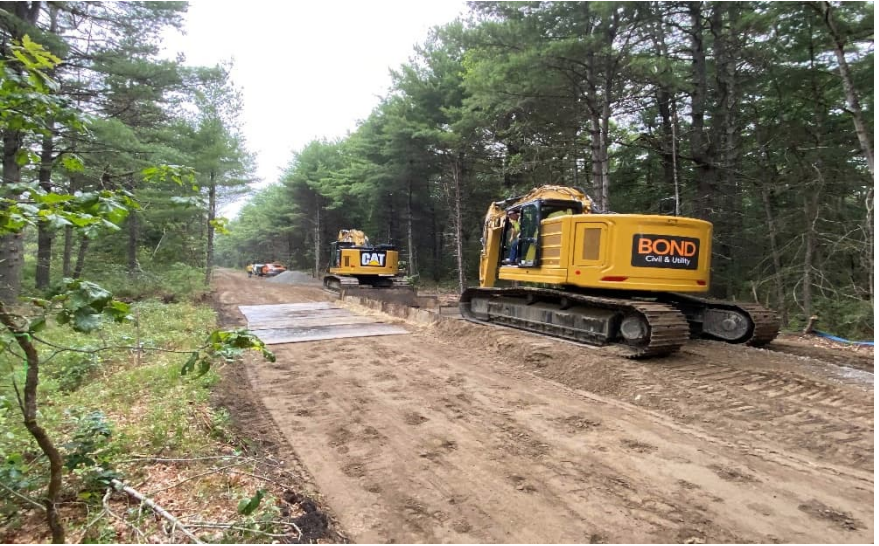
PHOTOGRAPHIC LOG	
Client Name: Eversource		Site Location: Sudbury to Hudson Transmission Reliability Project	Town: Sudbury
Photo No.: 1	Date: 8-7-23

Description: Work area within Segment 7, manhole #16 work, looking westward.

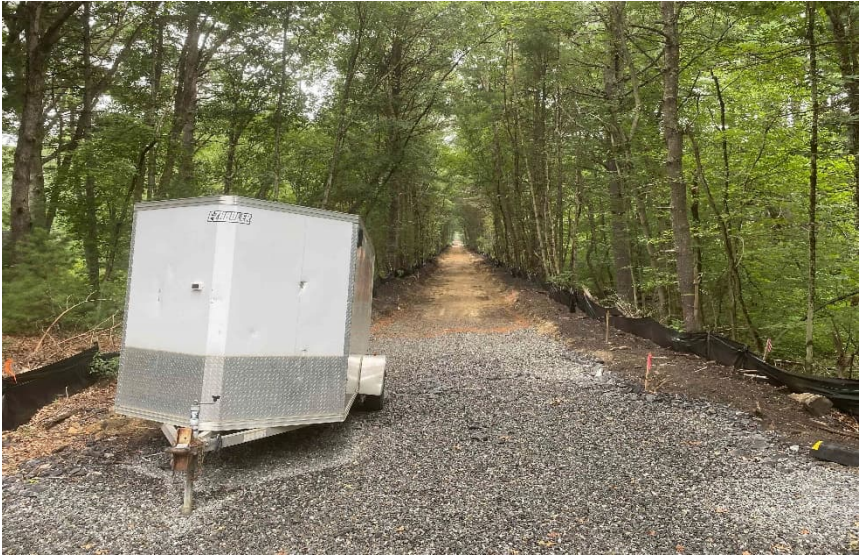
PHOTOGRAPHIC LOG	
Client Name: Eversource		Site Location: Sudbury to Hudson Transmission Reliability Project	Town: Sudbury
Photo No.: 3	Date: 8-7-23

Description: Work area within segment 9, existing erosion controls, looking westward.

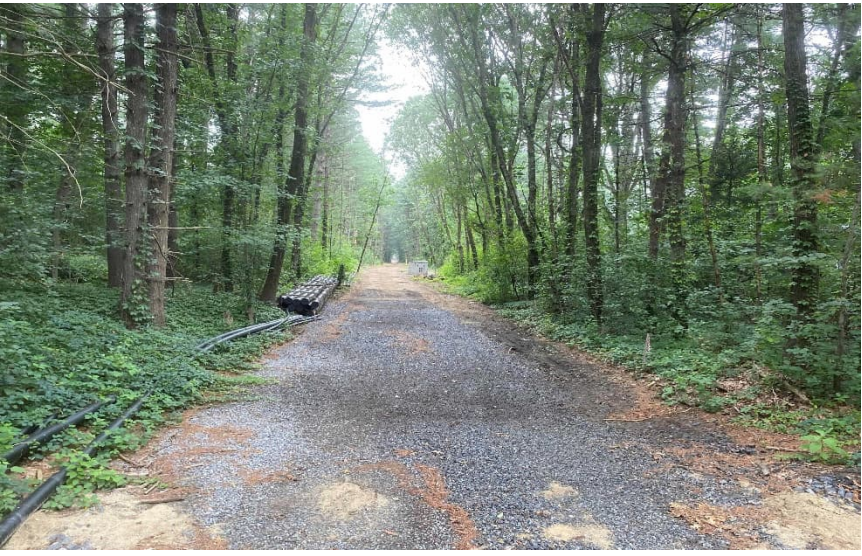
PHOTOGRAPHIC LOG	
Client Name: Eversource		Site Location: Sudbury to Hudson Transmission Reliability Project	Town: Sudbury
Photo No.: 4	Date: 8-7-23

Description: Work area within segment 10, existing erosion control, looking westward.

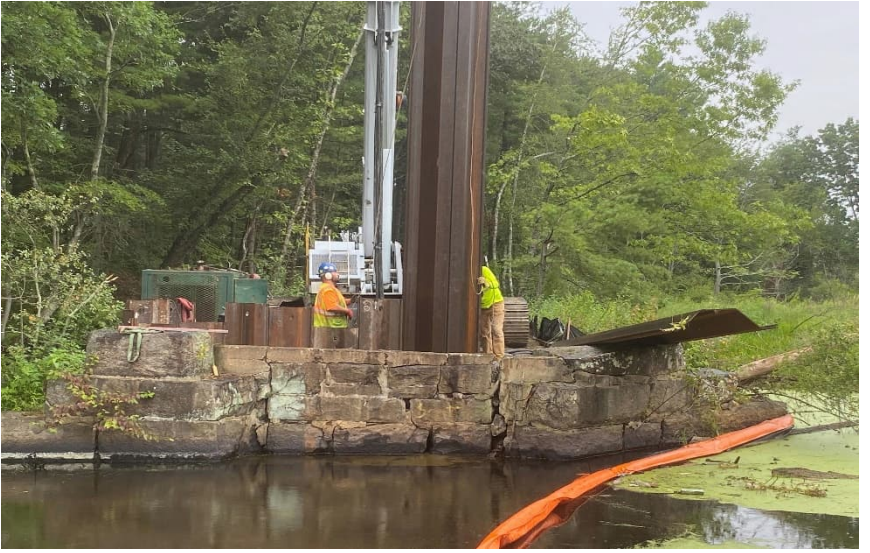
PHOTOGRAPHIC LOG	
Client Name: Eversource		Site Location: Sudbury to Hudson Transmission Reliability Project	Town: Sudbury
Photo No.: 7	Date: 8-7-23

Description: Bridge 127 sheeting placement within segment 13, looking westward.

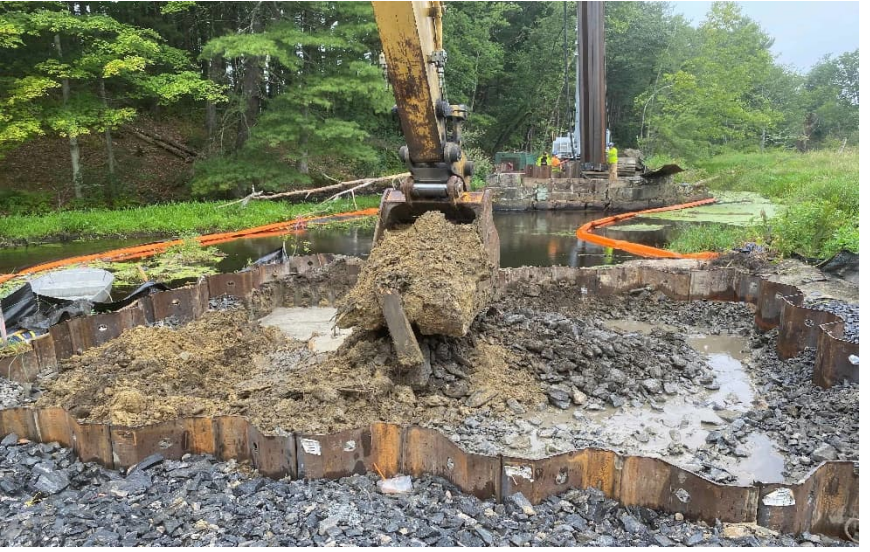
PHOTOGRAPHIC LOG	
Client Name: Eversource		Site Location: Sudbury to Hudson Transmission Reliability Project	Town: Sudbury
Photo No.: 8	Date: 8-7-23

Description: Work area at Bridge 127, excavation work for crane pad within segment 14, looking westward.

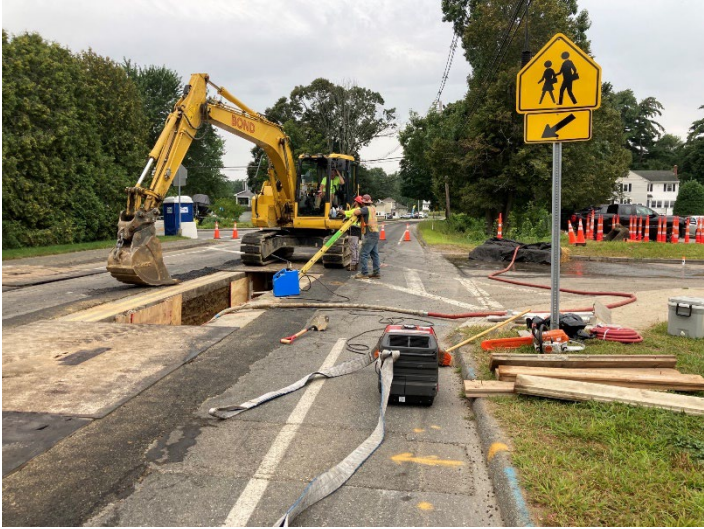
PHOTOGRAPHIC LOG		
Client Name: Eversource		Site Location: Sudbury to Hudson Transmission Reliability Project		Town: Hudson
Photo No.: 1	Date: 8/07/2023

Description: View of work area and dewatering operation at MH #3 south on Forest Ave in Hudson. Facing south.

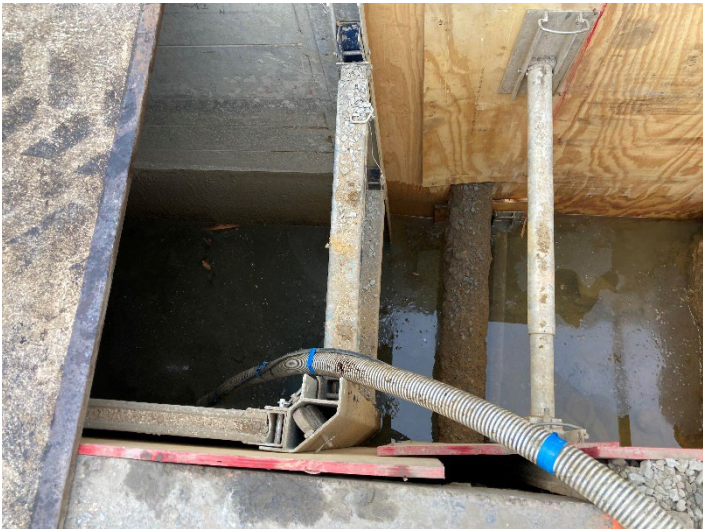
PHOTOGRAPHIC LOG		
Client Name: Eversource		Site Location: Sudbury to Hudson Transmission Reliability Project		Town: Hudson
Photo No.: 2	Date: 8/07/2023

Description: View of trench and water prior to treatment. Water appeared slightly turbid.

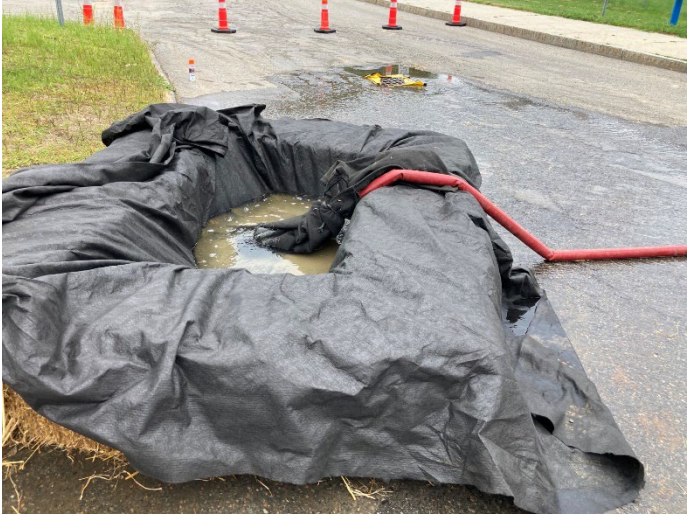
PHOTOGRAPHIC LOG		
Client Name: Eversource		Site Location: Sudbury to Hudson Transmission Reliability Project		Town: Hudson
Photo No.: 3	Date: 8/07/2023

Description: View of dewatering controls (straw bale corral with filter fabric and silt bag). Facing west.

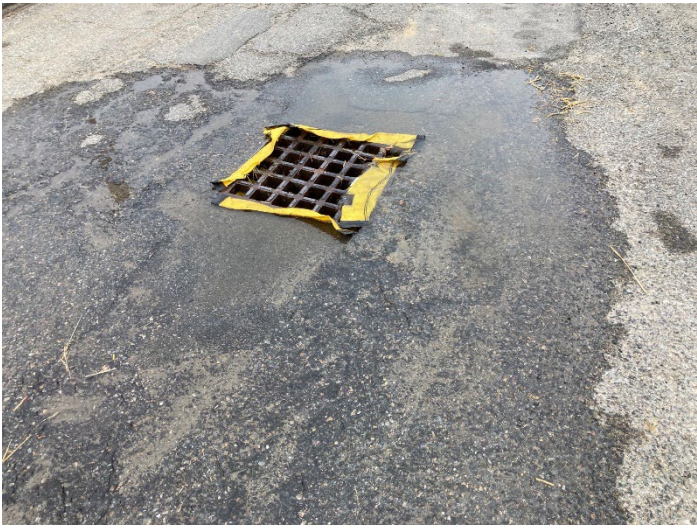
PHOTOGRAPHIC LOG		
Client Name: Eversource		Site Location: Sudbury to Hudson Transmission Reliability Project		Town: Hudson
Photo No.: 4	Date: 8/07/2023

Description: View of discharge point from project (catch basin below hay bale corral at intersection of Forest Ave and driveway to Forest Ave Elementary School). Discharge appeared clear. Turbidity reading was less than 50 NTUs. Facing west.

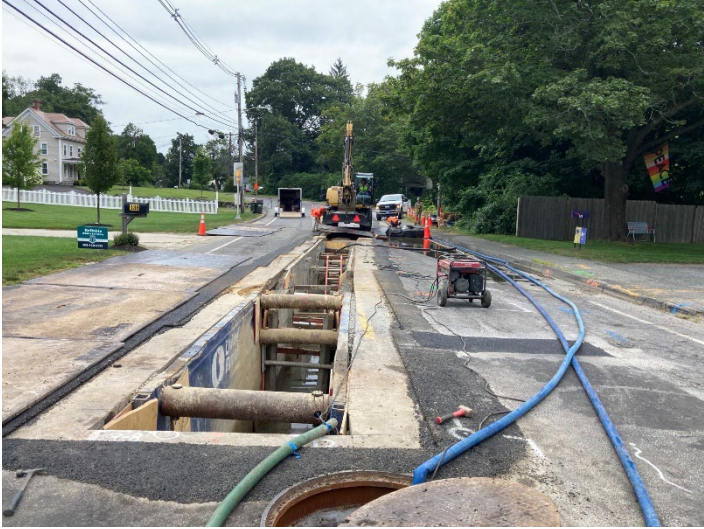
PHOTOGRAPHIC LOG		
Client Name: Eversource		Site Location: Sudbury to Hudson Transmission Reliability Project		Town: Hudson
Photo No.: 1	Date: 8/07/2023

Description: View of work area and dewatering operation at MH #3 north on Forest Ave in Hudson. Facing north.

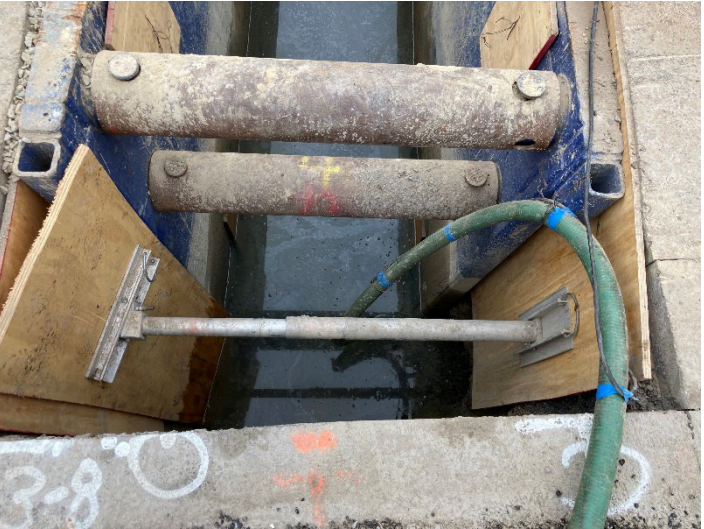
PHOTOGRAPHIC LOG		
Client Name: Eversource		Site Location: Sudbury to Hudson Transmission Reliability Project		Town: Hudson
Photo No.: 2	Date: 8/07/2023

Description: View of trench and water prior to treatment. Water appeared slightly turbid.

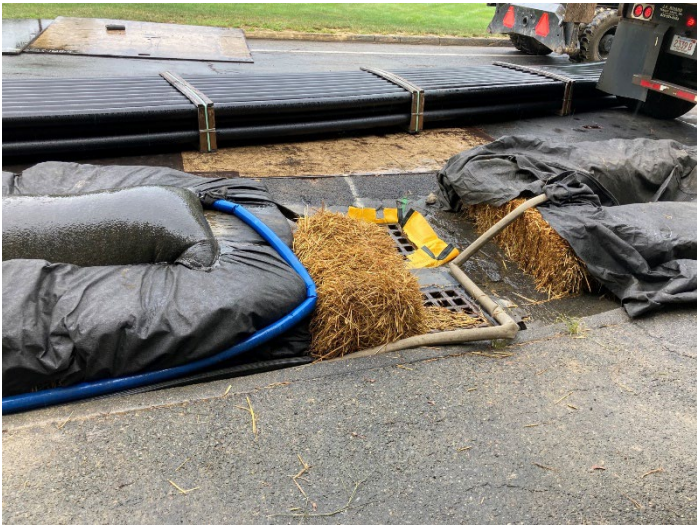
PHOTOGRAPHIC LOG		
Client Name: Eversource		Site Location: Sudbury to Hudson Transmission Reliability Project		Town: Hudson
Photo No.: 4	Date: 8/07/2023

Description: View of discharge point from project (catch basins below hay bale corrals on Forest Ave). Discharge appeared slightly turbid. Turbidity reading was higher than 50 NTUs. Facing east.

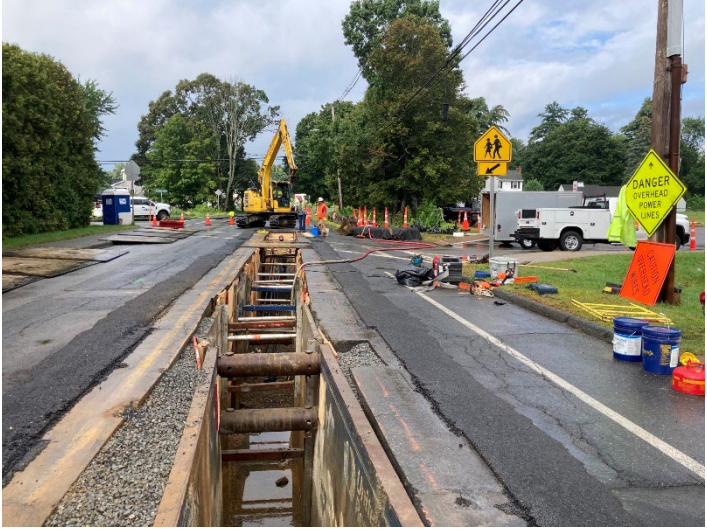
PHOTOGRAPHIC LOG	
Client Name: Eversource		Site Location: Sudbury to Hudson Transmission Reliability Project	Town: Hudson
Photo No.: 1	Date: 8/08/2023

Description: View of work area and dewatering operation at MH #3 south on Forest Ave in Hudson. Facing south.

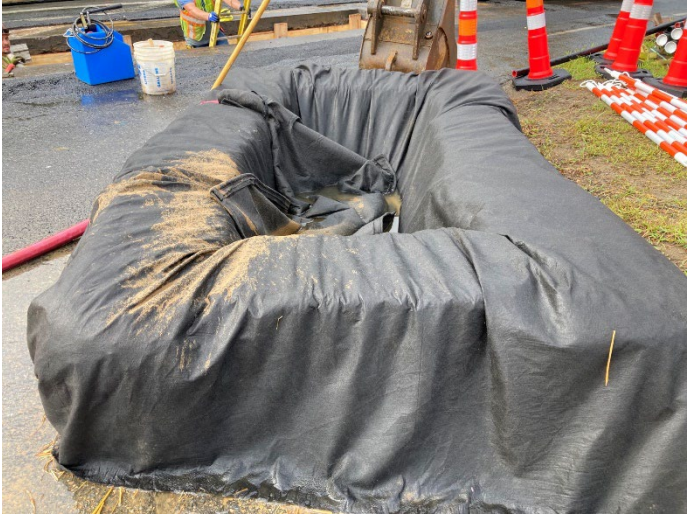
PHOTOGRAPHIC LOG		
Client Name: Eversource		Site Location: Sudbury to Hudson Transmission Reliability Project		Town: Hudson
Photo No.: 3	Date: 8/08/2023

Description: View of dewatering controls (straw bale corral with filter fabric and silt bag). Facing east.

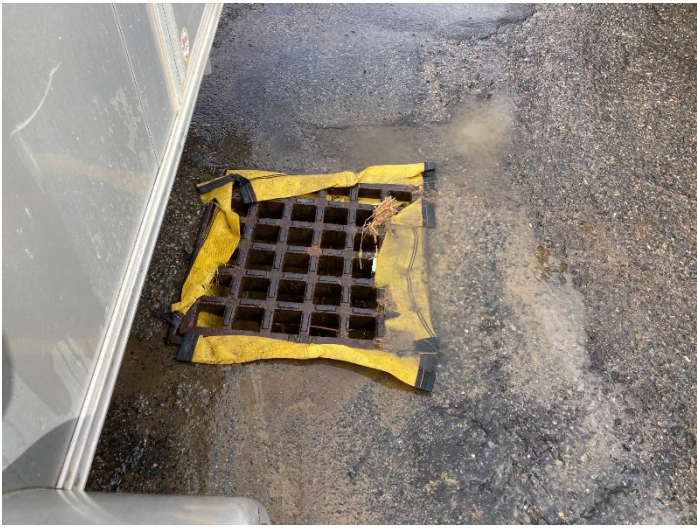
PHOTOGRAPHIC LOG		
Client Name: Eversource		Site Location: Sudbury to Hudson Transmission Reliability Project		Town: Hudson
Photo No.: 4	Date: 8/08/2023

Description: View of discharge point from project (catch basin below hay bale corral at intersection of Forest Ave and driveway to Forest Ave Elementary School). Discharge appeared slightly turbid. Turbidity reading was higher than 50 NTUs. Facing west.

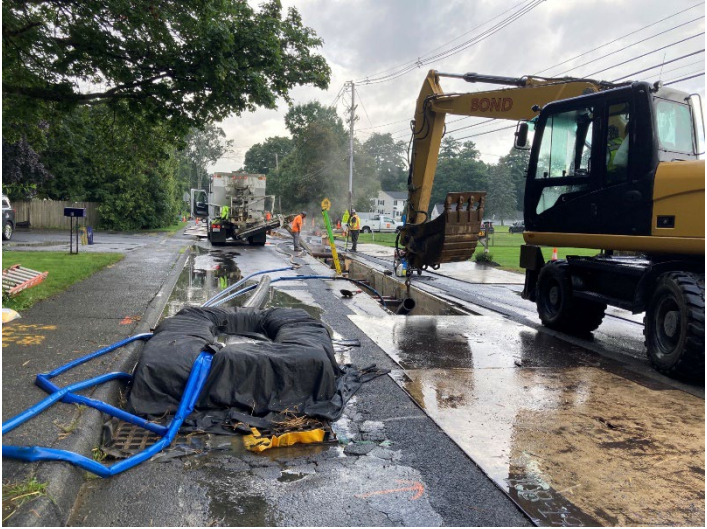
PHOTOGRAPHIC LOG		
Client Name: Eversource		Site Location: Sudbury to Hudson Transmission Reliability Project		Town: Hudson
Photo No.: 1	Date: 8/08/2023

Description: View of work area and dewatering operation at MH #3 north on Forest Ave in Hudson. Facing south.

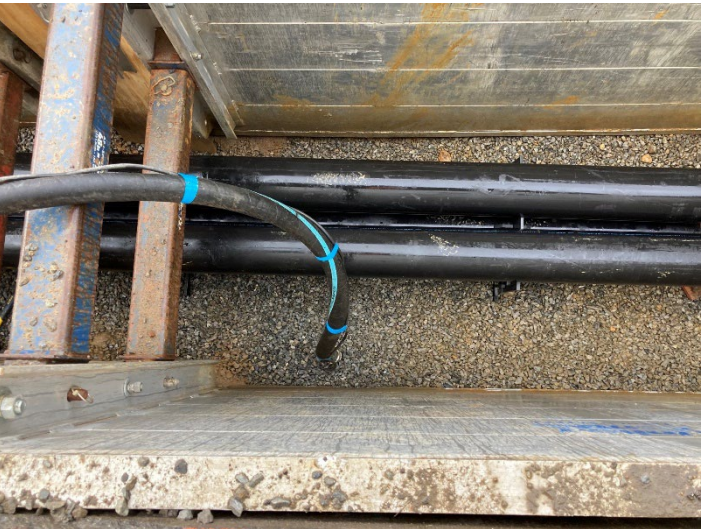
PHOTOGRAPHIC LOG		
Client Name: Eversource		Site Location: Sudbury to Hudson Transmission Reliability Project		Town: Hudson
Photo No.: 2	Date: 8/08/2023

Description: View of trench and water prior to treatment. Water appeared slightly turbid.

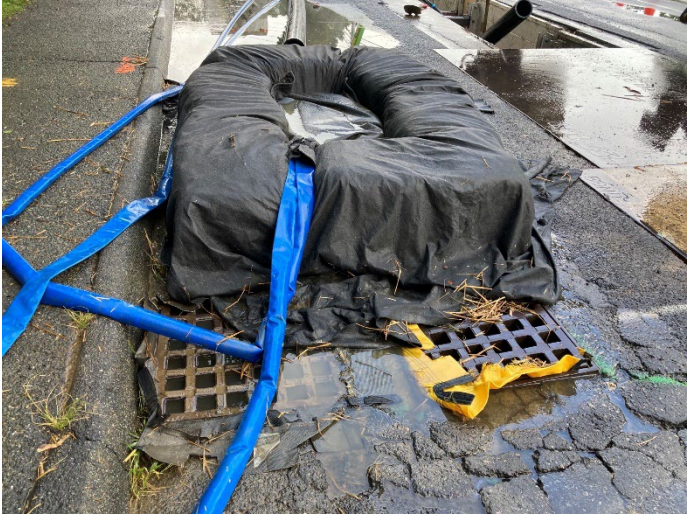
PHOTOGRAPHIC LOG		
Client Name: Eversource		Site Location: Sudbury to Hudson Transmission Reliability Project		Town: Hudson
Photo No.: 3	Date: 8/08/2023

Description: View of dewatering controls (straw bale corral with filter fabric and silt bag). Facing south.
