Weekly Environmental Compliance Summary

Sudbury to Hudson Transmission Reliability Project (USEPA Tracking # MAR1003UW)

Week of: August 7 to August 11, 2023

CONSTRUCTION MONITORING REPORT

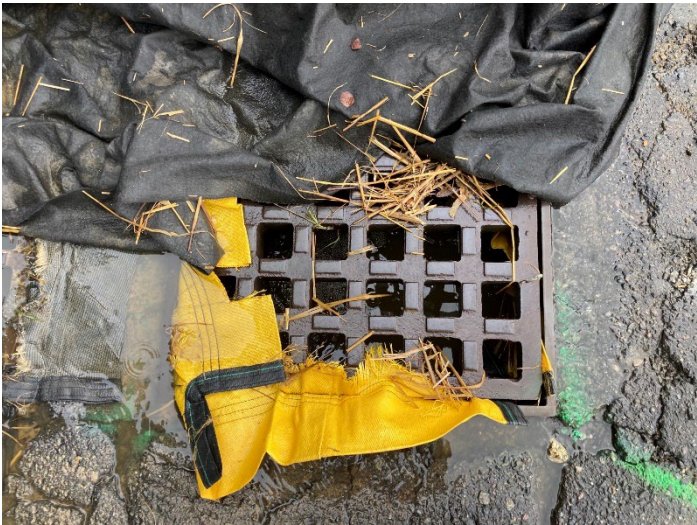
PHOTOGRAPHIC LOG		
Client Name: Eversource		Site Location: Sudbury to Hudson Transmission Reliability Project		Town: Hudson
Photo No.: 4	Date: 8/08/2023

Description: View of discharge point from project (catch basins below hay bale corral on Forest Ave). Discharge appeared slightly turbid. Turbidity reading was higher than 50 NTUs.

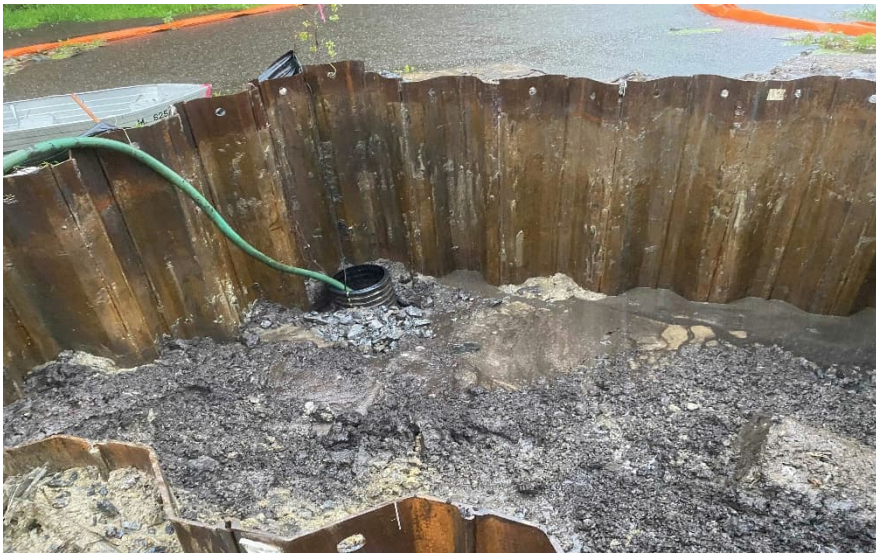
PHOTOGRAPHIC LOG	
Client Name: Eversource		Site Location: Sudbury to Hudson Transmission Reliability Project	Town: Sudbury
Photo No.: 1	Date: 8/8/2023

Description: View of area being pumped at Hop Brook (area in cofferdam), looking westward.

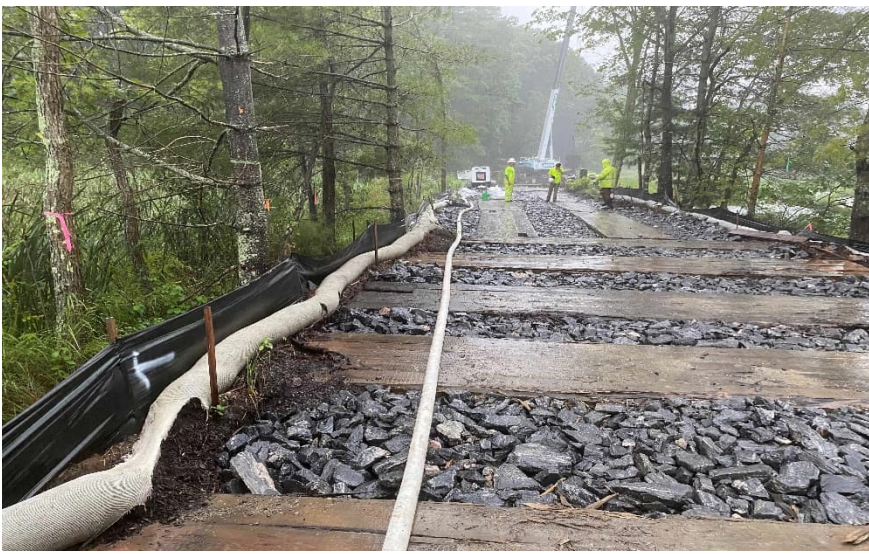
PHOTOGRAPHIC LOG	
Client Name: Eversource		Site Location: Sudbury to Hudson Transmission Reliability Project	Town: Sudbury
Photo No.: 2	Date: 8/8/2023

Description: Segment 14. View of dewatering operation (pumping at far end of area), looking westward.

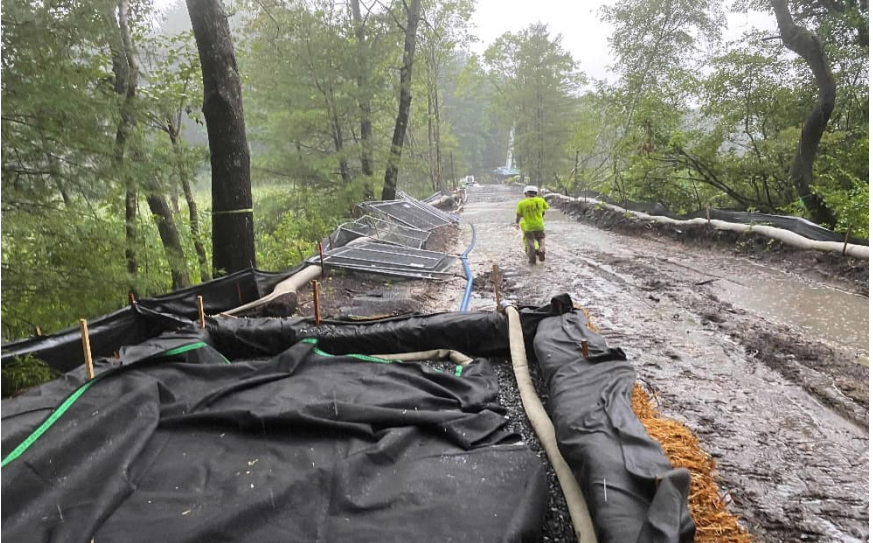
Client Name: Eversource		Site Location: Sudbury to Hudson Transmission Reliability Project	Town: Sudbury
Photo No.: 3	Date: 8/8/2023

Description: Segment 14. View of dewatering operation (pumping at far end of area), looking westward.

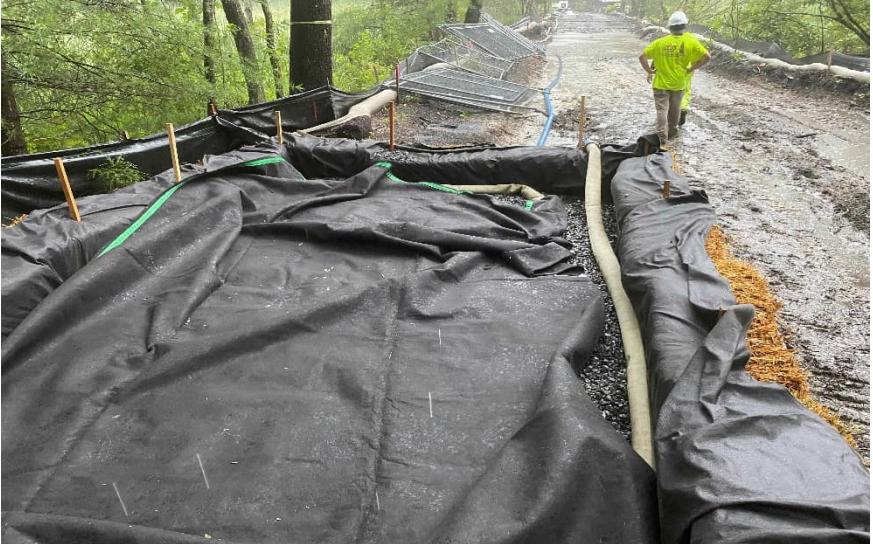
Client Name: Eversource		Site Location: Sudbury to Hudson Transmission Reliability Project	Town: Sudbury
Photo No.: 4	Date: 8/8/2023

Description: Segment 14. View of dewatering operation (pumping at far end of area), looking westward.

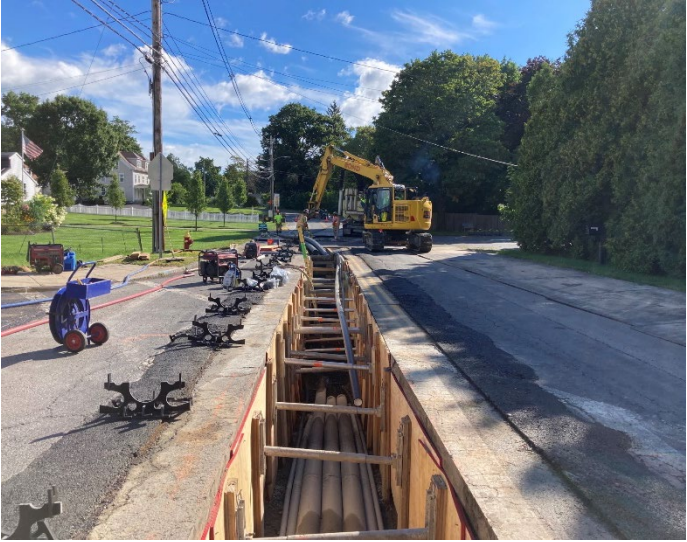
PHOTOGRAPHIC LOG	
Client Name: Eversource		Site Location: Sudbury to Hudson Transmission Reliability Project	Town: Hudson
Photo No.: 1	Date: 8-09-2023

Description: View of Bond crew #6 installing ductbank between MH#2 and MH#3 on Forest Ave. See additional dewatering inspection reports. Facing north.

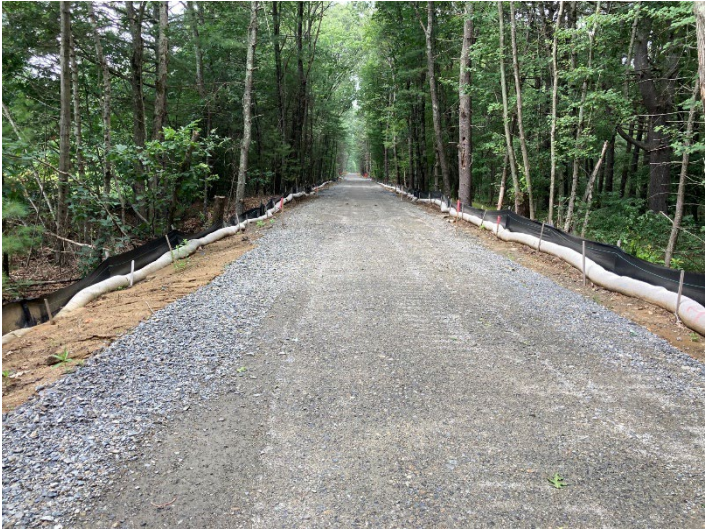
Epsilon ASSOCIATES INC.		PHOTOGRAPHIC LOG	
Client Name: Eversource		Site Location: Sudbury to Hudson Transmission Reliability Project	Town: Hudson
Photo No.: 9	Date: 8-09-2023

Description: View of Type A E&S controls in segment 4. Controls are operating properly. Facing west.

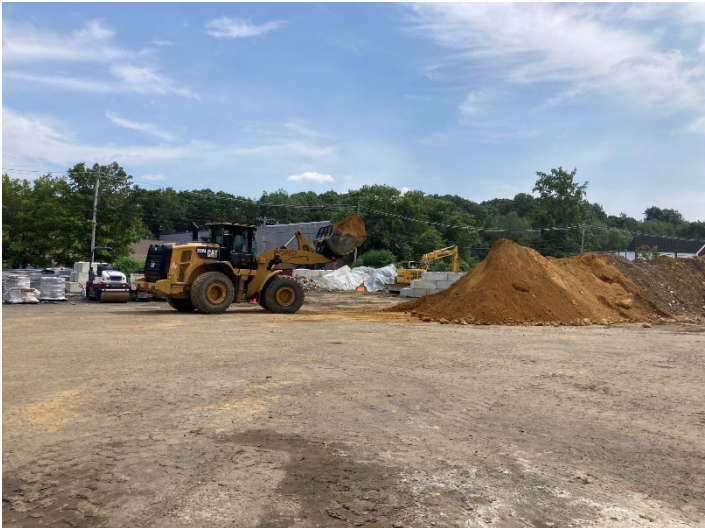
Epsilon ASSOCIATES INC.		PHOTOGRAPHIC LOG	
Client Name: Eversource		Site Location: Sudbury to Hudson Transmission Reliability Project	Town: Hudson
Photo No.: 10	Date: 8-09-2023

Description: View of laydown yard on Robert Bonazzoli Ave. Facing southwest.

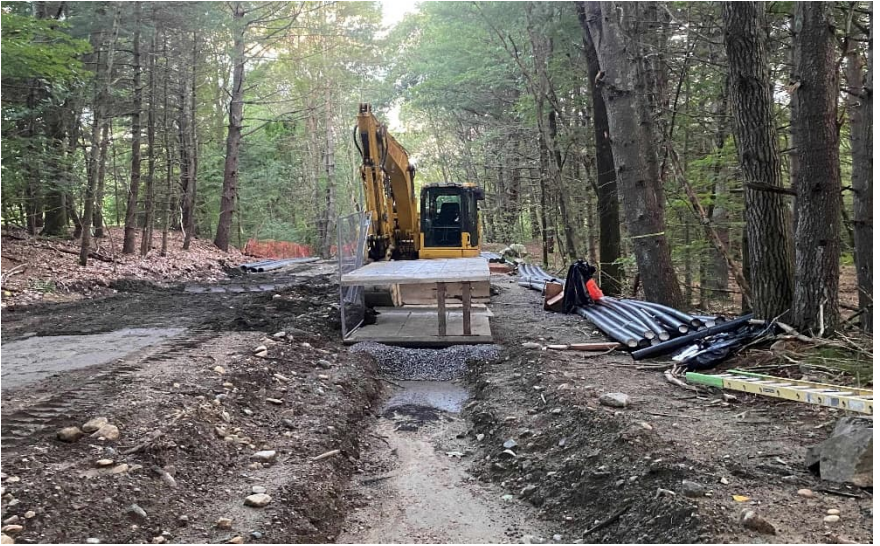
PHOTOGRAPHIC LOG	
Client Name: Eversource		Site Location: Sudbury to Hudson Transmission Reliability Project	Town: Sudbury
Photo No.: 1	Date: 8-9-23

Description: Work area within Segment 8, conduit work, looking westward.

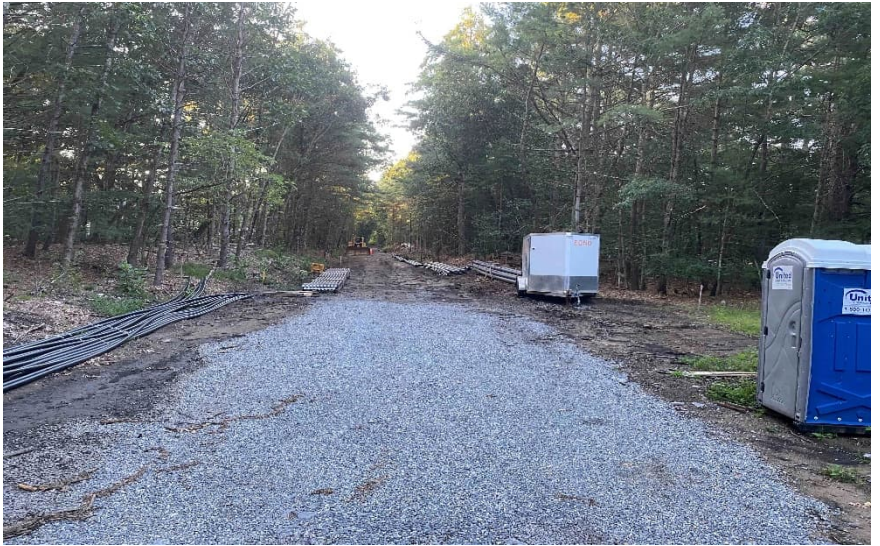
PHOTOGRAPHIC LOG	
Client Name: Eversource		Site Location: Sudbury to Hudson Transmission Reliability Project	Town: Sudbury
Photo No.: 2	Date: 8-9-23

Description: Work area within Segment 9, looking eastward.

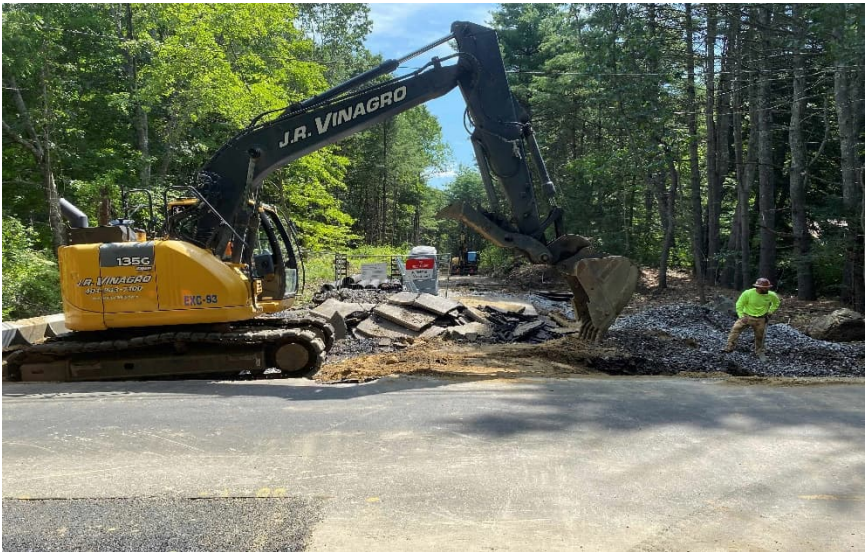
PHOTOGRAPHIC LOG	
Client Name: Eversource		Site Location: Sudbury to Hudson Transmission Reliability Project	Town: Sudbury
Photo No.: 4	Date: 8-9-23

Description: Work area within Peakham Road, replacement of waterline, looking eastward.

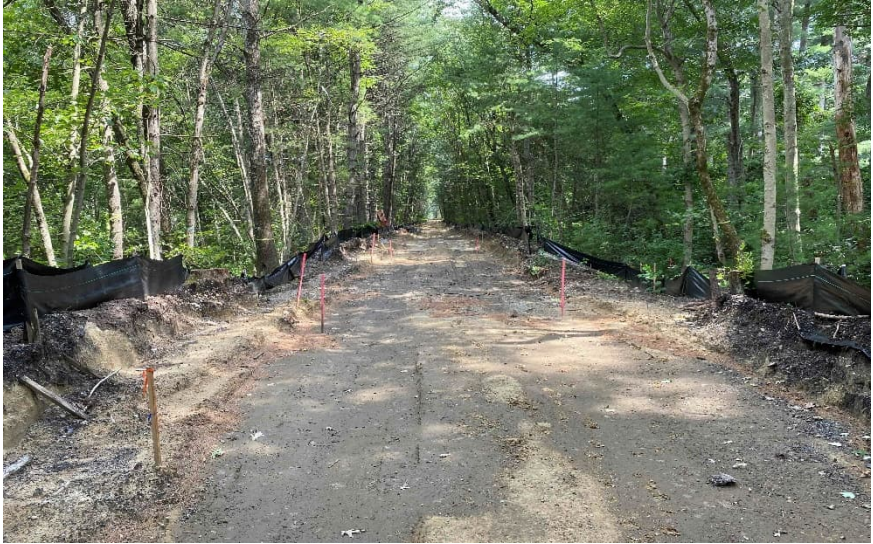
PHOTOGRAPHIC LOG	
Client Name: Eversource		Site Location: Sudbury to Hudson Transmission Reliability Project	Town: Sudbury
Photo No.: 5	Date: 8-9-23

Description: Work area within segment 10 over Dudley Brook at Sta# 539+40, existing erosion control, looking eastward.

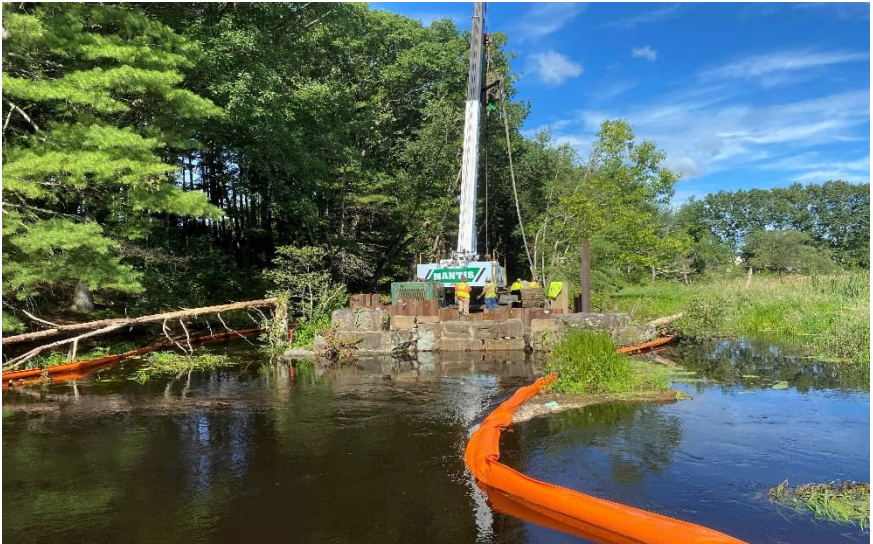
PHOTOGRAPHIC LOG	
Client Name: Eversource		Site Location: Sudbury to Hudson Transmission Reliability Project	Town: Sudbury
Photo No.: 6	Date: 8-9-23

Description: Work area within segment 13, placement of sheeting at Bridge 127 area, existing erosion control, looking westward.

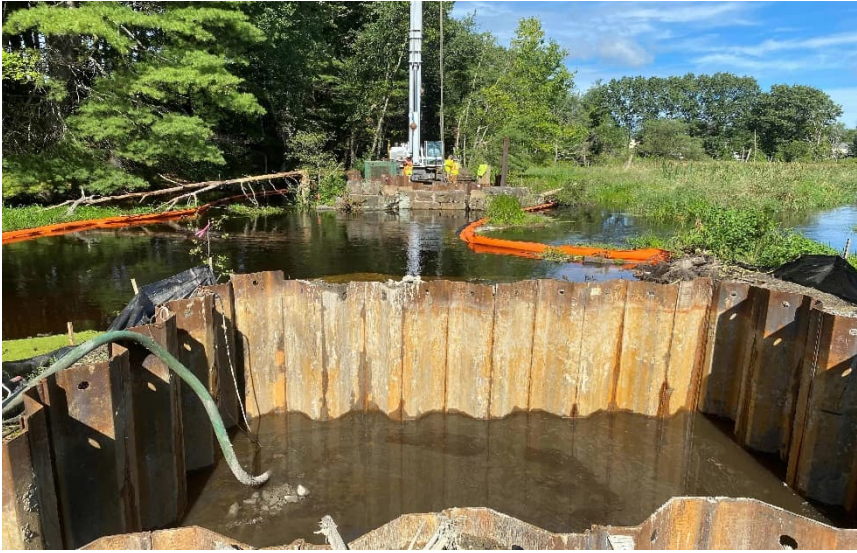
PHOTOGRAPHIC LOG	
Client Name: Eversource		Site Location: Sudbury to Hudson Transmission Reliability Project	Town: Sudbury
Photo No.: 7	Date: 8-9-23

Description: Bridge 127 work area within segment 14, looking westward.

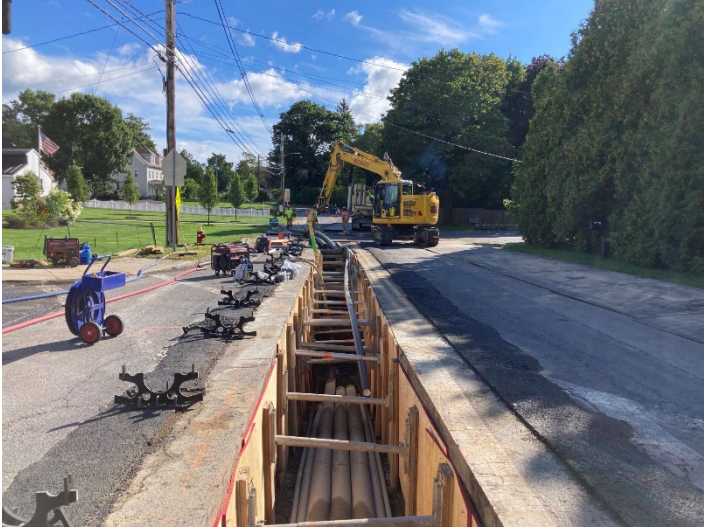
PHOTOGRAPHIC LOG		
Client Name: Eversource		Site Location: Sudbury to Hudson Transmission Reliability Project		Town: Hudson
Photo No.: 1	Date: 8/09/2023

Description: View of work area and dewatering operation at MH #3 south on Forest Ave in Hudson. Facing north.

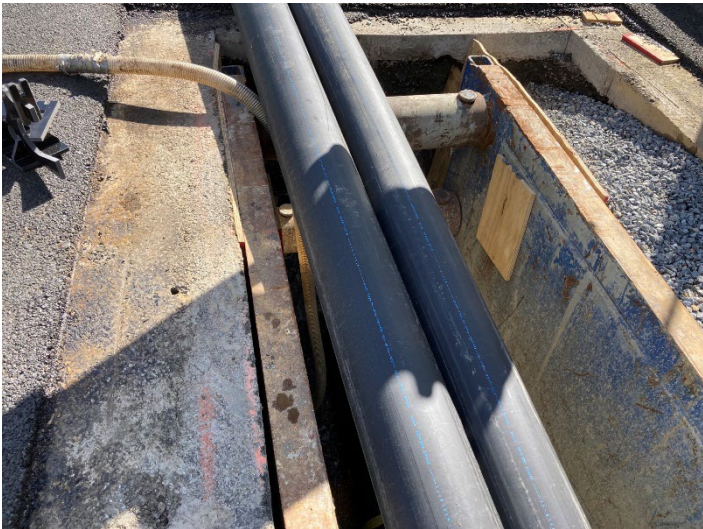
PHOTOGRAPHIC LOG		
Client Name: Eversource		Site Location: Sudbury to Hudson Transmission Reliability Project		Town: Hudson
Photo No.: 2	Date: 8/09/2023

Description: View of trench. Unable to visualize water prior to treatment.

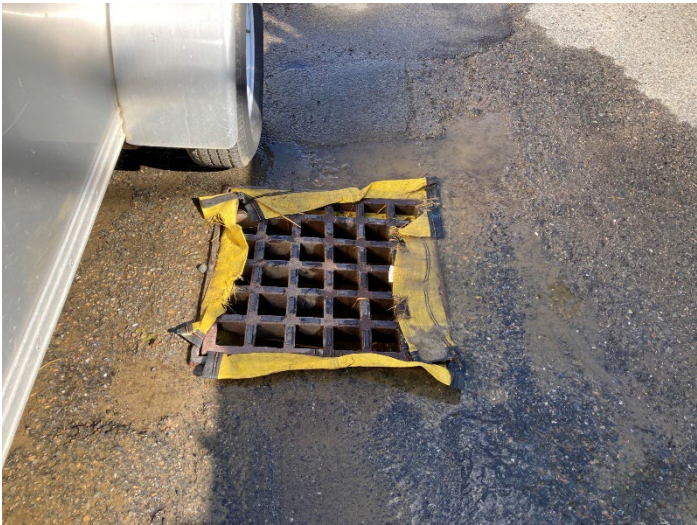
Photo No.: 4	Date: 8/09/2023		
Description: View of discharge point from project (catch basin below hay bale corral at intersection of Forest Ave and driveway to Forest Ave Elementary School). Discharge appeared slightly turbid. Turbidity reading was higher than 50 NTUs. Facing west.

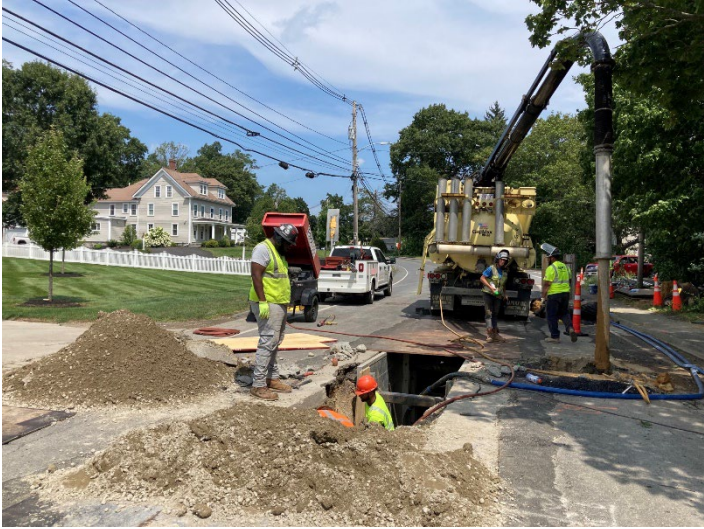
PHOTOGRAPHIC LOG	
Client Name: Eversource		Site Location: Sudbury to Hudson Transmission Reliability Project	Town: Hudson
Photo No.: 1	Date: 8/09/2023

Description: View of work area and dewatering operation at MH #3 north on Forest Ave in Hudson. Facing north.

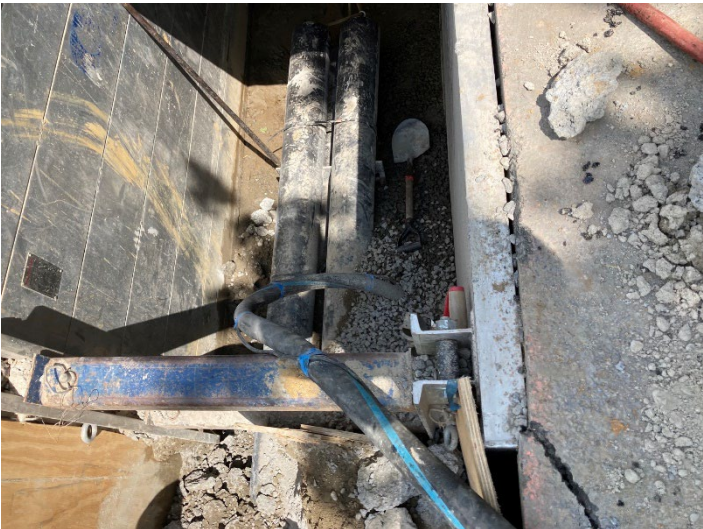
PHOTOGRAPHIC LOG	
Client Name: Eversource		Site Location: Sudbury to Hudson Transmission Reliability Project	Town: Hudson
Photo No.: 2	Date: 8/09/2023

Description: View of trench. Unable to visualize water prior to treatment.

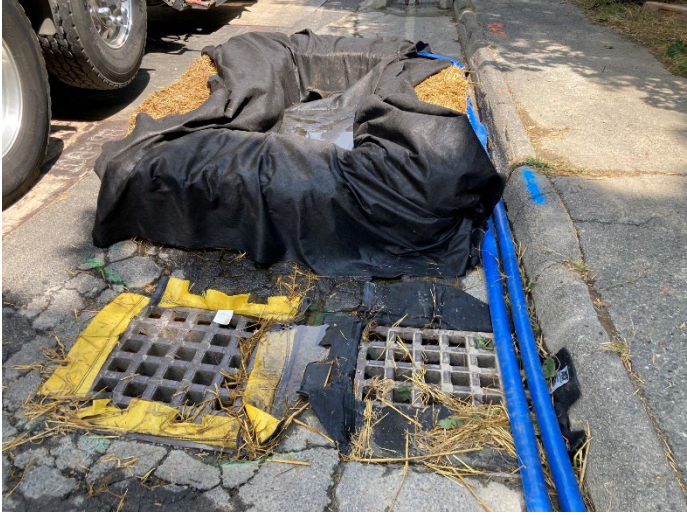
PHOTOGRAPHIC LOG		
Client Name: Eversource		Site Location: Sudbury to Hudson Transmission Reliability Project		Town: Hudson
Photo No.: 3	Date: 8/09/2023

Description: View of dewatering controls (straw bale corral with filter fabric and silt bag). Facing north.

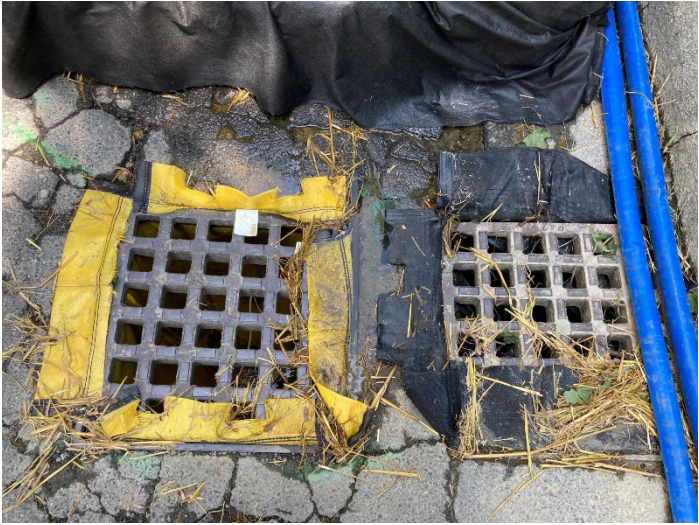
PHOTOGRAPHIC LOG		
Client Name: Eversource		Site Location: Sudbury to Hudson Transmission Reliability Project		Town: Hudson
Photo No.: 4	Date: 8/09/2023

Description: View of discharge point from project (catch basins below hay bale corral on Forest Ave). Discharge appeared clear. Turbidity reading was less than 50 NTUs.

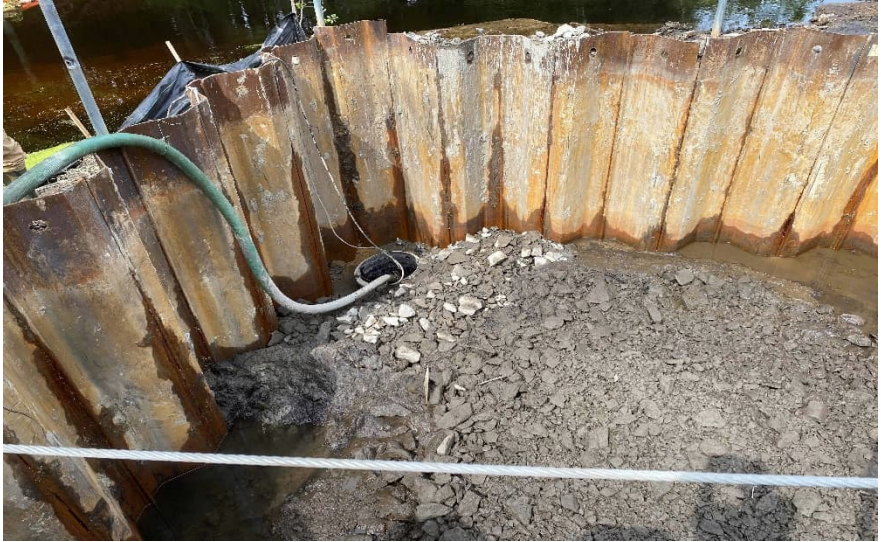
PHOTOGRAPHIC LOG	
Client Name: Eversource		Site Location: Sudbury to Hudson Transmission Reliability Project	Town: Sudbury
Photo No.: 1	Date: 8/10/2023

Description: View of area being pumped at Hop Brook (area in cofferdam), looking westward.

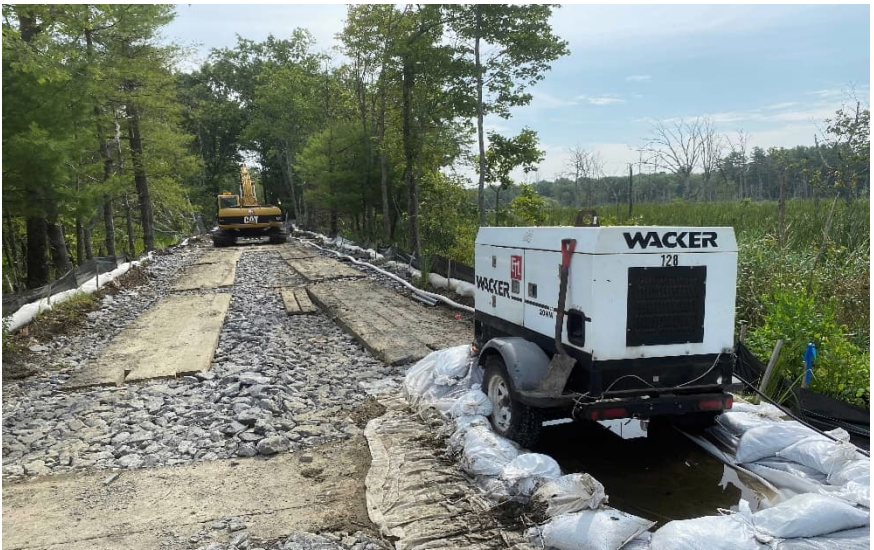
PHOTOGRAPHIC LOG	
Client Name: Eversource		Site Location: Sudbury to Hudson Transmission Reliability Project	Town: Sudbury
Photo No.: 2	Date: 8/10/2023

Description: Segment 14. View of dewatering operation (pumping at far end of area), looking eastward.

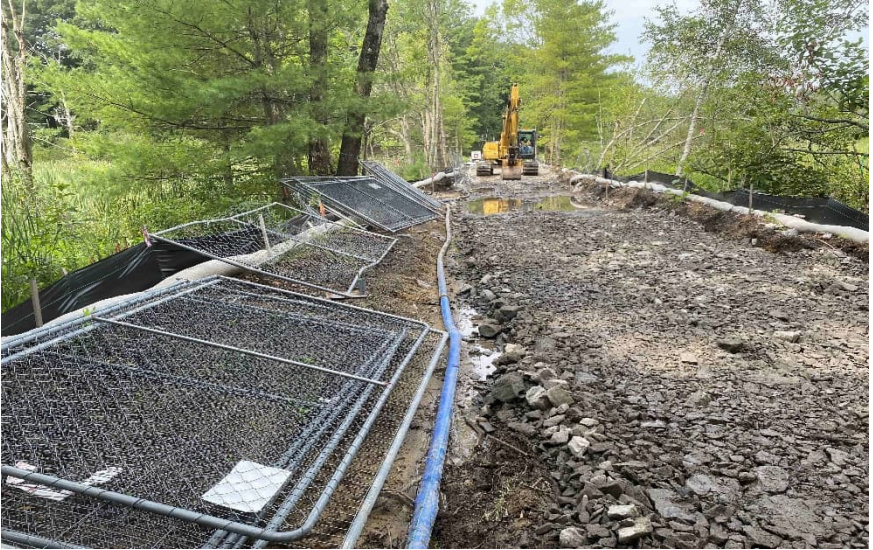
Client Name: Eversource		Site Location: Sudbury to Hudson Transmission Reliability Project	Town: Sudbury
Photo No.: 3	Date: 8/10/2023

Description: Segment 14. View of dewatering operation (pumping at far end of area), looking westward.

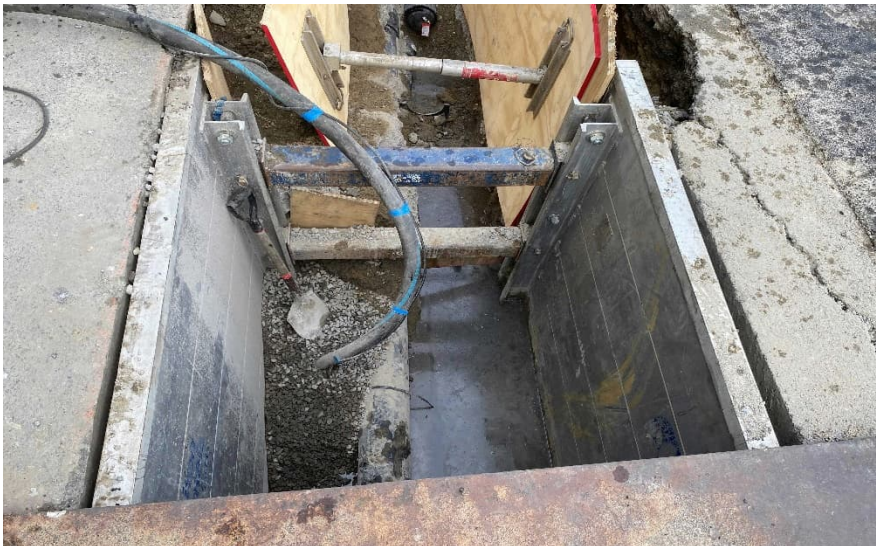
PHOTOGRAPHIC LOG	
Client Name: Eversource		Site Location: Sudbury to Hudson Transmission Reliability Project	Town: Hudson
Photo No.: 1	Date: 8/10/2023

Description: View of area being pumped at Forest Avenue (area in conduit trench), looking northward.

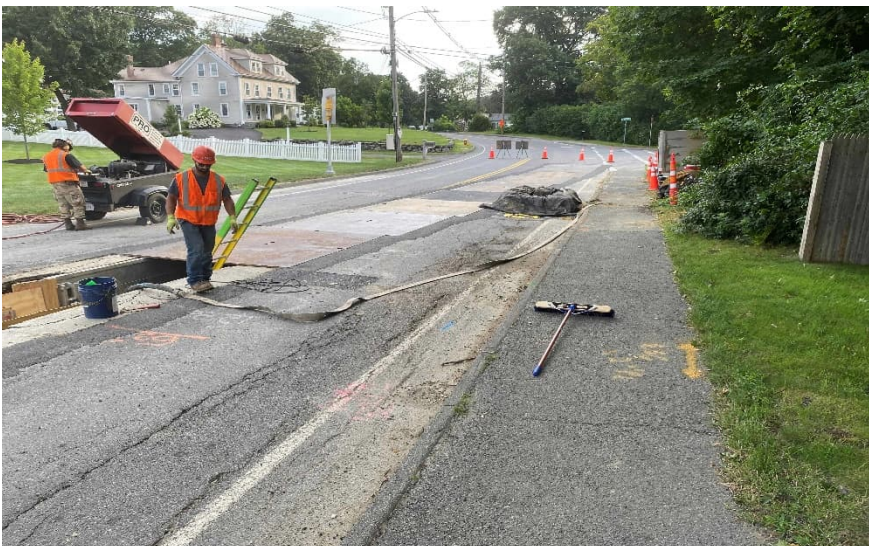
PHOTOGRAPHIC LOG	
Client Name: Eversource		Site Location: Sudbury to Hudson Transmission Reliability Project	Town: Hudson
Photo No.: 2	Date: 8/10/2023

Description: Forest Avenue. View of dewatering operation, looking northward.

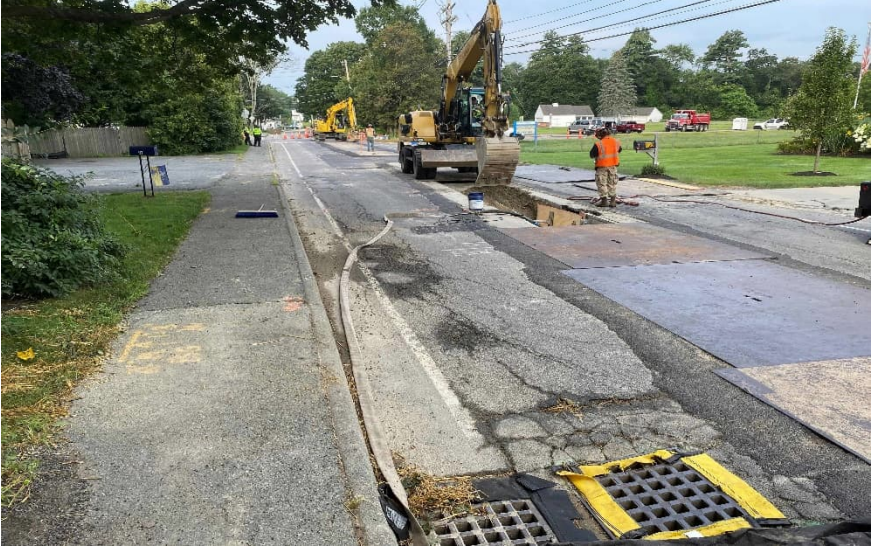
PHOTOGRAPHIC LOG	
Client Name: Eversource		Site Location: Sudbury to Hudson Transmission Reliability Project	Town: Hudson
Photo No.: 3	Date: 8/10/2023

Description: Forest Avenue. View of dewatering operation (pumping at far end of area), looking northward.

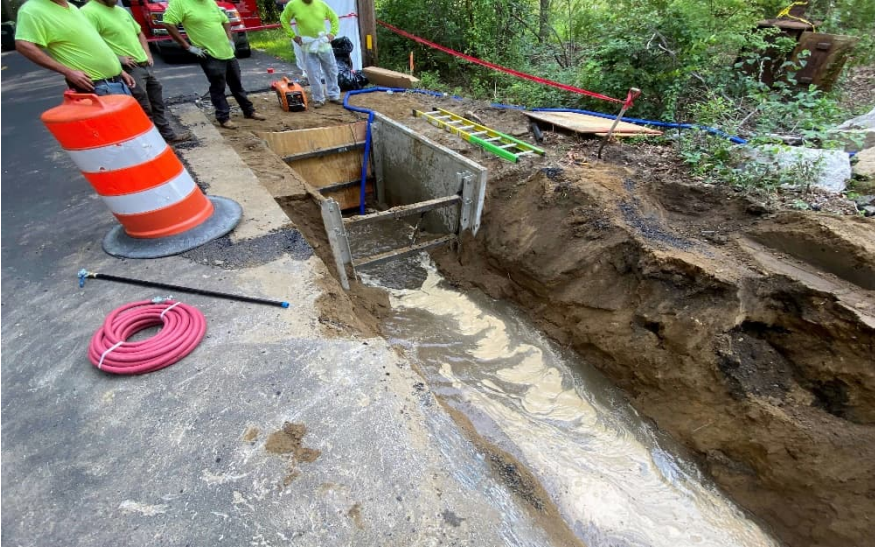
PHOTOGRAPHIC LOG	
Client Name: Eversource		Site Location: Sudbury to Hudson Transmission Reliability Project	Town: Sudbury
Photo No.: 1	Date: 8/10/2023

Description: Peakham trench for exposed water line, looking northward.

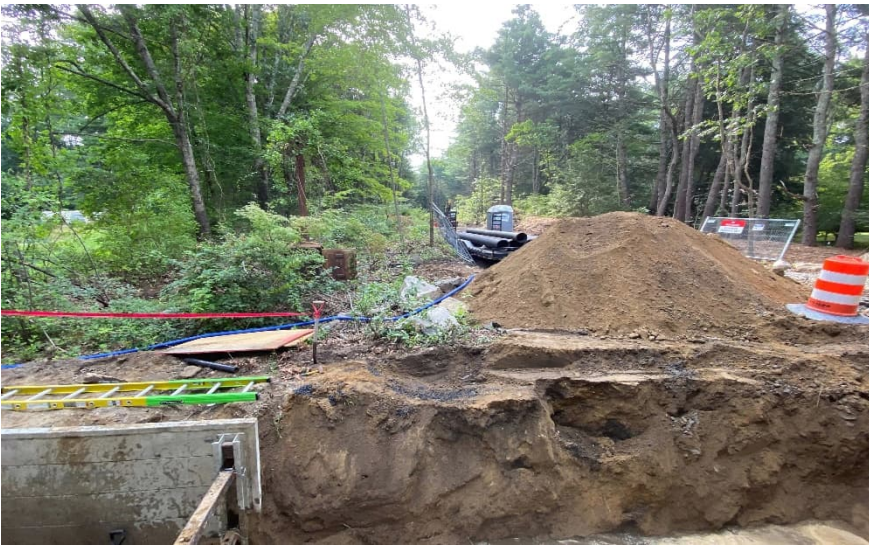
PHOTOGRAPHIC LOG	
Client Name: Eversource		Site Location: Sudbury to Hudson Transmission Reliability Project	Town: Sudbury
Photo No.: 2	Date: 8/10/2023

Description: Segment 9 off Peakham. View of dewatering operation (pumping at far end of area), looking eastward.

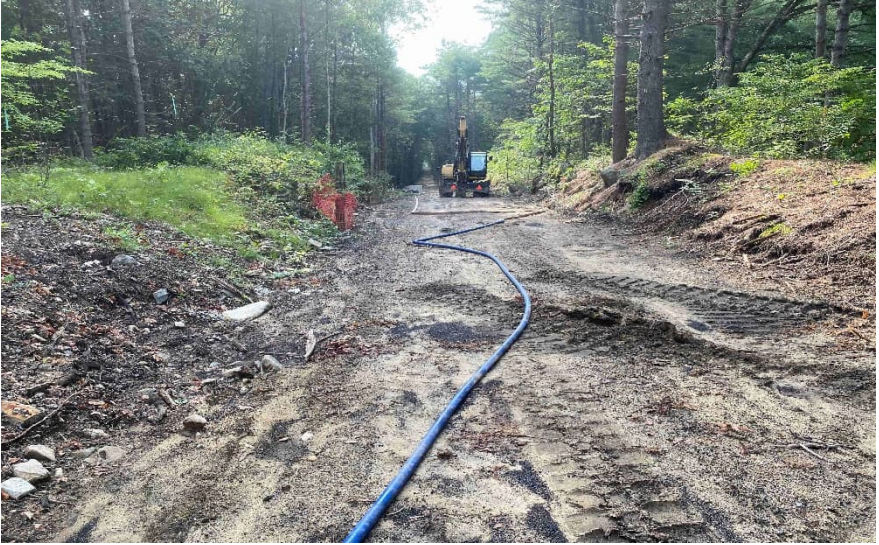
PHOTOGRAPHIC LOG	
Client Name: Eversource		Site Location: Sudbury to Hudson Transmission Reliability Project	Town: Sudbury
Photo No.: 3	Date: 8/10/2023

Description: Segment 9 off Peakham. View of dewatering operation (pumping at far end of area), looking eastward.

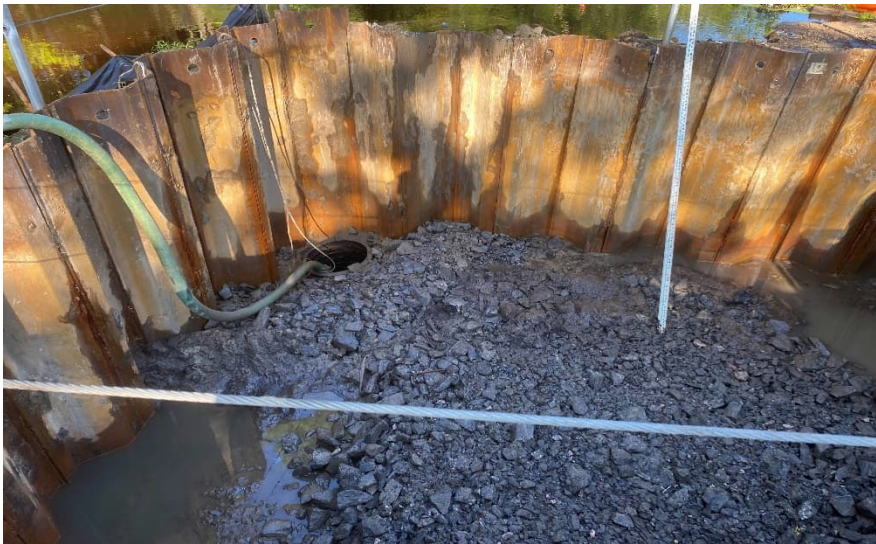
PHOTOGRAPHIC LOG	
Client Name: Eversource		Site Location: Sudbury to Hudson Transmission Reliability Project	Town: Sudbury
Photo No.: 1	Date: 8/11/2023

Description: View of area being pumped at Hop Brook (area in cofferdam), looking westward.

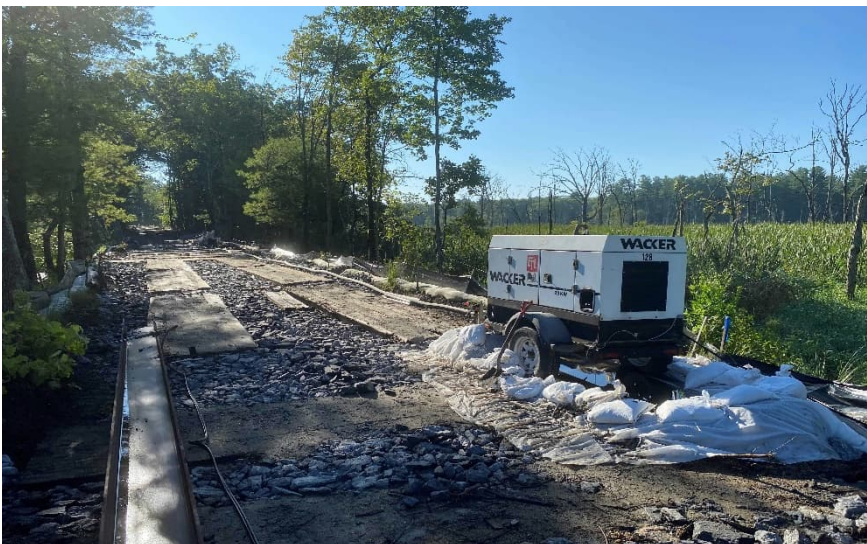
PHOTOGRAPHIC LOG	
Client Name: Eversource		Site Location: Sudbury to Hudson Transmission Reliability Project	Town: Sudbury
Photo No.: 2	Date: 8/11/2023

Description: Segment 14. View of dewatering operation (pumping at far end of area), looking eastward.

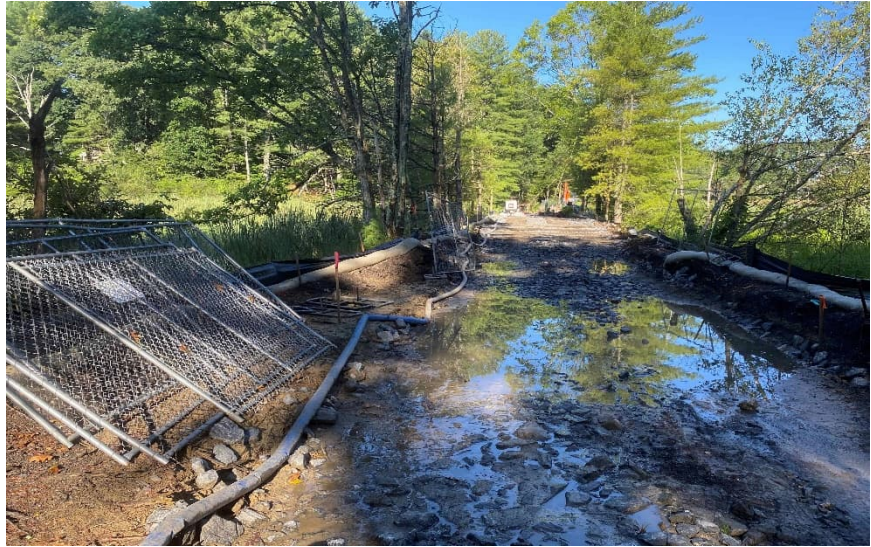
Photo No.: 3 Date: 8/11/2023

Description:
Segment 14. View of dewatering operation (pumping at far end of area), looking westward.

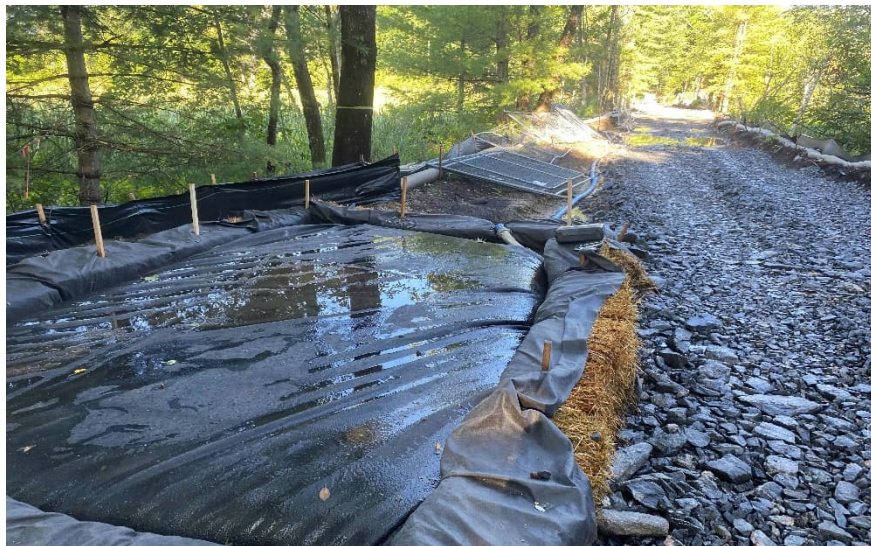
Photo No.: 4 Date: 8/11/2023

Description:
Segment 14. View of dewatering operation (pumping at far end of area), looking westward.

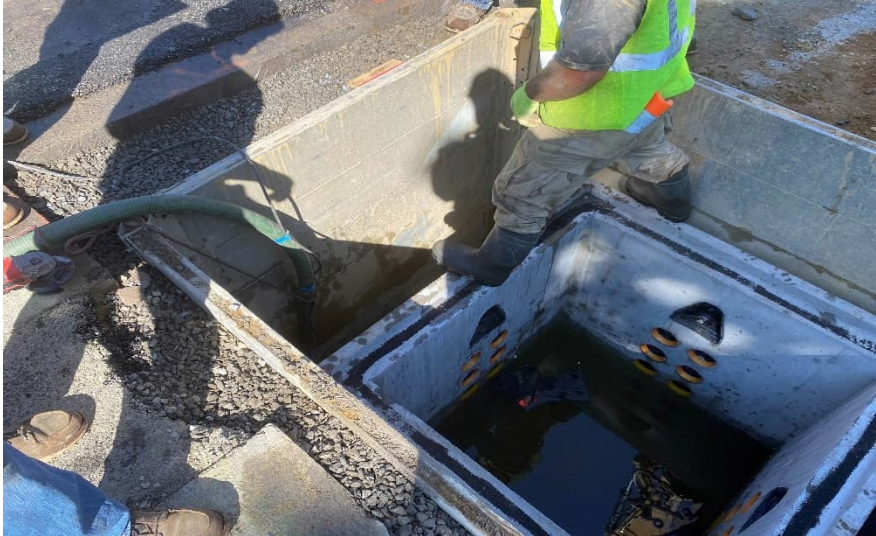
PHOTOGRAPHIC LOG	
Client Name: Eversource		Site Location: Sudbury to Hudson Transmission Reliability Project	Town: Hudson
Photo No.: 1	Date: 8/11/2023

Description: View of area being pumped at Forest Avenue (area in conduit trench), looking northward.

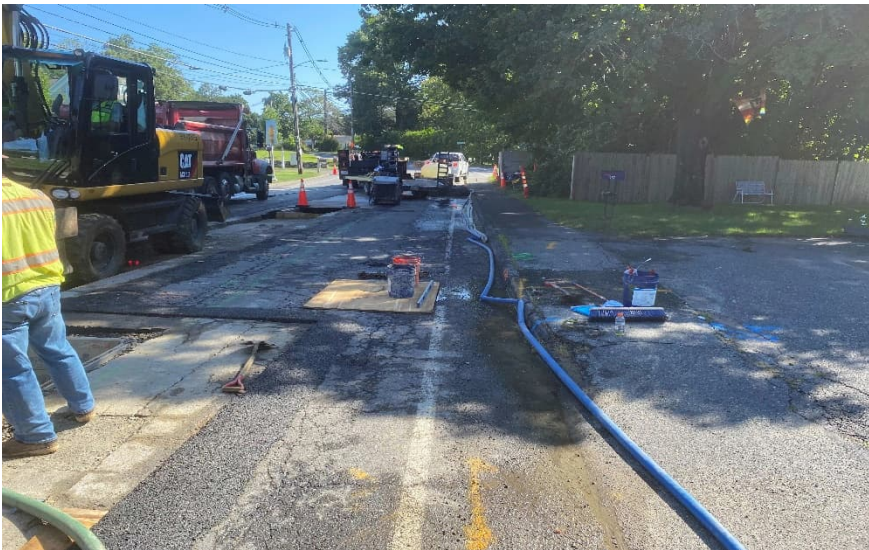
PHOTOGRAPHIC LOG	
Client Name: Eversource		Site Location: Sudbury to Hudson Transmission Reliability Project	Town: Hudson
Photo No.: 2	Date: 8/11/2023

Description: Forest Avenue. View of dewatering operation, looking northward.

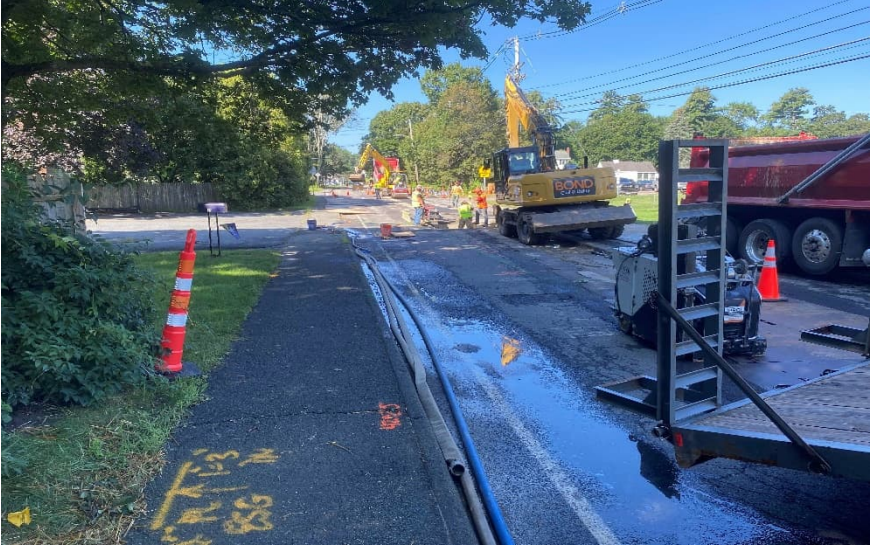
PHOTOGRAPHIC LOG	
Client Name: Eversource		Site Location: Sudbury to Hudson Transmission Reliability Project	Town: Hudson
Photo No.: 3	Date: 8/11/2023

Description: Forest Avenue. View of dewatering operation (pumping at far end of area), looking northward.

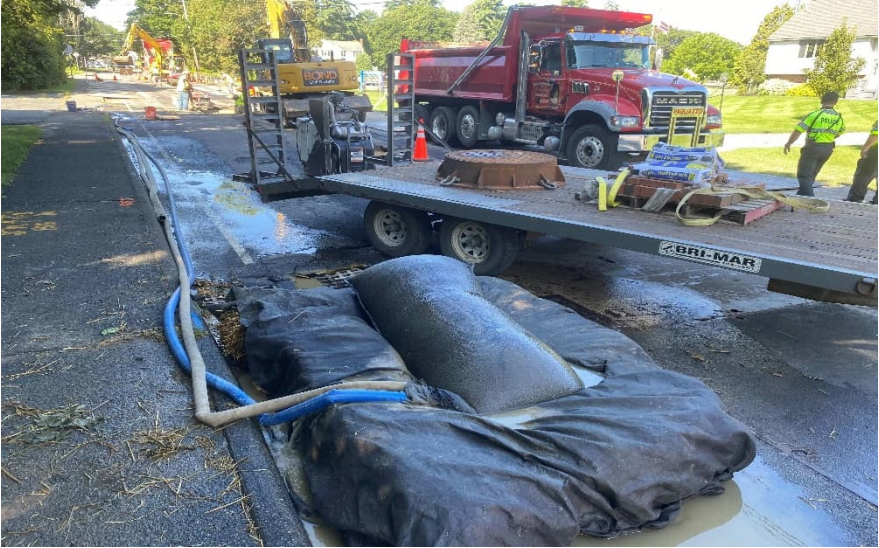
PHOTOGRAPHIC LOG	
Client Name: Eversource		Site Location: Sudbury to Hudson Transmission Reliability Project	Town: Hudson
Photo No.: 4	Date: 8/11/2023

Description: Forest Avenue. View of dewatering operation (corral/bag), looking northward.
