**Weekly Environmental Compliance Summary**

**Sudbury to Hudson Transmission Reliability Project (USEPA Tracking # MAR1003UW)**

Sudbury, Hudson, and Stow, MA

Week of: August 14 to August 18, 2023

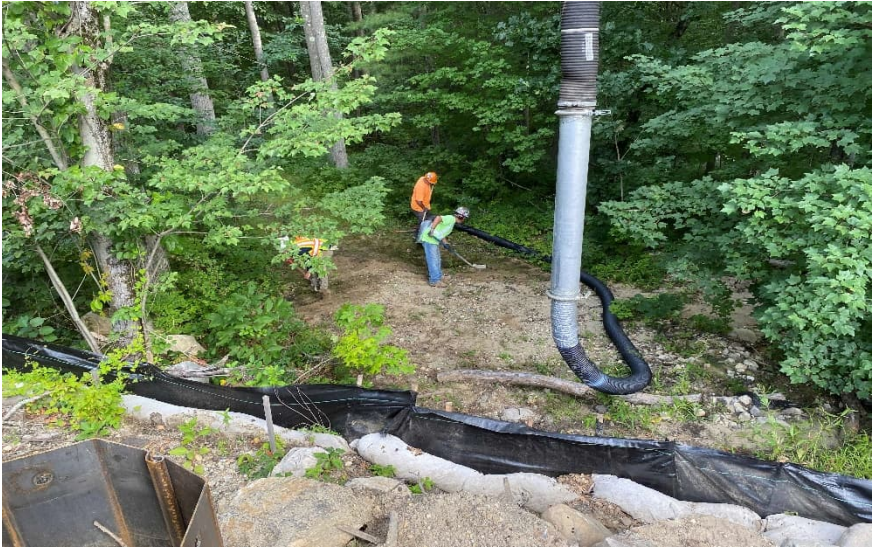
<b>PHOTOGRAPHIC LOG</b>	
Client Name: Eversource		Site Location: Sudbury to Hudson Transmission Reliability Project	Town: Hudson
Photo No.: 1	Date: 8-14-23

Description:  Work area within segment 1, cleanup at Sta# 125+00, existing erosion control, looking northward.

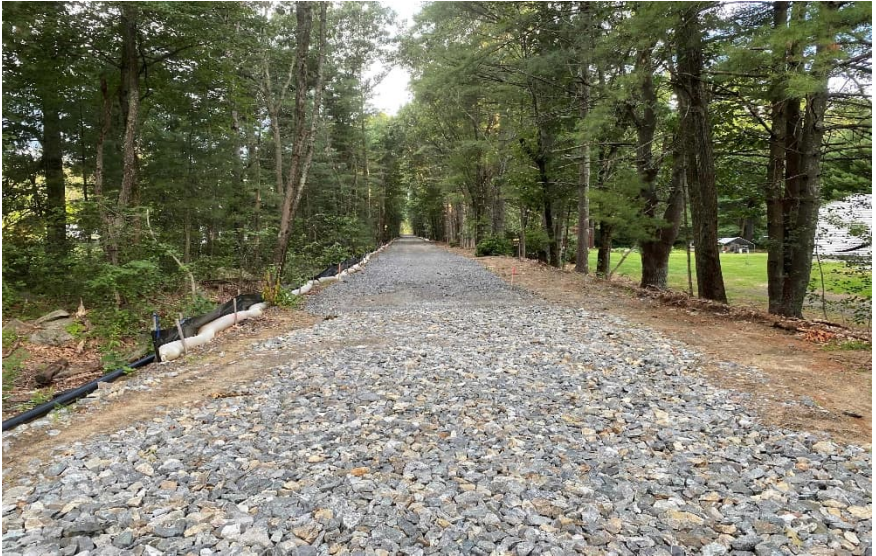
<b>PHOTOGRAPHIC LOG</b>	
Client Name: Eversource		Site Location: Sudbury to Hudson Transmission Reliability Project	Town: Hudson
Photo No.: 4	Date: 8-14-23

Description:  Work area within Segment 4, existing erosion control, looking westward.

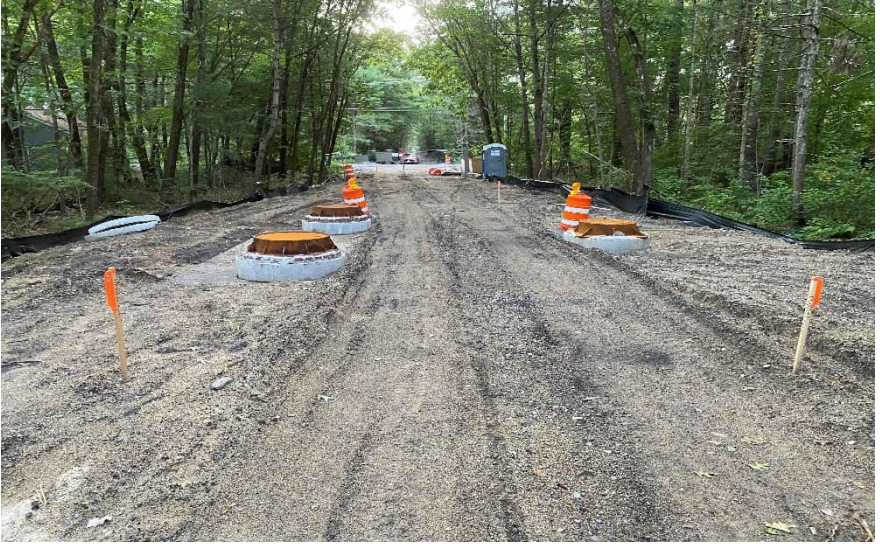
<b>PHOTOGRAPHIC LOG</b>	
Client Name: Eversource		Site Location: Sudbury to Hudson Transmission Reliability Project	Town: Hudson
Photo No.: 5	Date: 8-14-23

Description:  Work area within segment 5, manhole #13, existing erosion control, looking eastward.

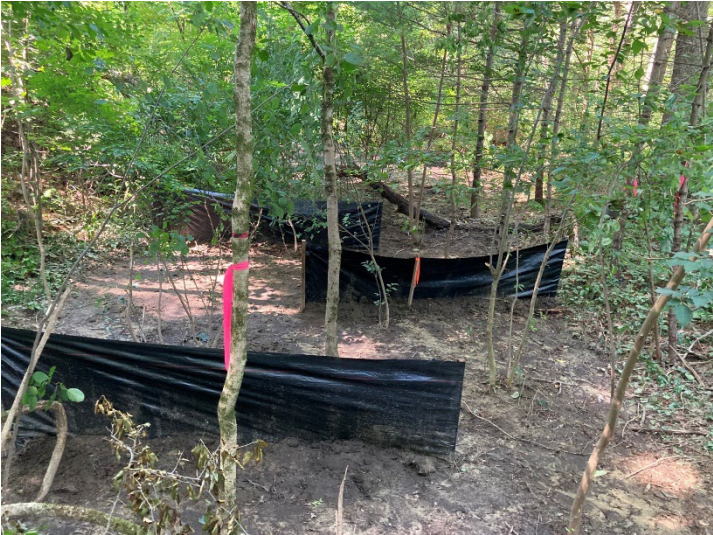
<b>PHOTOGRAPHIC LOG</b>	
<b>Client Name:</b> Eversource		<b>Site Location:</b> Sudbury to Hudson Transmission Reliability Project	<b>Town:</b> Sudbury
<b>Photo No.:</b> 2	<b>Date:</b> 8/14/2023

<b>Description:</b> View of wetland south of collapsed culvert in segment 9. Silt fence check dams have been installed to help prevent future sediment migration. Facing south.

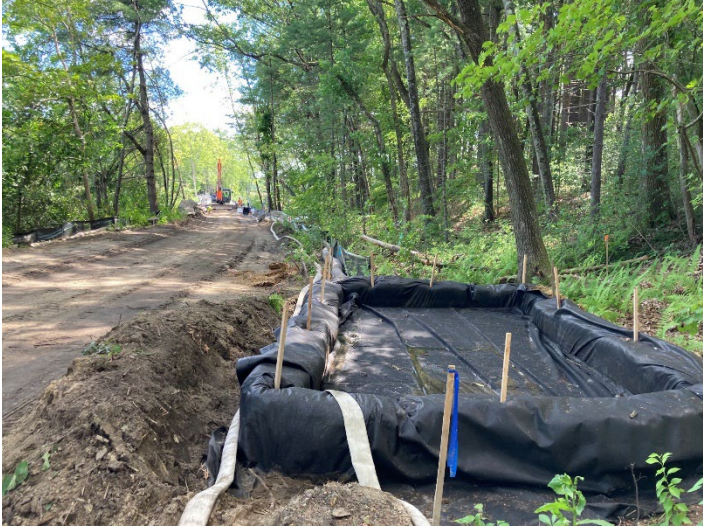
<p align="center"><b>PHOTOGRAPHIC LOG</b></p>	
<p><b>Client Name:</b> Eversource</p>		<p><b>Site Location:</b> Sudbury to Hudson Transmission Reliability Project</p>	<p><b>Town:</b> Sudbury</p>
<p><b>Photo No.:</b> 5</p>	<p><b>Date:</b> 8/14/2023</p>

<p><b>Description:</b> View of dewatering controls in segment 13. See additional dewatering inspection report. Facing east.</p>

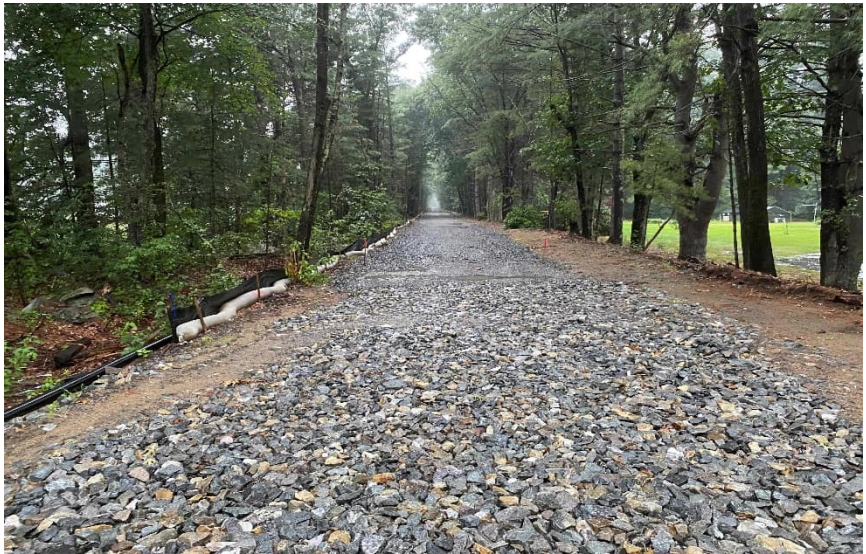
<b>PHOTOGRAPHIC LOG</b>	
Client Name: Eversource		Site Location: Sudbury to Hudson Transmission Reliability Project	Town: Hudson
Photo No.: 4	Date: 8-15-23

Description:  Work area within Segment 4, existing erosion control, looking westward.

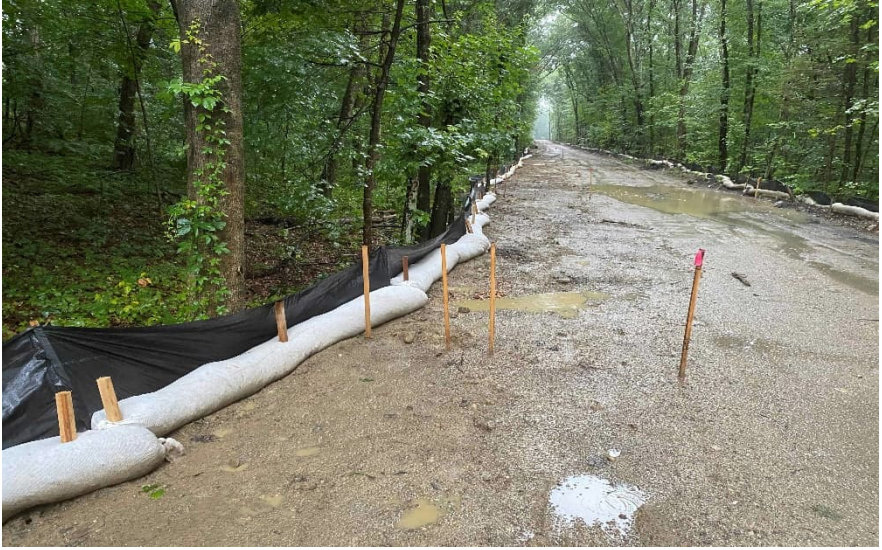
<b>PHOTOGRAPHIC LOG</b>	
Client Name: Eversource		Site Location: Sudbury to Hudson Transmission Reliability Project	Town: Hudson
Photo No.: 5	Date: 8-15-23

Description:  Work area within segment 1, new erosion control (Sta# 110 + 55 – 113+25) placed, looking westward.

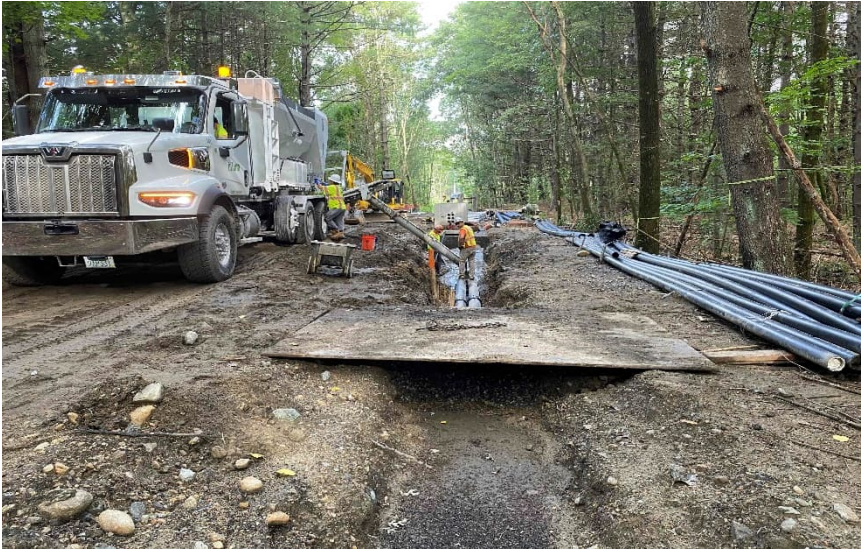
<b>PHOTOGRAPHIC LOG</b>	
Client Name: Eversource		Site Location: Sudbury to Hudson Transmission Reliability Project	Town: Sudbury
Photo No.: 7	Date: 8-17-23

Description:  Conduit work within Segment 8, existing erosion control, looking eastward.

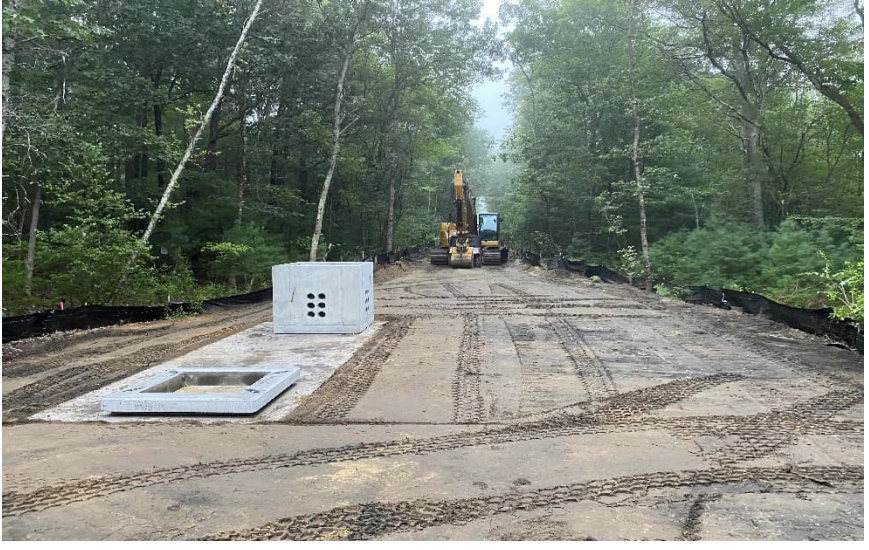
<p>PHOTOGRAPHIC LOG</p>	
<p>Client Name: Eversource</p>		<p>Site Location: Sudbury to Hudson Transmission Reliability Project</p>	<p>Town: Hudson</p>
<p>Photo No.: 4</p>	<p>Date: 8-18-23</p>

<p>Description:</p> <p>Work area within segment 6, manhole #14, existing erosion control, looking eastward.</p>

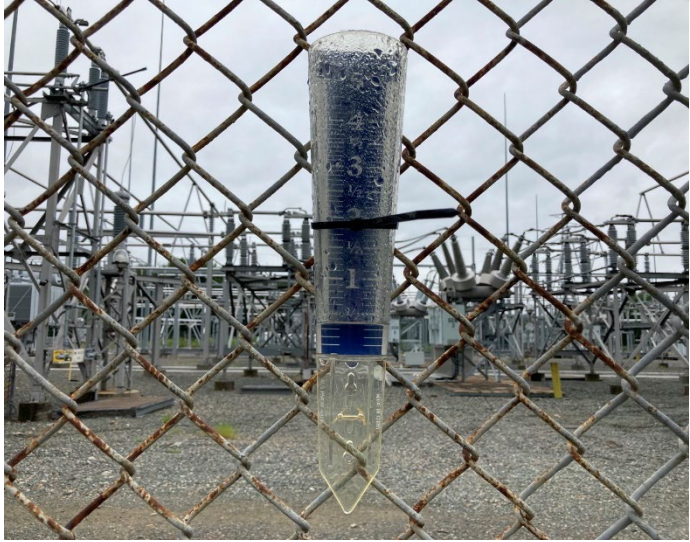
<b>PHOTOGRAPHIC LOG</b>	
<b>Client Name:</b> Eversource		<b>Site Location:</b> Sudbury to Hudson Transmission Reliability Project	<b>Town:</b> Sudbury
<b>Photo No.:</b> 1	<b>Date:</b> 8-16-2023

<b>Description:</b> View of rain gauge at Sudbury Substation. 0.35" observed in gauge at approximately 7:45am. Facing south.

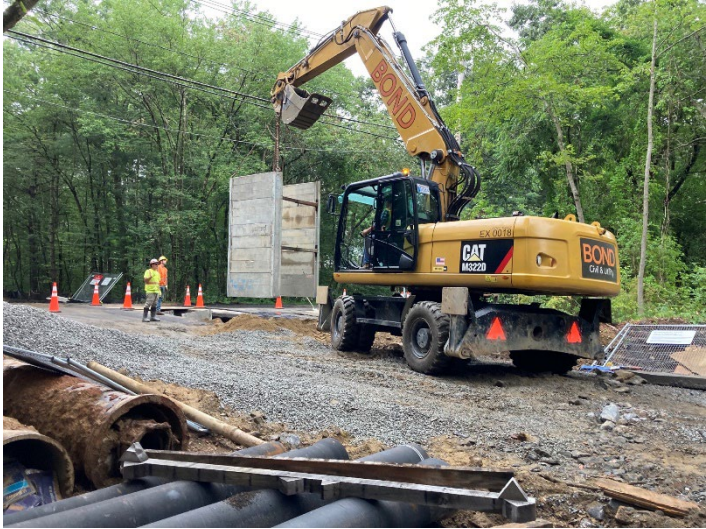
<b>PHOTOGRAPHIC LOG</b>	
<b>Client Name:</b> Eversource		<b>Site Location:</b> Sudbury to Hudson Transmission Reliability Project	<b>Town:</b> Sudbury
<b>Photo No.:</b> 2	<b>Date:</b> 8-16-2023

<b>Description:</b> View of Bond working at Peakham Rd crossing. Facing northwest.

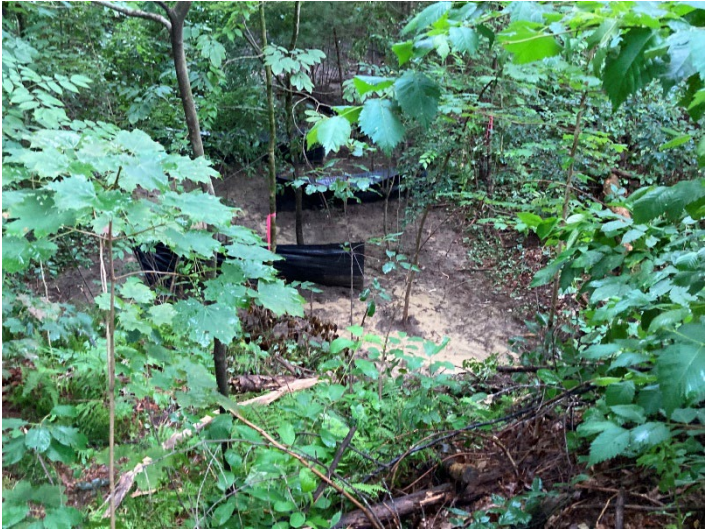
<b>Epsilon</b> ASSOCIATES INC.		<b>PHOTOGRAPHIC LOG</b>	
Client Name: Eversource		Site Location: Sudbury to Hudson Transmission Reliability Project	Town: Sudbury
Photo No.: 3	Date: 8-16-2023

Discharge Location	Observations
<b>1. Culvert at Sta. #521+69 in segment 9</b>	Documentation of discharge from 8/15/2023: During storm event, stormwater and sediment discharged from collapsed culvert. Small amount of sediment discharged into wetland south of culvert. Sediment should be removed.
<b>2. Sta. #595 in segment 11</b>	Documentation of discharge from 8/15/2023: During storm event, stormwater and sediment overtopped the silt fence and deposited beyond limit of work. Sediment did not reach a jurisdictional area. Silt fence should be repaired and sediment should be removed (routine maintenance).
<b>3.</b>	
<b>4.</b>	
<b>5.</b>

<b>Description:</b> View of wetland south of collapsed culvert in segment 9. Small amount of sediment has deposited beyond culvert and into wetland. Sediment should be removed. Facing south.

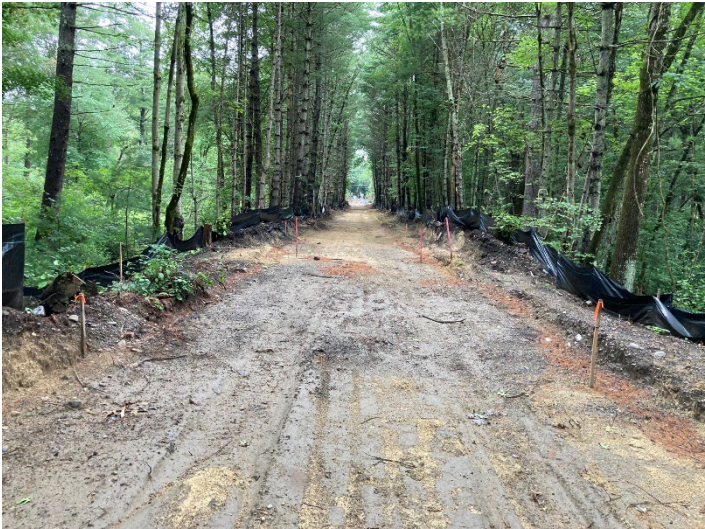
<b>Epsilon</b> ASSOCIATES INC.		<b>PHOTOGRAPHIC LOG</b>	
Client Name: Eversource		Site Location: Sudbury to Hudson Transmission Reliability Project	Town: Sudbury
Photo No.: 4	Date: 8-16-2023

<b>Description:</b> View of syncopated silt fence in segment 10. Facing east.

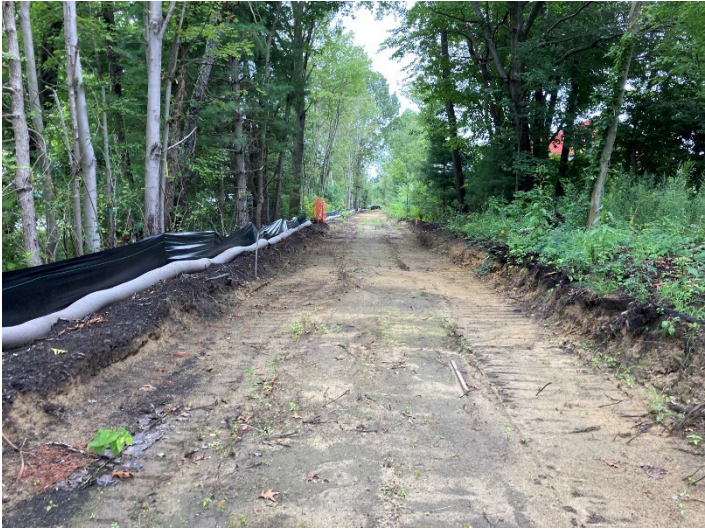
<b>Epsilon</b> ASSOCIATES INC.		<b>PHOTOGRAPHIC LOG</b>	
Client Name: Eversource		Site Location: Sudbury to Hudson Transmission Reliability Project	Town: Sudbury
Photo No.: 6	Date: 8-16-2023

<b>Description:</b> View of Type A E&S controls in segment 12. Facing east.

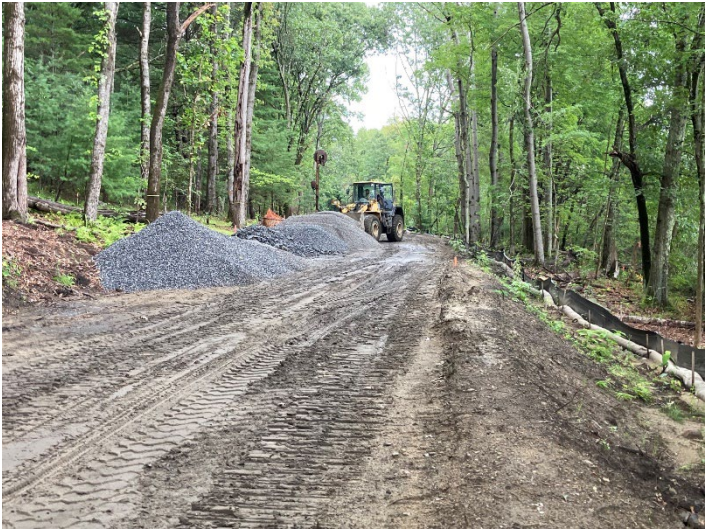
<b>Epsilon</b> ASSOCIATES INC.		<b>PHOTOGRAPHIC LOG</b>	
<b>Client Name:</b> Eversource		<b>Site Location:</b> Sudbury to Hudson Transmission Reliability Project	<b>Town:</b> Sudbury
<b>Photo No.:</b> 7	<b>Date:</b> 8-16-2023

<b>Description:</b> View of ET&L working in segment 14. Facing east.

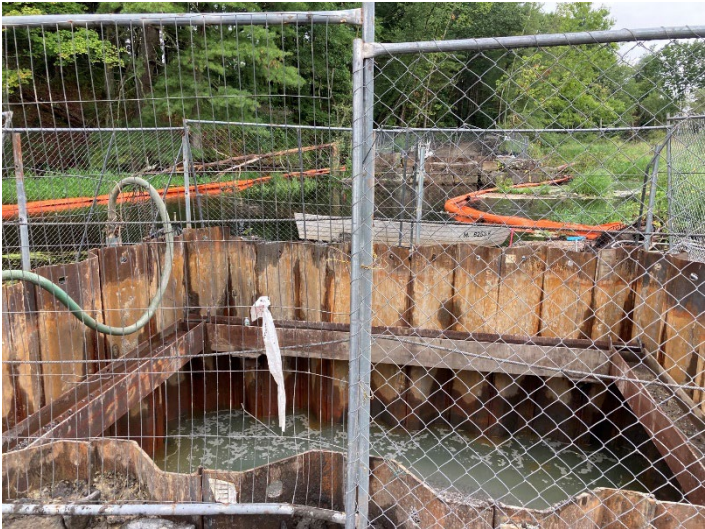
<b>Epsilon</b> ASSOCIATES INC.		<b>PHOTOGRAPHIC LOG</b>	
<b>Client Name:</b> Eversource		<b>Site Location:</b> Sudbury to Hudson Transmission Reliability Project	<b>Town:</b> Sudbury
<b>Photo No.:</b> 8	<b>Date:</b> 8-16-2023

<b>Description:</b> View of bridge 127 area. See additional dewatering inspection reports. Facing west.

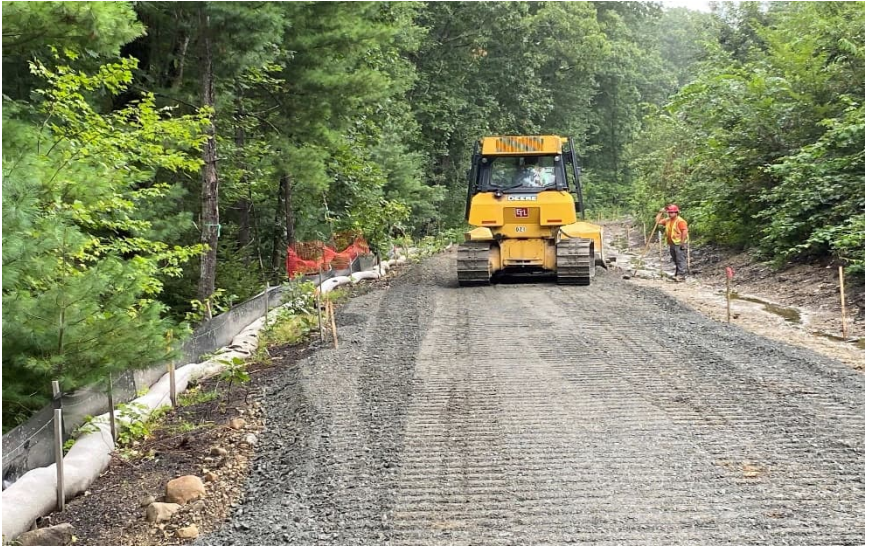
<b>PHOTOGRAPHIC LOG</b>	
Client Name: Eversource		Site Location: Sudbury to Hudson Transmission Reliability Project	Town: Hudson
Photo No.: 1	Date: 8-16-23

Description:  ET&L conducting grading activity within segment 1, existing erosion control, looking westward.

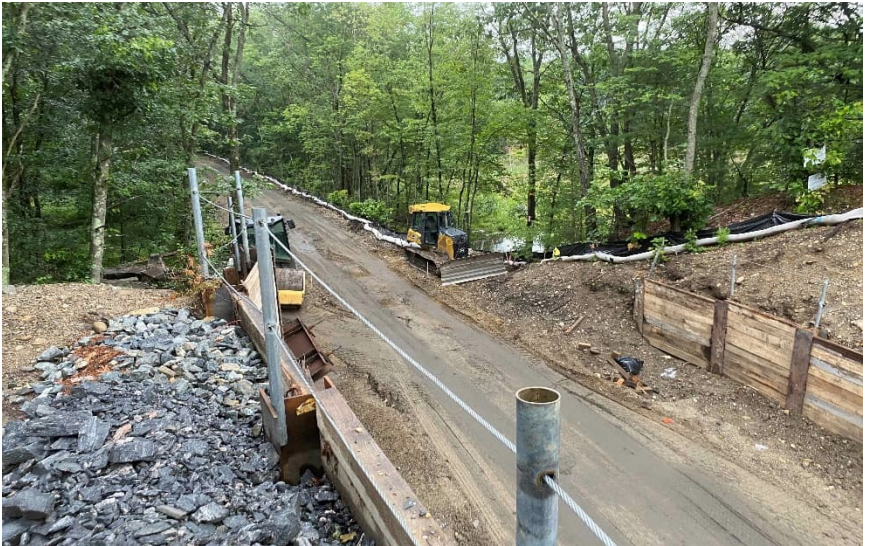
<b>PHOTOGRAPHIC LOG</b>	
Client Name: Eversource		Site Location: Sudbury to Hudson Transmission Reliability Project	Town: Hudson
Photo No.: 2	Date: 8-16-23

Description:  Chestnut Street crossing, looking westward.

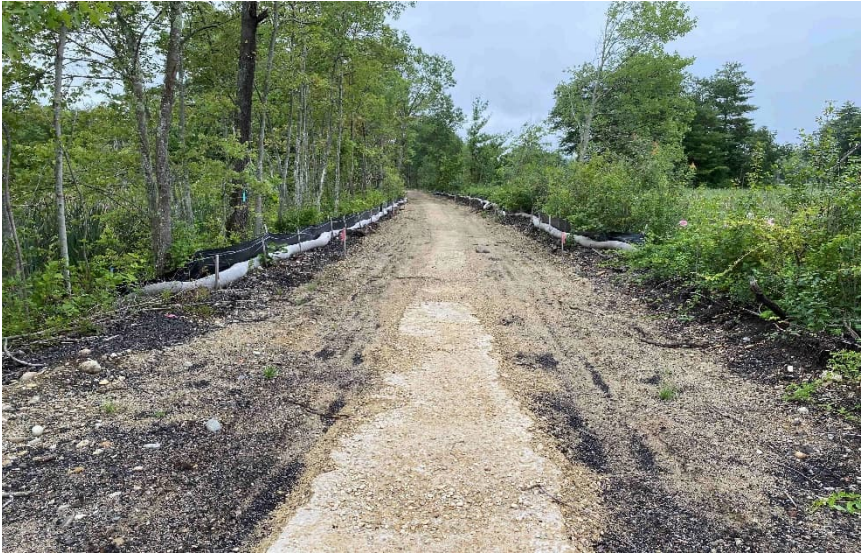
<b>PHOTOGRAPHIC LOG</b>	
Client Name: Eversource		Site Location: Sudbury to Hudson Transmission Reliability Project	Town: Hudson
Photo No.: 3	Date: 8-16-23

Description:  Work area within segment 3, existing erosion control, looking eastward.

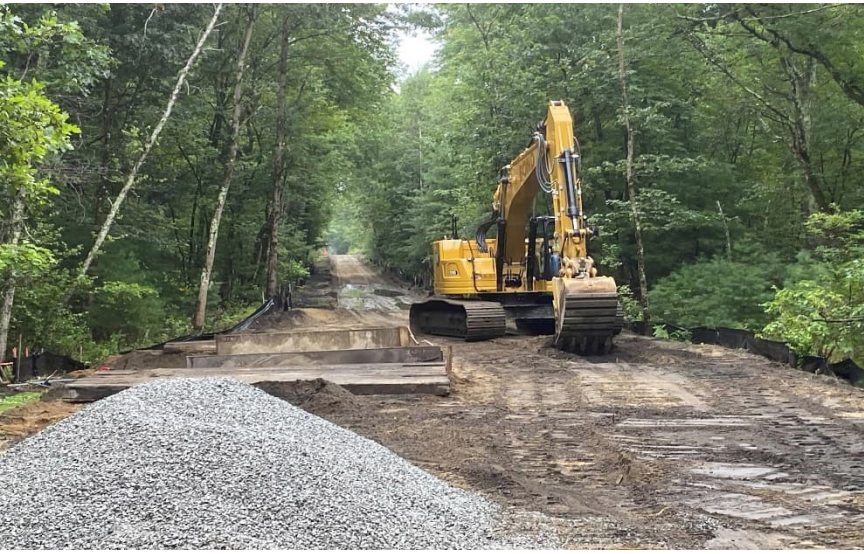
<b>PHOTOGRAPHIC LOG</b>	
Client Name: Eversource		Site Location: Sudbury to Hudson Transmission Reliability Project	Town: Hudson
Photo No.: 4	Date: 8-16-23

Description:  Manhole work (#14) within segment 6, existing erosion control, looking eastward.

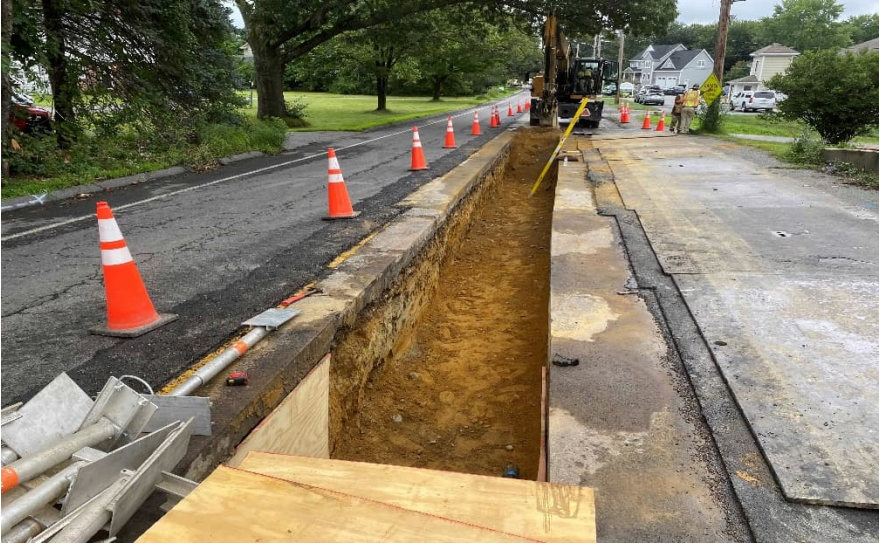
<b>PHOTOGRAPHIC LOG</b>	
Client Name: Eversource		Site Location: Sudbury to Hudson Transmission Reliability Project	Town: Hudson
Photo No.: 5	Date: 8-16-23

Description:  Conduit work within Forest Avenue (from manhole #2), looking northward.

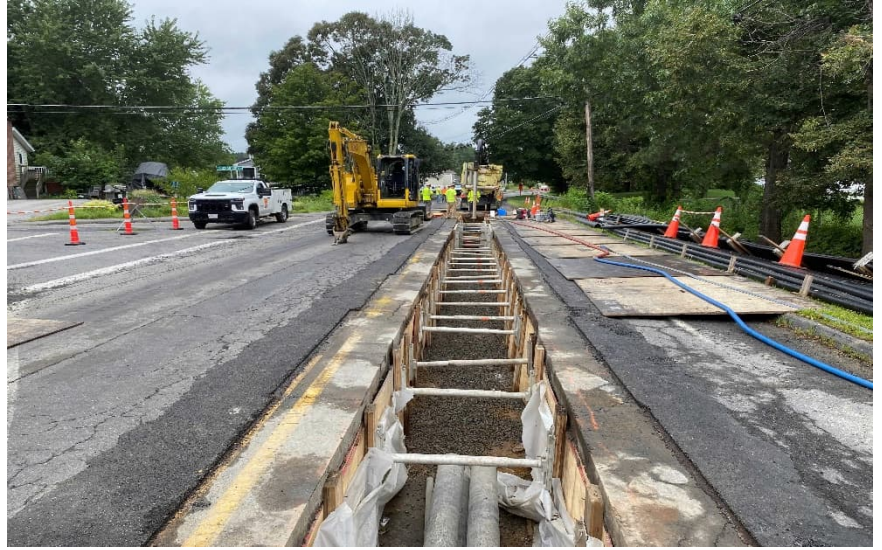
<b>PHOTOGRAPHIC LOG</b>	
Client Name: Eversource		Site Location: Sudbury to Hudson Transmission Reliability Project	Town: Hudson
Photo No.: 6	Date: 8-16-23

Description:  Conduit work within Forest Avenue (from manhole #3), heading northward.

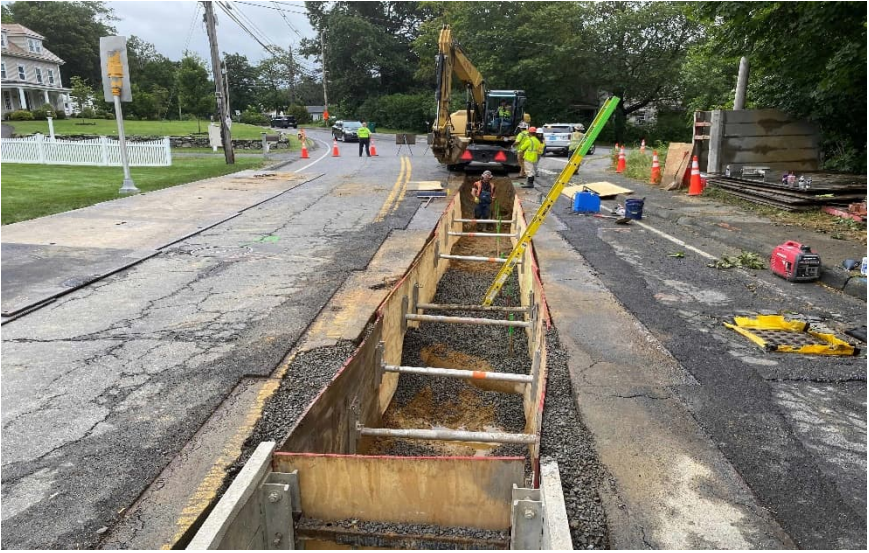
<b>PHOTOGRAPHIC LOG</b>	
Client Name: Eversource		Site Location: Sudbury to Hudson Transmission Reliability Project	Town: Hudson
Photo No.: 7	Date: 8-16-23

Description:  Conduit work within Forest Avenue (from manhole #3), heading southward.

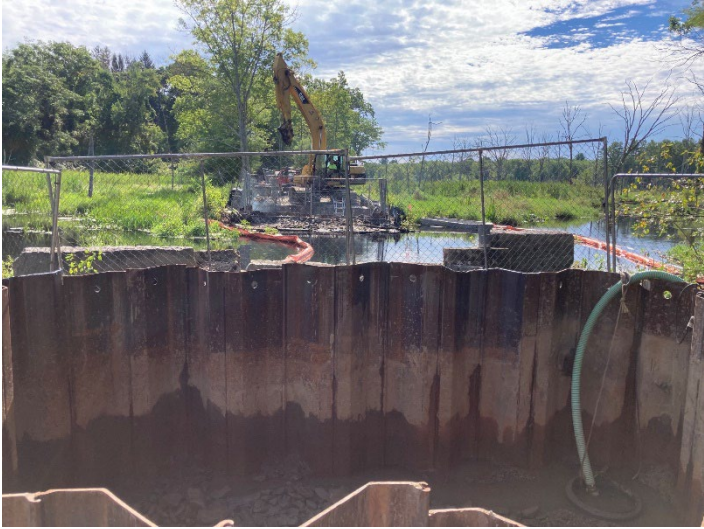
<b>PHOTOGRAPHIC LOG</b>		
<b>Client Name:</b> Eversource		<b>Site Location:</b> Sudbury to Hudson Transmission Reliability Project		<b>Town:</b> Sudbury
<b>Photo No.:</b> 1	<b>Date:</b> 8/14/2023

<b>Description:</b> View of work area and pumping operation at cofferdam at Bridge 127 work at Hop Brook. Facing east.

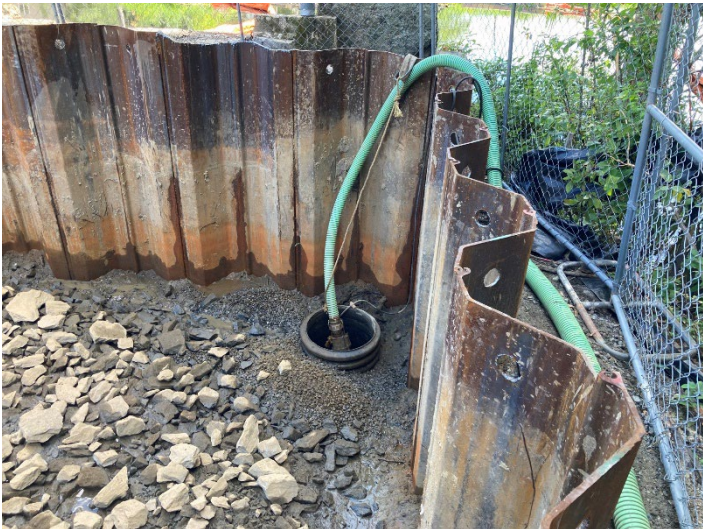
<b>PHOTOGRAPHIC LOG</b>		
<b>Client Name:</b> Eversource		<b>Site Location:</b> Sudbury to Hudson Transmission Reliability Project		<b>Town:</b> Sudbury
<b>Photo No.:</b> 2	<b>Date:</b> 8/14/2023

<b>Description:</b> Unable to visualize water in sump prior to treatment. Facing east.

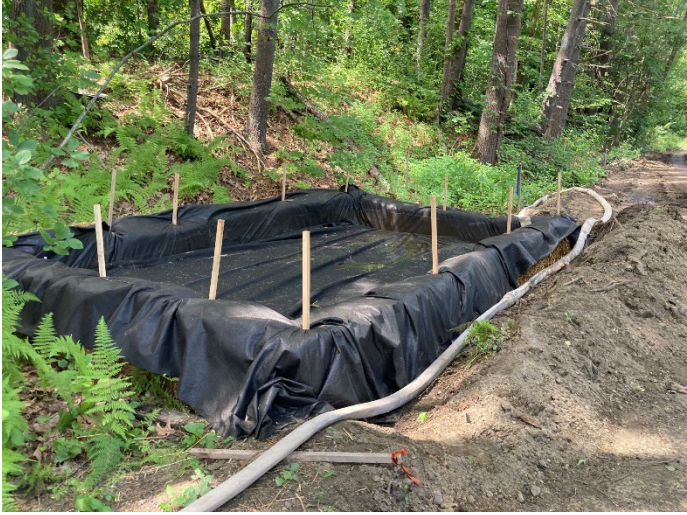
<b>PHOTOGRAPHIC LOG</b>		
<b>Client Name:</b> Eversource		<b>Site Location:</b> Sudbury to Hudson Transmission Reliability Project		<b>Town:</b> Sudbury
<b>Photo No.:</b> 3	<b>Date:</b> 8/14/2023

<b>Description:</b> View of dewatering controls (straw bale corral with filter fabric, stone, and silt bag). Facing southwest.

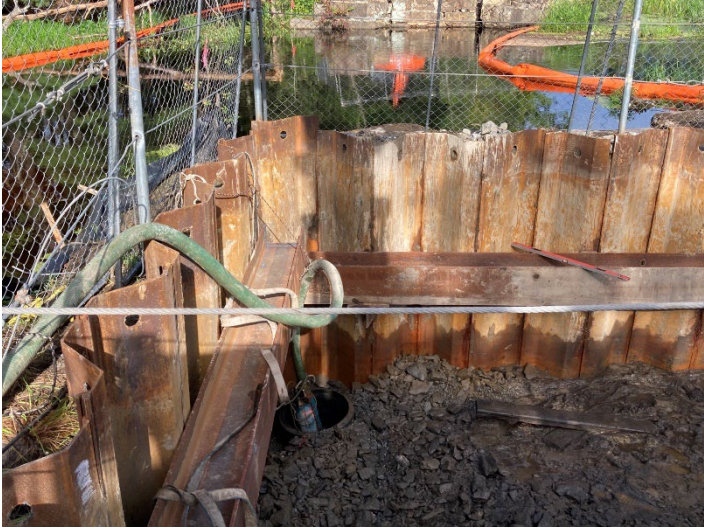
<b>PHOTOGRAPHIC LOG</b>		
<b>Client Name:</b> Eversource		<b>Site Location:</b> Sudbury to Hudson Transmission Reliability Project		<b>Town:</b> Sudbury
<b>Photo No.:</b> 1	<b>Date:</b> 8/14/2023

<b>Description:</b> View of work area and pumping operation at cofferdam at Bridge 127 work at Hop Brook. Unable to visualize water in sump prior to treatment. Facing west.

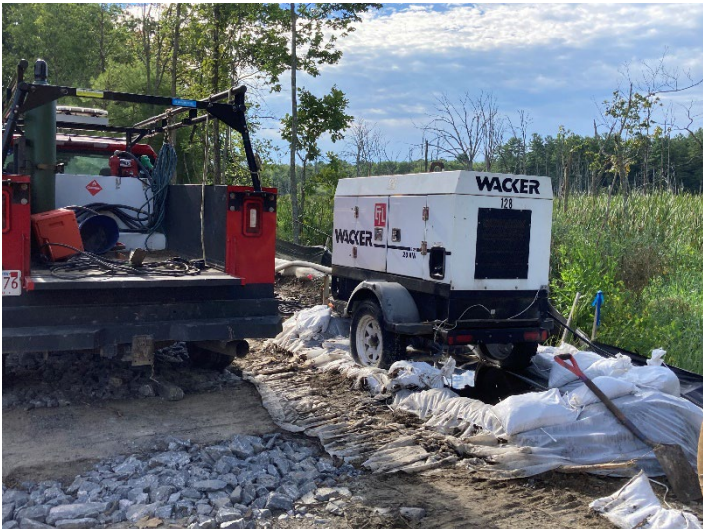
<b>PHOTOGRAPHIC LOG</b>		
<b>Client Name:</b> Eversource		<b>Site Location:</b> Sudbury to Hudson Transmission Reliability Project		<b>Town:</b> Sudbury
<b>Photo No.:</b> 2	<b>Date:</b> 8/14/2023

<b>Description:</b> View of generator being used for pumping operation. Generator has been placed in lined pit for spill prevention. Facing southeast.

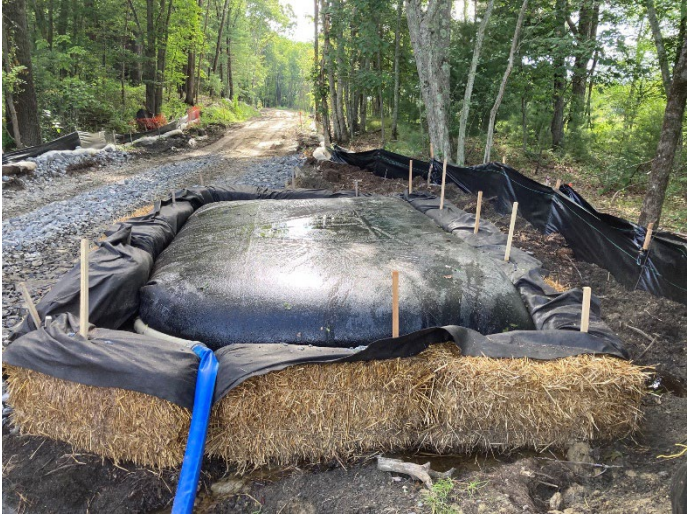
<b>PHOTOGRAPHIC LOG</b>		
<b>Client Name:</b> Eversource		<b>Site Location:</b> Sudbury to Hudson Transmission Reliability Project		<b>Town:</b> Sudbury
<b>Photo No.:</b> 3	<b>Date:</b> 8/14/2023

<b>Description:</b> View of dewatering controls (straw bale corral with filter fabric, stone, and silt bag). Facing east.

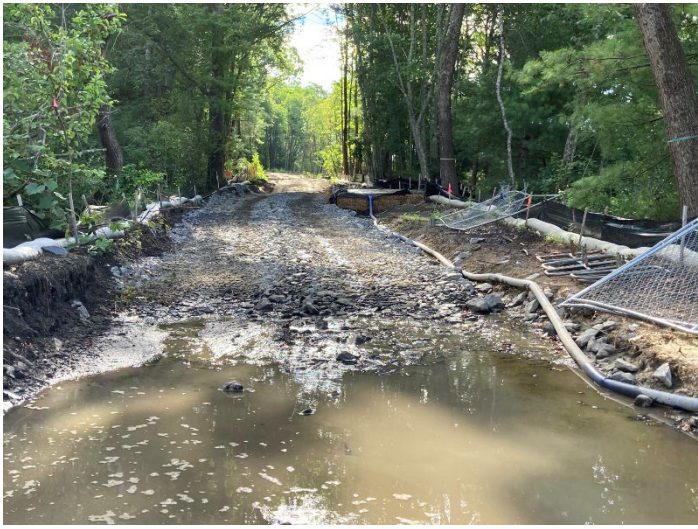
<b>PHOTOGRAPHIC LOG</b>		
<b>Client Name:</b> Eversource		<b>Site Location:</b> Sudbury to Hudson Transmission Reliability Project		<b>Town:</b> Sudbury
<b>Photo No.:</b> 4	<b>Date:</b> 8/14/2023

<b>Description:</b> View of discharge from straw bale corral. Discharge did not appear to be leaving the project at time of inspection but is within 100 ft of wetland. Discharge appeared slightly turbid. Turbidity reading was less than 50 NTUs. Facing east.

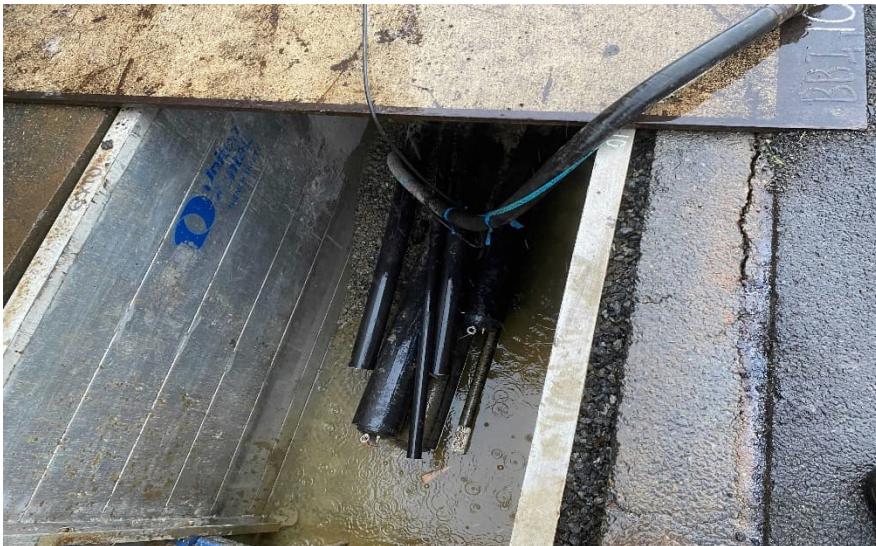
<b>PHOTOGRAPHIC LOG</b>	
Client Name: Eversource		Site Location: Sudbury to Hudson Transmission Reliability Project	Town: Hudson
Photo No.: 1	Date: 8/15/2023

Description: View of area being pumped at Forest Avenue (area in conduit trench), looking northward.

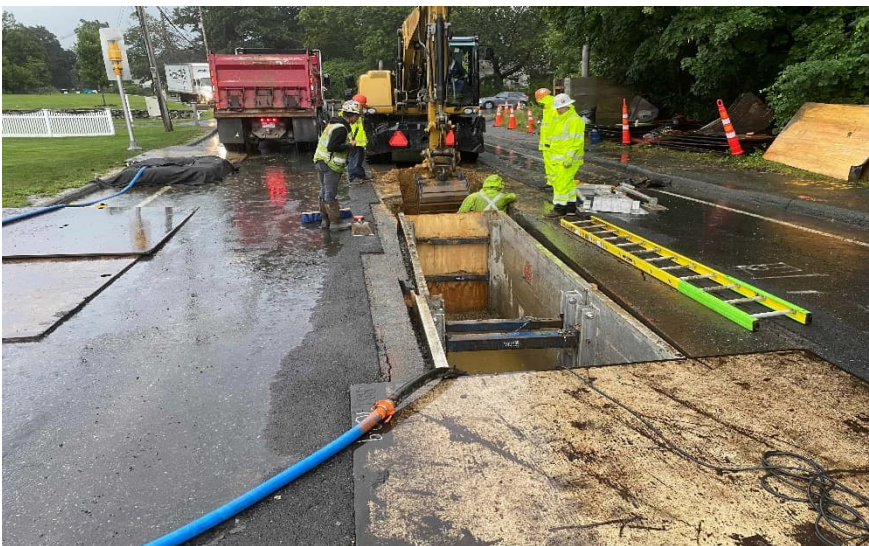
<b>PHOTOGRAPHIC LOG</b>	
Client Name: Eversource		Site Location: Sudbury to Hudson Transmission Reliability Project	Town: Hudson
Photo No.: 2	Date: 8/15/2023

Description: Forest Avenue. View of dewatering operation, looking northward.

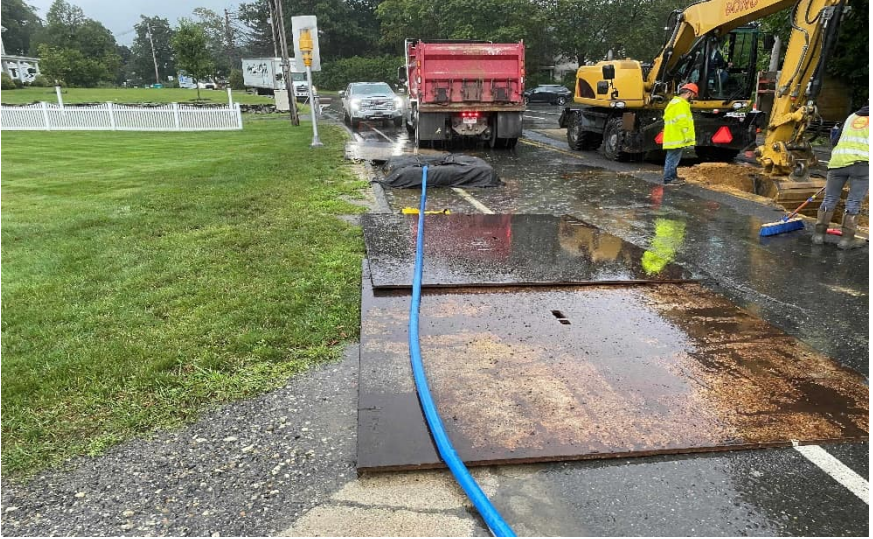
<b>PHOTOGRAPHIC LOG</b>	
Client Name: Eversource		Site Location: Sudbury to Hudson Transmission Reliability Project	Town: Hudson
Photo No.: 3	Date: 8/15/2023

Description: Forest Avenue. View of dewatering operation (pumping at far end of area), looking northward.

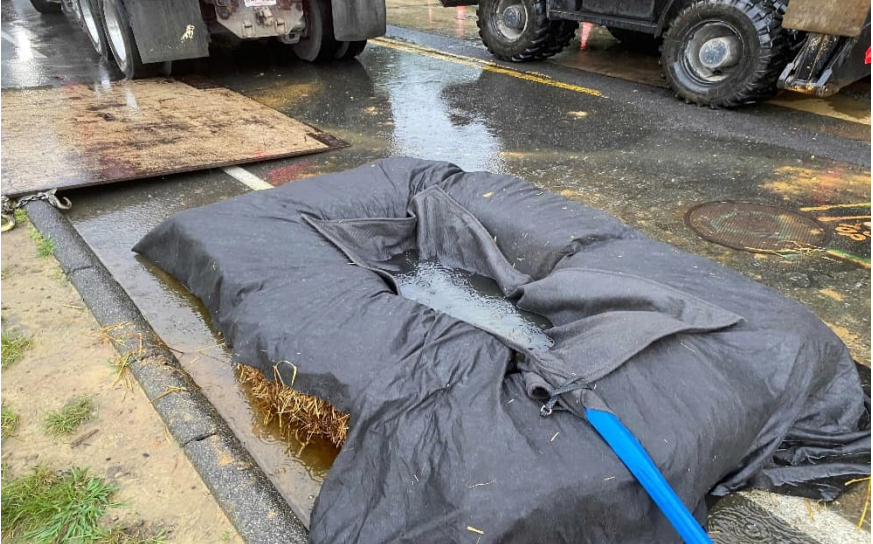
<b>PHOTOGRAPHIC LOG</b>	
Client Name: Eversource		Site Location: Sudbury to Hudson Transmission Reliability Project	Town: Hudson
Photo No.: 4	Date: 8/15/2023

Description: Forest Avenue. View of dewatering operation (corrugated bag), looking northward.

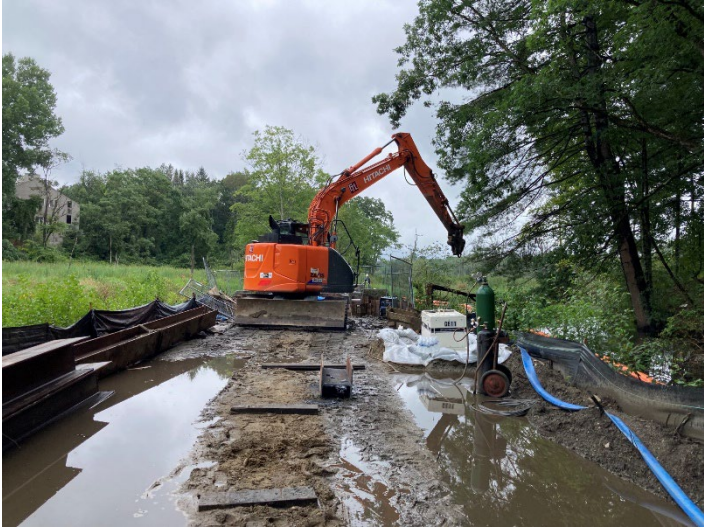
<b>PHOTOGRAPHIC LOG</b>		
<b>Client Name:</b> Eversource		<b>Site Location:</b> Sudbury to Hudson Transmission Reliability Project		<b>Town:</b> Sudbury
<b>Photo No.:</b> 1	<b>Date:</b> 8/15/2023

<b>Description:</b> View of work area and pumping operation at Bridge 127 work at Hop Brook. Facing east.

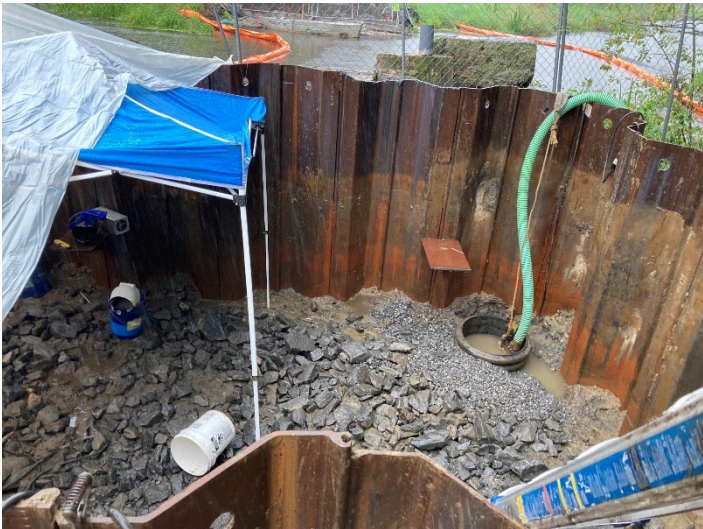
<b>PHOTOGRAPHIC LOG</b>		
<b>Client Name:</b> Eversource		<b>Site Location:</b> Sudbury to Hudson Transmission Reliability Project		<b>Town:</b> Sudbury
<b>Photo No.:</b> 2	<b>Date:</b> 8/15/2023

<b>Description:</b> View of water in sump prior to treatment. Water appeared to be slightly turbid. Facing east.

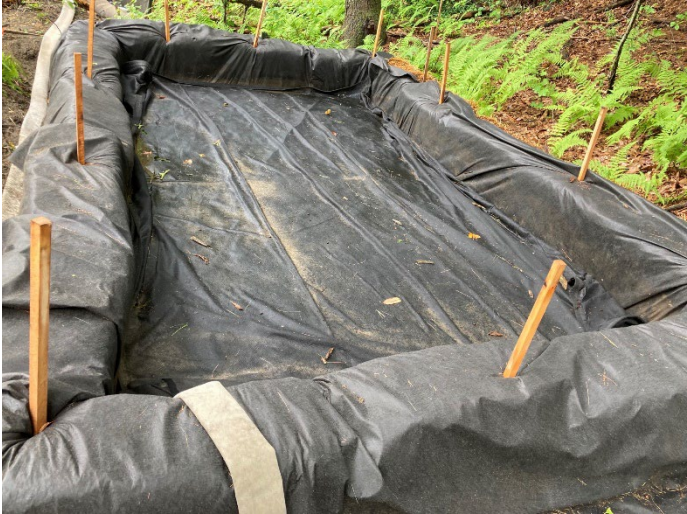
<b>Photo No.:</b> 3	<b>Date:</b> 8/15/2023		
<b>Description:</b> View of dewatering controls (straw bale corral with filter fabric, stone, and silt bag). Facing east.

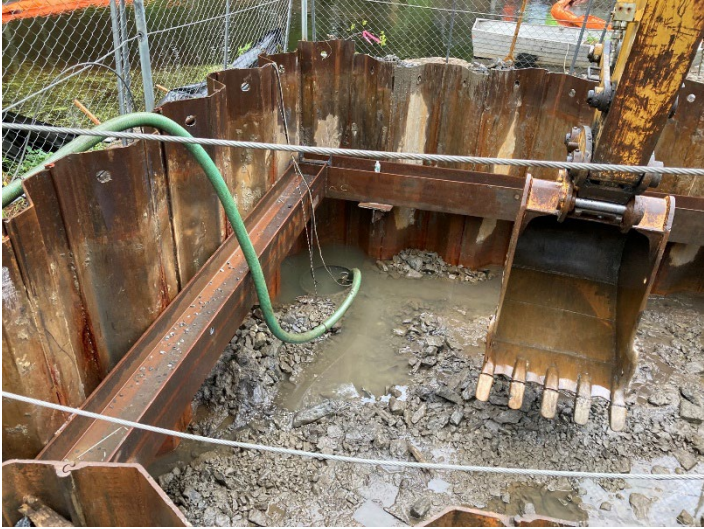
<b>PHOTOGRAPHIC LOG</b>		
<b>Client Name:</b> Eversource		<b>Site Location:</b> Sudbury to Hudson Transmission Reliability Project		<b>Town:</b> Sudbury
<b>Photo No.:</b> 1	<b>Date:</b> 8/15/2023

<b>Description:</b> View of work area and pumping operation at cofferdam at Bridge 127 work at Hop Brook. Water appeared slightly turbid prior to treatment. Facing west.

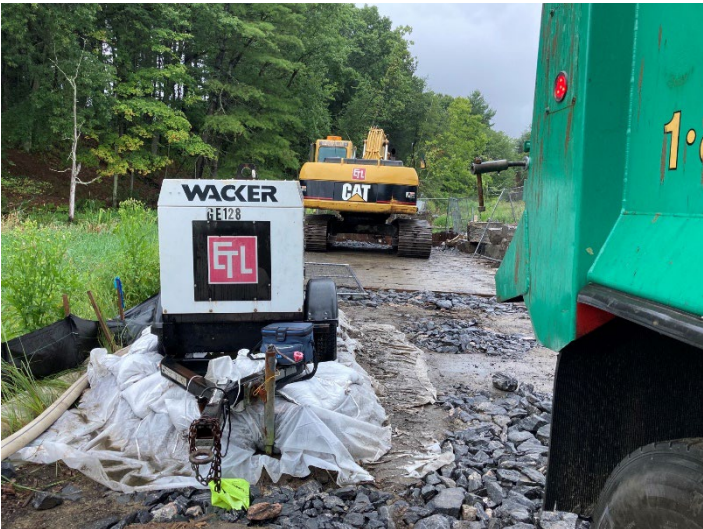
<b>PHOTOGRAPHIC LOG</b>		
<b>Client Name:</b> Eversource		<b>Site Location:</b> Sudbury to Hudson Transmission Reliability Project		<b>Town:</b> Sudbury
<b>Photo No.:</b> 2	<b>Date:</b> 8/15/2023

<b>Description:</b> View of generator being used for pumping operation. Generator has been placed in lined pit for spill prevention. Facing west.

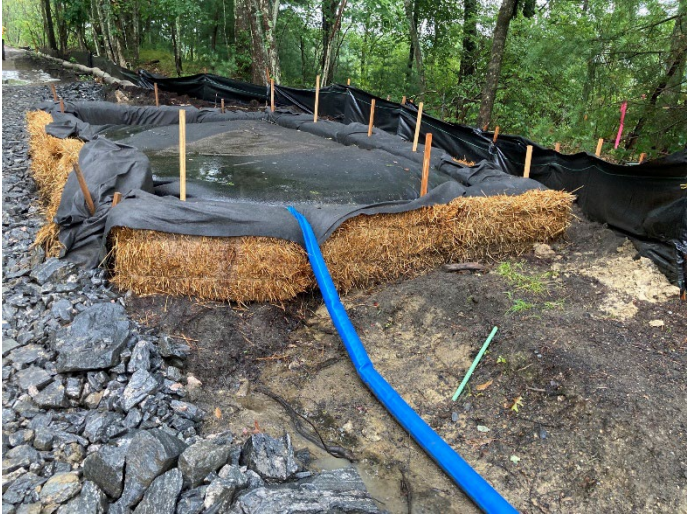
<b>PHOTOGRAPHIC LOG</b>	
<b>Client Name:</b> Eversource		<b>Site Location:</b> Sudbury to Hudson Transmission Reliability Project	<b>Town:</b> Sudbury
<b>Photo No.:</b> 3	<b>Date:</b> 8/15/2023

<b>Description:</b> View of dewatering controls (straw bale corral with filter fabric, stone, and silt bag) and discharge from controls. Discharge did not appear to be leaving the project at time of inspection but is within 100 ft of wetland. Water appeared slightly turbid. Turbidity reading was higher than 50 NTUs. Facing east.

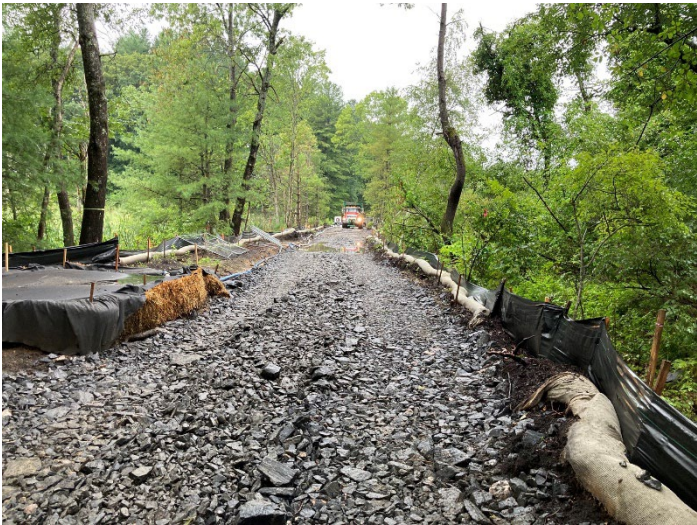
<b>PHOTOGRAPHIC LOG</b>	
<b>Client Name:</b> Eversource		<b>Site Location:</b> Sudbury to Hudson Transmission Reliability Project	<b>Town:</b> Sudbury
<b>Photo No.:</b> 4	<b>Date:</b> 8/15/2023

<b>Description:</b> Additional view of pumping/dewatering operation. Facing west.

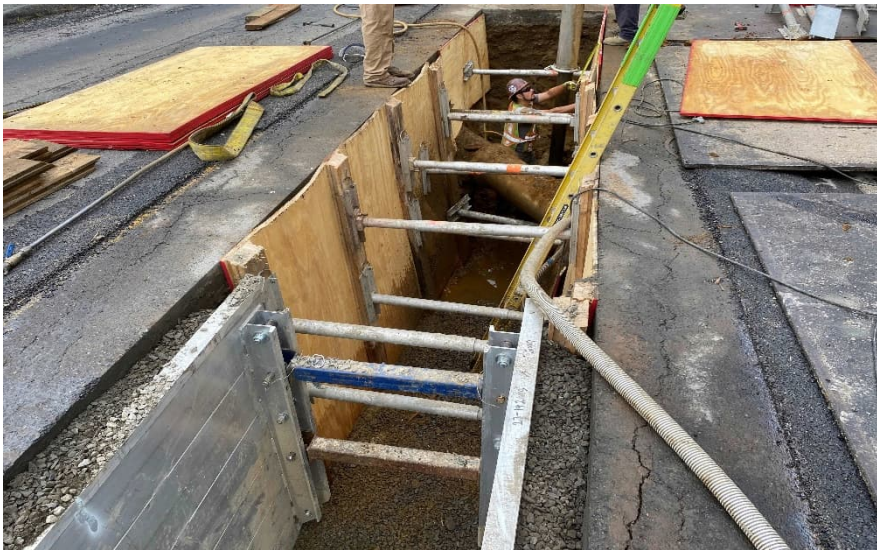
<b>PHOTOGRAPHIC LOG</b>	
Client Name: Eversource		Site Location: Sudbury to Hudson Transmission Reliability Project	Town: Hudson
Photo No.: 1	Date: 8/16/2023

Description: View of area being pumped at Forest Avenue (area in conduit trench), looking northward.

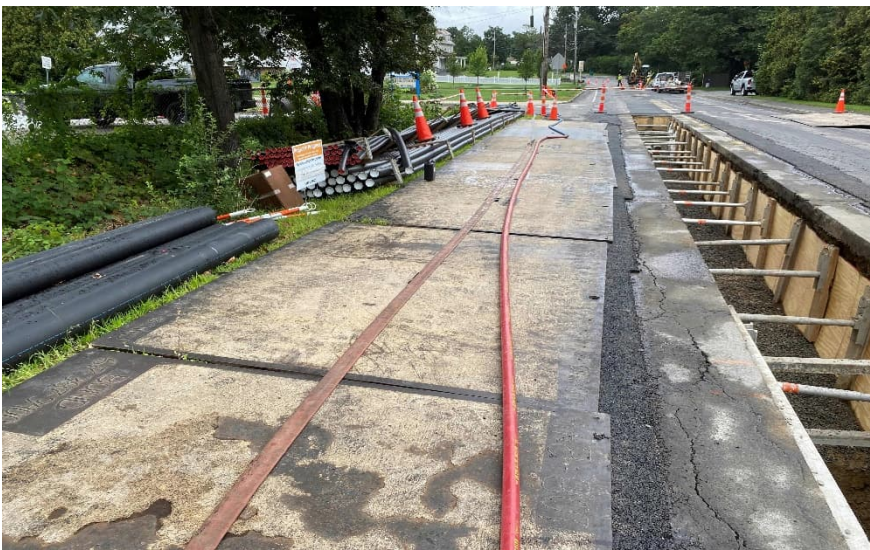
<b>PHOTOGRAPHIC LOG</b>	
Client Name: Eversource		Site Location: Sudbury to Hudson Transmission Reliability Project	Town: Hudson
Photo No.: 2	Date: 8/16/2023

Description: Forest Avenue. View of dewatering operation, looking southward.

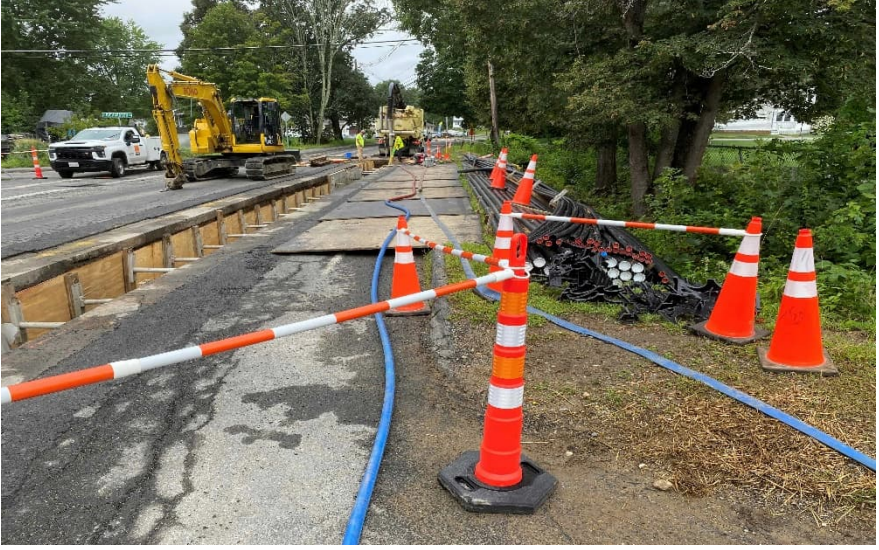
<b>PHOTOGRAPHIC LOG</b>	
Client Name: Eversource		Site Location: Sudbury to Hudson Transmission Reliability Project	Town: Hudson
Photo No.: 3	Date: 8/16/2023

Description: Forest Avenue. View of dewatering operation (pumping at far end of area), looking northward.

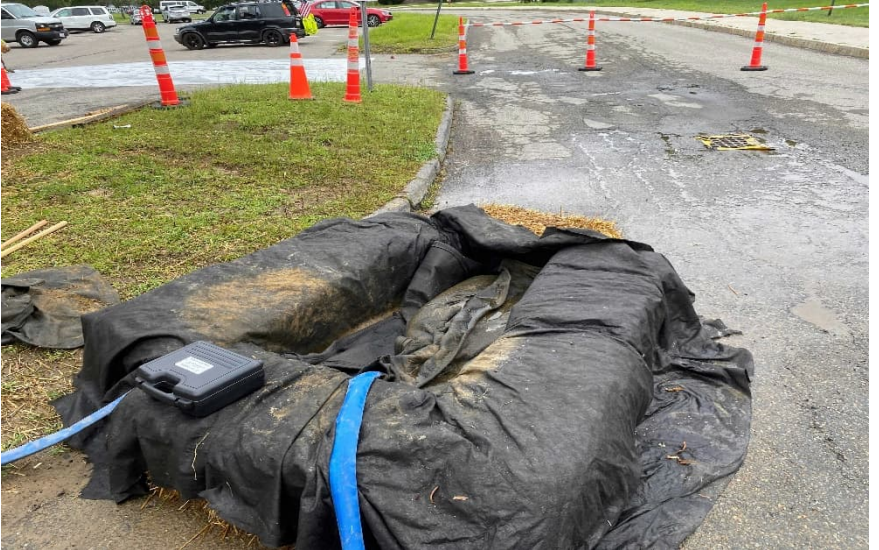
<b>PHOTOGRAPHIC LOG</b>	
Client Name: Eversource		Site Location: Sudbury to Hudson Transmission Reliability Project	Town: Hudson
Photo No.: 4	Date: 8/16/2023

Description: Forest Avenue. View of dewatering operation (corral/bag), looking southward.
