**Weekly Environmental Compliance Summary**

**Sudbury to Hudson Transmission Reliability Project (USEPA Tracking # MAR1003UW)**

Sudbury, Hudson, and Stow, MA

Week of: August 14 to August 18, 2023

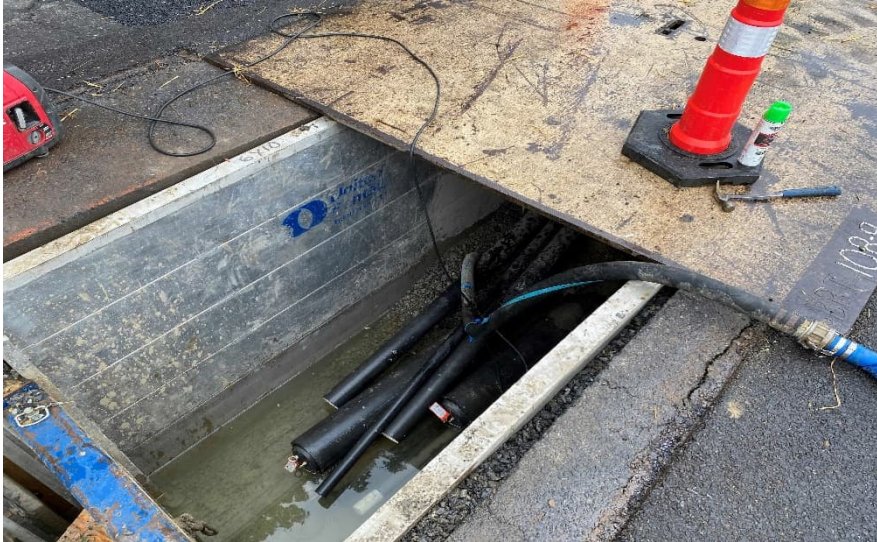
<b>PHOTOGRAPHIC LOG</b>	
Client Name: Eversource		Site Location: Sudbury to Hudson Transmission Reliability Project	Town: Hudson
Photo No.: 1	Date: 8/16/2023

Description: View of area being pumped at Forest Avenue (area in conduit trench), looking northward.

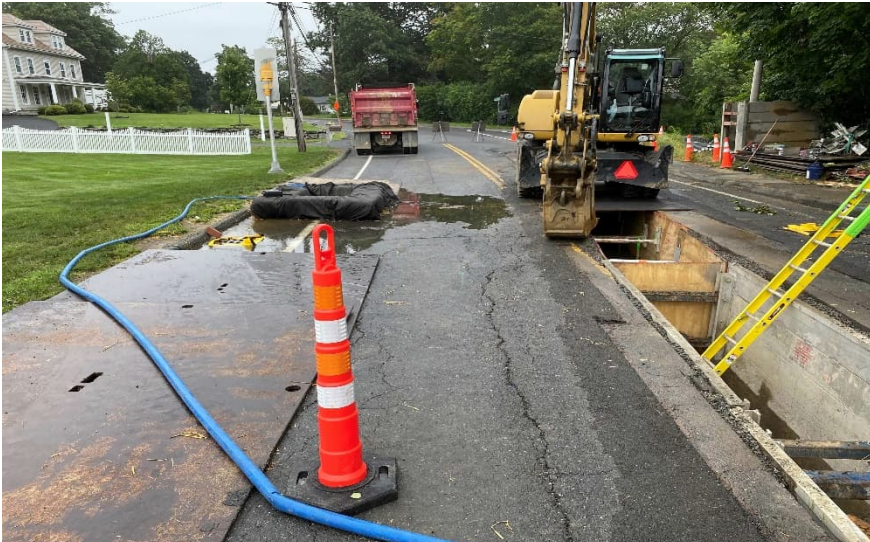
<b>PHOTOGRAPHIC LOG</b>	
Client Name: Eversource		Site Location: Sudbury to Hudson Transmission Reliability Project	Town: Hudson
Photo No.: 2	Date: 8/16/2023

Description: Forest Avenue. View of dewatering operation, looking northward.

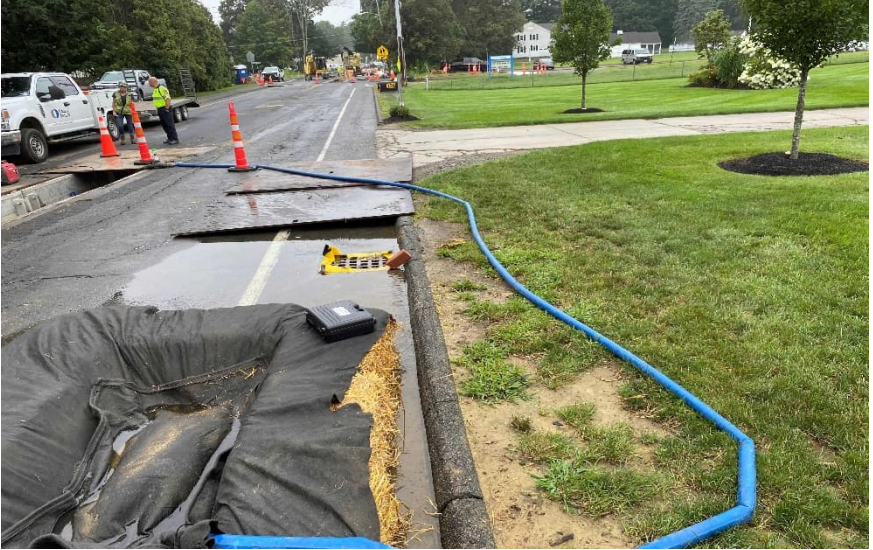
<b>PHOTOGRAPHIC LOG</b>	
Client Name: Eversource		Site Location: Sudbury to Hudson Transmission Reliability Project	Town: Hudson
Photo No.: 3	Date: 8/16/2023

Description: Forest Avenue. View of dewatering operation (pumping at far end of area), looking southward.

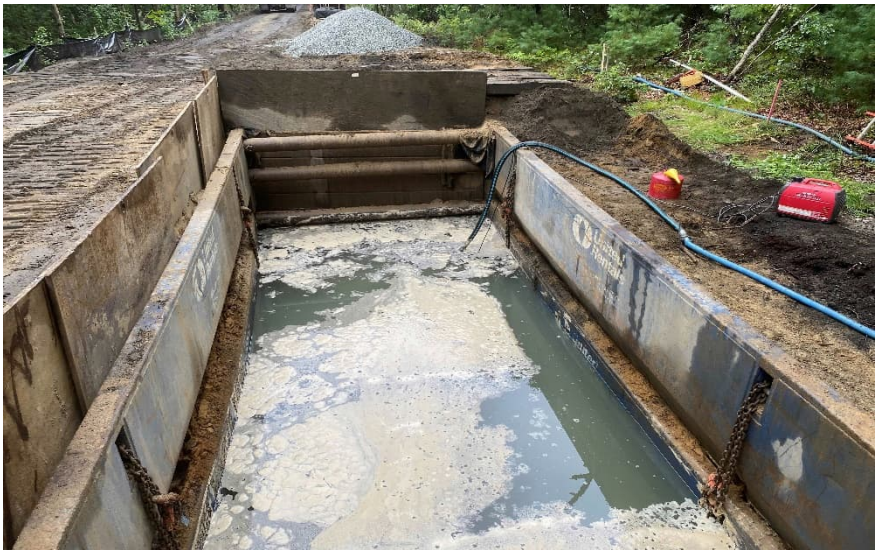
<b>PHOTOGRAPHIC LOG</b>	
Client Name: Eversource		Site Location: Sudbury to Hudson Transmission Reliability Project	Town: Hudson
Photo No.: 1	Date: 8/16/2023

Description: View of area being pumped at Segment 6, Manhole #14, looking westward.

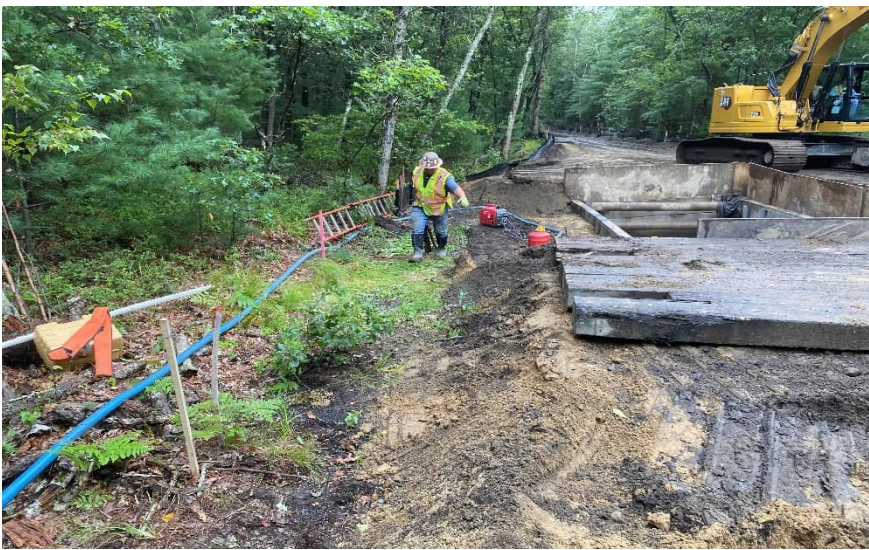
<b>PHOTOGRAPHIC LOG</b>	
Client Name: Eversource		Site Location: Sudbury to Hudson Transmission Reliability Project	Town: Hudson
Photo No.: 2	Date: 8/16/2023

Description: Segment 6. View of dewatering operation, looking eastward.

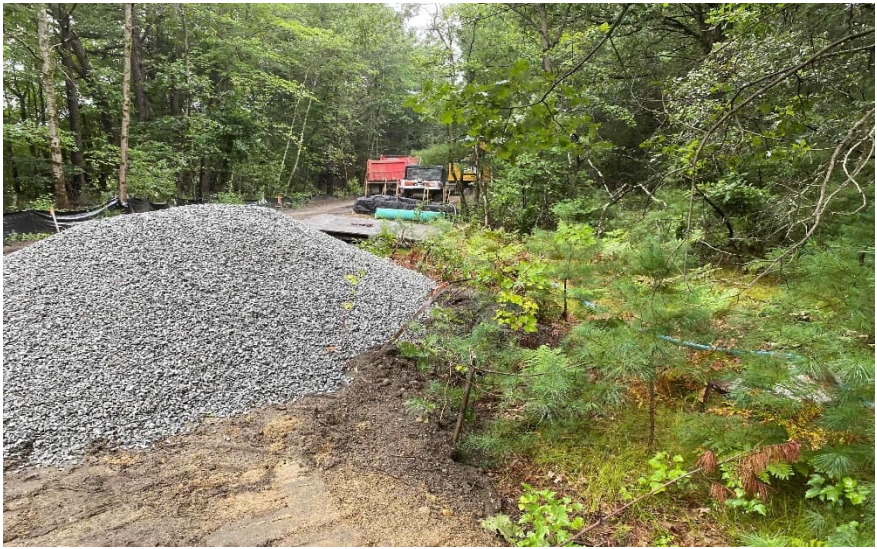
<b>PHOTOGRAPHIC LOG</b>	
Client Name: Eversource		Site Location: Sudbury to Hudson Transmission Reliability Project	Town: Hudson
Photo No.: 3	Date: 8/16/2023

Description: Segment 6. View of dewatering operation, looking eastward.

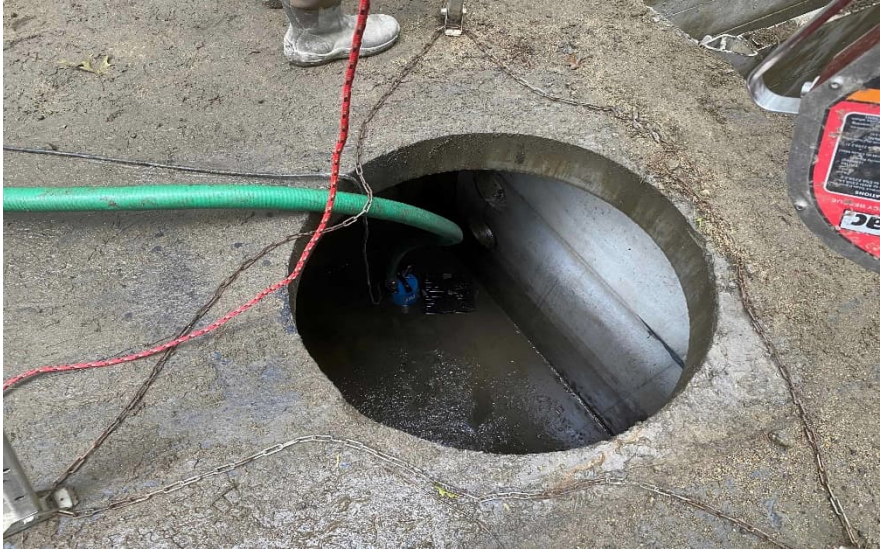
<b>PHOTOGRAPHIC LOG</b>	
Client Name: Eversource		Site Location: Sudbury to Hudson Transmission Reliability Project	Town: Sudbury
Photo No.: 1	Date: 8/16/2023

Description: View of area being pumped at Segment 8, Manhole #17, off Dutton road, looking eastward.

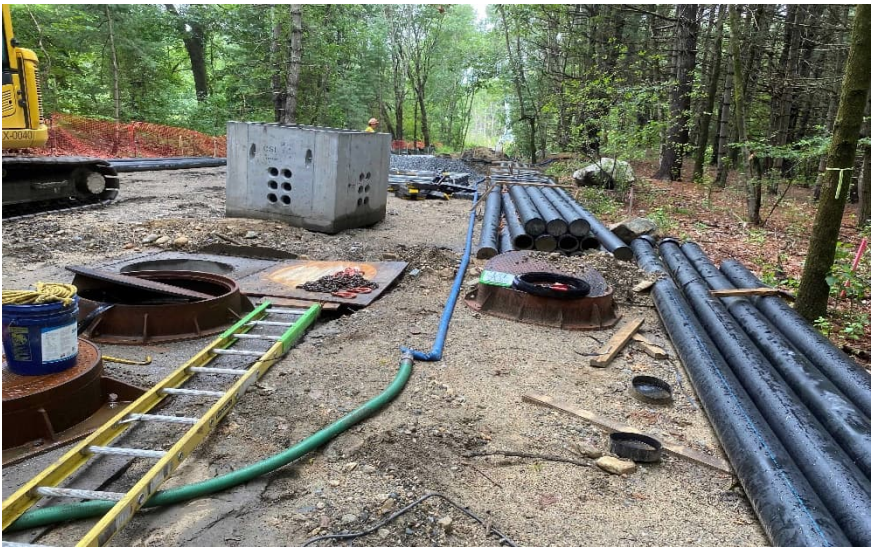
<b>PHOTOGRAPHIC LOG</b>	
Client Name: Eversource		Site Location: Sudbury to Hudson Transmission Reliability Project	Town: Sudbury
Photo No.: 2	Date: 7/21/2023

Description: Segment 8. View of dewatering operation, looking westward.

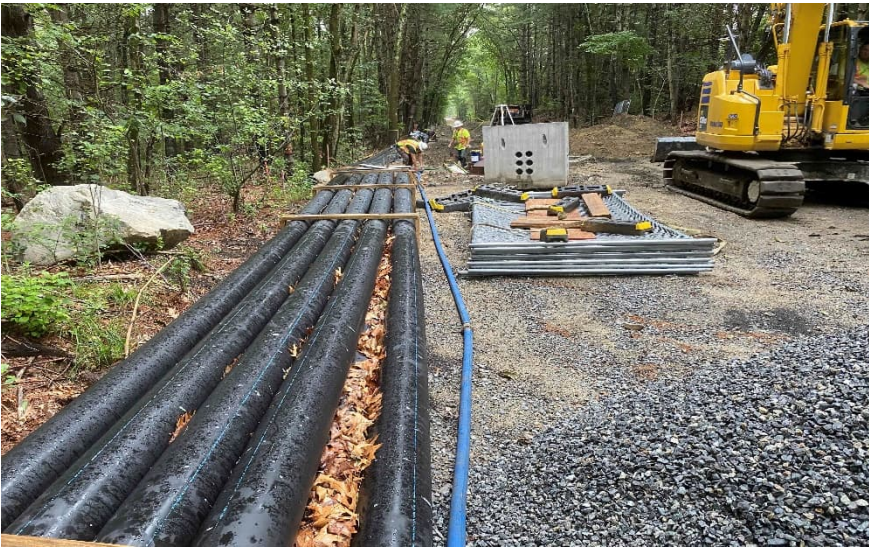
<b>PHOTOGRAPHIC LOG</b>	
Client Name: Eversource		Site Location: Sudbury to Hudson Transmission Reliability Project	Town: Sudbury
Photo No.: 3	Date: 7/21/2023

Description: Segment 8. View of dewatering operation, looking eastward.

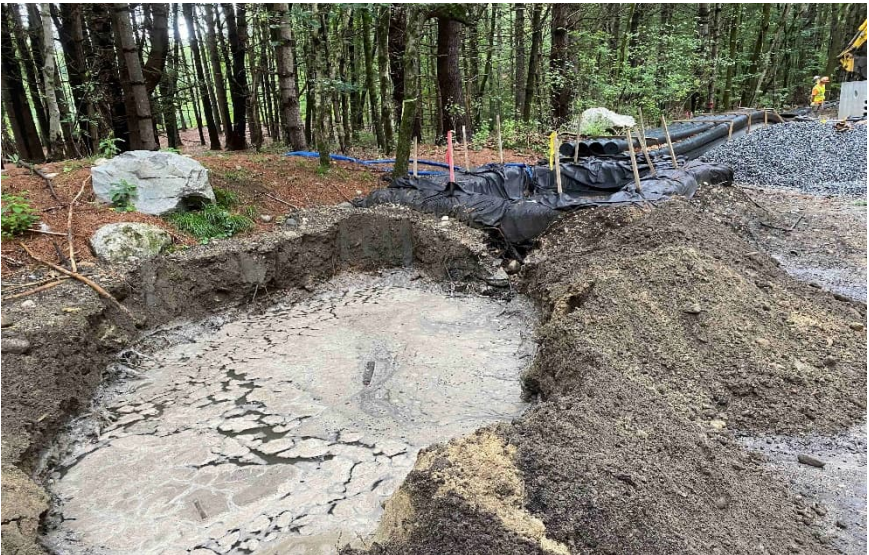
<b>PHOTOGRAPHIC LOG</b>	
Client Name: Eversource		Site Location: Sudbury to Hudson Transmission Reliability Project	Town: Sudbury
Photo No.: 4	Date: 7/21/2023

Description: Segment 8. View of discharge bag/bales/discharge hole, looking eastward. Water discharge to bag intermittent and appeared to be clear.

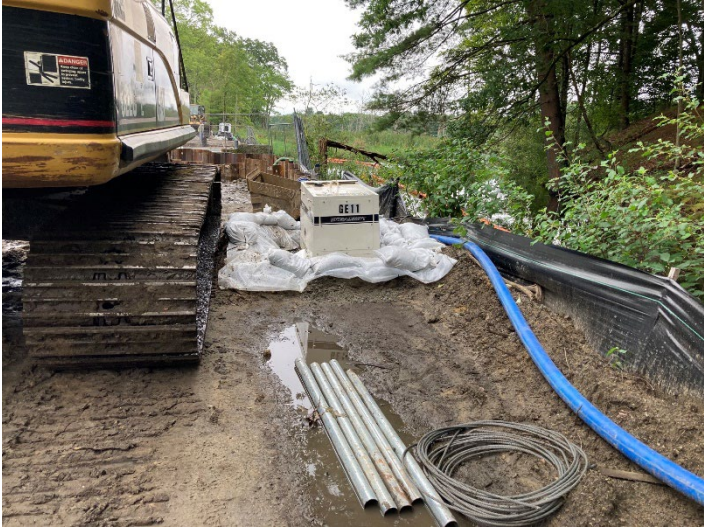
<b>PHOTOGRAPHIC LOG</b>	
<b>Client Name:</b> Eversource		<b>Site Location:</b> Sudbury to Hudson Transmission Reliability Project	<b>Town:</b> Sudbury
<b>Photo No.:</b> 1	<b>Date:</b> 8/16/2023

<b>Description:</b> View of work area and pumping operation at Bridge 127 work at Hop Brook. Facing east.

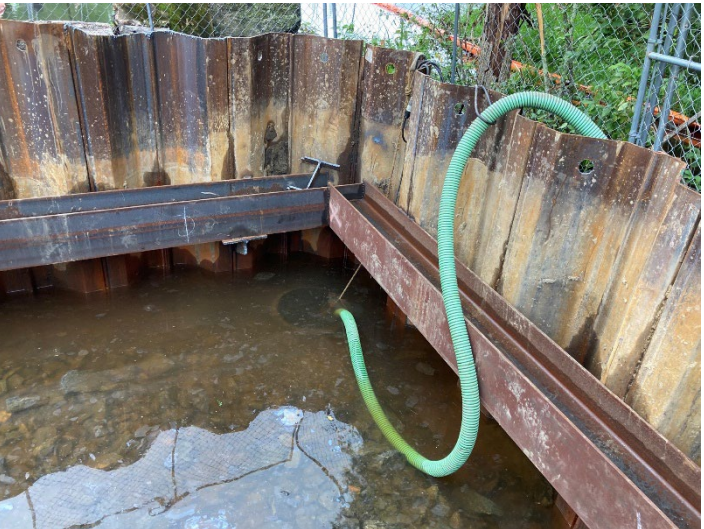
<b>PHOTOGRAPHIC LOG</b>	
<b>Client Name:</b> Eversource		<b>Site Location:</b> Sudbury to Hudson Transmission Reliability Project	<b>Town:</b> Sudbury
<b>Photo No.:</b> 2	<b>Date:</b> 8/16/2023

<b>Description:</b> View of water prior to treatment. Water appeared to be mostly clear. Facing east.

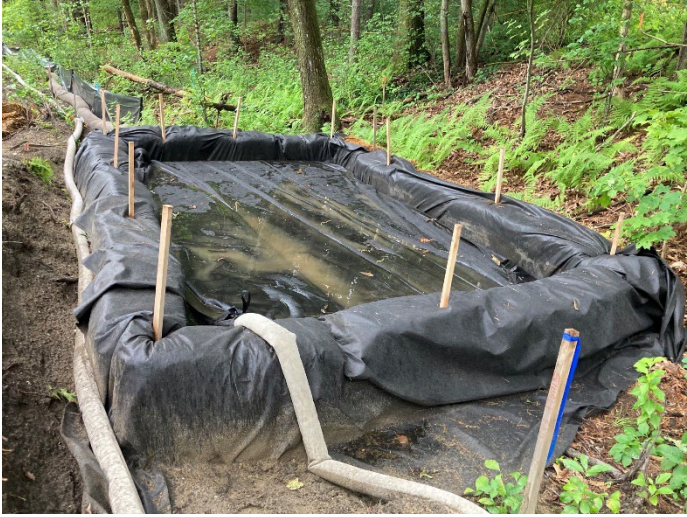
<b>PHOTOGRAPHIC LOG</b>	
<b>Client Name:</b> Eversource		<b>Site Location:</b> Sudbury to Hudson Transmission Reliability Project	<b>Town:</b> Sudbury
<b>Photo No.:</b> 3	<b>Date:</b> 8/16/2023

<b>Description:</b> View of dewatering controls (straw bale corral with filter fabric, stone, and silt bag). Facing east.

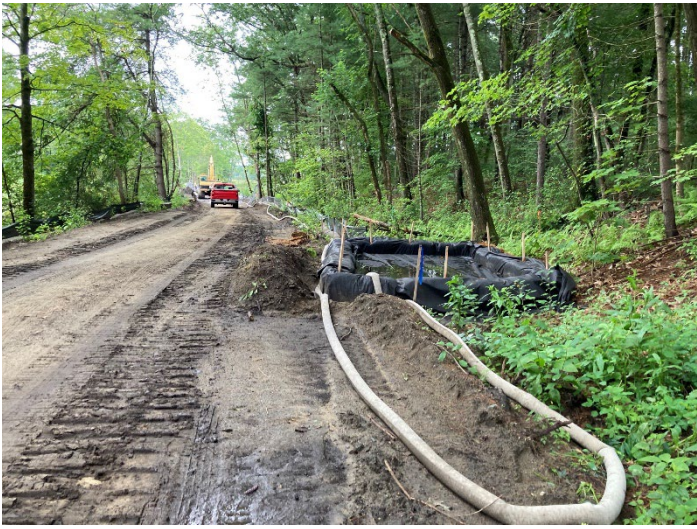
<b>PHOTOGRAPHIC LOG</b>	
<b>Client Name:</b> Eversource		<b>Site Location:</b> Sudbury to Hudson Transmission Reliability Project	<b>Town:</b> Sudbury
<b>Photo No.:</b> 4	<b>Date:</b> 8/16/2023

<b>Description:</b> Additional view of dewatering controls. No discharge from corral was observed. Facing east.

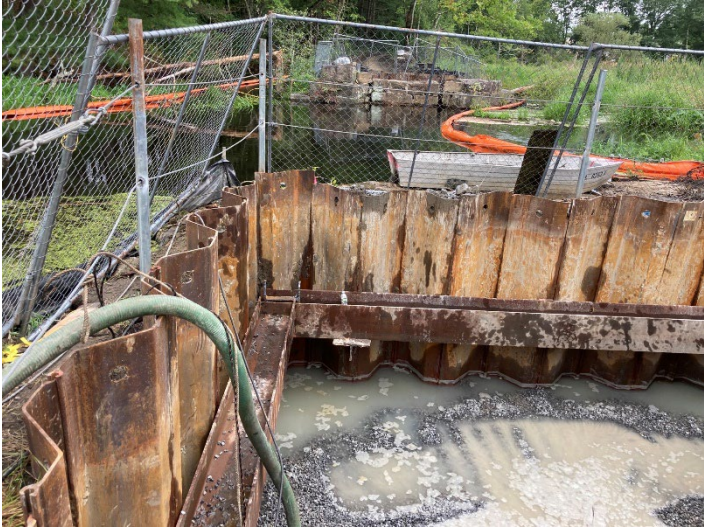
<b>PHOTOGRAPHIC LOG</b>	
<b>Client Name:</b> Eversource		<b>Site Location:</b> Sudbury to Hudson Transmission Reliability Project	<b>Town:</b> Sudbury
<b>Photo No.:</b> 1	<b>Date:</b> 8/16/2023

<b>Description:</b> View of work area and pumping operation at cofferdam at Bridge 127 work at Hop Brook. Water appeared slightly turbid prior to treatment. Facing west.

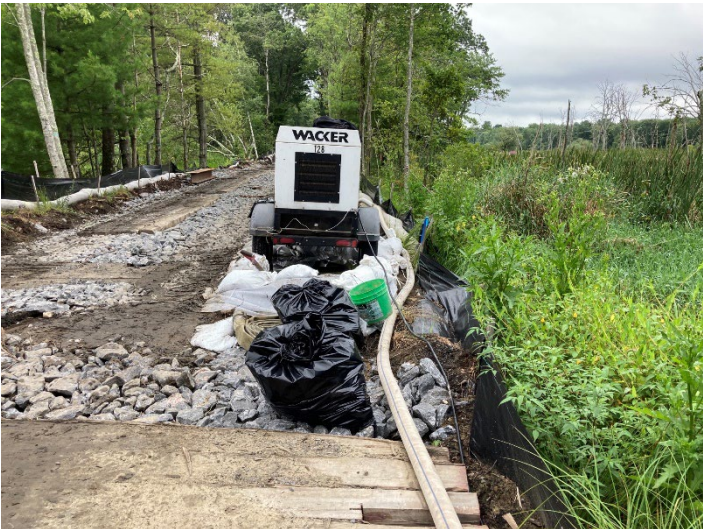
<b>PHOTOGRAPHIC LOG</b>	
<b>Client Name:</b> Eversource		<b>Site Location:</b> Sudbury to Hudson Transmission Reliability Project	<b>Town:</b> Sudbury
<b>Photo No.:</b> 2	<b>Date:</b> 8/16/2023

<b>Description:</b> View of generator being used for pumping operation. Generator has been placed in lined pit for spill prevention. Facing east.

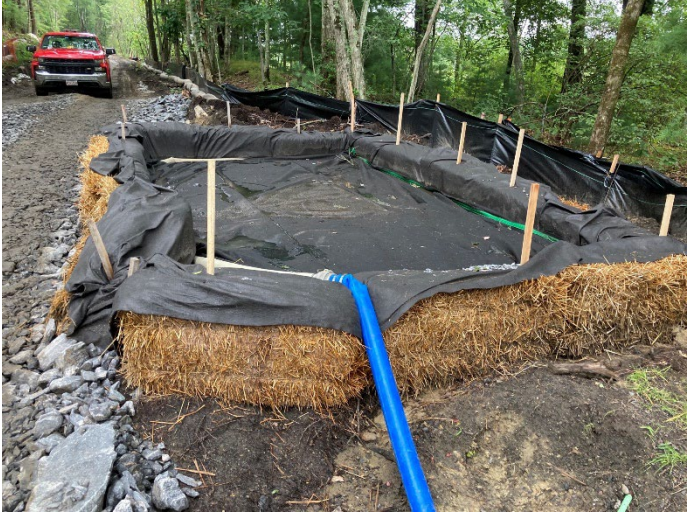
<b>Photo No.:</b> 3	<b>Date:</b> 8/16/2023		
<b>Description:</b> View of dewatering controls (straw bale corral with filter fabric, stone, and silt bag). Facing east.

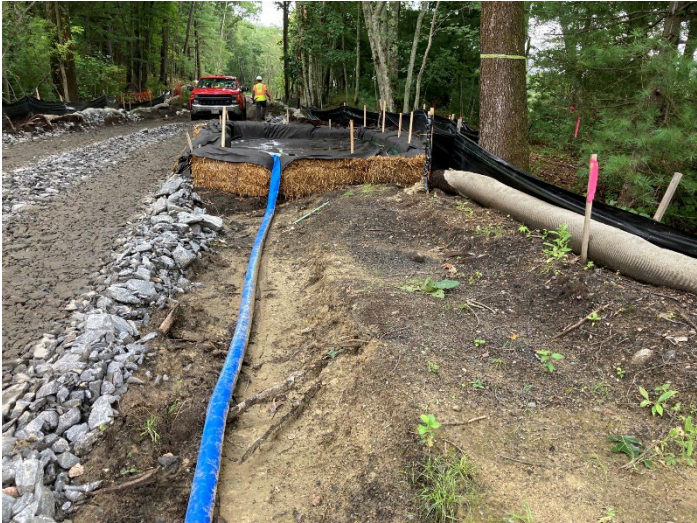
<b>Photo No.:</b> 4	<b>Date:</b> 8/16/2023		
<b>Description:</b> Additional view of dewatering controls. No discharge from corral was observed, and therefore no turbidity sampling was conducted. Facing east.

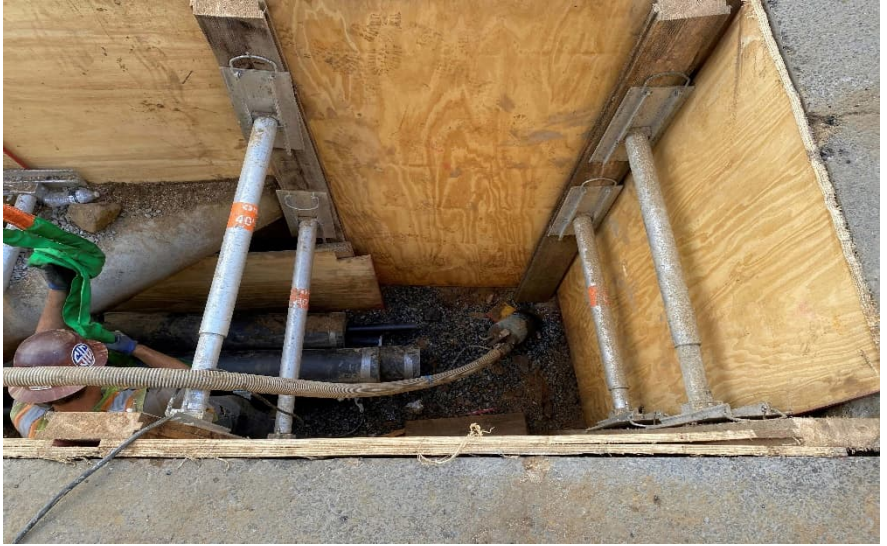
PHOTOGRAPHIC LOG	
Client Name: Eversource		Site Location: Sudbury to Hudson Transmission Reliability Project	Town: Hudson
Photo No.: 1	Date: 8/17/2023

Description: View of area being pumped at Forest Avenue (area in conduit trench), looking northward.

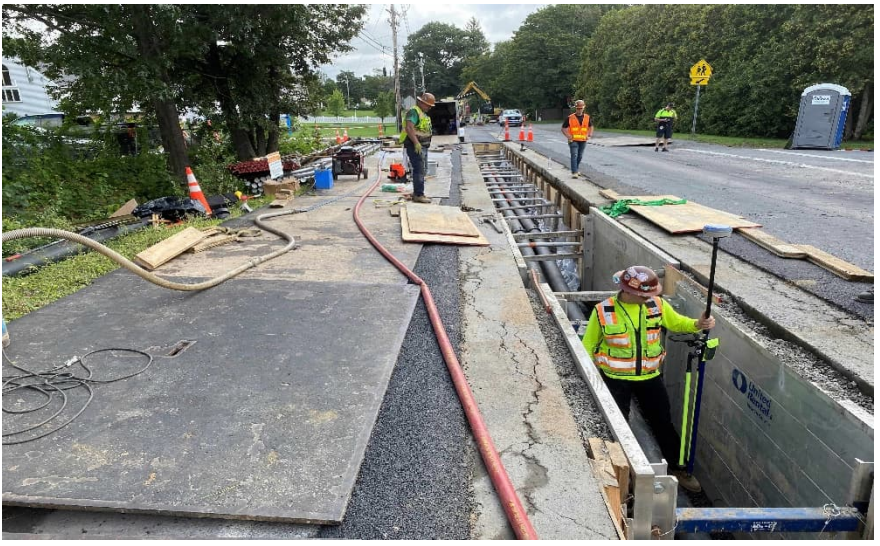
PHOTOGRAPHIC LOG	
Client Name: Eversource		Site Location: Sudbury to Hudson Transmission Reliability Project	Town: Hudson
Photo No.: 2	Date: 8/17/2023

Description: Forest Avenue. View of dewatering operation, looking southward.

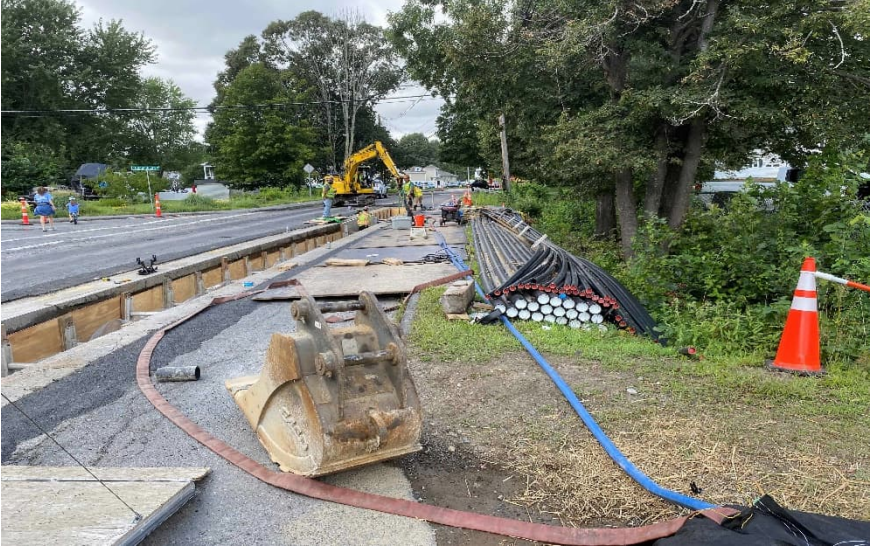
<b>PHOTOGRAPHIC LOG</b>	
Client Name: Eversource		Site Location: Sudbury to Hudson Transmission Reliability Project	Town: Hudson
Photo No.: 3	Date: 8/17/2023

Description: Forest Avenue. View of dewatering operation (pumping at far end of area), looking northward.

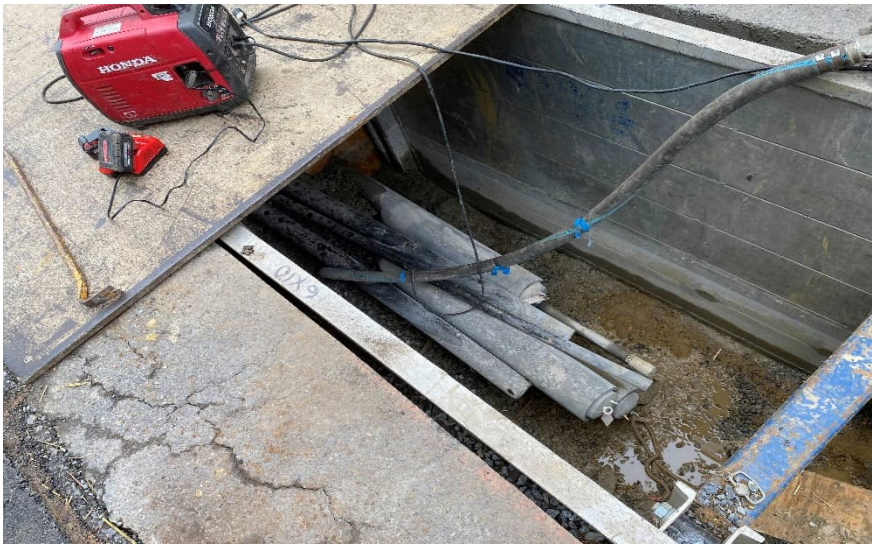
<b>PHOTOGRAPHIC LOG</b>	
Client Name: Eversource		Site Location: Sudbury to Hudson Transmission Reliability Project	Town: Hudson
Photo No.: 1	Date: 8/17/2023

Description: View of area being pumped at Forest Avenue (area in conduit trench), looking northward.

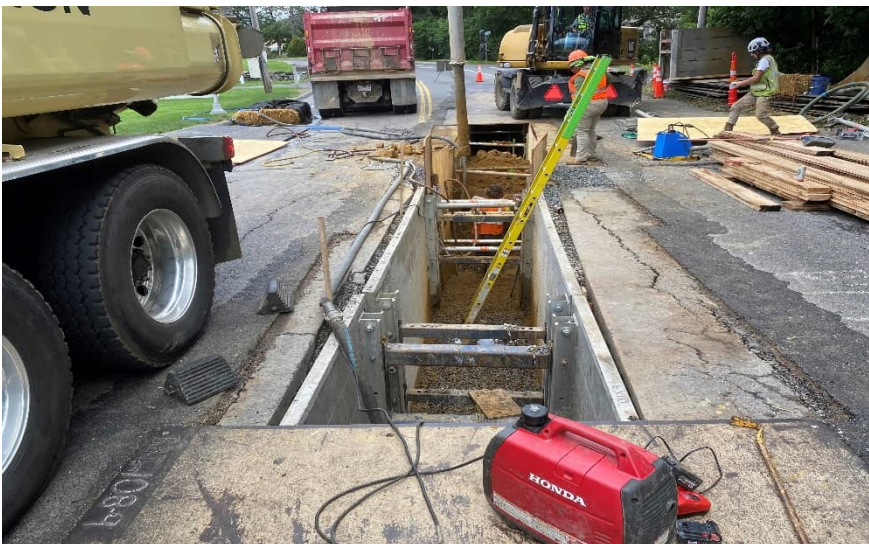
<b>PHOTOGRAPHIC LOG</b>	
Client Name: Eversource		Site Location: Sudbury to Hudson Transmission Reliability Project	Town: Hudson
Photo No.: 2	Date: 8/17/2023

Description: Forest Avenue. View of dewatering operation, looking northward.

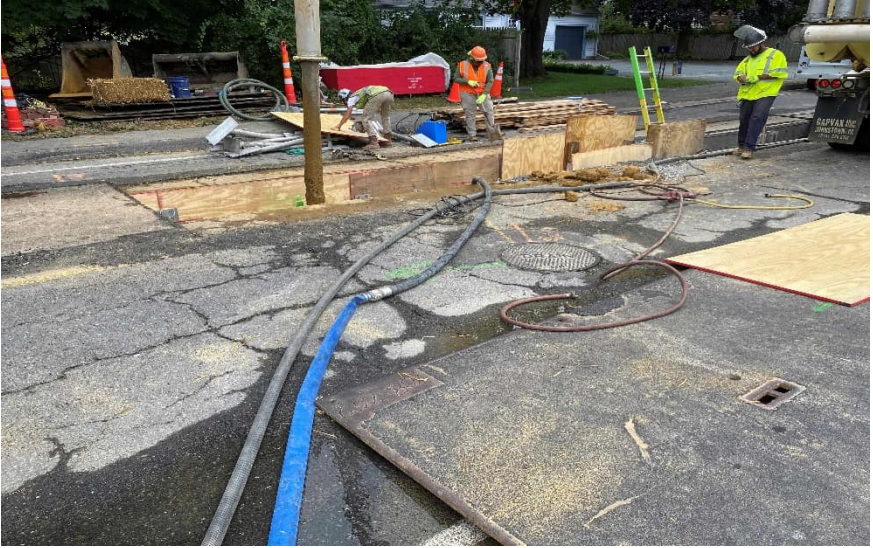
Client Name: Eversource		Site Location: Sudbury to Hudson Transmission Reliability Project	Town: Hudson
Photo No.: 3	Date: 8/17/2023

Description: Forest Avenue. View of dewatering operation (pumping at far end of area), looking southward.

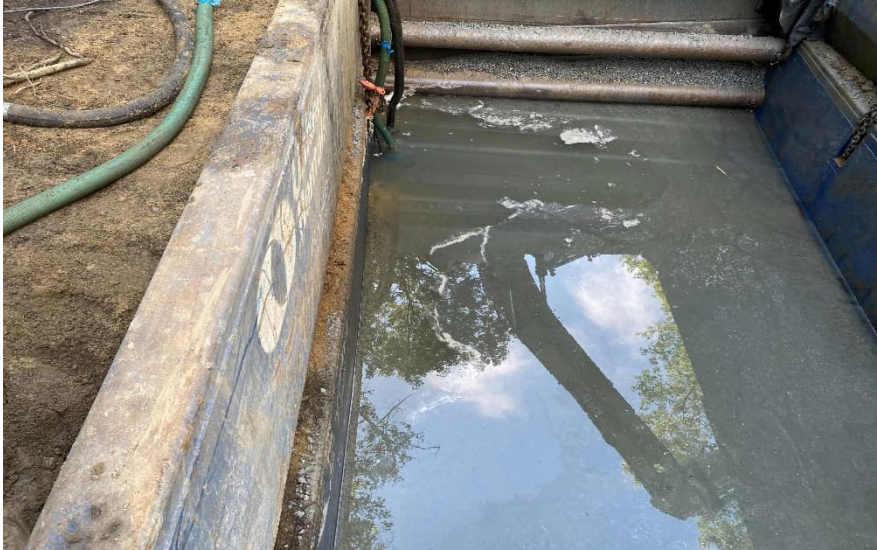
<b>PHOTOGRAPHIC LOG</b>	
Client Name: Eversource		Site Location: Sudbury to Hudson Transmission Reliability Project	Town: Hudson
Photo No.: 1	Date: 8/17/2023

Description: View of area being pumped at Segment 6, Manhole #14, looking eastward.

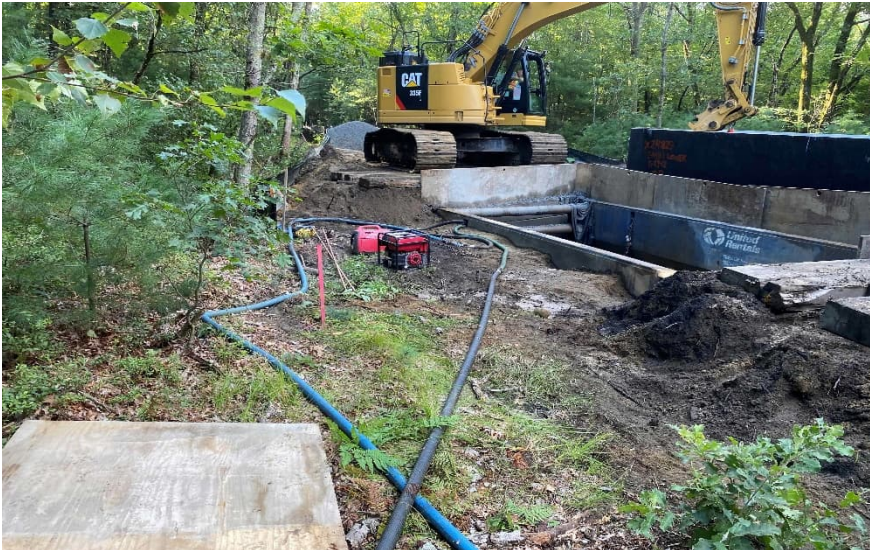
<b>PHOTOGRAPHIC LOG</b>	
Client Name: Eversource		Site Location: Sudbury to Hudson Transmission Reliability Project	Town: Hudson
Photo No.: 2	Date: 8/17/2023

Description: Segment 6. View of dewatering operation, looking eastward.

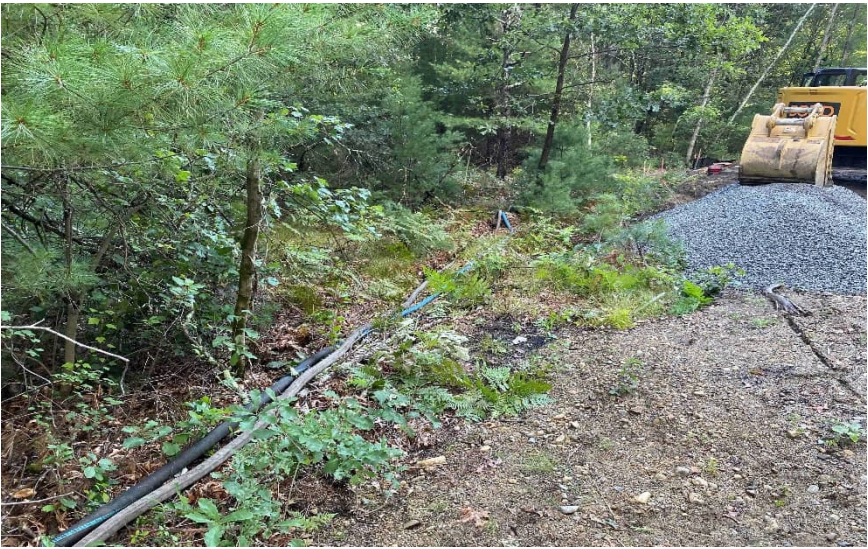
<b>PHOTOGRAPHIC LOG</b>	
Client Name: Eversource		Site Location: Sudbury to Hudson Transmission Reliability Project	Town: Hudson
Photo No.: 3	Date: 8/17/2023

Description: Segment 6. View of dewatering operation, looking eastward.

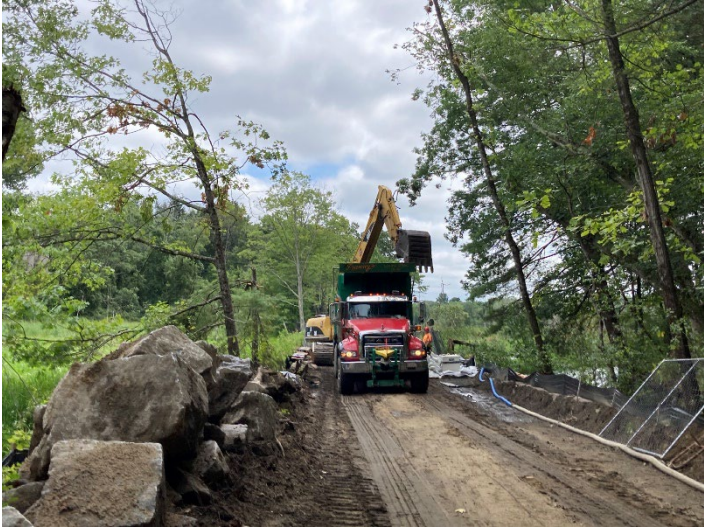
<b>PHOTOGRAPHIC LOG</b>	
<b>Client Name:</b> Eversource		<b>Site Location:</b> Sudbury to Hudson Transmission Reliability Project	<b>Town:</b> Sudbury
<b>Photo No.:</b> 1	<b>Date:</b> 8/17/2023

<b>Description:</b> View of work area and pumping operation at Bridge 127 work at Hop Brook. Facing east.

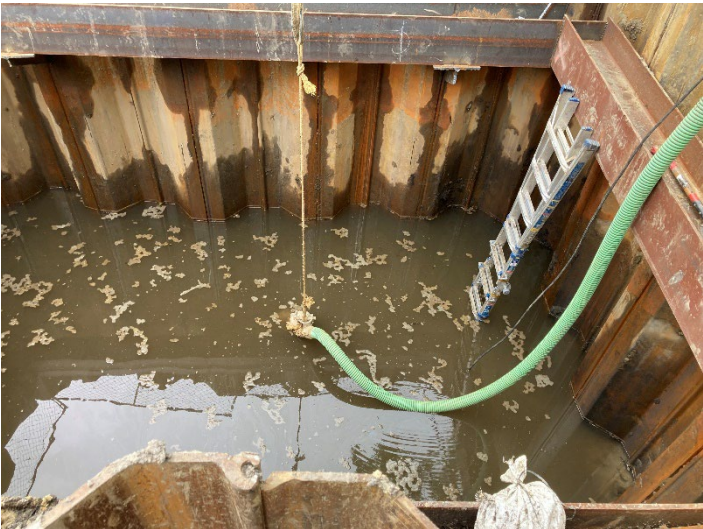
<b>PHOTOGRAPHIC LOG</b>	
<b>Client Name:</b> Eversource		<b>Site Location:</b> Sudbury to Hudson Transmission Reliability Project	<b>Town:</b> Sudbury
<b>Photo No.:</b> 2	<b>Date:</b> 8/17/2023

<b>Description:</b> View of water prior to treatment. Water appeared to be slightly turbid. Facing east.

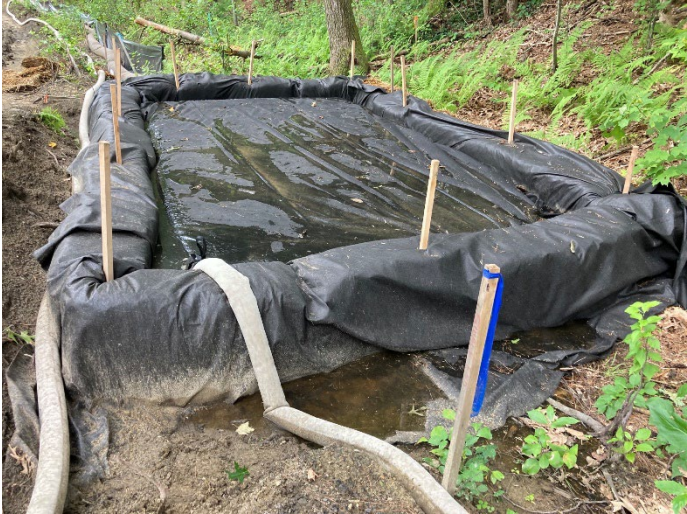
<b>PHOTOGRAPHIC LOG</b>	
<b>Client Name:</b> Eversource		<b>Site Location:</b> Sudbury to Hudson Transmission Reliability Project	<b>Town:</b> Sudbury
<b>Photo No.:</b> 3	<b>Date:</b> 8/17/2023

<b>Description:</b> View of dewatering controls (straw bale corral with filter fabric, stone, and silt bag) and discharge from corral. Facing east.

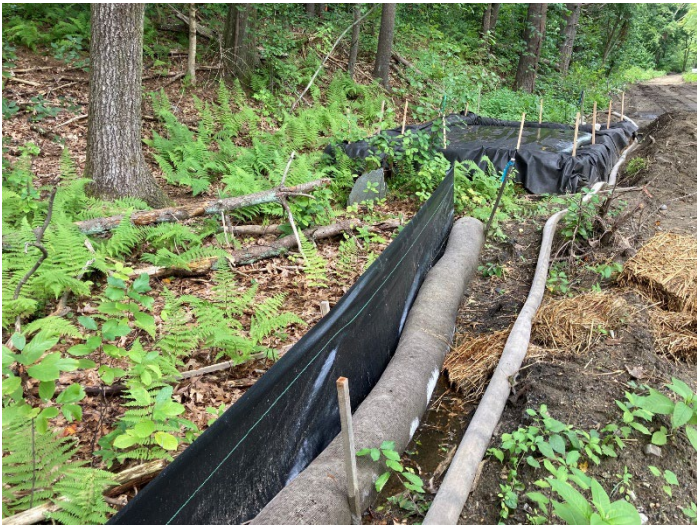
<b>PHOTOGRAPHIC LOG</b>	
<b>Client Name:</b> Eversource		<b>Site Location:</b> Sudbury to Hudson Transmission Reliability Project	<b>Town:</b> Sudbury
<b>Photo No.:</b> 4	<b>Date:</b> 8/17/2023

<b>Description:</b> Additional view of dewatering controls and discharge from corral. Discharge traveled east inside and outside of the silt fence but did not reach any jurisdictional areas. Discharge appeared slightly turbid. Turbidity reading was higher than 50 NTUs. Facing west.

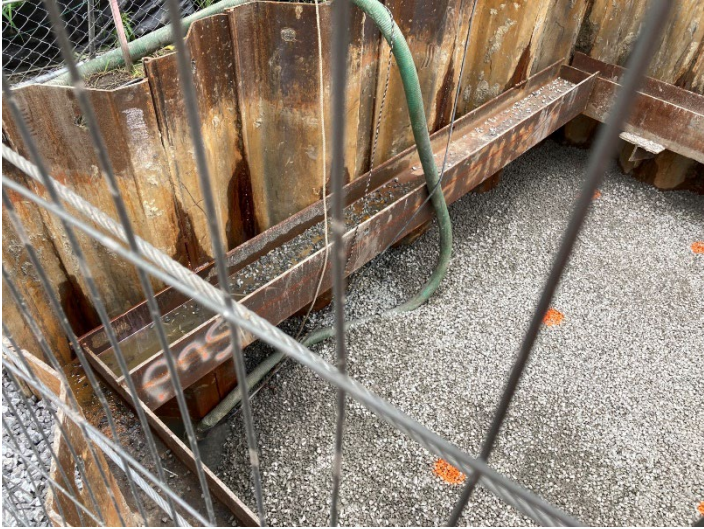
<b>PHOTOGRAPHIC LOG</b>	
<b>Client Name:</b> Eversource		<b>Site Location:</b> Sudbury to Hudson Transmission Reliability Project	<b>Town:</b> Sudbury
<b>Photo No.:</b> 1	<b>Date:</b> 8/17/2023

<b>Description:</b> View of work area and pumping operation at cofferdam at Bridge 127 work at Hop Brook. Water appeared slightly turbid prior to treatment. Facing southwest.

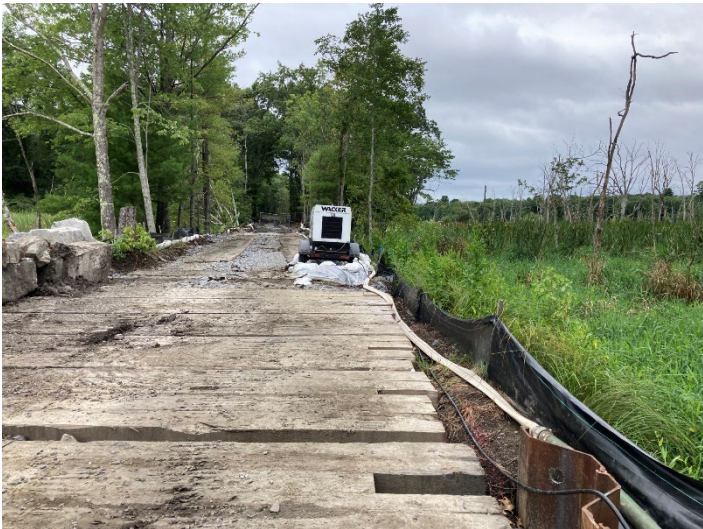
<b>PHOTOGRAPHIC LOG</b>	
<b>Client Name:</b> Eversource		<b>Site Location:</b> Sudbury to Hudson Transmission Reliability Project	<b>Town:</b> Sudbury
<b>Photo No.:</b> 2	<b>Date:</b> 8/17/2023

<b>Description:</b> View of generator being used for pumping operation. Generator has been placed in lined pit for spill prevention. Facing east.

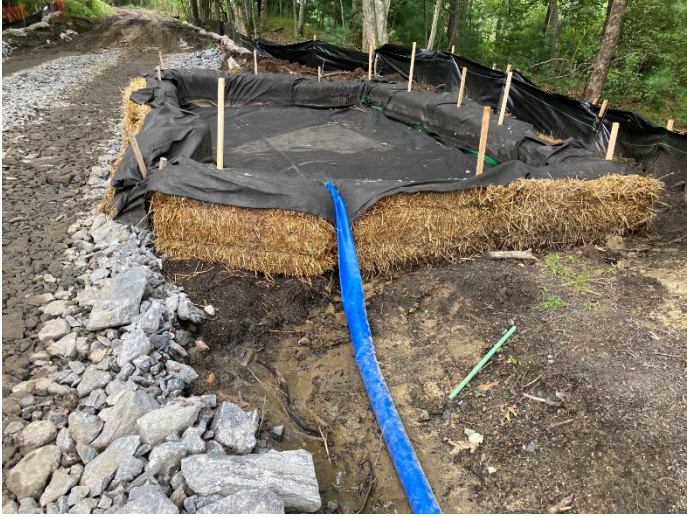
<b>PHOTOGRAPHIC LOG</b>		
<b>Client Name:</b> Eversource		<b>Site Location:</b> Sudbury to Hudson Transmission Reliability Project		<b>Town:</b> Sudbury
<b>Photo No.:</b> 3	<b>Date:</b> 8/17/2023

<b>Description:</b> View of dewatering controls (straw bale corral with filter fabric, stone, and silt bag). Facing east.

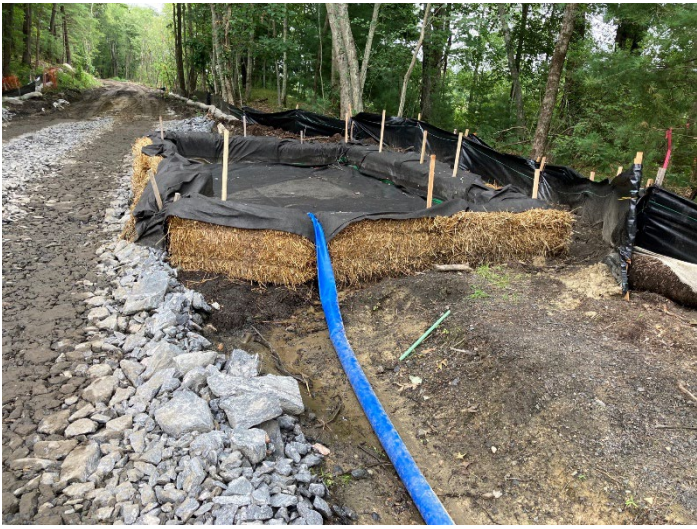
<b>PHOTOGRAPHIC LOG</b>		
<b>Client Name:</b> Eversource		<b>Site Location:</b> Sudbury to Hudson Transmission Reliability Project		<b>Town:</b> Sudbury
<b>Photo No.:</b> 4	<b>Date:</b> 8/17/2023

<b>Description:</b> Additional view of dewatering controls. Very little discharge from corral was observed, and therefore turbidity sample was unable to be collected. Facing east.

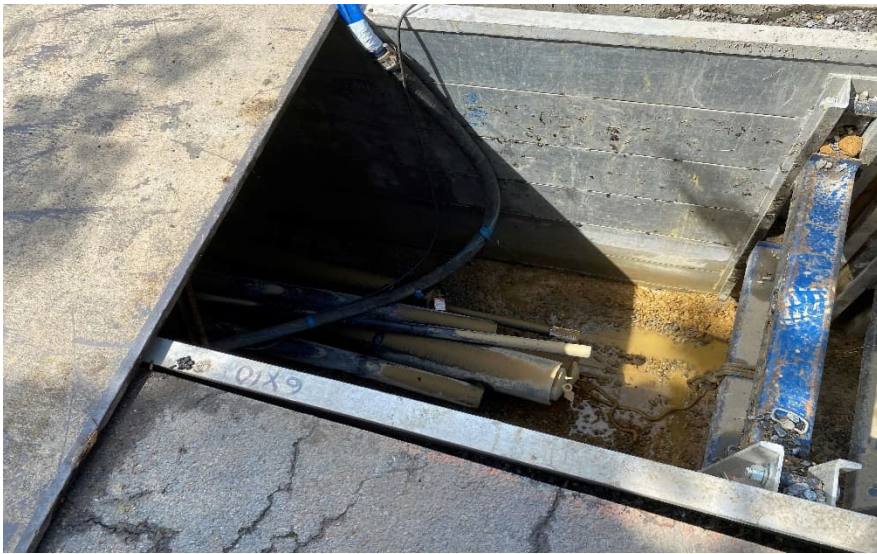
<b>PHOTOGRAPHIC LOG</b>	
Client Name: Eversource		Site Location: Sudbury to Hudson Transmission Reliability Project	Town: Hudson
Photo No.: 1	Date: 8/18/2023

Description: View of area being pumped at Forest Avenue (area in conduit trench), looking northward.

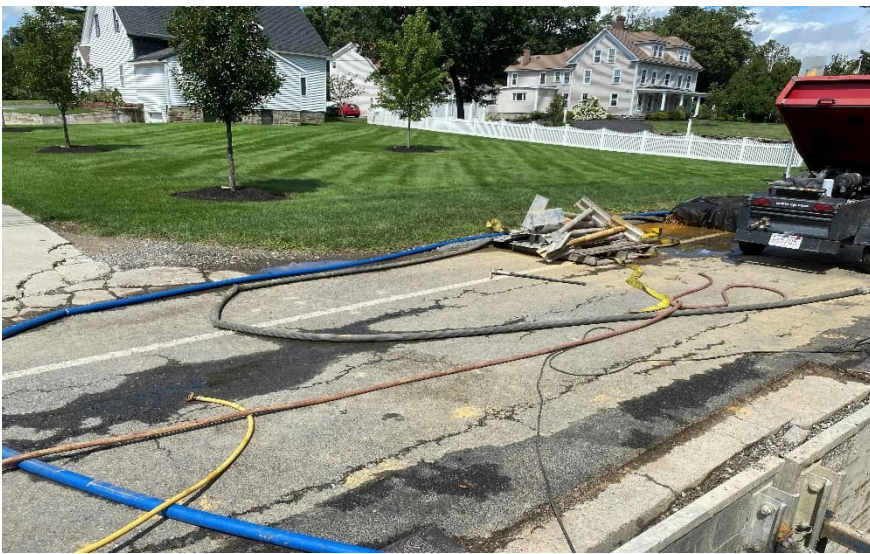
<b>PHOTOGRAPHIC LOG</b>	
Client Name: Eversource		Site Location: Sudbury to Hudson Transmission Reliability Project	Town: Hudson
Photo No.: 2	Date: 8/18/2023

Description: Forest Avenue. View of dewatering operation, looking southward.

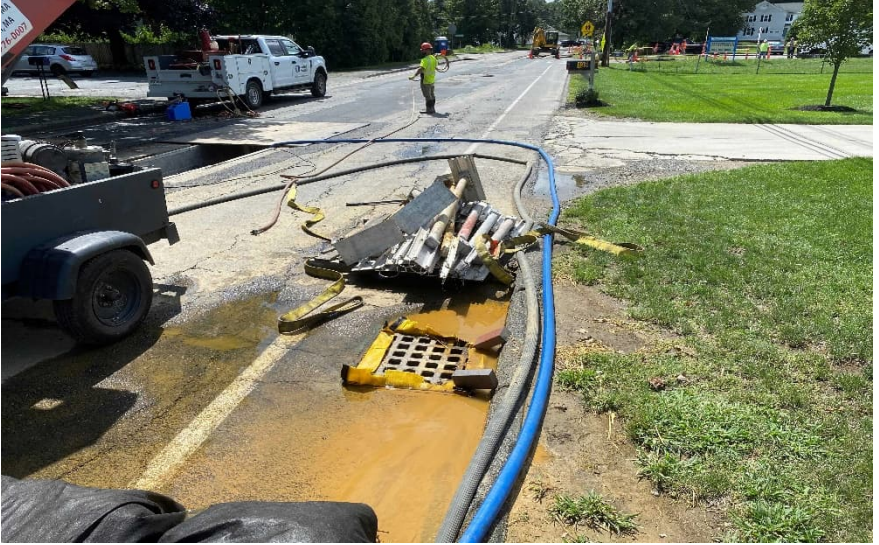
<b>PHOTOGRAPHIC LOG</b>	
Client Name: Eversource		Site Location: Sudbury to Hudson Transmission Reliability Project	Town: Hudson
Photo No.: 3	Date: 8/18/2023

Description: Forest Avenue. View of dewatering operation (pumping at far end of area), looking southward.

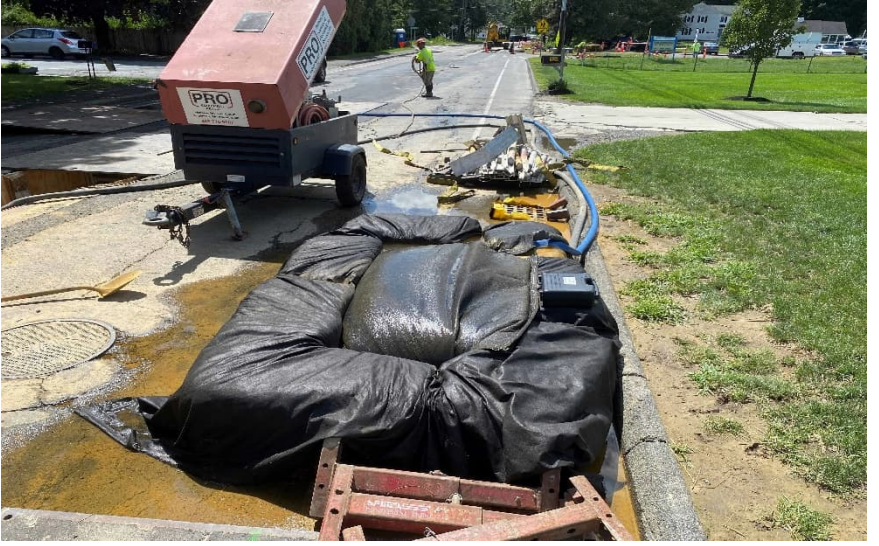
<b>PHOTOGRAPHIC LOG</b>	
Client Name: Eversource		Site Location: Sudbury to Hudson Transmission Reliability Project	Town: Hudson
Photo No.: 4	Date: 8/18/2023

Description: Forest Avenue. View of dewatering operation (corral/bag), looking southward.

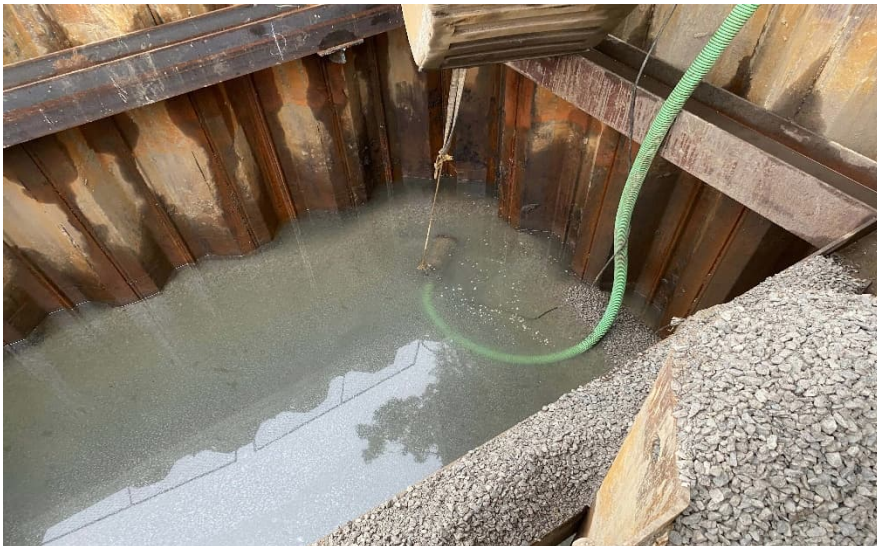
<b>PHOTOGRAPHIC LOG</b>	
Client Name: Eversource		Site Location: Sudbury to Hudson Transmission Reliability Project	Town: Sudbury
Photo No.: 1	Date: 8/18/2023

Description: View of area being pumped at Hop Brook (area in cofferdam), looking westward.

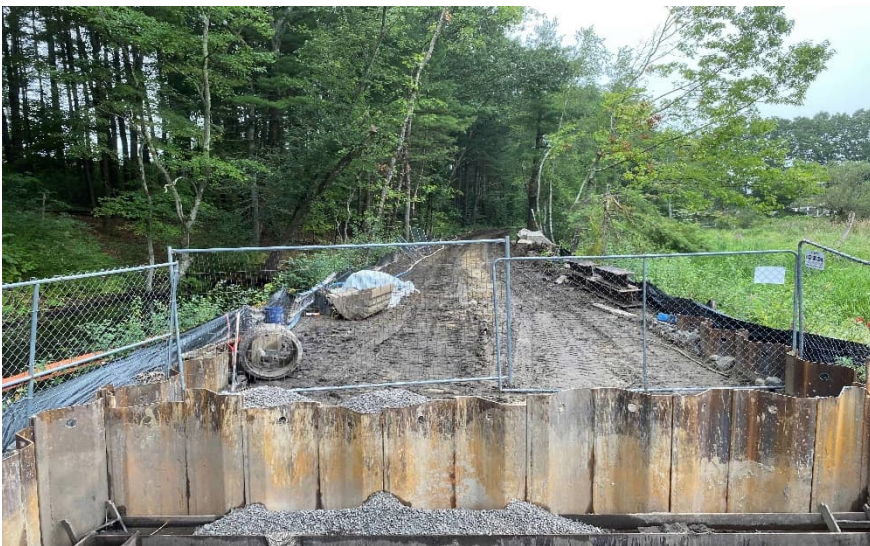
<b>PHOTOGRAPHIC LOG</b>	
Client Name: Eversource		Site Location: Sudbury to Hudson Transmission Reliability Project	Town: Sudbury
Photo No.: 2	Date: 8/18/2023

Description: Segment 13. View of dewatering operation (pumping at far end of area), looking westward.

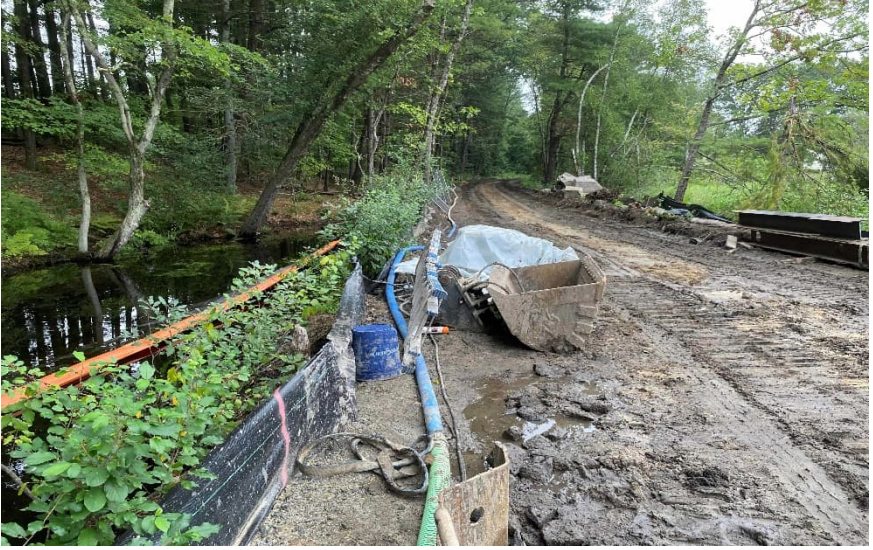
<b>PHOTOGRAPHIC LOG</b>	
Client Name: Eversource		Site Location: Sudbury to Hudson Transmission Reliability Project	Town: Sudbury
Photo No.: 3	Date: 8/18/2023

Description: Segment 13. View of dewatering operation (pumping at far end of area), looking westward.

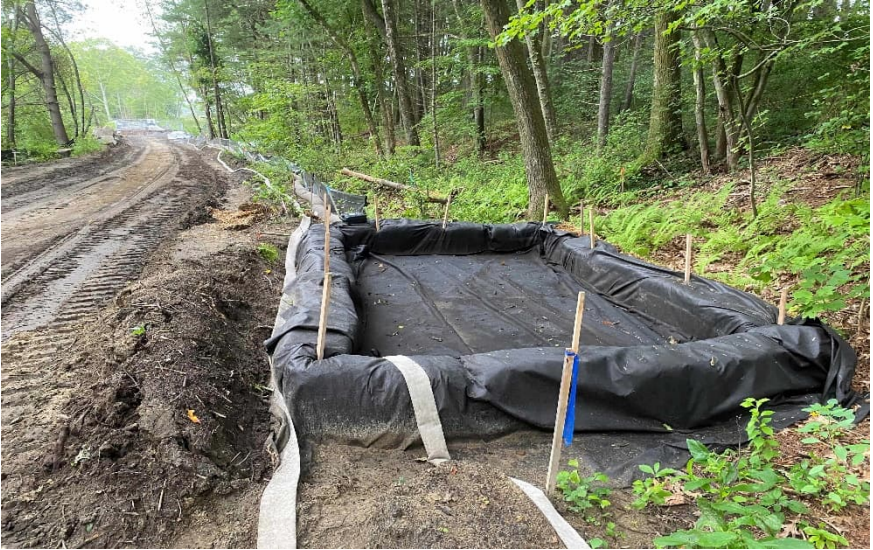
<b>PHOTOGRAPHIC LOG</b>	
Client Name: Eversource		Site Location: Sudbury to Hudson Transmission Reliability Project	Town: Sudbury
Photo No.: 4	Date: 8/18/2023

Description: Segment 13. View of dewatering operation (pumping at far end of area), looking eastward.
