**Weekly Environmental Compliance Summary**

**Sudbury to Hudson Transmission Reliability Project (USEPA Tracking # MAR1003UW)**

Sudbury, Hudson, and Stow, MA

Week of: August 21 to August 25, 2023

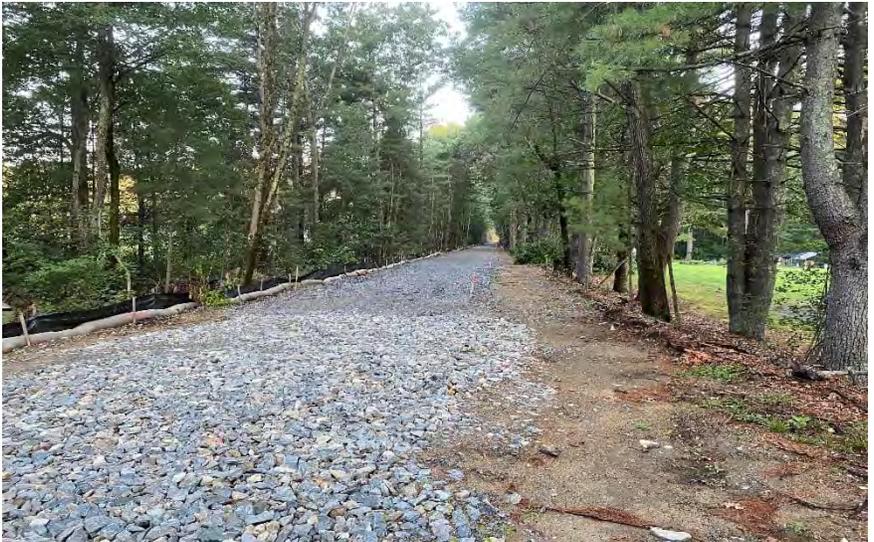
<b>PHOTOGRAPHIC LOG</b>	
Client Name: Eversource		Site Location: Sudbury to Hudson Transmission Reliability Project	Town: Hudson
Photo No.: 6	Date: 8-22-23

Description:  Work area within segment 4, existing erosion control, looking westward.

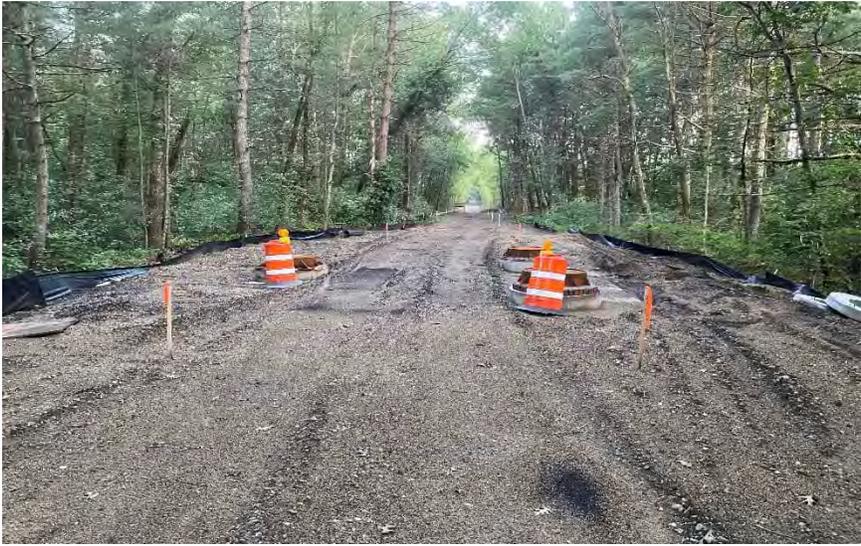
<b>PHOTOGRAPHIC LOG</b>	
Client Name: Eversource		Site Location: Sudbury to Hudson Transmission Reliability Project	Town: Hudson
Photo No.: 7	Date: 8-22-23

Description:  Work area within segment 5, manhole 13, existing erosion control, looking westward.

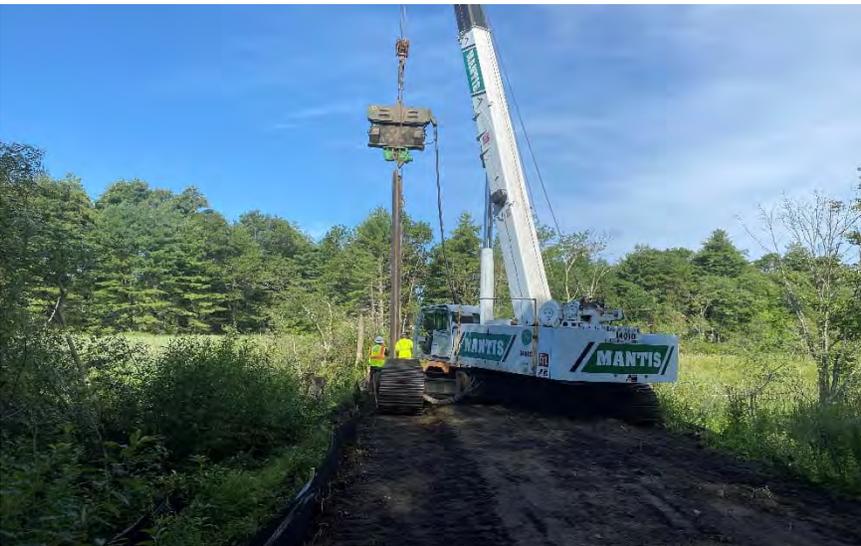
<b>PHOTOGRAPHIC LOG</b>	
Client Name: Eversource		Site Location: Sudbury to Hudson Transmission Reliability Project	Town: Sudbury
Photo No.: 8	Date: 8-22-23

Description:  Sheeting installation within segment 8 associated with bridge 128, looking westward.

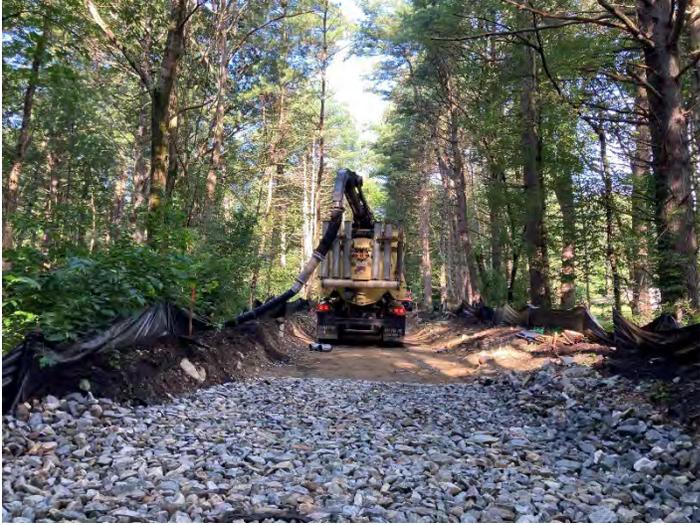
<p align="center"><b>PHOTOGRAPHIC LOG</b></p>	
Client Name: Eversource		Site Location: Sudbury to Hudson Transmission Reliability Project	Town: Sudbury
Photo No.: 1	Date: 8/22/2023

Description: View of vac truck in segment 9 for sediment removal. Facing west.

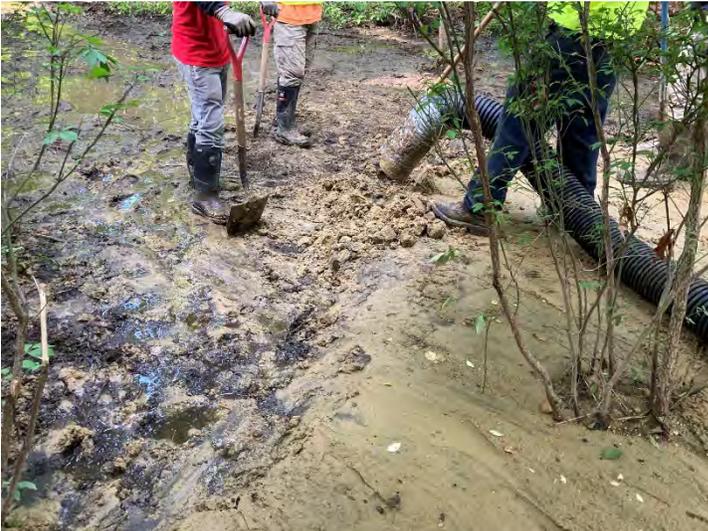
<p align="center"><b>PHOTOGRAPHIC LOG</b></p>	
Client Name: Eversource		Site Location: Sudbury to Hudson Transmission Reliability Project	Town: Sudbury
Photo No.: 2	Date: 8/22/2023

Description: View of sediment removal operation in wetland south of collapsed culvert in segment 9. Facing southwest.

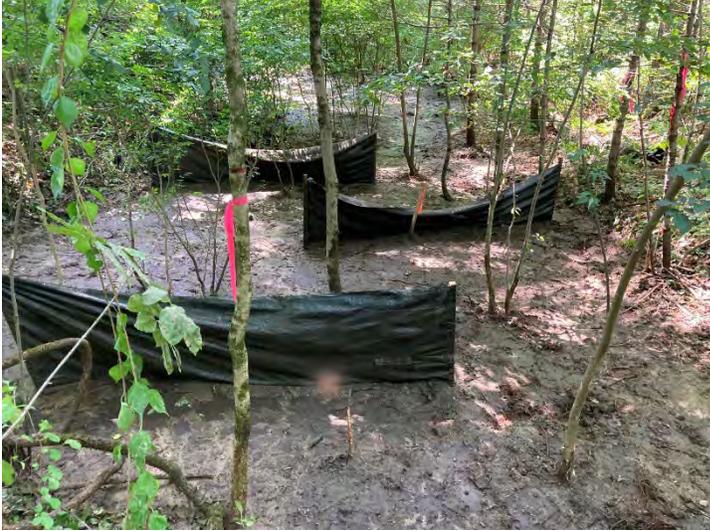
<p align="right"><b>PHOTOGRAPHIC LOG</b></p>	
Client Name: Eversource		Site Location: Sudbury to Hudson Transmission Reliability Project	Town: Sudbury
Photo No.: 3	Date: 8/22/2023

Description: View of wetland south of collapsed culvert in segment 9 following sediment removal. Facing south.

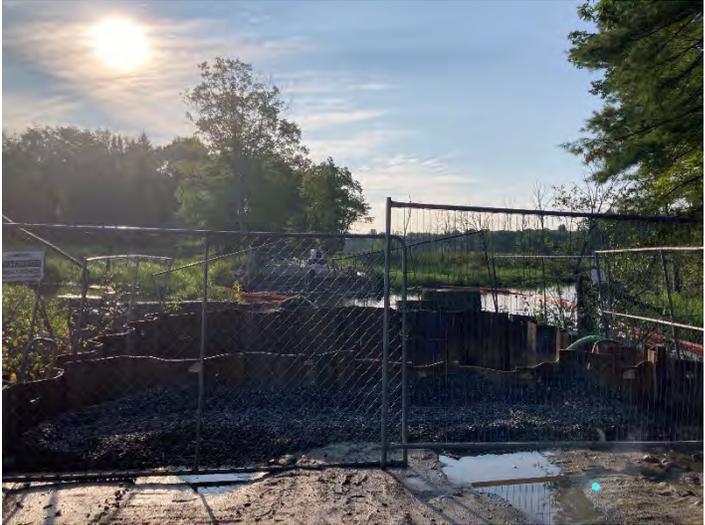
<p><b>PHOTOGRAPHIC LOG</b></p>	
<p>Client Name: Eversource</p>		<p>Site Location: Sudbury to Hudson Transmission Reliability Project</p>	<p>Town: Sudbury</p>
<p>Photo No.: 6</p>	<p>Date: 8/22/2023</p>

<p>Description: View of bridge 127 work area. No work or dewatering occurred today. Facing east.</p>

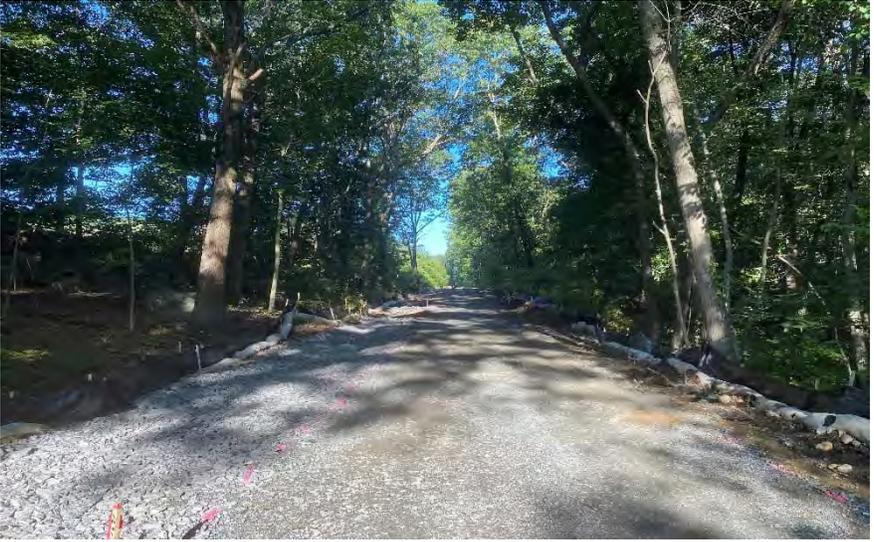
<b>PHOTOGRAPHIC LOG</b>	
Client Name: Eversource		Site Location: Sudbury to Hudson Transmission Reliability Project	Town: Hudson
Photo No.: 5	Date: 8-23-23

Description:  Work area within segment 1 at Sta# 129+00, existing erosion control, looking westward.

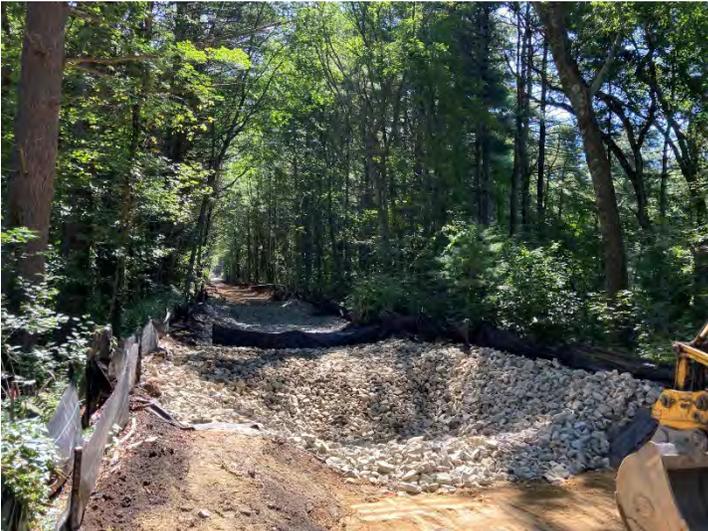
<b>PHOTOGRAPHIC LOG</b>	
Client Name: Eversource		Site Location: Sudbury to Hudson Transmission Reliability Project	Town: Sudbury
Photo No.: 2	Date: 8/23/2023

Description: View of plunge pools being installed near collapsed culvert in segment 9. Facing east.

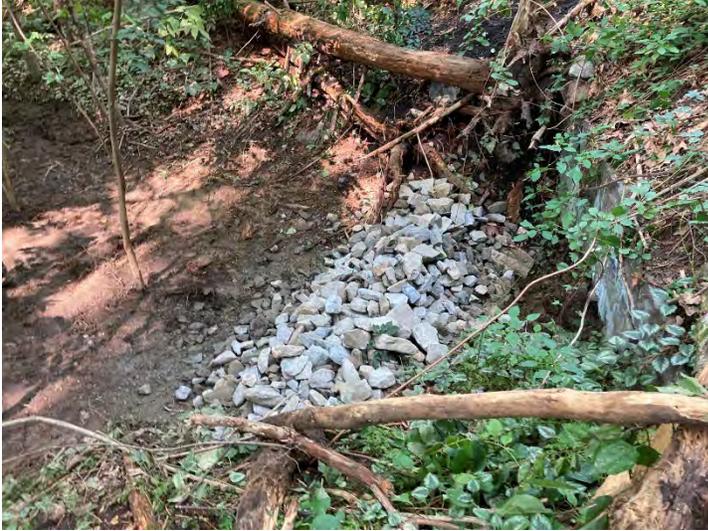
<p><b>PHOTOGRAPHIC LOG</b></p>	
<p>Client Name: Eversource</p>		<p>Site Location: Sudbury to Hudson Transmission Reliability Project</p>	<p>Town: Sudbury</p>
<p>Photo No.: 3</p>	<p>Date: 8/23/2023</p>

<p>Description: View of rock check dam installed just before wetland south of collapsed culvert in segment 9. Facing west.</p>

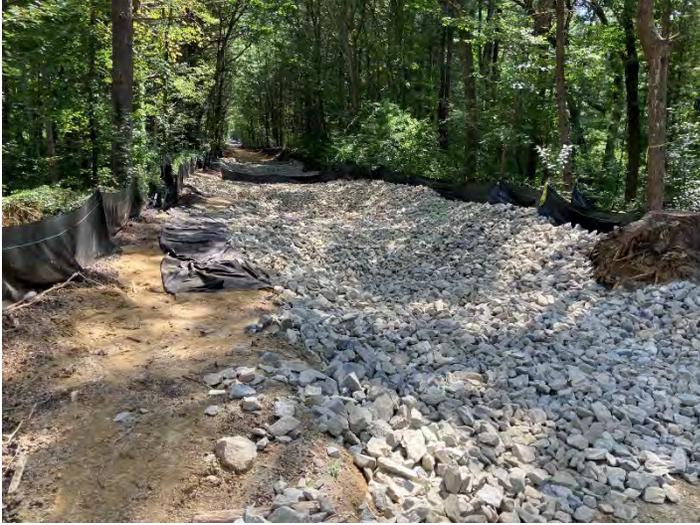
<p align="center"><b>PHOTOGRAPHIC LOG</b></p>	
Client Name: Eversource		Site Location: Sudbury to Hudson Transmission Reliability Project	Town: Sudbury
Photo No.: 1	Date: 8/24/2023

Description: View of plunge pools that have been installed near collapsed culvert in segment 9. Facing east.

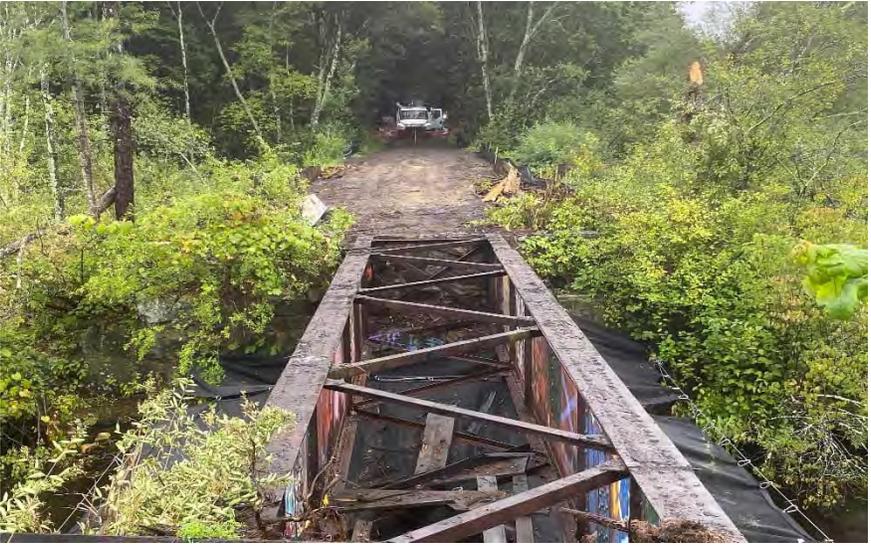
PHOTOGRAPHIC LOG	
Client Name: Eversource		Site Location: Sudbury to Hudson Transmission Reliability Project	Town: Sudbury
Photo No.: 5	Date: 8-25-23

Description:  Bridge 128 removed, looking eastward into segment 8.

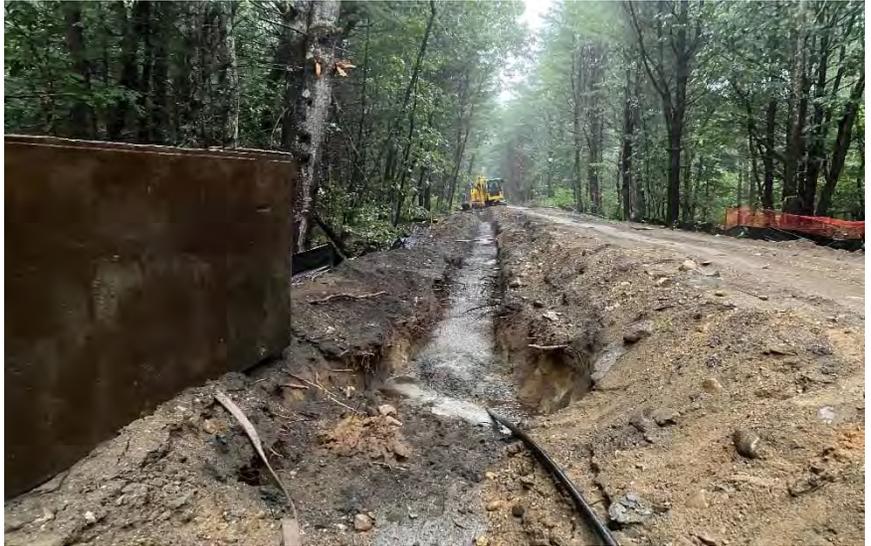
PHOTOGRAPHIC LOG	
Client Name: Eversource		Site Location: Sudbury to Hudson Transmission Reliability Project	Town: Sudbury
Photo No.: 6	Date: 8-25-23

Description:  Recent conduit work within segment 7 near manhole 15, looking eastward.

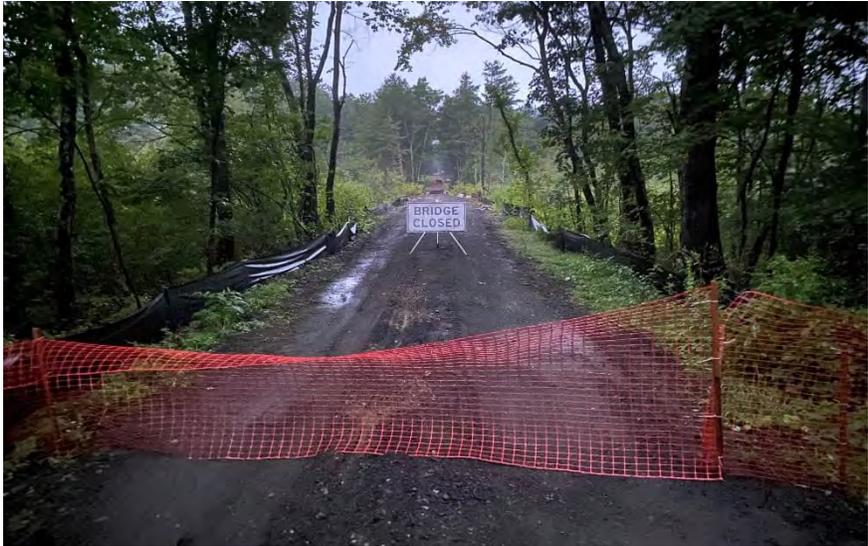
<p>PHOTOGRAPHIC LOG</p>	
<p>Client Name: Eversource</p>		<p>Site Location: Sudbury to Hudson Transmission Reliability Project</p>	<p>Town: Sudbury</p>
<p>Photo No.: 7</p>	<p>Date: 8-25-23</p>

<p>Description:</p> <p>Work area within Segment 8, at Bridge 128 area, looking westward.</p>

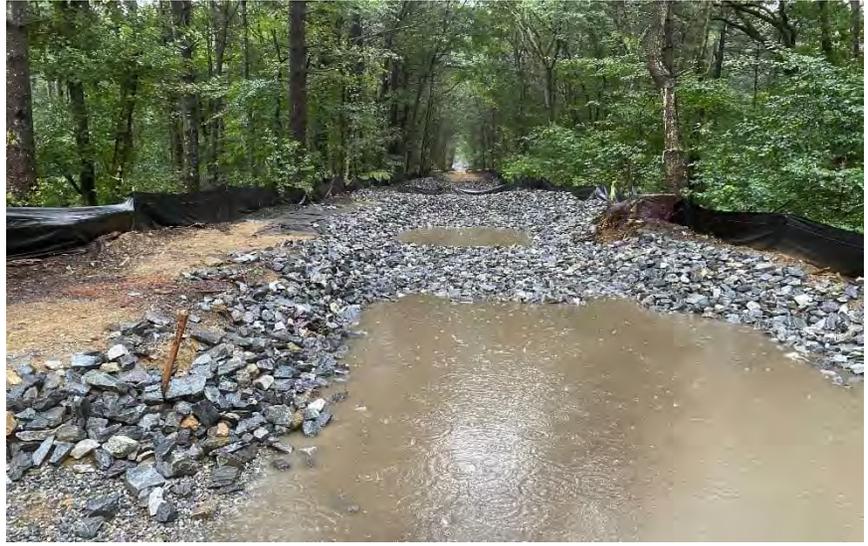
<p>PHOTOGRAPHIC LOG</p>	
<p>Client Name: Eversource</p>		<p>Site Location: Sudbury to Hudson Transmission Reliability Project</p>	<p>Town: Sudbury</p>
<p>Photo No.: 8</p>	<p>Date: 8-25-23</p>

<p>Description:</p> <p>Work area within segment 9, plunge pool near culvert, looking eastward.</p>

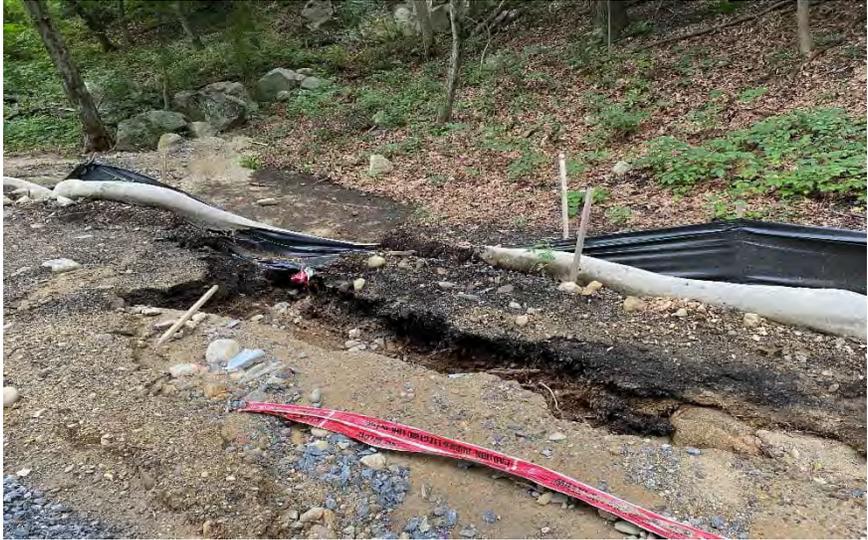
<b>PHOTOGRAPHIC LOG</b>	
Client Name: Eversource		Site Location: Sudbury to Hudson Transmission Reliability Project	Town: Hudson
Photo No.: 5	Date: 8-21-23

As a result of a rain event on 8-18, several deficiencies associated with erosion controls were noted within segments 1, 3, 5 & 6, see example in photo 5. Repairs to be completed.

Description:  Erosion control disturbance due to rain event within segment 1 at approximate Sta# 128+75, looking westward.

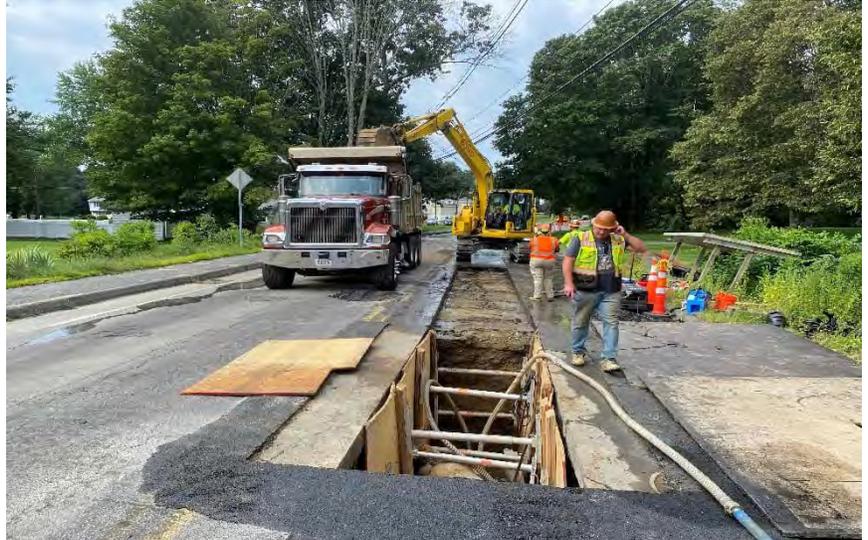
<b>PHOTOGRAPHIC LOG</b>	
Client Name: Eversource		Site Location: Sudbury to Hudson Transmission Reliability Project	Town: Hudson
Photo No.: 6	Date: 8-21-23

Description:  Conduit work within Forest Avenue (from manhole #3), heading northward.

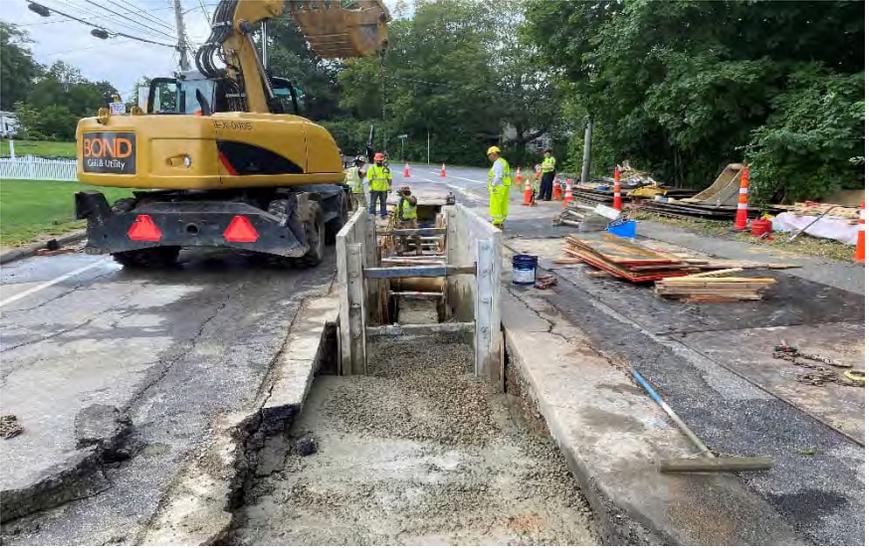
<b>PHOTOGRAPHIC LOG</b>	
Client Name: Eversource		Site Location: Sudbury to Hudson Transmission Reliability Project	Town: Hudson
Photo No.: 7	Date: 8-21-23

Description:  Conduit work within Forest Avenue (from manhole #3), heading southward.

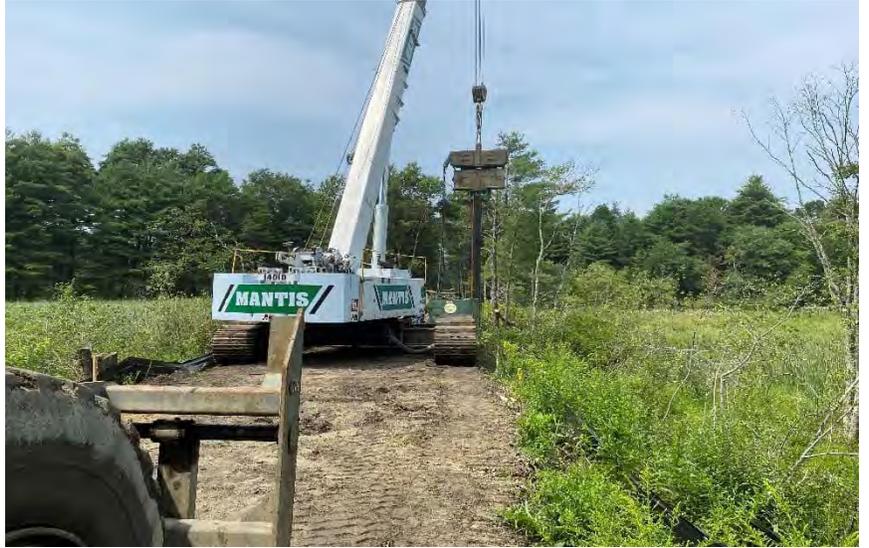
<b>PHOTOGRAPHIC LOG</b>	
Client Name: Eversource		Site Location: Sudbury to Hudson Transmission Reliability Project	Town: Sudbury
Photo No.: 8	Date: 8-21-23

Description:  Sheeting placement within segment 8 at bridge 128, looking westward.

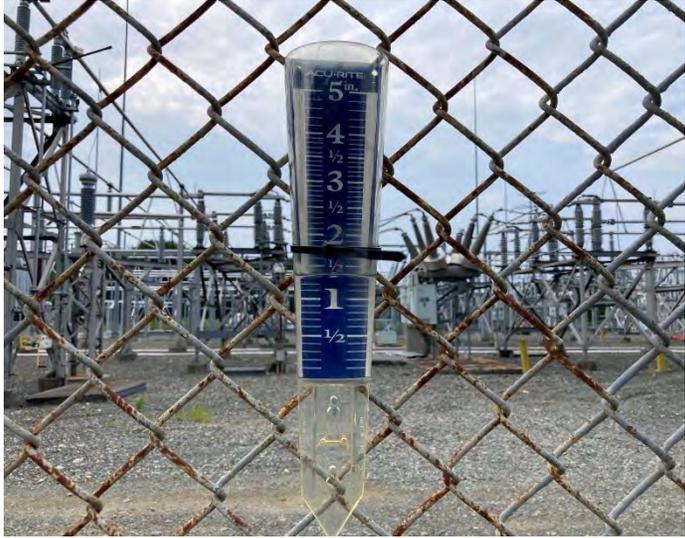
<b>PHOTOGRAPHIC LOG</b>	
Client Name: Eversource		Site Location: Sudbury to Hudson Transmission Reliability Project	Town: Sudbury
Photo No.: 1	Date: 8-21-2023

Description: View of rain gauge at Sudbury Substation. 1.40" observed in gauge at approximately 8:00am. Facing south.

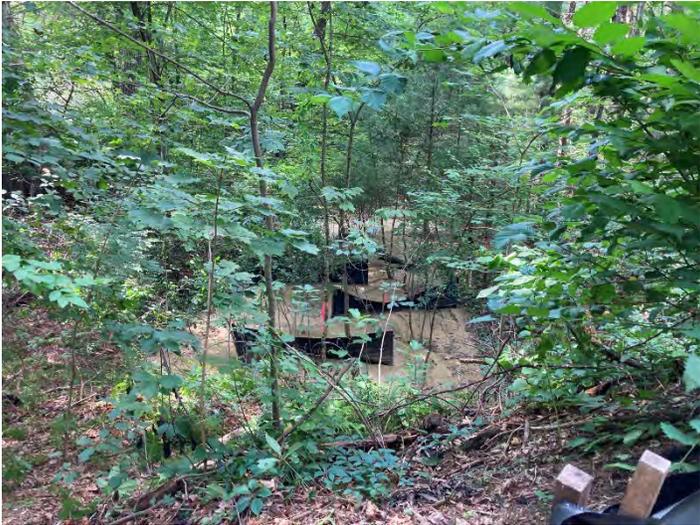
<b>PHOTOGRAPHIC LOG</b>	
Client Name: Eversource		Site Location: Sudbury to Hudson Transmission Reliability Project	Town: Sudbury
Photo No.: 4	Date: 8-21-2023

-During storm event on 8/18, south side of work area collapsed above culvert at Sta. #521+69 in segment 9. Sediment has deposited in wetland south of culvert and should be removed. Lori Capone (Sudbury CC) was notified. Repairs to stone cover over culvert occurred today. Project team and engineers are working towards long-term solution for this area.

Description: View of sediment that has deposited in wetland south of collapsed culvert in segment 9. Facing south.

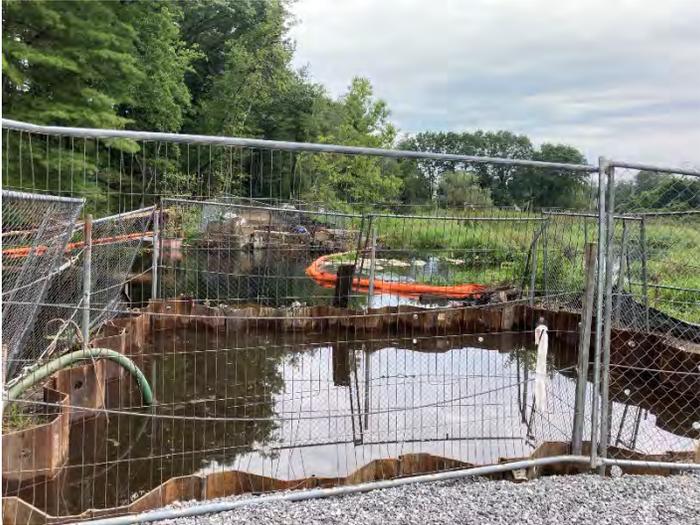
<b>PHOTOGRAPHIC LOG</b>	
Client Name: Eversource		Site Location: Sudbury to Hudson Transmission Reliability Project	Town: Sudbury
Photo No.: 9	Date: 8-21-2023

Description: View of bridge 127 work area. No work or dewatering occurred today. Facing west.

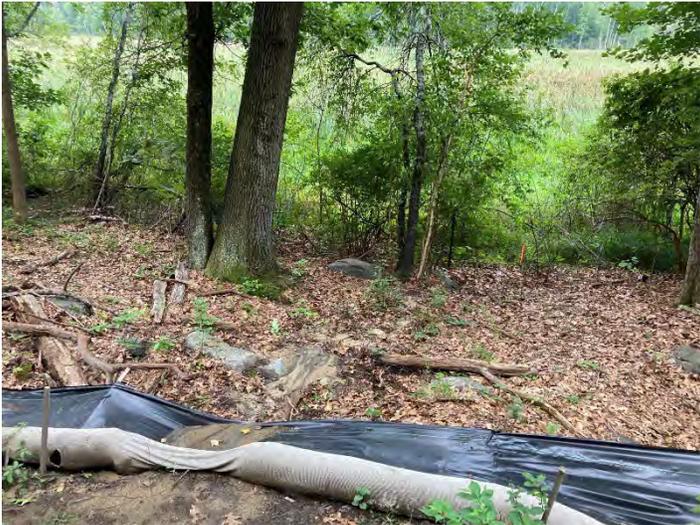
<b>PHOTOGRAPHIC LOG</b>	
Client Name: Eversource		Site Location: Sudbury to Hudson Transmission Reliability Project	Town: Sudbury
Photo No.: 10	Date: 8-21-2023

-Silt fence is in need of repair at Dudley Brook culvert in segment 10 (routine maintenance).  
-E&S controls are in need of repair in multiple locations in segment 11 (routine maintenance).  
-E&S controls are in need of repair at approximately Sta. #707 in segment 12 (routine maintenance).  
-E&S controls are in need of repairs in multiple locations in segment 14 (routine maintenance).

Description: View of Sta. #736 in segment 14. Stormwater and sediment knocked down the silt fence at this location. Sediment has deposited beyond limit of work but did not reach wetlands. Facing south.

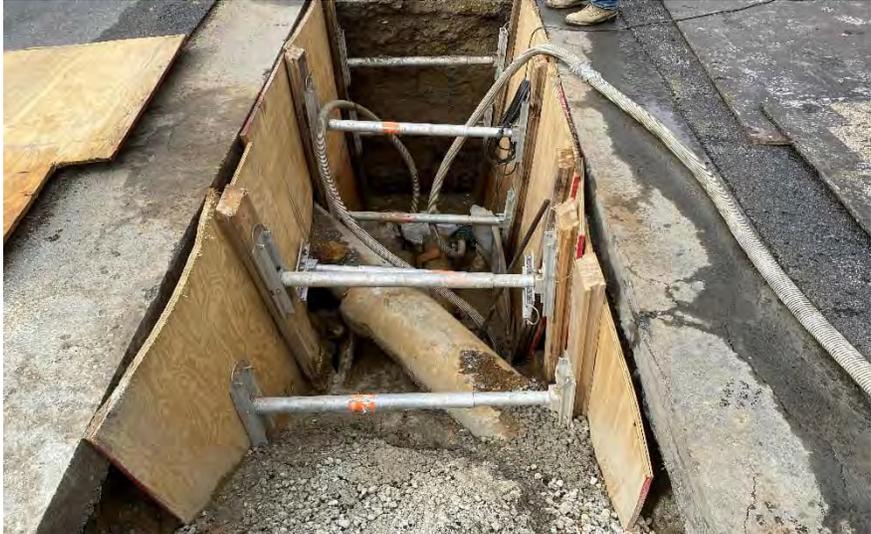
<b>PHOTOGRAPHIC LOG</b>	
Client Name: Eversource		Site Location: Sudbury to Hudson Transmission Reliability Project	Town: Hudson
Photo No.: 1	Date: 8/21/2023

Description: View of area being pumped at Forest Avenue (area in conduit trench), looking southward.

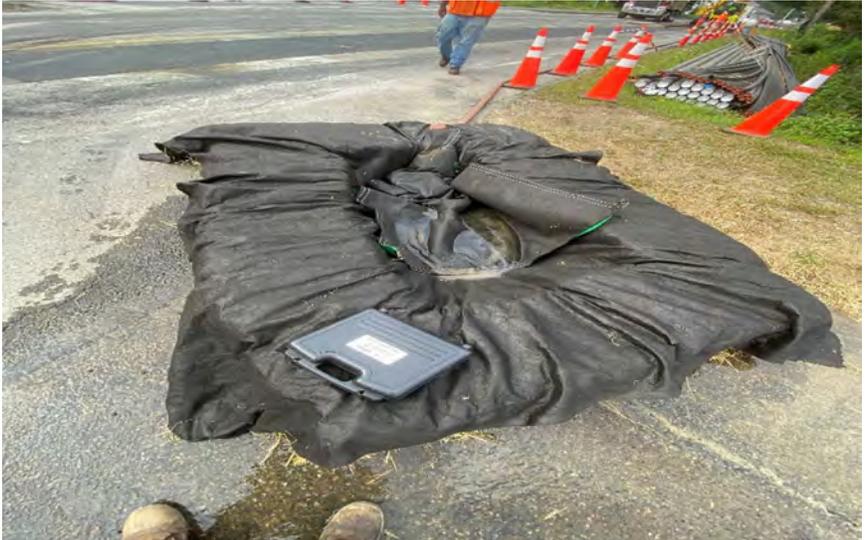
<b>PHOTOGRAPHIC LOG</b>	
Client Name: Eversource		Site Location: Sudbury to Hudson Transmission Reliability Project	Town: Hudson
Photo No.: 4	Date: 8/21/2023

Description: Forest Avenue. View of dewatering operation (corrugated metal bag), looking southward.

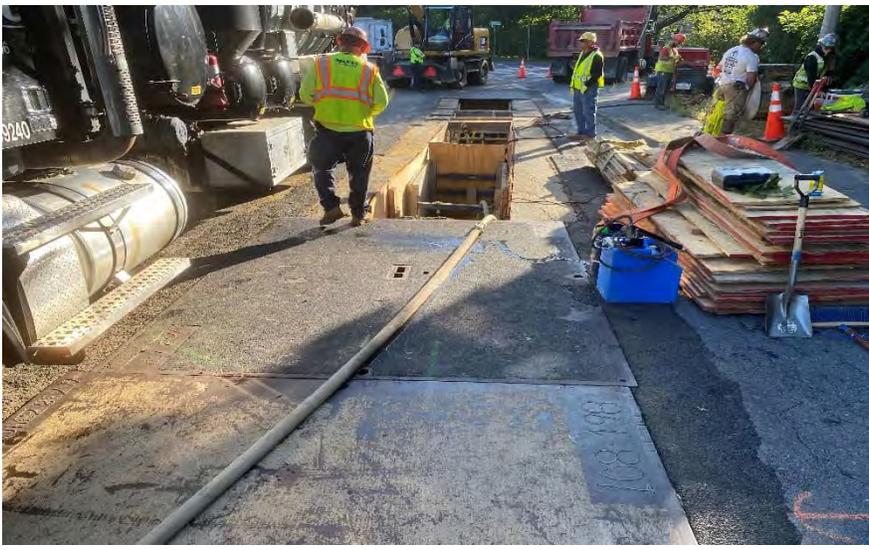
<b>PHOTOGRAPHIC LOG</b>	
Client Name: Eversource		Site Location: Sudbury to Hudson Transmission Reliability Project	Town: Hudson
Photo No.: 2	Date: 8/23/2023

Description: Forest Avenue. View of dewatering operation, looking southward.

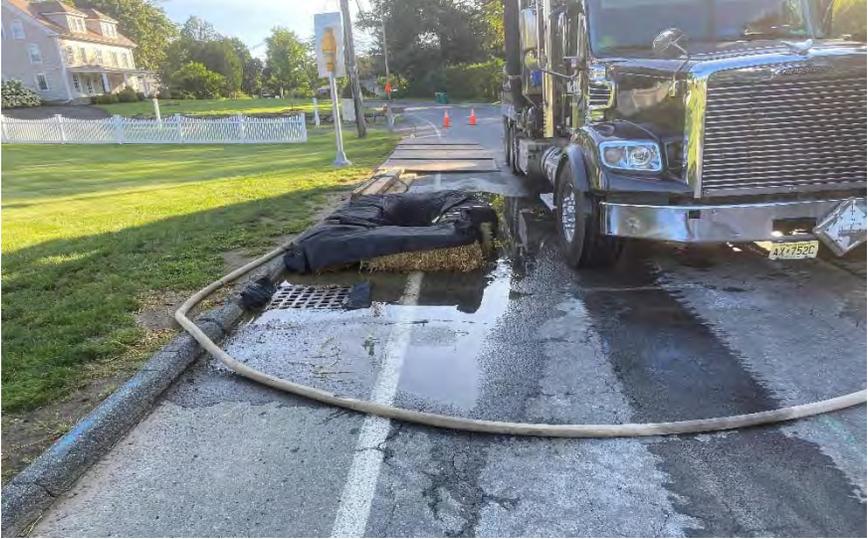
<b>PHOTOGRAPHIC LOG</b>	
Client Name: Eversource		Site Location: Sudbury to Hudson Transmission Reliability Project	Town: Hudson
Photo No.: 3	Date: 8/23/2023

Description: Forest Avenue. View of dewatering operation (pumping at far end of area), looking northward.

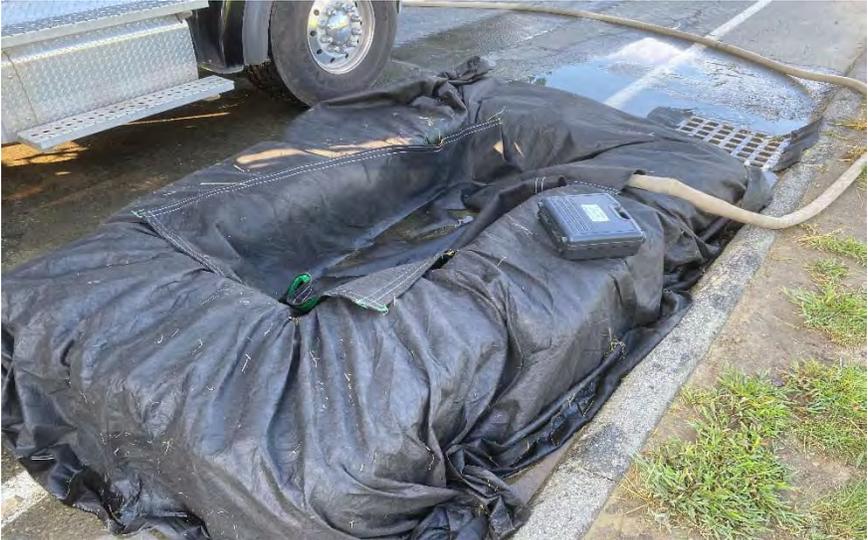
<b>PHOTOGRAPHIC LOG</b>	
Client Name: Eversource		Site Location: Sudbury to Hudson Transmission Reliability Project	Town: Hudson
Photo No.: 4	Date: 8/23/2023

Description: Forest Avenue. View of dewatering operation (corral/bag), looking southward.

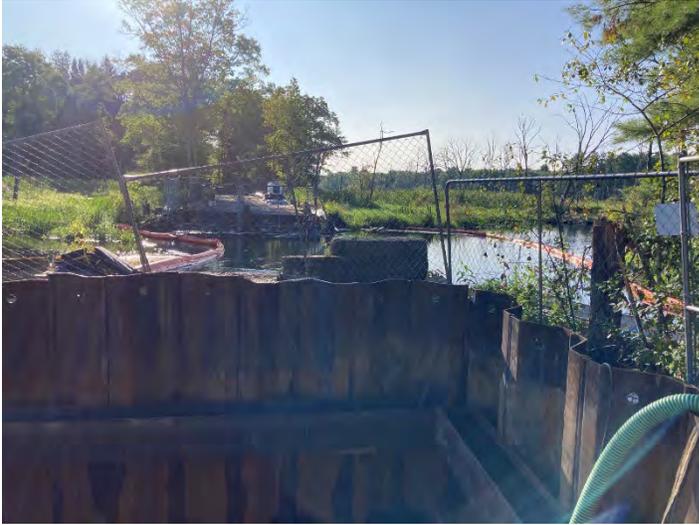
PHOTOGRAPHIC LOG	
Client Name: Eversource		Site Location: Sudbury to Hudson Transmission Reliability Project	Town: Sudbury
Photo No.: 1	Date: 8/23/2023

Description: View of work area and pumping operation at Bridge 127 work at Hop Brook. Facing east.

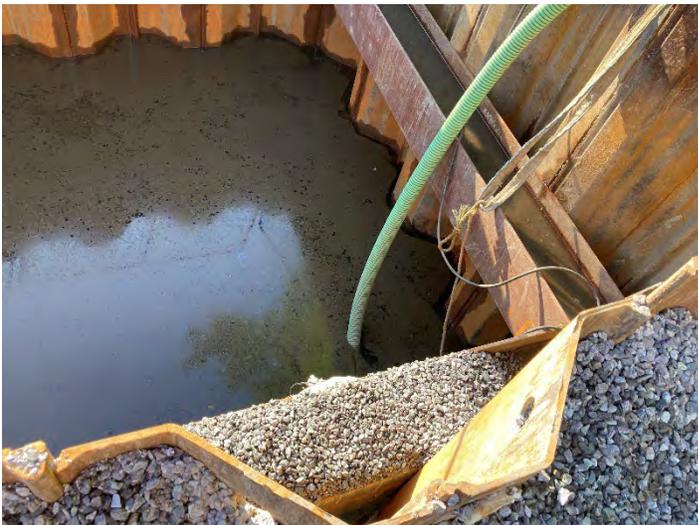
PHOTOGRAPHIC LOG	
Client Name: Eversource		Site Location: Sudbury to Hudson Transmission Reliability Project	Town: Sudbury
Photo No.: 2	Date: 8/23/2023

Description: View of water prior to treatment. Water appeared to be slightly turbid.

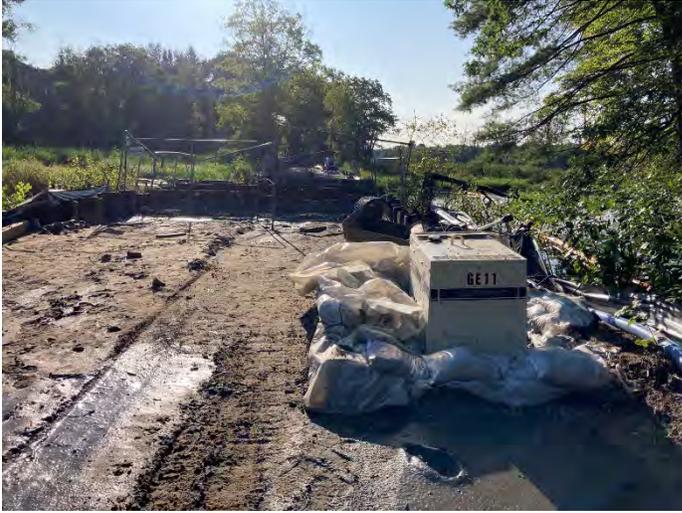
<b>PHOTOGRAPHIC LOG</b>	
Client Name: Eversource		Site Location: Sudbury to Hudson Transmission Reliability Project	Town: Sudbury
Photo No.: 3	Date: 8/23/2023

Description: View of work area and pump generator in lined containment pit. Facing east.

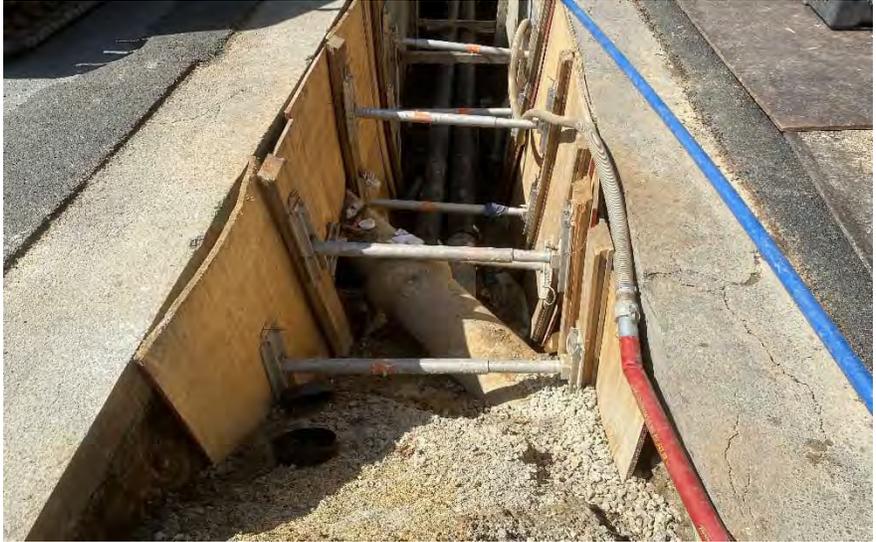
<b>PHOTOGRAPHIC LOG</b>	
Client Name: Eversource		Site Location: Sudbury to Hudson Transmission Reliability Project	Town: Hudson
Photo No.: 1	Date: 8/24/2023

Description: View of area being pumped at Forest Avenue (area in conduit trench), looking southward.

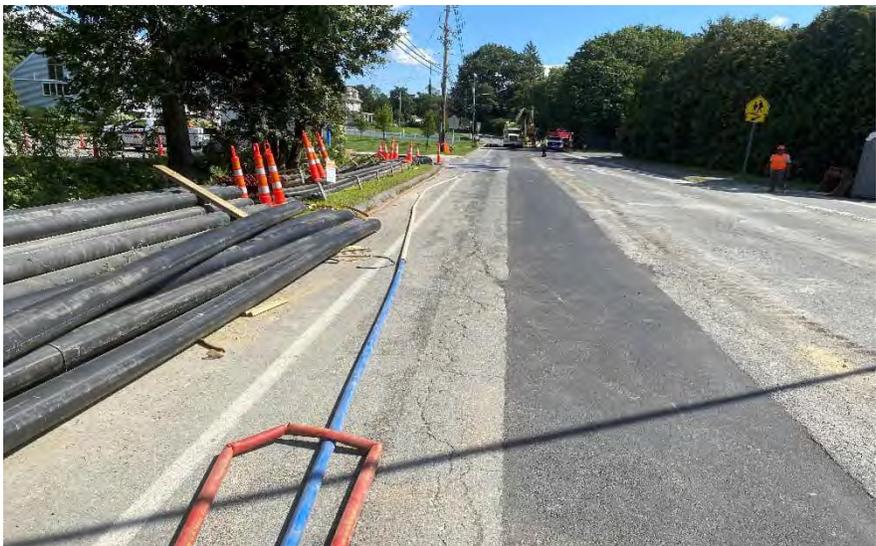
<b>PHOTOGRAPHIC LOG</b>	
Client Name: Eversource		Site Location: Sudbury to Hudson Transmission Reliability Project	Town: Hudson
Photo No.: 2	Date: 8/24/2023

Description: Forest Avenue. View of dewatering operation, looking northward.

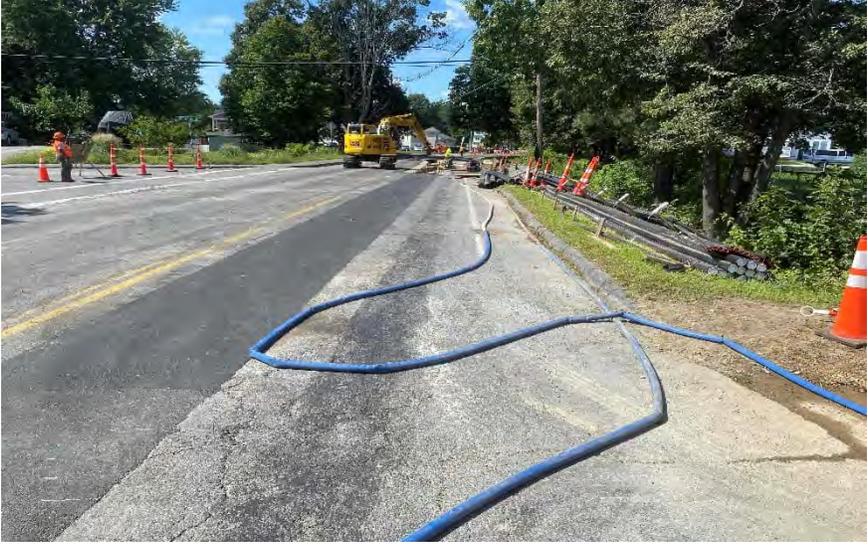
<b>PHOTOGRAPHIC LOG</b>	
Client Name: Eversource		Site Location: Sudbury to Hudson Transmission Reliability Project	Town: Hudson
Photo No.: 3	Date: 8/24/2023

Description: Forest Avenue. View of dewatering operation (pumping at far end of area), looking southward.

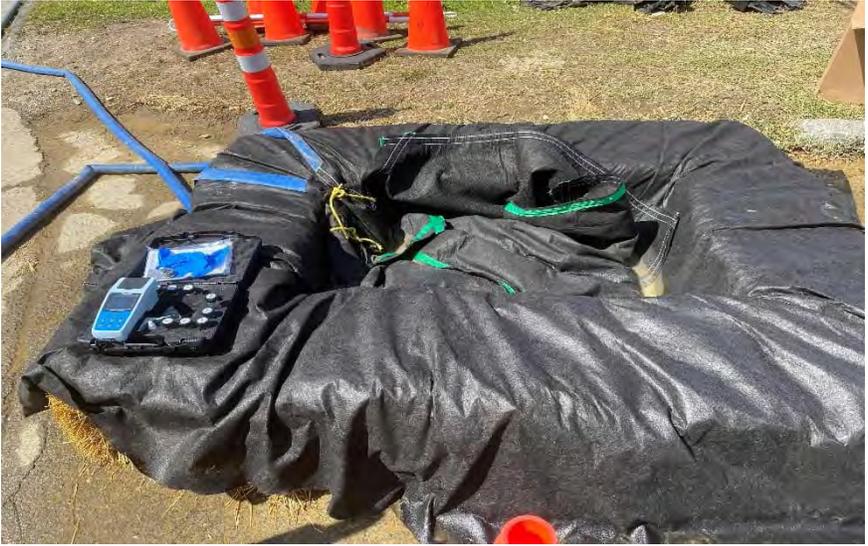
<b>PHOTOGRAPHIC LOG</b>	
Client Name: Eversource		Site Location: Sudbury to Hudson Transmission Reliability Project	Town: Hudson
Photo No.: 4	Date: 8/24/2023

Description: Forest Avenue. View of dewatering operation (corral/bag), looking northward.

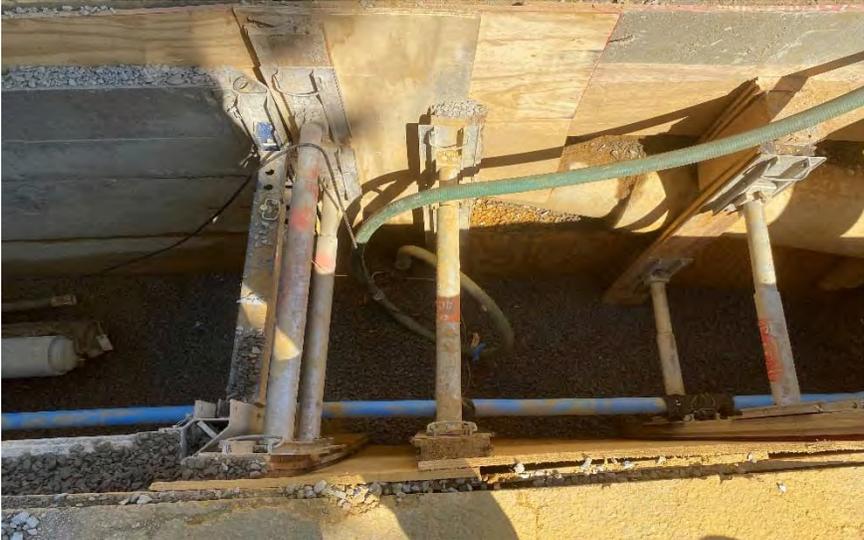
<b>PHOTOGRAPHIC LOG</b>	
Client Name: Eversource		Site Location: Sudbury to Hudson Transmission Reliability Project	Town: Hudson
Photo No.: 1	Date: 8/24/2023

Description: View of area being pumped at Forest Avenue (area in conduit trench).

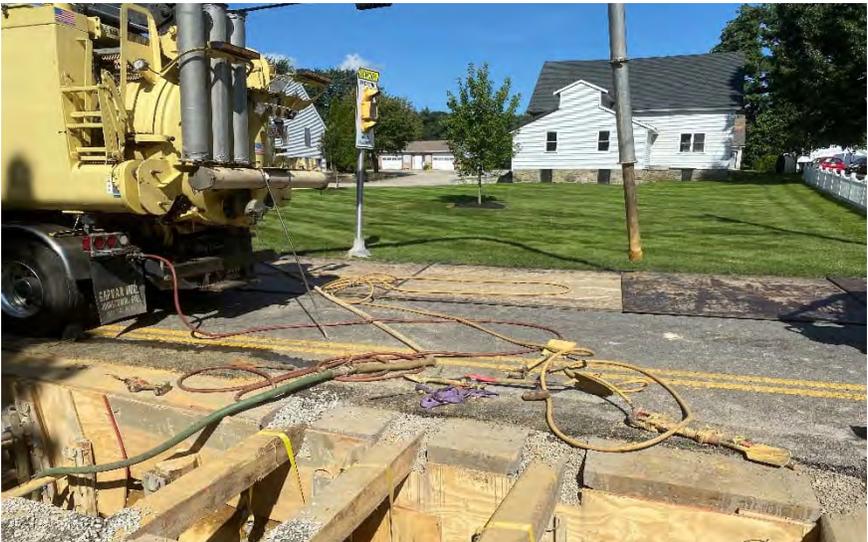
<b>PHOTOGRAPHIC LOG</b>	
Client Name: Eversource		Site Location: Sudbury to Hudson Transmission Reliability Project	Town: Hudson
Photo No.: 2	Date: 8/24/2023

Description: Forest Avenue. View of dewatering operation, looking westward.

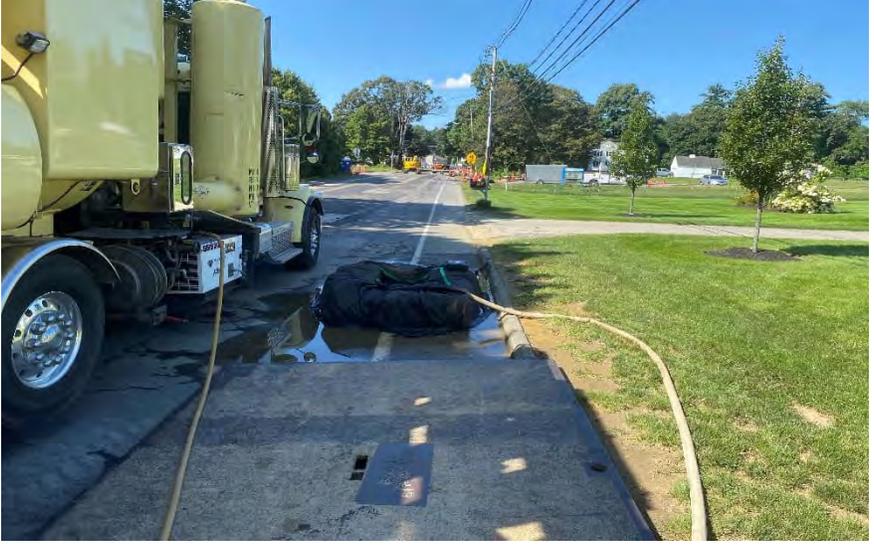
<b>PHOTOGRAPHIC LOG</b>	
Client Name: Eversource		Site Location: Sudbury to Hudson Transmission Reliability Project	Town: Hudson
Photo No.: 3	Date: 8/24/2023

Description: Forest Avenue. View of dewatering operation (pumping at far end of area), looking southward.

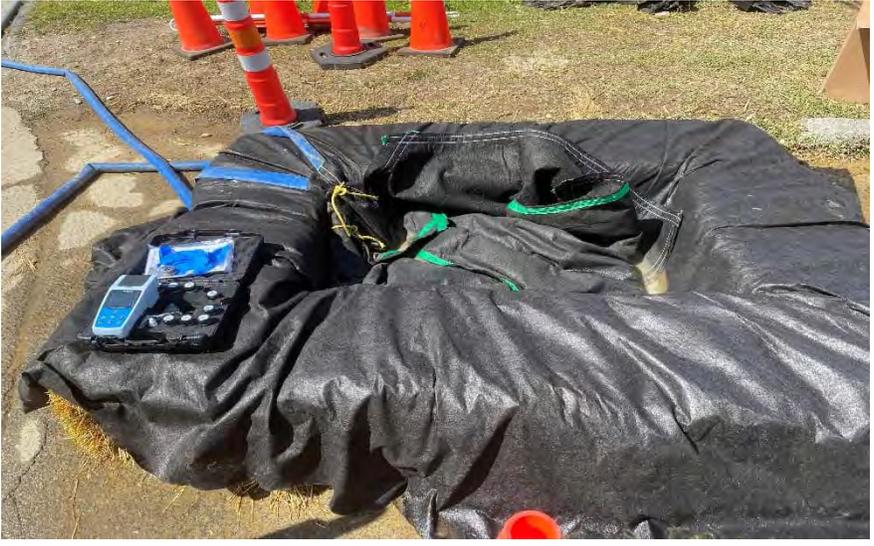
<b>PHOTOGRAPHIC LOG</b>	
Client Name: Eversource		Site Location: Sudbury to Hudson Transmission Reliability Project	Town: Hudson
Photo No.: 4	Date: 8/24/2023

Description: Forest Avenue. View of dewatering operation (corral/bag), looking southward.

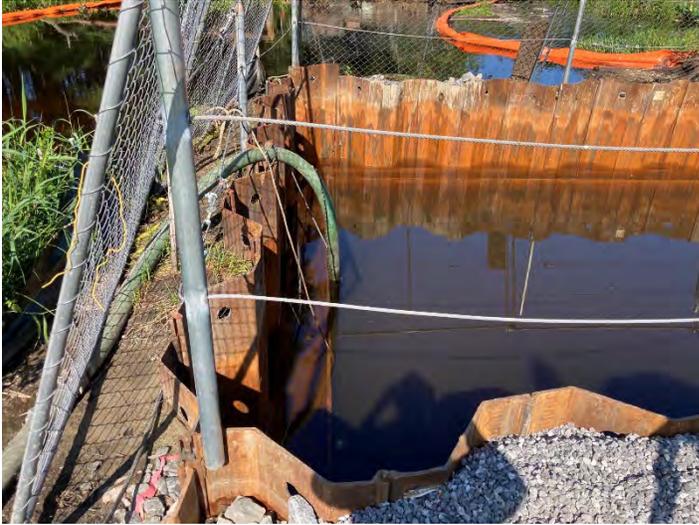
<b>PHOTOGRAPHIC LOG</b>	
Client Name: Eversource		Site Location: Sudbury to Hudson Transmission Reliability Project	Town: Sudbury
Photo No.: 1	Date: 8/24/2023

Description: View of work area and pumping operation at cofferdam at Bridge 127 work at Hop Brook. Water appeared slightly turbid prior to treatment. Facing west.

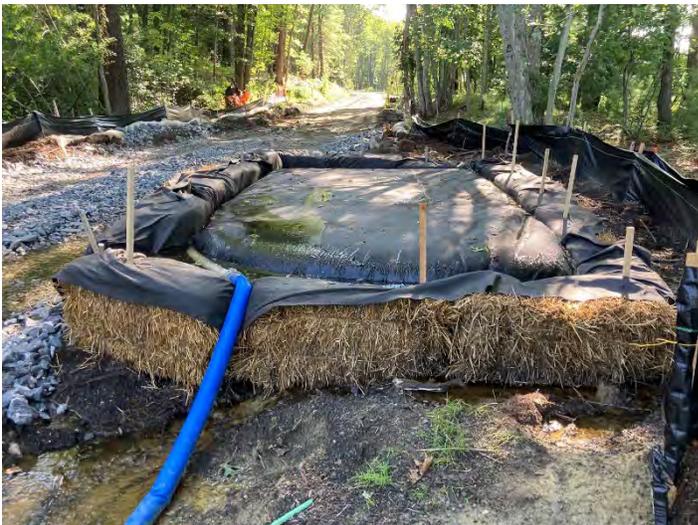
<b>PHOTOGRAPHIC LOG</b>	
Client Name: Eversource		Site Location: Sudbury to Hudson Transmission Reliability Project	Town: Sudbury
Photo No.: 2	Date: 8/24/2023

Description: View of dewatering controls (straw bale corral with filter fabric, stone, and silt bag). Facing east.

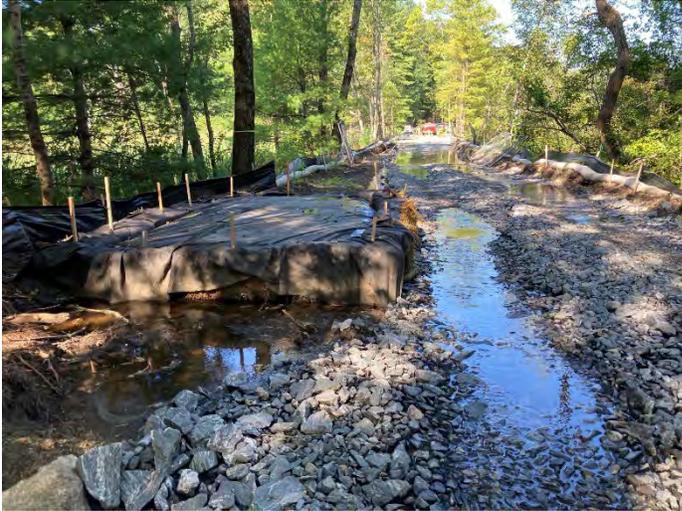
<b>PHOTOGRAPHIC LOG</b>	
Client Name: Eversource		Site Location: Sudbury to Hudson Transmission Reliability Project	Town: Sudbury
Photo No.: 3	Date: 8/24/2023

Description: Additional view of dewatering controls and discharge from controls. Discharge appeared to be leaving the work area and reaching wetlands. Facing west.

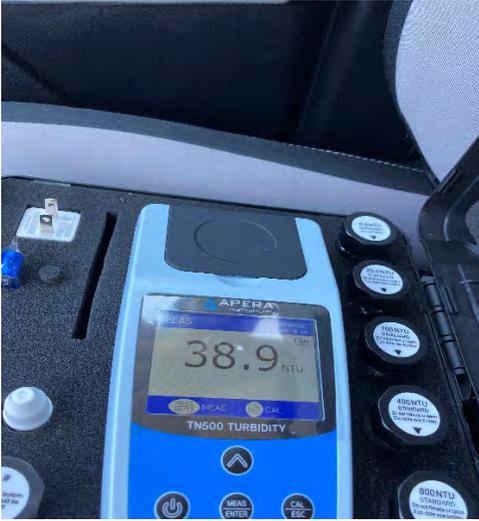
<b>PHOTOGRAPHIC LOG</b>	
Client Name: Eversource		Site Location: Sudbury to Hudson Transmission Reliability Project	Town: Sudbury
Photo No.: 4	Date: 8/24/2023

Description: View of turbidity meter. Turbidity reading was less than 50 NTUs.

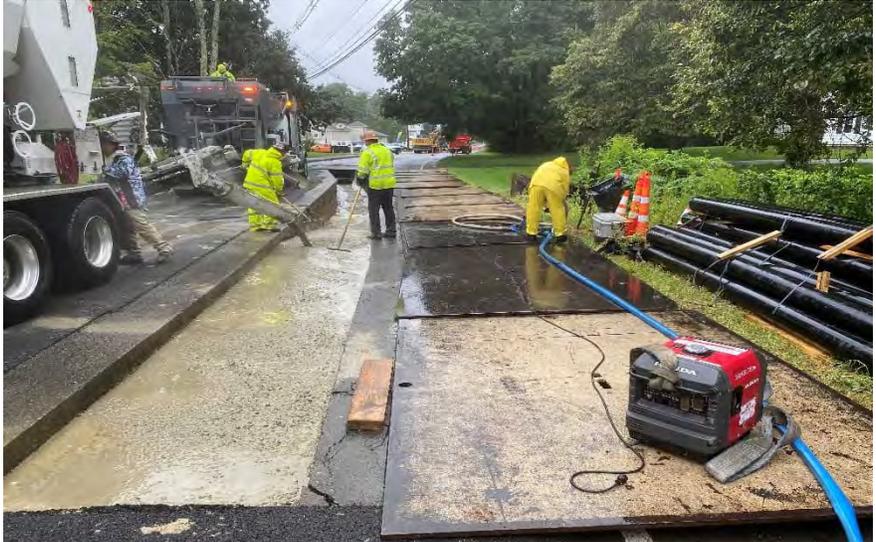
<b>PHOTOGRAPHIC LOG</b>	
Client Name: Eversource		Site Location: Sudbury to Hudson Transmission Reliability Project	Town: Hudson
Photo No.: 1	Date: 8/25/2023

Description: View of area being pumped at Forest Avenue (area in conduit trench), looking southward.

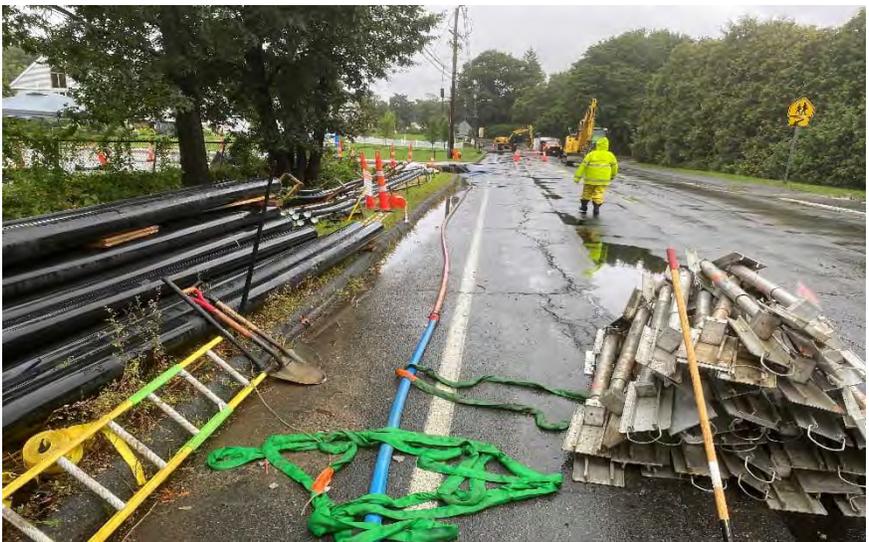
<b>PHOTOGRAPHIC LOG</b>	
Client Name: Eversource		Site Location: Sudbury to Hudson Transmission Reliability Project	Town: Hudson
Photo No.: 2	Date: 8/25/2023

Description: Forest Avenue. View of dewatering operation, looking northward.
