**Weekly Environmental Compliance Summary**

**Sudbury to Hudson Transmission Reliability Project (USEPA Tracking # MAR1003UW)**

Sudbury, Hudson, and Stow, MA

Week of: August 21 to August 25, 2023

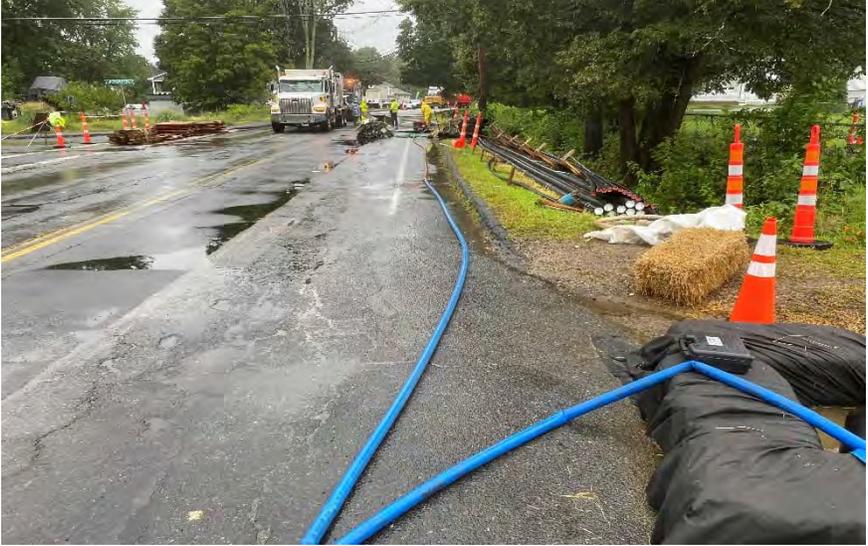
<b>PHOTOGRAPHIC LOG</b>	
Client Name: Eversource		Site Location: Sudbury to Hudson Transmission Reliability Project	Town: Hudson
Photo No.: 3	Date: 8/25/2023

Description: Forest Avenue. View of dewatering operation (pumping at far end of area), looking southward.

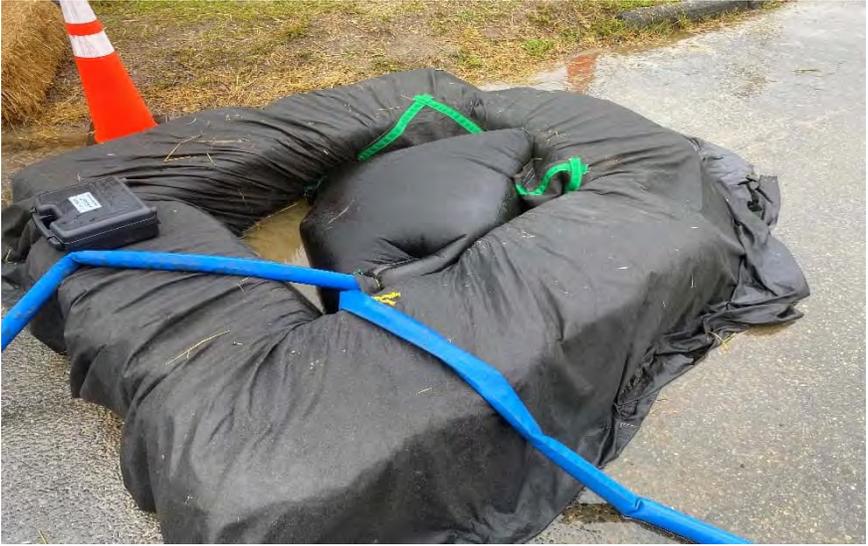
<b>PHOTOGRAPHIC LOG</b>	
Client Name: Eversource		Site Location: Sudbury to Hudson Transmission Reliability Project	Town: Hudson
Photo No.: 4	Date: 8/25/2023

Description: Forest Avenue. View of dewatering operation (corral/bag), looking northward.

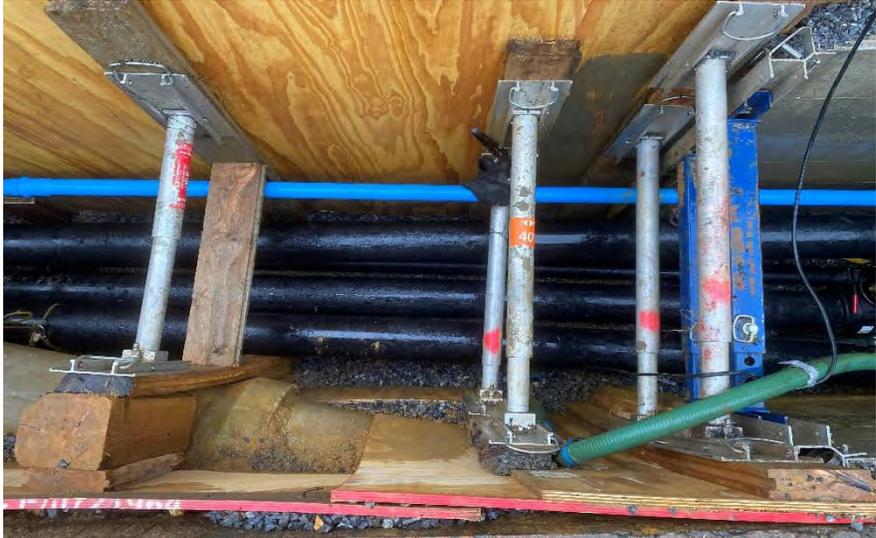
PHOTOGRAPHIC LOG	
Client Name: Eversource		Site Location: Sudbury to Hudson Transmission Reliability Project	Town: Hudson
Photo No.: 1	Date: 8/25/2023

Description: View of area being pumped at Forest Avenue (area in conduit trench).

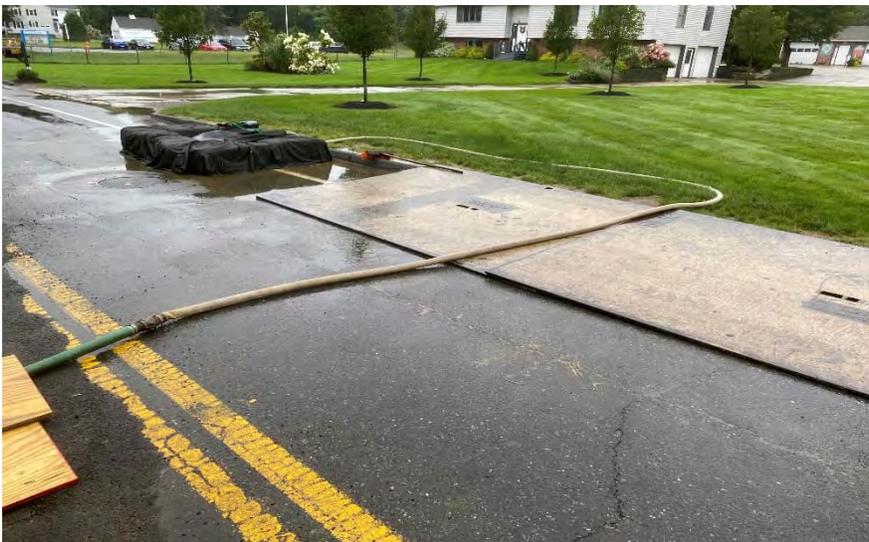
PHOTOGRAPHIC LOG	
Client Name: Eversource		Site Location: Sudbury to Hudson Transmission Reliability Project	Town: Hudson
Photo No.: 2	Date: 8/25/2023

Description: Forest Avenue. View of dewatering operation, looking southward.

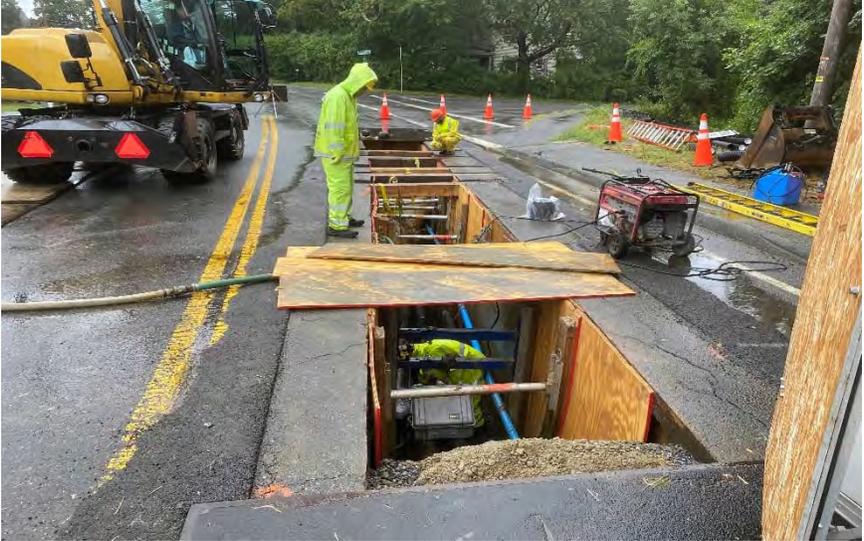
<b>PHOTOGRAPHIC LOG</b>	
Client Name: Eversource		Site Location: Sudbury to Hudson Transmission Reliability Project	Town: Hudson
Photo No.: 3	Date: 8/25/2023

Description: Forest Avenue. View of dewatering operation (pumping at far end of area), looking southward.

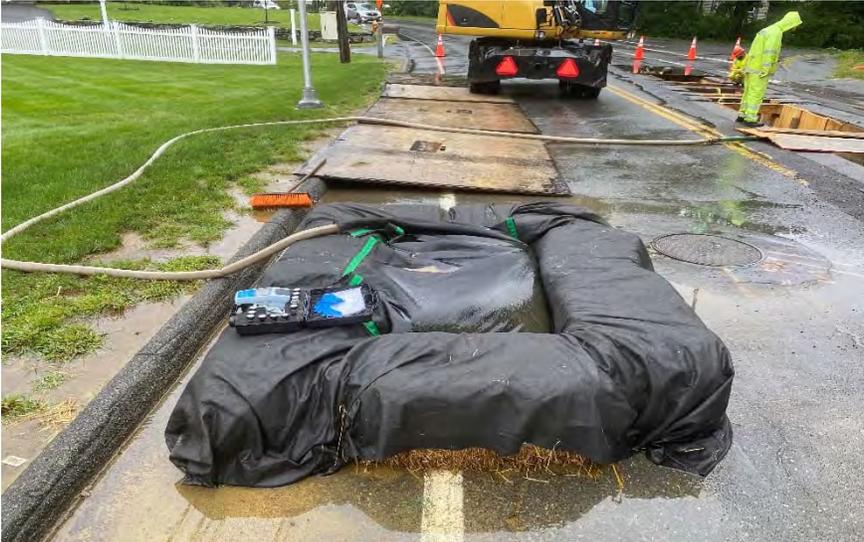
<b>PHOTOGRAPHIC LOG</b>	
Client Name: Eversource		Site Location: Sudbury to Hudson Transmission Reliability Project	Town: Hudson
Photo No.: 4	Date: 8/25/2023

Description: Forest Avenue. View of dewatering operation (corral/bag), looking southward.

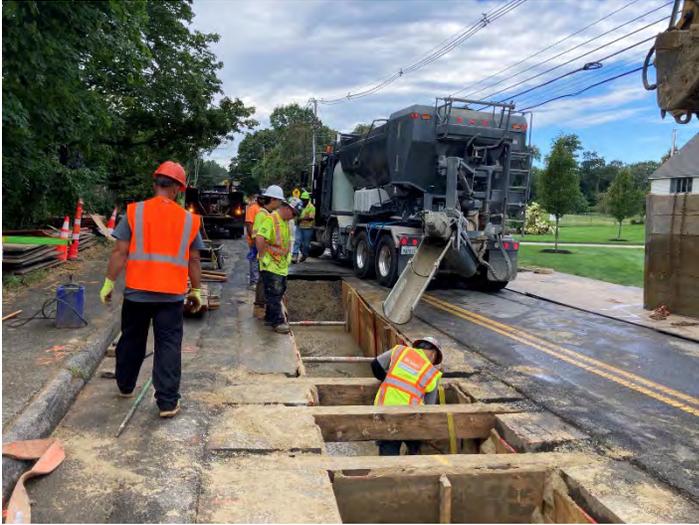
<b>PHOTOGRAPHIC LOG</b>	
Client Name: Eversource		Site Location: Sudbury to Hudson Transmission Reliability Project	
Town: Hudson			
Photo No.: 1	Date: 8/26/2023

Description: View of work area and at MH #3 north on Forest Ave in Hudson. Facing south.

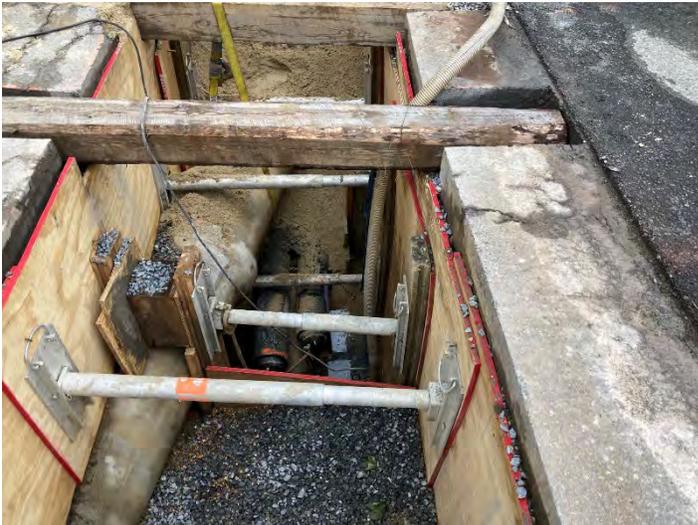
<b>PHOTOGRAPHIC LOG</b>	
Client Name: Eversource		Site Location: Sudbury to Hudson Transmission Reliability Project	
Town: Hudson			
Photo No.: 2	Date: 8/26/2023

Description: View of trench and water prior to treatment. Water appeared slightly turbid. Facing south.

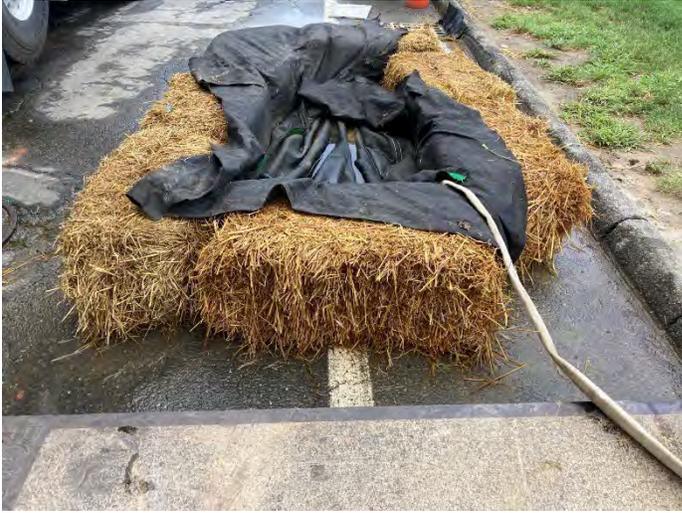
<b>PHOTOGRAPHIC LOG</b>		
Client Name: Eversource		Site Location: Sudbury to Hudson Transmission Reliability Project		Town: Hudson
Photo No.: 3	Date: 8/26/2023

Description: View of dewatering controls (straw bale corral with filter fabric and silt bag). Facing south.
