## Weekly Environmental Compliance Summary

**Sudbury to Hudson Transmission Reliability Project (USEPA Tracking # MAR1003UW)**

Sudbury, Hudson, and Stow, MA

Week of: September 4, 2023 to September 8, 2023

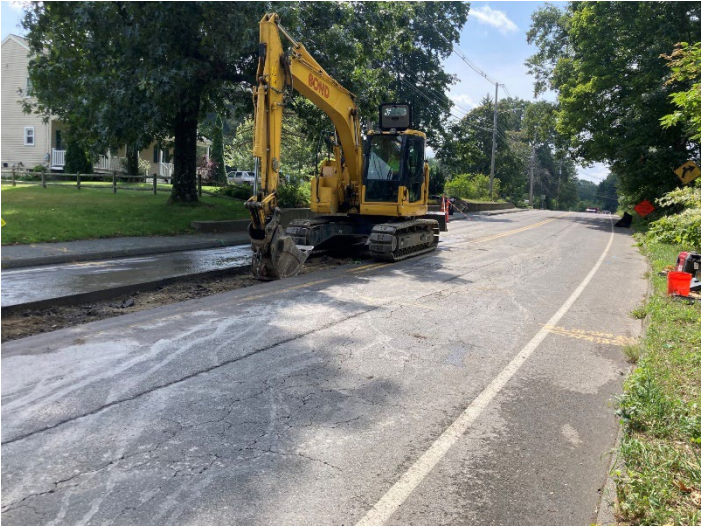
<p><b>PHOTOGRAPHIC LOG</b></p>	
<p><b>Client Name:</b> Eversource</p>		<p><b>Site Location:</b> Sudbury to Hudson Transmission Reliability Project</p>	<p><b>Town:</b> Hudson</p>
<p><b>Photo No.:</b> 2</p>	<p><b>Date:</b> 9/05/2023</p>

<p><b>Description:</b> View of Bond working on Forest Ave. Facing southeast.</p>

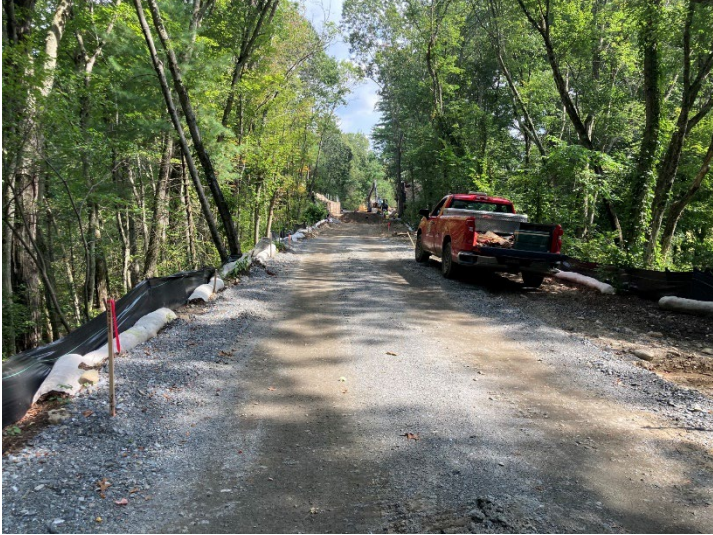
<p><b>PHOTOGRAPHIC LOG</b></p>	
<p><b>Client Name:</b> Eversource</p>		<p><b>Site Location:</b> Sudbury to Hudson Transmission Reliability Project</p>	<p><b>Town:</b> Hudson</p>
<p><b>Photo No.:</b> 3</p>	<p><b>Date:</b> 9/05/2023</p>

<p><b>Description:</b> View of east end of segment 1. Facing east.</p>

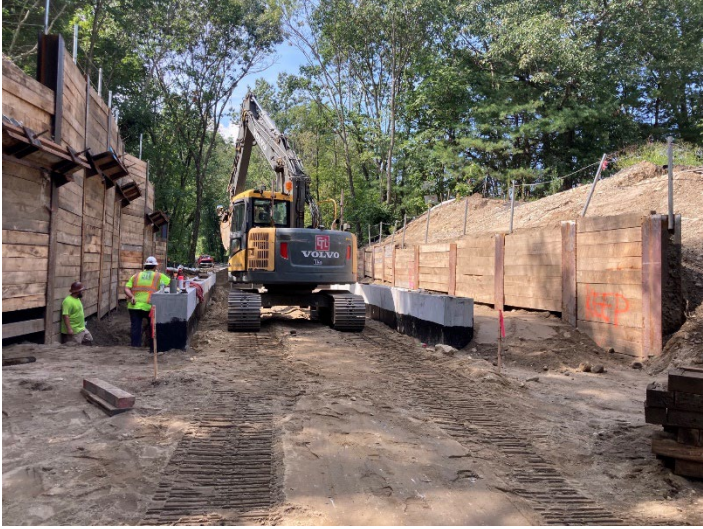
<p><b>PHOTOGRAPHIC LOG</b></p>	
<p><b>Client Name:</b> Eversource</p>		<p><b>Site Location:</b> Sudbury to Hudson Transmission Reliability Project</p>	<p><b>Town:</b> Hudson</p>
<p><b>Photo No.:</b> 4</p>	<p><b>Date:</b> 9/05/2023</p>

<p><b>Description:</b> View of ET&amp;L working at Chestnut St tunnel. Facing west.</p>

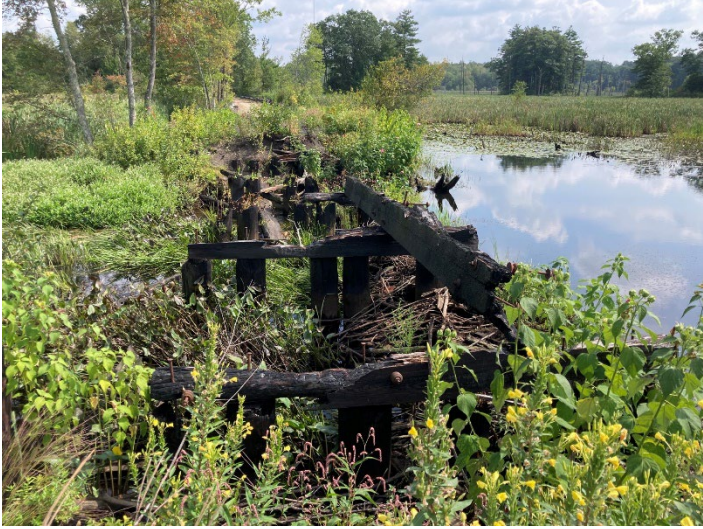
<p><b>PHOTOGRAPHIC LOG</b></p>	
<p><b>Client Name:</b> Eversource</p>		<p><b>Site Location:</b> Sudbury to Hudson Transmission Reliability Project</p>	<p><b>Town:</b> Hudson</p>
<p><b>Photo No.:</b> 5</p>	<p><b>Date:</b> 9/05/2023</p>

<p><b>Description:</b> View of bridge 130 from end of segment 2. Facing east.</p>

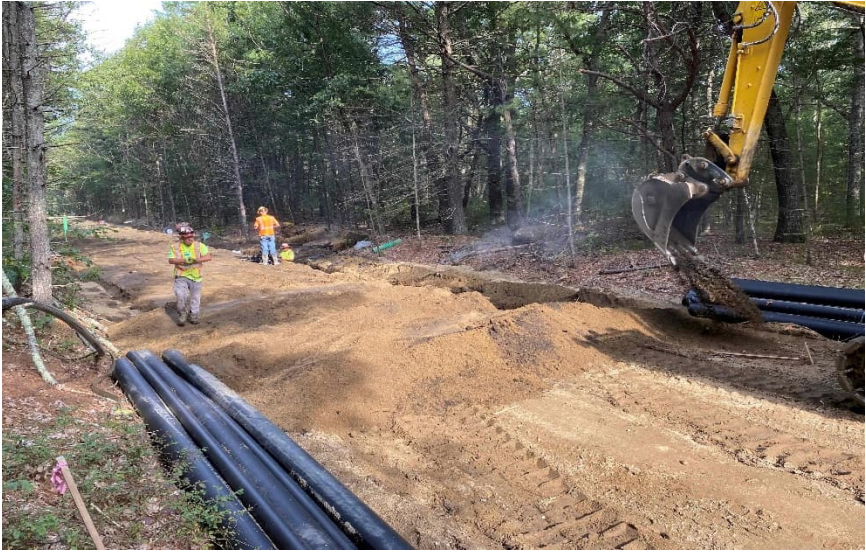
<b>PHOTOGRAPHIC LOG</b>	
Client Name: Eversource		Site Location: Sudbury to Hudson Transmission Reliability Project	Town: Sudbury
Photo No.: 3	Date: 9-5-23

Description:  Conduit work area within segment 7, looking westward.

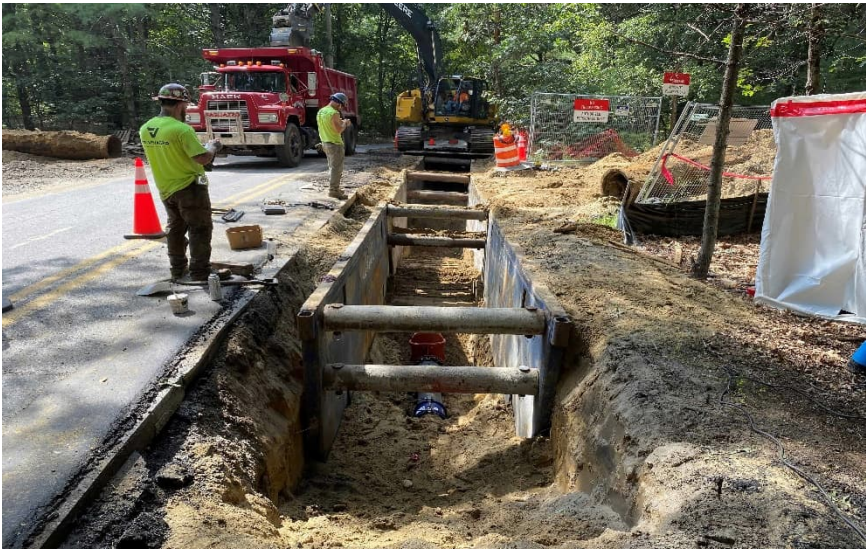
<b>PHOTOGRAPHIC LOG</b>	
Client Name: Eversource		Site Location: Sudbury to Hudson Transmission Reliability Project	Town: Sudbury
Photo No.: 4	Date: 9-5-23

Description:  Work area within Dutton Road, trenching to expose water line (west side of road), looking southward.

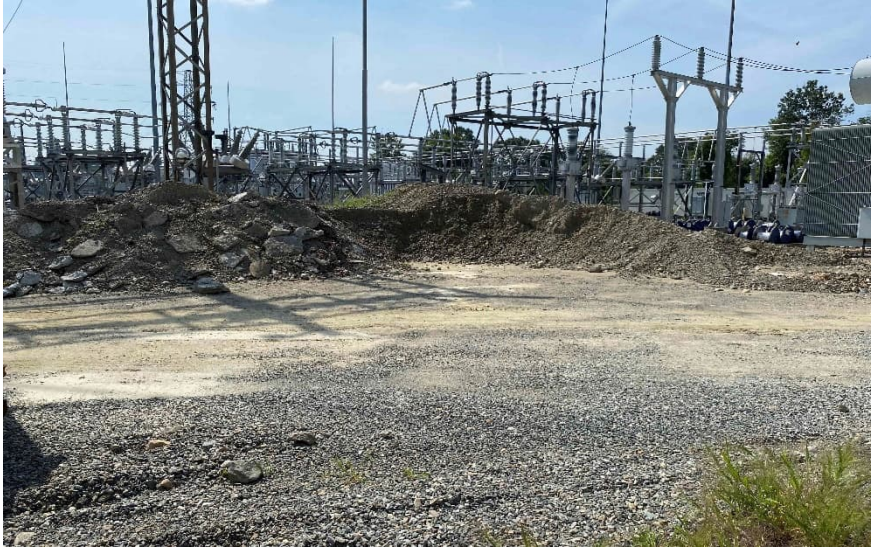
<b>PHOTOGRAPHIC LOG</b>	
Client Name: Eversource		Site Location: Sudbury to Hudson Transmission Reliability Project	Town: Sudbury
Photo No.: 5	Date: 9-5-23

Description:  Spoil area within substation, looking southward.

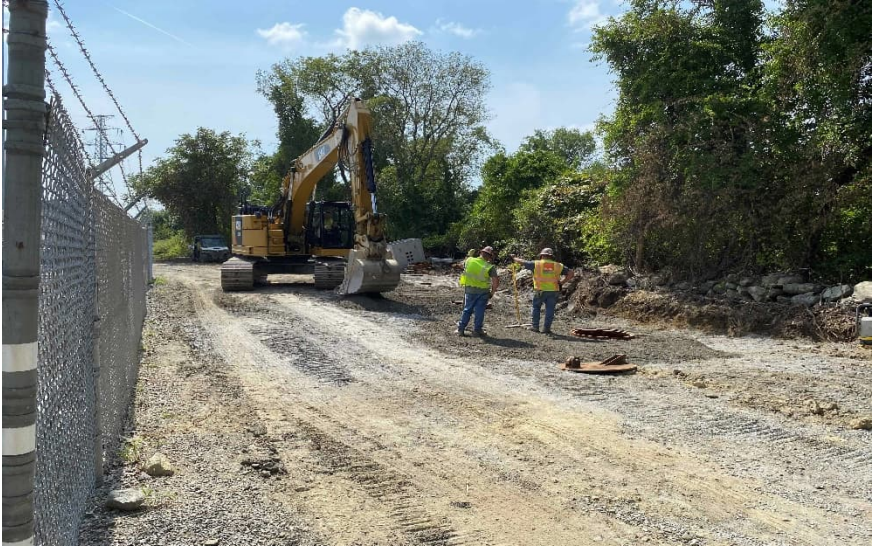
<b>PHOTOGRAPHIC LOG</b>	
Client Name: Eversource		Site Location: Sudbury to Hudson Transmission Reliability Project	Town: Sudbury
Photo No.: 6	Date: 9-5-23

Description:  Manhole #28 at Sudbury substation, looking southward.

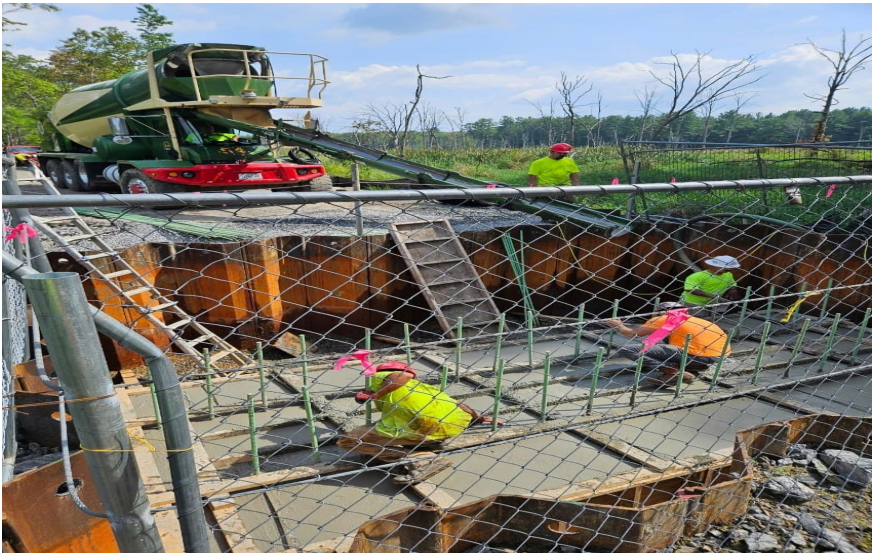
<b>PHOTOGRAPHIC LOG</b>	
Client Name: Eversource		Site Location: Sudbury to Hudson Transmission Reliability Project	Town: Sudbury
Photo No.: 8	Date: 9-5-23

Description:  Work area within segment 13, concrete pour for foundation, looking westward.

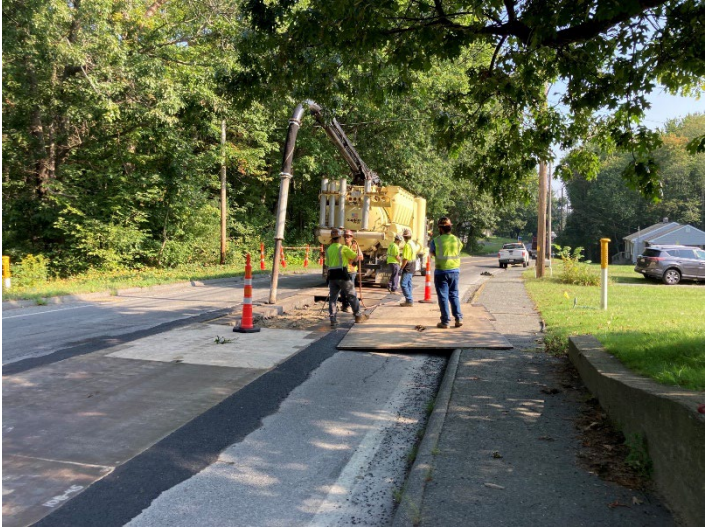
<p align="right"><b>PHOTOGRAPHIC LOG</b></p>	
<p><b>Client Name:</b> Eversource</p>		<p><b>Site Location:</b> Sudbury to Hudson Transmission Reliability Project</p>	<p><b>Town:</b> Hudson</p>
<p><b>Photo No.:</b> 1</p>	<p><b>Date:</b> 9/06/2023</p>

<p><b>Description:</b> View of Bond working on Forest Ave. Facing north.</p>

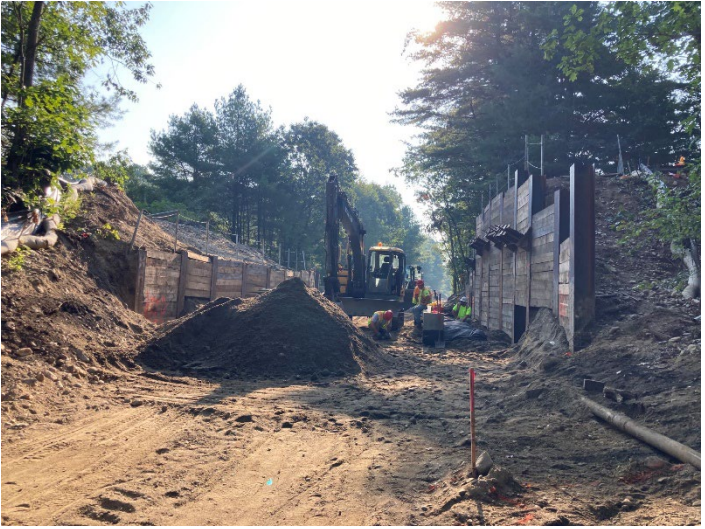
<p align="right"><b>PHOTOGRAPHIC LOG</b></p>	
<p><b>Client Name:</b> Eversource</p>		<p><b>Site Location:</b> Sudbury to Hudson Transmission Reliability Project</p>	<p><b>Town:</b> Hudson</p>
<p><b>Photo No.:</b> 2</p>	<p><b>Date:</b> 9/06/2023</p>

<p><b>Description:</b> View of ET&amp;L working at Chestnut St tunnel. Facing east.</p>

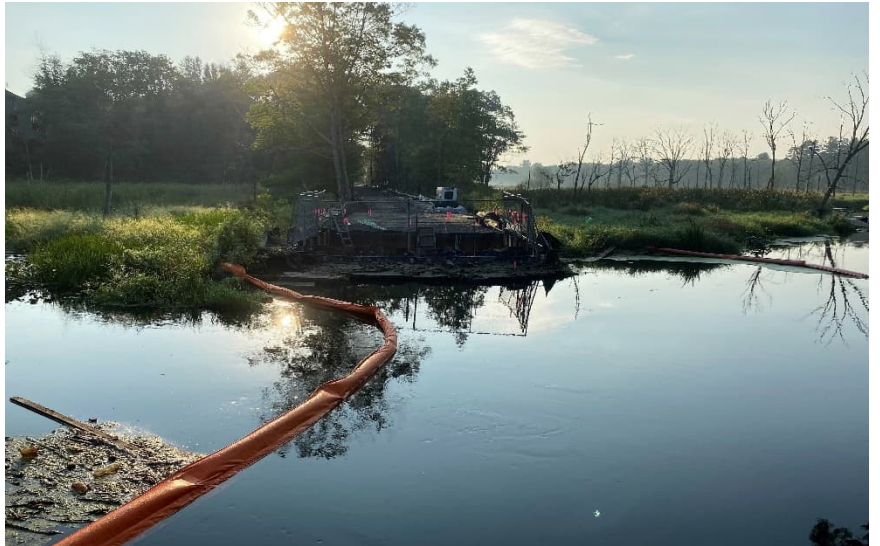
<b>PHOTOGRAPHIC LOG</b>	
Client Name: Eversource		Site Location: Sudbury to Hudson Transmission Reliability Project	Town: Sudbury
Photo No.: 2	Date: 9-6-23

Description:  Work area looking toward segment 14 across Hop Brook, existing erosion control, looking eastward.

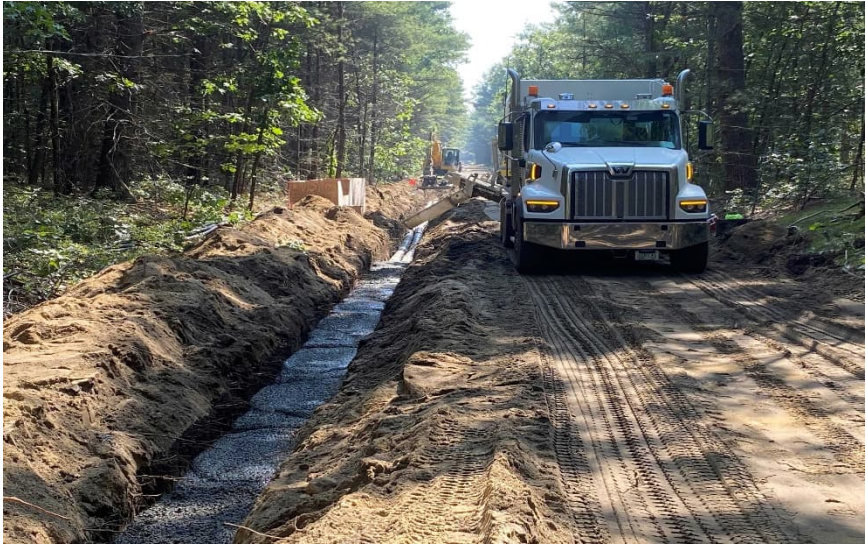
<b>PHOTOGRAPHIC LOG</b>	
Client Name: Eversource		Site Location: Sudbury to Hudson Transmission Reliability Project	Town: Sudbury
Photo No.: 3	Date: 9-6-23

Description:  Conduit work area within segment 7, looking eastward.

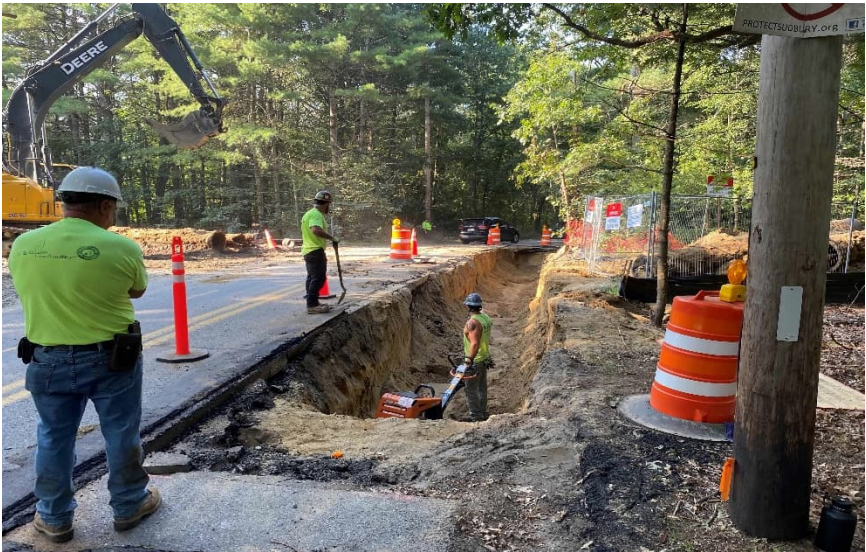
<b>PHOTOGRAPHIC LOG</b>	
Client Name: Eversource		Site Location: Sudbury to Hudson Transmission Reliability Project	Town: Sudbury
Photo No.: 4	Date: 9-6-23

Description:  Work area within Dutton Road, trenching to expose water line (west side of road), looking southward.

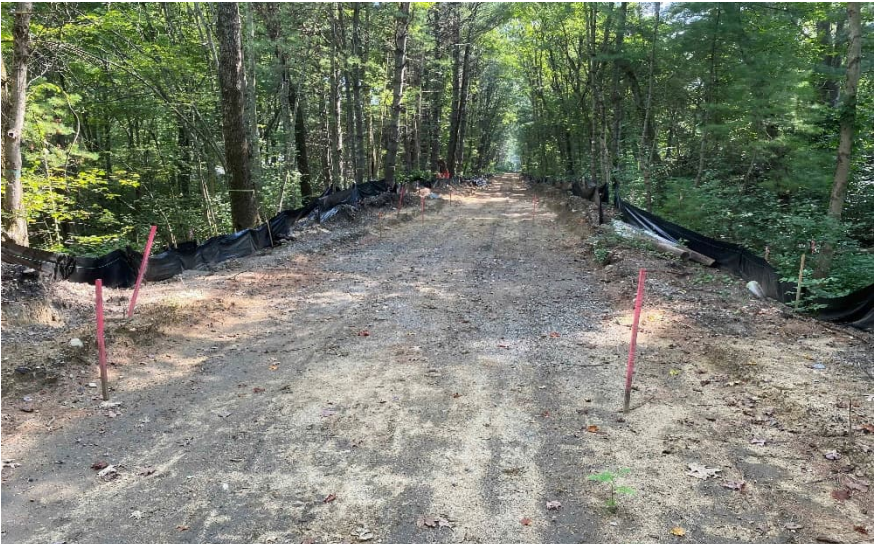
<b>PHOTOGRAPHIC LOG</b>	
Client Name: Eversource		Site Location: Sudbury to Hudson Transmission Reliability Project	Town: Sudbury
Photo No.: 6	Date: 9-6-23

Description:  Work area within segment 10, over Dudley Brook, looking eastward.

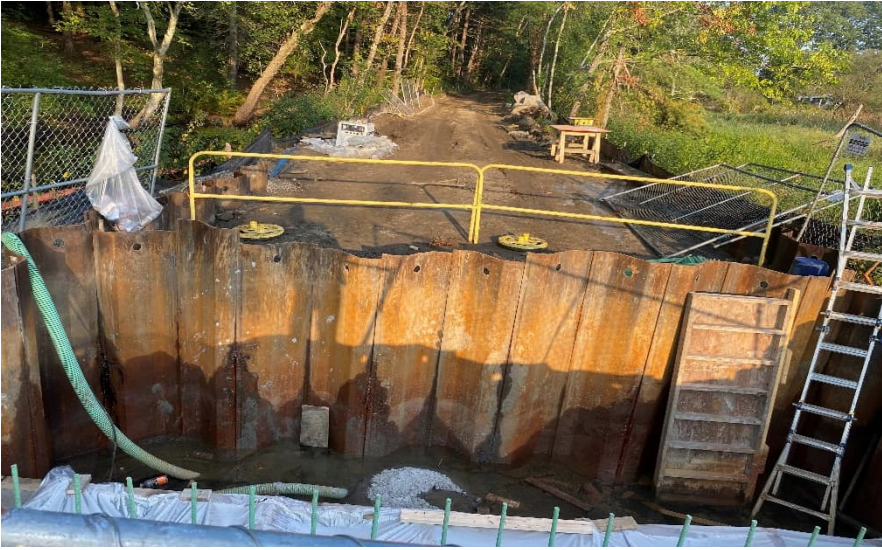
<b>PHOTOGRAPHIC LOG</b>	
Client Name: Eversource		Site Location: Sudbury to Hudson Transmission Reliability Project	Town: Sudbury
Photo No.: 8	Date: 9-6-23

Description:  Work area within segment 13, concrete pour area for foundation, looking westward.

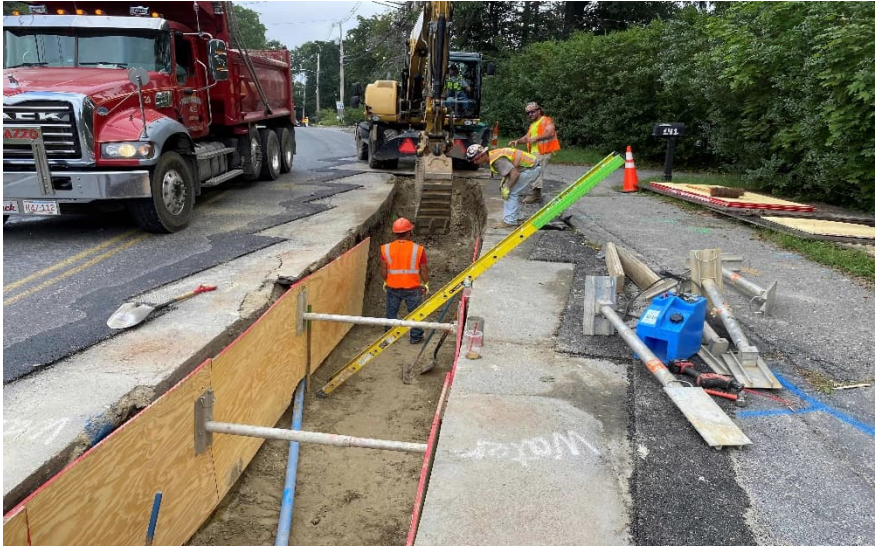
<p>PHOTOGRAPHIC LOG</p>	
<p>Client Name: Eversource</p>		<p>Site Location: Sudbury to Hudson Transmission Reliability Project</p>	<p>Town: Hudson</p>
<p>Photo No.: 1</p>	<p>Date: 9-8-23</p>

<p>Description:</p> <p>Work area within Forest Avenue, conduit work, looking northward.</p>

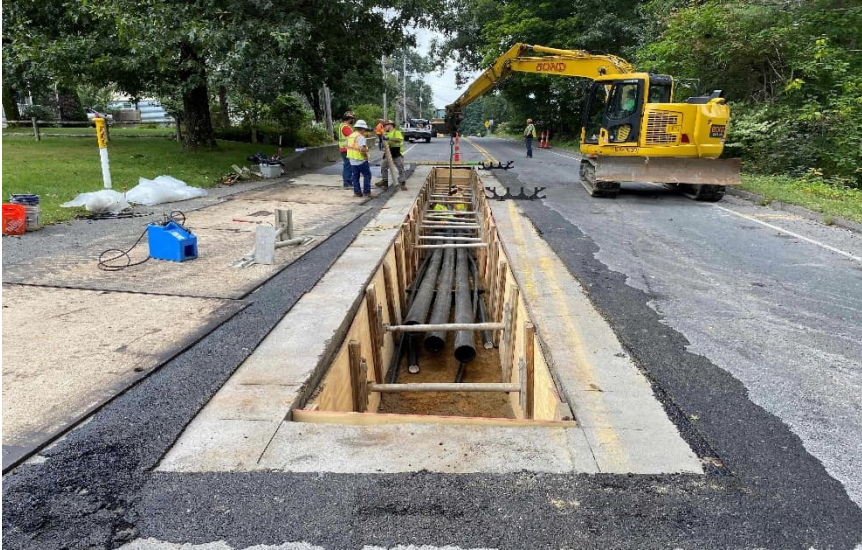
<p>PHOTOGRAPHIC LOG</p>	
<p>Client Name: Eversource</p>		<p>Site Location: Sudbury to Hudson Transmission Reliability Project</p>	<p>Town: Hudson</p>
<p>Photo No.: 2</p>	<p>Date: 9-8-23</p>

<p>Description:</p> <p>Work area within Forest Avenue, conduit work, looking northward.</p>

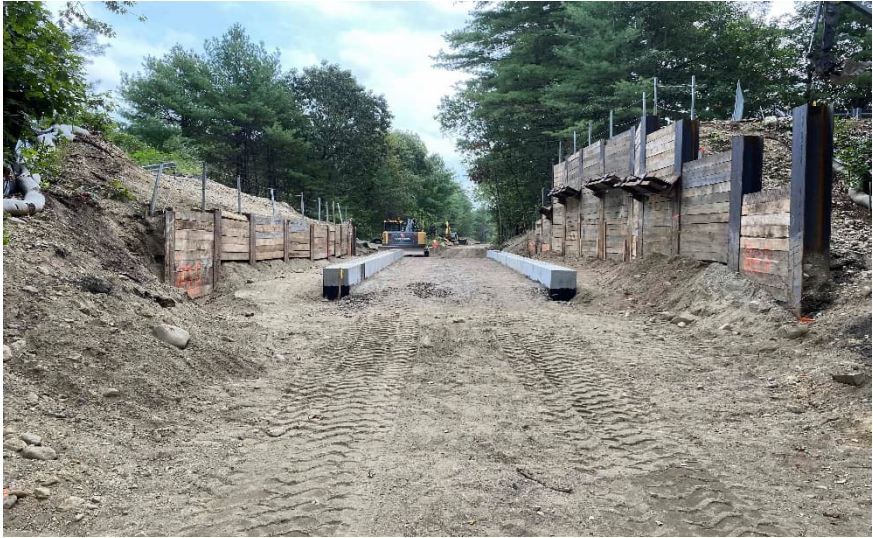
<p>PHOTOGRAPHIC LOG</p>	
<p>Client Name: Eversource</p>		<p>Site Location: Sudbury to Hudson Transmission Reliability Project</p>	<p>Town: Hudson</p>
<p>Photo No.: 3</p>	<p>Date: 9-8-23</p>

<p>Description:                  Work area within segment 1, Chestnut Street crossing, looking eastward.</p>

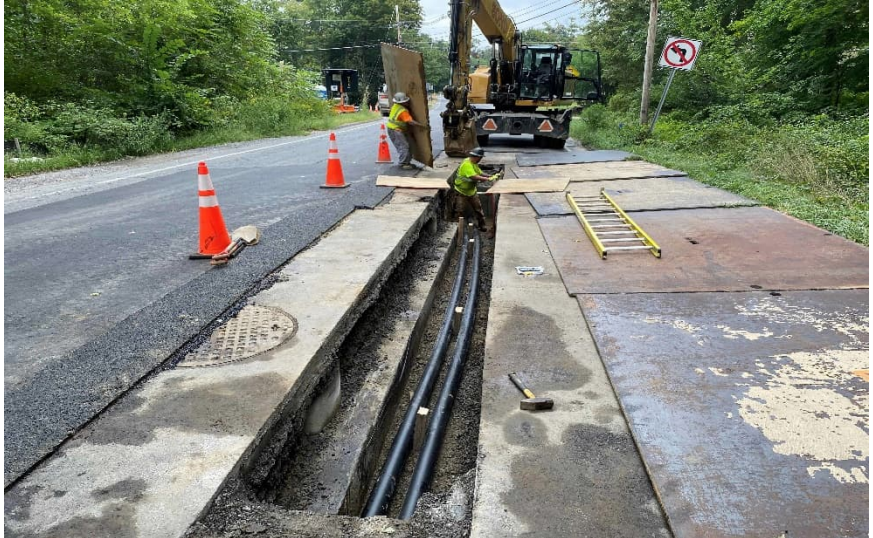
<p>PHOTOGRAPHIC LOG</p>	
<p>Client Name: Eversource</p>		<p>Site Location: Sudbury to Hudson Transmission Reliability Project</p>	<p>Town: Hudson</p>
<p>Photo No.: 4</p>	<p>Date: 9-8-23</p>

<p>Description:                  Work area within Forest Avenue, conduit work, looking northward.</p>

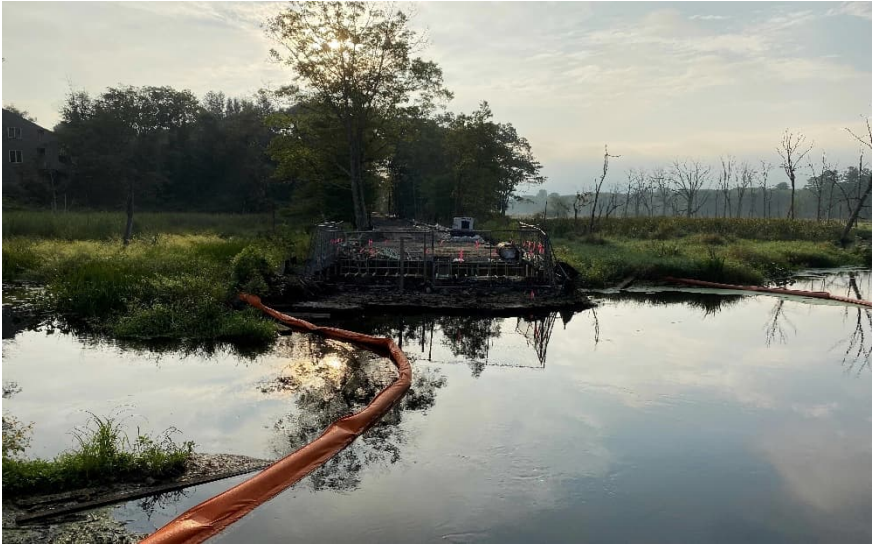
<p>PHOTOGRAPHIC LOG</p>	
<p>Client Name: Eversource</p>		<p>Site Location: Sudbury to Hudson Transmission Reliability Project</p>	<p>Town: Sudbury</p>
<p>Photo No.: 5</p>	<p>Date: 9-8-23</p>

<p>Description:</p> <p>Hop Brook at Bridge 127, looking from segment 13 to 14, looking eastward.</p>

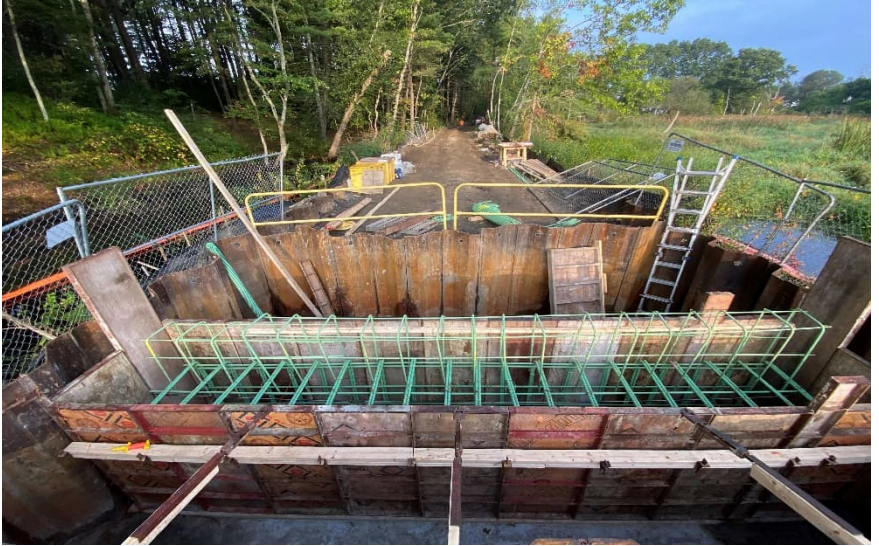
<p>PHOTOGRAPHIC LOG</p>	
<p>Client Name: Eversource</p>		<p>Site Location: Sudbury to Hudson Transmission Reliability Project</p>	<p>Town: Sudbury</p>
<p>Photo No.: 6</p>	<p>Date: 9-8-23</p>

<p>Description:</p> <p>Work area within segment 13, bridge 127 work, looking westward.</p>

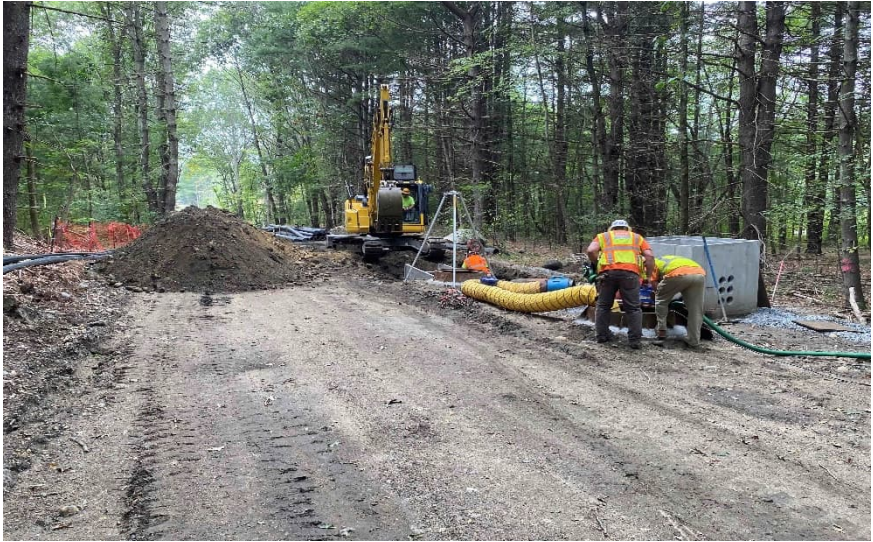
<p>PHOTOGRAPHIC LOG</p>	
<p>Client Name: Eversource</p>		<p>Site Location: Sudbury to Hudson Transmission Reliability Project</p>	<p>Town: Sudbury</p>
<p>Photo No.: 7</p>	<p>Date: 9-8-23</p>

<p>Description:                  Work area within Segment 8, at Manhole 17, looking westward.</p>

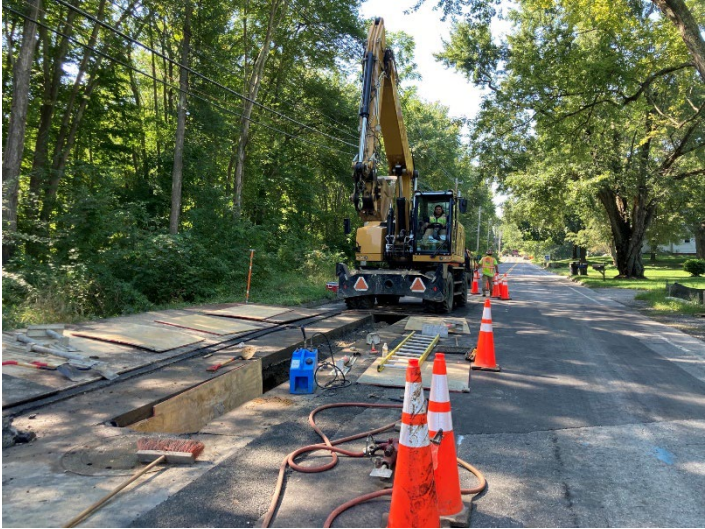
<b>PHOTOGRAPHIC LOG</b>	
<b>Client Name:</b> Eversource		<b>Site Location:</b> Sudbury to Hudson Transmission Reliability Project	<b>Town:</b> Hudson
<b>Photo No.:</b> 2	<b>Date:</b> 9-07-2023

<b>Description:</b> View of Bond working near MH #4 on Forest Ave. Facing south.

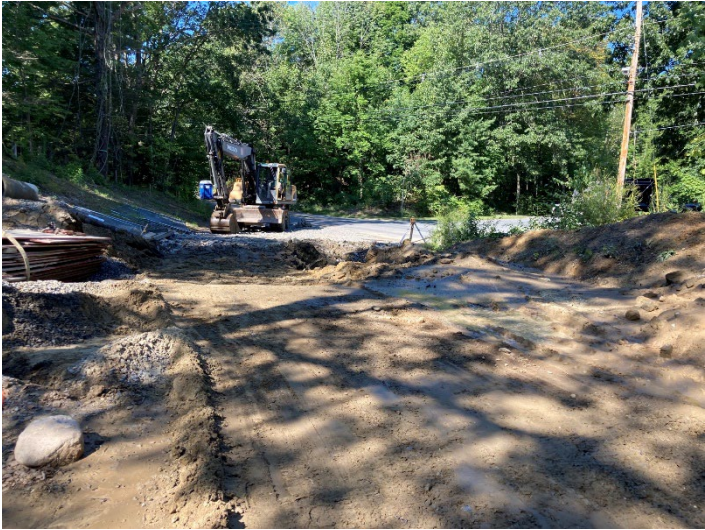
<b>PHOTOGRAPHIC LOG</b>	
Client Name: Eversource		Site Location: Sudbury to Hudson Transmission Reliability Project	Town: Hudson
Photo No.: 3	Date: 9-07-2023

<b>Description:</b> View of ET&L installing drainage structures 1 and 2 at entrance to segment 1. Facing west.

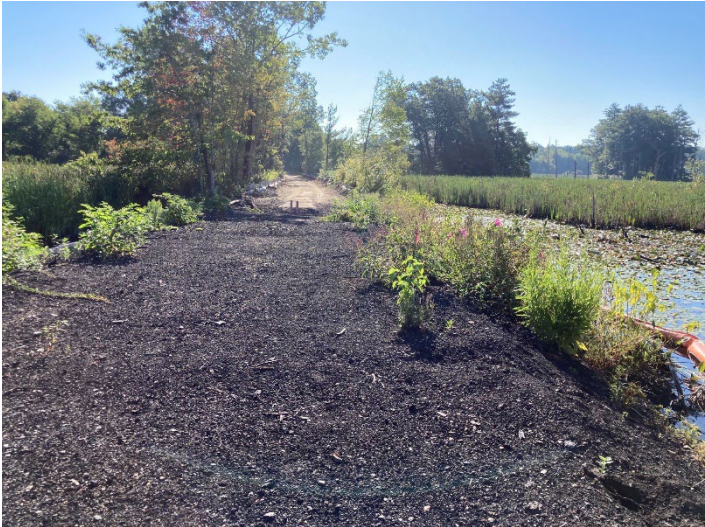
<b>Epsilon</b> ASSOCIATES INC.		<b>PHOTOGRAPHIC LOG</b>	
<b>Client Name: Eversource</b>		<b>Site Location: Sudbury to Hudson Transmission Reliability Project</b>	<b>Town: Hudson</b>
<b>Photo No.: 6</b>	<b>Date: 9-07-2023</b>

<b>Description:</b> <b>View of segment 3 from bridge 130. Facing east.</b>

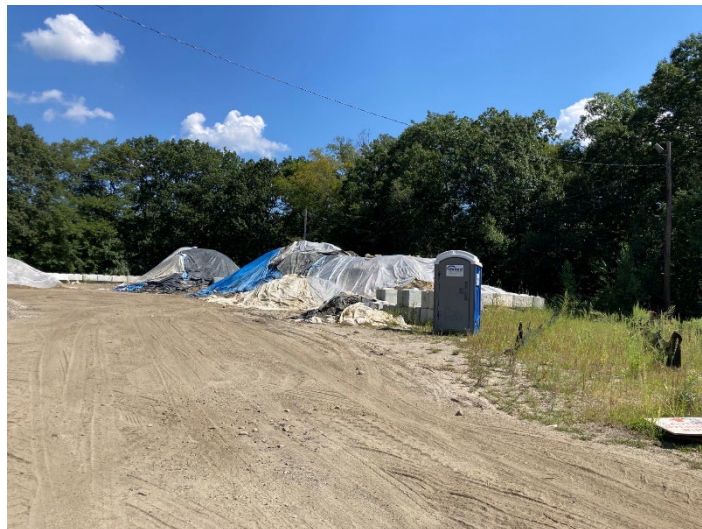
View of Stowe Ct laydown yard. Facing east.

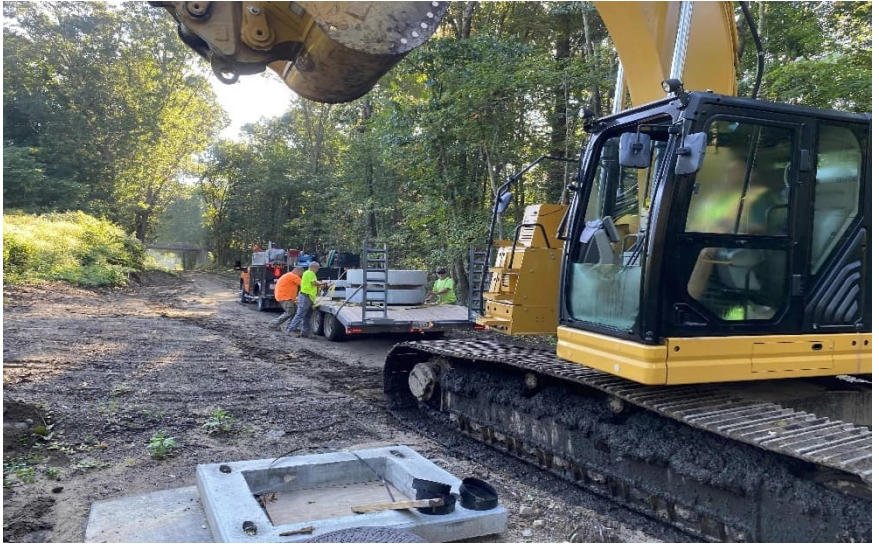
<b>PHOTOGRAPHIC LOG</b>	
Client Name: Eversource		Site Location: Sudbury to Hudson Transmission Reliability Project	Town: Sudbury
Photo No.: 1	Date: 9-7-23

Description:  Manhole work within segment 14, looking eastward.

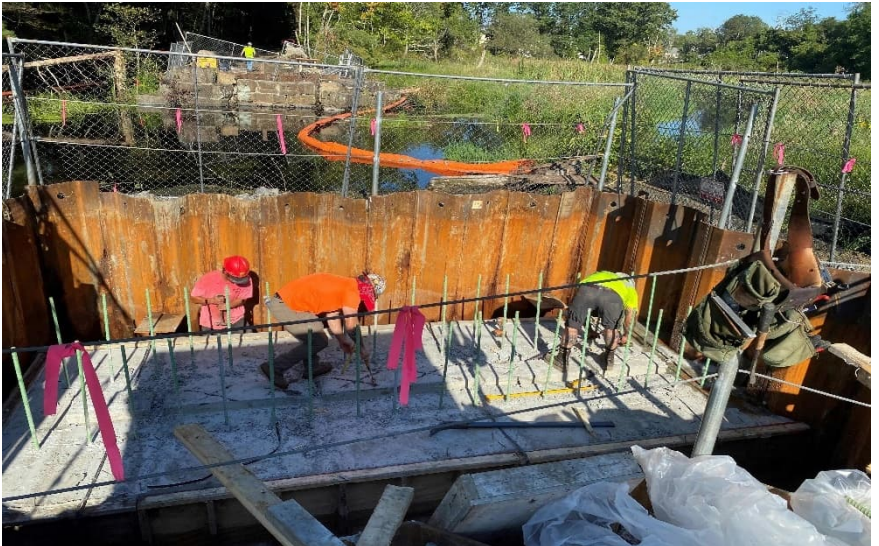
<b>PHOTOGRAPHIC LOG</b>	
Client Name: Eversource		Site Location: Sudbury to Hudson Transmission Reliability Project	Town: Sudbury
Photo No.: 2	Date: 9-7-23

Description:  Bridge work within segment 13, looking westward.

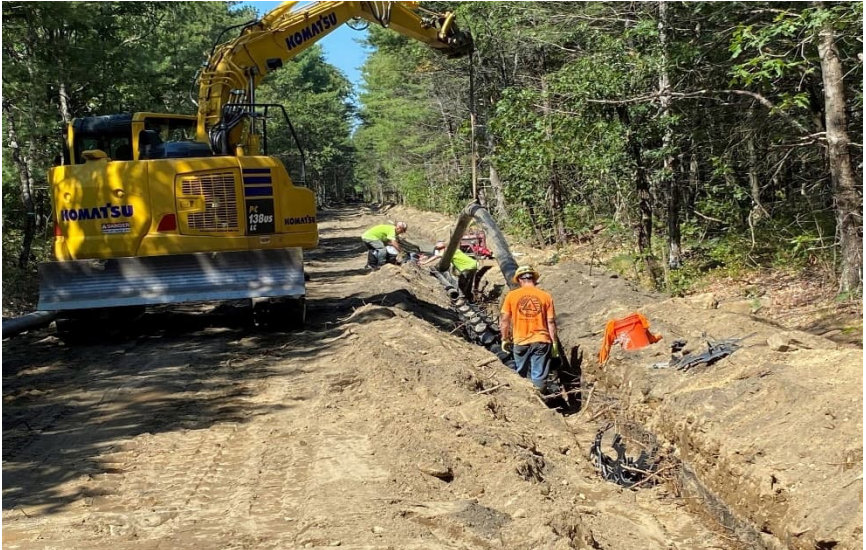
<b>PHOTOGRAPHIC LOG</b>	
Client Name: Eversource		Site Location: Sudbury to Hudson Transmission Reliability Project	Town: Sudbury
Photo No.: 4	Date: 9-7-23

Description:  Work area within segment 7, conduit work, looking westward.

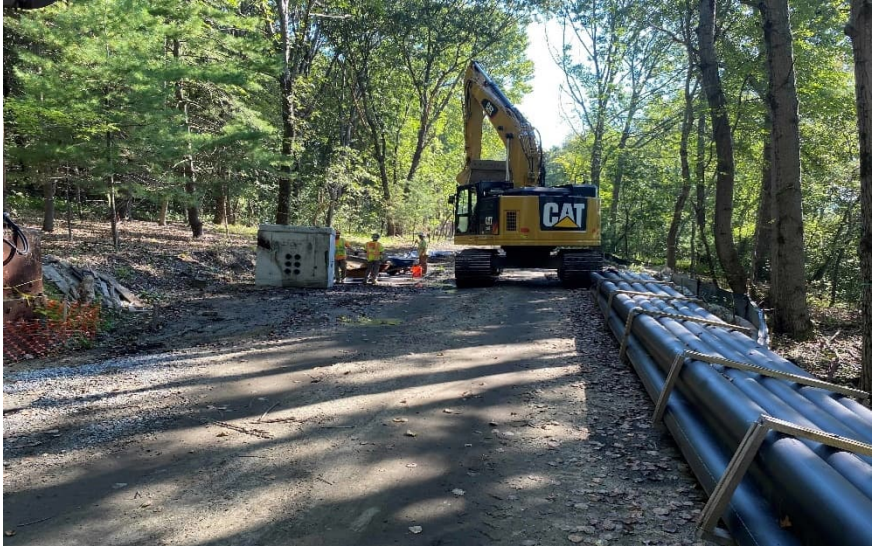
<b>PHOTOGRAPHIC LOG</b>	
Client Name: Eversource		Site Location: Sudbury to Hudson Transmission Reliability Project	Town: Sudbury
Photo No.: 5	Date: 9-7-23

Description:  Work area within segment 14, Bond conducting manhole work, existing erosion control, looking eastward.

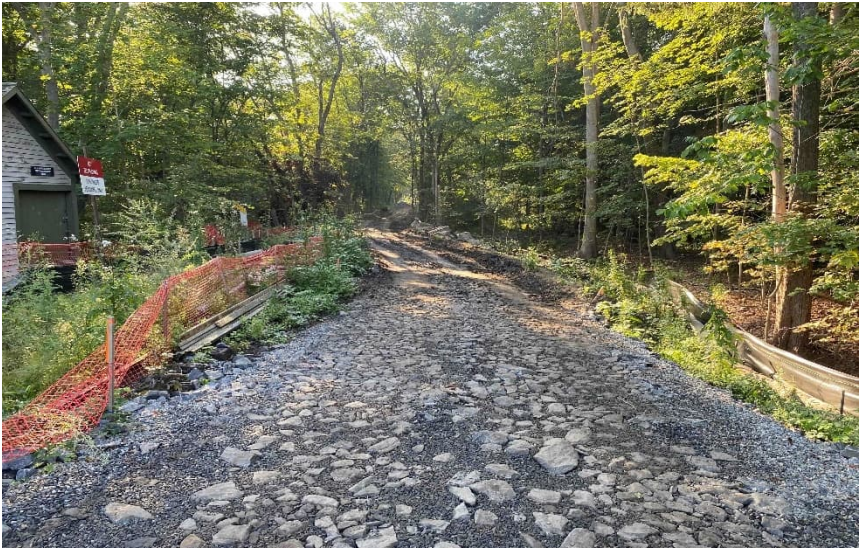
<b>PHOTOGRAPHIC LOG</b>	
Client Name: Eversource		Site Location: Sudbury to Hudson Transmission Reliability Project	Town: Sudbury
Photo No.: 7	Date: 9-7-23

Description:  Work area within segment 13, existing erosion control, looking eastward.

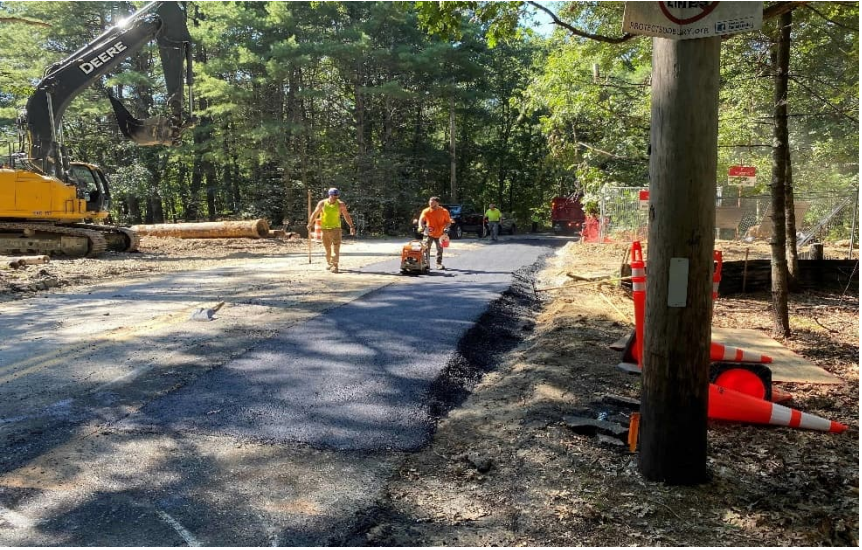
<b>PHOTOGRAPHIC LOG</b>	
Client Name: Eversource		Site Location: Sudbury to Hudson Transmission Reliability Project	Town: Sudbury
Photo No.: 8	Date: 9-7-23

Description:  Water line replacement work within Dutton Road, looking southward.

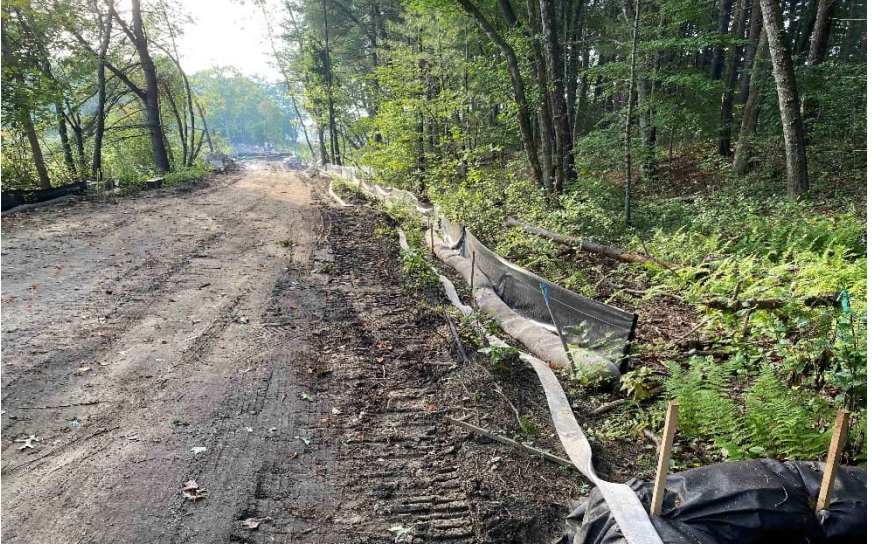
<b>PHOTOGRAPHIC LOG</b>	
Client Name: Eversource		Site Location: Sudbury to Hudson Transmission Reliability Project	Town: Sudbury
Photo No.: 3	Date: 9/5/2023

Description: Segment 13. View of dewatering operation (pumping at far end of area), looking eastward.

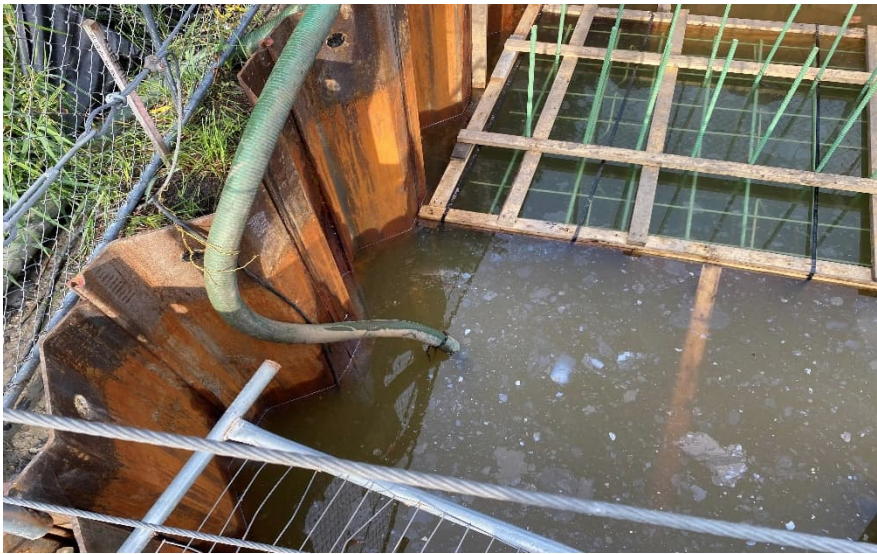
<b>PHOTOGRAPHIC LOG</b>	
Client Name: Eversource		Site Location: Sudbury to Hudson Transmission Reliability Project	Town: Sudbury
Photo No.: 1	Date: 9/5/2023

Description: View of area being pumped at Hop Brook (area in cofferdam), looking westward.

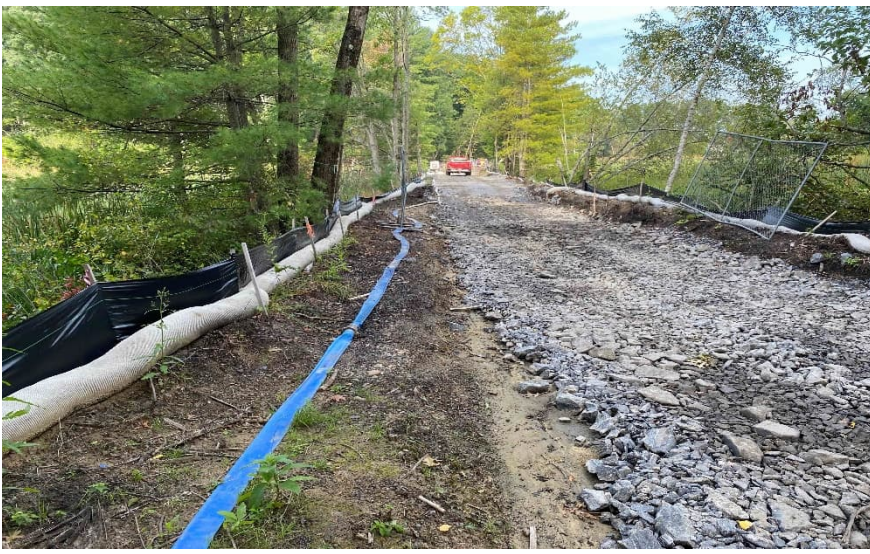
<b>PHOTOGRAPHIC LOG</b>	
Client Name: Eversource		Site Location: Sudbury to Hudson Transmission Reliability Project	Town: Sudbury
Photo No.: 2	Date: 9/5/2023

Description: Segment 14. View of dewatering operation (pumping at far end of area), looking westward.

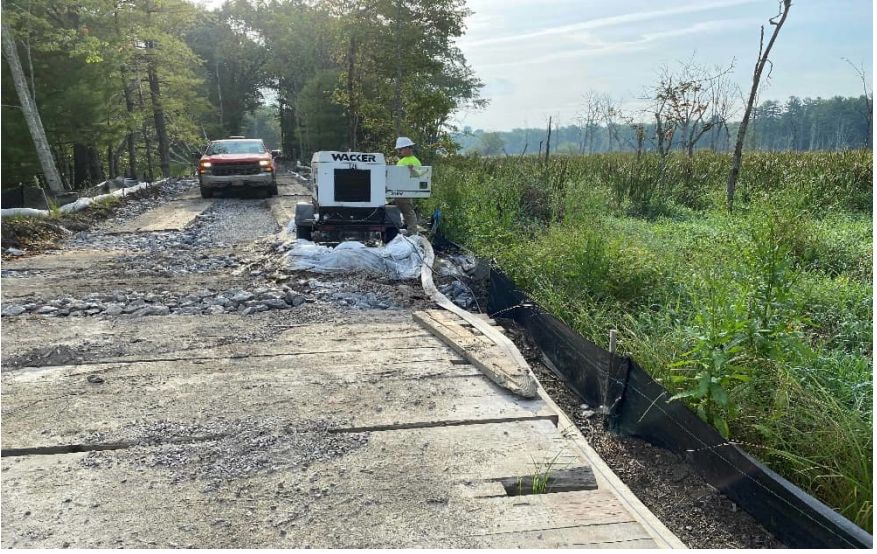
Client Name: Eversource		Site Location: Sudbury to Hudson Transmission Reliability Project	Town: Sudbury
Photo No.: 3	Date: 9/5/2023

Description: Segment 14. View of dewatering operation (pumping at far end of area), looking eastward.

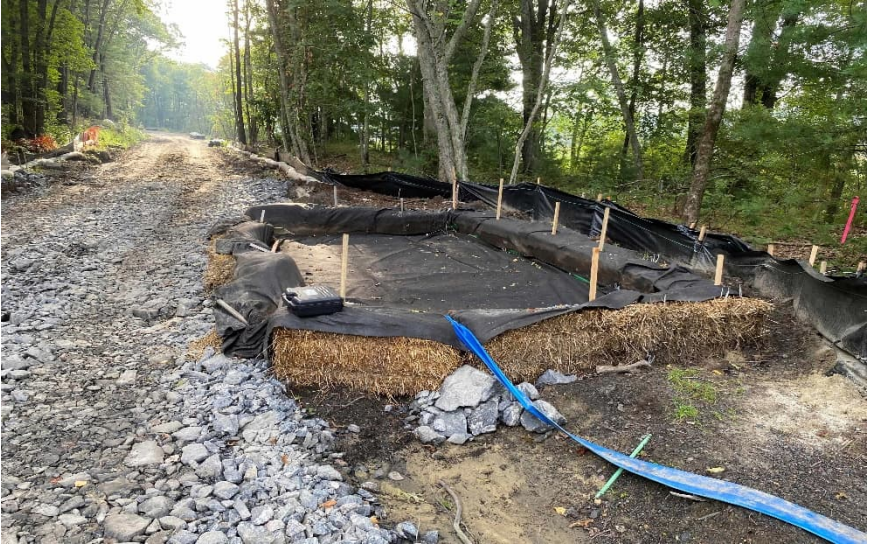
Client Name: Eversource		Site Location: Sudbury to Hudson Transmission Reliability Project	Town: Sudbury
Photo No.: 4	Date: 9/5/2023

Description: Segment 14. View of dewatering operation (pumping at far end of area), looking eastward.

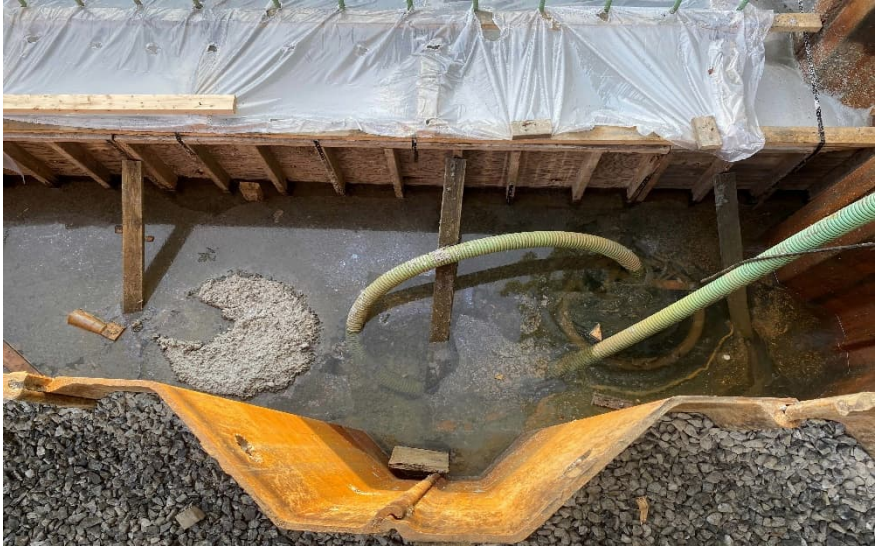
<b>PHOTOGRAPHIC LOG</b>	
Client Name: Eversource		Site Location: Sudbury to Hudson Transmission Reliability Project	Town: Sudbury
Photo No.: 1	Date: 9/6/2023

Description: View of area being pumped at Hop Brook (area in cofferdam), looking westward.

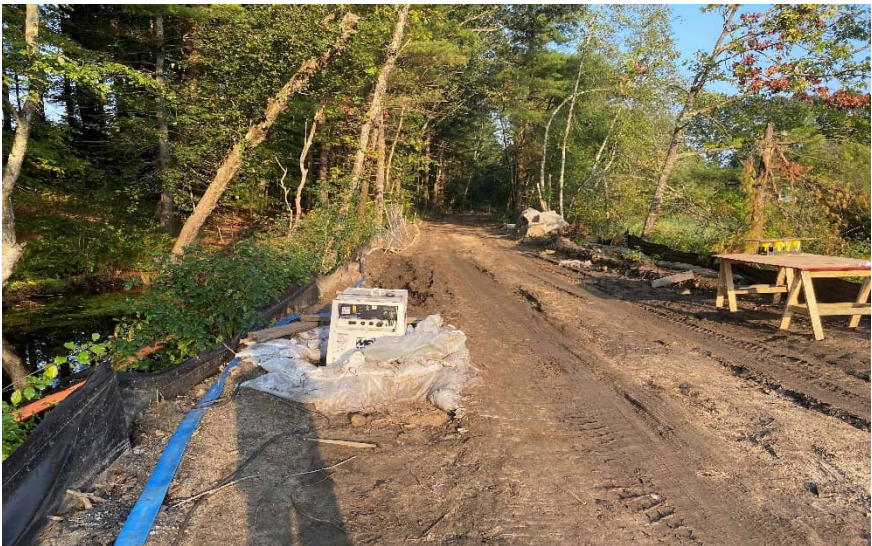
<b>PHOTOGRAPHIC LOG</b>	
Client Name: Eversource		Site Location: Sudbury to Hudson Transmission Reliability Project	Town: Sudbury
Photo No.: 2	Date: 9/6/2023

Description: Segment 13. View of dewatering operation (pumping at far end of area), looking westward.

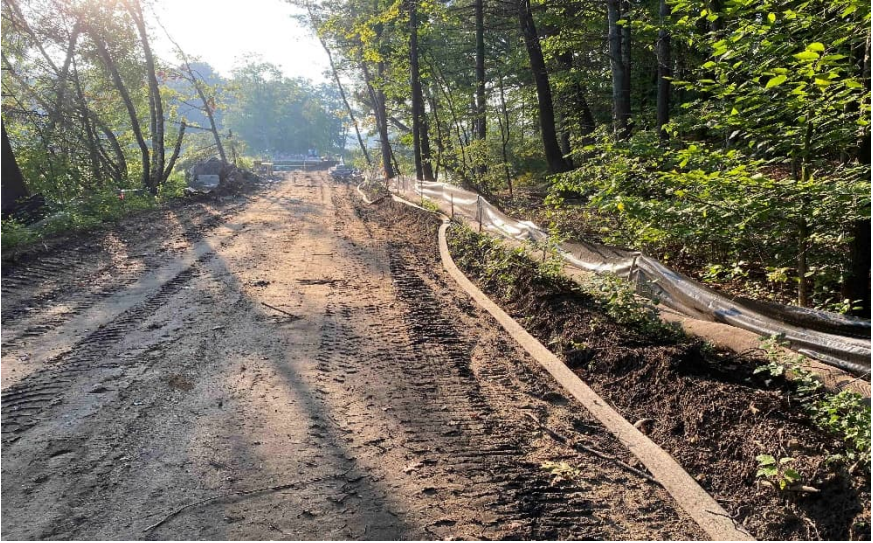
Client Name: Eversource		Site Location: Sudbury to Hudson Transmission Reliability Project	Town: Sudbury
Photo No.: 3	Date: 9/6/2023

Description: Segment 13. View of dewatering operation (pumping at far end of area), looking eastward.

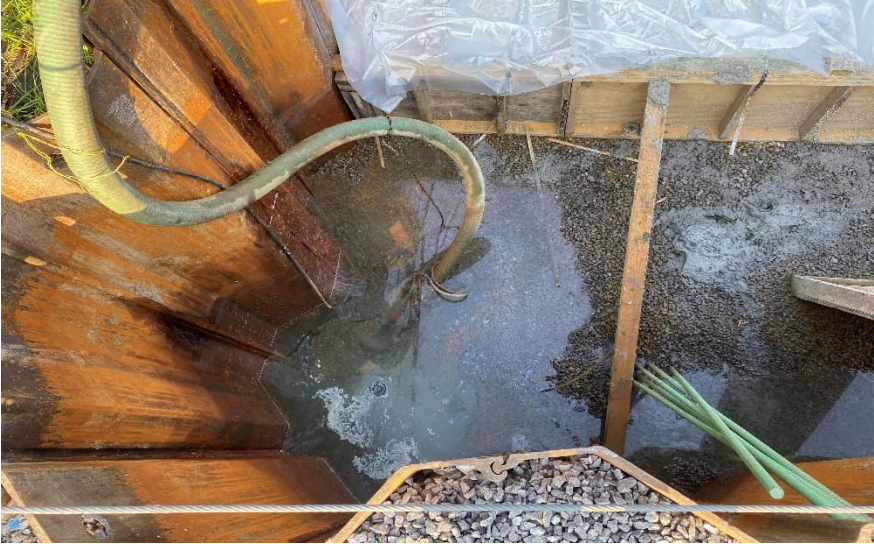
<b>PHOTOGRAPHIC LOG</b>	
Client Name: Eversource		Site Location: Sudbury to Hudson Transmission Reliability Project	Town: Sudbury
Photo No.: 1	Date: 9/6/2023

Description: View of area being pumped at Hop Brook (area in cofferdam), looking westward.

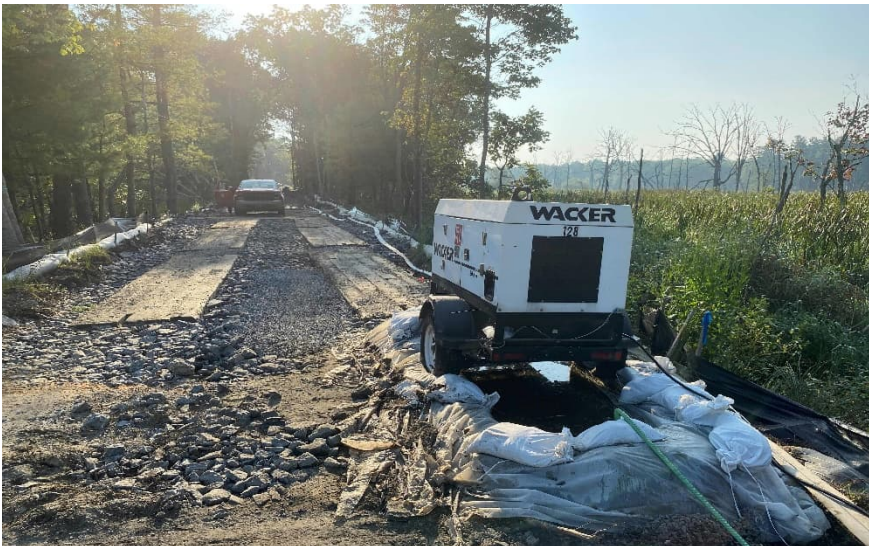
<b>PHOTOGRAPHIC LOG</b>	
Client Name: Eversource		Site Location: Sudbury to Hudson Transmission Reliability Project	Town: Sudbury
Photo No.: 2	Date: 9/6/2023

Description: Segment 14. View of dewatering operation (pumping at far end of area), looking westward.
