## Weekly Environmental Compliance Summary

**Sudbury to Hudson Transmission Reliability Project (USEPA Tracking # MAR1003UW)**

Sudbury, Hudson, and Stow, MA

Week of: September 4, 2023 to September 8, 2023

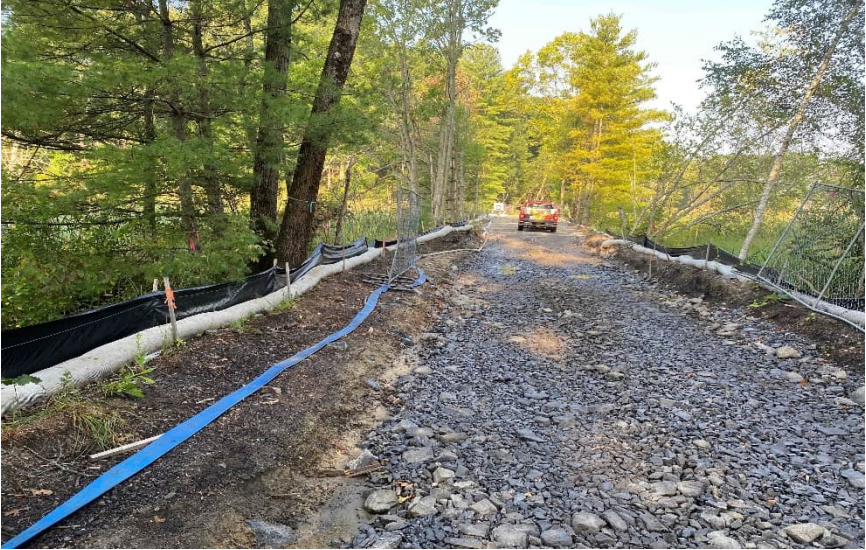
<b>PHOTOGRAPHIC LOG</b>	
Client Name: Eversource		Site Location: Sudbury to Hudson Transmission Reliability Project	Town: Sudbury
Photo No.: 3	Date: 9/6/2023

Description: Segment 14. View of dewatering operation (pumping at far end of area), looking westward.

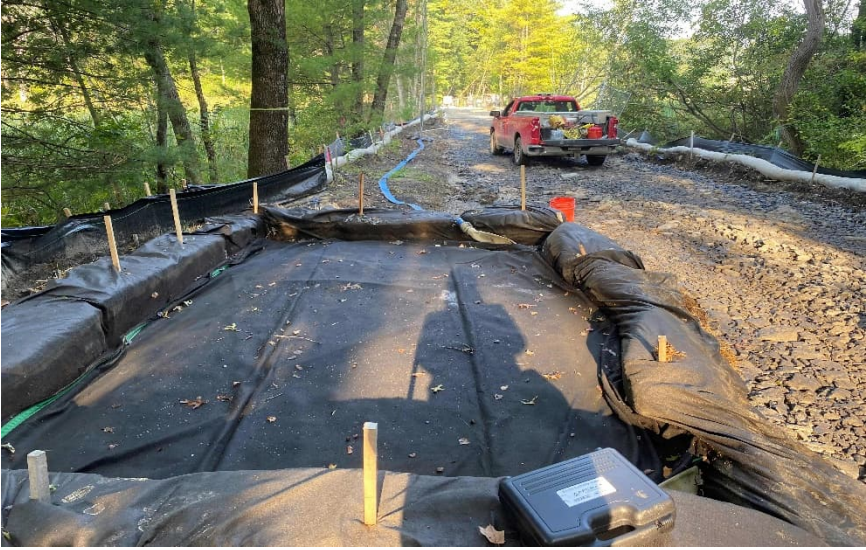
<b>PHOTOGRAPHIC LOG</b>	
Client Name: Eversource		Site Location: Sudbury to Hudson Transmission Reliability Project	Town: Sudbury
Photo No.: 4	Date: 9/6/2023

Description: Segment 14. View of dewatering operation (pumping at far end of area), looking westward.

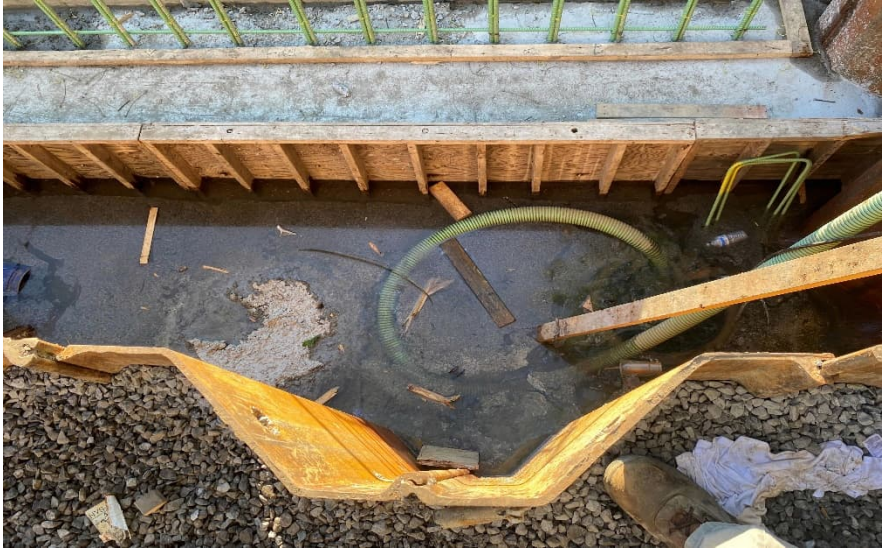
<b>PHOTOGRAPHIC LOG</b>	
Client Name: Eversource		Site Location: Sudbury to Hudson Transmission Reliability Project	Town: Sudbury
Photo No.: 1	Date: 9/7/2023

Description: View of area being pumped at Hop Brook (area in cofferdam), looking westward.

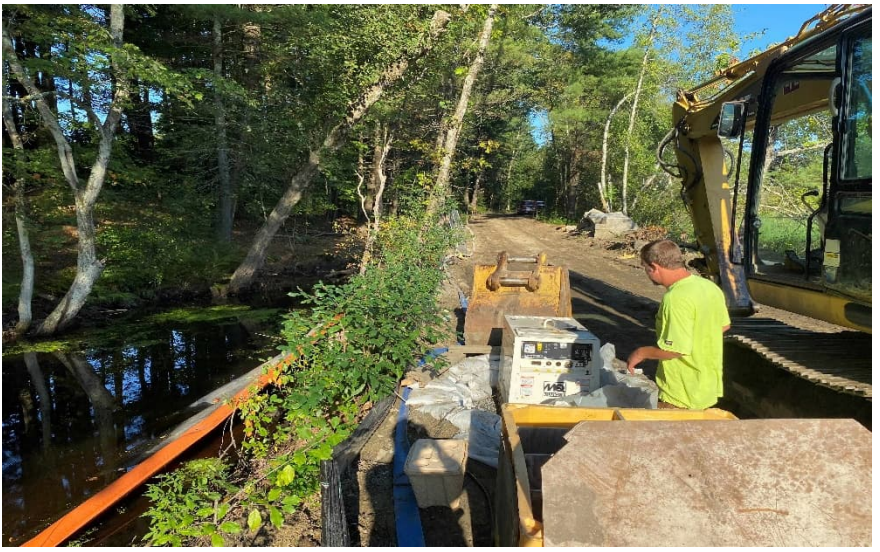
<b>PHOTOGRAPHIC LOG</b>	
Client Name: Eversource		Site Location: Sudbury to Hudson Transmission Reliability Project	Town: Sudbury
Photo No.: 2	Date: 9/7/2023

Description: Segment 13. View of dewatering operation (pumping at far end of area), looking westward.

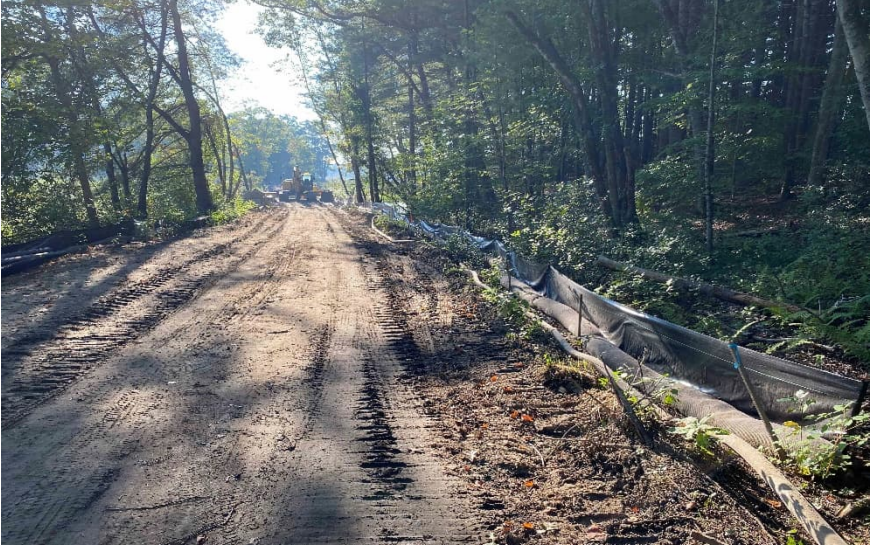
<b>PHOTOGRAPHIC LOG</b>	
Client Name: Eversource		Site Location: Sudbury to Hudson Transmission Reliability Project	Town: Sudbury
Photo No.: 3	Date: 9/7/2023

Description: Segment 13. View of dewatering operation (pumping at far end of area), looking eastward.

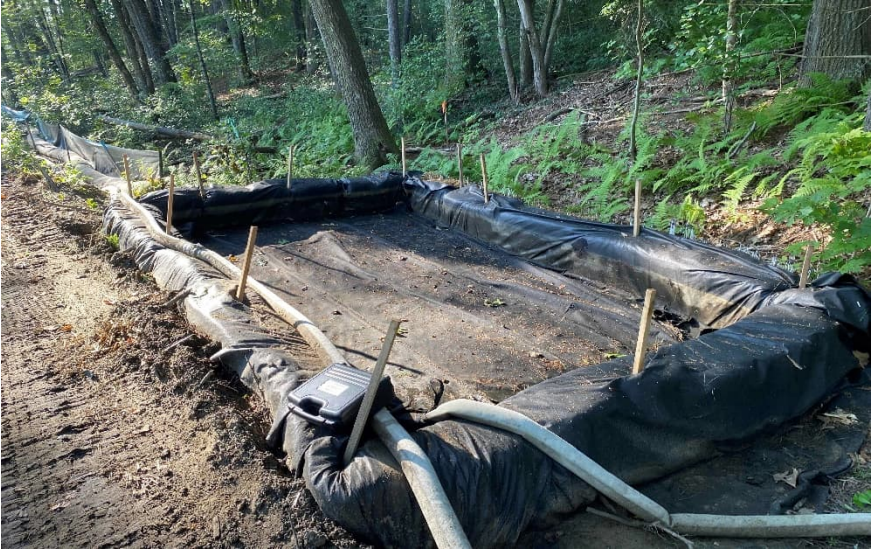
<b>PHOTOGRAPHIC LOG</b>	
Client Name: Eversource		Site Location: Sudbury to Hudson Transmission Reliability Project	Town: Sudbury
Photo No.: 4	Date: 9/7/2023

Description: Segment 13. View of dewatering operation (pumping at far end of area), looking eastward.

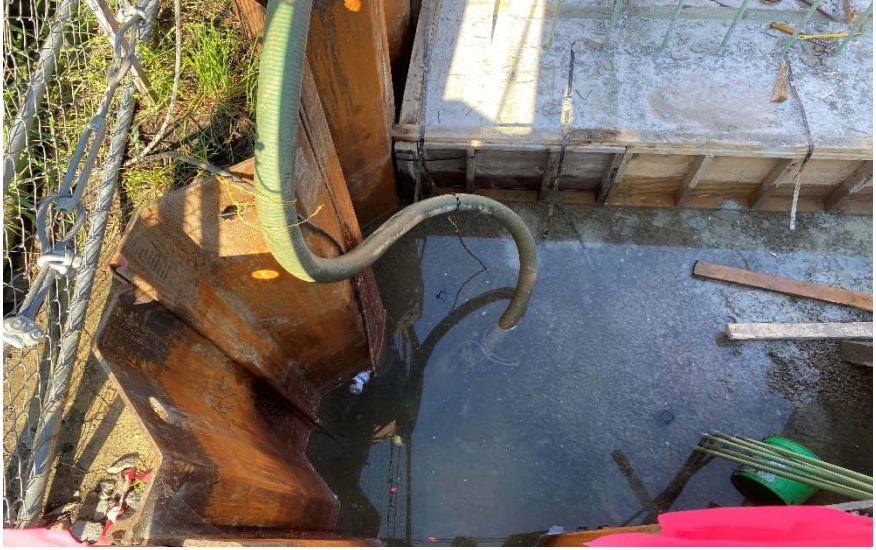
<b>PHOTOGRAPHIC LOG</b>	
Client Name: Eversource		Site Location: Sudbury to Hudson Transmission Reliability Project	Town: Sudbury
Photo No.: 1	Date: 9/7/2023

Description: View of area being pumped at Hop Brook (area in cofferdam), looking westward.

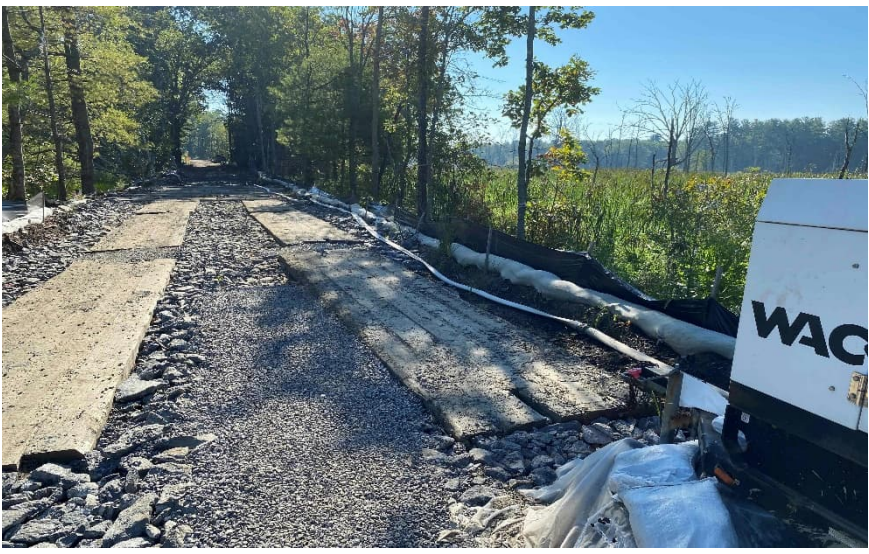
<b>PHOTOGRAPHIC LOG</b>	
Client Name: Eversource		Site Location: Sudbury to Hudson Transmission Reliability Project	Town: Sudbury
Photo No.: 2	Date: 9/7/2023

Description: Segment 14. View of dewatering operation (pumping at far end of area), looking eastward.

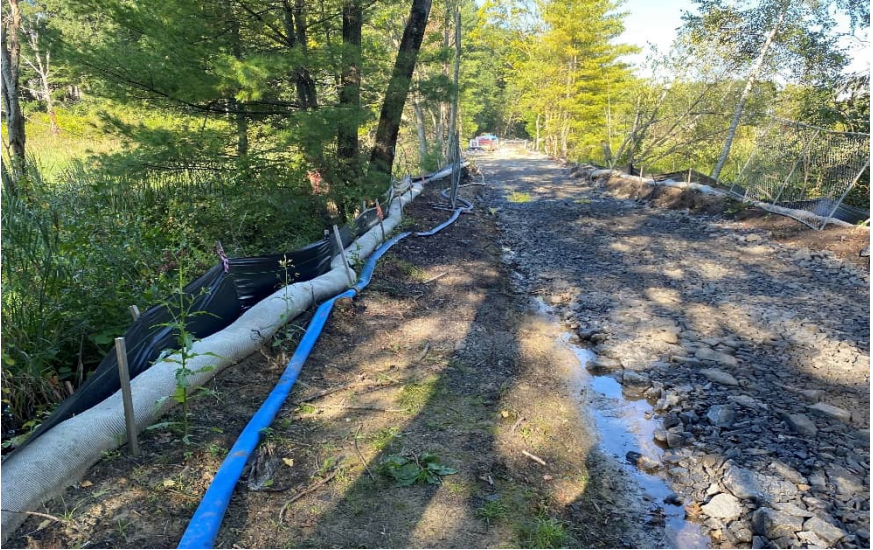
Client Name: Eversource		Site Location: Sudbury to Hudson Transmission Reliability Project	Town: Sudbury
Photo No.: 3	Date: 9/7/2023

Description: Segment 14. View of dewatering operation (pumping at far end of area), looking westward.

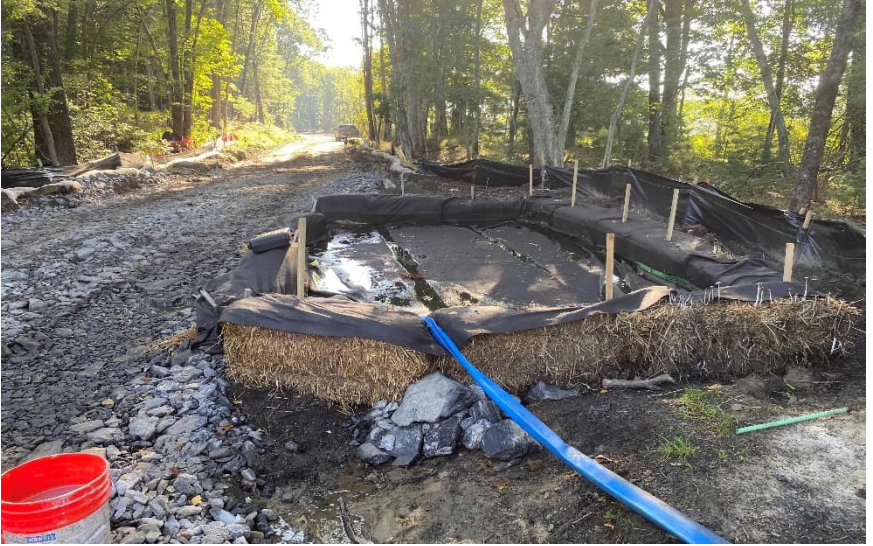
Client Name: Eversource		Site Location: Sudbury to Hudson Transmission Reliability Project	Town: Sudbury
Photo No.: 4	Date: 9/7/2023

Description: Segment 14. View of dewatering operation (pumping at far end of area), looking eastward.

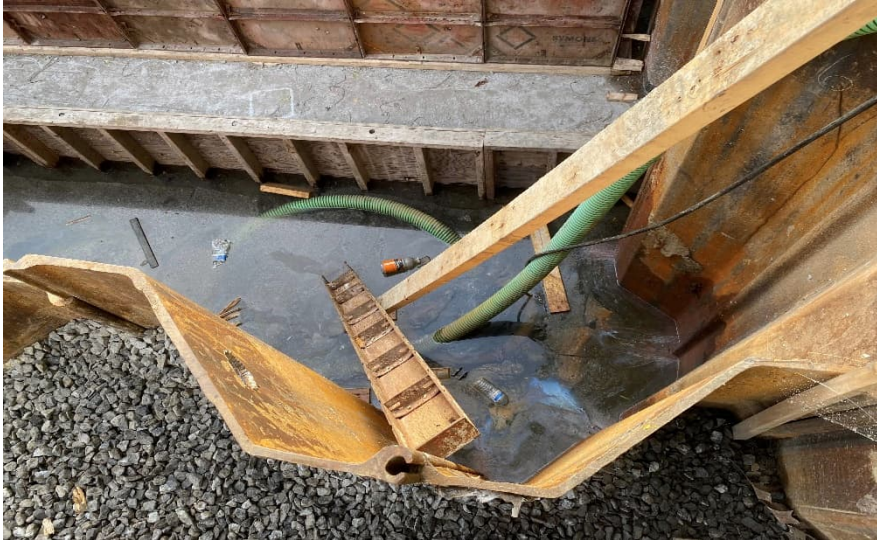
<b>PHOTOGRAPHIC LOG</b>	
Client Name: Eversource		Site Location: Sudbury to Hudson Transmission Reliability Project	Town: Sudbury
Photo No.: 1	Date: 9/8/2023

Description: View of area being pumped at Hop Brook (area in cofferdam), looking westward.

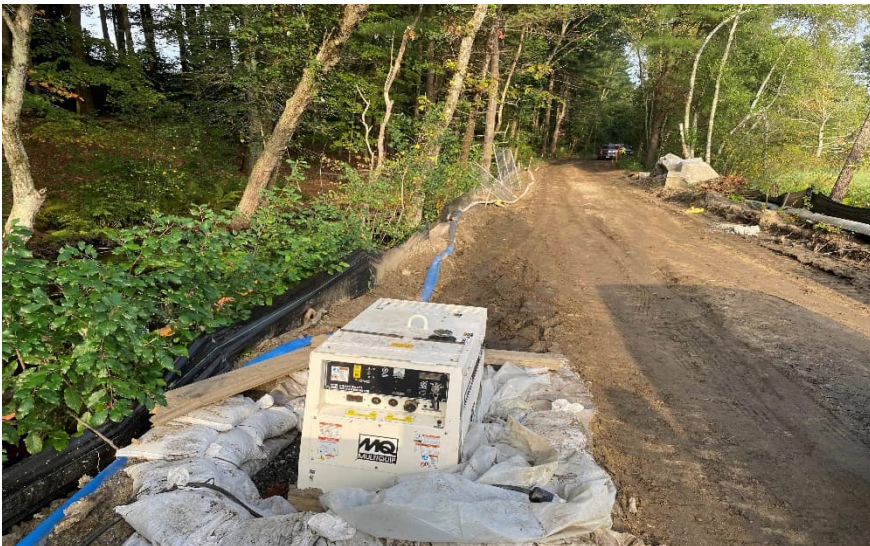
<b>PHOTOGRAPHIC LOG</b>	
Client Name: Eversource		Site Location: Sudbury to Hudson Transmission Reliability Project	Town: Sudbury
Photo No.: 2	Date: 9/8/2023

Description: Segment 13. View of dewatering operation (pumping at far end of area), looking westward.

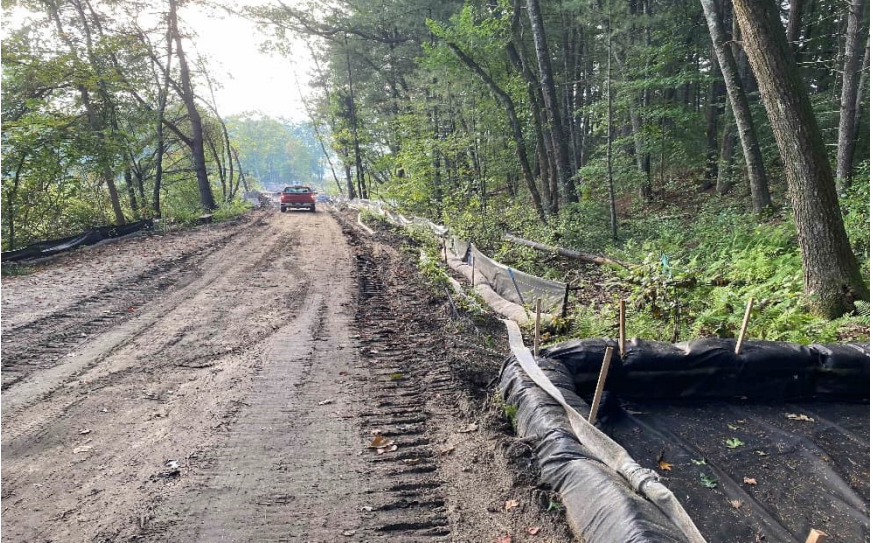
<b>PHOTOGRAPHIC LOG</b>	
Client Name: Eversource		Site Location: Sudbury to Hudson Transmission Reliability Project	Town: Sudbury
Photo No.: 3	Date: 9/8/2023

Description: Segment 13. View of dewatering operation (pumping at far end of area), looking eastward.

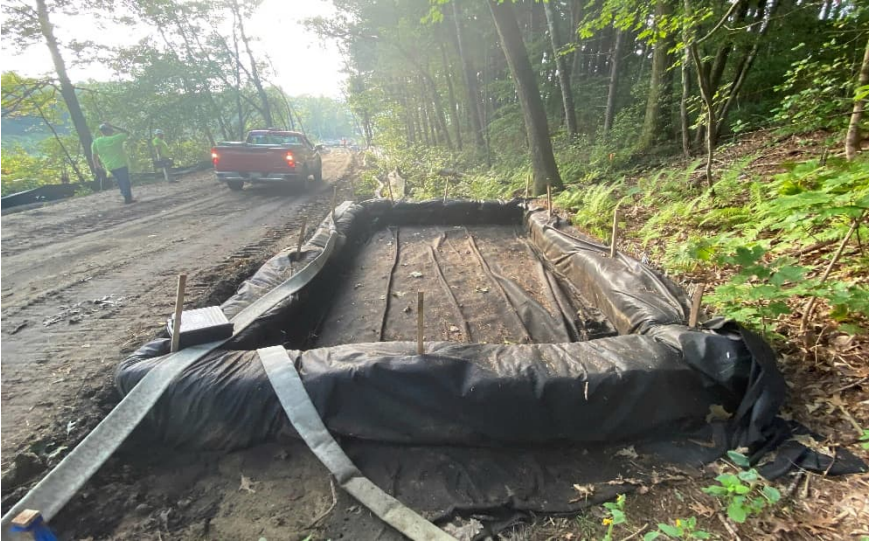
<b>PHOTOGRAPHIC LOG</b>	
Client Name: Eversource		Site Location: Sudbury to Hudson Transmission Reliability Project	Town: Sudbury
Photo No.: 4	Date: 9/8/2023

Description: Segment 13. View of dewatering operation (pumping at far end of area), looking eastward.

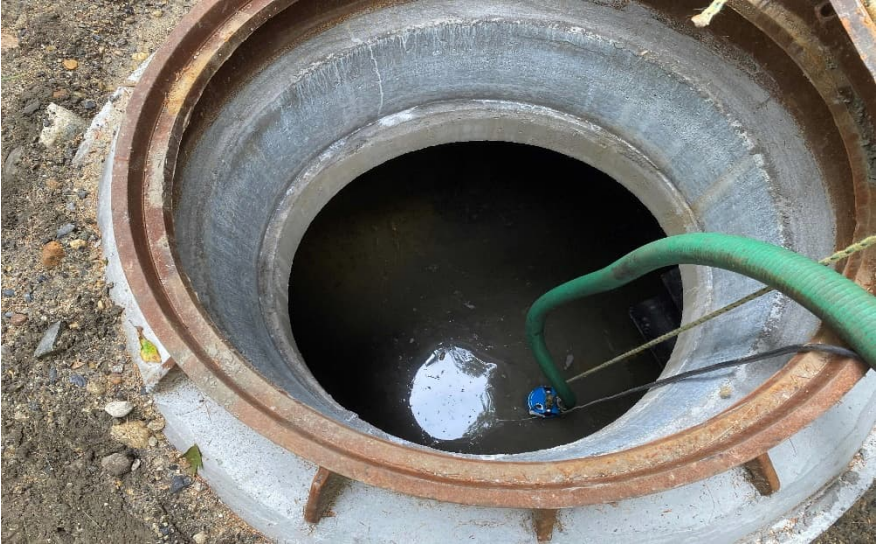
PHOTOGRAPHIC LOG	
Client Name: Eversource		Site Location: Sudbury to Hudson Transmission Reliability Project	Town: Sudbury
Photo No.: 1	Date: 9/8/2023

Section A – Dewatering Discharges (CGP Part 4.6.3) Complete this section <u>within 24 hours</u> of completing the inspection. (If necessary, complete additional inspection reports for each separate inspection location.)	
Inspector Information	
Inspector Name: Terry Ramborger, CPSS, CPESC, SPWS & EPA (CGP) Site Inspector	Title: Senior Environmental Scientist
Company Name: AECOM	Email: terry.ramborger@aecom.com
Address: 1155 Elm Street #401 Manchester, NH 03101	Phone Number: 603-557-0034
Inspection Details	
Inspection Date: 9/8/23	Inspection Location: Trench work west of MH#17 (Segment 8)
Discharge Start Time: 7:30 AM	Discharge End Time: 10:00 AM
Rate of Discharge (gallons per day): 50,400 (35 gallons per minute)	Corrective Action Required? <sup>1</sup> <input type="checkbox"/> Yes <input checked="" type="checkbox"/> No
Describe Indicators of Pollutant Discharge at Point of Dewatering Discharge: <sup>1</sup> Turbidity sampling conducted, dewatering setup to discharge to right-of-way east of the manhole #17. Turbidity sampling > 50 NTUs. Dewatering conducted to remove water from conduit trench.

Description: View of area being pumped at Segment 8 (Manhole #17), looking westward.

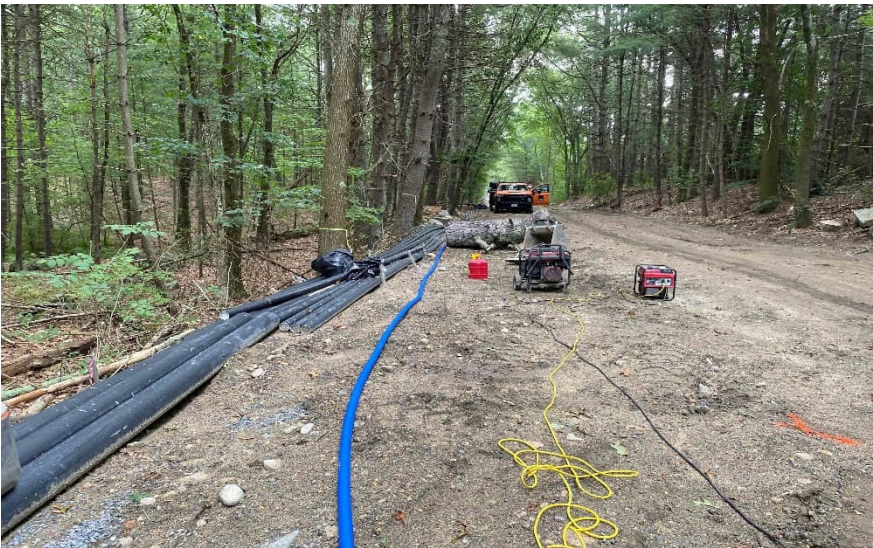
PHOTOGRAPHIC LOG	
Client Name: Eversource		Site Location: Sudbury to Hudson Transmission Reliability Project	Town: Sudbury
Photo No.: 2	Date: 9/8/2023

Description: Segment 8. View of dewatering operation, looking eastward.
