Weekly Environmental Compliance Summary

Sudbury to Hudson Transmission Reliability Project (USEPA Tracking # MAR1003UW)

Week of: September 11, 2023 to September 15, 2023

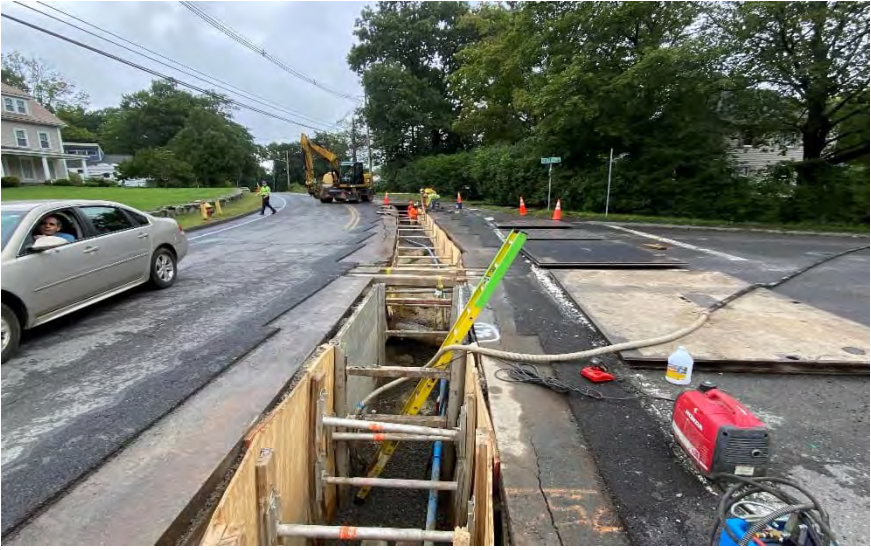
PHOTOGRAPHIC LOG	
Client Name: Eversource		Site Location: Sudbury to Hudson Transmission Reliability Project	Town: Hudson
Photo No.: 1	Date: 9-12-23

Description: Work area within Forest Avenue, conduit work (Marisa's crew), looking northward.

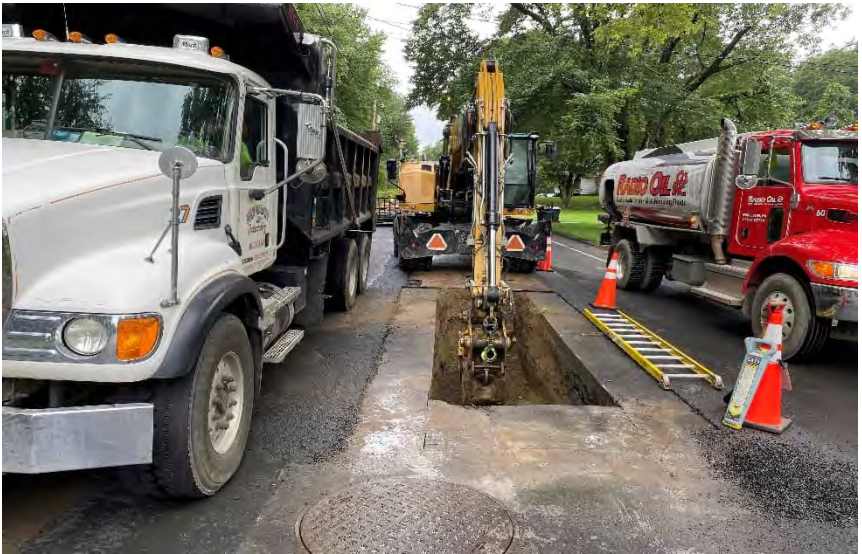
PHOTOGRAPHIC LOG	
Client Name: Eversource		Site Location: Sudbury to Hudson Transmission Reliability Project	Town: Hudson
Photo No.: 4	Date: 9-12-23

Description: Work area within Forest Avenue, conduit work (Oskar's crew), looking southward.

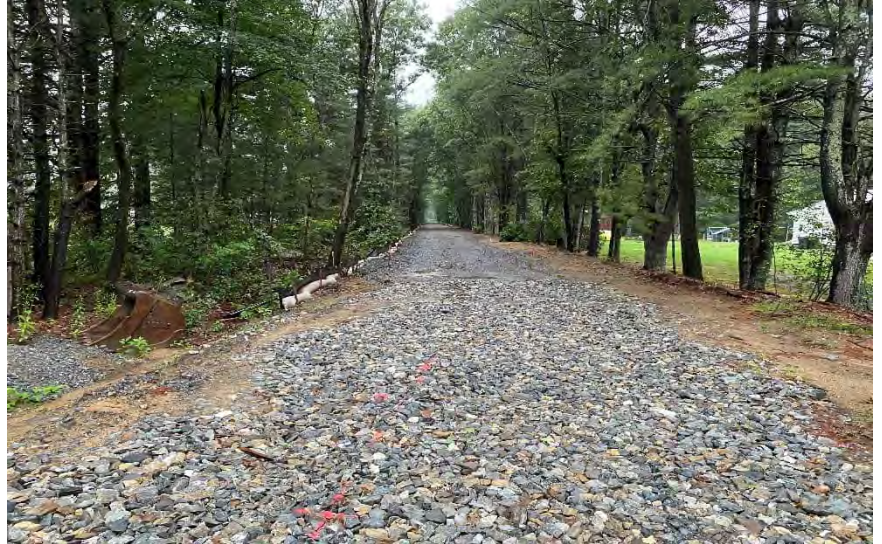
PHOTOGRAPHIC LOG	
Client Name: Eversource		Site Location: Sudbury to Hudson Transmission Reliability Project	Town: Hudson
Photo No.: 6	Date: 9-12-23

Description: Work area within segment 4, existing erosion control, looking westward.

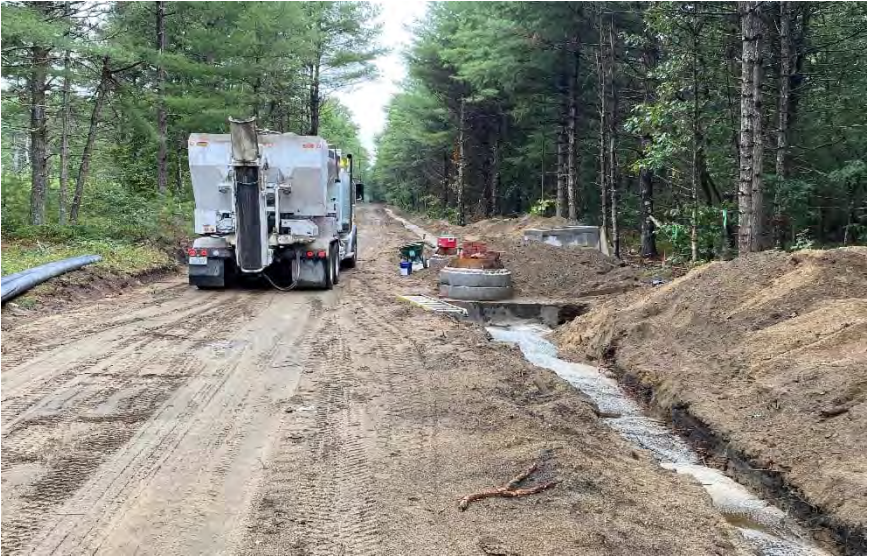
PHOTOGRAPHIC LOG	
Client Name: Eversource		Site Location: Sudbury to Hudson Transmission Reliability Project	Town: Sudbury
Photo No.: 7	Date: 9-12-23

Description: Work area within segment 7, conduit work, existing erosion control, looking westward.

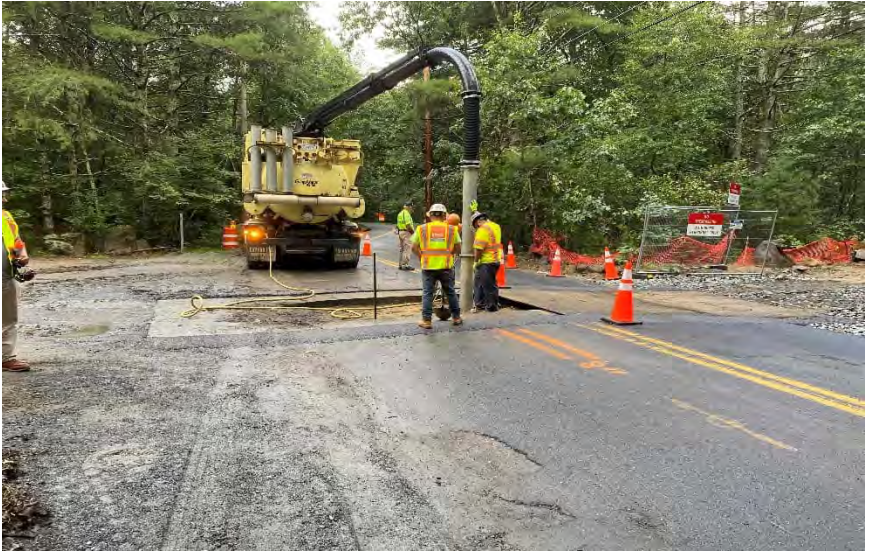
PHOTOGRAPHIC LOG	
Client Name: Eversource		Site Location: Sudbury to Hudson Transmission Reliability Project	Town: Sudbury
Photo No.: 8	Date: 9-12-23

Description: Bond conducting conduit work within Dutton Road, looking southward.

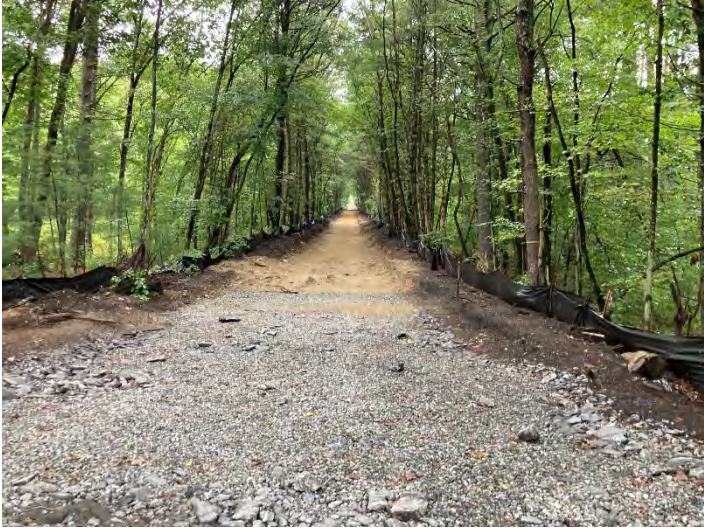
PHOTOGRAPHIC LOG	
Client Name: Eversource		Site Location: Sudbury to Hudson Transmission Reliability Project	Town: Sudbury
Photo No.: 1	Date: 9/12/2023

Description: View of segment 9 from construction entrance off Peakham Rd. Facing west.

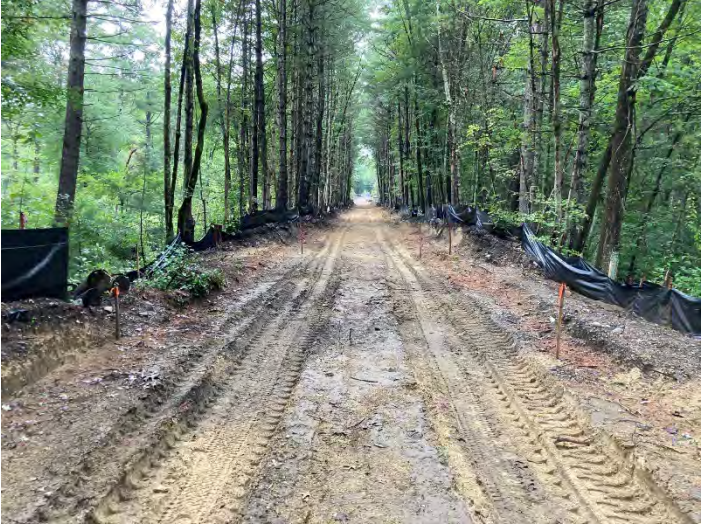
PHOTOGRAPHIC LOG	
Client Name: Eversource		Site Location: Sudbury to Hudson Transmission Reliability Project	Town: Sudbury
Photo No.: 2	Date: 9/12/2023

Description: View of Dudley Brook culvert area in segment 10. Facing west.

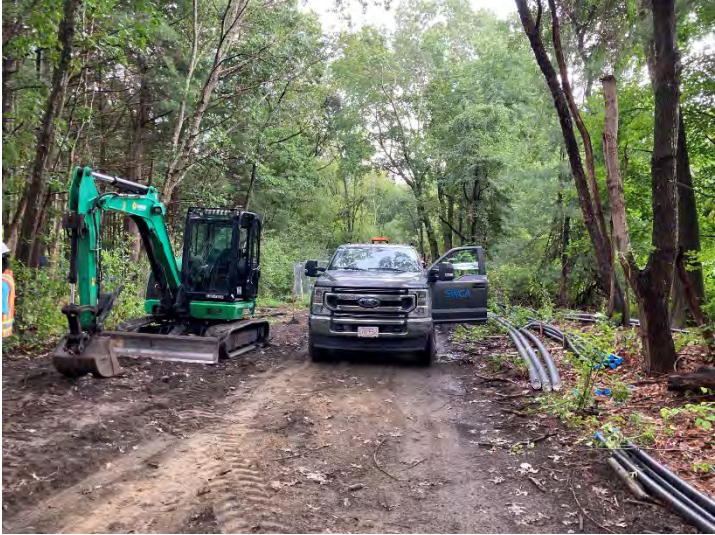
<p>PHOTOGRAPHIC LOG</p>	
<p>Client Name: Eversource</p>		<p>Site Location: Sudbury to Hudson Transmission Reliability Project</p>	<p>Town: Sudbury</p>
<p>Photo No.: 3</p>	<p>Date: 9/12/2023</p>

<p>Description: View of invasive vegetation removal activities in segment 11. Facing east.</p>

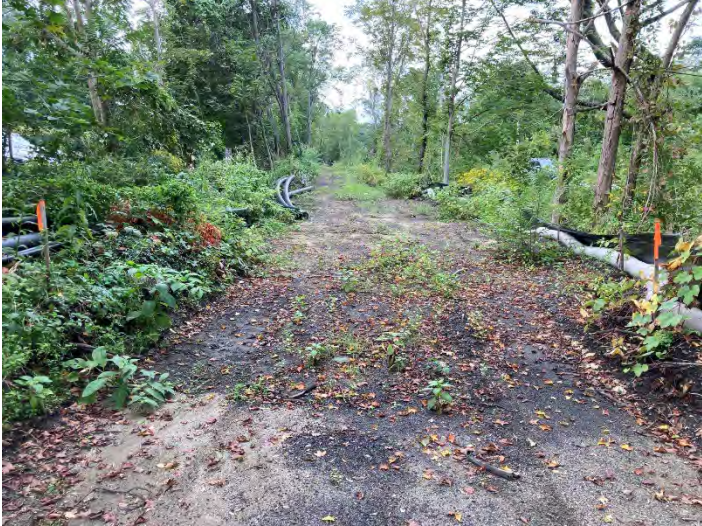
<p>PHOTOGRAPHIC LOG</p>	
<p>Client Name: Eversource</p>		<p>Site Location: Sudbury to Hudson Transmission Reliability Project</p>	<p>Town: Sudbury</p>
<p>Photo No.: 4</p>	<p>Date: 9/12/2023</p>

<p>Description: View of segment 12. Facing west.</p>

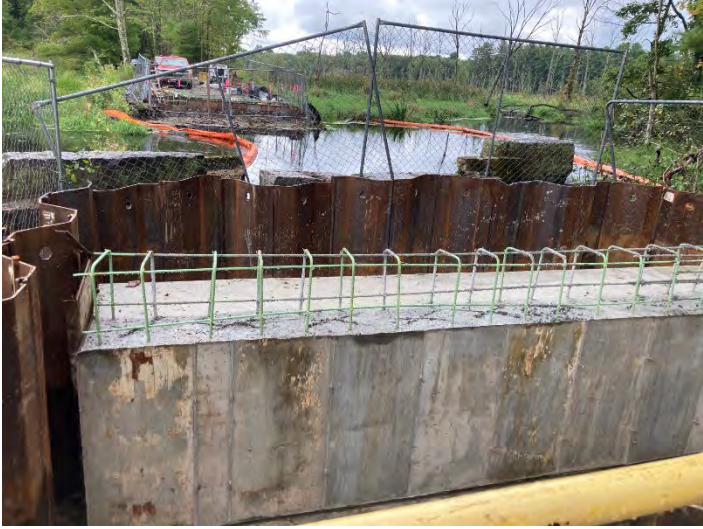
<p>PHOTOGRAPHIC LOG</p>	
<p>Client Name: Eversource</p>		<p>Site Location: Sudbury to Hudson Transmission Reliability Project</p>	<p>Town: Sudbury</p>
<p>Photo No.: 5</p>	<p>Date: 9/12/2023</p>

<p>Description: View of work at bridge 127 on segment 13 side. See additional dewatering inspection reports. Facing east.</p>

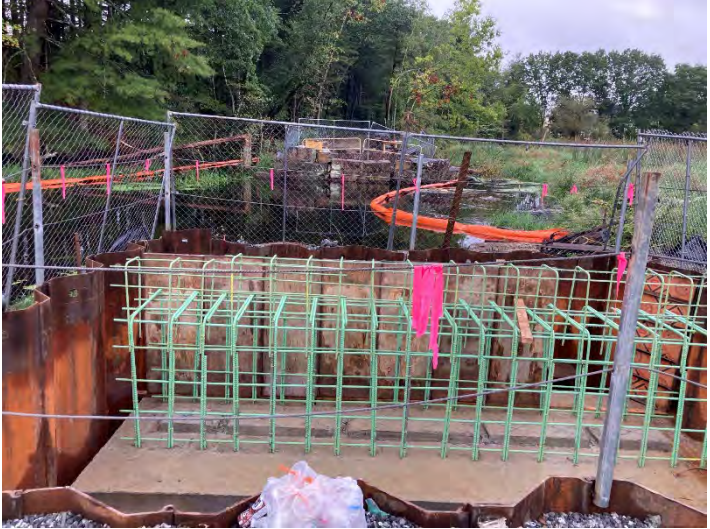
<p>PHOTOGRAPHIC LOG</p>	
<p>Client Name: Eversource</p>		<p>Site Location: Sudbury to Hudson Transmission Reliability Project</p>	<p>Town: Sudbury</p>
<p>Photo No.: 6</p>	<p>Date: 9/12/2023</p>

<p>Description: View of work at bridge 127 on segment 14 side. See additional dewatering inspection reports. Facing west.</p>

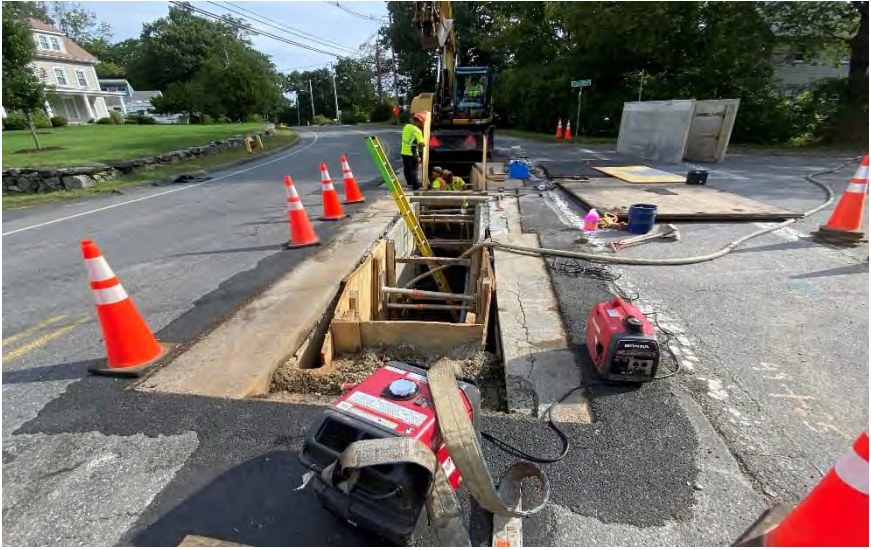
PHOTOGRAPHIC LOG	
Client Name: Eversource		Site Location: Sudbury to Hudson Transmission Reliability Project	Town: Hudson
Photo No.: 1	Date: 9-13-23

Description: Work area within Forest Avenue, conduit work (Marisa's crew), looking northward.

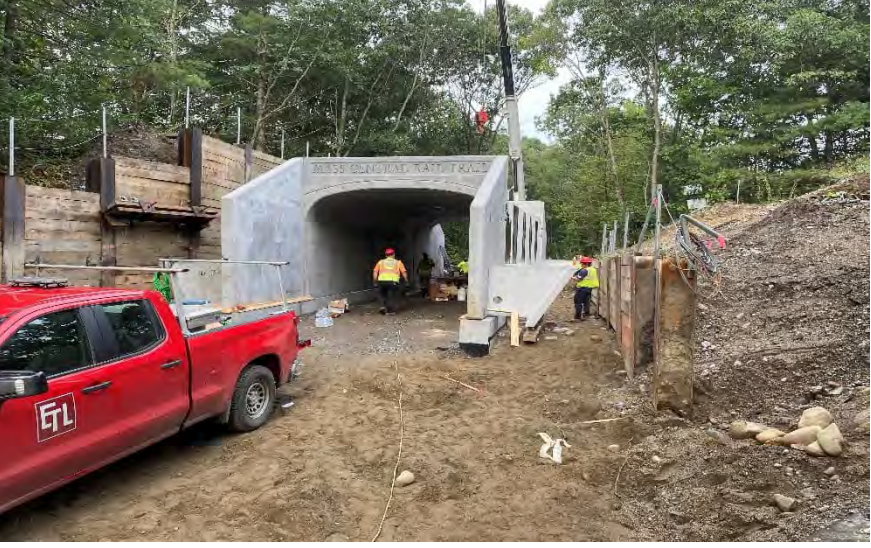
PHOTOGRAPHIC LOG	
Client Name: Eversource		Site Location: Sudbury to Hudson Transmission Reliability Project	Town: Hudson
Photo No.: 2	Date: 9-13-23

Description: Work area within Chestnut Street, looking westward.

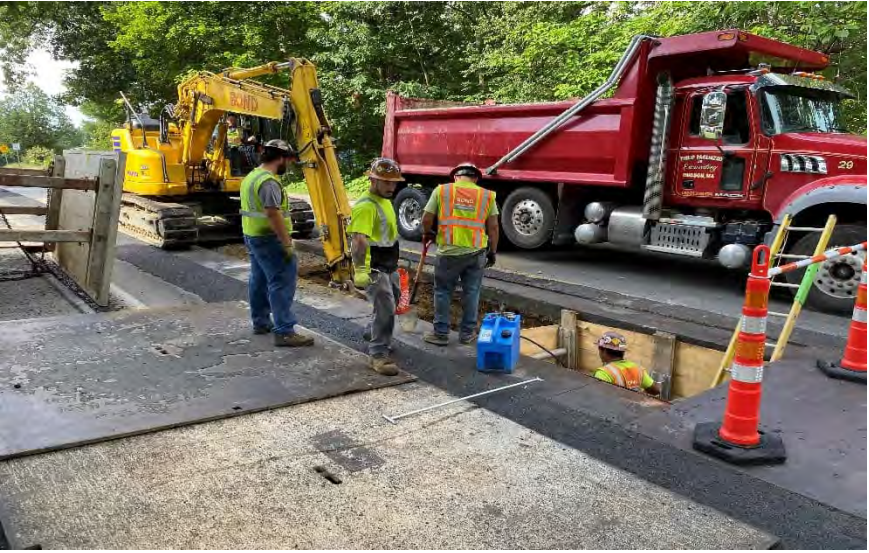
PHOTOGRAPHIC LOG	
Client Name: Eversource		Site Location: Sudbury to Hudson Transmission Reliability Project	Town: Hudson
Photo No.: 3	Date: 9-13-23

Description: Work area within Forest Avenue, conduit work (Jim's crew), looking southward.

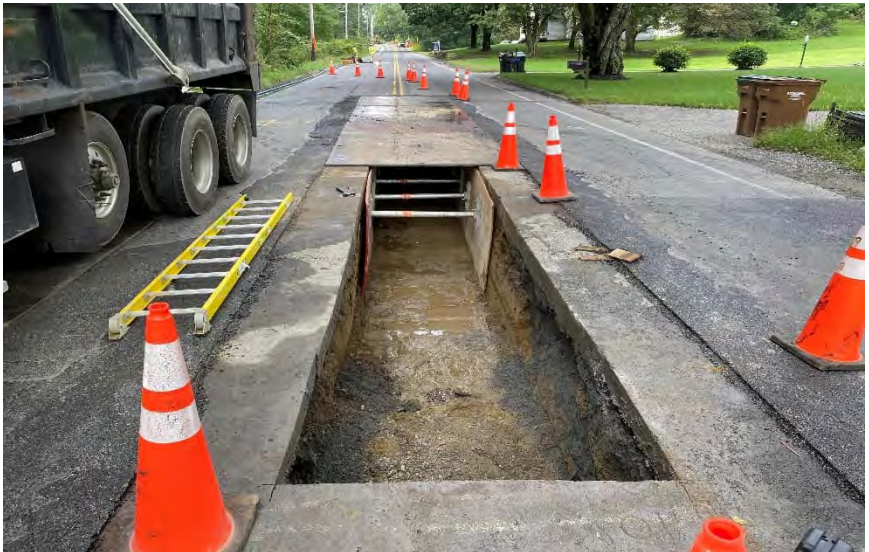
PHOTOGRAPHIC LOG	
Client Name: Eversource		Site Location: Sudbury to Hudson Transmission Reliability Project	Town: Hudson
Photo No.: 4	Date: 9-13-23

Description: Work area within Forest Avenue, conduit work (Oskar's crew), looking southward.

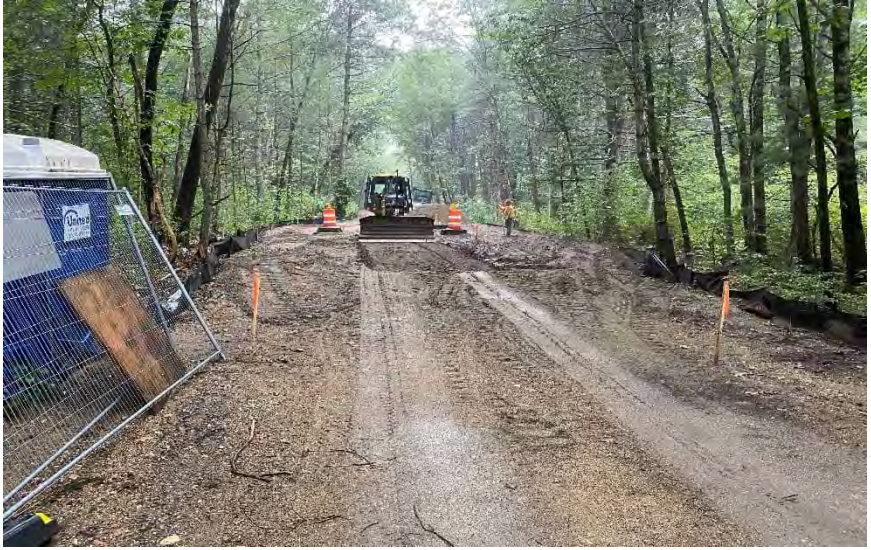
PHOTOGRAPHIC LOG	
Client Name: Eversource		Site Location: Sudbury to Hudson Transmission Reliability Project	
Town: Hudson			
Photo No.: 5	Date: 9-13-23

Description: Work area within segment 5, manhole #11, ET&L grading, existing erosion control, looking eastward.

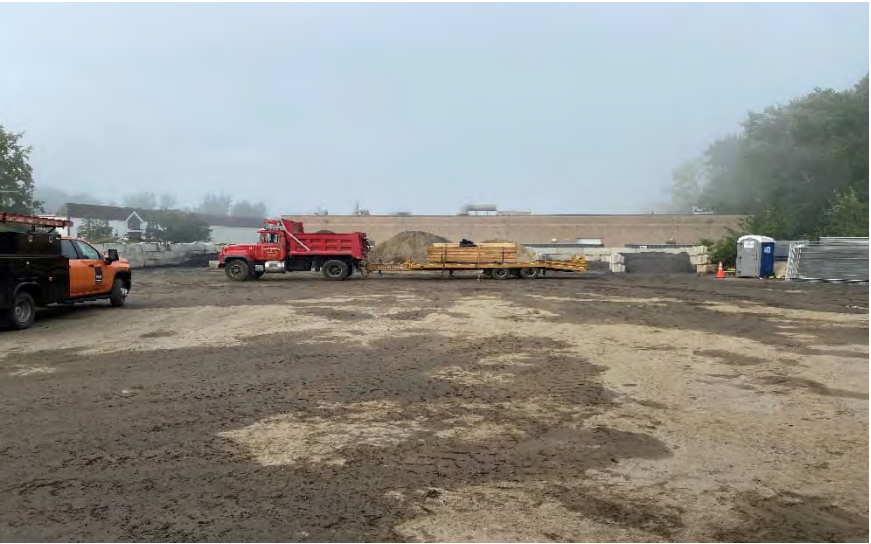
PHOTOGRAPHIC LOG	
Client Name: Eversource		Site Location: Sudbury to Hudson Transmission Reliability Project	
Town: Hudson			
Photo No.: 6	Date: 9-13-23

Description: Bonazzoli laydown yard, looking westward.

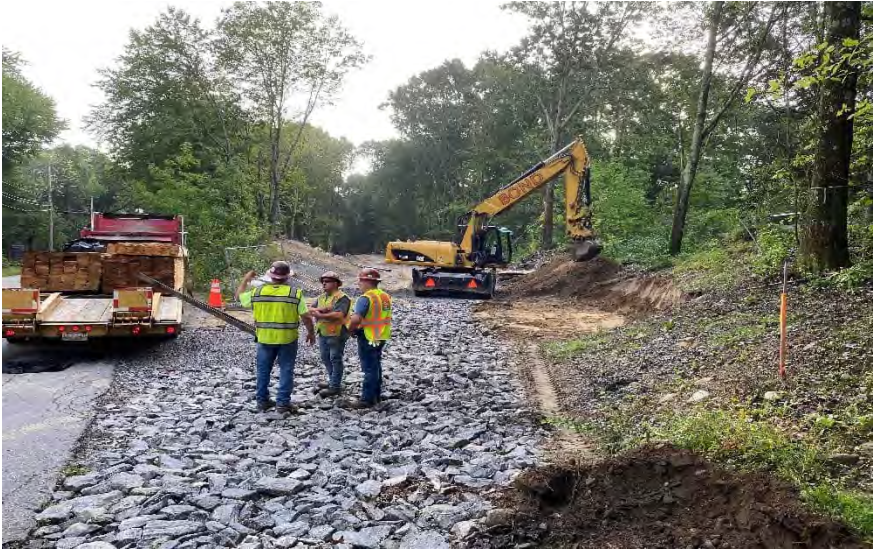
PHOTOGRAPHIC LOG	
Client Name: Eversource		Site Location: Sudbury to Hudson Transmission Reliability Project	Town: Hudson
Photo No.: 7	Date: 9-13-23

Description: Work area within segment 1, conduit work, existing erosion control, looking eastward.

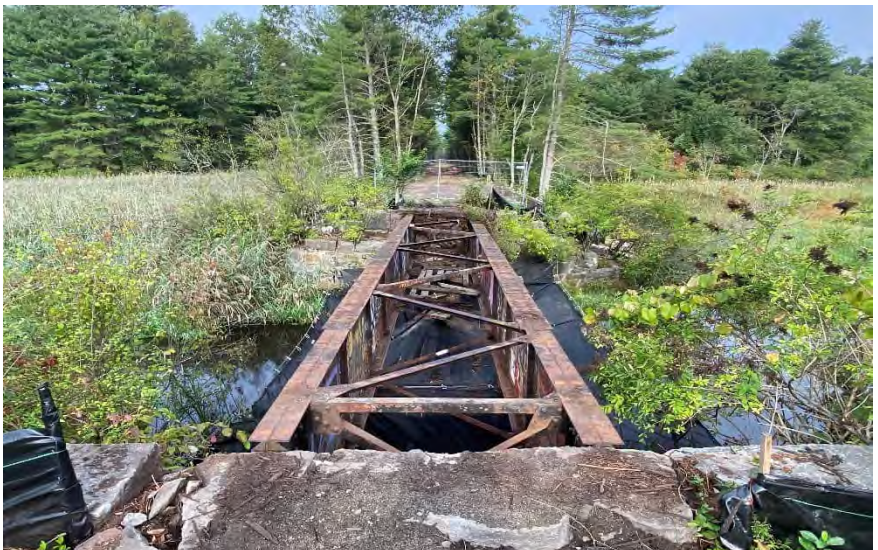
PHOTOGRAPHIC LOG	
Client Name: Eversource		Site Location: Sudbury to Hudson Transmission Reliability Project	Town: Sudbury
Photo No.: 8	Date: 9-13-23

Description: Bridge 128 from segment 8, looking westward.

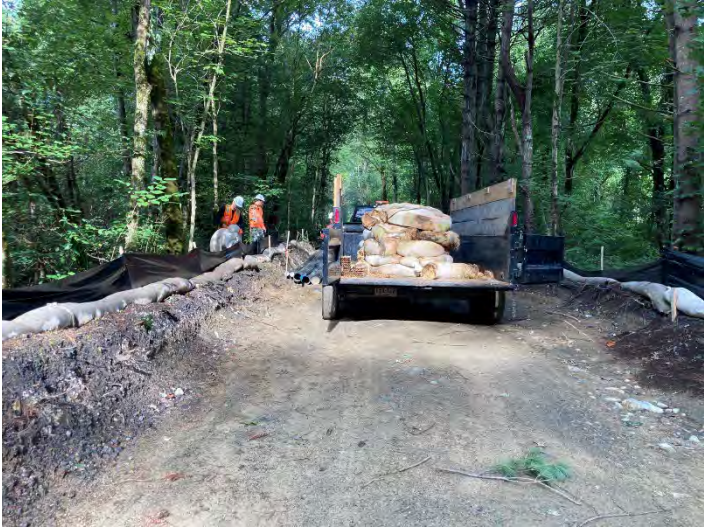
<p>PHOTOGRAPHIC LOG</p>	
<p>Client Name: Eversource</p>		<p>Site Location: Sudbury to Hudson Transmission Reliability Project</p>	<p>Town: Sudbury</p>
<p>Photo No.: 1</p>	<p>Date: 9/13/2023</p>

<p>Description: View of SWCA installing wattles for invasive removal work in segment 9. Facing west.</p>

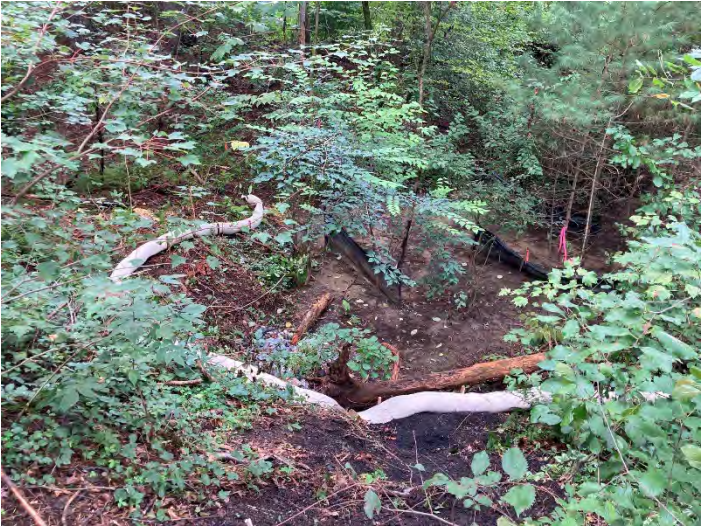
<p>PHOTOGRAPHIC LOG</p>	
<p>Client Name: Eversource</p>		<p>Site Location: Sudbury to Hudson Transmission Reliability Project</p>	<p>Town: Sudbury</p>
<p>Photo No.: 2</p>	<p>Date: 9/13/2023</p>

<p>Description: View of wattles installed along south side of collapsed culvert in segment 9. Facing southeast.</p>

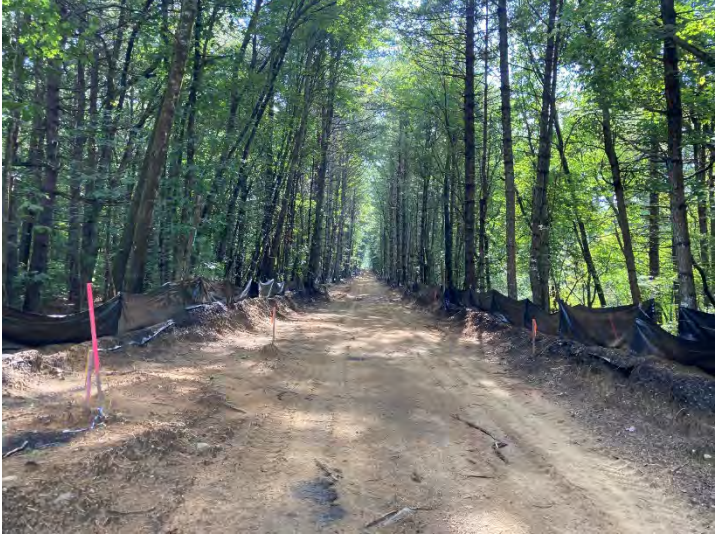
<p align="right">PHOTOGRAPHIC LOG</p>	
Client Name: Eversource		Site Location: Sudbury to Hudson Transmission Reliability Project	Town: Sudbury
Photo No.: 3	Date: 9/13/2023

Description: View of segment 10. Facing east.

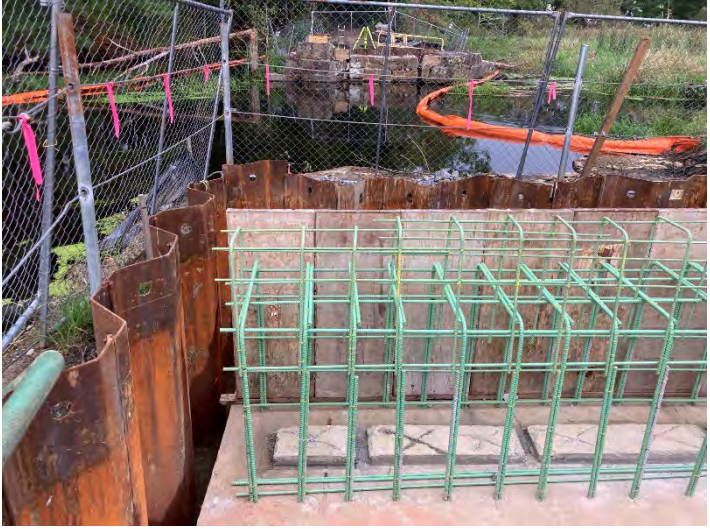
<p align="right">PHOTOGRAPHIC LOG</p>	
Client Name: Eversource		Site Location: Sudbury to Hudson Transmission Reliability Project	Town: Sudbury
Photo No.: 6	Date: 9/13/2023

Description: View of work at bridge 127 on segment 14 side. See additional dewatering inspection reports. Facing west.

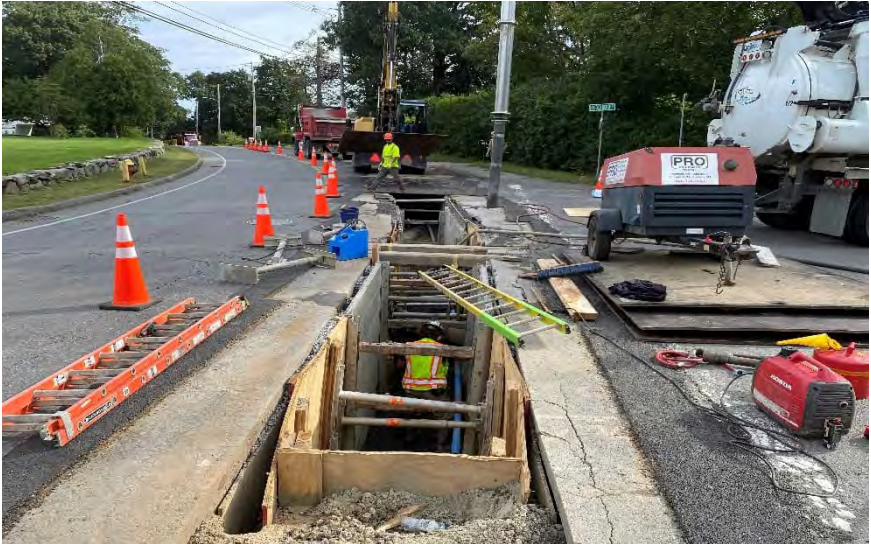
<p>PHOTOGRAPHIC LOG</p>	
<p>Client Name: Eversource</p>		<p>Site Location: Sudbury to Hudson Transmission Reliability Project</p>	<p>Town: Hudson</p>
<p>Photo No.: 1</p>	<p>Date: 9-15-23</p>

<p>Description:</p> <p>Work area within Forest Avenue, conduit work (Marisa's crew), looking northward.</p>

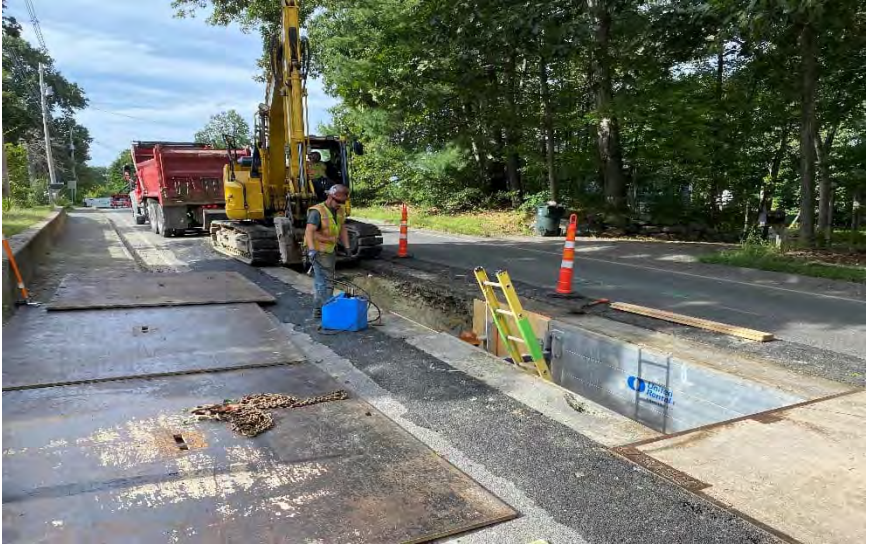
<p>PHOTOGRAPHIC LOG</p>	
<p>Client Name: Eversource</p>		<p>Site Location: Sudbury to Hudson Transmission Reliability Project</p>	<p>Town: Hudson</p>
<p>Photo No.: 2</p>	<p>Date: 9-15-23</p>

<p>Description:</p> <p>Work area within Forest Avenue, conduit work (Jim's crew), looking southward.</p>

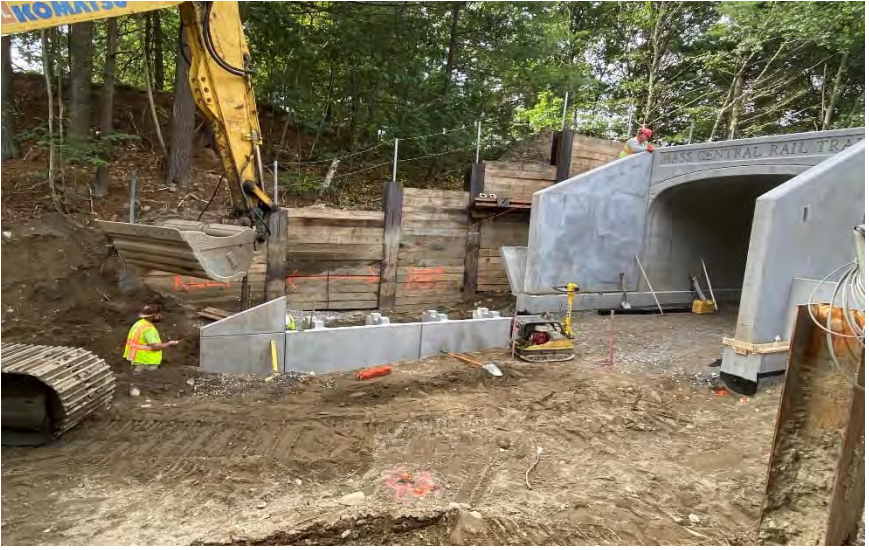
<p>PHOTOGRAPHIC LOG</p>	
<p>Client Name: Eversource</p>		<p>Site Location: Sudbury to Hudson Transmission Reliability Project</p>	<p>Town: Hudson</p>
<p>Photo No.: 3</p>	<p>Date: 9-15-23</p>

<p>Description:</p> <p>Work area within segment 1, Chestnut Street crossing, looking westward.</p>

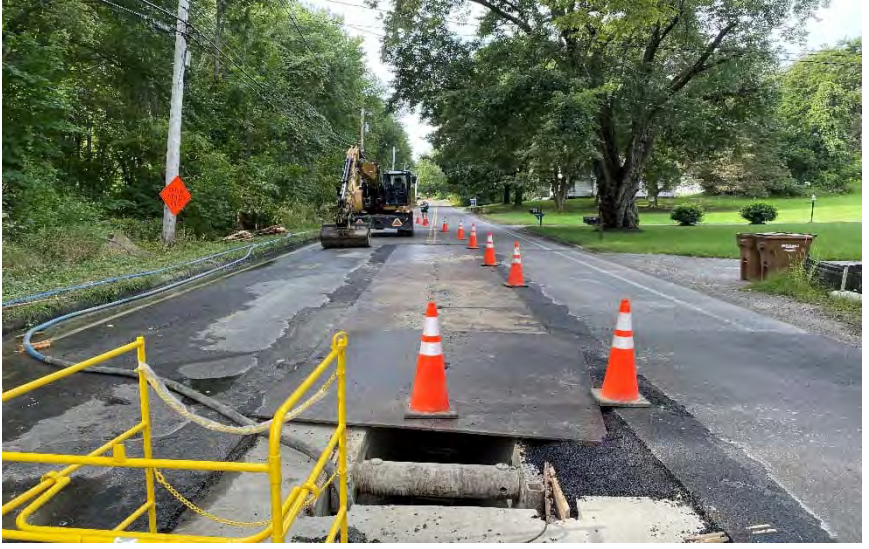
<p>PHOTOGRAPHIC LOG</p>	
<p>Client Name: Eversource</p>		<p>Site Location: Sudbury to Hudson Transmission Reliability Project</p>	<p>Town: Hudson</p>
<p>Photo No.: 4</p>	<p>Date: 9-15-23</p>

<p>Description:</p> <p>Work area within Forest Avenue, conduit work (Oskar's crew), looking southward.</p>

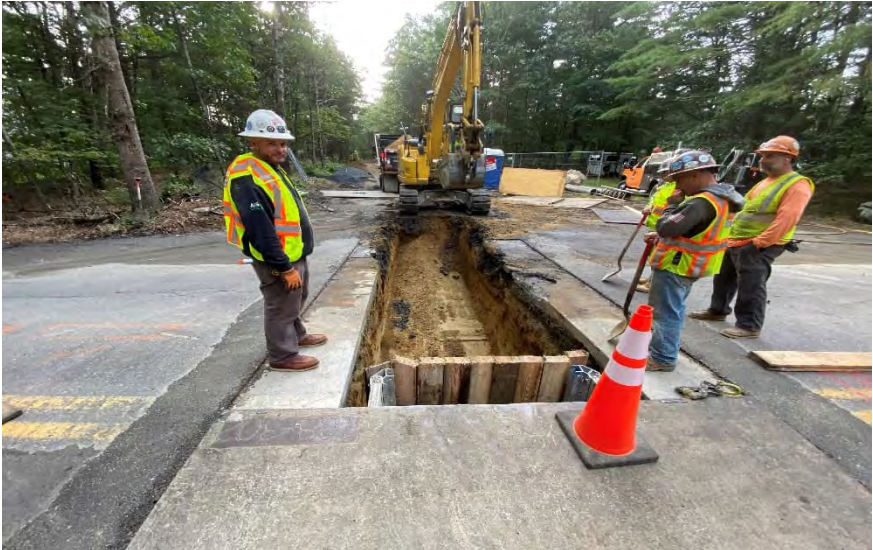
<p>PHOTOGRAPHIC LOG</p>	
<p>Client Name: Eversource</p>		<p>Site Location: Sudbury to Hudson Transmission Reliability Project</p>	<p>Town: Sudbury</p>
<p>Photo No.: 5</p>	<p>Date: 9-15-23</p>

<p>Description:</p> <p>Conduit work within Dutton Ave., looking eastward.</p>

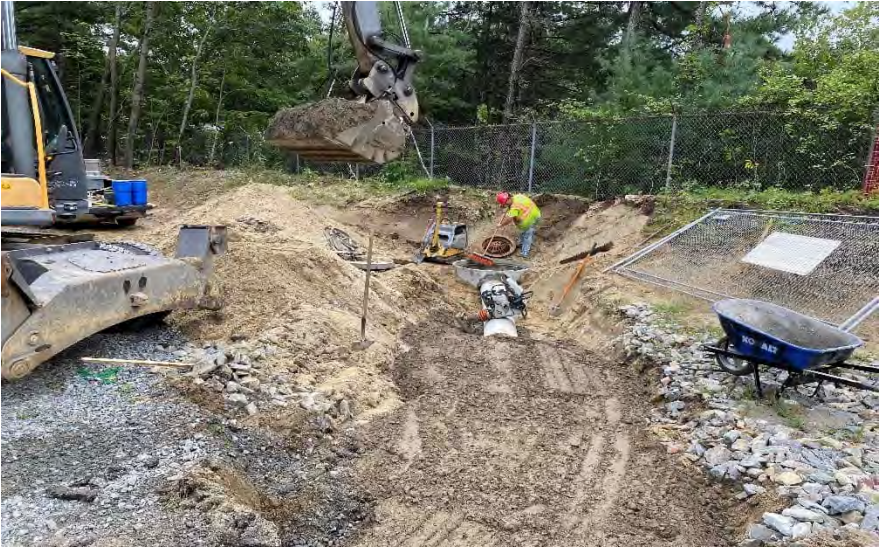
PHOTOGRAPHIC LOG	
Client Name: Eversource		Site Location: Sudbury to Hudson Transmission Reliability Project	Town: Hudson
Photo No.: 1	Date: 9-11-23

Description: Catch basin work within segment 4, looking westward.

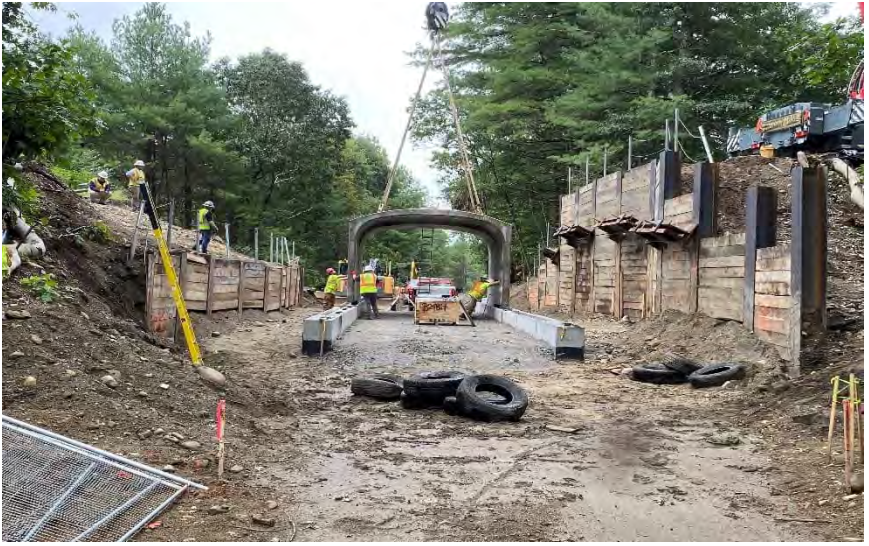
PHOTOGRAPHIC LOG	
Client Name: Eversource		Site Location: Sudbury to Hudson Transmission Reliability Project	Town: Hudson
Photo No.: 2	Date: 9-11-23

Description: Chestnut Street crossing, looking eastward.

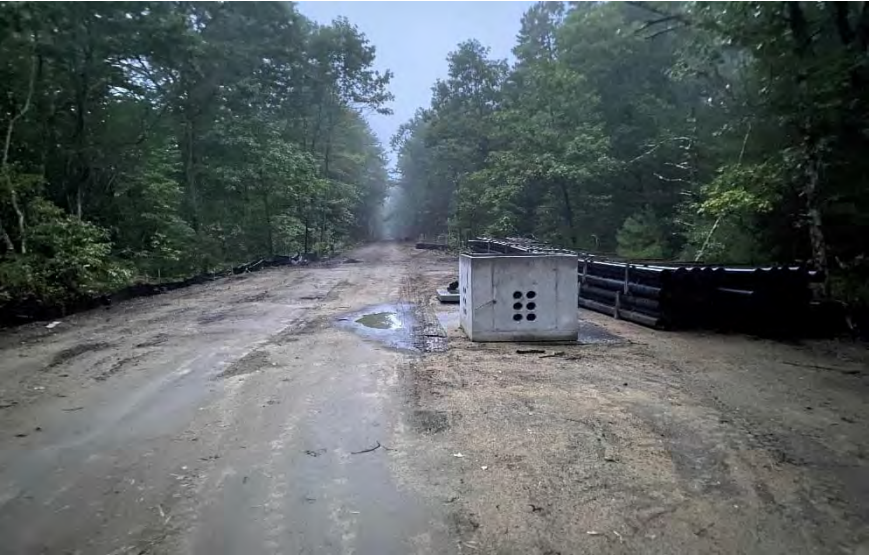
PHOTOGRAPHIC LOG	
Client Name: Eversource		Site Location: Sudbury to Hudson Transmission Reliability Project	Town: Hudson
Photo No.: 3	Date: 9-11-23

Description: Work area within segment 6, manhole #14, existing erosion control, looking westward.

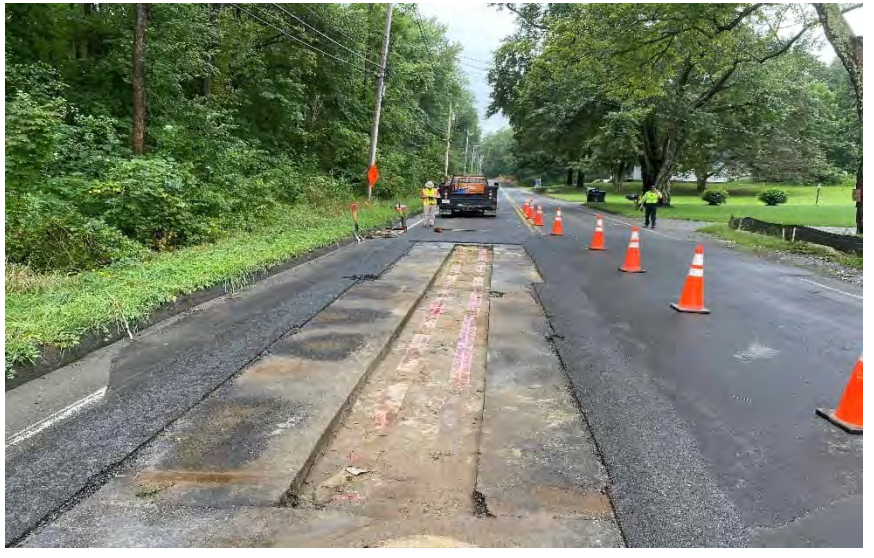
PHOTOGRAPHIC LOG	
Client Name: Eversource		Site Location: Sudbury to Hudson Transmission Reliability Project	Town: Hudson
Photo No.: 4	Date: 9-11-23

Description: Conduit work within Forest Avenue (Oskar's crew), looking southward.

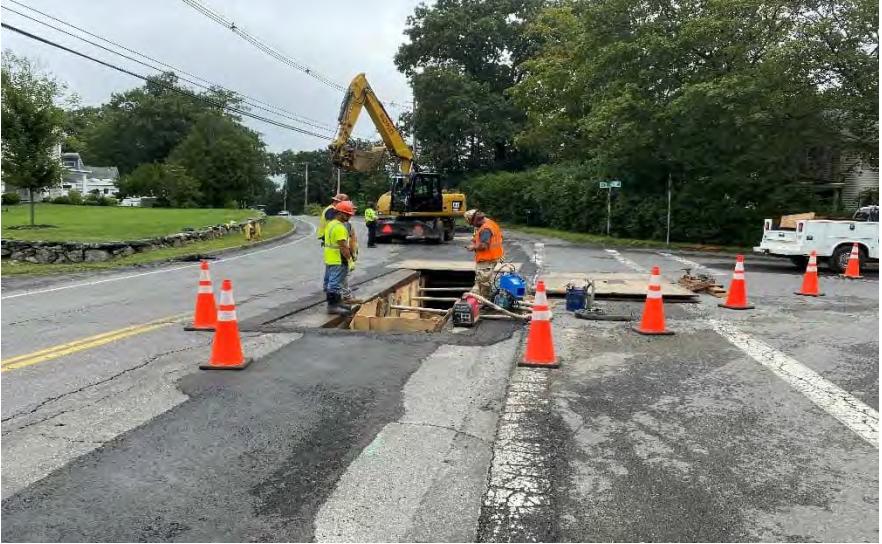
PHOTOGRAPHIC LOG	
Client Name: Eversource		Site Location: Sudbury to Hudson Transmission Reliability Project	Town: Hudson
Photo No.: 5	Date: 9-11-23

Description: Conduit work within Forest Avenue (Marisa's crew), looking northward.

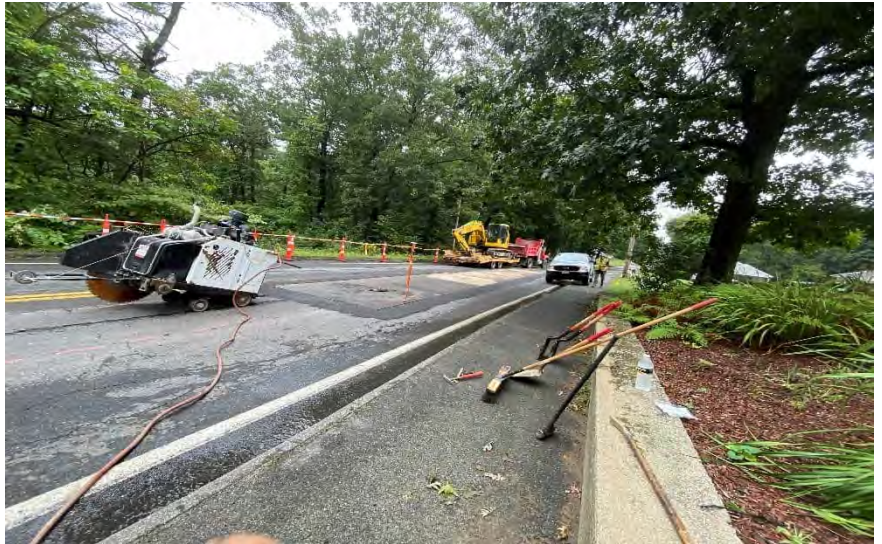
PHOTOGRAPHIC LOG	
Client Name: Eversource		Site Location: Sudbury to Hudson Transmission Reliability Project	Town: Hudson
Photo No.: 6	Date: 9-11-23

Description: Conduit work within Forest Avenue (Jim's crew), looking northward.

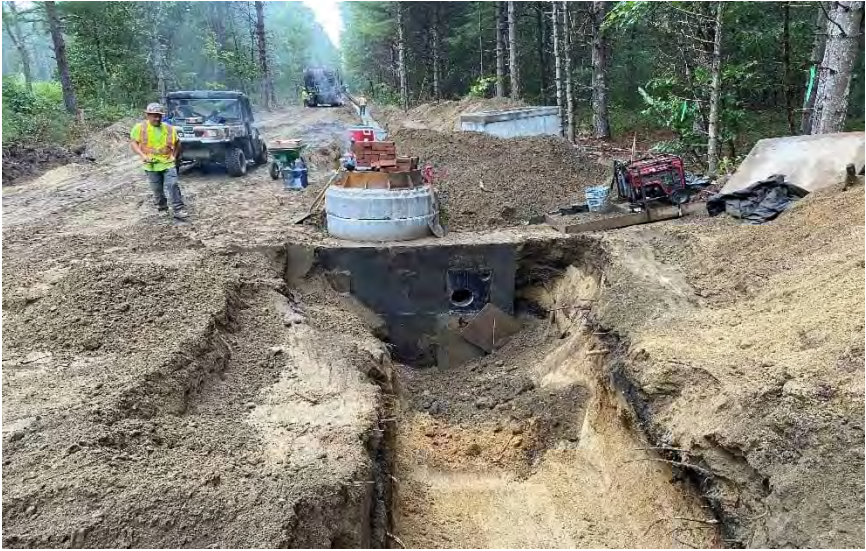
PHOTOGRAPHIC LOG	
Client Name: Eversource		Site Location: Sudbury to Hudson Transmission Reliability Project	Town: Sudbury
Photo No.: 7	Date: 9-11-23

Description: Conduit work within Segment 7 (from manhole #16), looking westward.

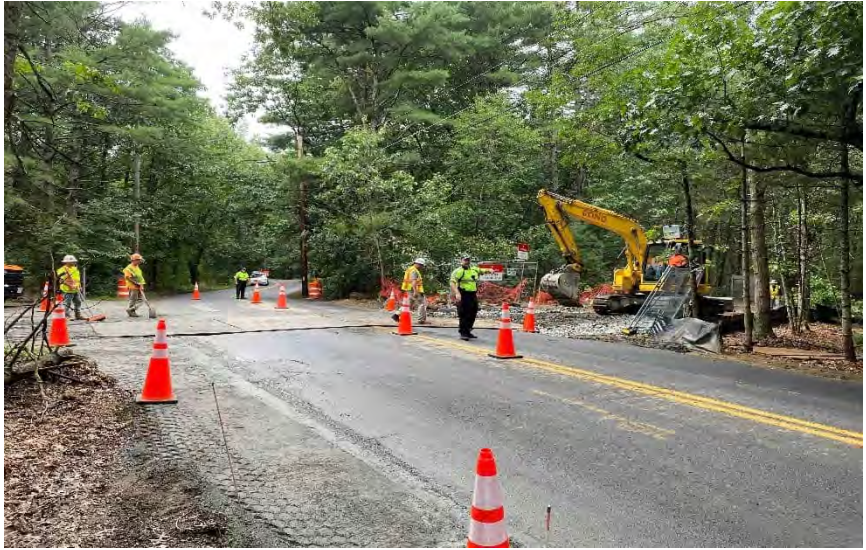
PHOTOGRAPHIC LOG	
Client Name: Eversource		Site Location: Sudbury to Hudson Transmission Reliability Project	Town: Sudbury
Photo No.: 8	Date: 9-11-23

Description: Conduit work within Dutton Road, looking southward.

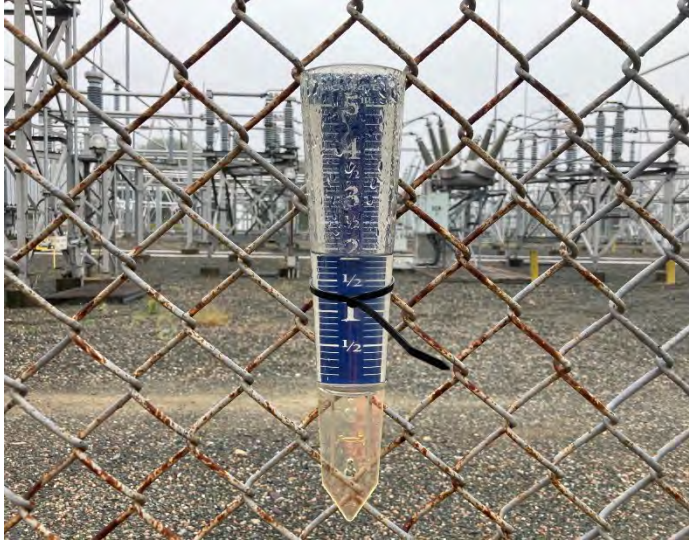
PHOTOGRAPHIC LOG	
Client Name: Eversource		Site Location: Sudbury to Hudson Transmission Reliability Project	Town: Sudbury
Photo No.: 1	Date: 9-11-2023

Description: View of rain gauge at Sudbury Substation. 2.00" observed in gauge at approximately 7:45am. Facing south.

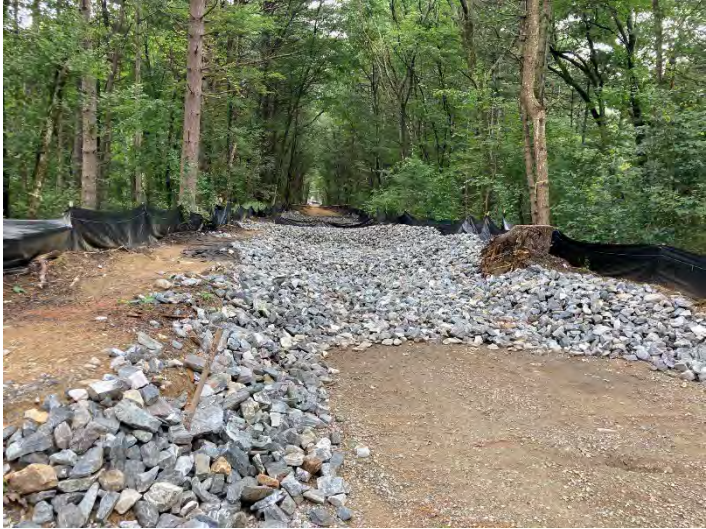
PHOTOGRAPHIC LOG	
Client Name: Eversource		Site Location: Sudbury to Hudson Transmission Reliability Project	Town: Sudbury
Photo No.: 2	Date: 9-11-2023

Description: View of area above collapsed culvert in segment 9. Facing east.

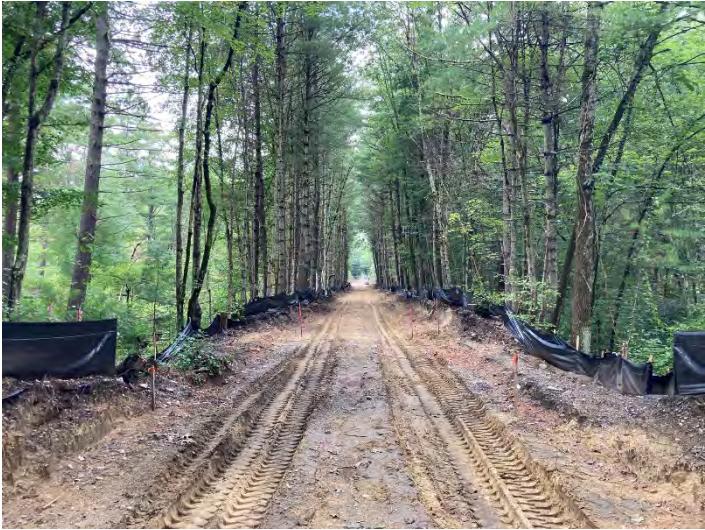
PHOTOGRAPHIC LOG	
Client Name: Eversource		Site Location: Sudbury to Hudson Transmission Reliability Project	Town: Sudbury
Photo No.: 3	Date: 9-11-2023

Description: View of Dudley Brook culvert area in segment 10. Facing west.

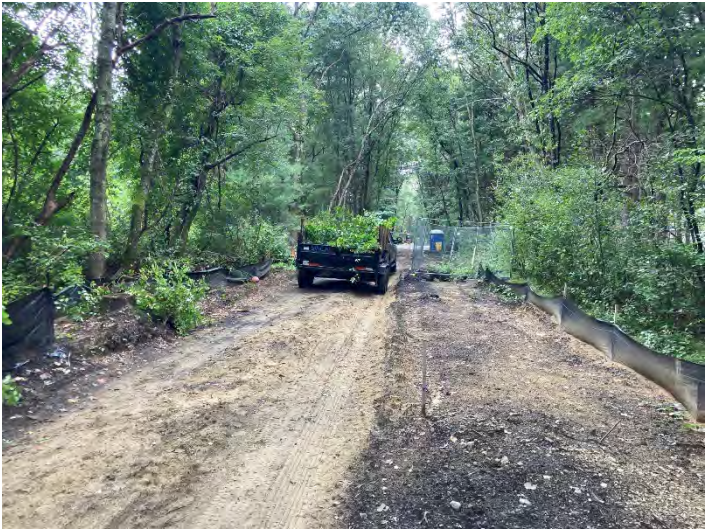
PHOTOGRAPHIC LOG	
Client Name: Eversource		Site Location: Sudbury to Hudson Transmission Reliability Project	Town: Sudbury
Photo No.: 4	Date: 9-11-2023

Description: View of invasive removal activities in segment 11. Facing west.

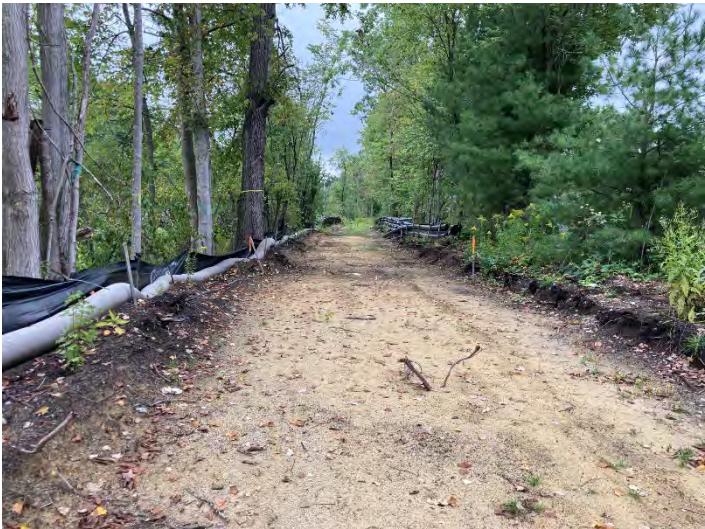
Epsilon ASSOCIATES INC.		PHOTOGRAPHIC LOG	
Client Name: Eversource		Site Location: Sudbury to Hudson Transmission Reliability Project	Town: Sudbury
Photo No.: 5	Date: 9-11-2023

Description: View of Type A E&S controls in segment 12. Facing east.

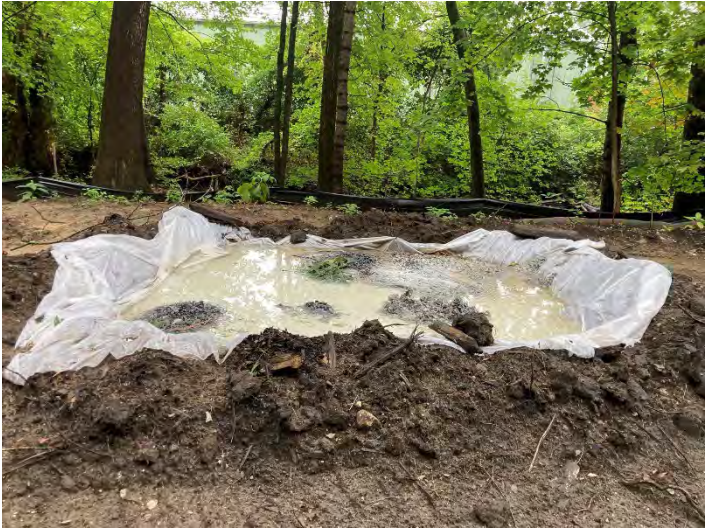
Epsilon ASSOCIATES INC.		PHOTOGRAPHIC LOG	
Client Name: Eversource		Site Location: Sudbury to Hudson Transmission Reliability Project	Town: Sudbury
Photo No.: 6	Date: 9-11-2023

Description: View of concrete washout pit in segment 13. Concrete waste appears to be contained. Facing north.

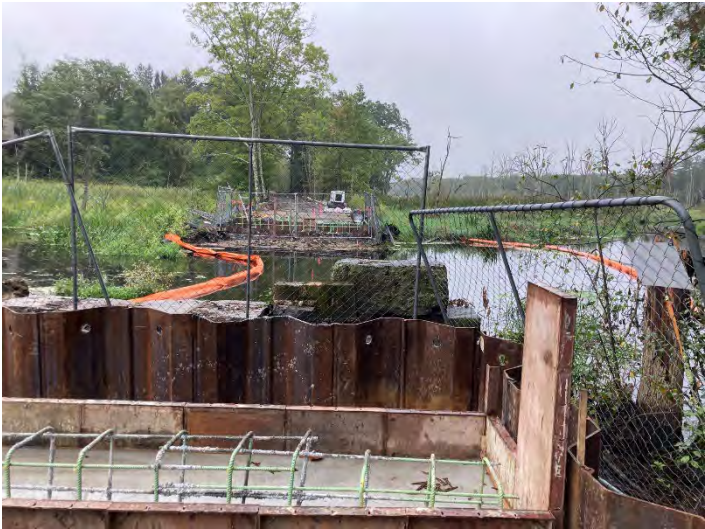
Epsilon ASSOCIATES INC.		PHOTOGRAPHIC LOG	
Client Name: Eversource		Site Location: Sudbury to Hudson Transmission Reliability Project	Town: Sudbury
Photo No.: 7	Date: 9-11-2023

Description: View of bridge 127 area. See additional dewatering inspection reports. Facing east.

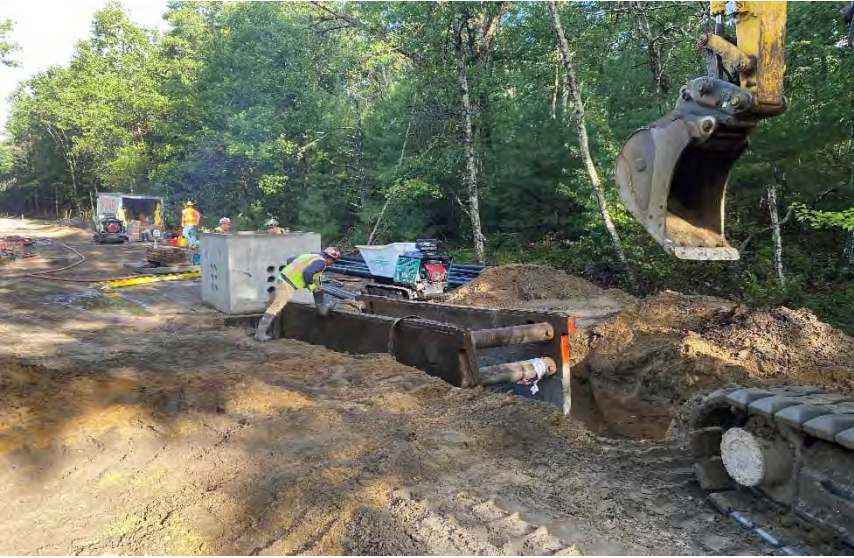
PHOTOGRAPHIC LOG	
Client Name: Eversource		Site Location: Sudbury to Hudson Transmission Reliability Project	Town: Hudson
Photo No.: 3	Date: 9-14-23

Description: Work area within segment 6, conduit work at manhole #14, existing erosion control, looking westward.

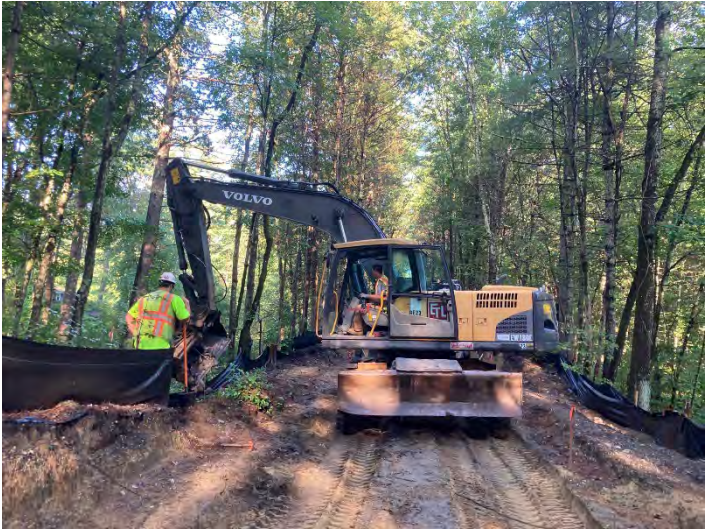
PHOTOGRAPHIC LOG	
Client Name: Eversource		Site Location: Sudbury to Hudson Transmission Reliability Project	Town: Sudbury
Photo No.: 3	Date: 9-14-2023

Description: View of ET&L applying stone to depression above Dudley Brook culvert in segment 10. Facing west.
