Weekly Environmental Compliance Summary

Sudbury to Hudson Transmission Reliability Project (USEPA Tracking # MAR1003UW)

Week of: September 11, 2023 to September 15, 2023

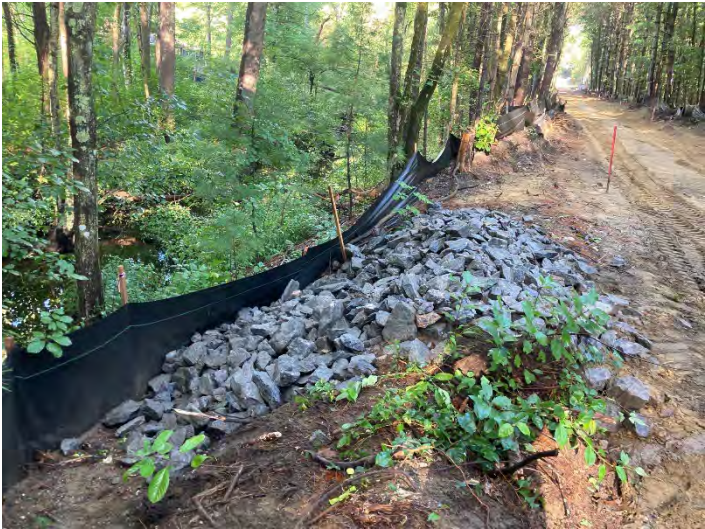
PHOTOGRAPHIC LOG	
Client Name: Eversource		Site Location: Sudbury to Hudson Transmission Reliability Project	Town: Sudbury
Photo No.: 4	Date: 9-14-2023

Description: View of stone applied to depression above Dudley Brook culvert. Facing west.

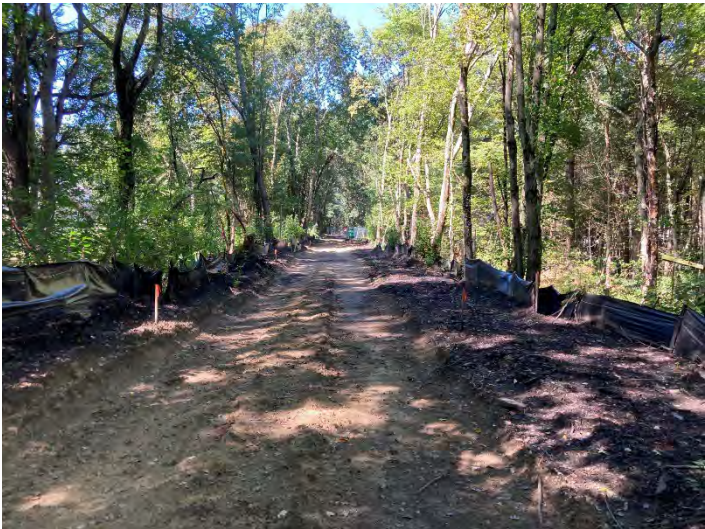
Epsilon ASSOCIATES INC.		PHOTOGRAPHIC LOG	
Client Name: Eversource		Site Location: Sudbury to Hudson Transmission Reliability Project	Town: Sudbury
Photo No.: 5	Date: 9-14-2023

Description: View of syncopated silt fence in segment 11. Facing west.

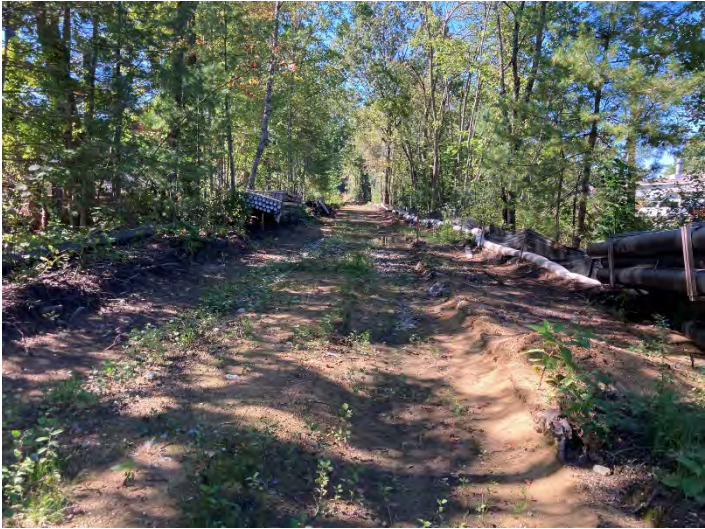
Epsilon ASSOCIATES INC.		PHOTOGRAPHIC LOG	
Client Name: Eversource		Site Location: Sudbury to Hudson Transmission Reliability Project	Town: Sudbury
Photo No.: 6	Date: 9-14-2023

Description: View of Type A E&S controls in segment 12. Facing west.

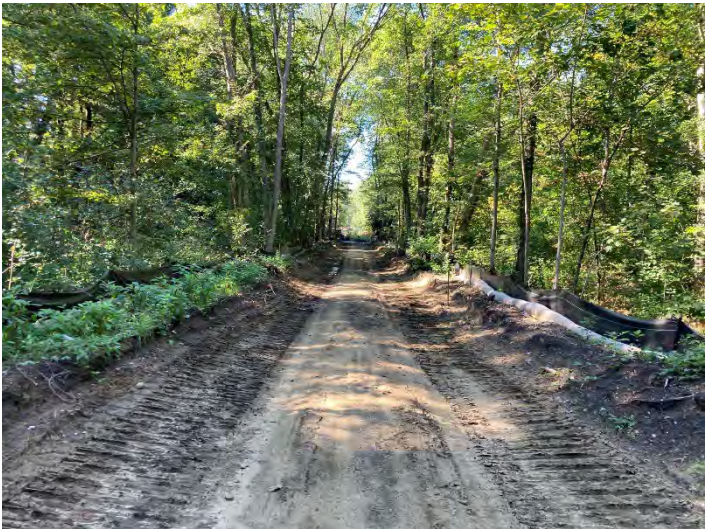
Client Name: Eversource		Site Location: Sudbury to Hudson Transmission Reliability Project	Town: Sudbury
Photo No.: 7	Date: 9-14-2023

Description: View of Type A E&S controls in segment 13. Facing west.

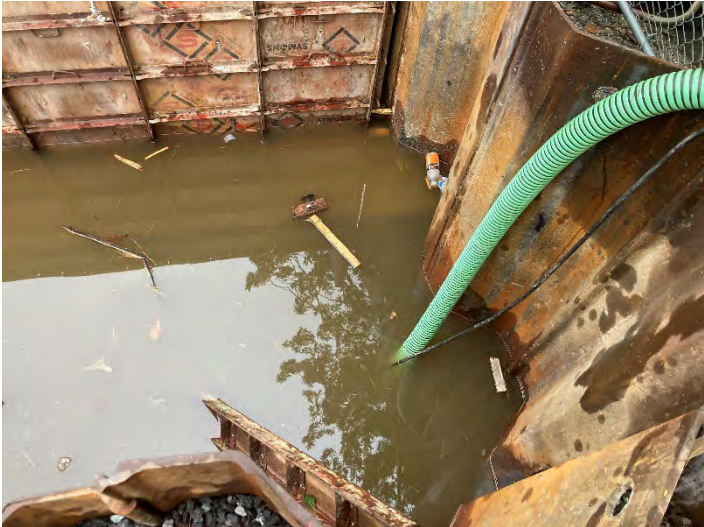
PHOTOGRAPHIC LOG		
Client Name: Eversource		Site Location: Sudbury to Hudson Transmission Reliability Project		Town: Sudbury
Photo No.: 2	Date: 9/11/2023

Description: View of pumping operation at Bridge 127 work at Hop Brook. Water prior to treatment appeared to be slightly turbid.

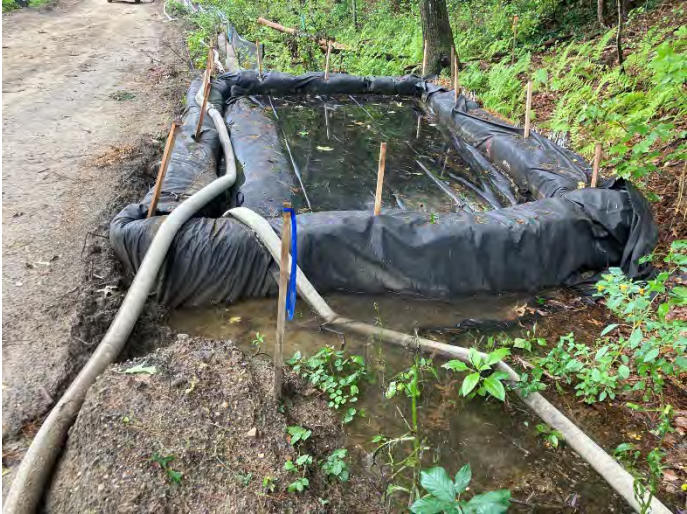
PHOTOGRAPHIC LOG	
Client Name: Eversource		Site Location: Sudbury to Hudson Transmission Reliability Project	
Photo No.: 3		Town: Sudbury	
Date: 9/11/2023			
Description: View of dewatering controls (straw bale corral with filter fabric, stone, and silt bag) and discharge from corral. Facing east.

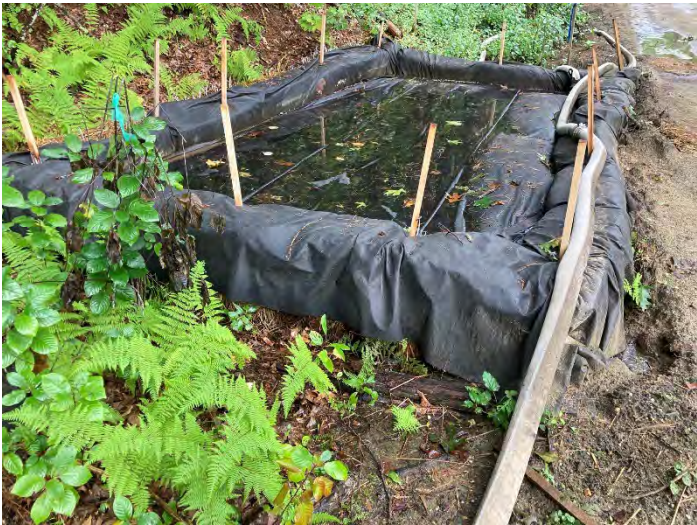
PHOTOGRAPHIC LOG	
Client Name: Eversource		Site Location: Sudbury to Hudson Transmission Reliability Project	
Photo No.: 4		Town: Sudbury	
Date: 9/11/2023			
Description: Additional view of dewatering controls (straw bale corral with filter fabric, stone, and silt bag) and discharge from corral. Discharge traveled east outside of the silt fence but did not reach any jurisdictional areas. Discharge appeared clear. Turbidity reading was less than 50 NTUs. Facing west.

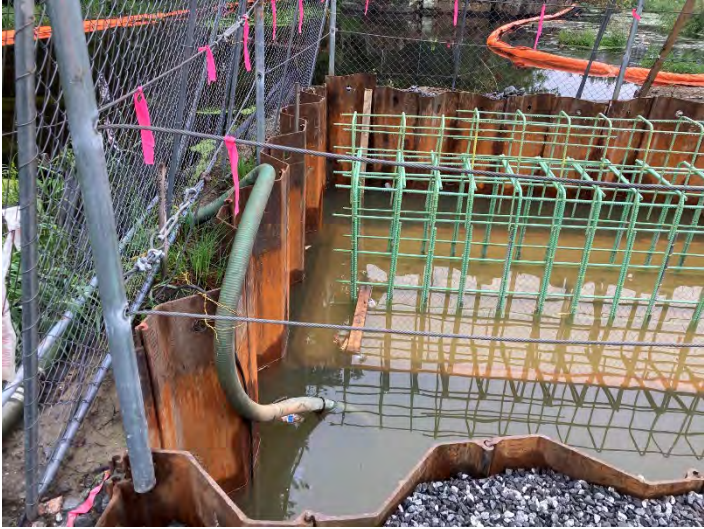
PHOTOGRAPHIC LOG	
Client Name: Eversource		Site Location: Sudbury to Hudson Transmission Reliability Project	
Town: Sudbury			
Photo No.: 1	Date: 9/11/2023

Description: View of work area and pumping operation at cofferdam at Bridge 127 work at Hop Brook. Water appeared slightly turbid prior to treatment. Facing west.

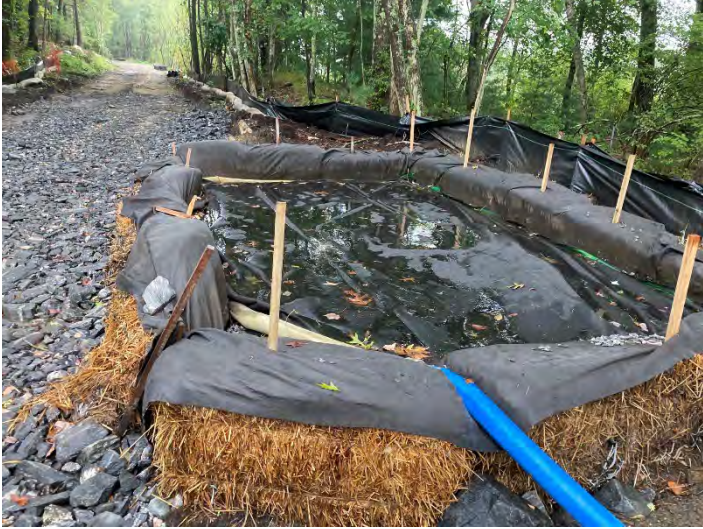
PHOTOGRAPHIC LOG	
Client Name: Eversource		Site Location: Sudbury to Hudson Transmission Reliability Project	
Town: Sudbury			
Photo No.: 2	Date: 9/11/2023

Description: View of dewatering controls (straw bale corral with filter fabric, stone, and silt bag). Facing east.

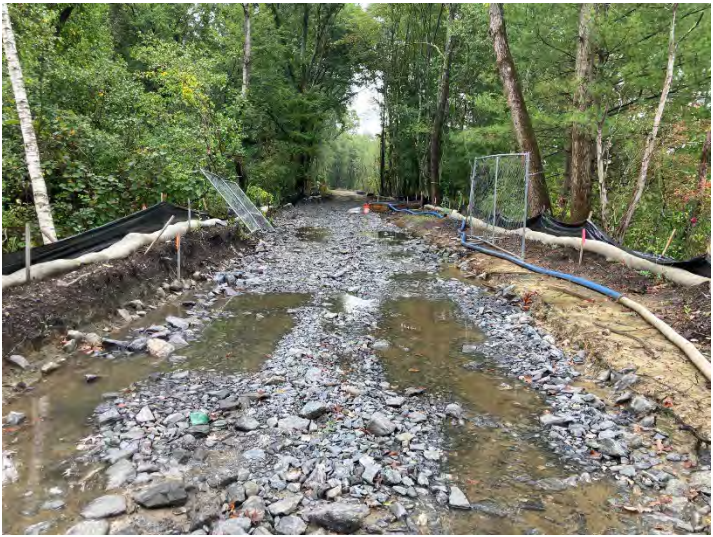
PHOTOGRAPHIC LOG	
Client Name: Eversource		Site Location: Sudbury to Hudson Transmission Reliability Project	Town: Sudbury
Photo No.: 4	Date: 9/11/2023

Description: Additional view of discharge from controls. Discharge appeared to be leaving the work area and reaching wetlands. Discharge appeared clear. Turbidity reading was less than 50 NTUs. Facing east.

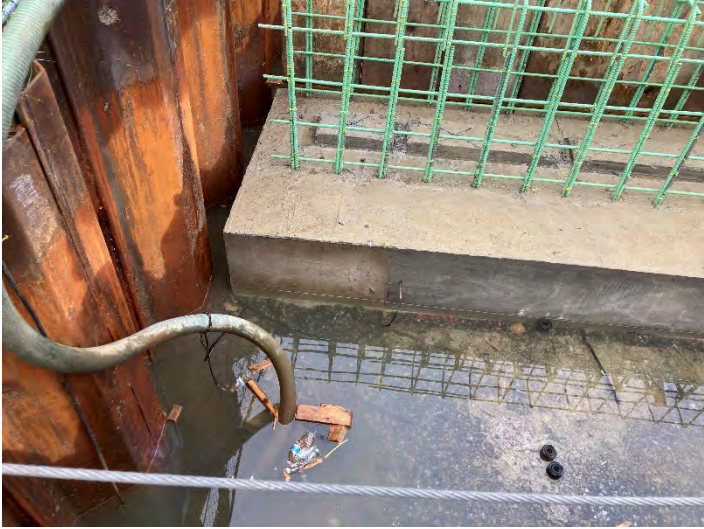
PHOTOGRAPHIC LOG	
Client Name: Eversource		Site Location: Sudbury to Hudson Transmission Reliability Project	Town: Sudbury
Photo No.: 1	Date: 9/12/2023

Description: View of pumping operation at cofferdam at Bridge 127 work at Hop Brook. Water appeared slightly turbid prior to treatment.

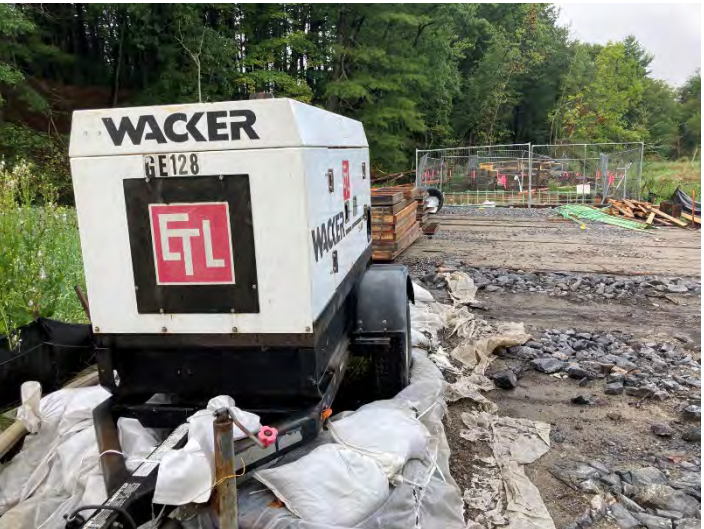
PHOTOGRAPHIC LOG	
Client Name: Eversource		Site Location: Sudbury to Hudson Transmission Reliability Project	Town: Sudbury
Photo No.: 2	Date: 9/12/2023

Description: View of generator used for pumping operation. Generator is placed in lined containment area. Facing west.

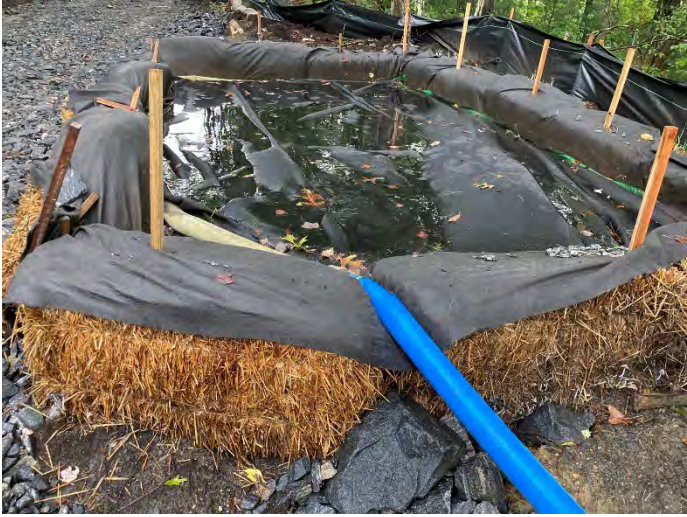
PHOTOGRAPHIC LOG		
Client Name: Eversource		Site Location: Sudbury to Hudson Transmission Reliability Project		Town: Sudbury
Photo No.: 3	Date: 9/12/2023

Description: View of dewatering controls (straw bale corral with filter fabric, stone, and silt bag). Facing east.

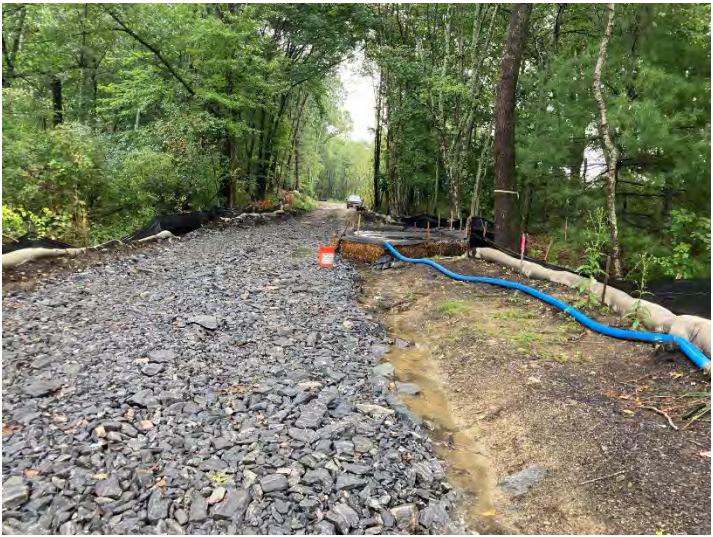
PHOTOGRAPHIC LOG		
Client Name: Eversource		Site Location: Sudbury to Hudson Transmission Reliability Project		Town: Sudbury
Photo No.: 4	Date: 9/12/2023

Description: View of discharge from controls. Discharge appeared to be leaving the work area and reaching wetlands. Discharge appeared clear. Turbidity reading was less than 50 NTUs. Facing east.

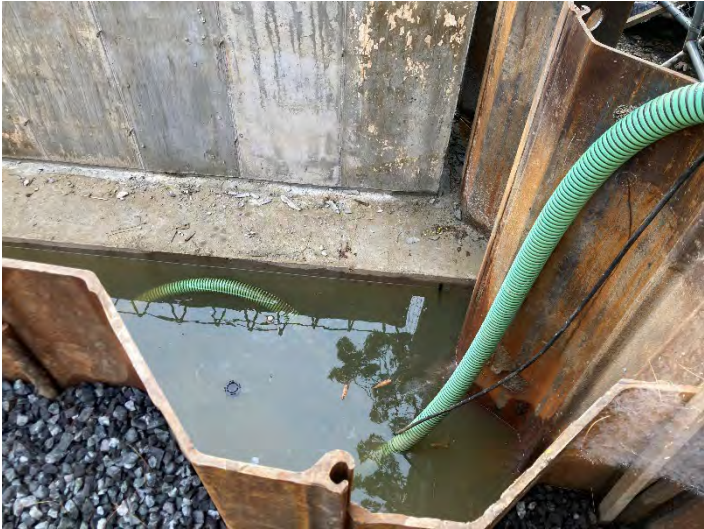
PHOTOGRAPHIC LOG	
Client Name: Eversource		Site Location: Sudbury to Hudson Transmission Reliability Project	Town: Sudbury
Photo No.: 2	Date: 9/13/2023

Description: View of pumping operation at Bridge 127 work at Hop Brook. Water prior to treatment appeared to be slightly turbid.

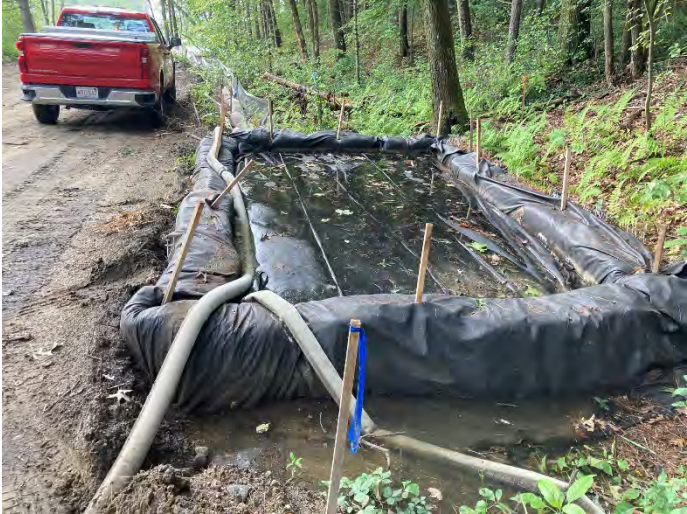
PHOTOGRAPHIC LOG	
Client Name: Eversource		Site Location: Sudbury to Hudson Transmission Reliability Project	
Photo No.: 3		Date: 9/13/2023	
Description: View of dewatering controls (straw bale corral with filter fabric, stone, and silt bag) and discharge from corral. Facing east.

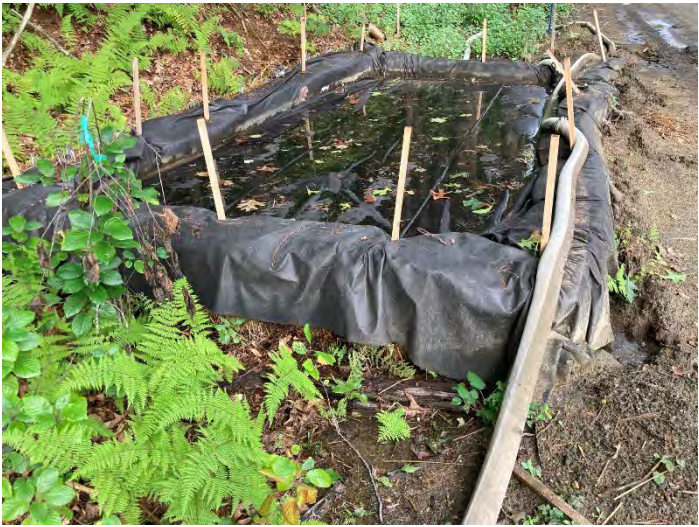
PHOTOGRAPHIC LOG	
Client Name: Eversource		Site Location: Sudbury to Hudson Transmission Reliability Project	
Photo No.: 4		Date: 9/13/2023	
Description: Additional view of dewatering controls (straw bale corral with filter fabric, stone, and silt bag) and discharge from corral. Discharge traveled east outside of the silt fence but did not reach any jurisdictional areas. Discharge appeared mostly clear. Turbidity reading was less than 50 NTUs. Facing west.

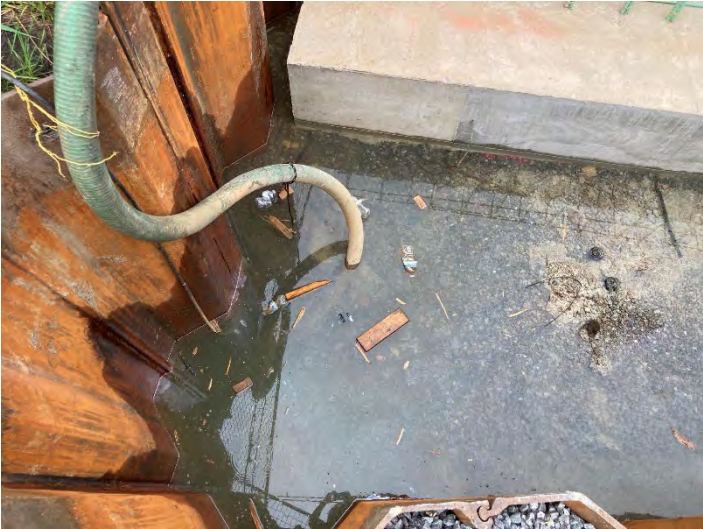
PHOTOGRAPHIC LOG		
Client Name: Eversource		Site Location: Sudbury to Hudson Transmission Reliability Project		Town: Sudbury
Photo No.: 2	Date: 9/13/2023

Description: View of water prior to treatment. Water appeared mostly clear.

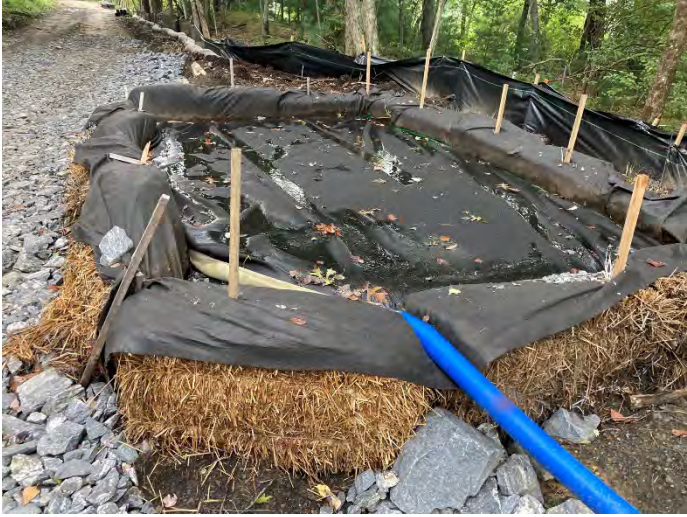
PHOTOGRAPHIC LOG	
Client Name: Eversource		Site Location: Sudbury to Hudson Transmission Reliability Project	
		Town: Sudbury	
Photo No.: 3	Date: 9/13/2023

Description: View of dewatering controls (straw bale corral with filter fabric, stone, and silt bag). Facing east.

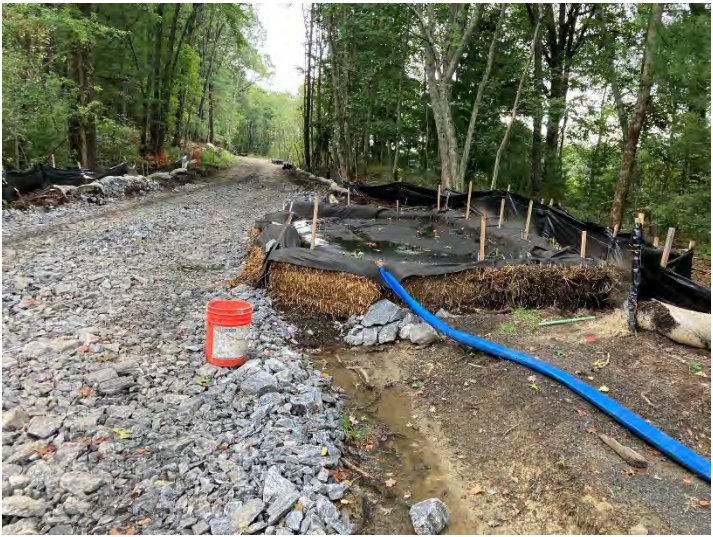
PHOTOGRAPHIC LOG	
Client Name: Eversource		Site Location: Sudbury to Hudson Transmission Reliability Project	
		Town: Sudbury	
Photo No.: 4	Date: 9/13/2023

Description: View of discharge from controls. Discharge appeared to be leaving the work area and reaching wetlands. Discharge appeared clear. Turbidity reading was less than 50 NTUs. Facing east.

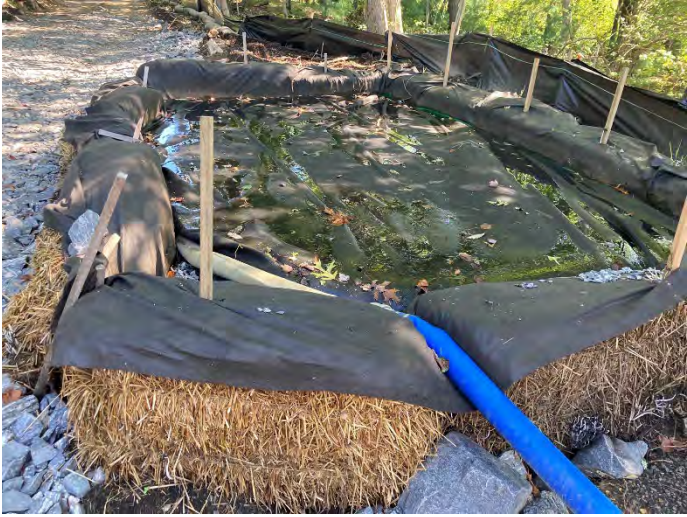
PHOTOGRAPHIC LOG	
Client Name: Eversource		Site Location: Sudbury to Hudson Transmission Reliability Project	Town: Sudbury
Photo No.: 3	Date: 9/14/2023

Description: View of dewatering controls (straw bale corral with filter fabric, stone, and silt bag). Facing east.

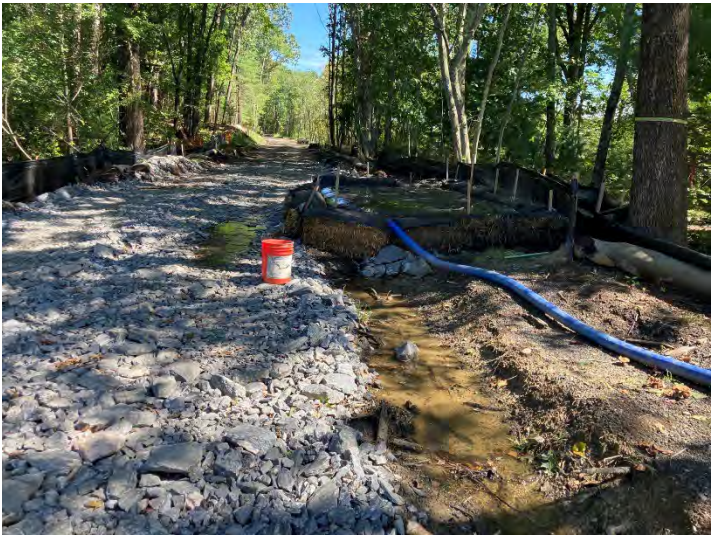
PHOTOGRAPHIC LOG	
Client Name: Eversource		Site Location: Sudbury to Hudson Transmission Reliability Project	Town: Sudbury
Photo No.: 4	Date: 9/14/2023

Description: View of discharge from controls. Discharge appeared to be leaving the work area and reaching wetlands. Discharge appeared clear. Turbidity reading was less than 50 NTUs. Facing east.

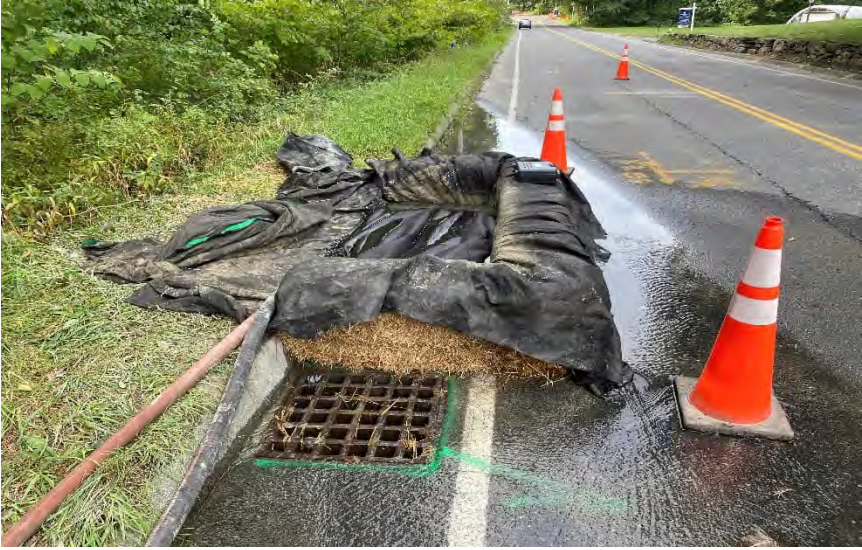
PHOTOGRAPHIC LOG	
Client Name: Eversource		Site Location: Sudbury to Hudson Transmission Reliability Project	Town: Hudson
Photo No.: 4	Date: 9/15/2023

Description: Forest Avenue. View of dewatering operation (corral/bag), looking southward.

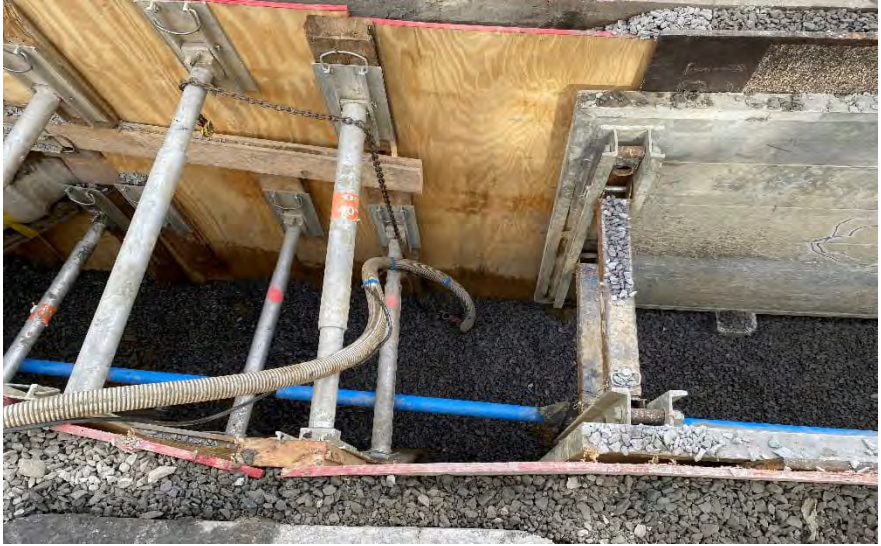
PHOTOGRAPHIC LOG	
Client Name: Eversource		Site Location: Sudbury to Hudson Transmission Reliability Project	Town: Hudson
Photo No.: 1	Date: 9/15/2023

Description: View of area being pumped at Forest Avenue (area in conduit trench).

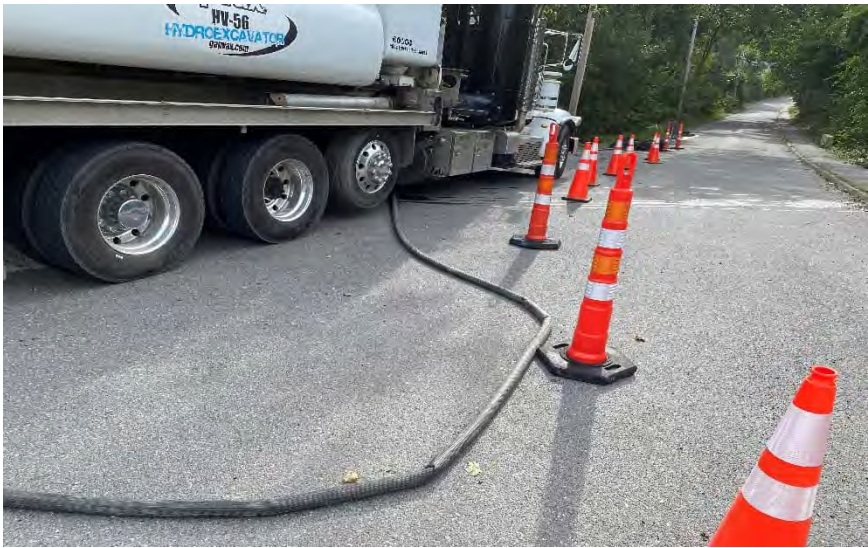
PHOTOGRAPHIC LOG	
Client Name: Eversource		Site Location: Sudbury to Hudson Transmission Reliability Project	Town: Hudson
Photo No.: 2	Date: 9/15/2023

Description: Forest Avenue. View of dewatering operation, looking eastward.

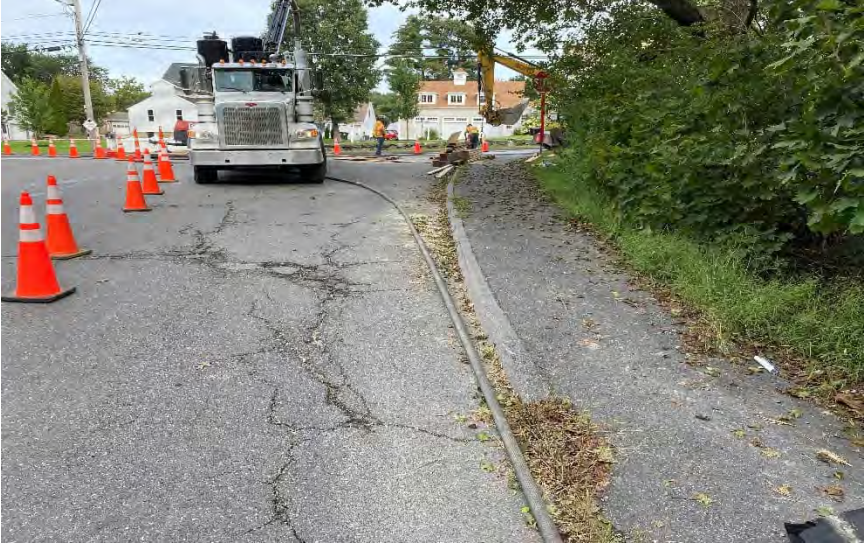
PHOTOGRAPHIC LOG	
Client Name: Eversource		Site Location: Sudbury to Hudson Transmission Reliability Project	Town: Hudson
Photo No.: 3	Date: 9/15/2023

Description: Forest Avenue. View of dewatering operation (pumping at far end of area), looking westward.

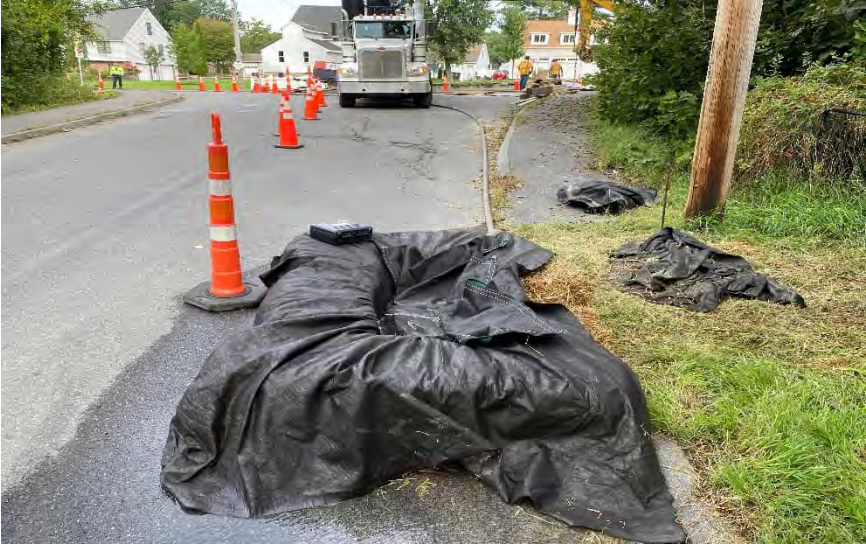
PHOTOGRAPHIC LOG	
Client Name: Eversource		Site Location: Sudbury to Hudson Transmission Reliability Project	Town: Hudson
Photo No.: 4	Date: 9/15/2023

Description: Forest Avenue. View of dewatering operation (corral/bag), looking westward.

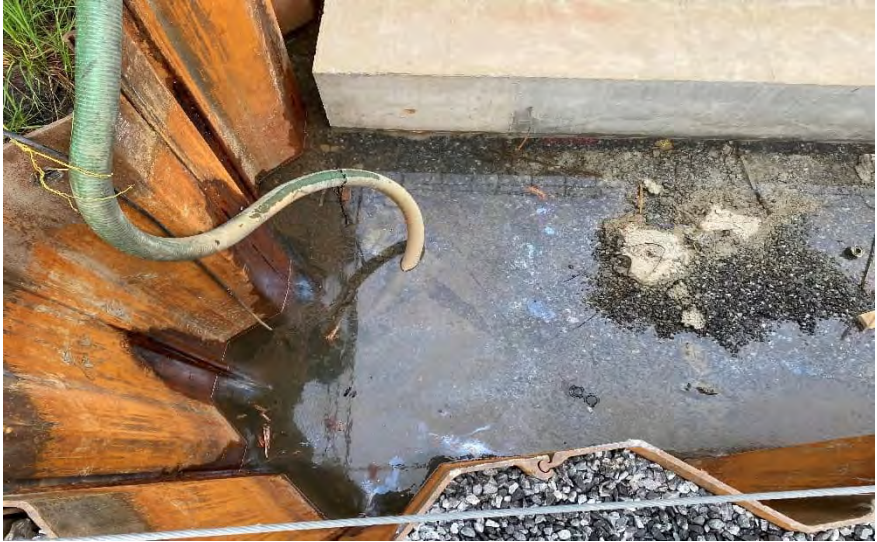
PHOTOGRAPHIC LOG	
Client Name: Eversource		Site Location: Sudbury to Hudson Transmission Reliability Project	Town: Sudbury
Photo No.: 1	Date: 9/15/2023

Description: View of area being pumped at Hop Brook (area in cofferdam), looking westward.

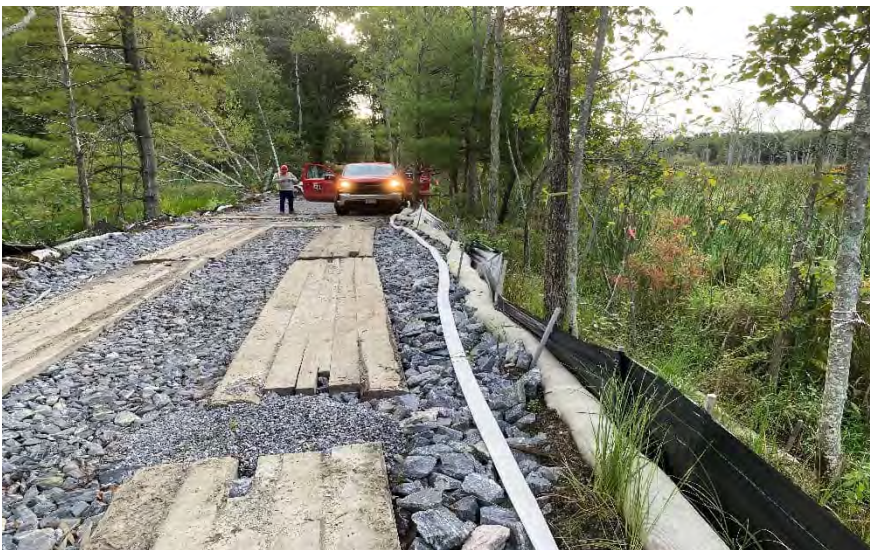
PHOTOGRAPHIC LOG	
Client Name: Eversource		Site Location: Sudbury to Hudson Transmission Reliability Project	Town: Sudbury
Photo No.: 2	Date: 9/15/2023

Description: Segment 14. View of dewatering operation (pumping at far end of area), looking eastward.

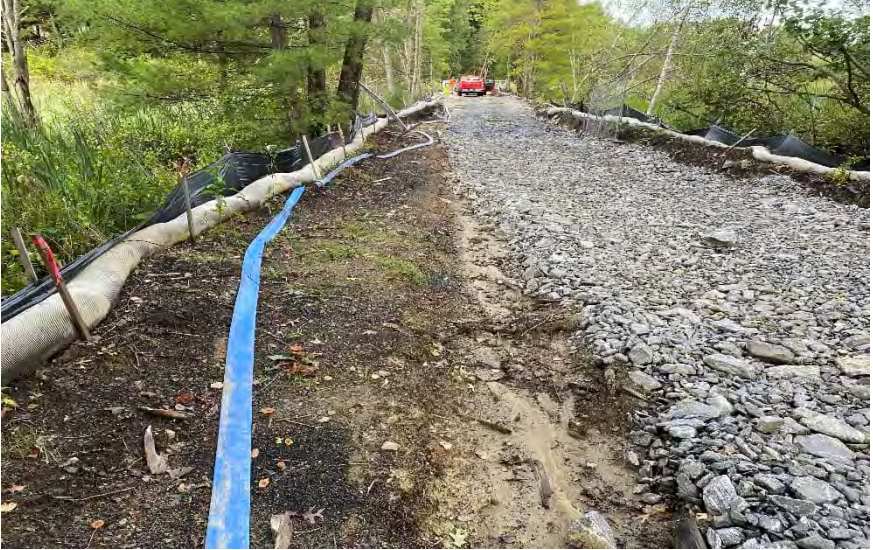
PHOTOGRAPHIC LOG	
Client Name: Eversource		Site Location: Sudbury to Hudson Transmission Reliability Project	Town: Sudbury
Photo No.: 3	Date: 9/15/2023

Description: Segment 14. View of dewatering operation (pumping at far end of area), looking westward.

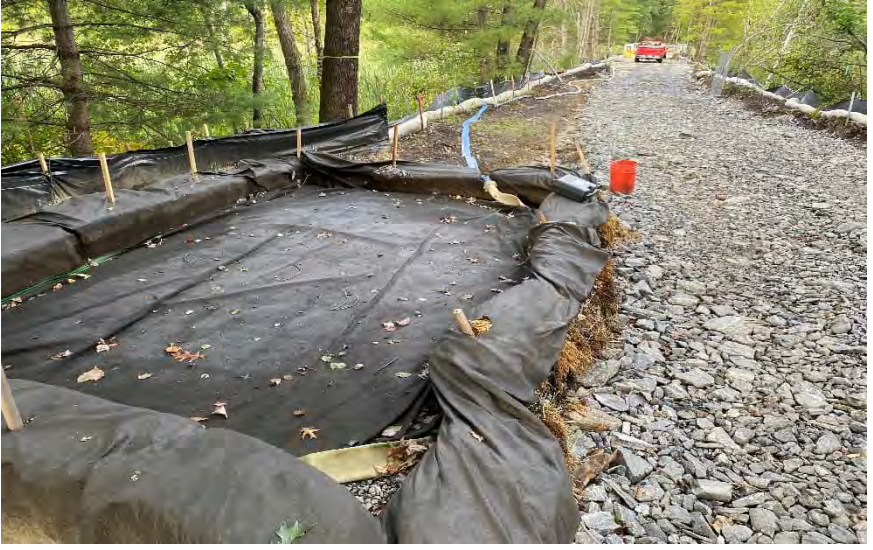
PHOTOGRAPHIC LOG	
Client Name: Eversource		Site Location: Sudbury to Hudson Transmission Reliability Project	Town: Sudbury
Photo No.: 4	Date: 9/15/2023

Description: Segment 14. View of dewatering operation (pumping at far end of area), looking westward.
