# Wildlife Habitat Features Report Eversource Sudbury to Hudson Transmission Reliability Project Sudbury, Massachusetts

DECEMBER 2022- MAY 2023

SWCA Project No. 67849

July 2023

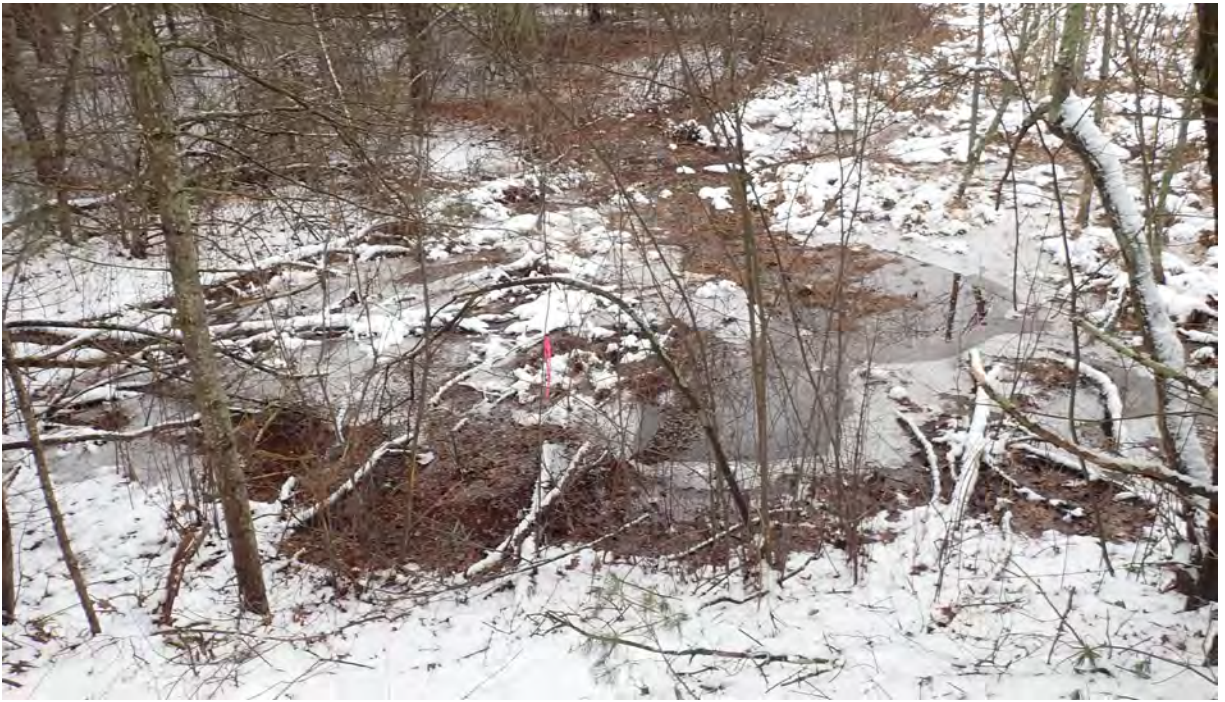
**Photo #1:** View of installed fallen logs within Impact Area 3 on the northern side of work area. *Facing north.*

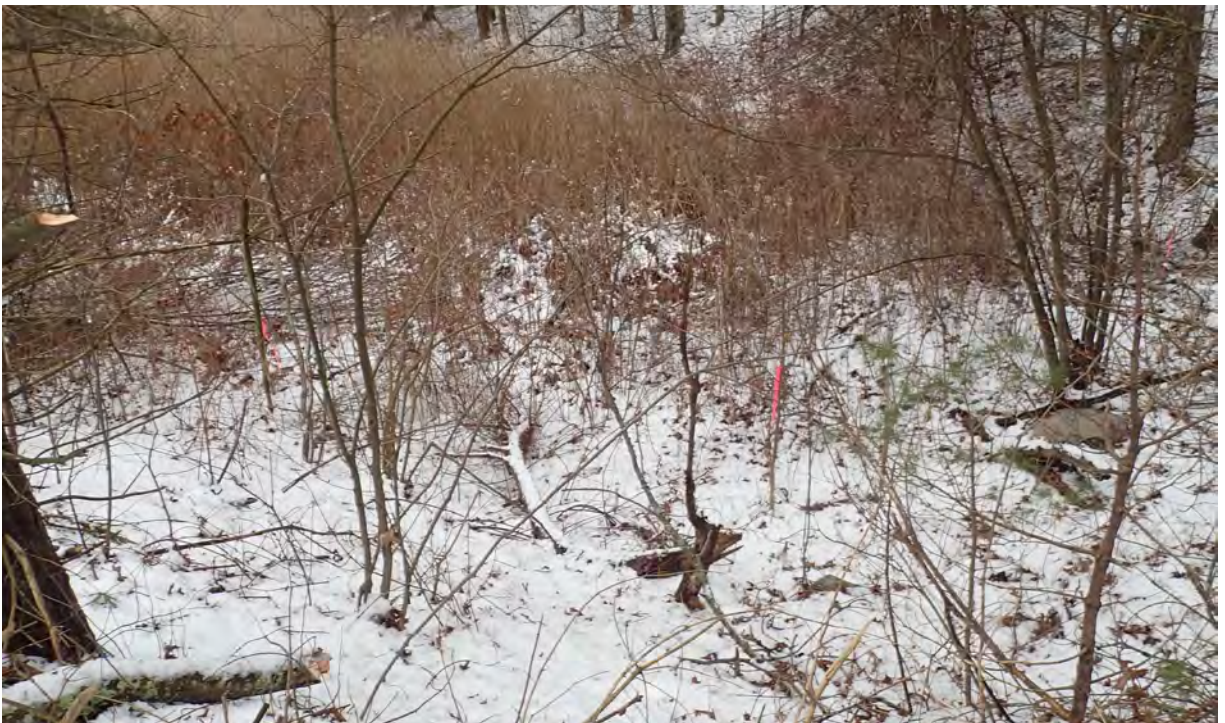
**Photo #2:** View of installed fallen logs within Impact Area 3 on the southwestern end of the work area. *Facing southeast.*

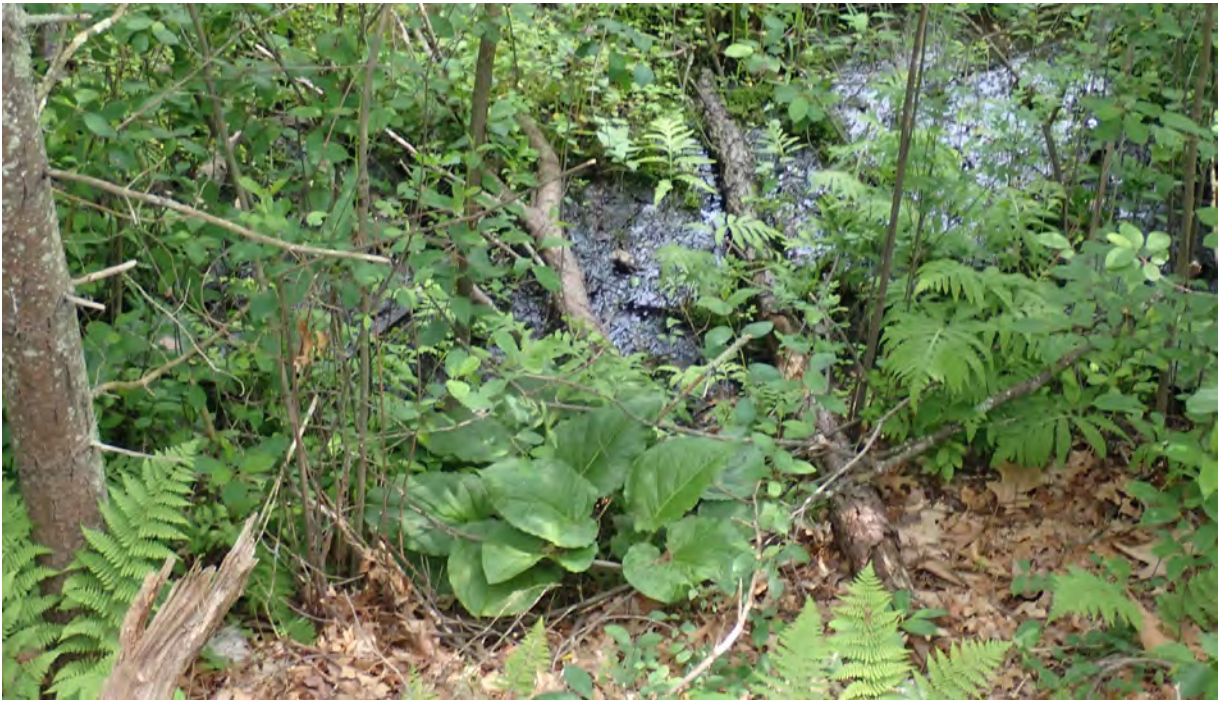
**Photo #3:** View of installed fallen log in Impact Area 3 . *Facing north.*

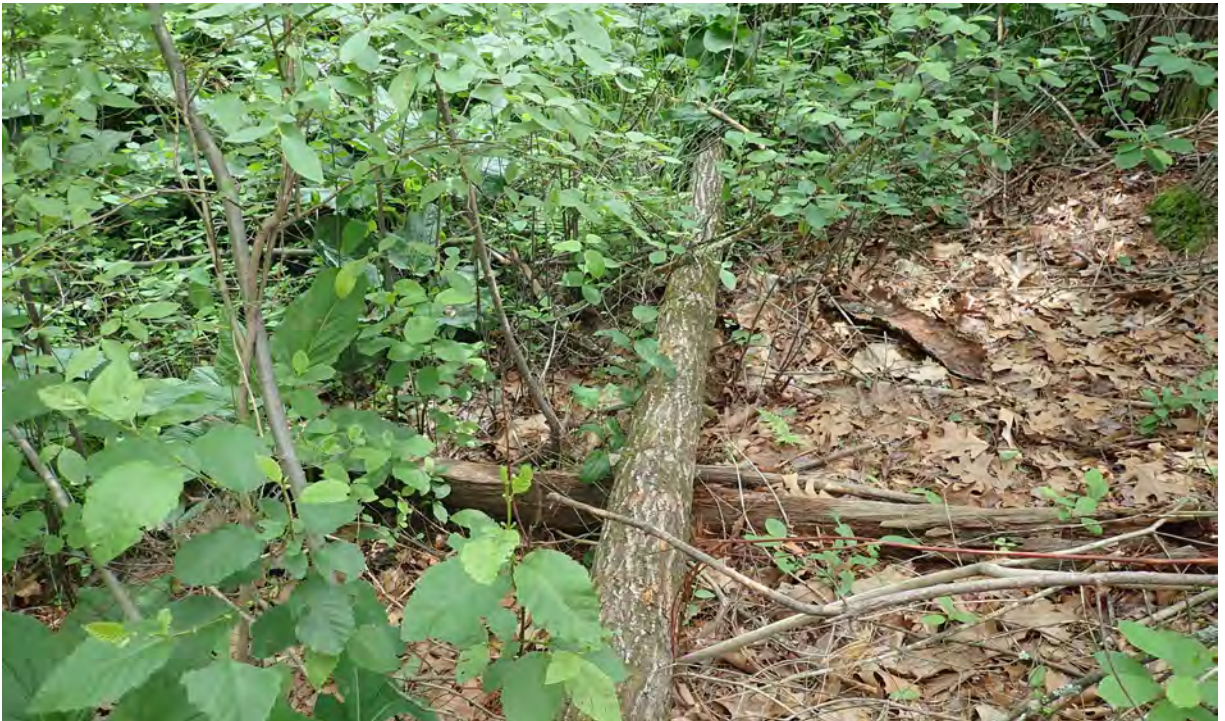
**Photo #4:** View of installed fallen log in Impact Area 3 . *Facing northeast.*

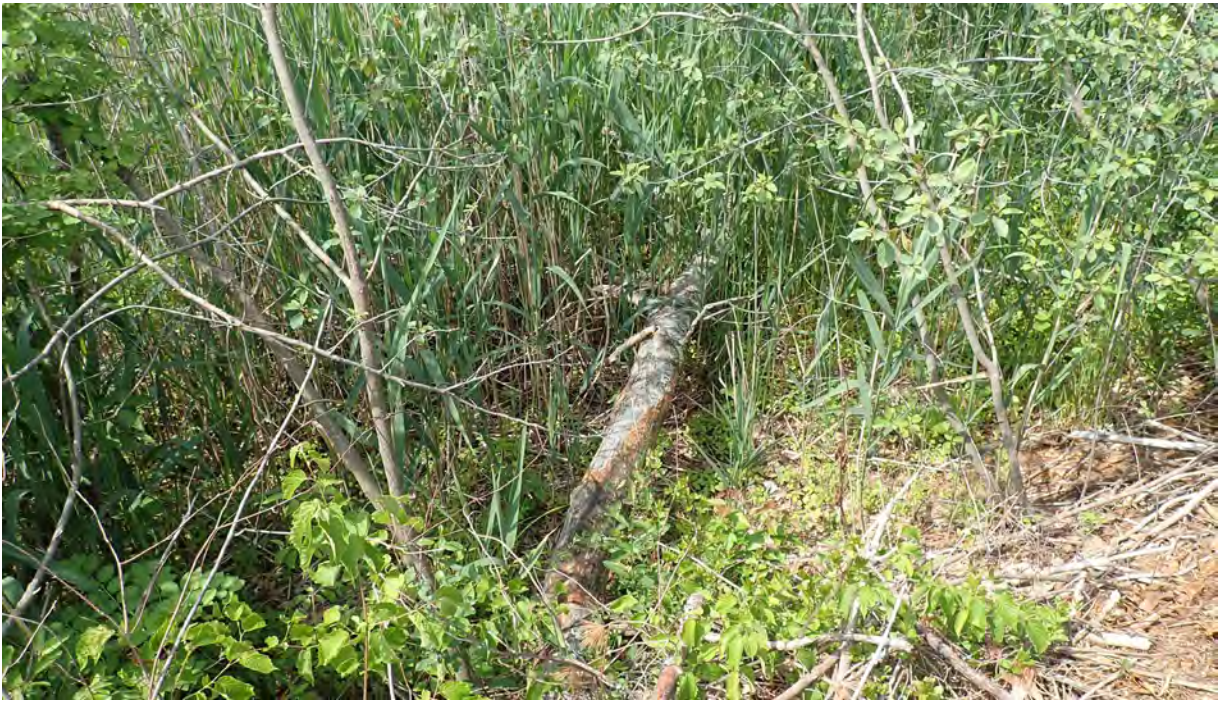
**Photo #5:** View of installed fallen log as a snag in Impact Area 4. *Facing south.*

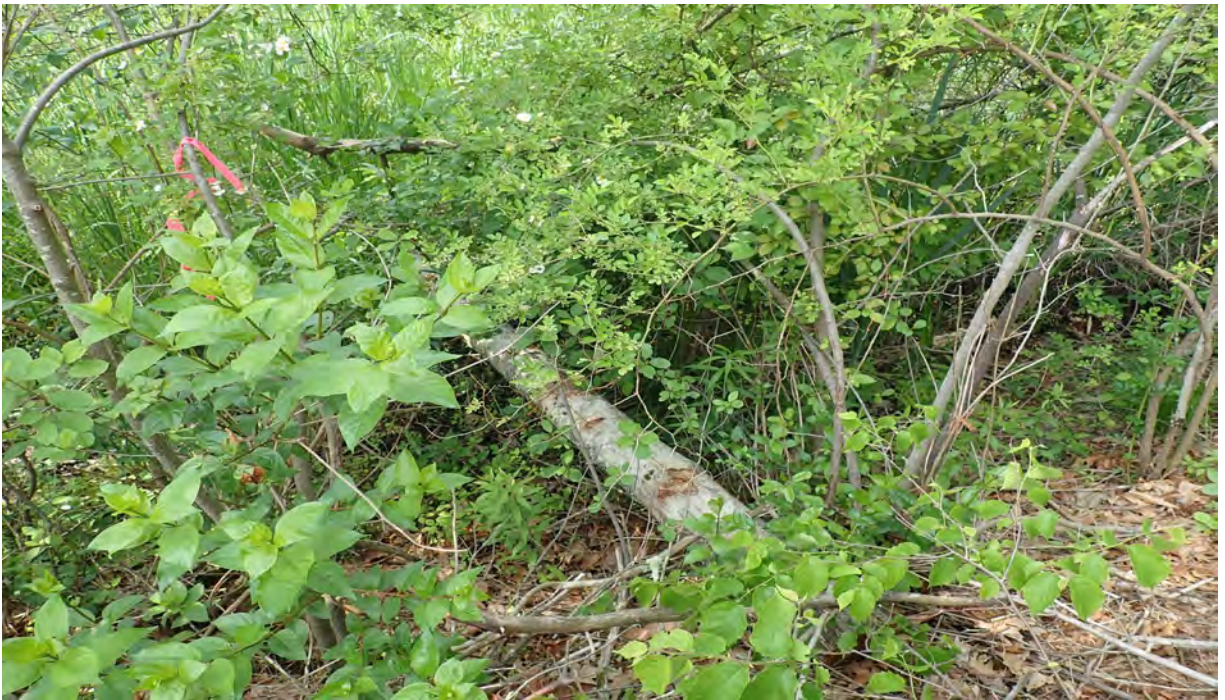
**Photo #6:** View of installed fallen log as a snag in Impact Area 4. *Facing south.*

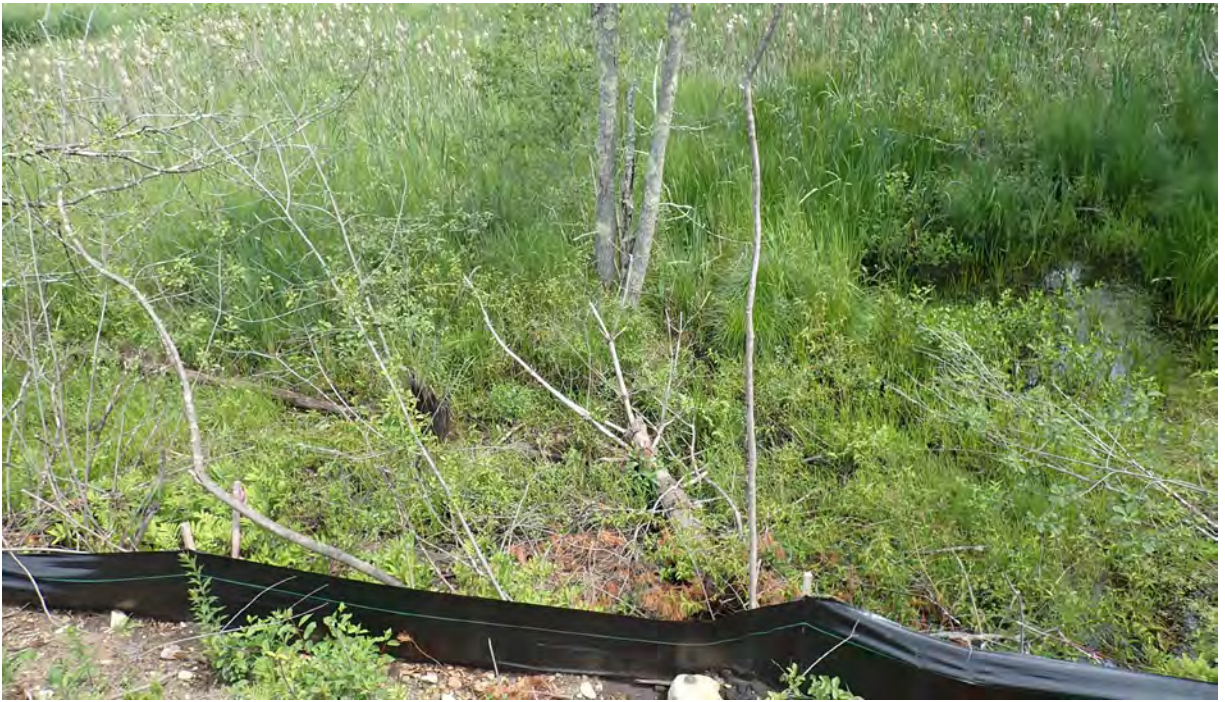
**Photo #7:** View of installed fallen log as a snag in Impact Area 5. *Facing north.*

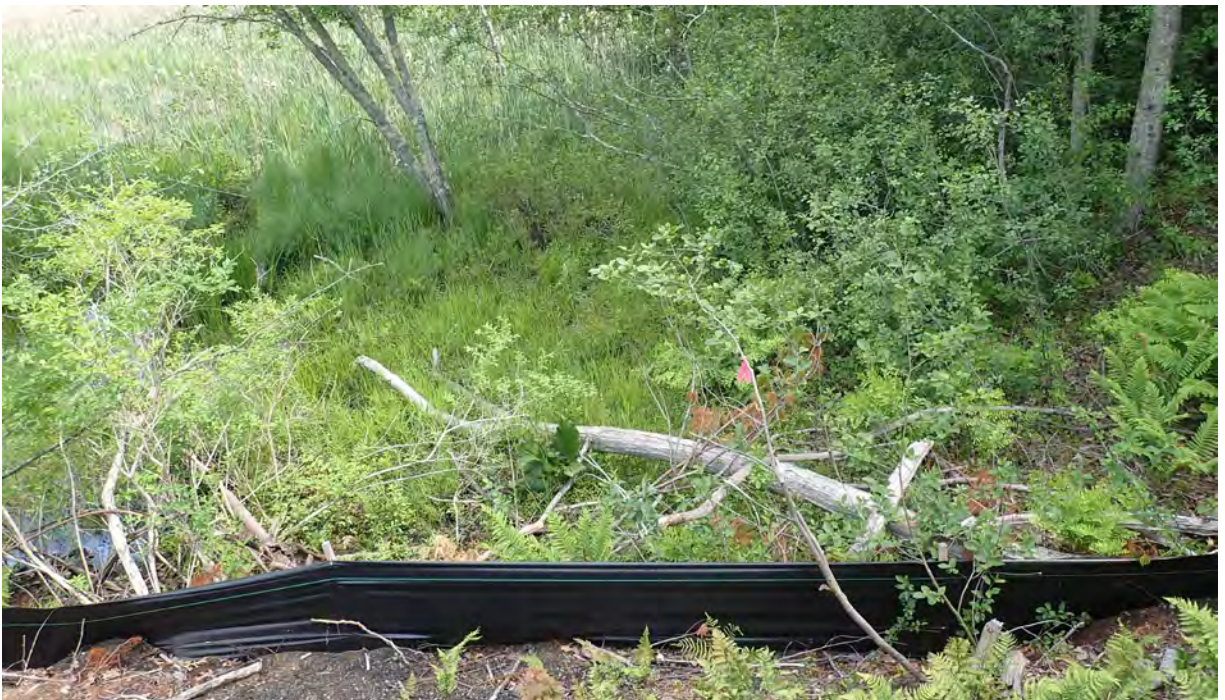
**Photo #10:** View of installed fallen log as a snag in Impact Area 6. *Facing north.*

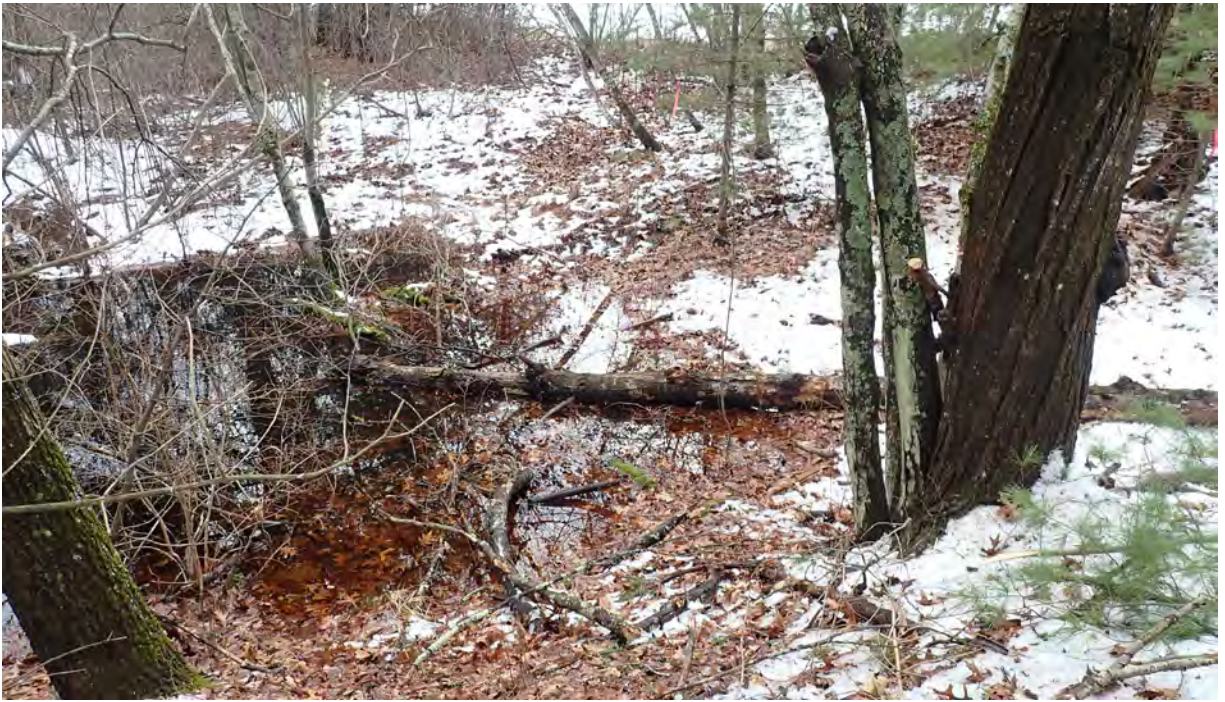
**Photo #11:** View of installed fallen log in vernal pool #11 in Impact Area 7. *Facing south.*

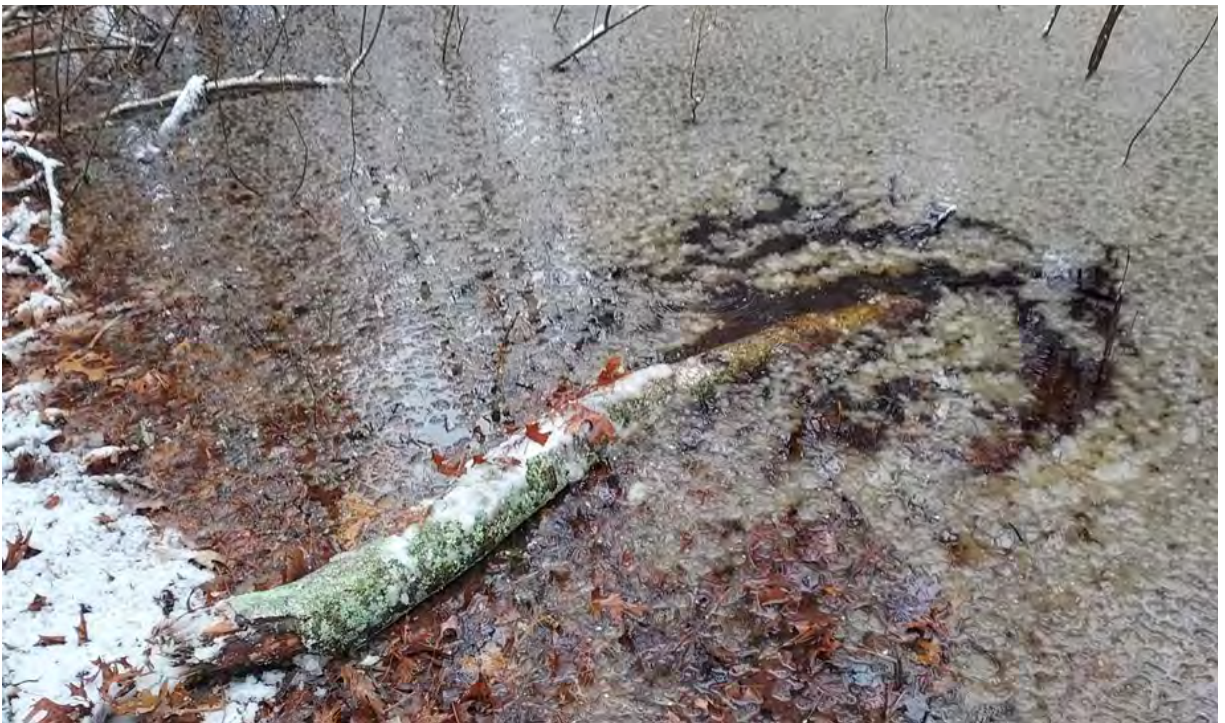
**Photo #12:** View of installed fallen log in vernal pool #10 in Impact Area 7. *Facing northwest.*

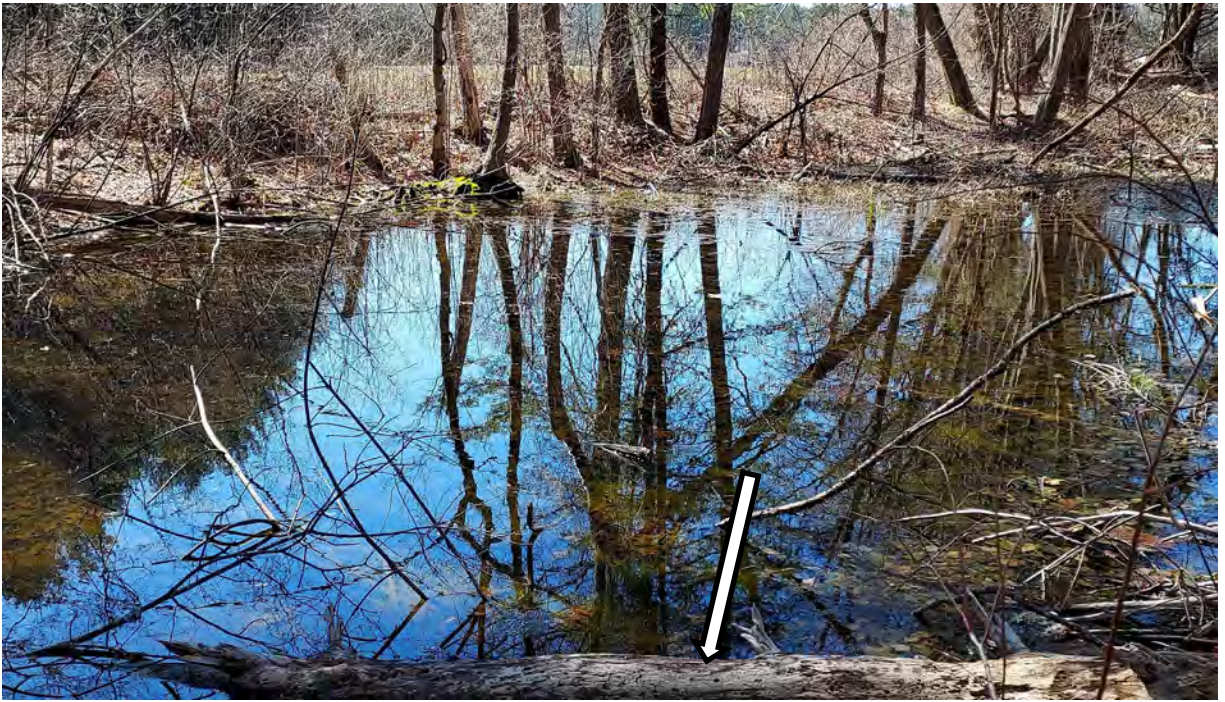
**Photo #15:** View of installed fallen log in vernal pool #6 in Impact Area 11. *Facing southeast.*

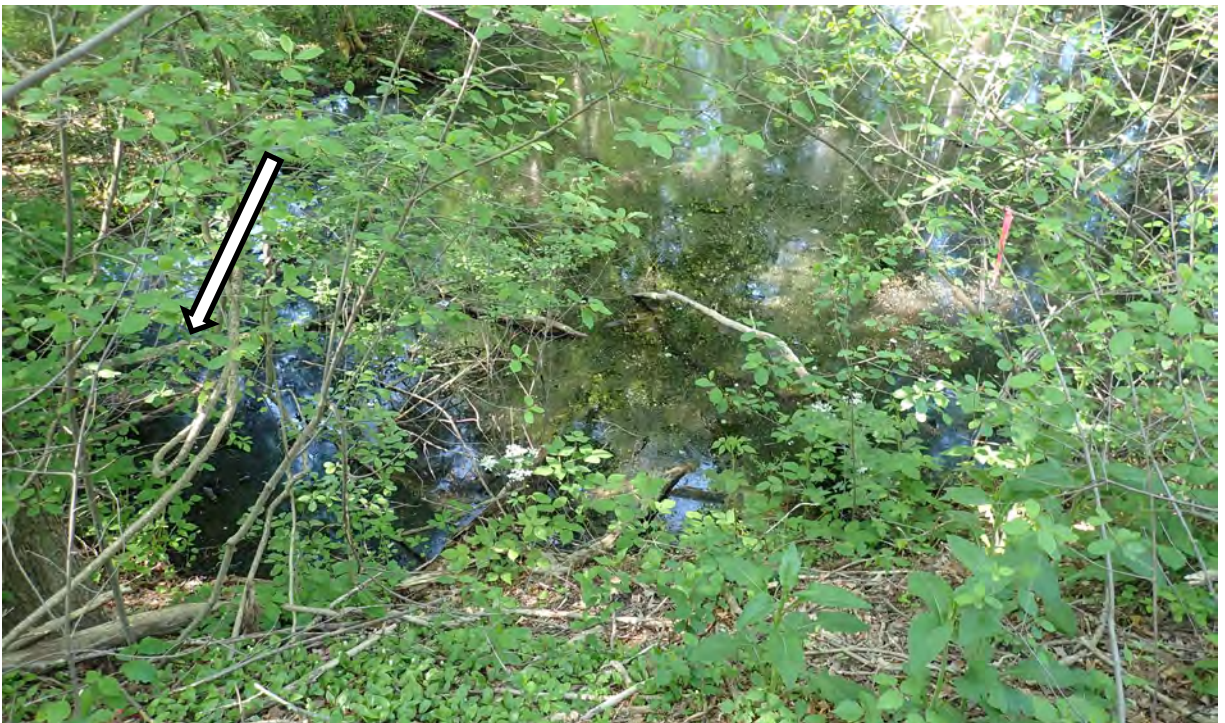
**Photo #16:** View of installed fallen log in vernal pool #6 in Impact Area 11. *Facing south.*

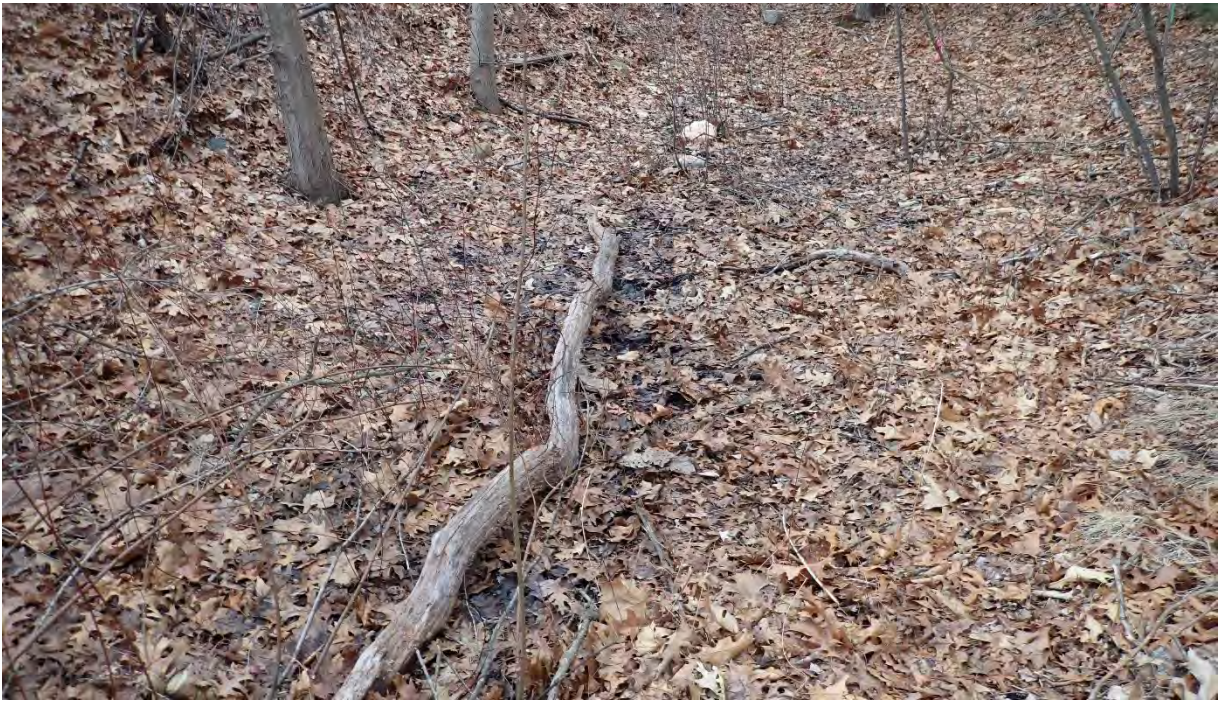
**Photo #17:** View of installed fallen log within resource area in Impact Area 12. *Facing south.*

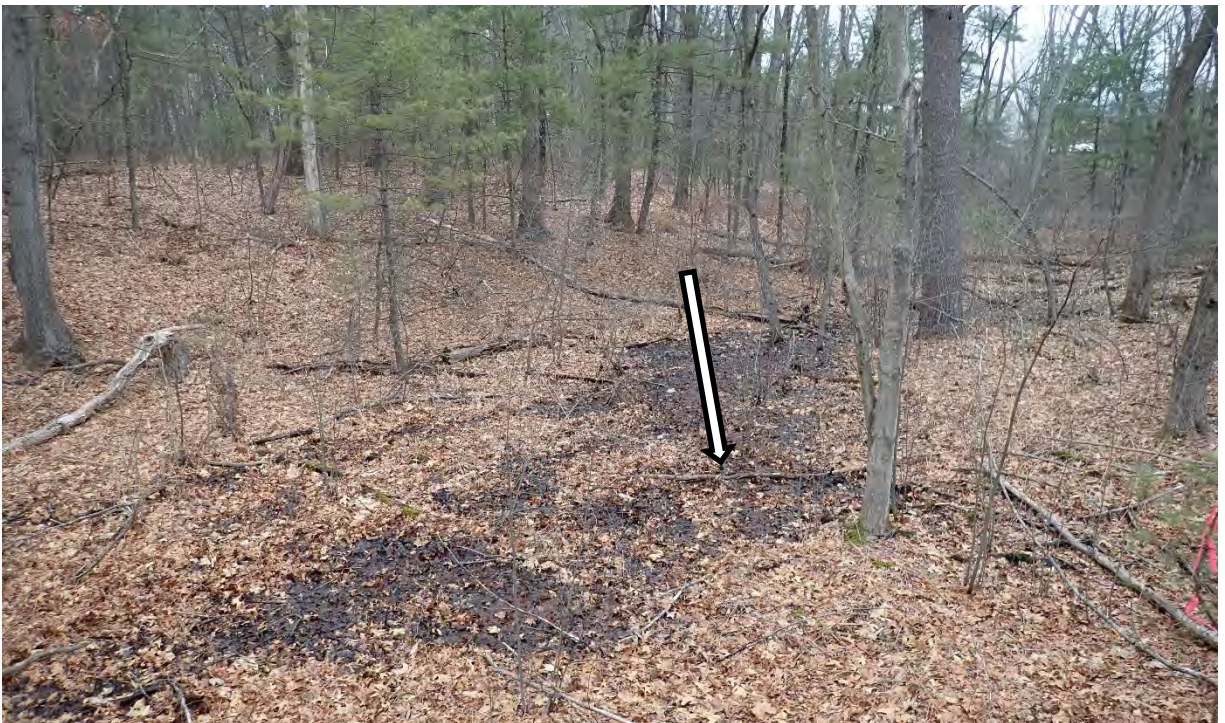
**Photo #18:** View of installed fallen log within resource area in Impact Area 12. *Facing north.*

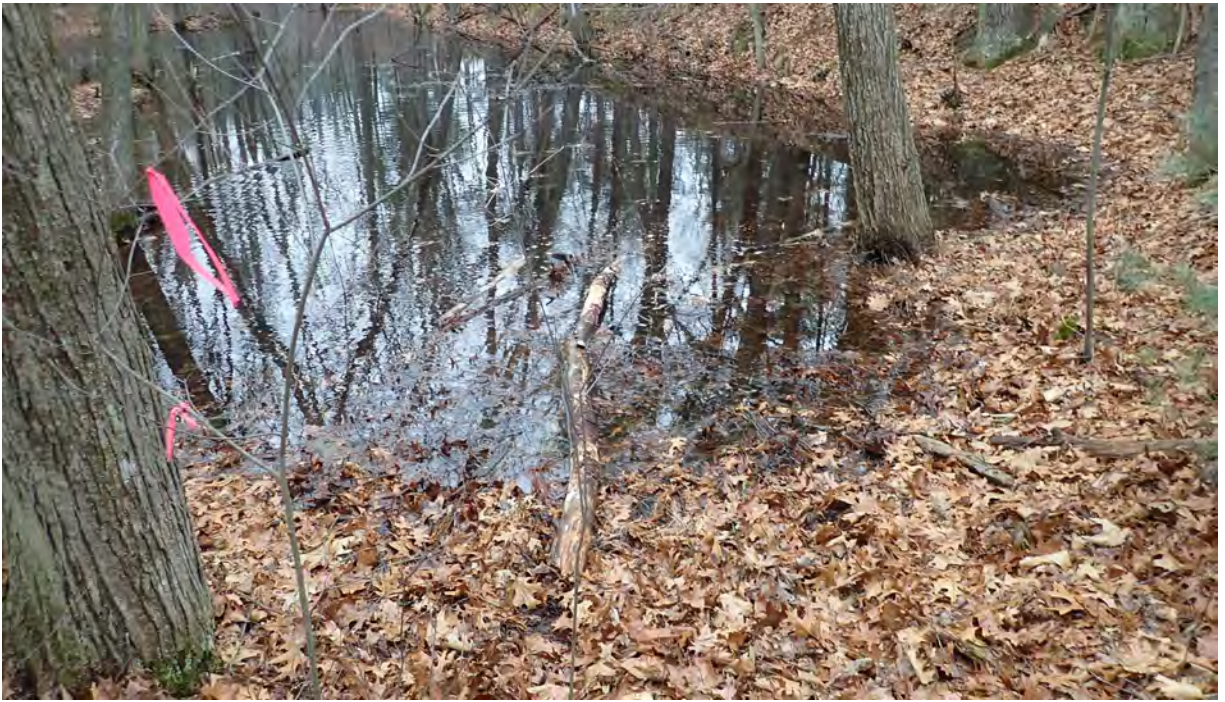
**Photo #21:** View of one of four fallen logs placed in vernal pool VP#5 in Impact Area 13. *Facing northwest.*

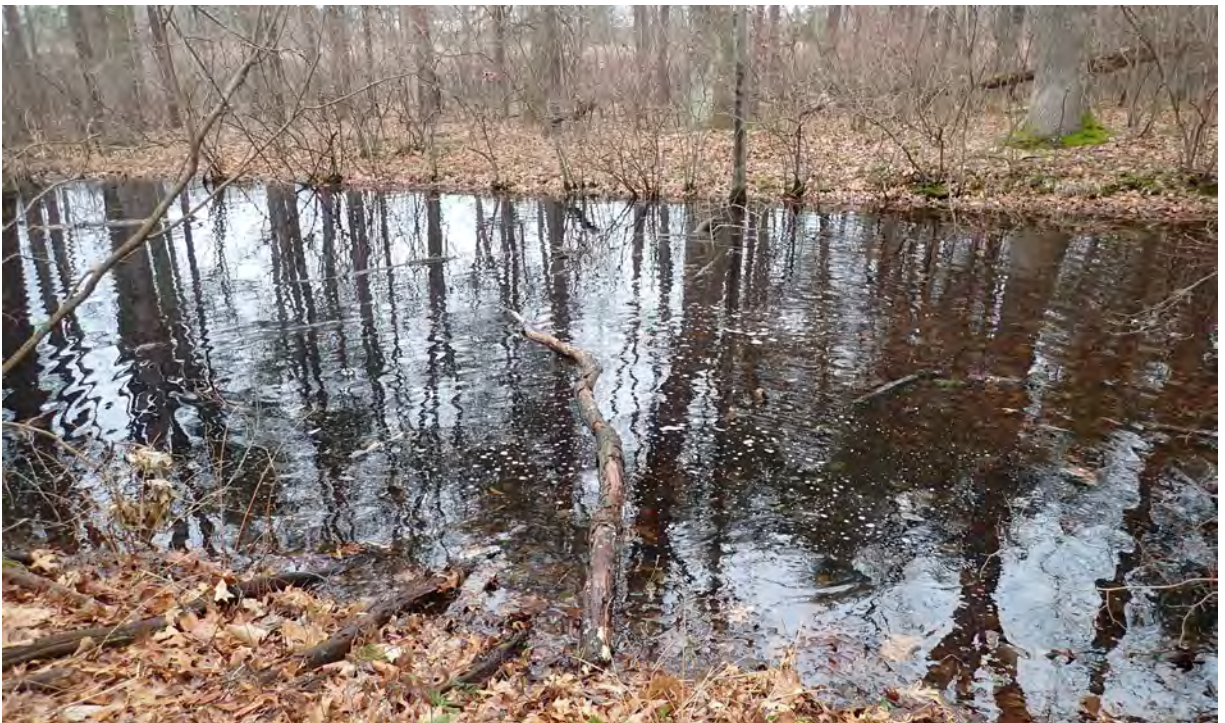
**Photo #22:** View of second fallen logs placed in vernal pool VP#5 in Impact Area 13. *Facing north.*

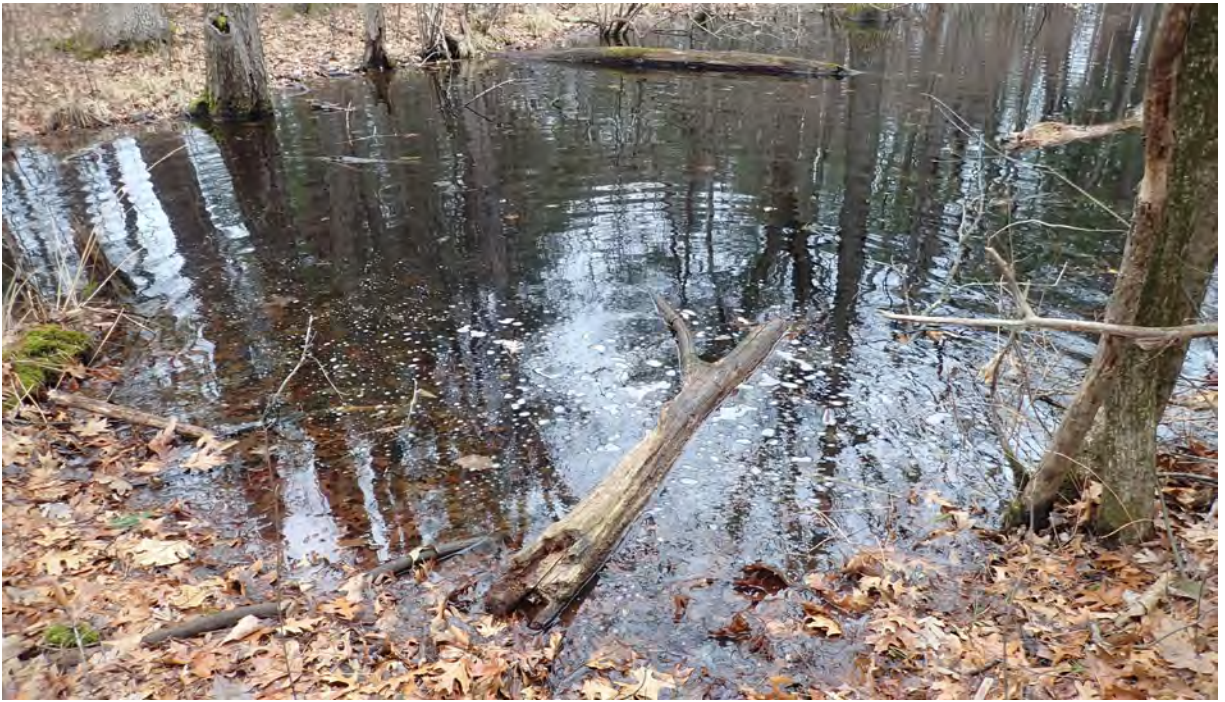
**Photo #23:** View of third fallen logs placed in vernal pool VP#5 in Impact Area 13. *Facing northeast.*

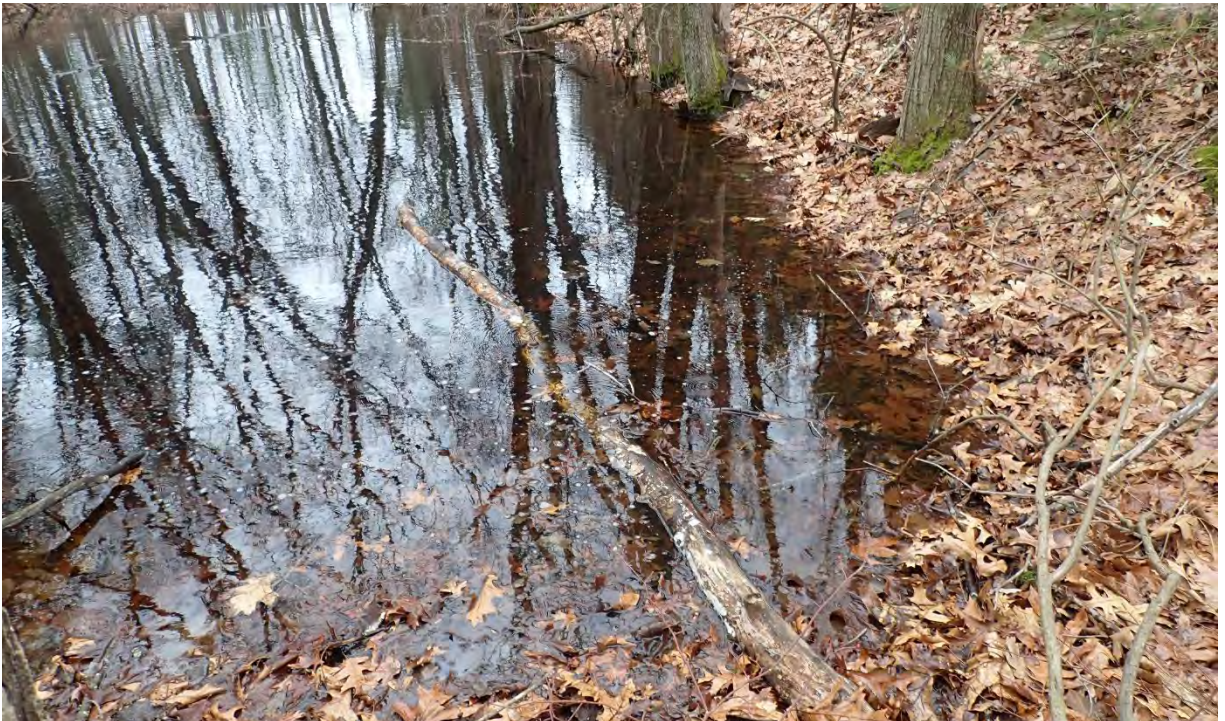
**Photo #24:** View of fourth fallen logs placed in vernal pool VP#5 in Impact Area 13. *Facing east.*

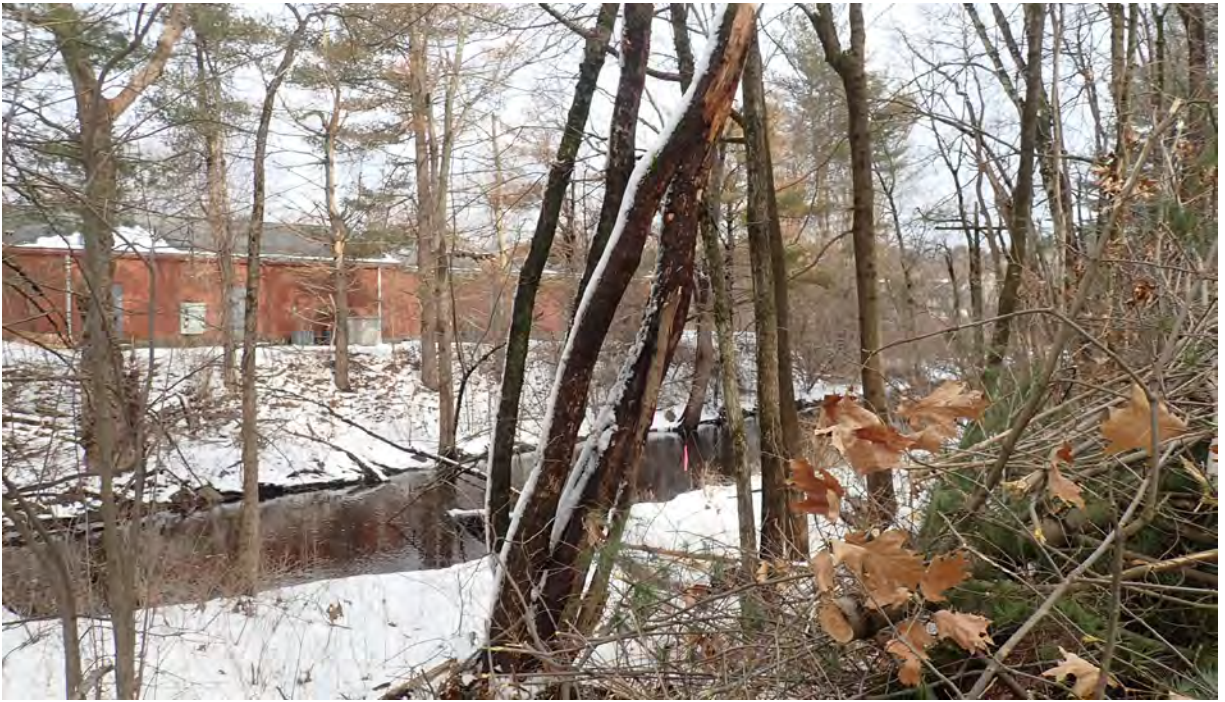
**Photo #25:** View of installed snag in Impact Area 16. Snag was placed upright. *Facing northeast.*

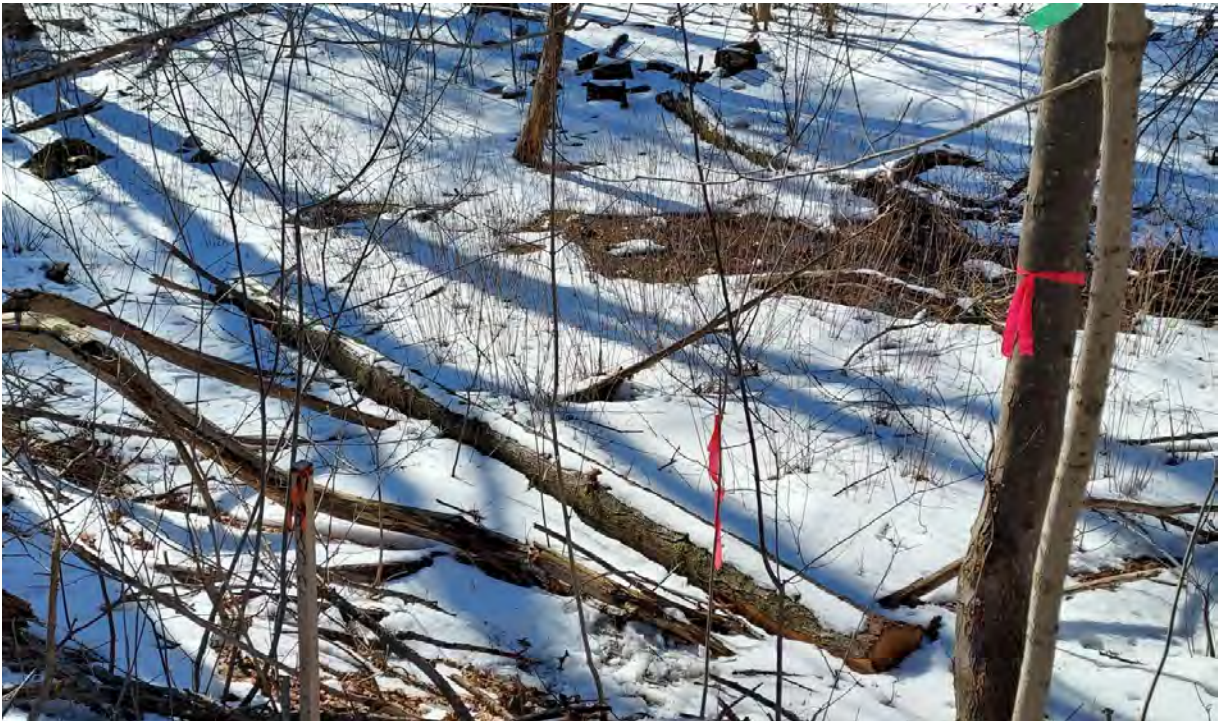
**Photo #26:** View of installed fallen log in Impact Area 16 within resource area. *Facing southeast.*

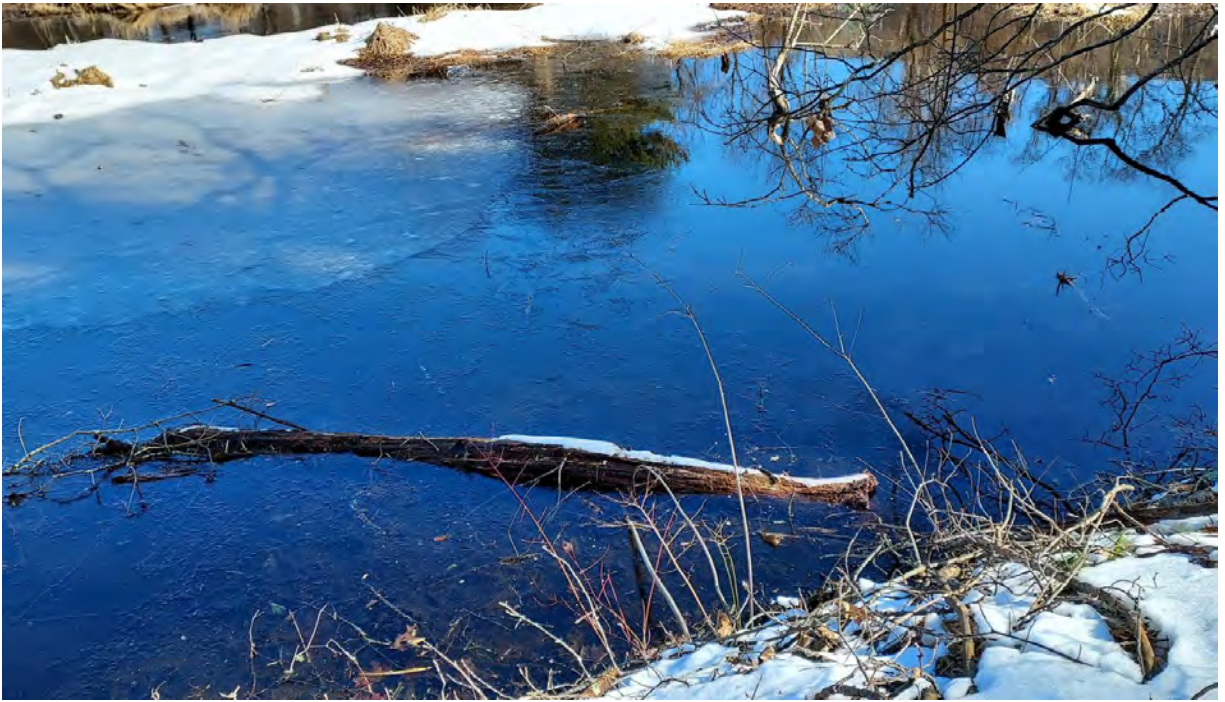
**Photo #27:** View of installed fallen log in Impact Area 16. *Facing northeast.*

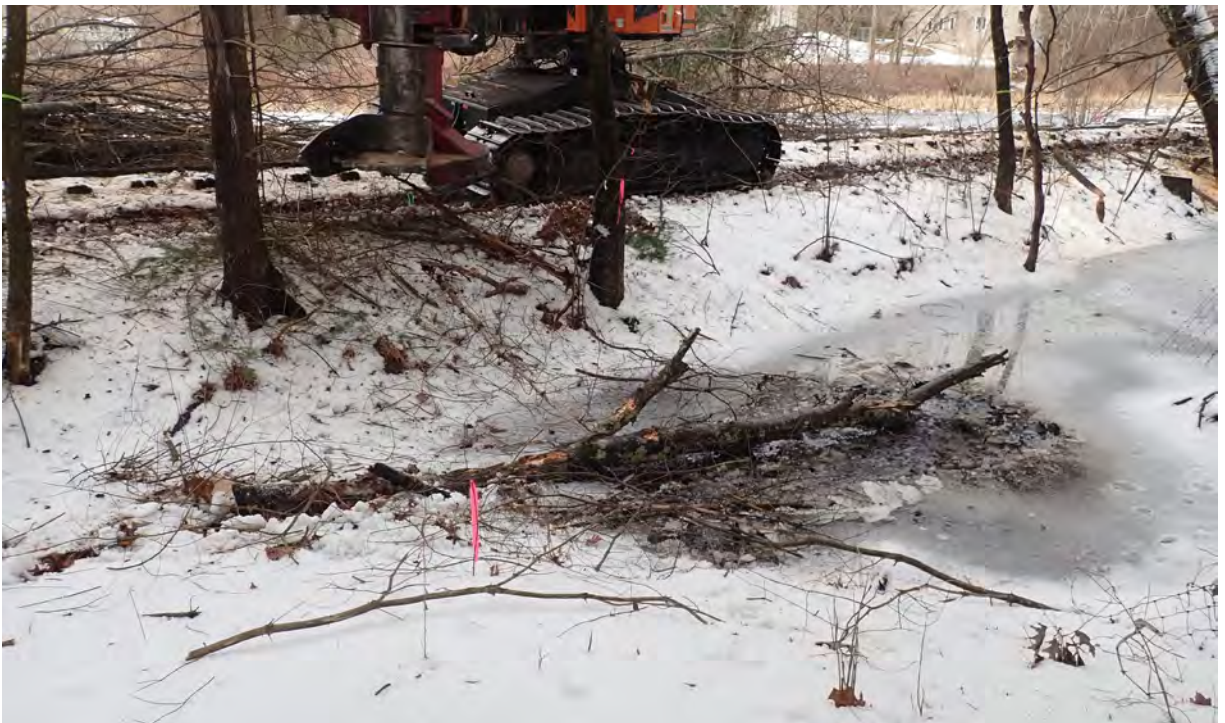
**Photo #28:** View of installed fallen log in Impact Area 16 near bridge crossing. *Facing northeast.*

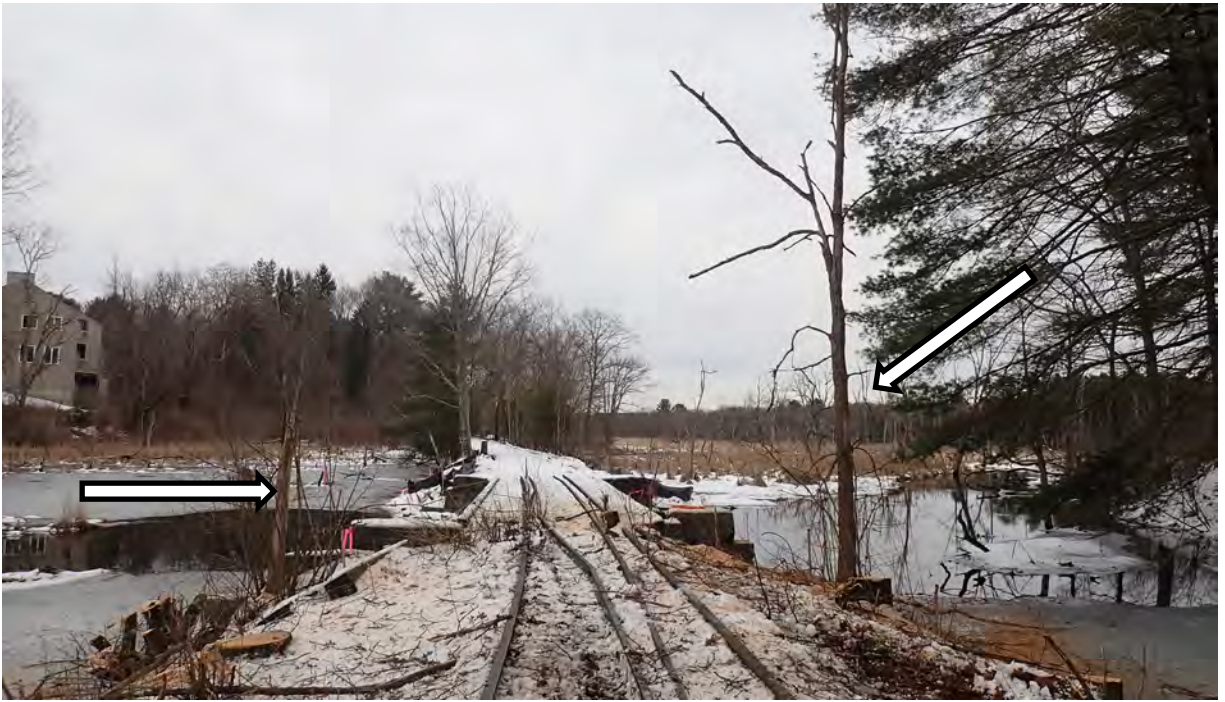
**Photo #29:** View of bridge crossing in Impact Area 17. Two snags (indicated with arrows) were saved and remain on either side of the bridge. *Facing east.*

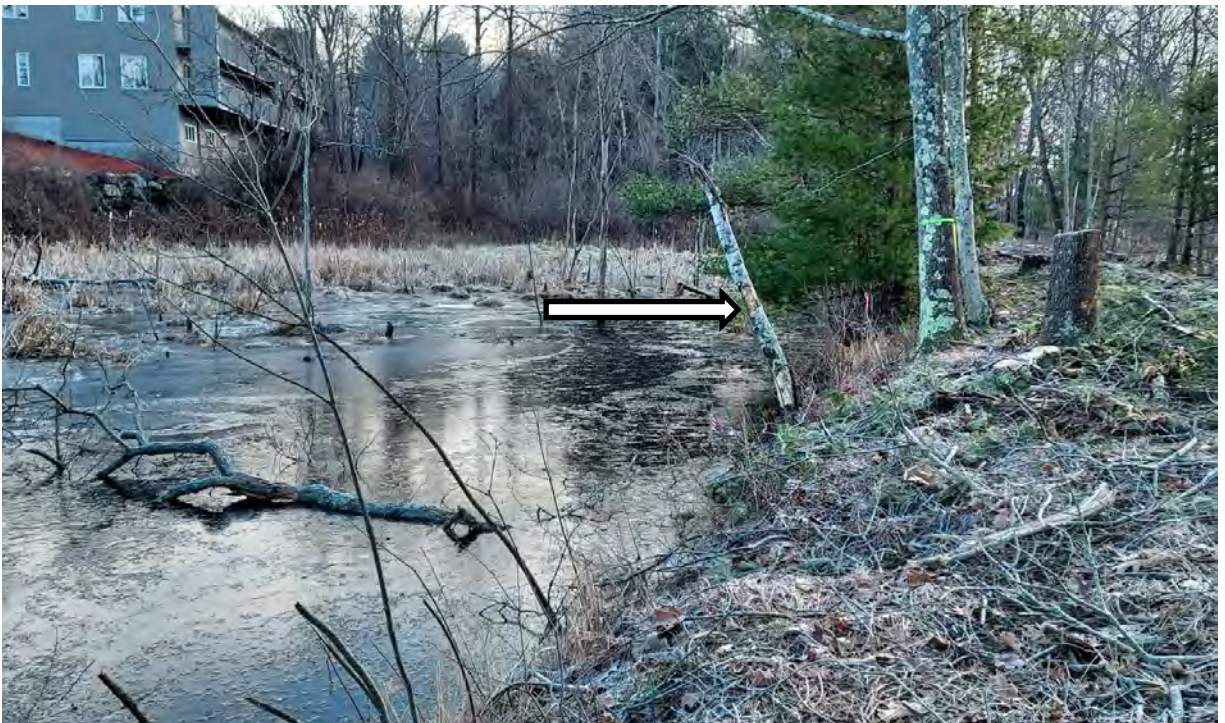
**Photo #30:** View of installed fallen log in Impact Area 18 near bridge crossing. One snag was saved and remains in place (indicated with arrow). *Facing northeast.*

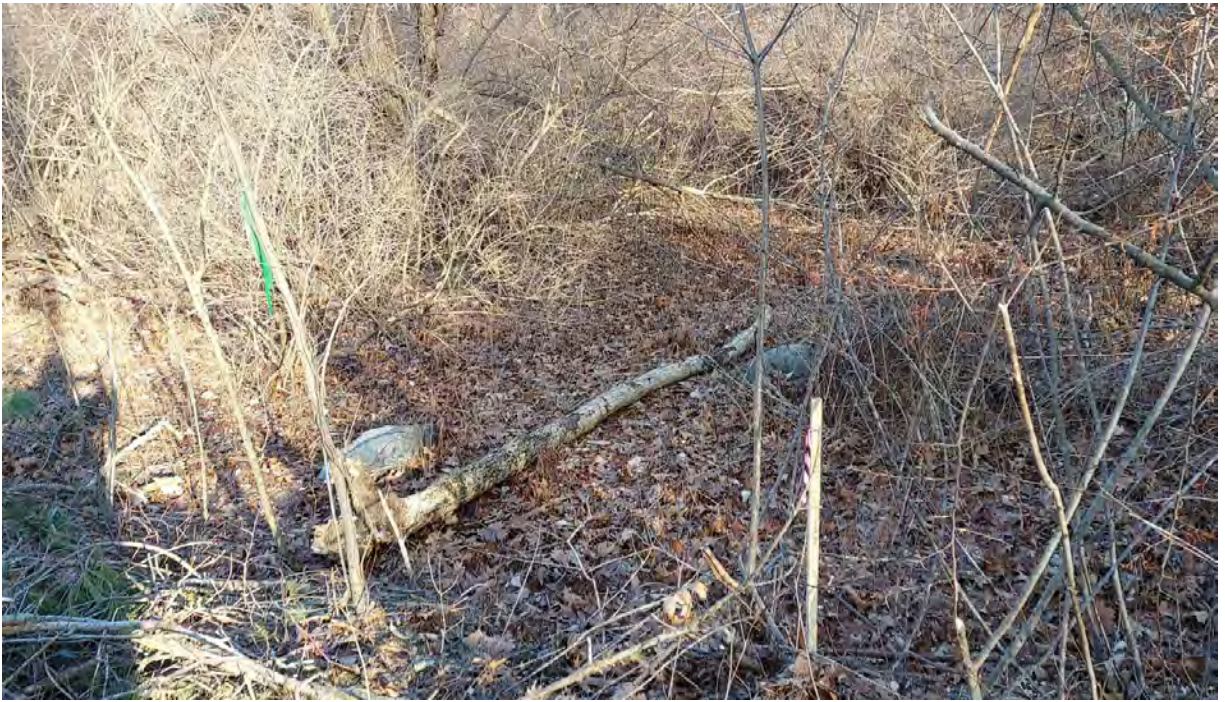
**Photo #31:** View of installed fallen log in Impact Area 19. *Facing north.*
