# Wildlife Habitat Features Report Eversource Sudbury to Hudson Transmission Reliability Project Sudbury, Massachusetts

DECEMBER 2022- MAY 2023

SWCA Project No. 67849

July 2023

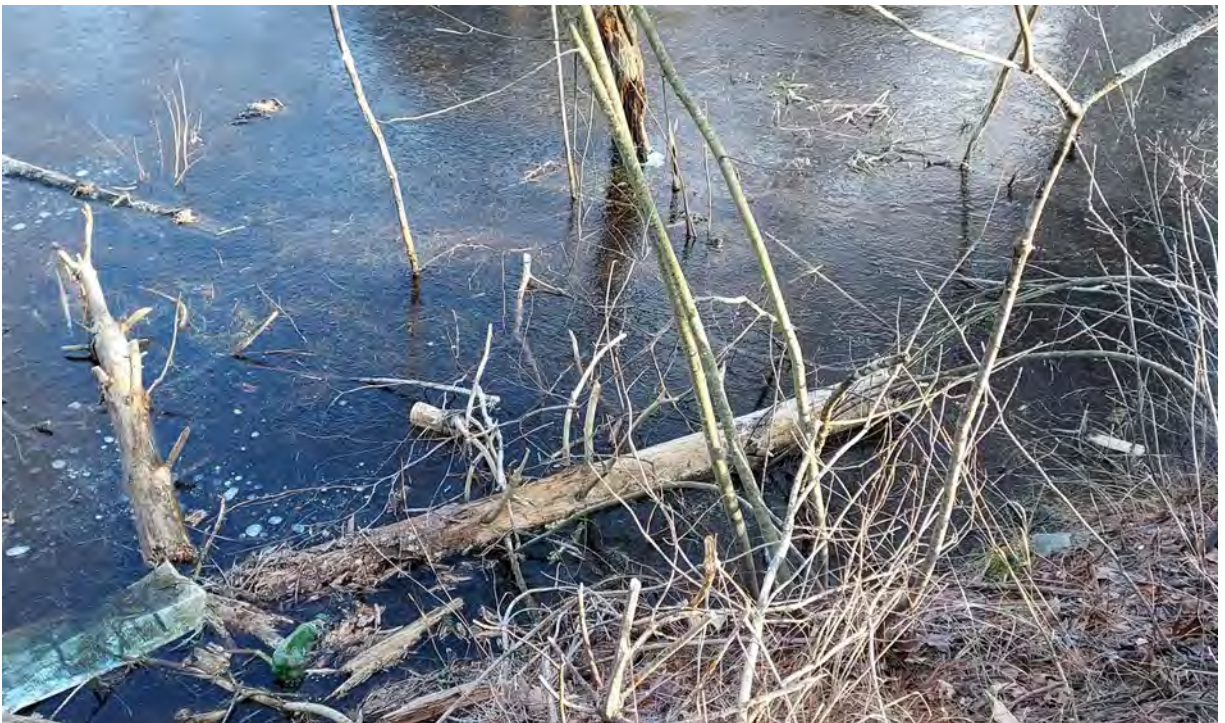
**Photo #32:** View of installed fallen log in Impact Area 19. *Facing northeast.*

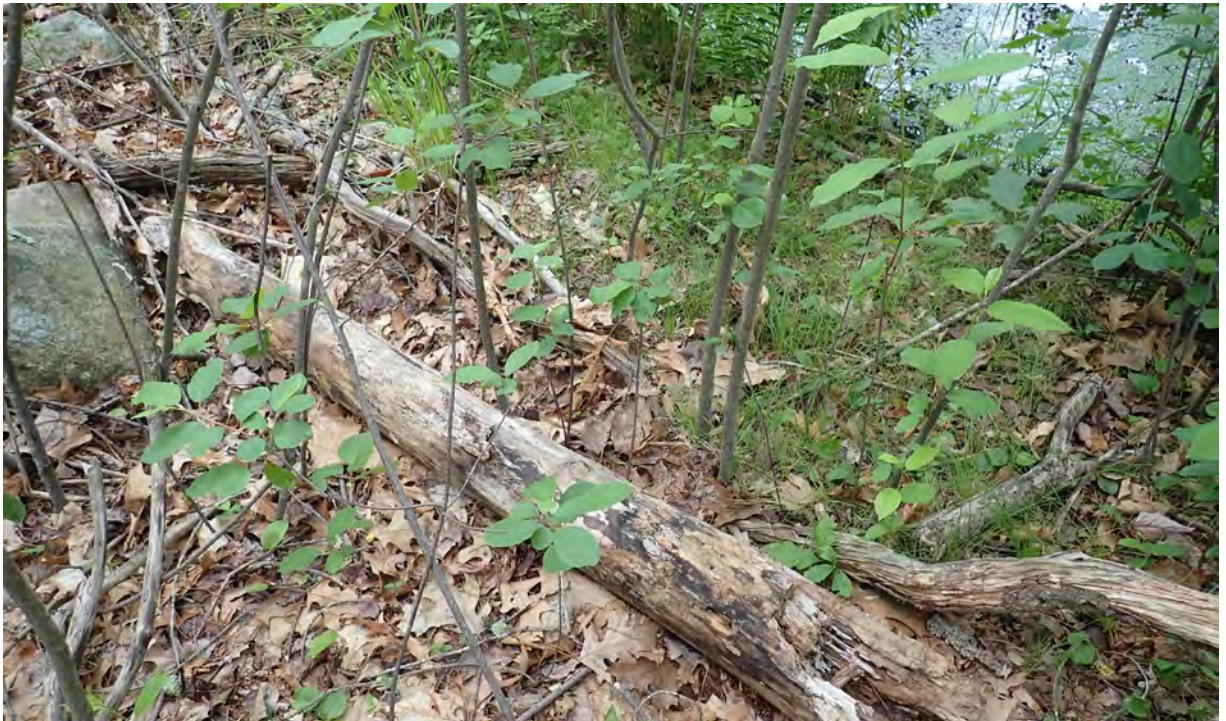
**Photo #34:** View of installed fallen log in Impact Area 19. *Facing southeast.*

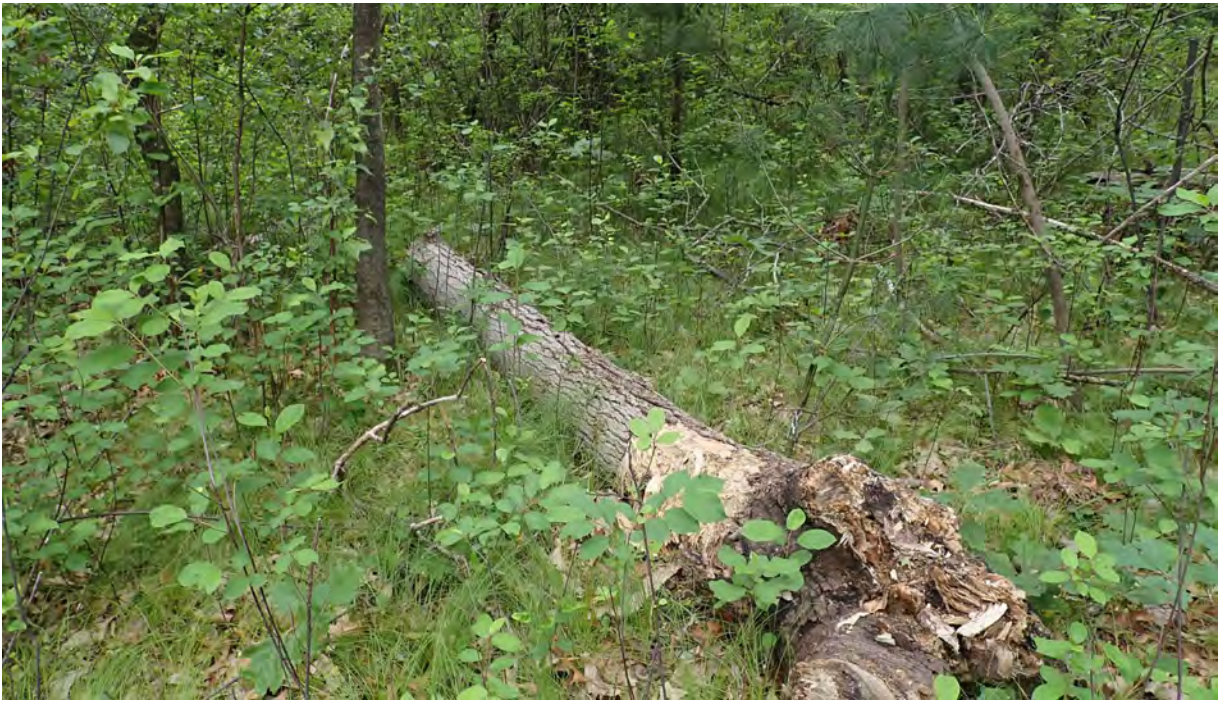
**Photo #35:** View of installed fallen log in Impact Area 19. *Facing southeast.*

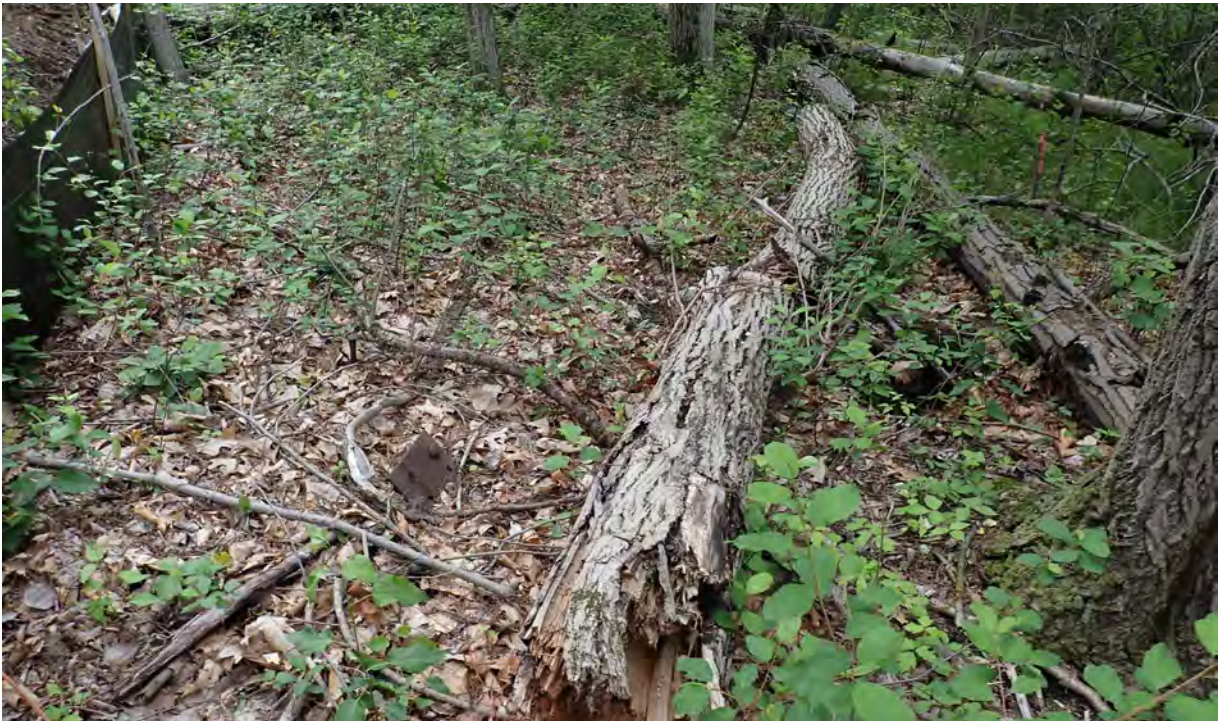
**Photo #36:** View of installed fallen log in Impact Area 19. *Facing southeast.*

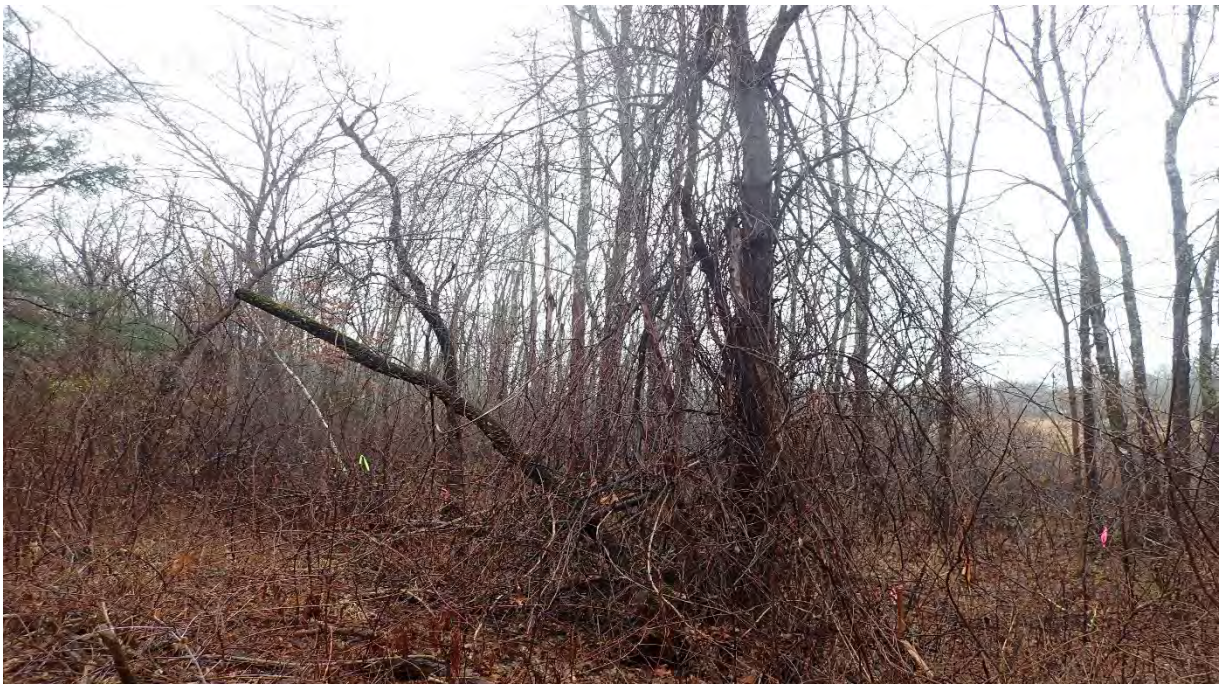
**Photo #37:** View of tree in Impact Area 19, at station 741+00, that is on the boundary of the work limit. The tree is engulfed with bittersweet vines. The vines could not be removed without also removing the tree. Tree was reviewed with by the Conservation Agent, who agreed it should be removed. *Facing south.*

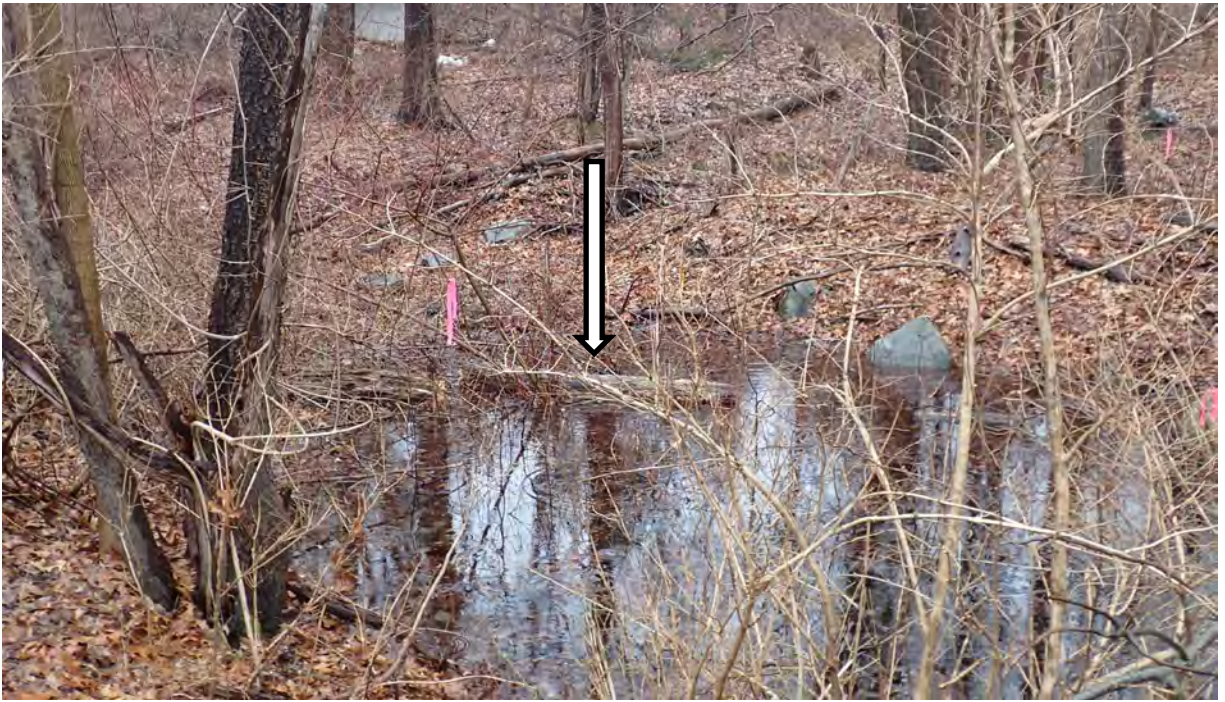
**Photo #39:** View of fallen log placement in vernal pool VP#3 in Impact Area 19. *Facing northwest.*

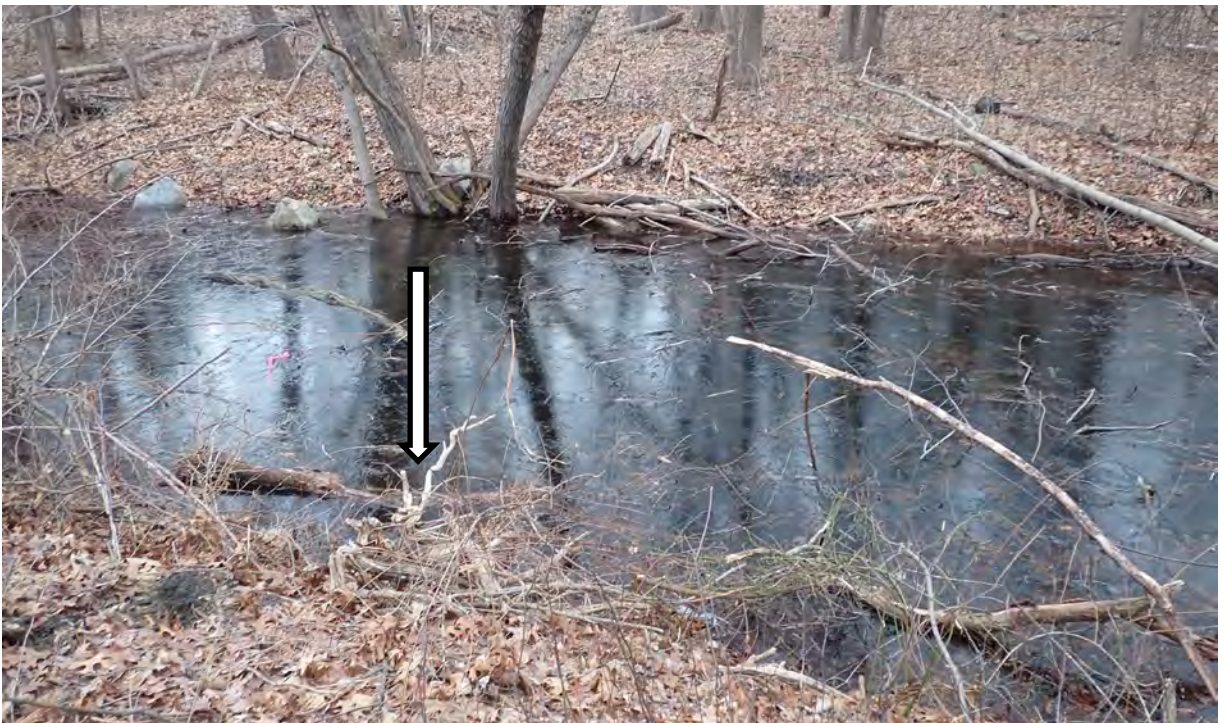
**Photo #40:** View of fallen log placement in vernal pool VP#3 in Impact Area 19. *Facing north.*

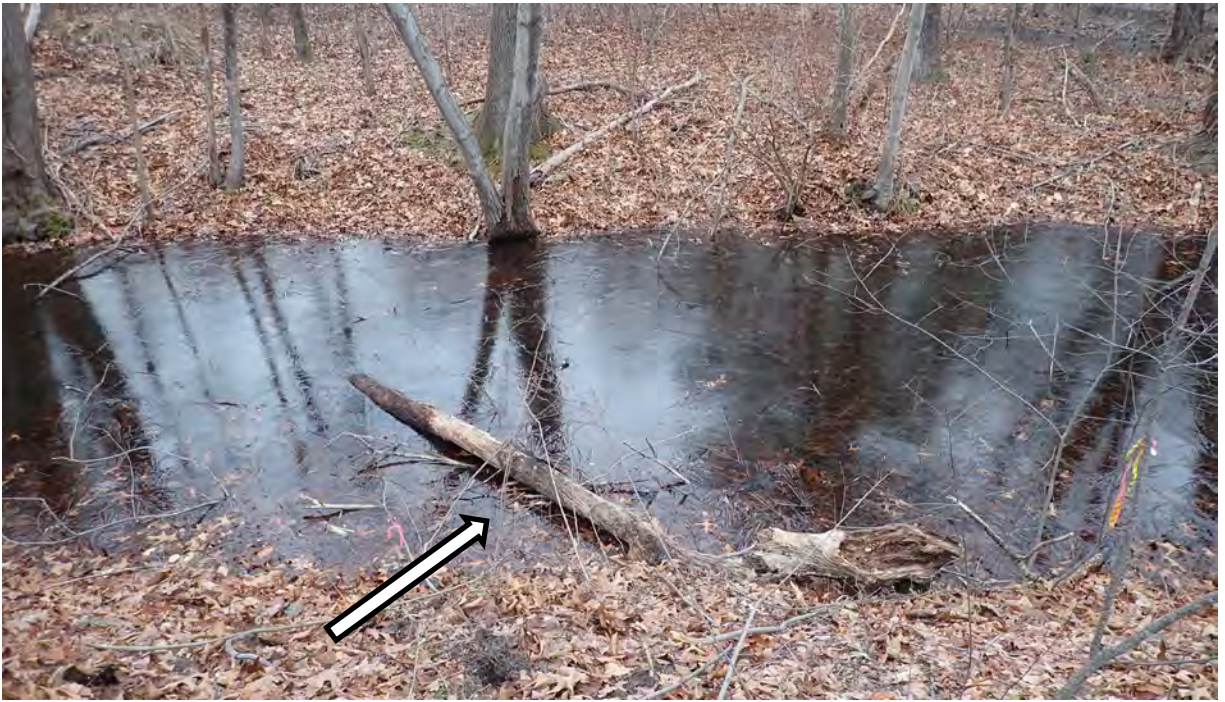
**Photo #41:** View of installed fallen log placement in VP2 in Impact Area 19. *Facing north.*

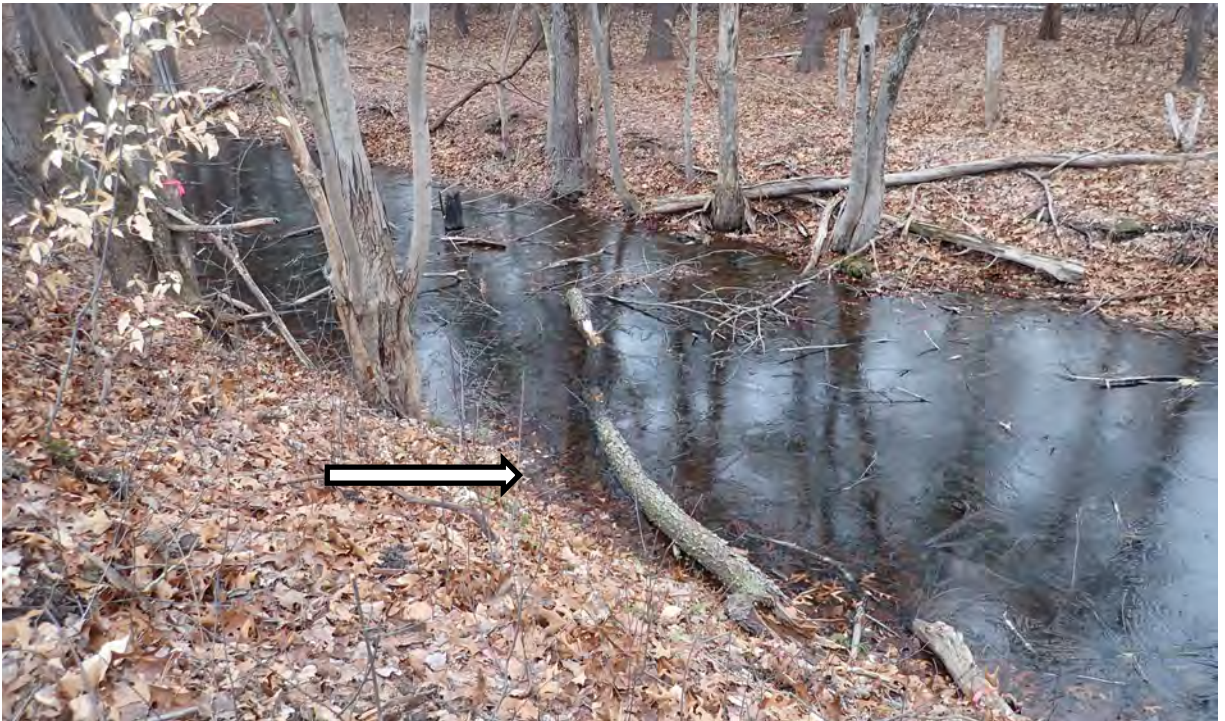
**Photo #42:** View of installed fallen log placement in VP2 in Impact Area 19. *Facing northwest.*

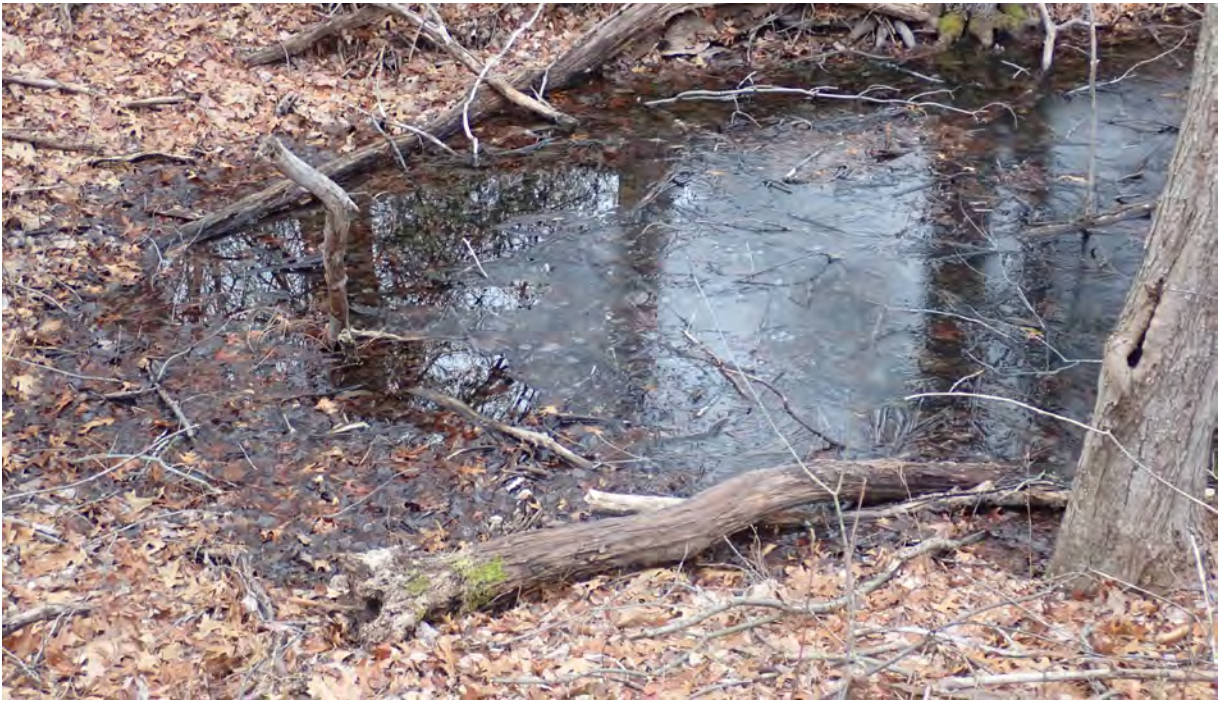
**Photo #43:** View of installed fallen log placement in VP2 in Impact Area 19 . *Facing northeast.*

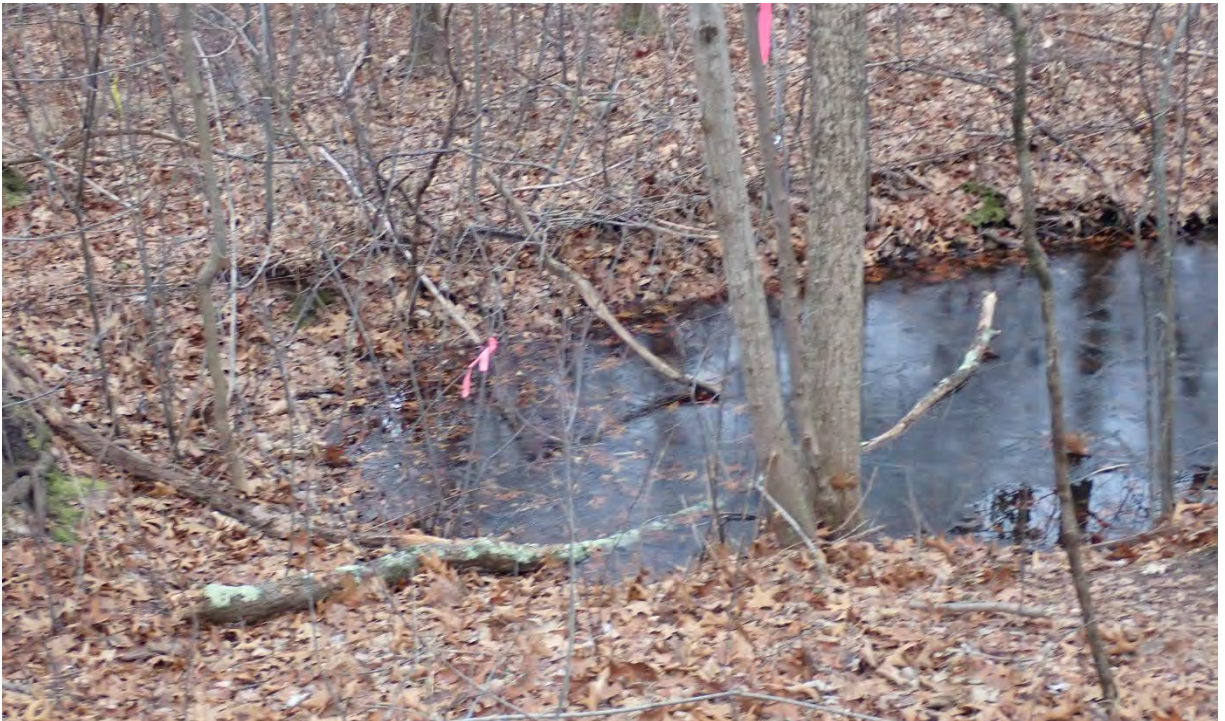
**Photo #44:** View of installed fallen log placement in VP4 in Impact Area 19 . *Facing south.*

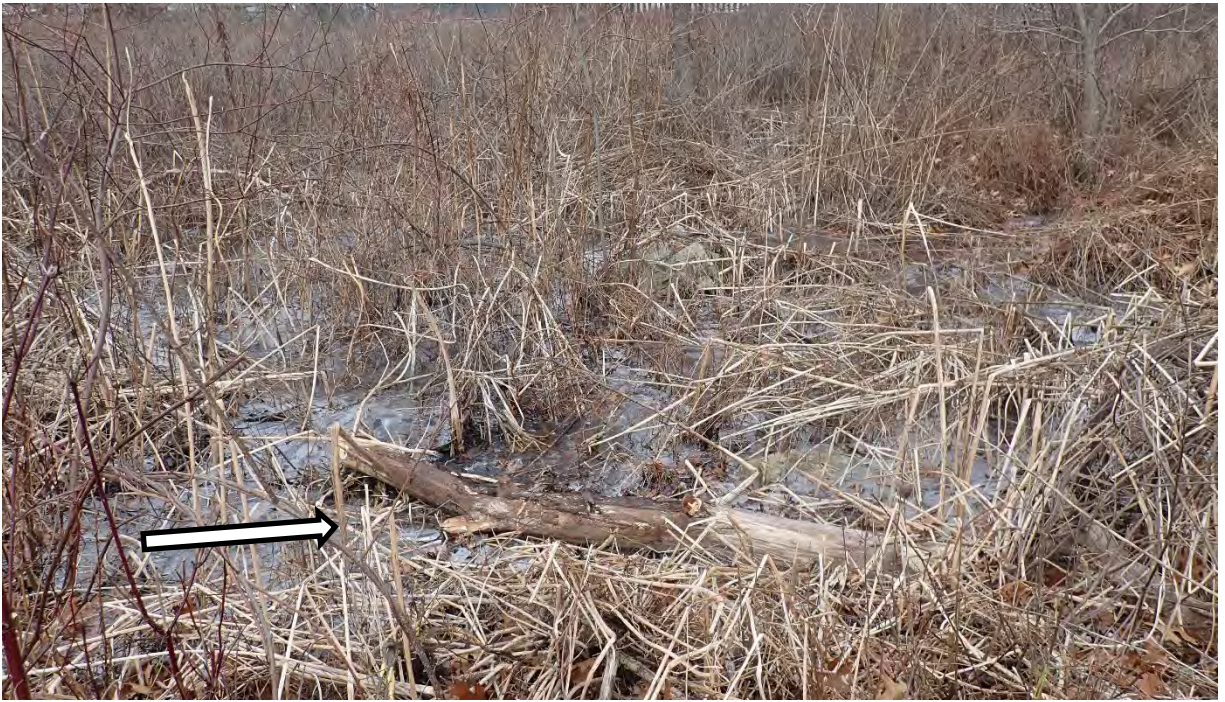
**Photo #45:** View of installed fallen log placed in vernal pool VP1, in Impact Area 20. An existing snag was used and placed along the edge of the vernal pool, extending into the water. *Facing north.*

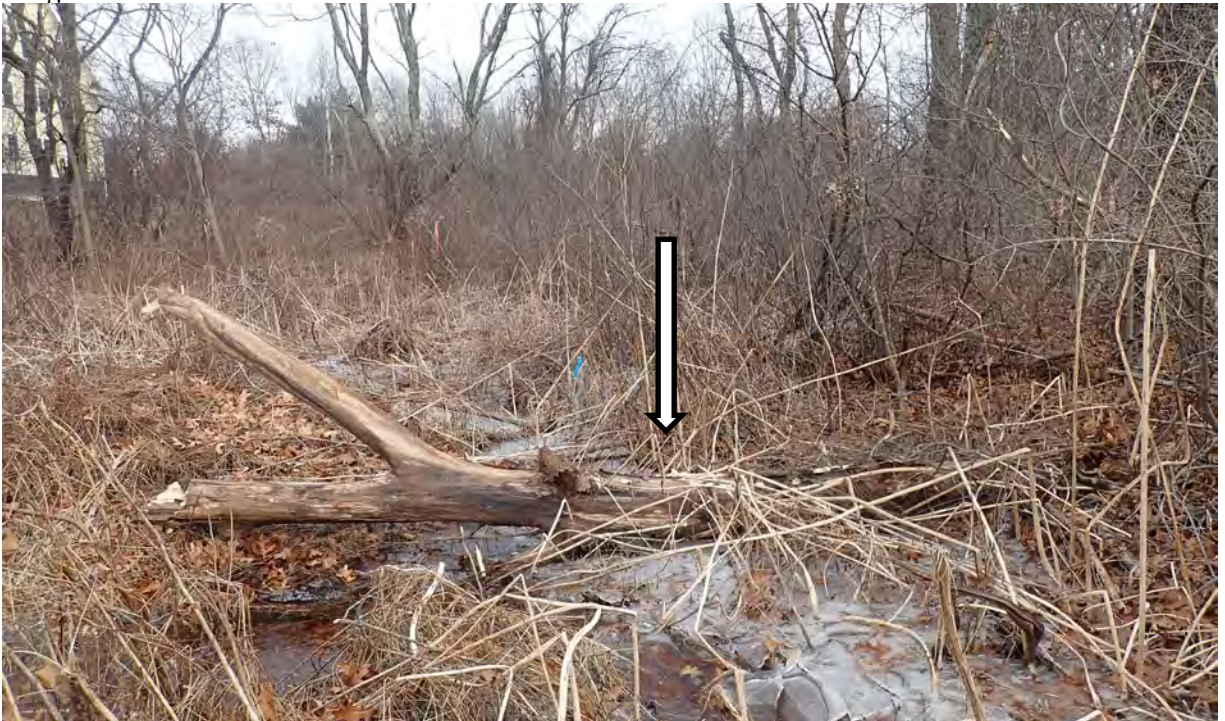
**Photo #46:** View of installed fallen log placed in vernal pool VP1 in Impact Area 20. An existing snag was used as a fallen log. *Facing northeast.*

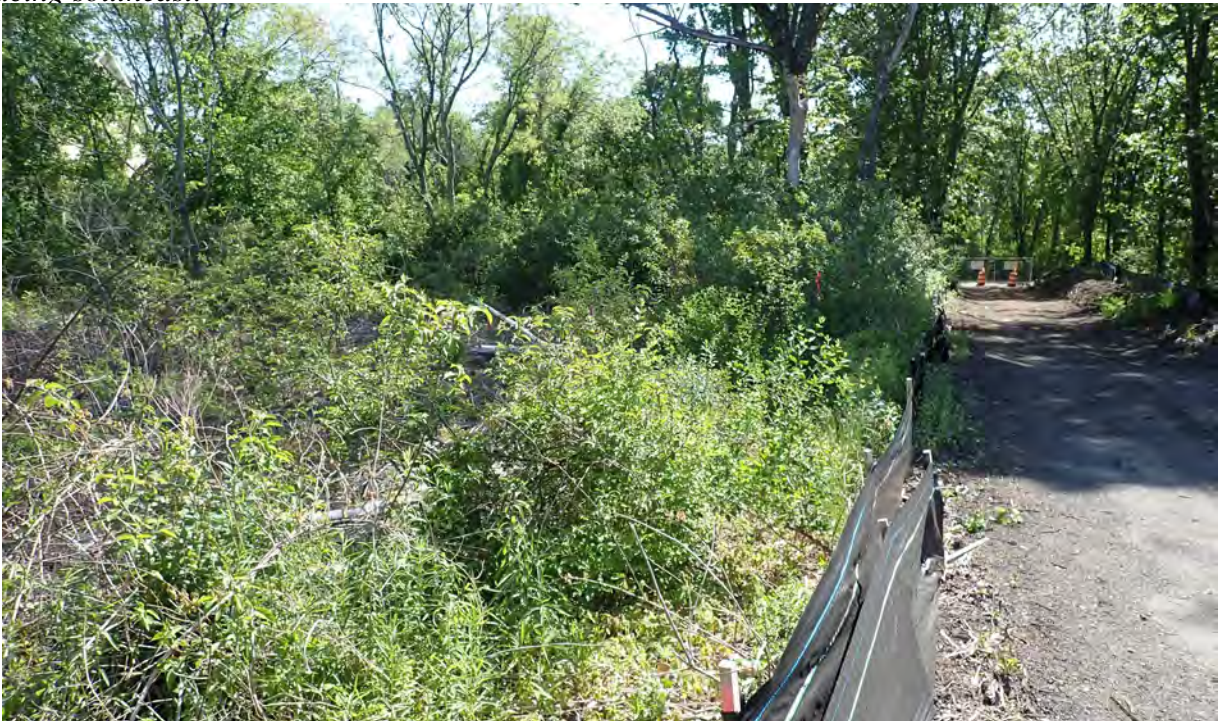
**Photo #4:** View of vernal pool #15 in Segment 14. Silt fence in good condition. No sediment or debris observed in the resource area or associated buffer zone. *Facing east.*
