Weekly Environmental Compliance Summary

Sudbury to Hudson Transmission Reliability Project (USEPA Tracking # MAR1003UW)

Week of: October 9, 2023 to October 13, 2023

CONSTRUCTION MONITORING REPORT

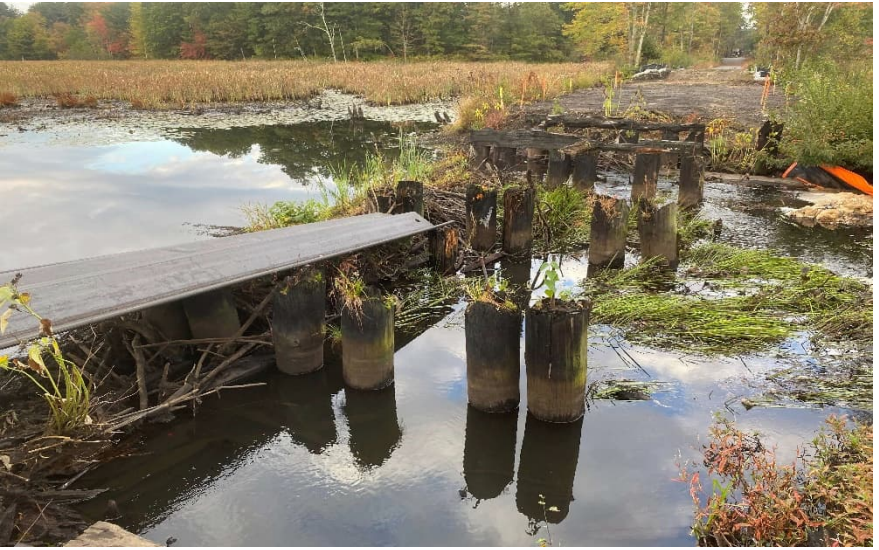
PHOTOGRAPHIC LOG	
Client Name: Eversource		Site Location: Sudbury to Hudson Transmission Reliability Project	Town: Hudson
Photo No.: 2	Date: 10-10-23

Description: Work area across Bridge 130/Fort Meadow Brook toward segment 2, looking westward.

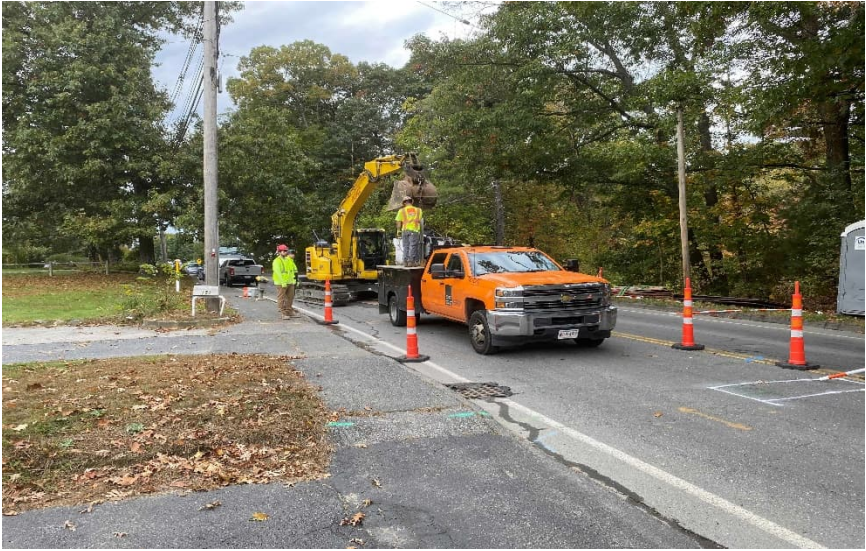
PHOTOGRAPHIC LOG	
Client Name: Eversource		Site Location: Sudbury to Hudson Transmission Reliability Project	Town: Hudson
Photo No.: 3	Date: 10-10-23

Description: Work area within Forest Avenue, conduit work (Jim's crew), looking northward.

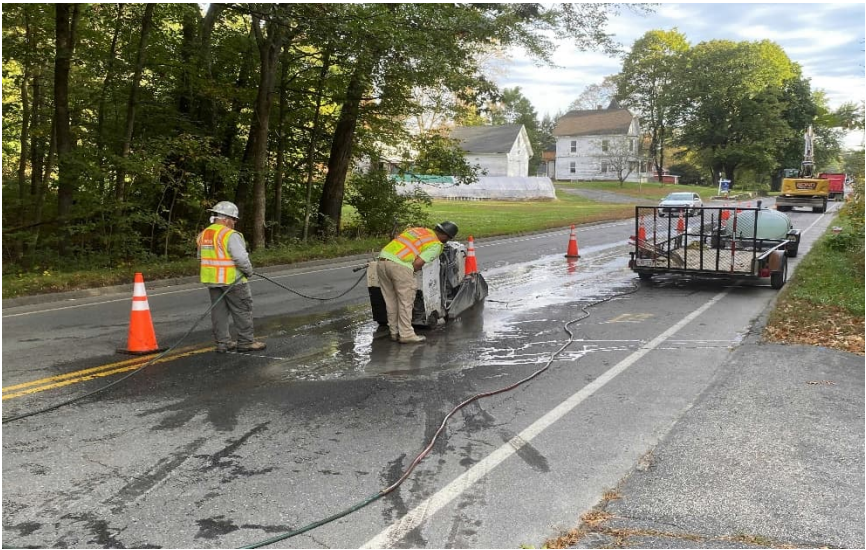
PHOTOGRAPHIC LOG	
Client Name: Eversource		Site Location: Sudbury to Hudson Transmission Reliability Project	Town: Hudson
Photo No.: 4	Date: 10-10-23

Description: Work area within Forest Avenue, conduit work (Oscar's crew), looking southward.

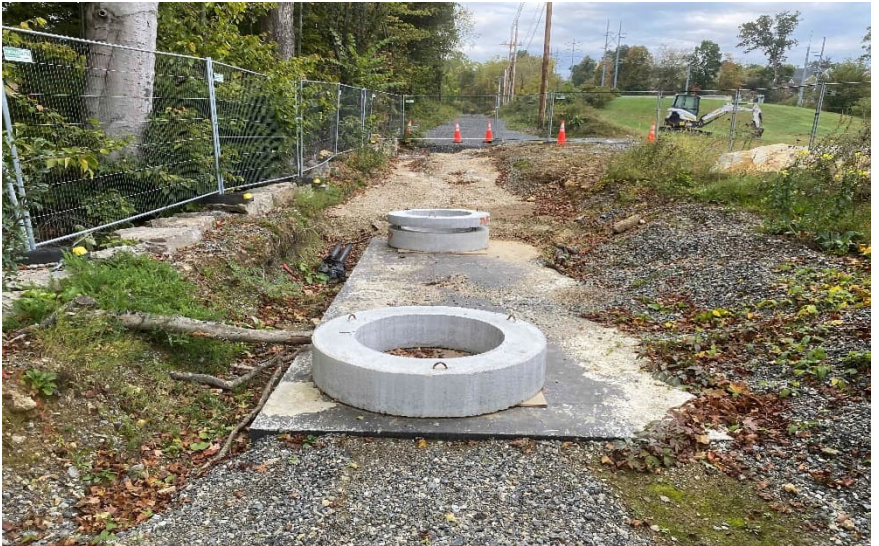
PHOTOGRAPHIC LOG	
Client Name: Eversource		Site Location: Sudbury to Hudson Transmission Reliability Project	Town: Hudson
Photo No.: 6	Date: 10-10-23

Description: Manhole #1, looking eastward.

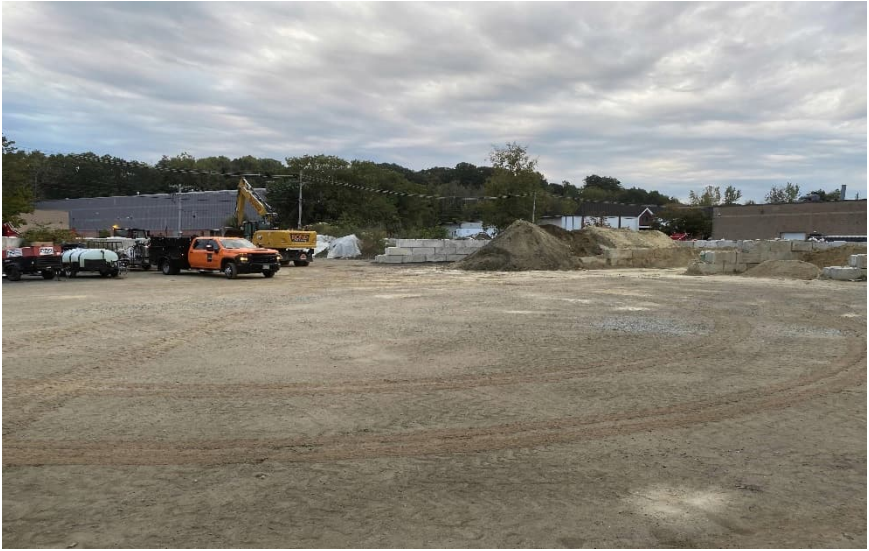
PHOTOGRAPHIC LOG	
Client Name: Eversource		Site Location: Sudbury to Hudson Transmission Reliability Project	Town: Hudson
Photo No.: 7	Date: 10-10-23

Description: Bonazzoli laydown yard, looking westward.

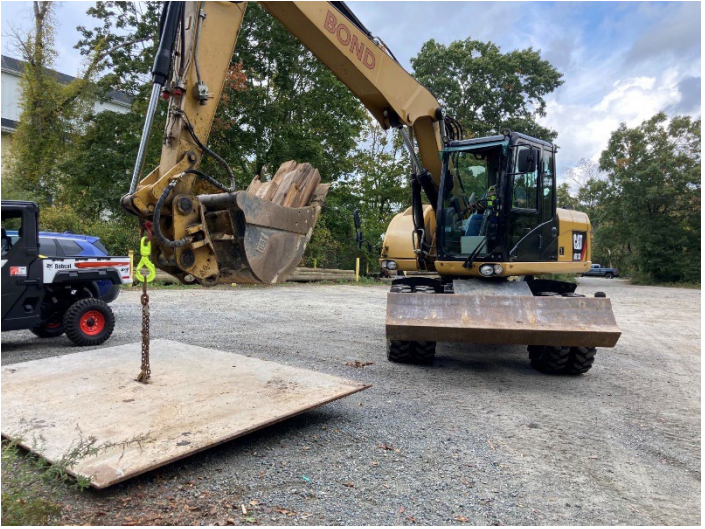
<p align="right">PHOTOGRAPHIC LOG</p>	
<p>Client Name: Eversource</p>		<p>Site Location: Sudbury to Hudson Transmission Reliability Project</p>	<p>Town: Sudbury</p>
<p>Photo No.: 2</p>	<p>Date: 10/10/2023</p>

<p>Description: View of Bond conducting site work at substation/segment 14. Facing northwest.</p>

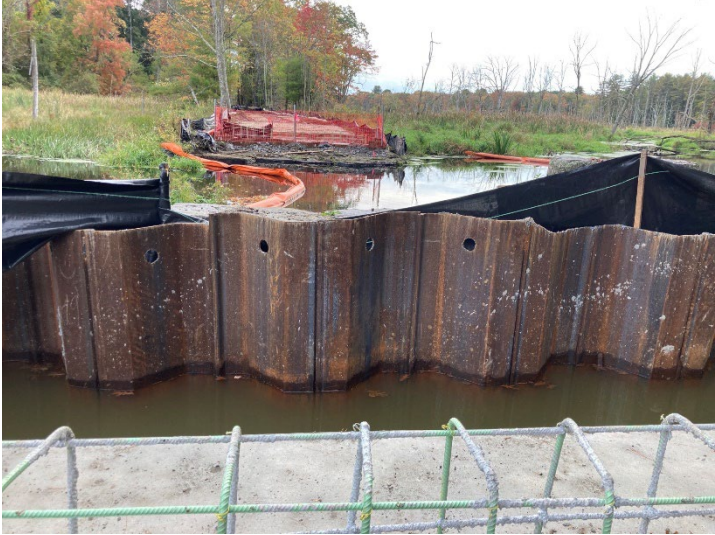
<p>PHOTOGRAPHIC LOG</p>	
<p>Client Name: Eversource</p>		<p>Site Location: Sudbury to Hudson Transmission Reliability Project</p>	<p>Town: Sudbury</p>
<p>Photo No.: 3</p>	<p>Date: 10/10/2023</p>

<p>Description: View of bridge 127. Work is paused in this area. Facing east.</p>

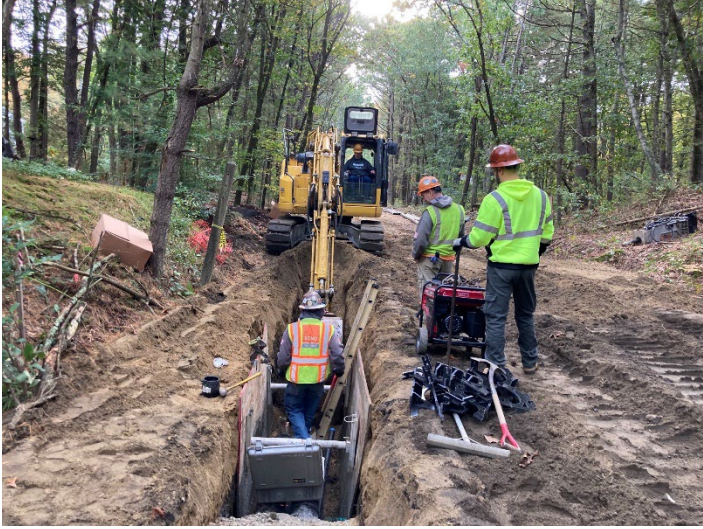
<p align="right">PHOTOGRAPHIC LOG</p>	
<p>Client Name: Eversource</p>		<p>Site Location: Sudbury to Hudson Transmission Reliability Project</p>	<p>Town: Sudbury</p>
<p>Photo No.: 5</p>	<p>Date: 10/10/2023</p>

<p>Description: View of Bond installing conduit in segment 9. Facing east.</p>

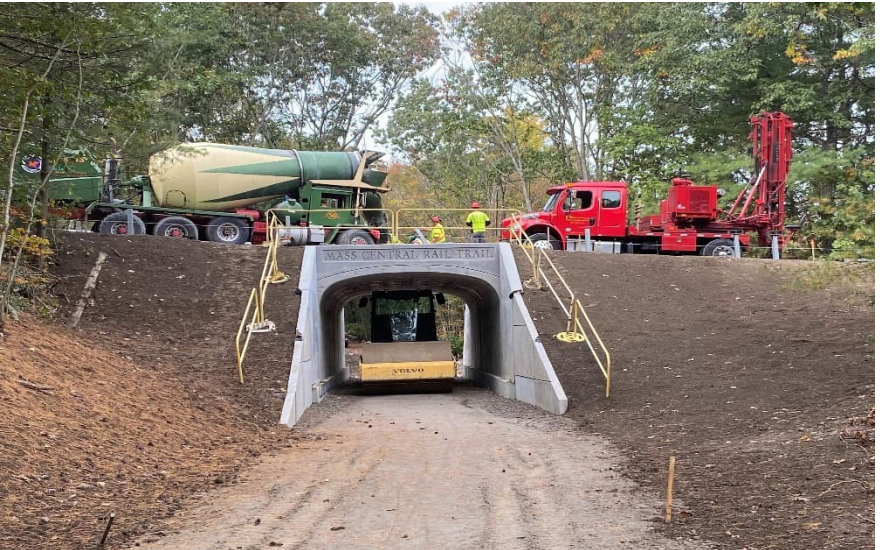
PHOTOGRAPHIC LOG	
Client Name: Eversource		Site Location: Sudbury to Hudson Transmission Reliability Project	Town: Hudson
Photo No.: 2	Date: 10-11-23

Description: Work area across Chestnut Street crossing from segment 2, looking westward.

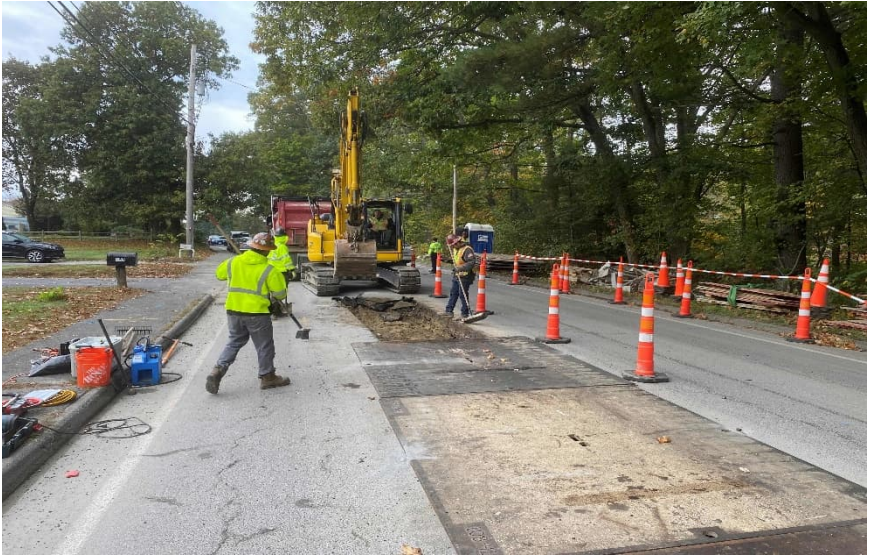
PHOTOGRAPHIC LOG	
Client Name: Eversource		Site Location: Sudbury to Hudson Transmission Reliability Project	Town: Hudson
Photo No.: 3	Date: 10-11-23

Description: Work area within Forest Avenue, conduit work (Jim's crew), looking southward.

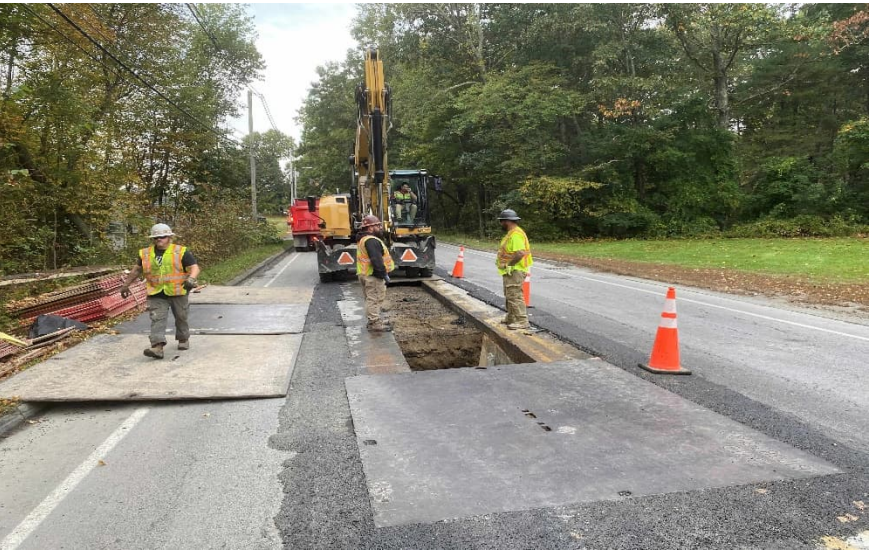
PHOTOGRAPHIC LOG	
Client Name: Eversource		Site Location: Sudbury to Hudson Transmission Reliability Project	Town: Hudson
Photo No.: 4	Date: 10-11-23

Description: Work area within Forest Avenue, conduit work (Oscar's crew), looking southward.

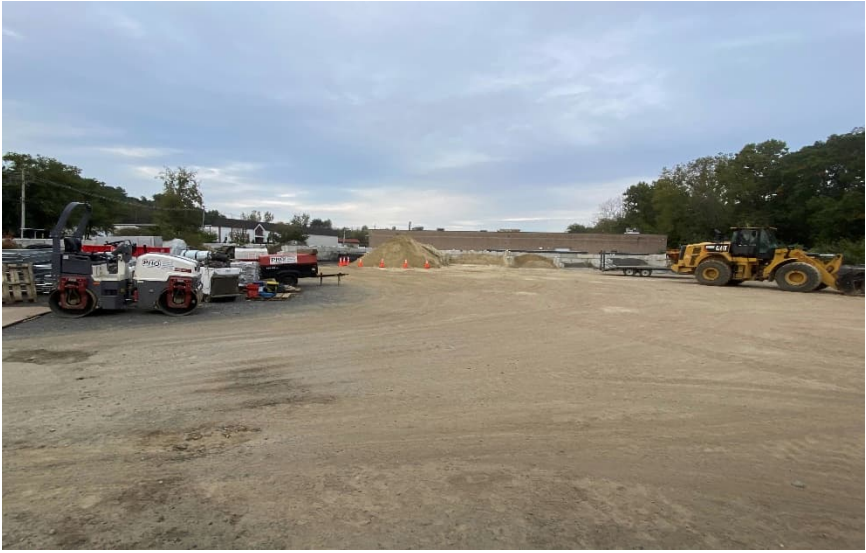
PHOTOGRAPHIC LOG	
Client Name: Eversource		Site Location: Sudbury to Hudson Transmission Reliability Project	Town: Hudson
Photo No.: 7	Date: 10-11-23

Description: Bonazzoli laydown yard, looking westward.

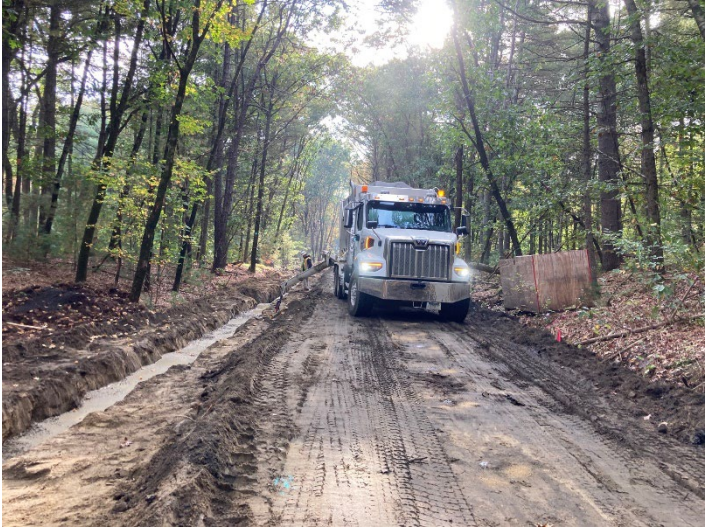
PHOTOGRAPHIC LOG	
Client Name: Eversource		Site Location: Sudbury to Hudson Transmission Reliability Project	Town: Sudbury
Photo No.: 1	Date: 10/11/2023

Description: View of Bond installing ductbank in segment 9. Facing east.

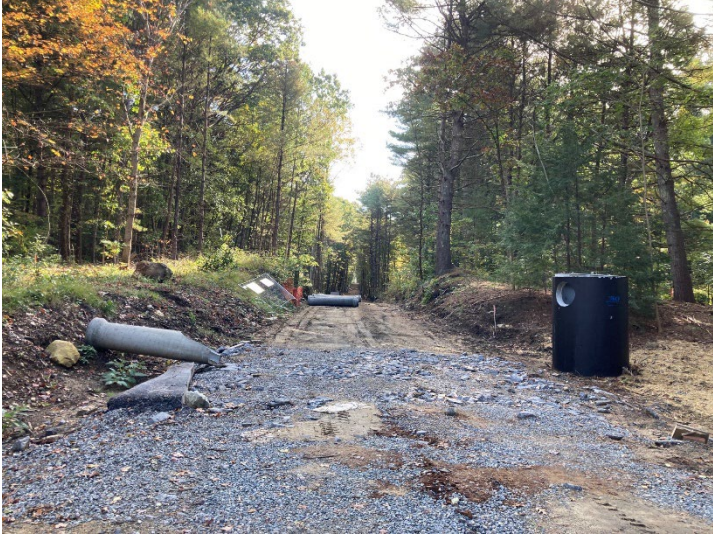
PHOTOGRAPHIC LOG	
Client Name: Eversource		Site Location: Sudbury to Hudson Transmission Reliability Project	Town: Sudbury
Photo No.: 3	Date: 10/11/2023

Description: View of segment 10 from construction entrance at Peakham Rd. Pipe has been delivered for drainage structures. Facing east.

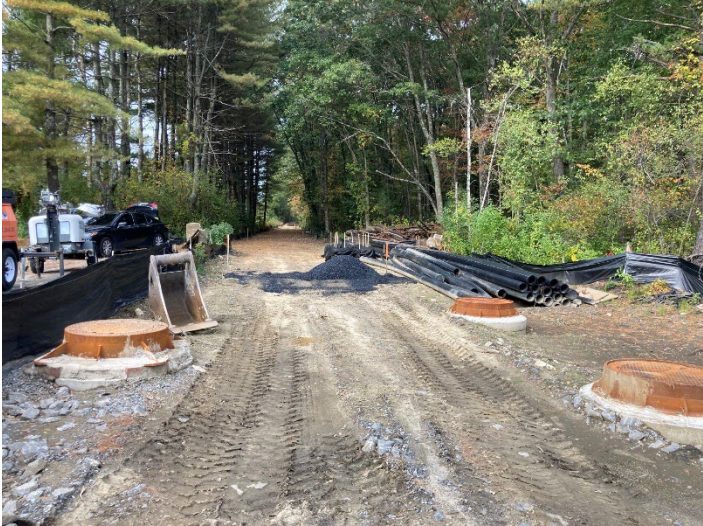
PHOTOGRAPHIC LOG	
Client Name: Eversource		Site Location: Sudbury to Hudson Transmission Reliability Project	Town: Sudbury
Photo No.: 4	Date: 10/11/2023

Description: View of east end of segment 11. Facing west.

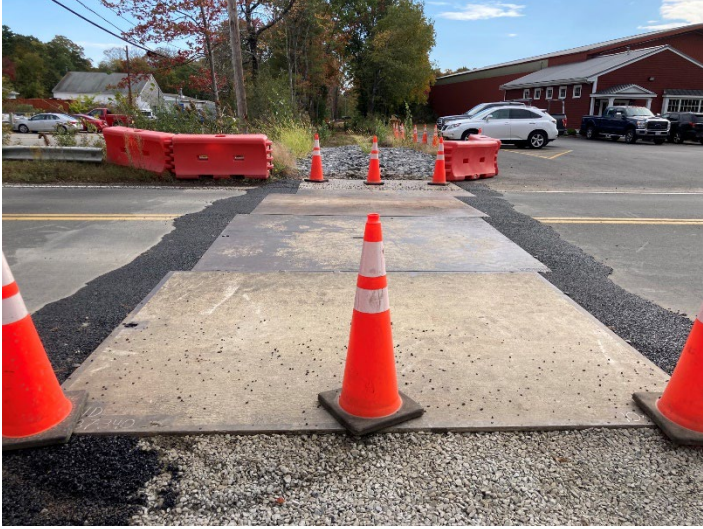
<p>PHOTOGRAPHIC LOG</p>	
<p>Client Name: Eversource</p>		<p>Site Location: Sudbury to Hudson Transmission Reliability Project</p>	<p>Town: Sudbury</p>
<p>Photo No.: 5</p>	<p>Date: 10/11/2023</p>

<p>Description: View of work area at Union Ave crossing. Facing east.</p>

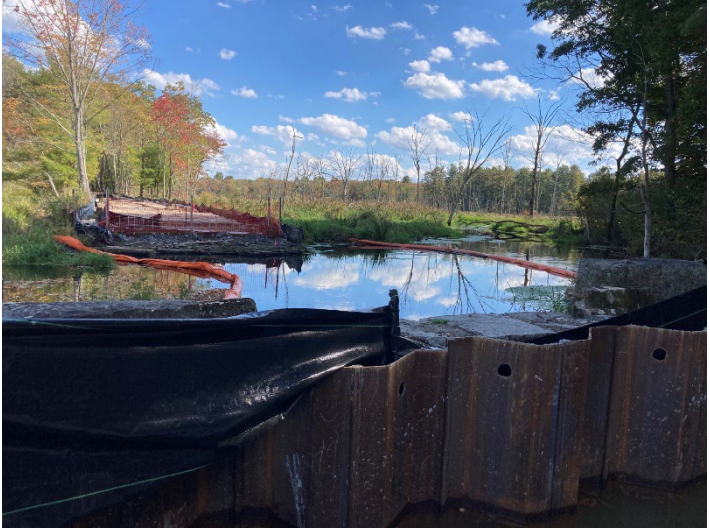
<p>PHOTOGRAPHIC LOG</p>	
<p>Client Name: Eversource</p>		<p>Site Location: Sudbury to Hudson Transmission Reliability Project</p>	<p>Town: Sudbury</p>
<p>Photo No.: 6</p>	<p>Date: 10/11/2023</p>

<p>Description: View of bridge 127. Work is paused in this area. Facing east.</p>

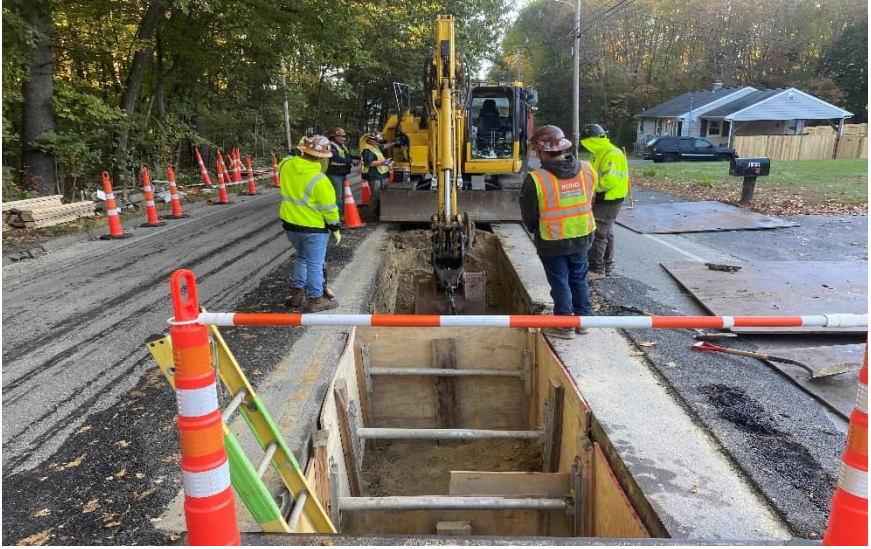
<p>PHOTOGRAPHIC LOG</p>	
<p>Client Name: Eversource</p>		<p>Site Location: Sudbury to Hudson Transmission Reliability Project</p>	<p>Town: Hudson</p>
<p>Photo No.: 2</p>	<p>Date: 10-13-23</p>

<p>Description:</p> <p>Work area within Forest Avenue, conduit work (Jim's crew), looking northward.</p>

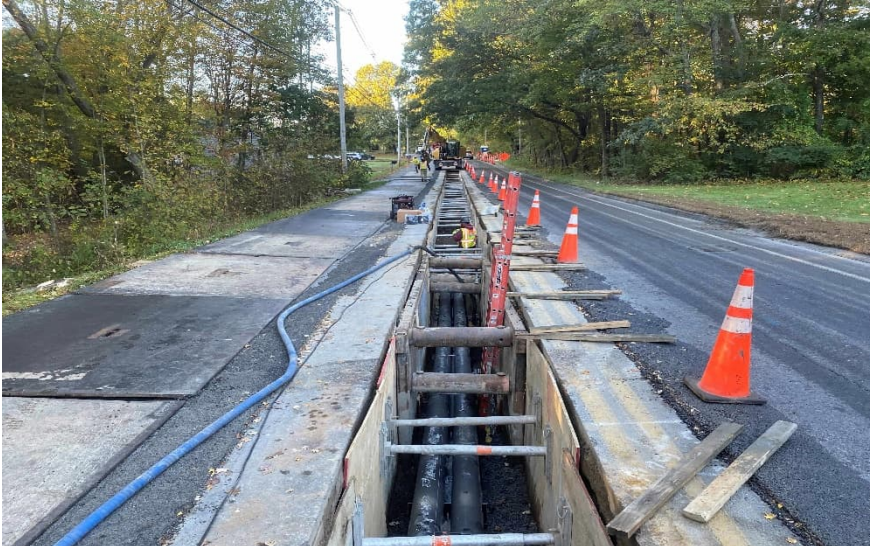
<p>PHOTOGRAPHIC LOG</p>	
<p>Client Name: Eversource</p>		<p>Site Location: Sudbury to Hudson Transmission Reliability Project</p>	<p>Town: Hudson</p>
<p>Photo No.: 4</p>	<p>Date: 10-13-23</p>

<p>Description: Work area within Forest Avenue, conduit work (Oscar's crew), looking northward.</p>

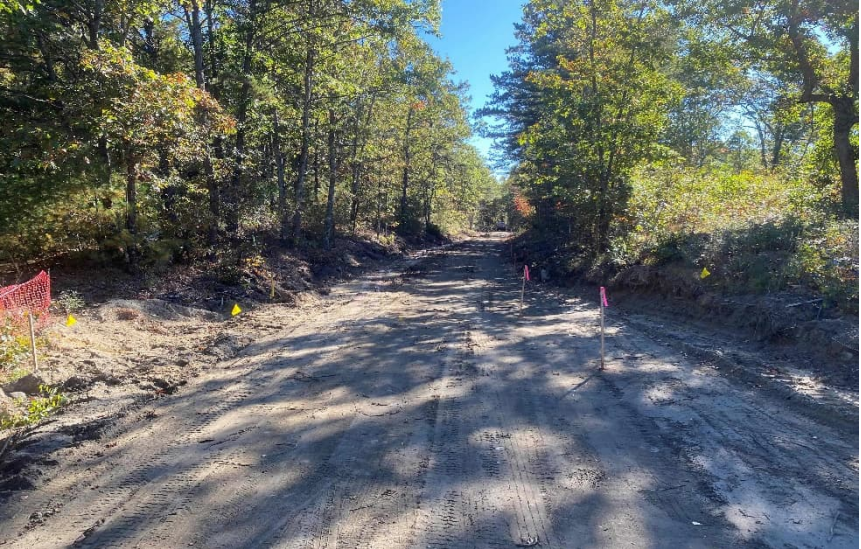
<p>PHOTOGRAPHIC LOG</p>	
<p>Client Name: Eversource</p>		<p>Site Location: Sudbury to Hudson Transmission Reliability Project</p>	<p>Town: Sudbury</p>
<p>Photo No.: 6</p>	<p>Date: 10-13-23</p>

<p>Description: Work area within segment 7 near town line, looking eastward.</p>

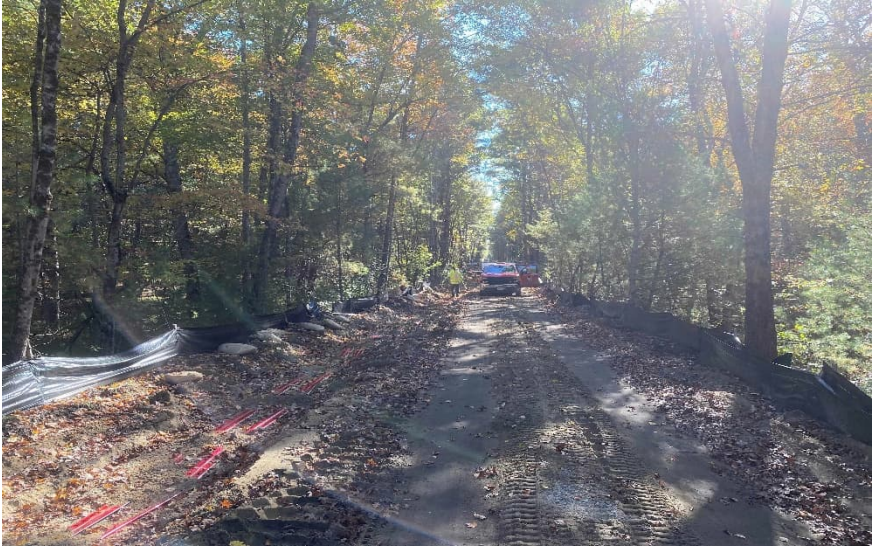
<p>PHOTOGRAPHIC LOG</p>	
<p>Client Name: Eversource</p>		<p>Site Location: Sudbury to Hudson Transmission Reliability Project</p>	<p>Town: Sudbury</p>
<p>Photo No.: 8</p>	<p>Date: 10-13-23</p>

<p>Description:</p> <p>Work area within segment 7, survey work, looking eastward.</p>

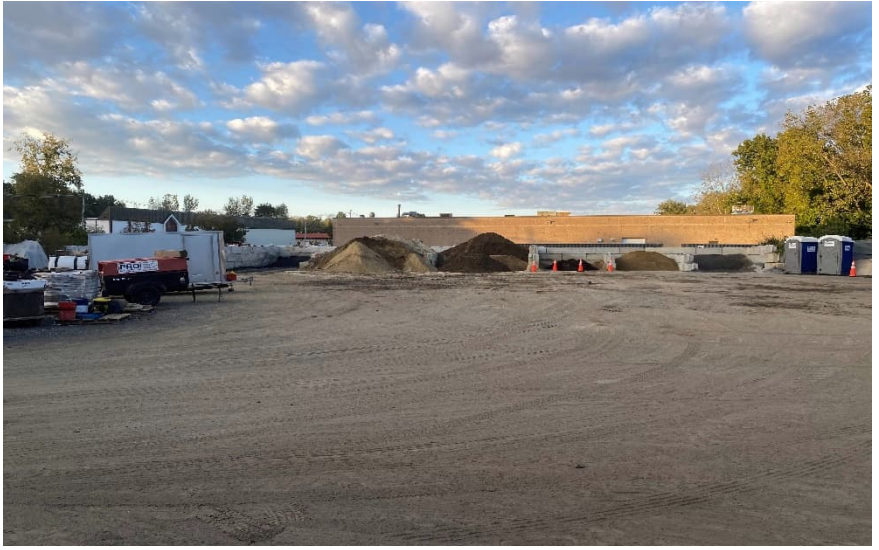
PHOTOGRAPHIC LOG	
Client Name: Eversource		Site Location: Sudbury to Hudson Transmission Reliability Project	Town: Hudson
Photo No.: 1	Date: 10-12-23

Description: Bonazzoli laydown yard, looking westward.

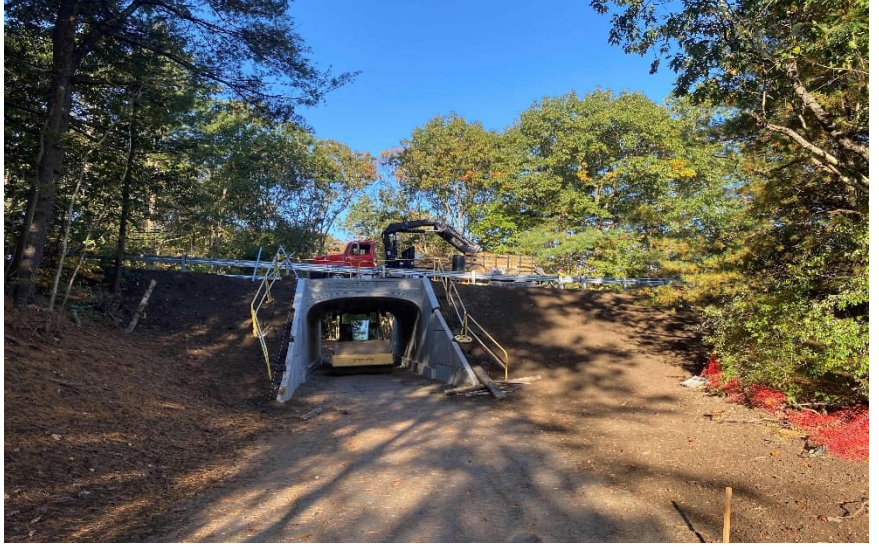
PHOTOGRAPHIC LOG	
Client Name: Eversource		Site Location: Sudbury to Hudson Transmission Reliability Project	Town: Hudson
Photo No.: 2	Date: 10-12-23

Description: Chestnut Street crossing, looking westward.

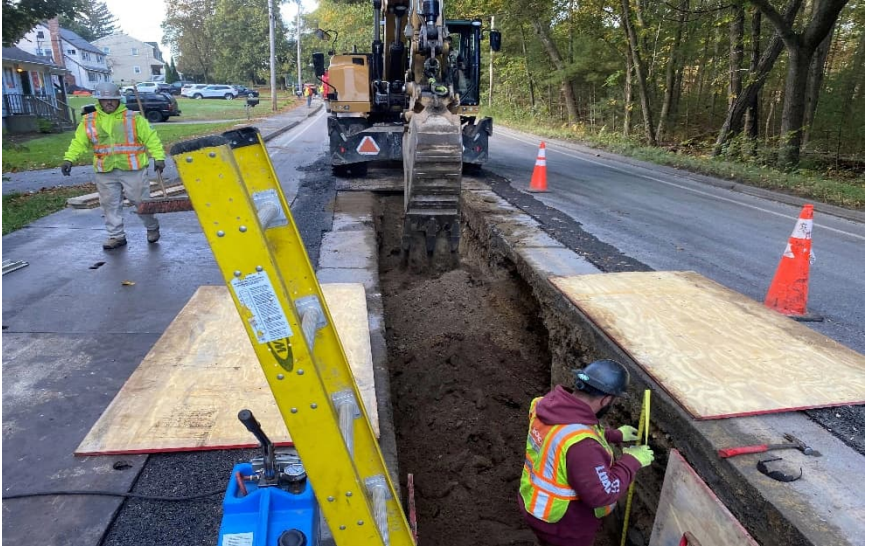
PHOTOGRAPHIC LOG	
Client Name: Eversource		Site Location: Sudbury to Hudson Transmission Reliability Project	Town: Hudson
Photo No.: 5	Date: 10-12-23

Description: Conduit work within Forest Avenue (Oscar's crew), looking southward.

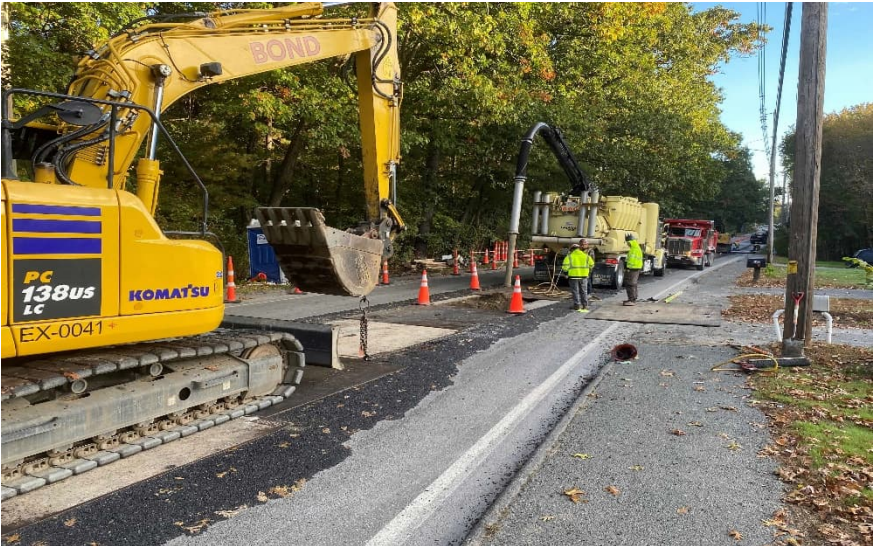
PHOTOGRAPHIC LOG	
Client Name: Eversource		Site Location: Sudbury to Hudson Transmission Reliability Project	Town: Hudson
Photo No.: 6	Date: 10-12-23

Description: Conduit work within Forest Avenue (Jim's crew), looking northward.

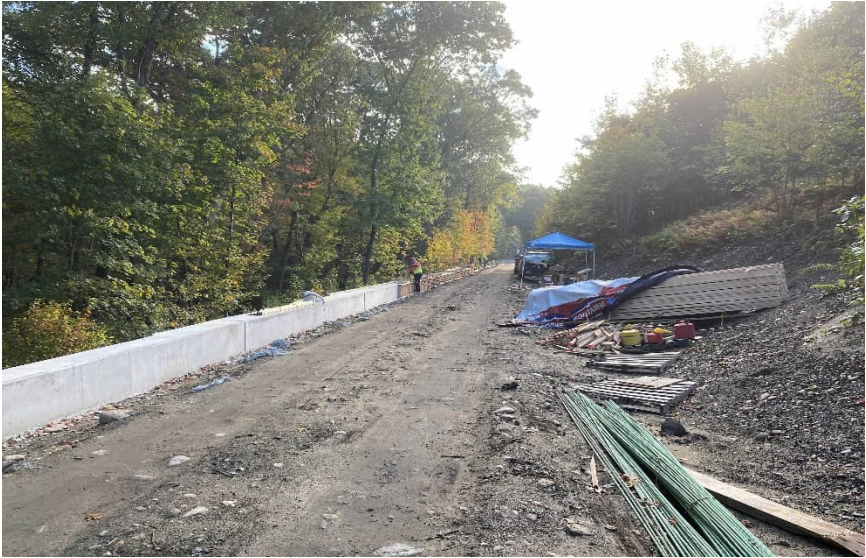
PHOTOGRAPHIC LOG	
Client Name: Eversource		Site Location: Sudbury to Hudson Transmission Reliability Project	Town: Hudson
Photo No.: 7	Date: 10-12-23

Description: Work area within Segment 1, caps for sheeting, looking eastward.

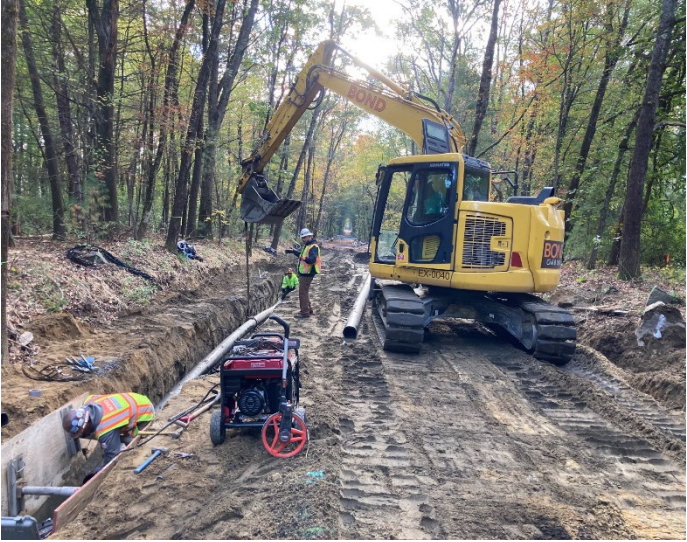
PHOTOGRAPHIC LOG	
Client Name: Eversource		Site Location: Sudbury to Hudson Transmission Reliability Project	Town: Sudbury
Photo No.: 1	Date: 10-12-2023

Description: View of Bond installing conduit in segment 9. Facing east.

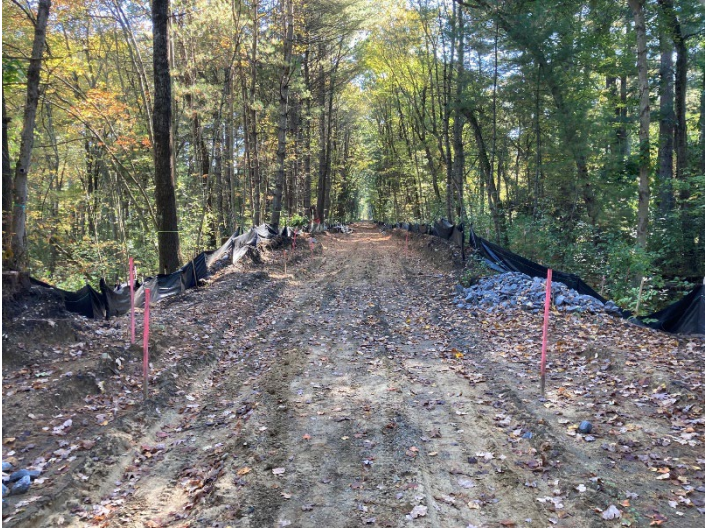
PHOTOGRAPHIC LOG	
Client Name: Eversource		Site Location: Sudbury to Hudson Transmission Reliability Project	Town: Sudbury
Photo No.: 2	Date: 10-12-2023

Description: View of Dudley Brook culvert area in segment 10. Facing east.

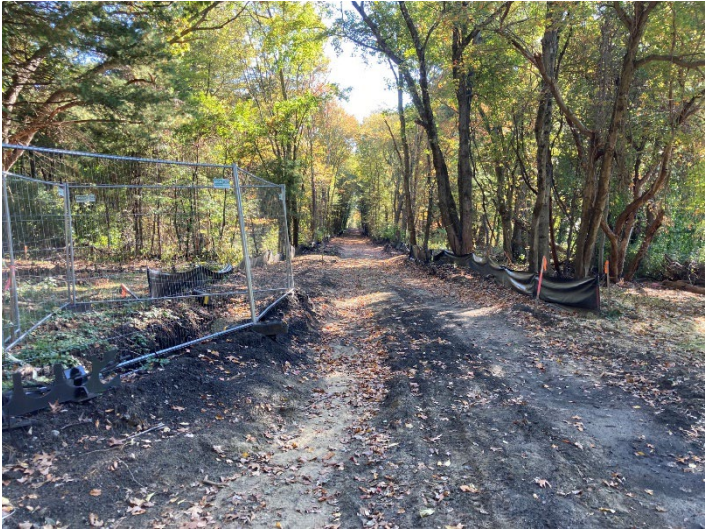
PHOTOGRAPHIC LOG	
Client Name: Eversource		Site Location: Sudbury to Hudson Transmission Reliability Project	Town: Sudbury
Photo No.: 3	Date: 10-12-2023

Description: View of west end of segment 11. Facing east.

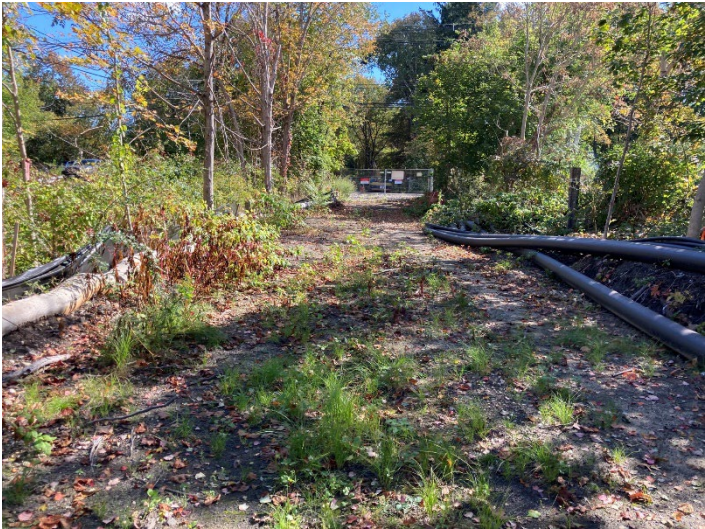
PHOTOGRAPHIC LOG	
Client Name: Eversource		Site Location: Sudbury to Hudson Transmission Reliability Project	Town: Sudbury
Photo No.: 4	Date: 10-12-2023

Description: View of east end of segment 12. Facing east.

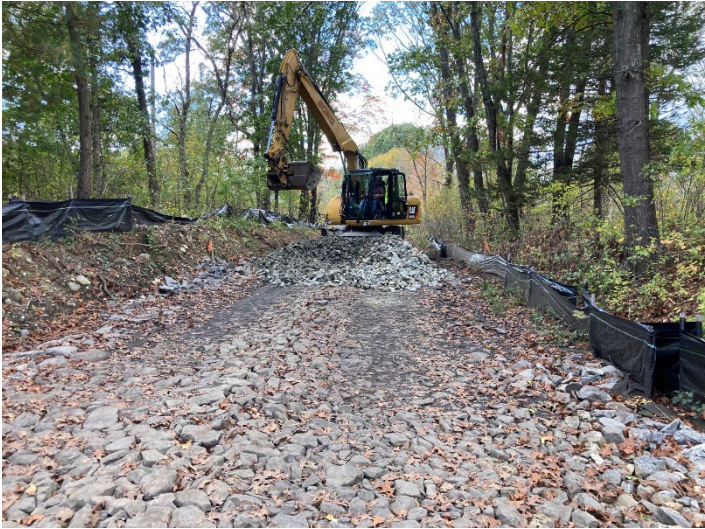
Client Name: Eversource		Site Location: Sudbury to Hudson Transmission Reliability Project	Town: Sudbury
Photo No.: 6	Date: 10-12-2023

Description: View of Bond conducting site work in segment 14. Facing west.

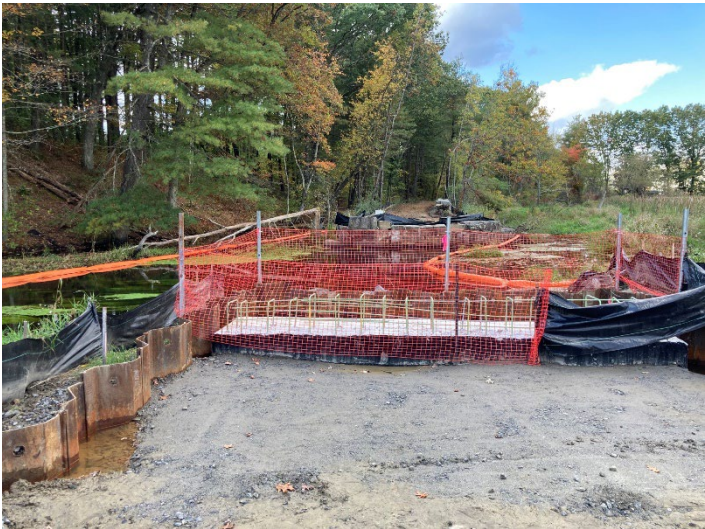
Epsilon ASSOCIATES INC.		PHOTOGRAPHIC LOG	
Client Name: Eversource		Site Location: Sudbury to Hudson Transmission Reliability Project	Town: Sudbury
Photo No.: 7	Date: 10-12-2023

Description: View of bridge 127 area from segment 14. Facing west.

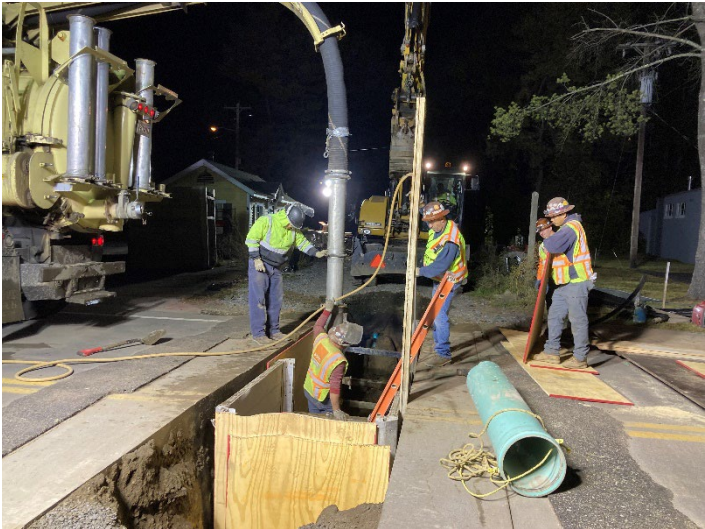
Epsilon ASSOCIATES INC.		PHOTOGRAPHIC LOG	
Client Name: Eversource		Site Location: Sudbury to Hudson Transmission Reliability Project	Town: Sudbury
Photo No.: 8	Date: 10-12-2023

Description: View of Bond working at Union Ave crossing (night shift). Facing west.

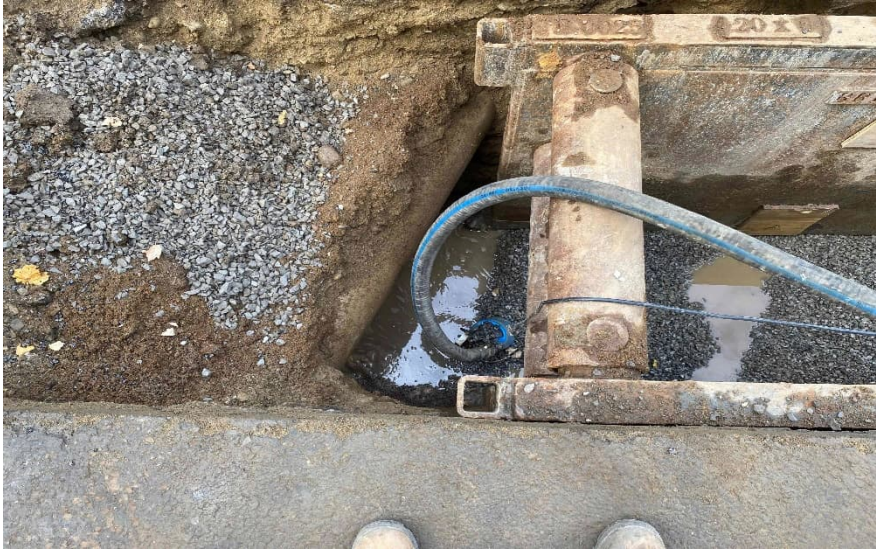
PHOTOGRAPHIC LOG	
Client Name: Eversource		Site Location: Sudbury to Hudson Transmission Reliability Project	Town: Hudson
Photo No.: 1	Date: 10/11/2023

Description: View of area being pumped at Forest Avenue (area near manhole #4).

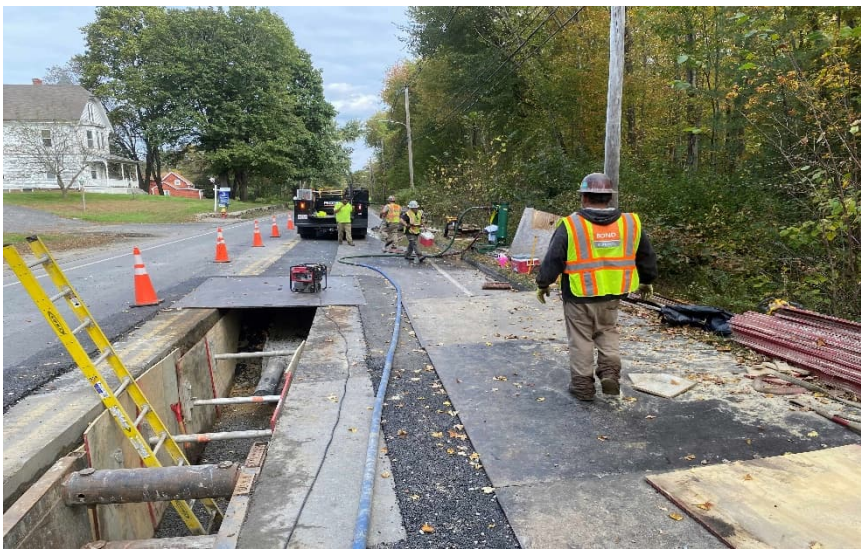
PHOTOGRAPHIC LOG	
Client Name: Eversource		Site Location: Sudbury to Hudson Transmission Reliability Project	Town: Hudson
Photo No.: 2	Date: 10/11/2023

Description: Forest Avenue. View of dewatering operation, looking northward.

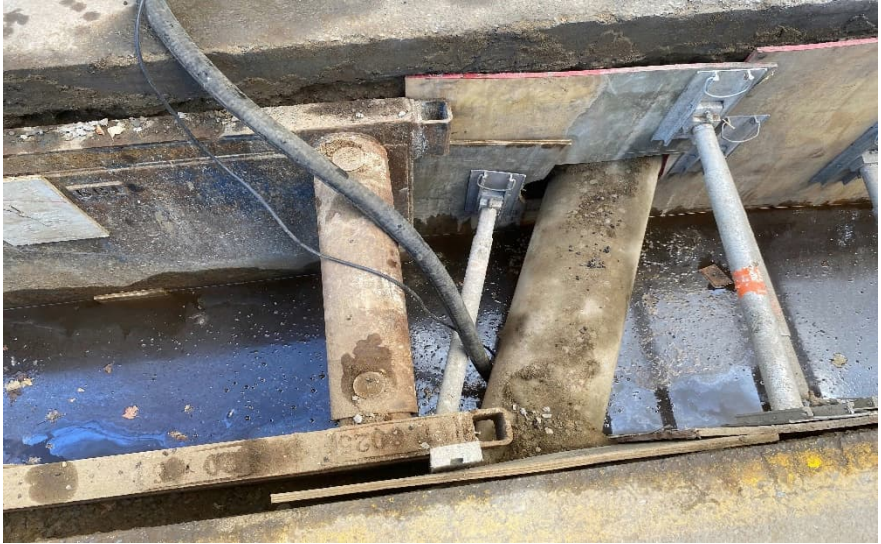
PHOTOGRAPHIC LOG	
Client Name: Eversource		Site Location: Sudbury to Hudson Transmission Reliability Project	Town: Hudson
Photo No.: 1	Date: 10/12/2023

Description: View of area being pumped at Forest Avenue (area near manhole #4).

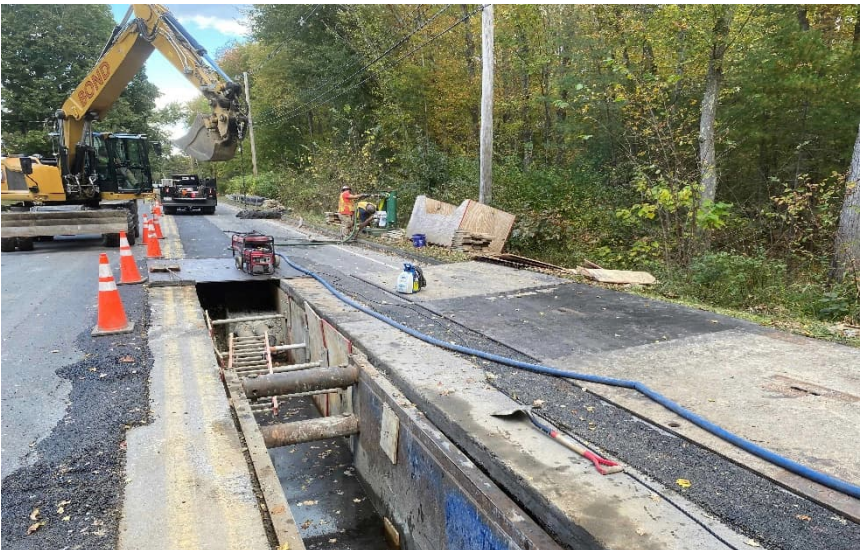
PHOTOGRAPHIC LOG	
Client Name: Eversource		Site Location: Sudbury to Hudson Transmission Reliability Project	Town: Hudson
Photo No.: 2	Date: 10/12/2023

Description: Forest Avenue. View of dewatering operation, looking northward.

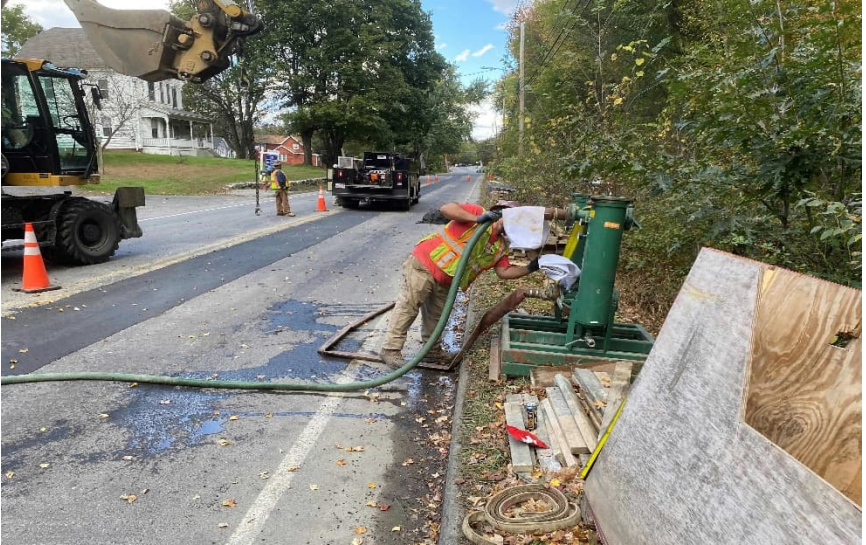
Client Name: Eversource		Site Location: Sudbury to Hudson Transmission Reliability Project	Town: Hudson
Photo No.: 3	Date: 10/12/2023

Description: Forest Avenue. View of dewatering operation (pumping at far end of area), looking northward.

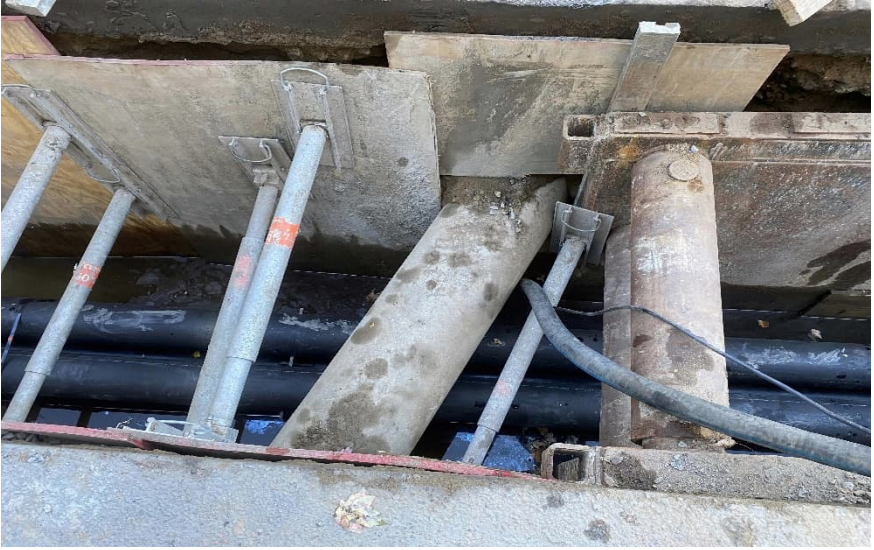
PHOTOGRAPHIC LOG	
Client Name: Eversource		Site Location: Sudbury to Hudson Transmission Reliability Project	Town: Hudson
Photo No.: 1	Date: 10/13/2023

Description: View of area being pumped at Forest Avenue (area near manhole #4).

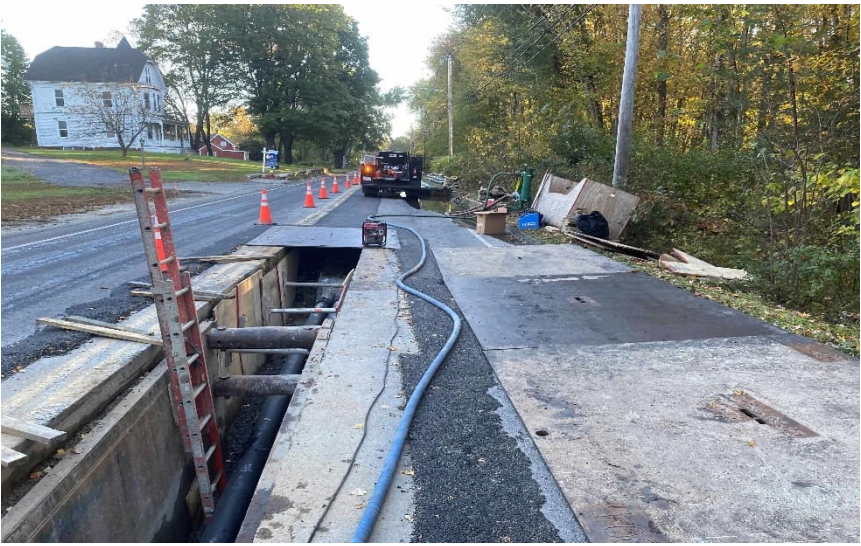
PHOTOGRAPHIC LOG	
Client Name: Eversource		Site Location: Sudbury to Hudson Transmission Reliability Project	Town: Hudson
Photo No.: 2	Date: 10/13/2023

Description: Forest Avenue. View of dewatering operation, looking northward.

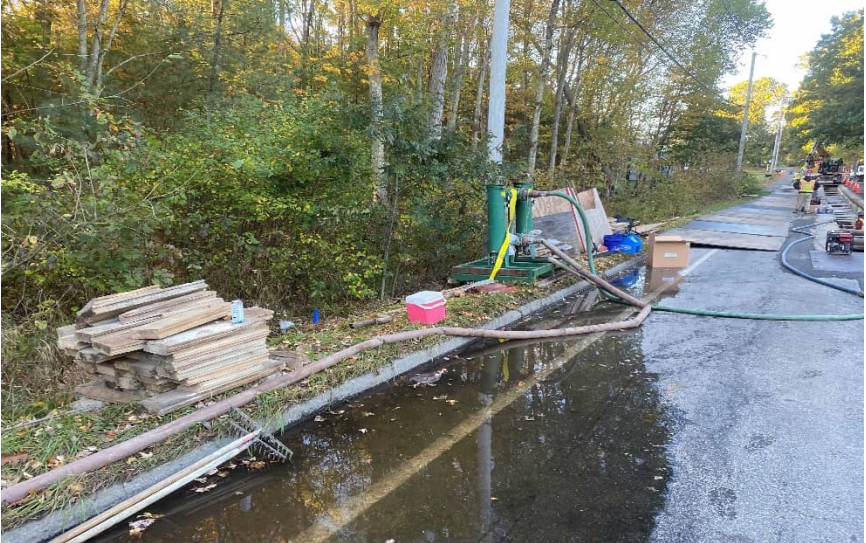
Client Name: Eversource		Site Location: Sudbury to Hudson Transmission Reliability Project	Town: Hudson
Photo No.: 3	Date: 10/13/2023

Description: Forest Avenue. View of dewatering operation (pumping at far end of area), looking southward.

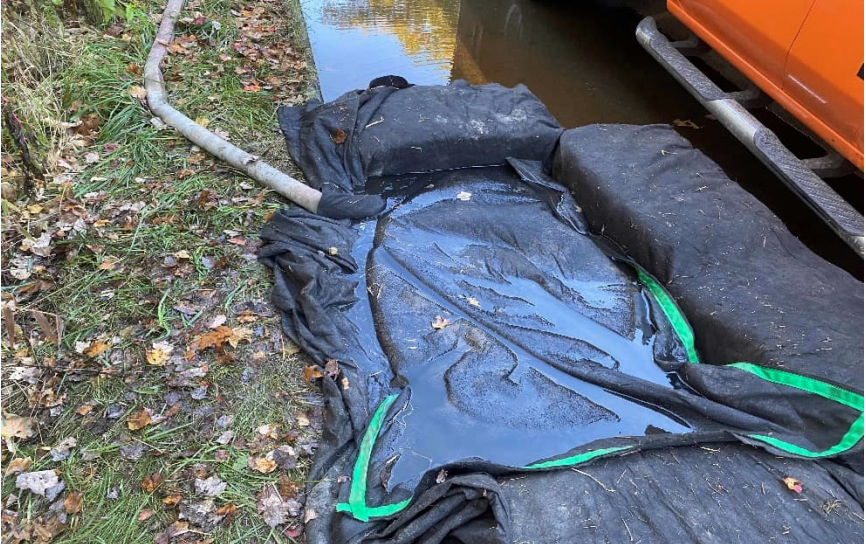
Client Name: Eversource		Site Location: Sudbury to Hudson Transmission Reliability Project	Town: Hudson
Photo No.: 4	Date: 10/13/2023

Description: Forest Avenue. View of dewatering operation (corral/bag), looking southward.

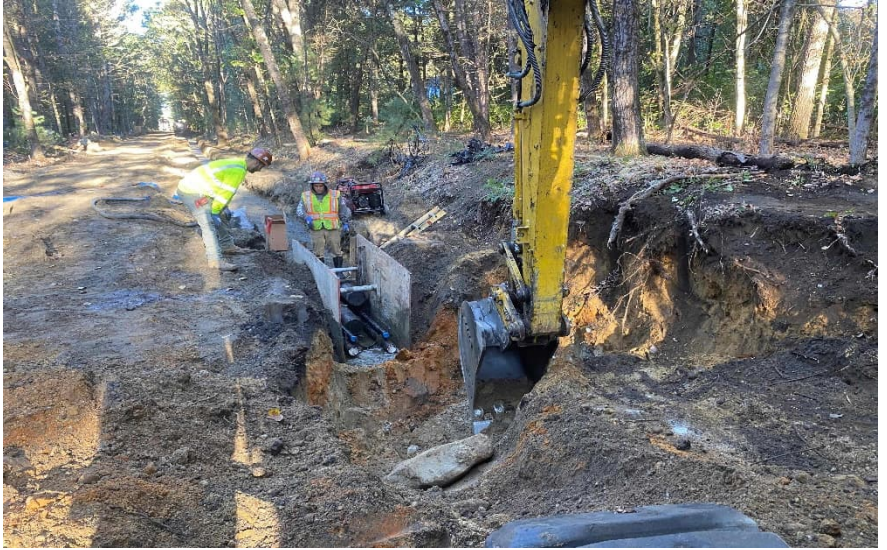
PHOTOGRAPHIC LOG	
Client Name: Eversource		Site Location: Sudbury to Hudson Transmission Reliability Project	Town: Sudbury
Photo No.: 1	Date: 10/13/2023

Description: View of area being pumped within Segment 9, looking westward.

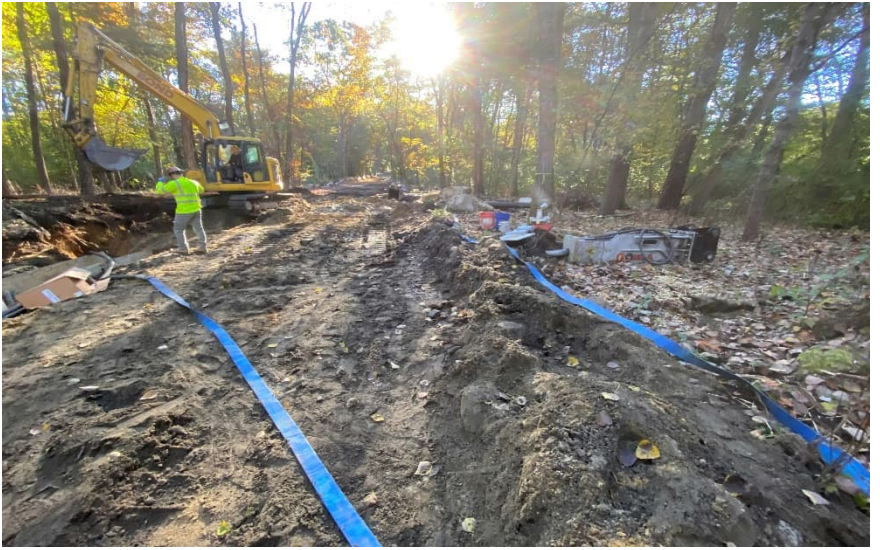
PHOTOGRAPHIC LOG	
Client Name: Eversource		Site Location: Sudbury to Hudson Transmission Reliability Project	Town: Sudbury
Photo No.: 2	Date: 10/13/2023

Description: Segment 9. View of dewatering operation, looking eastward.

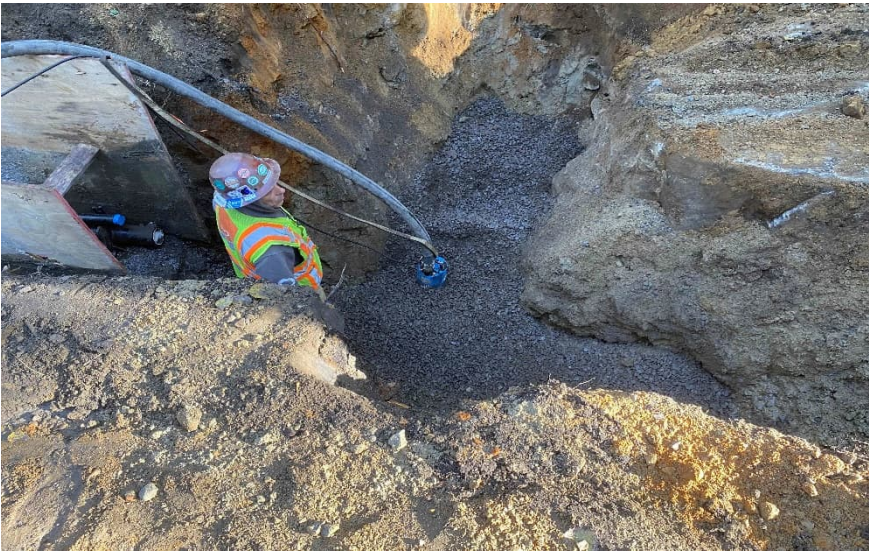
PHOTOGRAPHIC LOG	
Client Name: Eversource		Site Location: Sudbury to Hudson Transmission Reliability Project	Town: Sudbury
Photo No.: 3	Date: 10/13/2023

Description: Segment 9. View of dewatering operation.
