**Weekly Environmental Compliance Summary**

**Sudbury to Hudson Transmission Reliability Project (USEPA Tracking # MAR1003UW)**

Sudbury, Hudson, and Stow, MA

Week of: October 16, 2023 to October 20, 2023

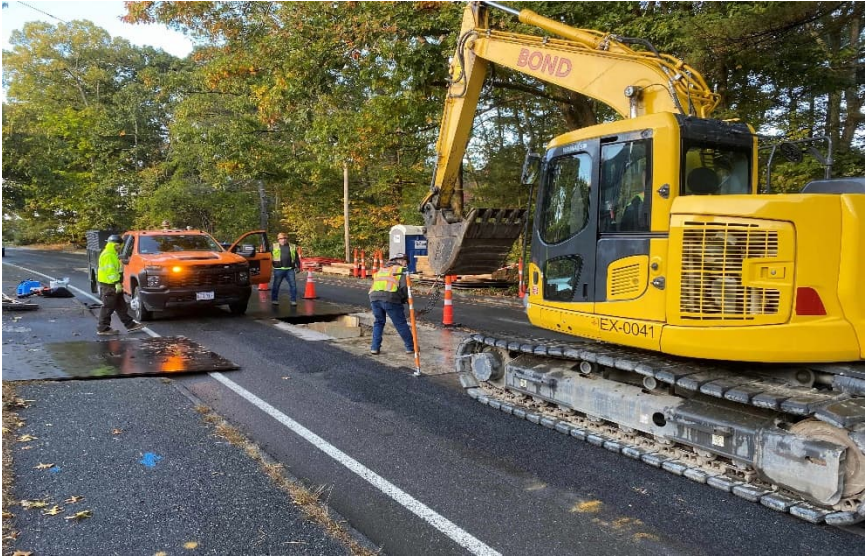
<b>PHOTOGRAPHIC LOG</b>	
Client Name: Eversource		Site Location: Sudbury to Hudson Transmission Reliability Project	Town: Hudson
Photo No.: 3	Date: 10-16-23

Description:  Work area within Forest Avenue, conduit work (Jim's crew), looking southward.

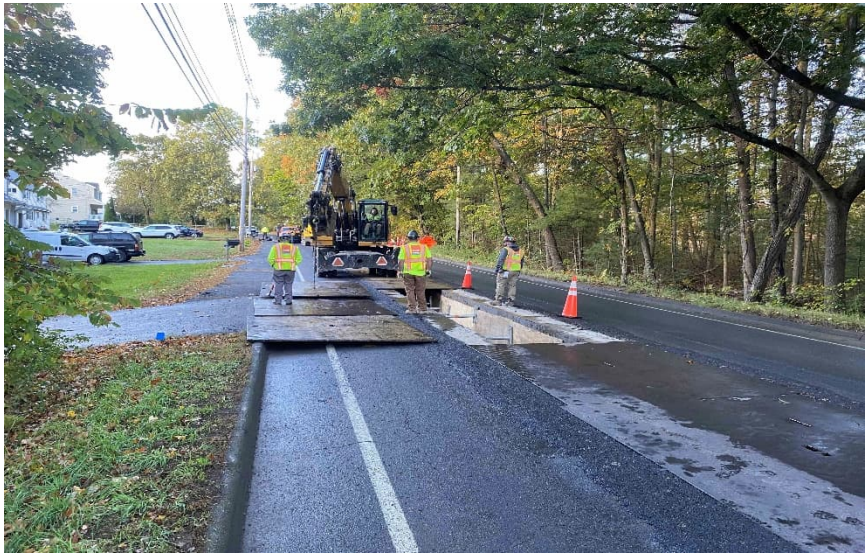
<b>PHOTOGRAPHIC LOG</b>	
Client Name: Eversource		Site Location: Sudbury to Hudson Transmission Reliability Project	Town: Hudson
Photo No.: 4	Date: 10-16-23

Description:  Work area within Forest Avenue, conduit work (Oscar's crew), looking southward.

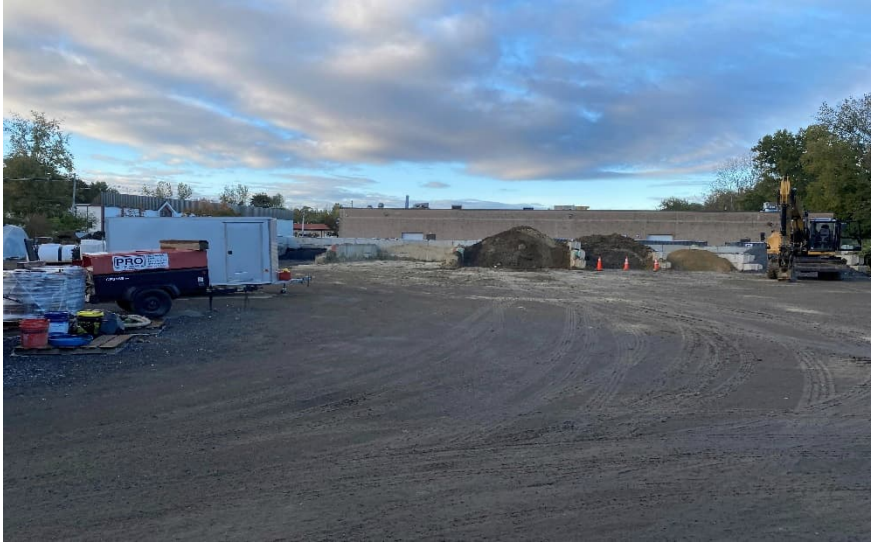
<b>PHOTOGRAPHIC LOG</b>	
Client Name: Eversource		Site Location: Sudbury to Hudson Transmission Reliability Project	Town: Hudson
Photo No.: 5	Date: 10-16-23

Description:  Laydown yard at Bonazzoli, looking westward.

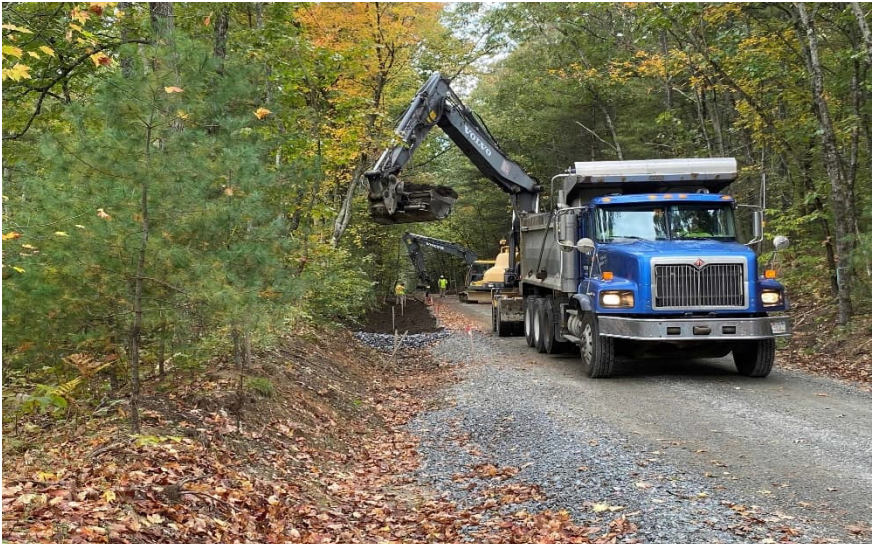
<b>PHOTOGRAPHIC LOG</b>	
Client Name: Eversource		Site Location: Sudbury to Hudson Transmission Reliability Project	Town: Hudson
Photo No.: 6	Date: 10-16-23

Description:  Segment 5, ET&L conducting site work (loam placement), looking westward.

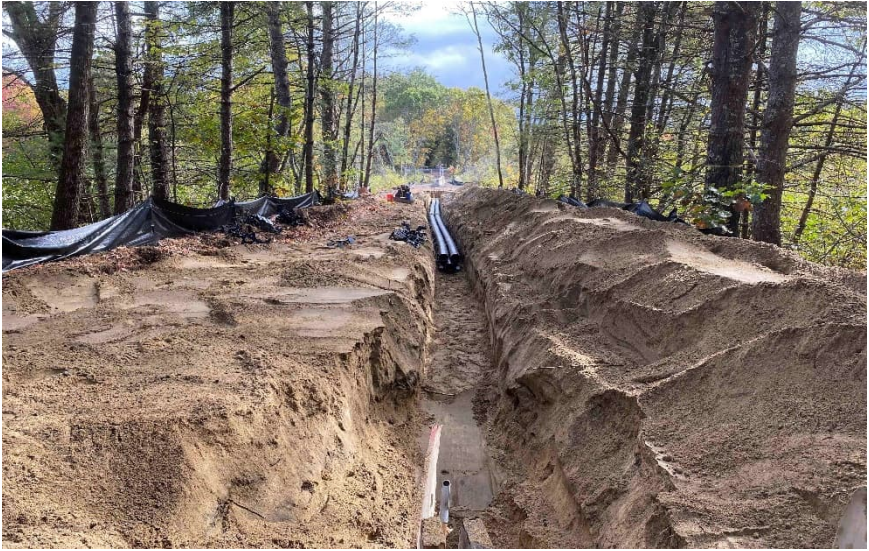
<b>PHOTOGRAPHIC LOG</b>	
Client Name: Eversource		Site Location: Sudbury to Hudson Transmission Reliability Project	Town: Sudbury
Photo No.: 7	Date: 10-16-23

Description:  Conduit work within segment 7, existing erosion control, looking eastward.

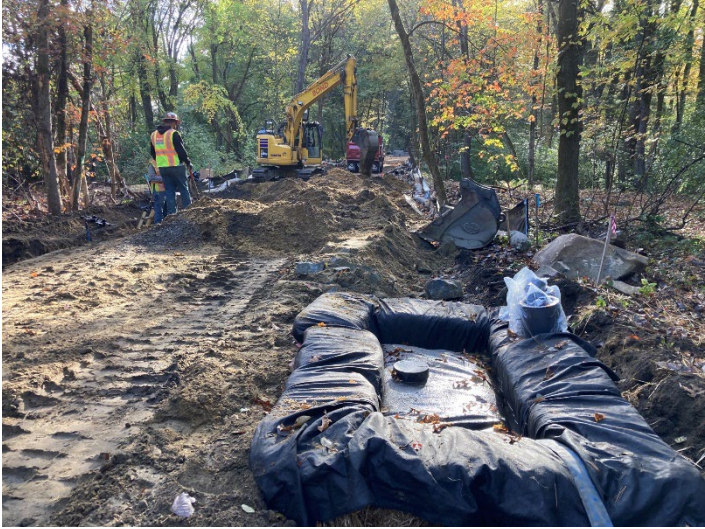
<p align="right"><b>PHOTOGRAPHIC LOG</b></p>	
<p><b>Client Name:</b> Eversource</p>		<p><b>Site Location:</b> Sudbury to Hudson Transmission Reliability Project</p>	<p><b>Town:</b> Sudbury</p>
<p><b>Photo No.:</b> 1</p>	<p><b>Date:</b> 10/16/2023</p>

<p><b>Description:</b> View of Bond installing conduit and dewatering in segment 9. See additional dewatering inspection report. Facing east.</p>

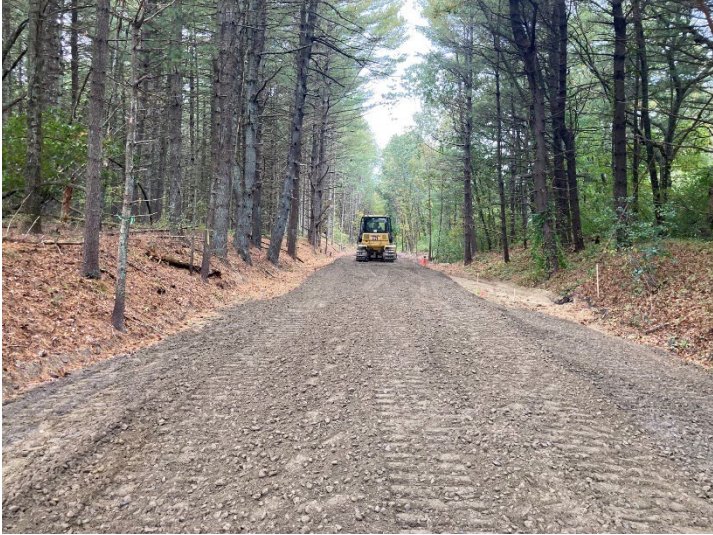
<b>PHOTOGRAPHIC LOG</b>	
<b>Client Name:</b> Eversource		<b>Site Location:</b> Sudbury to Hudson Transmission Reliability Project	<b>Town:</b> Sudbury
<b>Photo No.:</b> 3	<b>Date:</b> 10/16/2023

<b>Description:</b> View of ET&L working in segment 11. Facing east.

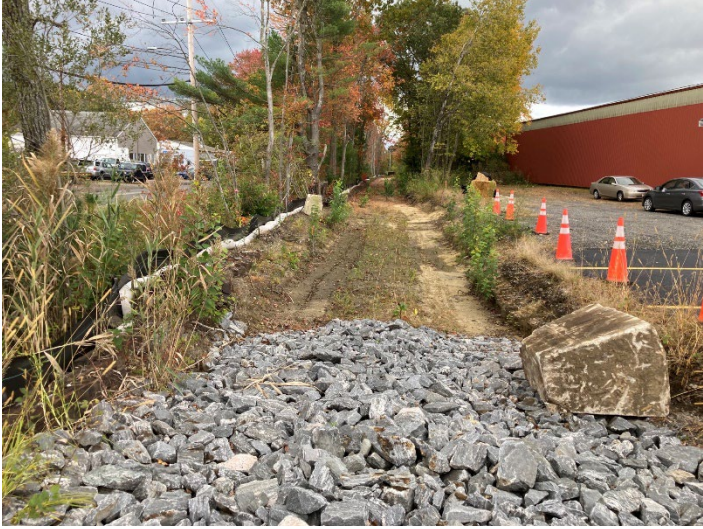
<b>PHOTOGRAPHIC LOG</b>	
<b>Client Name:</b> Eversource		<b>Site Location:</b> Sudbury to Hudson Transmission Reliability Project	<b>Town:</b> Sudbury
<b>Photo No.:</b> 4	<b>Date:</b> 10/16/2023

<b>Description:</b> View of west end of segment 12. Facing east.

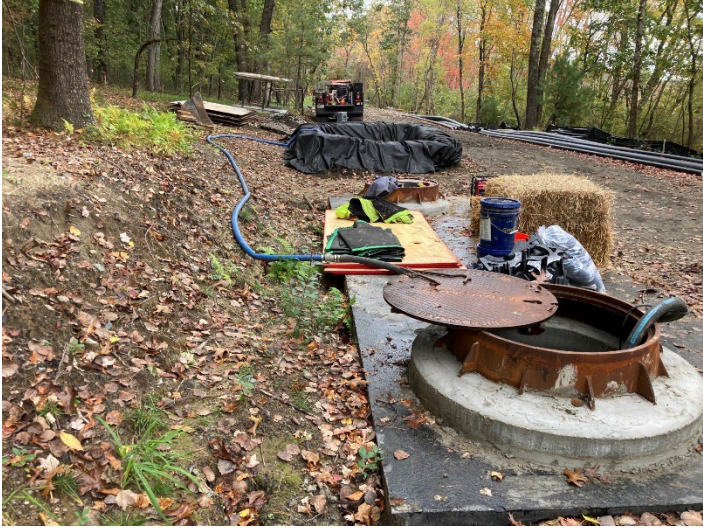
<b>PHOTOGRAPHIC LOG</b>	
<b>Client Name:</b> Eversource		<b>Site Location:</b> Sudbury to Hudson Transmission Reliability Project	<b>Town:</b> Sudbury
<b>Photo No.:</b> 5	<b>Date:</b> 10/16/2023

<b>Description:</b> View of dewatering setup at MH #26 in segment 14. See additional dewatering inspection report. Facing east.

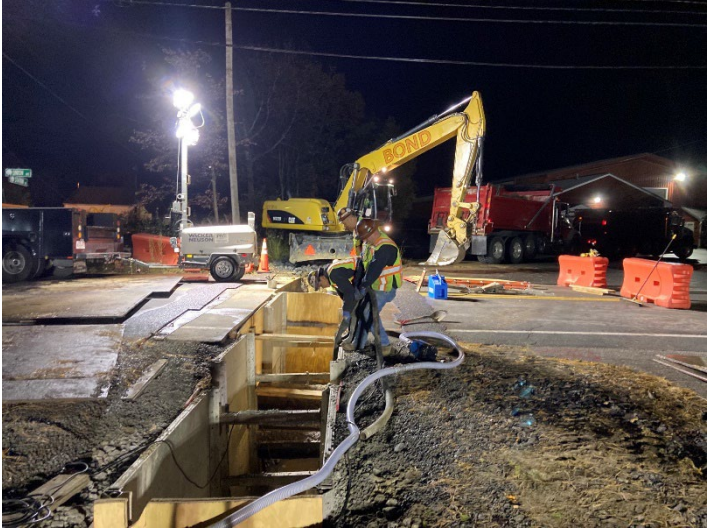
<b>PHOTOGRAPHIC LOG</b>	
<b>Client Name:</b> Eversource		<b>Site Location:</b> Sudbury to Hudson Transmission Reliability Project	<b>Town:</b> Sudbury
<b>Photo No.:</b> 6	<b>Date:</b> 10/16/2023

<b>Description:</b> View of night work at Union Ave crossing. See additional dewatering inspection report. Facing east.

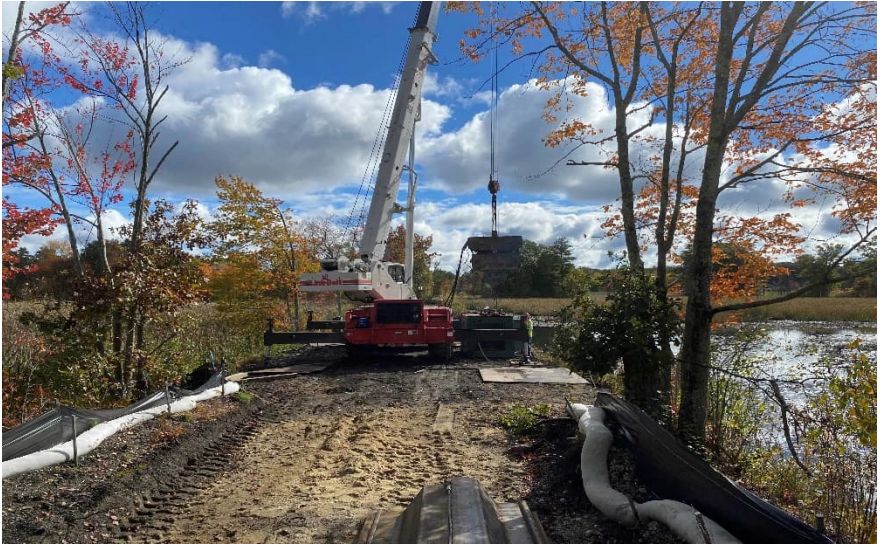
<b>PHOTOGRAPHIC LOG</b>	
Client Name: Eversource		Site Location: Sudbury to Hudson Transmission Reliability Project	Town: Hudson
Photo No.: 1	Date: 10-17-23

Description:  Work area within segment 2 -> segment 3, bridge 130 work (sheeting installation), existing erosion control, looking eastward.

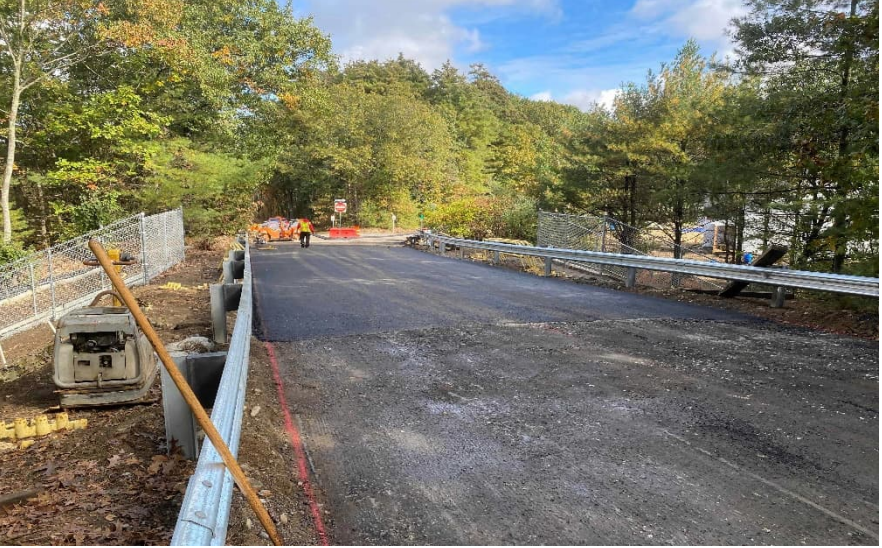
<b>PHOTOGRAPHIC LOG</b>	
Client Name: Eversource		Site Location: Sudbury to Hudson Transmission Reliability Project	Town: Hudson
Photo No.: 2	Date: 10-17-23

Description:  Work area across Chestnut Street crossing (recent paving), looking eastward.

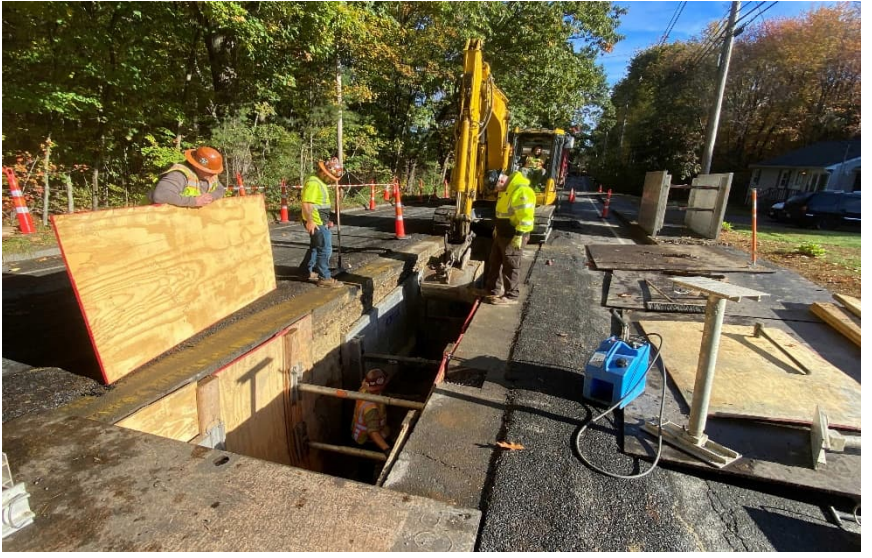
<b>PHOTOGRAPHIC LOG</b>	
Client Name: Eversource		Site Location: Sudbury to Hudson Transmission Reliability Project	Town: Hudson
Photo No.: 3	Date: 10-17-23

Description:  Work area within Forest Avenue, conduit work (Jim's crew), looking northward.

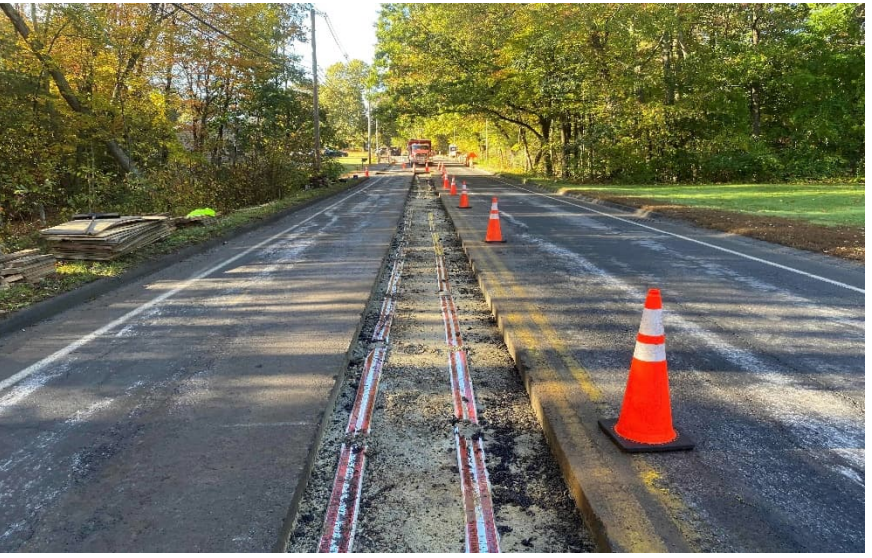
<b>PHOTOGRAPHIC LOG</b>	
Client Name: Eversource		Site Location: Sudbury to Hudson Transmission Reliability Project	Town: Hudson
Photo No.: 4	Date: 10-17-23

Description:  Work area within Forest Avenue, conduit work (Oscar's crew), looking southward.

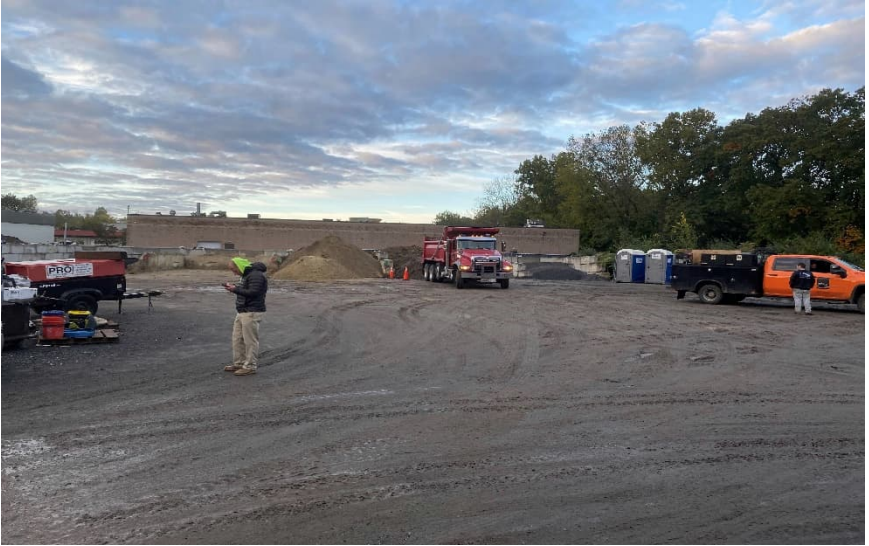
<b>PHOTOGRAPHIC LOG</b>	
Client Name: Eversource		Site Location: Sudbury to Hudson Transmission Reliability Project	Town: Hudson
Photo No.: 5	Date: 10-17-23

Description:  Laydown yard at Bonazzoli, looking westward.

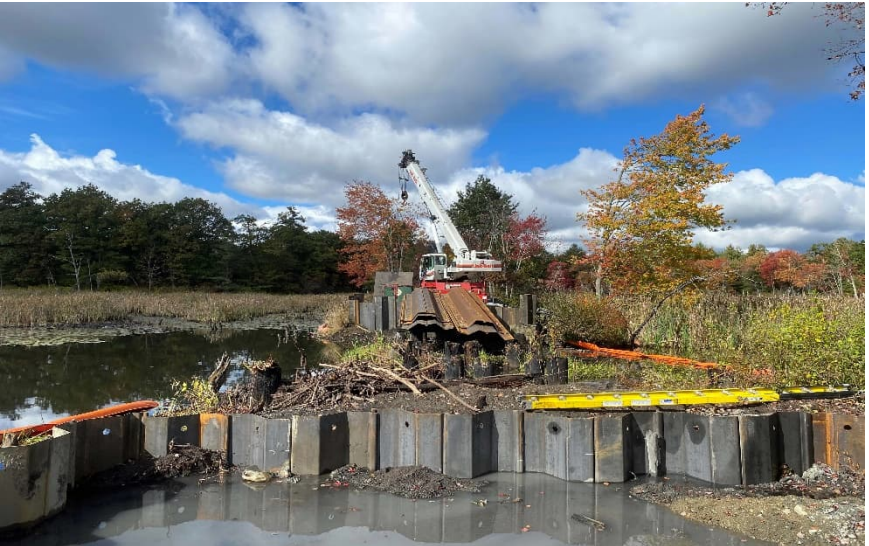
<b>PHOTOGRAPHIC LOG</b>	
Client Name: Eversource		Site Location: Sudbury to Hudson Transmission Reliability Project	Town: Hudson
Photo No.: 6	Date: 10-17-23

Description:  Work area within segment 2 looking from segment 3, bridge 130 work (sheeting installation), looking westward.

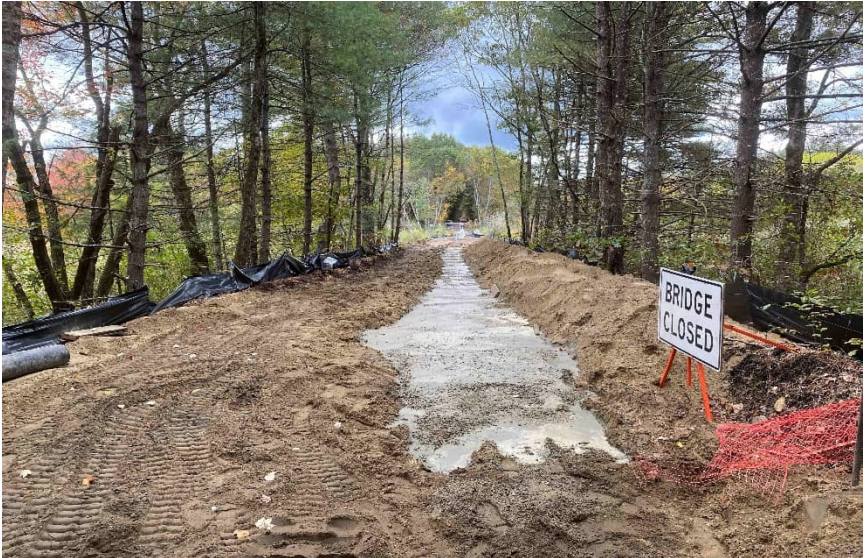
<b>PHOTOGRAPHIC LOG</b>	
Client Name: Eversource		Site Location: Sudbury to Hudson Transmission Reliability Project	Town: Sudbury
Photo No.: 7	Date: 10-17-23

Description:  Conduit work within segment 7 (bridge 128 in the background), existing erosion control, looking eastward.

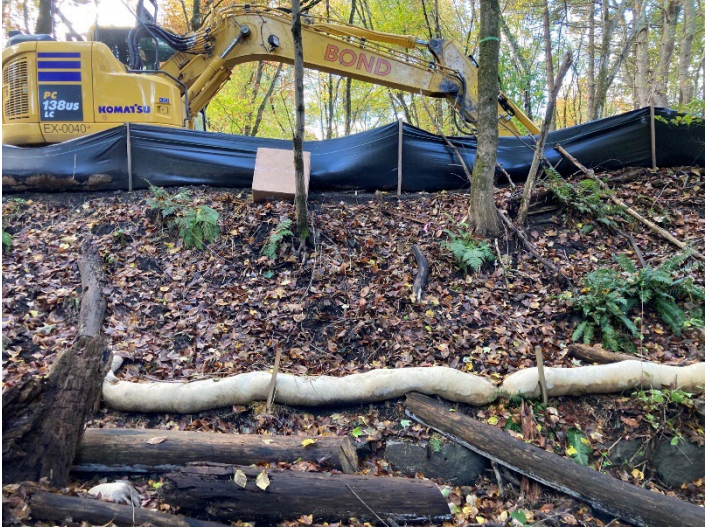
<p align="right"><b>PHOTOGRAPHIC LOG</b></p>	
<p><b>Client Name:</b> Eversource</p>		<p><b>Site Location:</b> Sudbury to Hudson Transmission Reliability Project</p>	<p><b>Town:</b> Sudbury</p>
<p><b>Photo No.:</b> 1</p>	<p><b>Date:</b> 10/17/2023</p>

<p><b>Description:</b> View of Bond installing conduit over the culvert at Sta. 323+10 in segment 9. Facing south.</p>

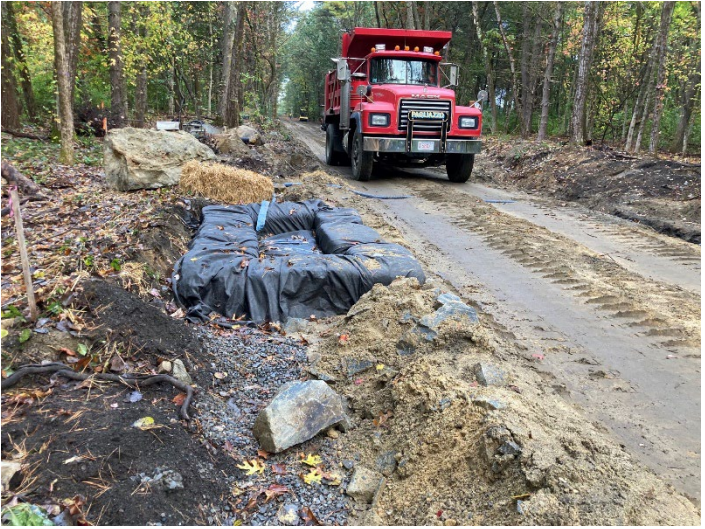
<p align="right"><b>PHOTOGRAPHIC LOG</b></p>	
<p><b>Client Name:</b> Eversource</p>		<p><b>Site Location:</b> Sudbury to Hudson Transmission Reliability Project</p>	<p><b>Town:</b> Sudbury</p>
<p><b>Photo No.:</b> 2</p>	<p><b>Date:</b> 10/17/2023</p>

<p><b>Description:</b> View of dewatering controls in segment 9. See additional dewatering inspection report. Facing west.</p>

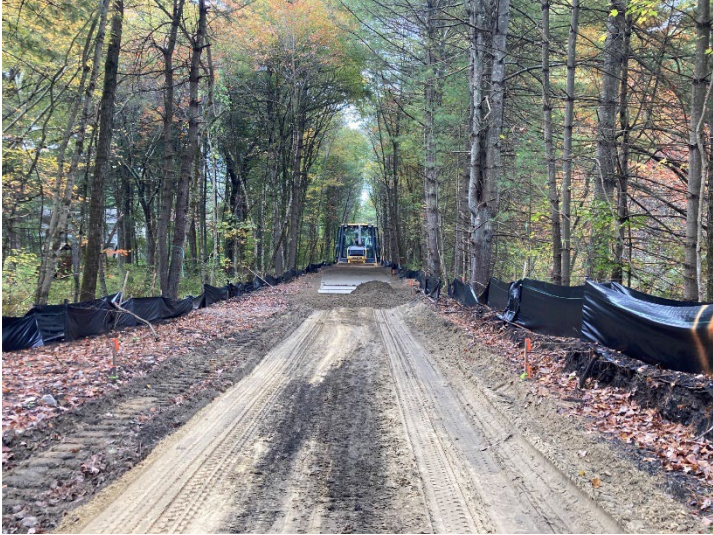
<p><b>PHOTOGRAPHIC LOG</b></p>	
<p><b>Client Name:</b> Eversource</p>		<p><b>Site Location:</b> Sudbury to Hudson Transmission Reliability Project</p>	<p><b>Town:</b> Sudbury</p>
<p><b>Photo No.:</b> 3</p>	<p><b>Date:</b> 10/17/2023</p>

<p><b>Description:</b> View of ET&amp;L working in segment 11. Facing east.</p>

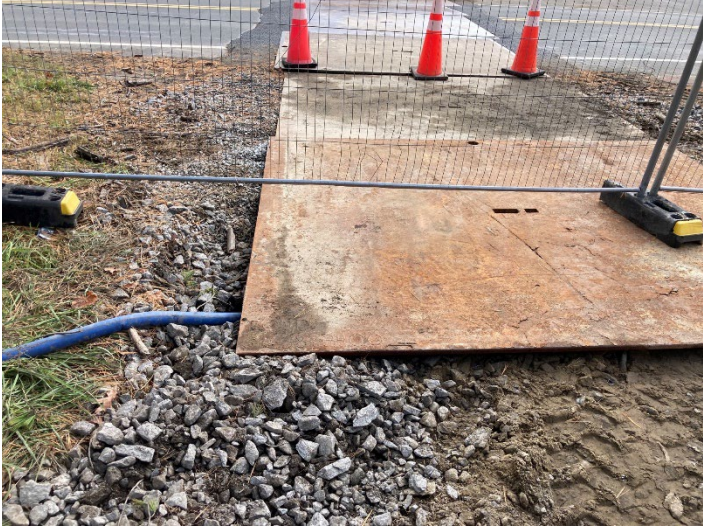
<p><b>PHOTOGRAPHIC LOG</b></p>	
<p><b>Client Name:</b> Eversource</p>		<p><b>Site Location:</b> Sudbury to Hudson Transmission Reliability Project</p>	<p><b>Town:</b> Sudbury</p>
<p><b>Photo No.:</b> 4</p>	<p><b>Date:</b> 10/17/2023</p>

<p><b>Description:</b> View of west end of Union Ave crossing work area. See additional dewatering inspection report. Facing east.</p>

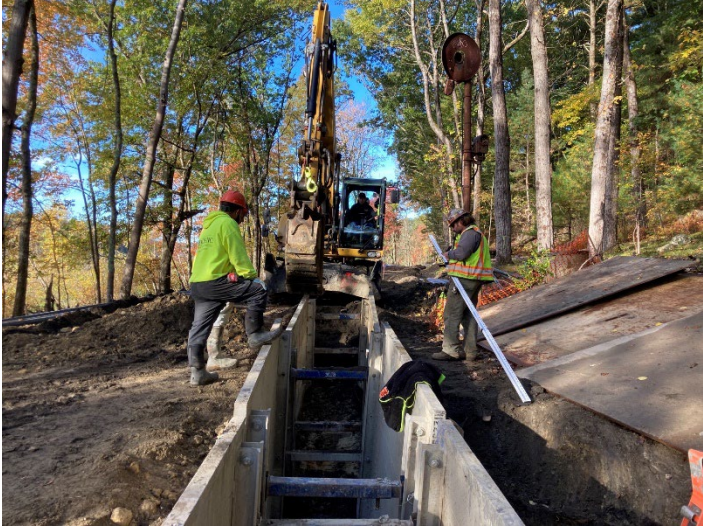
<p align="right"><b>PHOTOGRAPHIC LOG</b></p>	
<p><b>Client Name:</b> Eversource</p>		<p><b>Site Location:</b> Sudbury to Hudson Transmission Reliability Project</p>	<p><b>Town:</b> Sudbury</p>
<p><b>Photo No.:</b> 5</p>	<p><b>Date:</b> 10/17/2023</p>

<p><b>Description:</b> View of Bond installing conduit near MH #26 in segment 14. See additional dewatering inspection report. Facing west.</p>

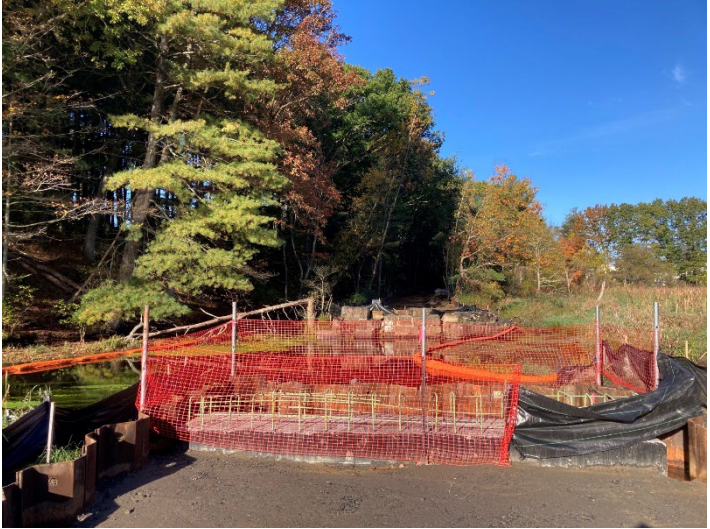
<p align="right"><b>PHOTOGRAPHIC LOG</b></p>	
<p><b>Client Name:</b> Eversource</p>		<p><b>Site Location:</b> Sudbury to Hudson Transmission Reliability Project</p>	<p><b>Town:</b> Sudbury</p>
<p><b>Photo No.:</b> 6</p>	<p><b>Date:</b> 10/17/2023</p>

<p><b>Description:</b> View of bridge 127 from segment 14. Facing west.</p>

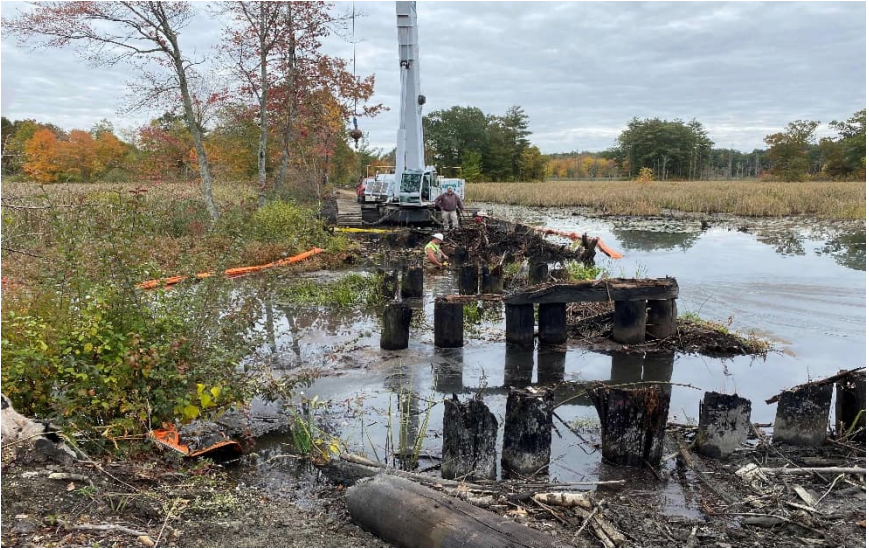
<b>PHOTOGRAPHIC LOG</b>	
Client Name: Eversource		Site Location: Sudbury to Hudson Transmission Reliability Project	Town: Hudson
Photo No.: 1	Date: 10-18-23

Description:  Work area within Fort Meadow Brook between segment 2 and segment 3, bridge 130 former supports removal, looking eastward.

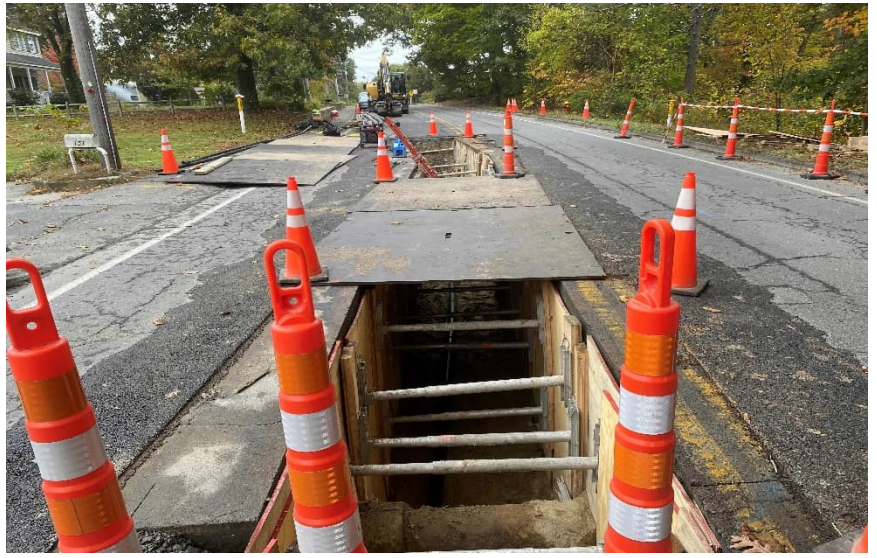
<b>PHOTOGRAPHIC LOG</b>	
Client Name: Eversource		Site Location: Sudbury to Hudson Transmission Reliability Project	Town: Hudson
Photo No.: 4	Date: 10-18-23

Description:  Work area within Forest Avenue, conduit work (Oscar's crew), looking southward.

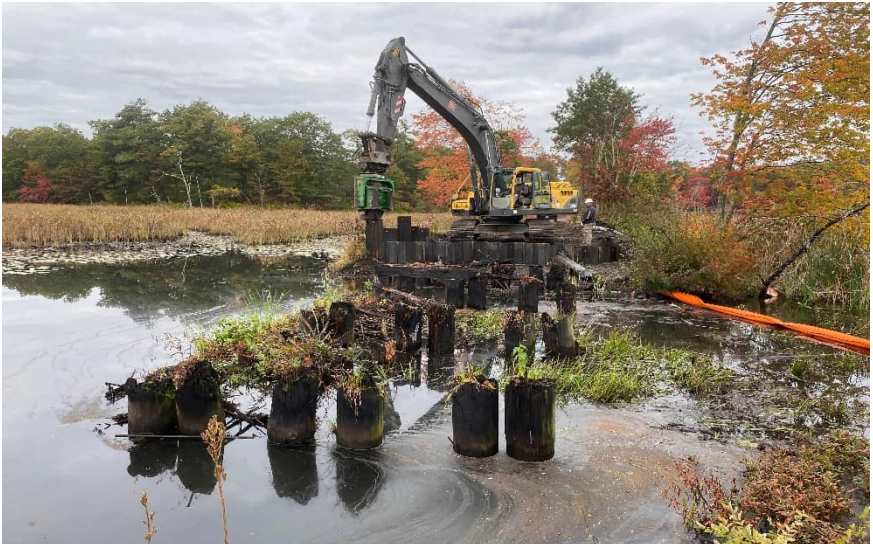
<b>PHOTOGRAPHIC LOG</b>	
Client Name: Eversource		Site Location: Sudbury to Hudson Transmission Reliability Project	Town: Hudson
Photo No.: 6	Date: 10-18-23

Description:  Work area within segment 2 looking from segment 3, bridge 130 sheeting work, looking westward.

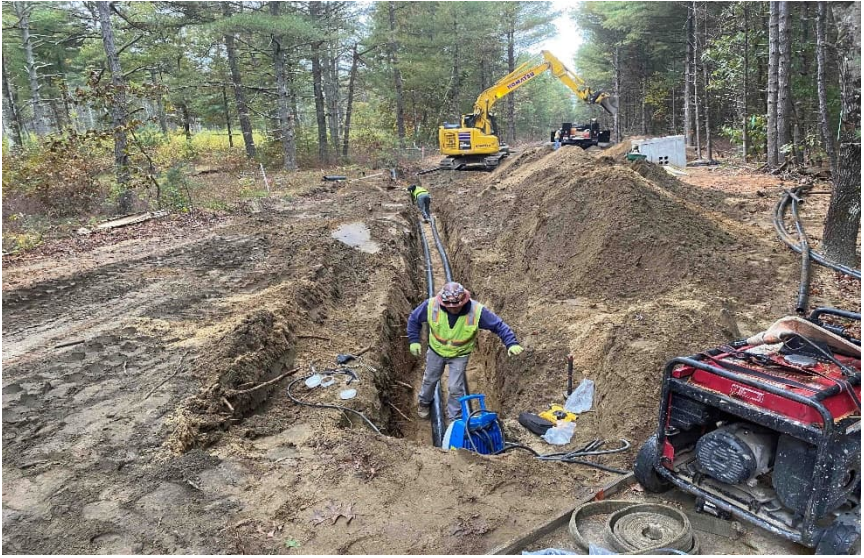
<b>PHOTOGRAPHIC LOG</b>	
Client Name: Eversource		Site Location: Sudbury to Hudson Transmission Reliability Project	Town: Sudbury
Photo No.: 7	Date: 10-18-23

Description:  Conduit work within segment 7 (hand hole to manhole #16), looking westward.

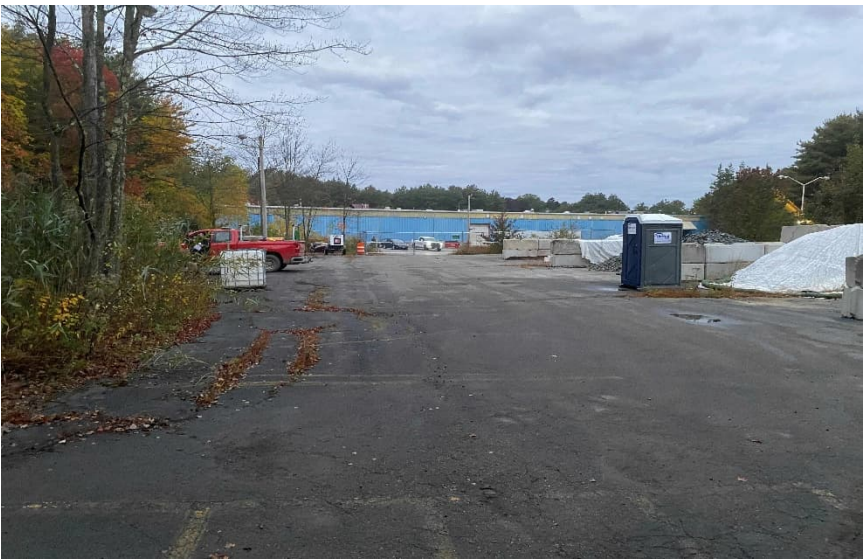
<b>PHOTOGRAPHIC LOG</b>	
Client Name: Eversource		Site Location: Sudbury to Hudson Transmission Reliability Project	Town: Hudson
Photo No.: 8	Date: 10-18-23

Description:  Main Street laydown yard, looking westward.

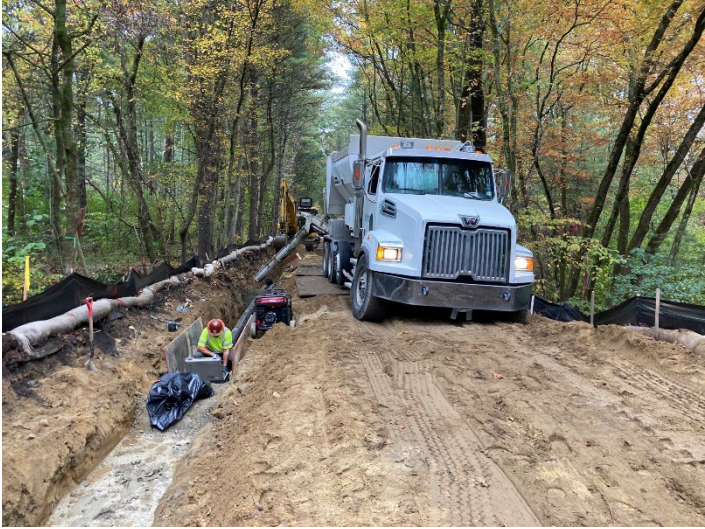
<p align="right"><b>PHOTOGRAPHIC LOG</b></p>	
<p><b>Client Name:</b> Eversource</p>		<p><b>Site Location:</b> Sudbury to Hudson Transmission Reliability Project</p>	<p><b>Town:</b> Sudbury</p>
<p><b>Photo No.:</b> 1</p>	<p><b>Date:</b> 10/18/2023</p>

<p><b>Description:</b> View of Bond installing ductbank in segment 9. Facing east.</p>

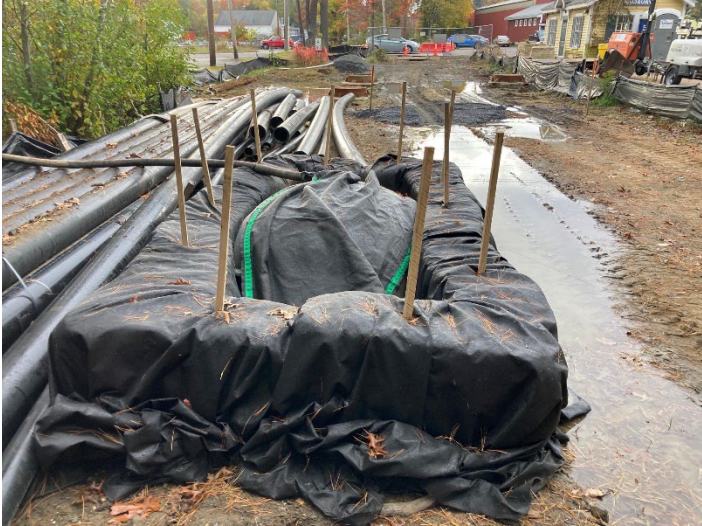
<p><b>PHOTOGRAPHIC LOG</b></p>	
<p><b>Client Name:</b> Eversource</p>		<p><b>Site Location:</b> Sudbury to Hudson Transmission Reliability Project</p>	<p><b>Town:</b> Sudbury</p>
<p><b>Photo No.:</b> 4</p>	<p><b>Date:</b> 10/18/2023</p>

<p><b>Description:</b> View of dewatering set up at Union Ave crossing work area. See additional dewatering inspection report. Facing east.</p>

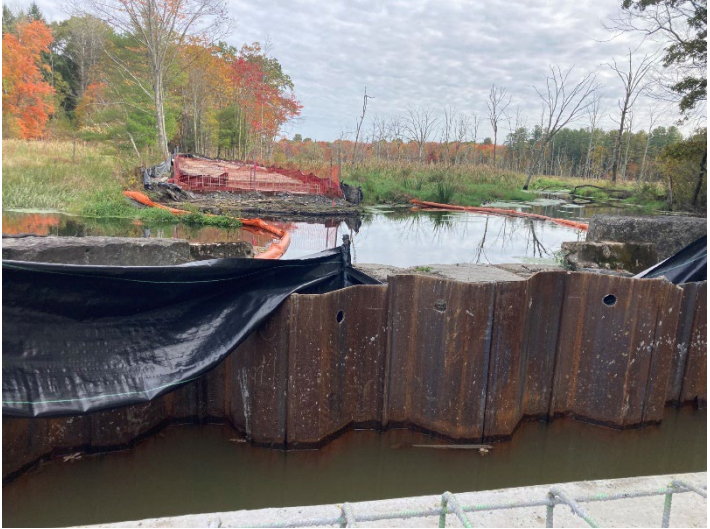
<b>PHOTOGRAPHIC LOG</b>	
<b>Client Name:</b> Eversource		<b>Site Location:</b> Sudbury to Hudson Transmission Reliability Project	<b>Town:</b> Sudbury
<b>Photo No.:</b> 6	<b>Date:</b> 10/18/2023

<b>Description:</b> View of bridge 127 from segment 13. Facing east.

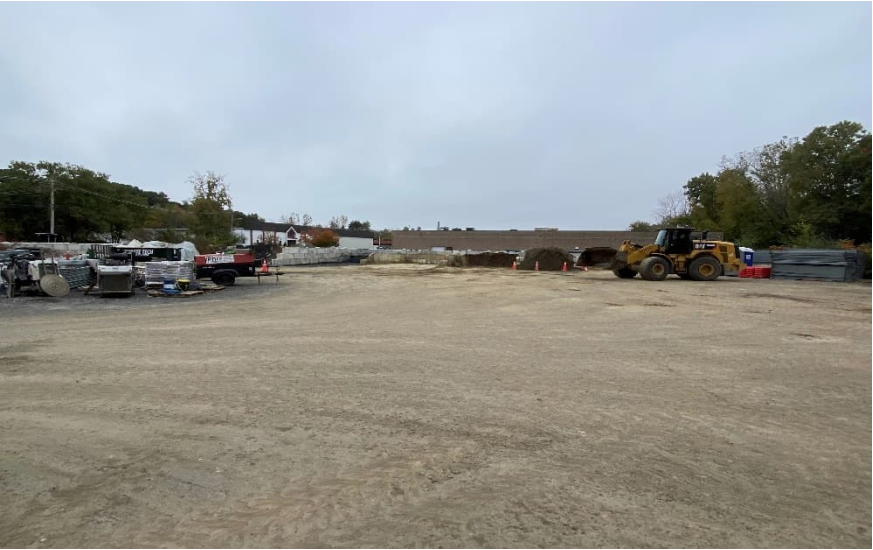
<p>PHOTOGRAPHIC LOG</p>	
<p>Client Name: Eversource</p>		<p>Site Location: Sudbury to Hudson Transmission Reliability Project</p>	<p>Town: Hudson</p>
<p>Photo No.: 1</p>	<p>Date: 10-20-23</p>

<p>Description:</p> <p>Laydown yard at Bonazzoli, looking westward.</p>

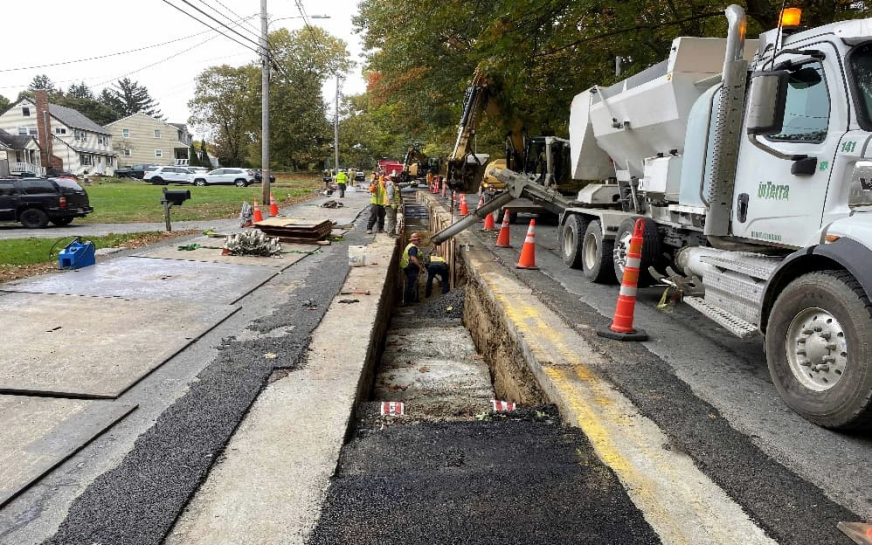
<p>PHOTOGRAPHIC LOG</p>	
<p>Client Name: Eversource</p>		<p>Site Location: Sudbury to Hudson Transmission Reliability Project</p>	<p>Town: Hudson</p>
<p>Photo No.: 2</p>	<p>Date: 10-20-23</p>

<p>Description:</p> <p>Work area within Forest Avenue, conduit work (Jim's crew), looking southward.</p>

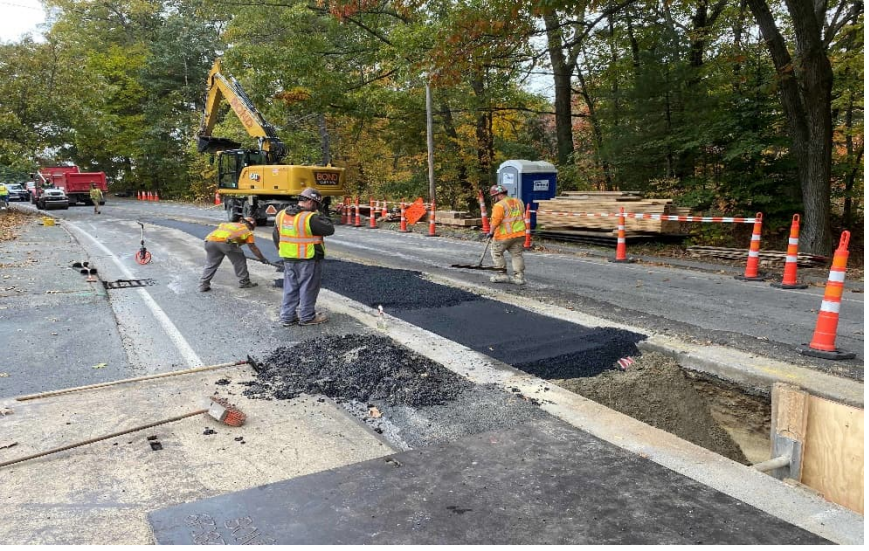
<p>PHOTOGRAPHIC LOG</p>	
<p>Client Name: Eversource</p>		<p>Site Location: Sudbury to Hudson Transmission Reliability Project</p>	<p>Town: Hudson</p>
<p>Photo No.: 4</p>	<p>Date: 10-20-23</p>

<p>Description:</p> <p>Work area within Forest Avenue, conduit work - paving (Oscar's crew), looking southward.</p>

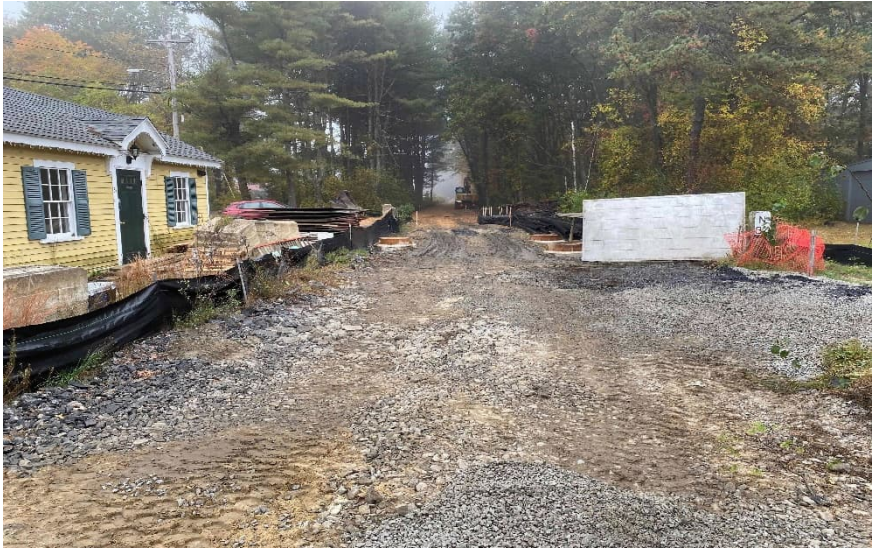
<p align="center">PHOTOGRAPHIC LOG</p>	
<p>Client Name: Eversource</p>		<p>Site Location: Sudbury to Hudson Transmission Reliability Project</p>	<p>Town: Sudbury</p>
<p>Photo No.: 5</p>	<p>Date: 10-20-23</p>

<p>Description:</p> <p>Work area within segment 11, manhole area, existing erosion control, looking westward.</p>

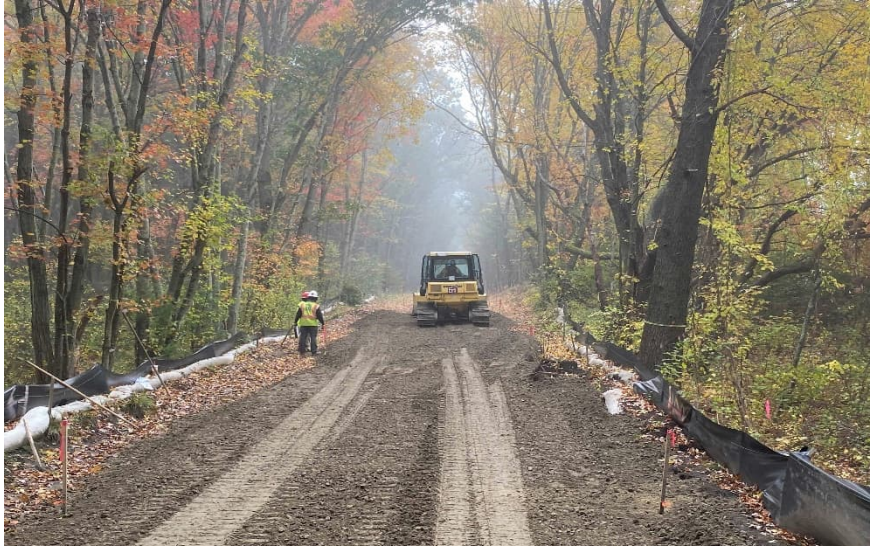
<p align="center">PHOTOGRAPHIC LOG</p>	
<p>Client Name: Eversource</p>		<p>Site Location: Sudbury to Hudson Transmission Reliability Project</p>	<p>Town: Sudbury</p>
<p>Photo No.: 6</p>	<p>Date: 10-20-23</p>

<p>Description:</p> <p>ET&amp;L conducting grading within segment 11 (Sta# 577+50), existing erosion control, looking eastward.</p>

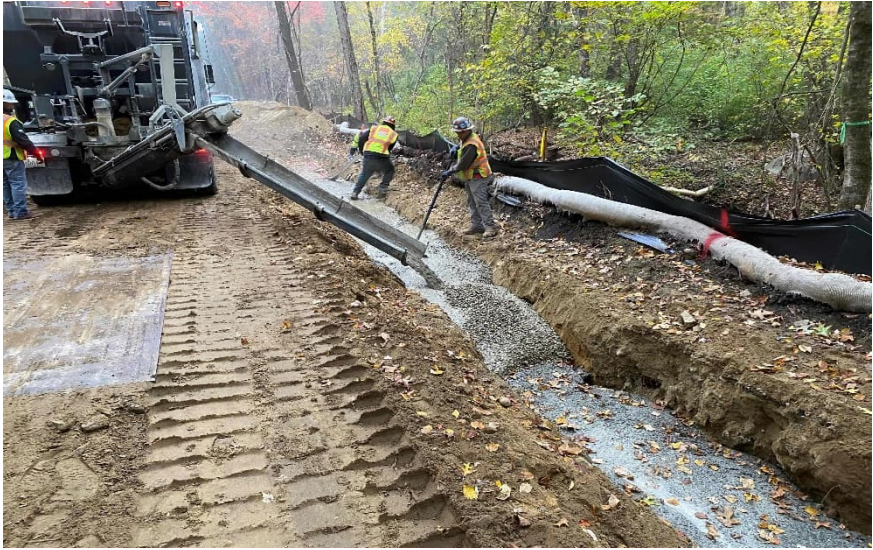
<p>PHOTOGRAPHIC LOG</p>	
<p>Client Name: Eversource</p>		<p>Site Location: Sudbury to Hudson Transmission Reliability Project</p>	<p>Town: Sudbury</p>
<p>Photo No.: 7</p>	<p>Date: 10-20-23</p>

<p>Description:</p> <p>Work area within Segment 9, conduit work – placement of flowable fill, existing erosion control, looking westward.</p>

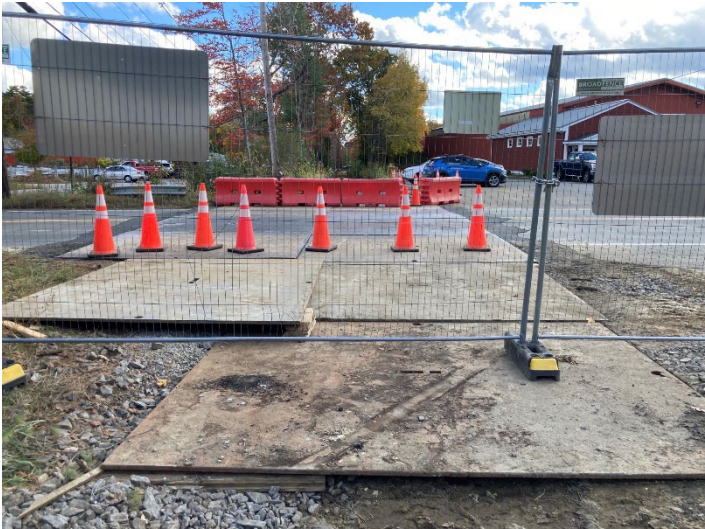
<b>PHOTOGRAPHIC LOG</b>	
<b>Client Name:</b> Eversource		<b>Site Location:</b> Sudbury to Hudson Transmission Reliability Project	<b>Town:</b> Sudbury
<b>Photo No.:</b> 4	<b>Date:</b> 10-19-2023

<b>Description:</b> View of Bond's work area at Union Ave crossing. Dewatering operation has ceased. Facing east.

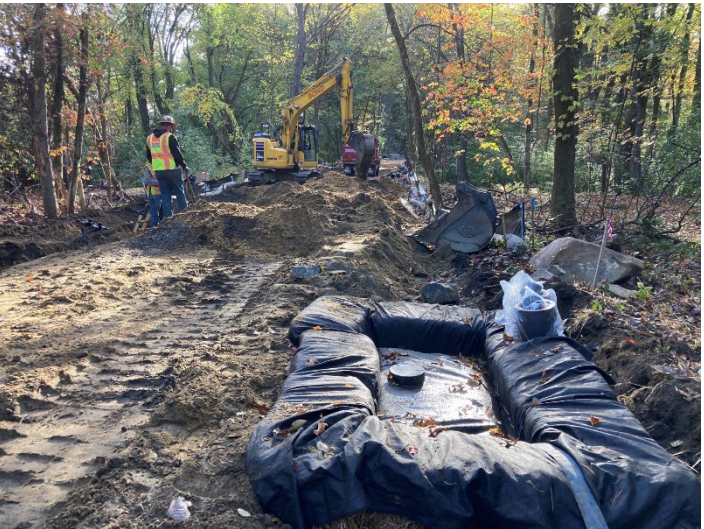
<b>PHOTOGRAPHIC LOG</b>		
<b>Client Name:</b> Eversource		<b>Site Location:</b> Sudbury to Hudson Transmission Reliability Project		<b>Town:</b> Sudbury
<b>Photo No.:</b> 2	<b>Date:</b> 10/16/2023

<b>Description:</b> View of Bond working and of dewatering controls (straw bale corral with filter fabric and silt bag). Facing east.

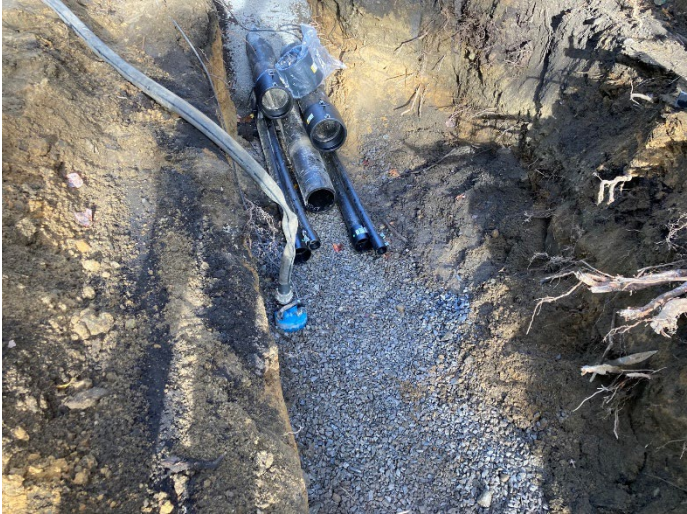
<b>PHOTOGRAPHIC LOG</b>	
<b>Client Name:</b> Eversource		<b>Site Location:</b> Sudbury to Hudson Transmission Reliability Project	<b>Town:</b> Sudbury
<b>Photo No.:</b> 3	<b>Date:</b> 10/16/2023

<b>Description:</b> View of pump in trench. Unable to visualize water prior to treatment. Facing west.

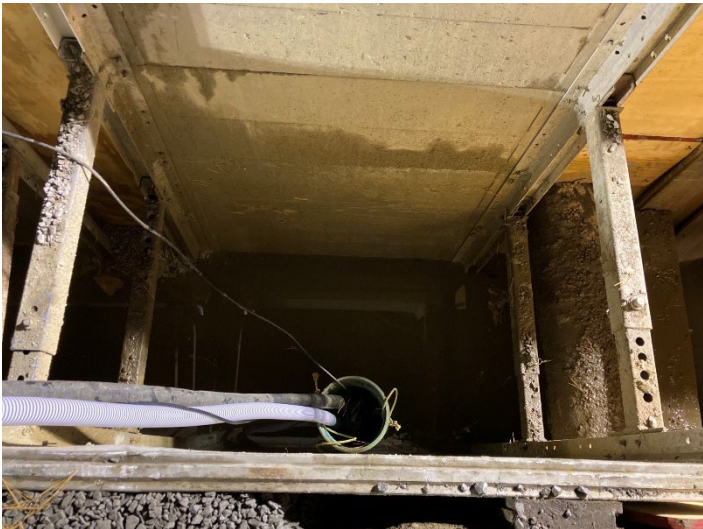
<b>PHOTOGRAPHIC LOG</b>		
<b>Client Name:</b> Eversource		<b>Site Location:</b> Sudbury to Hudson Transmission Reliability Project		<b>Town:</b> Sudbury
<b>Photo No.:</b> 2	<b>Date:</b> 10/16/2023

<b>Description:</b> View of pump in trench. Water appeared slightly turbid prior to treatment.

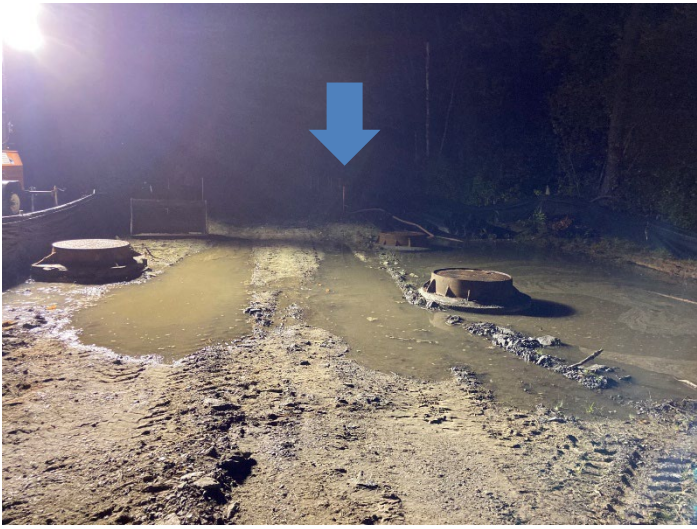
<b>PHOTOGRAPHIC LOG</b>		
<b>Client Name:</b> Eversource		<b>Site Location:</b> Sudbury to Hudson Transmission Reliability Project		<b>Town:</b> Sudbury
<b>Photo No.:</b> 4	<b>Date:</b> 10/16/2023

<b>Description:</b> View of discharge from dewatering controls (blue arrow indicates location of controls). Discharge appeared slightly turbid. Turbidity reading was above 50 NTUs, but discharge did not appear to be leaving project boundary. Facing west.

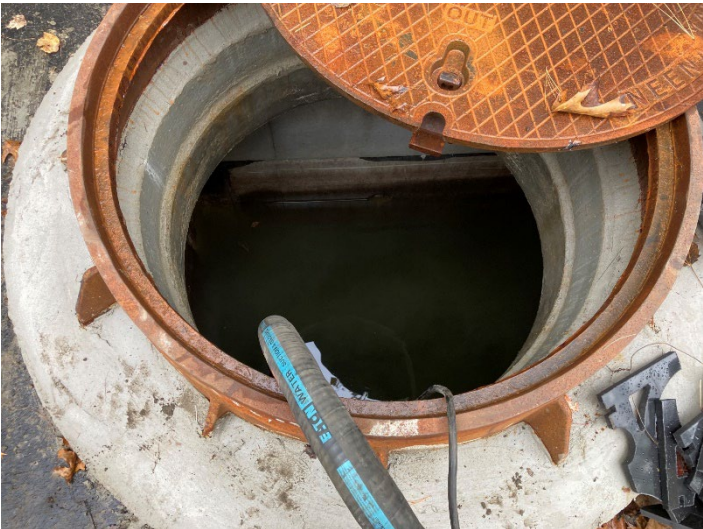
<b>PHOTOGRAPHIC LOG</b>	
<b>Client Name:</b> Eversource		<b>Site Location:</b> Sudbury to Hudson Transmission Reliability Project	<b>Town:</b> Sudbury
<b>Photo No.:</b> 2	<b>Date:</b> 10/16/2023

<b>Description:</b> View of pump in manhole. Water appeared slightly turbid prior to treatment.

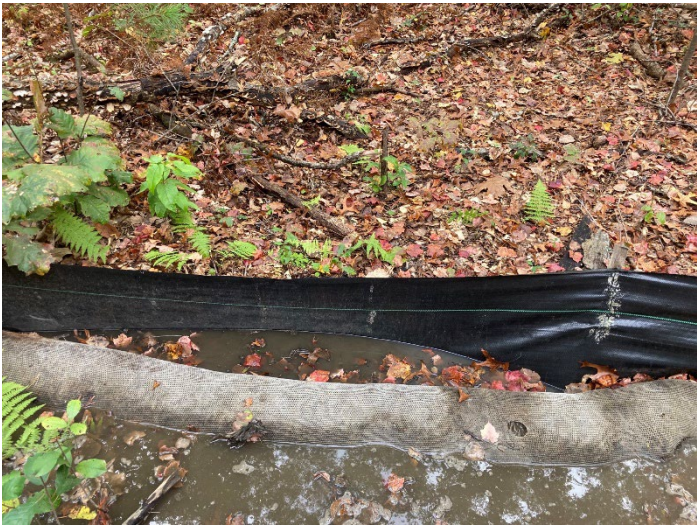
<b>PHOTOGRAPHIC LOG</b>		
<b>Client Name:</b> Eversource		<b>Site Location:</b> Sudbury to Hudson Transmission Reliability Project		<b>Town:</b> Sudbury
<b>Photo No.:</b> 4	<b>Date:</b> 10/16/2023

<b>Description:</b> View of discharge point from project (approximately Sta. #737+50). Discharge appeared slightly turbid. Turbidity reading was above 50 NTUs, but discharge did not reach wetlands. Facing south.

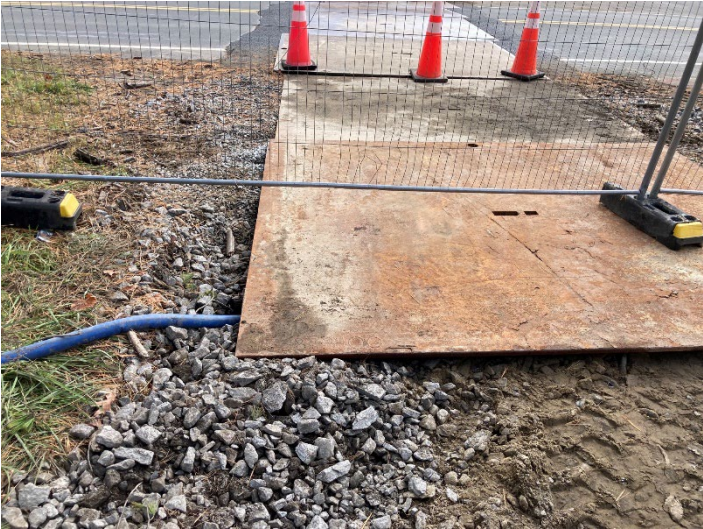
<b>PHOTOGRAPHIC LOG</b>		
<b>Client Name:</b> Eversource		<b>Site Location:</b> Sudbury to Hudson Transmission Reliability Project		<b>Town:</b> Sudbury
<b>Photo No.:</b> 2	<b>Date:</b> 10/17/2023

<b>Description:</b> View of pump in trench. Unable to visualize water prior to treatment due to plates. Facing east.
