**Weekly Environmental Compliance Summary**

**Sudbury to Hudson Transmission Reliability Project (USEPA Tracking # MAR1003UW)**

Sudbury, Hudson, and Stow, MA

Week of: October 16, 2023 to October 20, 2023

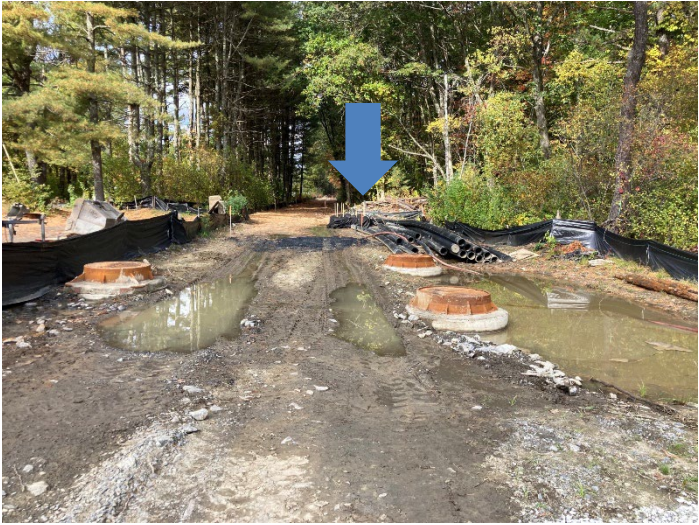
<b>PHOTOGRAPHIC LOG</b>		
<b>Client Name:</b> Eversource		<b>Site Location:</b> Sudbury to Hudson Transmission Reliability Project		<b>Town:</b> Sudbury
<b>Photo No.:</b> 4	<b>Date:</b> 10/17/2023

<b>Description:</b> View of discharge from dewatering controls (blue arrow indicates location of controls). Discharge appeared turbid. Turbidity reading was above 50 NTUs, but discharge did not appear to be leaving project boundary. Facing west.

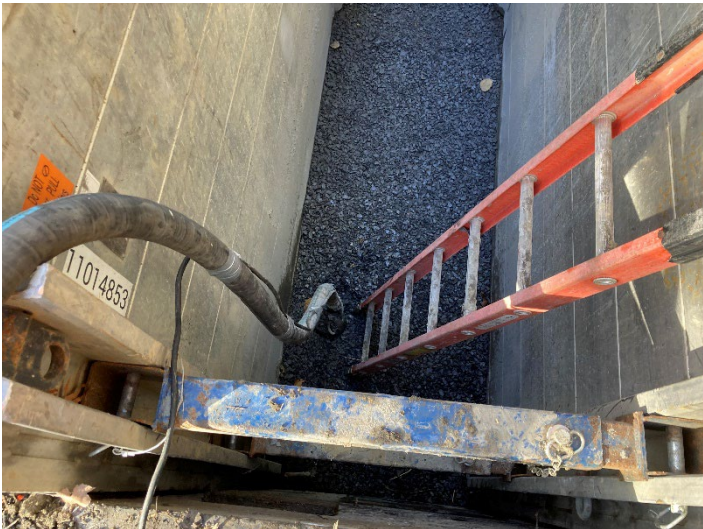
<b>PHOTOGRAPHIC LOG</b>		
<b>Client Name:</b> Eversource		<b>Site Location:</b> Sudbury to Hudson Transmission Reliability Project		<b>Town:</b> Sudbury
<b>Photo No.:</b> 2	<b>Date:</b> 10/17/2023

<b>Description:</b> View of pump in trench. Unable to visualize water prior to treatment.

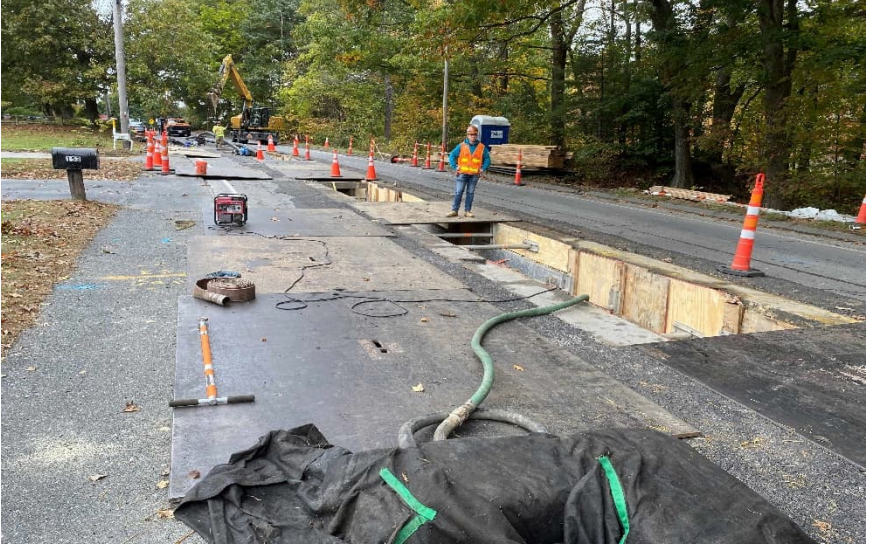
<b>PHOTOGRAPHIC LOG</b>	
Client Name: Eversource		Site Location: Sudbury to Hudson Transmission Reliability Project	Town: Hudson
Photo No.: 3	Date: 10/18/2023

Description: Forest Avenue. View of dewatering operation (pumping at far end of area), looking southward.

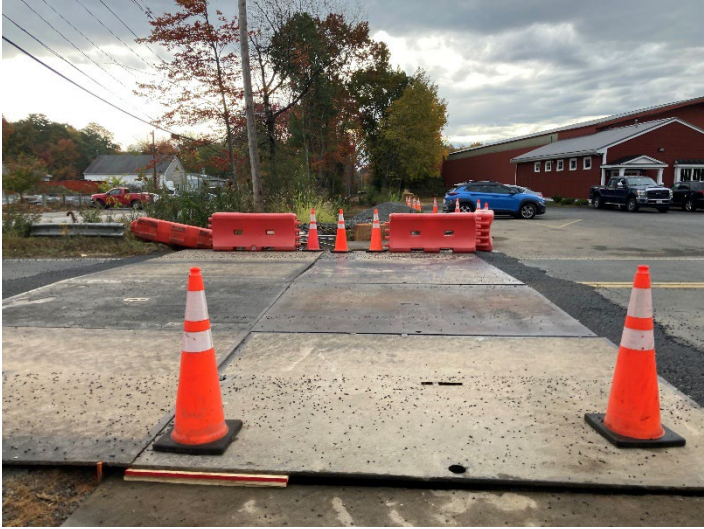
<b>PHOTOGRAPHIC LOG</b>		
<b>Client Name:</b> Eversource		<b>Site Location:</b> Sudbury to Hudson Transmission Reliability Project		<b>Town:</b> Sudbury
<b>Photo No.:</b> 1	<b>Date:</b> 10/18/2023

<b>Description:</b> View of Bond's work area at Union Ave crossing. Facing east.

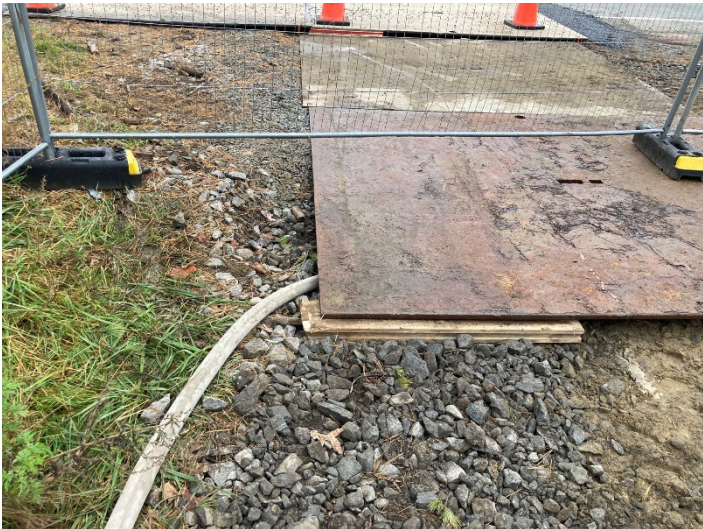
<b>PHOTOGRAPHIC LOG</b>		
<b>Client Name:</b> Eversource		<b>Site Location:</b> Sudbury to Hudson Transmission Reliability Project		<b>Town:</b> Sudbury
<b>Photo No.:</b> 2	<b>Date:</b> 10/18/2023

<b>Description:</b> View of pump in trench. Unable to visualize water prior to treatment due to plates. Facing east.

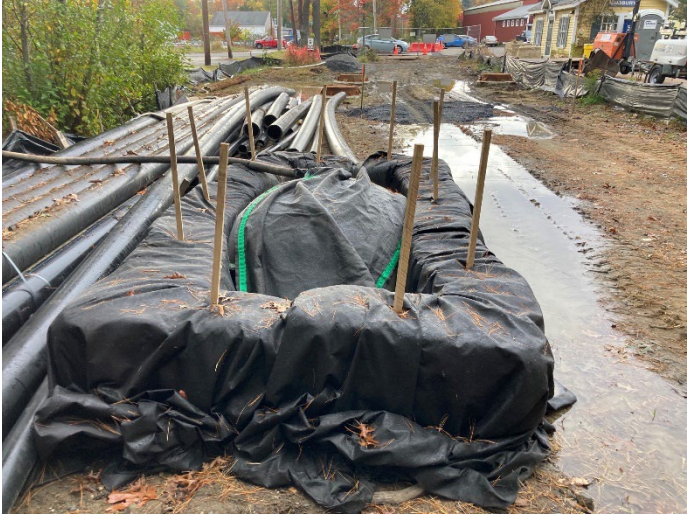
<b>PHOTOGRAPHIC LOG</b>		
<b>Client Name:</b> Eversource		<b>Site Location:</b> Sudbury to Hudson Transmission Reliability Project		<b>Town:</b> Sudbury
<b>Photo No.:</b> 3	<b>Date:</b> 10/18/2023

<b>Description:</b> View of dewatering controls (straw bale corral with filter fabric and silt bag). New silt bag was installed overtop of previous bag that was full. Facing east.

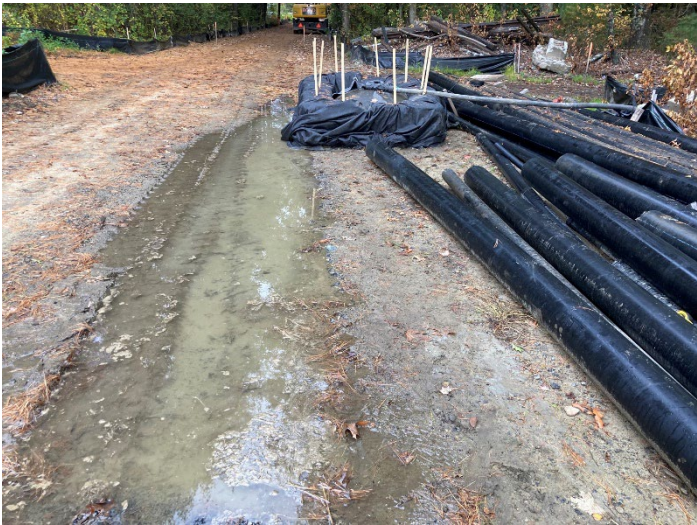
<b>PHOTOGRAPHIC LOG</b>		
<b>Client Name:</b> Eversource		<b>Site Location:</b> Sudbury to Hudson Transmission Reliability Project		<b>Town:</b> Sudbury
<b>Photo No.:</b> 4	<b>Date:</b> 10/18/2023

<b>Description:</b> View of discharge from dewatering controls. Discharge appeared slightly turbid. Turbidity reading was above 50 NTUs, but discharge did not appear to be leaving project boundary. Facing west.

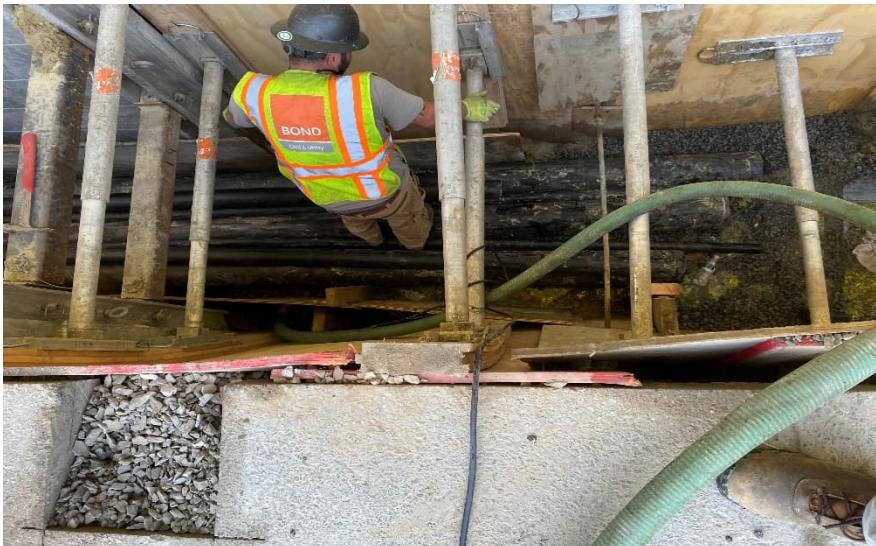
<b>PHOTOGRAPHIC LOG</b>	
Client Name: Eversource		Site Location: Sudbury to Hudson Transmission Reliability Project	Town: Hudson
Photo No.: 1	Date: 10/19/2023

Description: View of area being pumped at Forest Avenue (area near manhole #4).

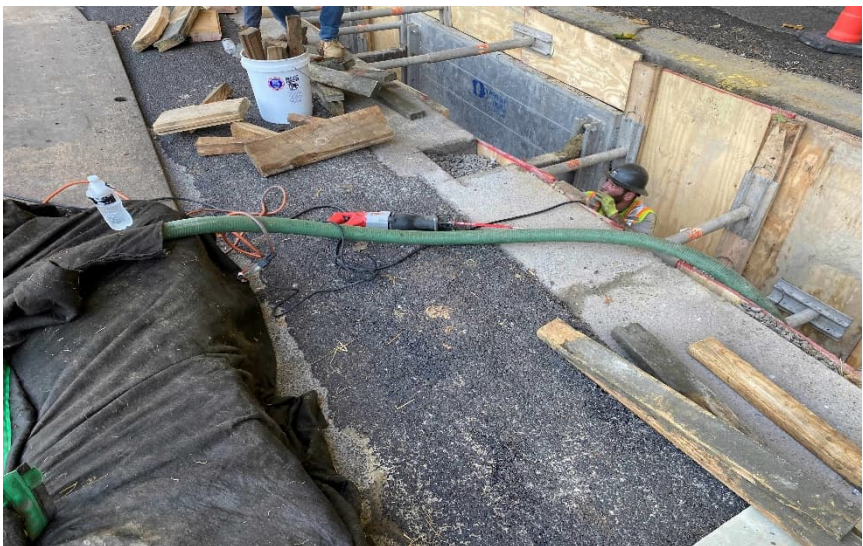
<b>PHOTOGRAPHIC LOG</b>	
Client Name: Eversource		Site Location: Sudbury to Hudson Transmission Reliability Project	Town: Hudson
Photo No.: 2	Date: 10/19/2023

Description: Forest Avenue. View of dewatering operation, looking northward.

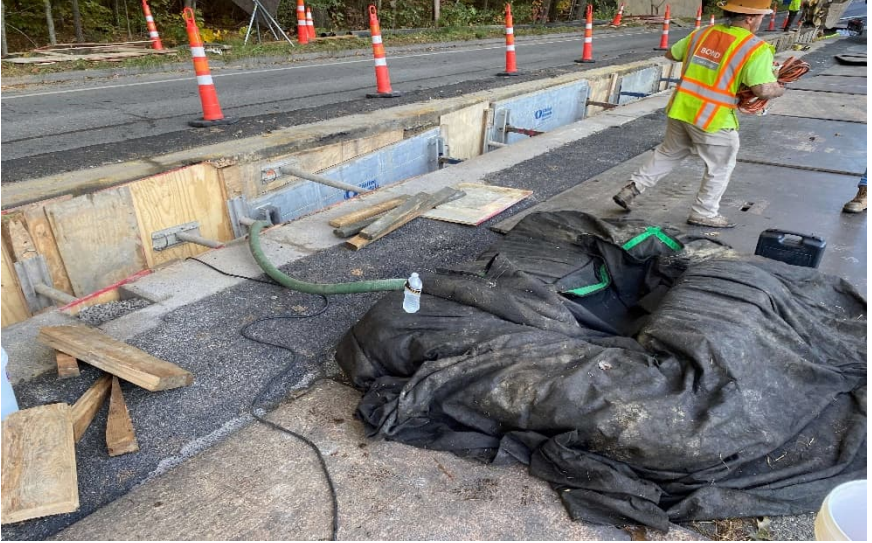
<b>PHOTOGRAPHIC LOG</b>	
Client Name: Eversource		Site Location: Sudbury to Hudson Transmission Reliability Project	Town: Hudson
Photo No.: 3	Date: 10/19/2023

Description: Forest Avenue. View of dewatering operation (pumping at far end of area), looking northward.

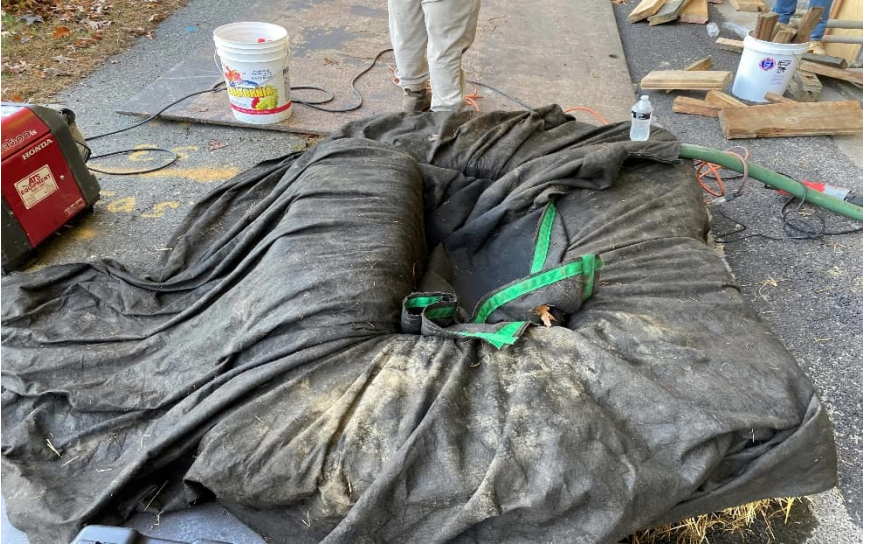
<b>PHOTOGRAPHIC LOG</b>	
Client Name: Eversource		Site Location: Sudbury to Hudson Transmission Reliability Project	Town: Hudson
Photo No.: 4	Date: 10/19/2023

Description: Forest Avenue. View of dewatering operation (corral/bag).

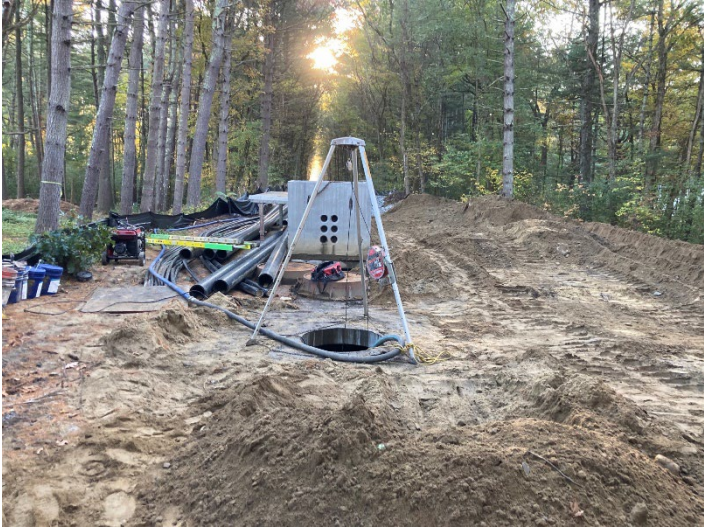
<b>PHOTOGRAPHIC LOG</b>	
<b>Client Name:</b> Eversource		<b>Site Location:</b> Sudbury to Hudson Transmission Reliability Project	<b>Town:</b> Sudbury
<b>Photo No.:</b> 1	<b>Date:</b> 10/19/2023

<b>Description:</b> View of Bond's work area at MH #18 in segment 9. Facing east.

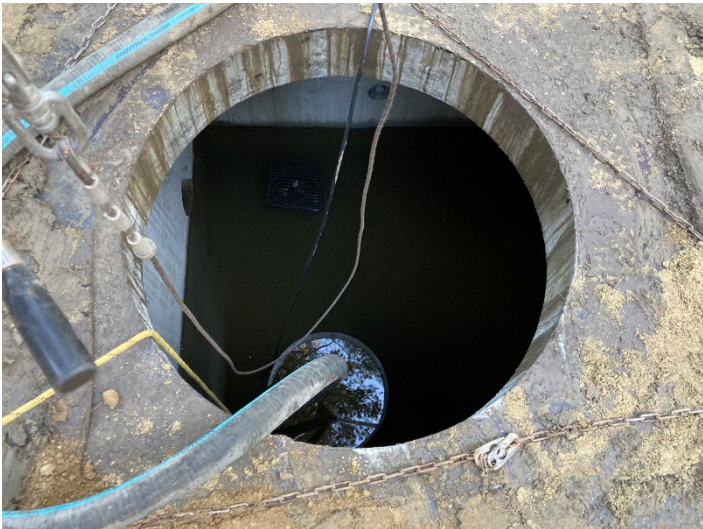
<b>PHOTOGRAPHIC LOG</b>	
<b>Client Name:</b> Eversource		<b>Site Location:</b> Sudbury to Hudson Transmission Reliability Project	<b>Town:</b> Sudbury
<b>Photo No.:</b> 2	<b>Date:</b> 10/19/2023

<b>Description:</b> View of pump in manhole. Water appeared slightly turbid prior to treatment.

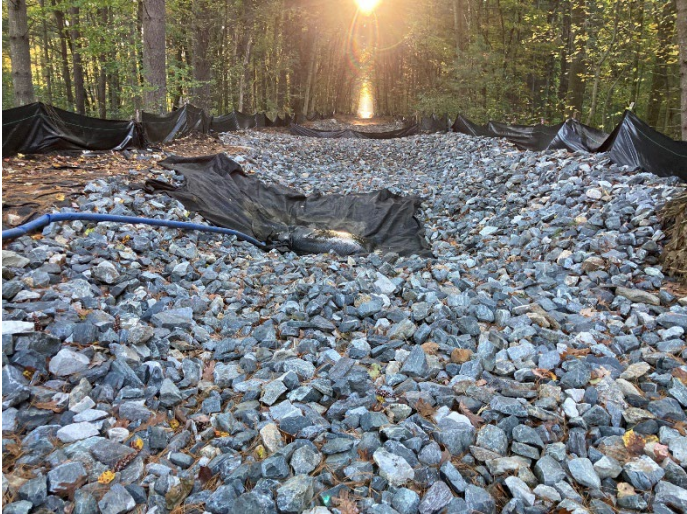
<b>PHOTOGRAPHIC LOG</b>		
<b>Client Name:</b> Eversource		<b>Site Location:</b> Sudbury to Hudson Transmission Reliability Project		<b>Town:</b> Sudbury
<b>Photo No.:</b> 3	<b>Date:</b> 10/19/2023

<b>Description:</b> View of dewatering controls. Filter fabric and silt bag was placed in rock basin with approval from Lori Capone (Sudbury CC). Facing east.

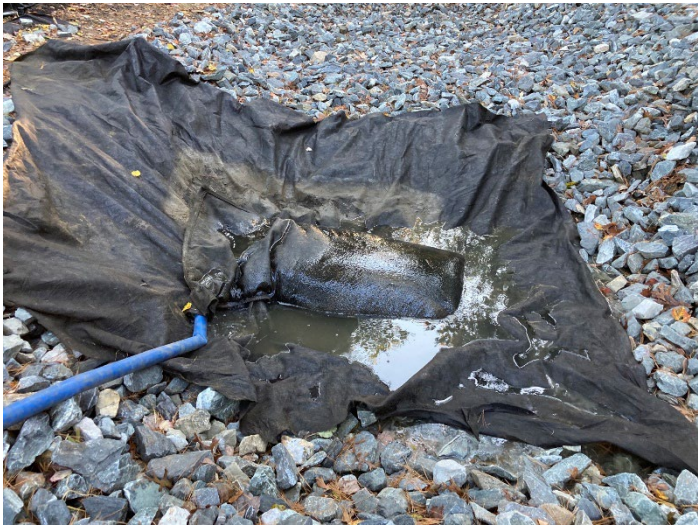
<b>PHOTOGRAPHIC LOG</b>		
<b>Client Name:</b> Eversource		<b>Site Location:</b> Sudbury to Hudson Transmission Reliability Project		<b>Town:</b> Sudbury
<b>Photo No.:</b> 4	<b>Date:</b> 10/19/2023

<b>Description:</b> Additional view of dewatering controls (filter fabric and silt bag in rock basin). Sample was collected from outside the silt bag. Turbidity reading was above 50 NTUs, but discharge did not appear to be leaving the project. Facing east.
