**Weekly Environmental Compliance Summary**

**Sudbury to Hudson Transmission Reliability Project (USEPA Tracking # MAR1003UW)**

Sudbury, Hudson, and Stow, MA

Week of: September 18, 2023 to September 22, 2023

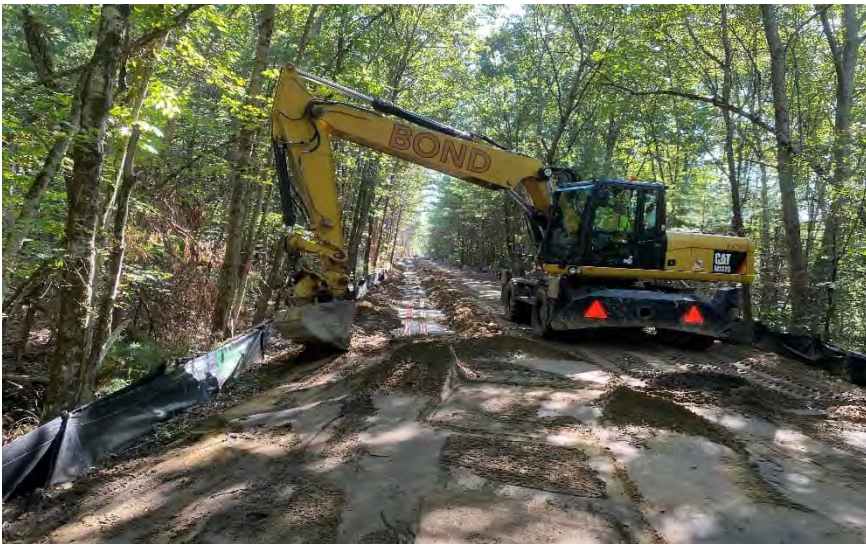
<b>PHOTOGRAPHIC LOG</b>	
Client Name: Eversource		Site Location: Sudbury to Hudson Transmission Reliability Project	
Town: Hudson			
Photo No.: 6	Date: 9-21-23

Description:  Work area within segment 6 backfill work, existing erosion control, looking eastward.

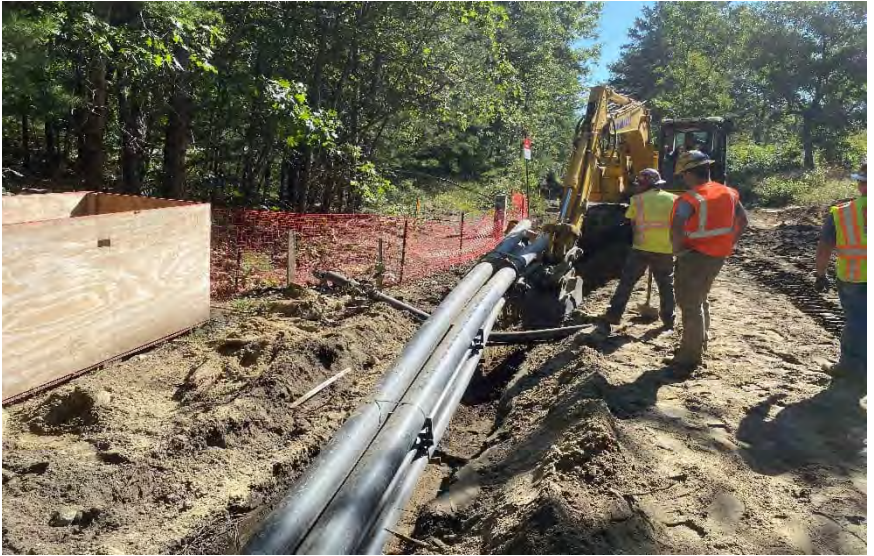
<h2 style="text-align: center;">PHOTOGRAPHIC LOG</h2>	
Client Name: Eversource		Site Location: Sudbury to Hudson Transmission Reliability Project	
Photo No.: 7      Date: 9-21-23		Town: Hudson	
Description:  Work area within segment 6 conduit work, existing erosion control, looking eastward.

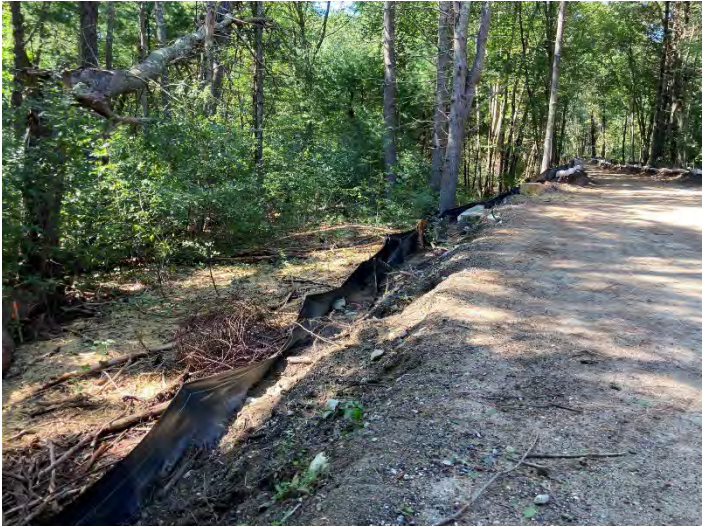
<b>PHOTOGRAPHIC LOG</b>	
Client Name: Eversource		Site Location: Sudbury to Hudson Transmission Reliability Project	
Photo No.: 2		Date: 9/21/2023	
Description: View of area of segment 9 where invasive vegetation removal has been completed and seed and straw mulch have been applied. Facing west.

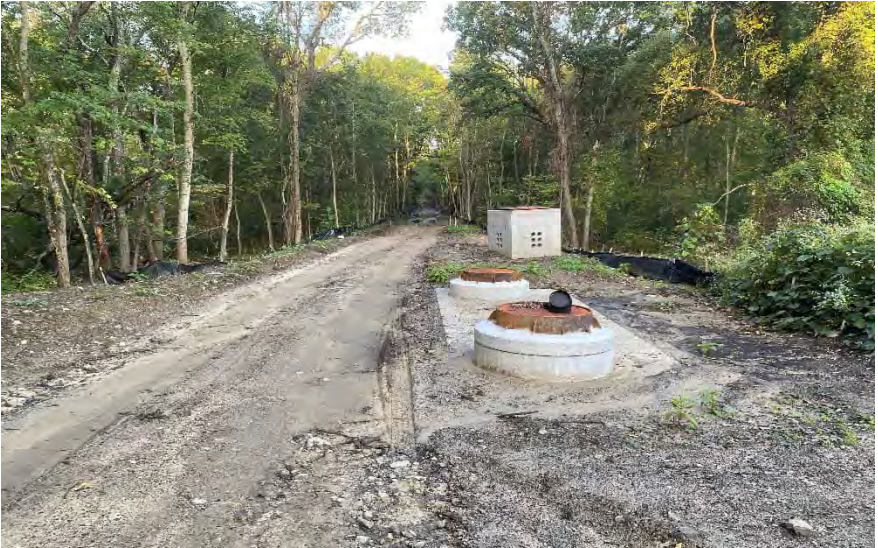
<b>PHOTOGRAPHIC LOG</b>	
Client Name: Eversource		Site Location: Sudbury to Hudson Transmission Reliability Project	
Photo No.: 7		Date: 9-22-23	
Description:  Work area within Segment 14, existing erosion control, looking westward.

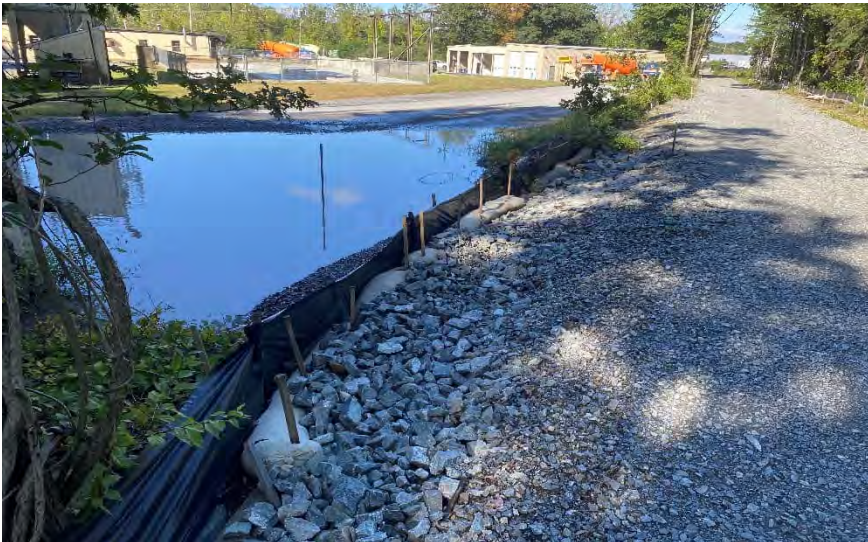
<b>PHOTOGRAPHIC LOG</b>	
Client Name: Eversource		Site Location: Sudbury to Hudson Transmission Reliability Project	
Photo No.: 1		Date: 9-19-23	
Description:  Work area within segment 3, existing erosion control, looking westward.

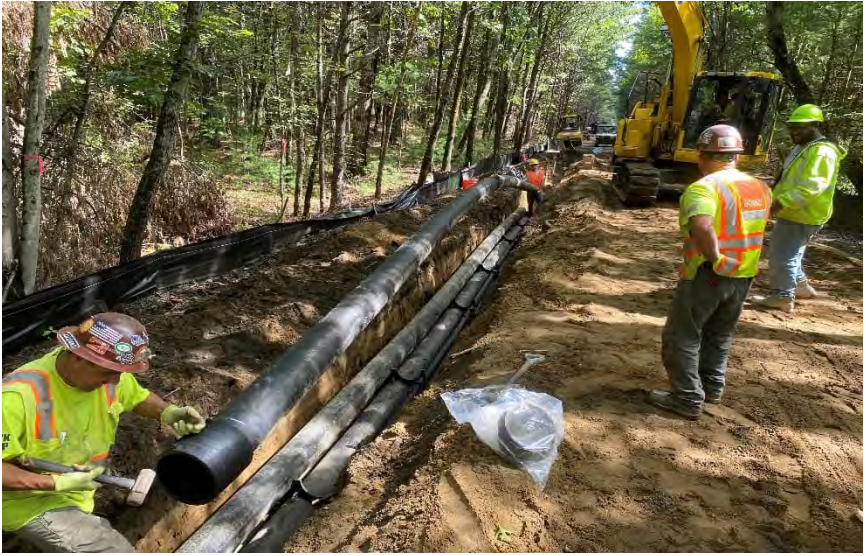
<b>PHOTOGRAPHIC LOG</b>	
Client Name: Eversource		Site Location: Sudbury to Hudson Transmission Reliability Project	
Photo No.: 3      Date: 9-19-23		Town: Hudson	
Description:  Work area within segment 6, conduit work, existing erosion control, looking eastward.

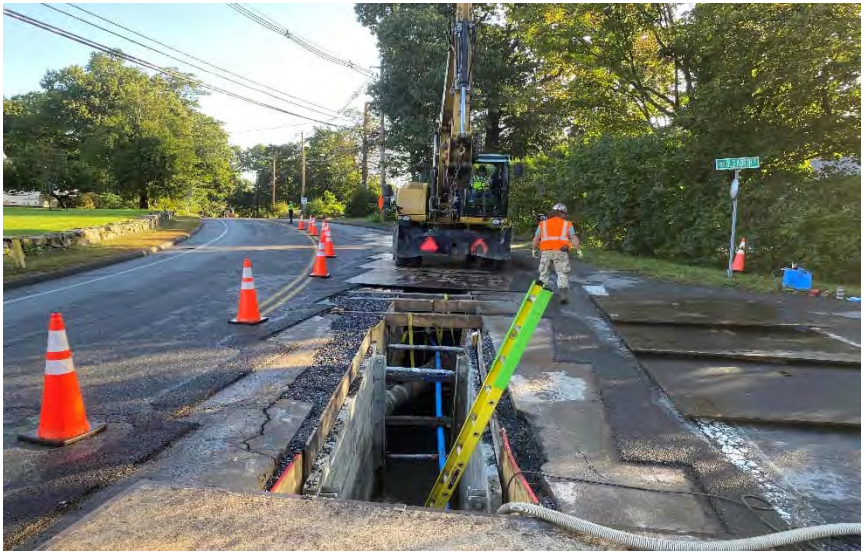
<b>PHOTOGRAPHIC LOG</b>	
Client Name: Eversource		Site Location: Sudbury to Hudson Transmission Reliability Project	
Photo No.: 4      Date: 9-19-23		Town: Hudson	
Description:  Conduit work within Forest Avenue (Marisa's crew), looking northward.

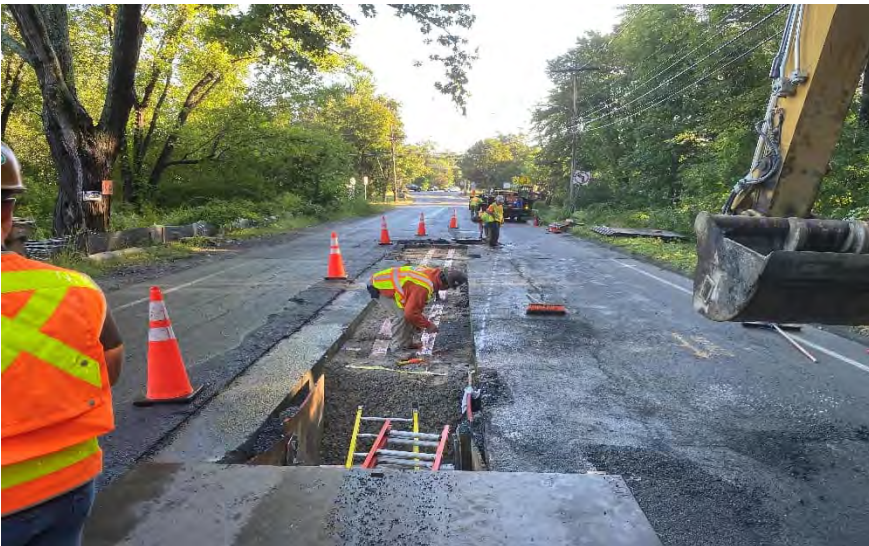
<b>PHOTOGRAPHIC LOG</b>	
Client Name: Eversource		Site Location: Sudbury to Hudson Transmission Reliability Project	
Town: Hudson			
Photo No.: 5	Date: 9-19-23

Description:  Conduit work within Forest Avenue (Oscar's crew), looking northward.

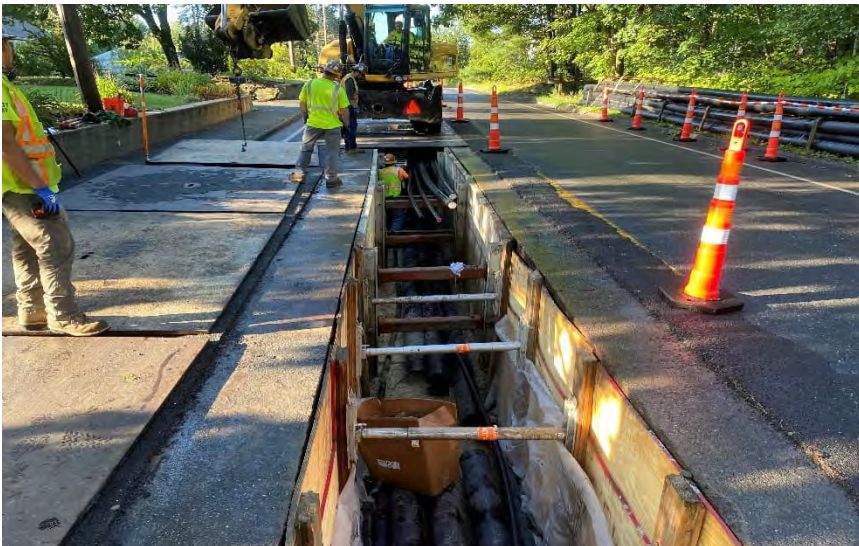
<b>PHOTOGRAPHIC LOG</b>	
Client Name: Eversource		Site Location: Sudbury to Hudson Transmission Reliability Project	
Town: Hudson			
Photo No.: 6	Date: 9-19-23

Description:  Conduit work within Forest Avenue (Jim's crew), looking southward.

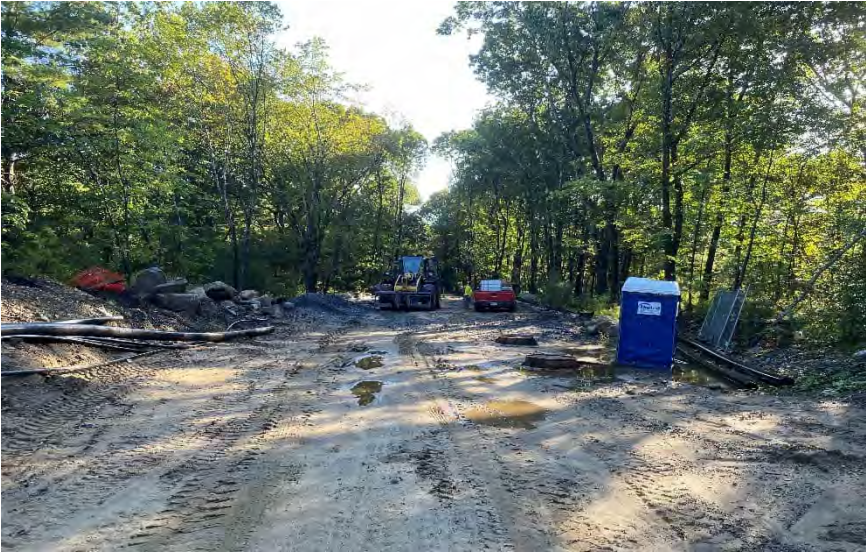
<b>PHOTOGRAPHIC LOG</b>	
Client Name: Eversource		Site Location: Sudbury to Hudson Transmission Reliability Project	
Town: Hudson			
Photo No.: 7	Date: 9-19-23

Description:  Work area within Segment 1, manhole #5 area, looking eastward.

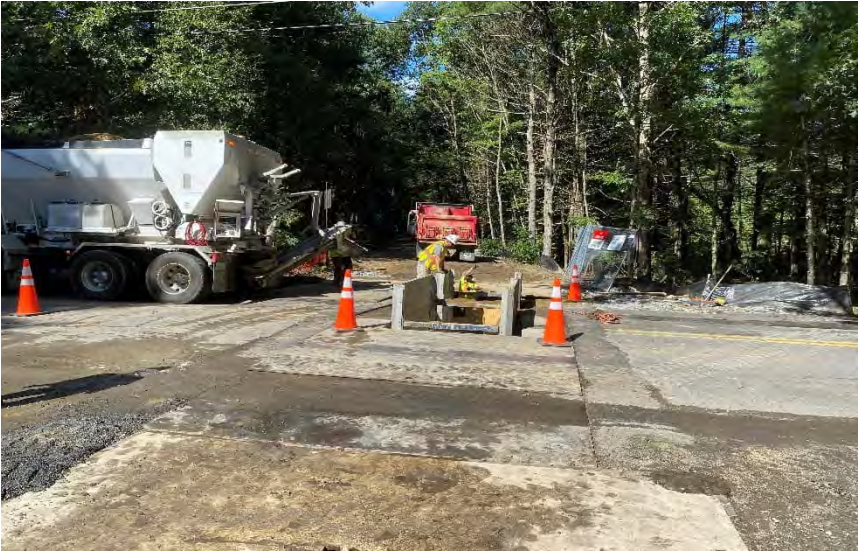
<b>PHOTOGRAPHIC LOG</b>	
Client Name: Eversource		Site Location: Sudbury to Hudson Transmission Reliability Project	
Town: Sudbury			
Photo No.: 8	Date: 9-19-23

Description:  Conduit work within Dutton Road, looking westward.

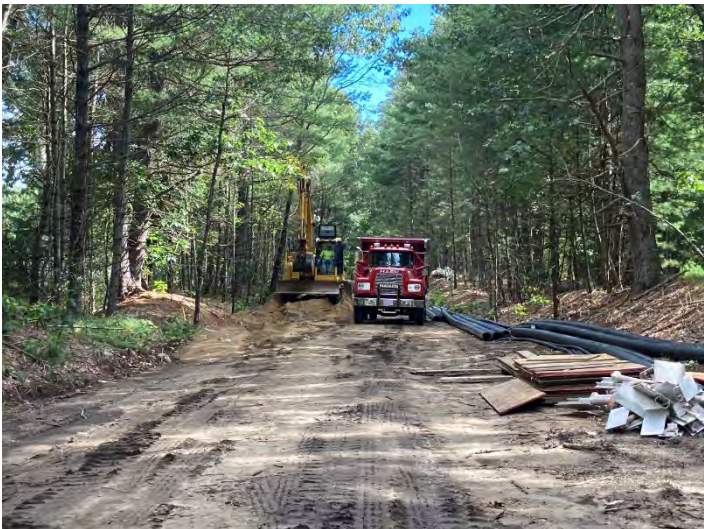
<b>PHOTOGRAPHIC LOG</b>			
Client Name: Eversource		Site Location: Sudbury to Hudson Transmission Reliability Project		Town: Sudbury	
Photo No.: 2	Date: 9-19-2023

Description: View of Bond working at west end of segment 9. Facing east.

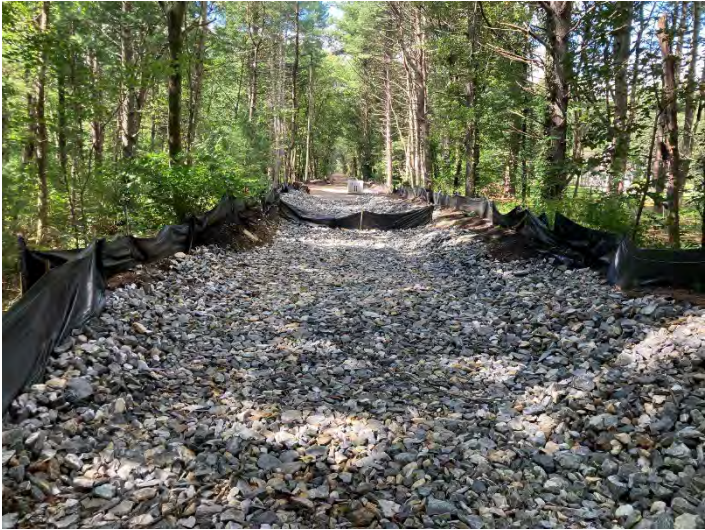
<b>PHOTOGRAPHIC LOG</b>	
Client Name: Eversource		Site Location: Sudbury to Hudson Transmission Reliability Project	
Town: Sudbury			
Photo No.: 3	Date: 9-19-2023

Description: View of area above collapsed culvert in segment 9. Facing west.

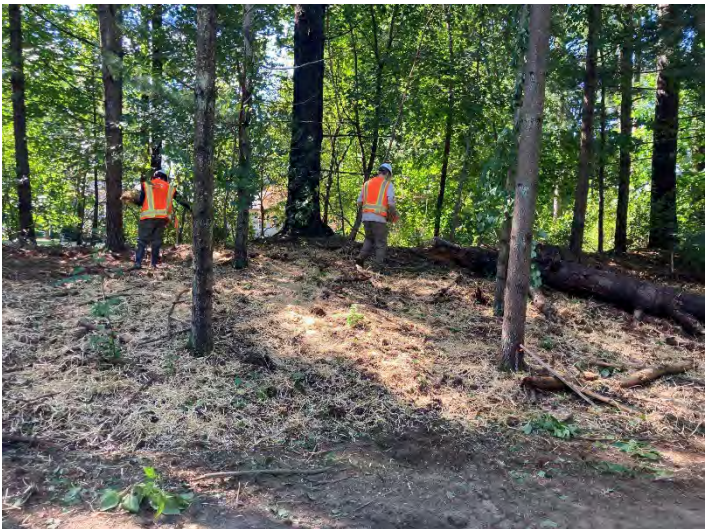
<b>PHOTOGRAPHIC LOG</b>	
Client Name: Eversource		Site Location: Sudbury to Hudson Transmission Reliability Project	
Town: Sudbury			
Photo No.: 4	Date: 9-19-2023

Description: View of SWCA invasive management crew applying seed and straw to area where removal work is completed in segment 10. Facing south.

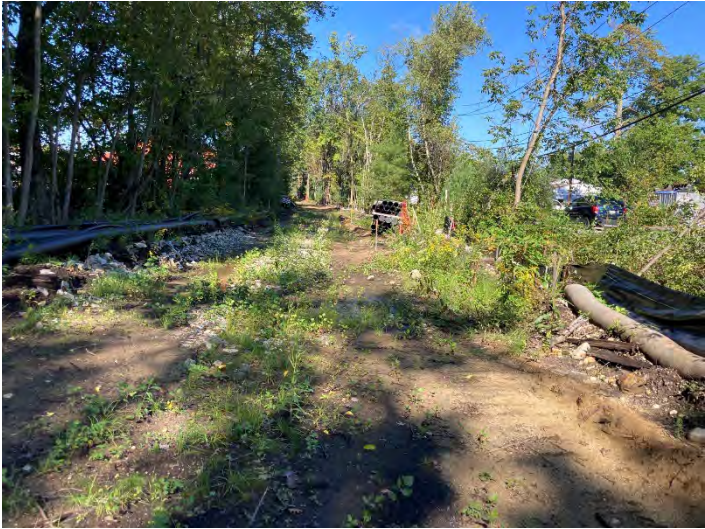
<b>PHOTOGRAPHIC LOG</b>	
Client Name: Eversource		Site Location: Sudbury to Hudson Transmission Reliability Project	
Town: Sudbury			
Photo No.: 6	Date: 9-19-2023

Description: View of Type A E&S controls in segment 12. Facing west.

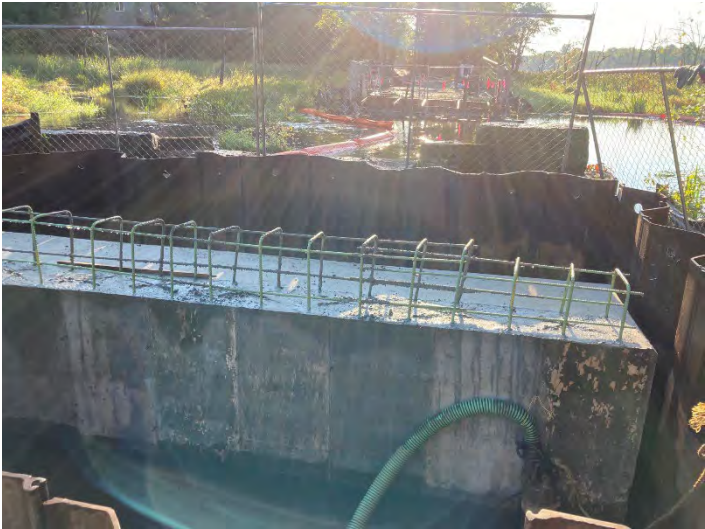
<b>PHOTOGRAPHIC LOG</b>	
Client Name: Eversource		Site Location: Sudbury to Hudson Transmission Reliability Project	
Town: Sudbury			
Photo No.: 7	Date: 9-19-2023

Description: View of bridge 127 area. See additional dewatering inspection reports. Facing east.

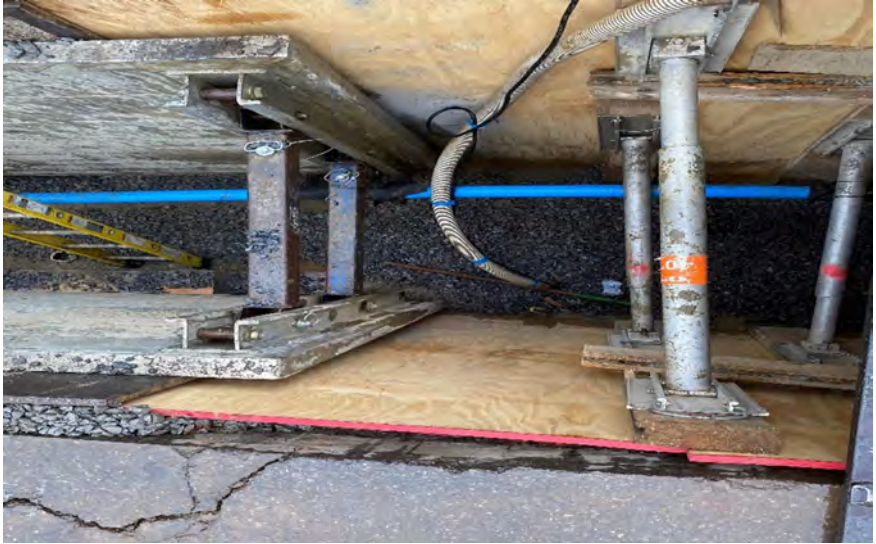
<b>PHOTOGRAPHIC LOG</b>	
Client Name: Eversource		Site Location: Sudbury to Hudson Transmission Reliability Project	
Photo No.: 1		Date: 9/18/2023	
Description: View of area being pumped at Forest Avenue (area in conduit trench).

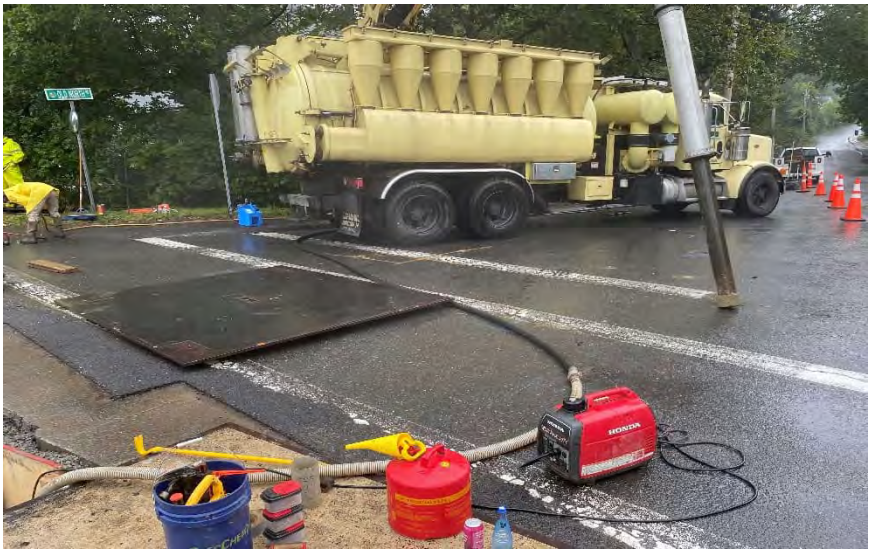
<b>PHOTOGRAPHIC LOG</b>	
Client Name: Eversource		Site Location: Sudbury to Hudson Transmission Reliability Project	
Photo No.: 2		Date: 9/18/2023	
Description: Forest Avenue. View of dewatering operation, looking eastward.

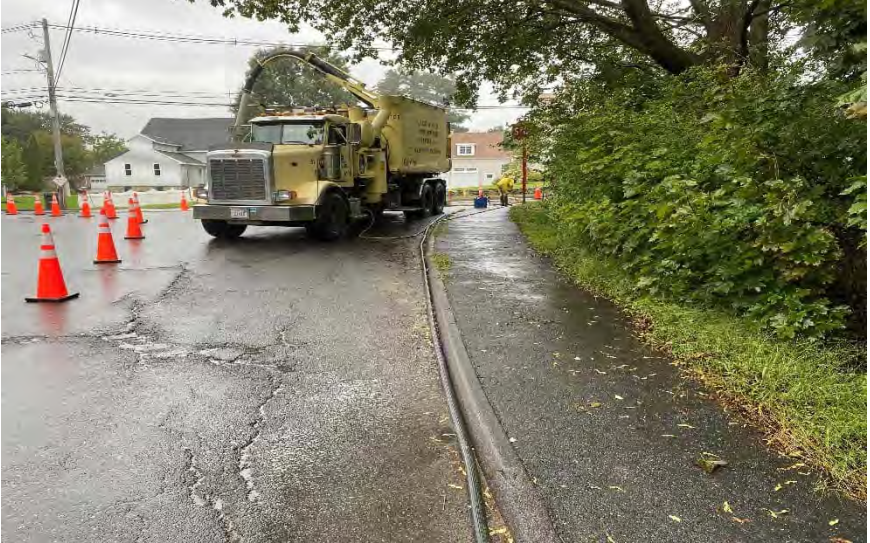
<b>PHOTOGRAPHIC LOG</b>	
Client Name: Eversource		Site Location: Sudbury to Hudson Transmission Reliability Project	
Photo No.: 3      Date: 9/18/2023		Town: Hudson	
Description: Forest Avenue. View of dewatering operation (pumping at far end of area), looking westward.

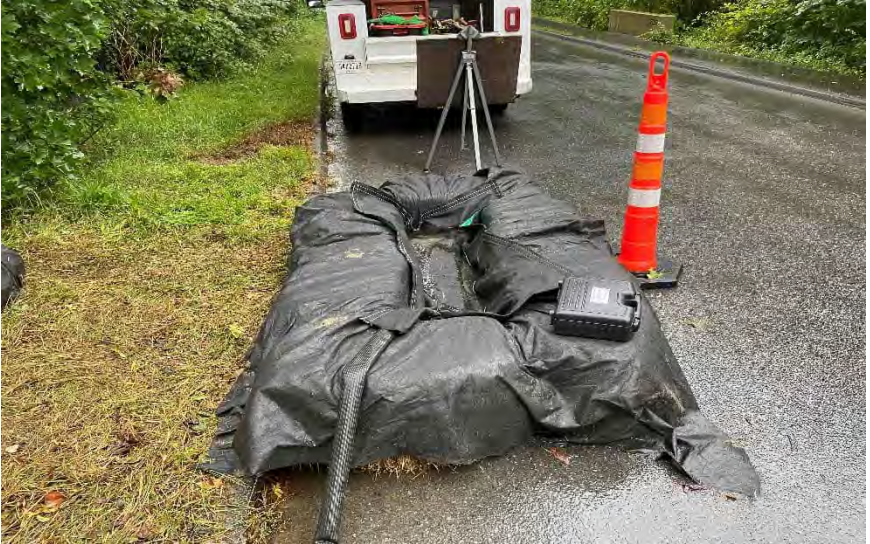
<b>PHOTOGRAPHIC LOG</b>	
Client Name: Eversource		Site Location: Sudbury to Hudson Transmission Reliability Project	
Photo No.: 4      Date: 9/18/2023		Town: Hudson	
Description: Forest Avenue. View of dewatering operation (corral/bag), looking eastward.

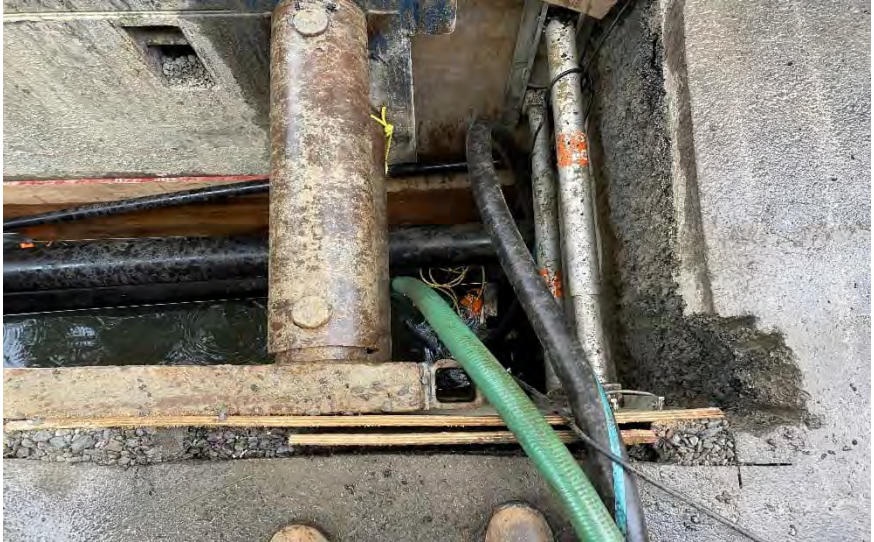
<b>PHOTOGRAPHIC LOG</b>	
Client Name: Eversource		Site Location: Sudbury to Hudson Transmission Reliability Project	
Photo No.: 1		Date: 9/18/2023	
Description: View of area being pumped at Forest Avenue (area near manhole #4).

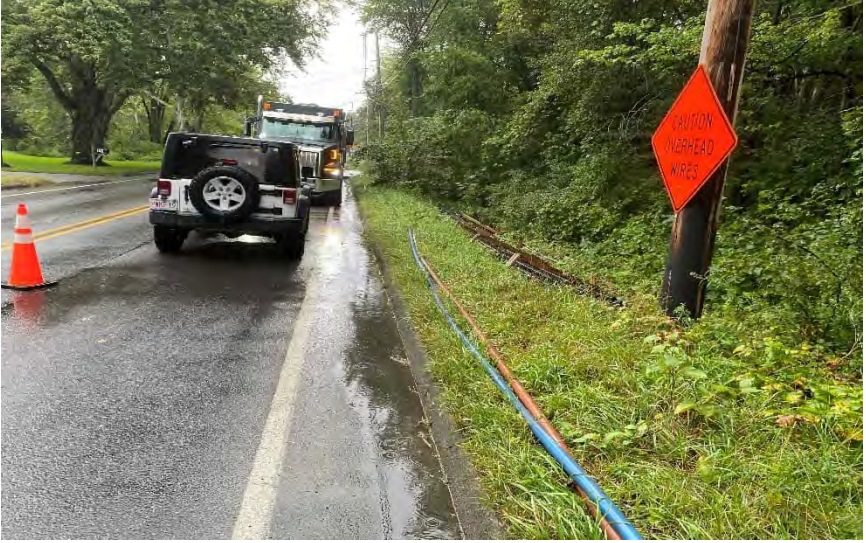
<b>PHOTOGRAPHIC LOG</b>	
Client Name: Eversource		Site Location: Sudbury to Hudson Transmission Reliability Project	
Photo No.: 3      Date: 9/18/2023		Town: Hudson	
Description: Forest Avenue. View of dewatering operation (pumping at far end of area), looking northward.

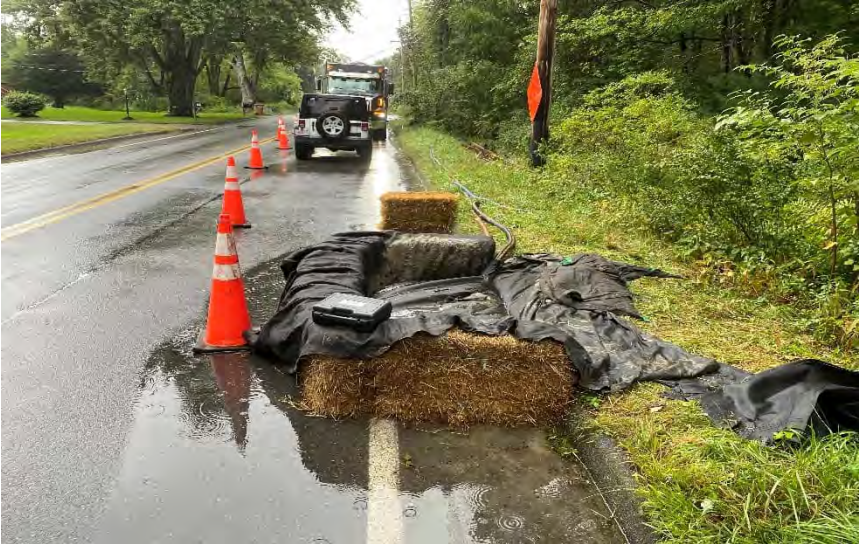
<b>PHOTOGRAPHIC LOG</b>	
Client Name: Eversource		Site Location: Sudbury to Hudson Transmission Reliability Project	
Photo No.: 4      Date: 9/18/2023		Town: Hudson	
Description: Forest Avenue. View of dewatering operation (corral/bag), looking northward.

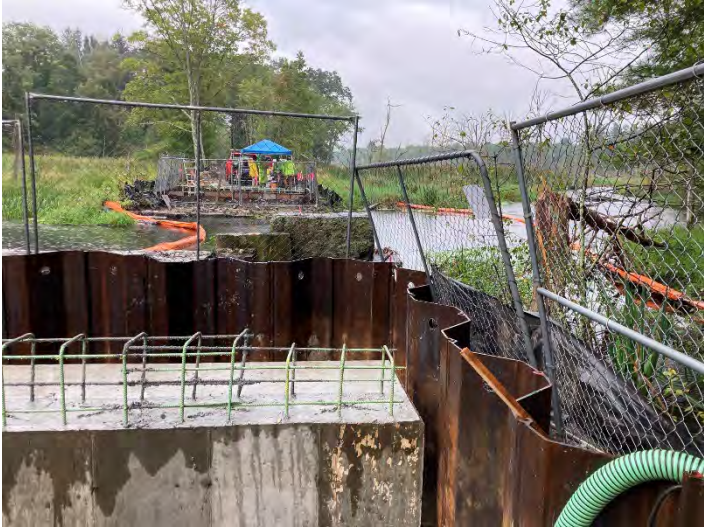
<b>PHOTOGRAPHIC LOG</b>	
Client Name: Eversource		Site Location: Sudbury to Hudson Transmission Reliability Project	
Town: Sudbury			
Photo No.: 1	Date: 9/18/2023

Description: View of work at bridge 127. Facing east.

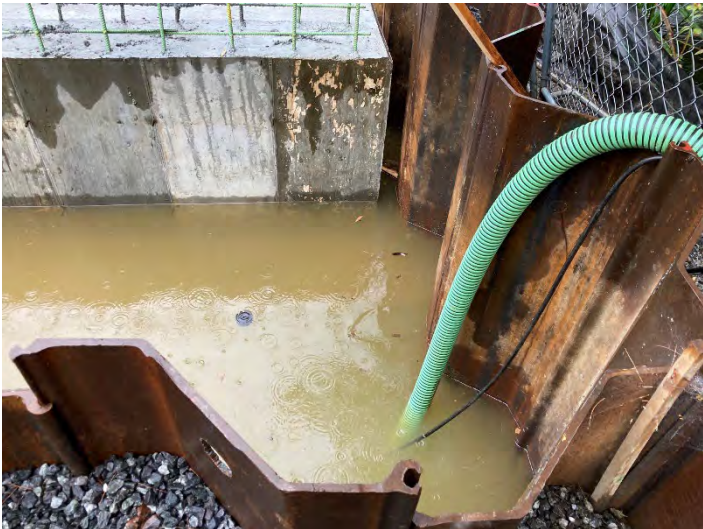
<b>PHOTOGRAPHIC LOG</b>	
Client Name: Eversource		Site Location: Sudbury to Hudson Transmission Reliability Project	
Town: Sudbury			
Photo No.: 2	Date: 9/18/2023

Description: View of pumping operation at Bridge 127 work at Hop Brook. Water prior to treatment appeared turbid.

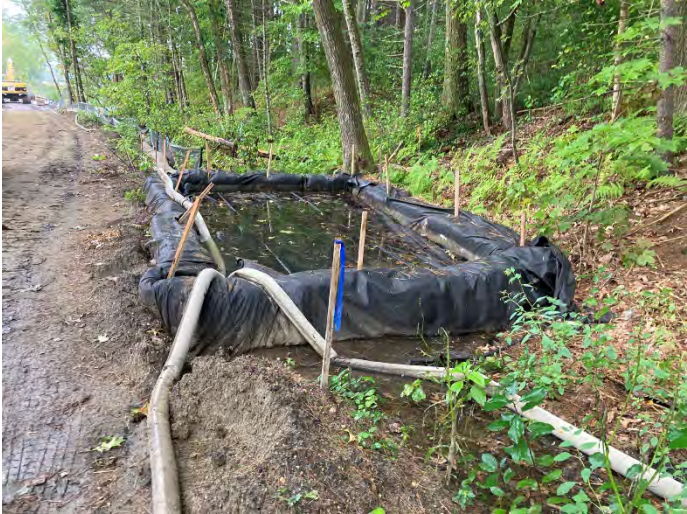
<b>PHOTOGRAPHIC LOG</b>	
Client Name: Eversource		Site Location: Sudbury to Hudson Transmission Reliability Project	
Photo No.: 3		Date: 9/18/2023	
Description: View of dewatering controls (straw bale corral with filter fabric, stone, and silt bag) and discharge from corral. Facing east.

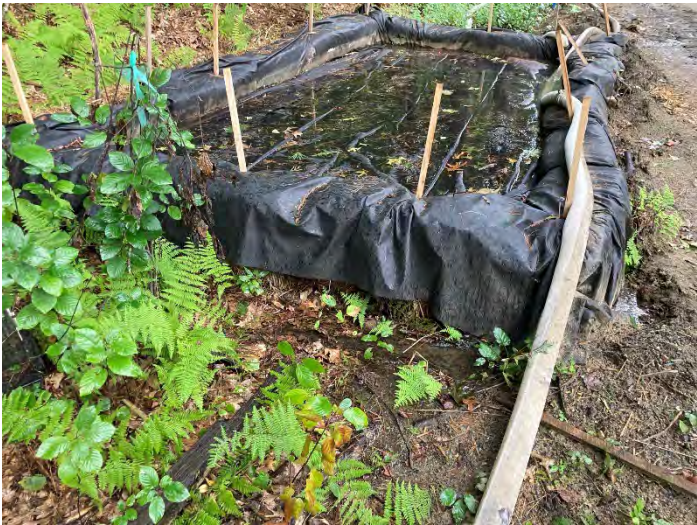
Section A – Dewatering Discharges (CGP Part 4.6.3) Complete this section <u>within 24 hours</u> of completing the inspection. (If necessary, complete additional inspection reports for each separate inspection location.)	
Inspector Information	
Inspector Name: Ariel Leclerc	Title: Compliance Monitor, CESSWI, QCIS, QPSWPPP
Company Name: SWCA Environmental Consultants	Email: ariel.leclerc@swca.com
Address: 153 Cordaville Road, Suite 130, Southborough, MA 01772	Phone Number: 401-496-8471
Inspection Details	
Inspection Date: 9/18/2023	Inspection Location: Bridge 127 work off Hop Brook- Segment 13
Discharge Start Time: 8:00am	Discharge End Time: 10:00am
Rate of Discharge (gallons per day): 188,640 (131 gallons per minute)	Corrective Action Required? <sup>1</sup> <input type="checkbox"/> Yes <input checked="" type="checkbox"/> No
Describe Indicators of Pollutant Discharge at Point of Dewatering Discharge: <sup>1</sup> Dewatering setup to corral/bag within work area west of the bridge 127 work. Dewatering conducted to remove water from cofferdam off Hop Brook. Turbidity reading was slightly higher than 50 NTUs but did not appear to be reaching wetlands.

<b>PHOTOGRAPHIC LOG</b>	
Client Name: Eversource		Site Location: Sudbury to Hudson Transmission Reliability Project	
Photo No.: 4		Date: 9/18/2023	
Description: Additional view of dewatering controls (straw bale corral with filter fabric, stone, and silt bag) and discharge from corral. Discharge traveled east outside of the silt fence but did not reach any jurisdictional areas. Discharge appeared mostly clear. Turbidity reading was slightly higher than 50 NTUs. Facing west.

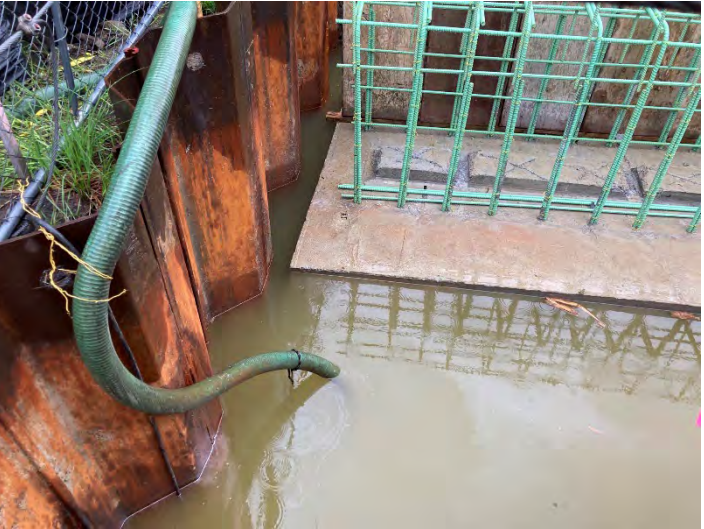
<b>PHOTOGRAPHIC LOG</b>	
Client Name: Eversource		Site Location: Sudbury to Hudson Transmission Reliability Project	
Photo No.: 2		Date: 9/18/2023	
Description: View of water prior to treatment. Water appeared turbid.

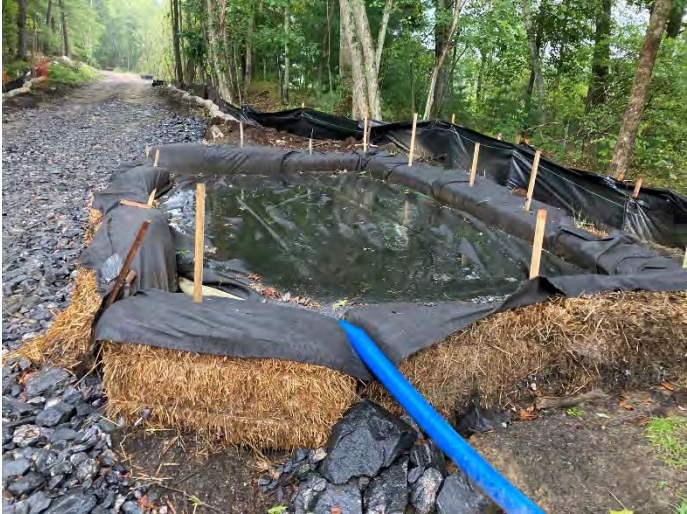
<b>PHOTOGRAPHIC LOG</b>	
Client Name: Eversource		Site Location: Sudbury to Hudson Transmission Reliability Project	
Photo No.: 3		Date: 9/18/2023	
Description: View of dewatering controls (straw bale corral with filter fabric, stone, and silt bag). Facing east.

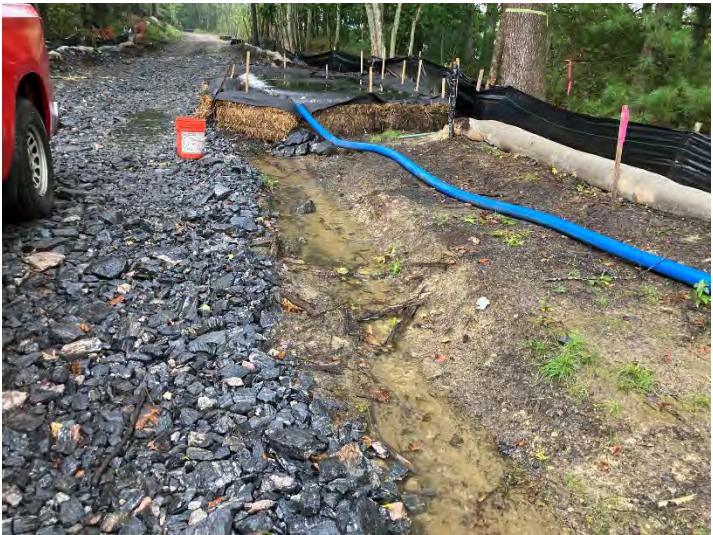
Section A – Dewatering Discharges (CGP Part 4.6.3) Complete this section <u>within 24 hours</u> of completing the inspection. (If necessary, complete additional inspection reports for each separate inspection location.)	
Inspector Information	
Inspector Name: Ariel Leclerc	Title: Compliance Monitor, CESSWI, QCIS, QPSWPPP
Company Name: SWCA Environmental Consultants	Email: ariel.leclerc@swca.com
Address: 153 Cordaville Road, Suite 130, Southborough, MA 01772	Phone Number: 401-496-8471
Inspection Details	
Inspection Date: 9/18/2023	Inspection Location: Bridge 127 work off Hop Brook- Segment 14
Discharge Start Time: 8:20am	Discharge End Time: 10:30am
Rate of Discharge (gallons per day): 188,640 (131 gallons per minute)	Corrective Action Required? <sup>1</sup> <input type="checkbox"/> Yes <input checked="" type="checkbox"/> No
Describe Indicators of Pollutant Discharge at Point of Dewatering Discharge: <sup>1</sup> Dewatering setup to corral/bag within work area east of the bridge 127 work. Dewatering conducted to remove water from cofferdam off Hop Brook. Discharge from corral observed to be reaching wetlands. Discharge appeared clear. Turbidity sampling conducted and reading was less than 50 NTUs.

<b>PHOTOGRAPHIC LOG</b>	
Client Name: Eversource		Site Location: Sudbury to Hudson Transmission Reliability Project	
Photo No.: 4		Date: 9/18/2023	
Description: View of discharge from controls. Discharge appeared to be leaving the work area and reaching wetlands. Discharge appeared clear. Turbidity reading was less than 50 NTUs. Facing east.

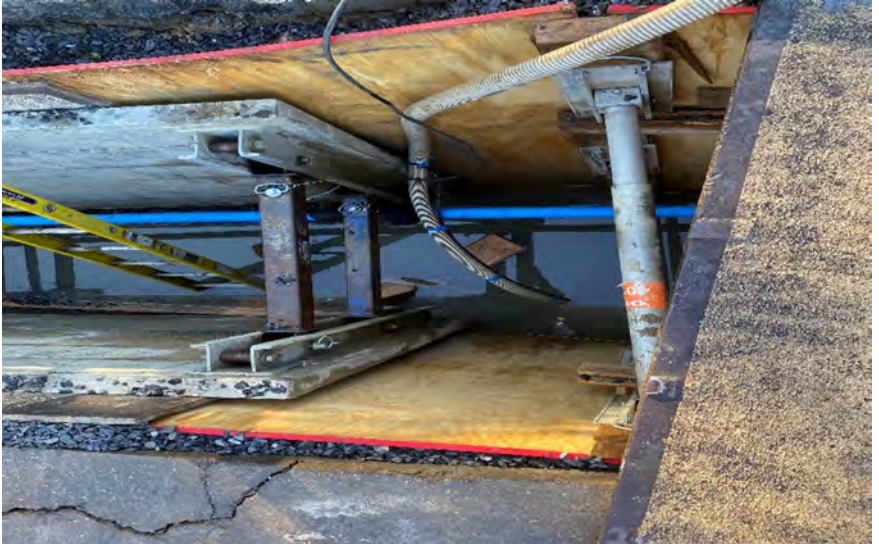
<b>PHOTOGRAPHIC LOG</b>	
Client Name: Eversource		Site Location: Sudbury to Hudson Transmission Reliability Project	
Photo No.: 1		Date: 9/19/2023	
Description: View of area being pumped at Forest Avenue (area in conduit trench).

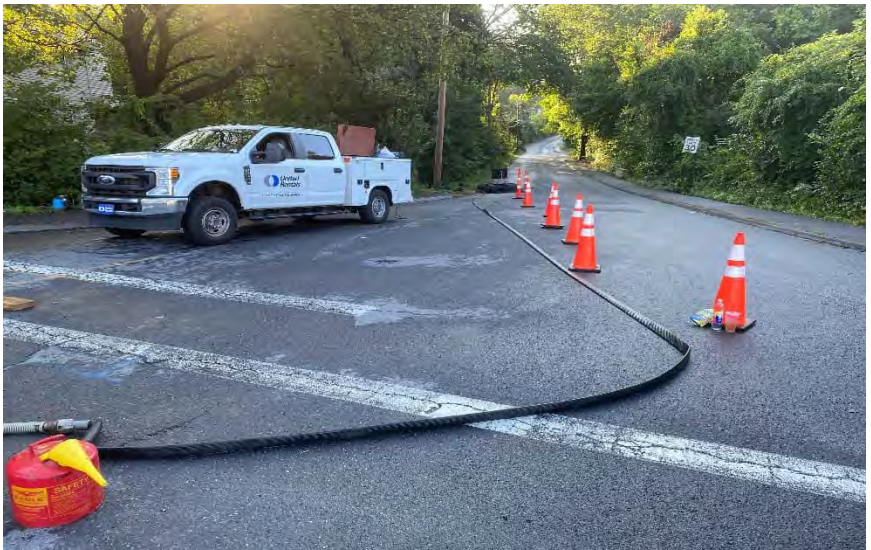
<b>PHOTOGRAPHIC LOG</b>	
Client Name: Eversource		Site Location: Sudbury to Hudson Transmission Reliability Project	
Photo No.: 2		Date: 9/19/2023	
Description: Forest Avenue. View of dewatering operation, looking eastward.

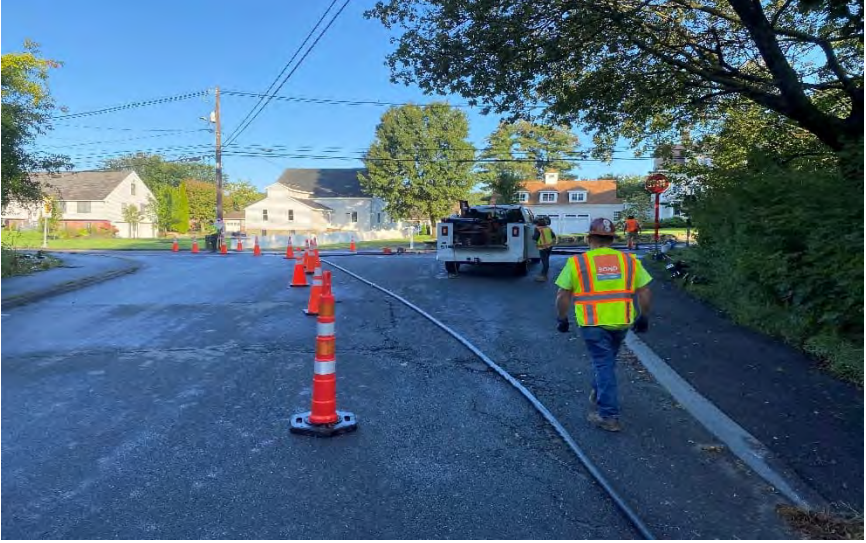
<b>PHOTOGRAPHIC LOG</b>	
Client Name: Eversource		Site Location: Sudbury to Hudson Transmission Reliability Project	
Photo No.: 3      Date: 9/19/2023		Town: Hudson	
Description: Forest Avenue. View of dewatering operation (pumping at far end of area), looking westward.

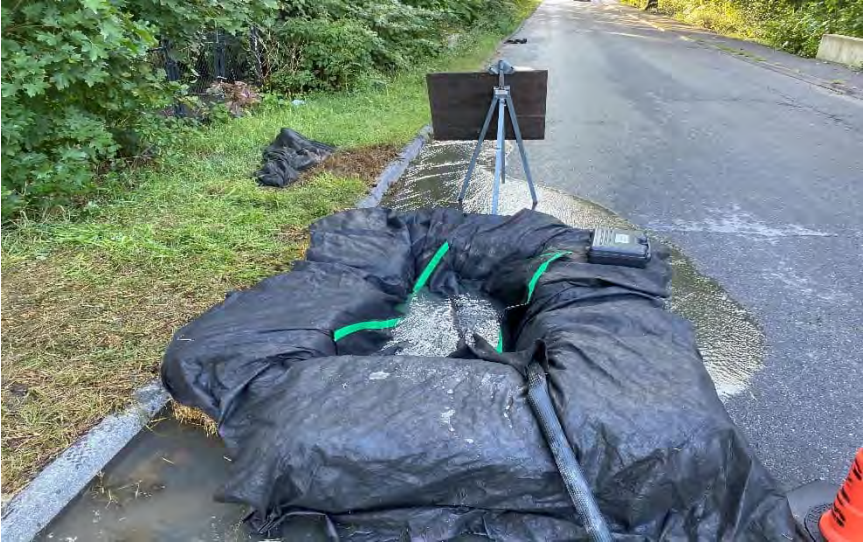
<b>PHOTOGRAPHIC LOG</b>	
Client Name: Eversource		Site Location: Sudbury to Hudson Transmission Reliability Project	
Photo No.: 4      Date: 9/19/2023		Town: Hudson	
Description: Forest Avenue. View of dewatering operation (corral/bag), looking eastward.

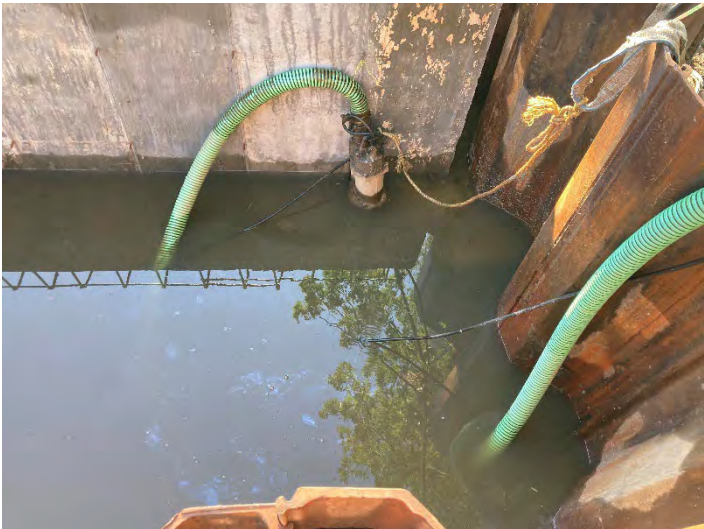
<b>PHOTOGRAPHIC LOG</b>	
Client Name: Eversource		Site Location: Sudbury to Hudson Transmission Reliability Project	
Photo No.: 2		Date: 9/19/2023	
Description: View of pumping operation at Bridge 127 work at Hop Brook. Water prior to treatment appeared slightly turbid.

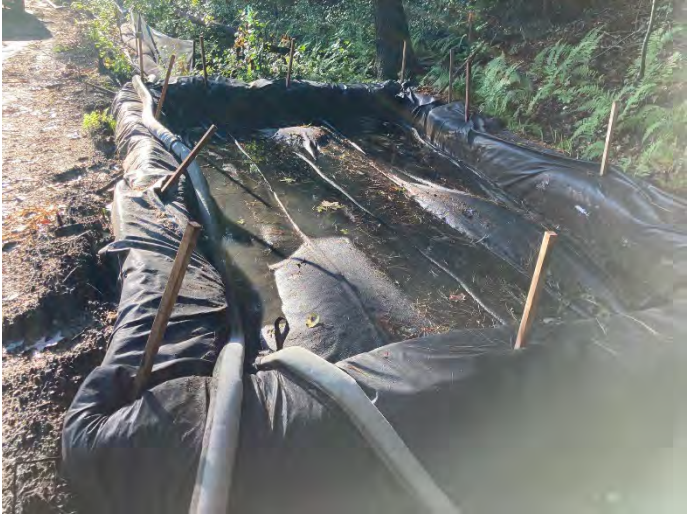
<b>PHOTOGRAPHIC LOG</b>	
Client Name: Eversource		Site Location: Sudbury to Hudson Transmission Reliability Project	
Photo No.: 3		Town: Sudbury	
Date: 9/19/2023

Description: View of dewatering controls (straw bale corral with filter fabric, stone, and silt bag). Facing east.

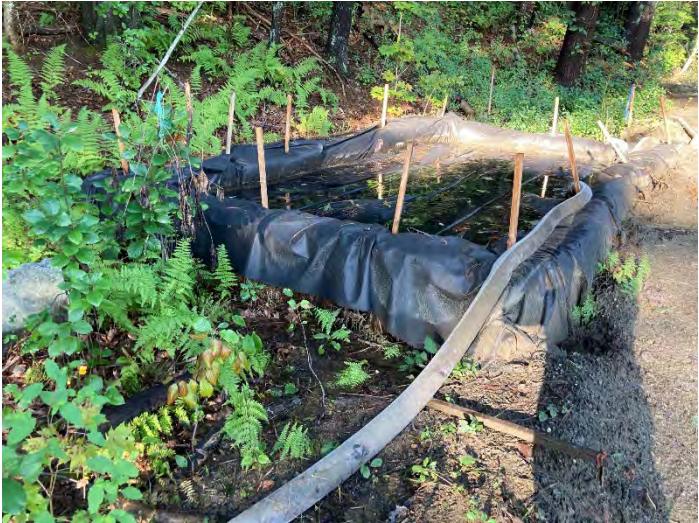
<b>PHOTOGRAPHIC LOG</b>	
Client Name: Eversource		Site Location: Sudbury to Hudson Transmission Reliability Project	
Photo No.: 4		Town: Sudbury	
Date: 9/19/2023

Section A – Dewatering Discharges (CGP Part 4.6.3) Complete this section <u>within 24 hours</u> of completing the inspection. (If necessary, complete additional inspection reports for each separate inspection location.)	
Inspector Information	
Inspector Name: Ariel Leclerc	Title: Compliance Monitor, CESSWI, QCIS, QPSWPPP
Company Name: SWCA Environmental Consultants	Email: ariel.leclerc@swca.com
Address: 153 Cordaville Road, Suite 130, Southborough, MA 01772	Phone Number: 401-496-8471
Inspection Details	
Inspection Date: 9/19/2023	Inspection Location: Bridge 127 work off Hop Brook- Segment 13
Discharge Start Time: 7:55am	Discharge End Time: 10:30am
Rate of Discharge (gallons per day): 188,640 (131 gallons per minute)	Corrective Action Required? <sup>1</sup> <input type="checkbox"/> Yes <input checked="" type="checkbox"/> No
Describe Indicators of Pollutant Discharge at Point of Dewatering Discharge: <sup>1</sup> Dewatering setup to corral/bag within work area west of the bridge 127 work. Dewatering conducted to remove water from cofferdam off Hop Brook. Turbidity reading was higher than 50 NTUs but did not appear to be reaching wetlands.

Description: Additional view of dewatering controls (straw bale corral with filter fabric, stone, and silt bag) and discharge from corral. Discharge traveled east outside of the silt fence but did not reach any jurisdictional areas. Discharge appeared slightly turbid. Turbidity reading was higher than 50 NTUs. Facing west.

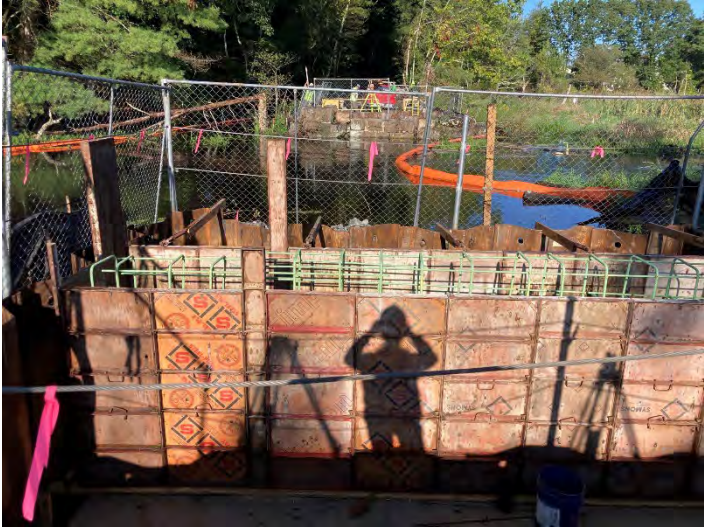
<b>PHOTOGRAPHIC LOG</b>	
Client Name: Eversource		Site Location: Sudbury to Hudson Transmission Reliability Project	
Photo No.: 1		Date: 9/19/2023	
Description: View of work area at Bridge 127 at Hop Brook. Facing west.

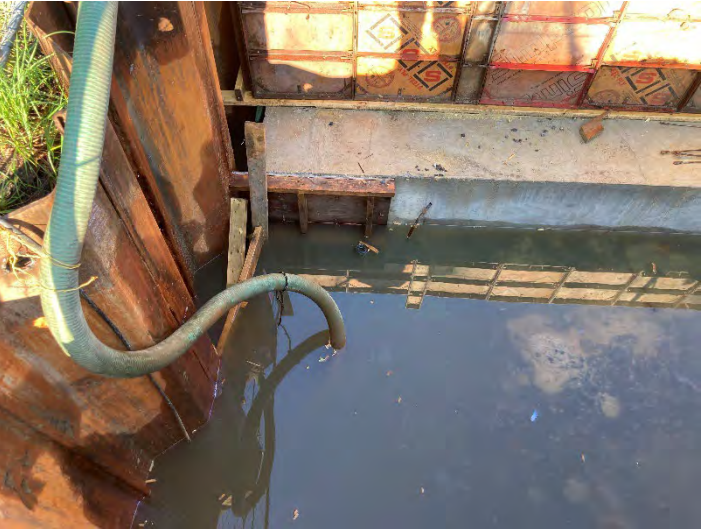
<b>PHOTOGRAPHIC LOG</b>	
Client Name: Eversource		Site Location: Sudbury to Hudson Transmission Reliability Project	
Photo No.: 2		Date: 9/19/2023	
Description: View of water prior to treatment. Water appeared slightly turbid.

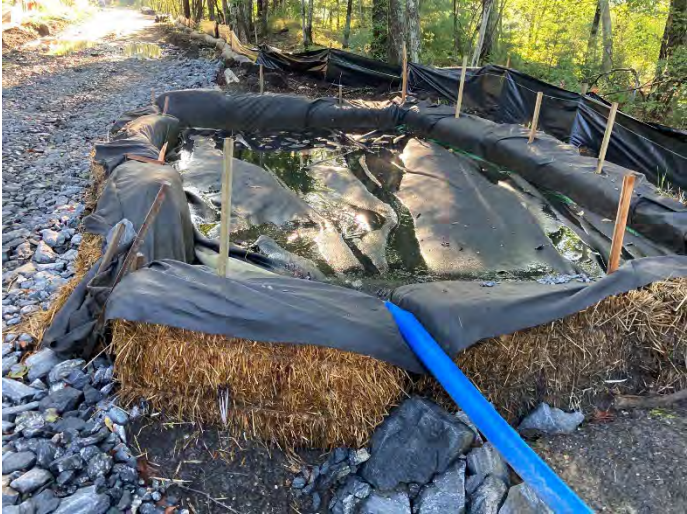
<b>PHOTOGRAPHIC LOG</b>	
Client Name: Eversource		Site Location: Sudbury to Hudson Transmission Reliability Project	
Photo No.: 3		Town: Sudbury	
Date: 9/19/2023

Description: View of dewatering controls (straw bale corral with filter fabric, stone, and silt bag). Facing east.

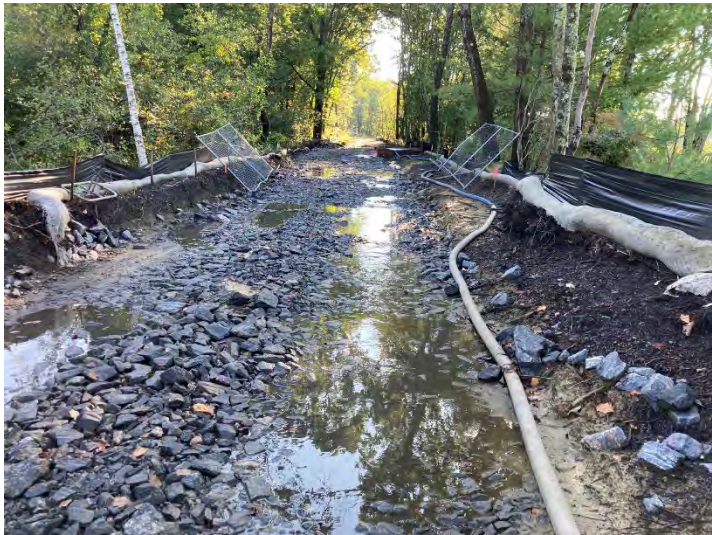
<b>PHOTOGRAPHIC LOG</b>	
Client Name: Eversource		Site Location: Sudbury to Hudson Transmission Reliability Project	
Photo No.: 4		Town: Sudbury	
Date: 9/19/2023

Description: View of discharge from controls. Discharge appeared to be leaving the work area and reaching wetlands. Discharge appeared mostly clear. Turbidity reading was higher than 50 NTUs. Facing east.

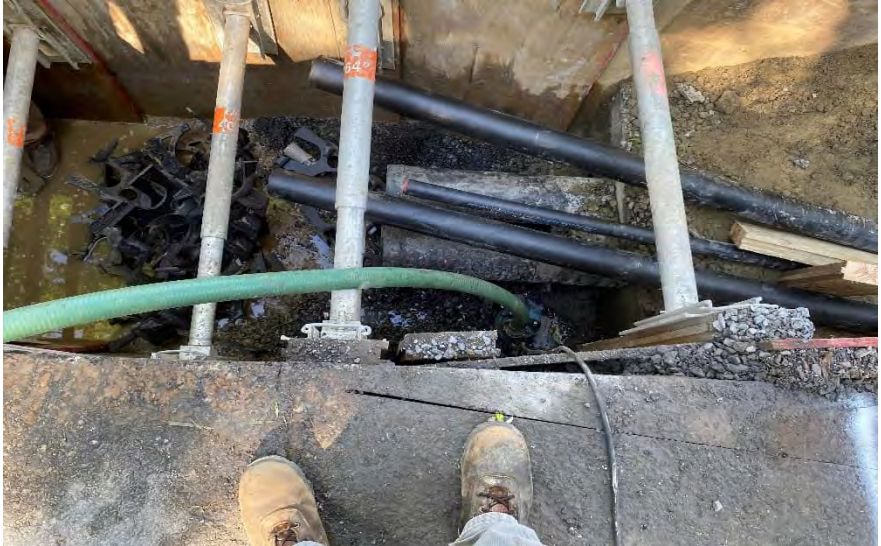
<b>PHOTOGRAPHIC LOG</b>	
Client Name: Eversource		Site Location: Sudbury to Hudson Transmission Reliability Project	
Photo No.: 1      Date: 9/20/2023		Town: Hudson	
Description: View of area being pumped at Forest Avenue (area near manhole #4).

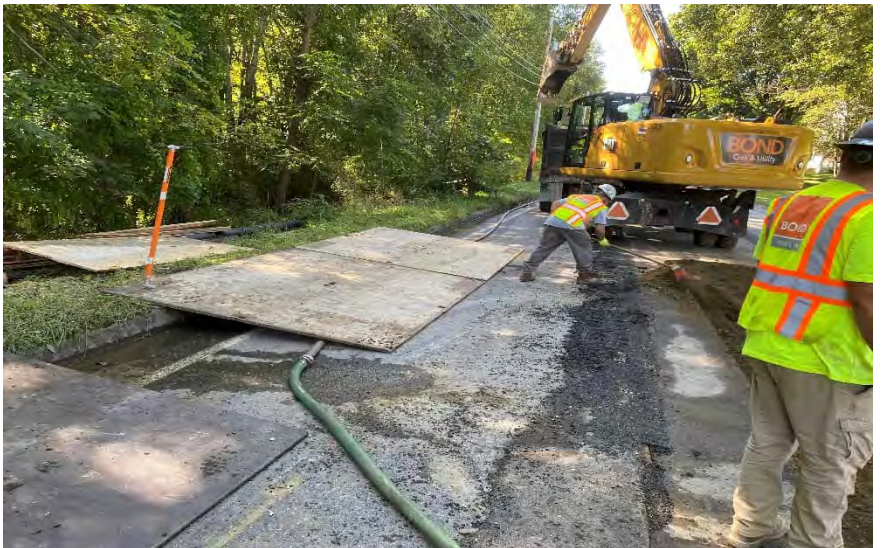
<b>PHOTOGRAPHIC LOG</b>	
Client Name: Eversource		Site Location: Sudbury to Hudson Transmission Reliability Project	
Photo No.: 2      Date: 9/20/2023		Town: Hudson	
Description: Forest Avenue. View of dewatering operation, looking southward.
