**Weekly Environmental Compliance Summary**

**Sudbury to Hudson Transmission Reliability Project (USEPA Tracking # MAR1003UW)**

Sudbury, Hudson, and Stow, MA

Week of: September 18, 2023 to September 22, 2023

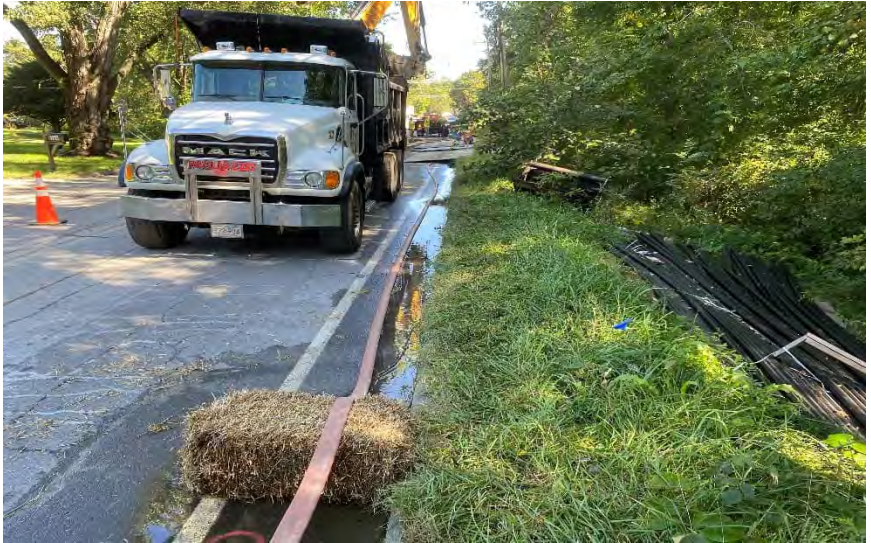
PHOTOGRAPHIC LOG	
Client Name: Eversource		Site Location: Sudbury to Hudson Transmission Reliability Project	Town: Hudson
Photo No.: 3	Date: 9/20/2023

Description: Forest Avenue. View of dewatering operation (pumping at far end of area), looking northward.

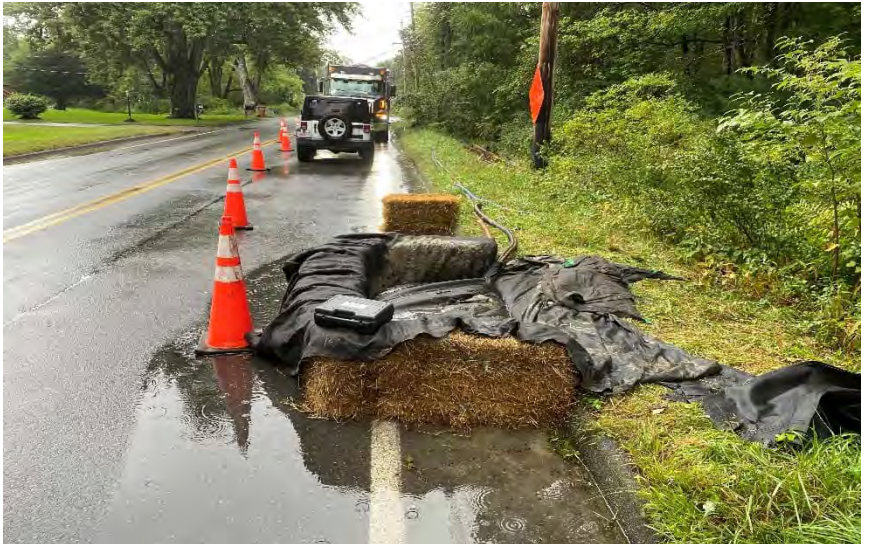
PHOTOGRAPHIC LOG	
Client Name: Eversource		Site Location: Sudbury to Hudson Transmission Reliability Project	Town: Hudson
Photo No.: 4	Date: 9/20/2023

Description: Forest Avenue. View of dewatering operation (corral/bag), looking northward.

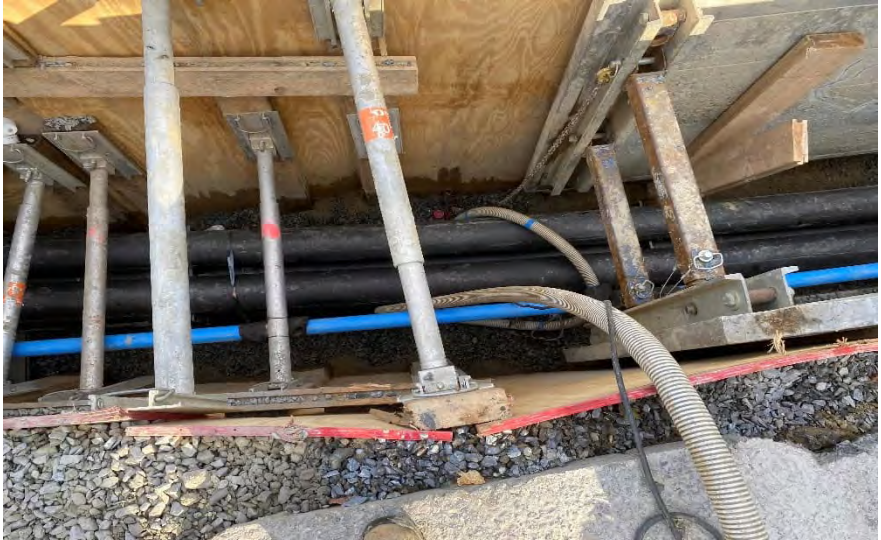
<b>PHOTOGRAPHIC LOG</b>	
Client Name: Eversource		Site Location: Sudbury to Hudson Transmission Reliability Project	
Photo No.: 1		Town: Hudson	
Date: 9/20/2023

Description: View of area being pumped at Forest Avenue (area in conduit trench).

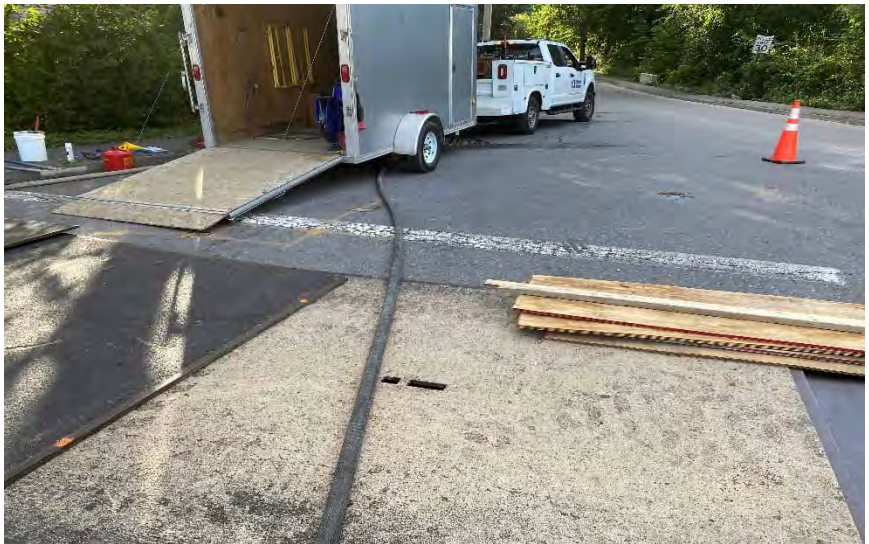
<b>PHOTOGRAPHIC LOG</b>	
Client Name: Eversource		Site Location: Sudbury to Hudson Transmission Reliability Project	
Photo No.: 2		Town: Hudson	
Date: 9/20/2023

Description: Forest Avenue. View of dewatering operation, looking eastward.

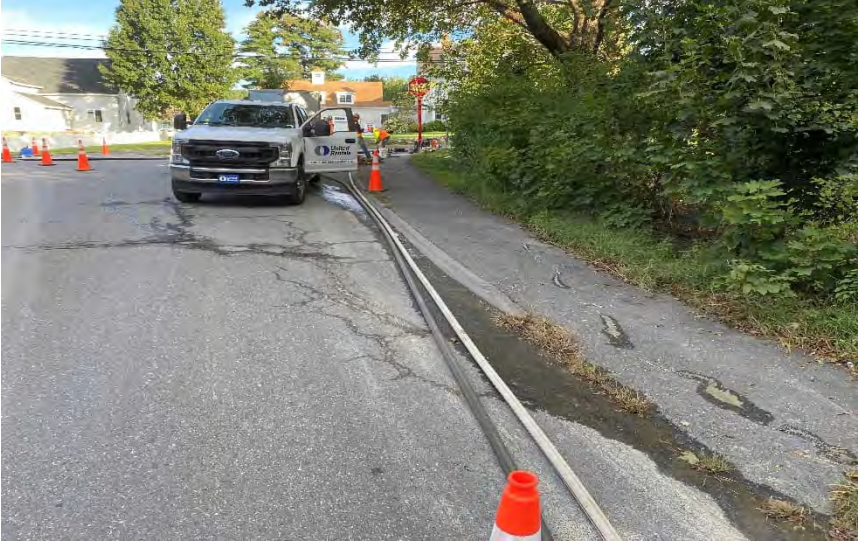
<b>PHOTOGRAPHIC LOG</b>	
Client Name: Eversource		Site Location: Sudbury to Hudson Transmission Reliability Project	
Photo No.: 3      Date: 9/20/2023		Town: Hudson	
Description: Forest Avenue. View of dewatering operation (pumping at far end of area), looking westward.

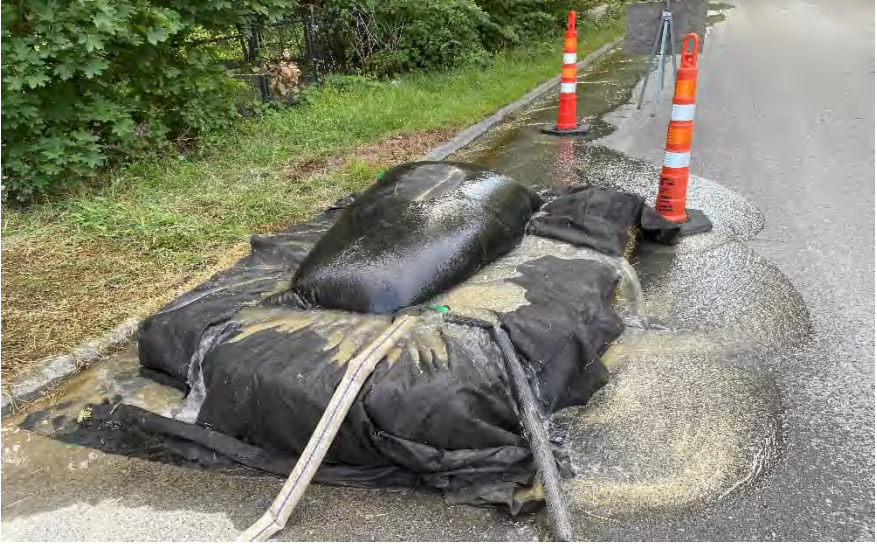
<b>PHOTOGRAPHIC LOG</b>	
Client Name: Eversource		Site Location: Sudbury to Hudson Transmission Reliability Project	
Photo No.: 4      Date: 9/20/2023		Town: Hudson	
Description: Forest Avenue. View of dewatering operation (corral/bag), looking eastward.

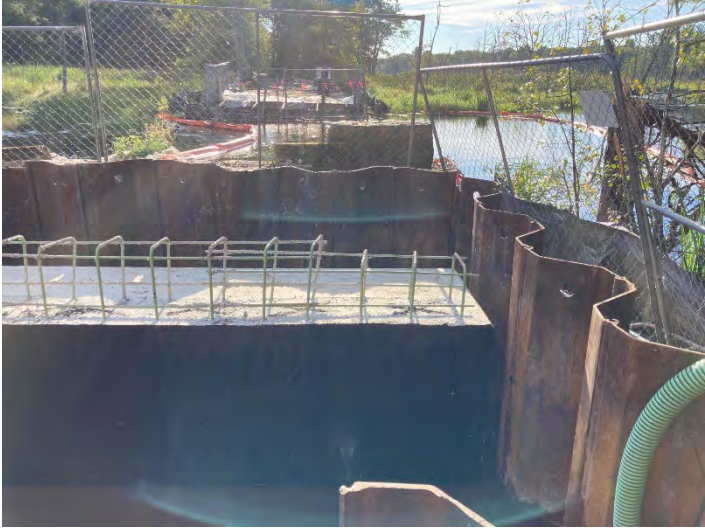
<b>PHOTOGRAPHIC LOG</b>	
Client Name: Eversource		Site Location: Sudbury to Hudson Transmission Reliability Project	
Town: Sudbury			
Photo No.: 1	Date: 9/20/2023

Description: View of work at bridge 127. Facing east.

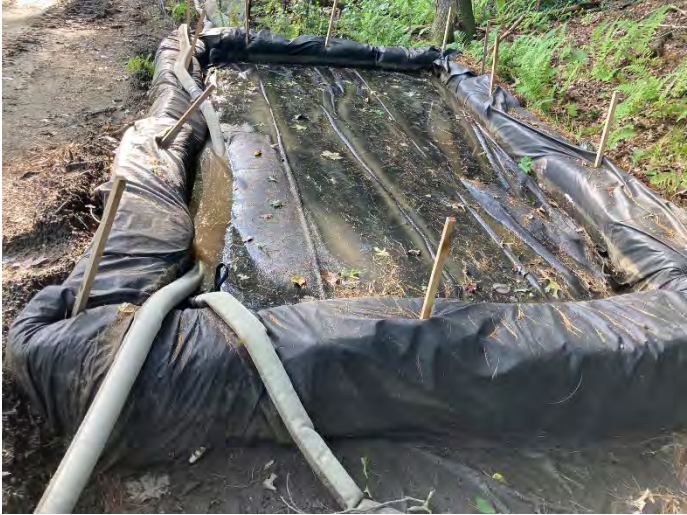
<b>PHOTOGRAPHIC LOG</b>	
Client Name: Eversource		Site Location: Sudbury to Hudson Transmission Reliability Project	
Photo No.: 3		Date: 9/20/2023	
Description: View of dewatering controls (straw bale corral with filter fabric, stone, and silt bag). Facing east.

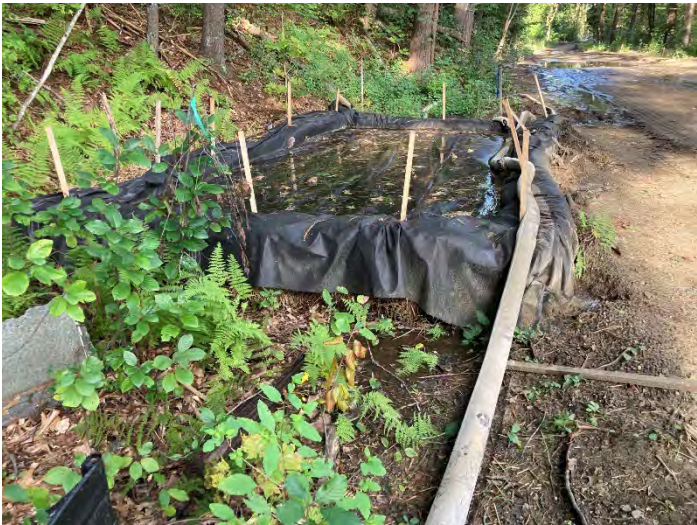
<b>PHOTOGRAPHIC LOG</b>	
Client Name: Eversource		Site Location: Sudbury to Hudson Transmission Reliability Project	
Photo No.: 4		Date: 9/20/2023	
Description: Additional view of dewatering controls (straw bale corral with filter fabric, stone, and silt bag) and discharge from corral. Discharge traveled east outside of the silt fence but did not reach any jurisdictional areas. Discharge appeared slightly turbid. Turbidity reading was higher than 50 NTUs. Facing west.

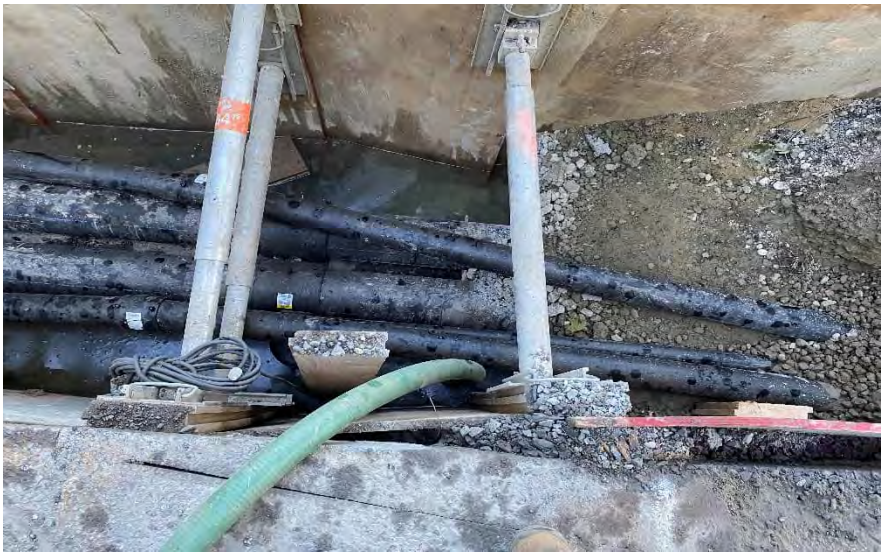
<b>PHOTOGRAPHIC LOG</b>	
Client Name: Eversource		Site Location: Sudbury to Hudson Transmission Reliability Project	
Photo No.: 1		Date: 9/21/2023	
Description: View of area being pumped at Forest Avenue (area near manhole #4).

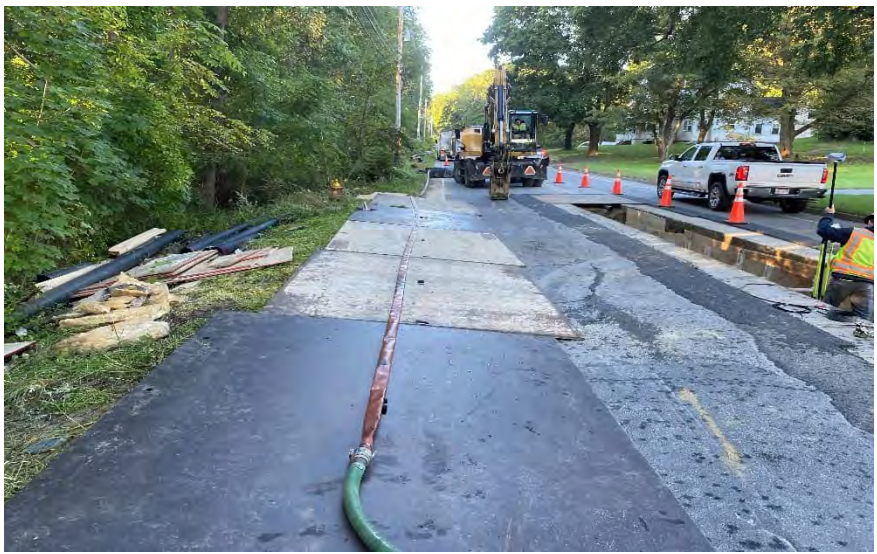
<b>PHOTOGRAPHIC LOG</b>	
Client Name: Eversource		Site Location: Sudbury to Hudson Transmission Reliability Project	
Photo No.: 2		Date: 9/21/2023	
Description: Forest Avenue. View of dewatering operation, looking southward.

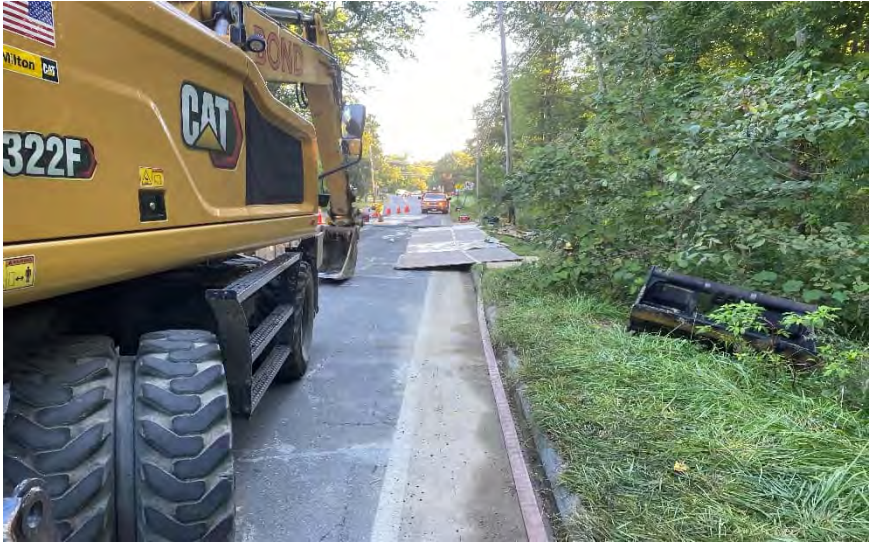
PHOTOGRAPHIC LOG	
Client Name: Eversource		Site Location: Sudbury to Hudson Transmission Reliability Project	Town: Hudson
Photo No.: 3	Date: 9/21/2023

Description: Forest Avenue. View of dewatering operation (pumping at far end of area), looking northward.

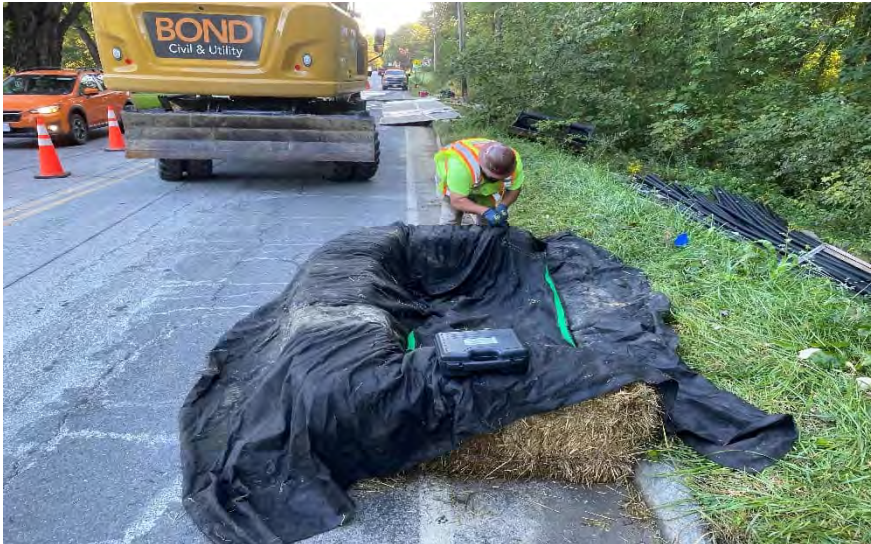
Epsilon ASSOCIATES INC.		PHOTOGRAPHIC LOG	
Client Name: Eversource		Site Location: Sudbury to Hudson Transmission Reliability Project	Town: Hudson
Photo No.: 4	Date: 9/21/2023

Description: Forest Avenue. View of dewatering operation (corral/bag), looking northward.

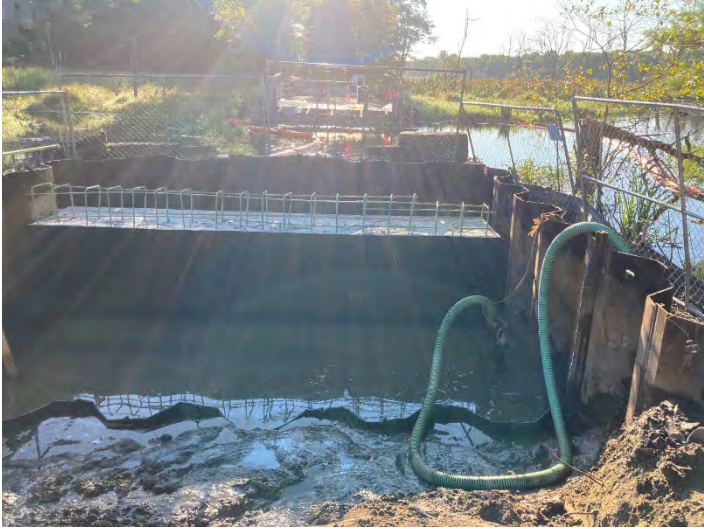
<b>PHOTOGRAPHIC LOG</b>	
Client Name: Eversource		Site Location: Sudbury to Hudson Transmission Reliability Project	
Town: Sudbury			
Photo No.: 1	Date: 9/21/2023

Description: View of work at bridge 127. Facing east.

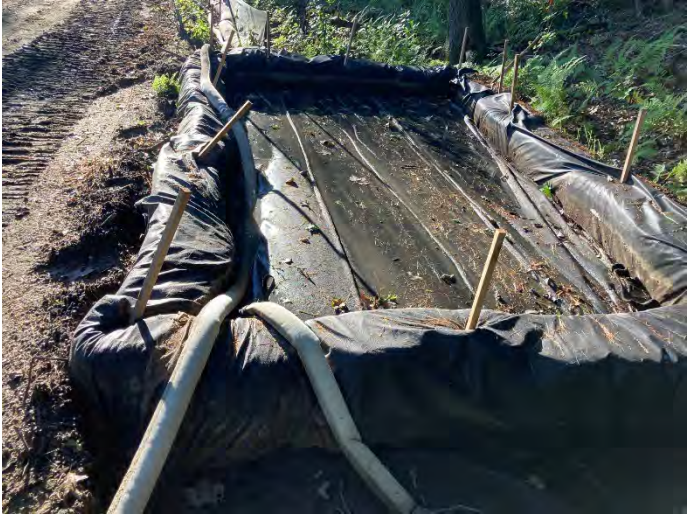
<b>PHOTOGRAPHIC LOG</b>	
Client Name: Eversource		Site Location: Sudbury to Hudson Transmission Reliability Project	
Photo No.: 3		Date: 9/21/2023	
Description: View of dewatering controls (straw bale corral with filter fabric, stone, and silt bag). Facing east.

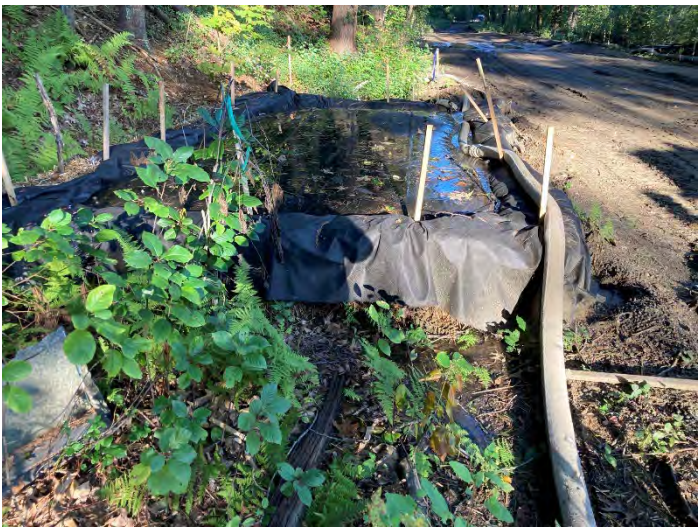
<b>PHOTOGRAPHIC LOG</b>	
Client Name: Eversource		Site Location: Sudbury to Hudson Transmission Reliability Project	
Photo No.: 4		Date: 9/21/2023	
Description: Additional view of dewatering controls (straw bale corral with filter fabric, stone, and silt bag) and discharge from corral. Discharge traveled east outside of the silt fence but did not reach any jurisdictional areas. Discharge appeared slightly turbid. Turbidity reading was higher than 50 NTUs. Facing west.

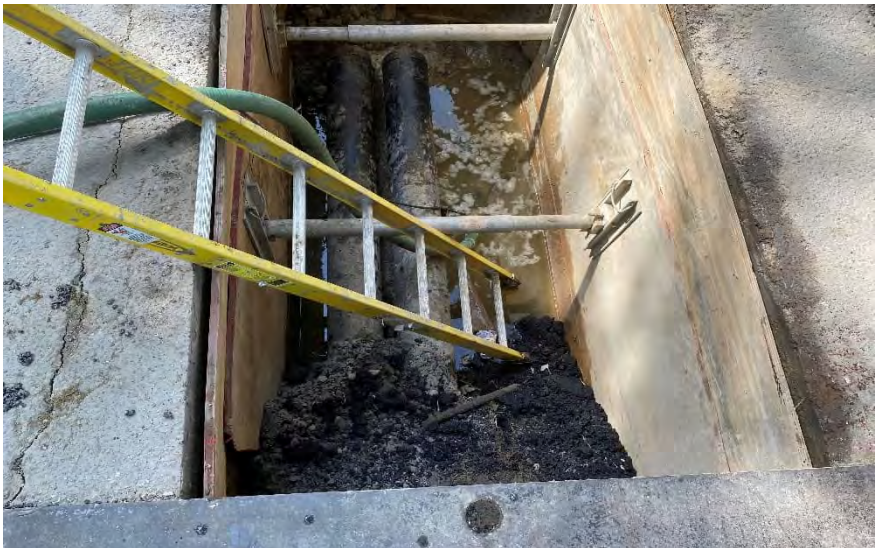
<b>PHOTOGRAPHIC LOG</b>	
Client Name: Eversource		Site Location: Sudbury to Hudson Transmission Reliability Project	
Photo No.: 1		Date: 9/22/2023	
Description: View of area being pumped at Forest Avenue (area near manhole #4).

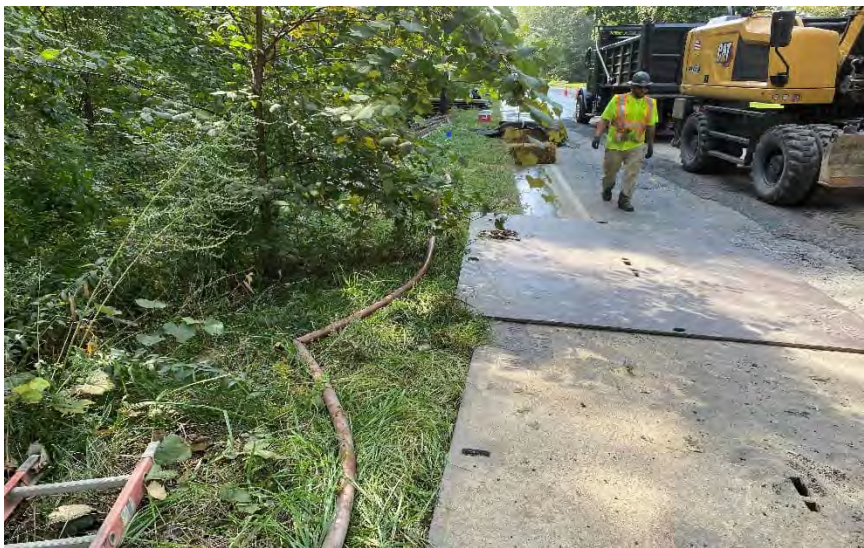
<b>PHOTOGRAPHIC LOG</b>	
Client Name: Eversource		Site Location: Sudbury to Hudson Transmission Reliability Project	
Photo No.: 2		Date: 9/22/2023	
Description: Forest Avenue. View of dewatering operation, looking southward.

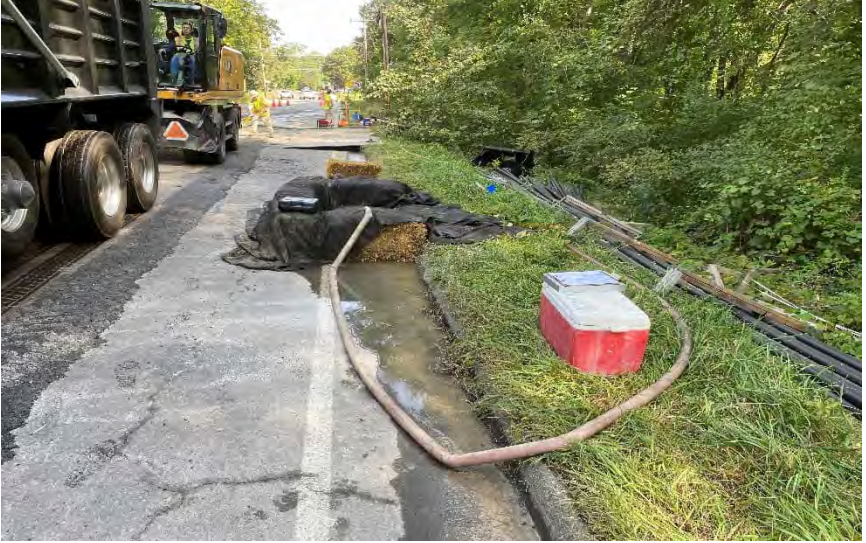
<b>PHOTOGRAPHIC LOG</b>	
Client Name: Eversource		Site Location: Sudbury to Hudson Transmission Reliability Project	
Town: Hudson			
Photo No.: 3	Date: 9/22/2023

Description: Forest Avenue. View of dewatering operation (pumping at far end of area), looking northward.

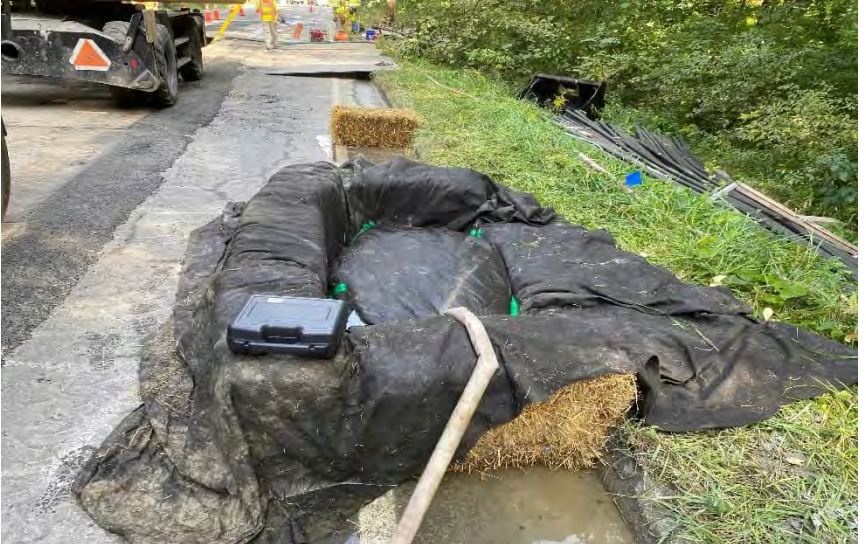
<b>PHOTOGRAPHIC LOG</b>	
Client Name: Eversource		Site Location: Sudbury to Hudson Transmission Reliability Project	
Town: Hudson			
Photo No.: 4	Date: 9/22/2023

Description: Forest Avenue. View of dewatering operation (corral/bag), looking northward.

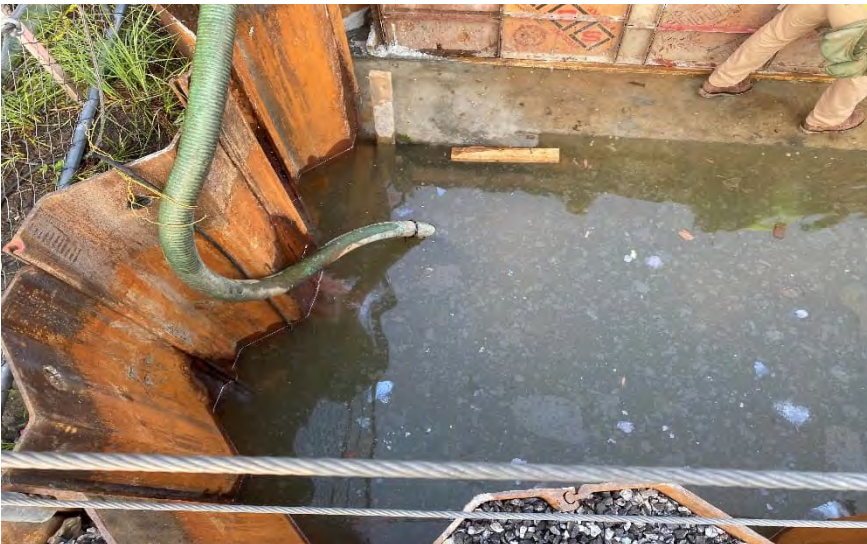
<b>PHOTOGRAPHIC LOG</b>	
Client Name: Eversource		Site Location: Sudbury to Hudson Transmission Reliability Project	Town: Sudbury
Photo No.: 1	Date: 9/22/2023

Description: View of area being pumped at Hop Brook (area in cofferdam), looking westward.

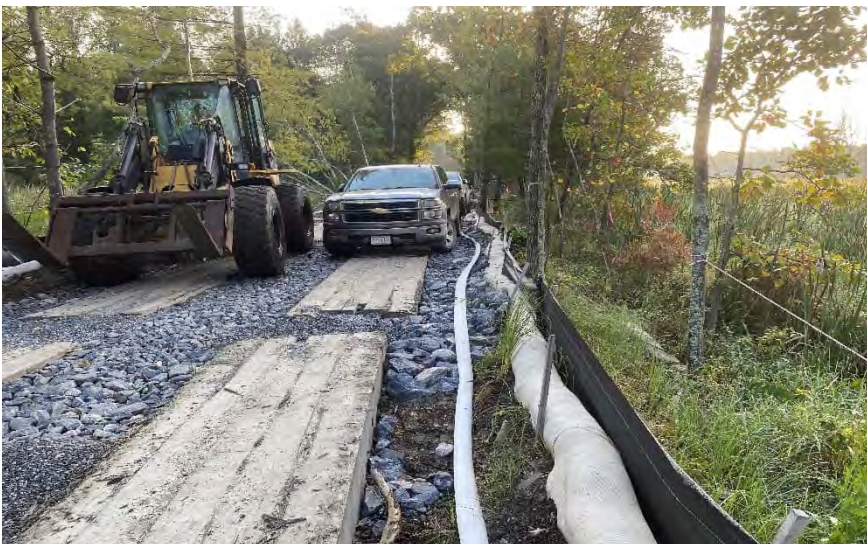
<b>PHOTOGRAPHIC LOG</b>	
Client Name: Eversource		Site Location: Sudbury to Hudson Transmission Reliability Project	Town: Sudbury
Photo No.: 2	Date: 9/22/2023

Description: Segment 14. View of dewatering operation (pumping at far end of area), looking eastward.

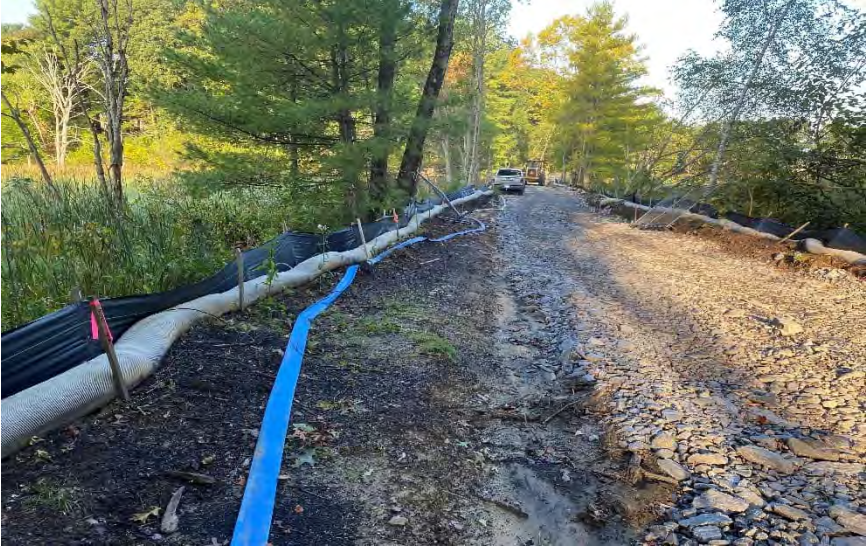
<b>PHOTOGRAPHIC LOG</b>	
Client Name: Eversource		Site Location: Sudbury to Hudson Transmission Reliability Project	
Photo No.: 3      Date: 9/22/2023

Description: Segment 14. View of dewatering operation (pumping at far end of area), looking westward.

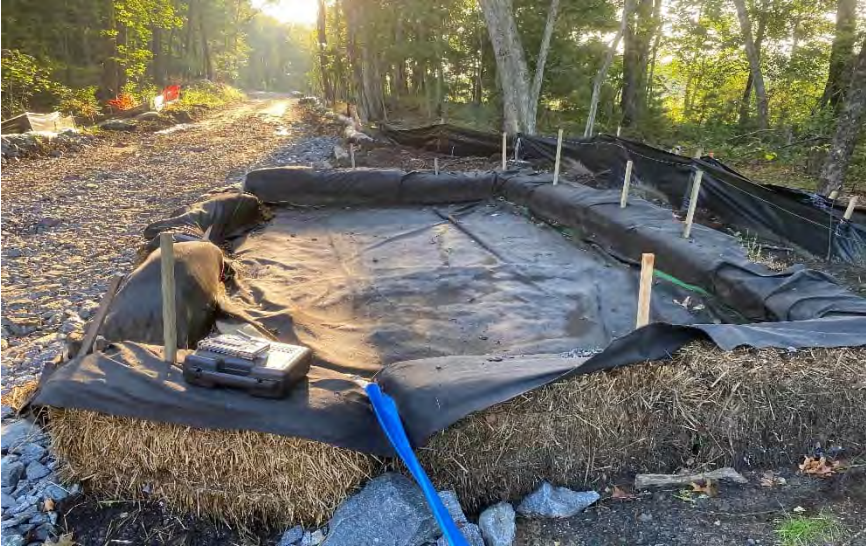
<b>PHOTOGRAPHIC LOG</b>	
Client Name: Eversource		Site Location: Sudbury to Hudson Transmission Reliability Project	
Photo No.: 4      Date: 9/22/2023

Description: Segment 14. View of dewatering operation (pumping at far end of area), looking eastward.
