Weekly Environmental Compliance Summary

Sudbury to Hudson Transmission Reliability Project (USEPA Tracking # MAR1003UW)

Week of: September 25, 2023 to September 29, 2023

CONSTRUCTION MONITORING REPORT

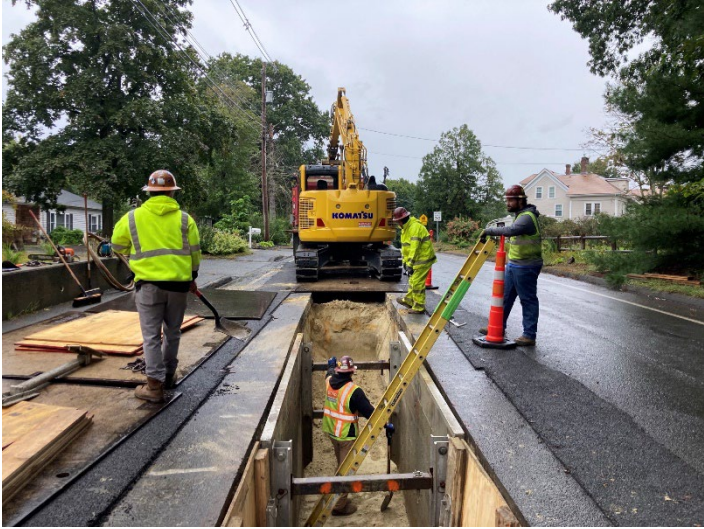
<p>PHOTOGRAPHIC LOG</p>	
<p>Client Name: Eversource</p>		<p>Site Location: Sudbury to Hudson Transmission Reliability Project</p>	<p>Town: Hudson</p>
<p>Photo No.: 1</p>	<p>Date: 9/25/2023</p>

<p>Description: View of Bond working in roadway on Forest Ave. Facing south.</p>

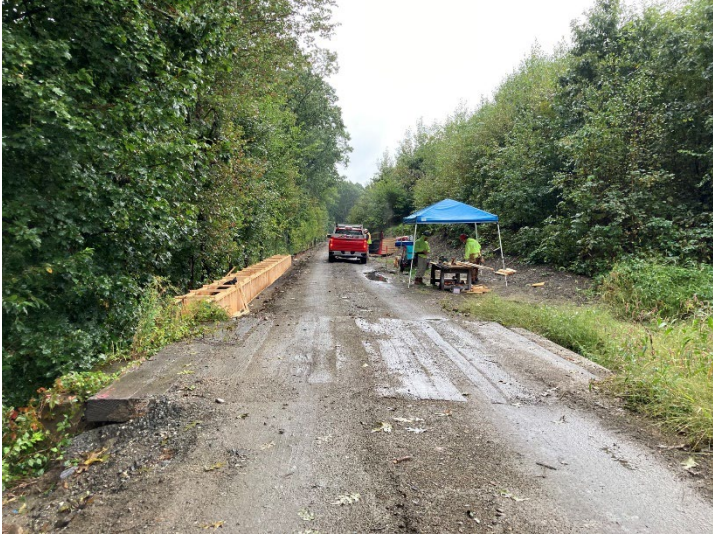
PHOTOGRAPHIC LOG	
Client Name: Eversource		Site Location: Sudbury to Hudson Transmission Reliability Project	Town: Hudson
Photo No.: 3	Date: 9/25/2023

Description: View of ET&L working at walls 1 and 2 in segment 1. Facing east.

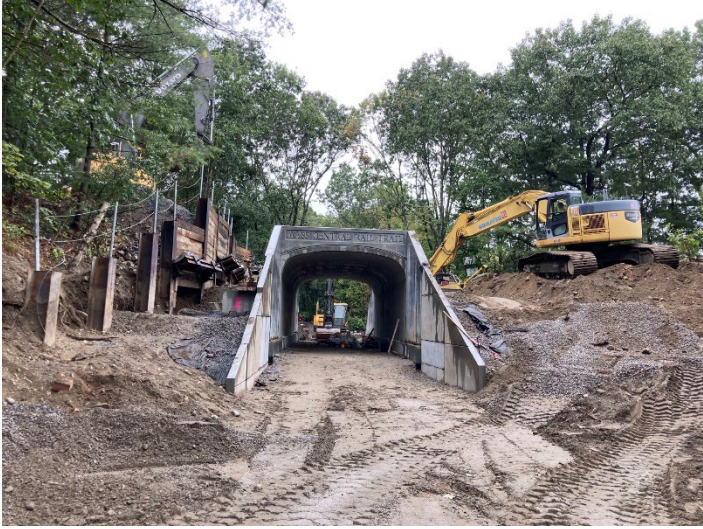
PHOTOGRAPHIC LOG	
Client Name: Eversource		Site Location: Sudbury to Hudson Transmission Reliability Project	Town: Hudson
Photo No.: 4	Date: 9/25/2023

Description: View of work at Chestnut St tunnel. Facing west.

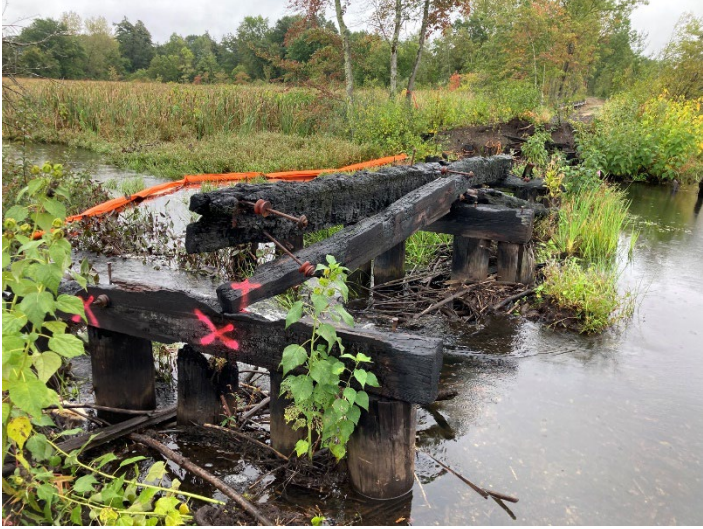
PHOTOGRAPHIC LOG	
Client Name: Eversource		Site Location: Sudbury to Hudson Transmission Reliability Project	Town: Hudson
Photo No.: 5	Date: 9/25/2023

Description: View of Bridge 130. No work was conducted at the bridge today. Facing northeast.

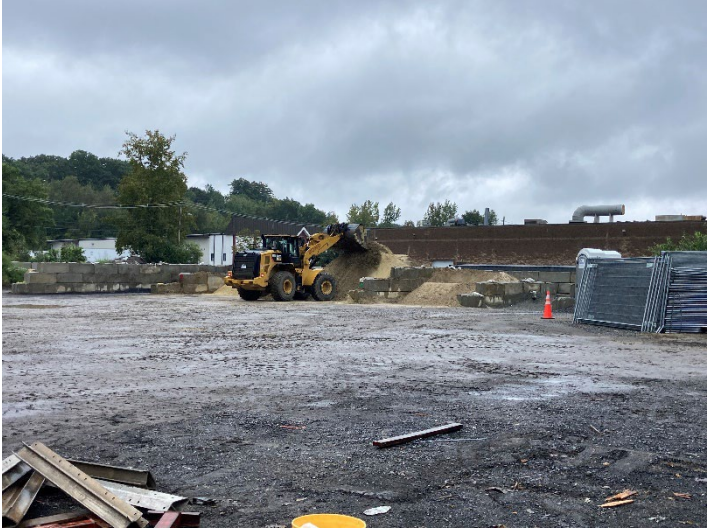
PHOTOGRAPHIC LOG	
Client Name: Eversource		Site Location: Sudbury to Hudson Transmission Reliability Project	Town: Hudson
Photo No.: 6	Date: 9/25/2023

Description: View of laydown yard on Bonazzoli Ave. Facing south.

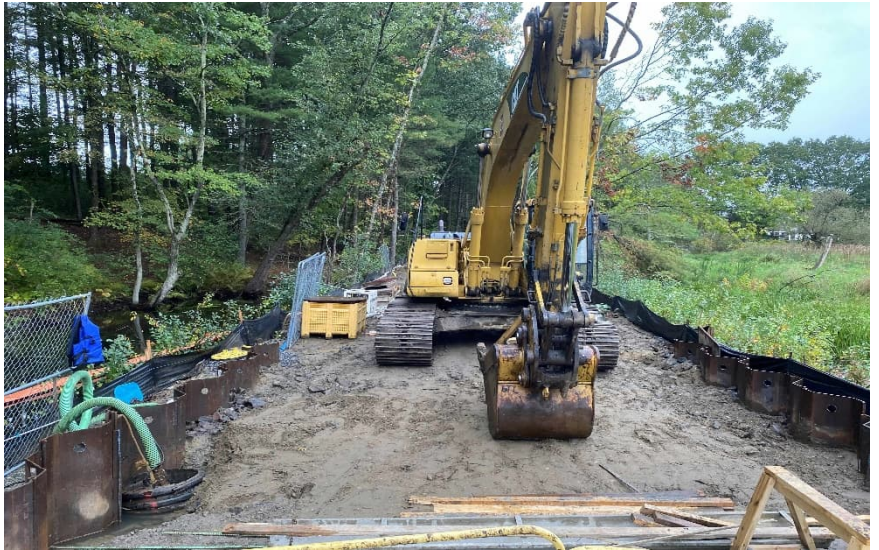
PHOTOGRAPHIC LOG	
Client Name: Eversource		Site Location: Sudbury to Hudson Transmission Reliability Project	Town: Sudbury
Photo No.: 2	Date: 9-25-23

Description: Work area within segment 13, existing erosion control, looking westward.

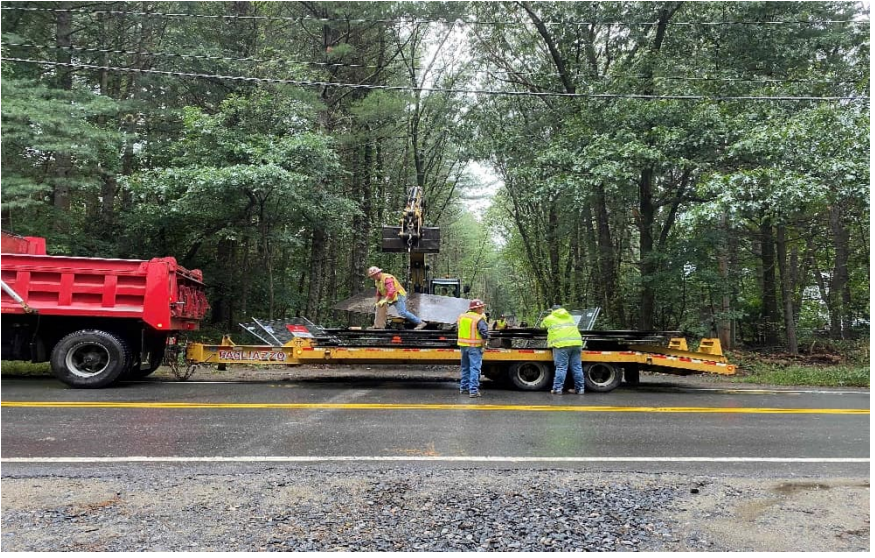
PHOTOGRAPHIC LOG	
Client Name: Eversource		Site Location: Sudbury to Hudson Transmission Reliability Project	Town: Sudbury
Photo No.: 3	Date: 9-25-23

Description: Bond staging equipment for conduit work across Horse Pond Road, looking westward.

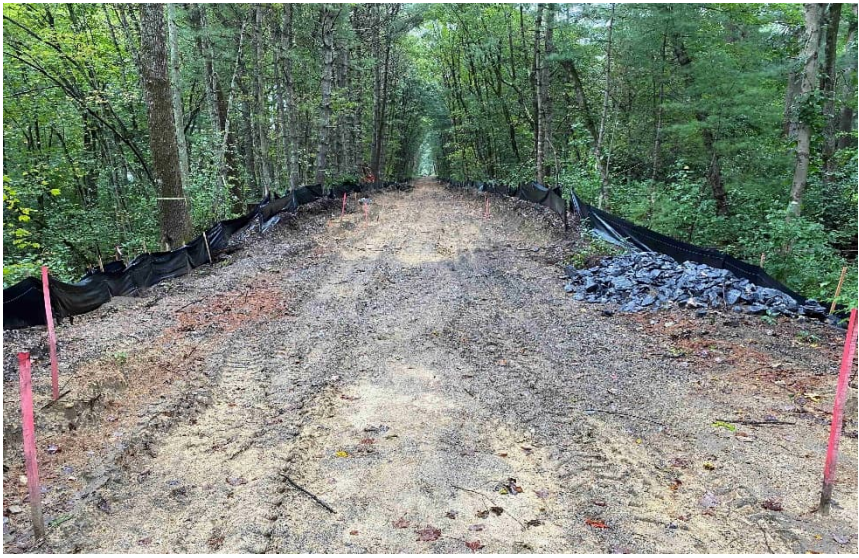
PHOTOGRAPHIC LOG	
Client Name: Eversource		Site Location: Sudbury to Hudson Transmission Reliability Project	Town: Sudbury
Photo No.: 4	Date: 9-25-23

Description: Work area within segment 10, over Dudley Brook, looking eastward.

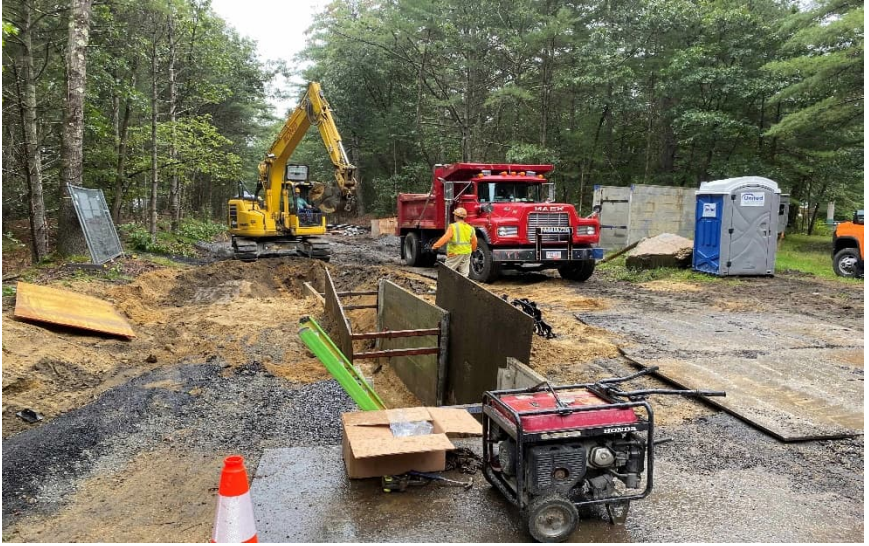
PHOTOGRAPHIC LOG	
Client Name: Eversource		Site Location: Sudbury to Hudson Transmission Reliability Project	Town: Sudbury
Photo No.: 6	Date: 9-25-23

Description: Work area within segment 9, conduit work, looking eastward.

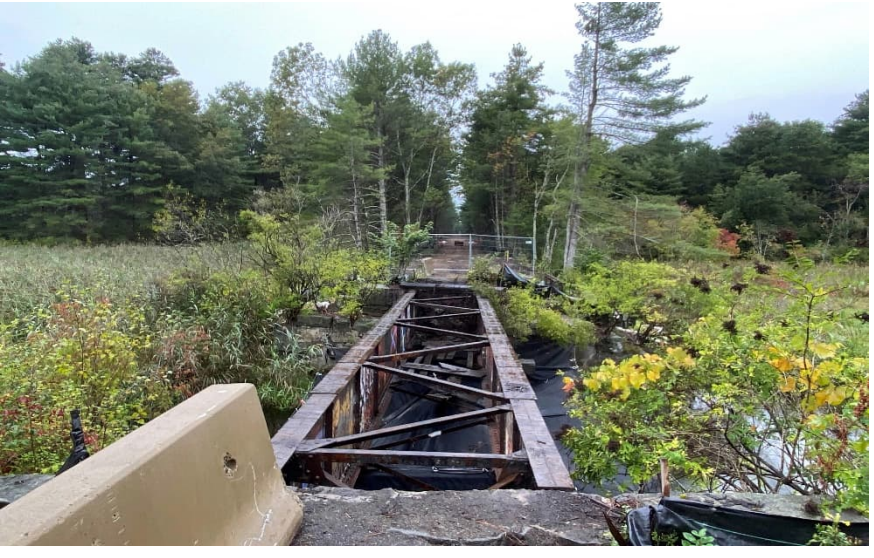
PHOTOGRAPHIC LOG	
Client Name: Eversource		Site Location: Sudbury to Hudson Transmission Reliability Project	Town: Sudbury
Photo No.: 7	Date: 9-25-23

Description: Work area within segment 7, bridge 128 work, existing erosion control, looking eastward.

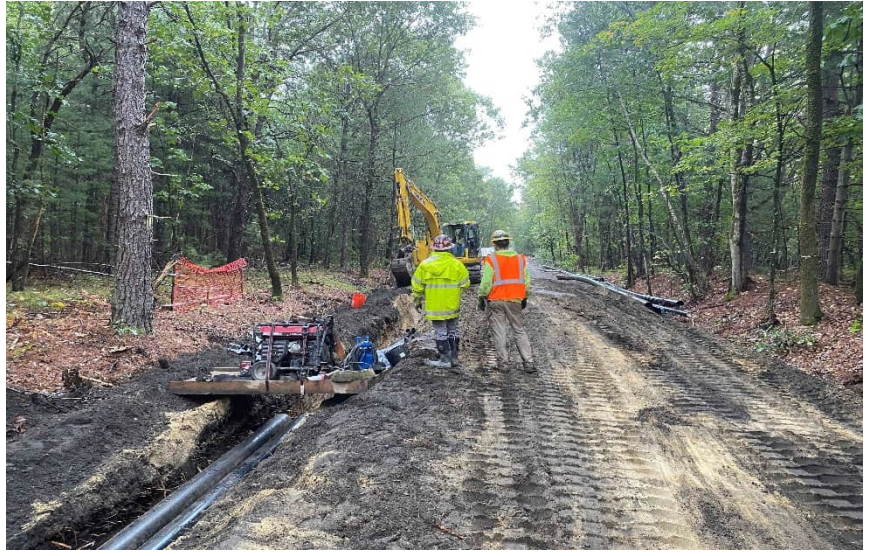
PHOTOGRAPHIC LOG	
Client Name: Eversource		Site Location: Sudbury to Hudson Transmission Reliability Project	Town: Hudson
Photo No.: 8	Date: 9-25-23

Description: Work area within segment 6, conduit work, looking eastward.

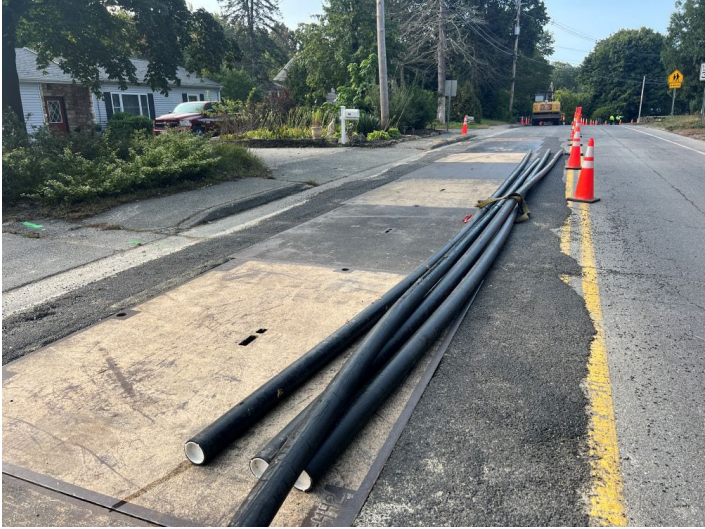
<p align="center">PHOTOGRAPHIC LOG</p>	
<p>Client Name: Eversource</p>		<p>Site Location: Sudbury to Hudson Transmission Reliability Project</p>	<p>Town: Hudson</p>
<p>Photo No.: 1</p>	<p>Date: 9/27/2023</p>

<p>Description: View of Forest Ave. Bond crews were working in the roadway. Facing south.</p>

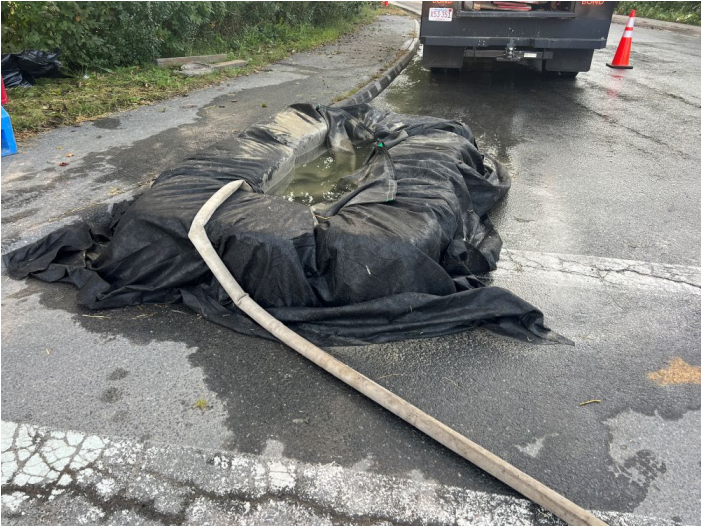
<p align="center">PHOTOGRAPHIC LOG</p>	
<p>Client Name: Eversource</p>		<p>Site Location: Sudbury to Hudson Transmission Reliability Project</p>	<p>Town: Hudson</p>
<p>Photo No.: 2</p>	<p>Date: 9/27/2023</p>

<p>Description: View of dewatering controls near MH #2 on Forest Ave and Old North Road. See additional dewatering inspection report. Facing east.</p>

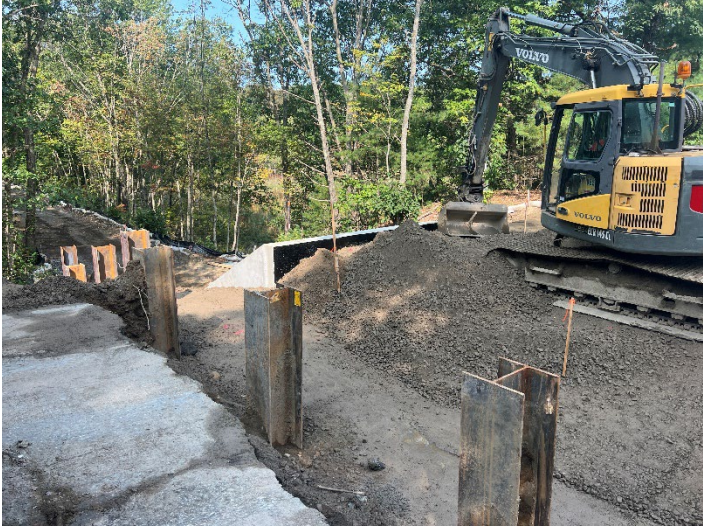
PHOTOGRAPHIC LOG	
Client Name: Eversource		Site Location: Sudbury to Hudson Transmission Reliability Project	Town: Hudson
Photo No.: 4	Date: 9/27/2023

Description: View of work at Chestnut St tunnel. ET&L was working at the tunnel. Facing southwest.

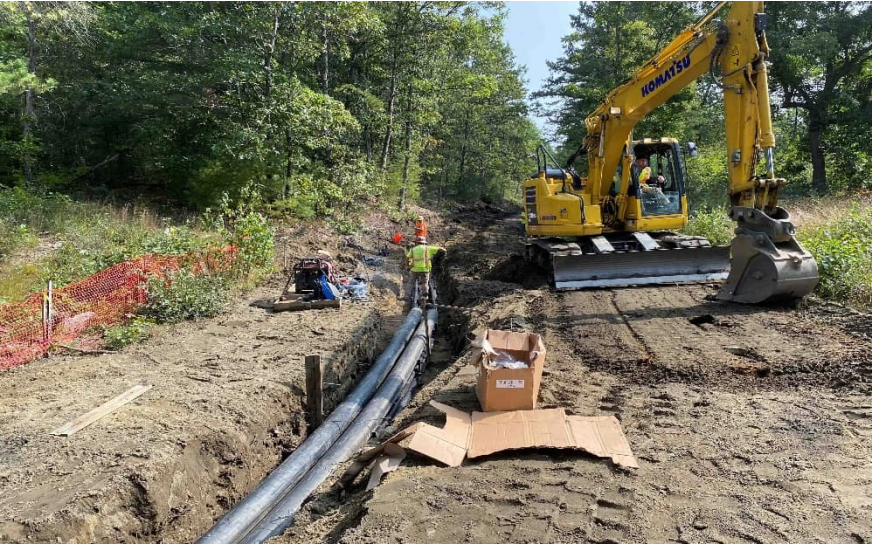
PHOTOGRAPHIC LOG	
Client Name: Eversource		Site Location: Sudbury to Hudson Transmission Reliability Project	Town: Sudbury
Photo No.: 1	Date: 9-27-23

Description: Conduit work area within segment 7 working over existing gas line, looking eastward.

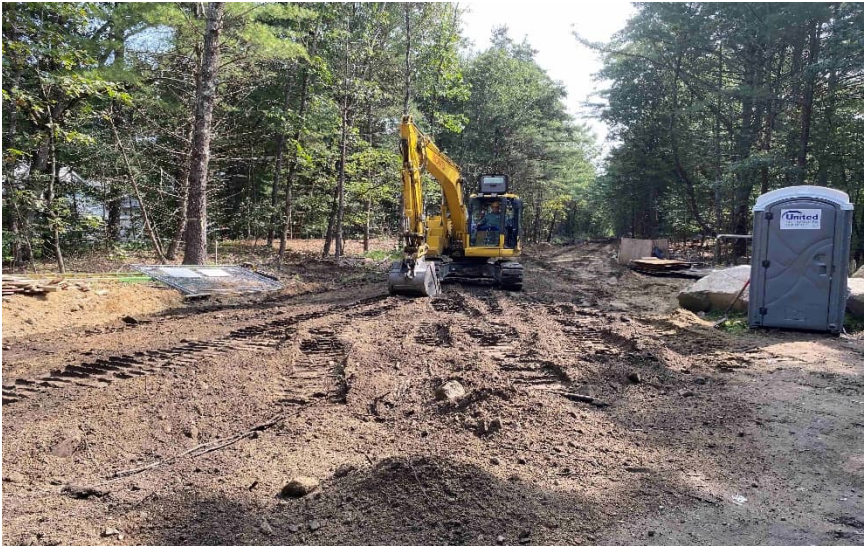
PHOTOGRAPHIC LOG	
Client Name: Eversource		Site Location: Sudbury to Hudson Transmission Reliability Project	Town: Sudbury
Photo No.: 2	Date: 9-27-23

Description: Work area within segment 9, conduit work, looking eastward.

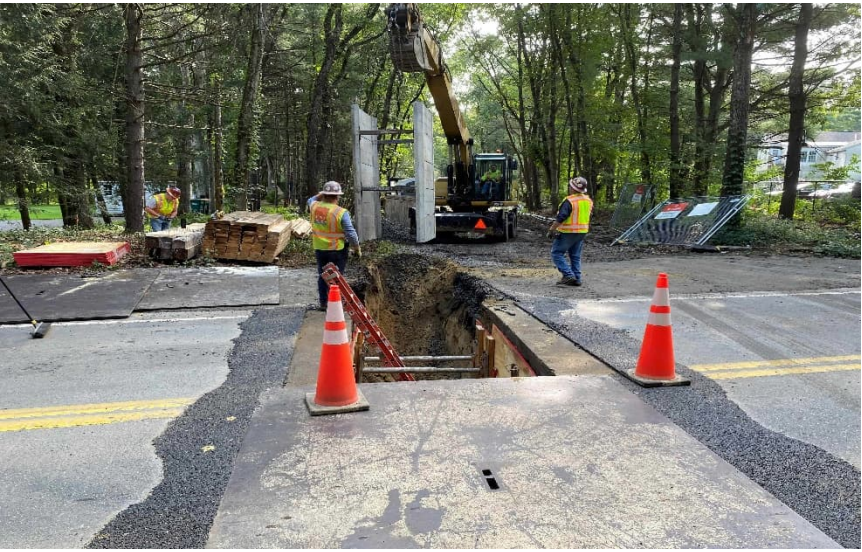
PHOTOGRAPHIC LOG	
Client Name: Eversource		Site Location: Sudbury to Hudson Transmission Reliability Project	Town: Sudbury
Photo No.: 4	Date: 9-27-23

Description: Work area within Horse Pond Road, trenching (east side of road), looking eastward.

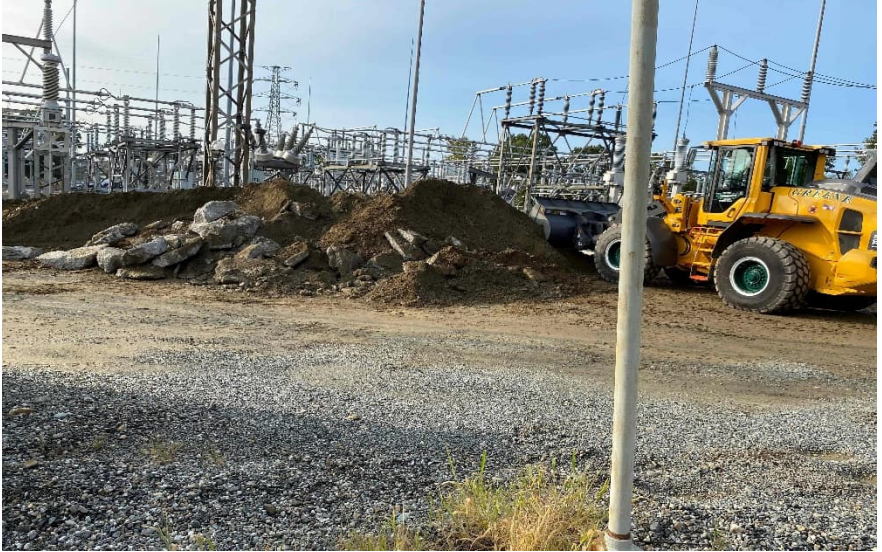
PHOTOGRAPHIC LOG	
Client Name: Eversource		Site Location: Sudbury to Hudson Transmission Reliability Project	Town: Sudbury
Photo No.: 5	Date: 9-27-23

Description: Spoil within substation being removed, looking southward.

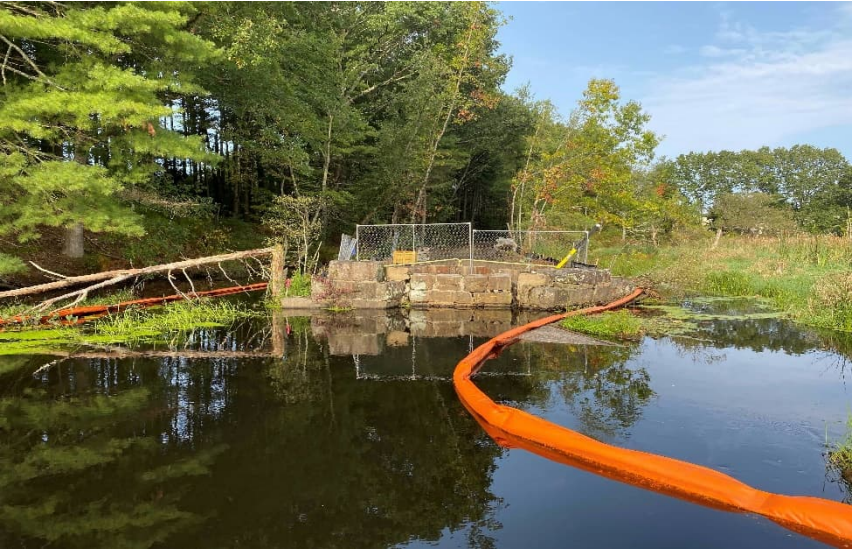
PHOTOGRAPHIC LOG	
Client Name: Eversource		Site Location: Sudbury to Hudson Transmission Reliability Project	Town: Sudbury
Photo No.: 7	Date: 9-27-23

Description: Work area within segment 14 -> 13, bridge 127 work area, existing erosion control, looking westward.

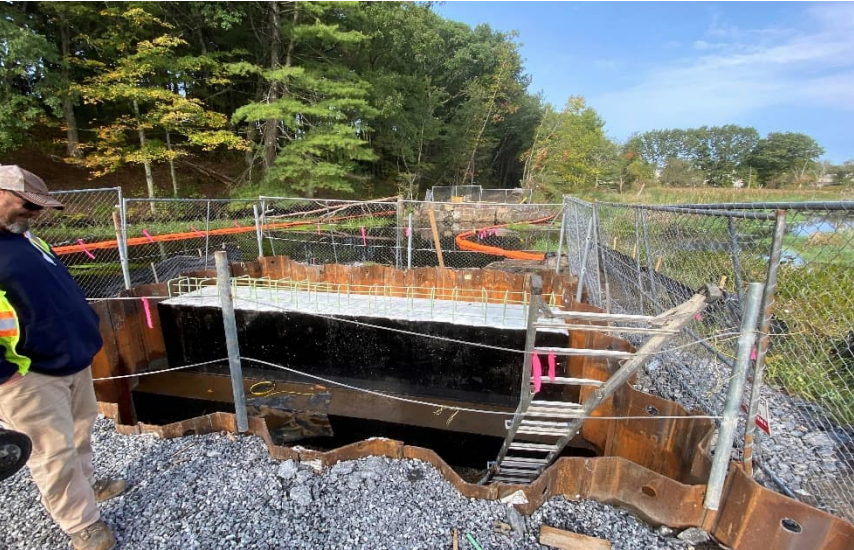
PHOTOGRAPHIC LOG	
Client Name: Eversource		Site Location: Sudbury to Hudson Transmission Reliability Project	Town: Sudbury
Photo No.: 8	Date: 9-27-23

Description: Work area within segment 14, looking westward.

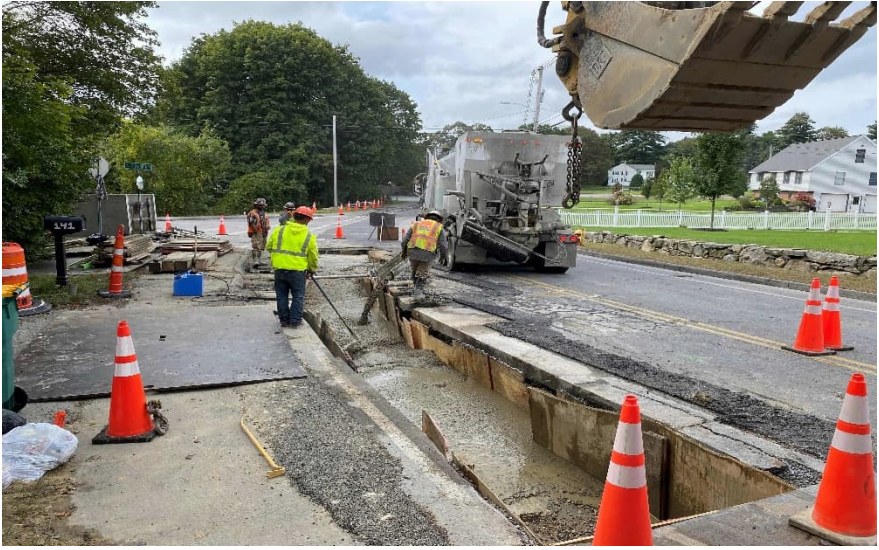
<p>PHOTOGRAPHIC LOG</p>	
<p>Client Name: Eversource</p>		<p>Site Location: Sudbury to Hudson Transmission Reliability Project</p>	<p>Town: Hudson</p>
<p>Photo No.: 1</p>	<p>Date: 9-28-23</p>

<p>Description:</p> <p>Work area within Forest Avenue, conduit work (Marisa's crew), looking southward.</p>

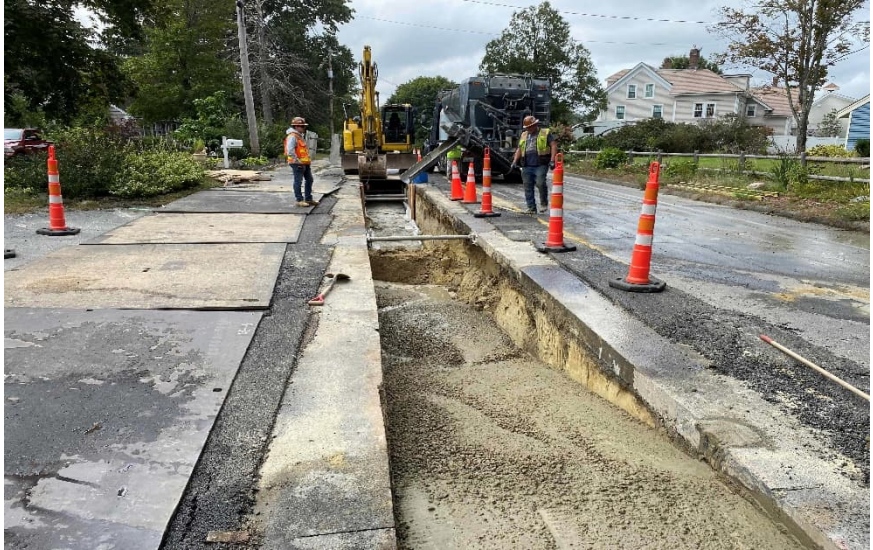
<p>PHOTOGRAPHIC LOG</p>	
<p>Client Name: Eversource</p>		<p>Site Location: Sudbury to Hudson Transmission Reliability Project</p>	<p>Town: Hudson</p>
<p>Photo No.: 2</p>	<p>Date: 9-28-23</p>

<p>Description:</p> <p>Work area within Forest Avenue, conduit work (Jim's crew), looking northward.</p>

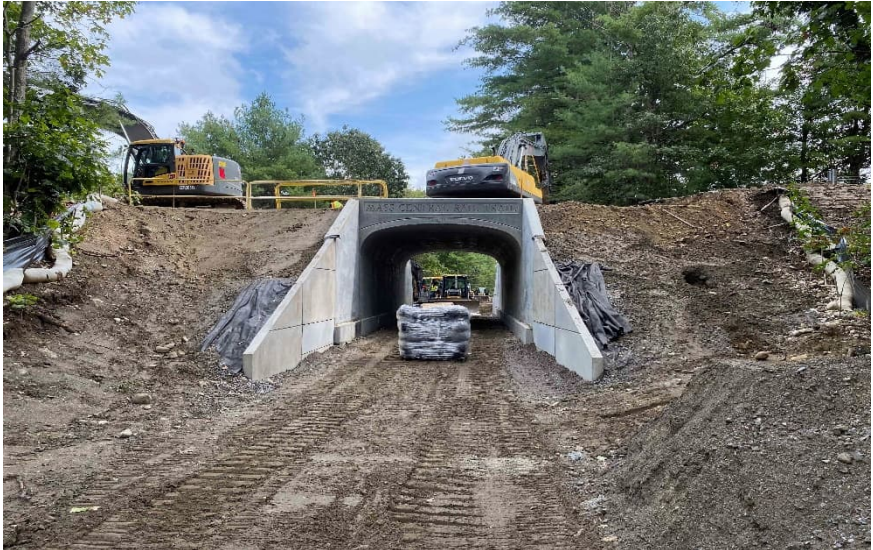
<p>PHOTOGRAPHIC LOG</p>	
<p>Client Name: Eversource</p>		<p>Site Location: Sudbury to Hudson Transmission Reliability Project</p>	<p>Town: Hudson</p>
<p>Photo No.: 3</p>	<p>Date: 9-28-23</p>

<p>Description:</p> <p>Work area within segment 1, Chestnut Street crossing, looking eastward.</p>

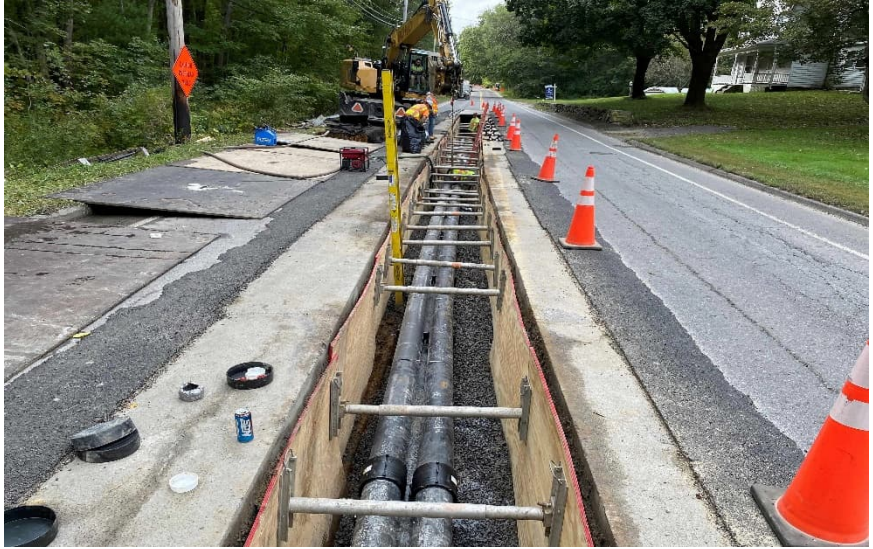
<p>PHOTOGRAPHIC LOG</p>	
<p>Client Name: Eversource</p>		<p>Site Location: Sudbury to Hudson Transmission Reliability Project</p>	<p>Town: Hudson</p>
<p>Photo No.: 4</p>	<p>Date: 9-28-23</p>

<p>Description:</p> <p>Work area within Forest Avenue, conduit work (Oscar's crew), looking southward.</p>

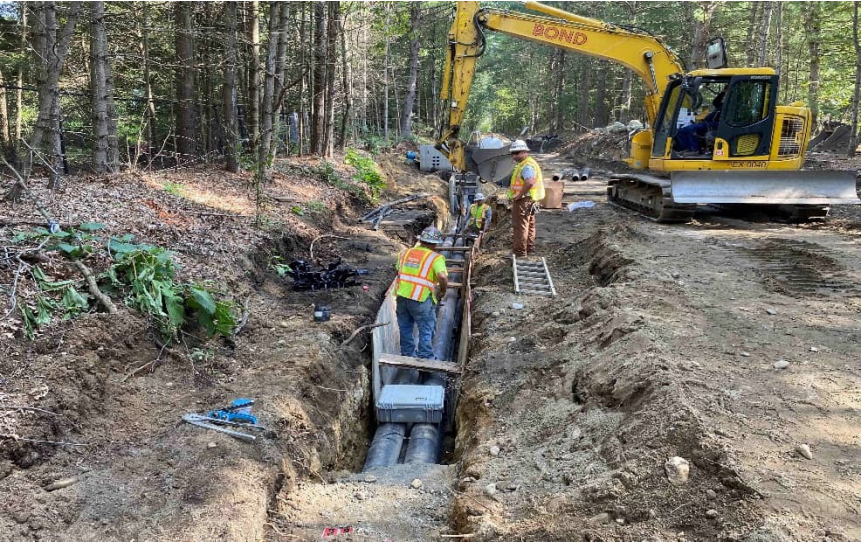
<p>PHOTOGRAPHIC LOG</p>	
<p>Client Name: Eversource</p>		<p>Site Location: Sudbury to Hudson Transmission Reliability Project</p>	<p>Town: Sudbury</p>
<p>Photo No.: 5</p>	<p>Date: 9-28-23</p>

<p>Description: Conduit work within segment 9, looking eastward.</p>

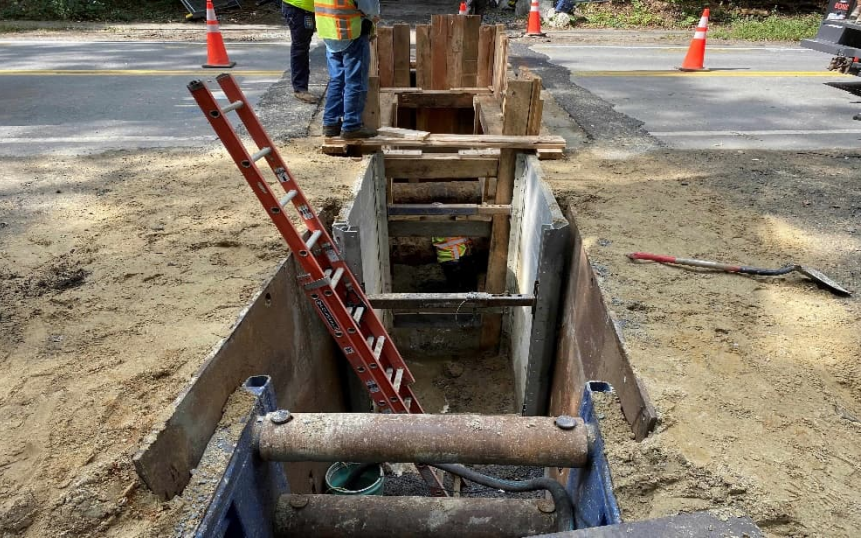
<p>PHOTOGRAPHIC LOG</p>	
<p>Client Name: Eversource</p>		<p>Site Location: Sudbury to Hudson Transmission Reliability Project</p>	<p>Town: Sudbury</p>
<p>Photo No.: 6</p>	<p>Date: 9-28-23</p>

<p>Description: Conduit work within segment 11 & Horse Pond Road, looking westward.</p>

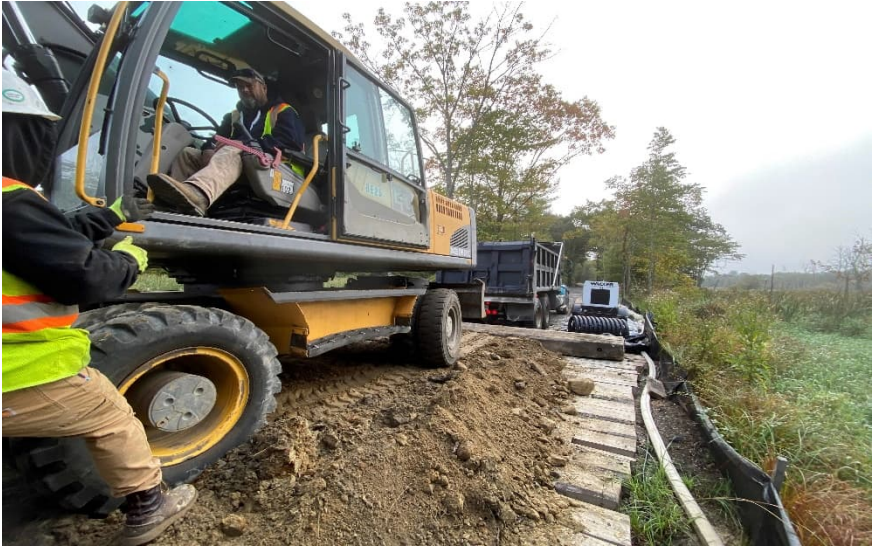
<p>PHOTOGRAPHIC LOG</p>	
<p>Client Name: Eversource</p>		<p>Site Location: Sudbury to Hudson Transmission Reliability Project</p>	<p>Town: Sudbury</p>
<p>Photo No.: 7</p>	<p>Date: 9-28-23</p>

<p>Description:</p> <p>Work area within Segment 14, existing erosion control, looking eastward.</p>

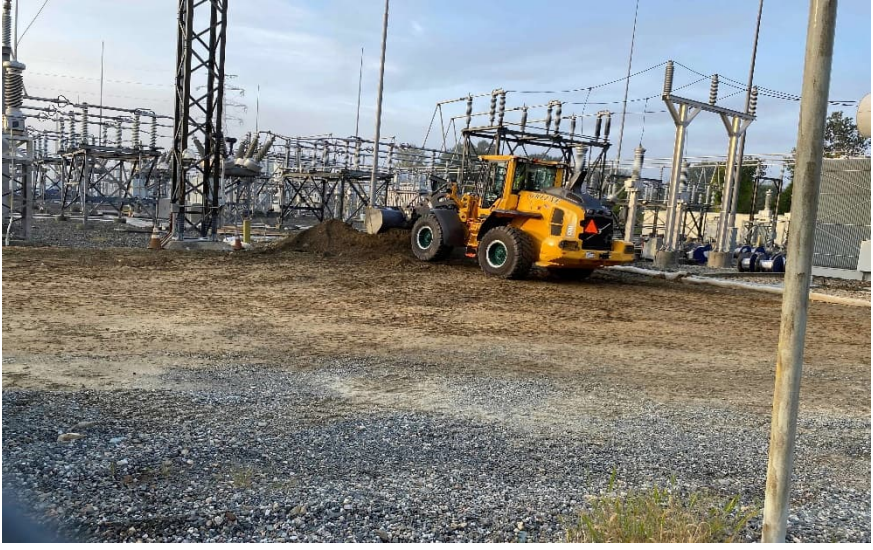
<p>PHOTOGRAPHIC LOG</p>	
<p>Client Name: Eversource</p>		<p>Site Location: Sudbury to Hudson Transmission Reliability Project</p>	<p>Town: Sudbury</p>
<p>Photo No.: 8</p>	<p>Date: 9-28-23</p>

<p>Description:</p> <p>Spoil pile removal at the substation, looking southward.</p>

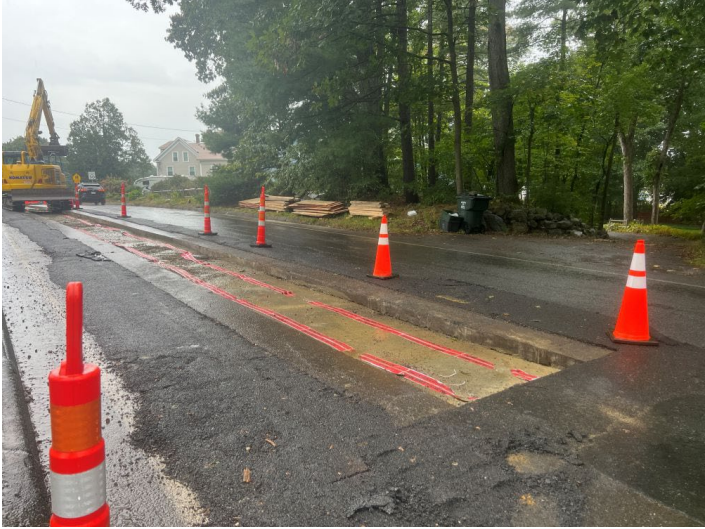
<p align="right">PHOTOGRAPHIC LOG</p>	
<p>Client Name: Eversource</p>		<p>Site Location: Sudbury to Hudson Transmission Reliability Project</p>	<p>Town: Hudson</p>
<p>Photo No.: 1</p>	<p>Date: 9/29/2023</p>

<p>Description: View of Forest Ave. Bond crews were working in the roadway. Facing south.</p>

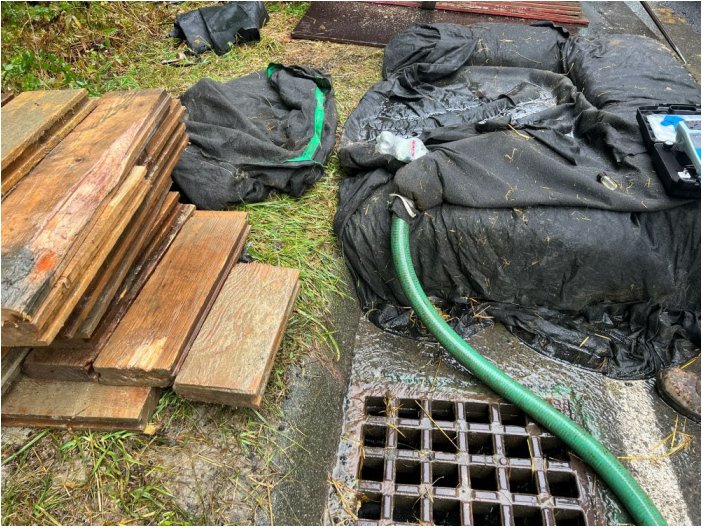
<p align="right">PHOTOGRAPHIC LOG</p>	
<p>Client Name: Eversource</p>		<p>Site Location: Sudbury to Hudson Transmission Reliability Project</p>	<p>Town: Hudson</p>
<p>Photo No.: 2</p>	<p>Date: 9/29/2023</p>

<p>Description: View of dewatering controls near MH #4 on Forest Ave. See additional dewatering inspection report. Facing east.</p>

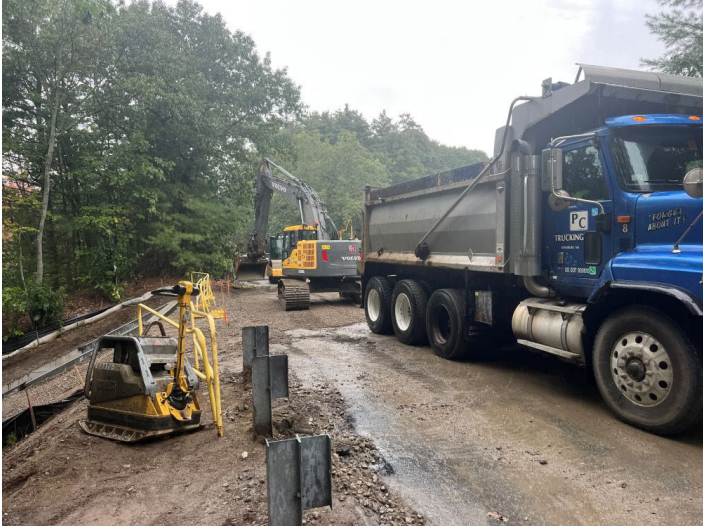
PHOTOGRAPHIC LOG	
Client Name: Eversource		Site Location: Sudbury to Hudson Transmission Reliability Project	Town: Hudson
Photo No.: 4	Date: 9/29/2023

Description: View of work at Chestnut St tunnel. ET&L was working at the tunnel. Facing west.

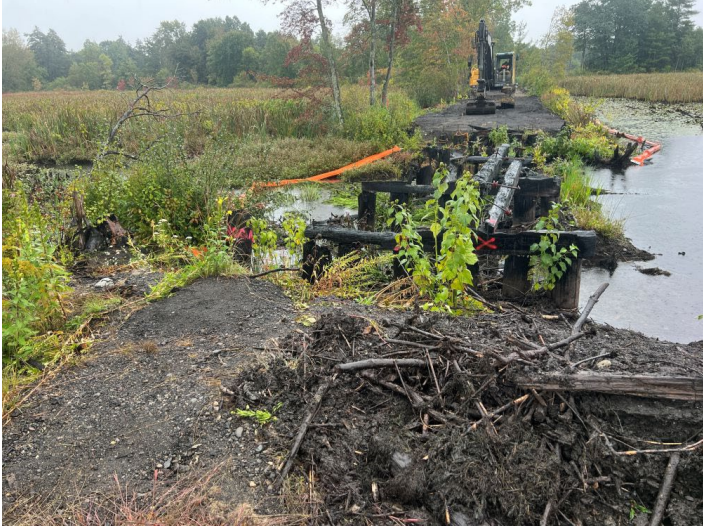
<p>PHOTOGRAPHIC LOG</p>	
<p>Client Name: Eversource</p>		<p>Site Location: Sudbury to Hudson Transmission Reliability Project</p>	<p>Town: Hudson</p>
<p>Photo No.: 5</p>	<p>Date: 9/29/2023</p>

<p>Description: View of Bridge 130. Work was being conducted at the bridge today. Facing northeast.</p>

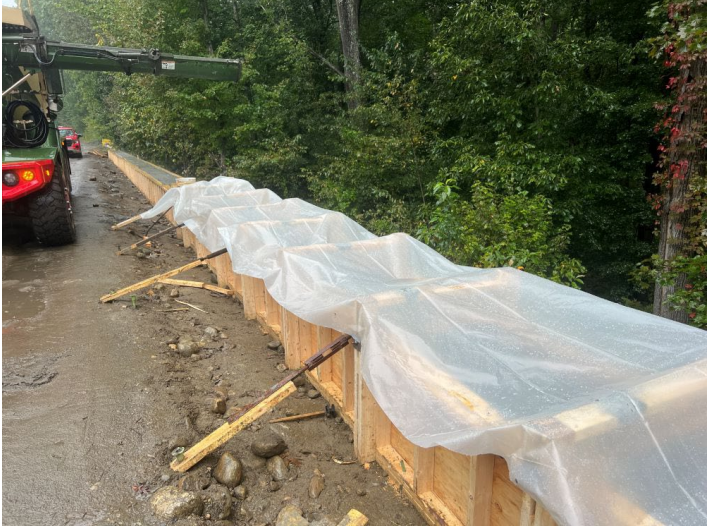
<p>PHOTOGRAPHIC LOG</p>	
<p>Client Name: Eversource</p>		<p>Site Location: Sudbury to Hudson Transmission Reliability Project</p>	<p>Town: Hudson</p>
<p>Photo No.: 6</p>	<p>Date: 9/29/2023</p>

<p>Description: Concrete was being poured at walls 1 and 2 in segment 1. Facing west.</p>

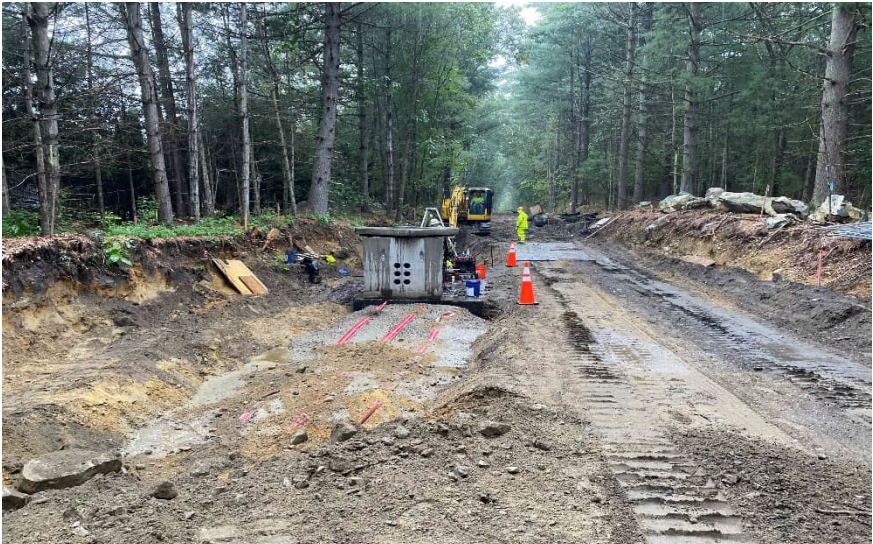
PHOTOGRAPHIC LOG	
Client Name: Eversource		Site Location: Sudbury to Hudson Transmission Reliability Project	Town: Sudbury
Photo No.: 2	Date: 9-29-23

Description: Work area within segment 9, conduit work, looking eastward.

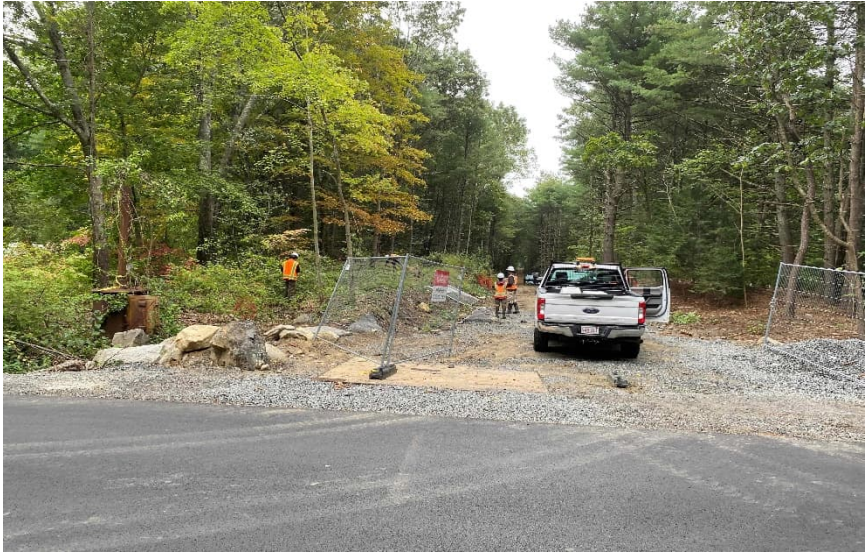
PHOTOGRAPHIC LOG	
Client Name: Eversource		Site Location: Sudbury to Hudson Transmission Reliability Project	Town: Sudbury
Photo No.: 3	Date: 9-29-23

Description: Work area within segment 10, invasive species removal, looking eastward.

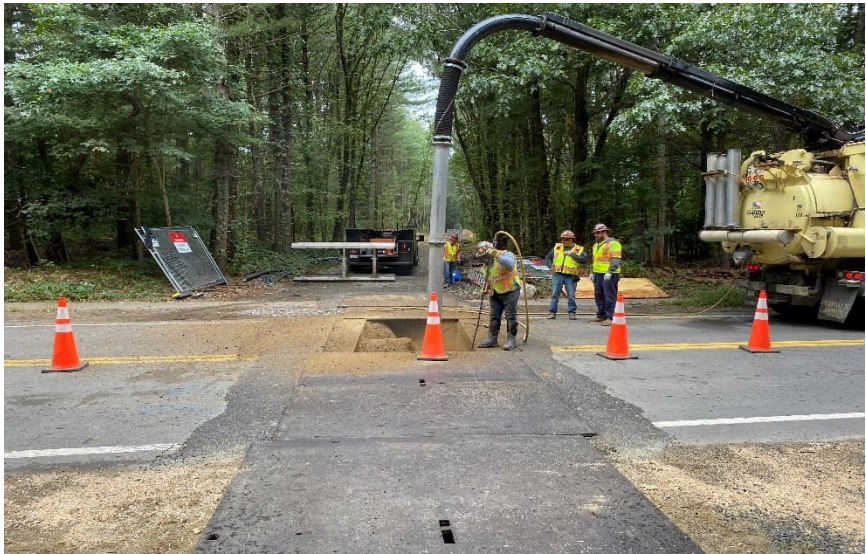
PHOTOGRAPHIC LOG	
Client Name: Eversource		Site Location: Sudbury to Hudson Transmission Reliability Project	Town: Sudbury
Photo No.: 4	Date: 9-29-23

Description: Work area within Horse Pond Road, trenching (east side of road), looking westward.

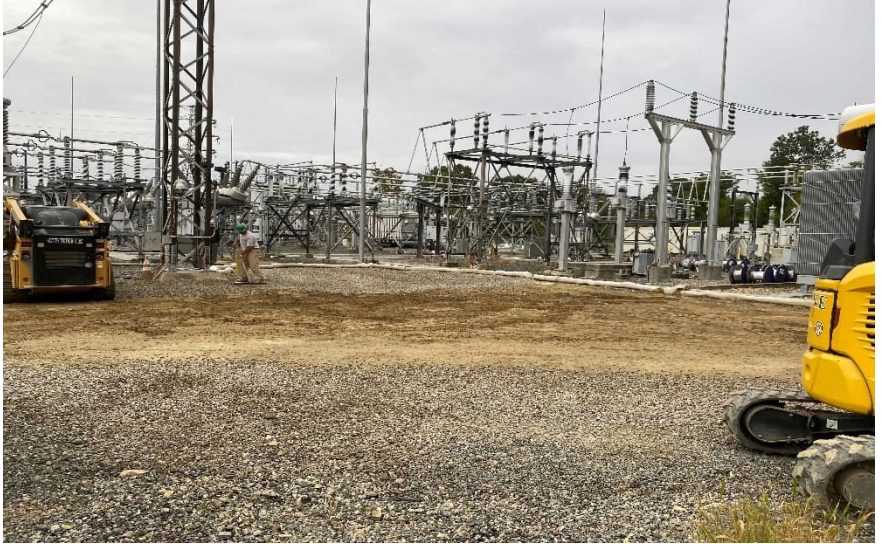
PHOTOGRAPHIC LOG	
Client Name: Eversource		Site Location: Sudbury to Hudson Transmission Reliability Project	Town: Sudbury
Photo No.: 5	Date: 9-29-23

Description: Spoil removal from within substation, looking southward.

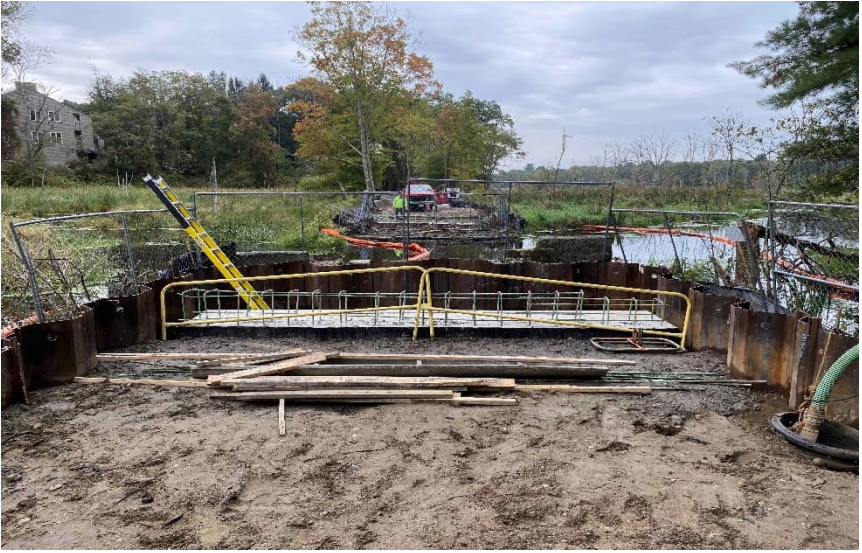
PHOTOGRAPHIC LOG	
Client Name: Eversource		Site Location: Sudbury to Hudson Transmission Reliability Project	Town: Sudbury
Photo No.: 7	Date: 9-29-23

Description: Work area within segment 13 -> 14, bridge 127 work area, existing erosion control, looking eastward.

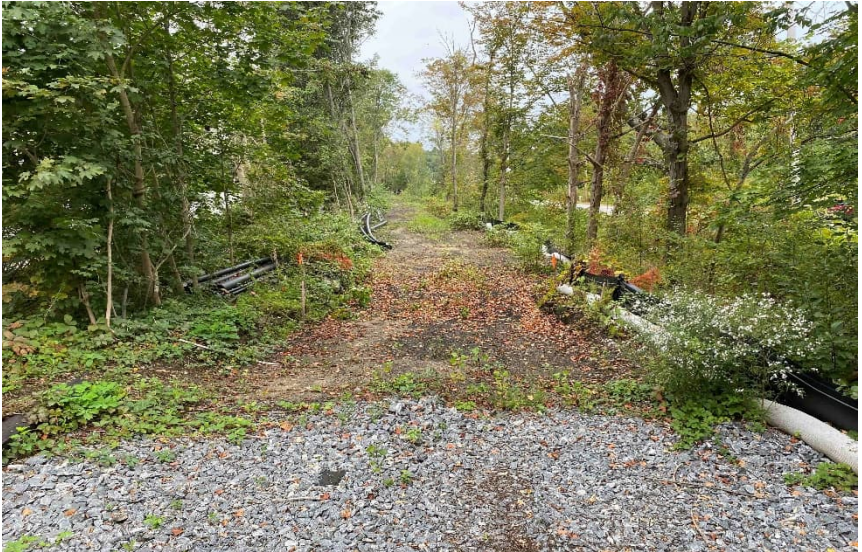
PHOTOGRAPHIC LOG	
Client Name: Eversource		Site Location: Sudbury to Hudson Transmission Reliability Project	Town: Sudbury
Photo No.: 8	Date: 9-29-23

Description: Work area within segment 12, looking westward.

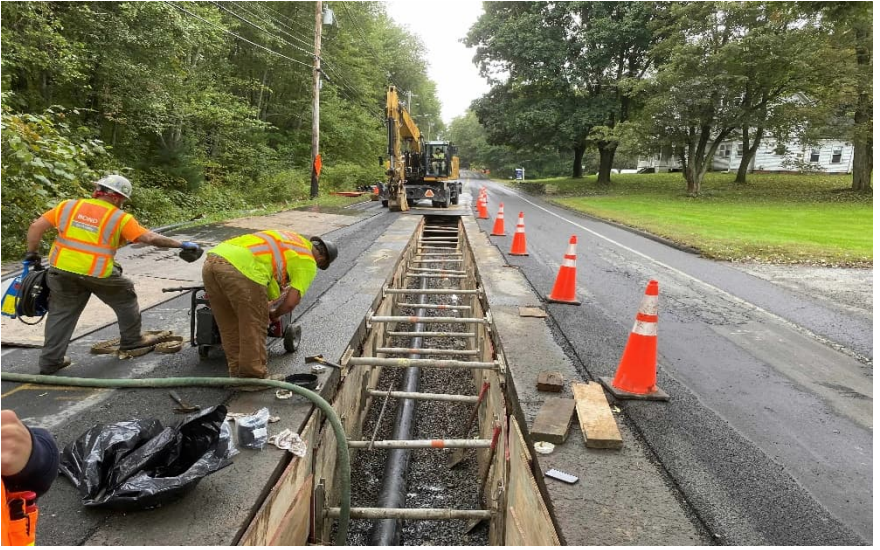
PHOTOGRAPHIC LOG	
Client Name: Eversource		Site Location: Sudbury to Hudson Transmission Reliability Project	Town: Hudson
Photo No.: 1	Date: 9-26-23

Description: Conduit work within Forest Avenue (Oscar's crew), looking southward.

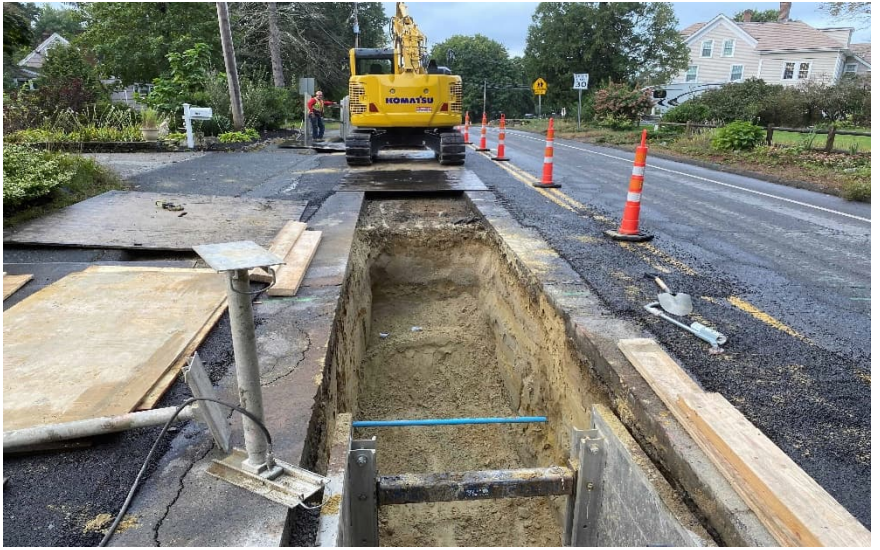
PHOTOGRAPHIC LOG	
Client Name: Eversource		Site Location: Sudbury to Hudson Transmission Reliability Project	Town: Hudson
Photo No.: 2	Date: 9-26-23

Description: Conduit work within Forest Avenue (Jim's crew), looking southward.

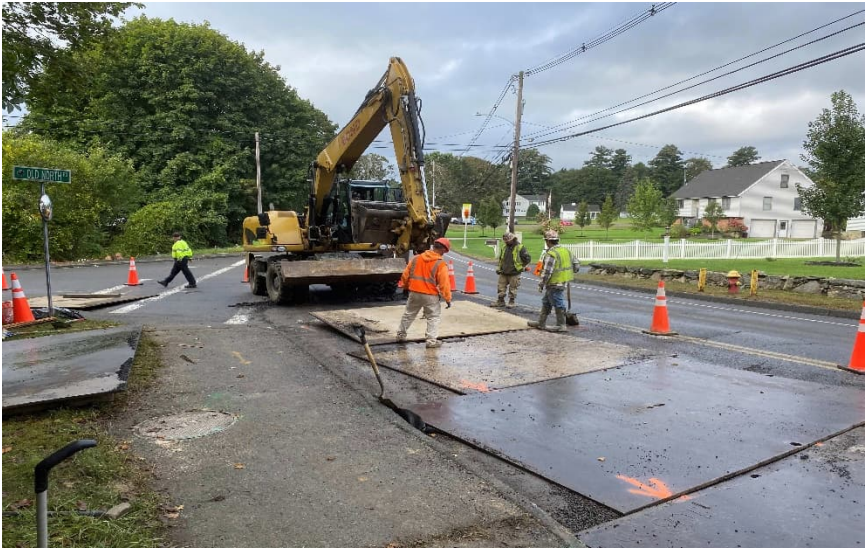
PHOTOGRAPHIC LOG	
Client Name: Eversource		Site Location: Sudbury to Hudson Transmission Reliability Project	Town: Hudson
Photo No.: 3	Date: 9-26-23

Description: Conduit work within Forest Avenue (Marisa's crew), looking northward.

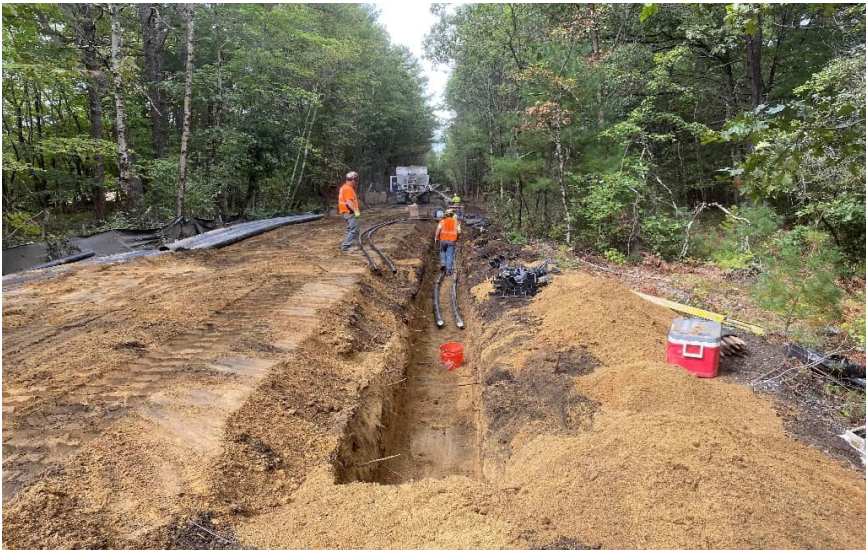
PHOTOGRAPHIC LOG	
Client Name: Eversource		Site Location: Sudbury to Hudson Transmission Reliability Project	Town: Hudson
Photo No.: 4	Date: 9-26-23

Description: Work area within segment 6, conduit work, existing erosion control, looking westward.

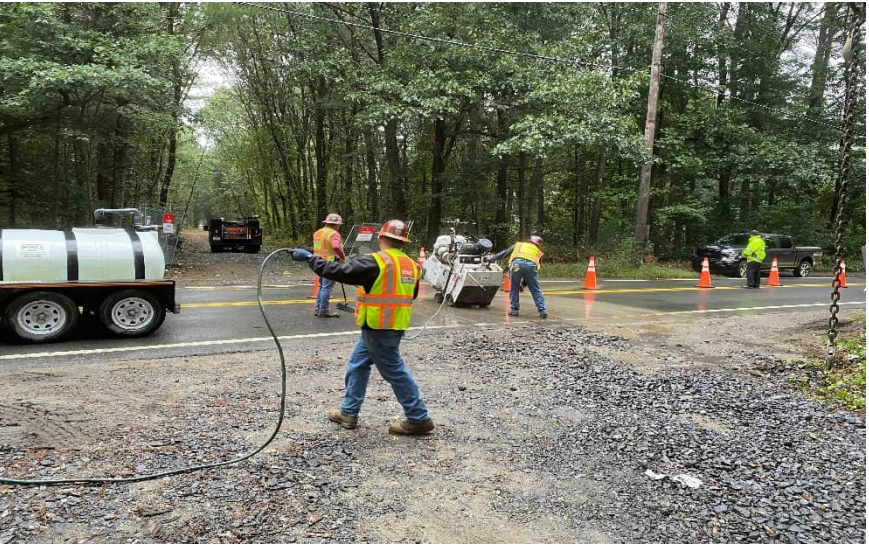
PHOTOGRAPHIC LOG	
Client Name: Eversource		Site Location: Sudbury to Hudson Transmission Reliability Project	Town: Sudbury
Photo No.: 6	Date: 9-26-23

Description: Conduit work within Horse pond Road, saw cutting of road, looking westward.
