Weekly Environmental Compliance Summary

Sudbury to Hudson Transmission Reliability Project (USEPA Tracking # MAR1003UW)

Week of: September 25, 2023 to September 29, 2023

CONSTRUCTION MONITORING REPORT

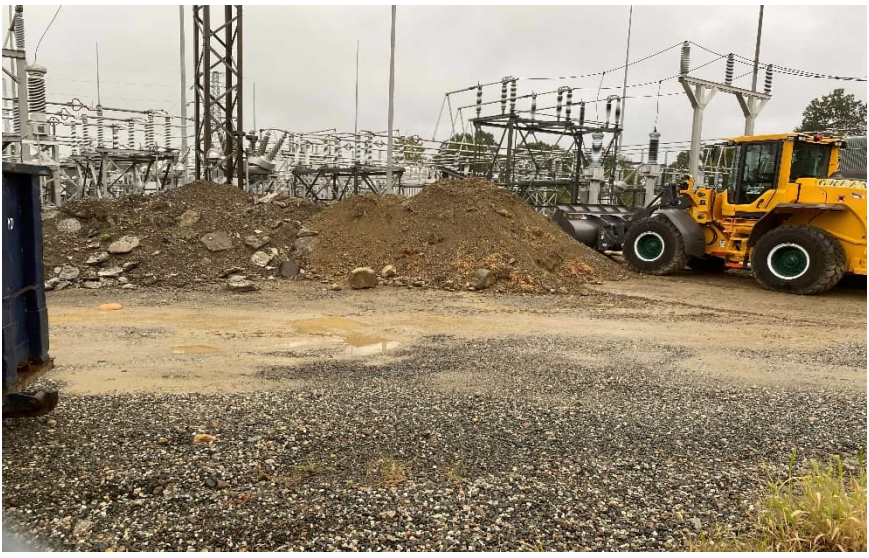
PHOTOGRAPHIC LOG	
Client Name: Eversource		Site Location: Sudbury to Hudson Transmission Reliability Project	Town: Sudbury
Photo No.: 8	Date: 9-26-23

Description: Spoil pile within the substation, looking southward.

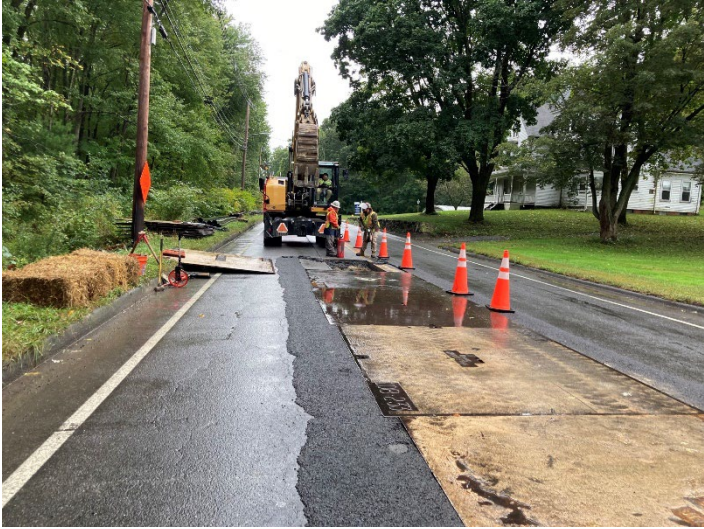
PHOTOGRAPHIC LOG	
Client Name: Eversource		Site Location: Sudbury to Hudson Transmission Reliability Project	Town: Hudson
Photo No.: 1	Date: 9/25/2023

Description: View of work area near MH #4 on Forest Ave in Hudson. Facing south.

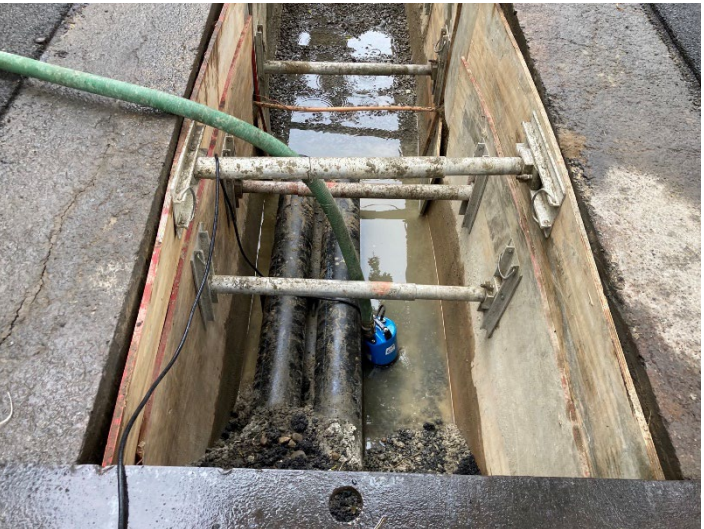
PHOTOGRAPHIC LOG	
Client Name: Eversource		Site Location: Sudbury to Hudson Transmission Reliability Project	Town: Hudson
Photo No.: 2	Date: 9/25/2023

Description: View of pump in trench. Water appeared to be slightly turbid prior to treatment.

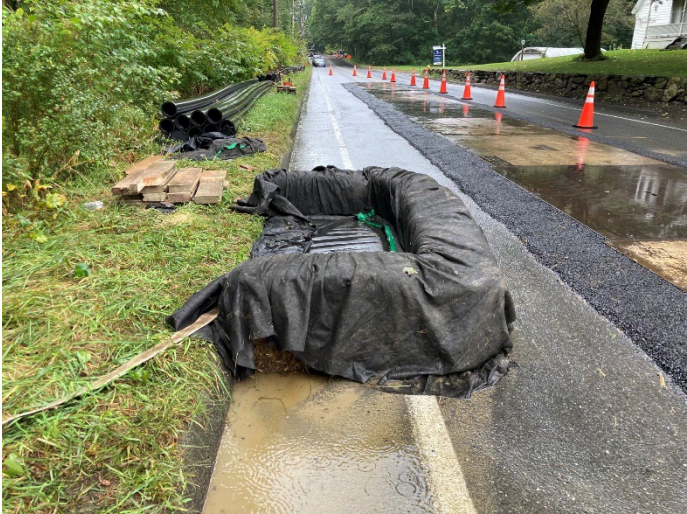
PHOTOGRAPHIC LOG		
Client Name: Eversource		Site Location: Sudbury to Hudson Transmission Reliability Project		Town: Hudson
Photo No.: 3	Date: 9/25/2023

Description: View of dewatering controls (straw bale corral with filter fabric and silt bag). Facing south.

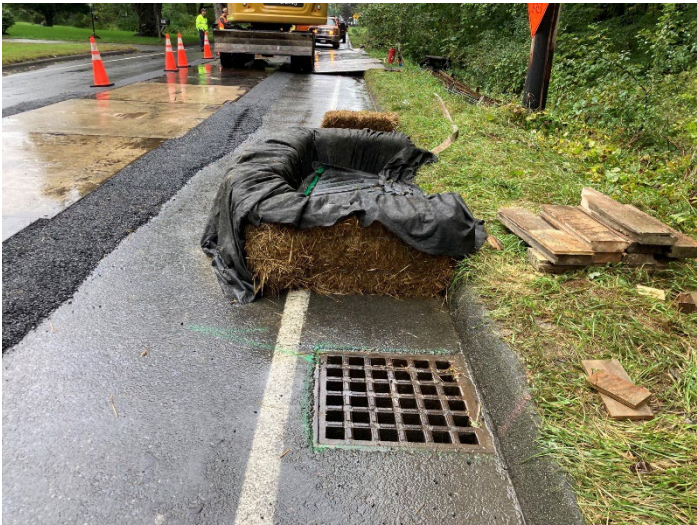
PHOTOGRAPHIC LOG		
Client Name: Eversource		Site Location: Sudbury to Hudson Transmission Reliability Project		Town: Hudson
Photo No.: 4	Date: 9/25/2023

Description: View dewatering controls (straw bale corral with filter fabric and silt bag) and discharge point from project (catch basin below hay bale corral on Forest Ave). Discharge appeared slightly turbid, but turbidity reading was below 50 NTUs. Facing north.

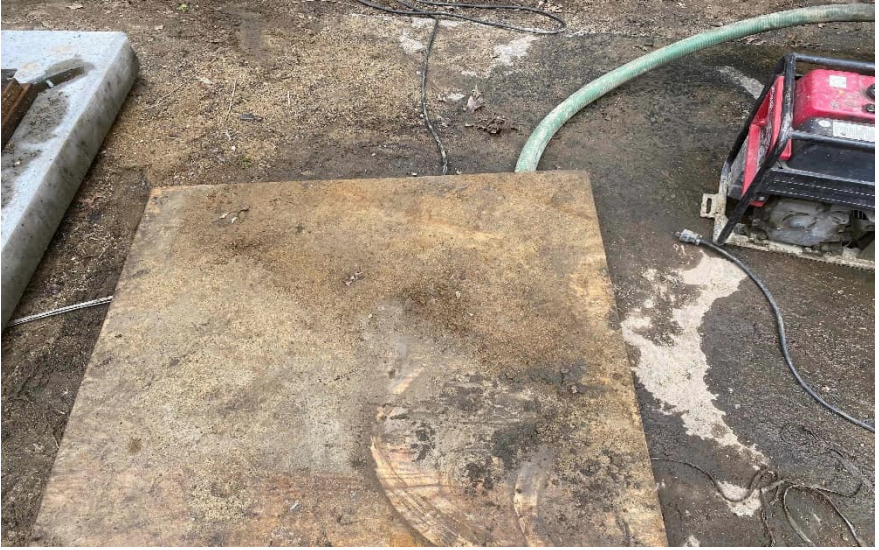
PHOTOGRAPHIC LOG	
Client Name: Eversource		Site Location: Sudbury to Hudson Transmission Reliability Project	Town: Hudson
Photo No.: 1	Date: 9/26/2023

Description: View of area being pumped at Segment 6 (Manhole #14).

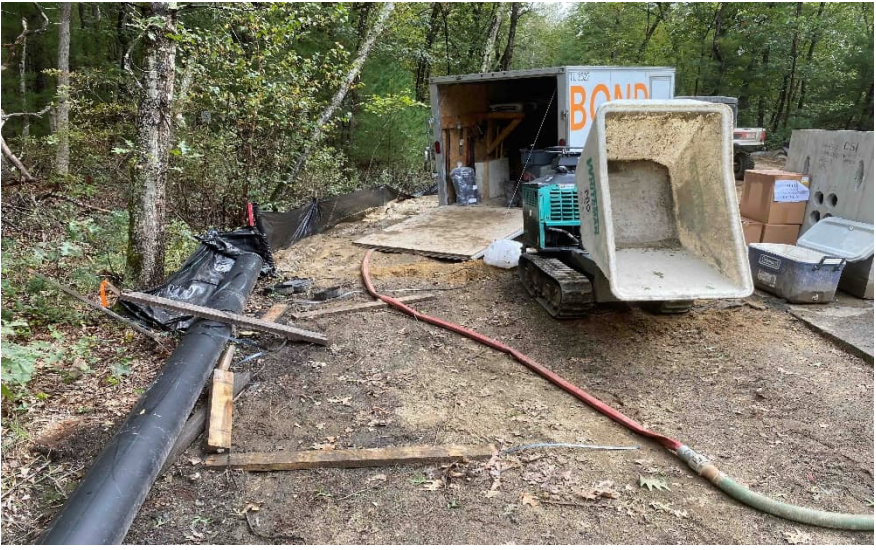
PHOTOGRAPHIC LOG	
Client Name: Eversource		Site Location: Sudbury to Hudson Transmission Reliability Project	Town: Hudson
Photo No.: 2	Date: 9/26/2023

Description: Segment 6. View of dewatering operation, looking eastward.

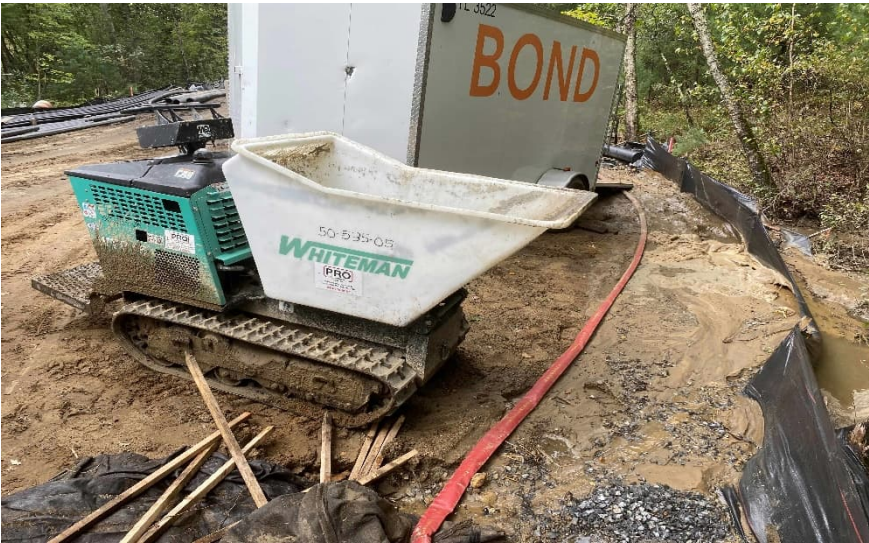
<h2 style="margin: 0;">PHOTOGRAPHIC LOG</h2>	
Client Name: Eversource		Site Location: Sudbury to Hudson Transmission Reliability Project	Town: Hudson
Photo No.: 3	Date: 9/26/2023

Description: Segment 6. View of dewatering operation, looking westward.

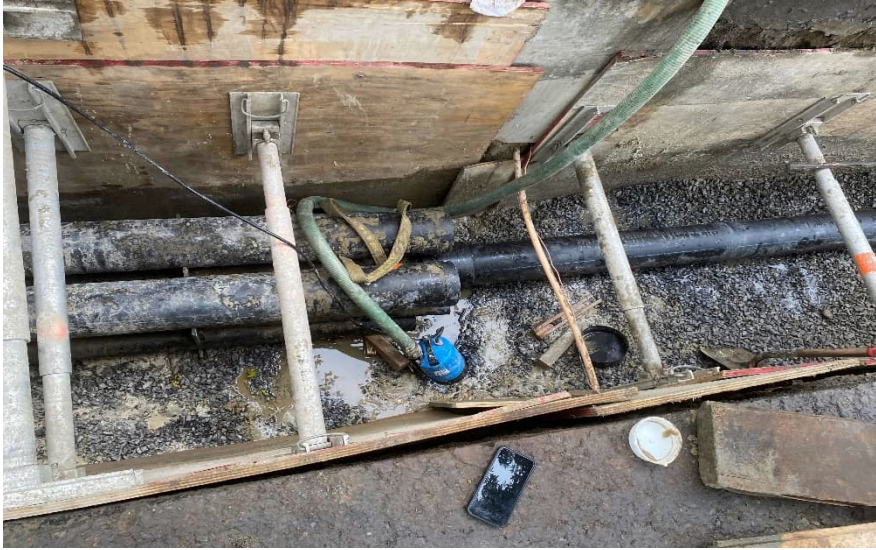
PHOTOGRAPHIC LOG	
Client Name: Eversource		Site Location: Sudbury to Hudson Transmission Reliability Project	Town: Hudson
Photo No.: 1	Date: 9/26/2023

Description: View of area being pumped at Forest Avenue (area near manhole #4).

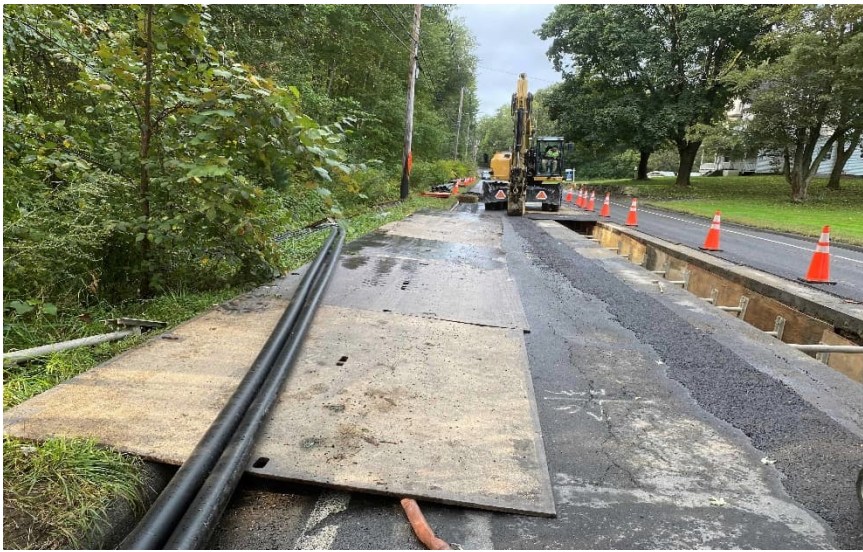
PHOTOGRAPHIC LOG	
Client Name: Eversource		Site Location: Sudbury to Hudson Transmission Reliability Project	Town: Hudson
Photo No.: 2	Date: 9/26/2023

Description: Forest Avenue. View of dewatering operation, looking southward.

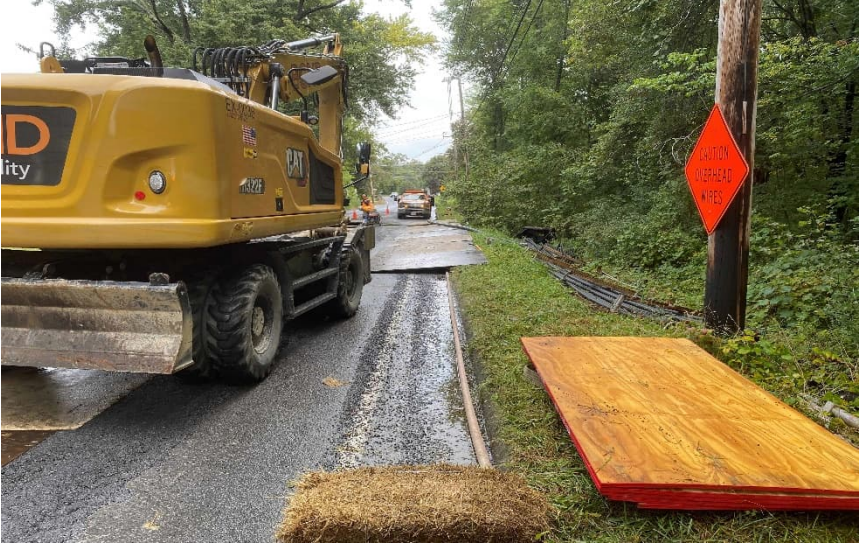
PHOTOGRAPHIC LOG	
Client Name: Eversource		Site Location: Sudbury to Hudson Transmission Reliability Project	Town: Hudson
Photo No.: 3	Date: 9/26/2023

Description: Forest Avenue. View of dewatering operation (pumping at far end of area), looking northward.

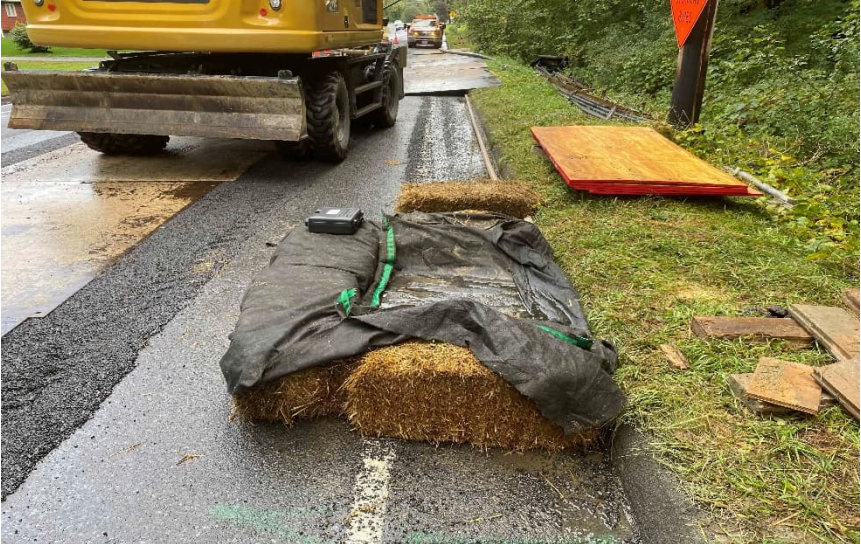
PHOTOGRAPHIC LOG	
Client Name: Eversource		Site Location: Sudbury to Hudson Transmission Reliability Project	Town: Hudson
Photo No.: 4	Date: 9/26/2023

Description: Forest Avenue. View of dewatering operation (corral/bag), looking northward.

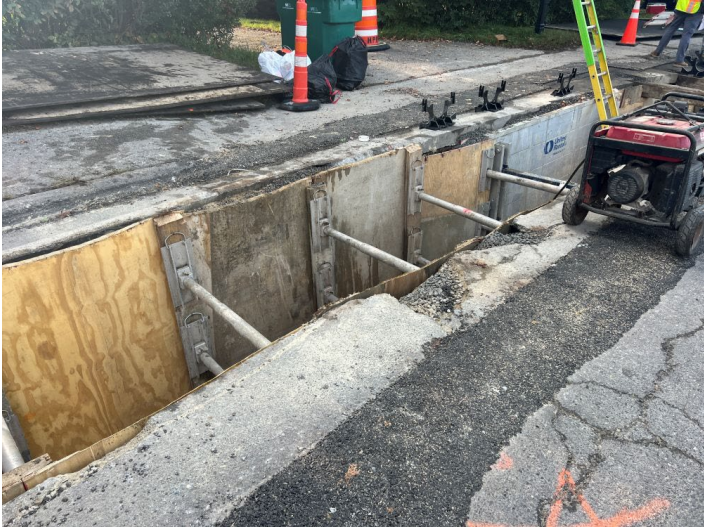
PHOTOGRAPHIC LOG		
Client Name: Eversource		Site Location: Sudbury to Hudson Transmission Reliability Project		Town: Hudson
Photo No.: 1	Date: 9/27/2023

Description: View of work area near MH #2 on Forest Ave in Hudson. Facing east.

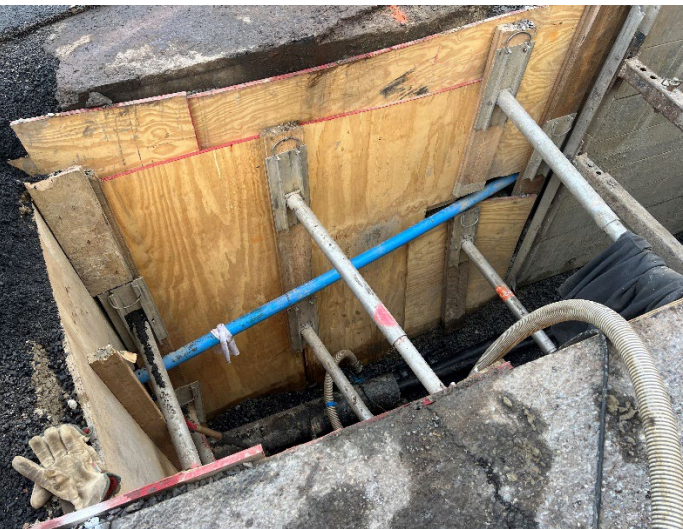
PHOTOGRAPHIC LOG		
Client Name: Eversource		Site Location: Sudbury to Hudson Transmission Reliability Project		Town: Hudson
Photo No.: 2	Date: 9/27/2023

Description: View of pump in trench. Water appeared to be slightly turbid prior to treatment. Facing west.

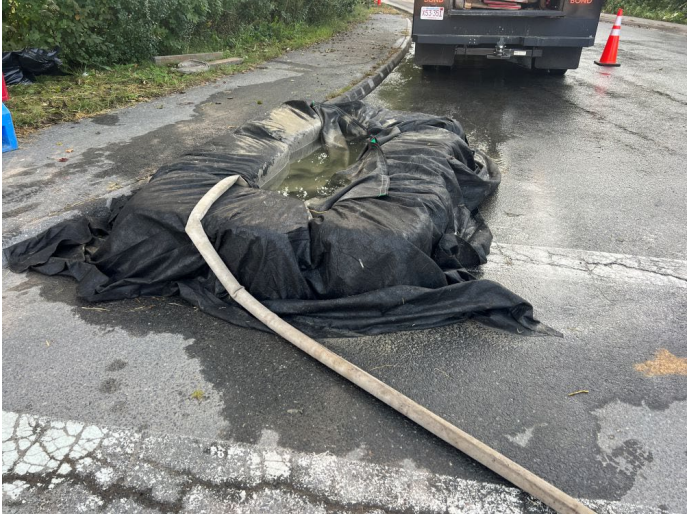
PHOTOGRAPHIC LOG		
Client Name: Eversource		Site Location: Sudbury to Hudson Transmission Reliability Project		Town: Hudson
Photo No.: 3	Date: 9/27/2023

Description: View of dewatering controls (straw bale corral with filter fabric and silt bag). Facing east.

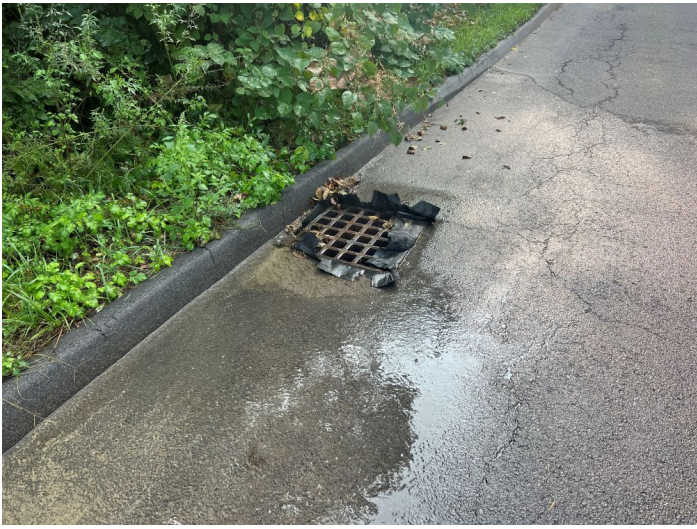
PHOTOGRAPHIC LOG		
Client Name: Eversource		Site Location: Sudbury to Hudson Transmission Reliability Project		Town: Hudson
Photo No.: 4	Date: 9/27/2023

Description: View of discharge point from project. Catch basin below hay bale corral on Old North Road. Discharge appeared clear, and turbidity reading was below 50 NTUs. Facing east.

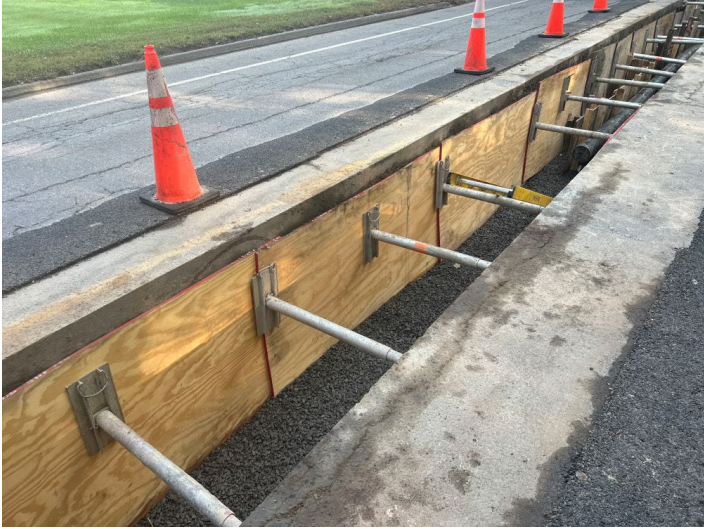
PHOTOGRAPHIC LOG		
Client Name: Eversource		Site Location: Sudbury to Hudson Transmission Reliability Project		Town: Hudson
Photo No.: 1	Date: 9/27/2023

Description: View of work area near MH #4 on Forest Ave in Hudson. Facing northwest.

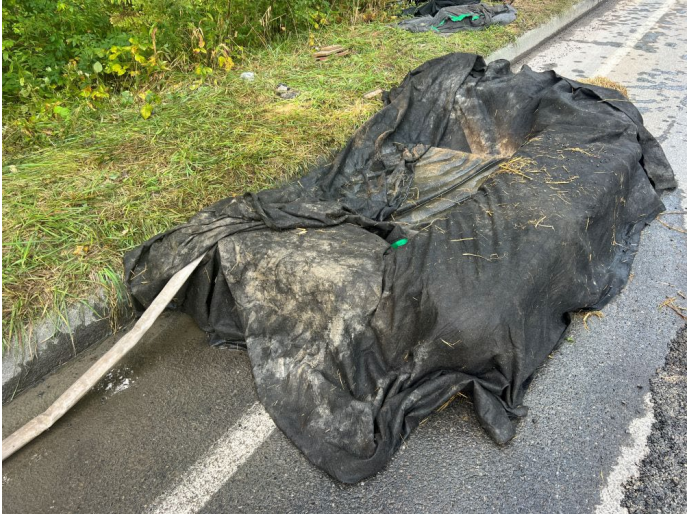
PHOTOGRAPHIC LOG		
Client Name: Eversource		Site Location: Sudbury to Hudson Transmission Reliability Project		Town: Hudson
Photo No.: 3	Date: 9/27/2023

Description: View of dewatering controls (straw bale corral with filter fabric and silt bag). Facing southeast.

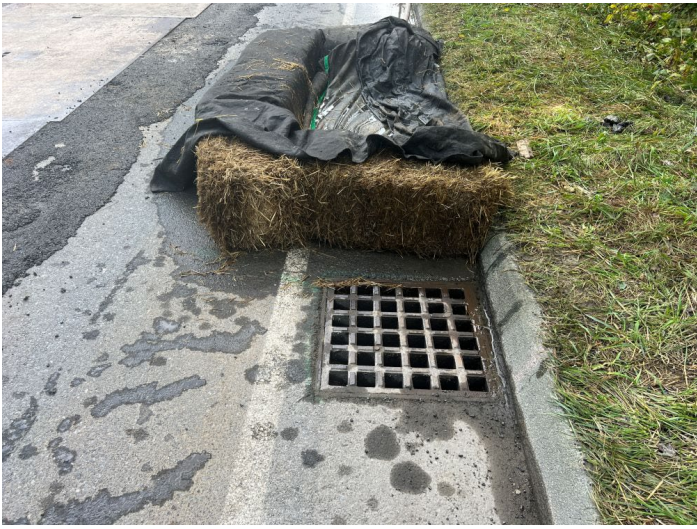
PHOTOGRAPHIC LOG		
Client Name: Eversource		Site Location: Sudbury to Hudson Transmission Reliability Project		Town: Hudson
Photo No.: 4	Date: 9/27/2023

Description: View dewatering controls (straw bale corral with filter fabric and silt bag) and discharge point from project (catch basin below hay bale corral on Forest Ave). Discharge appeared clear, and turbidity reading was below 50 NTUs. Facing north.

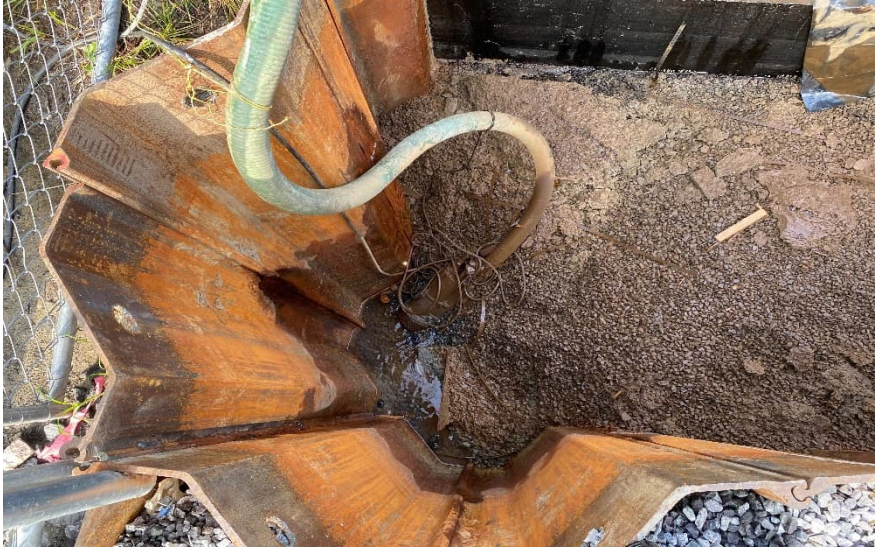
PHOTOGRAPHIC LOG	
Client Name: Eversource		Site Location: Sudbury to Hudson Transmission Reliability Project	Town: Sudbury
Photo No.: 1	Date: 9/27/2023

Description: View of area being pumped at Hop Brook (area in cofferdam).

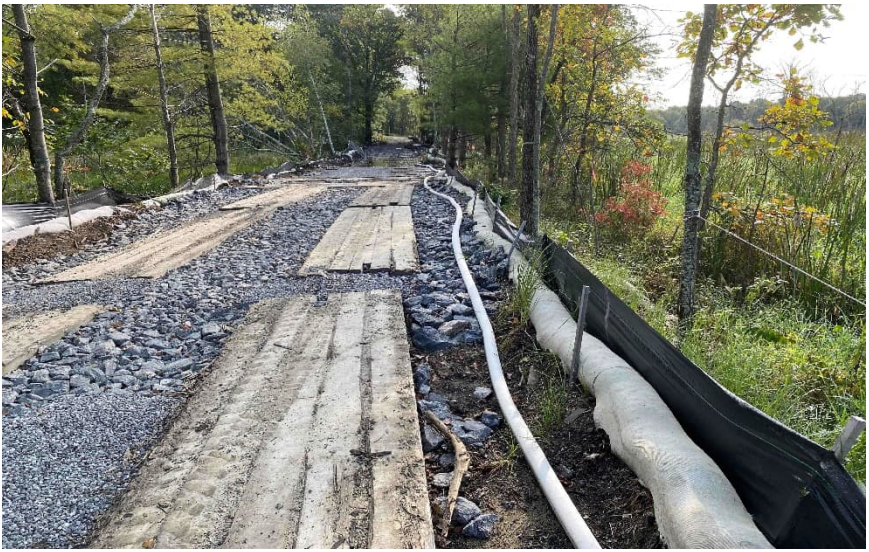
PHOTOGRAPHIC LOG	
Client Name: Eversource		Site Location: Sudbury to Hudson Transmission Reliability Project	Town: Sudbury
Photo No.: 2	Date: 9/27/2023

Description: Segment 14. View of dewatering operation (pumping at far end of area), looking eastward.

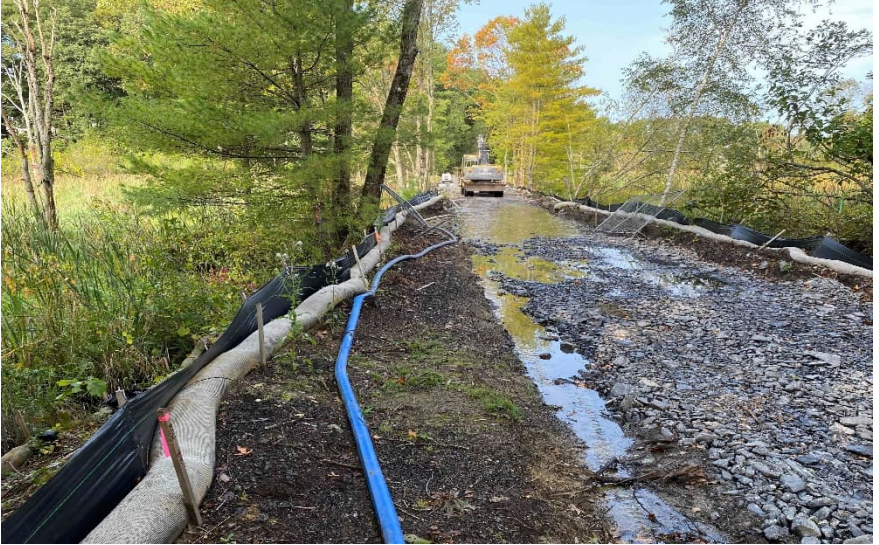
PHOTOGRAPHIC LOG	
Client Name: Eversource		Site Location: Sudbury to Hudson Transmission Reliability Project	Town: Sudbury
Photo No.: 3	Date: 9/27/2023

Description: Segment 14. View of dewatering operation (pumping at far end of area), looking westward.

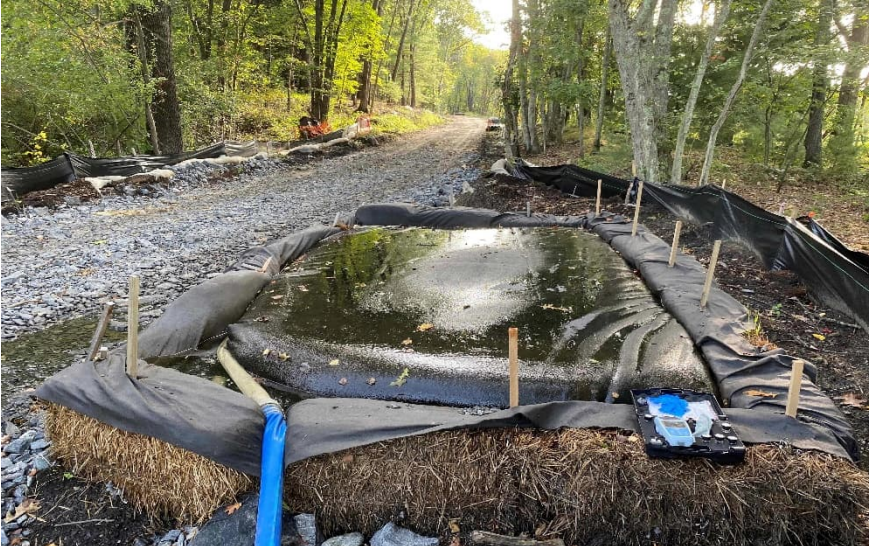
PHOTOGRAPHIC LOG	
Client Name: Eversource		Site Location: Sudbury to Hudson Transmission Reliability Project	Town: Sudbury
Photo No.: 4	Date: 9/27/2023

Description: Segment 14. View of dewatering operation, looking eastward.

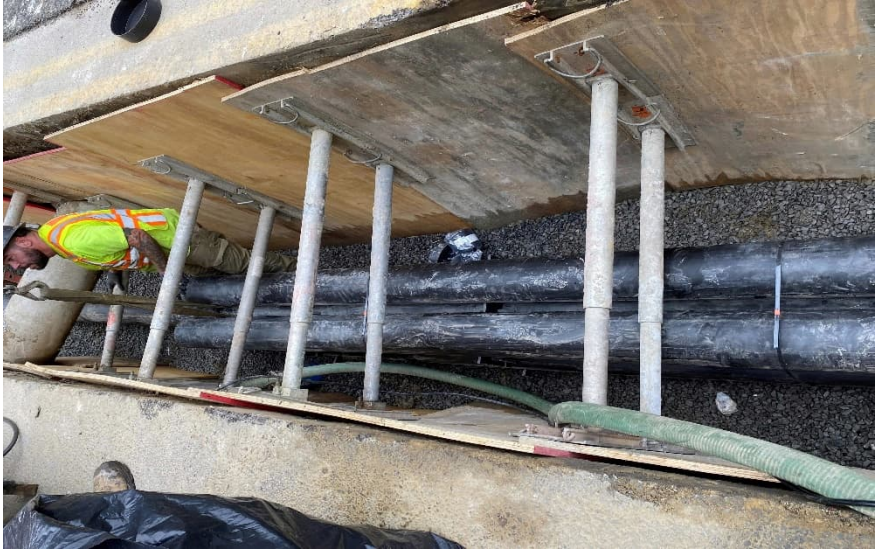
PHOTOGRAPHIC LOG	
Client Name: Eversource		Site Location: Sudbury to Hudson Transmission Reliability Project	Town: Hudson
Photo No.: 1	Date: 9/28/2023

Description: View of area being pumped at Forest Avenue (area near manhole #4).

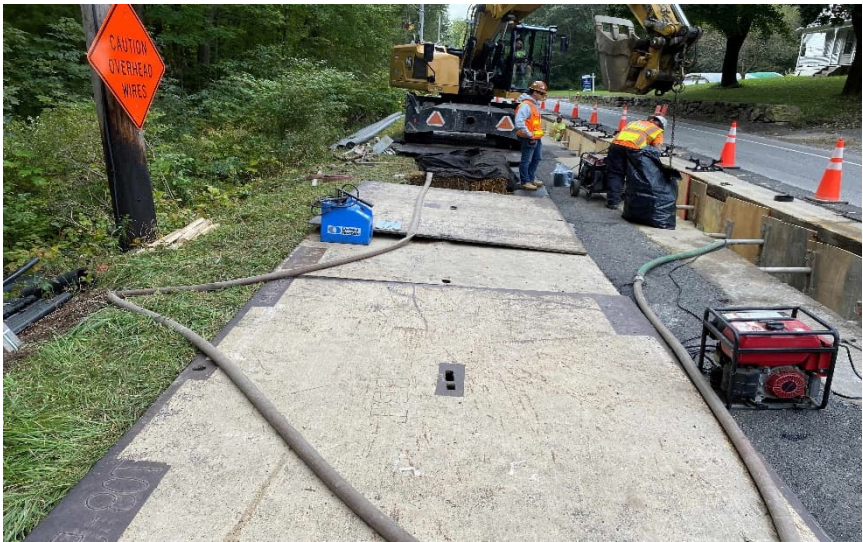
PHOTOGRAPHIC LOG	
Client Name: Eversource		Site Location: Sudbury to Hudson Transmission Reliability Project	Town: Hudson
Photo No.: 2	Date: 9/28/2023

Description: Forest Avenue. View of dewatering operation, looking southward.

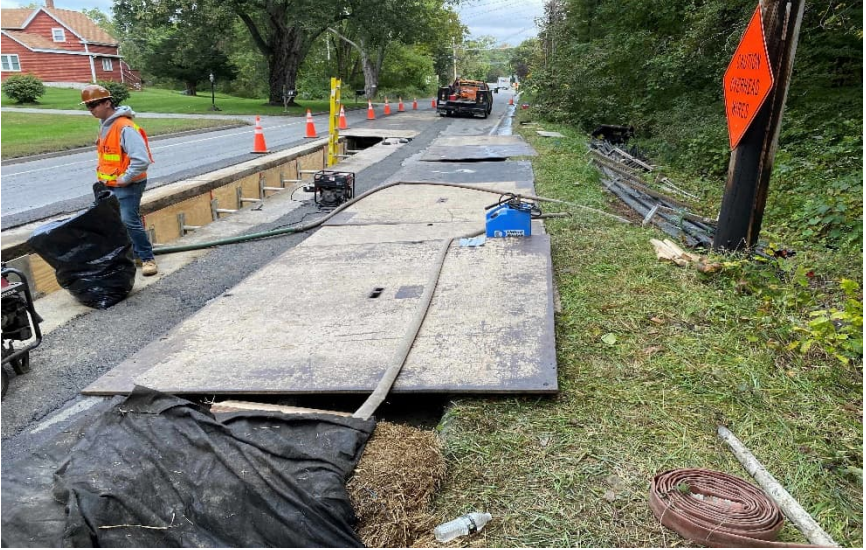
PHOTOGRAPHIC LOG	
Client Name: Eversource		Site Location: Sudbury to Hudson Transmission Reliability Project	Town: Hudson
Photo No.: 3	Date: 9/28/2023

Description: Forest Avenue. View of dewatering operation (pumping at far end of area), looking northward.

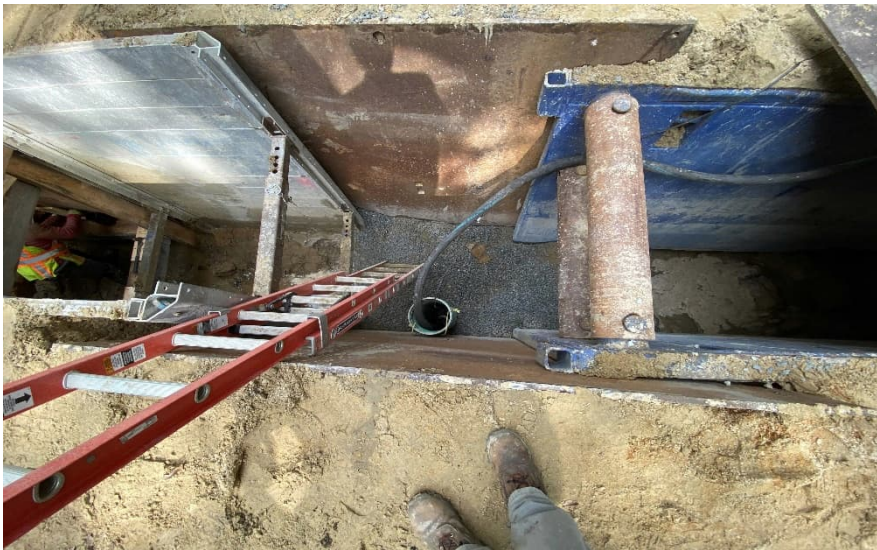
PHOTOGRAPHIC LOG	
Client Name: Eversource		Site Location: Sudbury to Hudson Transmission Reliability Project	Town: Sudbury
Photo No.: 1	Date: 9/28/2023

Description: View of area being pumped in Horse Pond Road.

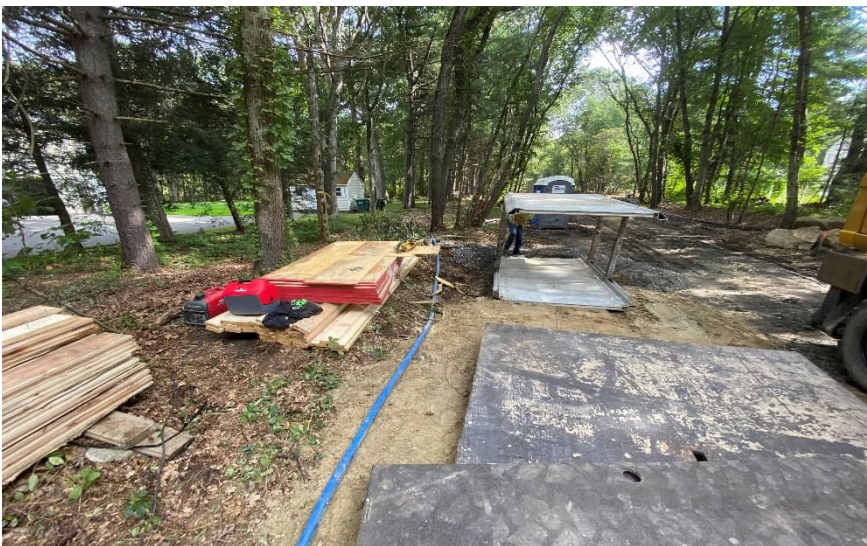
PHOTOGRAPHIC LOG	
Client Name: Eversource		Site Location: Sudbury to Hudson Transmission Reliability Project	Town: Sudbury
Photo No.: 2	Date: 9/28/2023

Description: Segment 11. View of dewatering operation, looking eastward.

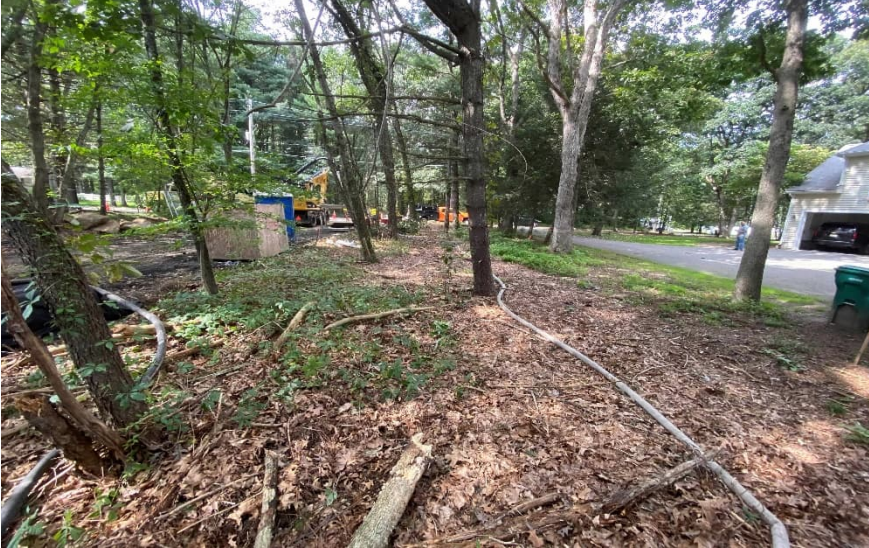
PHOTOGRAPHIC LOG	
Client Name: Eversource		Site Location: Sudbury to Hudson Transmission Reliability Project	Town: Sudbury
Photo No.: 3	Date: 9/28/2023

Description: Segment 11. View of dewatering operation, looking westward.

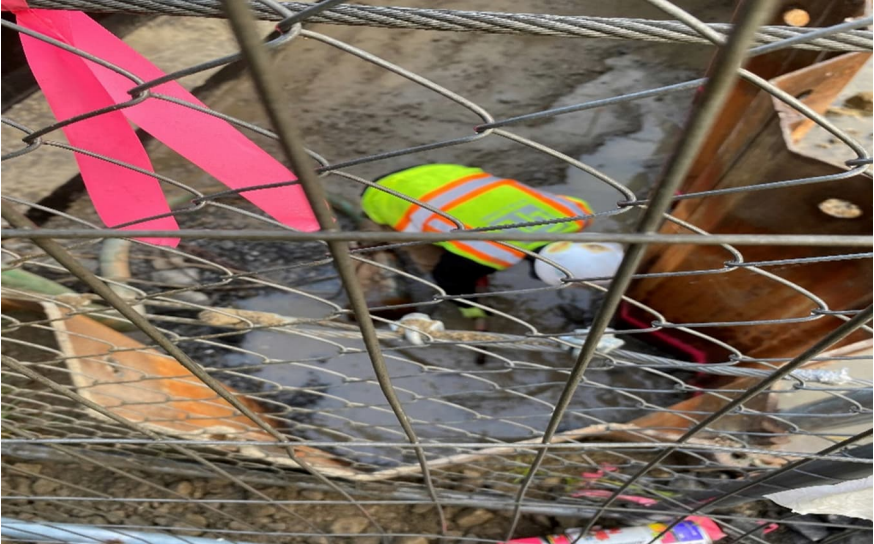
PHOTOGRAPHIC LOG	
Client Name: Eversource		Site Location: Sudbury to Hudson Transmission Reliability Project	Town: Sudbury
Photo No.: 1	Date: 9/28/2023

Description: View of area being pumped at Hop Brook (area in cofferdam).

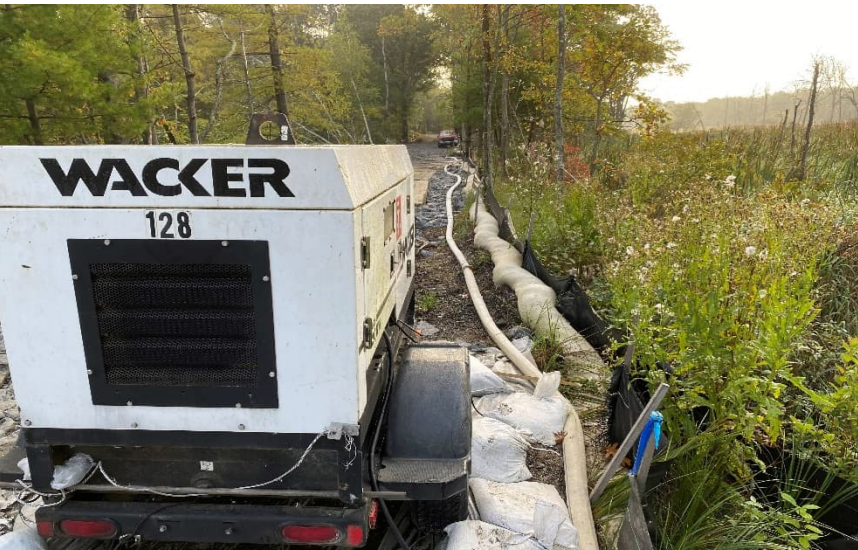
PHOTOGRAPHIC LOG	
Client Name: Eversource		Site Location: Sudbury to Hudson Transmission Reliability Project	Town: Sudbury
Photo No.: 2	Date: 9/28/2023

Description: Segment 14. View of dewatering operation (pumping near), looking eastward.

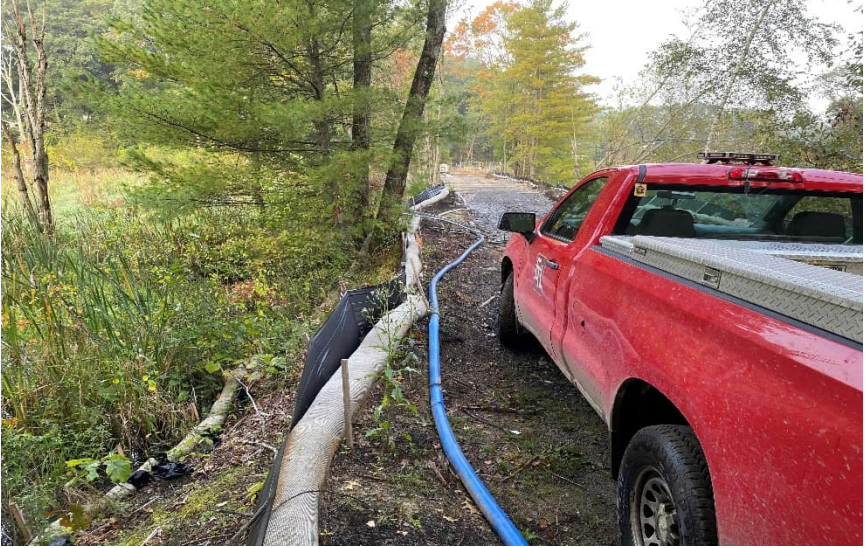
PHOTOGRAPHIC LOG	
Client Name: Eversource		Site Location: Sudbury to Hudson Transmission Reliability Project	Town: Sudbury
Photo No.: 3	Date: 9/28/2023

Description: Segment 14. View of dewatering operation (pumping at far end of area), looking westward.

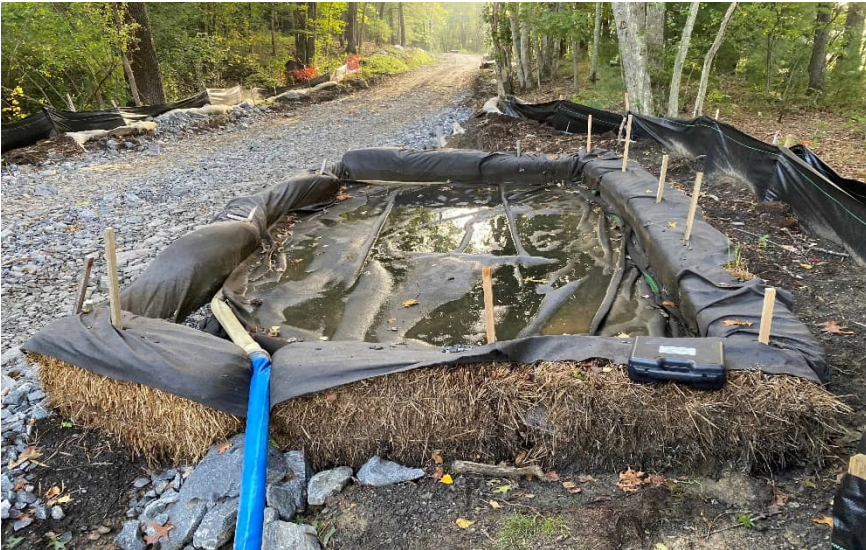
PHOTOGRAPHIC LOG	
Client Name: Eversource		Site Location: Sudbury to Hudson Transmission Reliability Project	Town: Sudbury
Photo No.: 4	Date: 9/28/2023

Description: Segment 14. View of dewatering operation, looking eastward.

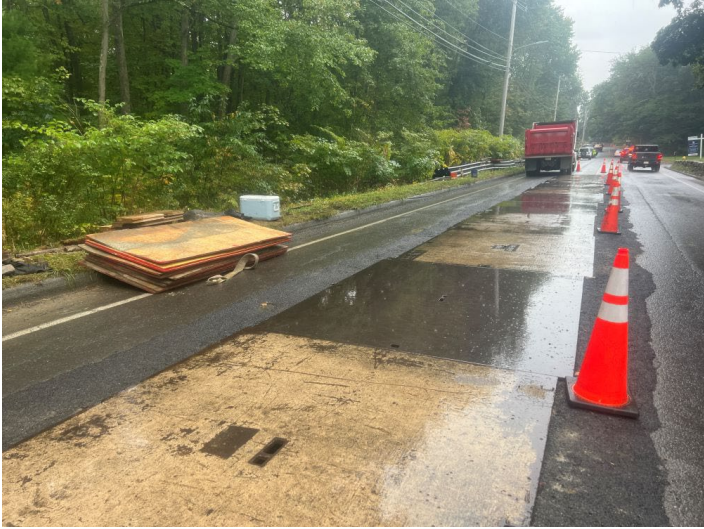
PHOTOGRAPHIC LOG		
Client Name: Eversource		Site Location: Sudbury to Hudson Transmission Reliability Project		Town: Hudson
Photo No.: 1	Date: 9/29/2023

Description: View of work area near MH #4 on Forest Ave in Hudson. Facing northwest.

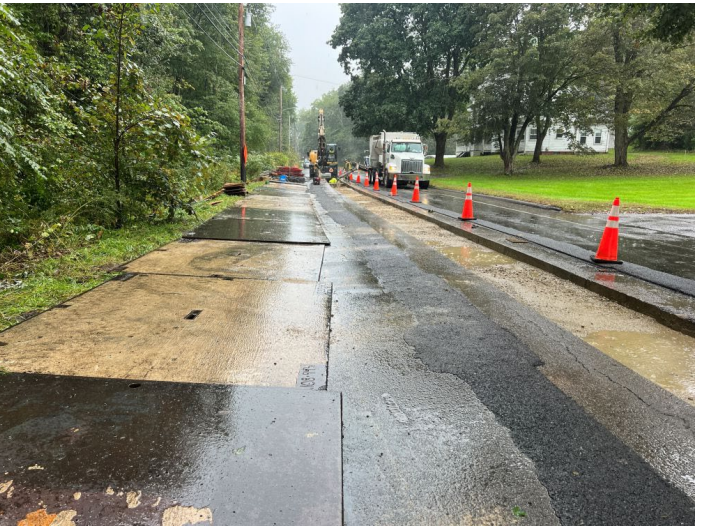
PHOTOGRAPHIC LOG		
Client Name: Eversource		Site Location: Sudbury to Hudson Transmission Reliability Project		Town: Hudson
Photo No.: 2	Date: 9/29/2023

Description: View trench in work area near MH #4 on Forest Ave. Water appeared to be slightly turbid prior to treatment. Facing north.

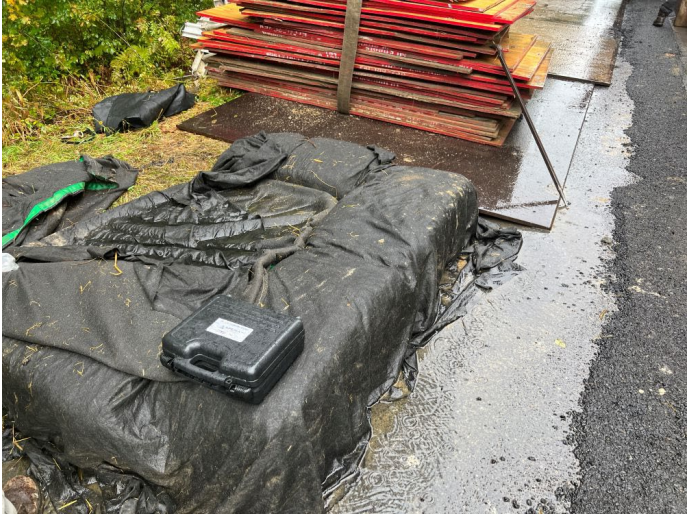
PHOTOGRAPHIC LOG		
Client Name: Eversource		Site Location: Sudbury to Hudson Transmission Reliability Project		Town: Hudson
Photo No.: 3	Date: 9/27/2023

Description: View of dewatering controls (straw bale corral with filter fabric and silt bag). Facing west.
