Weekly Environmental Compliance Summary

Sudbury to Hudson Transmission Reliability Project (USEPA Tracking # MAR1003UW)

Week of: October 23, 2023 to October 27, 2023

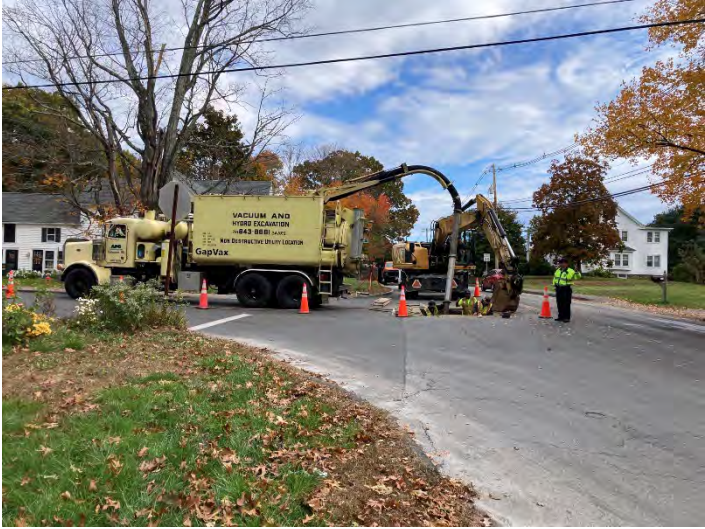
<p align="center">PHOTOGRAPHIC LOG</p>	
<p>Client Name: Eversource</p>		<p>Site Location: Sudbury to Hudson Transmission Reliability Project</p>	<p>Town: Hudson</p>
<p>Photo No.: 1</p>	<p>Date: 10/24/2023</p>

<p>Description: View of Bond working on Forest Ave. Facing north.</p>

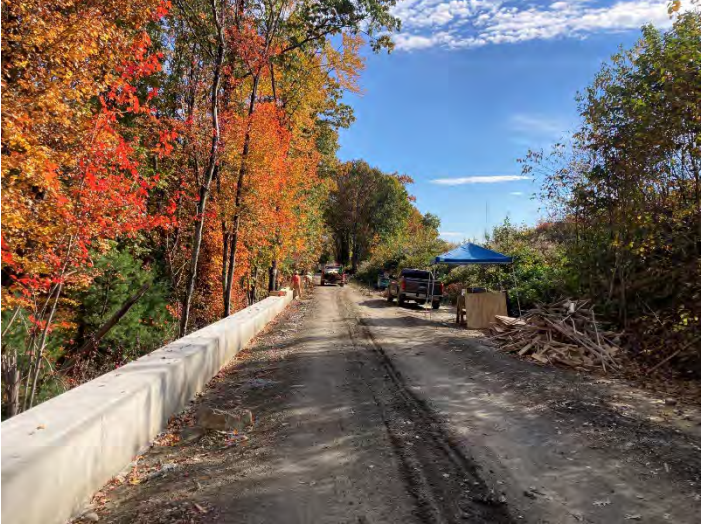
<p align="center">PHOTOGRAPHIC LOG</p>	
<p>Client Name: Eversource</p>		<p>Site Location: Sudbury to Hudson Transmission Reliability Project</p>	<p>Town: Hudson</p>
<p>Photo No.: 2</p>	<p>Date: 10/24/2023</p>

<p>Description: View of ET&L working on walls 1 and 2 in segment 1. Facing east.</p>

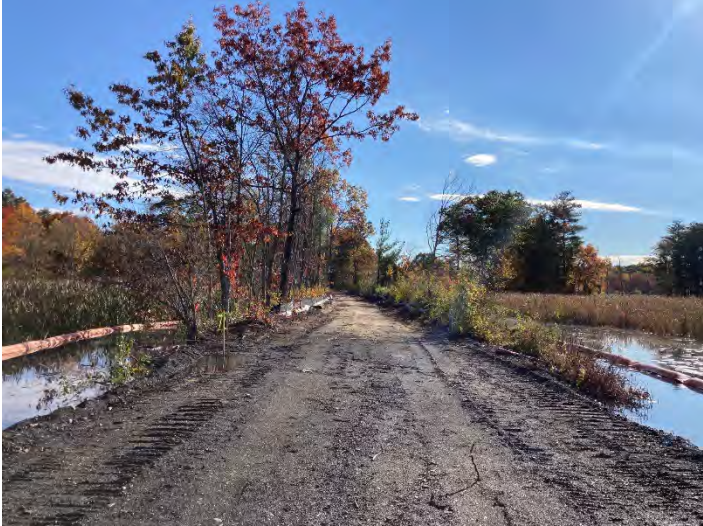
<p align="center">PHOTOGRAPHIC LOG</p>	
<p>Client Name: Eversource</p>		<p>Site Location: Sudbury to Hudson Transmission Reliability Project</p>	<p>Town: Hudson</p>
<p>Photo No.: 4</p>	<p>Date: 10/24/2023</p>

<p>Description: View of segment 3 from bridge 130. Facing east.</p>

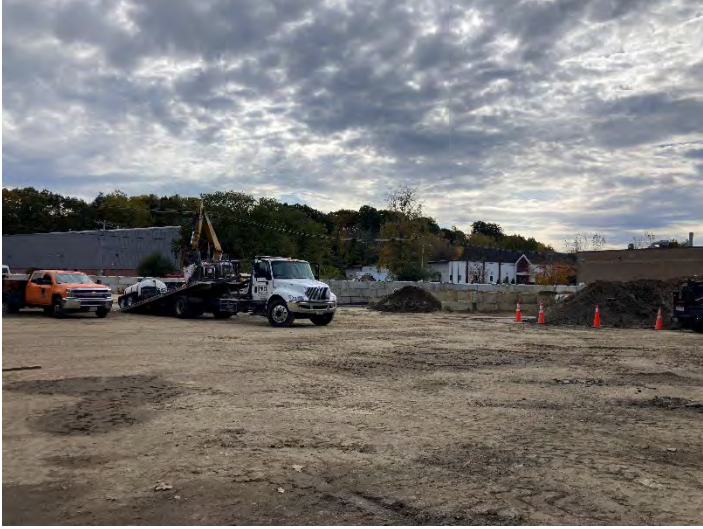
Epsilon ASSOCIATES INC.		PHOTOGRAPHIC LOG	
Client Name: Eversource		Site Location: Sudbury to Hudson Transmission Reliability Project	Town: Hudson
Photo No.: 5	Date: 10/24/2023

<p>Description: View of activities at Bonazzoli laydown yard. Facing southwest.</p>

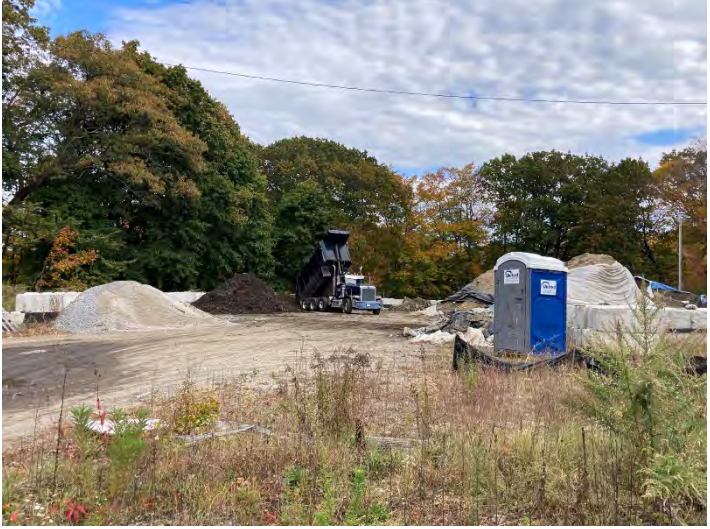
Epsilon ASSOCIATES INC.		PHOTOGRAPHIC LOG	
Client Name: Eversource		Site Location: Sudbury to Hudson Transmission Reliability Project	Town: Hudson
Photo No.: 6	Date: 10/24/2023

<p>Description: View of activities at Stowe Ct laydown yard. Facing northeast.</p>

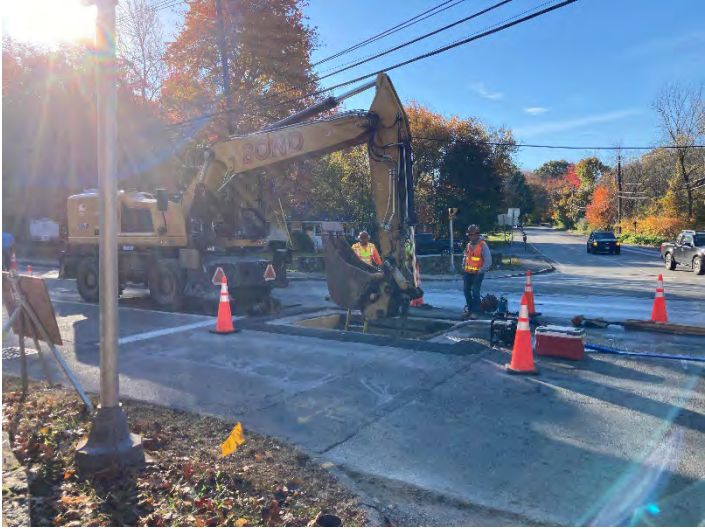
<p align="right">PHOTOGRAPHIC LOG</p>	
<p>Client Name: Eversource</p>		<p>Site Location: Sudbury to Hudson Transmission Reliability Project</p>	<p>Town: Hudson</p>
<p>Photo No.: 1</p>	<p>Date: 10/25/2023</p>

<p>Description: View of Bond and Town of Hudson DPW working on Forest Ave. Hudson DPW dewatered the trench at this location. Bond and Eversource were not responsible for these dewatering activities. Facing southeast.</p>

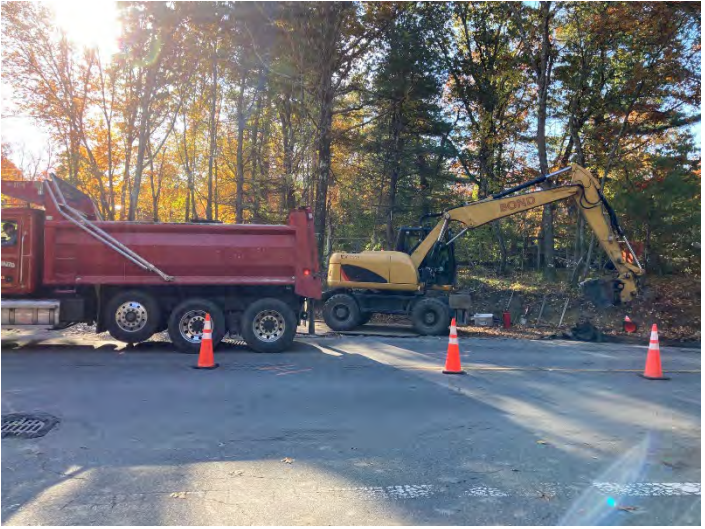
<p align="right">PHOTOGRAPHIC LOG</p>	
<p>Client Name: Eversource</p>		<p>Site Location: Sudbury to Hudson Transmission Reliability Project</p>	<p>Town: Hudson</p>
<p>Photo No.: 2</p>	<p>Date: 10/25/2023</p>

<p>Description: View of Bond working on Wilkins St. Facing east.</p>

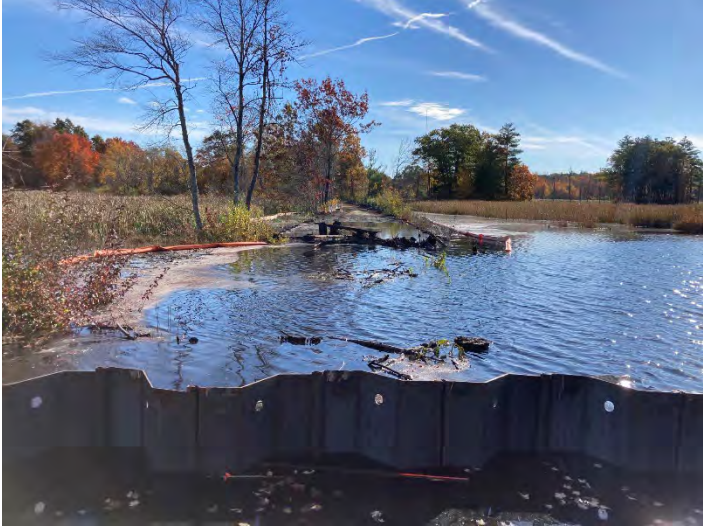
PHOTOGRAPHIC LOG	
Client Name: Eversource		Site Location: Sudbury to Hudson Transmission Reliability Project	Town: Hudson
Photo No.: 4	Date: 10/25/2023

Description: View of Bridge 130 from segment 2. Facing east.

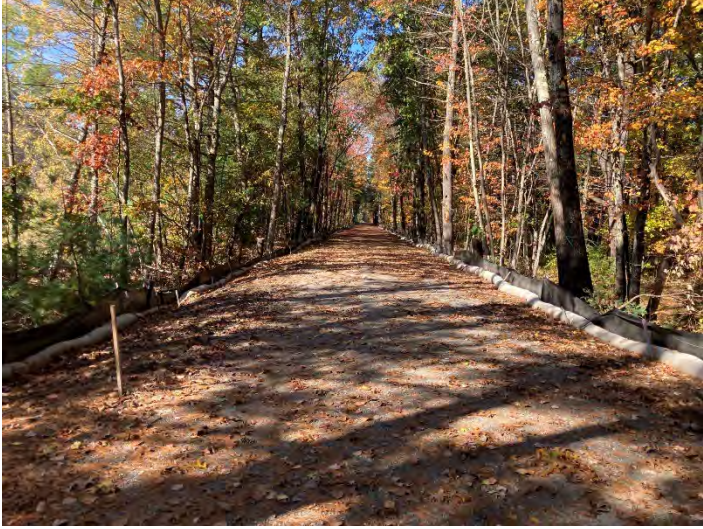
<p align="right">PHOTOGRAPHIC LOG</p>	
<p>Client Name: Eversource</p>		<p>Site Location: Sudbury to Hudson Transmission Reliability Project</p>	<p>Town: Hudson</p>
<p>Photo No.: 5</p>	<p>Date: 10/25/2023</p>

<p>Description: View of E&S controls in segment 4. Facing west.</p>

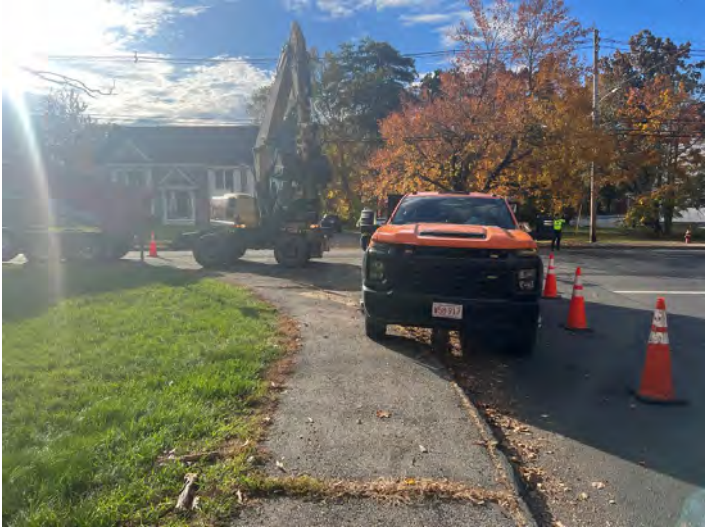
<p>PHOTOGRAPHIC LOG</p>	
<p>Client Name: Eversource</p>		<p>Site Location: Sudbury to Hudson Transmission Reliability Project</p>	<p>Town: Hudson</p>
<p>Photo No.: 1</p>	<p>Date: 10/26/2023</p>

<p>Description: View of Bond working on Forest Ave at the Woodrow St intersection. Bond was paving in the roadway. Facing southeast.</p>

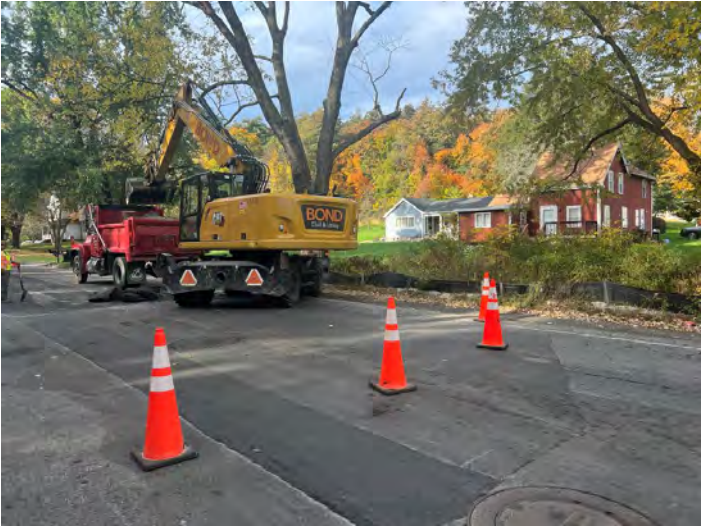
<p>PHOTOGRAPHIC LOG</p>	
<p>Client Name: Eversource</p>		<p>Site Location: Sudbury to Hudson Transmission Reliability Project</p>	<p>Town: Hudson</p>
<p>Photo No.: 2</p>	<p>Date: 10/26/2023</p>

<p>Description: View of Bond working on Forest Ave. Facing south.</p>

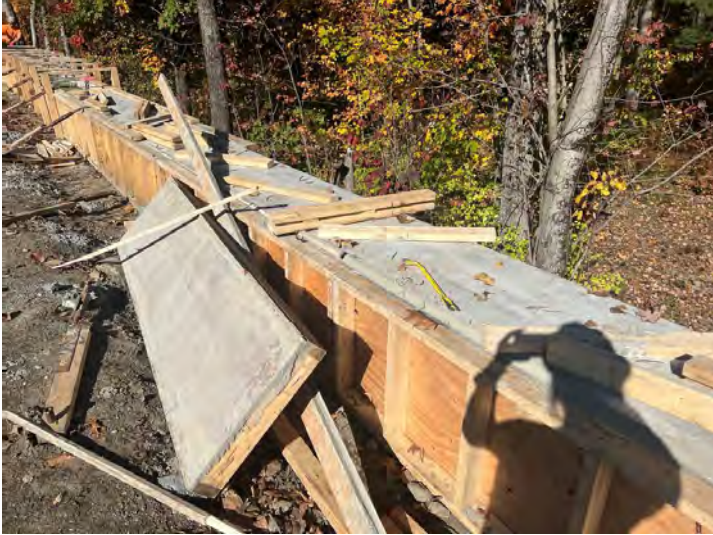
<p>PHOTOGRAPHIC LOG</p>	
<p>Client Name: Eversource</p>		<p>Site Location: Sudbury to Hudson Transmission Reliability Project</p>	<p>Town: Hudson</p>
<p>Photo No.: 3</p>	<p>Date: 10/26/2023</p>

<p>Description: View of wall that ET&L was working on. ET&L crews were working on walls 1 and 2 in segment 1. Facing east.</p>

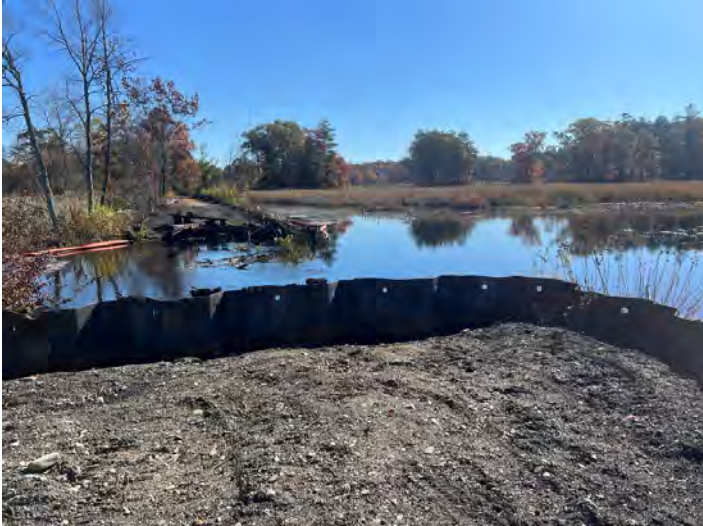
<p>PHOTOGRAPHIC LOG</p>	
<p>Client Name: Eversource</p>		<p>Site Location: Sudbury to Hudson Transmission Reliability Project</p>	<p>Town: Hudson</p>
<p>Photo No.: 4</p>	<p>Date: 10/26/2023</p>

<p>Description: View of Bridge 130 from segment 2. Facing east.</p>

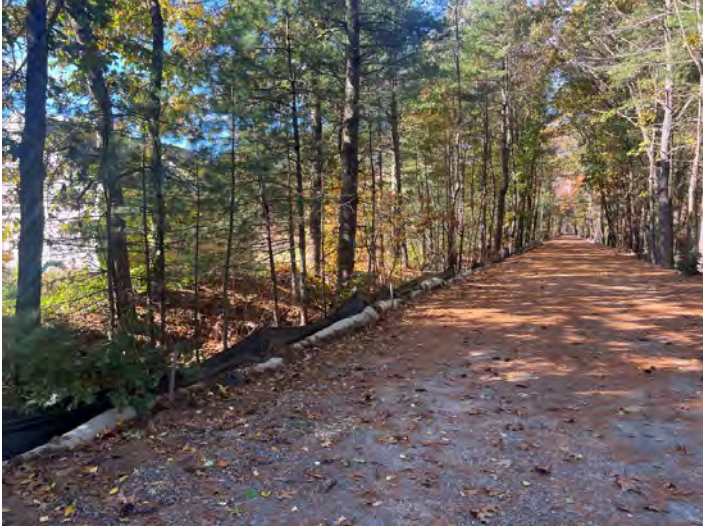
<p align="center">PHOTOGRAPHIC LOG</p>	
<p>Client Name: Eversource</p>		<p>Site Location: Sudbury to Hudson Transmission Reliability Project</p>	<p>Town: Hudson</p>
<p>Photo No.: 5</p>	<p>Date: 10/26/2023</p>

<p>Description: View of E&S controls in segment 4. Facing west.</p>

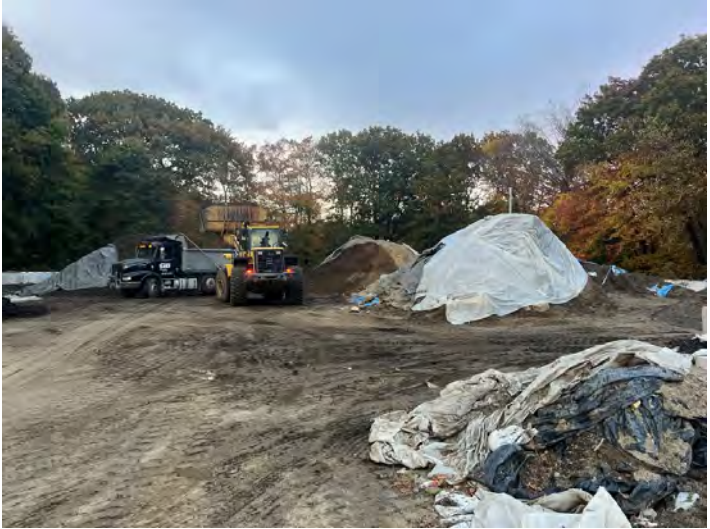
<p align="center">PHOTOGRAPHIC LOG</p>	
<p>Client Name: Eversource</p>		<p>Site Location: Sudbury to Hudson Transmission Reliability Project</p>	<p>Town: Hudson</p>
<p>Photo No.: 6</p>	<p>Date: 10/26/2023</p>

<p>Description: View of activities at Stowe Ct laydown yard. Crews were hauling dirt from stockpiles. Facing northeast.</p>

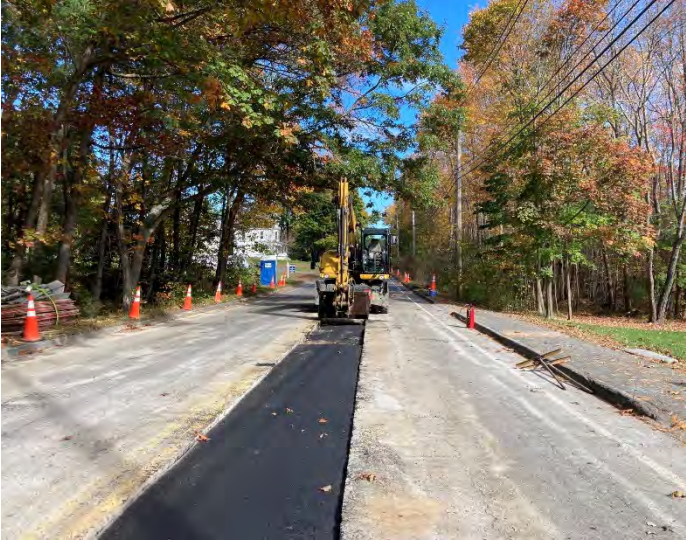
PHOTOGRAPHIC LOG	
Client Name: Eversource		Site Location: Sudbury to Hudson Transmission Reliability Project	Town: Hudson
Photo No.: 1	Date: 10-23-2023

Description: View of Bond working on Forest Ave. Facing north.

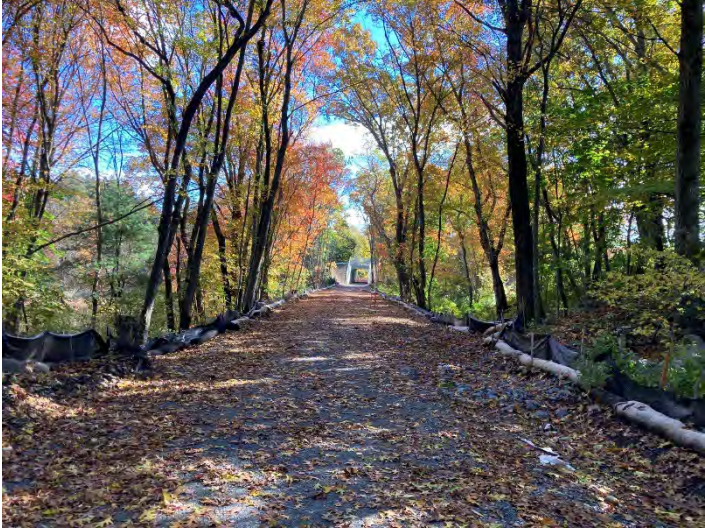
PHOTOGRAPHIC LOG	
Client Name: Eversource		Site Location: Sudbury to Hudson Transmission Reliability Project	Town: Hudson/Stow
Photo No.: 2	Date: 10-23-2023

Description: View of Hudson/ Stow town line in segment 1. E&S controls are operating properly. Facing east.

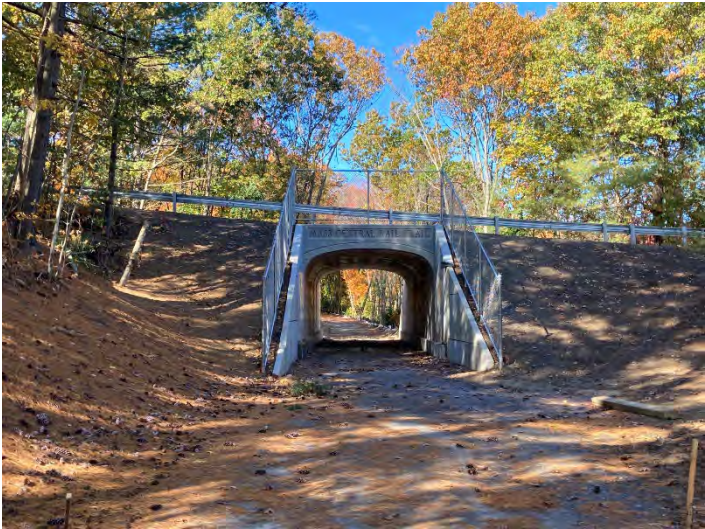
PHOTOGRAPHIC LOG	
Client Name: Eversource		Site Location: Sudbury to Hudson Transmission Reliability Project	Town: Hudson
Photo No.: 4	Date: 10-23-2023

Description: View of Chestnut St tunnel. Work on tunnel is complete and Chestnut St has been reopened. Facing west.

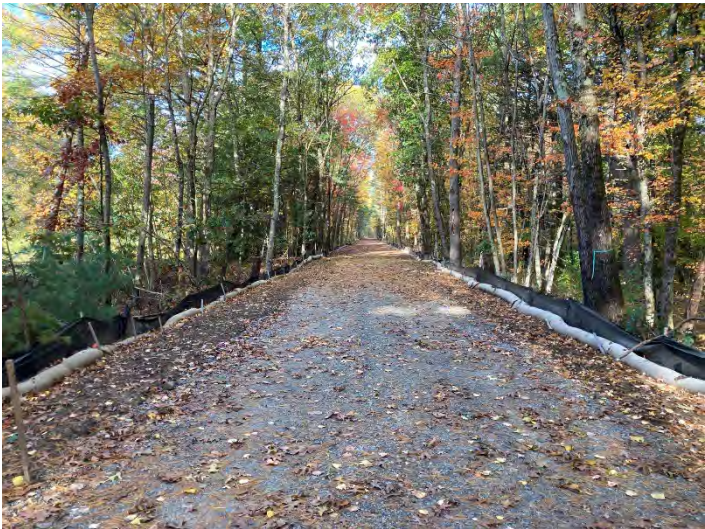
Epsilon ASSOCIATES INC.		PHOTOGRAPHIC LOG	
Client Name: Eversource		Site Location: Sudbury to Hudson Transmission Reliability Project	Town: Hudson
Photo No.: 7	Date: 10-23-2023

Description: View of Type B E&S controls in segment 4. Facing west.

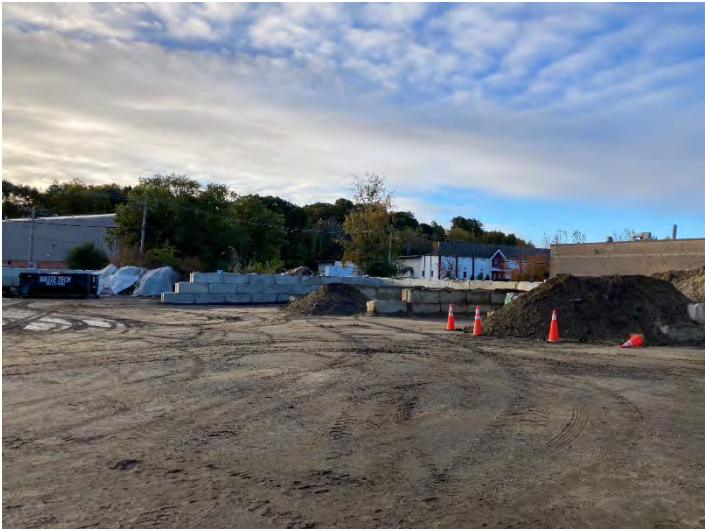
Epsilon ASSOCIATES INC.		PHOTOGRAPHIC LOG	
Client Name: Eversource		Site Location: Sudbury to Hudson Transmission Reliability Project	Town: Hudson
Photo No.: 8	Date: 10-23-2023

Description: View of Bonazzoli laydown yard. Facing southwest.
