**Weekly Environmental Compliance Summary**

**Sudbury to Hudson Transmission Reliability Project (USEPA Tracking # MAR1003UW)**

Sudbury, Hudson, and Stow, MA

Week of: October 30, 2023 to November 3, 2023

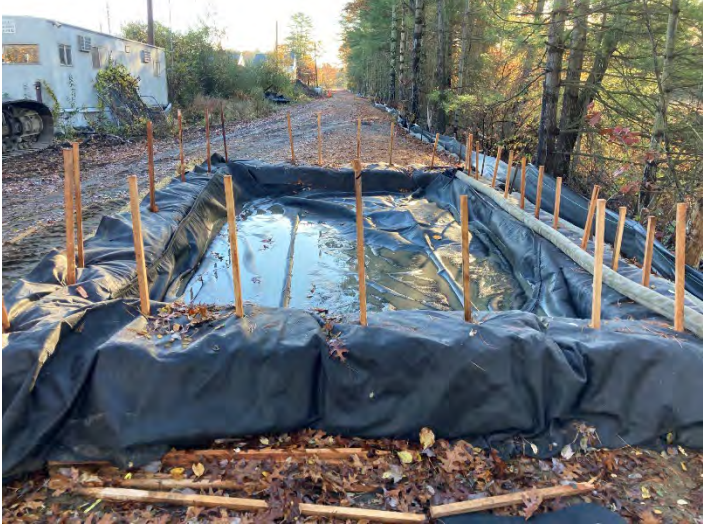
<p align="center"><b>PHOTOGRAPHIC LOG</b></p>	
<p>Client Name: Eversource</p>		<p>Site Location: Sudbury to Hudson Transmission Reliability Project</p>	<p>Town: Hudson</p>
<p>Photo No.: 4</p>	<p>Date: 10/31/2023</p>

<p><b>Description:</b> View of dewatering controls at bridge 130 in segment 3. See additional dewatering inspection report. Facing east.</p>

- Assess dewatering controls at bridge 130 in segment 3 prior to resuming pumping operation at this location. Alternative controls such as frac tank are recommended.**
- 
-

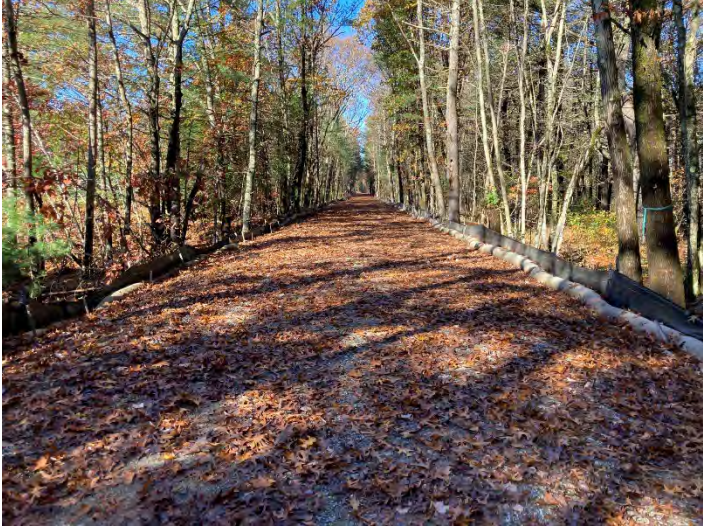
<p align="right"><b>PHOTOGRAPHIC LOG</b></p>	
<p>Client Name: Eversource</p>		<p>Site Location: Sudbury to Hudson Transmission Reliability Project</p>	<p>Town: Hudson</p>
<p>Photo No.: 5</p>	<p>Date: 10/31/2023</p>

<p><b>Description:</b> View of E&amp;S controls in segment 4. Facing west.</p>

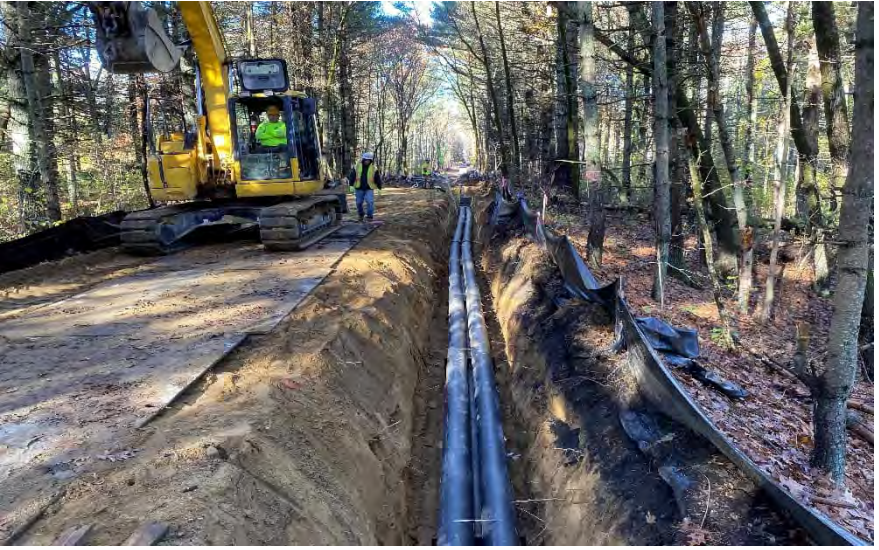
<b>PHOTOGRAPHIC LOG</b>	
Client Name: Eversource		Site Location: Sudbury to Hudson Transmission Reliability Project	Town: Sudbury
Photo No.: 1	Date: 10-31-23

Description:  Conduit work area within segment 9, looking eastward.

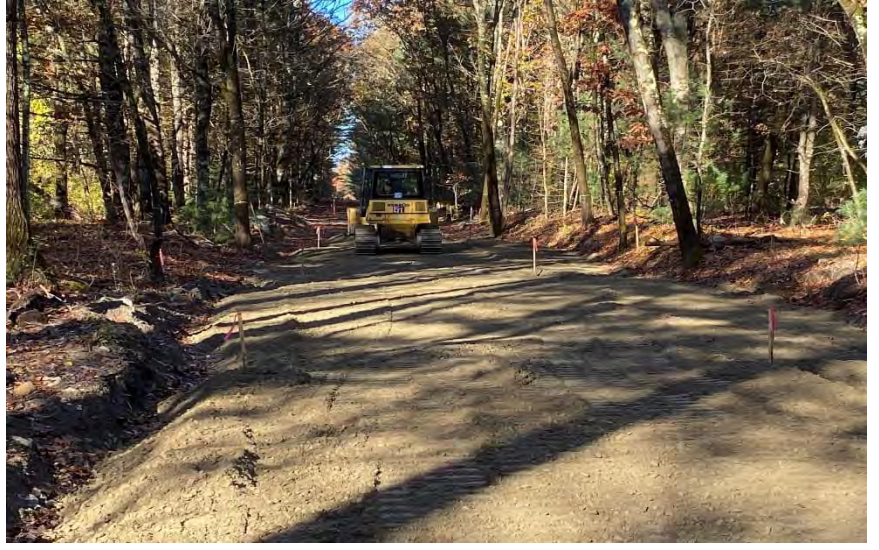
<b>PHOTOGRAPHIC LOG</b>	
Client Name: Eversource		Site Location: Sudbury to Hudson Transmission Reliability Project	Town: Sudbury
Photo No.: 2	Date: 10-31-23

Description:  Grading within segment 9, looking westward.

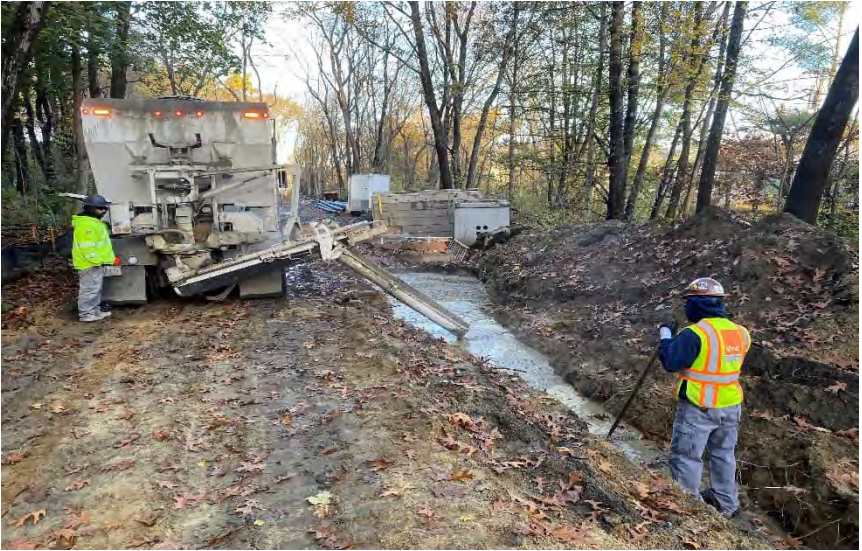
PHOTOGRAPHIC LOG	
Client Name: Eversource		Site Location: Sudbury to Hudson Transmission Reliability Project	Town: Sudbury
Photo No.: 3	Date: 10-31-23

Description:  Work area within segment 13, existing erosion control, looking westward.

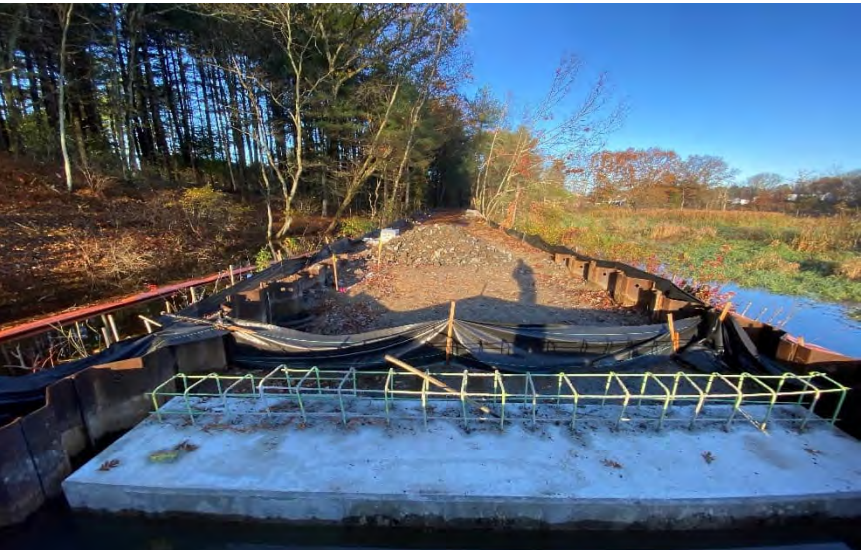
PHOTOGRAPHIC LOG	
Client Name: Eversource		Site Location: Sudbury to Hudson Transmission Reliability Project	Town: Sudbury
Photo No.: 4	Date: 10-31-23

Description:  Work area within segment 13, existing erosion control, looking westward.

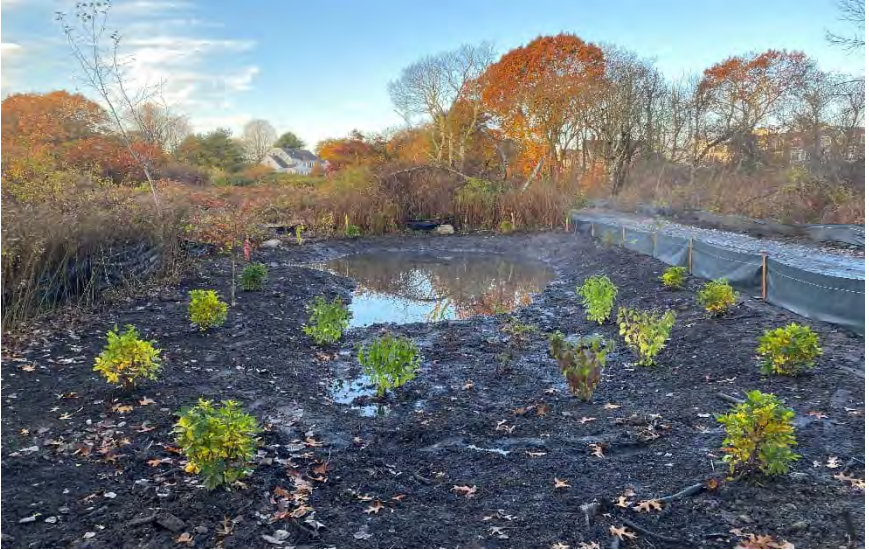
<b>PHOTOGRAPHIC LOG</b>	
<b>Client Name:</b> Eversource		<b>Site Location:</b> Sudbury to Hudson Transmission Reliability Project	<b>Town:</b> Sudbury
<b>Photo No.:</b> 5	<b>Date:</b> 10-31-23

<b>Description:</b>  Work area within segment 14, wetland replication area, prior to mulching for winter, looking westward.

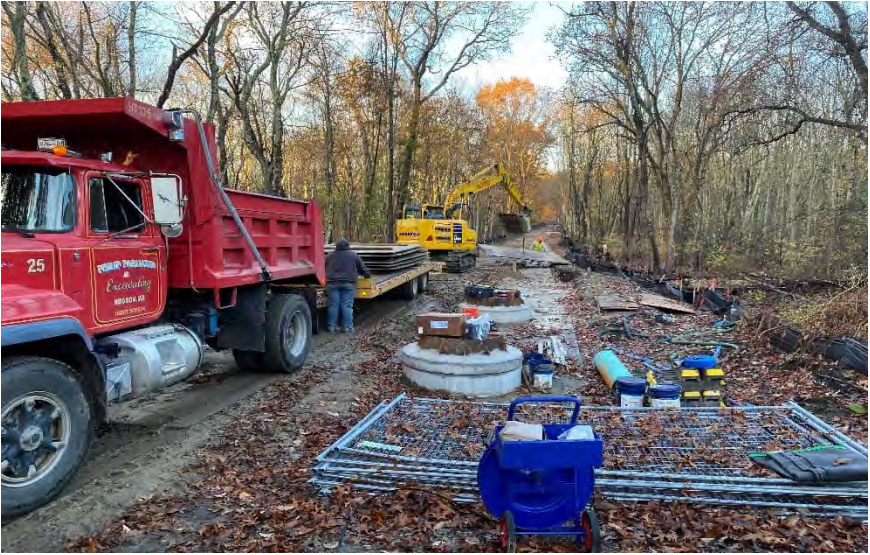
<b>PHOTOGRAPHIC LOG</b>	
<b>Client Name:</b> Eversource		<b>Site Location:</b> Sudbury to Hudson Transmission Reliability Project	<b>Town:</b> Sudbury
<b>Photo No.:</b> 7	<b>Date:</b> 10-31-23

<b>Description:</b>  Work area within segment 14, conduit work, looking westward.

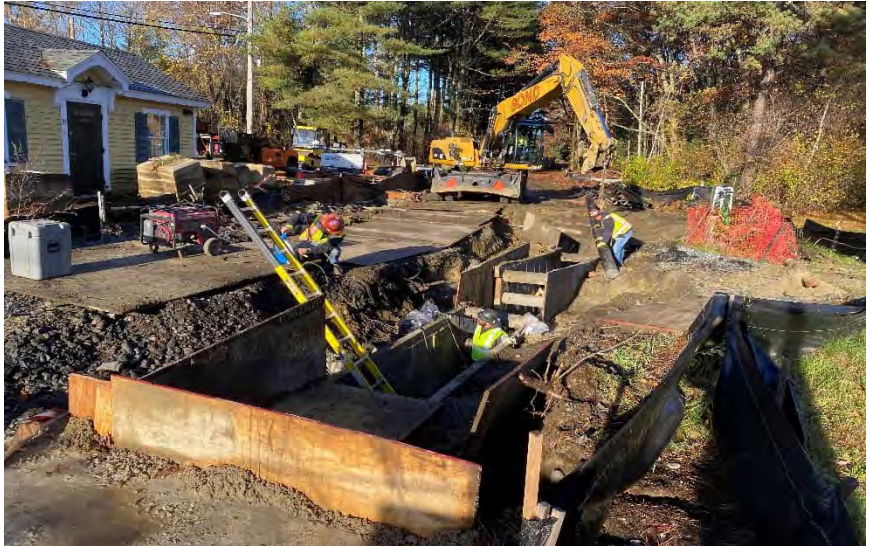
<b>PHOTOGRAPHIC LOG</b>	
<b>Client Name:</b> Eversource		<b>Site Location:</b> Sudbury to Hudson Transmission Reliability Project	<b>Town:</b> Sudbury
<b>Photo No.:</b> 8	<b>Date:</b> 10-31-23

<b>Description:</b>  Work area within segment 11, conduit work, existing erosion control, looking westward.

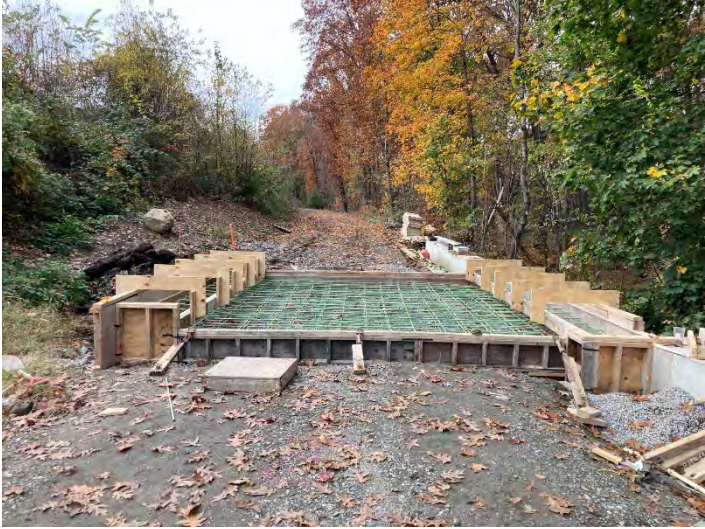
<p align="right"><b>PHOTOGRAPHIC LOG</b></p>	
<p>Client Name: Eversource</p>		<p>Site Location: Sudbury to Hudson Transmission Reliability Project</p>	<p>Town: Hudson</p>
<p>Photo No.: 1</p>	<p>Date: 11/01/2023</p>

<p><b>Description:</b> View of cattle crossing in segment 1. No work observed in this area at time of inspection. Facing west.</p>

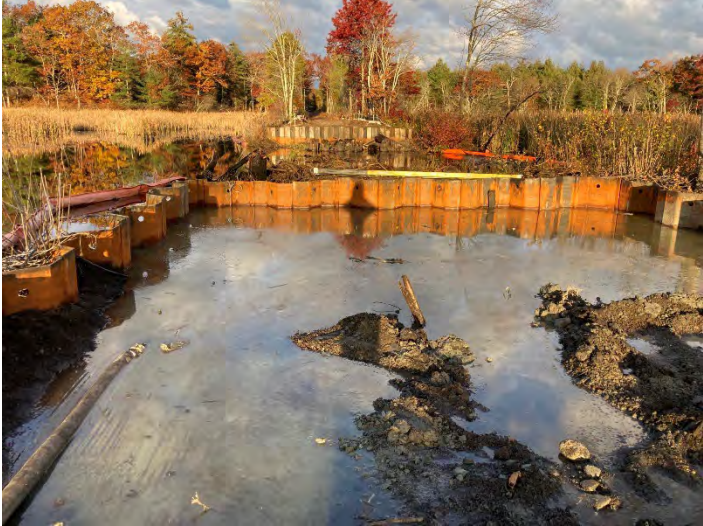
<p align="center"><b>PHOTOGRAPHIC LOG</b></p>	
<p>Client Name: Eversource</p>		<p>Site Location: Sudbury to Hudson Transmission Reliability Project</p>	<p>Town: Hudson</p>
<p>Photo No.: 4</p>	<p>Date: 11/01/2023</p>

<p><b>Description:</b> View of work area at bridge 130 in segment 3. See additional dewatering inspection report. Facing west.</p>

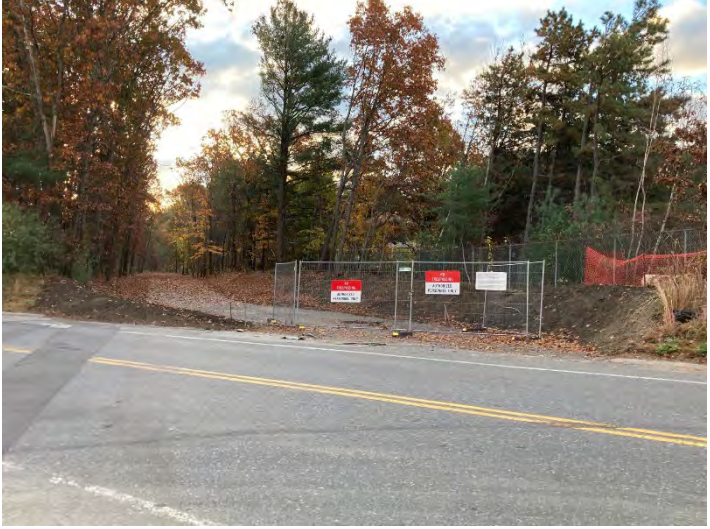
<b>PHOTOGRAPHIC LOG</b>	
Client Name: Eversource		Site Location: Sudbury to Hudson Transmission Reliability Project	Town: Hudson
Photo No.: 6	Date: 11/01/2023

Description: View of entrance to segment 4 at Main St. Facing east.

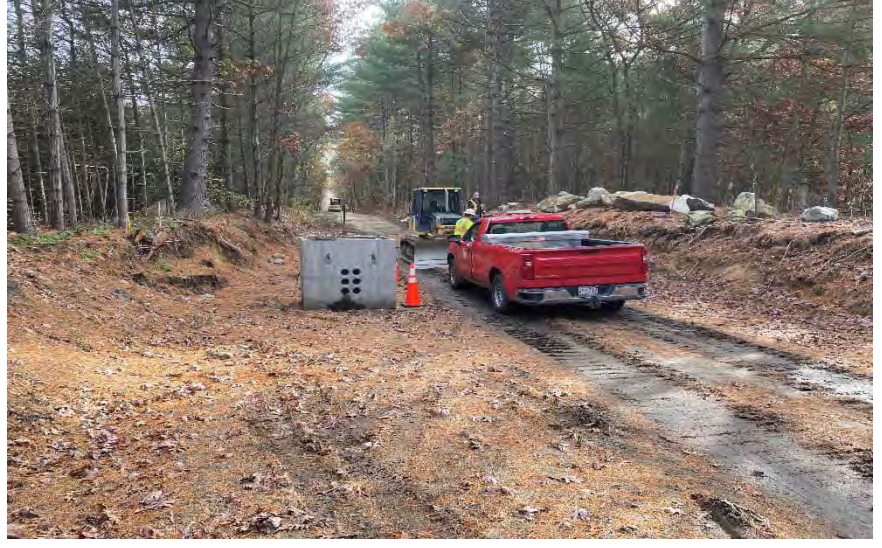
<b>PHOTOGRAPHIC LOG</b>	
Client Name: Eversource		Site Location: Sudbury to Hudson Transmission Reliability Project	Town: Sudbury
Photo No.: 2	Date: 11-1-23

Description:  Grading within segment 9, looking eastward.

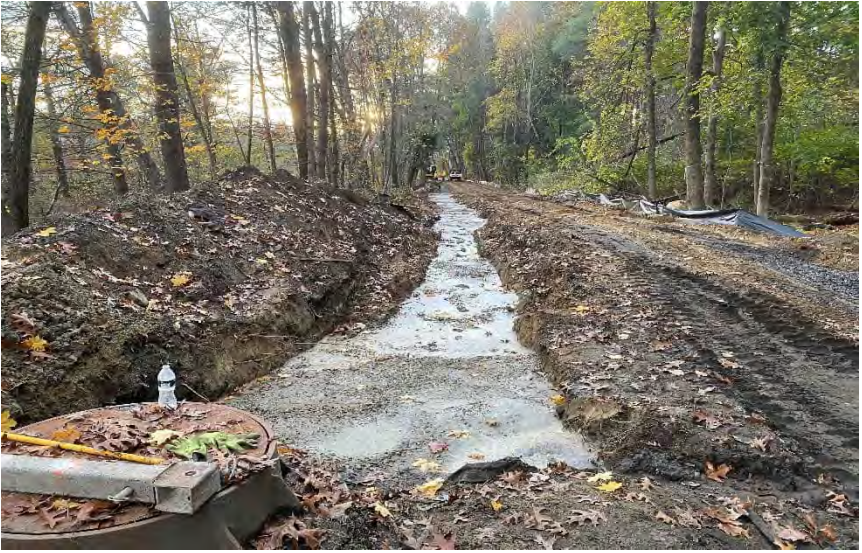
<b>PHOTOGRAPHIC LOG</b>	
<b>Client Name:</b> Eversource		<b>Site Location:</b> Sudbury to Hudson Transmission Reliability Project	<b>Town:</b> Sudbury
<b>Photo No.:</b> 3	<b>Date:</b> 11-1-23

<b>Description:</b>  Work area within segment 13, existing erosion control, looking eastward.

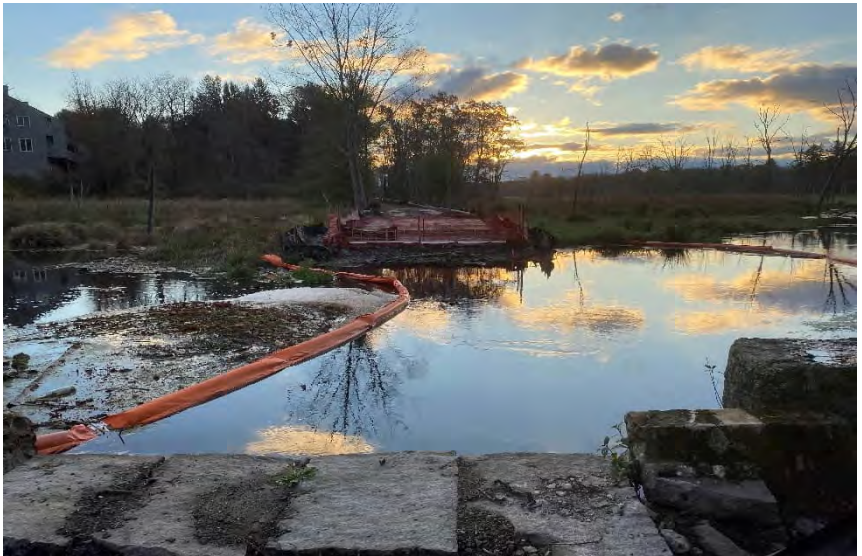
<b>PHOTOGRAPHIC LOG</b>	
<b>Client Name:</b> Eversource		<b>Site Location:</b> Sudbury to Hudson Transmission Reliability Project	<b>Town:</b> Sudbury
<b>Photo No.:</b> 4	<b>Date:</b> 11-1-23

<b>Description:</b>  Work area looking from segment 13 to segment 14 across Hop Brook, looking eastward.

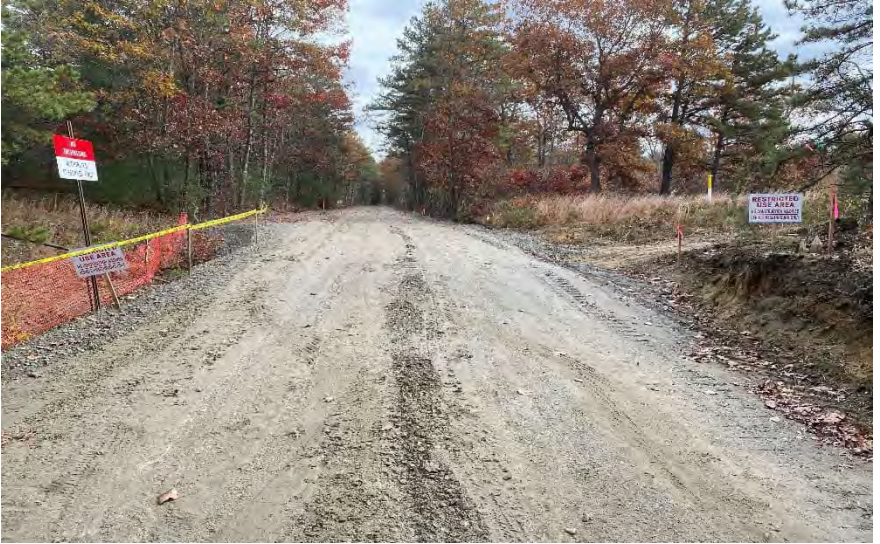
<b>PHOTOGRAPHIC LOG</b>	
Client Name: Eversource		Site Location: Sudbury to Hudson Transmission Reliability Project	Town: Sudbury
Photo No.: 5	Date: 11-1-23

Description:  Work area within segment 7, black racer restrictive signs placed, looking eastward.

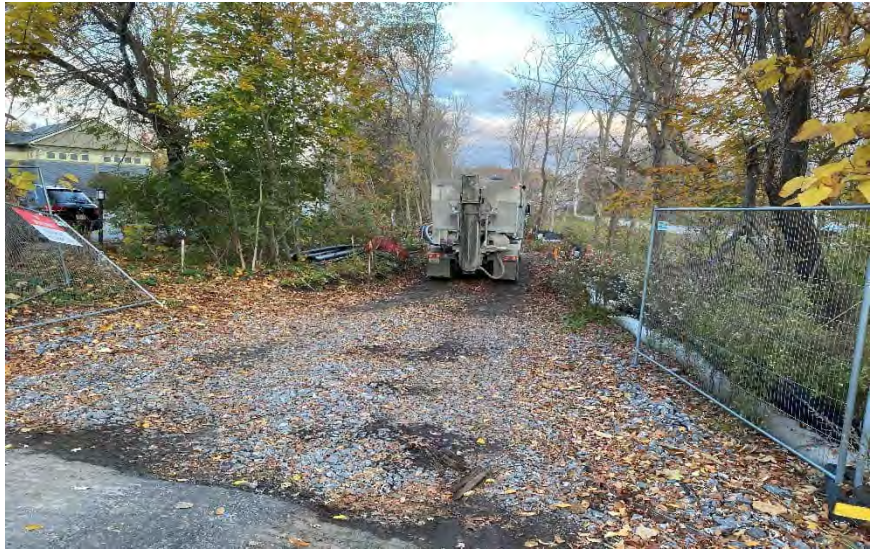
<b>PHOTOGRAPHIC LOG</b>	
Client Name: Eversource		Site Location: Sudbury to Hudson Transmission Reliability Project	Town: Sudbury
Photo No.: 6	Date: 11-1-23

Description:  Work area within segment 12, existing erosion control, looking westward.

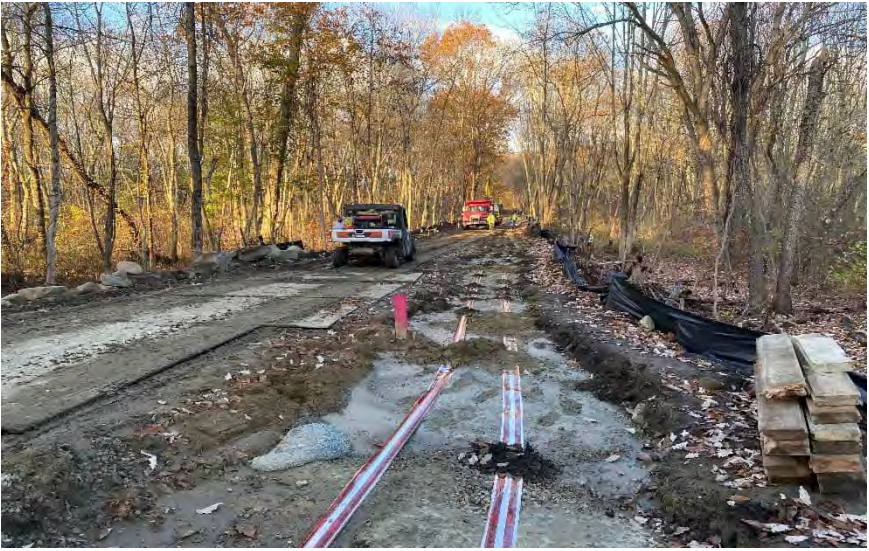
<b>PHOTOGRAPHIC LOG</b>	
<b>Client Name:</b> Eversource		<b>Site Location:</b> Sudbury to Hudson Transmission Reliability Project	<b>Town:</b> Sudbury
<b>Photo No.:</b> 7	<b>Date:</b> 11-1-23

<b>Description:</b>  Work area within segment 14, conduit work, looking westward.

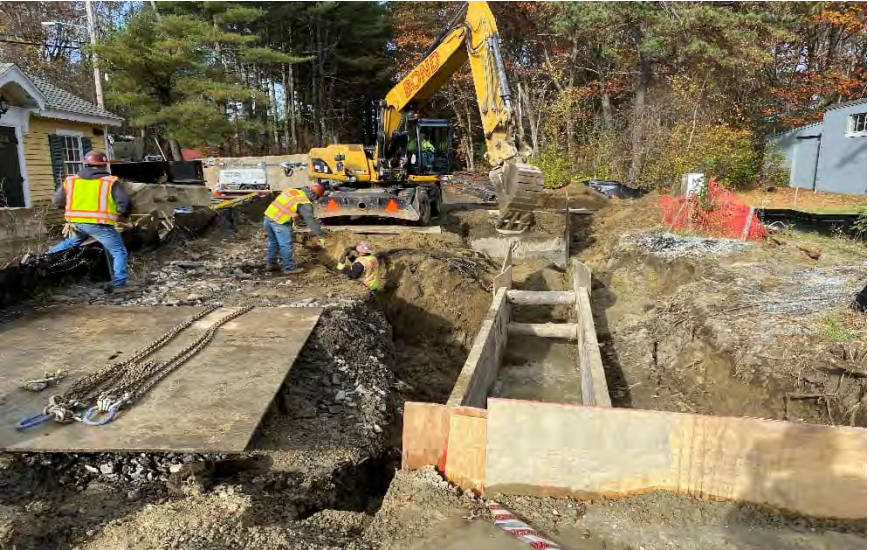
<b>PHOTOGRAPHIC LOG</b>	
<b>Client Name:</b> Eversource		<b>Site Location:</b> Sudbury to Hudson Transmission Reliability Project	<b>Town:</b> Sudbury
<b>Photo No.:</b> 8	<b>Date:</b> 11-1-23

<b>Description:</b>  Work area within segment 11, conduit work, existing erosion control, looking westward.

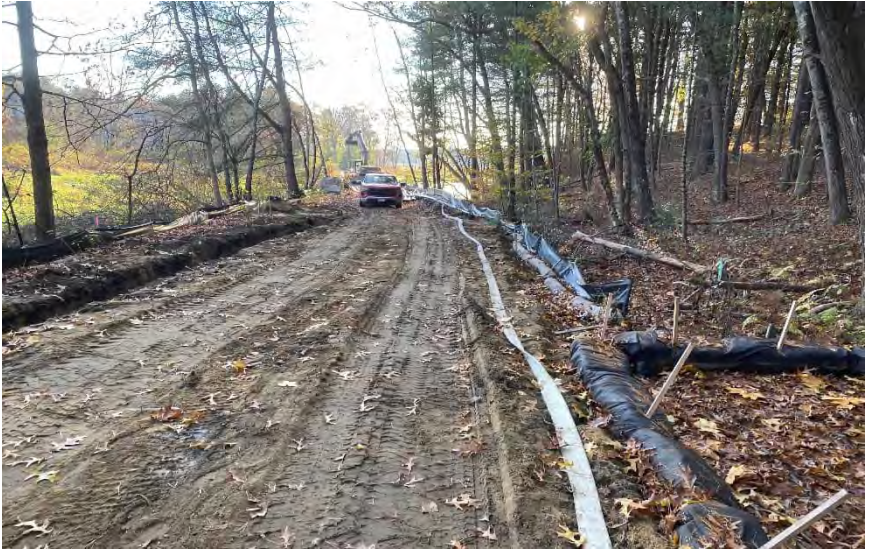
<p>PHOTOGRAPHIC LOG</p>	
<p>Client Name: Eversource</p>		<p>Site Location: Sudbury to Hudson Transmission Reliability Project</p>	<p>Town: Sudbury</p>
<p>Photo No.: 1</p>	<p>Date: 11-3-23</p>

<p>Description:</p> <p>Work area within segment 13, bridge 127 work, looking eastward.</p>

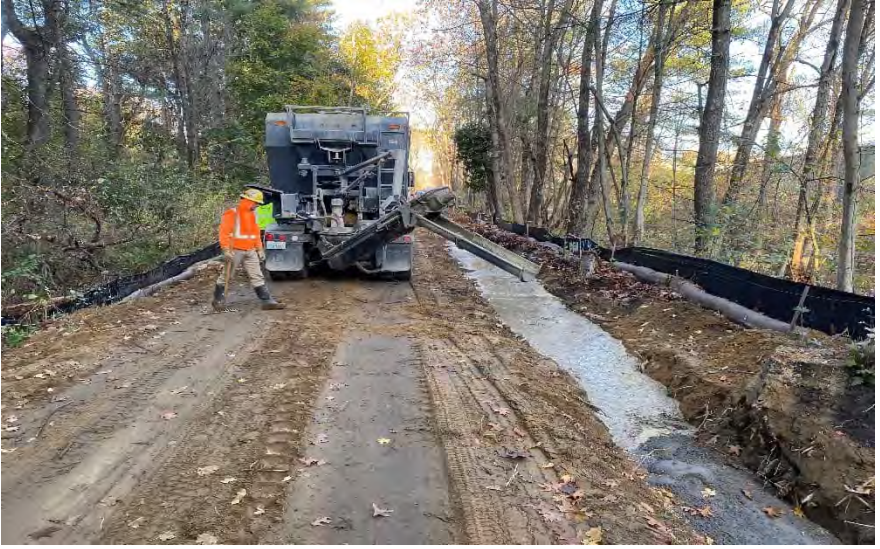
<p>PHOTOGRAPHIC LOG</p>	
<p>Client Name: Eversource</p>		<p>Site Location: Sudbury to Hudson Transmission Reliability Project</p>	<p>Town: Sudbury</p>
<p>Photo No.: 4</p>	<p>Date: 11-3-23</p>

<p>Description:</p> <p>Work area within segment 13, conduit backfill, looking westward.</p>

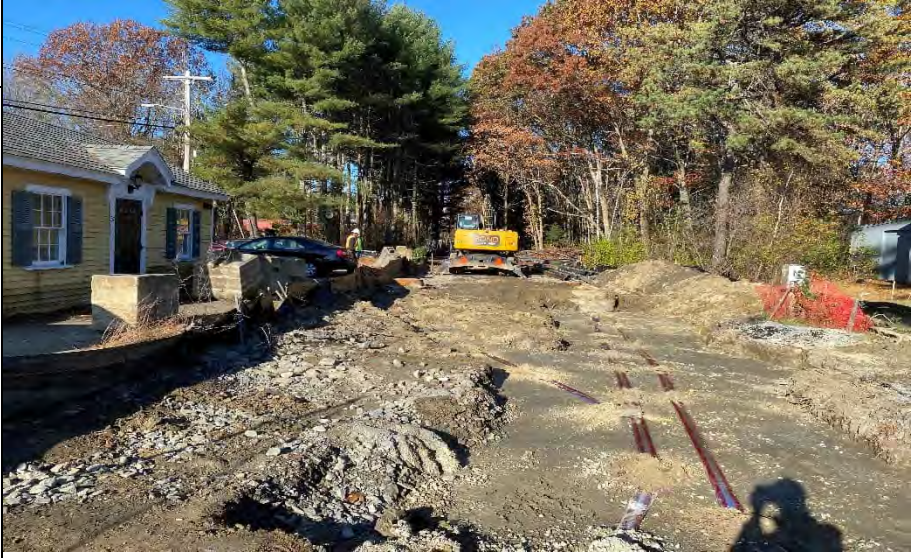
<p>PHOTOGRAPHIC LOG</p>	
<p>Client Name: Eversource</p>		<p>Site Location: Sudbury to Hudson Transmission Reliability Project</p>	<p>Town: Sudbury</p>
<p>Photo No.: 5</p>	<p>Date: 11-3-23</p>

<p>Description:</p> <p>Work area within segment 11, recent conduit work, existing erosion control, looking westward.</p>

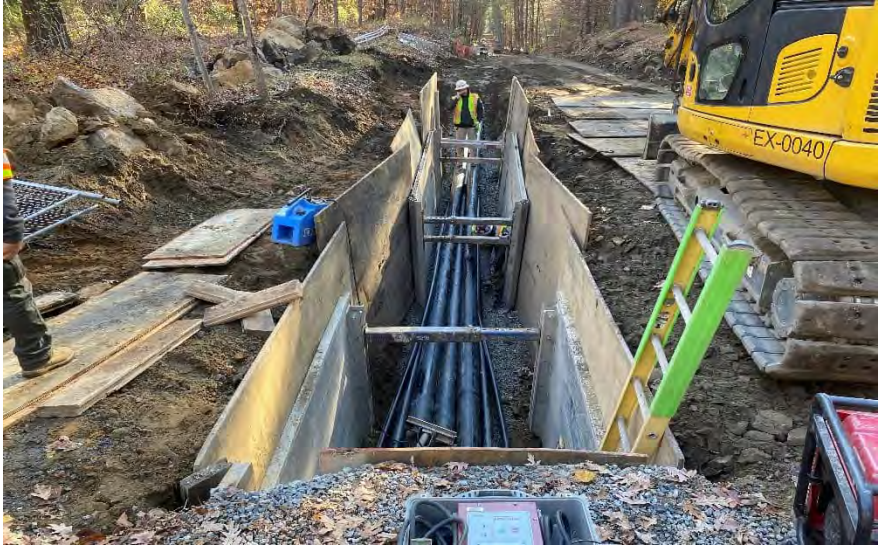
<p>PHOTOGRAPHIC LOG</p>	
<p>Client Name: Eversource</p>		<p>Site Location: Sudbury to Hudson Transmission Reliability Project</p>	<p>Town: Sudbury</p>
<p>Photo No.: 6</p>	<p>Date: 11-3-23</p>

<p>Description:</p> <p>Work area within Segment 10, conduit work, existing erosion control, looking eastward.</p>

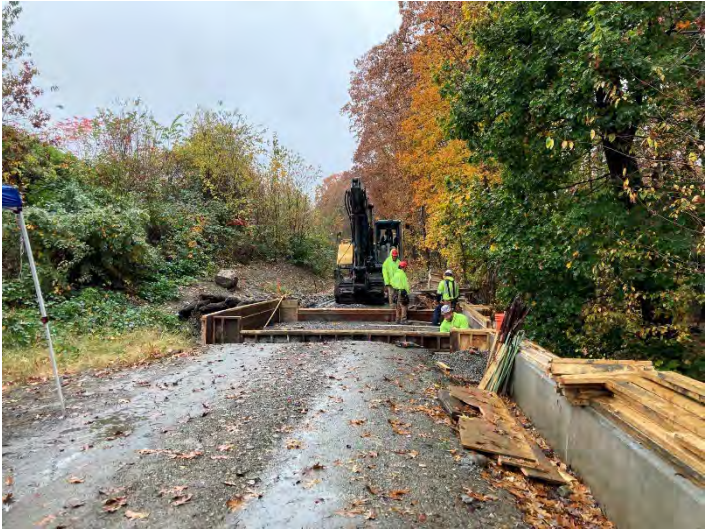
<b>PHOTOGRAPHIC LOG</b>	
Client Name: Eversource		Site Location: Sudbury to Hudson Transmission Reliability Project	Town: Hudson
Photo No.: 3	Date: 10-30-2023

Description: View of ET&L working at walls 1 and 2 and cattle crossing in segment 1. Facing west.

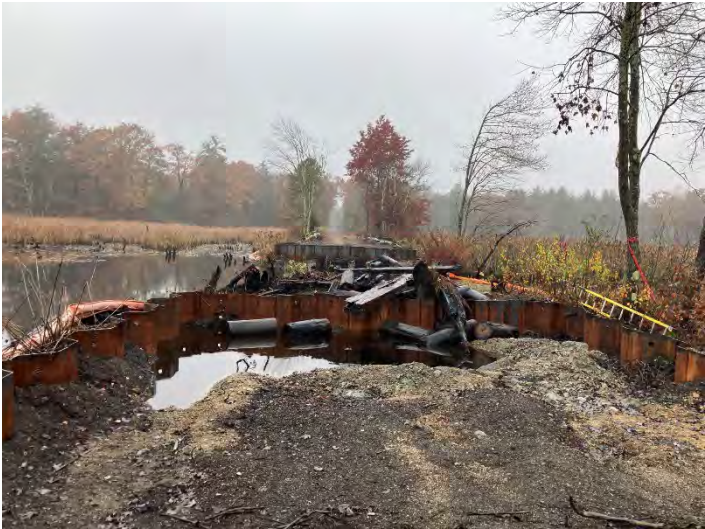
<b>PHOTOGRAPHIC LOG</b>	
Client Name: Eversource		Site Location: Sudbury to Hudson Transmission Reliability Project	Town: Hudson
Photo No.: 4	Date: 10-30-2023

Description: View of bridge 130 from segment 3. Facing west.

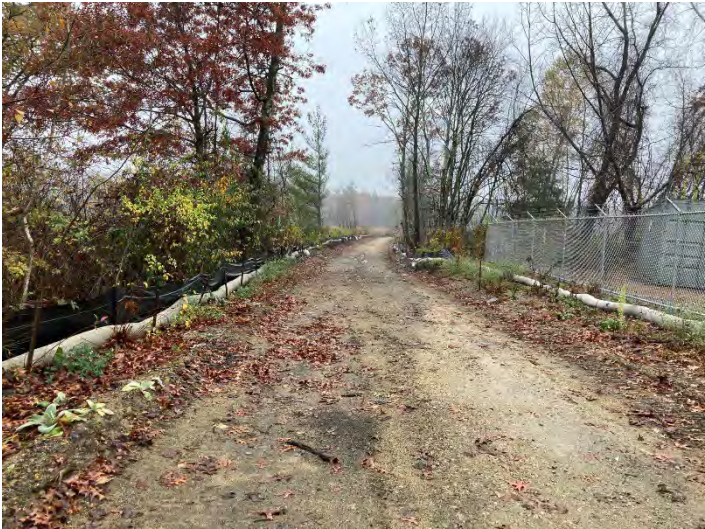
Client Name: Eversource		Site Location: Sudbury to Hudson Transmission Reliability Project	Town: Hudson
Photo No.: 5	Date: 10-30-2023

Description: View of Type B E&S controls on west end of segment 3.

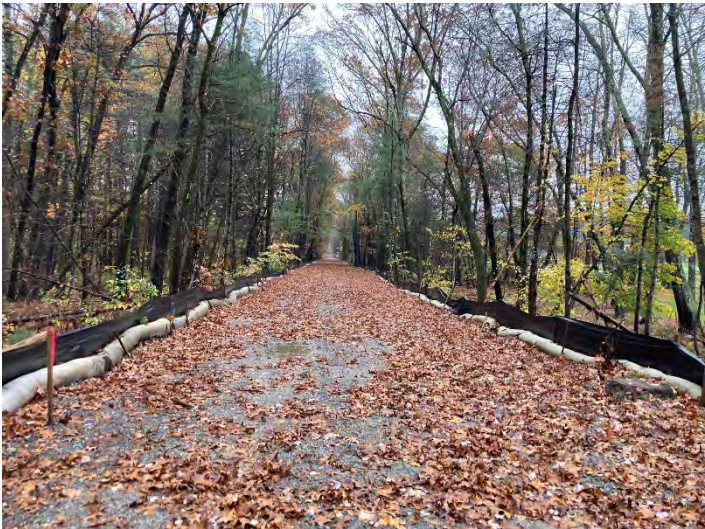
Client Name: Eversource		Site Location: Sudbury to Hudson Transmission Reliability Project	Town: Hudson
Photo No.: 6	Date: 10-30-2023

Description: View of Type B E&S controls in segment 4. Facing east.

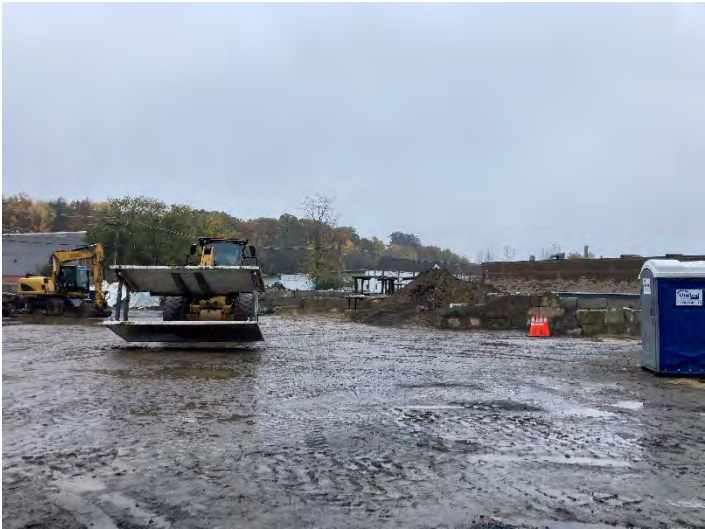
<b>Epsilon</b> ASSOCIATES INC.		<b>PHOTOGRAPHIC LOG</b>	
Client Name: Eversource		Site Location: Sudbury to Hudson Transmission Reliability Project	Town: Hudson
Photo No.: 7	Date: 10-30-2023

Description: View of activities at Bonazzoli laydown yard. Facing southwest.

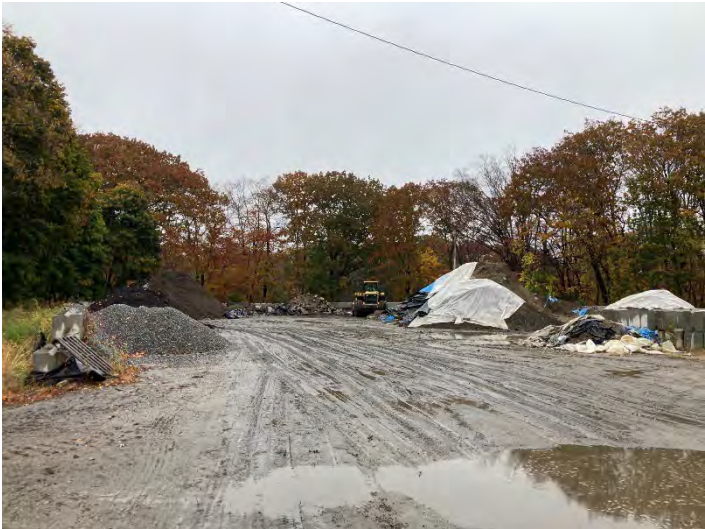
<b>Epsilon</b> ASSOCIATES INC.		<b>PHOTOGRAPHIC LOG</b>	
Client Name: Eversource		Site Location: Sudbury to Hudson Transmission Reliability Project	Town: Hudson
Photo No.: 8	Date: 10-30-2023

Description: View of activities at Stowe Ct laydown yard. Facing northeast.

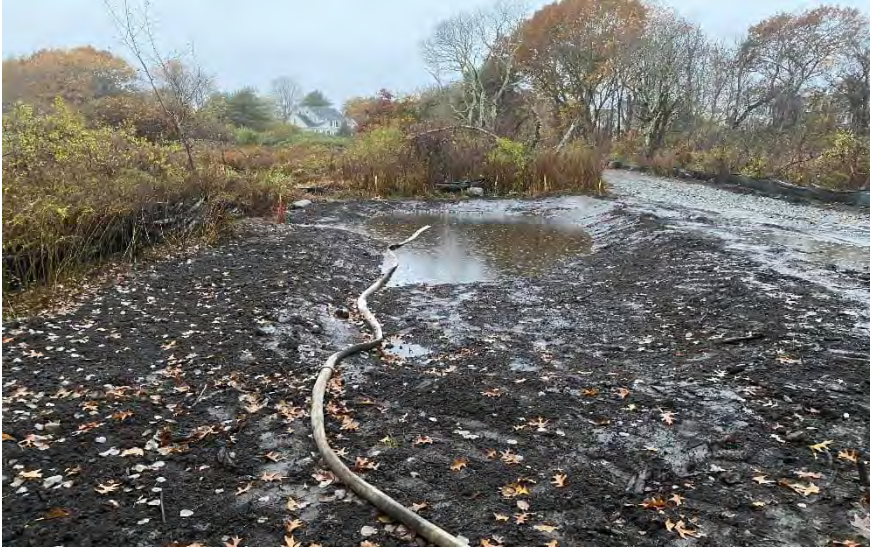
PHOTOGRAPHIC LOG	
Client Name: Eversource		Site Location: Sudbury to Hudson Transmission Reliability Project	Town: Sudbury
Photo No.: 2	Date: 10-30-23

Description:  Work area from segment 14, wetland replication area prior to plantings, looking westward.

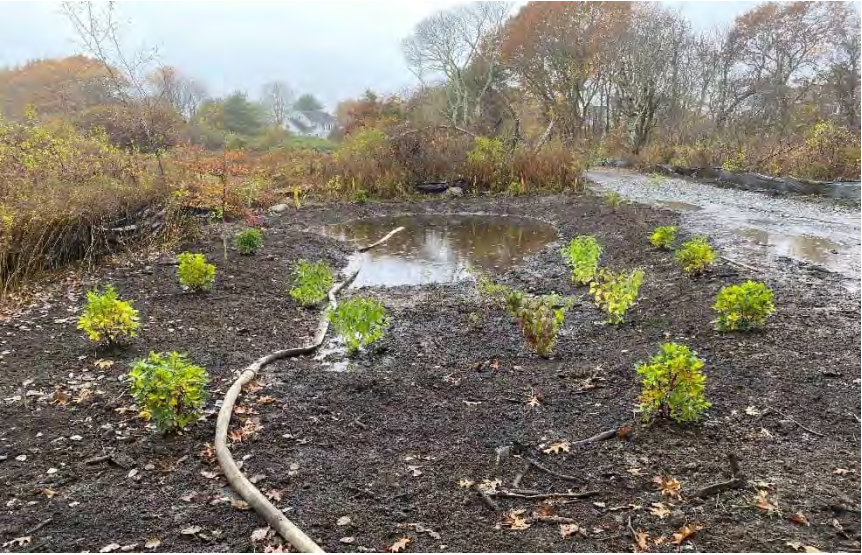
PHOTOGRAPHIC LOG	
Client Name: Eversource		Site Location: Sudbury to Hudson Transmission Reliability Project	Town: Sudbury
Photo No.: 3	Date: 10-30-23

Description:  Work area from segment 14, wetland replication area after plantings, looking westward.

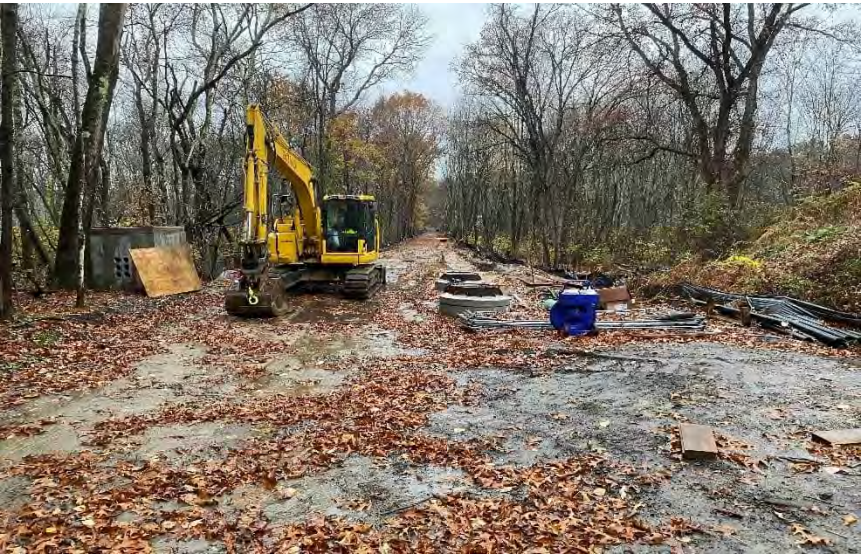
PHOTOGRAPHIC LOG	
Client Name: Eversource		Site Location: Sudbury to Hudson Transmission Reliability Project	Town: Sudbury
Photo No.: 4	Date: 10-30-23

Description:  Work area within segment 14, conduit work, looking westward.

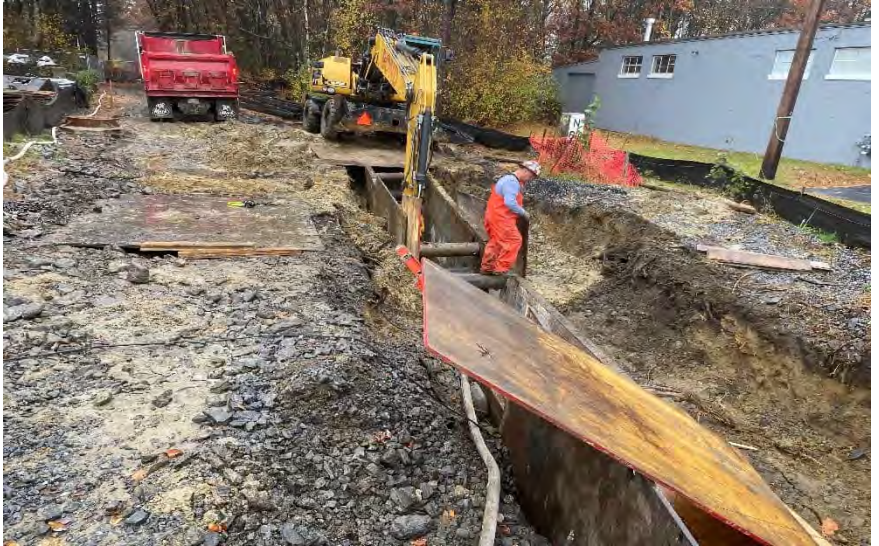
PHOTOGRAPHIC LOG	
Client Name: Eversource		Site Location: Sudbury to Hudson Transmission Reliability Project	Town: Sudbury
Photo No.: 5	Date: 10-30-23

Description:  Bond conducting conduit work within segment 11, looking westward.

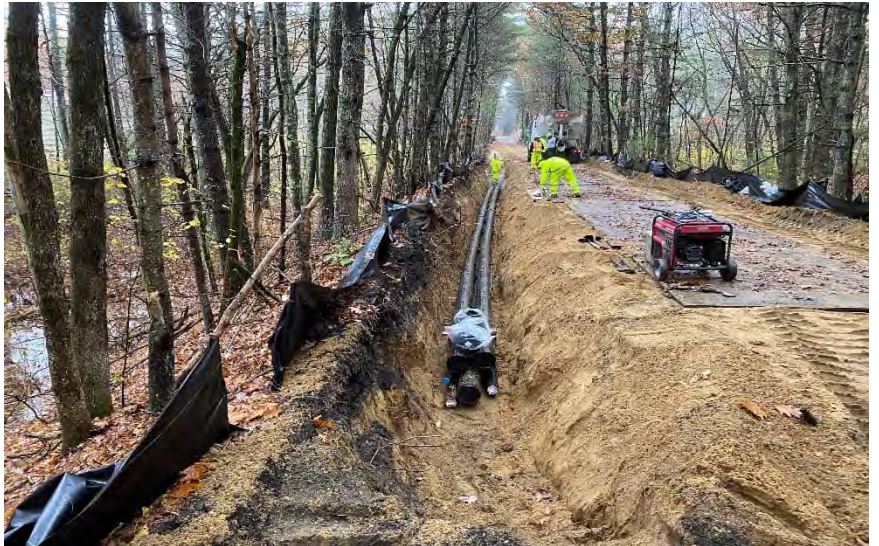
PHOTOGRAPHIC LOG	
Client Name: Eversource		Site Location: Sudbury to Hudson Transmission Reliability Project	Town: Sudbury
Photo No.: 6	Date: 10-30-23

Description:  Work area within segment 9, conduit work, looking eastward.

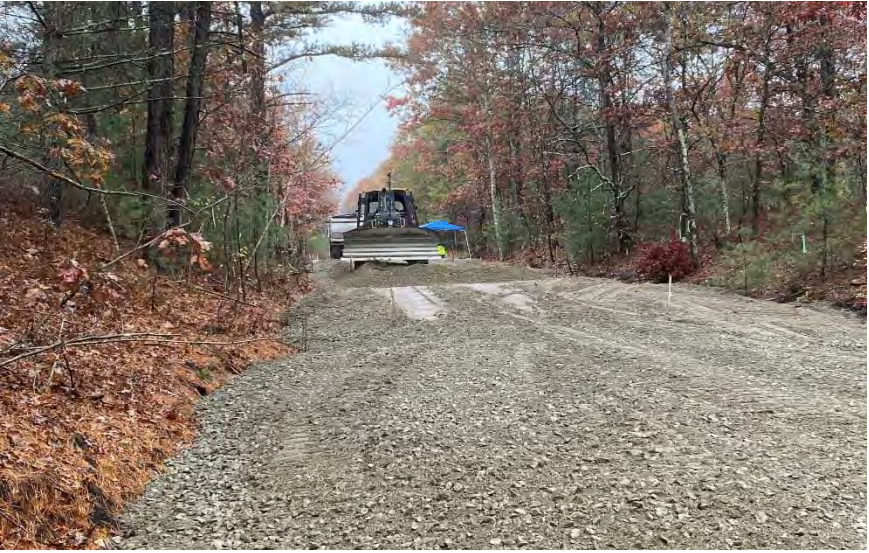
<b>PHOTOGRAPHIC LOG</b>	
<b>Client Name:</b> Eversource		<b>Site Location:</b> Sudbury to Hudson Transmission Reliability Project	<b>Town:</b> Sudbury
<b>Photo No.:</b> 7	<b>Date:</b> 10-30-23

<b>Description:</b>  Work area within segment 7, grading work, looking westward.

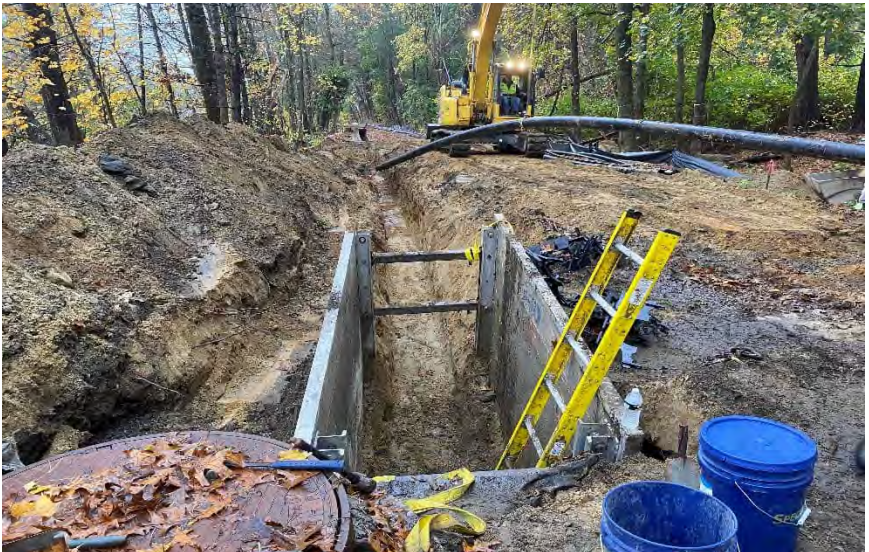
<b>PHOTOGRAPHIC LOG</b>	
<b>Client Name:</b> Eversource		<b>Site Location:</b> Sudbury to Hudson Transmission Reliability Project	<b>Town:</b> Sudbury
<b>Photo No.:</b> 8	<b>Date:</b> 10-30-23

<b>Description:</b>  Conduit work within segment 13, conduit work, looking eastward.

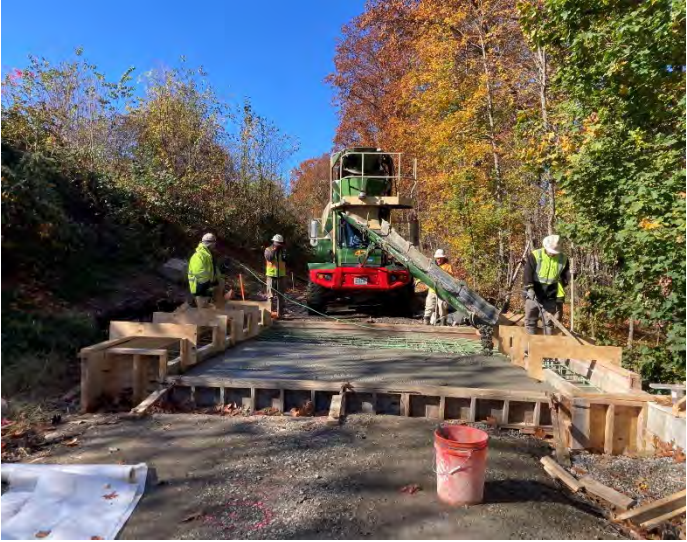
<b>PHOTOGRAPHIC LOG</b>	
Client Name: Eversource		Site Location: Sudbury to Hudson Transmission Reliability Project	Town: Hudson
Photo No.: 1	Date: 11-02-2023

Description: View of concrete pour at cattle crossing in segment 1. Facing west.

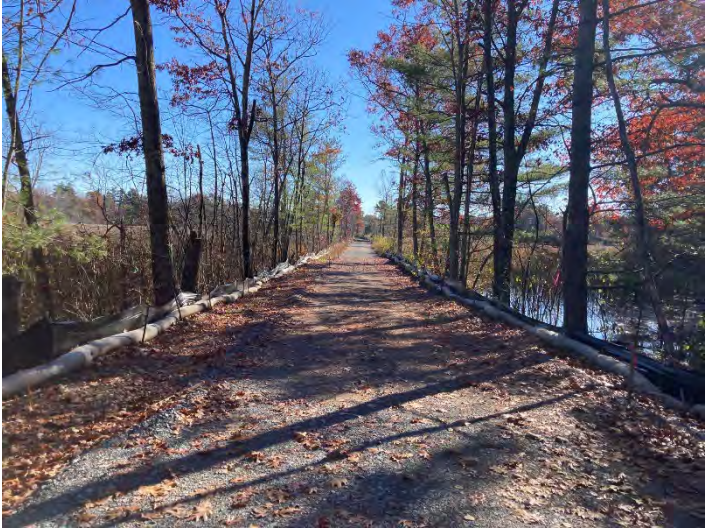
<b>PHOTOGRAPHIC LOG</b>	
Client Name: Eversource		Site Location: Sudbury to Hudson Transmission Reliability Project	Town: Hudson/Stow
Photo No.: 2	Date: 11-02-2023

Description: View of Type B E&S controls in segment 2. Facing east.

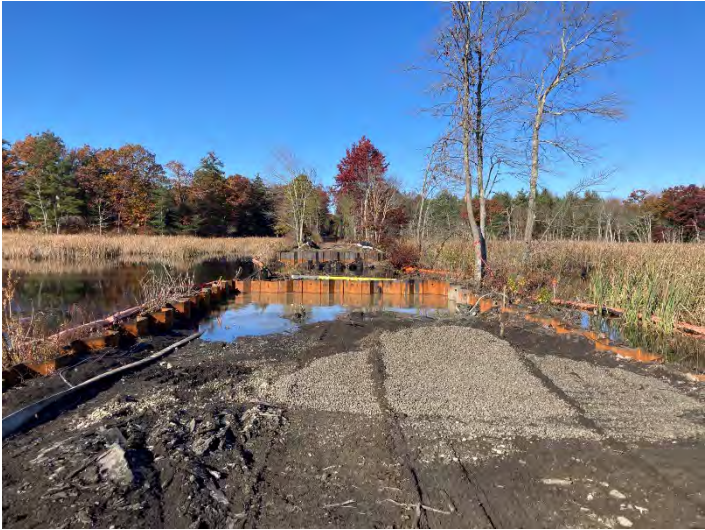
<b>Epsilon</b> ASSOCIATES INC.		<b>PHOTOGRAPHIC LOG</b>	
Client Name: Eversource		Site Location: Sudbury to Hudson Transmission Reliability Project	Town: Hudson
Photo No.: 3	Date: 11-02-2023

Description: View of bridge 130 from segment 3. No work occurred at this location today. Facing west.

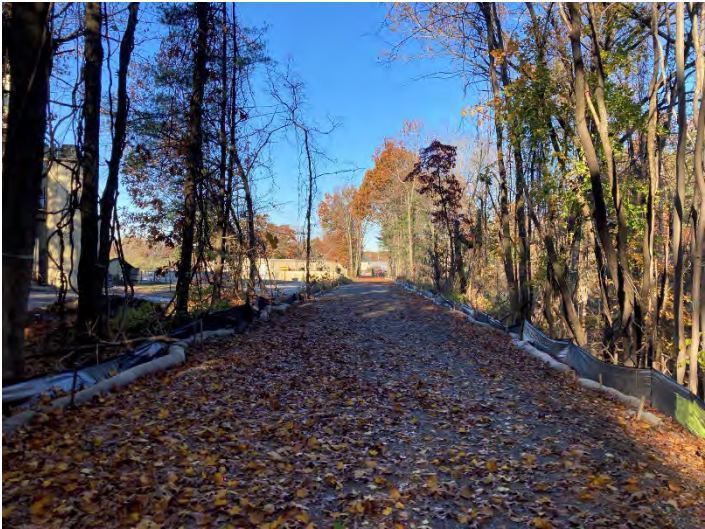
<b>Epsilon</b> ASSOCIATES INC.		<b>PHOTOGRAPHIC LOG</b>	
Client Name: Eversource		Site Location: Sudbury to Hudson Transmission Reliability Project	Town: Hudson
Photo No.: 4	Date: 11-02-2023

Description: View of Type B E&S controls in segment 3. Facing west.

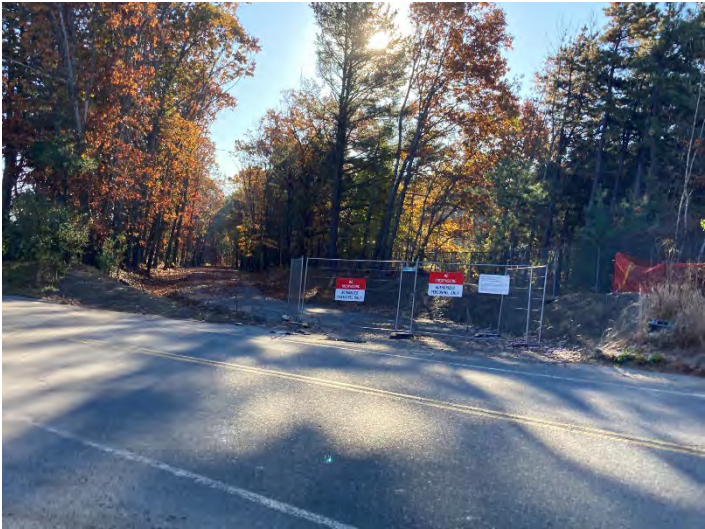
Client Name: Eversource		Site Location: Sudbury to Hudson Transmission Reliability Project	Town: Hudson
Photo No.: 5	Date: 11-02-2023

Description: View of entrance to segment 4 at Main St. Facing east.

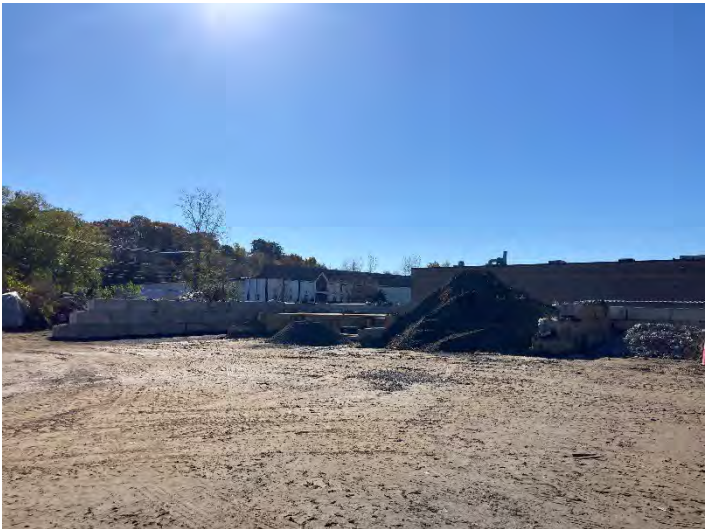
Client Name: Eversource		Site Location: Sudbury to Hudson Transmission Reliability Project	Town: Hudson
Photo No.: 7	Date: 11-02-2023

Description: View of Bonazzoli laydown yard. Facing southwest.

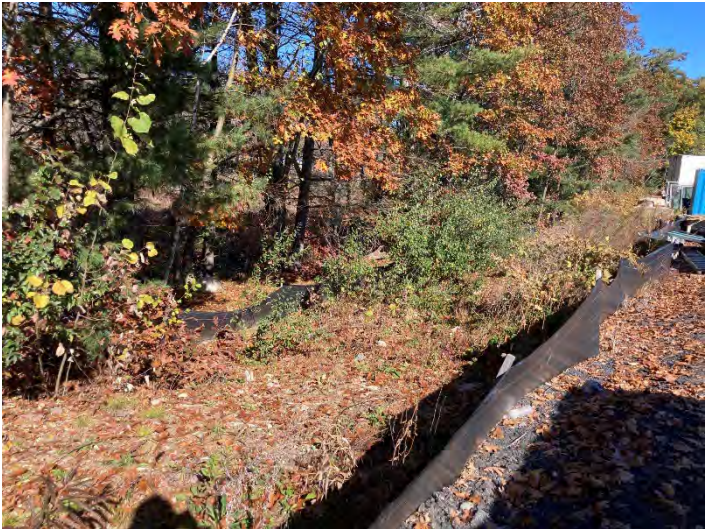
Client Name: Eversource		Site Location: Sudbury to Hudson Transmission Reliability Project	Town: Hudson
Photo No.: 8	Date: 11-02-2023

Description: View of silt fence at Bonazzoli laydown yard. Facing northwest.

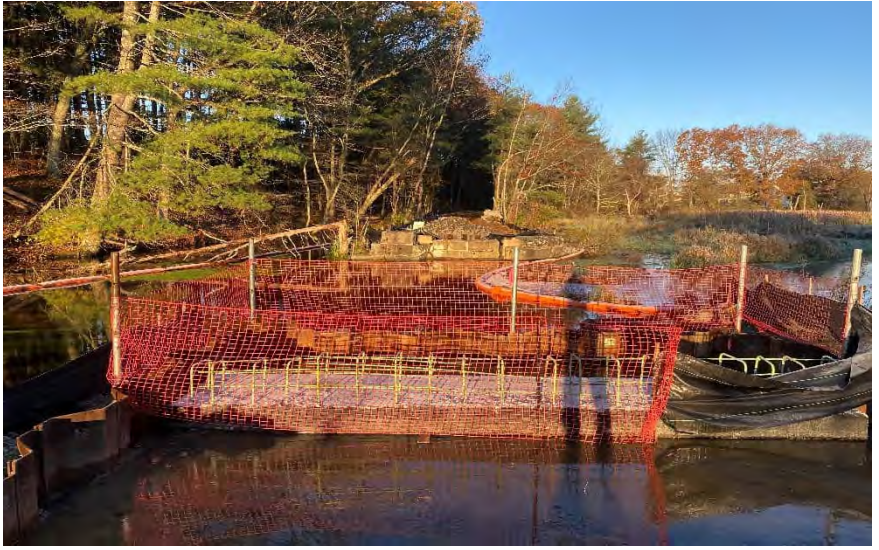
<b>PHOTOGRAPHIC LOG</b>	
Client Name: Eversource		Site Location: Sudbury to Hudson Transmission Reliability Project	Town: Sudbury
Photo No.: 1	Date: 11-2-23

Description:  Work area from segment 14 -> segment 13 (bridge 127 area), looking westward.

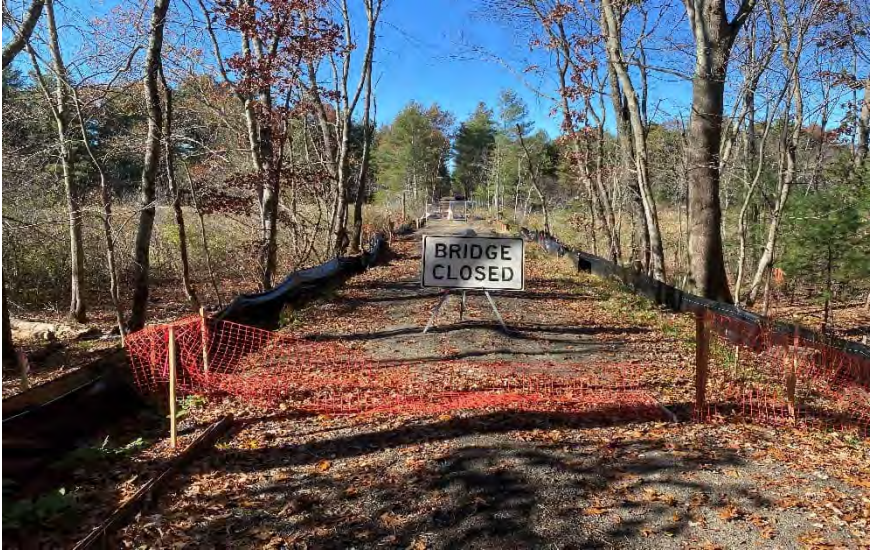
<b>PHOTOGRAPHIC LOG</b>	
Client Name: Eversource		Site Location: Sudbury to Hudson Transmission Reliability Project	Town: Sudbury
Photo No.: 2	Date: 11-2-23

Description:  Work area from segment 8, existing erosion control, looking westward.
