**Weekly Environmental Compliance Summary**

**Sudbury to Hudson Transmission Reliability Project (USEPA Tracking # MAR1003UW)**

Sudbury, Hudson, and Stow, MA

Week of: October 30, 2023 to November 3, 2023

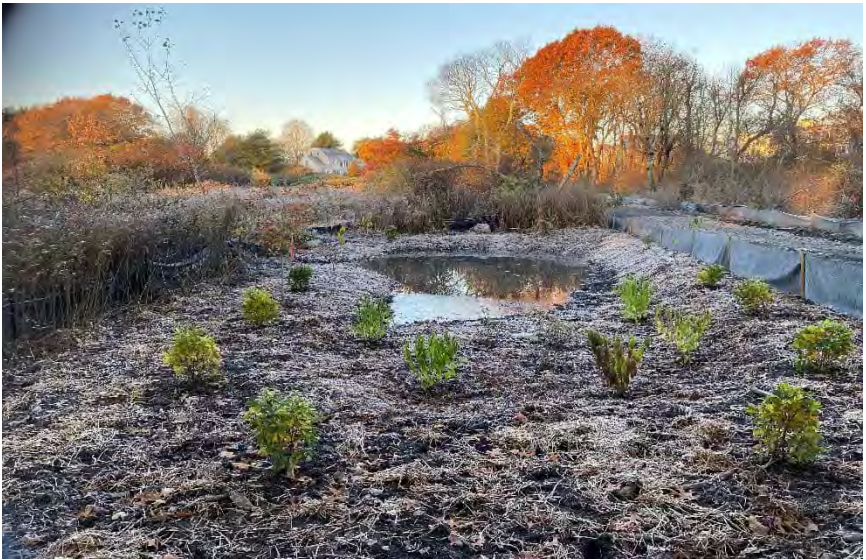
PHOTOGRAPHIC LOG	
Client Name: Eversource		Site Location: Sudbury to Hudson Transmission Reliability Project	Town: Sudbury
Photo No.: 3	Date: 11-2-23

Description:  Work area from segment 14, wetland replication area after mulching, looking westward.

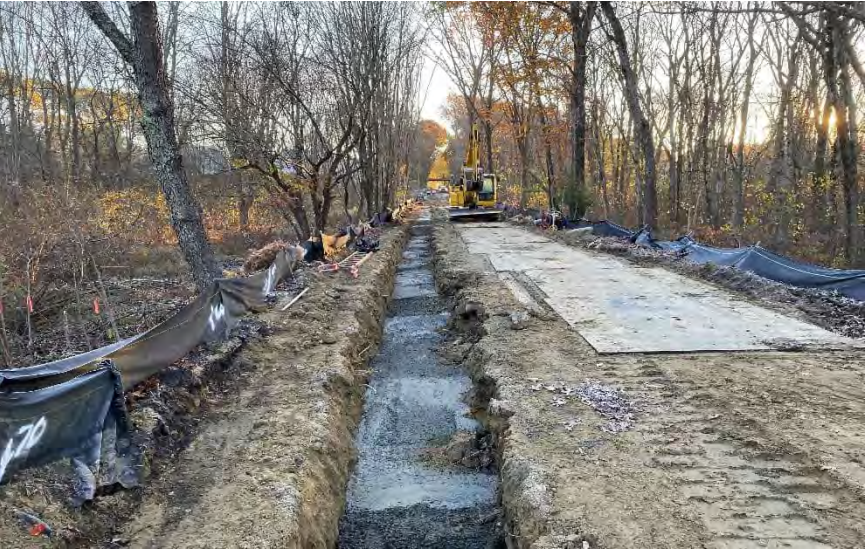
PHOTOGRAPHIC LOG	
Client Name: Eversource		Site Location: Sudbury to Hudson Transmission Reliability Project	Town: Sudbury
Photo No.: 4	Date: 11-2-23

Description:  Work area within segment 14, conduit work, looking eastward.

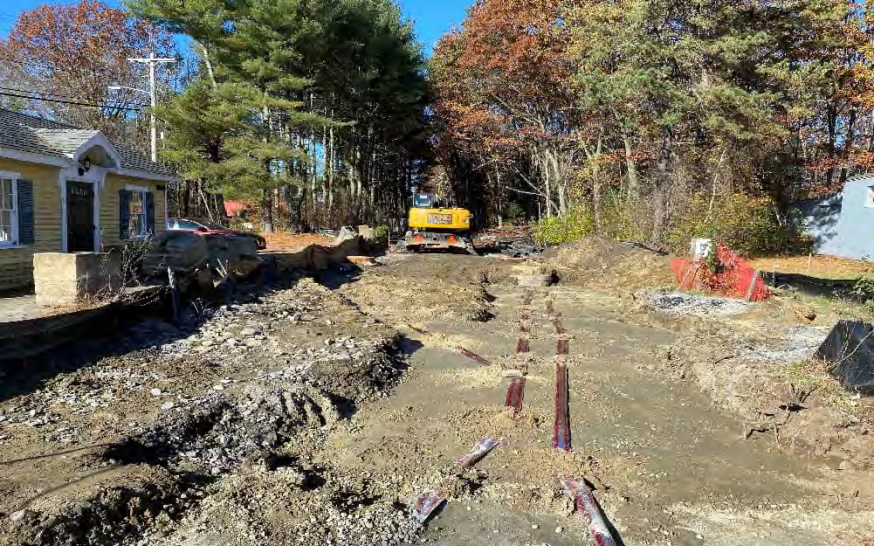
<b>PHOTOGRAPHIC LOG</b>	
Client Name: Eversource		Site Location: Sudbury to Hudson Transmission Reliability Project	Town: Sudbury
Photo No.: 5	Date: 11-2-23

Description:  Work area, recent conduit work, within segment 11, looking westward.

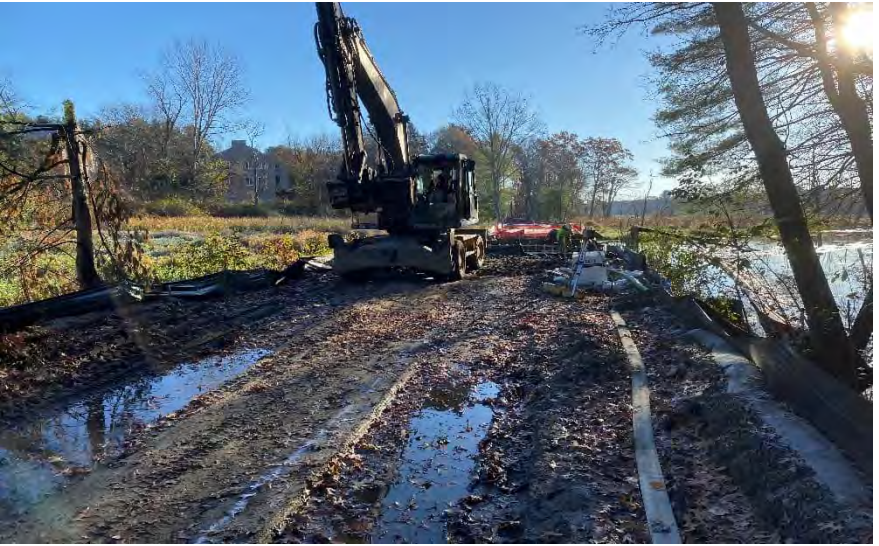
<b>PHOTOGRAPHIC LOG</b>	
Client Name: Eversource		Site Location: Sudbury to Hudson Transmission Reliability Project	Town: Sudbury
Photo No.: 6	Date: 11-2-23

Description:  Work area within segment 13, bridge work, looking eastward.

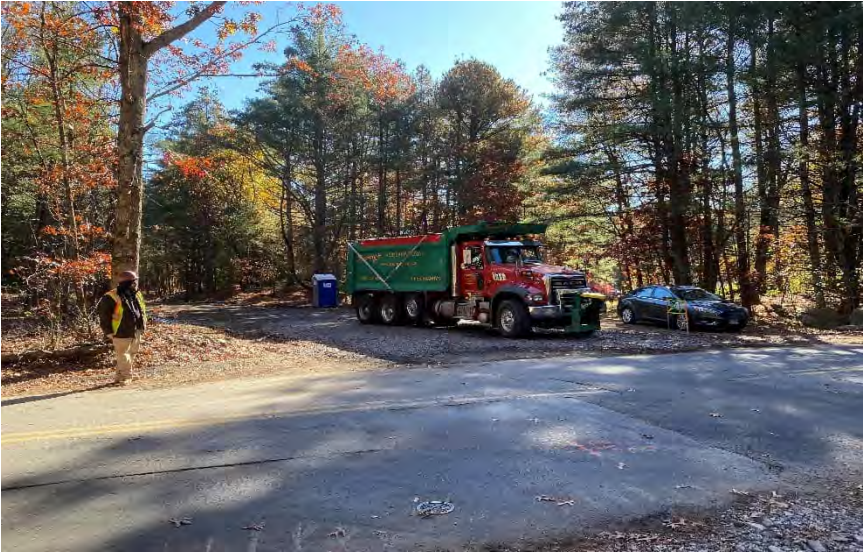
<b>PHOTOGRAPHIC LOG</b>	
<b>Client Name:</b> Eversource		<b>Site Location:</b> Sudbury to Hudson Transmission Reliability Project	<b>Town:</b> Sudbury
<b>Photo No.:</b> 7	<b>Date:</b> 11-2-23

<b>Description:</b>  Work area within segment 9, grading work, looking eastward.

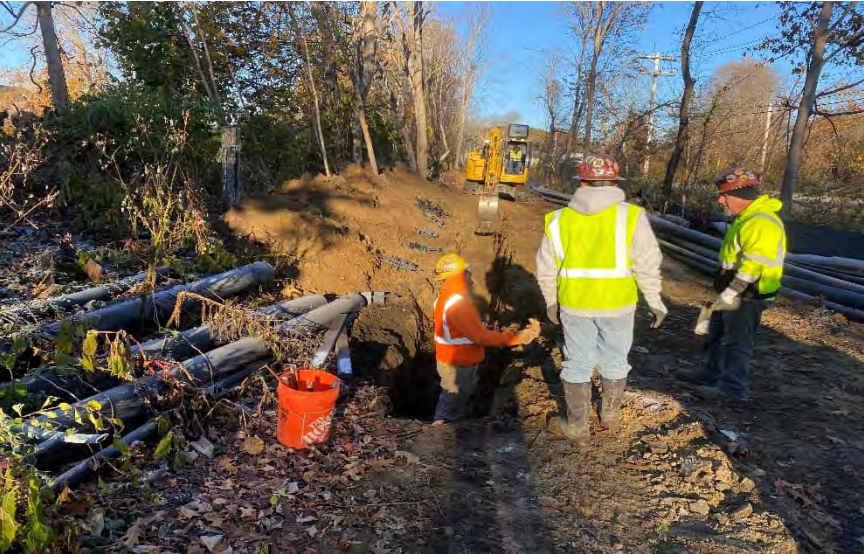
<b>PHOTOGRAPHIC LOG</b>	
<b>Client Name:</b> Eversource		<b>Site Location:</b> Sudbury to Hudson Transmission Reliability Project	<b>Town:</b> Sudbury
<b>Photo No.:</b> 8	<b>Date:</b> 11-2-23

<b>Description:</b>  Conduit work within segment 12, conduit work, looking westward.

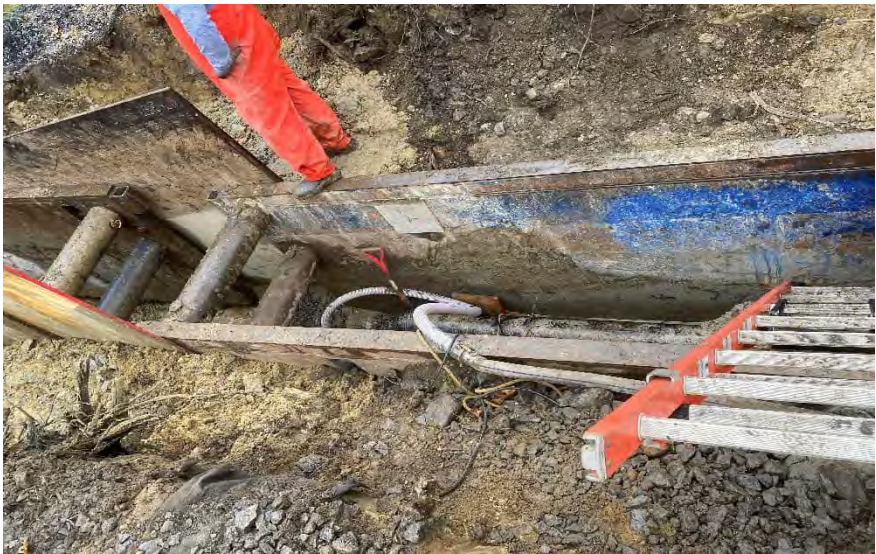
<b>PHOTOGRAPHIC LOG</b>	
<b>Client Name:</b> Eversource		<b>Site Location:</b> Sudbury to Hudson Transmission Reliability Project	
<b>Town:</b> Sudbury			
<b>Photo No.:</b> 1	<b>Date:</b> 10/30/2023

<b>Description:</b> View of area being pumped from manhole #24 within segment 11, looking westward.

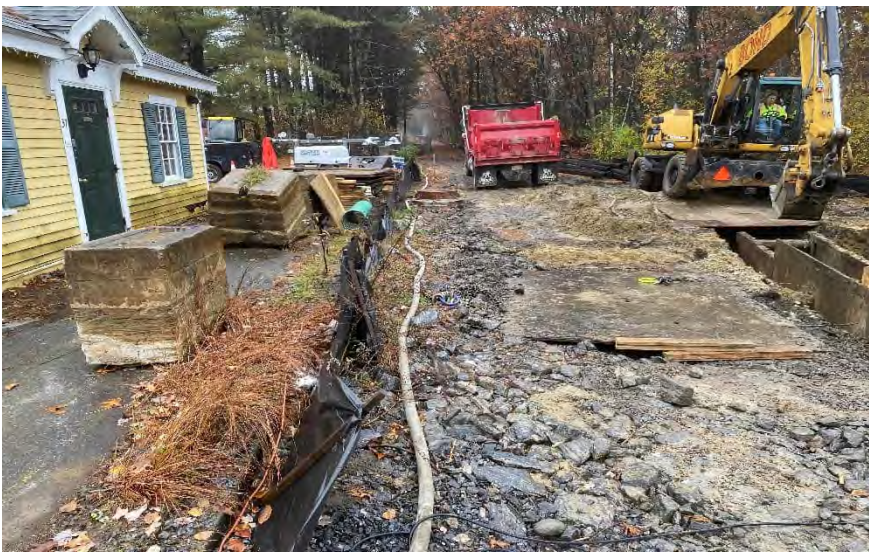
<b>PHOTOGRAPHIC LOG</b>	
<b>Client Name:</b> Eversource		<b>Site Location:</b> Sudbury to Hudson Transmission Reliability Project	
<b>Town:</b> Sudbury			
<b>Photo No.:</b> 2	<b>Date:</b> 10/30/2023

<b>Description:</b> Segment 11. View of dewatering operation. Looking westward.

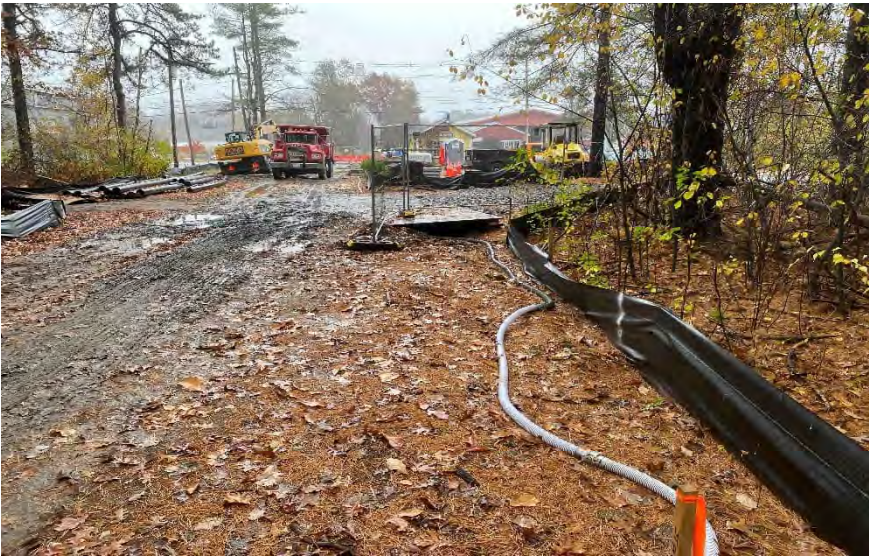
<b>PHOTOGRAPHIC LOG</b>	
Client Name: Eversource		Site Location: Sudbury to Hudson Transmission Reliability Project	Town: Sudbury
Photo No.: 3	Date: 10/30/2023

<b>Description:</b> Segment 11. View of dewatering operation, looking eastward.

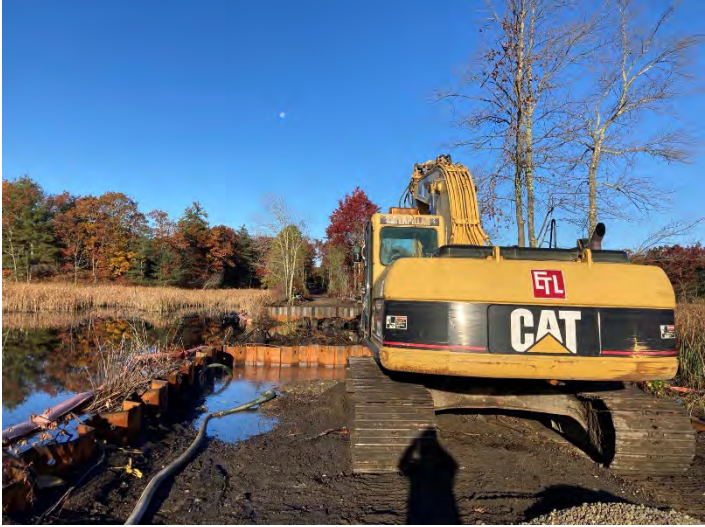
<b>PHOTOGRAPHIC LOG</b>			
Client Name: Eversource		Site Location: Sudbury to Hudson Transmission Reliability Project		Town: Hudson	
Photo No.: 1	Date: 10/31/2023

Description: View of work at bridge 130 at Fort Meadow Brook. Facing west.

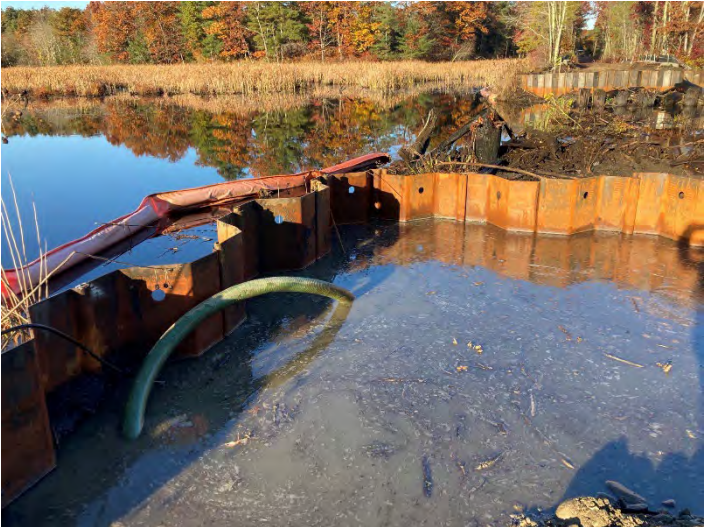
<b>PHOTOGRAPHIC LOG</b>			
Client Name: Eversource		Site Location: Sudbury to Hudson Transmission Reliability Project		Town: Hudson	
Photo No.: 2	Date: 10/31/2023

Description: View of water prior to treatment. Water appeared turbid. Facing southwest.

Specific location where problem identified: Dewatering operation at bridge 130 in segment 3	
Provide a description of the specific condition that triggered the need for corrective action and the cause (if identifiable): Turbidity reading exceeded 355 NTUs and discharge appeared turbid. Discharge appeared to have reach adjacent wetland. Assess dewatering controls at bridge 130 in segment 3 prior to resuming pumping operation at this location. Alternative controls such as frac tank are recommended.	
Section C – Corrective Action Completion (CGP Part 5.4.1.b)	
Complete this section <u>within 24 hours</u> after completing the corrective action.	
For site condition # 1, 2, 3, 4, or 6 (those not related to a dewatering discharge) confirm that you met the following deadlines (CGP Part 5.2.1):	
<input type="checkbox"/> Immediately took all reasonable steps to address the condition, including cleaning up any contaminated surfaces so the material will not discharge in subsequent storm events. <b>AND</b>

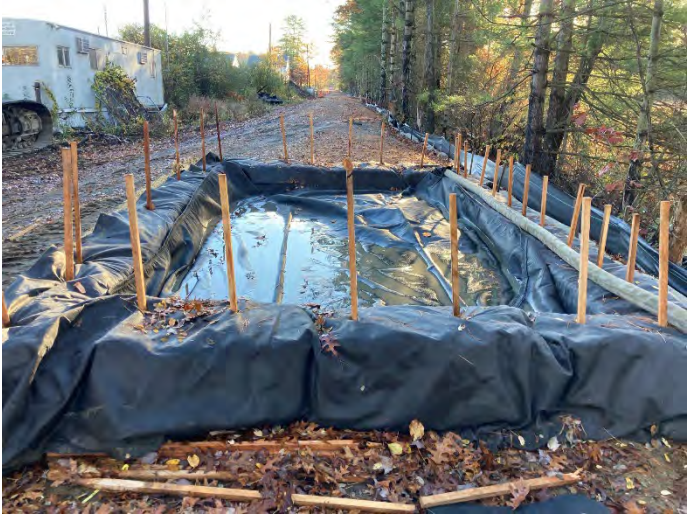
<b>PHOTOGRAPHIC LOG</b>			
Client Name: Eversource		Site Location: Sudbury to Hudson Transmission Reliability Project		Town: Hudson	
Photo No.: 3	Date: 10/31/2023

<b>Description:</b> View of dewatering controls (straw bale corral with filter fabric, stone, and silt bag). Facing east.

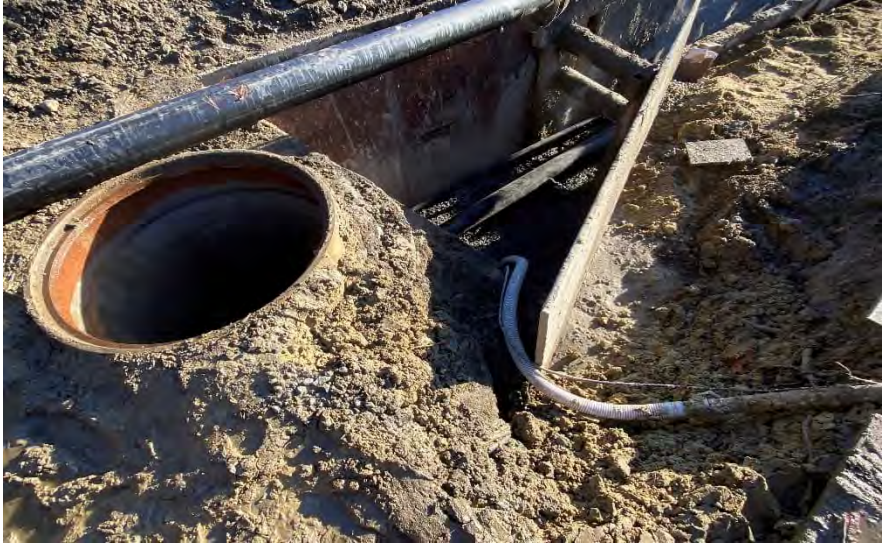
<b>PHOTOGRAPHIC LOG</b>	
Client Name: Eversource		Site Location: Sudbury to Hudson Transmission Reliability Project	Town: Sudbury
Photo No.: 1	Date: 10/31/2023

Description: View of area being pumped from manhole #24 within segment 11, looking eastward.

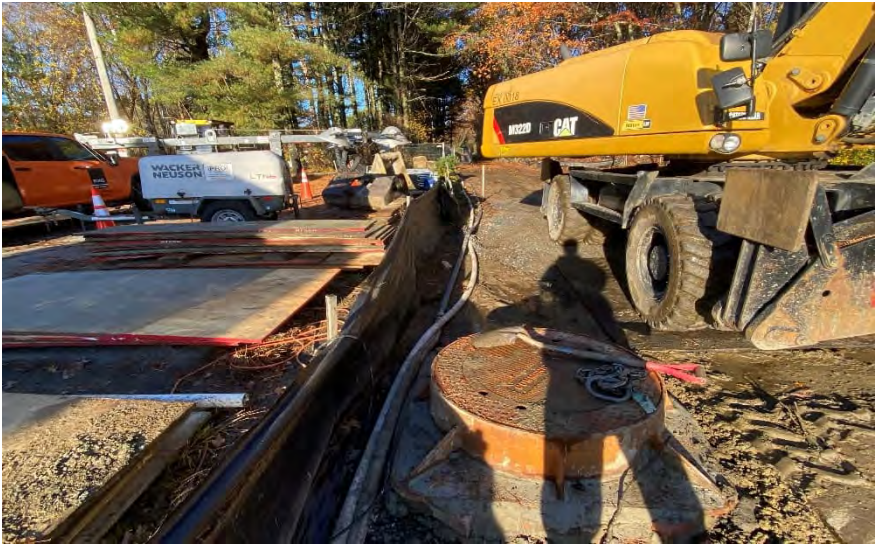
<b>PHOTOGRAPHIC LOG</b>	
Client Name: Eversource		Site Location: Sudbury to Hudson Transmission Reliability Project	Town: Sudbury
Photo No.: 2	Date: 10/31/2023

Description: Segment 11. View of dewatering operation. Looking westward.

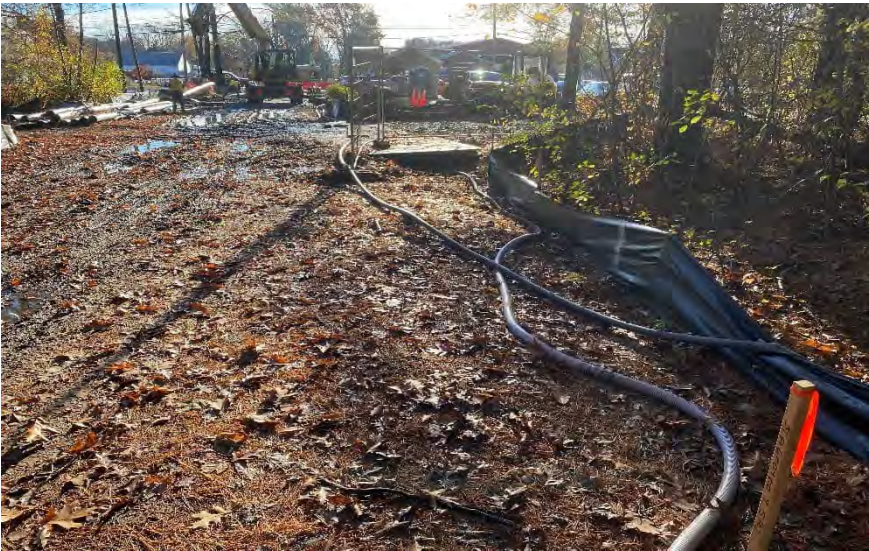
<b>PHOTOGRAPHIC LOG</b>	
<b>Client Name:</b> Eversource		<b>Site Location:</b> Sudbury to Hudson Transmission Reliability Project	
<b>Town:</b> Sudbury			
<b>Photo No.:</b> 3	<b>Date:</b> 10/31/2023

<b>Description:</b> Segment 11. View of dewatering operation, looking eastward.

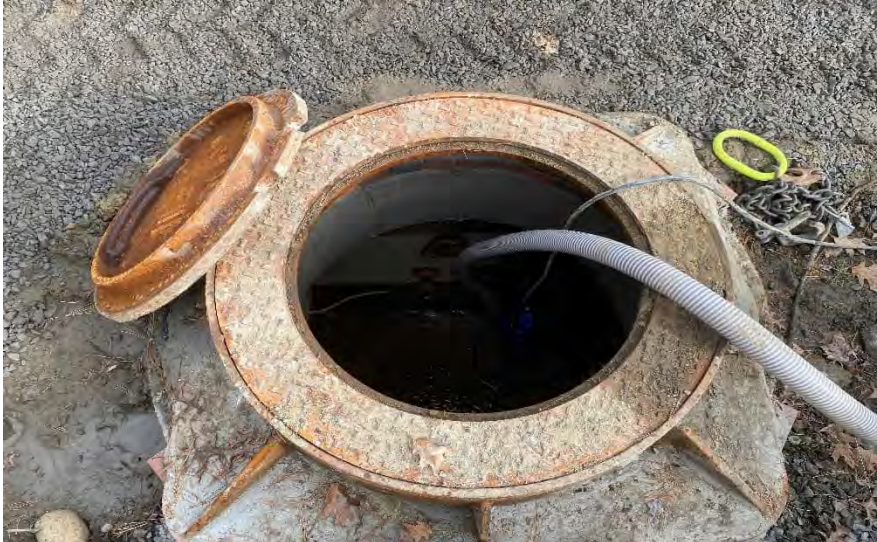
PHOTOGRAPHIC LOG	
Client Name: Eversource		Site Location: Sudbury to Hudson Transmission Reliability Project	Town: Sudbury
Photo No.: 1	Date: 11/1/2023

Description: View of area being pumped from manhole #24 within segment 11.

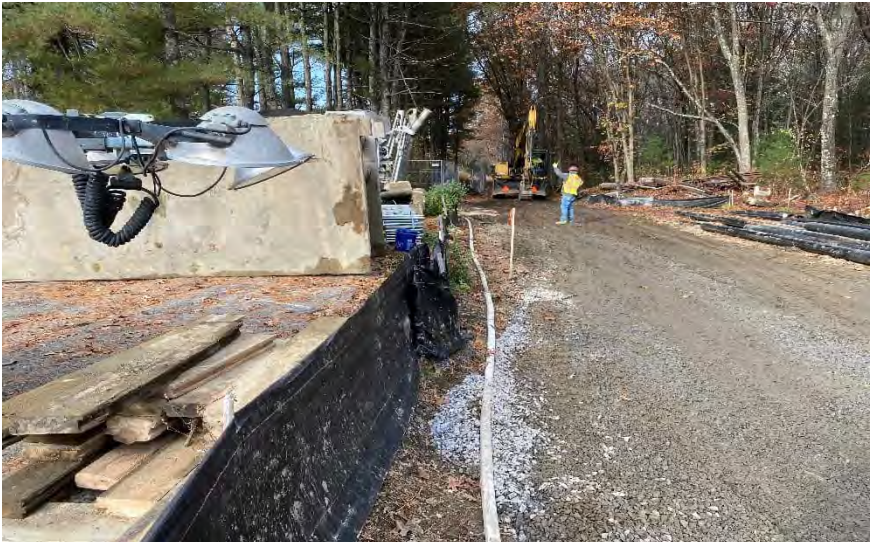
PHOTOGRAPHIC LOG	
Client Name: Eversource		Site Location: Sudbury to Hudson Transmission Reliability Project	Town: Sudbury
Photo No.: 2	Date: 11/1/2023

Description: Segment 11. View of dewatering operation. Looking westward.

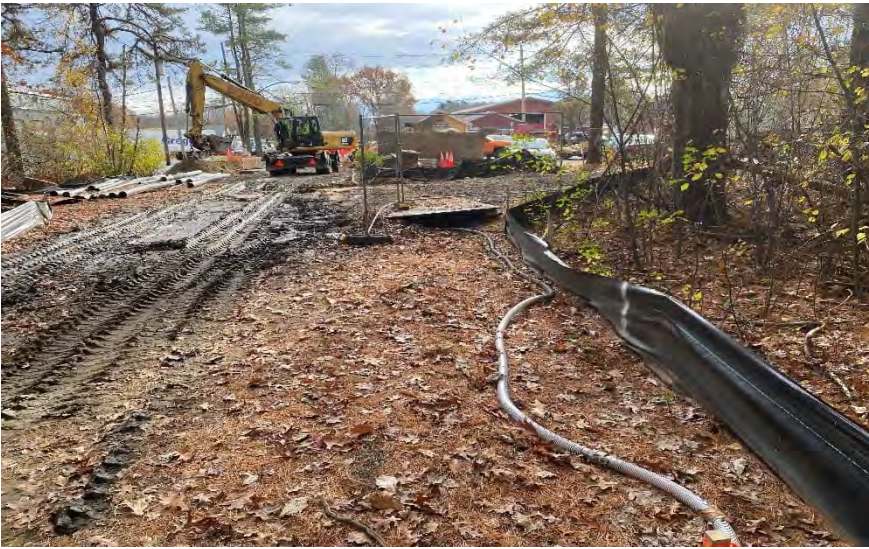
<b>PHOTOGRAPHIC LOG</b>	
<b>Client Name:</b> Eversource		<b>Site Location:</b> Sudbury to Hudson Transmission Reliability Project	<b>Town:</b> Sudbury
<b>Photo No.:</b> 3	<b>Date:</b> 11/1/2023

<b>Description:</b> Segment 11. View of dewatering operation, looking eastward.

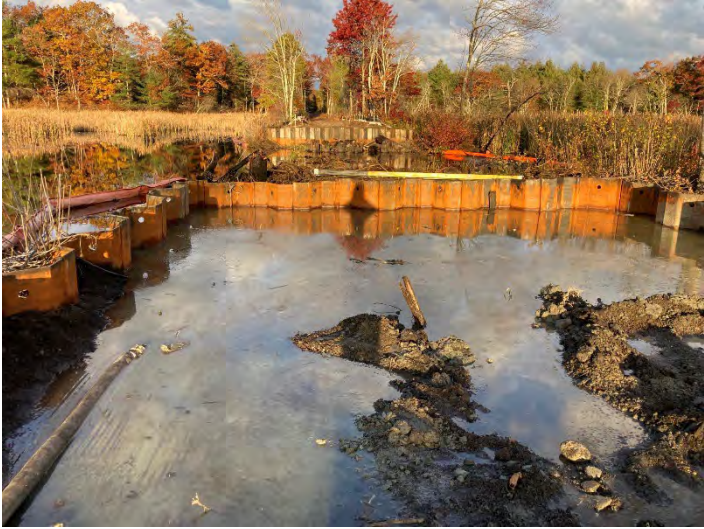
<b>PHOTOGRAPHIC LOG</b>	
Client Name: Eversource		Site Location: Sudbury to Hudson Transmission Reliability Project	
		Town: Hudson	
Photo No.: 1	Date: 11/01/2023

<b>Description:</b> View of water prior to treatment. Water appeared turbid. Facing west.

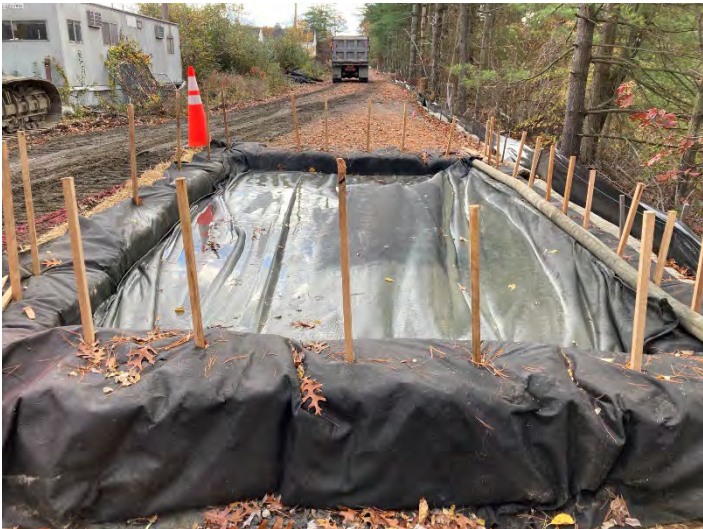
<b>PHOTOGRAPHIC LOG</b>	
Client Name: Eversource		Site Location: Sudbury to Hudson Transmission Reliability Project	
		Town: Hudson	
Photo No.: 2	Date: 11/01/2023

<b>Description:</b> View of dewatering controls (straw bale corral with filter fabric, stone, and silt bag) at 8:45am. Facing east.

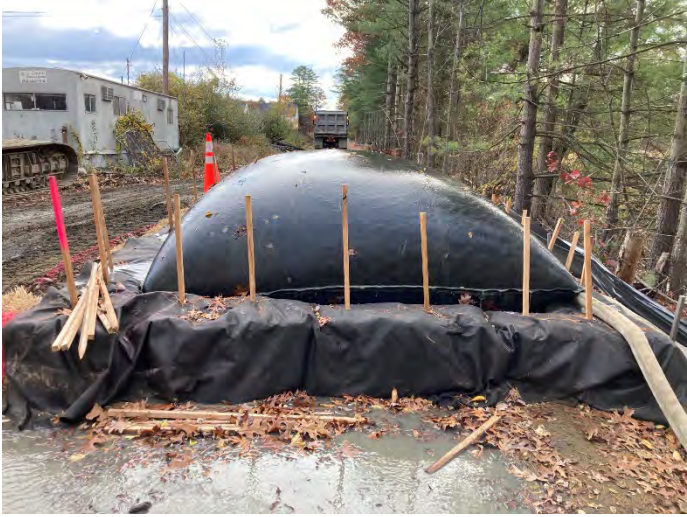
<b>PHOTOGRAPHIC LOG</b>	
Client Name: Eversource		Site Location: Sudbury to Hudson Transmission Reliability Project	Town: Hudson
Photo No.: 3	Date: 11/01/2023

<b>Description:</b> View of dewatering controls at approximately 9:30am. Pump was turned off temporarily due to size of silt bag. Facing east.

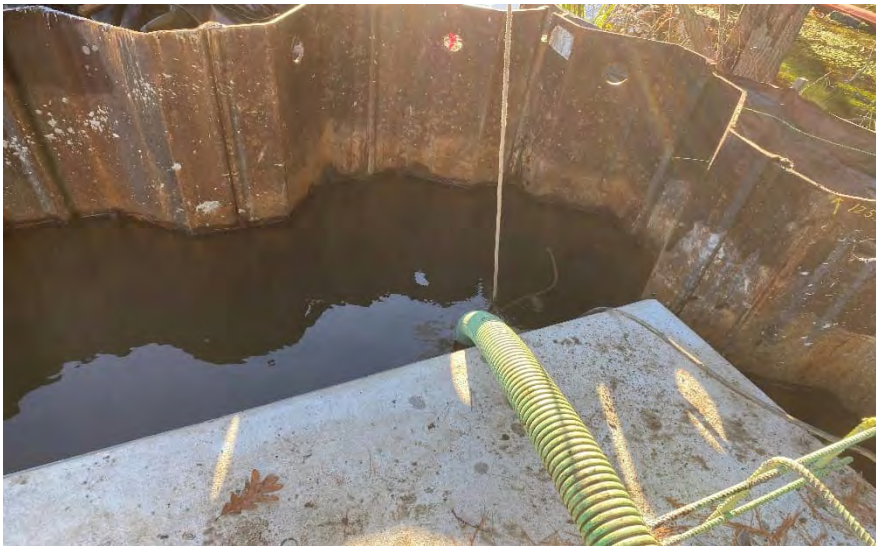
<b>PHOTOGRAPHIC LOG</b>	
Client Name: Eversource		Site Location: Sudbury to Hudson Transmission Reliability Project	Town: Sudbury
Photo No.: 1	Date: 11/2/2023

Description: View of area being pumped from bridge 127 abutment within segment 13.

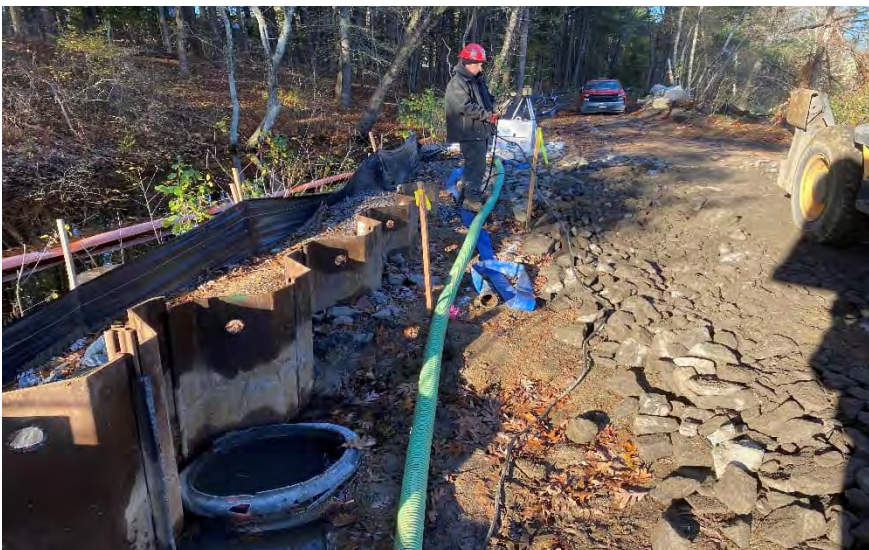
<b>PHOTOGRAPHIC LOG</b>	
Client Name: Eversource		Site Location: Sudbury to Hudson Transmission Reliability Project	Town: Sudbury
Photo No.: 2	Date: 11/2/2023

Description: Segment 13. View of dewatering operation. Looking westward.

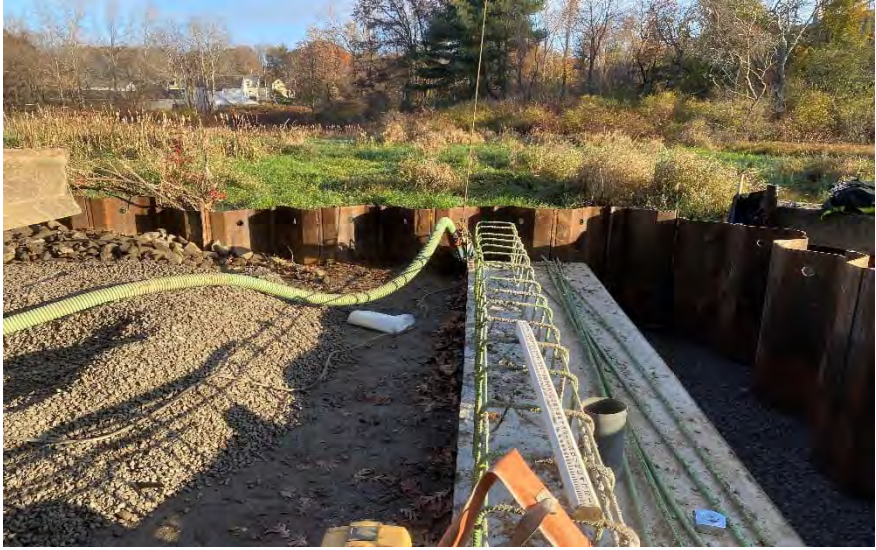
PHOTOGRAPHIC LOG	
Client Name: Eversource		Site Location: Sudbury to Hudson Transmission Reliability Project	Town: Sudbury
Photo No.: 1	Date: 11/3/2023

Description: View of area being pumped from bridge 127 abutment within segment 13.

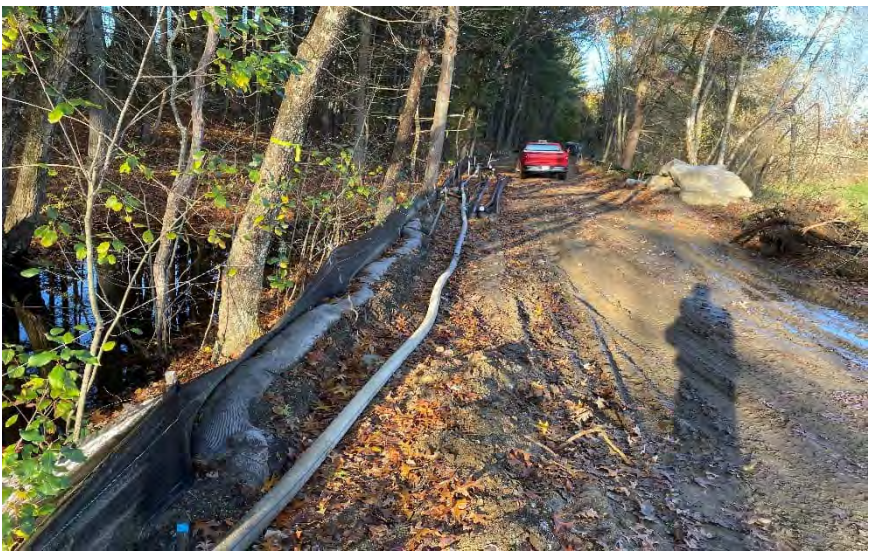
PHOTOGRAPHIC LOG	
Client Name: Eversource		Site Location: Sudbury to Hudson Transmission Reliability Project	Town: Sudbury
Photo No.: 2	Date: 11/3/2023

Description: Segment 13. View of dewatering operation. Looking westward.

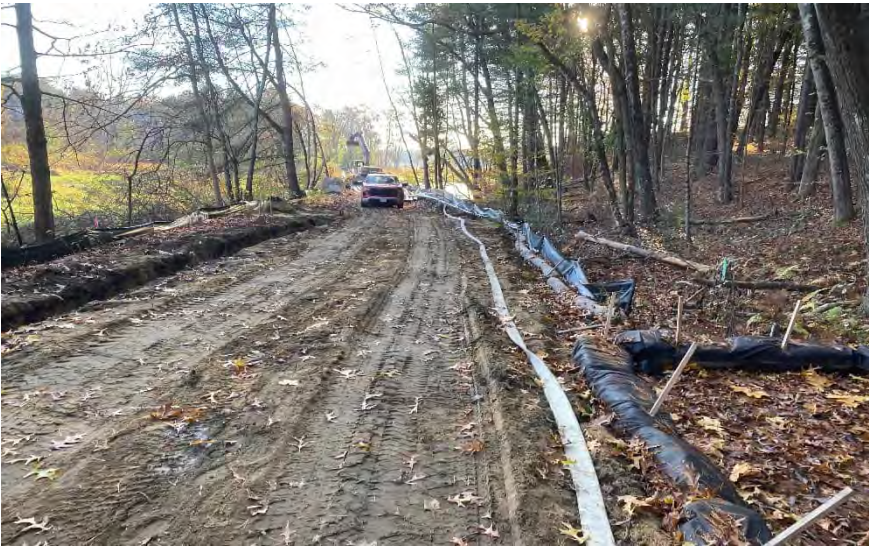
PHOTOGRAPHIC LOG	
Client Name: Eversource		Site Location: Sudbury to Hudson Transmission Reliability Project	Town: Sudbury
Photo No.: 3	Date: 11/3/2023

Description: Segment 13. View of dewatering operation, looking eastward.
